Building and Timber Pest Inspection Report

Inspection Date: Wed, 25 Mar 2026

Property Address: 41 Murphy St, Blaxland NSW 2774,
Australia

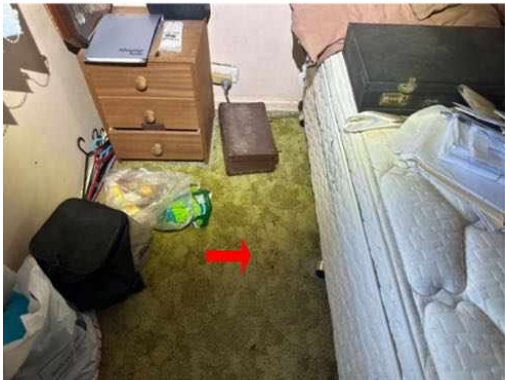
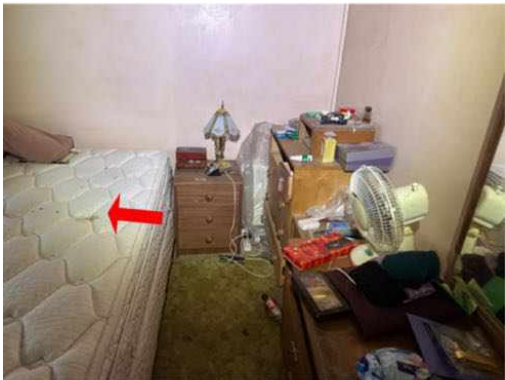
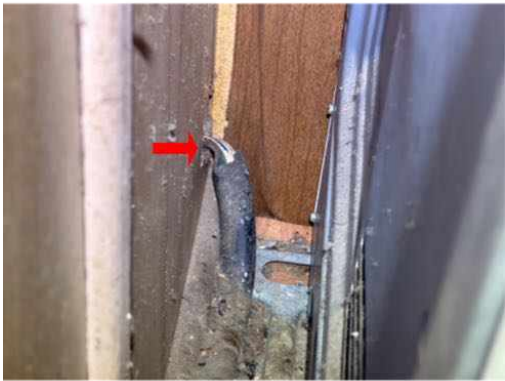
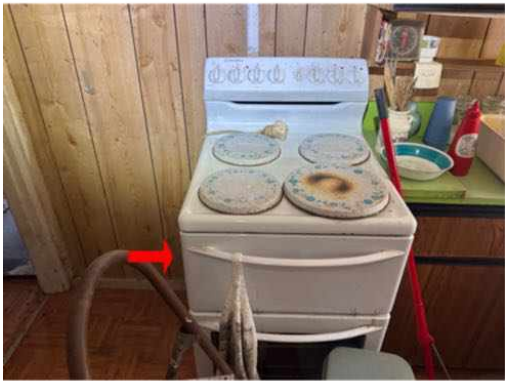
Building: Main Building
Location: All Areas > All Areas
Finding: Evidence of Vermin
Information: Evidence of pests or rodents were present at time of inspection including animal pings and odor. Rodents can cause issues ranging from smells and stains through to physical damage to wiring and other elements in the subfloor, interior, and roof void.

A licensed pest controller should be appointed to free all areas of any pests and to install deterrents or seal access points to ensure that rodents cannot enter the property as easily.

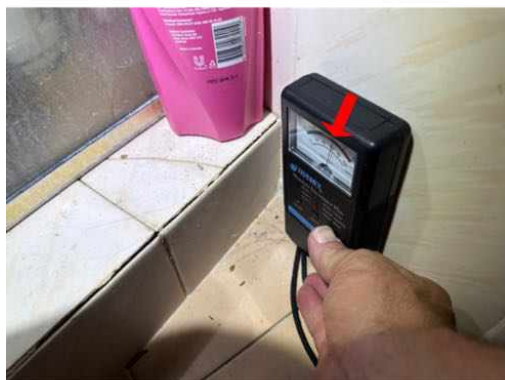
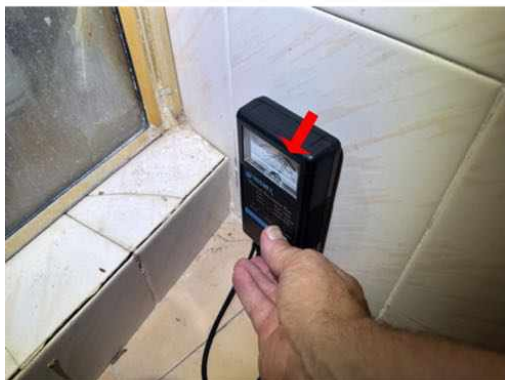
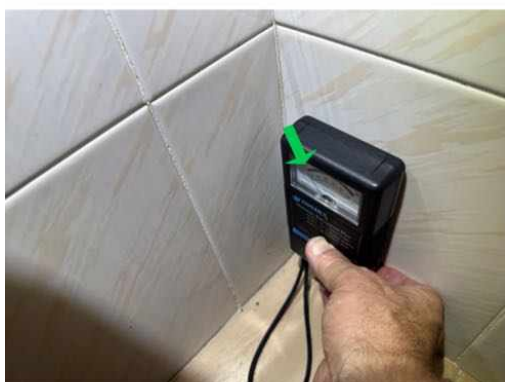
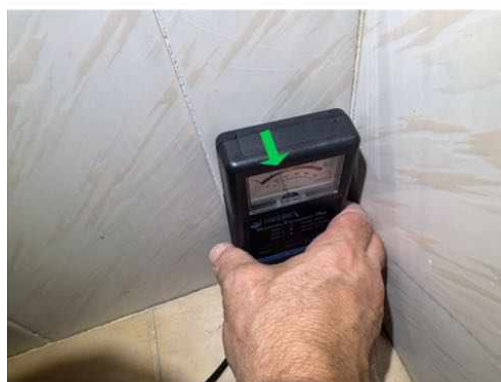
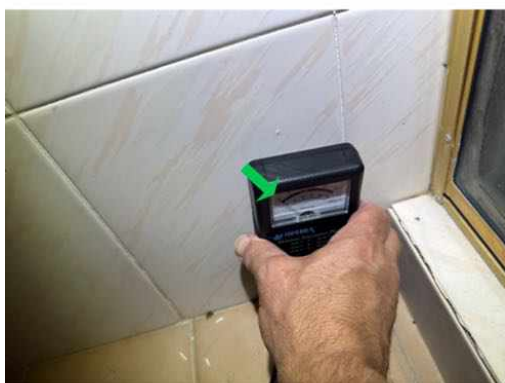
Finding 2.01

Location: Bathroom > Centre,Rear
Finding: Moisture meter: used in Shower area.
Information: A moisture meter was used during the inspection and isolated spots of excessive moisture was detected to accessible walls inside the property at the time of inspection.

It was noted on inspection that sealant or grout is in fair condition to most of the tiled shower alcove, with some areas requiring maintenance.

Different materials and floor areas move at different rates, generally causing cracking to grout or sealant at this point. A flexible sealant is required to allow for expected expansion and contraction, while keeping the joint water tight and protective of all associated building materials.

Flexible and mould resistant materials should be applied to affected areas to prevent any subsequent water damage that is likely to occur. Regular maintenance and replacement of damage or missing or damaged sealant and grout is highly recommended to the wet areas, as this is a regular wear and tear defect. Sealant and grouting in areas that come into regular contact with water should be maintained for the long term care of your property.

Monitoring the area is advised and if any visual signs of excessive moisture appear (peeling paint, mould) then consultation with a qualified plumber or bathroom specialist would be advised to identify the cause of damp and to perform remedial works as required.

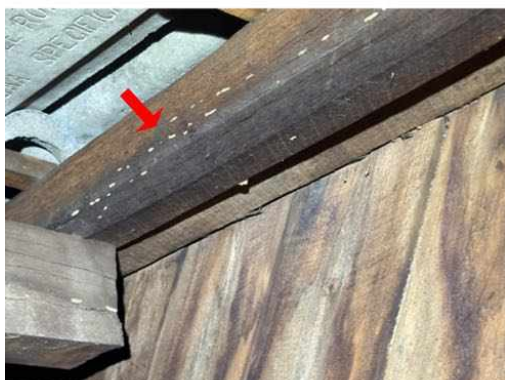
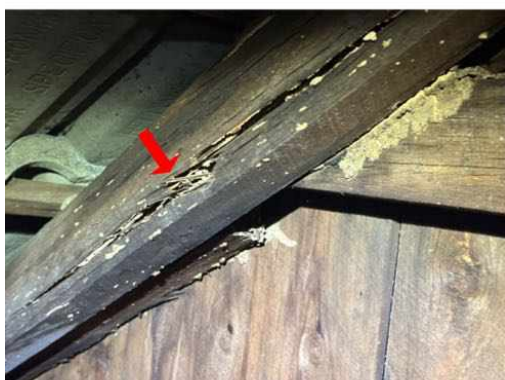
Finding 2.02

Building:	Main Building
Location:	Roof Void > All Areas
Finding:	Evidence of termite damage - structural
Information:	Despite no live termite or timber pest activity being identified, previous termite damage was found in this area. This damage is considered to be major and structural in nature. Such damage creates a potential safety hazard, and is likely to worsen and cause further damage to adjoining building materials.

If left unattended, this damage creates an unsafe environment and is likely to lead to the need for major structural works.

A building contractor should be appointed immediately to advise on options to prevent further damage and repair all affected building materials. Until such time, caution should be taken by all people coming into contact with these building elements and this area.

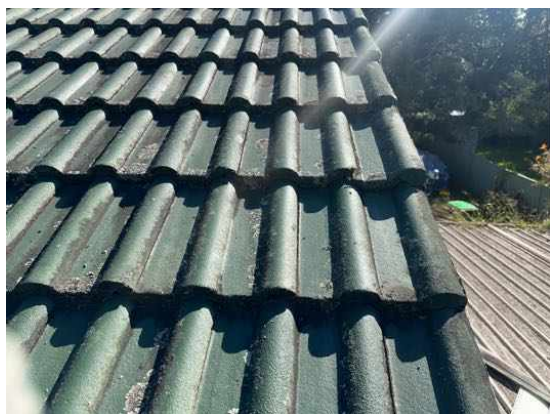
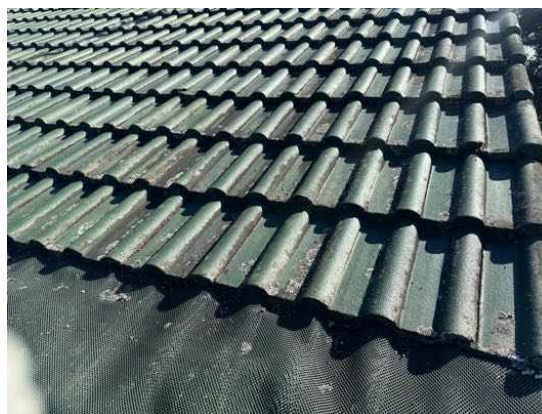
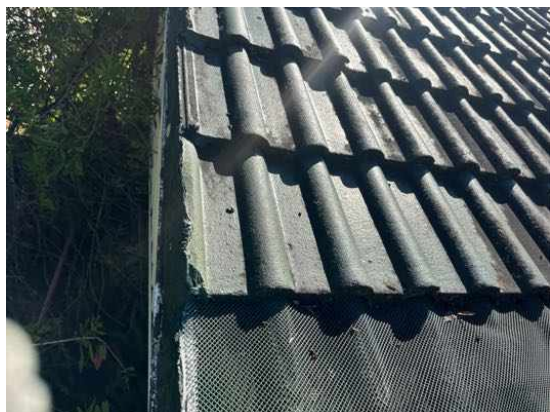
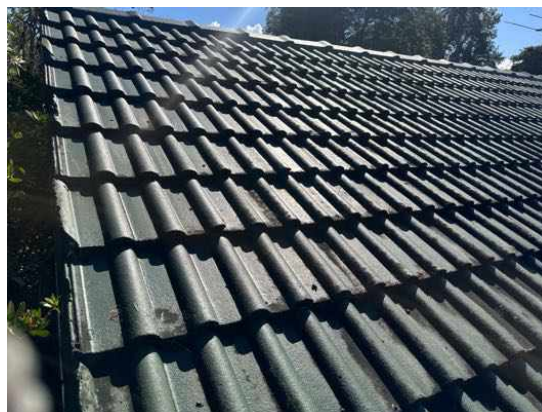
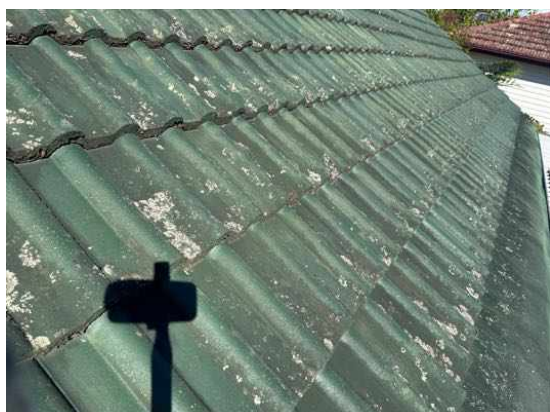
Finding 3.01

Building:	Main Building
Location:	Roof Exterior > All Areas
Finding:	Roof tiles - Weathered
Information:	Upon inspection of the exterior roofing, the majority of roof tiles were considered to be in a fair condition. While weathering of the tiles is consistent with the age of the property, maintenance works are required.

Where left unmanaged, deteriorating roof tiles are likely to lead to a number of secondary defects, including minor water leaks and weather exposure to internal roofing structures.

Consultation with a roofing contractor is highly advised to gain advice on cost of remedial works that may be required in the short to medium term. Remedial works are likely to increase the longevity of the exterior roofing structure.

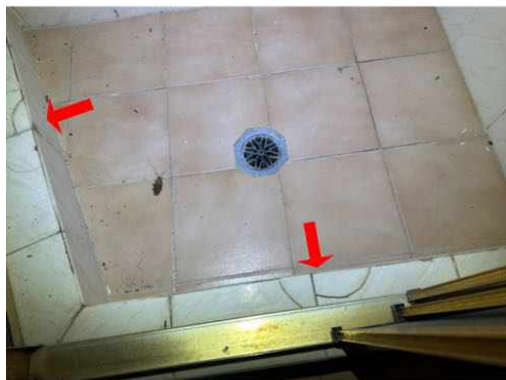
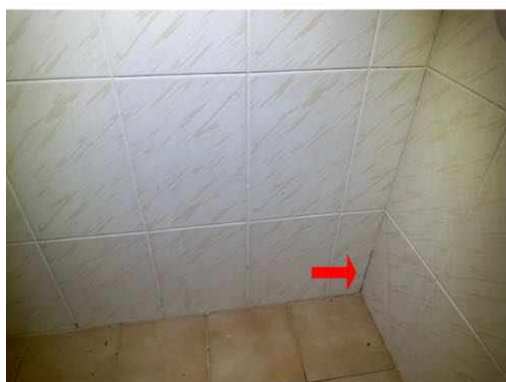
Finding 3.02

Building: Main Building
 Location: Bathroom > Centre,Rear
 Finding: Tiles - Cracked or damaged

Information: Cracking was evident to the tiling in this area at the time of inspection. While the cracking appears to be minor, this area is frequently exposed to water, allowing potential for water penetration into adjoining sections of walls or flooring.

If left unmanaged, water penetration to these areas may lead to subsequent water damage, which is likely necessitate repair work to affected building elements.

A tiling contractor should be appointed to ensure that no further water damage

occurs. The re-application of silicone and grouting throughout remaining tile work is also advised, to further protect the area against water penetration.

Where water penetration has led to water damage, appointment of a relevant tradesperson may be required to repair damaged building elements.

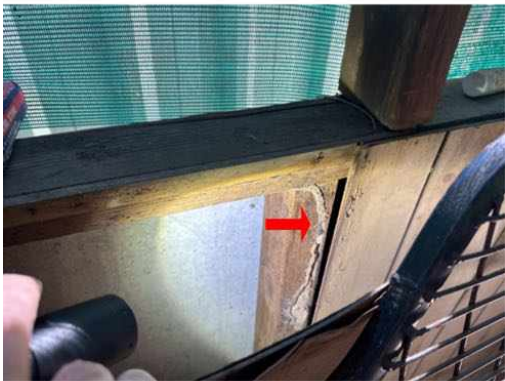
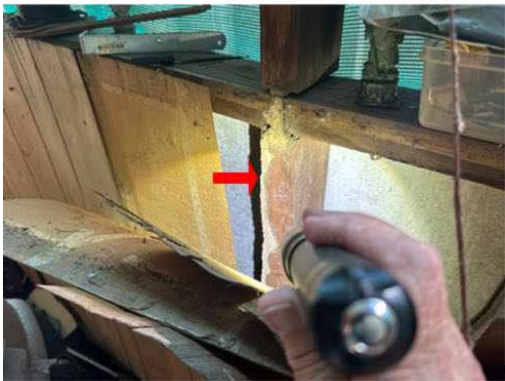
Finding 5.01

Building:	Main Building
Location:	Exterior walls - rear > Centre
Finding:	Termite - damage identified
Information:	It is suspected that termite activity is occurring or has occurred or there is evidence of termite damage. Damage caused by termites found in termite d areas is considered a defect if the termite management system is not installed in accordance with the BCA / NCC and relevant Australian Standards.

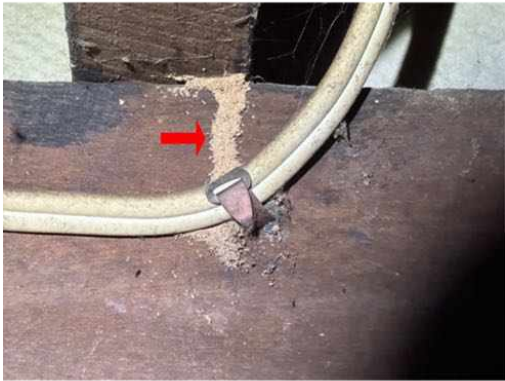
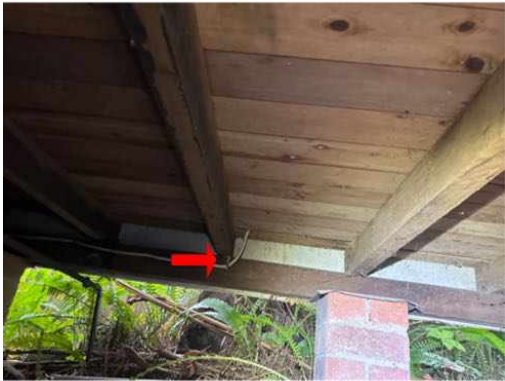
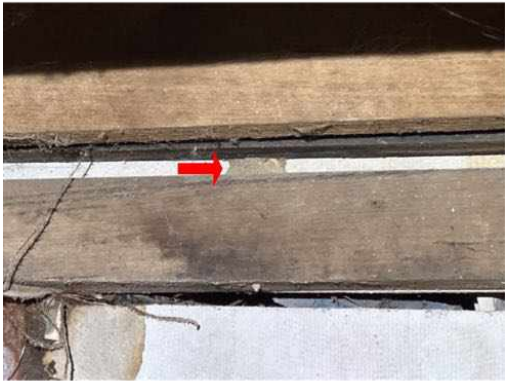
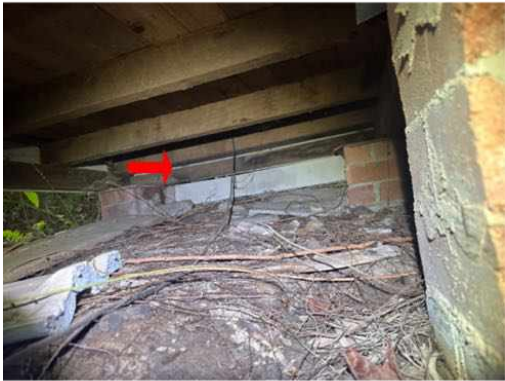
Finding 5.02

Building: Main Building
Location: Subfloor > Rear Left
Finding: Suspected termite activity identified
Information: Although no evidence of live termite activity was found at the time of inspection it is suspected that a termite colony is present on the property. Further inspection of external and internal areas is required in order to correctly identify the presence of termite activity and may include works of an intrusive nature.

It is strongly recommended that further inspection be conducted as soon as possible in order to prevent any further damage that may ensue.

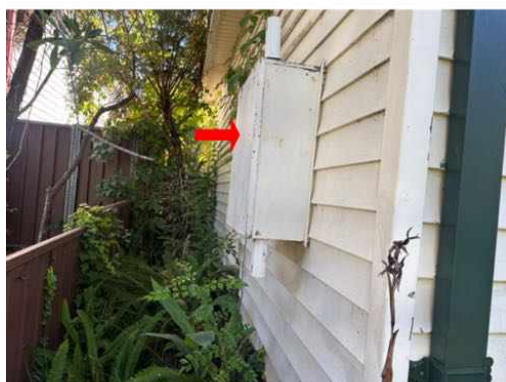
Finding 6.01

Building:	Main Building
Location:	Electrical circuit box > Front Left
Finding:	Termite Management System - no evidence of a chemical installation
Information:	The application of a post-construction chemical termite barrier is highly recommended for all properties, particularly if live termite activity has been found on the site previously. Such barriers are highly effective in preventing termite attack on any timber building elements throughout the property.

A durable notice should be placed in the switchboard unit to indicate current termite barriers. At the time of inspection, it appeared as though no termite management system has been installed, with no evidence to suggest preventative works taking place.

The client may consider gaining further advice from a pest controller as to the costs and procedures involved with this application. It is recommended that obtaining such advice be a short-term priority.

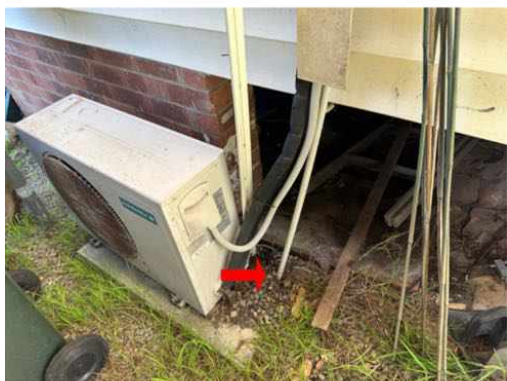
Finding 6.02

Building:	Main Building
Location:	Exterior walls - right side > Centre Right
Finding:	Air conditioner - Disconnected overflow
Information:	The Air Conditioner (A/C) overflow was found to be disconnected from storm water drainage and is creating excessive moisture in the surrounding area.

Such leaking creates an environment which is conducive to an array of defects, including water damage to associated building elements and the attraction of termite or timber pest infestation.

It is highly recommended that a licensed plumber be appointed to connect the A/C overflow in order to prevent such an environment from being created. These minor works should be carried out as soon as possible.

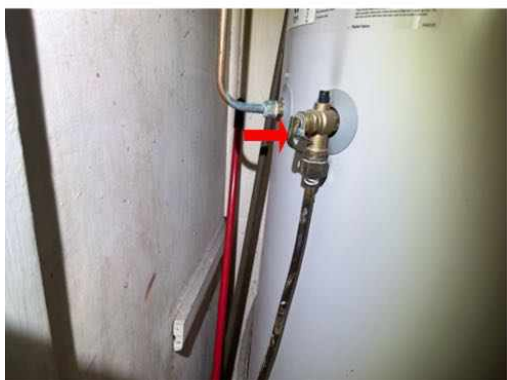
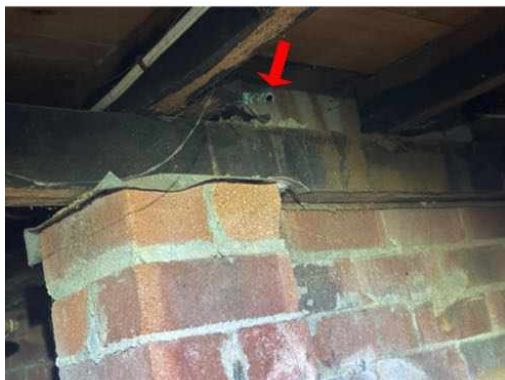
Finding 6.03

Building: Main Building
Location: Laundry/subfloor > Centre,Rear
Finding: HWS Overflow - Not Connected
Information:

The Hot Water System (HWS) overflow was found to be disconnected from storm water drainage and is creating excessive moisture in the surrounding area.

These damp conditions can lead to secondary defects such as rot, rust or corrosion of associated building elements, the formation of fungal decay, or even the creation of potential slip hazards. When coupled with poor site drainage, pooling of water may also attract termite activity to this area.

It is highly recommended that a licensed plumber be appointed to connect the HWS overflow in order to prevent such an environment from being created. These minor works should be carried out as soon as possible.

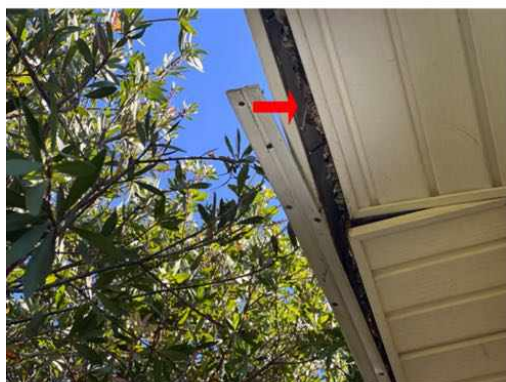
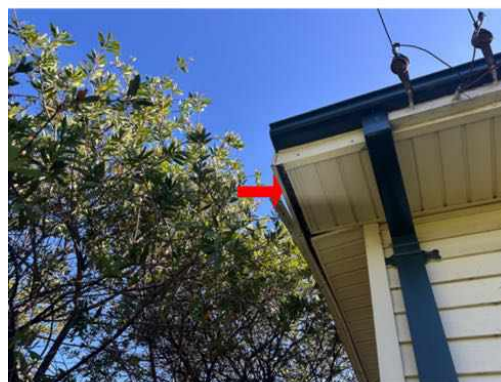
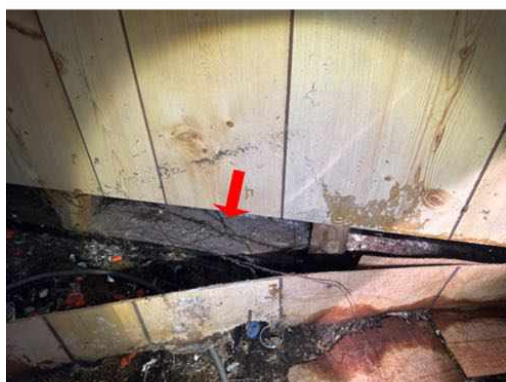
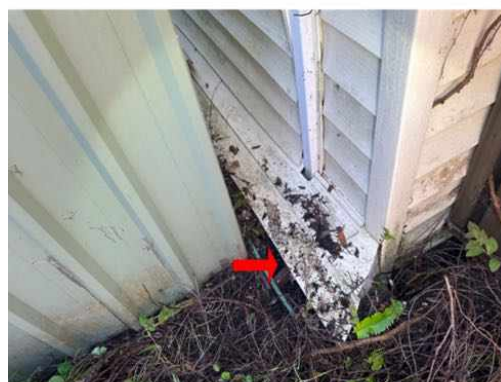
Finding 6.04

Building:	Main Building
Location:	All Areas > All Areas
Finding:	Wood rot
Information:	This building element shows evidence of wood rot. Wood rot, also known as Fungal Decay, occurs when timbers and other cellulose building materials are exposed to damp conditions on an ongoing basis. This could be the result of exposure to weathering over a prolonged period of time, or the attraction of excessive moisture from other abutting building materials. Contributing factors also include poor air ventilation in the area.

Wood rot is often associated with general damp problems and is evidenced by a 'musty' smell or mould and mildew occurring on surfaces. If left unmanaged, damp conditions can lead to further health problems and the decay of timbers will continue.

Early intervention and regular maintenance, particularly of exterior timbers, will prolong the useful life of these building elements. Prior to any works being performed, the cause of the moisture that has created the visible wood rot should be identified and addressed in a suitable manner. Replacement of affected timbers may then be a necessary step in protecting surrounding building elements from such deterioration.

A qualified plumber may be appointed to assess the cause of excessive moisture and to provide advice on any remedial works as required. A qualified carpenter or registered builder may also be required to replace affected building materials.

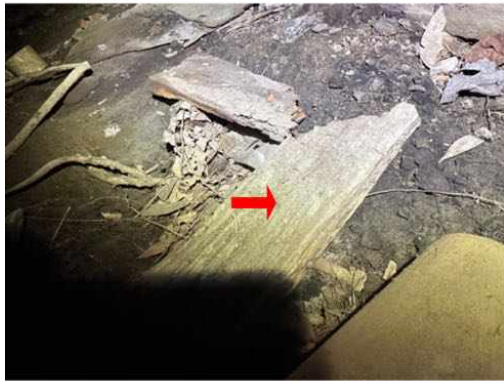
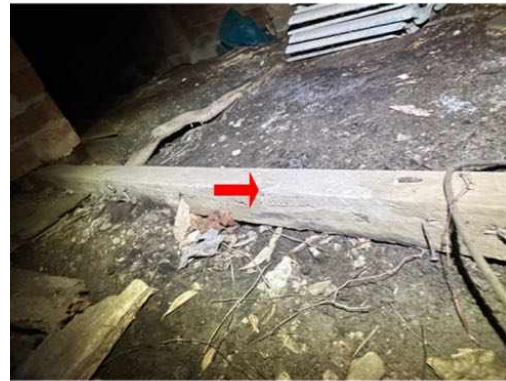
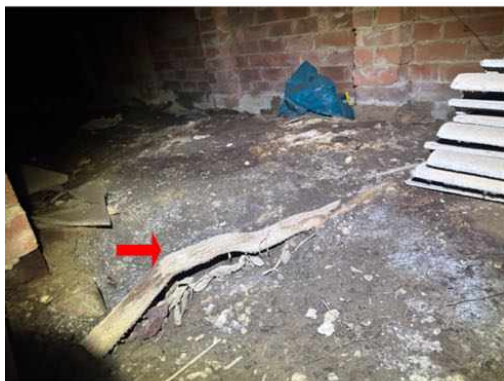
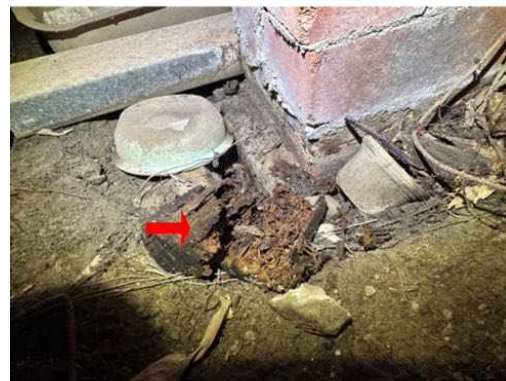
Information: An array of debris was found in the subfloor area at the time of inspection. Debris in this area restricts subfloor ventilation and creates potential for concealed pest entry. Stored timbers and other materials may also make the area susceptible to termite activity and wood rot.

A clear and empty subfloor will be better ventilated and easier to maintain in a dry condition. The removal of any timber debris is vital in minimising the risk of termite or wood borer activity.

Debris in the subfloor should be removed as soon as possible. Depending on the location and amount of debris and stored items, the homeowner may elect to undertake this task. Alternatively there are a large number of rubbish removal subcontractors that could undertake these works.

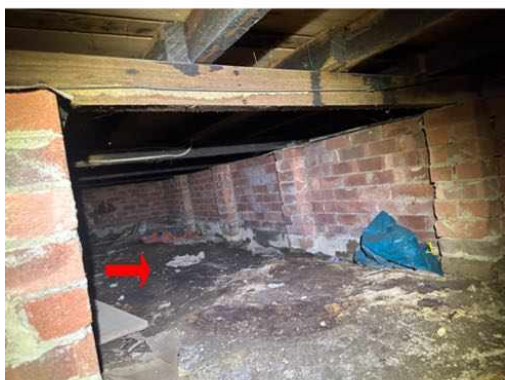
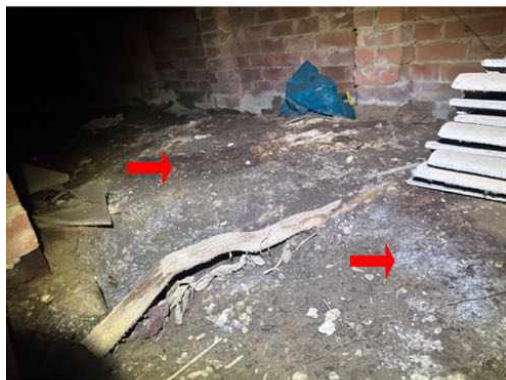
Finding 6.07

At the time of inspection there appeared to be sections of the subfloor area with excessive moisture which can lead to secondary defect of other building materials. A well drained sub floor can aid in preventing secondary damage such as wood rot and pest activity, as well as preventing the development of mould and mildew (which can lead to respiratory safety hazards for occupants). This should be investigated as soon as possible by a plumber for leaking pipes or to improve site drainage.

Ventilation can be restricted by a variety of minor defects, including obstructions in the subfloor space, a lack of vents or a low clearance, or inadequate site drainage.

The client may also consider mechanical ventilation (powered fans) to improve subfloor airflow. Remedial works should be conducted as a matter of urgency to protect against the development of potentially harmful subfloor conditions.

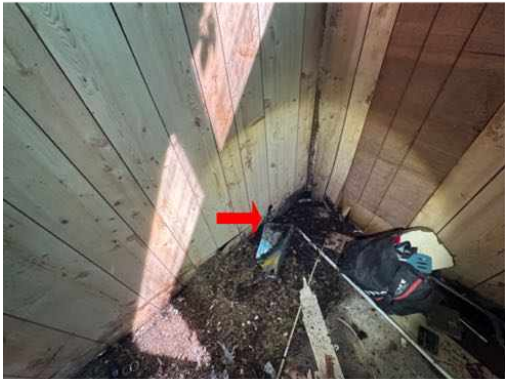
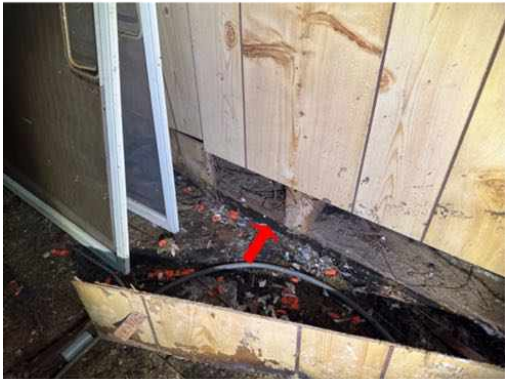
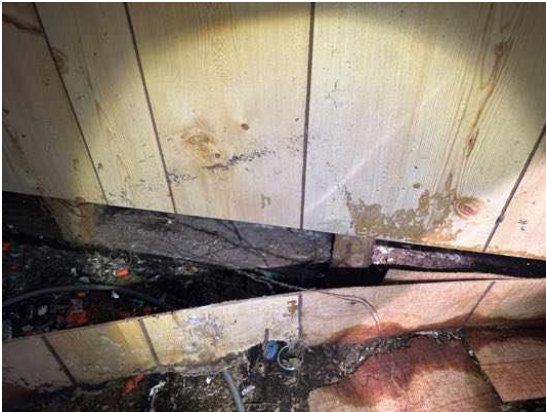
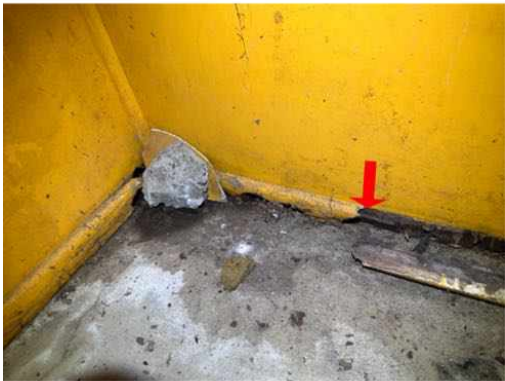
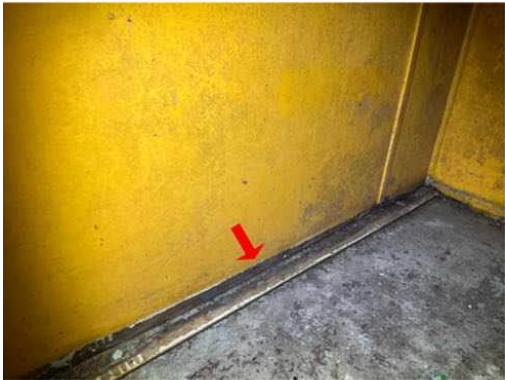
Finding 7.01

Building:	Main Building
Location:	Exterior walls - rear > All Areas
Finding:	Wood rot
Information:	This building element shows evidence of wood rot. Wood rot, also known as Fungal Decay, occurs when timbers and other cellulose building materials are exposed to damp conditions on an ongoing basis. This could be the result of exposure to weathering over a prolonged period of time, or the attraction of excessive moisture from other abutting building materials. Contributing factors also include poor air ventilation in the area.

Wood rot is often associated with general damp problems and is evidenced by a 'musty' smell or mould and mildew occurring on surfaces. If left unmanaged, damp conditions can lead to further health problems and the decay of timbers will continue.

Early intervention and regular maintenance, particularly of exterior timbers, will prolong the useful life of these building elements. Prior to any works being performed, the cause of the moisture that has created the visible wood rot should be identified and addressed in a suitable manner. Replacement of affected timbers may then be a necessary step in protecting surrounding building elements from such deterioration.

A qualified plumber may be appointed to assess the cause of excessive moisture and to provide advice on any remedial works as required. A qualified carpenter or registered builder may also be required to replace affected building materials.

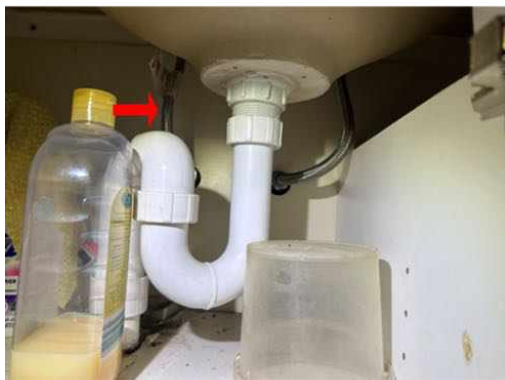
Building: Main Building
 Location: All Areas > All Areas
 Finding: Pipe: Flexible Braided pipes.
 Information: Braided Stainless Steel Flexi connector hose are popular in modern home fit outs because they can be bent into shape. They started to be installed in the early two thousands and their use is now extremely widespread in contemporary construction and renovations.

Flexible braided hoses accounted for more than one in five water damage claims lodged by Australian households according to research released by general insurer IAG.

It is recommended that the Flexi pipes to be replaced at the owners discretion to avoid an “escape water incident” which may lead to water damage to other building elements in the home.

This work can be undertaken by a licensed plumber, general handy person at the owners discretion.

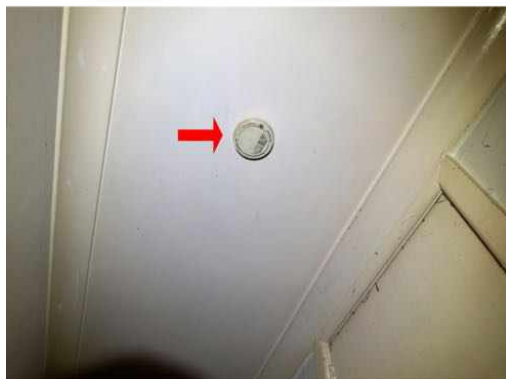
Building:	Main Building
Location:	Hallway > Centre
Finding:	Smoke Detectors and Alarms
Information:	Reporting on Smoke Detectors or Alarms, including hard wired smoke detection systems and their legislative requirements, is outside the Scope of this Report.

Please note that this defect is highlighted as a caution only. We suspect, based on our experience in the building industry, that the absence of smoke detectors, or their poor condition, should be addressed as a matter of urgency to improve occupant safety.

Always ensure sufficient working and suitable smoke detectors are installed prior to occupying any building. Additionally, it is advised that all smoke detectors be tested by the homeowner on a monthly basis.

Please refer to AS3786 and state based legislation, which may also apply.
