# Building and Timber Pest Inspection Report

Inspection Date: Tue, 3 Mar 2026

Property Address: 7 The Island Court, Shell Cove NSW 2529,  
Australia

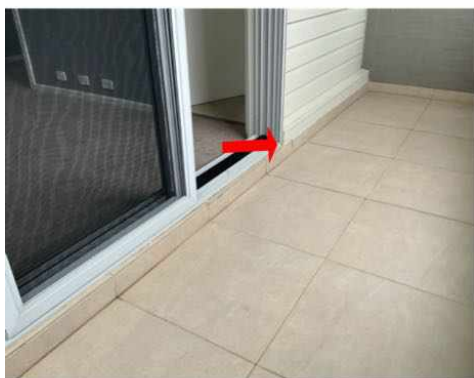
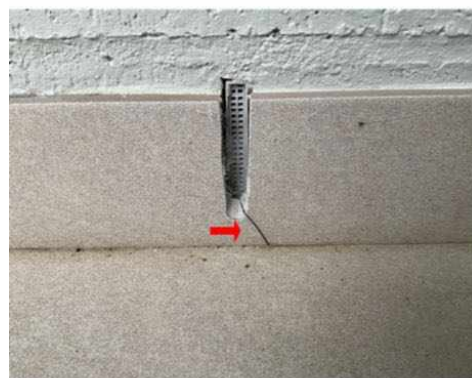
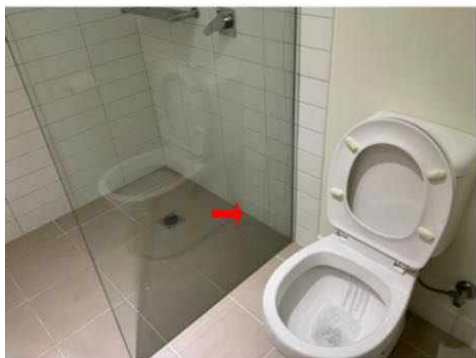
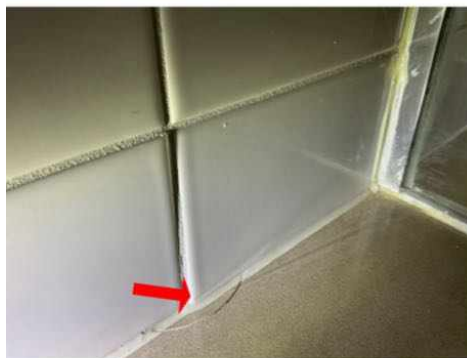
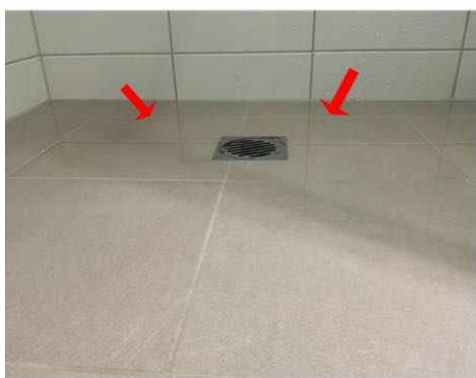
#### Finding 3.01

Building: Building 1  
Location: Balcony & Bathroom  
Finding: Tiles cracked and water pooling.  
Information: Two cracked tiles were evident in these pictured areas at the time of inspection. It is suspected that this cracking has occurred as a result of damage installed during installation. Cracked tiles throughout the household detract from the overall appearance of the affected areas. In wet areas of kitchens and bathrooms, it can lead to water damage of adjoining walls and floors.

2-3 millimetres of water also did not drain in the main bathroom shower between the drain and the wall after running the shower for 5 minutes. The sealant in the area should be checked annually and replaced if any pinholes are found in the shower alcove. Alternatively the drain can be adjusted by a licensed plumber or tiling contractor to allow this water to escape.

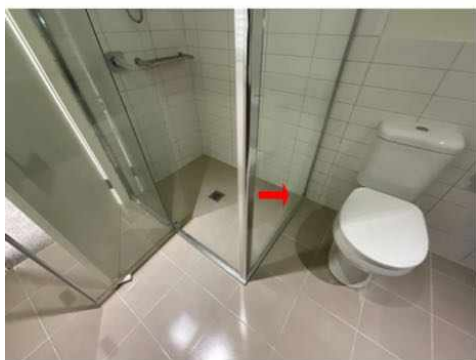
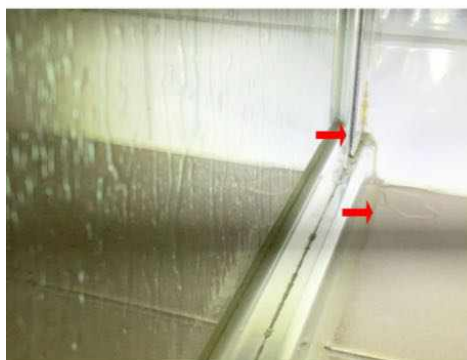
### Finding 3.02

Building:	Building 1
Location:	Ensuite - Master
Finding:	Shower screen - Leaking
Information:	<p>A small leak was evident to the shower screen at the time of inspection. It is suspected that this leak has occurred as a result missing sealant. Leaking from the shower , where left unattended, is likely to lead to water damage to adjoining flooring and walls. Such damage can lead to water damage and necessitate extensive remedial works being required. Active water leaks may also create an environment that is susceptible to the formation and development of mould.</p> <p>Appointment of a sealant expert is required to repair or replace this missing sealant. Such works should be performed as soon as possible to ensure that no further damage occurs.</p>

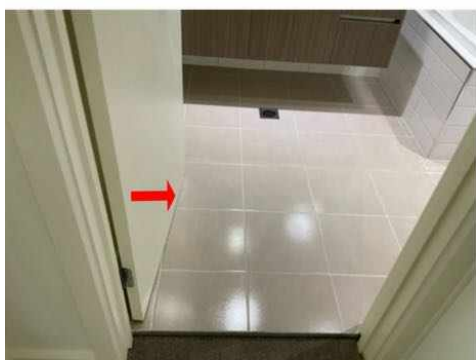
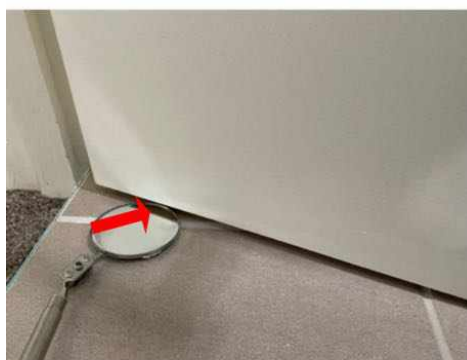
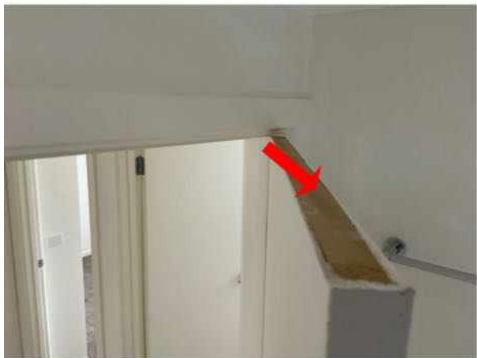
### Finding 3.03

Building:	Building 1
Location:	Wet area doors
Finding:	Paint finish on doors - Incomplete
Information:	The paint finish to the bathroom doors was identified as being incomplete at the time of inspection. Whilst incomplete or missing paint finish is generally an appearance defect, it can also lead to the development of secondary building defects over time. Incomplete areas of paint finish expose the area to moisture, potentially accelerating the deterioration of underlying building materials. Incomplete paint finishes should be sanded back, filled, leveled and painted, as applicable.

A painting contractor should be appointed as soon as possible to perform necessary works to aid the appearance of the affected area and to ensure the area is protected against further deterioration. Alternatively, the homeowner following manufacturer instructions may perform these works.

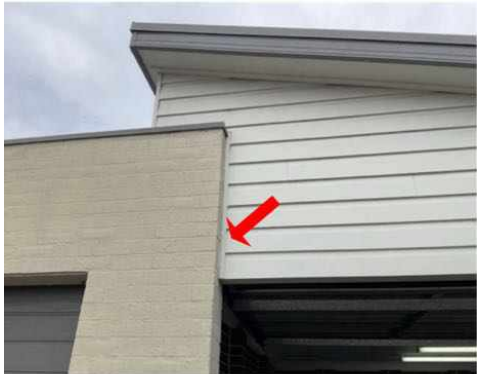
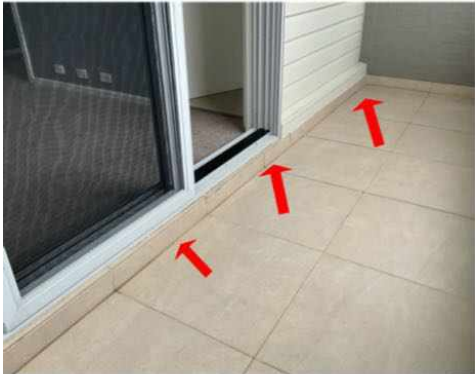
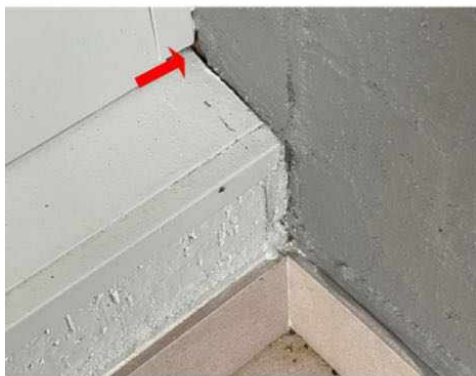
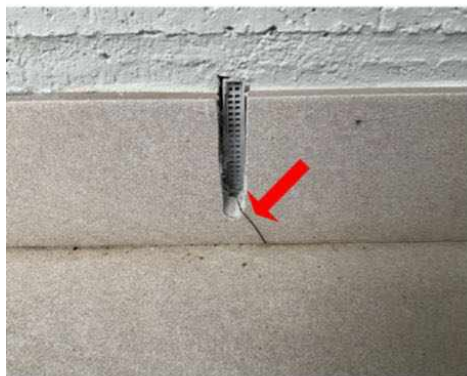
**Finding 3.04**

Building: Building 1  
Location: Small wall areas  
Finding: Sealant (external) - missing  
Information: It was noted on inspection that small areas of external sealant was missing to small areas of the external walls.

A flexible sealant or flashing is required to protect the associated building materials from rainwater ingress.

A sealant specialist or skilled handy person should be appointed to complete these works. These are wear and tear defects.

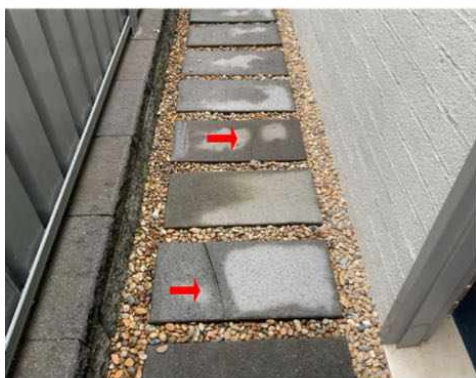
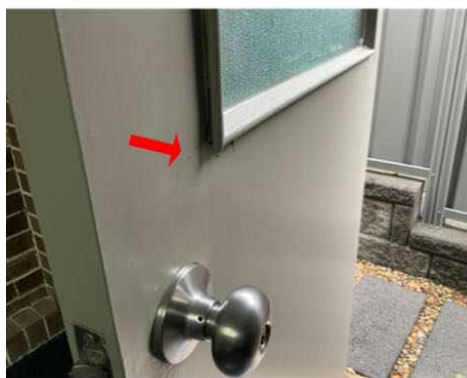
### Finding 3.05

Building: Building 1  
 Location: Pictured external areas  
 Finding: Building elements - Damaged  
 Information: Evidence of minor damaged areas was identified at the time of the inspection. These include -

1. A few garage pavers have cracked requiring replacement.
2. The garage door has very minor panel damage (possibly minor wood rot) not requiring repairs at this time except sealing from rain ingress.

A carpenter would be the trade responsible for rectification of these areas when convenient.

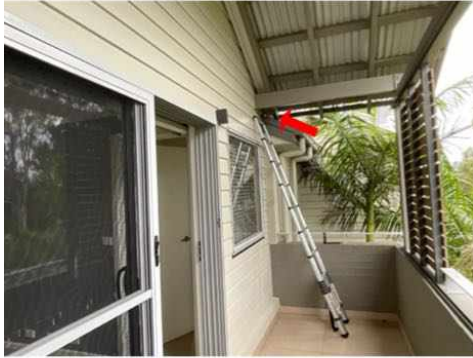
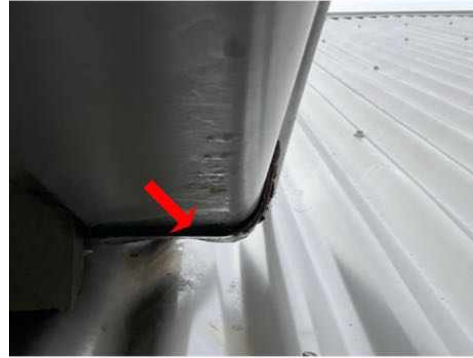
### Finding 3.06

Building: Building 1  
 Location: Roof Exterior front right  
 Finding: Roof bracket - Rusted  
 Information: One front right gutter bracket has areas of rust. A licensed plumber or handyperson should be appointed to replace this bracket in the next 2 years. It is advised that such works be completed as soon as possible to prevent any further damage and

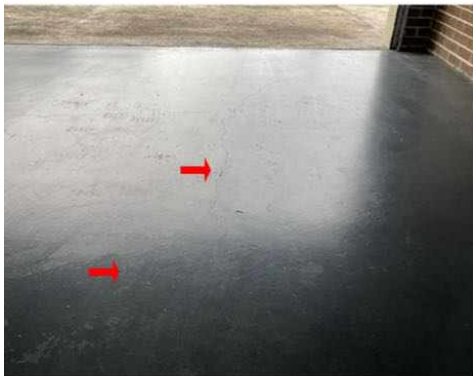
### Finding 3.07

Building:	Building 1
Location:	Garage
Finding:	Crack in concrete slab - Category 1
Information:	A crack coded as Category 1 was identified in the slab. A Category 1 crack is common and described as a fine but noticeable crack, with the slab at an otherwise reasonable level. To be considered Category 1, the approximate width of the crack is less than 1.0mm, or a less than 10mm change in offset when a 3m straight edge is placed over the defect.

Category 1 cracks should be monitored for a period of 12 months. At the end of the monitoring period, identified cracks that are rated greater than Category 2 are considered defects, and require rectification.

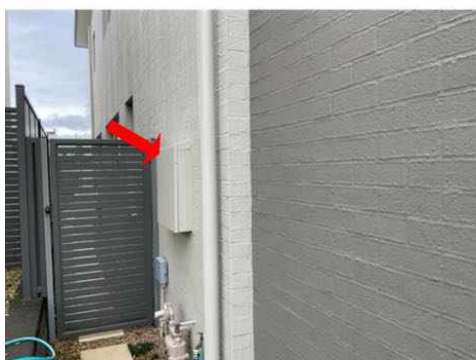
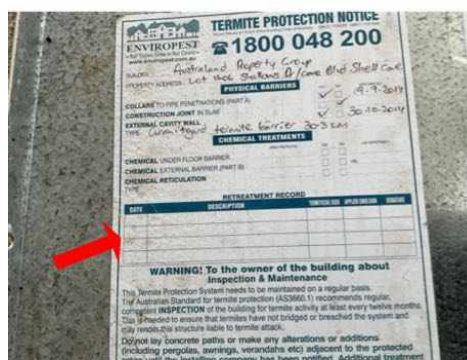
### Finding 6.01

Building: Building 1  
 Location: Meter Box  
 Finding: Termite Management System - no evidence of a chemical installation  
 Information: The application of a post-construction chemical termite barrier is highly recommended for all properties. Such barriers are highly effective in preventing termite attack on any timber building elements throughout the property.

A durable notice should be placed in the switchboard unit to indicate current termite barriers. At the time of inspection, the durable notice was evident and it appeared as though no chemical termite management system has been installed, with no evidence to suggest preventative works taking place since 2015.

The client may consider gaining further advice from a pest controller as to the costs and procedures involved with a 'chemical' application. It is recommended that obtaining such advice be a short-term priority.

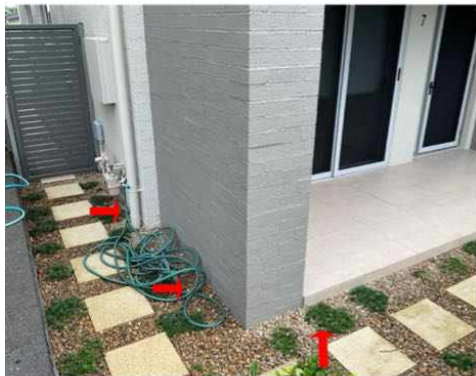
### Finding 6.02

Building: Building 1  
 Location: Exterior walls  
 Finding: Slab Edge - Exposure  
 Information: An inspection zone of at least 75mm in relation to the exposed slab edge, between the bottom brick and the perimeter pavement, is required. This inspection zone should be maintained in order to force termites into the open where they can be detected more readily during regular inspections. The slab edge should not be concealed by anything that may prevent inspection of the area, including render, landscaping, soil, turf, paving, concrete cladding or other structures.

If the slab edge is not properly exposed there is a high risk of termite attack. Sometimes, in order to determine the type of slab, a suitably qualified person such as an architect or builder may be required to consult the construction plans.

Where the slab edge cannot be properly inspected, it is highly recommended that termite or timber pest inspections be carried out every 12 months to aid protection of the property against termites.

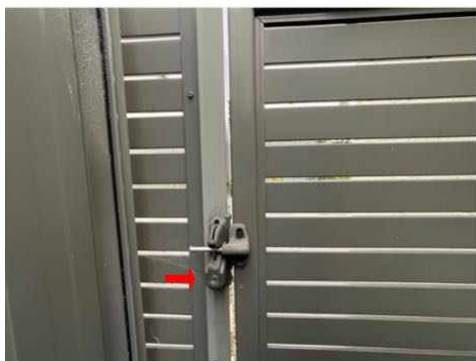
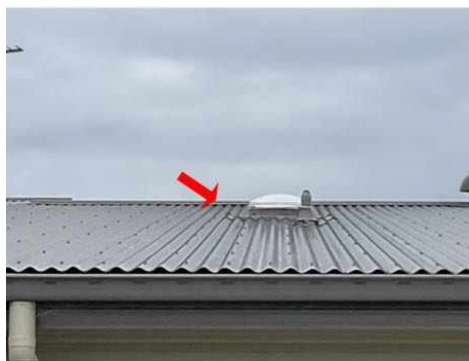
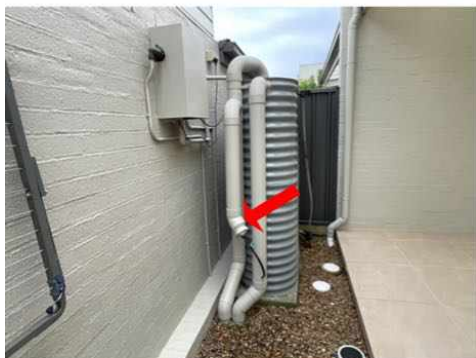
Building: Building 1  
Location: All External Areas  
Finding: Additional Photos - Obstructions and Limitations of EXTERNAL AREAS  
Information: These photographs are an indication of the obstructions and limitations which impeded full inspection of external areas at the time of inspection. These obstructions can hide an array of defects and should be removed to allow full inspection to be carried out. A re-inspection is recommended once the areas are made accessible.

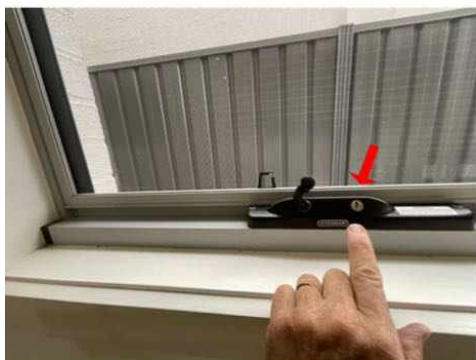
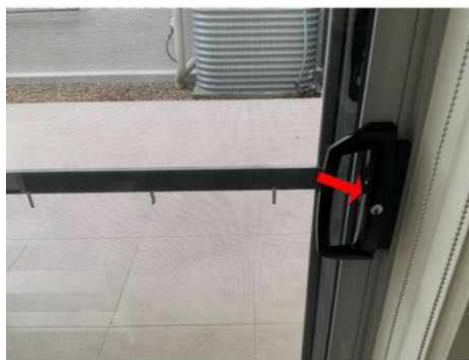
Building: Building 1  
Location: All Internal Areas  
Finding: Additional Photos - Obstructions and Limitations of INTERNAL AREAS  
Information: These photographs are an indication of the obstructions and limitations which impeded full inspection of Internal areas at the time of inspection. These obstructions can hide an array of defects and should be removed to allow full inspection to be

carried out. A re-inspection is recommended once the areas are made accessible.

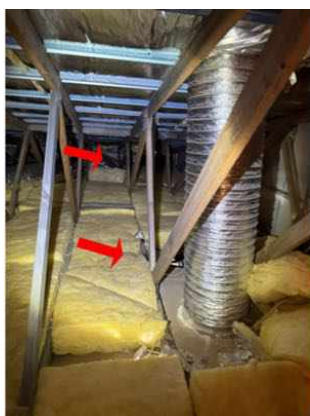
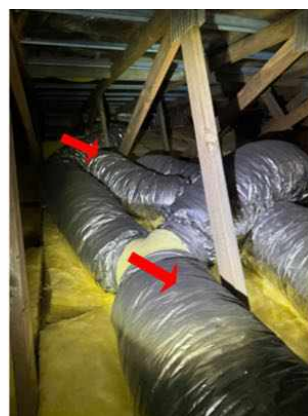
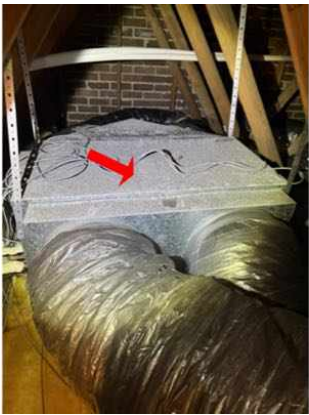
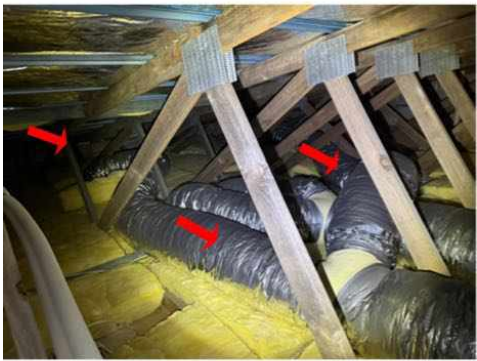
Building: Building 1  
 Location: All Roof cavity areas  
 Finding: Additional Photos - Obstructions and Limitations of the ROOF CAVITY  
 Information: These photographs are an indication of the obstructions and limitations which impeded full inspection of roof cavity areas at the time of inspection. These obstructions can hide an array of defects and should be removed to allow full inspection to be carried out if applicable. A re-inspection is recommended once the areas are made accessible.

The inspection was also limited to areas with an allowable crawl space of 600mm x 600mm, in particular towards the external walls where the roof line diminishes, these areas were not accessible.
