Building and Timber Pest Inspection Report

Inspection Date: Wed, 1 Apr 2026

Property Address: 6 Schubert Cres, Wodonga VIC 3690,
Australia

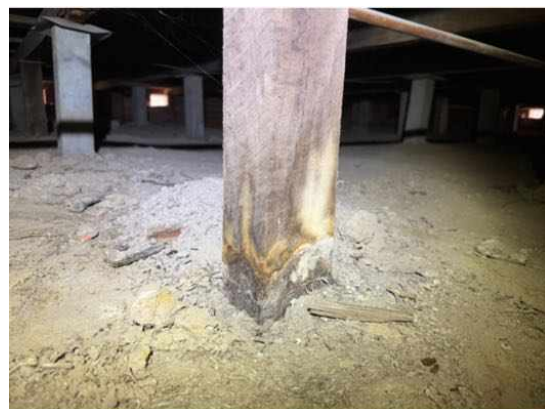
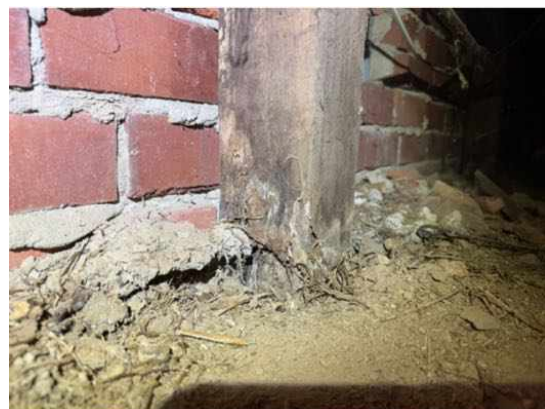
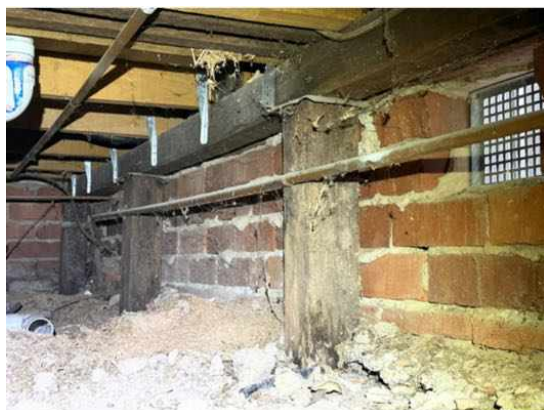
Finding 2.01

Building: Main Building
Location: Subfloor
Finding: Subfloor piers - Insufficient support / Fungal Decay & Termite Damage
Information: Some timber stumps at, but not limited to the right side of the subfloor, along the external wall appeared to be affected by fungal decay & termite damage. Some of the new timber stumps were also found to be loose and not fixed to the associated bearers. This affects the structural integrity of the subfloor structure in this area.

Recommend engaging a registered builder in the short term, to provide remedial works & replace any affected timbers, to ensure the subfloor structure is sufficiently supported.

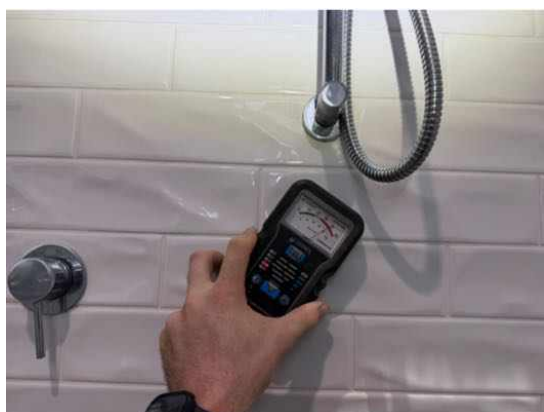
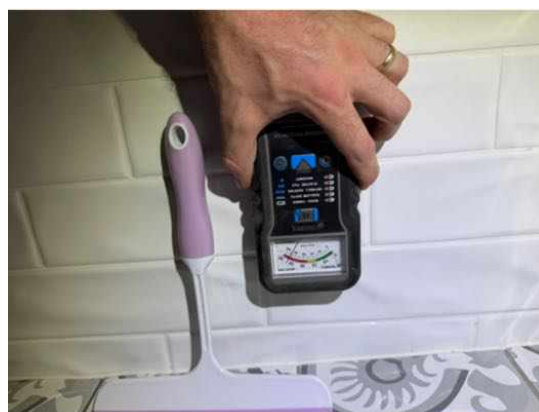
Finding 3.01

Building: Main Building
 Location: Rear Shower
 Finding: Shower - High Moisture
 Information: It appears that high moisture is present at but not limited to, below the shower taps, and to the base of the shower wall. Potential causes of leaking include but are not limited to loose or damaged plumbing fittings and fixtures, and/or deteriorated / missing seals. This creates an environment conducive to termite activity.

Recommend engaging a licensed plumber promptly, to identify the cause of the moisture & provide remedial works where necessary.

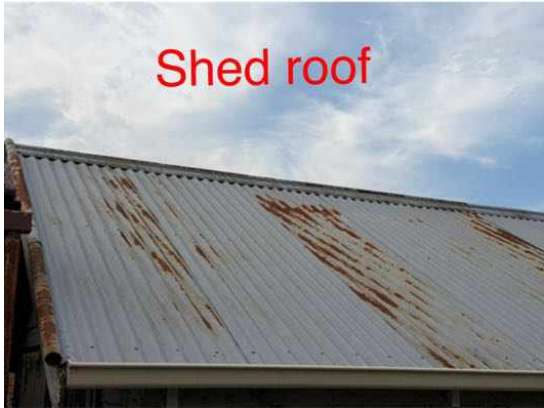
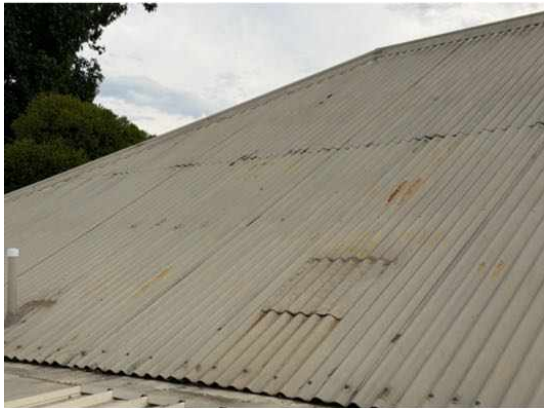
Finding 3.02

Building: Main Building
 Location: Roof Exterior
 Finding: Roof Exterior - Weathered, Rust
 Information: The roof exterior was found to be in a weathered condition evidenced by areas of rust, and general weathering. Some loose screws to the carport sheeting were also noted.

While weathering of the roof exterior is consistent with the age of the property, maintenance works are advised

Recommend consulting with a licensed roofing contractor at clients convenience, to provide further advice on maintenance works required and to ensure all roof sheeting is secure.

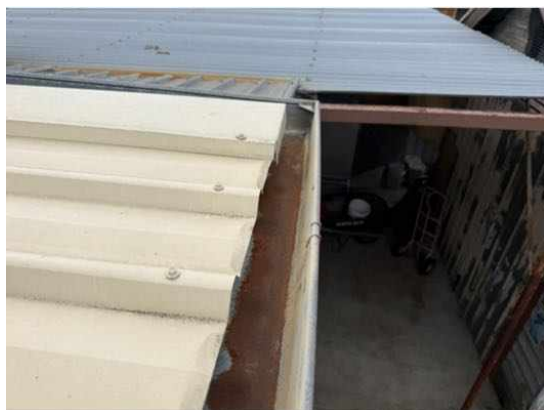
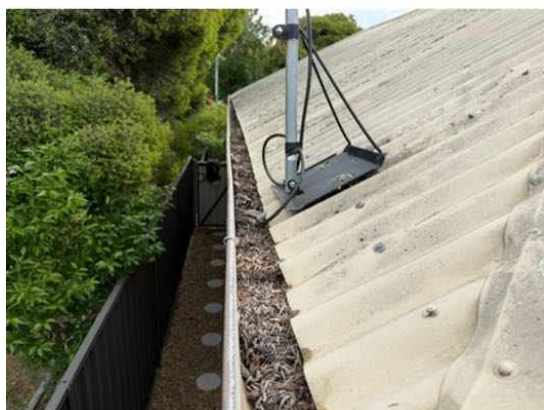
Finding 3.04

Building: Main Building

Location: Gutters

Finding: Gutters - Rust & Debris

Information: It appears that the gutters have areas of surface rust, a common finding in buildings of a similar age. Debris was also noted to some areas of the gutters.

Recommend engaging a licensed roof plumber, to provide further advice regarding maintenance works advised. All debris should be removed from the gutters, to avoid further accumulation & overflows.

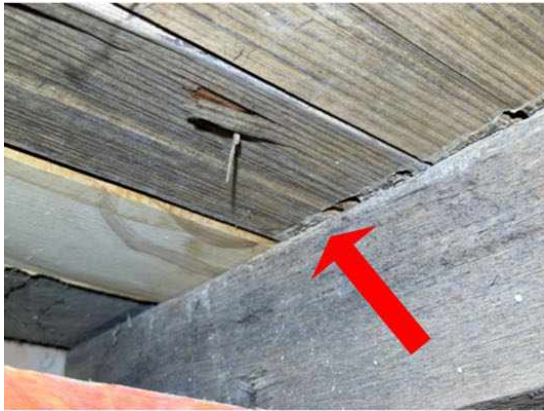
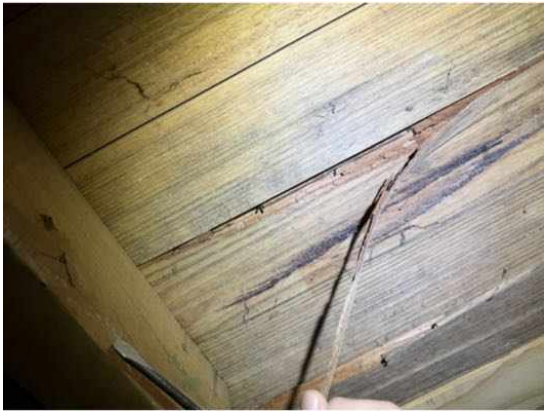
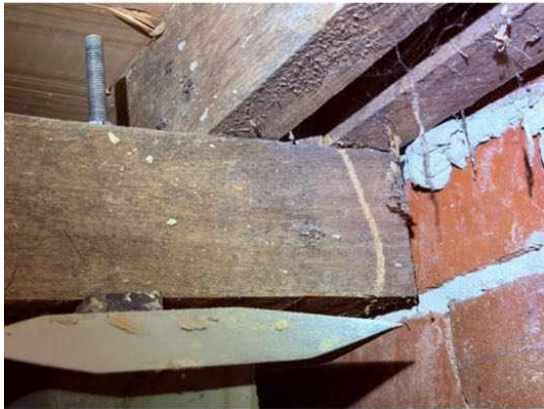
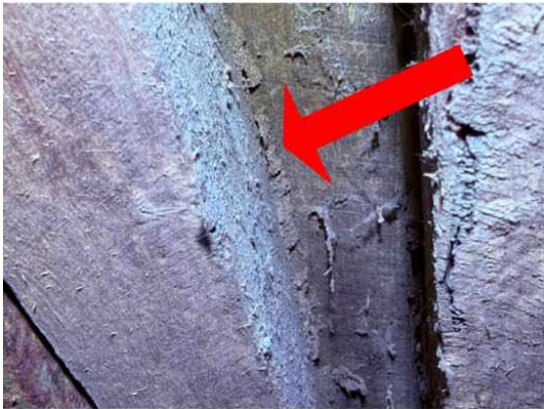
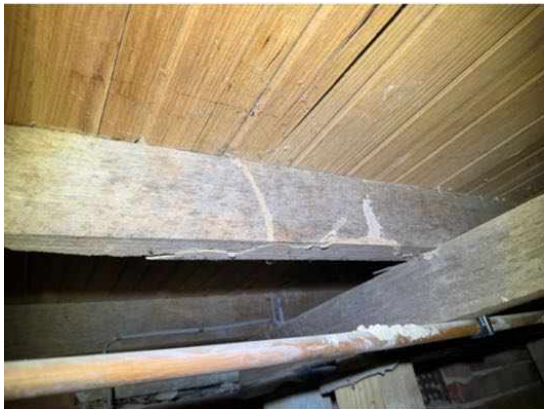
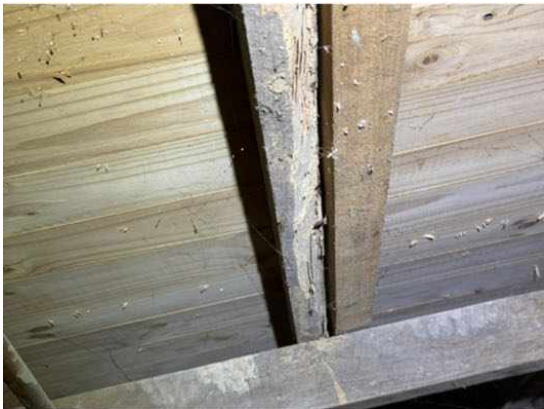
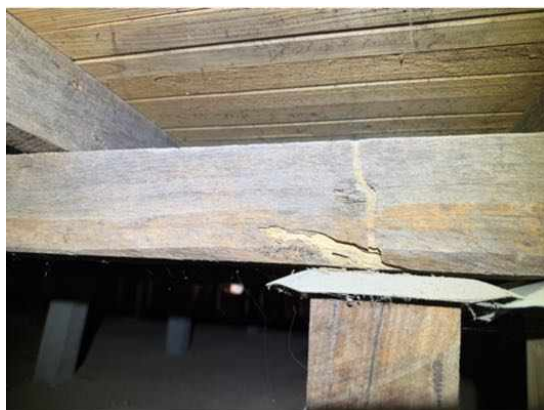
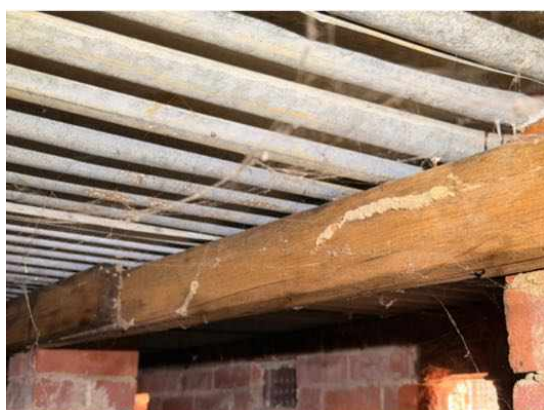
Finding 5.01

Building:	Main Building
Location:	Subfloor
Finding:	Evidence of termite workings & damage
Information:	Termite damage & workings were identified at, but not limited to, several areas throughout the subfloor. Although remedial works have been conducted, it appears some structural members (timber stumps) have been affected and should be replaced. It is also advised that a more invasive inspection be conducted to identify the extent of the damage.

Recommend engaging a licensed pest controller promptly, to provide further advice regarding installation of a termite treatment.

12 monthly ongoing termite inspections, conducted by a qualified termite inspector, are also recommended

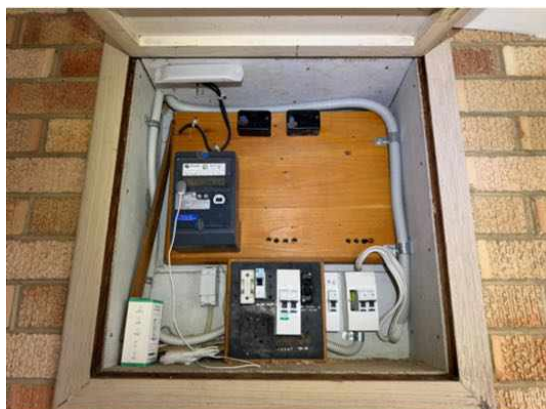
Finding 6.01

Building:	Main Building
Location:	Switchboard
Finding:	Termite Management System - no evidence of a chemical installation
Information:	The application of a termite barrier is strongly recommended, as it appears no termite management system has been installed, with no evidence or durable notice to suggest works taking place. Generally, a durable notice is placed in the meter box to indicate current termite barriers.

Such barriers are highly effective in preventing termite attack on the building and therefore should be installed.

Recommend seeking further advice from a licensed pest controller.

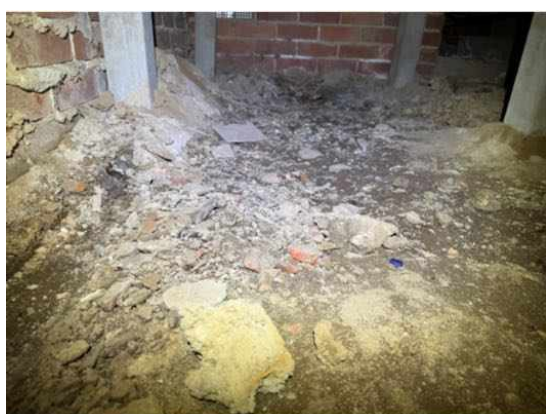
Finding 6.02

Building: Main Building
 Location: Subfloor
 Finding: Subfloor - Moist Conditions
 Information: Moist conditions were evident in areas of the subfloor. This defect could be attributed to water pooling against the building.

This creates an environment conducive to termite activity, and the development of secondary building defects overtime, if neglected.

Recommend consulting with a licensed plumber specialising in drainage to provide further advice and remedial works in the short term.

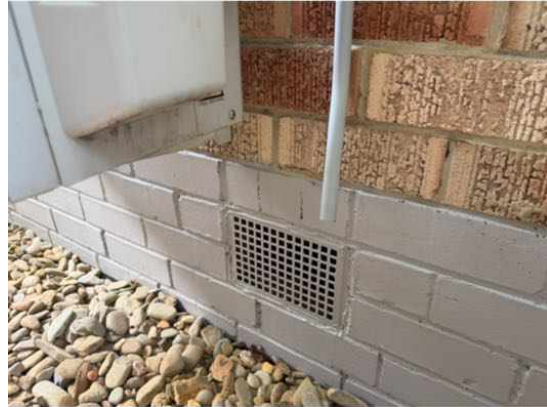
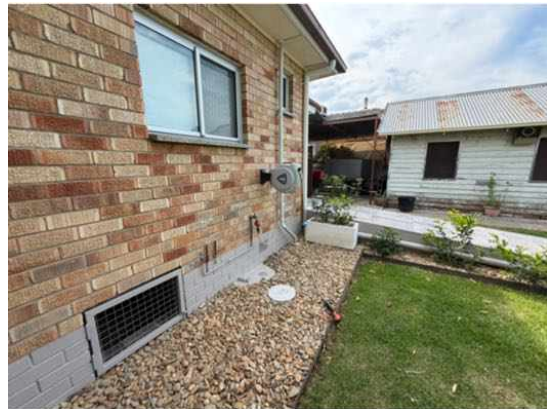
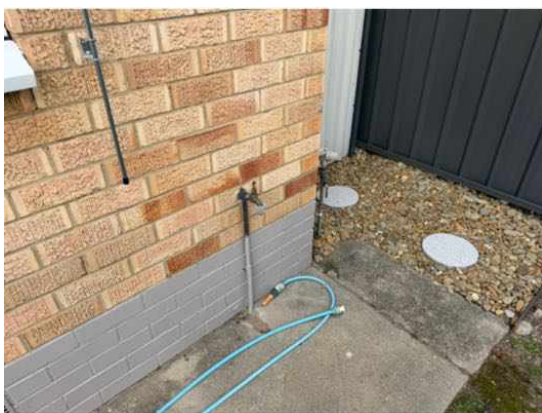
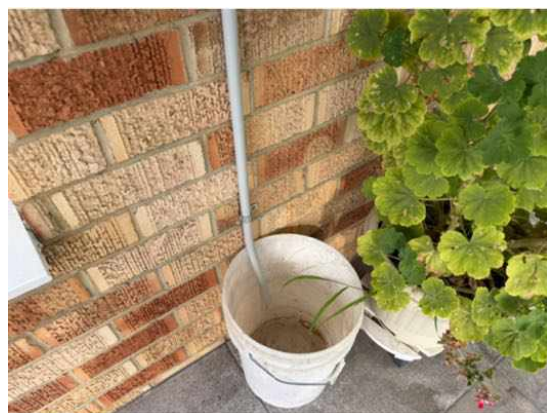
Finding 6.03

Building: Main Building
 Location: All external areas

Finding: Potential Water pooling - against property

Information: It appears that there are potential areas around the perimeter of the property that could be susceptible to water pooling. Where insufficient drainage of roof plumbing, taps, hot water system & aircon overflows, and garden beds against the house are present, water pooling is likely to occur, and can create areas conducive to timber pests and moist conditions in the subfloor, if neglected.

Recommend consulting with a licensed plumber in the short term to further assess and provide remedial advice.

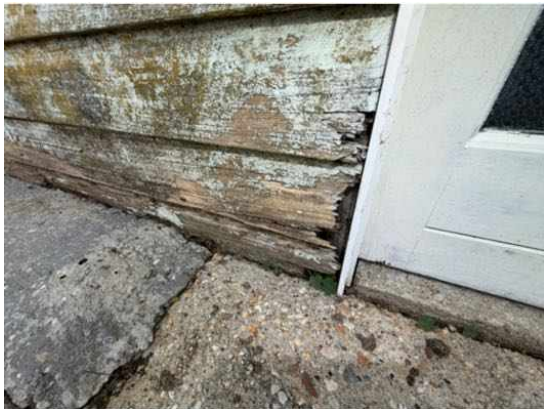
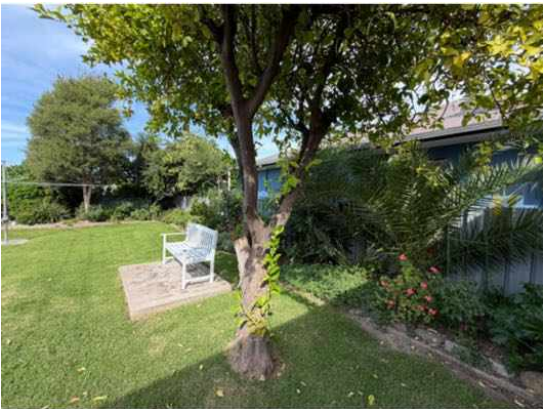
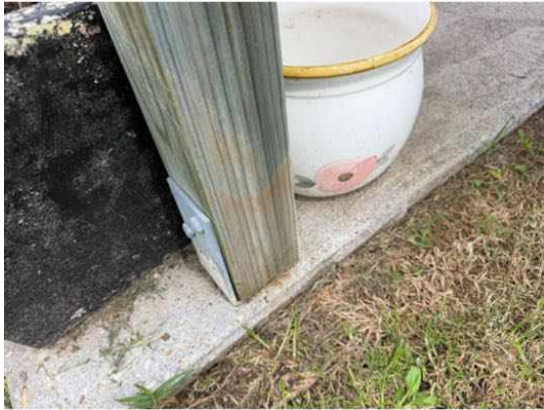
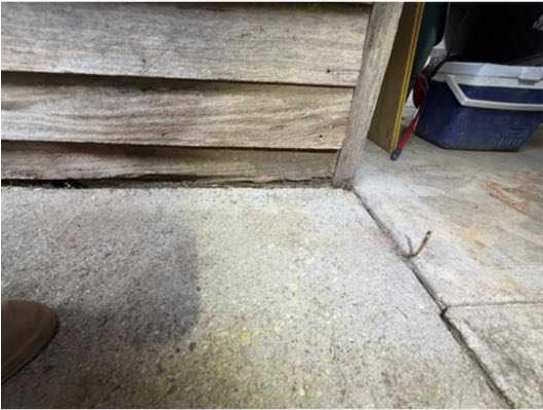
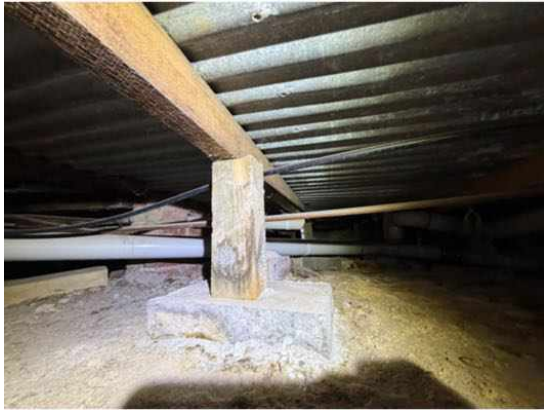
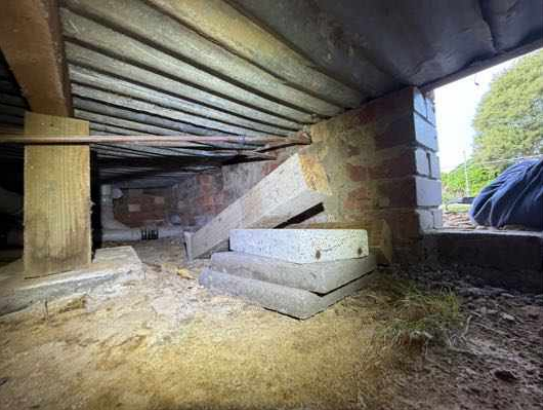
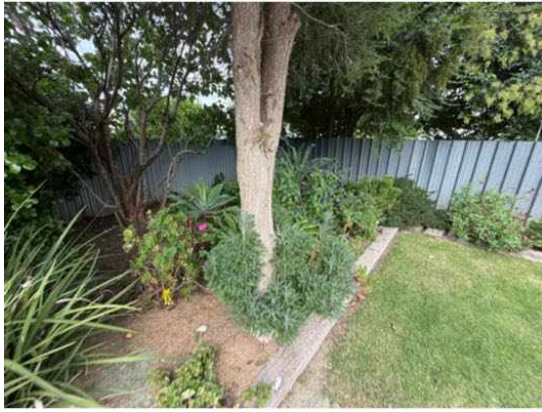
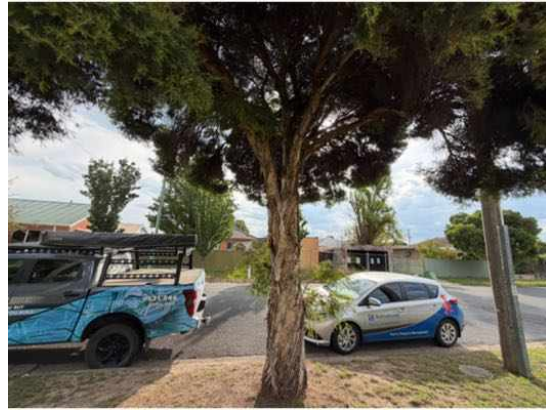
Finding 6.04

Building: Main Building
Location: All External Areas
Finding: Timber in direct ground contact & trees - conducive to termites
Information: Where timber materials are in direct contact with the ground and consequently moisture, they become conducive to termite activity. The timber debris in the subfloor, and trees surrounding the building create an environment conducive to termite infestation.

Where feasible, any timbers in direct contact with the ground should be removed and any trees in close proximity to the building should be removed or test drilled (inspected) at least annually to reduce the risk of termite infestation & detect any early signs of termite activity.

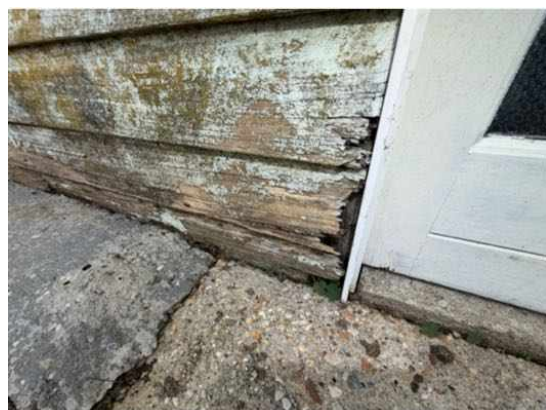
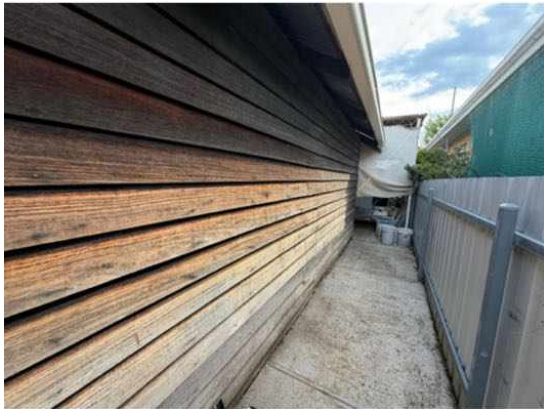
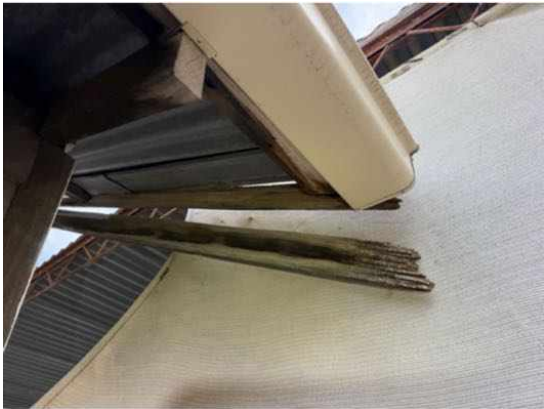
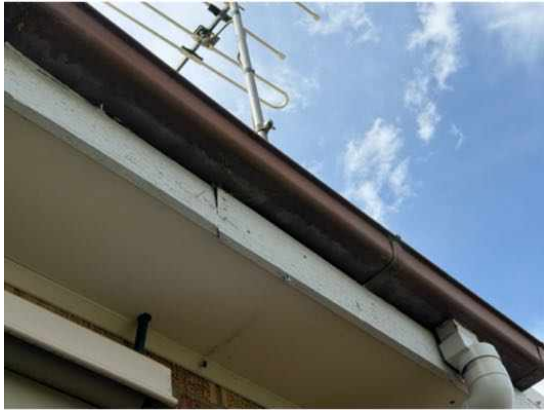
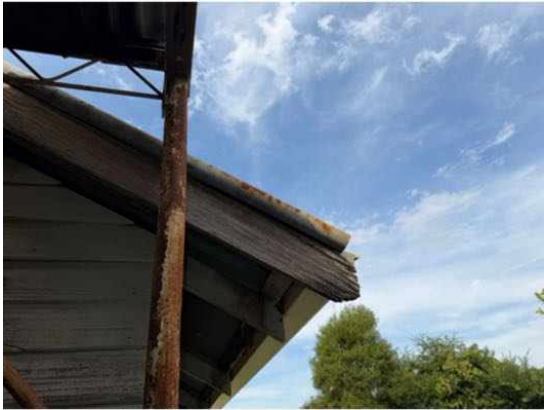
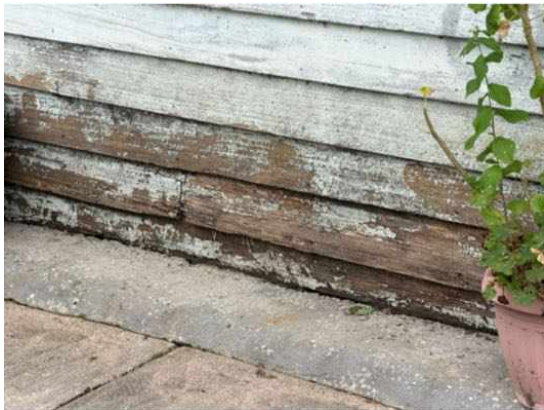
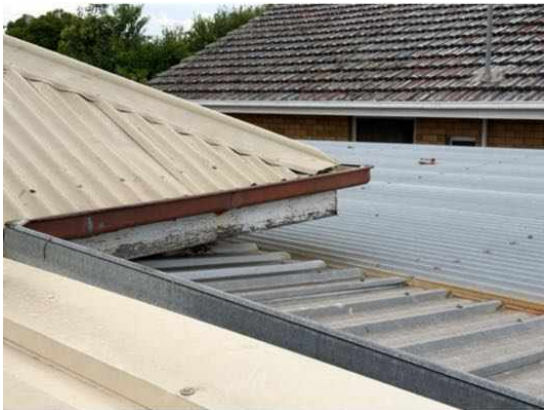
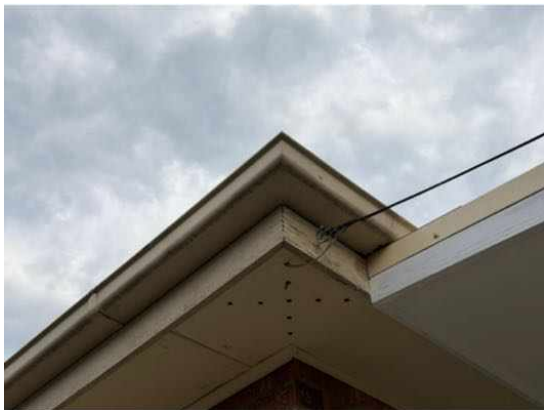
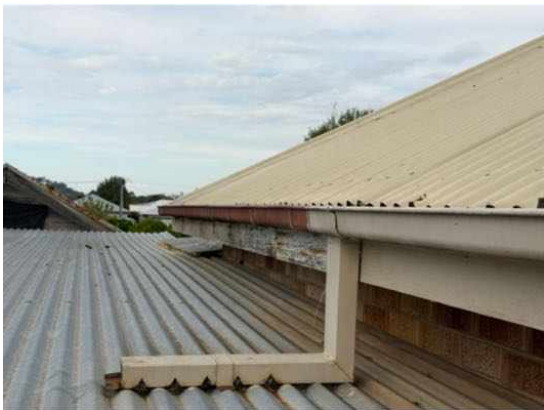
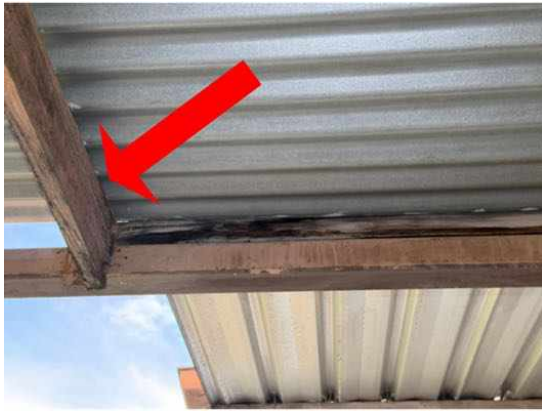
Finding 7.01

Building:	Main Building
Location:	Subfloor timbers, fascias, shed framing & cladding
Finding:	Fungal decay & weathering
Information:	Areas of fungal decay (wood rot) & weathering were identified at but not limited to some subfloor timbers, fascias, shed & carport framing & the weatherboard cladding.

For areas of fungal decay, the client can engage a licensed carpenter at their discretion to replace affected materials. For areas of general weathering, it is advised the client engage a licensed painter to apply protective sealant or coating to areas of weathered external timbers.

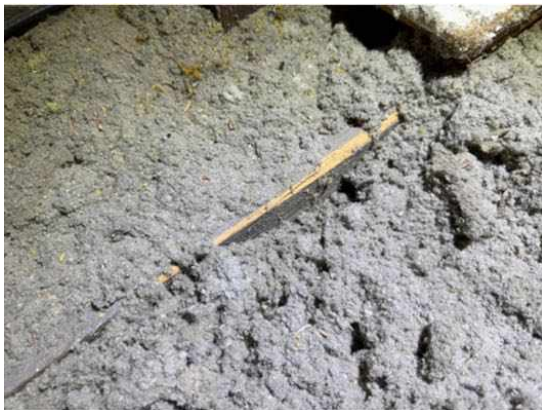
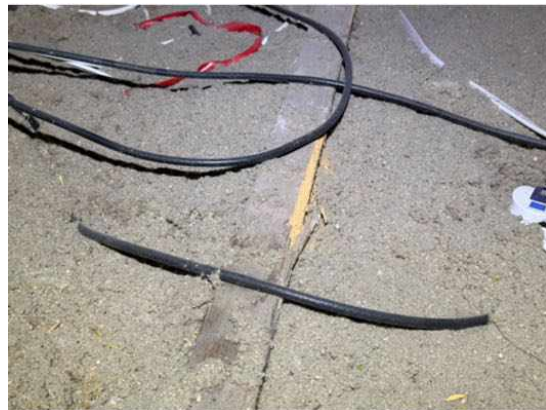
Finding 8.01

Building:	Main Building
Location:	Roof Void
Finding:	Evidence of wood borer damage identified (powder-post)
Information:	Evidence of previous Lyctus Borer (powder-post beetle) damage was identified to the edges of some ceiling battens. Wood borer damage is generally considered superficial damage to the affected timber. As no live wood borer activity was identified treatment is not required.

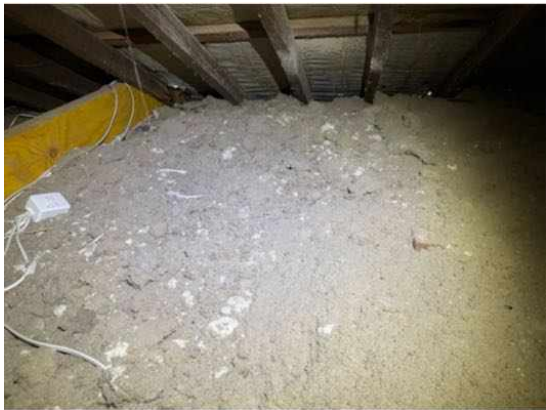
Building: Main Building
Location: Roof Void
Finding: ACM - Loose Fill Insulation
Information: Some types of loose-fill ceiling insulation may contain Asbestos fibres. The removal of a sample for lab analysis to confirm the presence of ACM is advised. In the interim, the client is advised to assume the presence of ACM. Once confirmed, removal by a Licensed Asbestos Removal firm would be recommended.

No works or disturbance should be carried out to the ACM without further specialist advice.

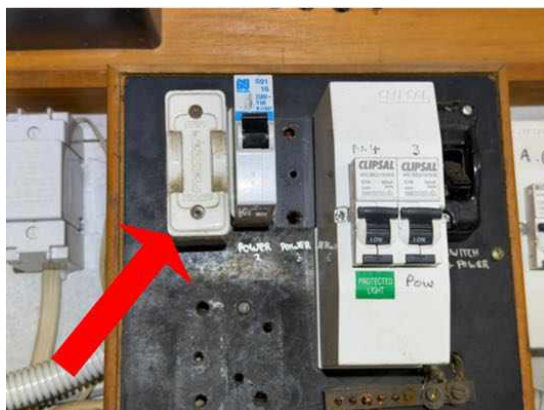
Building:	Main Building
Location:	Switchboard
Finding:	Electrical switchboard - Old ceramic fuses
Information:	It was noted that the electrical switchboard has an old ceramic fuse in place. Recommend consulting with a licensed electrician to provide further advice.

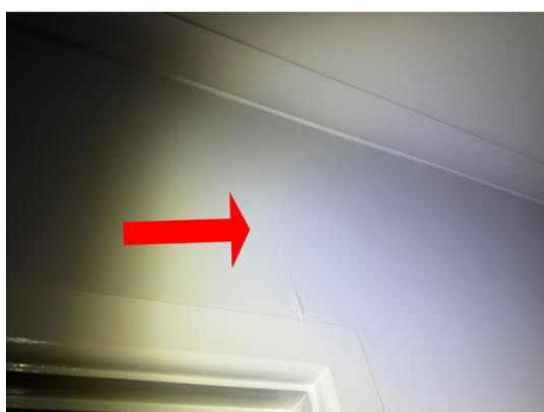
Building:	Main Building
Location:	Internal Walls
Finding:	Plaster - Cracking
Information:	There appears to be minor cracking in some areas of the wall linings. Cracking of this type is common in buildings of a similar age. Although this is mostly a visual defect, it is advised that the client monitor these areas.

Should cracking widen, lengthen, or become more numerous, the client should consult with a structural engineer for further evaluation.
