Building and Timber Pest Inspection Report

Inspection Date: Mon, 16 Mar 2026

Property Address: 131 Merool Rd, Moama NSW 2731,
Australia cabin 81

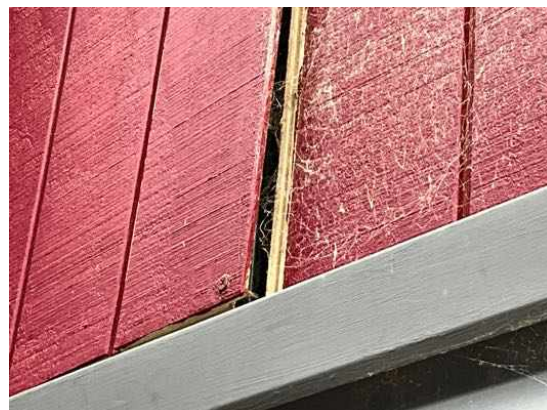
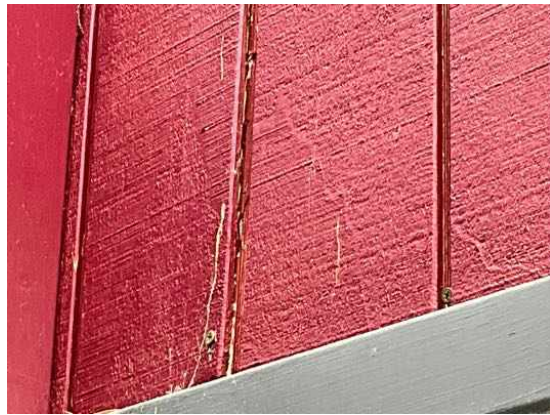
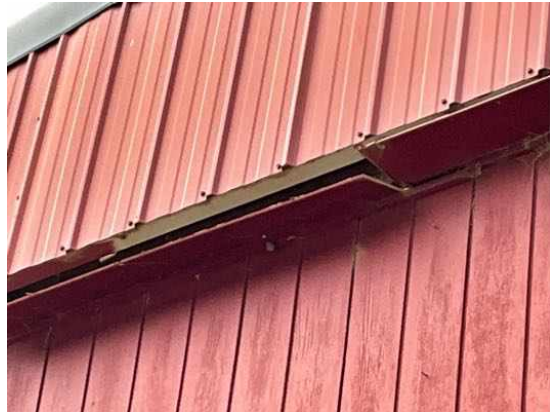
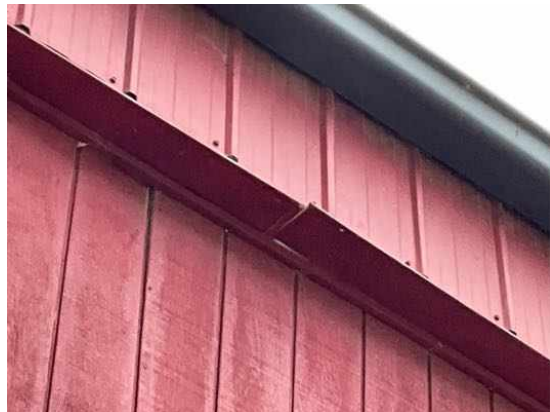
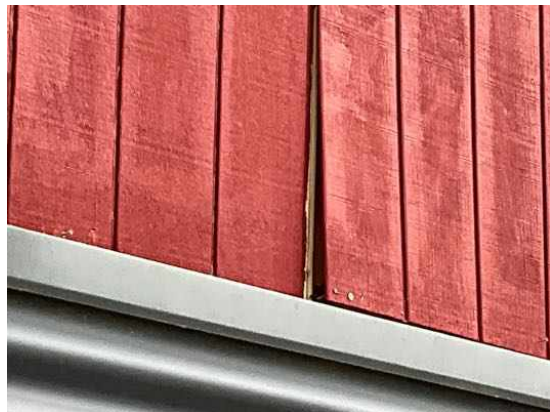
Finding: Cladding- deteriorated

Information: The external cladding shows signs of damage in several areas. Although not serious at this point, monitoring should be undertaken at intervals to ensure no further damage occurs.

A cladding specialist or handyman could be contacted as needed to patch any damage to prevent further deterioration.

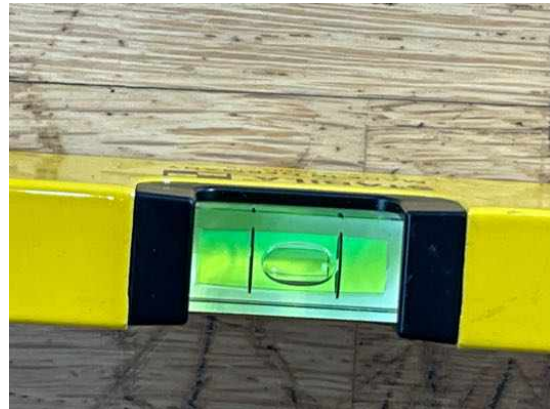
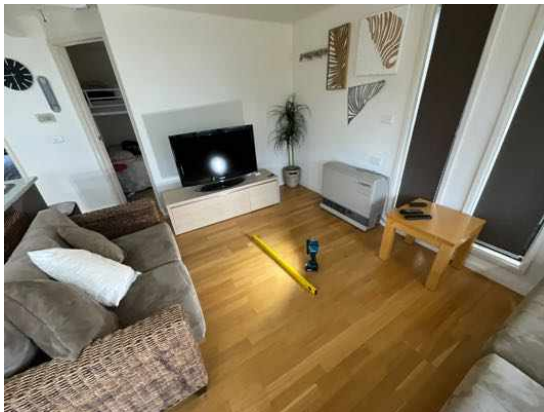
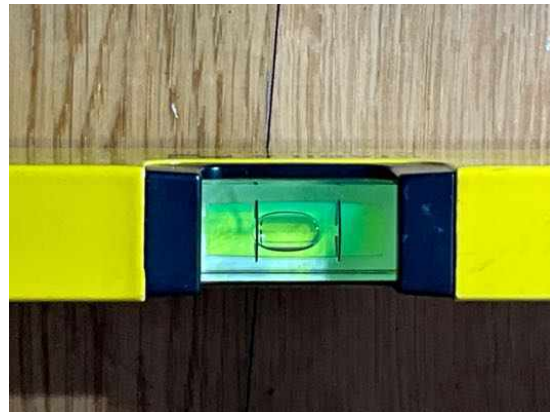
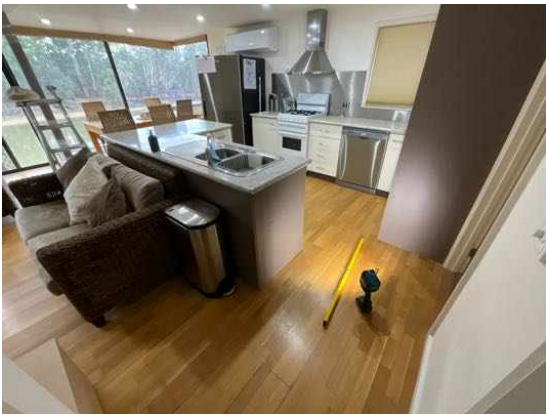
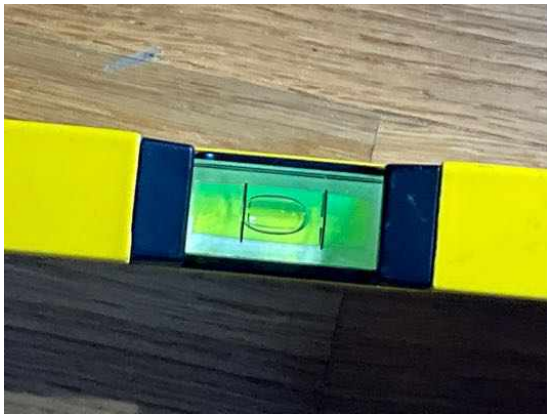
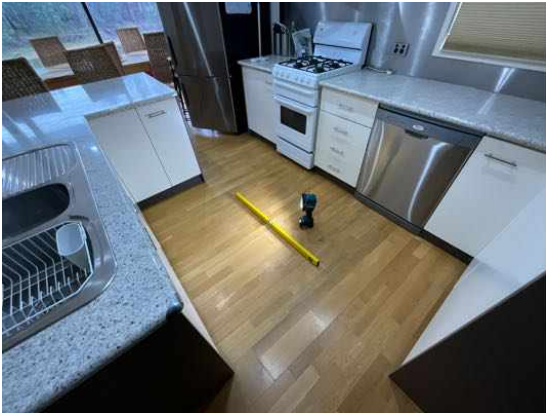
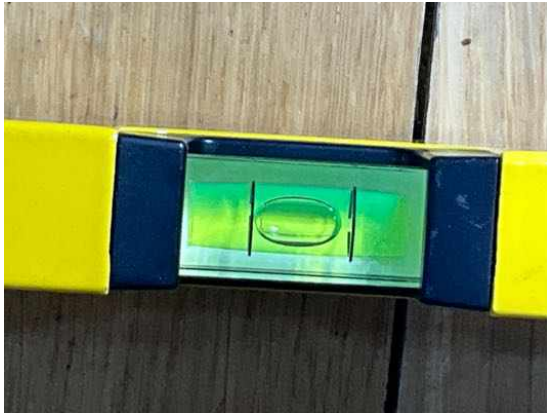
Finding 3.02

Building: Building 1
Location: All Internal Areas
Finding: Flooring - Uneven
Information: The internal flooring in this area is out of level and uneven. Uneven flooring is likely to indicate minor defects such as expected movement of the foundations of the property, but may also indicate subsidence of the associated subfloor support.

It is advised that the flooring be closely monitored to identify any further movement. Where flooring remains relatively unchanged for an extended period of time (i.e. several months), it is likely that this defect has been caused by expected movement of the foundations of the property.

Where flooring becomes increasingly uneven, a registered builder should be consulted to determine the extent of any needed works.

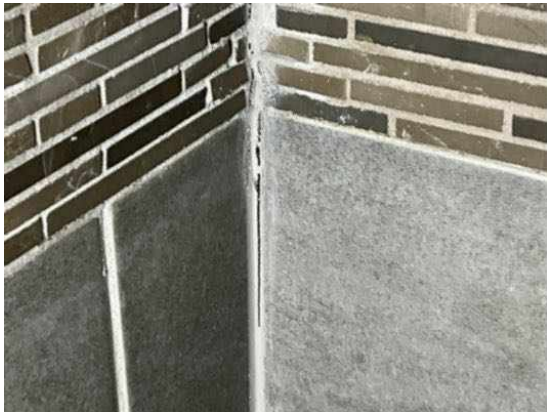
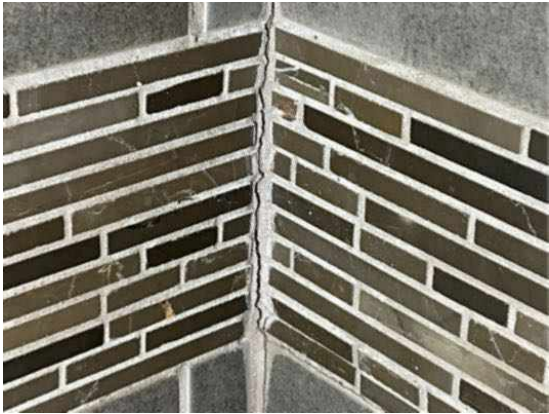
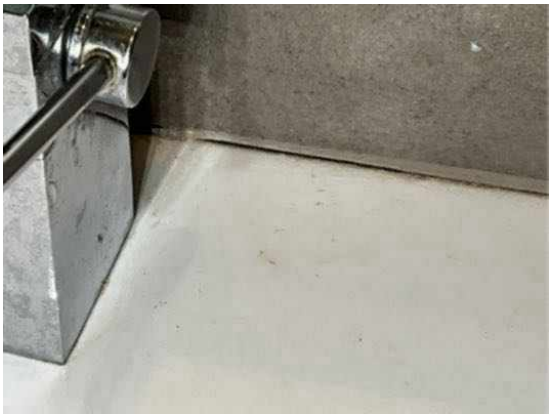
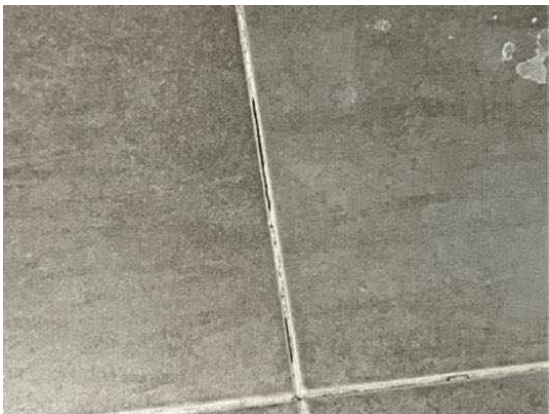
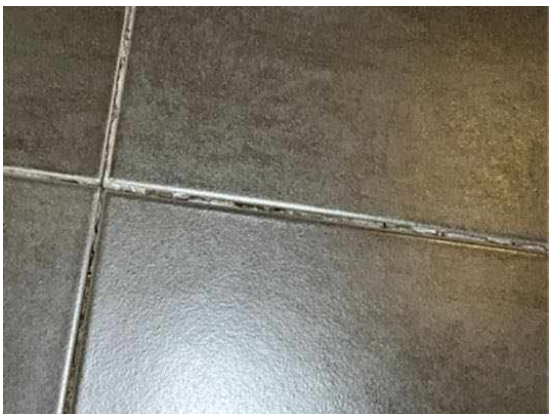
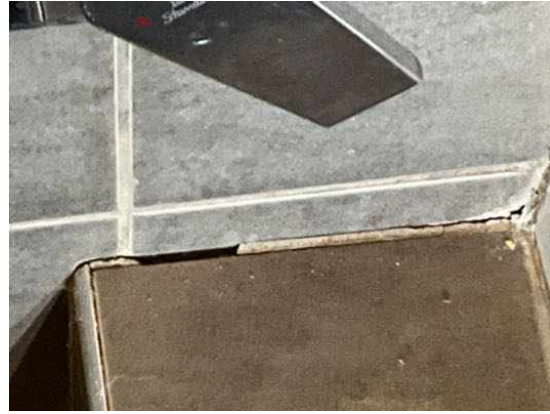
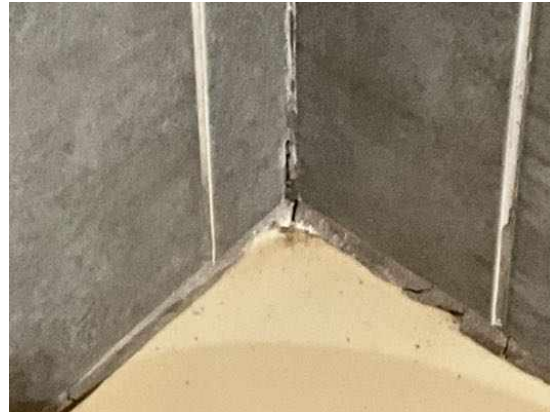
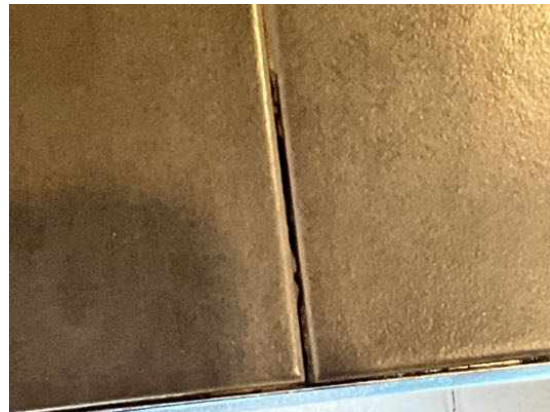
Finding 3.03

Building: Building 1
 Location: Ensuite
 Finding: Inadequate sealant or Grout
 Information: This area has a lack of effective Sealant or Grout. This is allowing the ingress of water to the structure inside the wall.

The presence of water encourages Termite attack, Mould and Fungal Decay.

A Tiler or General Handy person must be contacted as soon as possible to effect repairs and prevent further deterioration.

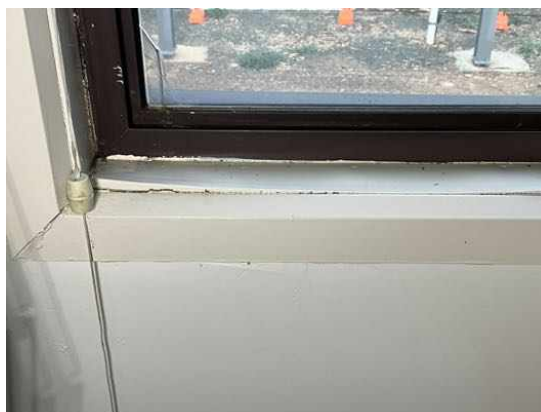
Finding 3.04

Building:	Building 1
Location:	Bedroom - Master
Finding:	MDF- Moisture affected
Information:	<p>The Particle board (MDF) in this area has been affected by excess moisture. This moisture has caused swelling of the material. A lack of effective paint or other coating has probably allowed the moisture to penetrate and deteriorate the material over time.</p> <p>In cases of minor swelling a painter or Handy person could re-paint and restore the area.</p> <p>In cases where the material is structurally compromised a carpenter or General handy</p>

person could be contacted to replace the damaged elements and complete all needed restoration.

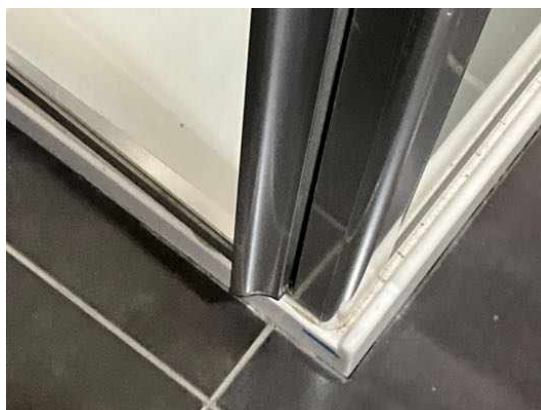
Finding 3.05

Building: Building 1
 Location: Bathroom
 Finding: Shower Door- jamming
 Information: The door to the shower alcove is sticking during normal operation. Poor operation of building elements is inconvenient and potentially dangerous to the elderly or younger members of the home.

A Handy person or bathroom specialist should be contacted soon to adjust the door to prevent any further deterioration.

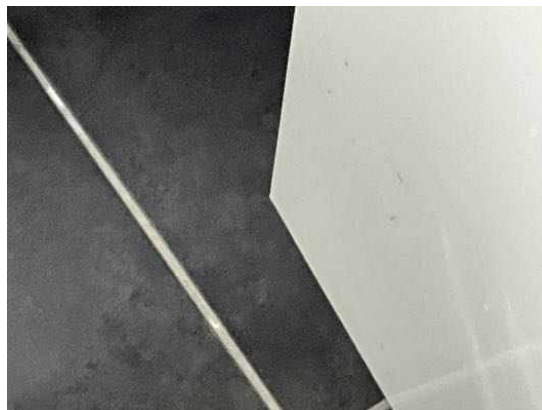
Finding 3.06

Building: Building 1
 Location: Bathroom
 Finding: Door- Binding/jamming
 Information: Binding and/or jamming of this door is evident during standard operation. This defect inhibits the functionality of the affected door as well as creating potential for secondary defects to associated building elements, such as damage to the floor covering.

A qualified carpenter or general handyperson should be appointed to perform minor rectification works at client discretion.

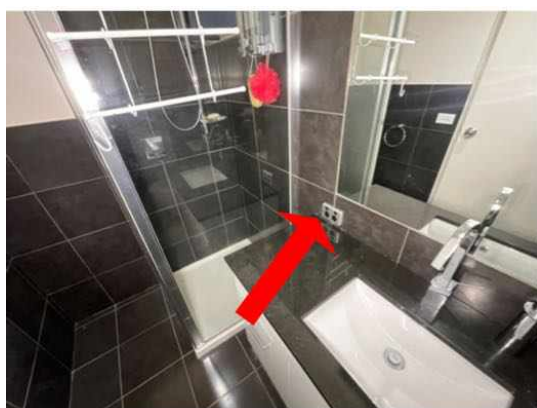
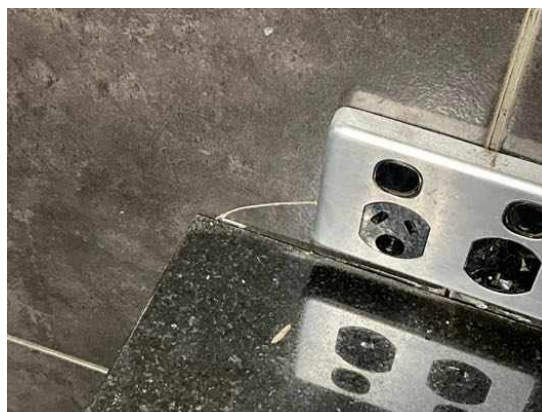
Finding 3.07

Building:	Building 1
Location:	Bathroom
Finding:	Wall Tiles- Cracked
Information:	Cracked tiles within the household detract from the overall appearance of the affected areas, as well as creating potential for water penetration to adjoining building elements. If left unmanaged, water damage may occur as a result of constant water penetration over a prolonged period of time.

While not considered a matter of urgency, replacement of tiles is advised as a solution. A Tiling Contractor may be appointed to perform these works at client discretion.

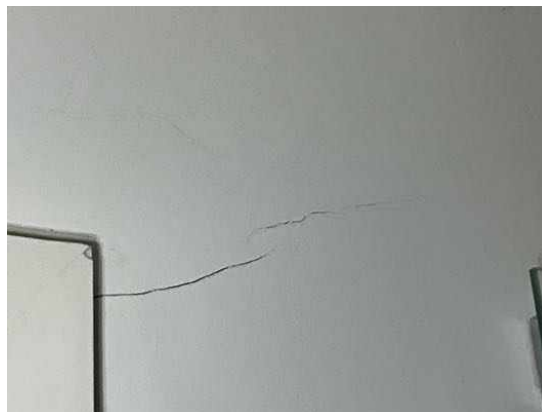
Finding 3.08

Building:	Building 1
Location:	Bedroom 3
Finding:	Cracking - Damage Category 1 - Fine (up to 1mm)
Information:	Although fine cracks are quite noticeable, they are often only considered to be an appearance defect, and usually do not indicate any structural damage. Generally, the

cause of a fine crack is indicative of a separation between building materials and finishes (e.g. paint, plaster, etc.) along joints.

Cracking of this nature can generally be repaired with minor sanding, filling and/or repainting. Such works should be performed by a qualified painter or a general handyman.

Monitoring of all cracking should be conducted frequently. Always contact a building inspector should cracks widen, lengthen, or become more numerous.

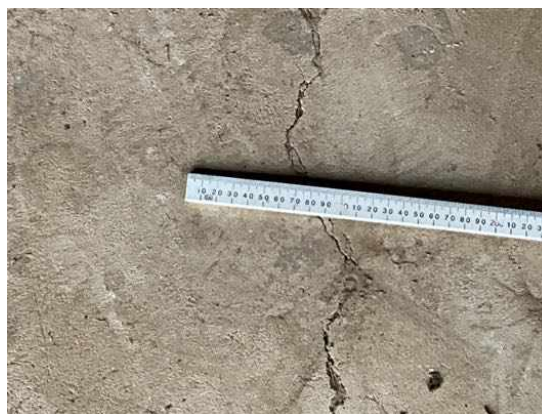
Finding 3.09

Building:	Building 1
Location:	Garage
Finding:	Crack in concrete slab - Category 1
Information:	A crack coded as Category 1 was identified in the slab. A Category 1 crack is described as a fine but noticeable crack, with the slab at an otherwise reasonable level.

To be considered Category 1, the approximate width of the crack is less than 1.0mm, or a less than 10mm change in offset when a 3m straight edge is placed over the defect.

Category 1 cracks should be monitored for a period of 12 months. At the end of the monitoring period, identified cracks that are rated greater than Category 2 are considered defects, and require rectification.

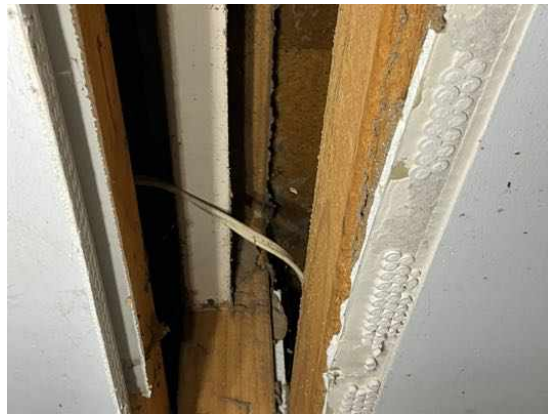
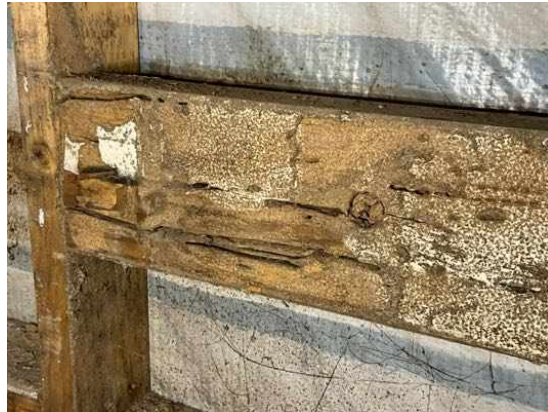
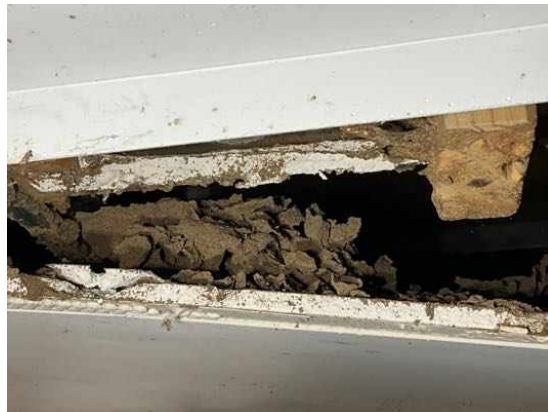
Building: Building 1
 Location: Previous laundry area
 Finding: Evidence of termite damage- not structural
 Information: Despite no live termite or timber pest activity being indicated, previous termite damage was found to have affected this area. This damage is considered to be inactive and is minor in nature.

It is advised that the area be visually inspected frequently to ensure that the condition of affected building materials does not worsen. At the time of inspection, damage is not structural and is only considered to be superficial.

A building contractor may be appointed to provide a further invasive inspection if further damage is evident.

A Pest control company should be consulted soon to initiate a termite management plan and prevent further damage.

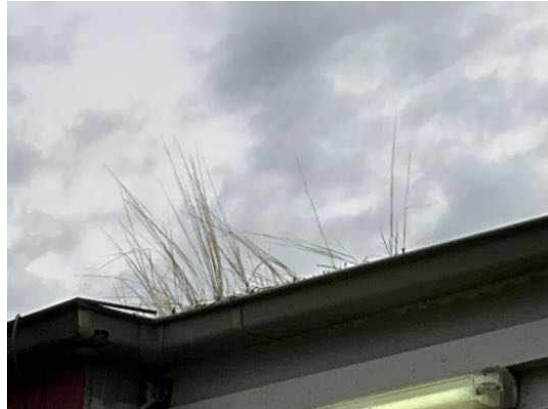
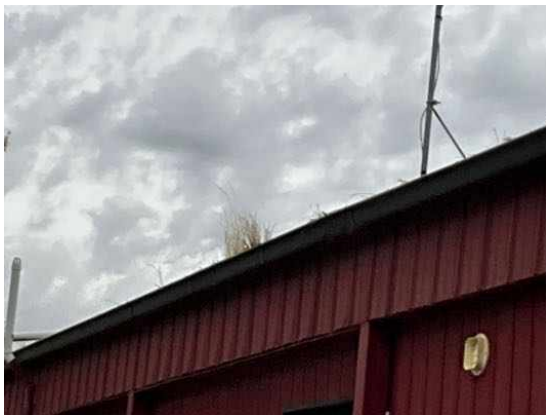
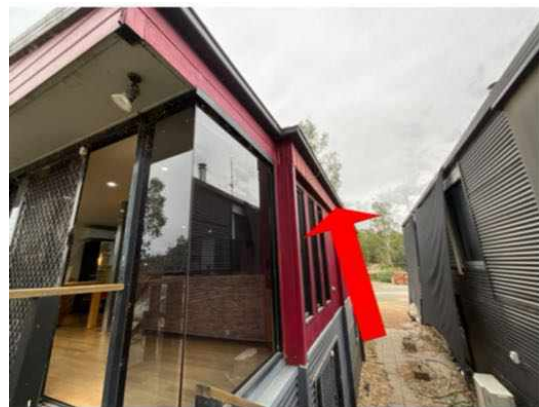
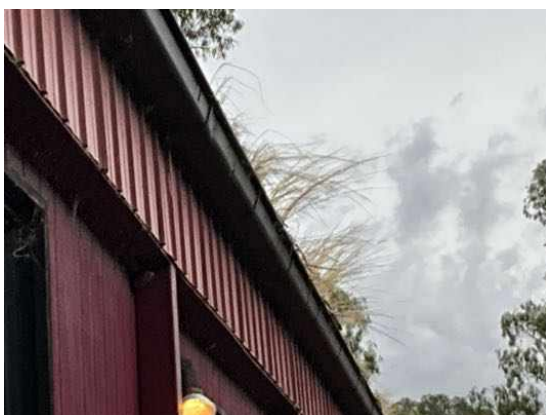
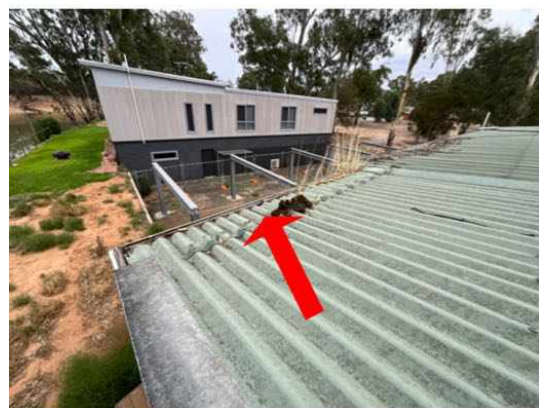
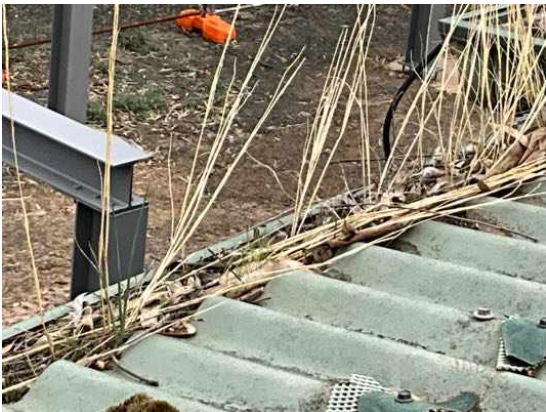
Finding 6.01

Blocked gutters are likely to lead to high levels of moisture in the affected areas. Such moisture will not only cause rust and decay of the associated building materials, but can also provide conditions that are conducive to termite and timber pest activity. Blockages in gutters should therefore be removed immediately to ensure dry conditions are maintained.

Consult a Licensed Plumber for further specific advice on remedial works that may be required. In the interim, it is highly advised that blocked gutters be removed by the homeowner or a general handyperson as a matter of urgency.

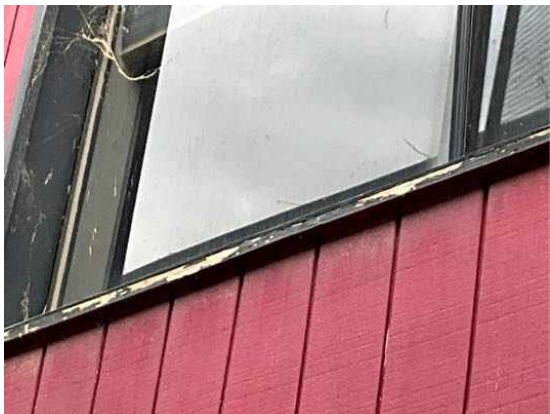
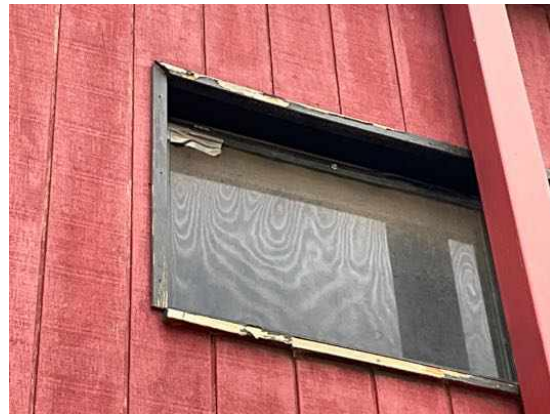
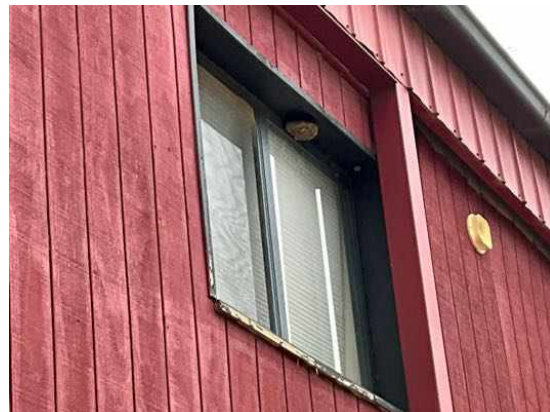
Finding 6.02

Building: Building 1
Location: External timber
Finding: Timber - exposed to weather
Information: External timbers that are frequently exposed to harsh weather conditions require adequate protection in order to maintain their condition. Where timbers have not been painted or treated adequately, general deterioration is likely to occur at an accelerated rate.

If left unattended, replacement of these timbers is likely to be necessary in the short-term future. Adequate treatment of these timbers is required as soon as possible by a painting contractor or general handyman.

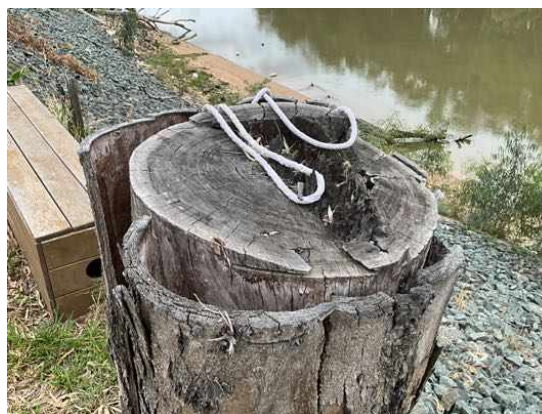
Finding 6.03

Building:	Building 1
Location:	River side
Finding:	Tree Stump in Ground
Information:	Any tree stumps in the yard not removed during the tree removal process provides the opportunity for Termite infestation and is likely to be subject to decay from damp conditions against the stump.

All tree stumps should be removed by professional tree removal services where possible. Meanwhile regular inspections are advised to identify any termite activity in the areas identified.

Services for tree stump removal should be contacted as soon as possible to reduce the risk of timber pest attack.

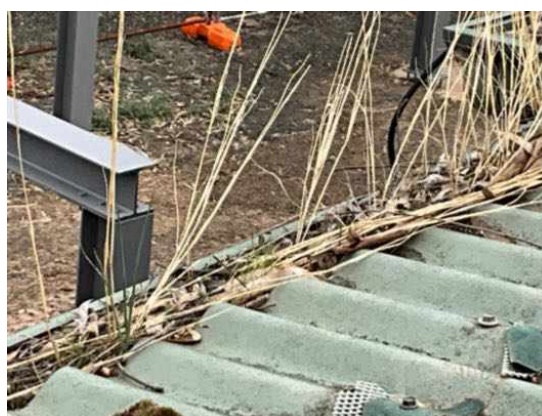
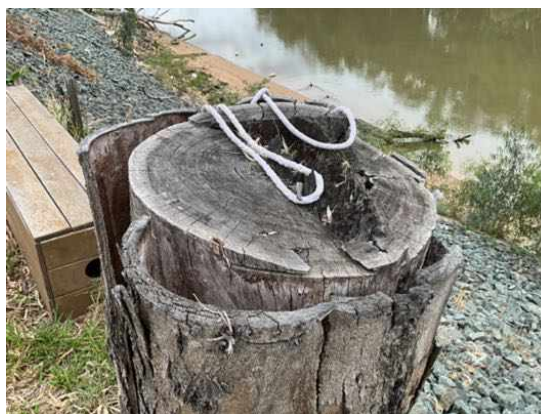
Finding 6.04

Building:	Building 1
Location:	All External Areas
Finding:	Termite Management System - no evidence of a chemical installation
Information:	The application of a post-construction chemical termite barrier is highly recommended for all properties, particularly if live termite activity has been found on the site previously. Such barriers are highly effective in preventing termite attack on any timber building elements throughout the property.

A durable notice should be placed in the switchboard unit to indicate current termite barriers. At the time of inspection, it appeared as though no termite management system has been installed, with no evidence to suggest preventative works taking place.

The client may consider gaining further advice from a pest controller as to the costs and procedures involved with this application. It is recommended that obtaining such advice be a short-term priority.

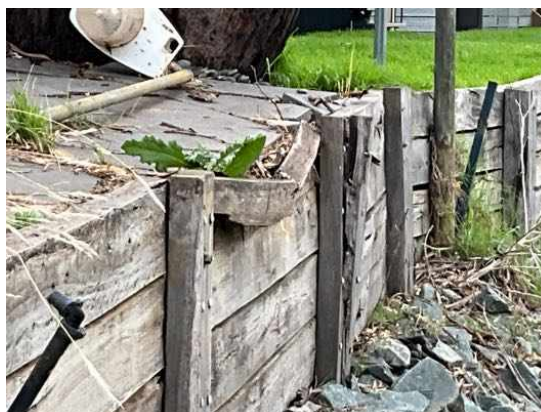
Finding 7.01

Building:	Building 1
Location:	Retaining wall
Finding:	Fungal decay - present (localised)
Information:	Fungal decay also known as wood decay or wood rot generally refers to the deterioration of timber elements when in contact with excessive levels of moisture for a prolonged period of time.

The development of fungal decay is accelerated by temperatures in the range of 5degreeC to 40degreeC as well as the presence of oxygen. Generally fungal decay develops on timber elements that are in use in an external environment which are exposed to rain penetration.

In this case although the affected timber element is in a decaying state the extent of any visible damage appears to be localised to a specific area and is yet to spread to other parts of the building element or affect adjoining structures. The fungal decay is therefore likely to be of a relatively superficial nature with minimal impact on the structural integrity or tensile strength of the timber element.

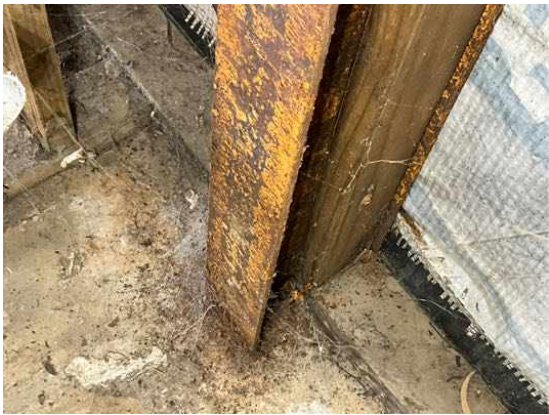
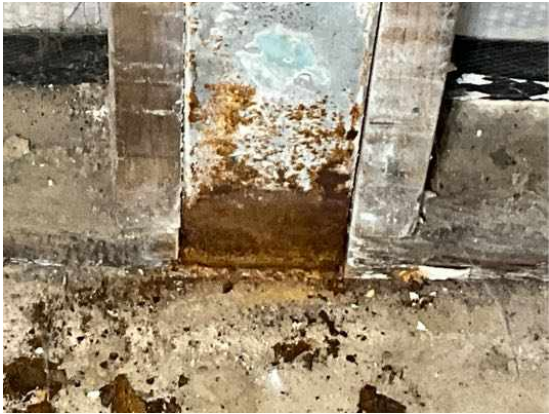
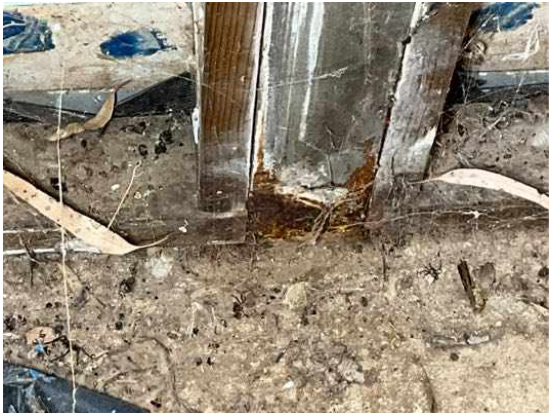
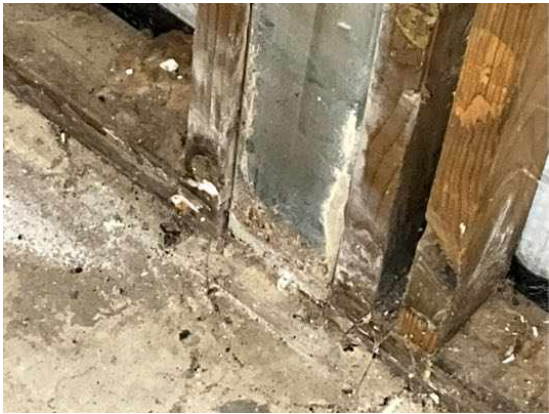
Building:	Building 1
Location:	Lower floor
Finding:	Steel- rust
Information:	The question of rust damaging the steel supporting uprights can be answered. The rust is generally superficial. No penetration through the material could be found at the time of inspection. Sounding of the steel revealed no weakened areas.

The structure has been built in separate sections brought together over time. The lack of cracking in the walls and flooring would indicate that no movement has occurred.

If further investigation is needed, a structural engineer should be consulted to determine potential improvements to the structure.

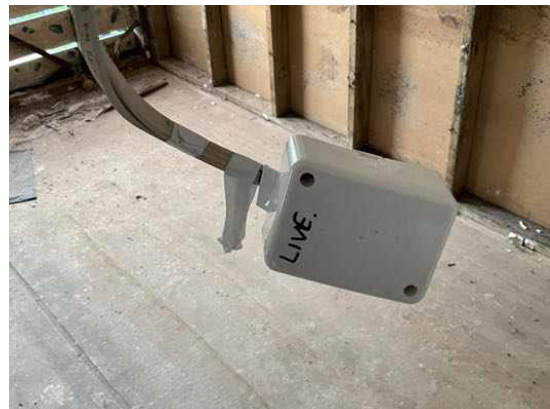
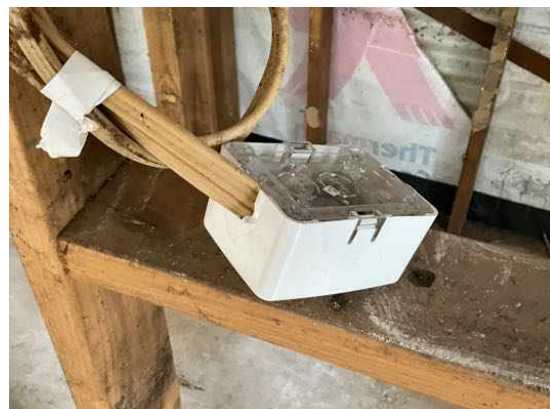
Building: Building 1
Location: Lower floor
Finding: Plumbing and Electrical
Information: Some installations appear of in finished/ poor quality. A plumber should be contacted at client discretion, to improve the installation and prevent further deterioration.

It is highly recommended that the client makes immediate arranges to have the gas appliances checked by a licensed gas plumber to ensure that the appliances are working safely and efficiently.

We recommend all other installations be checked also.

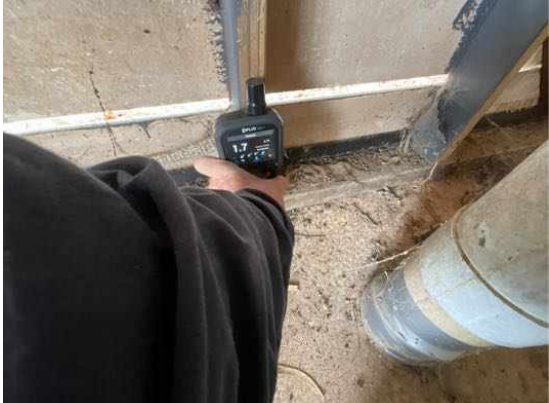
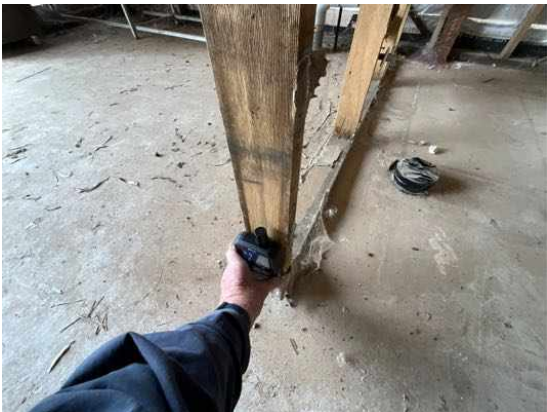
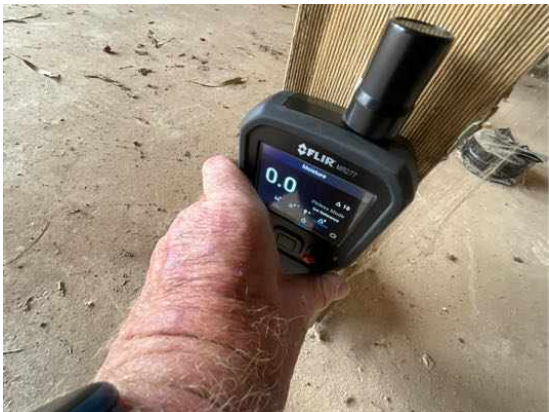
Building: Building 1
Location: Lower floor
Finding: Moisture levels
Information: The timber frame around the lower floor shows no signs of excess moisture.
