Building and Timber Pest Inspection Report

Inspection Date: Mon, 2 Feb 2026

Property Address: 2 Manhattan Dr, Eagleby QLD 4207,
Australia

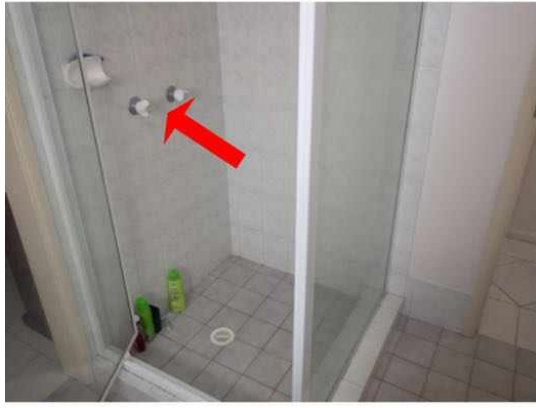
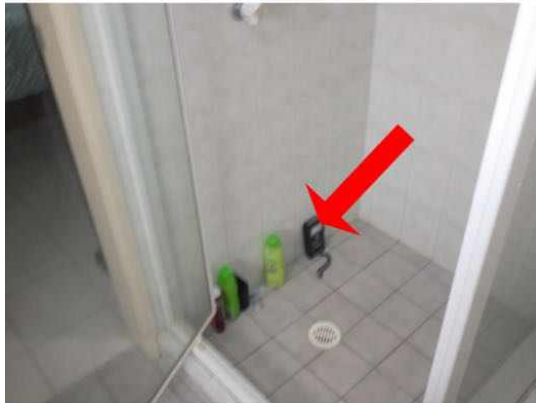
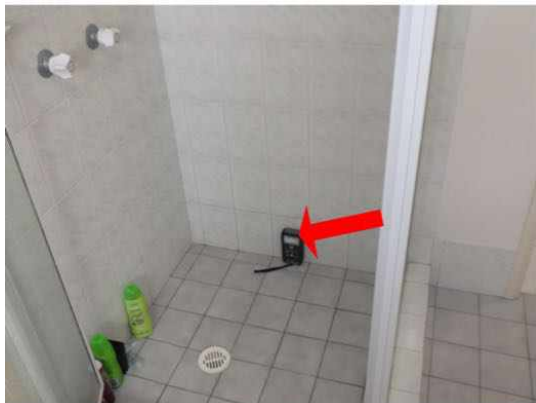
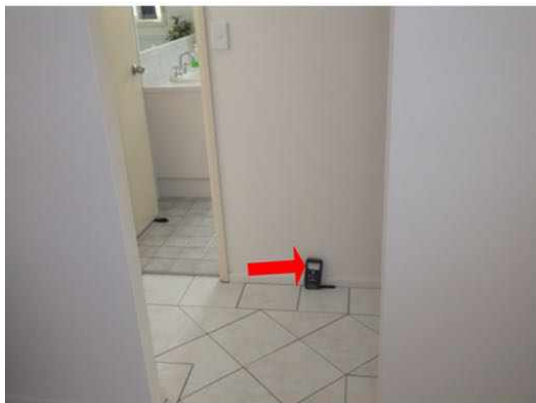
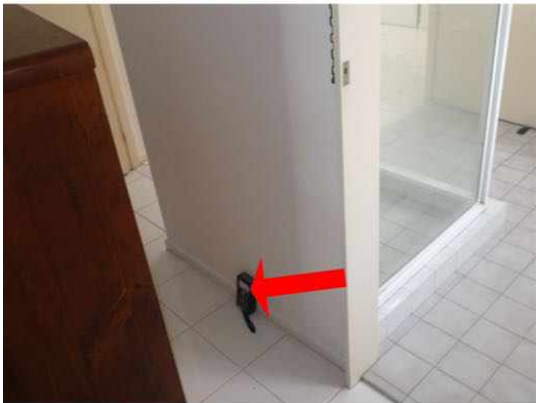
Building: Main Building
Location: Bathroom > Front Right
Finding: Shower - Leaking
Information: The bathroom shower registered elevated moisture level readings to the lower wall areas of the shower cubicle at the time of inspection, with the elevated moisture level readings transferring to the opposite side of the wall which would generally indicate the shower is leaking.

It is suspected that the leaking has occurred as a result of general ageing of the building elements (waterproofing Membrane) and/or deterioration of sealants and grout.

Leaking from the shower area, where left unattended, is likely to lead to water damage to adjoining flooring and walls. Such damage can necessitate extensive remedial works being required. Active water leaks may also create an environment that is susceptible to the formation and development of mould and /or timber termite activity.

A qualified plumber should be engaged to undertake a pressure test on the shower base and/or plumbing pipes. Additionally a licensed builder or shower area specialist may be required to repair or replace the shower cubicle. Such works should be performed as soon as possible to ensure that no damage occurs.

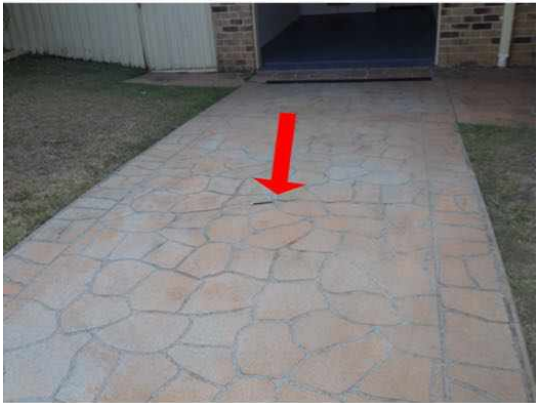
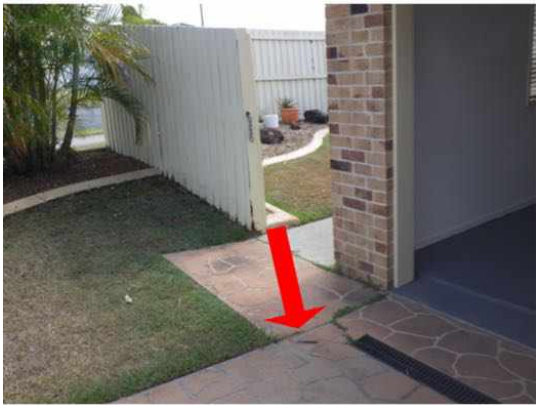
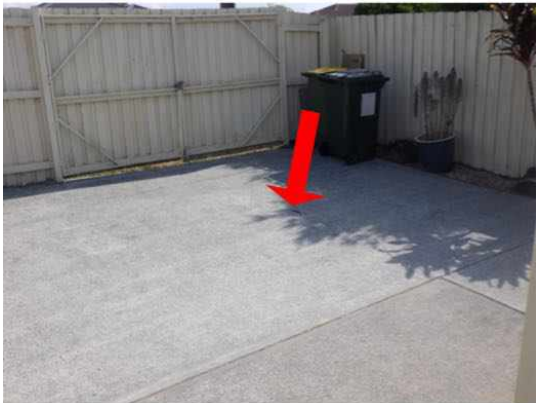
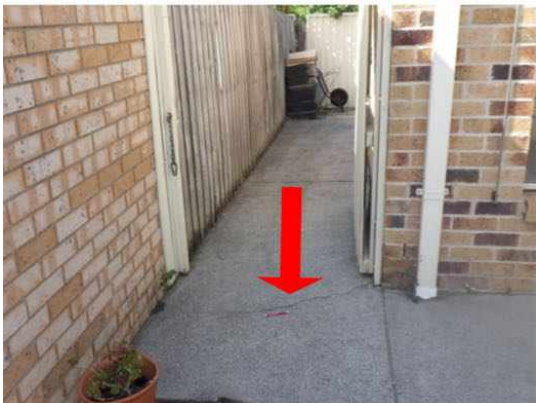
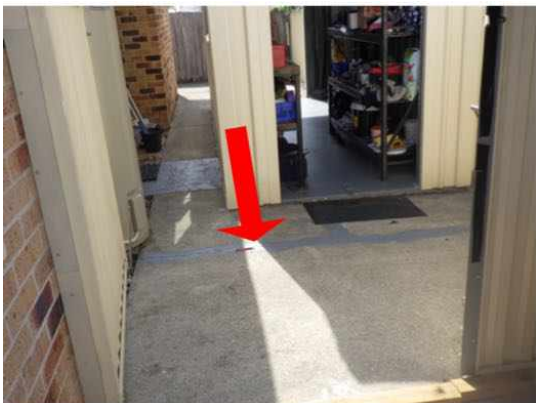
Finding 3.01

Building: Main Building
 Location: Driveway > Ground Level
 Finding: Cracking in concrete slab - Category 1
 Information: Cracking coded as Category 1 was identified in the driveway and footpaths concrete slabs (as pre example photos). A Category 1 crack is described as a fine but noticeable crack, with the slab at an otherwise reasonable level.

To be considered Category 1, the approximate width of the crack is less than 1.0mm, or a less than 10mm change in offset when a 3m straight edge is placed over the defect.

Category 1 cracks should be monitored for a period of 12 months. At the end of the monitoring period, identified cracks that are rated greater than Category 2 are considered defects, and require rectification.

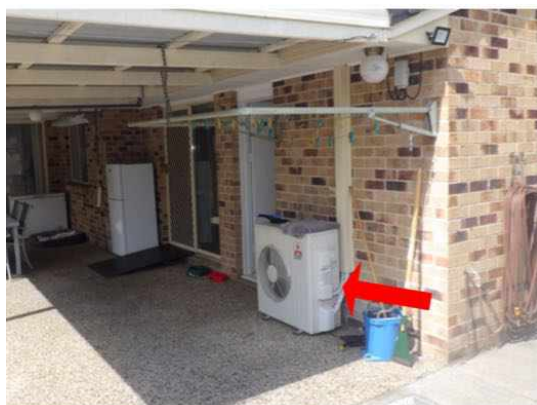
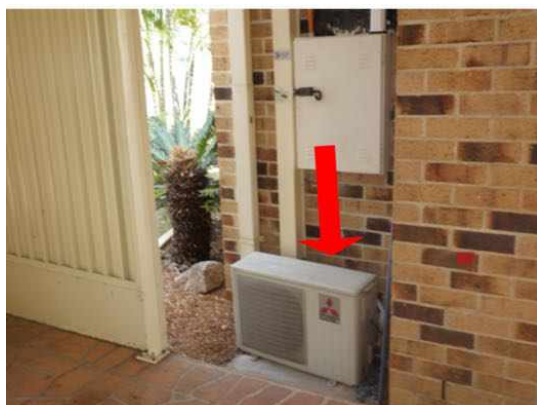
Finding 3.02

Building: Main Building
 Location: Exterior walls > Front Right,Rear Left
 Finding: Pipework - Insulation deteriorated
 Information: At the time of inspection sections of the air conditioning units pipe work insulation showed evidence of damage and deterioration. It is suspected that this deterioration has developed as a result of excessive exposure to weather, including UV exposure in daylight. Deteriorated insulation reduces the effectiveness of the material in helping to maintain the desired temperature and work most efficiently.

If left in an exposed position, it is likely that the deterioration will continue and worsen over time, potentially resulting in secondary building defects as well as a further loss in insulating properties.

Some areas of replacement of pipe insulation is likely to be required. Further preventative measures to remove or protect the material from future exposure are also advisable. Consultation with a licensed air conditioning installer is advised to gain quotes for the repair and/or replacement of deteriorated insulation.

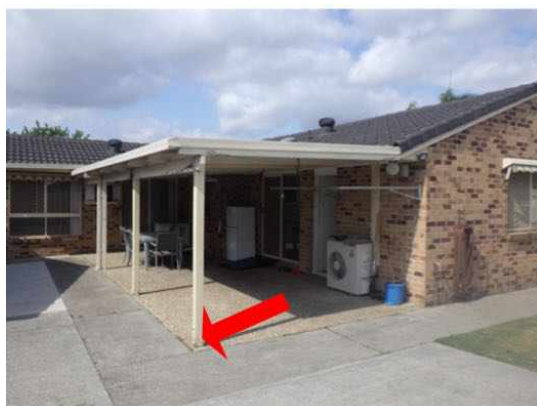
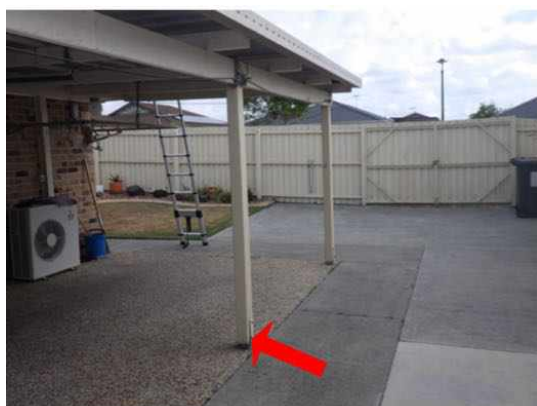
Finding 3.03

Building: Main Building
 Location: Alfresco > Rear Left
 Finding: Wood rot

Information: The timber support posts on the rear left side of the alfresco area show evidence of wood rot to the bottom edges. Wood rot, also known as Fungal Decay, occurs when timbers and other cellulose building materials are exposed to damp conditions on an ongoing basis. This could be the result of exposure to weathering over a prolonged period of time, or the attraction of excessive moisture from other abutting building materials.

A registered builder or qualified carpenter may be required to repair or replace the affected timber posts..

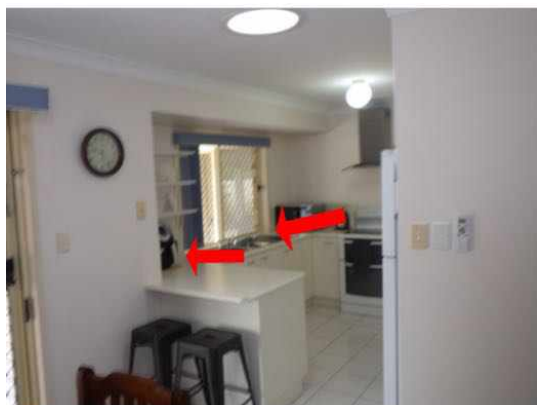
Finding 3.04

Building: Main Building
 Location: Kitchen > Centre Left
 Finding: Kitchen Bench -Sealant
 Information: It was noted on inspection that sealant is missing or deteriorated from the kitchen bench / tiled splash back intersection. It is important this area is sealed to prevent moisture or liquids penetrating the generally unsealed edges. Sealant also prevents vermin from accessing and or nesting in these areas.

A flexible sealant is required to allow for expected expansion and contraction, while keeping the joint water tight and protective of all associated building materials.

A sealant specialist or tiling contractor should be appointed to complete these works as soon as possible.

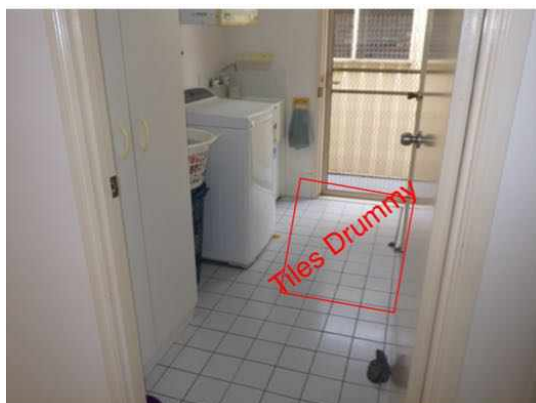
Finding 3.05

Building:	Main Building
Location:	Laundry > Centre,Rear
Finding:	Tiles - Drummy
Information:	Drummy tiled areas were identified in the Laundry area floor at the time of inspection. The term 'drummy' refers to tiles that despite being in relatively good condition have a hollow sound when tapped on and may be inclined to crack from heavy impact whether accidental or deliberate. Drummy tiled areas may be a direct result of poor workmanship during the construction process.

A tiling contractor could be appointed to perform works if necessary.

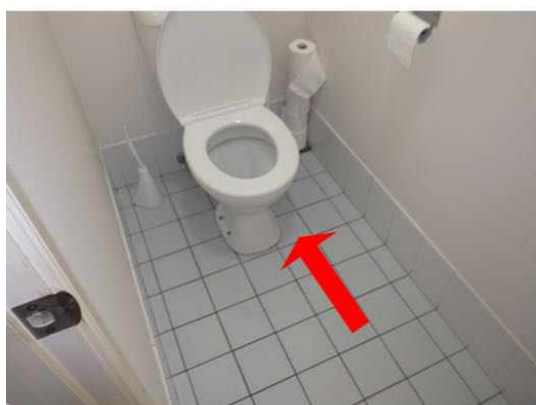
Finding 3.06

Building:	Main Building
Location:	Toilet (WC) > Centre
Finding:	Tile - Cracked
Information:	A cracked tile to the WC floor area was identified at the time of inspection. Such defects are generally caused by impact. Cracked or broken tiled areas may also be a direct result of poor workmanship during the construction process.

A tiling contractor could be appointed to perform repair works at the clients discretion.

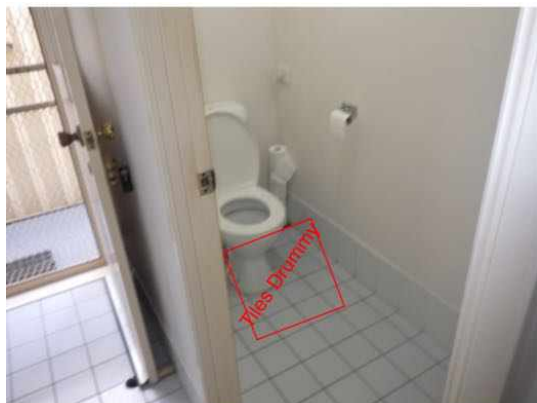
Finding 3.07

Building:	Main Building
Location:	Toilet (WC) > Centre
Finding:	Tiles - Drummy
Information:	Drummy tiled areas were identified in the WC area floor at the time of inspection. The term 'drummy' refers to tiles that despite being in relatively good condition have a hollow sound when tapped on and may be inclined to crack from heavy impact whether accidental or deliberate. Drummy tiled areas may be a direct result of poor workmanship during the construction process.

A tiling contractor could be appointed to perform works if necessary.

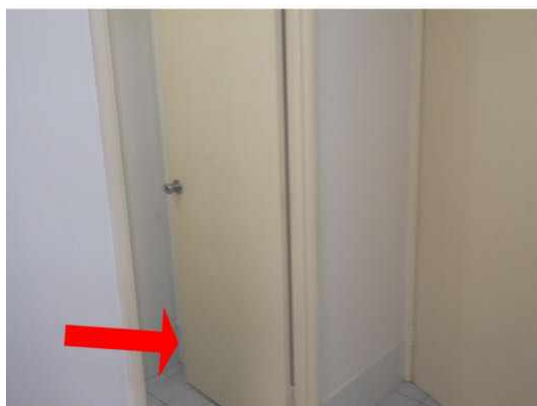
Finding 3.08

Building:	Main Building
Location:	Toilet (WC) > Front Right
Finding:	Door stop - Missing
Information:	The WC door stop is missing or is inadequate to stop the door handle from damaging the wall.

Re-installation or replacement of the door stop is advised to prevent any subsequent damage to the wall linings or associated structures.

A general handyman may be appointed to perform these works at client discretion.

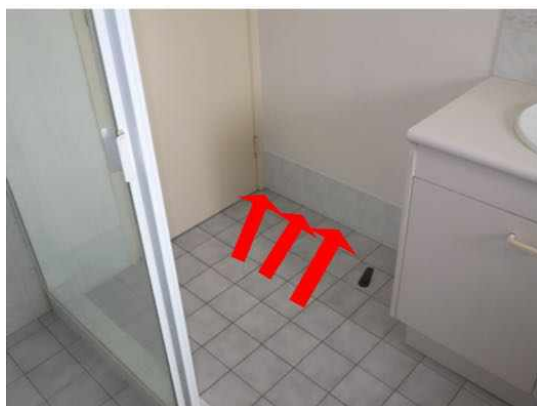
Building: Main Building
 Location: Bathroom > Front Left, Front Right
 Finding: Tiles - Cracked
 Information: Cracked tiles to the bathroom floor area were identified at the time of inspection. Such defects are generally caused by impact or moisture damage to the area. Cracked tiled areas may also be a direct result of poor workmanship during the construction process.

It is advised that a tiling contractor be appointed to perform repair works as necessary.

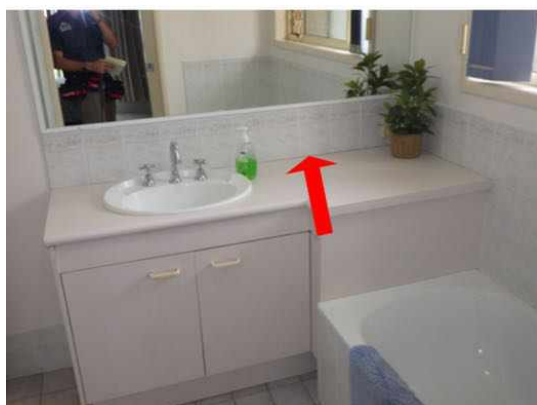
Finding 3.11

Building: Main Building
 Location: Bathroom > Centre Left
 Finding: Bathroom - Sealant
 Information: It was noted on inspection that sealant is missing or deteriorated from the bathroom vanity unit top / tiled splash back intersection. It is important this area is sealed to prevent moisture or liquids penetrating the generally unsealed edges. Sealant also prevents vermin from accessing and or nesting in these areas.

A flexible sealant is required to allow for expected expansion and contraction, while keeping the joint water tight and protective of all associated building materials.

A sealant specialist or tiling contractor should be appointed to complete these works as soon as possible.

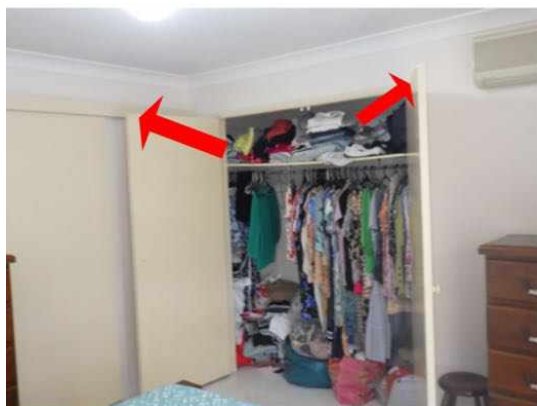
Finding 3.12

Building: Main Building
 Location: Bedroom - Master > Centre Left
 Finding: Door - Broken Catch
 Information: The door catches to the main bedroom cupboard doors were found to be broken at the time of inspection. Breakage occurs generally when the building materials have

aged and decayed, but may be indicative of impact damage (accidental or deliberate).

Replacement of the broken door catches is advised to improve the operational state of the associated doors.

A general handyman could be appointed to replace the door latches at the client's discretion.

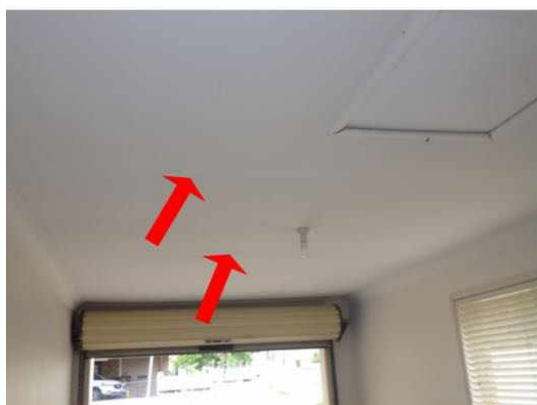
Finding 3.13

Building:	Main Building
Location:	Garage > Existing
Finding:	Ceiling - Sagging
Information:	The ceiling linings in the garage area showed signs of minor sagging at the time of inspection. Sagging to the fixed ceiling structure generally indicates that the building materials have swollen, due to exposure to moisture, or that fixings (e.g. nails or glue) have become loose and require reattachment.

Where minor sagging is evident, comparatively minor works, such as re-gluing and re-screwing of ceiling sheets, may be required.

Such works may be performed by relevant tradespeople, such as plasterers and painters.

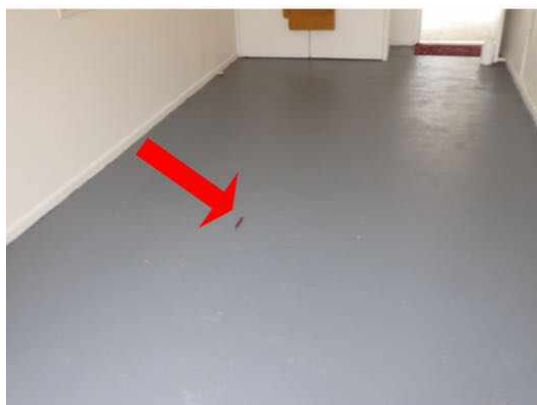
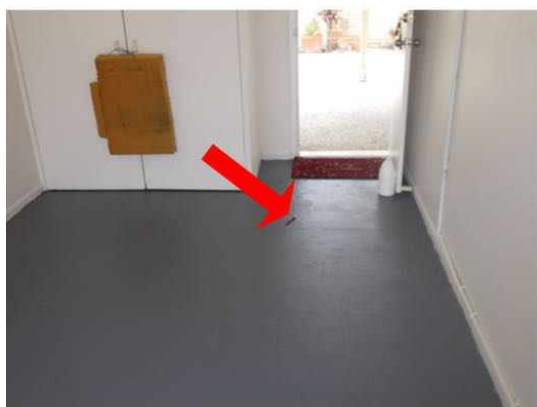
Finding 3.14

Building: Main Building
 Location: Garage > Ground Level
 Finding: Cracking in concrete slab - Category 1
 Information: Cracking coded as Category 1 was identified in the garage floor concrete slab. A Category 1 crack is described as a fine but noticeable crack, with the slab at an otherwise reasonable level.

To be considered Category 1, the approximate width of the crack is less than 1.0mm, or a less than 10mm change in offset when a 3m straight edge is placed over the defect.

Category 1 cracks should be monitored for a period of 12 months. At the end of the monitoring period, identified cracks that are rated greater than Category 2 are considered defects, and require rectification.

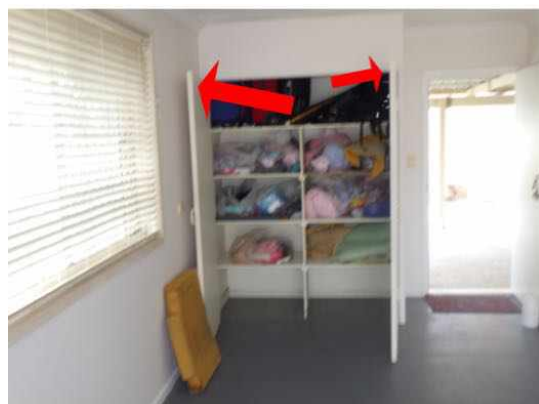
Finding 3.15

Building: Main Building
 Location: Garage > Rear Left
 Finding: Door Catches - Missing
 Information: It was noted that the door catches to the garage area cupboard doors were missing

at the time of inspection.

A general handyperson may be appointed to perform rectification works as necessary, at client discretion.

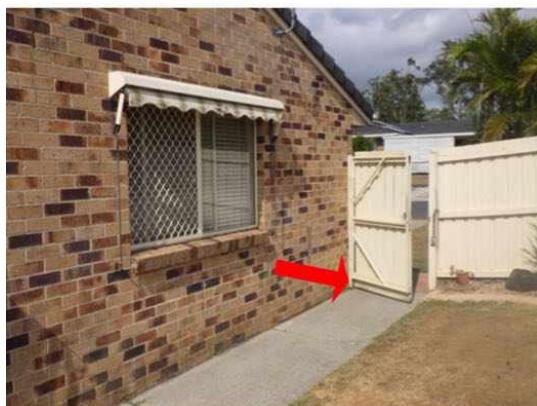
Finding 6.02

Building: Main Building
 Location: Exterior walls - left side > Front Left
 Finding: In ground contact
 Information: The timber gate post fixed to the exterior wall brickwork is in direct contact with the footpath concrete slab.

Any timbers in direct ground contact provide opportunity for concealed termite entry and are likely to be subject to premature rot and decay as the ground retains moisture

or damp conditions against the timbers.

Ideally these types of timber members would be clear of the ground area by a minimum of 50mm to provide a clear inspection zone.

Frequent pest inspections are advised to readily identify any termite activity in these areas.

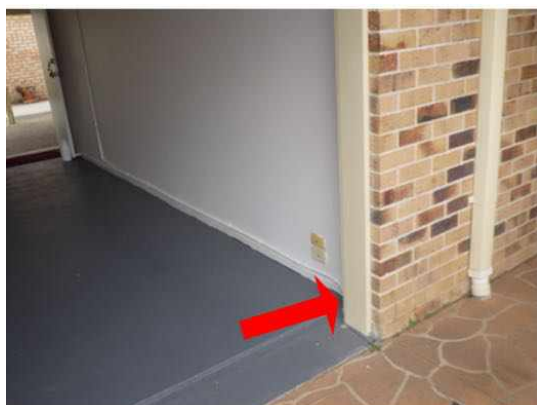
Finding 6.03

Building:	Main Building
Location:	Garage > Front Right
Finding:	Overflow - Not plumbed for drainage
Information:	The air conditioning unit overflow is not plumbed or connected to suitable drainage, which can result in the surrounding area becoming excessively damp. These damp conditions can lead to secondary defects such as rot, rust or corrosion of associated building elements, the formation of fungal decay, or even the creation of potential slip hazards. When coupled with poor site drainage, pooling of water may also attract termite activity to this area. It is highly recommended that a qualified plumber be appointed to install adequate drainage to the overflow. These works will ensure that the area remains dry and free of any secondary defects.
