Building Inspection Report

Inspection Date: Wed, 18 Feb 2026

Property Address: 9 Murray Rd, CROYDON, VIC, 3136,
Australia

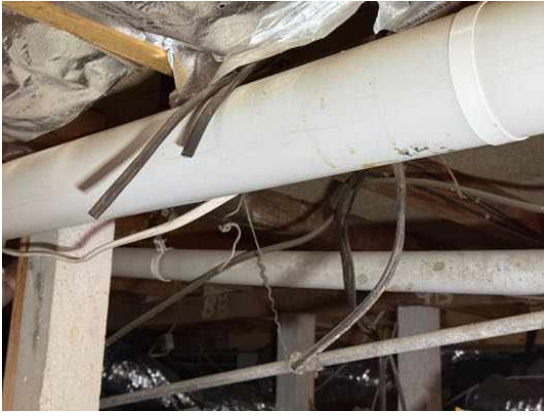
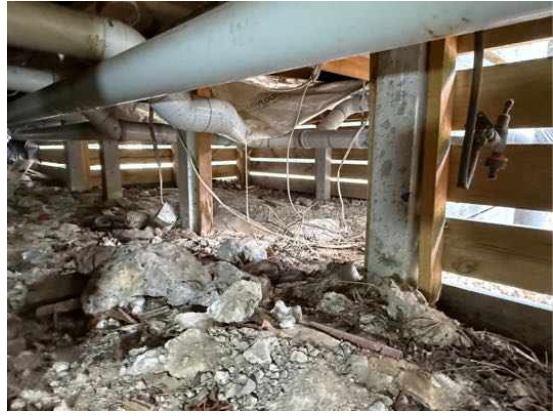
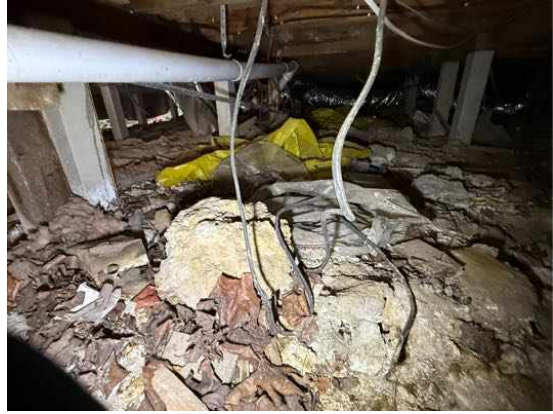
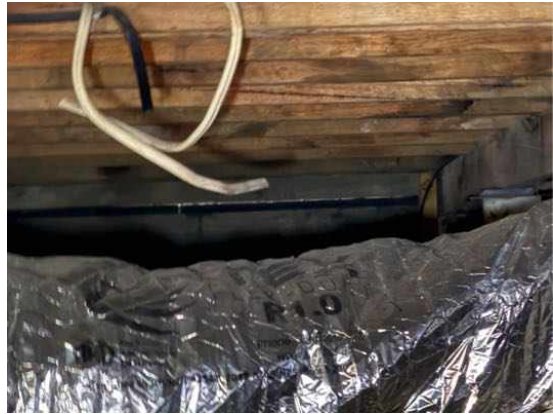
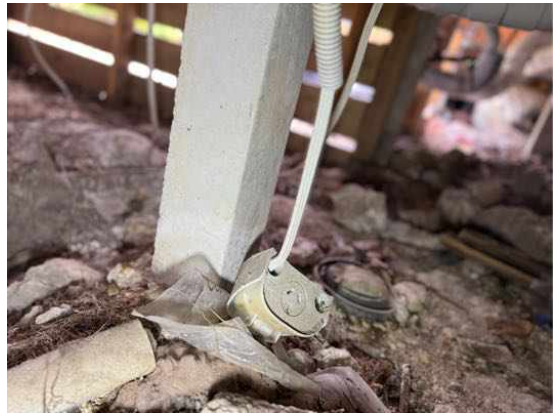
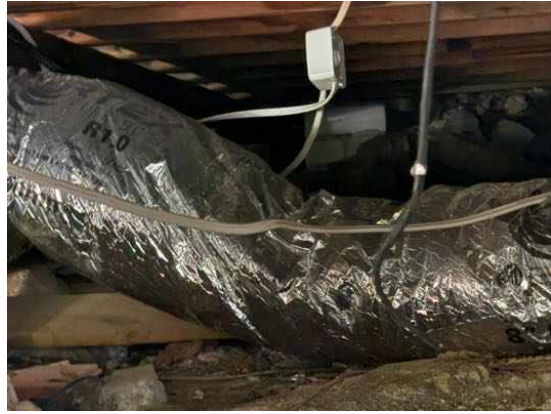
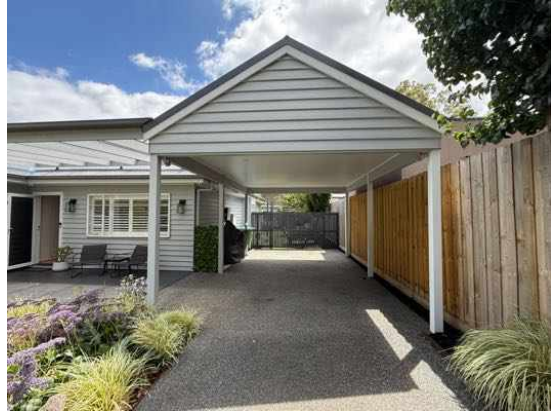
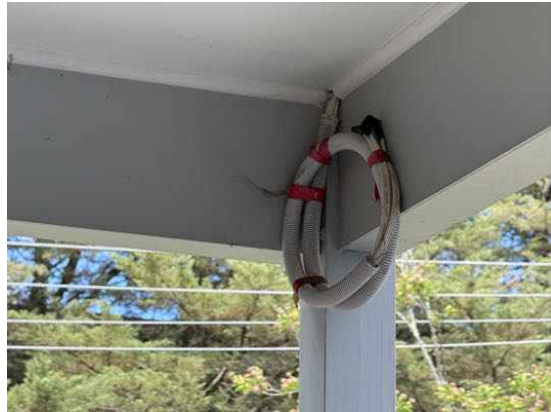
Defects 1.01

Building:	Building 1
Location:	All Areas > All Areas
Finding:	Electrical wiring in subfloor area
Information:	At the time of the inspection the subfloor area was considered to be a safety hazard to tradespersons and occupants that enter the subfloor area. Electrical wiring was observed in numerous areas not to be adequately clipped off and showed numerous areas of unprofessional work practices. Electrical wiring and fittings and not installed in a tradesmen like manner. With un-tradesmen like work practices shown in the subfloor areas, it is suspected that some areas may not have been installed by a licensed electrician and are considered a potential safety hazard including for fire and personal contact. Is recommended that the client contact a licensed electrician to investigate and carry out further inspection, where deemed necessary.

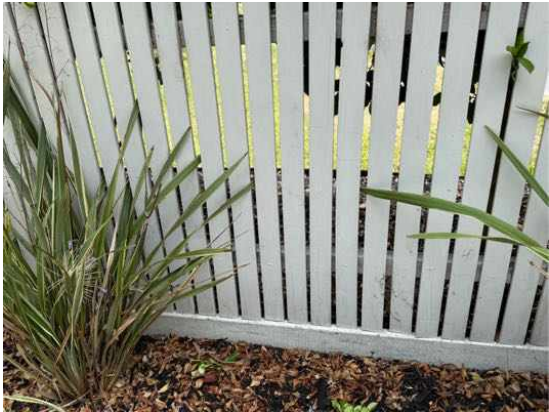
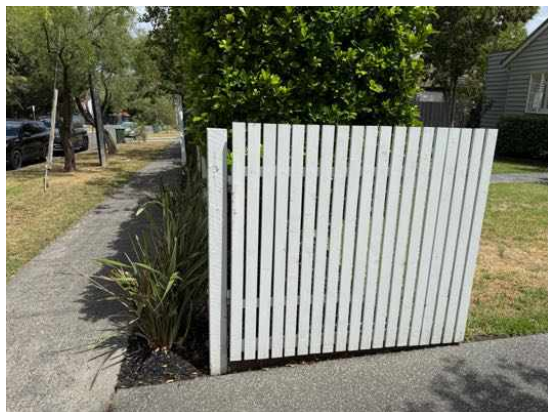
Defects 3.01

Building: Building 1
Location: All Areas > All Areas
Finding: Front picket fence show some damage and deterioration

Information: Some of the front picket fence posts appeared to be loose and wobble in the ground. Some areas showed some minor damage and deterioration. Some of the damage observed is suspected to have happened over time through normal exposure to extreme weather conditions.

However left unmanaged, further deterioration will develop over time, necessitating in further repair and or replacement of some sections. To maintain the security of the property these areas of the fencing should be repaired or replaced with either metal or pre-treated timbers. A qualified fencing contractor can be appointed to repair and replace the fencing where deemed to be necessary. This is at the client's discretion.

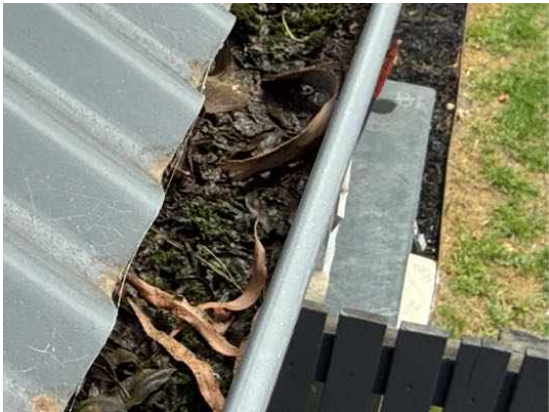
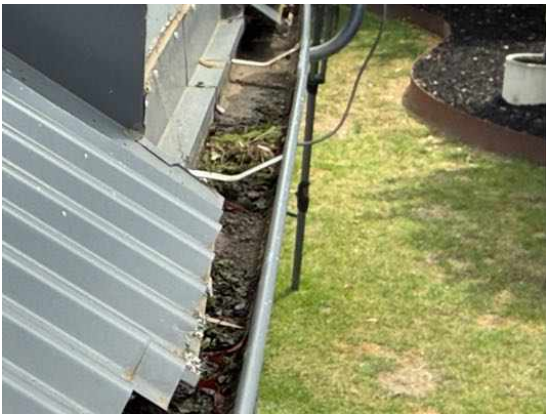
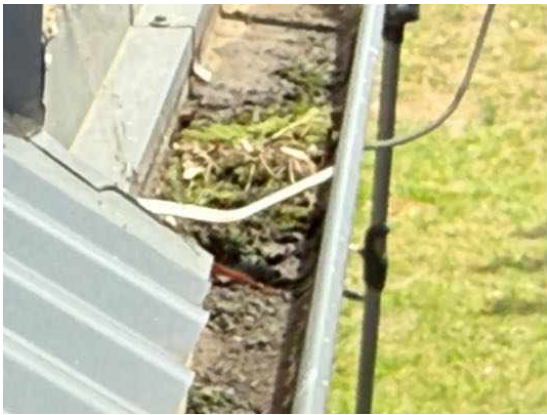
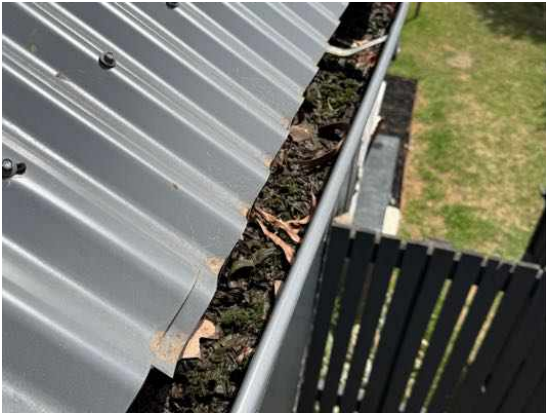
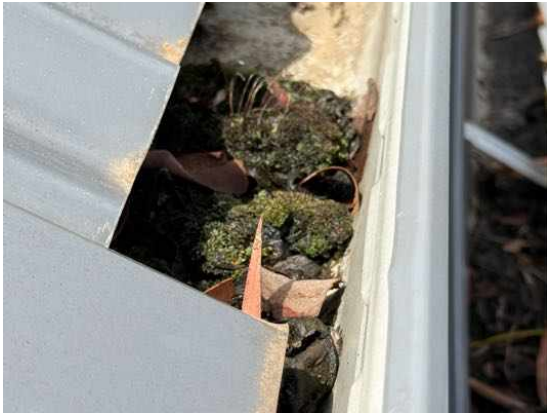
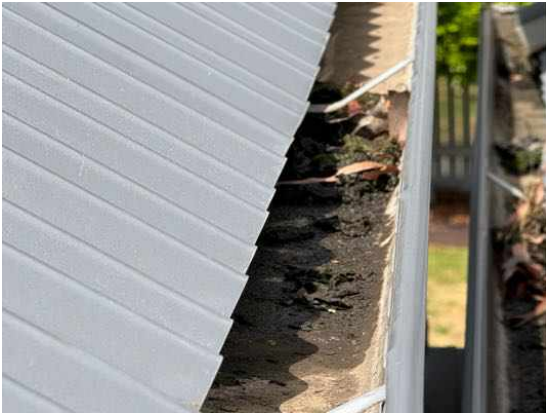
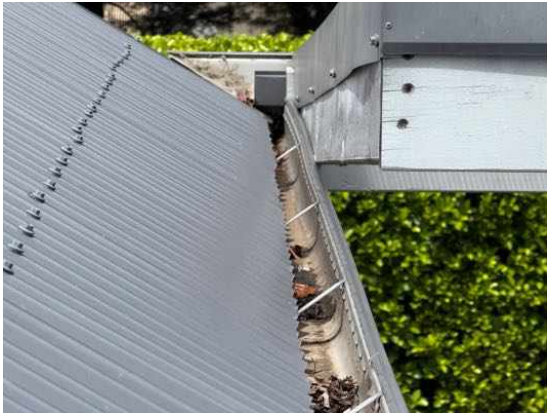
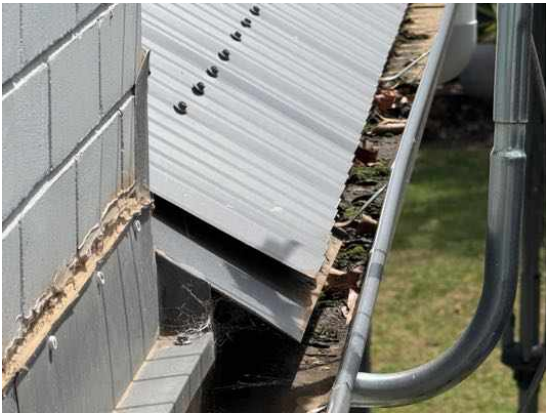
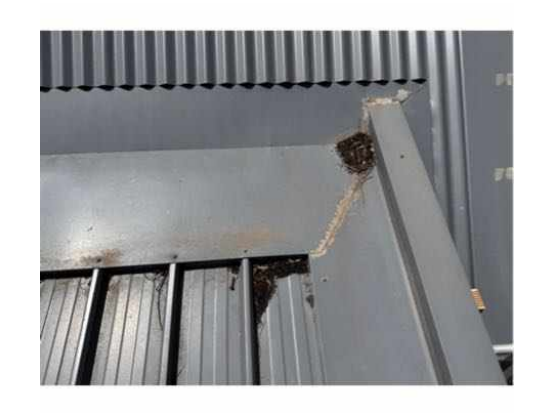
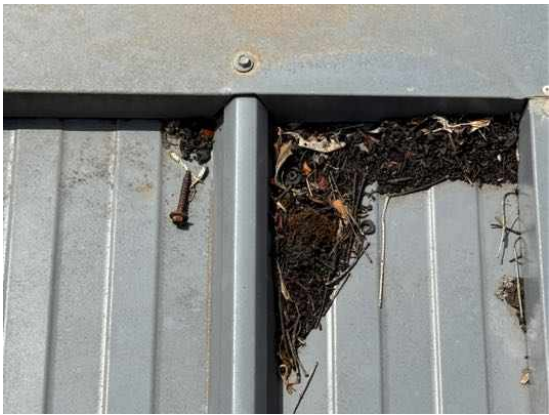
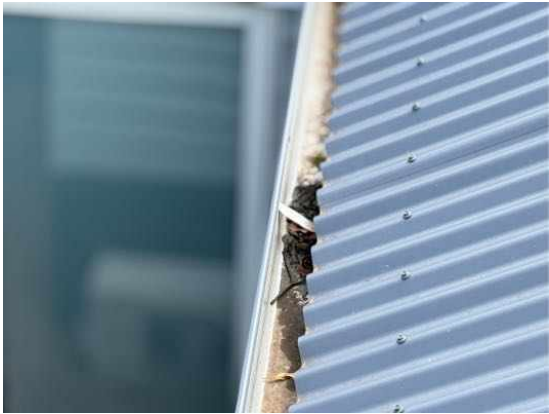
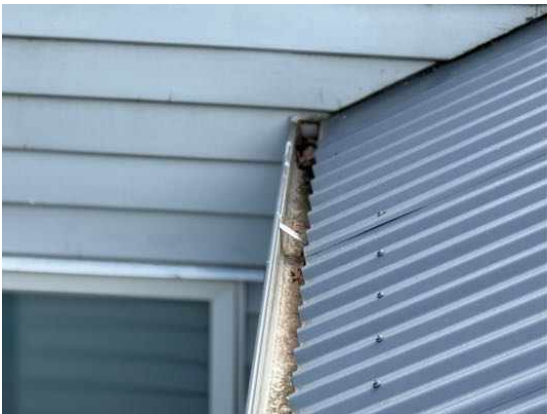
Defects 3.03

Building:	Building 1
Location:	All Areas > All Areas
Finding:	Gutters - partially blocked in some minor areas and minor water pooling
Information:	Gutters were observed to be partially blocked in some areas and water was found to be pooling in the carport roof guttering. Water pooling is generally a secondary defect caused by blocked or partially blocked gutters. Such blockages and subsequent water pooling is suspected to have rusted and deteriorated, water damage to

associated structures is likely to occur if left unattended over long periods of time.

Any areas of guttering that shows evidence of water pooling should be checked for partial or full blockages and any secondary damage that may have occurred as a result. Depending on the extent, building elements may require repair or adjustment to ensure adequate roof drainage and function of plumbing system.

A roofing plumber should be appointed in the future to rectify these issues. It is highly recommended that all gutters be well maintained on a frequent and periodic basis to ensure the best condition of all roof plumbing.

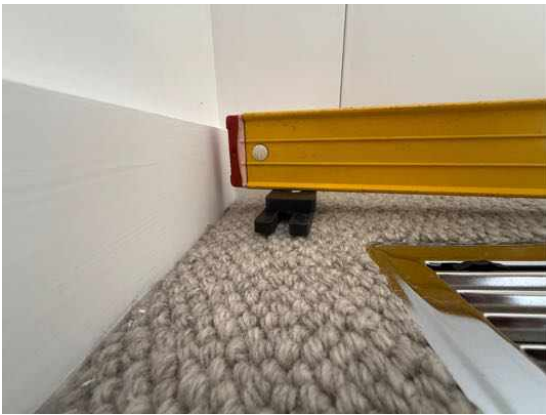
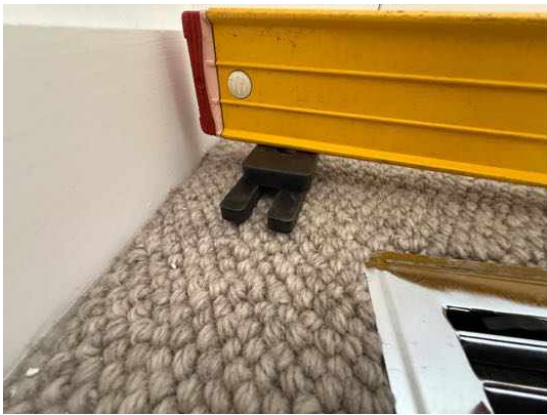
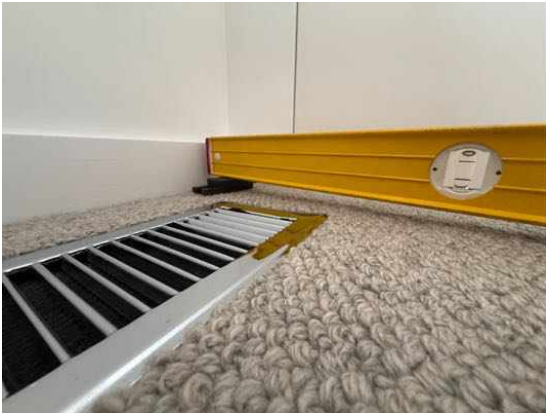
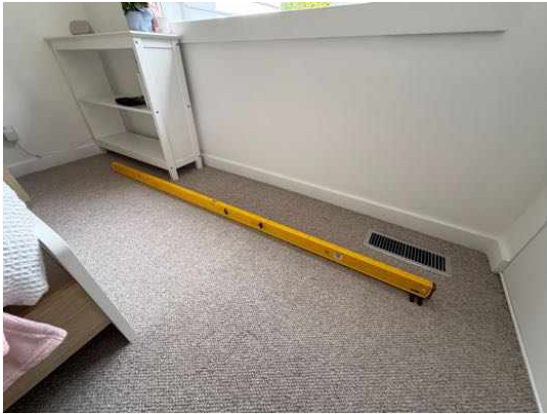
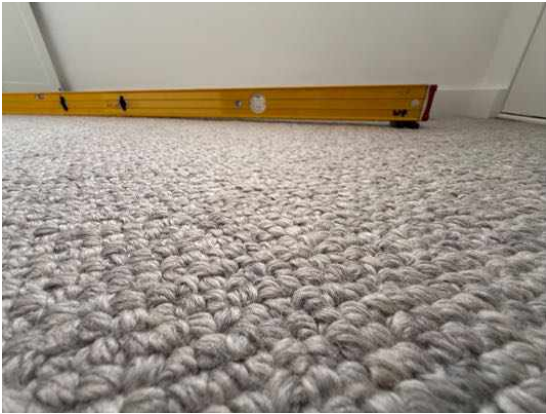
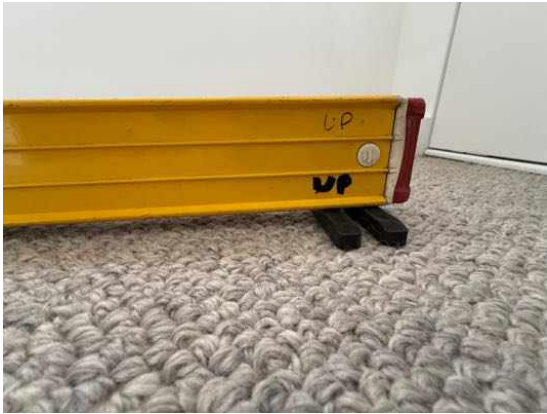
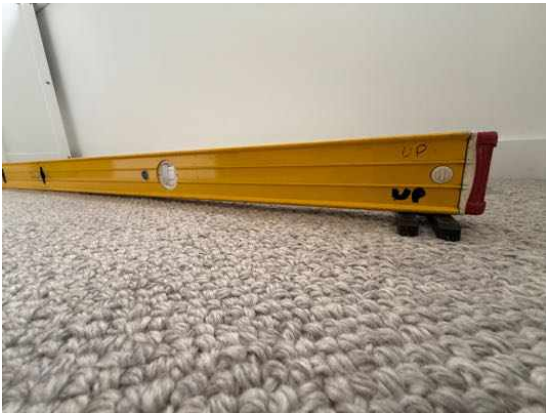
Defects 3.06

Building: Building 1
Location: Bedroom > All Areas
Finding: Bedroom floor levels
Information:

The internal bedroom floor was observed to be showing signs of being out of level and uneven. Uneven and out of level floors with a property of this age is considered in most cases to be normal however it was felt walking in this area meaning that in this area it was more than normal. The uneven and out of level floor is highly likely to indicate some subsidence and movement in the stumps and associated subfloor structures.

Floor levels can have complex and varying causes, which will influence the required remedial works where deemed to be necessary. Due to only observed in a small area of the home the client may continue to observe over a specific period of time for any changes or by consulting a registered builder who has expertise in re-stumping to determine the required scope of works that may be deemed necessary. This may include some form of packing the subfloor in some areas, at the same time as addressing the underlying cause of the uneven and out of level floors. Client may also consider an additional consultation with a geotechnical engineer to understand what and how the surrounding soil is reacting to surrounding moisture. These options are at the clients discretion.

It is advised that the floors be closely monitored to identify any further movement even after any floors have been rectified. Where flooring is uneven further, a potentially invasive inspection of the subfloor stumps and floor structures is required.

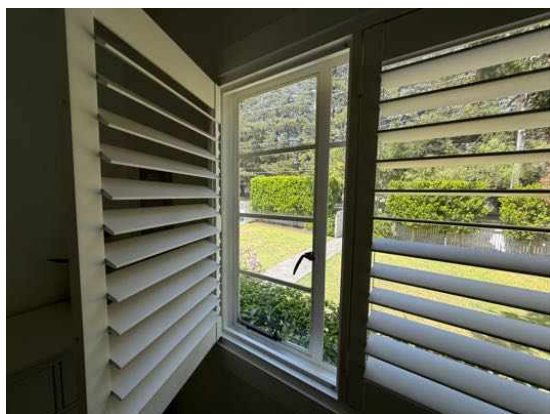
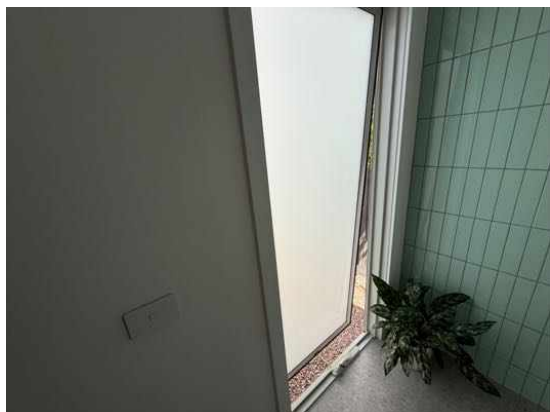
Defects 3.07

Building: Building 1
Location: All Areas > All Areas
Finding: Flyscreens
Information: Numerous flyscreens were found to be missing to the windows throughout the home at the time of inspection. Whether the flyscreens have not been installed or have been removed for maintenance and or painting purposes, this missing building element detracts from the operational state of the window.

Where not replaced, missing flyscreens allow pest and insect ingress into the adjoining room/s. It is advised that all missing building elements be installed or replaced in order to ensure the full function of all building structures.

A qualified carpenter may be appointed to replace flyscreens at the discretion of the client.

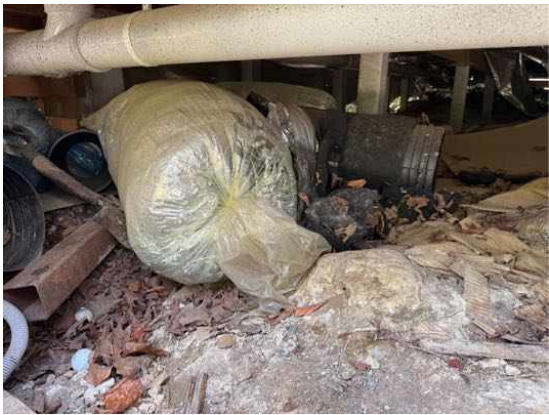
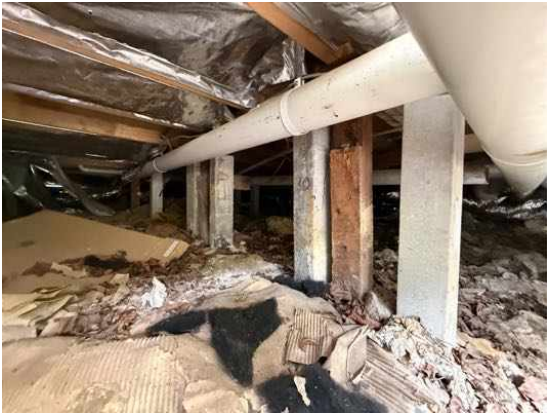
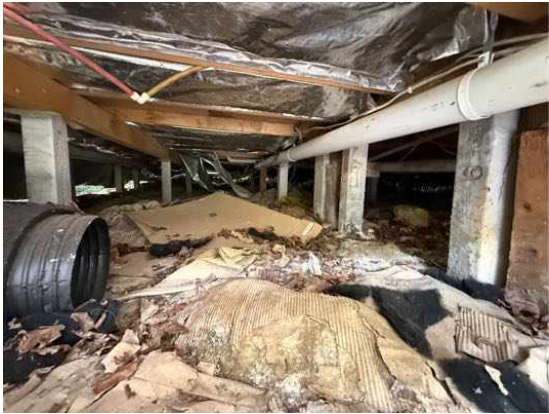
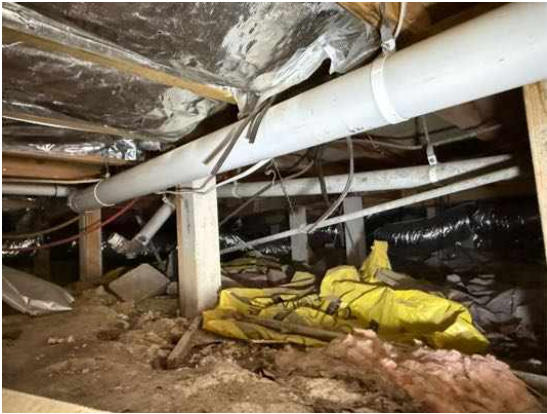
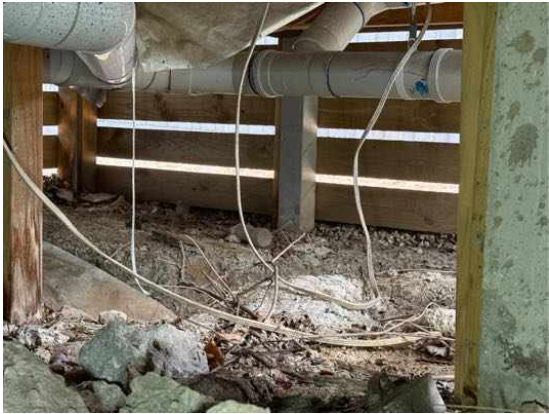
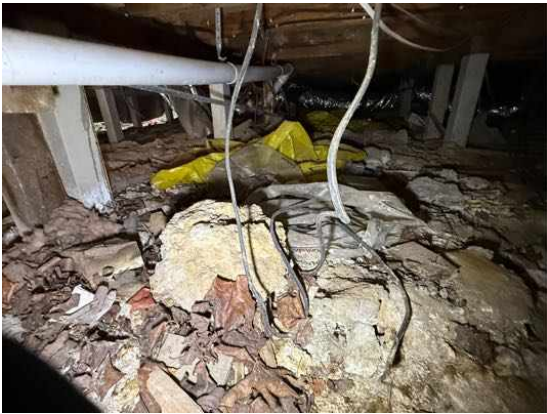
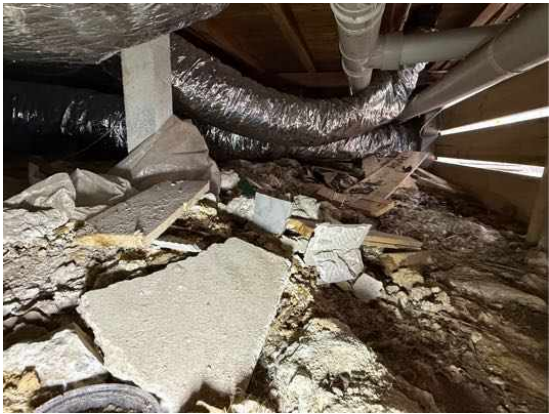
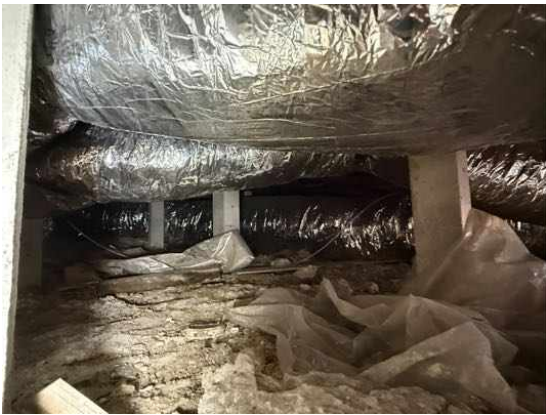
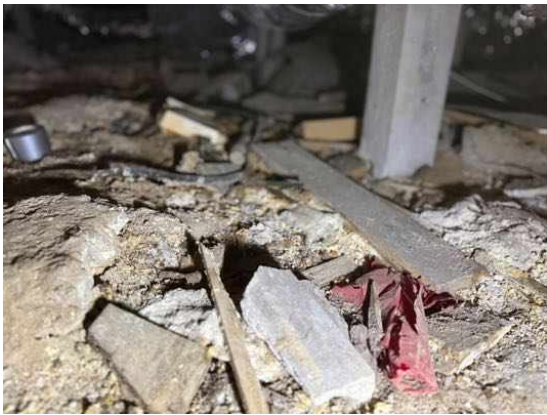
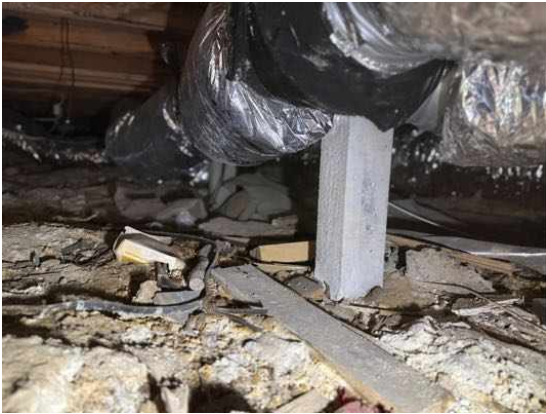
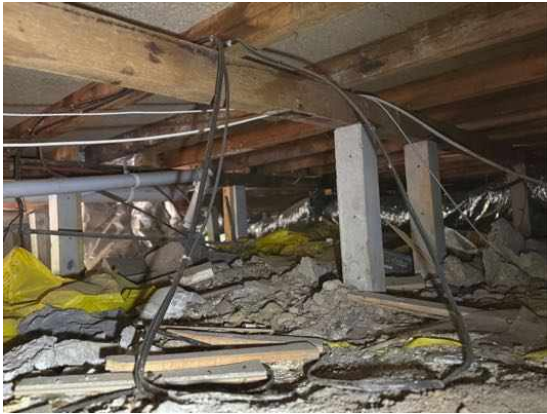
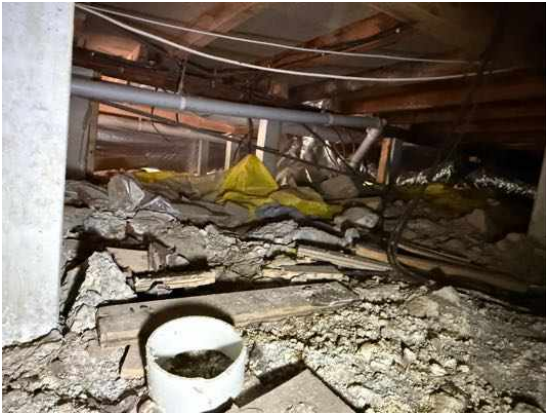
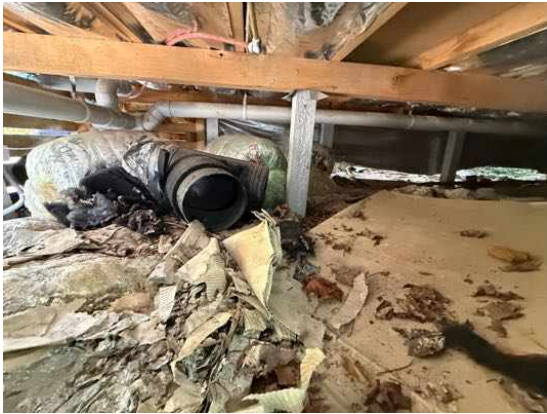
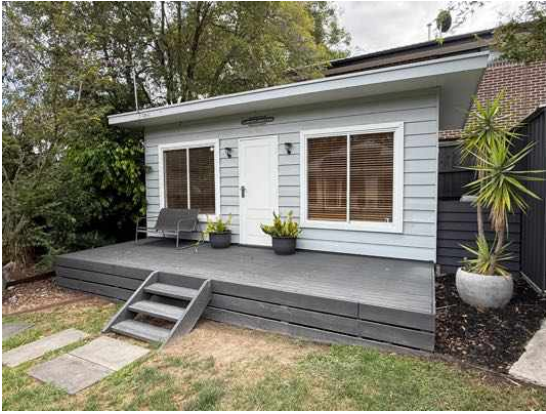
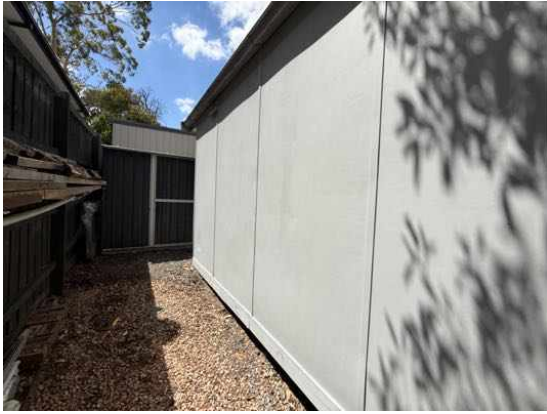
Defects 3.08

Building:	Building 1
Location:	All Areas > All Areas
Finding:	Subfloor - Debris
Information:	A minor array of debris was found in the subfloor area at the time of inspection. Debris in this area restricts subfloor ventilation and creates potential for concealed pest entry. Stored household goods and other materials may also make these areas susceptible to termite activity, insects and vermin. A clear and empty subfloor will be better ventilated and easier to maintain in a dry condition. The removal of any debris is vital in minimising the risk of termite, insects, rats, mice or wood borer activity.

Debris in the subfloor should be removed in the short to medium term future. Depending on the location and amount of debris and stored items, the homeowner may elect to undertake this task. Alternatively there are a large number of rubbish removal subcontractors that could undertake these works.

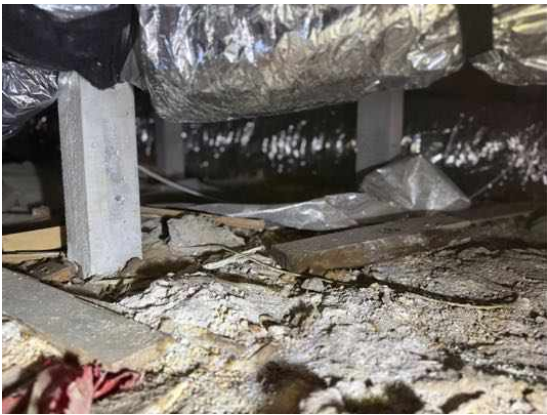
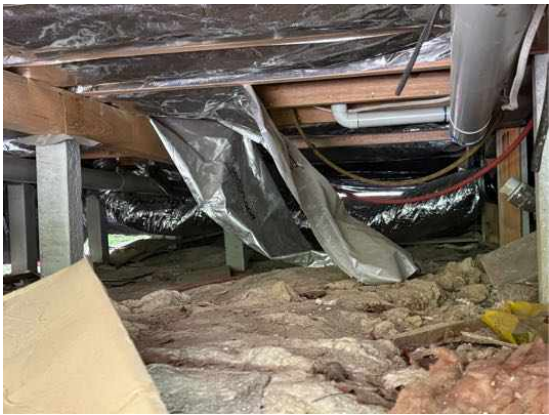
Defects 3.09

Building:	Building 1
Location:	All Areas > All Areas
Finding:	Subfloor heating / cooling ducts
Information:	Some of the subfloor heating / cooling ducts could be better supported so as not to sit on the ground. When ducting is found to be hanging down and rubbing on the ground, it is suspected that more support for the ducting is required to ensure ducts are as efficient as possible, subfloor ducting will not be running at a fully operational level. Generally, damage to ducts occurs as a result of aging and material deterioration, vermin damage or when they hang or touch the ground they are more likely to be impacted by rats, mice or other vermin and pests.

The ducts require remedial work to add better support throughout the subfloor area to ensure smooth air flow for increased energy efficiency. The airflow within the property is likely to be restricted, particularly in areas where ducting shows signs of minimal support or minor damage. A heating/cooling specialist or a relevant tradespersons should be appointed to provide remedial work and to perform any works deemed necessary.

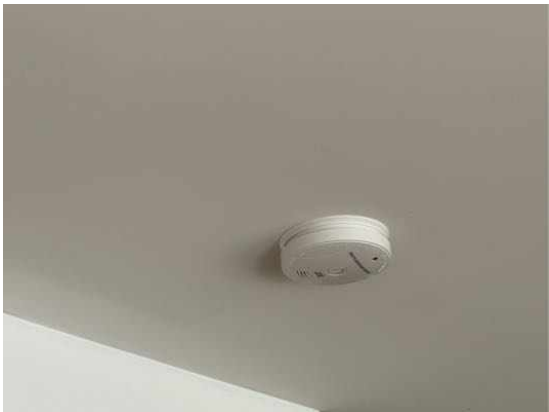
Building: Building 1
Location: All Areas > All Areas
Finding: Smoke detectors and alarms
Information: Reporting on Smoke Detectors or Alarms, including hard wired smoke detection systems and their legislative requirements, is outside the Scope of this Report. Please note that this defect is highlighted as a caution only. We suspect, based on our experience in the building industry, that smoke detectors are sometimes get overlooked, or they may be in a poor condition, so we recommend that they always should be addressed prior to occupation to improve occupant safety.

Always ensure sufficient working and suitable smoke detectors are installed prior and during to occupying any building. Additionally, it is advised that all smoke detectors be tested by the homeowner on a monthly basis.

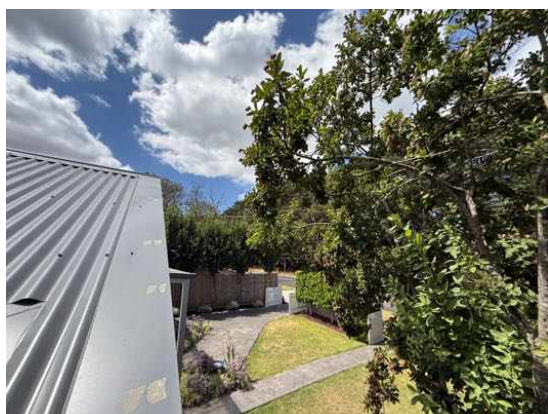
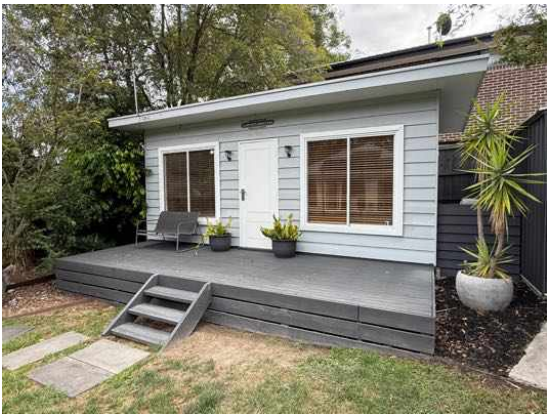
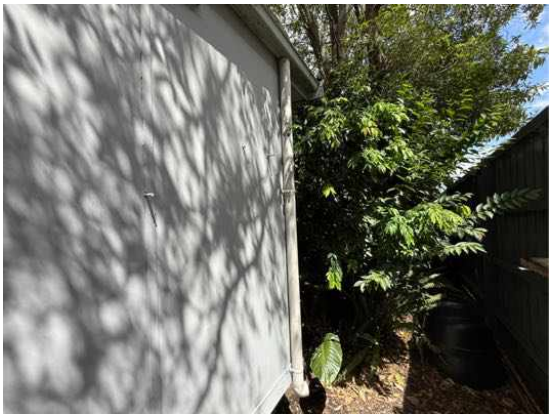
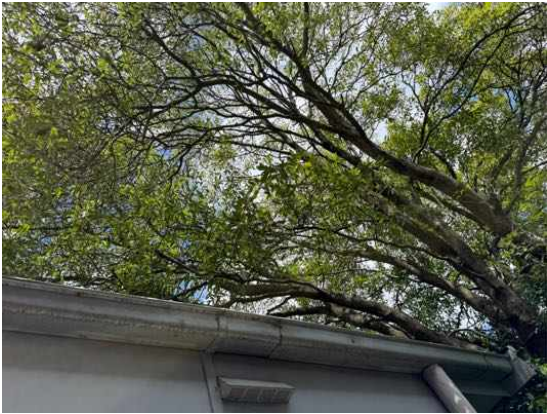
Finding: Trees - Surrounding or overhanging trees are filling gutters

Information: Some trees around the property or neighbouring properties are highly suspected to be littering the roof with excessive leaf matter. The perimeter gutters, downpipes and drainage systems with excessive amounts of leaf matter and other debris which is suspected to eventually filter through the top holes of the gutter guard and into the gutters.

Gutters are a critical part of the building's management of storm water and rain. It is therefore important that they be kept clear to prevent secondary damage to associated building elements, including exterior and interior walls, ceiling linings and any adjoining building elements. It is therefore recommended that all trees close or near by the home be trimmed down and all overhanging tree branches be removed. Such works should be performed by the relevant tradespersons, appointed arborist or landscape contractor may be required.

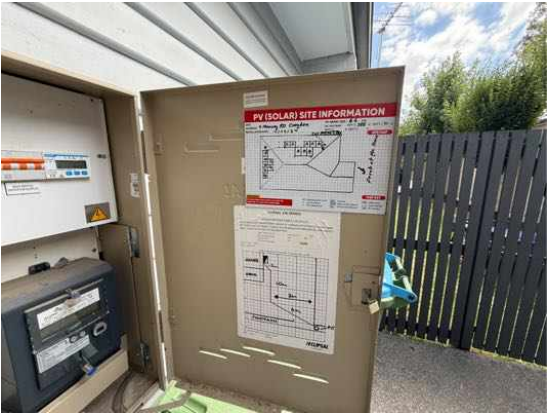
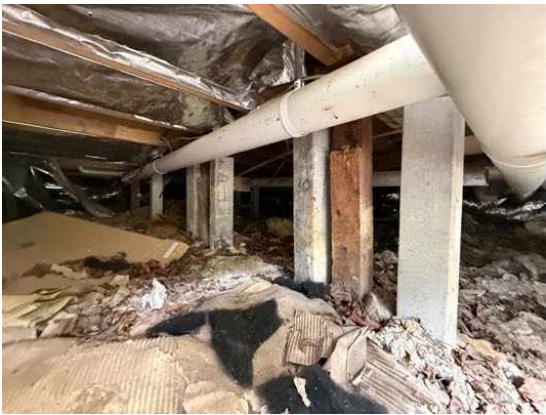
Building: Building 1
 Location: All Areas > All Areas
 Finding: Termite Management System - no evidence of a chemical installation or durable notice
 Information: At the time of the inspection no application of a chemical termite barrier or durable notice was observed. Such barriers are highly effective and highly recommended for all properties in preventing termite attack on any timber building elements throughout the property.

A durable notice should be placed in the switchboard unit or in the another accessible area to indicate current termite barriers. At the time of inspection, no evidence to suggest preventative works taking place. The client may consider gaining further advice from builders or a pest controller and as to the costs and procedures involved with this application. It is recommended that obtaining such advice be a short-term priority.

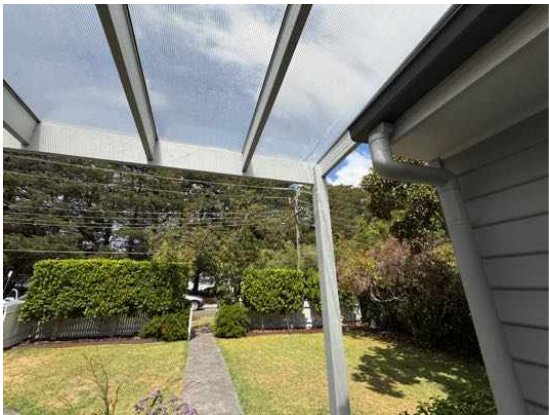
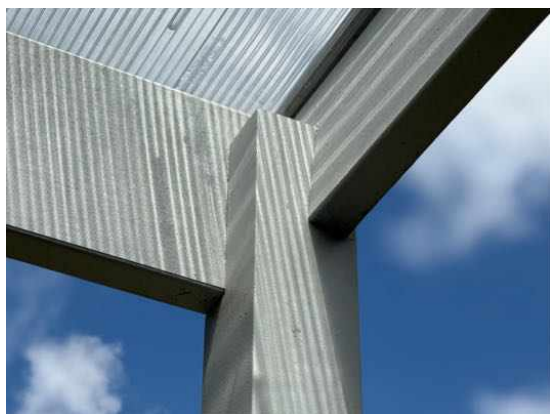
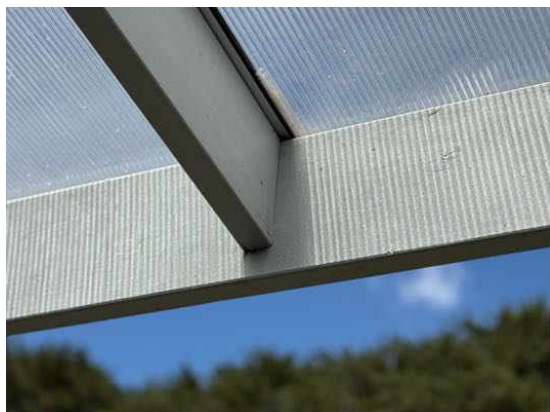
Building: Building 1
Location: All Areas > All Areas
Finding: Building elements such as rafter brackets and post bolts not installed
Information: The front pergola rafter brackets and post bolts were observed to have been omitted or missing at the time of the inspection. These roof areas have not had rafter brackets installed to the rafters and perimeter beams, these types of building elements will improve the longevity of the building structure as it becomes aged and deteriorated. Although some building elements may seem irrelevant or unnecessary, all building elements play a key role in the operation and function of the overall structure and its performance.

All maintenance or replacement of any missing building elements should be conducted to ensure that no secondary damage or functional issues occur in the future to associated building elements or materials not being installed. A qualified carpenter or another appropriate tradesperson should be appointed to maintain or replace the missing building elements or materials deemed necessary.

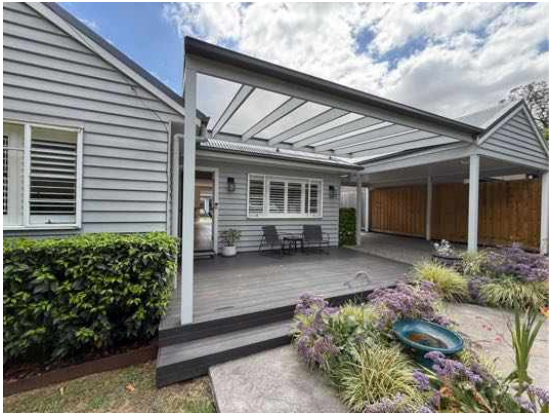
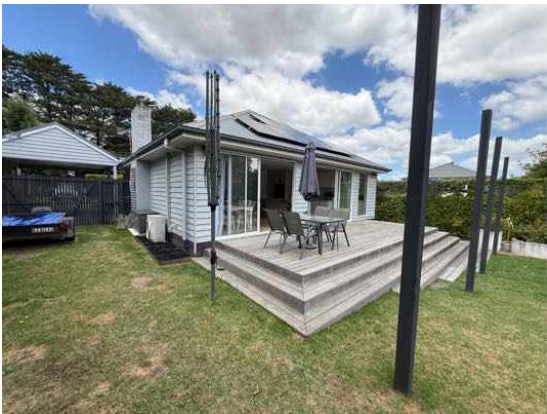
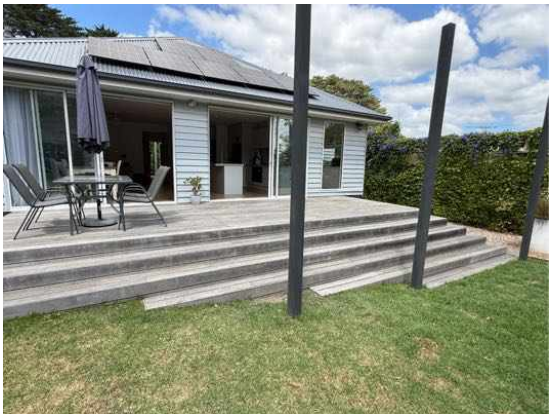
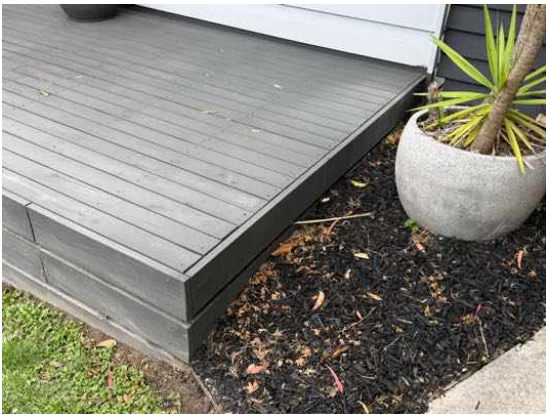
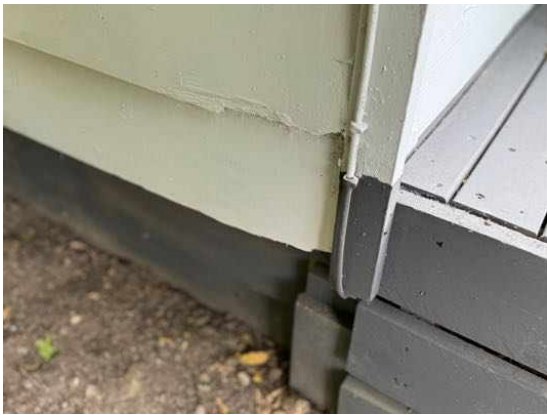
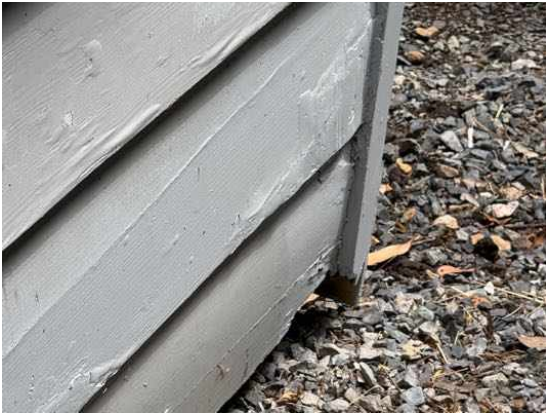
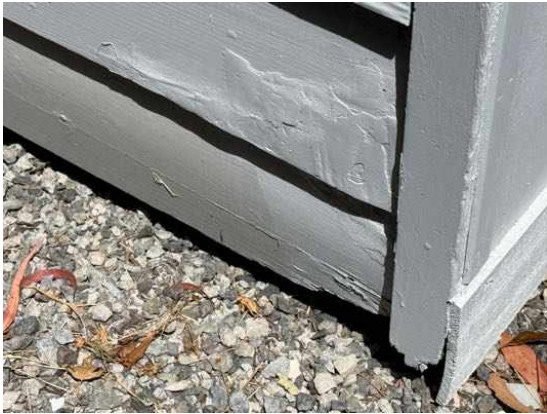
Building:	Building 1
Location:	All Areas > All Areas
Finding:	Deck timbers that are in or close to the ground and exposed to extreme weather conditions
Information:	It was observed that the timber deck structures were sitting close to the ground soil which exposes these timbers to accelerated damage and deterioration over time. It is good practice to have a minimum of at least 200mm away from the ground soil to the timber. Due to the susceptibility to wood rot and deterioration over a prolonged period of time. Good airflow through the subfloor areas should also be maintained to ensure a healthy environment. The client should be prepared that in purchasing a property, that some remedial work in the near future will be required to paint and preserve these timber deck areas that are frequently susceptible to excessive moisture from extreme exterior weather conditions.

External timbers that are frequently exposed to harsh and extreme weather conditions and sitting in the ground or close to the soil will require adequate protection and maintenance in order to maintain their condition. Any timbers that are exposed to harsh weather conditions and moisture from ground contact, exposes these areas to accelerated damage and deterioration. Where timbers have not been painted or protected properly or treated adequately, will show signs of general deterioration which is likely to occur at an accelerated rate. If left unattended, replacement of these timbers is likely to be necessary in the future. Adequate treatment of these timbers is

required by a painting contractor, home owner or general handyman.
