Building and Timber Pest Inspection Report

Inspection Date: Thu, 22 Jan 2026

Property Address: 21 St John St, Adelaide SA 5000, Australia

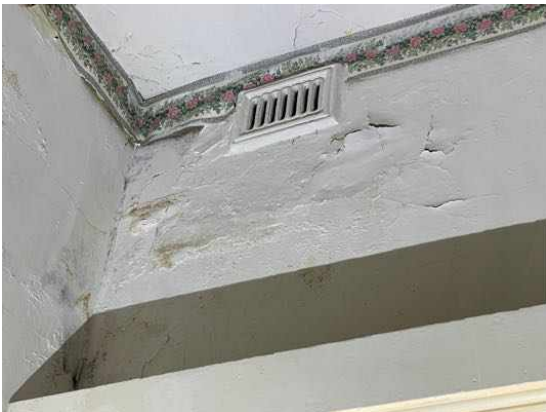
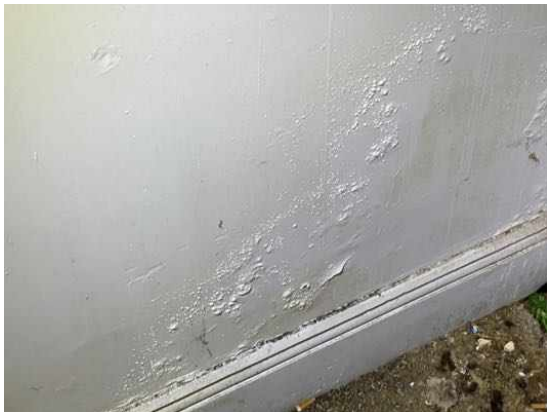
Building:	Main Building
Location:	Bedroom
Finding:	Water Leak Evident on Ceiling
Information:	The roof is suspected to be leaking to the bedroom in front of the left courtyard. Evidence of moisture damage and water staining was present to the walls in this area.

No high moisture was recorded in these areas at the time of inspection, however recent relatively dry weather may hinder the detection of moisture.

A licenced roofing plumber should be appointed as soon as possible to identify any and all sources of the leak and perform rectification works as necessary, ensuring the water damage is restricted, and the chance of further damage nullified.

Once the leak is repaired, consultation with relevant licenced tradespeople, including plasterers and painters, is advised. Rectification works may include replacement of ceiling lining or minor repainting, depending on the extent of the damage.

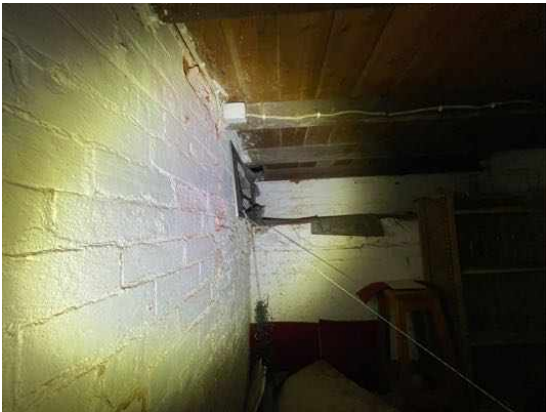
Building: Main Building
Location: All Areas
Finding: Damp - Rising
Information: Rising damp and evidence of damages likely caused by rising damp was identified throughout the masonry walls of the dwelling at the time of inspection. Although not all areas had high moisture recorded at the time of inspection, recent consistent dry weather may have contributed to a lack of moisture in the walls at this time of inspection. Changes in weather and return of damp or wet weather will likely lead to moisture issues returning in the future if the deteriorating areas are not rectified.

Damp damages were visible to the walls in the left side courtyard area, however this area was not accessible at time inspection. This damage could only be viewed through the window. It is suspected that this area may lack adequate drainage, provision for access should be made so further investigation can be carried out in this area.

The evidence of damp in this building includes areas of high moisture, a white salt line to several walls which is suspected to be an indicator of the height moisture has reached in the walls, and multiple areas of damaged, bubbling or deteriorating plaster. It is suspected that rising damp has been highly contributive to termite damage around these areas.

The first step in addressing rising damp is to diagnose the cause. The identified cause should be addressed first before addressing the appearance and other defects which have resulted from the rising damp. If the original cause is not resolved, further cases of damp are likely to ensue, resulting in secondary defects.

Consultation with a Damp proof specialist is advised immediately to identify the cause of the damp and perform remedial works as required.

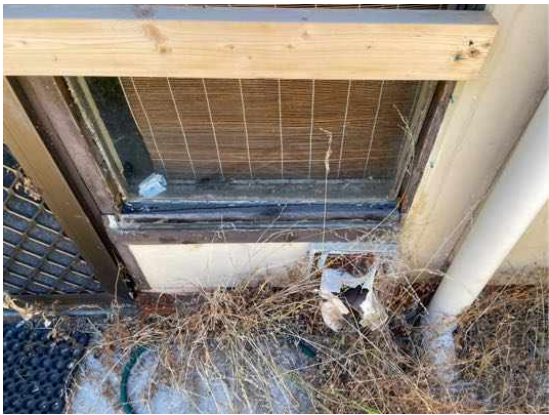
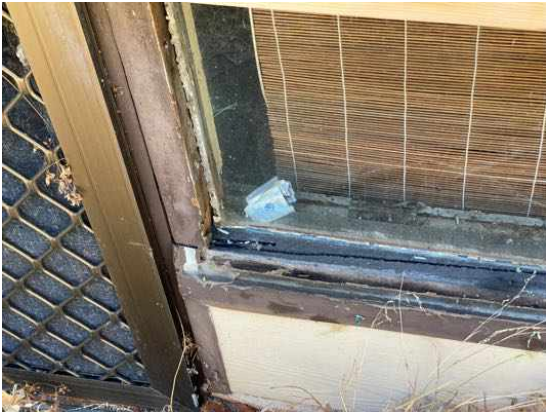
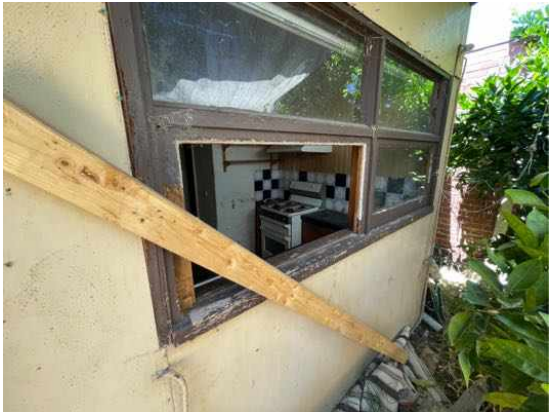
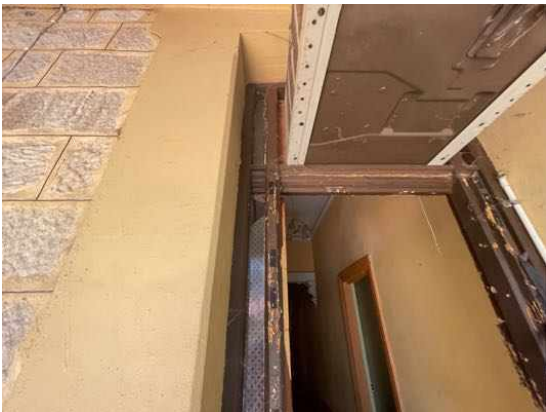
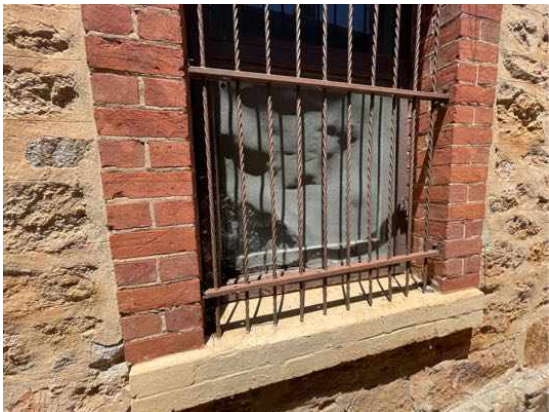
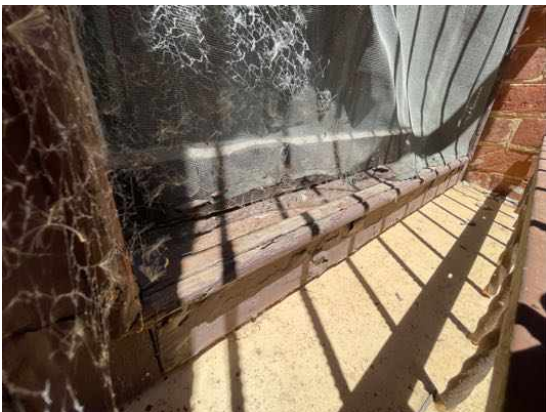
Building:	Main Building
Location:	All Areas
Finding:	Windows and Doors - Damaged
Information:	The building is in a poor condition at the time inspection with advanced deterioration, wear and tear damages, as well as physical vandal damages to most doors, door frames, window and window frames.

Damaged and deteriorated doors and windows will impair the weather tightness of the building, creating potential for water leaks.

Where replacement of the windows and doors is required a licenced builder or carpenter should be engaged. Please be advised that any persons coming into contact with broken glass windows should do so with due caution to avoid any personal injury that may ensue.

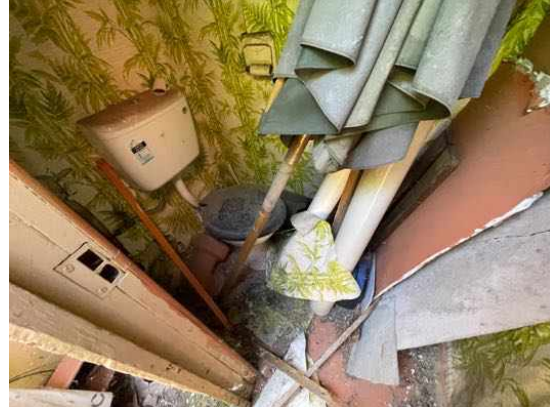
Finding: Bathroom - Poor condition

Information: The rear toilet access by the backyard was in an extremely poor condition at the time of inspection. This area appeared to be used as a storeroom and as such no access was available to test function of the toilet. The door and walls surrounding the area are all in a poor condition.

This bathroom is unlikely to function correctly and extremely likely to lead to further defects or deterioration of surrounding building elements.

Full renovation is likely required and should be performed before the building is occupied, its is recommended that further invasive inspection to the internals of the walls should be conducted to asses the condition of the walls.

Consultation with a licenced builder is required immediately.

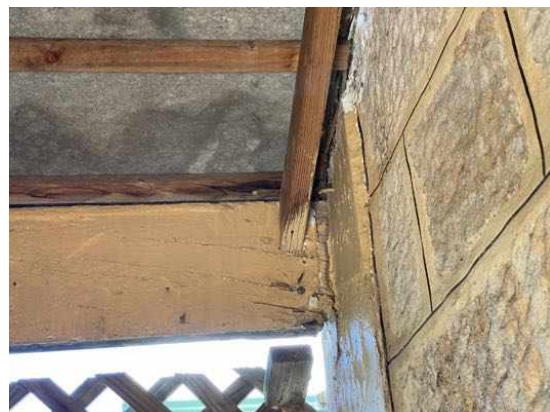
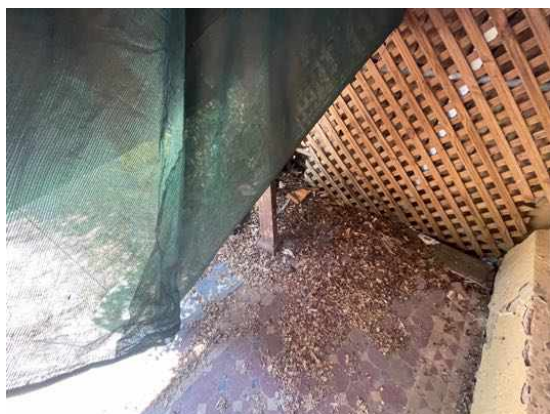
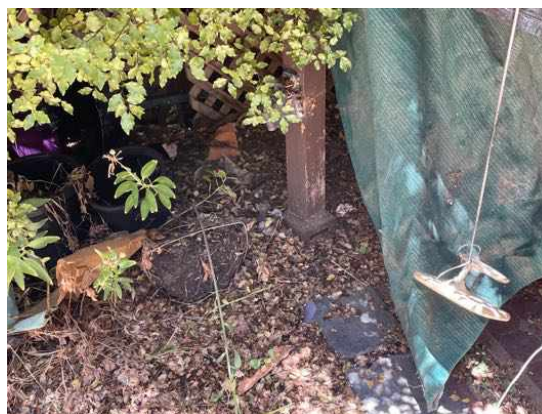
Finding: Verandah posts - Damaged

Information: The front verandah posts to the left corner is heavily twisted. Such damage will likely compromise the structural integrity of the verandah. A replacement of the damaged post may be required in this area to prevent the possible future failing of the front verandah.

A qualified carpenter or registered builder is required to repair or replace affected building materials as soon as possible.

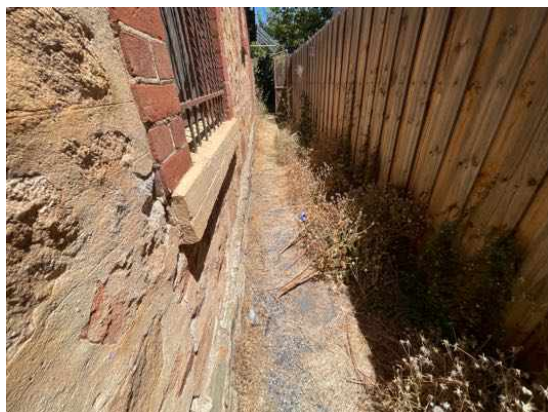
Perimeter bare ground levels should fall away from the house by 50mm in the first meter. This standard ensures that water cannot pool against the sides of the building.

Where ground levels do not have adequate fall, a licensed paving contractor should be appointed to install pavement to a correct fall. Garden beds should be removed from close proximity to the building.

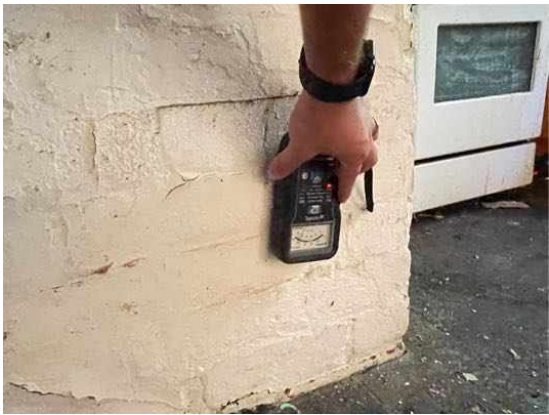
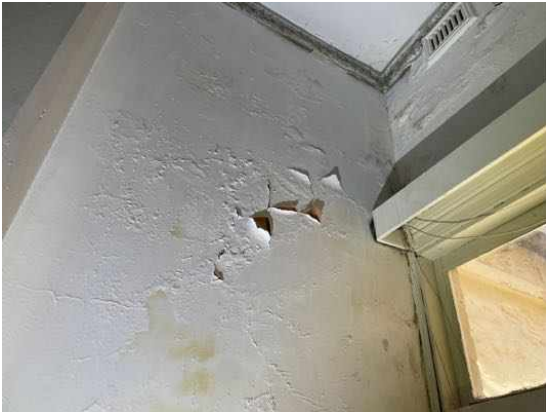
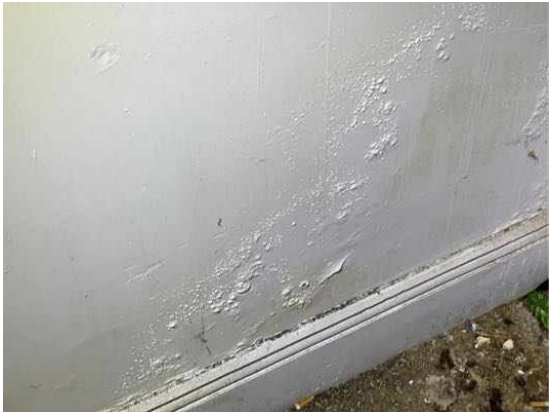
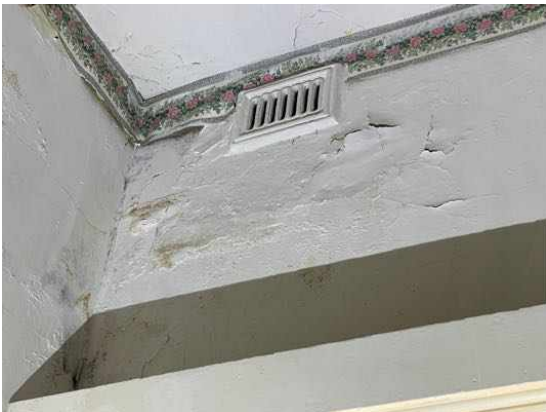
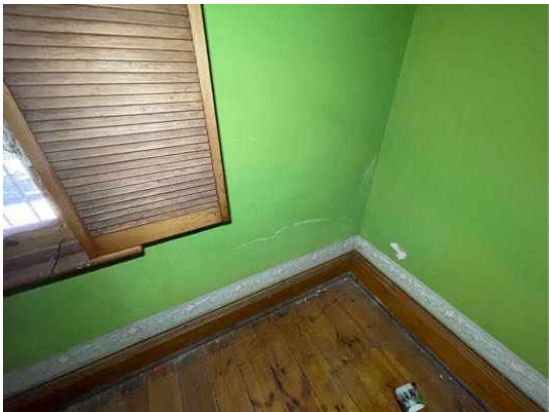
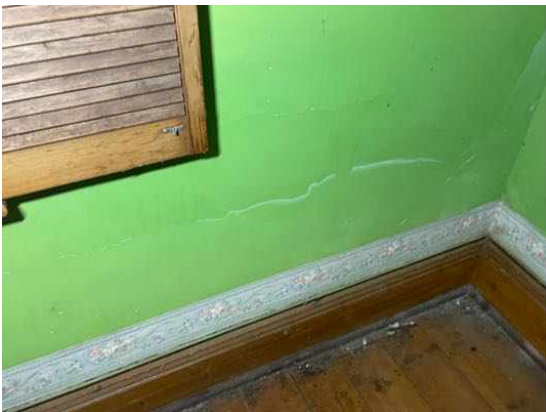
Building:	Main Building
Location:	All Areas
Finding:	Evidence of current or previous excessive moisture was present at the time of inspection
Information:	Excessive moisture can attract termites and produce conditions that promote termite attack fungal growth and wood decay.

Excessive moisture is generally caused by deterioration or leaking to wet areas, inadequate or missing roof drainage leaking plumbing pipes or fixtures poorly plumbed HWS overflows or condenser units and poor site drainage.

It is highly recommended that all plumbing and drainage fixtures and fittings be maintained regularly in order to prevent excessive moisture being present in the external / internal property.

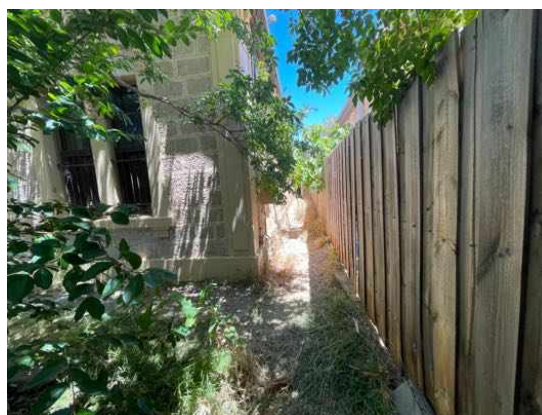
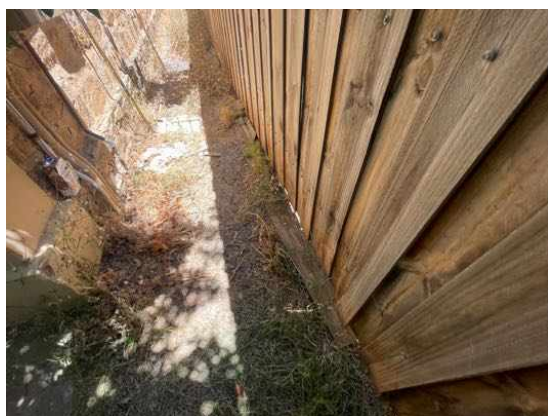
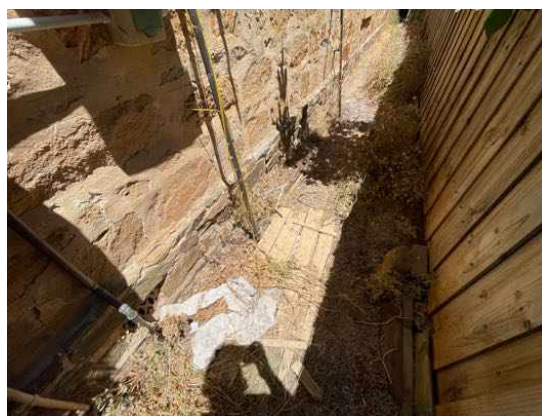
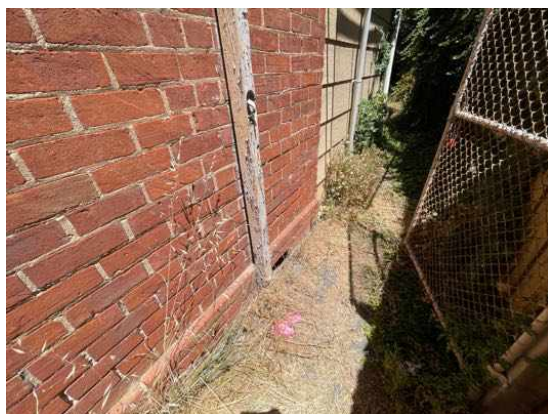
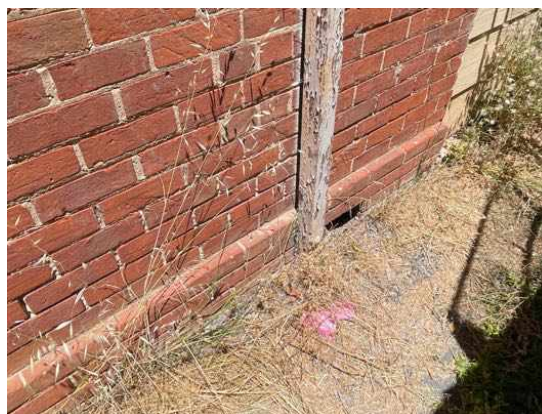
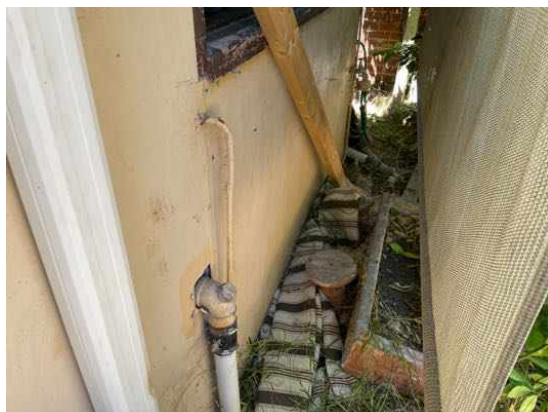
Building: Main Building
Location: All External Areas
Finding: Timber - In ground contact
Information: Any timbers in direct ground contact provide opportunity for concealed termite entry and are likely to be subject to premature rot and decay as the soil retains moisture or damp conditions against the timbers. This includes but is not limited to, tree stumps, timber sleepers, loose branches, timber pallets and loose timbers, firewood piles and timber elements of external structures.

Remove untreated timber that is in direct contact with external grounds. Consider replacement with more durable materials i.e. treated timber or non timber elements. Frequent pest inspections are advised to readily identify any termite activity in these areas.

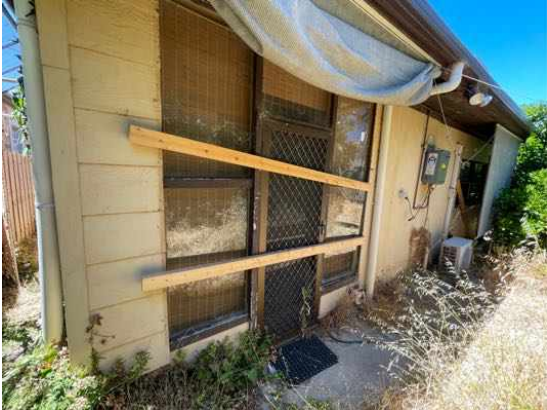
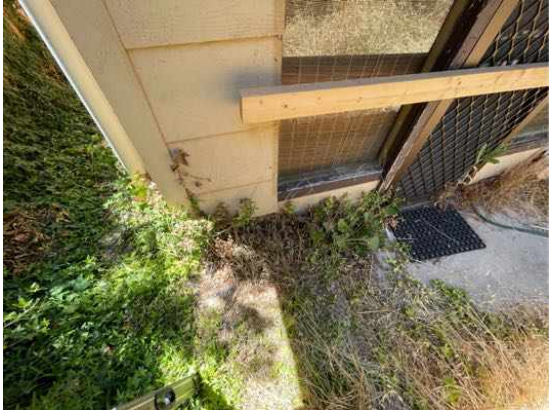
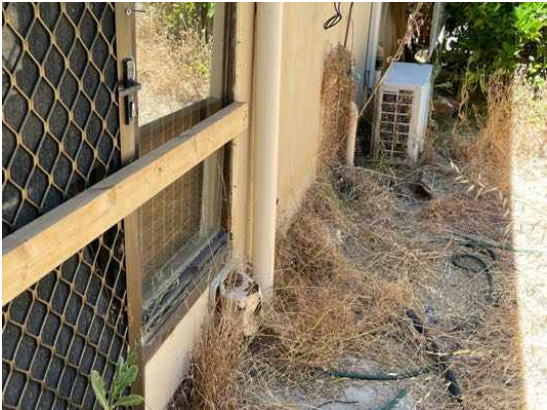
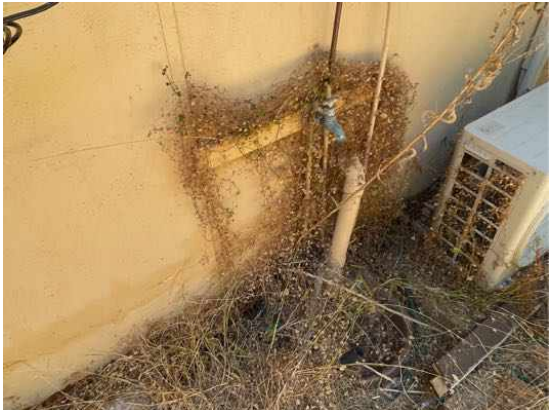
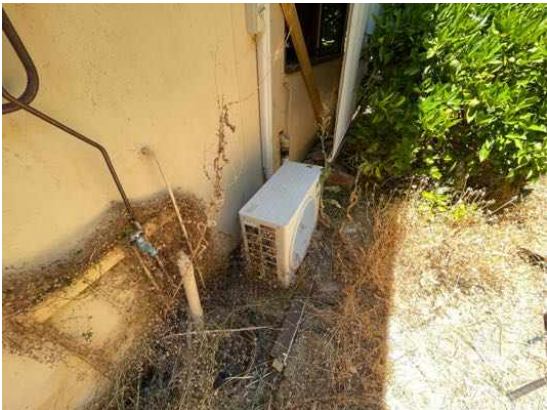
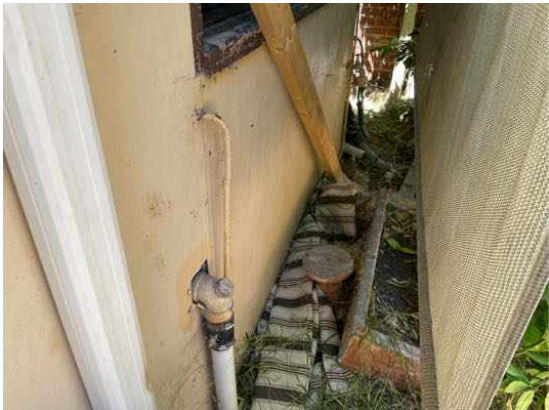
Building:	Main Building
Location:	All External Areas
Finding:	Bridging
Information:	Bridging is the spanning of a termite barrier or inspection zone so that subterranean termites are provided with passage over or around that barrier.

Generally this takes the form of finished ground levels external paving or concrete being retrospectively installed above the damp course level, the adjacent internal floor level or weep and ventilation holes, but may also take the form of building elements (ie; gate or fence posts, down pipes, air conditioning units, etc) or stored items covering the span of the inspection zone.

Where bridging has occurred full inspection is prevented and termites may enter a property in a concealed or undetectable manner.
