Building and Timber Pest Inspection Report

Inspection Date: Fri, 16 Jan 2026

Property Address: 6 Java Court, Kialla VIC 3631, Australia

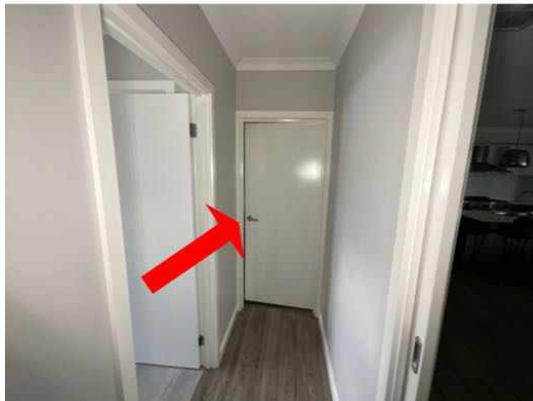
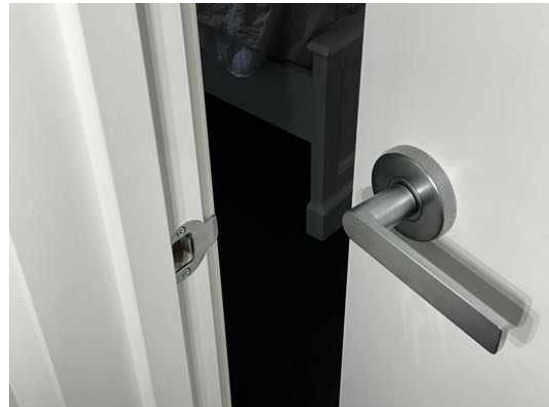
Finding 3.01

Building: Building 1
 Location: Bedroom 2
 Finding: Door - Striker plate misaligned
 Information: The striker plate to this door appears to have become misaligned and has consequently resulted in the door's operation being compromised.

This is a common defect and is expected in a property of this age, whether being due to substandard installation or general deterioration of the door hardware.

Readjustment of the striker plate is recommended at client discretion. Works such as these can be completed by a general handyman or qualified carpenter.

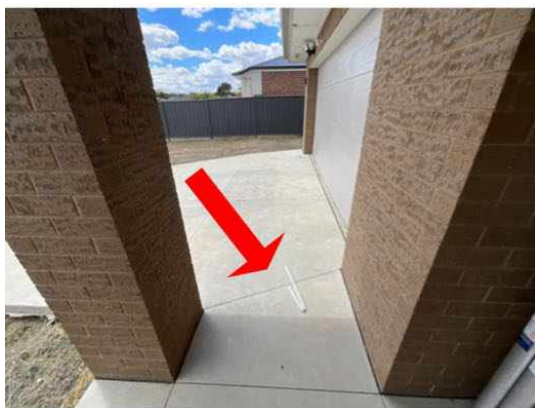
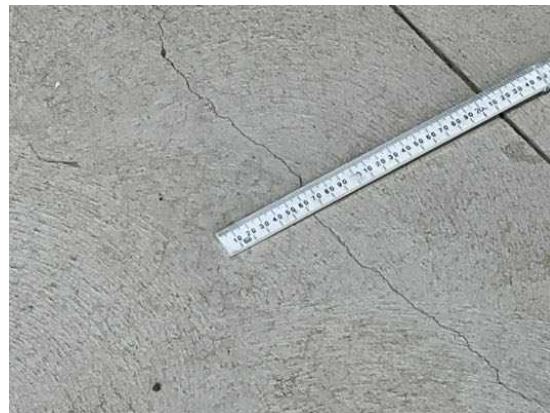
Finding 3.02

Building: Building 1
 Location: Driveway area
 Finding: Cracking - External Concrete Paving Damage Category 1 - Fine (less than 2mm)
 Information: Fine cracks were identified in external concrete paving. Although fine cracks are quite noticeable, they are often only considered to be an appearance defect, and usually do not indicate any structural damage. To be considered a Category 1 or fine crack, the

crack is found to be less than 2mm in width.

Generally the cause of a hairline crack in existing concrete paving such as driveways and pathways is indicative of the expansion and contraction of the concrete. Such causes are generally due to environmental factors, such as moisture levels, weather conditions, root systems of nearby trees or the soil types on which they are laid.

Fine cracks may also be due to poor original installation of the concrete. Factors such as poor compaction of the sub surface and/or inadequate reinforcing of the slab may create cracking and other secondary defects.

Monitoring of all cracking should be conducted frequently. Always contact a building inspector should cracks widen, lengthen, or become more numerous.

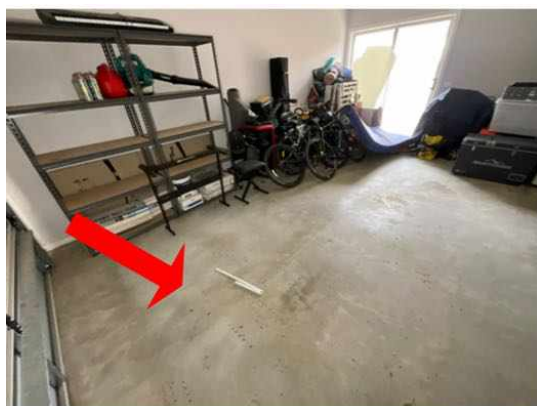
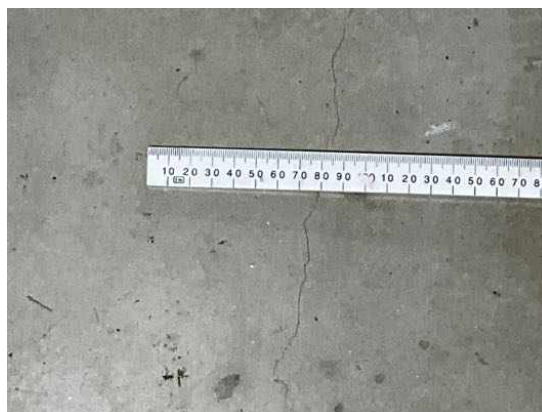
Finding 3.03

Building:	Building 1
Location:	Garage
Finding:	Crack in concrete slab - Category 1
Information:	A crack coded as Category 1 was identified in the slab. A Category 1 crack is described as a fine but noticeable crack, with the slab at an otherwise reasonable level.

To be considered Category 1, the approximate width of the crack is less than 1.0mm, or a less than 10mm change in offset when a 3m straight edge is placed over the defect.

Category 1 cracks should be monitored for a period of 12 months. At the end of the monitoring period, identified cracks that are rated greater than Category 2 are considered defects, and require rectification.

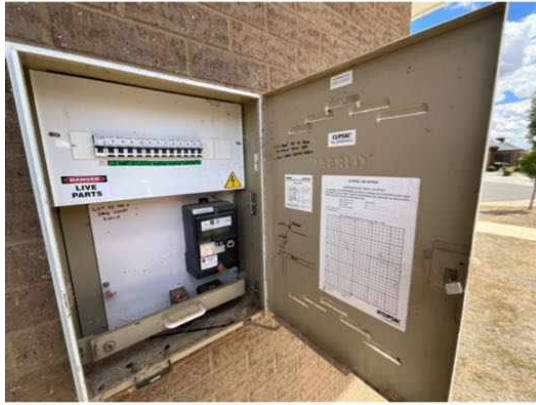
Finding 6.01

Building:	Building 1
Location:	All External Areas
Finding:	Termite Management System - no evidence of a chemical installation
Information:	The application of a post-construction chemical termite barrier is highly recommended for all properties, particularly if live termite activity has been found on the site previously. Such barriers are highly effective in preventing termite attack on any timber building elements throughout the property.

A durable notice should be placed in the switchboard unit to indicate current termite barriers. At the time of inspection, it appeared as though no termite management system has been installed, with no evidence to suggest preventative works taking place.

The client may consider gaining further advice from a pest controller as to the costs and procedures involved with this application. It is recommended that obtaining such advice be a short-term priority.

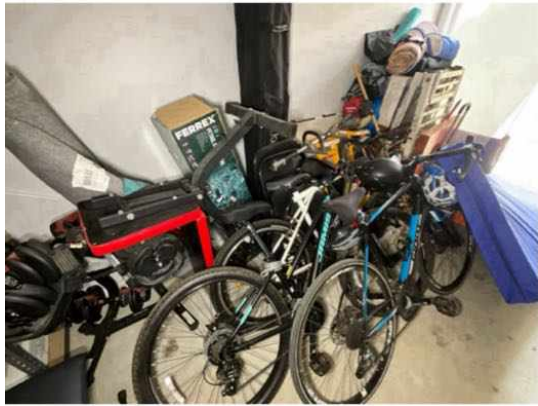
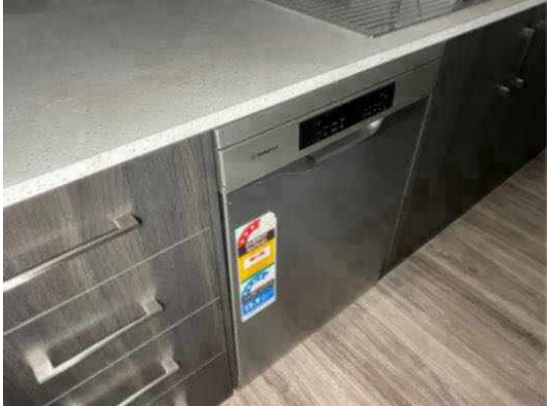
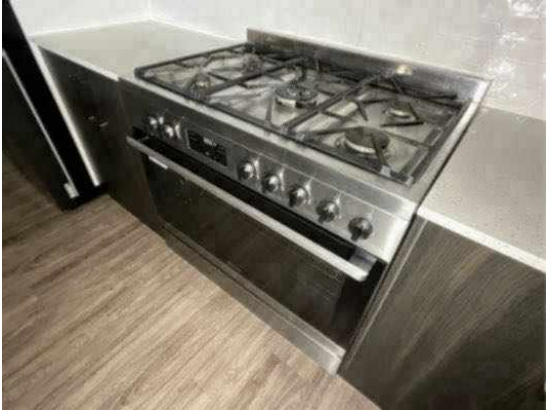
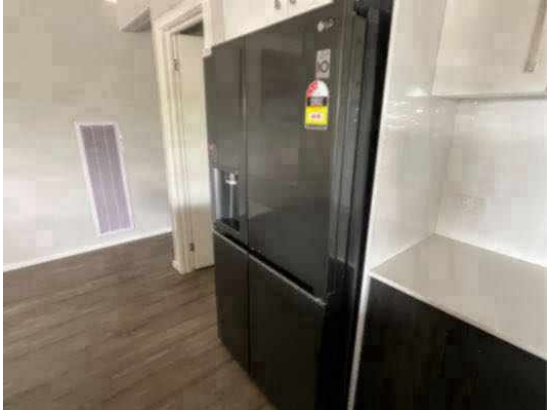
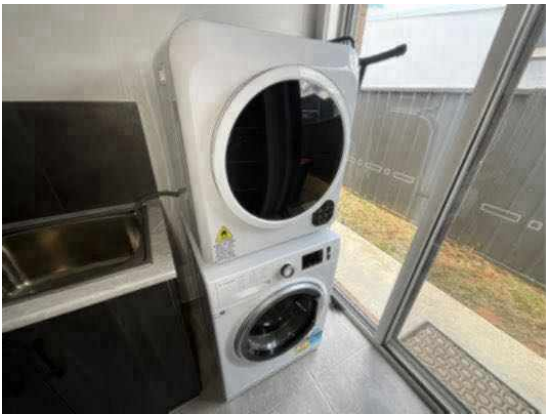
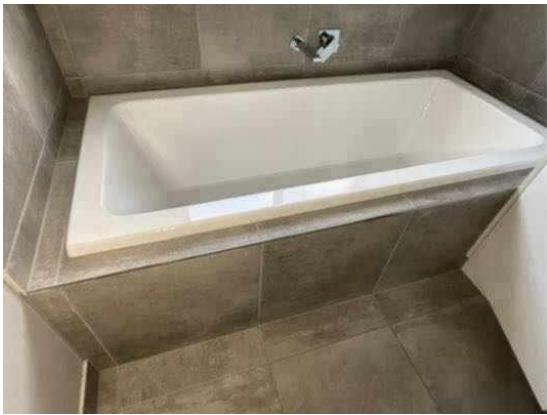
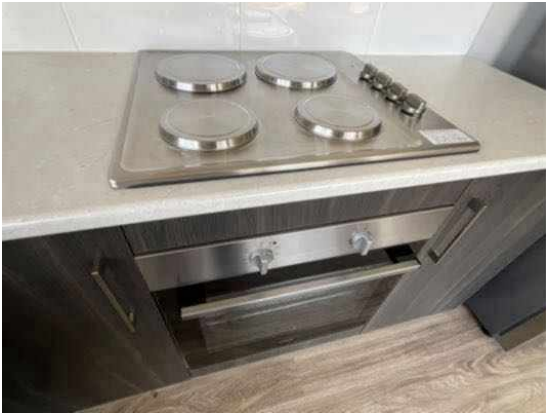
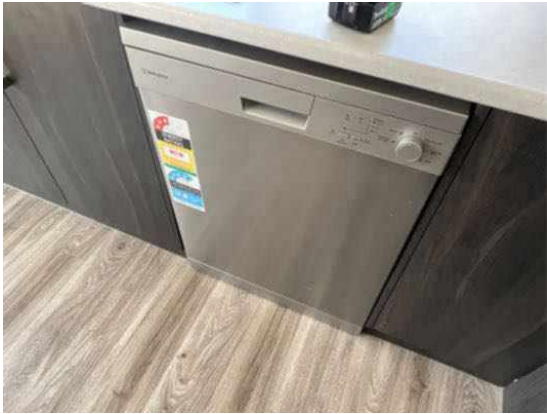
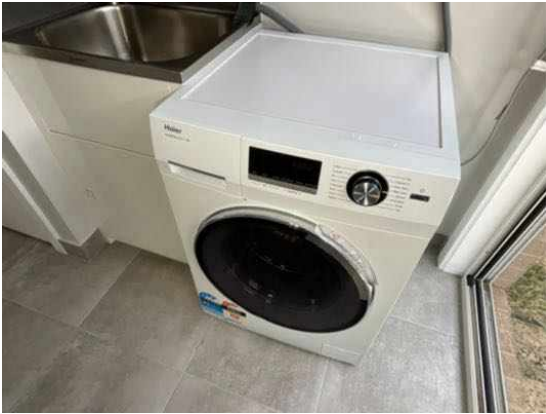
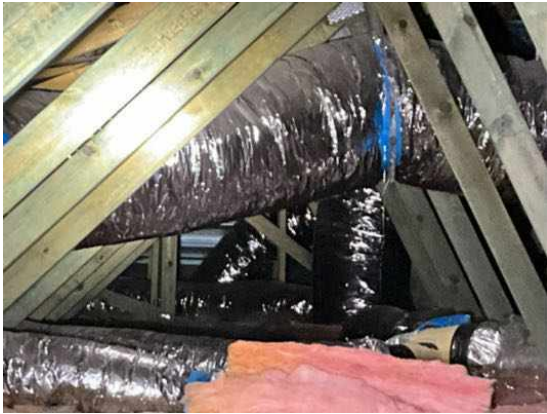
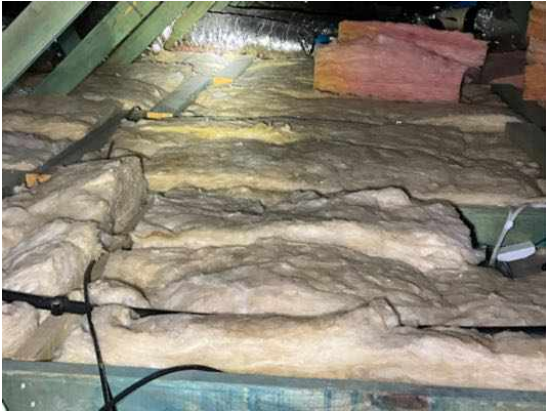
Noted Item

Building: Building 1
Location: All Areas
Finding: Additional Photos - Obstructions and Limitations
Information: These photographs are an indication of the obstructions and limitations which impeded full inspection of the property at the time of inspection. These obstructions can hide an array of defects and should be removed to allow full inspection to be carried out. A re-inspection is recommended once the areas are made accessible.
