Building and Timber Pest Inspection Report

Inspection Date: Wed, 28 Jan 2026

Property Address: 131 Fern St, Gerringong NSW 2534,
Australia

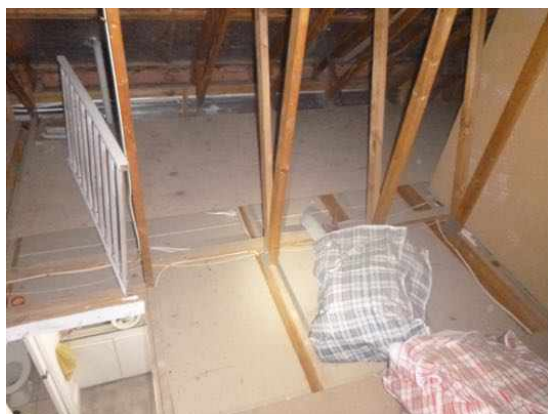
Building:	Building 2
Location:	Roof Void
Finding:	Ceiling Insulation - Missing
Information:	Upon inspection of the roof void it was noted that insulation is not present.

Where insulation is absent, the area does not meet current Australian Standards. Installation of adequate insulation is required and should be conducted as soon as possible.

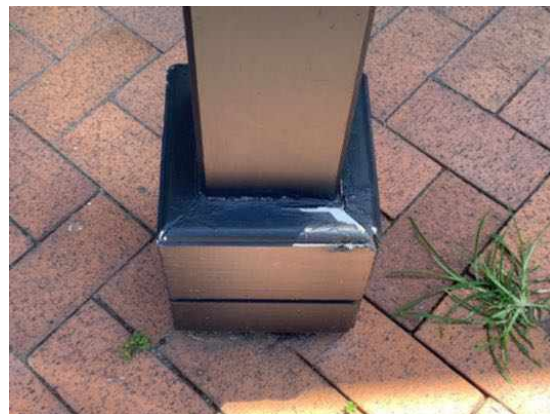
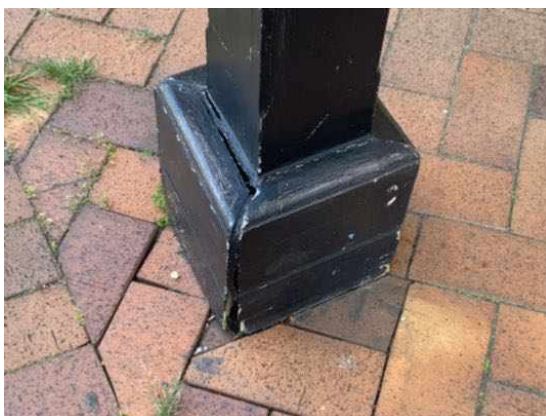
Finding: External paint to timbers - deteriorated
 Information: Much of the external paintwork including but not limited to external timbers and trims have been neglected and require attention to prepare and re-paint.

Whilst incomplete or missing paint finish is generally an appearance defect, it can also lead to the development of secondary building defects over time. Incomplete areas of paint finish expose the area to moisture, potentially accelerating the deterioration of underlying building materials.

Degraded paint finishes should be sanded back, filled, leveled and painted, as applicable. Where inadequate or missing paint protection has led to the deterioration of the associated building element, repair and/or replacement of this building element may be required.

A painting contractor should be appointed as soon as possible to perform necessary works to aid the appearance of the affected area and to ensure the area is protected against further deterioration. Alternatively, the homeowner following manufacturer instructions may perform these works.

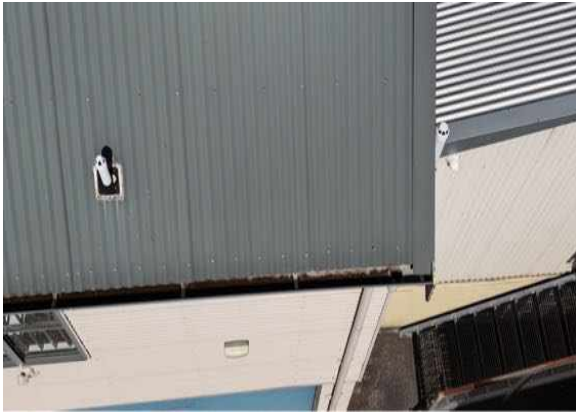
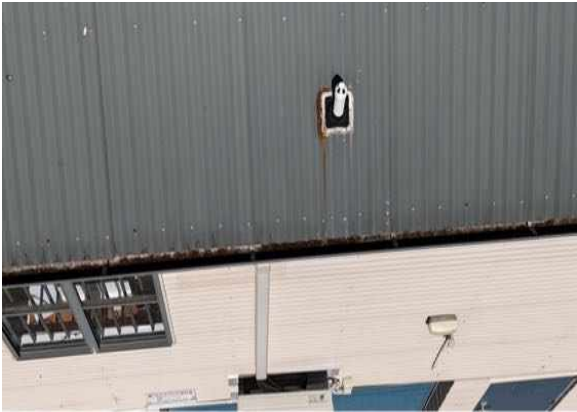
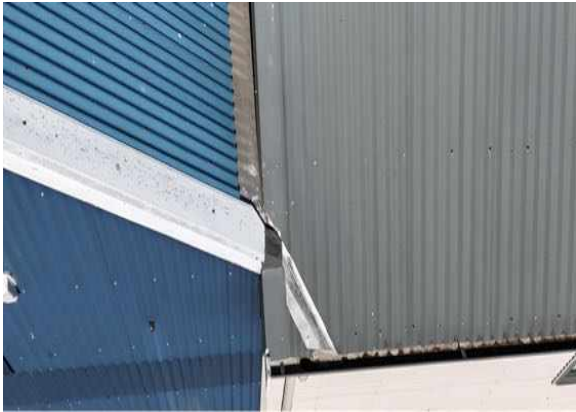
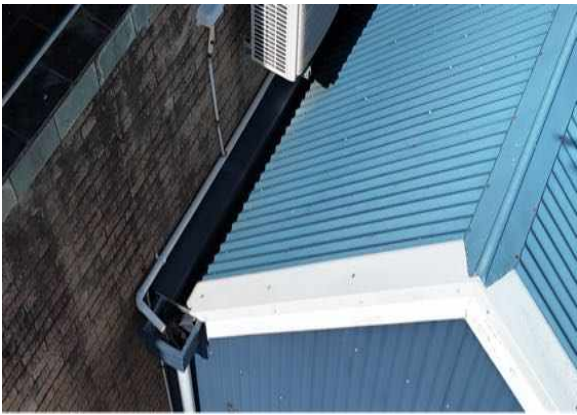
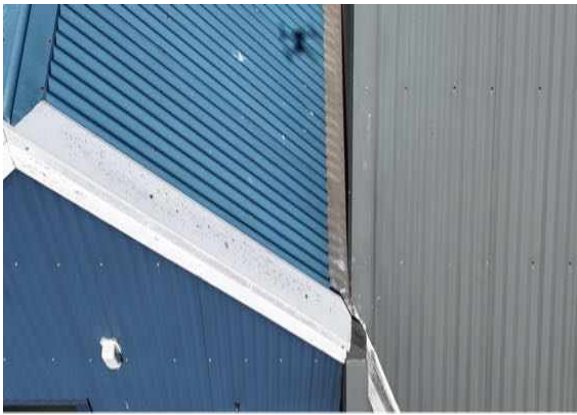
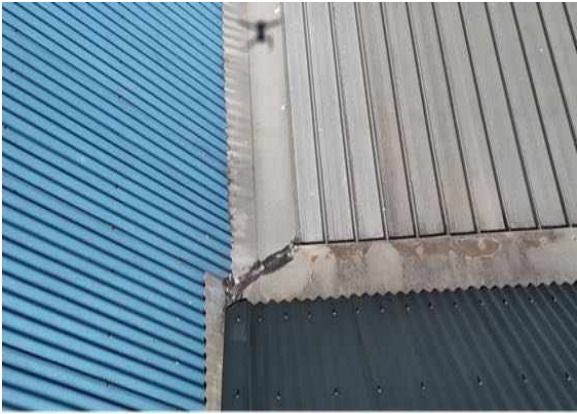
Noted Item

Building: Main Building
Location: Roof Exterior
Finding: Additional Photos - Obstructions and Limitations
Information: These photographs are an indication of the obstructions and limitations which impeded full inspection of the property at the time of inspection. These obstructions can hide an array of defects and should be removed to allow full inspection to be carried out. A re-inspection is recommended once the areas are made accessible.

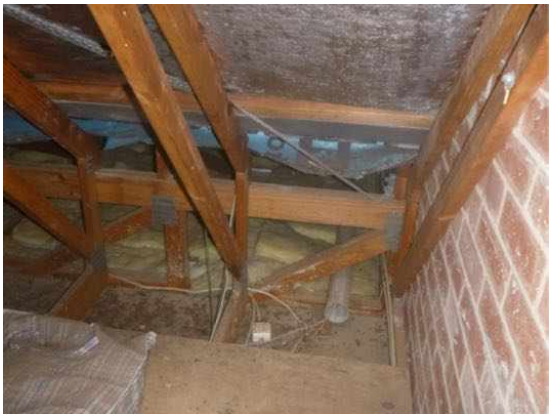
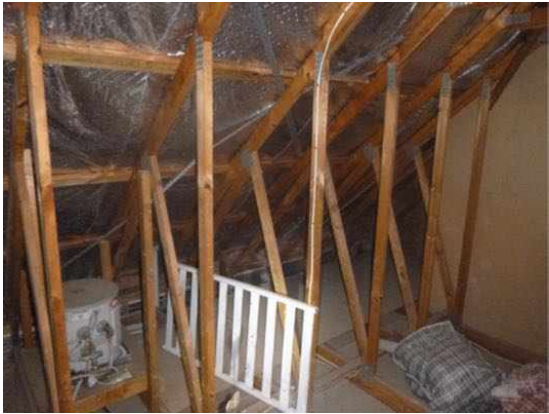
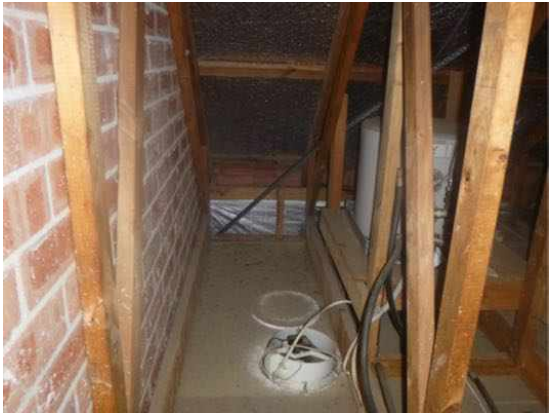
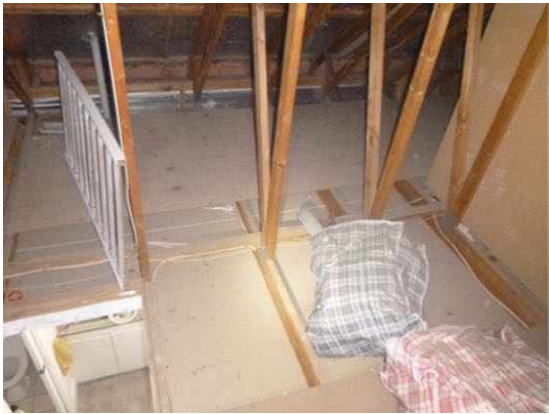
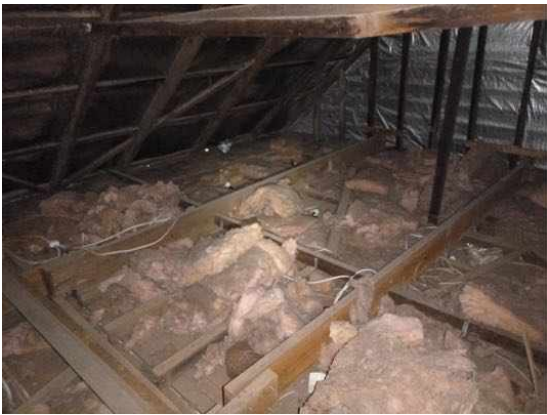
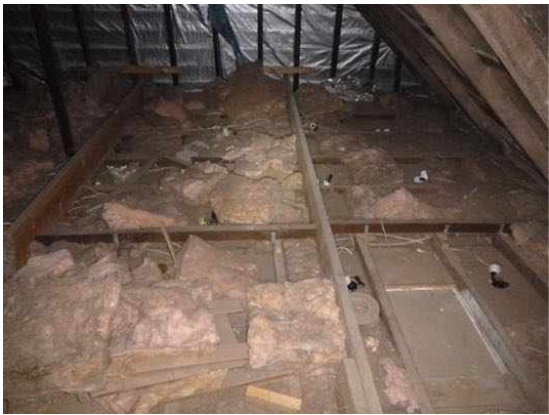
Noted Item

Building: Building 1
Location: Roof Void
Finding: Additional Photos - Obstructions and Limitations
Information: These photographs are an indication of the obstructions and limitations which impeded full inspection of the property at the time of inspection. These obstructions can hide an array of defects and should be removed to allow full inspection to be carried out. A re-inspection is recommended once the areas are made accessible.

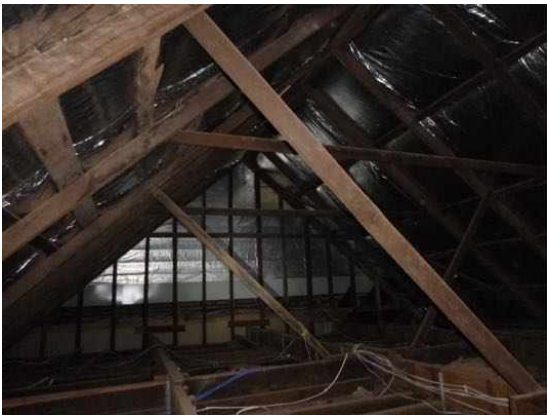
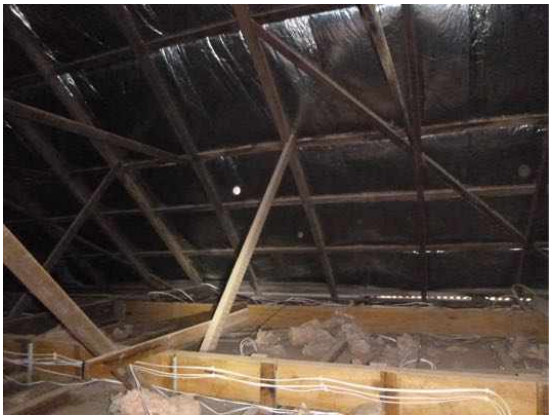
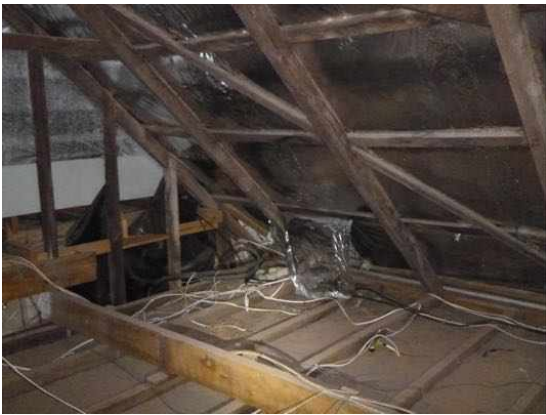
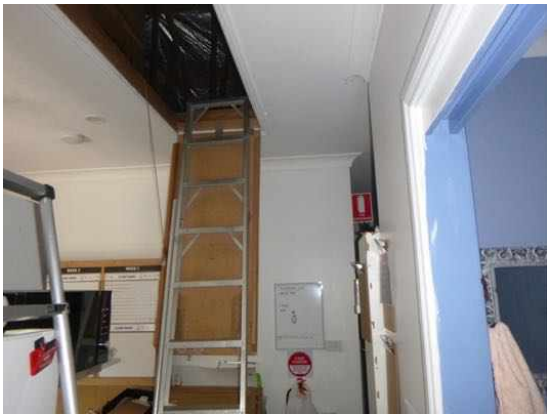
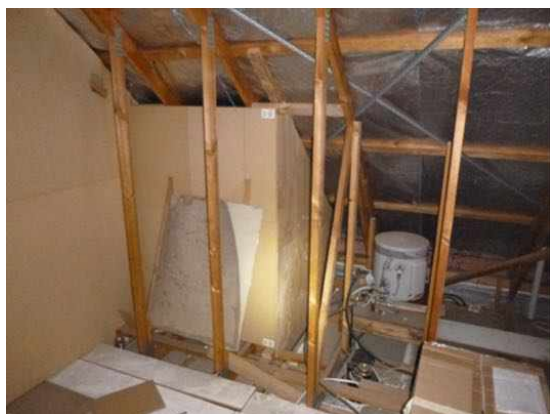
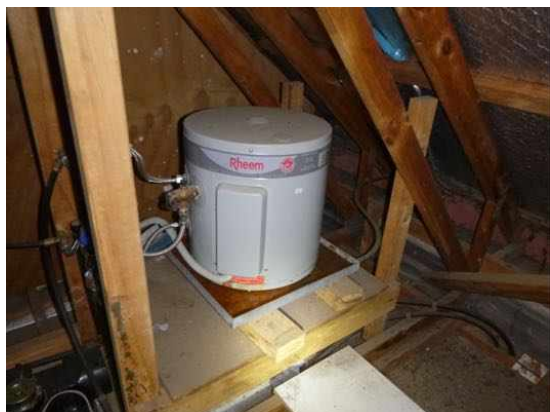
Noted Item

Building: Building 2
Location: Roof Void
Finding: Additional Photos - Obstructions and Limitations
Information: These photographs are an indication of the obstructions and limitations which impeded full inspection of the property at the time of inspection. These obstructions can hide an array of defects and should be removed to allow full inspection to be carried out. A re-inspection is recommended once the areas are made accessible.

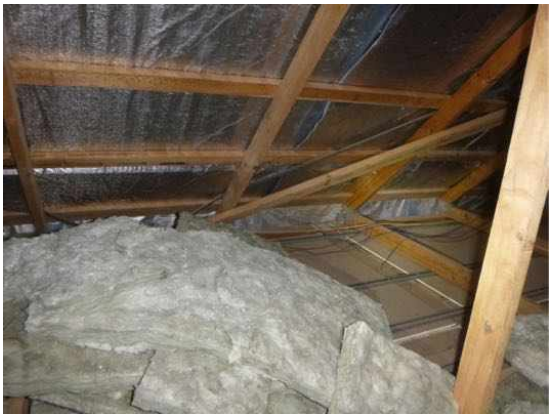
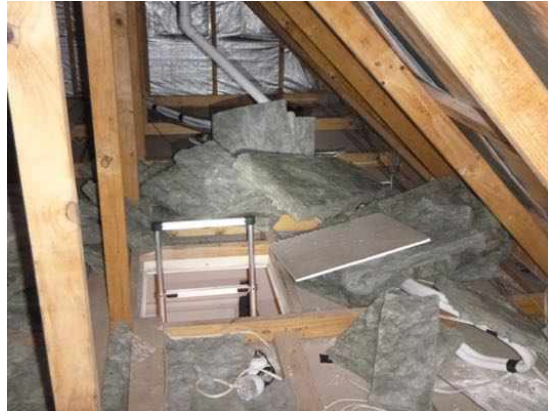
Noted Item

Building: Building 3
 Location: Roof Void
 Finding: Additional Photos - Obstructions and Limitations
 Information: These photographs are an indication of the obstructions and limitations which impeded full inspection of the property at the time of inspection. These obstructions can hide an array of defects and should be removed to allow full inspection to be carried out. A re-inspection is recommended once the areas are made accessible.

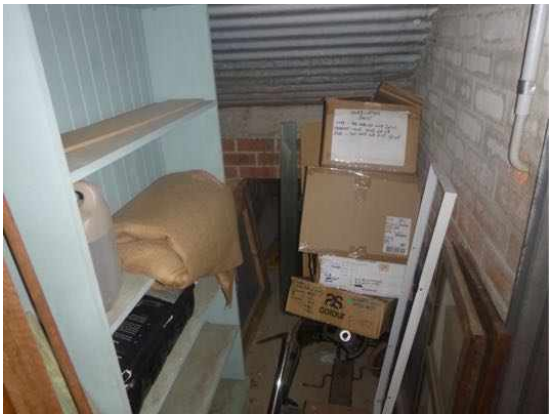
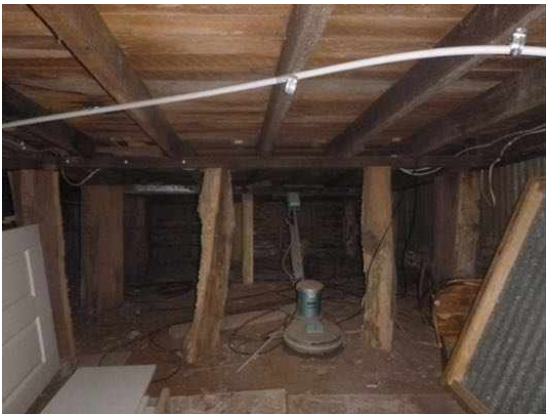
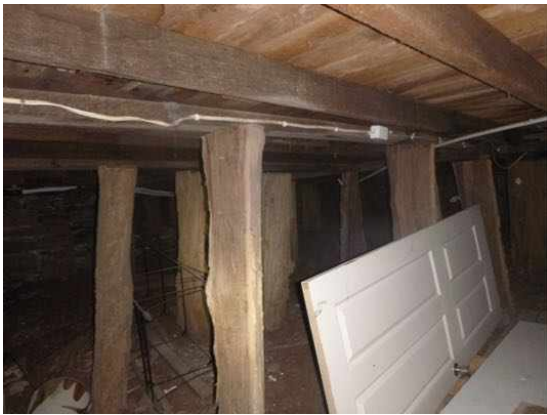
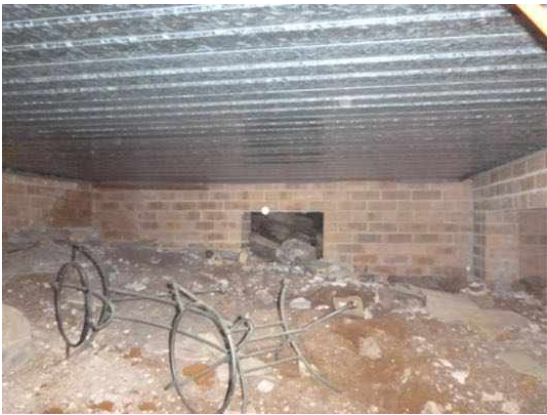
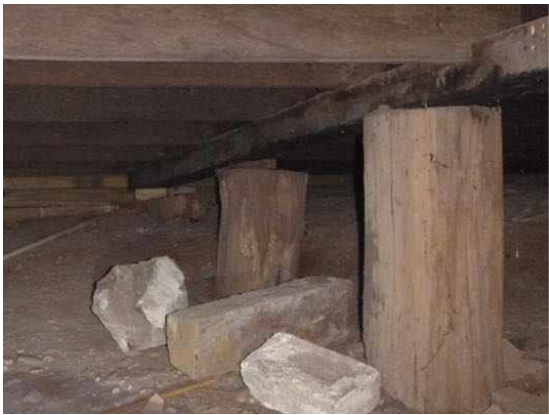
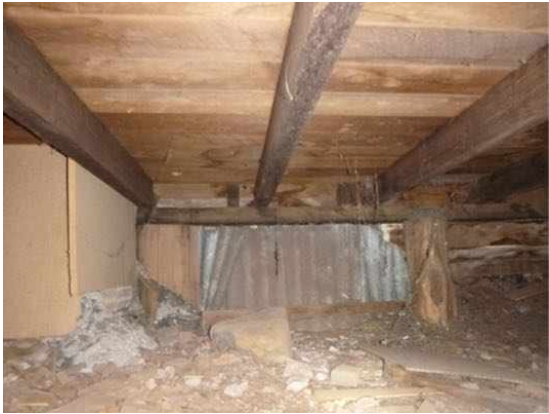
Noted Item

Building:	Building 1
Location:	Subfloor below shops 1 & 2
Finding:	Additional Photos - Obstructions and Limitations
Information:	These photographs are an indication of the obstructions and limitations which impeded full inspection of the property at the time of inspection. These obstructions can hide an array of defects and should be removed to allow full inspection to be carried out. A re-inspection is recommended once the areas are made accessible.

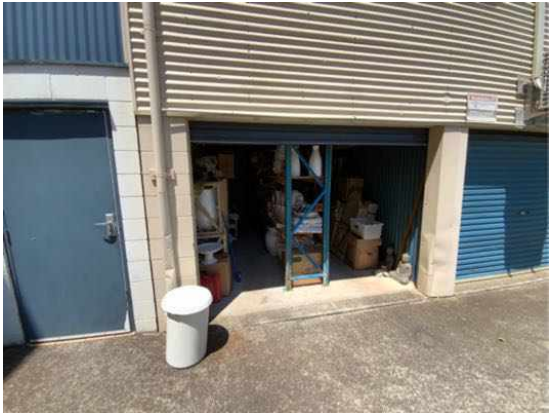
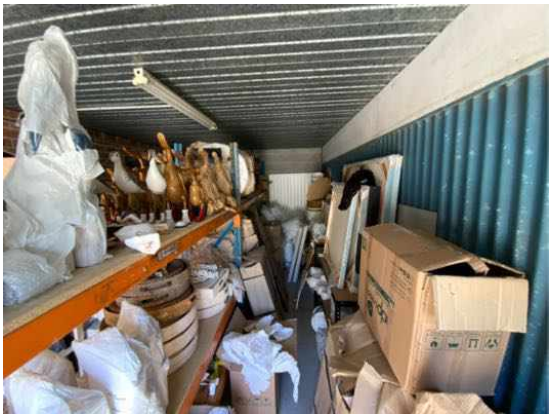
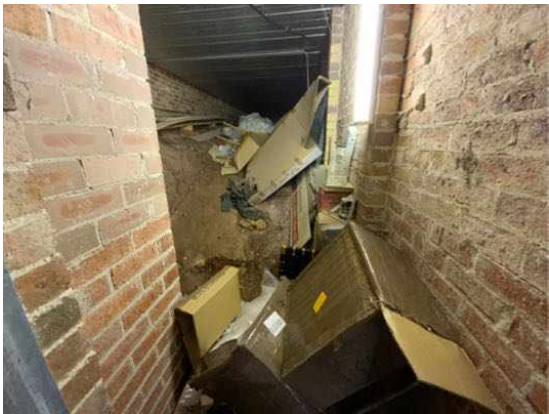
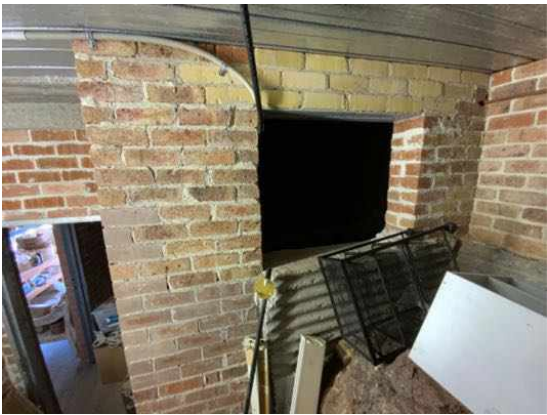
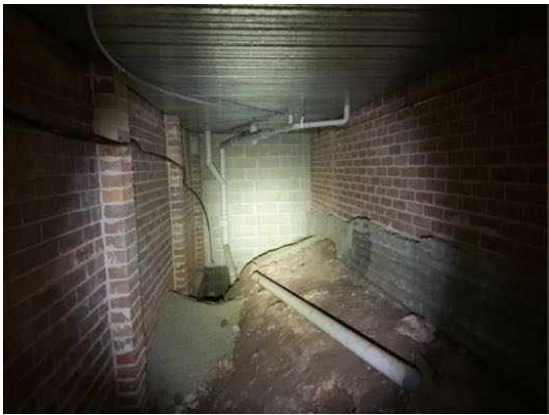
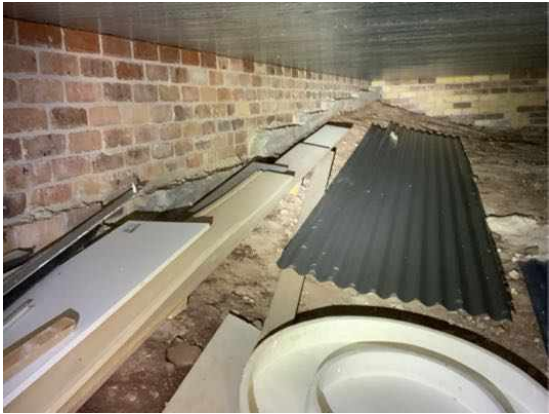
Noted Item

Building: Building 3
Location: Subfloor
Finding: Additional Photos - Obstructions and Limitations
Information: These photographs are an indication of the obstructions and limitations which impeded full inspection of the property at the time of inspection. These obstructions can hide an array of defects and should be removed to allow full inspection to be carried out. A re-inspection is recommended once the areas are made accessible.

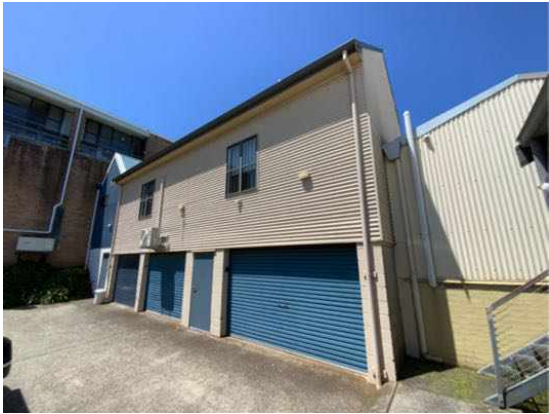
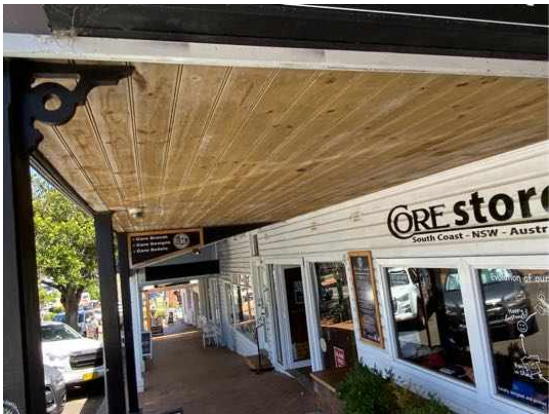
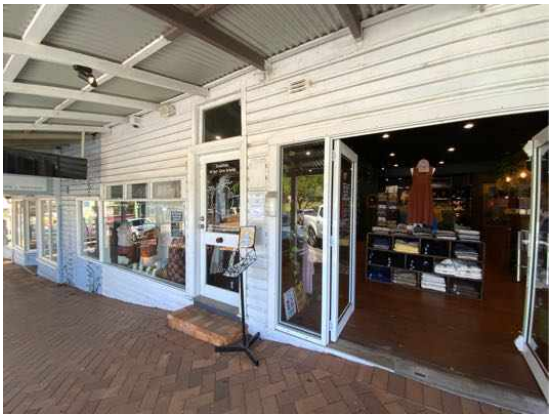
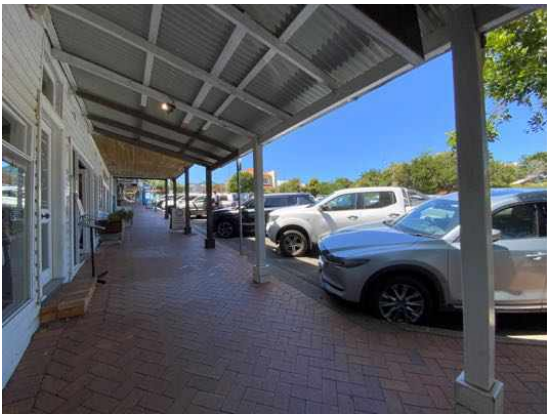
Noted Item

Building: Main Building
Location: All Areas
Finding: Additional Photos - Obstructions and Limitations
Information: These photographs are an indication of the obstructions and limitations which impeded full inspection of the property at the time of inspection. These obstructions can hide an array of defects and should be removed to allow full inspection to be carried out. A re-inspection is recommended once the areas are made accessible.

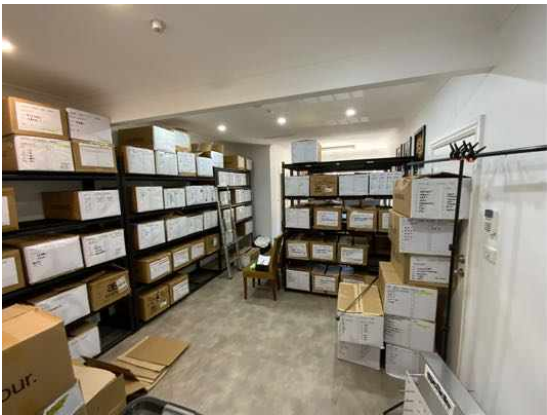
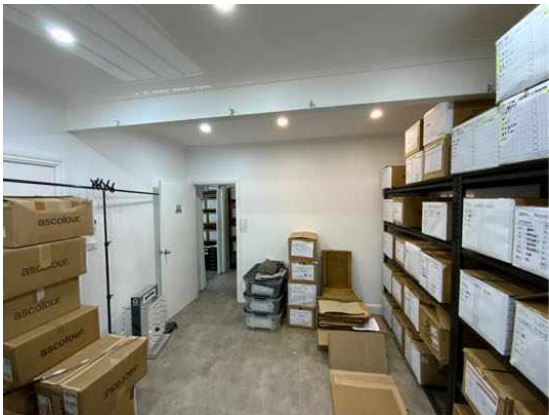
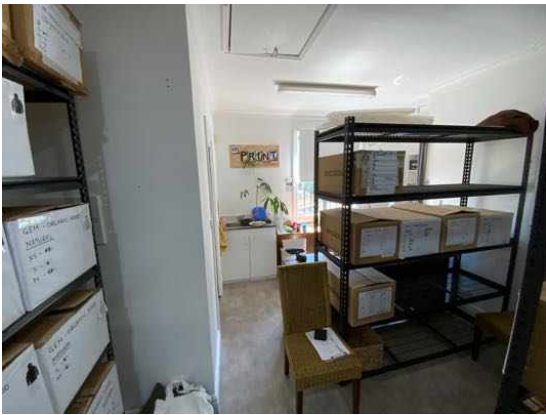
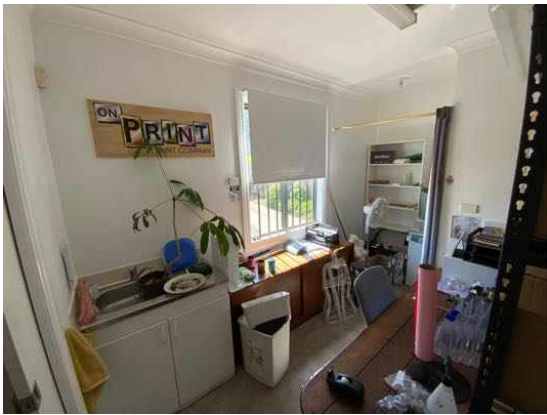
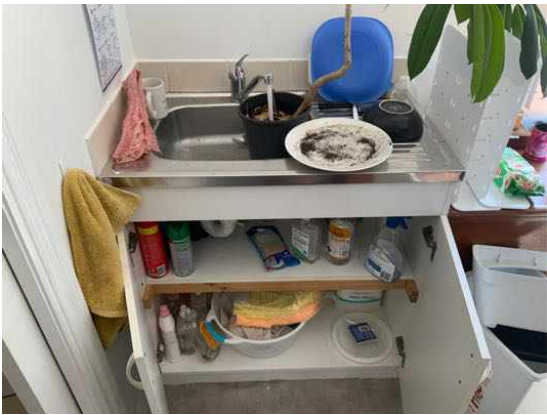
Noted Item

Building: Building 1
Location: Interior - All Areas
Finding: Additional Photos - Obstructions and Limitations
Information: These photographs are an indication of the obstructions and limitations which impeded full inspection of the property at the time of inspection. These obstructions can hide an array of defects and should be removed to allow full inspection to be carried out. A re-inspection is recommended once the areas are made accessible.

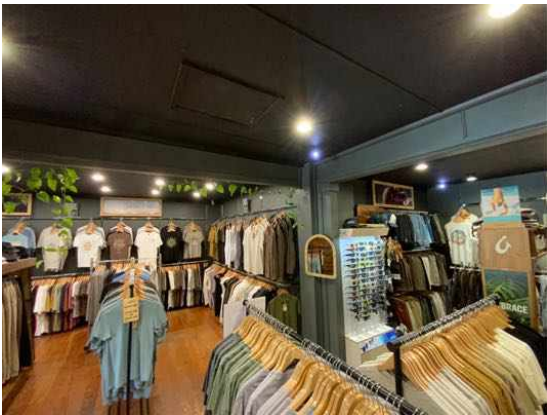
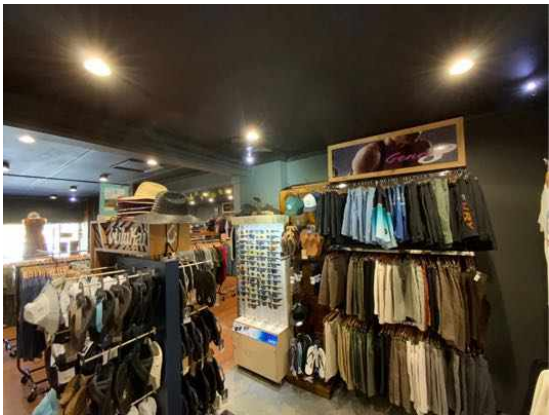
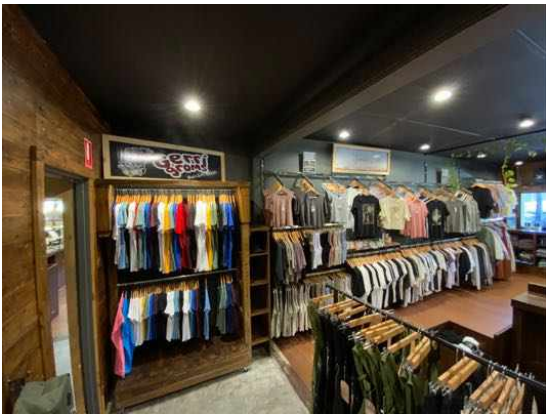
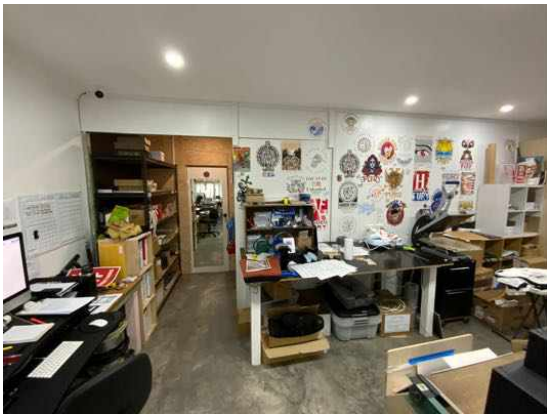
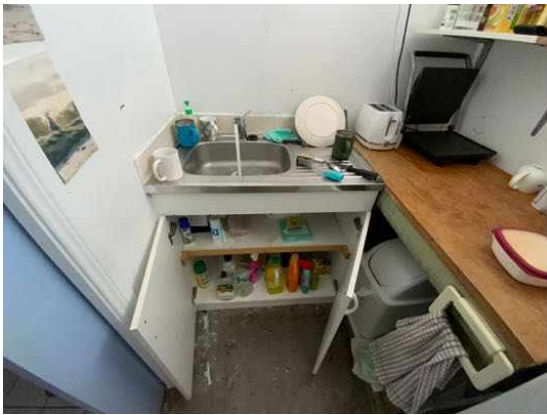
Noted Item

Building: Building 2
Location: Interior - All Areas
Finding: Additional Photos - Obstructions and Limitations
Information: These photographs are an indication of the obstructions and limitations which impeded full inspection of the property at the time of inspection. These obstructions can hide an array of defects and should be removed to allow full inspection to be carried out. A re-inspection is recommended once the areas are made accessible.

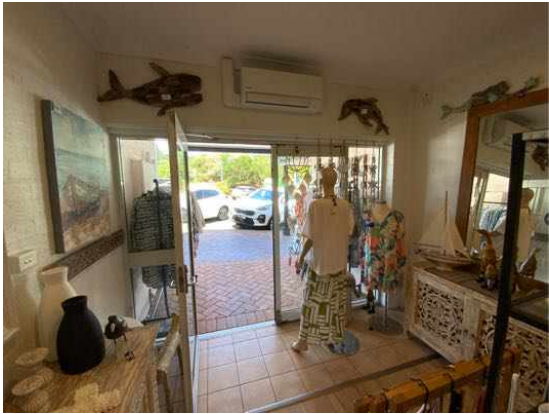
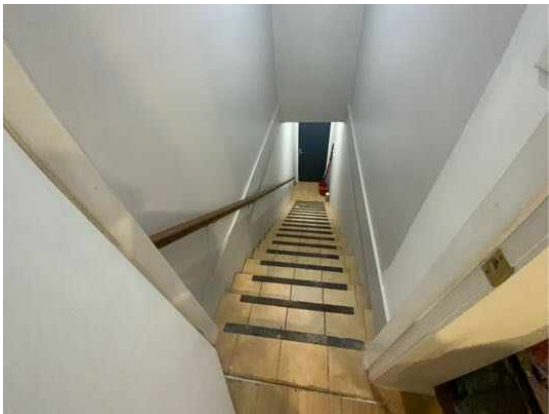
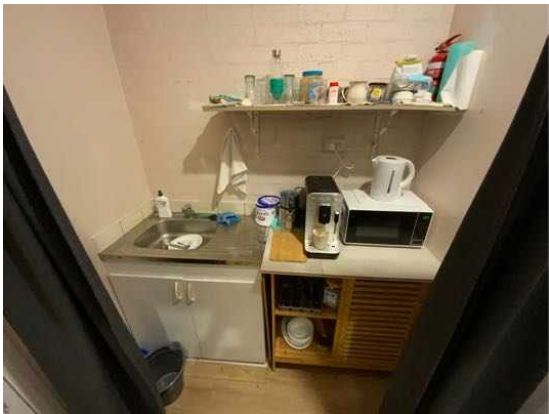
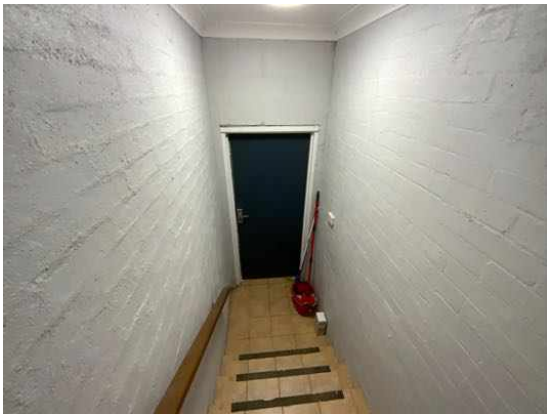
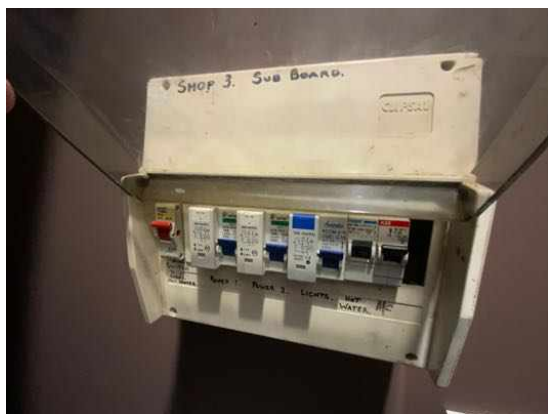
Noted Item

Building: Building 3
Location: Interior - All Areas
Finding: Additional Photos - Obstructions and Limitations
Information: These photographs are an indication of the obstructions and limitations which impeded full inspection of the property at the time of inspection. These obstructions can hide an array of defects and should be removed to allow full inspection to be carried out. A re-inspection is recommended once the areas are made accessible.
