Building and Timber Pest Inspection Report

Inspection Date: Thu, 5 Mar 2026

Property Address: 15 Grandiflora St, Rouse Hill NSW 2155,
Australia

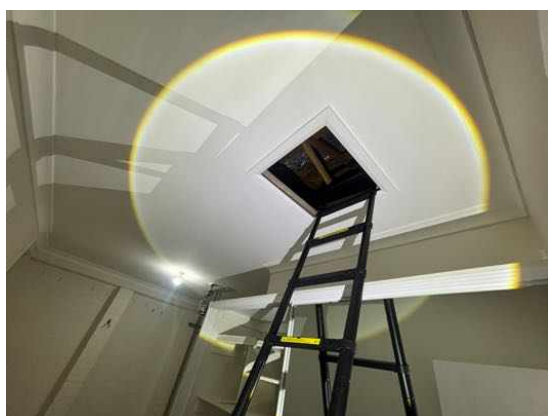
Building: Main Building
 Location: Roof Void
 Finding: Vent - Extracted into Roof Space
 Information: During the inspection, it was noted that the exhaust vent has been improperly terminated into the roof space instead of being ducted to the exterior of the property.

This configuration is a defect as it allows moist air to accumulate within the roof cavity, increasing the risk of condensation, mould growth, and deterioration of insulation or timber framing. Proper ventilation is essential to maintain a healthy indoor environment and protect the structural integrity of the building. It is recommended that the vent be appropriately re-routed to discharge externally in compliance with relevant building standards.

A licensed mechanical ventilation contractor/electrician should be appointed as soon as possible to provide further consultation on the scope of these works and to provide quotations for any necessary works.

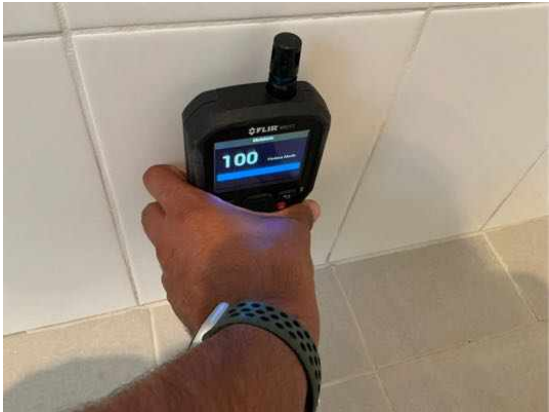
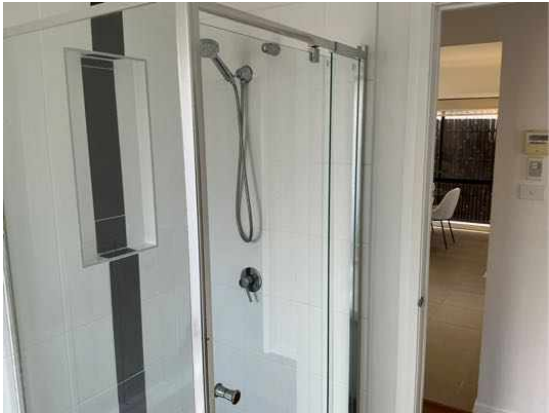
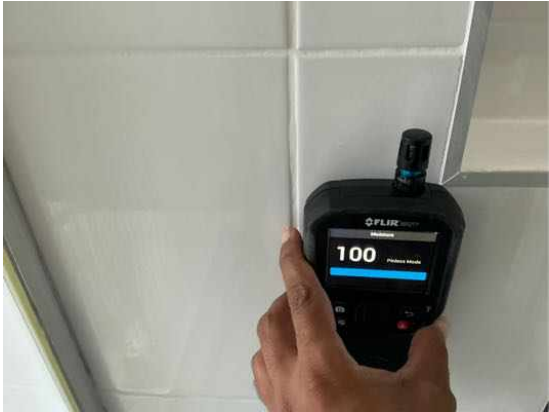
Finding 3.08

Building: Main Building
 Location: Both Bathrooms
 Finding: Excessive Moisture - Shower Damp
 Information: At the time of inspection, excessive moisture was noted within the shower area, which

is a common issue in wet areas due to the continual exposure to water. This condition is typically caused by moisture seeping through grout lines and settling behind tiles, resulting in localised high-moisture zones. Provided there is no evidence of water staining or elevated moisture readings on the opposite side of the wall, this is considered a minor defect.

However, persistently damp conditions may act as conducive conditions for termite activity, as termites are strongly attracted to moisture-rich environments. It is recommended that the client ensures regular use of the exhaust fan and maintains adequate ventilation after shower use to promote drying and reduce long-term moisture build-up, thereby also reducing the risk of attracting termites.

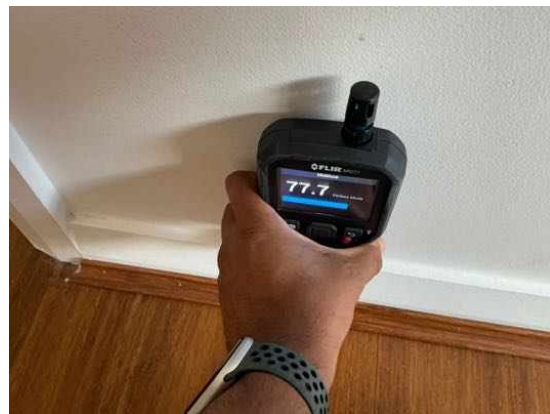
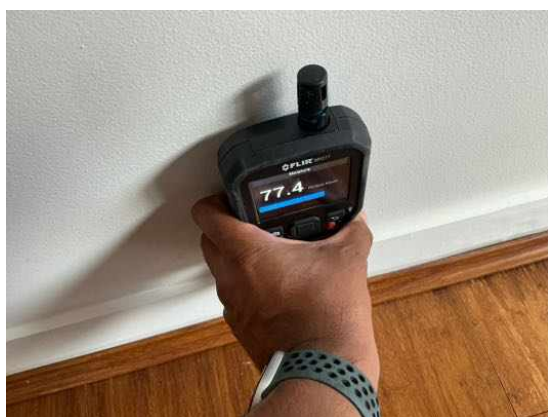
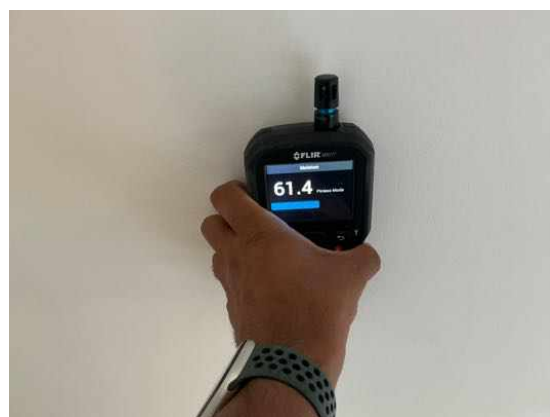
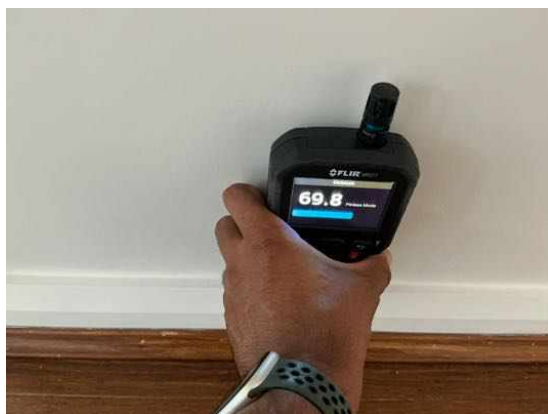
Finding 3.09

Information: At the time of inspection, elevated moisture levels were detected on the wall adjacent to the shower area. While no visible water damage or deterioration was noted, the presence of moisture suggests possible seepage or condensation associated with regular shower use.

At this stage, no immediate action is required. However, the area should be monitored over the next 12 months for any signs of deterioration such as staining, bubbling paint, or mould growth. It should be noted that moisture ingress of this nature does not generally resolve without intervention, and at some point remedial works are likely to be required. Should conditions worsen, the client is advised to engage services of a licensed plumber or waterproofing specialist to rectify the issue of moisture before this minor defect turns into major defect.

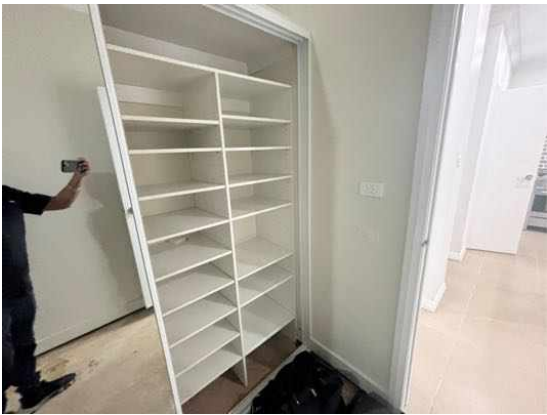
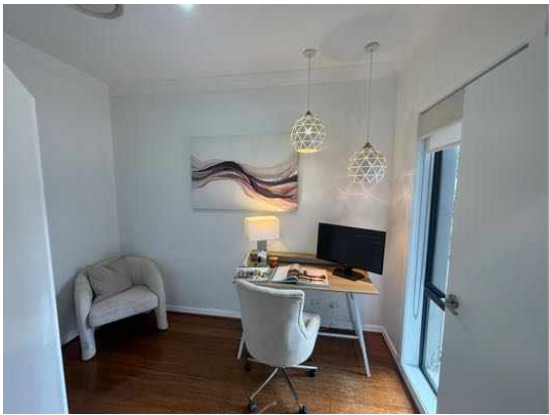
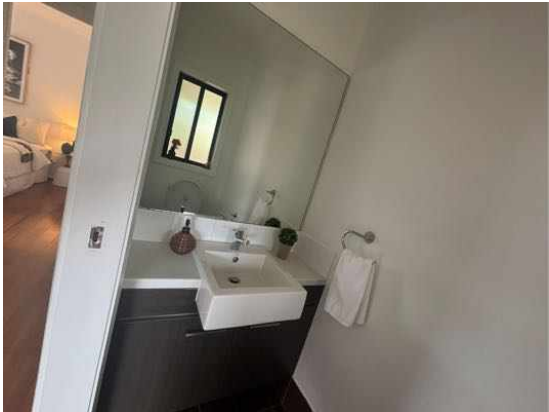
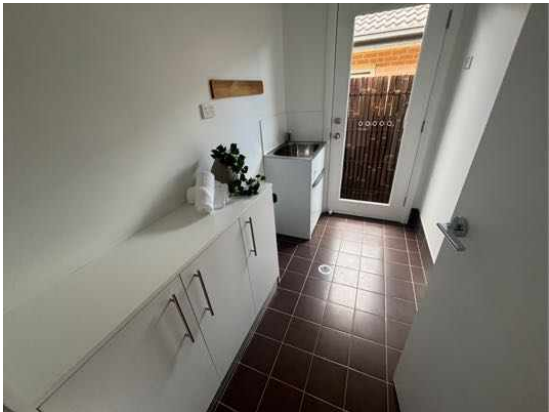
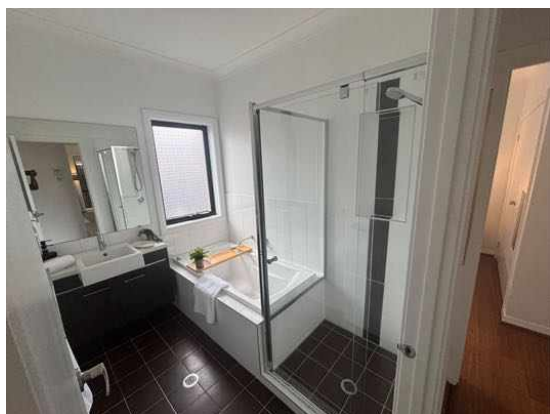
Noted Item

Building:	Main Building
Location:	All Internal Areas
Finding:	Obstructions and Limitations - Internal Areas
Information:	<p>The accompanying photographs provide clear evidence of the obstructions and limitations that restricted a comprehensive inspection of the internal areas of the property at the time of assessment. These obstructions, which may include furniture, personal belongings, stored items, or structural elements such as wall coverings and built-ins, significantly hindered the ability to thoroughly evaluate these areas. It is important to note that such obstructions can potentially conceal a wide array of defects, ranging from hidden structural damage, water leaks, pest infestations, or electrical issues, to deteriorating materials that may not be visible during the initial inspection.</p>

In summary, the limitations encountered during the inspection highlight the importance of ensuring full access to all areas of the property to accurately assess its overall condition. A re-inspection is strongly advised once these areas are made accessible.

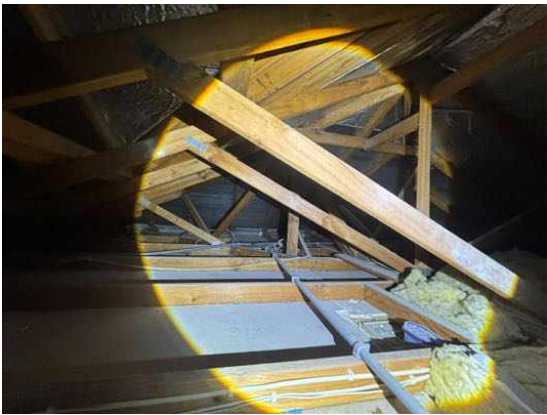
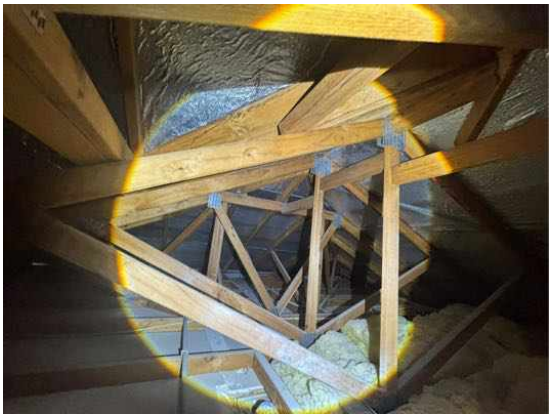
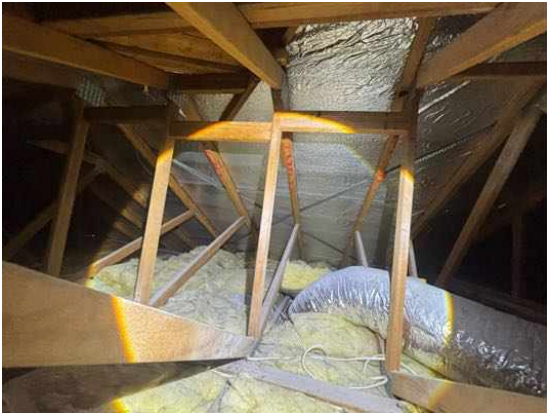
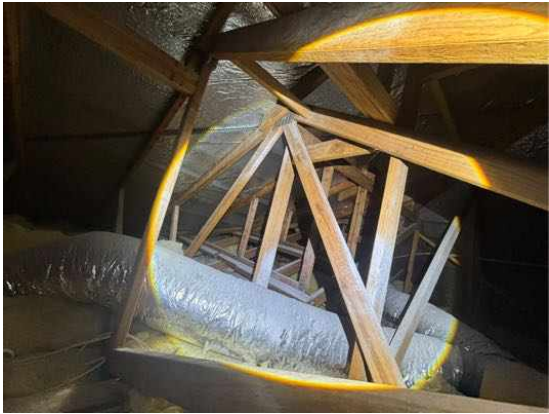
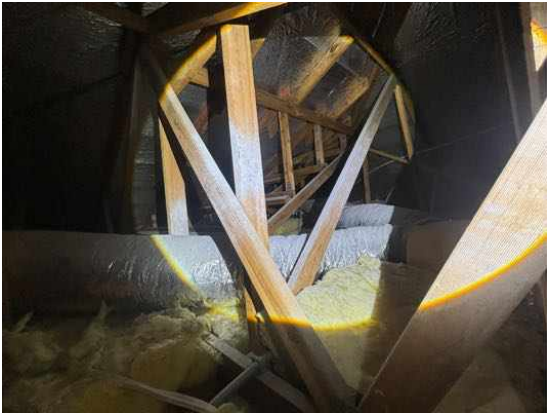
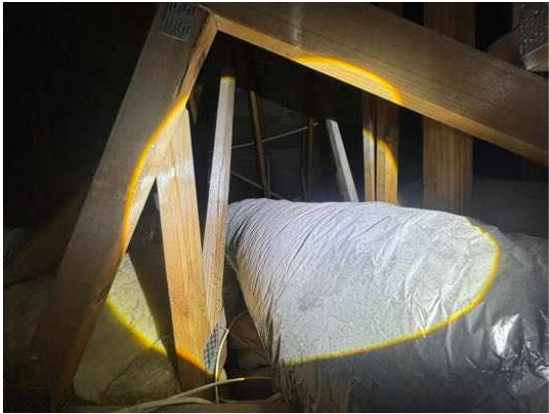
Noted Item

Building:	Main Building
Location:	Roof Void
Finding:	Obstructions, Limitations, and General Roof Space Condition
Information:	The photographs provided document both the general condition and the obstructions and limitations that were present in the roof cavity of the main building at the time of inspection. These obstructions—such as insulation materials, stored items, structural elements, or electrical wiring—restricted safe and adequate access to key areas within the roof space. As a result, a comprehensive inspection of all components could not be completed.

It is recommended that these barriers be removed or repositioned to facilitate full and safe access to the roof space. Once clear, a follow-up inspection should be conducted to allow for a thorough assessment of all concealed areas. This will help ensure that the condition of the roof cavity is accurately evaluated and any hidden issues are appropriately identified and addressed.

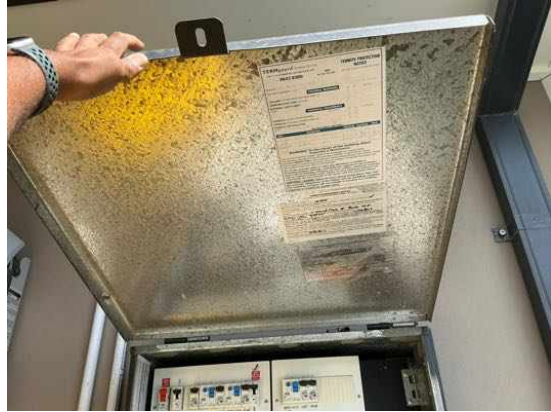
Noted Item

Building: Main Building
 Location: Meter Box
 Finding: Termite Management Recommendation – No Evidence of Chemical Installation
 Information: At the time of inspection, there was no visible evidence of a chemical termite management system installed around the property. Chemical barriers are a key component of termite protection and are particularly important in preventing concealed termite entry into timber elements of the structure.
