Building and Timber Pest Inspection Report

Inspection Date: Mon, 16 Feb 2026

Property Address: 29 Myall St, Gympie QLD 4570, Australia

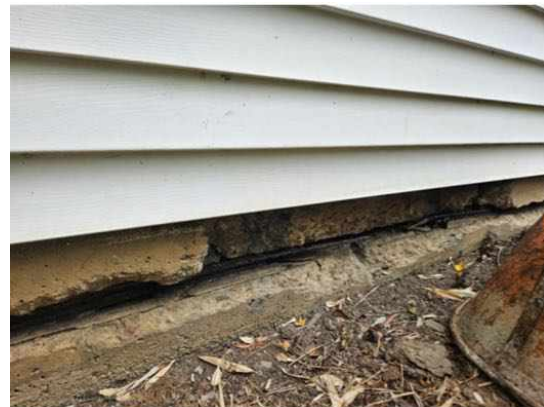
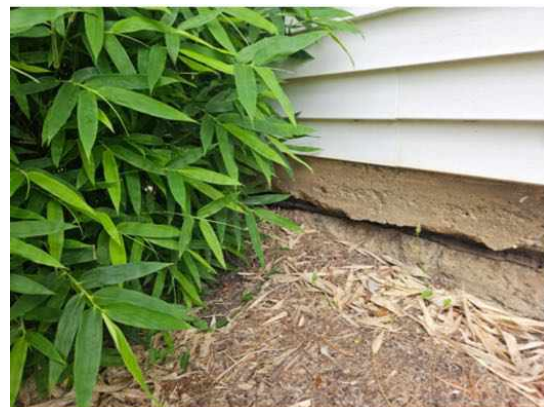
Building: Main Building
 Location: Unit 2 storeroom and laundry
 Finding: House foundation - concrete cracking, severe
 Information: During the inspection of the subfloor, the building exterior and the ground floor laundry of unit 2, it was noted that the concrete foundation (rat wall) of this area was severely cracked, and in some places broken and separating. The reinforcing is exposed and rusting.

As this section of the building is supporting the full height of the two storey section of the floor and wall framing, it appears to be structurally compromised.

It is advised that the services of a structural engineer and a licensed builder be sought to investigate and provide a repair solution for the foundation without delay.

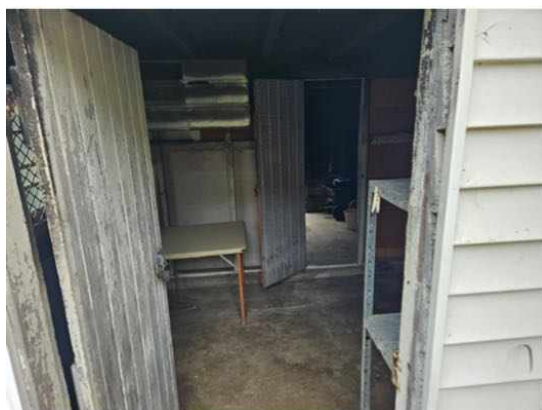
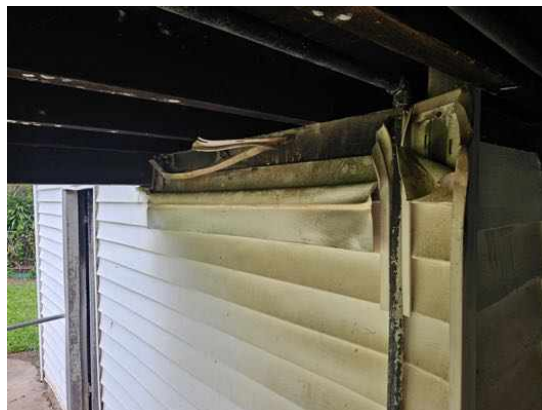
| Finding: | Fire damage - storeroom / laundry |
| Information: | Whilst inspecting the ground floor storeroom and laundry space, moderate and severe fire damage was observed to the structural frame of the floor and walls. This does not appear to be recent and no visible repairs appear to have been made. There are sections of severe damage, these are indicated by red arrows, that will require assessment for integrity and repairs made accordingly. When reviewed in conjunction with the damaged footing / slab in the same area, this is considered urgent and should be dealt with without delay. |

The client should engage a RPEQ structural engineer or licensed builder to assess the rooms structurally and provide a repair proposal.

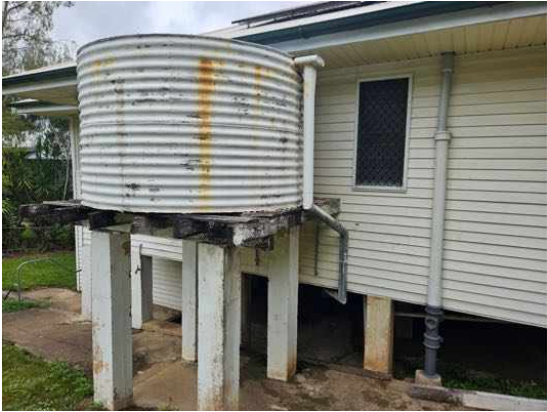
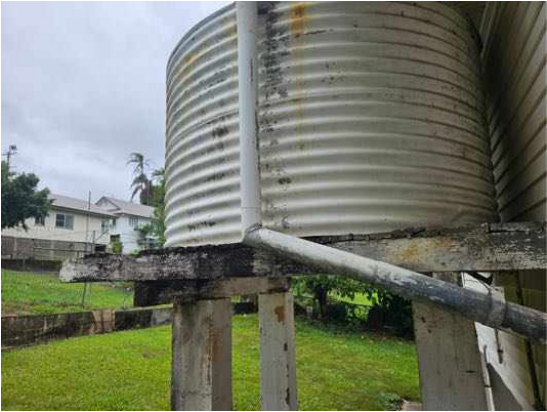
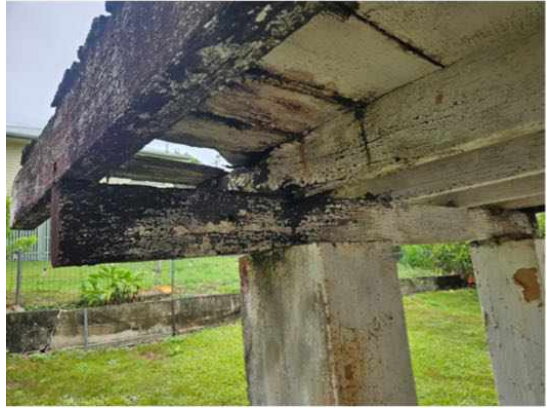
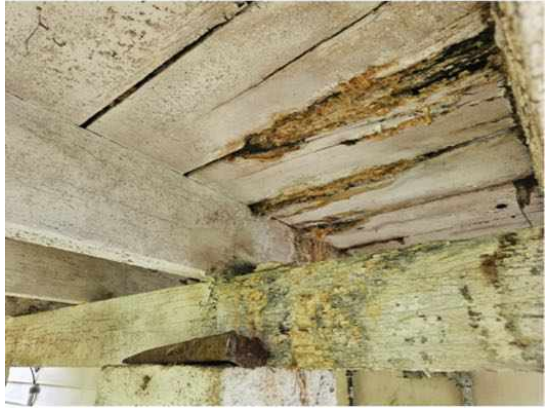
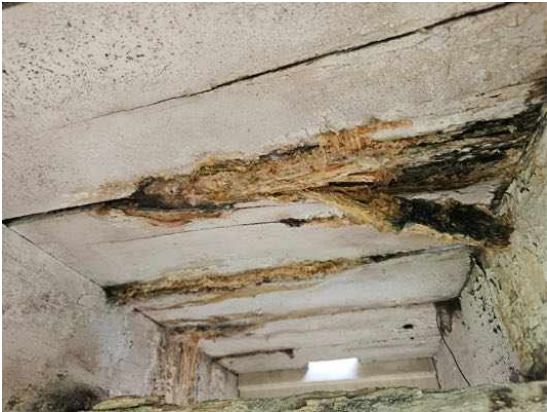
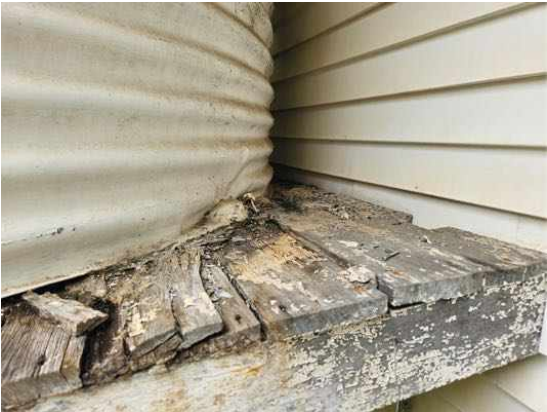
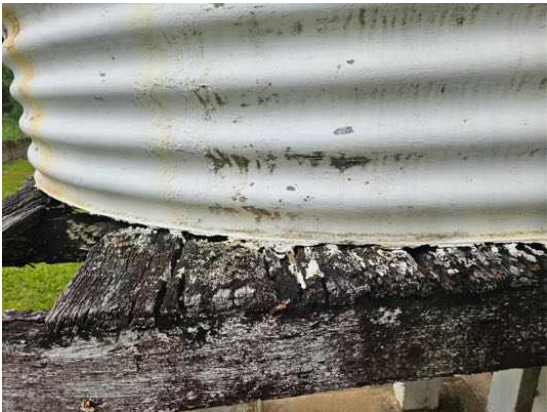
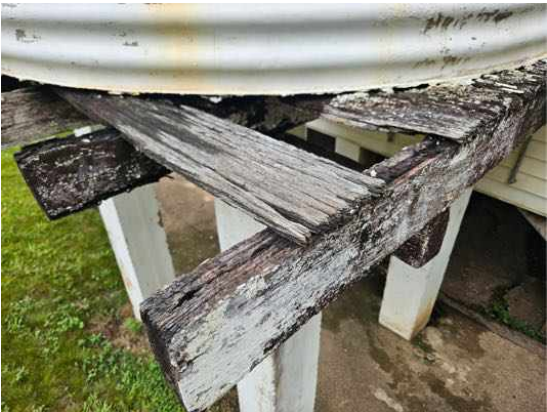
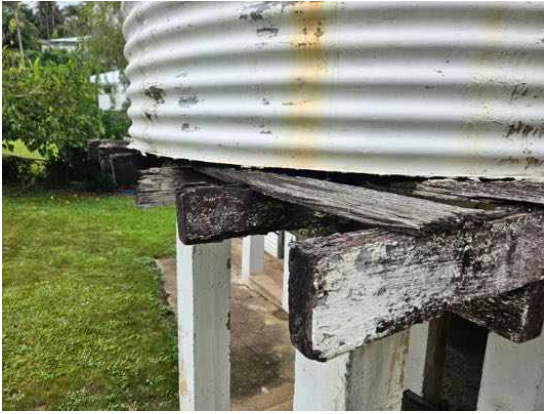
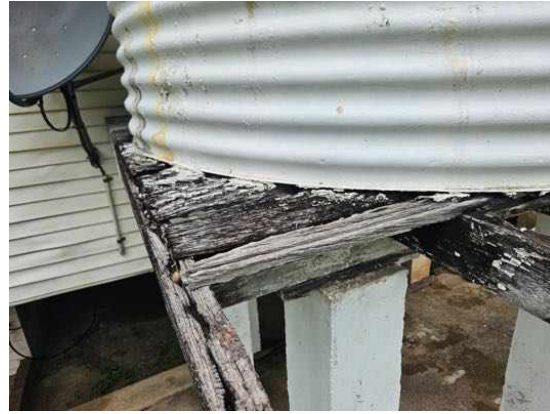
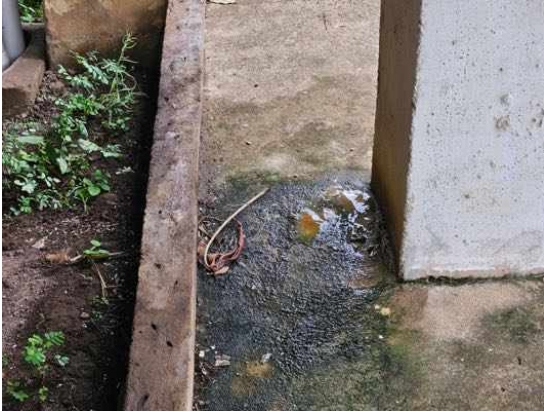
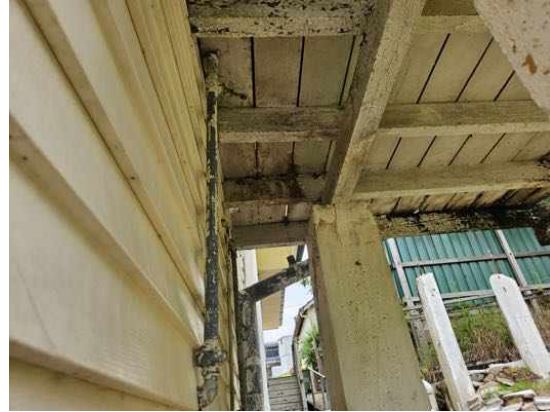
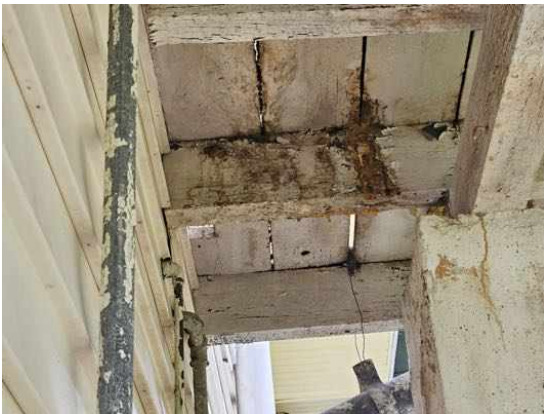
| Finding: | Wood rot - tank stand |
| Information: | The rain water tank stand shows evidence of severe wood rot in the slats and structural frame. The fungal decay appears to be compromising the integrity of the structure. |

Wood rot, also known as Fungal Decay, occurs when timbers and other cellulose building materials are exposed to damp conditions on an ongoing basis. This could be the result of exposure to weathering over a prolonged period of time, or the attraction of excessive moisture from other abutting building materials. There appears to be chemical delignification developing in some sections of the slats.

A licensed carpenter or licensed builder should be consulted for a repair solution. This would be considered as urgent.

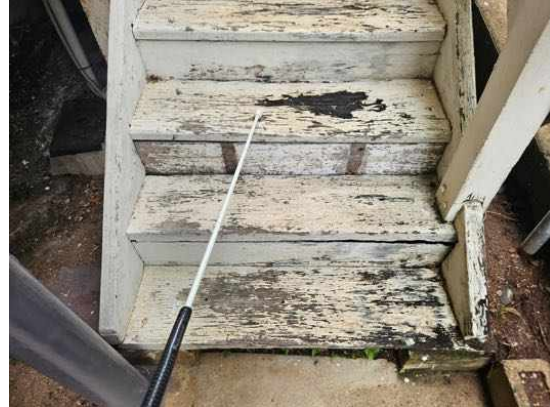
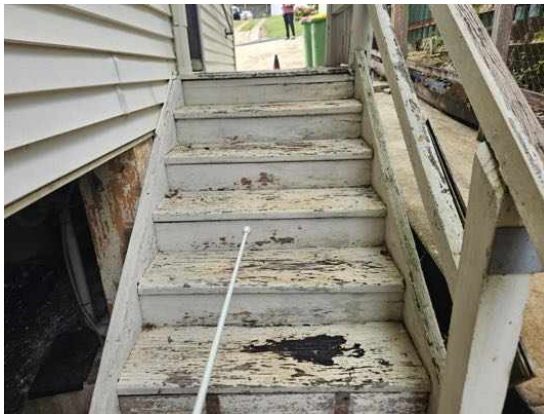
| Finding: | Wood rot / fungal decay |
| Information: | The timber components show evidence of wood rot beginning in various sections of the timber. |

Wood rot, also known as Fungal Decay, occurs when timbers and other cellulose building materials are exposed to damp conditions on an ongoing basis. This could be the result of exposure to weathering over a prolonged period of time, or the attraction of excessive moisture from other abutting building materials.

Early intervention and regular maintenance, particularly of exterior timbers, will prolong the useful life of these building elements. Prior to any works being performed, the cause of the moisture that has created the visible wood rot should be identified and addressed in a suitable manner. Replacement of affected timbers may then be a necessary step in protecting surrounding building elements from such deterioration.

A licensed carpenter or licensed builder should be consulted to advise on a solution for the affected building materials.

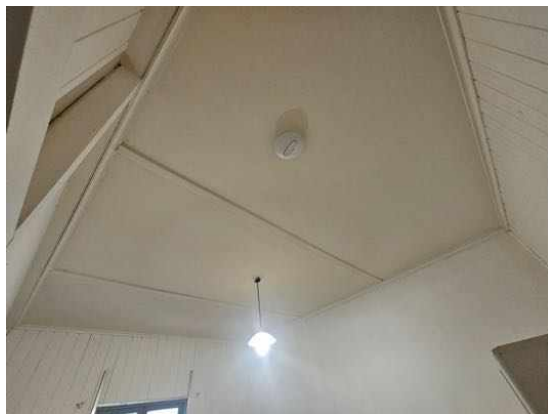
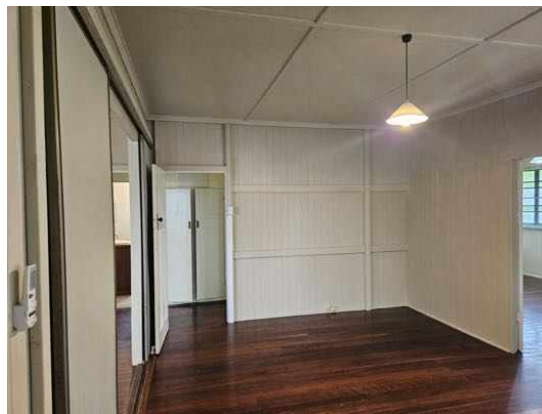
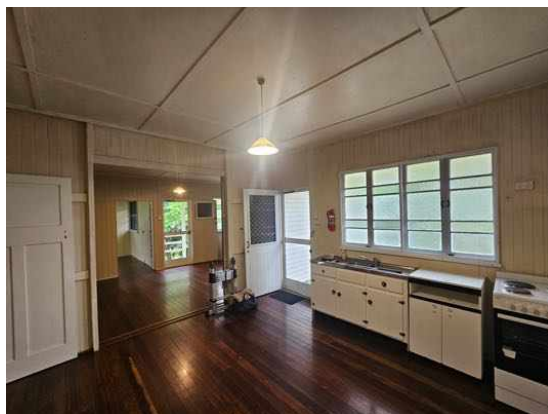
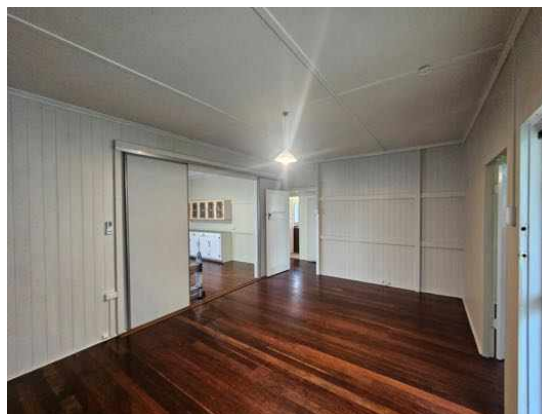
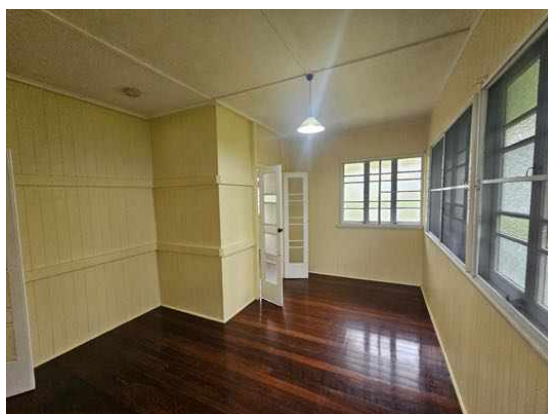
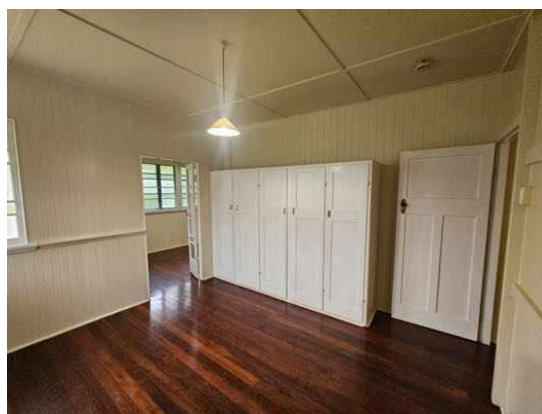
| Finding: | ACM - Suspected ceiling sheet - good condition |
| Information: | The ceiling sheets throughout the building are suspected to have been constructed with the use of asbestos-containing materials (ACM). The observable areas of ceiling sheeting appear to have minimal obvious signs of damage or deterioration, indicating that the asbestos is currently reasonably encapsulated and reasonably well contained. The sheet indicated by a pointer is the only sheet not suspected to be ACM. |

If maintained in good condition, ACM sheets pose little risk; therefore care should be taken to maintain the walls. As shown in the photos, there are small holes where the screws were removed from decorative lace work at the top of the posts. Carefully filling and painting these holes prior to painting should encapsulate any reasonable defects on the sheet surface. At the driveway end of the ceiling there is a patch fitted into the sheet. This is suspected to be ACM as well as the surrounding sheets, these gaps should be carefully filled and wet tooled. DO NOT sand these sheets under any circumstance. Painting should be done as soon as possible to complete the surface sealing. This should be maintained until it is scheduled for renovation.

Where the client elects to retain the ACM, the client should regularly monitor the condition of the wall sheets to identify any further damage or deterioration. Such monitoring should be conducted at least annually, but more frequently should damage or evidence of deterioration occur. Additional remedial work is a potential short to medium term solution to reduce the risk presented by the ACM.

No works should be carried out to the ACM or associated building elements without further specialist advice.

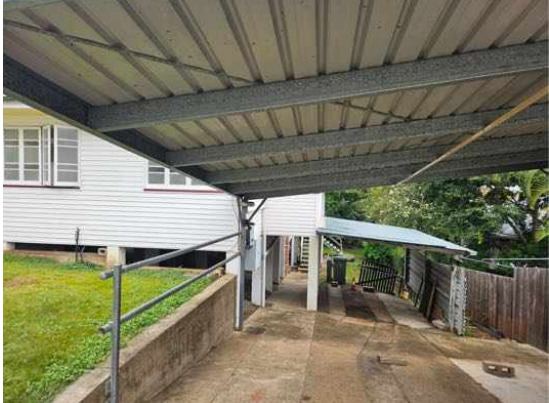
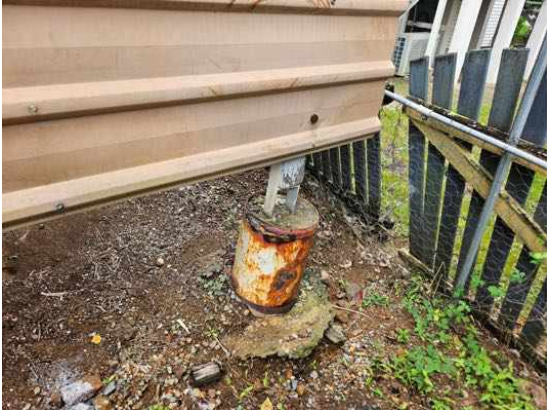
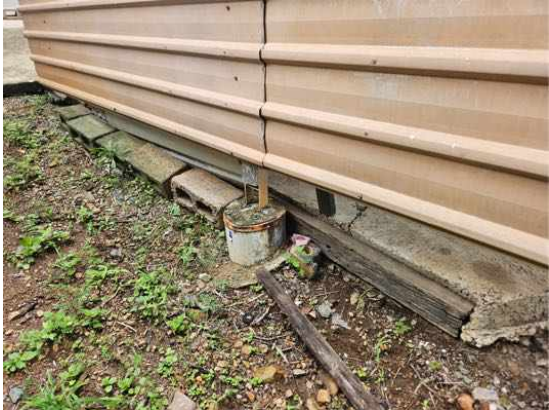
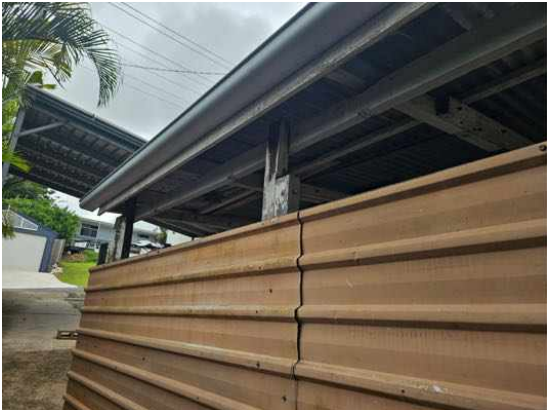
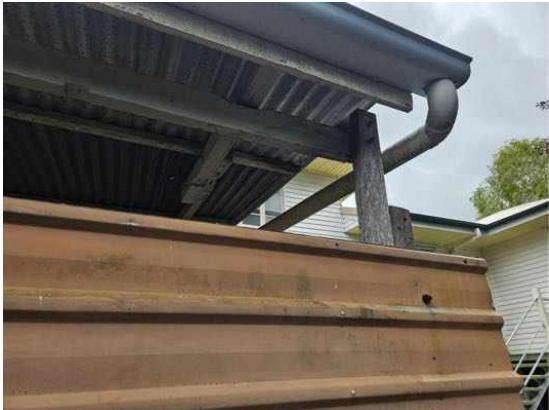
Building: Out Building
 Location: Carport
 Finding: Suspected - non certified construction, deteriorating
 Information: On the day of inspection additional building works constructed on the property, suspected as being non certified, were noted. It is suspected that these works, whilst being functional and have been in position for a lengthy period, are deteriorating, and may not be approved construction works.

building area not requiring council approval, the client should seek advice regarding council approval / certification if they wish to make further alterations.

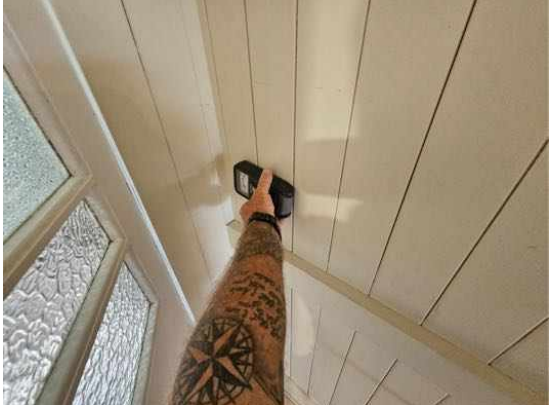
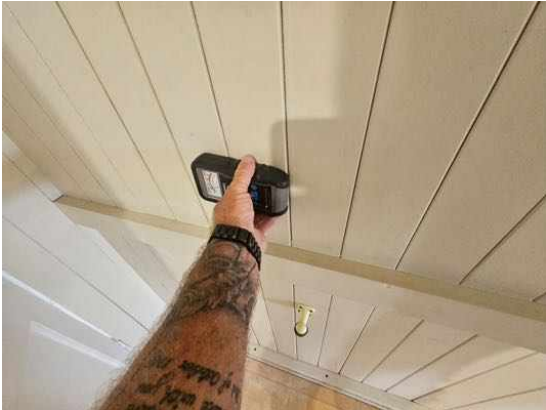
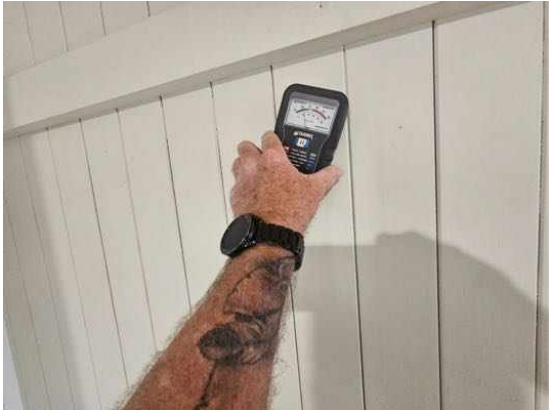
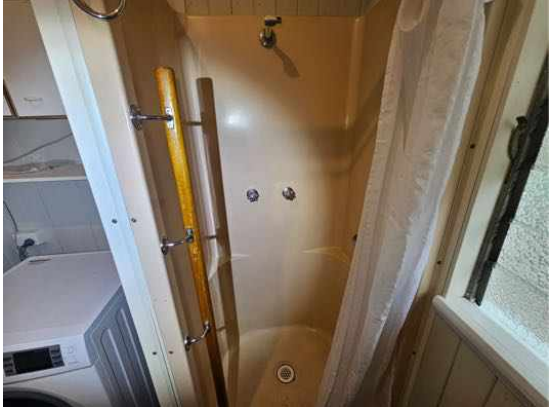
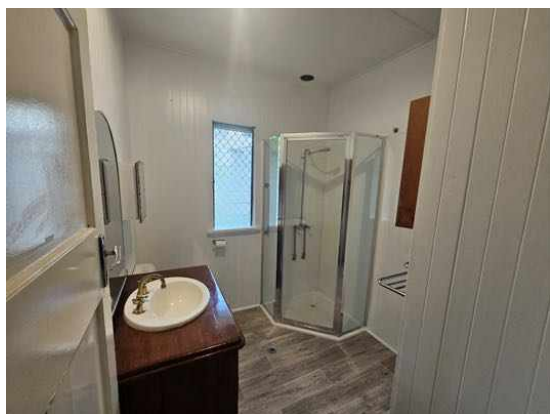
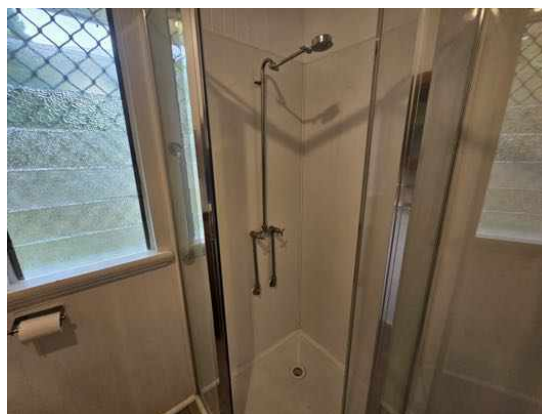
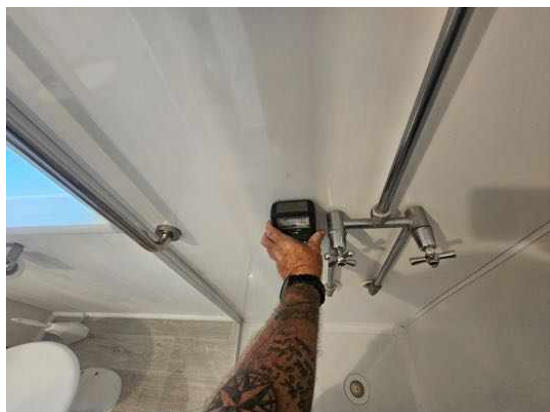
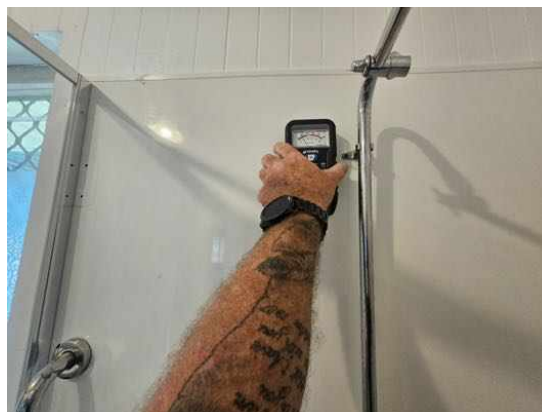
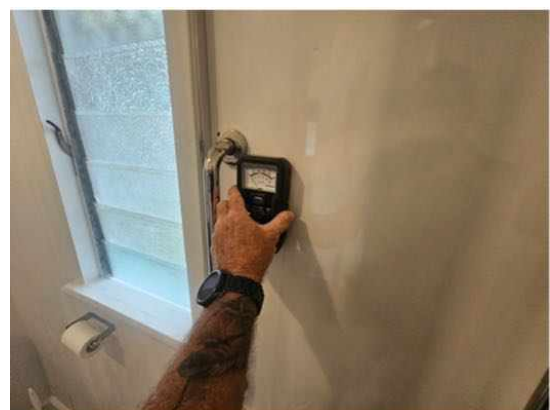
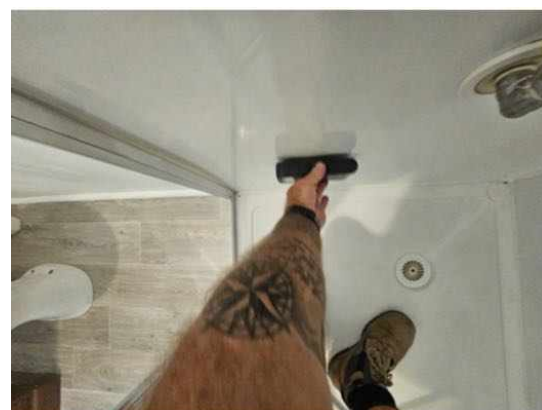
Building: Main Building
Location: Bathrooms
Finding: No moisture detected in bathrooms
Information: On the day of inspection the showers in the bathroom/s are measure for moisture

using a "Tramex" moisture meter. During this inspection no moisture was detected in these areas and the tiled / sheeted surfaces appear to be in good order.

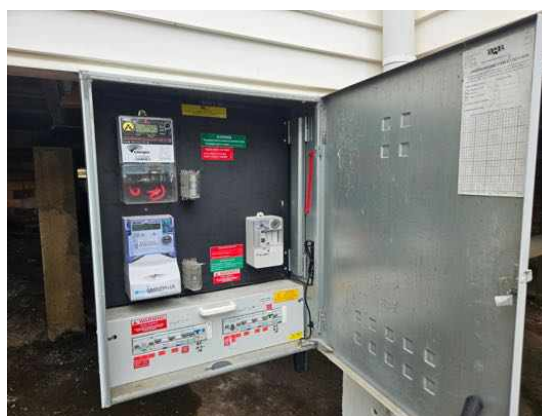
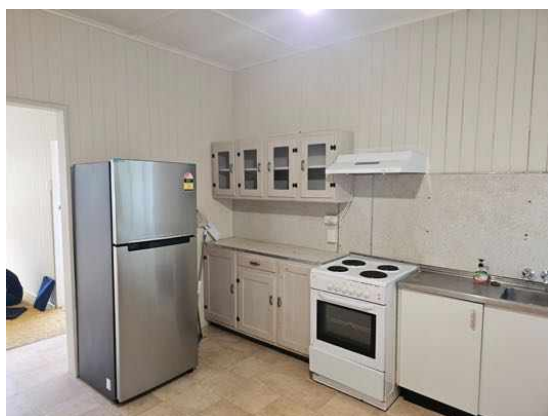
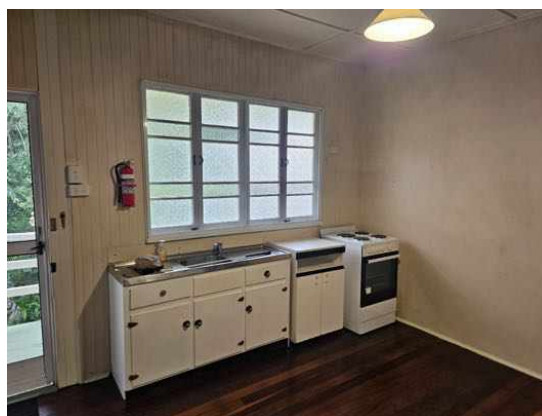
Building: Main Building
 Location: Meter box, kitchen cupboard
 Finding: Durable pest inspection notice - not assessable
 Information: On the day of inspection it was noted that the durable timber pest inspection / treatment notice was missing, not visible or out of date. These notices / stickers are to verify the timber pest inspection dates, the inspector, the currency and type of timber pest system / barrier in place or being used in and around the property.

It is recommended that a licensed timber pest controller be contacted to assess the properties needs and provide costings for an annual inspection programme.

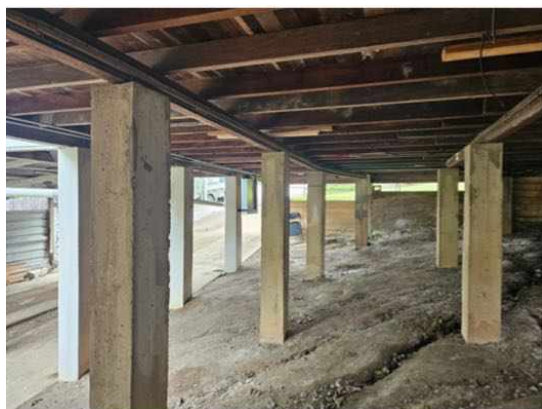
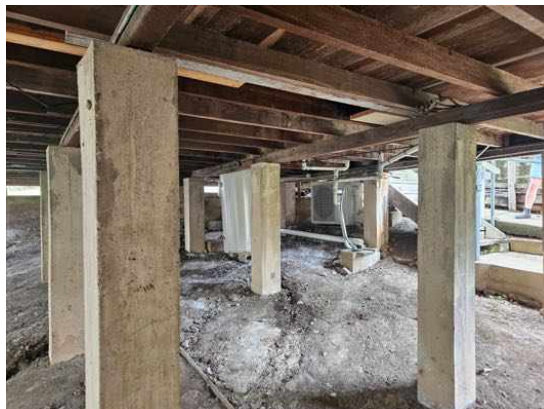
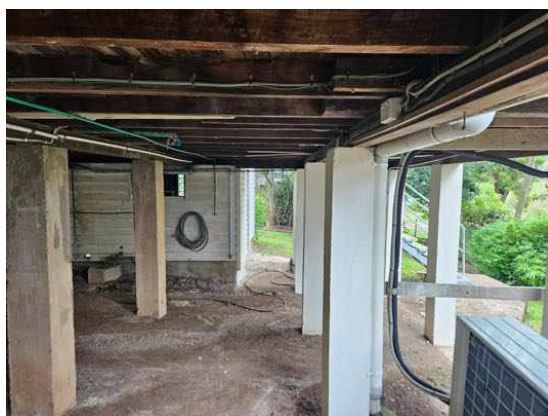
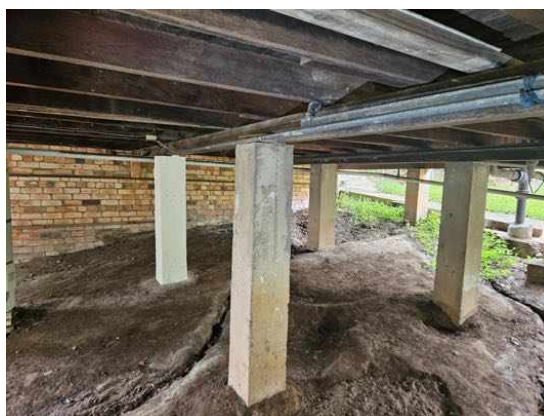
The building employs a physical barrier system to the perimeter of the party wall and the ground floor laundry area, the balance of the subfloor is considered a visual inspection zone. In order for a barrier system to be effective, the property must have regular inspections at intervals of not greater than 12 months. Depending on the risk profile attributed to the property, these inspections may be recommended at lesser time periods.
