# Building and Timber Pest Inspection Report

Inspection Date: Wed, 4 Mar 2026

Property Address: 2B Dingle Street, Riverstone, NSW 2765

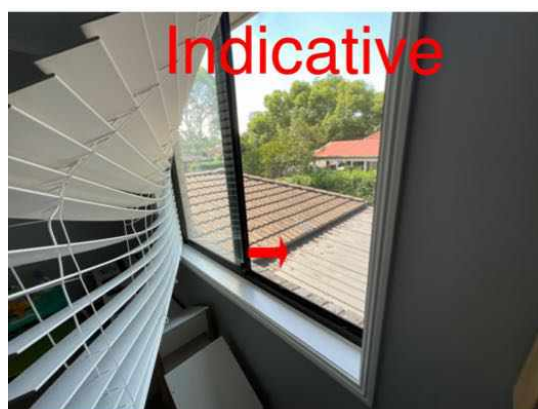
Building:	Main Building
Location:	Upstairs Windows
Finding:	Window restrictions - Missing
Information:	Window restrictors were found to be missing.

The National Construction Code (NCC) requirements apply to all openable bedroom windows in residential buildings, including hotels, motels and for all windows in early childhood centres.

Windows need to be locked at 12.5cm when the devices are engaged. The safety devices must be robust and child proof. The alternative is security screens such as bars or grills on the windows so long as they have gaps no bigger than 12.5cm. Flyscreens do not comply unless they are the reinforced security type and capable of resisting the very strong outward pressure which would prevent a child falling through. The laws apply to openable windows in a building within 1700mm of the internal floor and if the internal floor is more than 2m above the ground floor outside.

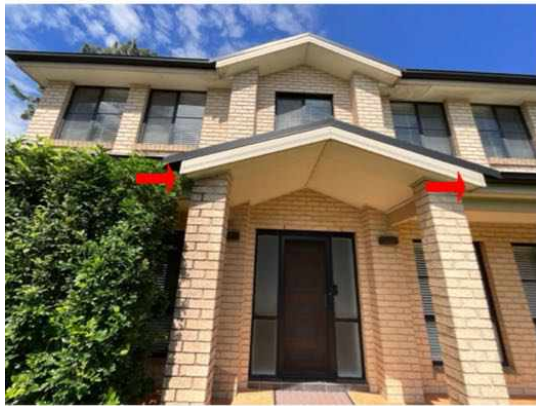
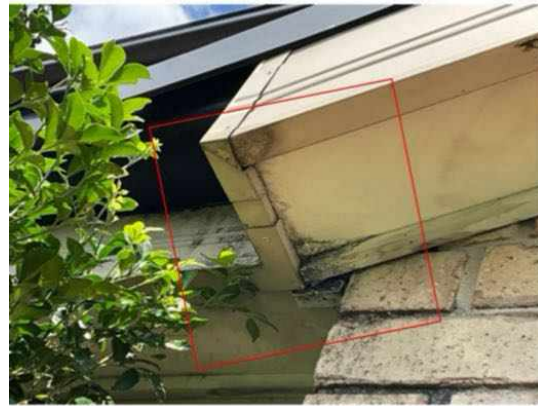
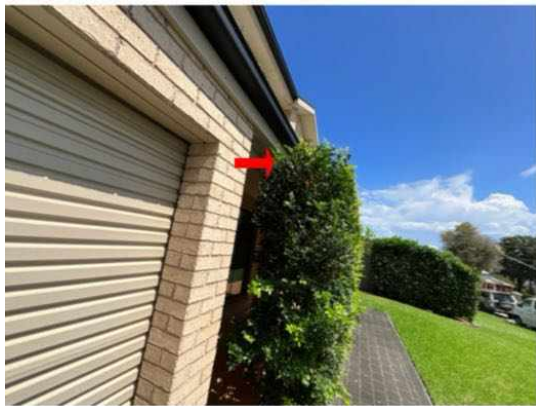
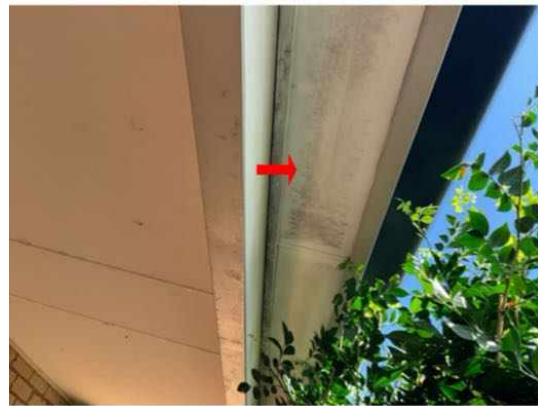
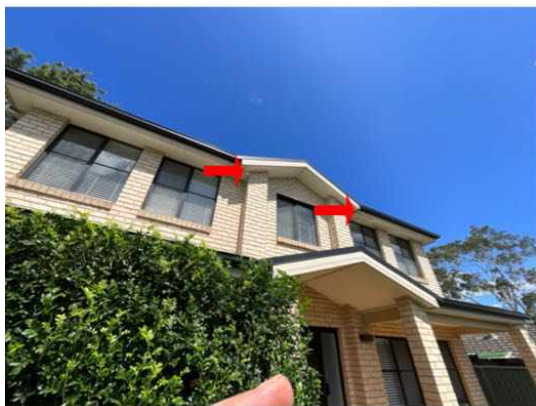
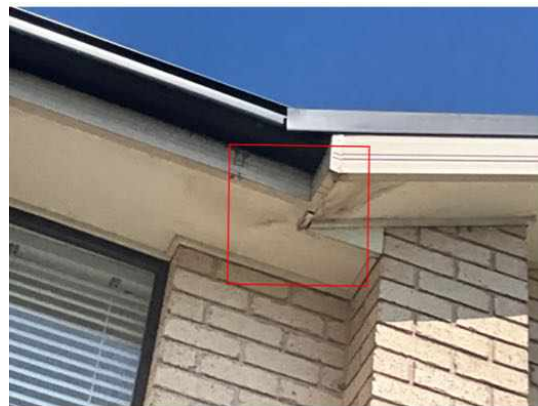
Finding: Eaves/Roof plumping -- water damages

Information: Water damage is generally an indication of excessive moisture being present, usually via a leak. It is suspected that gutter blockages causing stormwater to backflow into the eaves causing water damages. This is additionally conducive to termite activity due to the damp conditions.

Where water damage is evident, the primary requirement is to identify and rectify the source of the leak. Gutters must be kept clear of any blockages moving forward. A roofing plumber should be appointed for further assessment if the problem persists.

Once the leak is repaired, consultation with relevant tradespeople, including carpenters, plasterers and painters, is advised.

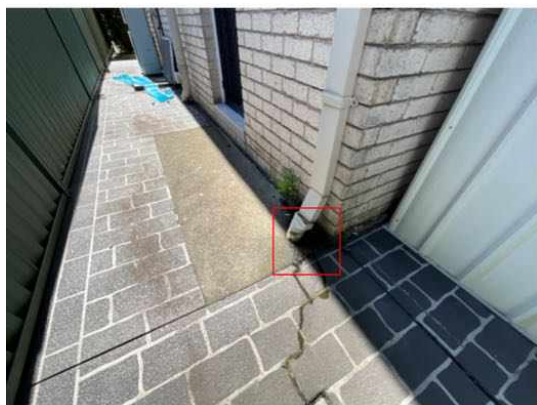
### Finding 3.02

Building:	Main Building
Location:	Rear left corner
Finding:	Stormwater drain - Not connected
Information:	The roof plumbing is not adequately connected to stormwater drainage on the site. This disconnection negatively impacts the functional capacity of the roof plumbing.

Where roof plumbing doesn't drain adequately, the area at the base perimeter can become excessively damp, potentially creating an environment that is susceptible to rust and corrosion of surrounding building elements, as well as attracting termites and other pests.

It is highly recommended that a plumber be appointed to further inspect the area and to install adequate drainage equipment where necessary.

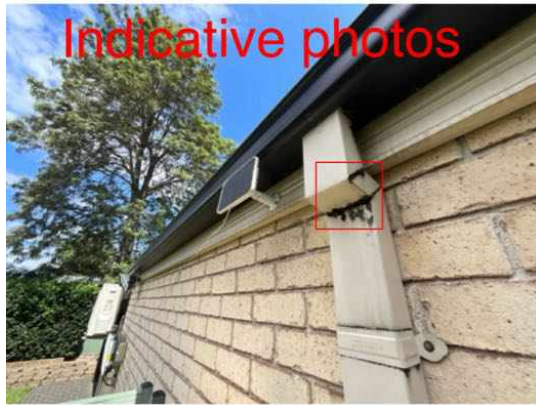
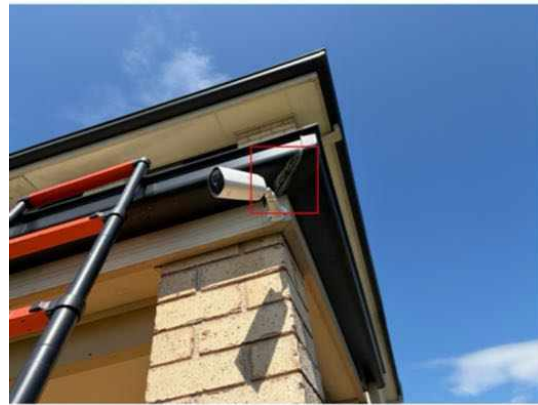
### Finding 3.03

Building:	Main Building
Location:	Multiple areas of roof plumbing
Finding:	Water leak - External
Information:	Water leaks were found to be present to exterior plumbing work. Leaks are generally caused by deterioration of the plumbing elements over time, due to exposure to weather conditions, but may have also been caused by minor impact damage.

Such leaking creates damp conditions in the affected area, causing potential for water pooling and subsequent water damage if left unattended. These conditions may also attract termite attack, particularly if the area is subject to minimal levels of sun throughout daylight hours.

It is highly advised that a licensed plumber be appointed to rectify any water leaks that may be present. Areas of repair and replacement of plumbing fittings and fixtures may be required and, as such, a quotation should be sought.

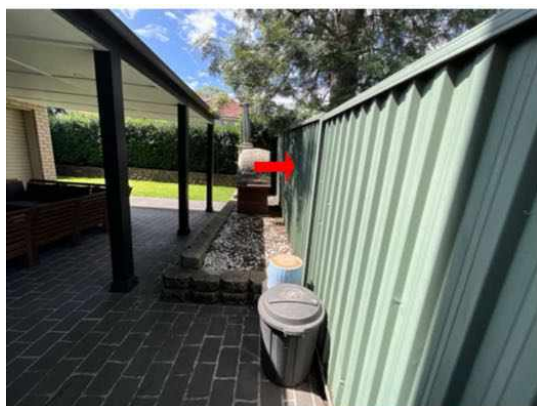
### Finding 3.04

Finding: Fencing - Deteriorated

Information: It was noted at the time of inspection that sections of the fencing in this area has deteriorated. Typically fencing deteriorates due to age and or wear, rot and or rust which is generally expected for a structure of this age, due to prolonged exposure to weather conditions. Sometimes inadequate installation or maintenance can be to blame.

If left unattended, it is likely that further damage will occur. It is suspected that repair of several elements of the fencing may be required however replacement may be a consideration of the client also.

A licensed fencing contractor should be appointed to provide further advice and perform rectification works as necessary.

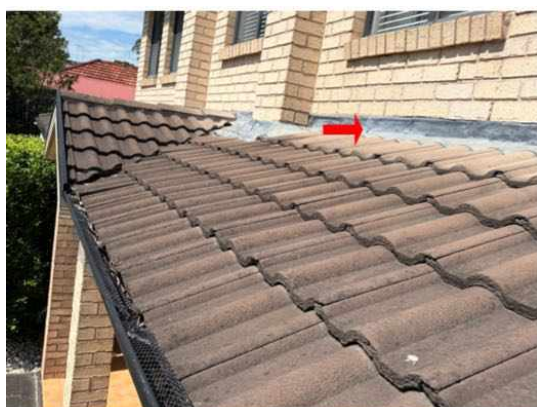
Building:	Main Building
Location:	Front Elevation
Finding:	Roof plumbing - Flashing cracked
Information:	Water leaks generally occur when a particular area of the property is not weather or water tight. Cracks were evident to the roof flashing in this area at the time of inspection.

Regardless of the location, if left unmanaged, even minor leaks can lead to serious damage of associated building elements, potentially resulting in the need for replacement of building materials. Damage to ceilings, wood rot, mould and other hazards, such as electrical hazards, may also arise if left unmanaged.

Further inspection and repair by a roof specialist or a licensed roof plumber is advised to adequately rectify the potential leak.

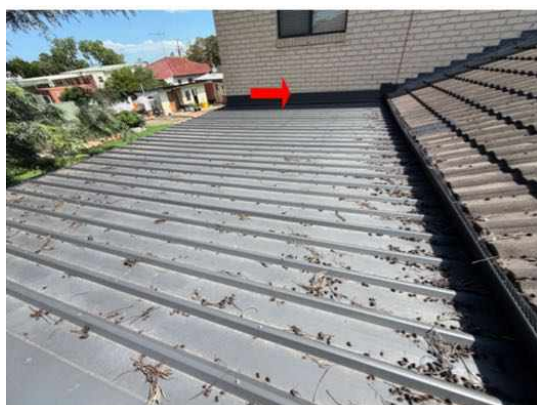
The roof flashing that has been installed does not appear to comply with current building practice. However the flashing appears to be in an acceptable condition and is fulfilling its purpose in ensuring the roof covering is weather-tight.

Whilst retrospective fixing is not required if flashing begins to come loose from its fixing or deteriorates as evidenced by roof leaks a licensed roofing plumber should be appointed immediately to replace the building element.

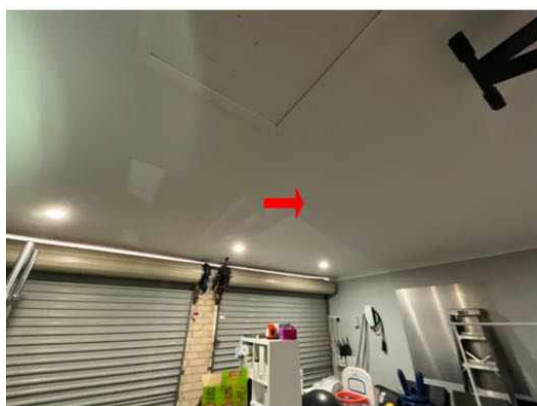
Building:	Main Building
Location:	Garage
Finding:	Cracking - Damage Category 1 - Fine (up to 1mm)
Information:	Although fine cracks are quite noticeable, they are often only considered to be an appearance defect, and usually do not indicate any structural damage. Generally, the cause of a fine crack is indicative of a separation between building materials and finishes (e.g. paint, plaster, etc.) along joints.

Cracking of this nature can generally be repaired with minor sanding, filling and/or repainting. Such works should be performed by a qualified painter or a general handyman.

Monitoring of all cracking should be conducted frequently. Always contact a building inspector should cracks widen, lengthen, or become more numerous.

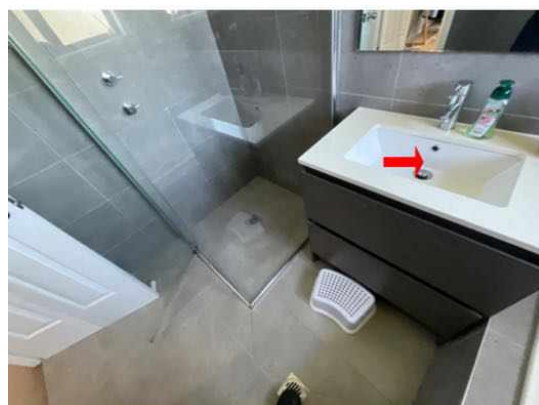
### Finding 3.12

Building: Main Building  
 Location: Bathroom  
 Finding: Basin - Cracked  
 Information: Cracking was evident to the basin at the time of inspection, which is suspected to have been by minor impact damage. While the cracking appears to be minor, any further impact damage sustained by the basin may lead to additional cracking.

As the cracking provides potential ingress for water, secondary water damage may occur to associated cabinetry, walls or flooring, if the cracking is left unmanaged.

Consultation with a plumber regarding basin repair or replacement is required. Remedial works may be required to protect against any further damage.

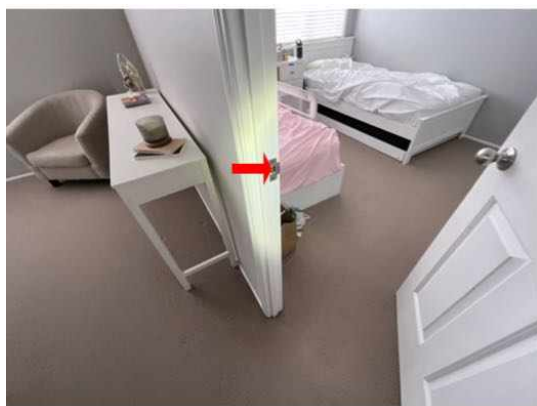
### Finding 3.13

Building: Main Building  
 Location: Bedroom 2  
 Finding: Door - Striker plate misaligned  
 Information: The striker plate to this door appears to have become misaligned and has consequently resulted in the door's operation being compromised.

This is a common defect and is expected in a property of this age, whether being due to substandard installation or general deterioration of the door hardware.

Readjustment of the striker plate is recommended at client discretion. Works such as these can be completed by a general handyman or qualified carpenter.

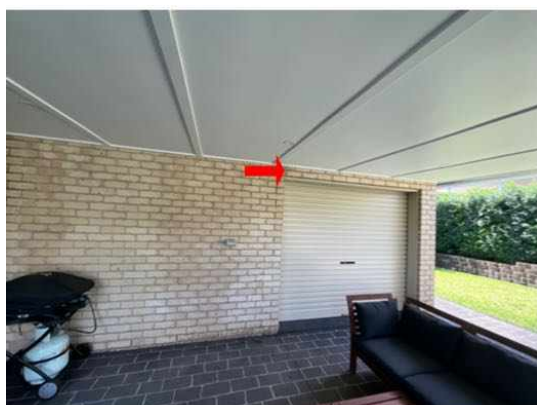
### Finding 3.14

Finding: Brickwork - Cracking [Fine]

Information: Although fine cracks are quite noticeable, they are often only considered to be an appearance defect and usually do not indicate any structural damage. Generally, the cause of a fine crack is indicative of a separation between brickwork and mortar throughout the structure, but single bricks may also show cracks of this nature.

Cracking of this nature can generally be repaired with minor filling and should be conducted by a qualified bricklayer.

Always contact a building inspector should cracks widen lengthen or become more numerous.

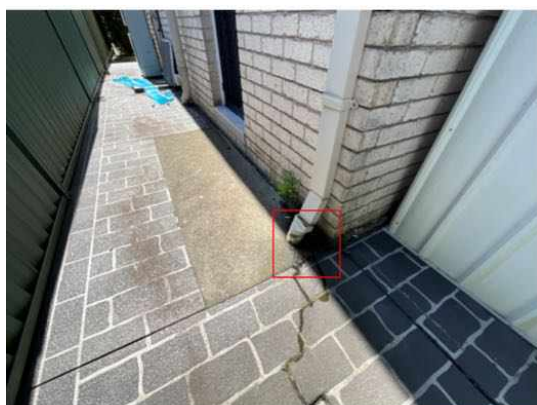
Where roof plumbing doesn't drain adequately, the area at the base perimeter can become excessively damp, potentially creating an environment that is susceptible to rust and corrosion of surrounding building elements, as well as attracting termites and other pests.

It is highly recommended that a plumber be appointed to further inspect the area and to install adequate drainage equipment where necessary.

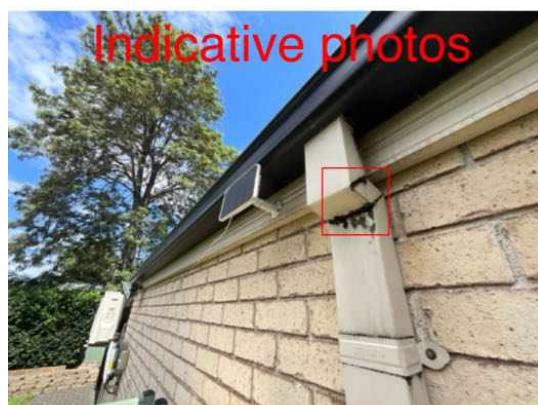
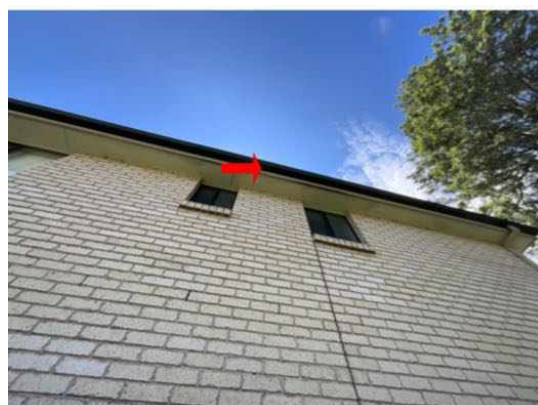
### Finding 6.02

Building:	Main Building
Location:	Multiple areas of roof plumbing
Finding:	Water leak - External
Information:	Water leaks were found to be present to exterior plumbing work. Leaks are generally caused by deterioration of the plumbing elements over time, due to exposure to weather conditions, but may have also been caused by minor impact damage.

Such leaking creates damp conditions in the affected area, causing potential for water pooling and subsequent water damage if left unattended. These conditions may also attract termite attack, particularly if the area is subject to minimal levels of sun throughout daylight hours.

It is highly advised that a licensed plumber be appointed to rectify any water leaks that may be present. Areas of repair and replacement of plumbing fittings and fixtures may be required and, as such, a quotation should be sought.

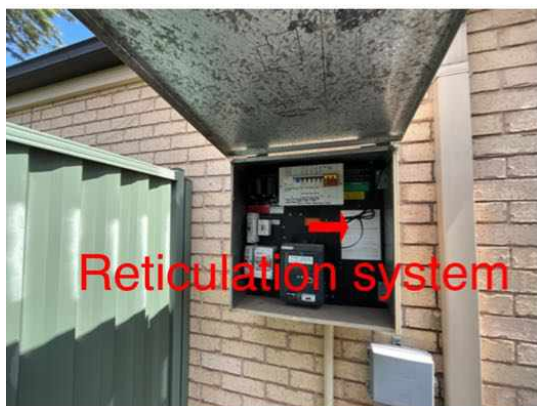
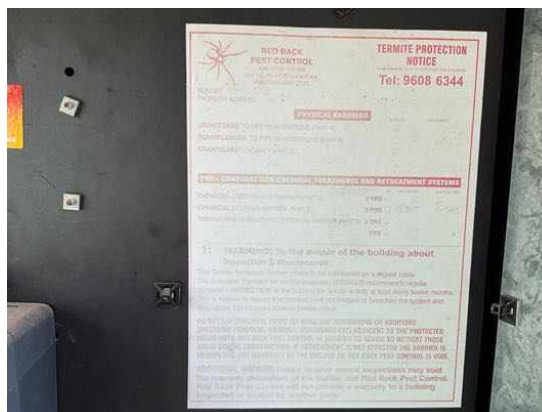
### Finding 6.03

Building:	Main Building
Location:	All Areas
Finding:	Re-application of chemical termite barrier - required
Information:	Chemical treated barriers deteriorate over time necessitating the need for re-application of a barrier every 6-10 years depending on the product type environment etc. Due to this deterioration chemical barriers decline in their effectiveness exponentially if not replenished.

Consult the record of installation to identify the type of chemical and date of application. It is then advised to consult a licensed pest controller regarding reapplication intervals. Annual inspections are almost always required for all system types.

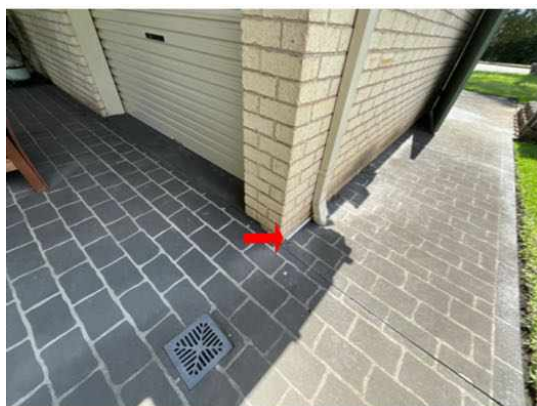
### Finding 6.04

Building: Main Building  
 Location: Yard - Side  
 Finding: Overflow - Not plumbed for drainage  
 Information: The overflow is not plumbed or connected to suitable drainage, which can result in the surrounding area becoming excessively damp.

These damp conditions can lead to secondary defects such as rot, rust or corrosion of associated building elements, the formation of fungal decay, or even the creation of potential slip hazards. When coupled with poor site drainage, pooling of water may also attract termite activity to this area.

It is highly recommended that a licensed plumber be appointed to install adequate drainage to the overflow. These works will ensure that the area remains dry and free of any secondary defects.

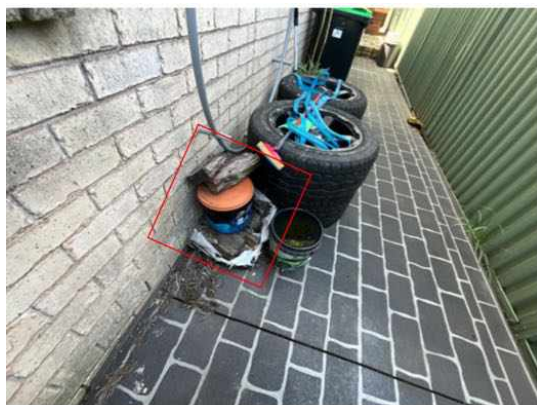
### Finding 6.05

Building:	Main Building
Location:	Yard
Finding:	Stored timbers - subfloor space or external area
Information:	The storing of timbers in the subfloor space or around the external property increases the risk of termite activity being present. As they are likely to come into contact with weather conditions or excessive moisture wood rot is likely to develop on timbers that are not treated.

It is highly recommended that any stored timbers be immediately removed from areas in which they may attract any termite / timber pest attack. Minimisation of risk / prevention of termite attack is far more adequate than dealing with the presence of termite activity.

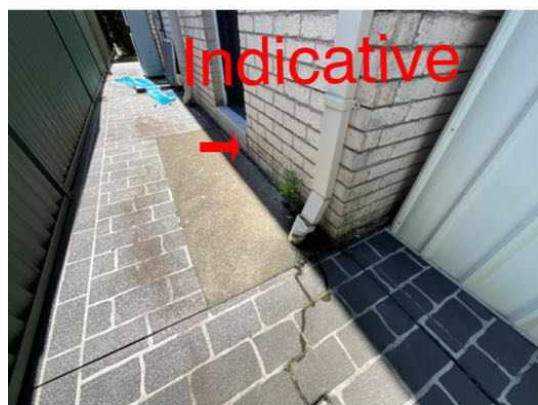
arrange to have the slab edge exposed for inspection. Concealed termite entry may already be taking place but could not be detected at the time of the inspection. This may have resulted in concealed timber damage. Does the slab edge inspection zone fully comply?

Not able to comment. A very high proportion of termite attacks are over the edge of both Infill and other concrete slabs types. Covering the edge of a concrete slab makes concealed termite entry easy. Infill slab type construction has an even higher risk of concealed termite ingress as the slab edge is concealed due to the construction design and cannot be exposed. The type of slab may only be determined by assessment of the construction plans by a qualified person e.g. Builder, Architect. Construction Plans may be obtainable by your local Council or Builder. Termite activity and or damage may be present in concealed timbers of the building. We strongly recommend frequent regular inspections in accordance with AS 3660.2. Where the slab edge is not fully exposed or the slab is an infill slab or the slab type cannot be determined then we strongly recommend inspections every 3 to 6 months in accordance with AS 3660.2 or AS 4349.3.
