Building and Timber Pest Inspection Report

Inspection Date: Wed, 18 Mar 2026

Property Address: 3-14 Moodie St, Caulfield East VIC 3145,
Australia

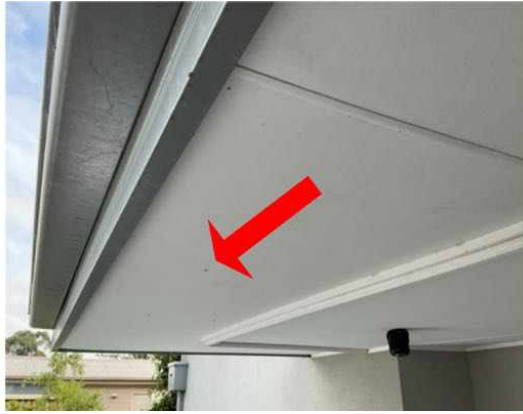
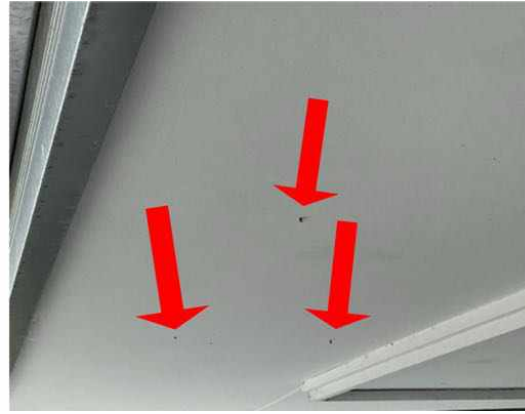
Information: Parts of the entry eaves are sagging and some nails are coming loose. It is suspected water is getting into the eaves through blocked gutters or missing flashings.

Recommend engaging a roof plumber to clean gutters and install flashings where appropriate to reduce the risk of water penetration to the building as soon as possible.

Recommend engaging a carpenter to repair as necessary to reduce the risk of further deterioration as soon as possible.

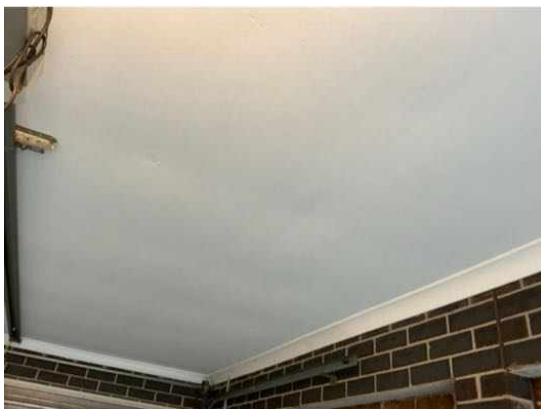
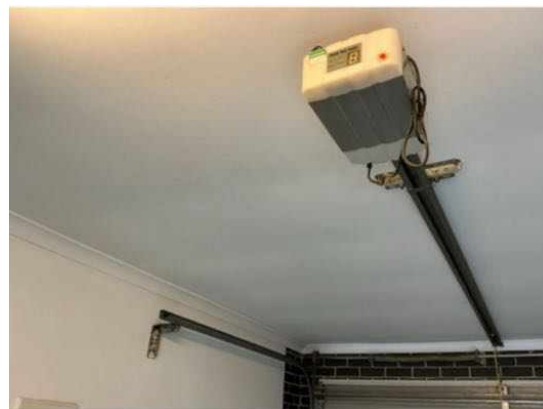
Finding 3.02

Building:	Main Building
Location:	Garage
Finding:	Ceiling - Sagging garage
Information:	Sections of the garage ceiling were found to be sagging at the time of inspection. Sagging to the fixed ceiling structure generally indicates that the building materials/fixings (e.g. nails or glue) have become loose and require reattachment. This is quite a common defect in garages of this age. It is suspected that internal plaster is used where wet board plasterboard should be used and it gets affected by the moisture and condensation in the air. There is normally no insulation in the garage ceiling allowing the moisture to accelerate the deterioration.

Where sagging is evident repairs such as re-gluing or replacing of ceiling sheets, may be required. Such works may be performed by relevant tradespeople, such as plasterers and painters.

The appropriate action should be taken by the client as soon as possible to ensure that any potential further damage is limited.

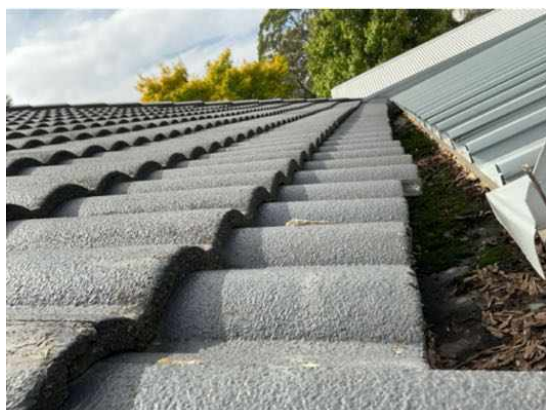
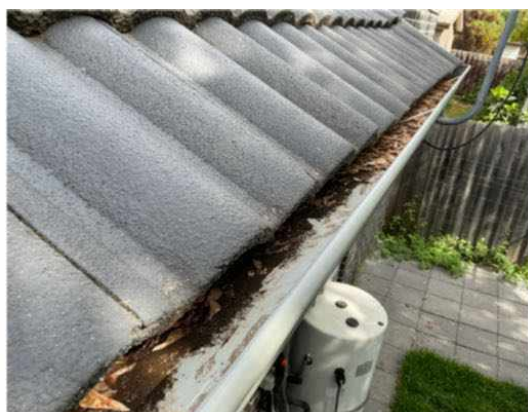
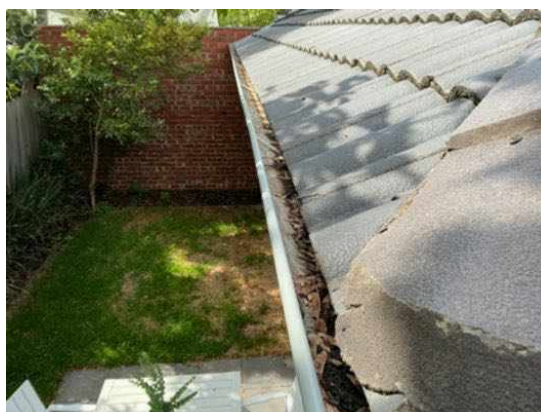
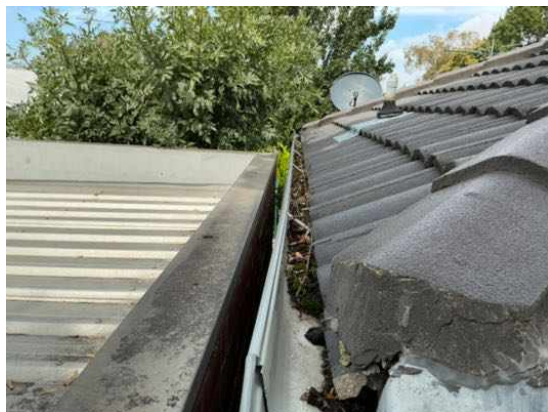
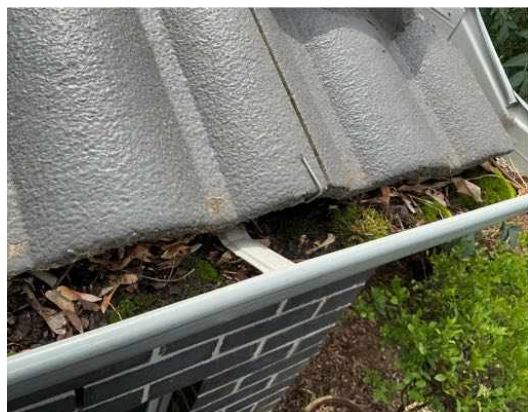
Finding 3.03

Building:	Main Building
Location:	Roof Exterior

Blocked gutters are likely to lead to high levels of moisture in the affected areas. Such moisture will not only cause rust and decay of the associated building materials, but can also provide conditions that are conducive to termite and timber pest activity. Blockages in gutters should therefore be removed immediately to ensure dry conditions are maintained.

Consult a Licensed Plumber for further specific advice on remedial works that may be required. In the interim, it is highly advised that blocked gutters be removed by the homeowner or a general handyperson as a matter of urgency.

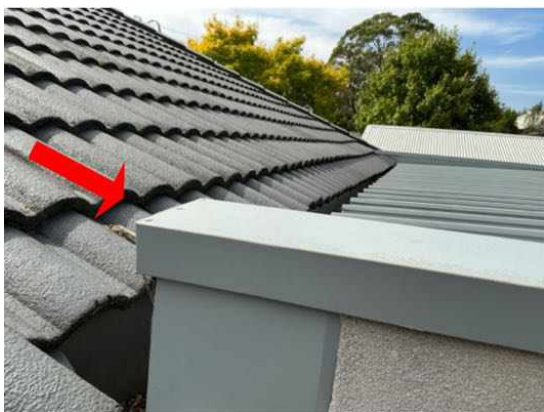
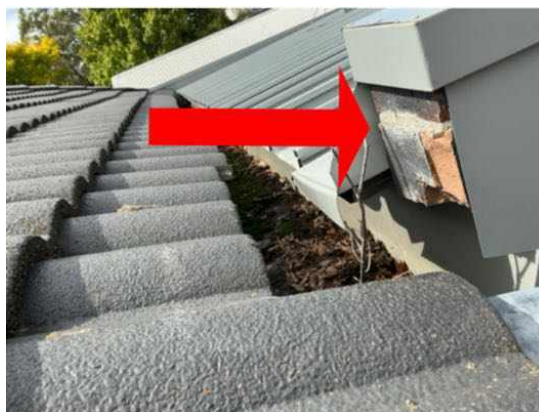
Finding 3.04

Building:	Main Building
Location:	Roof Exterior
Finding:	Missing flashing
Information:	There is a missing flashing above the entrance that could potentially let water into the eaves. Flashings are metal and other materials which are applied to seals and intersections between roof coverings and building elements. They are designed to aid in weatherproofing of roof joins.

Flashings that are not installed adequately or are missing are likely to result in water penetration to the interior of the property, as well as creating excessively damp conditions against the exterior surfaces and around the base perimeter of the building.

Premature ageing and secondary building defects are imminent where roof plumbing is missing or inadequately installed. Additionally, water pooling also creates an environment that is susceptible to termite and pest infestation.

A roofing plumber should be appointed as soon as possible to install relevant roof plumbing materials, ensuring that no further damage is sustained.

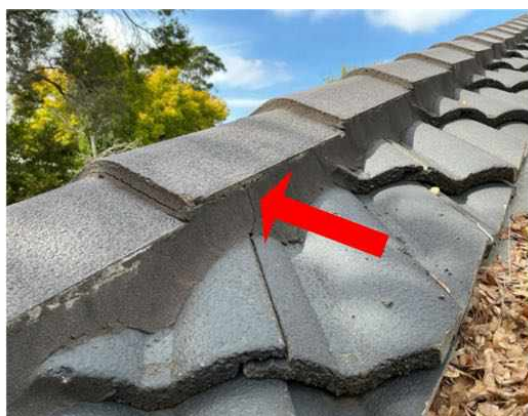
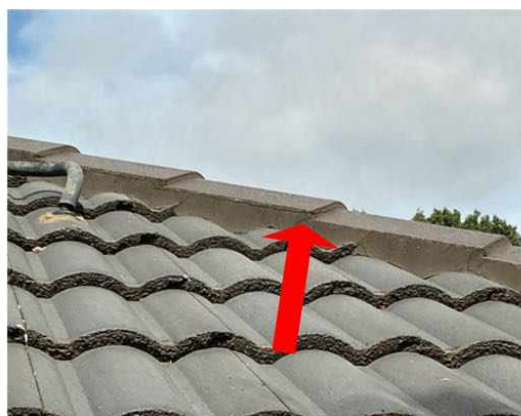
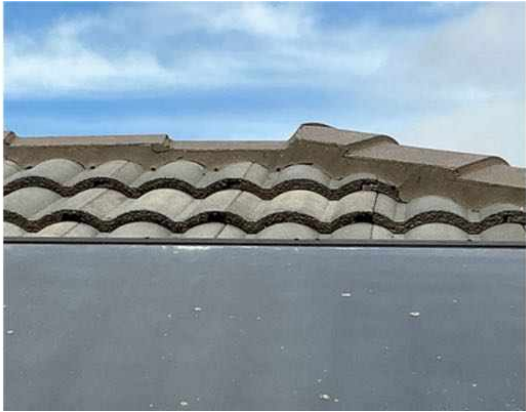
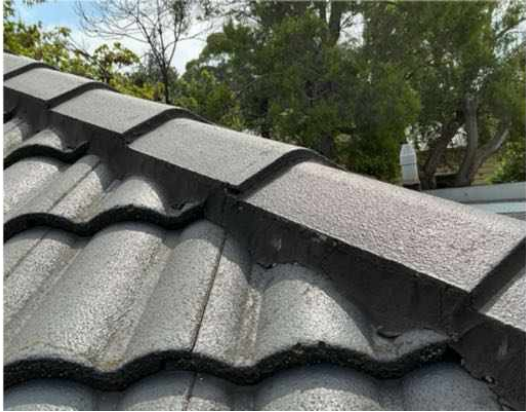
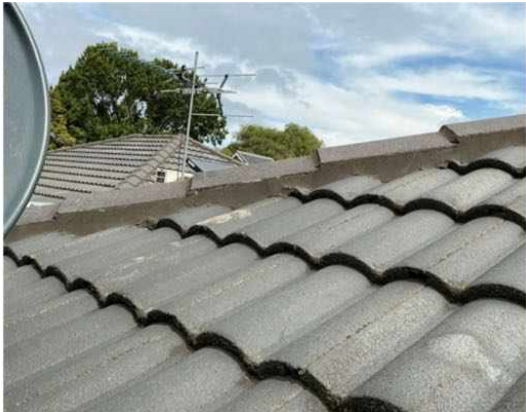
Finding 3.05

Building:	Main Building
Location:	Roof Exterior
Finding:	Roof tile mortar deterioration and cracking
Information:	Cracking and deterioration was observed in the ridge and hip tile mortar bedding. The mortar has separated in several areas, with visible gaps forming between ridge tiles and the underlying bedding. This condition indicates age-related degradation and exposure to the elements, which has caused the mortar to become brittle and lose its bonding integrity.

Compromised mortar may lead to further deterioration, potentially allowing water ingress and structural damage to the roof structure below.

Recommend engaging a qualified roofing contractor to carry out repointing or full re-bedding of affected ridge and hip tiles as necessary. All deteriorated mortar should be removed and replaced with new flexible roof bedding compound in accordance with current Australian Standards (AS 2050).

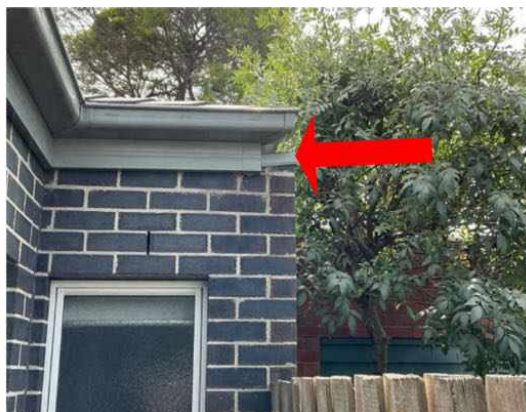
Finding 3.06

Building: Main Building
Location: Roof Exterior
Finding: Flashing leaning wrong way and could hold water.
Information: The flashing on the right hand rear side of the building is leaning the wrong way and could hold water. Flashings are metal and other materials which are applied to seals and intersections between roof coverings and building elements. They are designed to aid in weatherproofing of roof joins.

Flashings that are not installed adequately or are missing are likely to result in water penetration to the interior of the property, as well as creating excessively damp conditions against the exterior surfaces and around the base perimeter of the building.

Premature ageing and secondary building defects are imminent where roof plumbing is missing or inadequately installed. Additionally, water pooling also creates an environment that is susceptible to termite and pest infestation.

A roofing plumber should be appointed as soon as possible to install relevant roof plumbing materials, ensuring that no further damage is sustained.

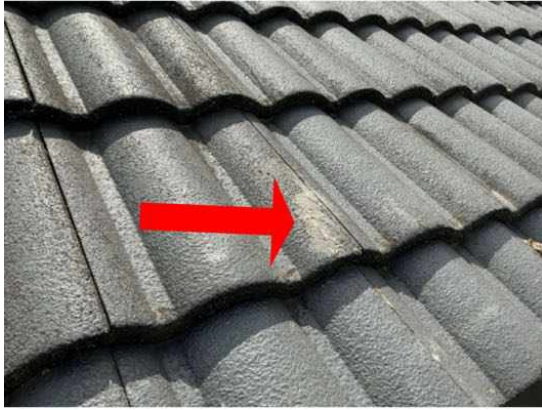
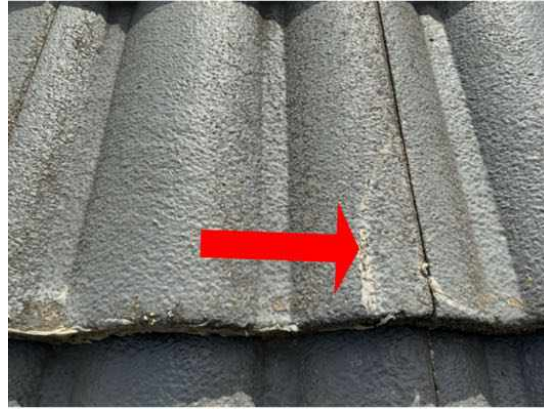
Finding 3.07

Building:	Main Building
Location:	Roof Exterior
Finding:	Roof tiles - Broken
Information:	Upon inspection of the exterior roof covering, broken roofing tiles were identified. Broken tiles are generally the result of ageing and weathering of what is essentially a porous material.

If left to further deteriorate, broken and brittle roof tiles are likely to lead to water penetration via the roof into the ceiling space, causing excessive moisture and secondary damage to ceiling linings, insulation and roof structures. Broken roof tiles are also likely to detract from the effectiveness of the roof drainage system, creating potential for secondary damage to the exterior roof covering and roof plumbing. Excessive moisture could attract termites.

Replacement of broken tiles is required and should be performed by a roofing contractor as soon as possible.

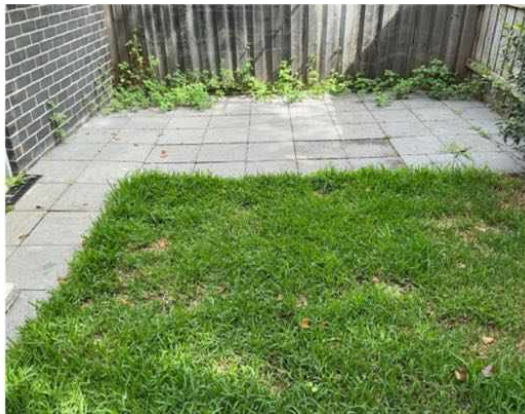
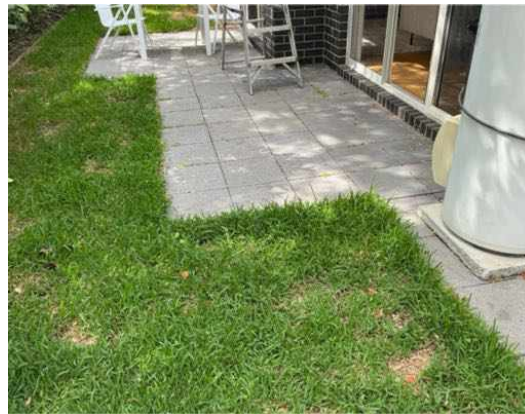
Finding 3.08

Information: Sections of the external paved areas are uneven, creating a potential trip hazard. It appears as though the area has been subject to rough installation, or that paving sections have lifted due to movements in the foundation of the property.

Where paving creates a trip hazard, personal injury may ensue if due caution is not taken by all persons within this area.

Re-paving of the area is required as soon as possible to remedy this situation. Further consultation with a specialist paver is advised.

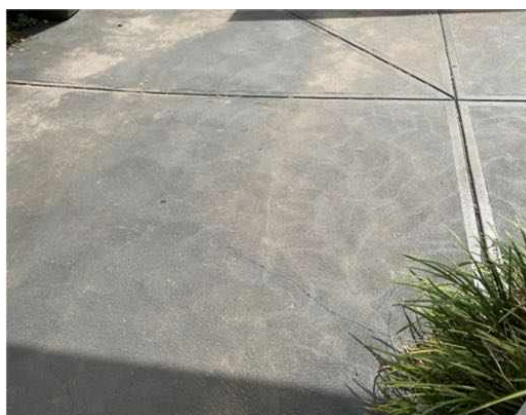
Finding 3.09

Building:	Main Building
Location:	Driveway
Finding:	Driveway Cracking - External Concrete Paving Damage Category 1 - Fine (less than 2mm)
Information:	Fine cracks were identified in the driveway external concrete paving. Although fine cracks are quite noticeable, they are often only considered to be an appearance defect, and usually do not indicate any structural damage. To be considered a Category 1 or fine crack, the crack is found to be less than 2mm in width.

Generally the cause of a hairline crack in existing concrete paving such as driveways and pathways is indicative of the expansion and contraction of the concrete. Such causes are generally due to environmental factors, such as moisture levels, weather conditions, root systems of nearby trees or the soil types on which they are laid.

Fine cracks may also be due to poor original installation of the concrete. Factors such as poor compaction of the sub surface and/or inadequate reinforcing of the slab may create cracking and other secondary defects.

Monitoring of all cracking should be conducted frequently. Always contact a building inspector should cracks widen, lengthen, or become more numerous.

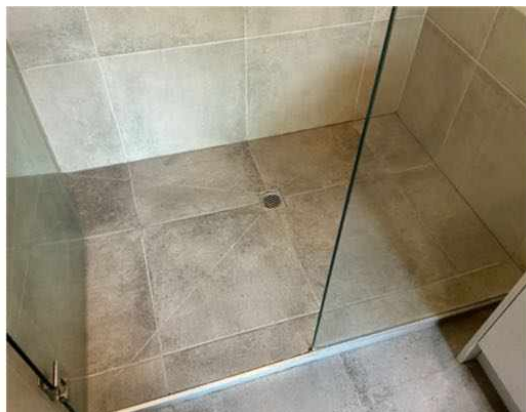
Finding 3.10

Building:	Main Building
Location:	Ensuite - Master
Finding:	Bathroom Sealant and grouting - Missing or damaged
Information:	It was noted on inspection that sealant or grout is degraded to the tiled shower alcove and or other areas of the bathroom.

Different materials and floor areas move at different rates, generally causing cracking to grout or sealant at this point. A flexible sealant is required to allow for expected expansion and contraction, while keeping the joint water tight and protective of all associated building materials.

Flexible and mould resistant materials should be applied to affected areas to prevent any subsequent water damage that is likely to occur. Regular maintenance and replacement of damage or missing or damaged sealant and grout is highly recommended to the wet areas, as this is a regular wear and tear defect. Sealant and grouting in areas that come into regular contact with water should be maintained for the long term care of your property.

A sealant specialist or tiling contractor should be appointed to complete these works as soon as possible

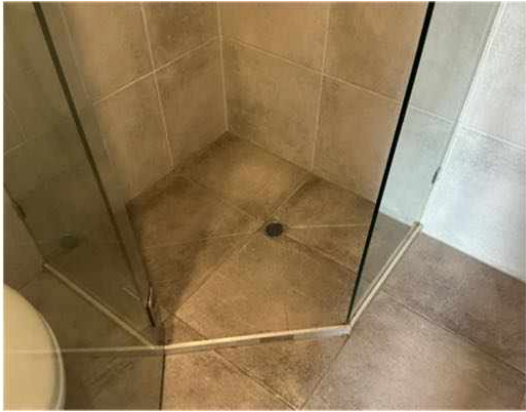
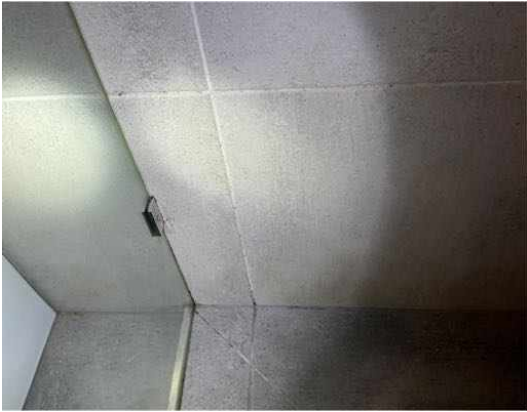
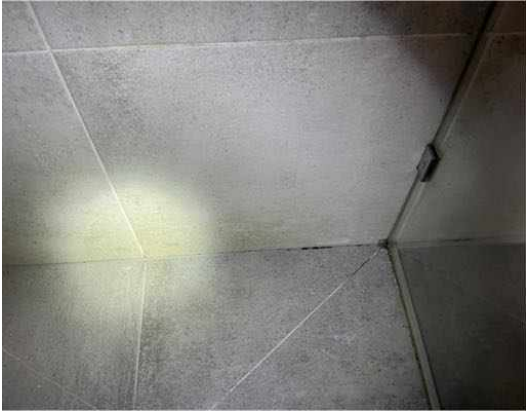
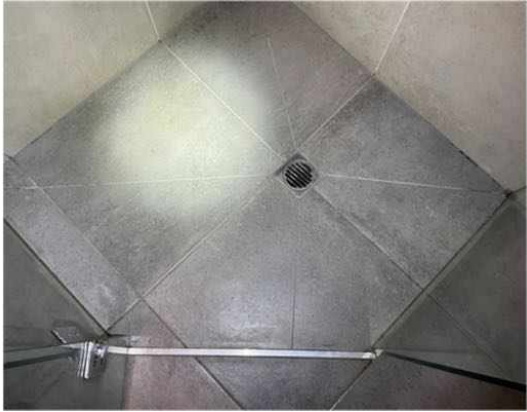
Finding 3.11

Building:	Main Building
Location:	Bathroom
Finding:	Bathroom Sealant and grouting - Missing or damaged
Information:	It was noted on inspection that sealant or grout is degraded to the tiled shower alcove and or other areas of the bathroom.

Different materials and floor areas move at different rates, generally causing cracking to grout or sealant at this point. A flexible sealant is required to allow for expected expansion and contraction, while keeping the joint water tight and protective of all associated building materials.

Flexible and mould resistant materials should be applied to affected areas to prevent any subsequent water damage that is likely to occur. Regular maintenance and replacement of damage or missing or damaged sealant and grout is highly recommended to the wet areas, as this is a regular wear and tear defect. Sealant and grouting in areas that come into regular contact with water should be maintained for the long term care of your property.

A sealant specialist or tiling contractor should be appointed to complete these works as soon as possible

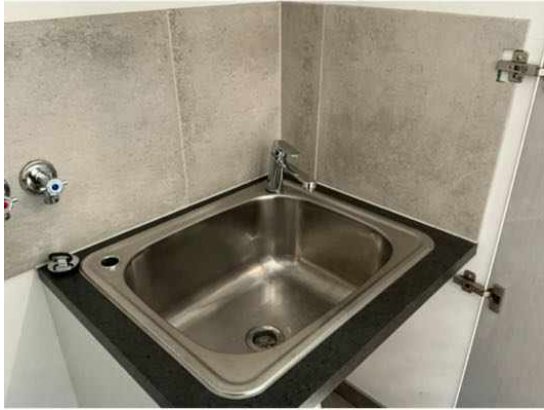
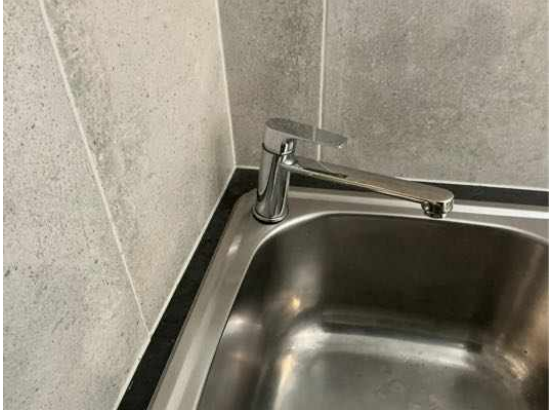
Finding 3.12

Building: Main Building
Location: Laundry
Finding: Laundry Tap - Loose
Information: The tap in the laundry has not been installed correctly, or has deteriorated with age, and is consequently loose. This tap being loose creates potential for water leaks and subsequent water damage to the surrounding area.

Where taps or spouts are loose, a qualified plumber should be appointed to re-fix the plumbing fitting.

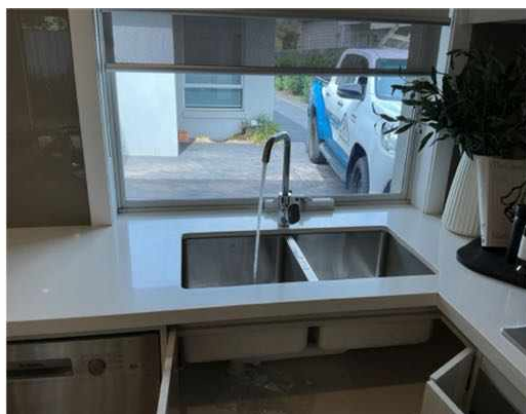
Finding 3.13

Building:	Main Building
Location:	Kitchen
Finding:	Kitchen Tap - Loose
Information:	The tap in the kitchen has not been installed correctly, or has deteriorated with age, and is consequently loose. This tap being loose creates potential for water leaks and subsequent water damage to the surrounding area.

Where taps or spouts are loose, a qualified plumber should be appointed to re-fix the plumbing fitting.

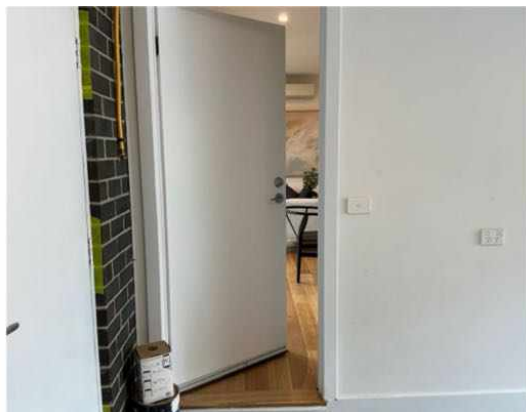
Finding 3.14

Building:	Main Building
Location:	Garage
Finding:	Garage Door - Binding/jamming
Information:	Binding and/or jamming of the garage door is evident during standard operation. This defect inhibits the functionality of the affected door as well as creating potential for secondary defects to associated building elements, such as damage to the floor covering.

A door that binds to flooring or to the associated door frame may have several causes, ranging from minor defects, such as poor installation of the door or deteriorated hinges.

For minor causes, a qualified carpenter or general handyperson should be appointed to perform minor rectification works at client discretion.

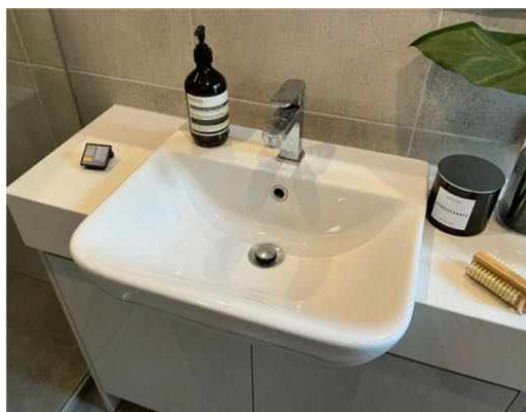
Finding 3.15

Building:	Main Building
Location:	Ensuite - Master
Finding:	Basin cracked
Information:	The basin in the ensuite bathroom is cracked. This can happen with deterioration over time or accidental impact damage. Recommend engaging a plumber to replace to reduce the risk of further deterioration as soon as possible.

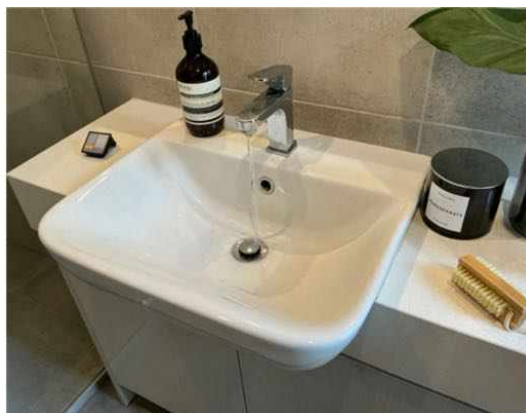
Finding 3.16

Building:	Main Building
Location:	Ensuite - Master
Finding:	Tap - Leaking bathroom
Information:	<p>The tap in the ensuite bathroom was found to be leaking at the time of inspection. This is a common defect that is consistent with general ageing of the building element. However, it may be indicative of substandard plumbing workmanship if the tap is relatively new.</p> <p>While this defect only seems minor, if left unmanaged, it is likely to result in the development of rust, water damage and/or extensive water usage and can attract termites and other pests.</p>

It is advised that a handyman or licensed plumber be appointed to perform remedial works on the affected tap. Such works should be performed prior to the development of secondary defects to ensure adequate functionality of all associated building elements.

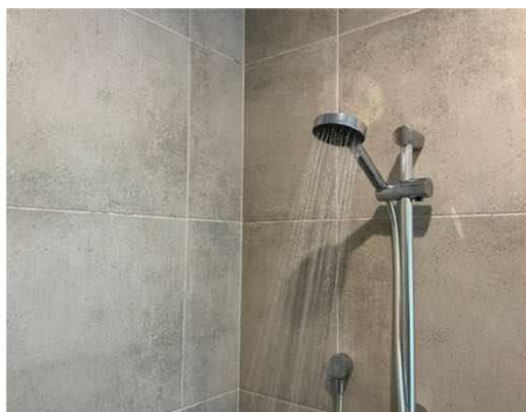
Finding 3.17

Building:	Main Building
Location:	Ensuite - Master
Finding:	Ensuite Shower head is dripping/leaking
Information:	The shower head to the ensuite bathroom is loose and dripping/leaking. This can often happen over time with deterioration or if the shower head is loose and needs tightening. Recommend engaging a plumber to repair/replace the shower head to reduce the risk of further deterioration and water leaks as soon as possible.

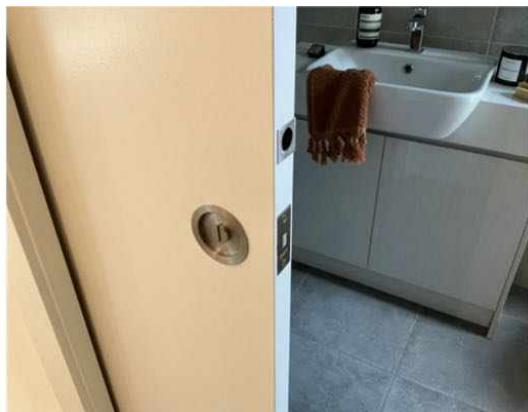
Finding 3.18

Building:	Main Building
Location:	Ensuite - Master
Finding:	Door lock requires adjustment
Information:	The ensuite bathroom door lock is not operating correctly and requires adjustment to make it operate properly. This can happen overtime with deterioration or lack of

maintenance. Recommend engaging a carpenter to repair/maintain at the owners discretion.

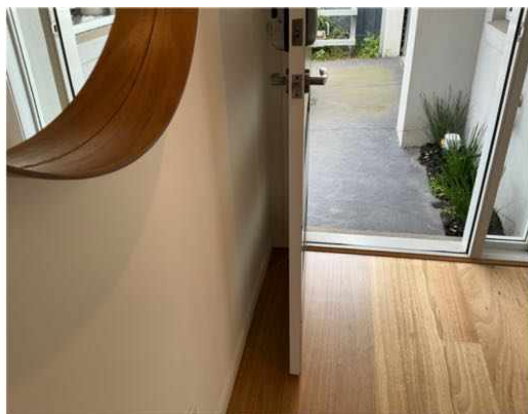
Finding 3.19

Building: Main Building
 Location: Entry
 Finding: Door stop- missing
 Information: The entry doorstop is missing and is unable to stop the door handle/lock from damaging the wall. Although some building elements may seem irrelevant or unnecessary, all building elements play a key role in the operation and function of the overall structure and its performance.

Re-installation or replacement of the door stop is advised as soon as possible to prevent any subsequent damage to the door or associated structures. A general handyman may be appointed to perform these works at client discretion.

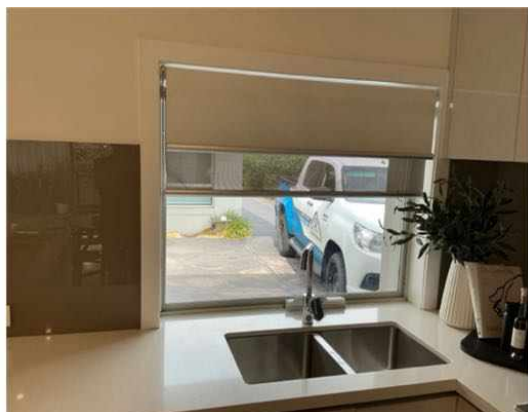
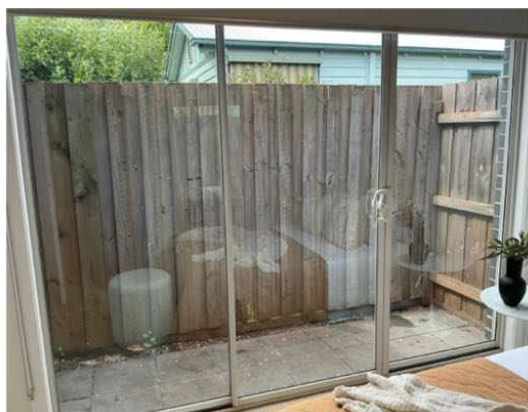
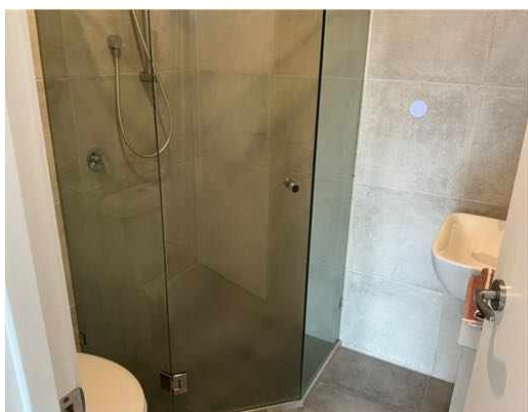
Finding 3.20

Building: Main Building
 Location: Various parts of the building
 Finding: Doors and windows required maintenance
 Information: Some of the doors and windows to the building require some maintenance to make

them operate more smoothly. This can happen overtime with deterioration or lack of maintenance. Recommend engaging a carpenter to repair/maintain windows and doors at the owners discretion.

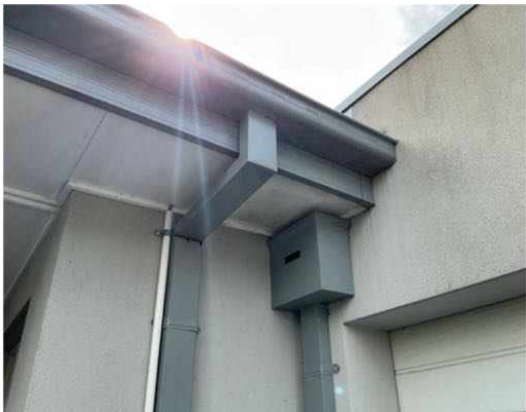
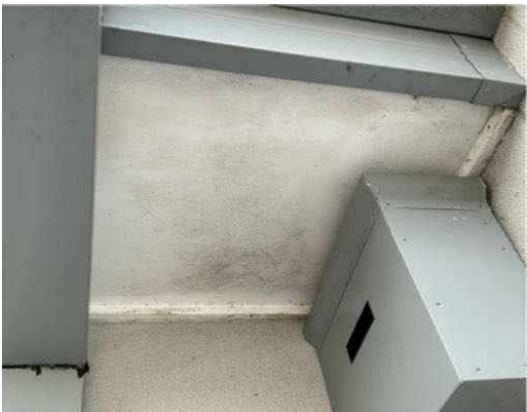
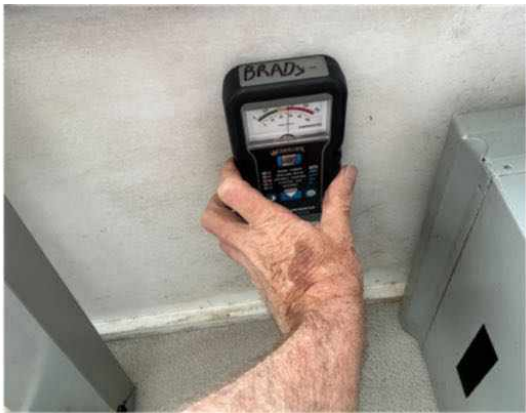
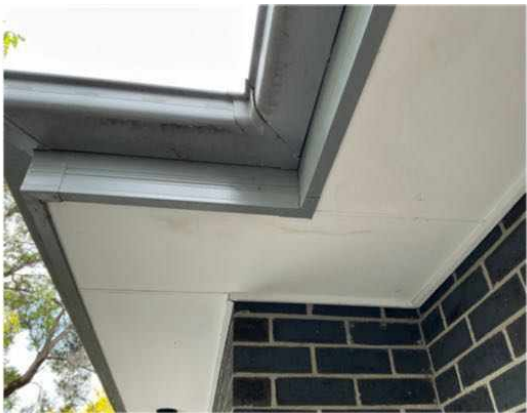
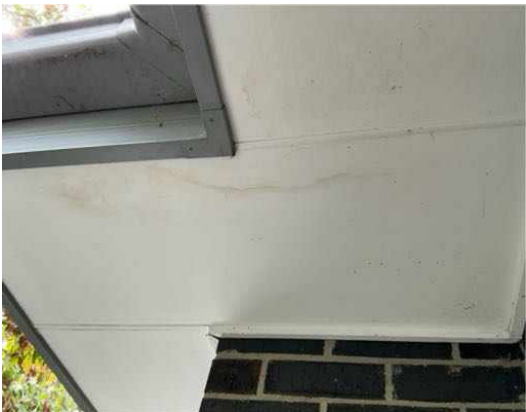
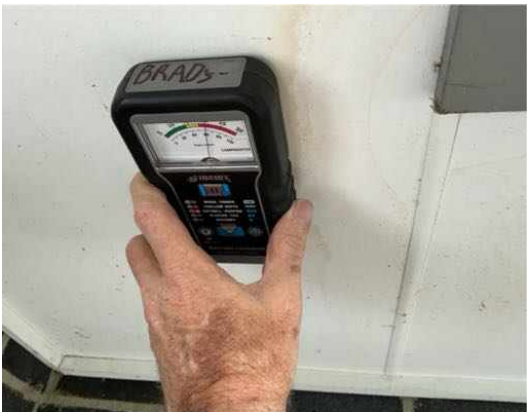
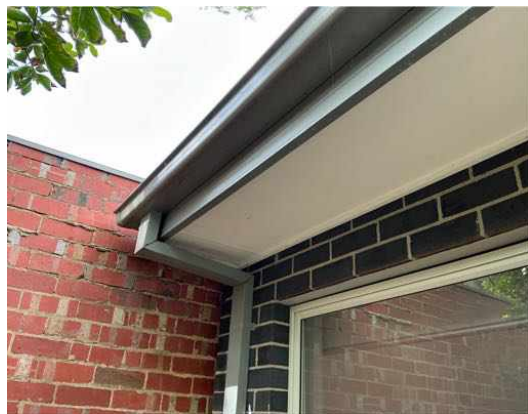
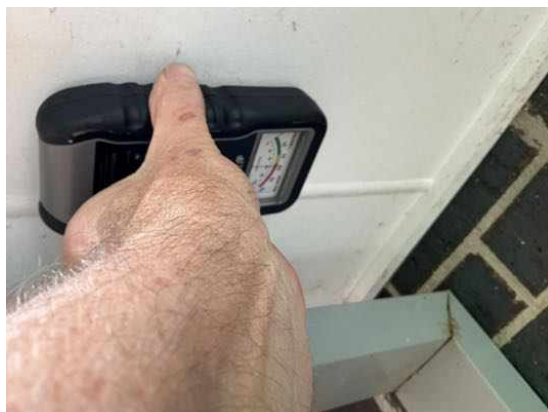
Finding 6.02

Building:	Main Building
Location:	Eaves
Finding:	Eaves- Evidence of excessive moisture was present at the time of inspection
Information:	Evidence of excessive moisture was found to parts of the eaves using a moisture meter. It is suspected that this has been caused by blocked gutters. Recommend cleaning gutters and monitoring, and if further staining is noticed engage a roof plumber as soon as possible to rectify. Excessive moisture can attract termites and produce conditions that promote termite attack, fungal growth and wood decay. Excessive moisture is generally caused by deteriorated, inadequate, blocked or missing roof drainage, leaking plumbing pipes or fixtures, poorly plumbed HWS overflows or condenser units and poor site drainage. It is highly recommended that all

plumbing and drainage fixtures and fittings be maintained regularly in order to prevent excessive moisture being present in the external / internal property.

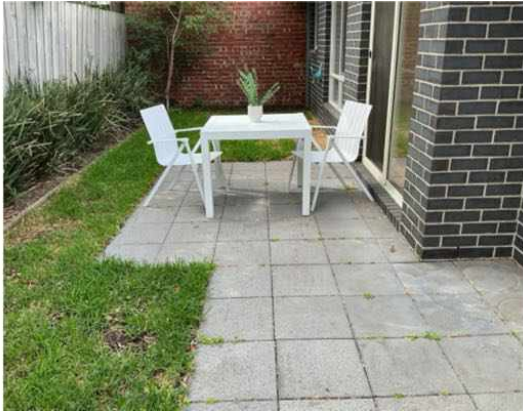
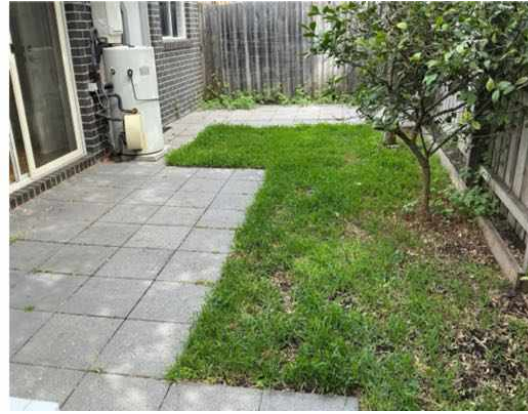
Finding 6.03

Building:	Main Building
Location:	Yards
Finding:	Site drainage - poor/inadequate
Information:	The site drainage to parts of the yards was found to be inadequate at the time of inspection, creating potential for subsequent water damage to associated building elements. Excessive moisture will attract termites.

Where site drainage is inadequate, installation of an Agricultural (Aggie) Drain may be required. A qualified plumber should be appointed to further inspect the property and perform any remedial works as necessary. Water damage and secondary defects are likely to occur if left unmanaged.

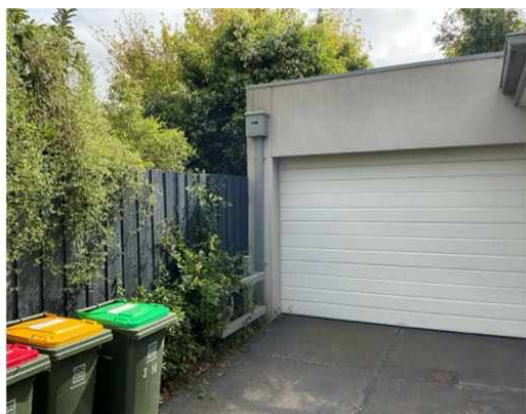
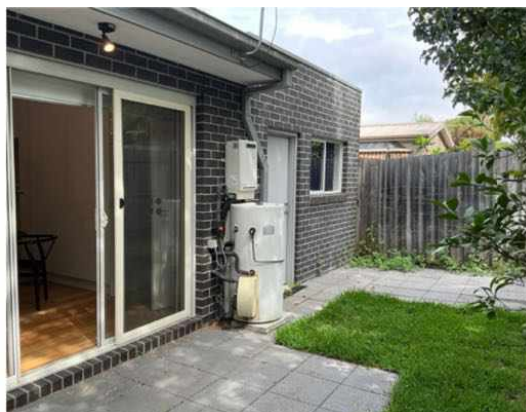
Finding 6.04

Building:	Main Building
Location:	Various parts of the building
Finding:	Bridging attachments to buildings
Information:	Bridging occurs when items against a building provide a concealed entry point for termites into the building or by passing around a termite management system.

Building attachments of this nature need to be frequently inspected for termite activity by a qualified inspector.

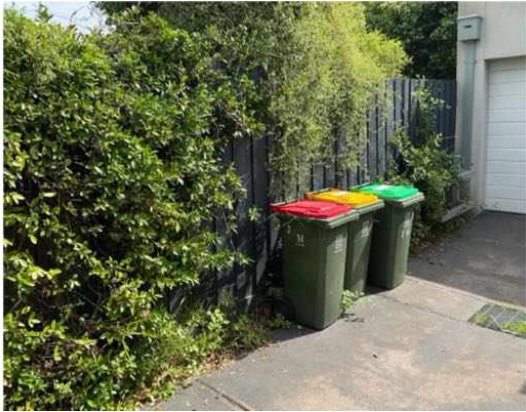
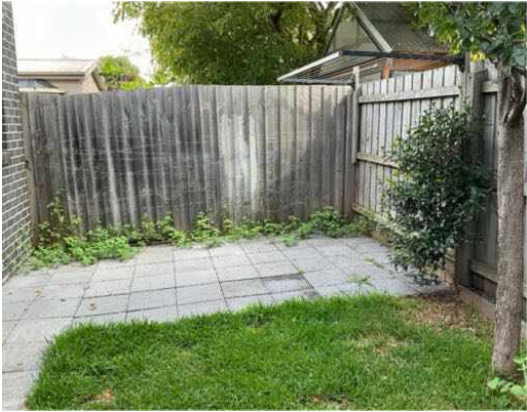
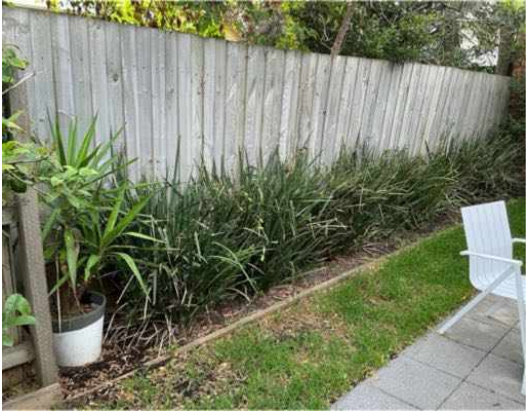
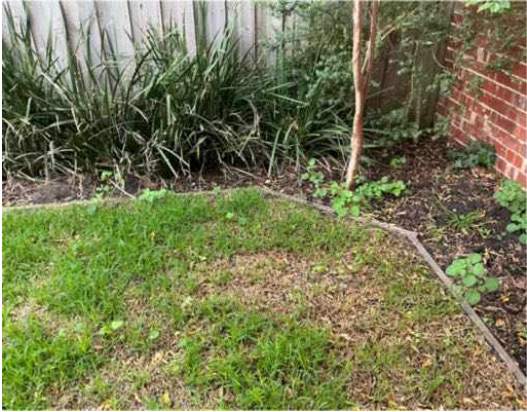
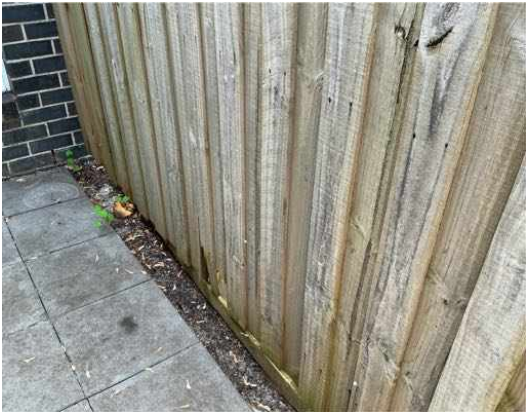
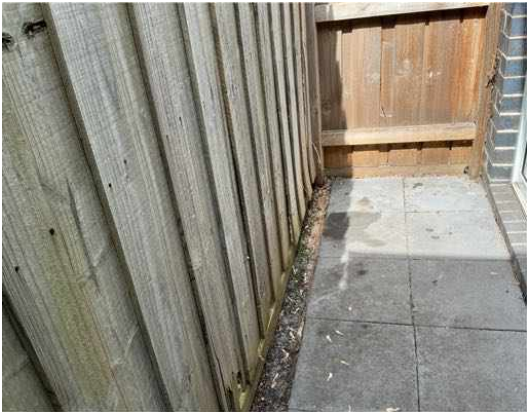
Finding 6.05

Building:	Main Building
Location:	Various parts of the building
Finding:	In ground contact
Information:	Any timbers in direct ground contact provide opportunity for concealed termite entry and are likely to be subject to premature rot and decay as the soil retains moisture or damp conditions against the timbers.

Remove untreated timber that is in direct contact with external grounds. Consider replacement with more durable materials i.e. treated timber or non timber elements. Frequent pest inspections are advised to readily identify any termite activity in these areas.

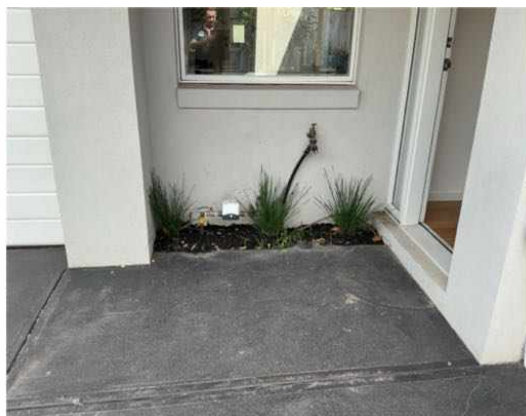
Finding 6.06

Building: Main Building
Location: Yard - Front
Finding: Garden Beds Conditions Conducive to Termites
Information: Garden beds were found to be evident in close proximity to the building. Garden beds immediately adjacent to the perimeter of the building block the visual inspection of these areas, providing a concealed termite entry point.

These garden beds can include untreated timber, and with a combination of moisture from watering hosing can make conditions conducive to termite activity and termite ingress.

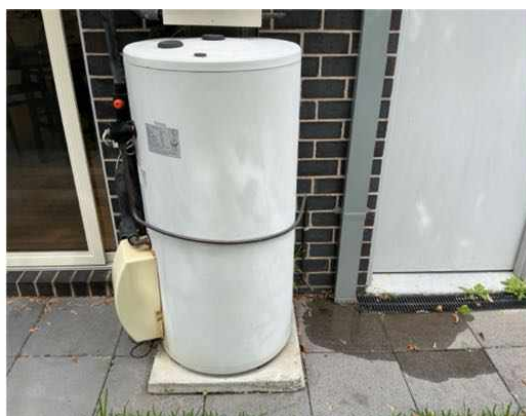
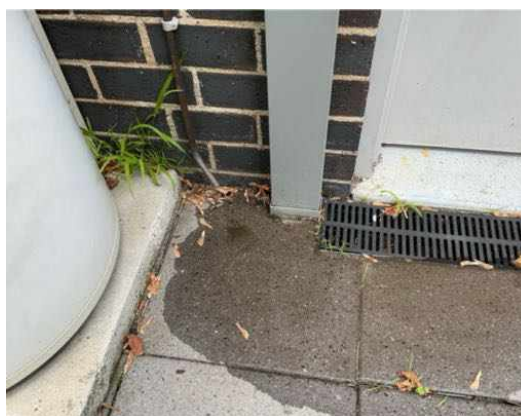
Finding 6.07

Building: Main Building
 Location: Yard - Back
 Finding: HWS Overflow - Not Connected
 Information: The Hot Water System (HWS) overflow was found to be disconnected from storm water drainage and is creating excessive moisture in the surrounding area.

These damp conditions can lead to secondary defects such as rot, rust or corrosion of associated building elements, the formation of fungal decay, or even the creation of potential slip hazards. When coupled with poor site drainage, pooling of water may also attract termite activity to this area.

It is highly recommended that a licensed plumber be appointed to connect the HWS overflow in order to prevent such an environment from being created. These minor works should be carried out as soon as possible.

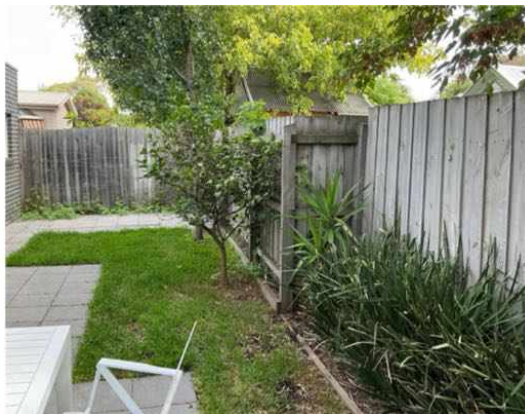
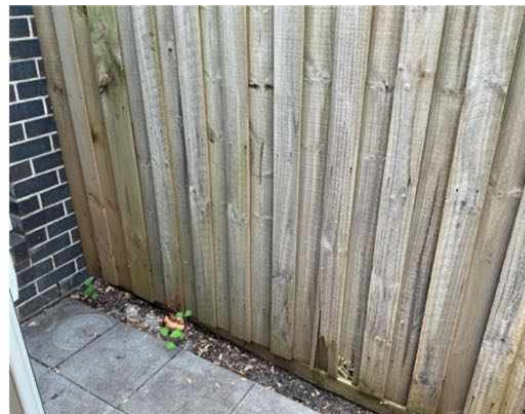
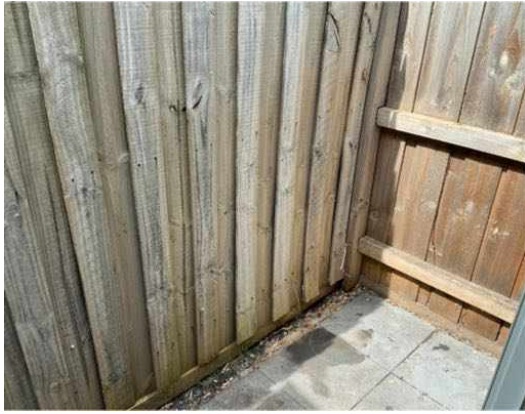
Finding 7.01

Location: Yards
Finding: Fencing - wood rot-fungal decay

Information: It was noted at the time of inspection that sections of the fencing throughout the property have deteriorated and have fungal decay/wood rot present. Typically fencing deteriorates due to age and or wear, rot and or rust which is generally expected for a structure of this age, due to prolonged exposure to weather conditions. Sometimes inadequate installation or maintenance can be to blame.

If left unattended, it is likely that further damage will occur. It is suspected that repair of several elements of the fencing may be required however replacement may be a consideration of the client also.

A licensed fencing contractor should be appointed to provide further advice and perform rectification works as necessary.
