# Building and Timber Pest Inspection Report

Inspection Date: Tue, 3 Feb 2026

Property Address: 2/1 Maritana Ave, Reservoir VIC 3073, Australia

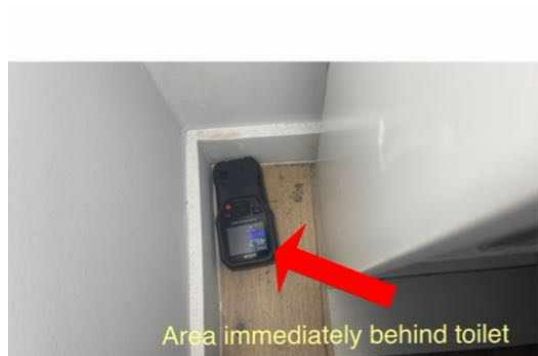
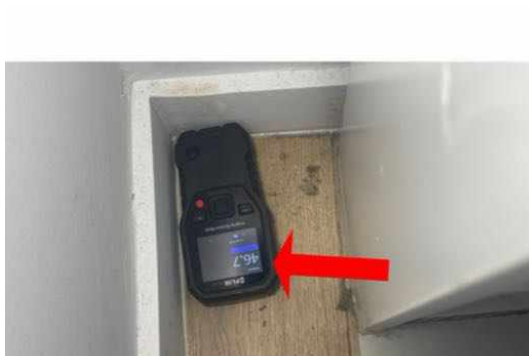
Finding: Staining and current moisture noted to the wall and floor in this area.

Information: Evidence of moisture staining was identified to the lower wall of the toilet at the time of inspection. Current Moisture was noted within parts of the area, along with elevated moisture readings being noted in areas of the tiled flooring of the toilet when tested with a moisture meter. Elevated moisture readings along with some suspected staining was also noted in the flooring of the study behind this toilet area. As dampness has been found in areas where it shouldn't be, which can cause further determine of the property, this defect is classified as a major defect\*

It is unclear as to the source of the suspected dampness. The toilet operated as intended with no obvious signs of leaking visible. The dampness may be from damaged pipes within the walls or flooring or from moisture coming up through the concrete slab under the tiles.

It is highly recommended that a licensed plumber or damp specialist be engaged to inspect the area to determine the source of the dampness. This would most likely involve an invasive inspection ie cutting open the wall to inspect inside the wall cavity for the cause of the moisture. Once this cause has been determined, repairs would then be carried out which may involve repairs to any plumbing work, replacing any damaged insulation or replastering the section of the wall which has been opened up and repainting.

This defect should not be ignored and should be acted on as a matter of urgency.

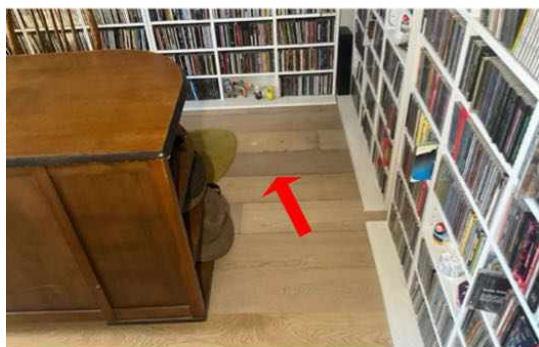
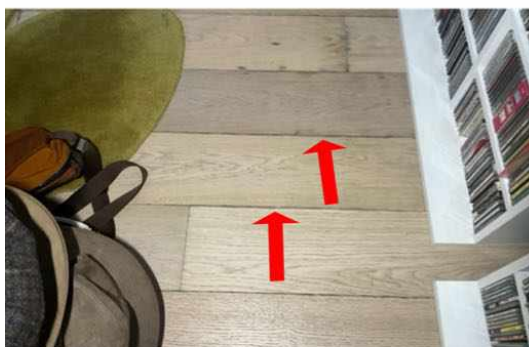
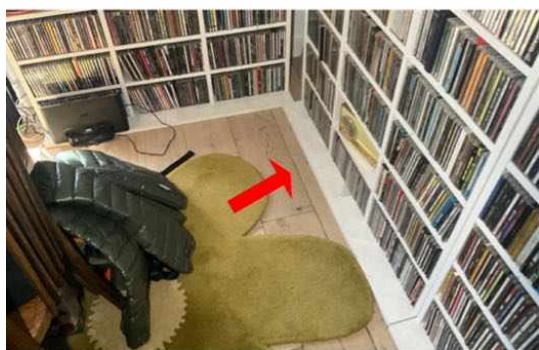
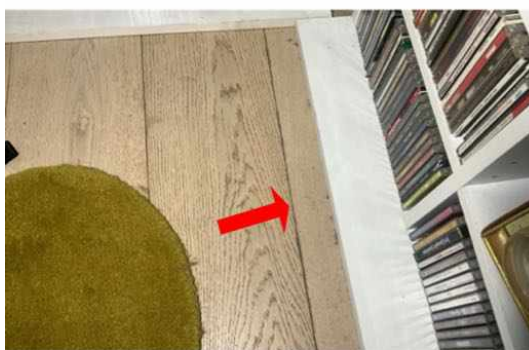
### Finding 3.01

At the time of inspection, the flooring in the study room has small gaps between some of the boards. This generally occurs due to shrinkage of the boards which can result from installation issues, moisture imbalance within the boards, failure to acclimatise the boards prior to installation, natural variation within the timbers or seasonal movement of the boards. It can also be due to moisture underneath the boards in the area caused by other factors( see separate defect statement re damp evident to area)

The flooring should be monitored for a period of time to see if any changes occur. Should the gaps widen, consultation with a flooring specialist should be undertaken to determine the best course of action. This may involve filling the gaps or replacing the boards in this area.

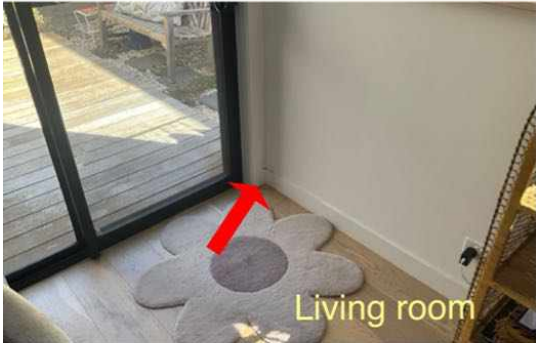
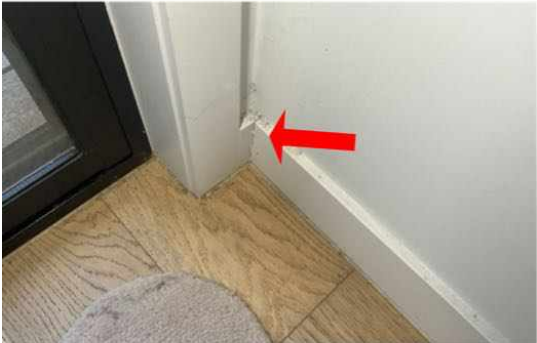
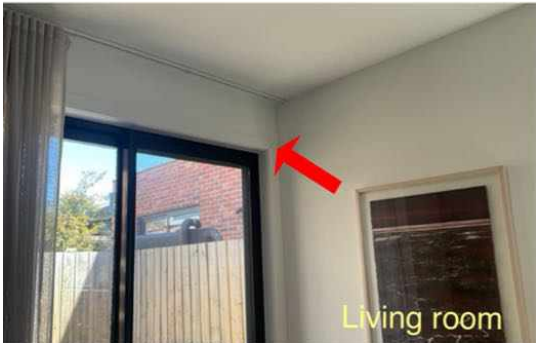
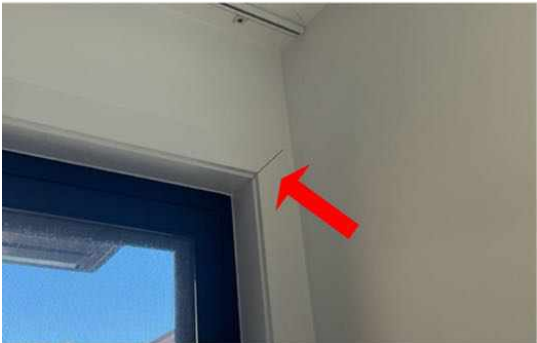
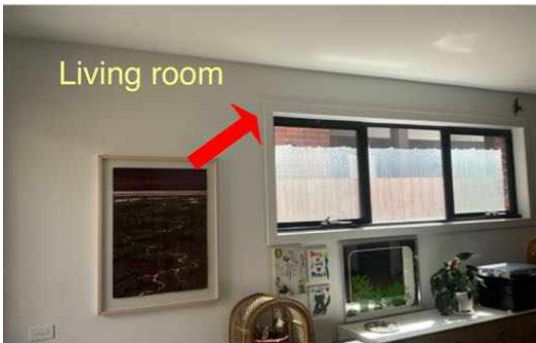
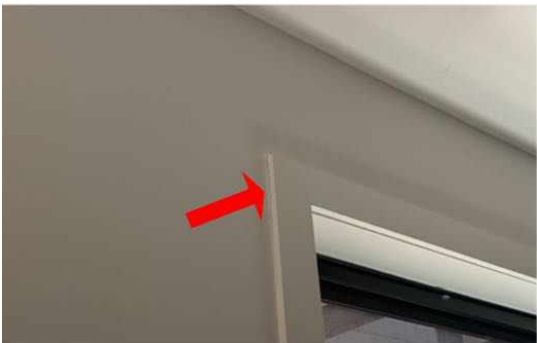
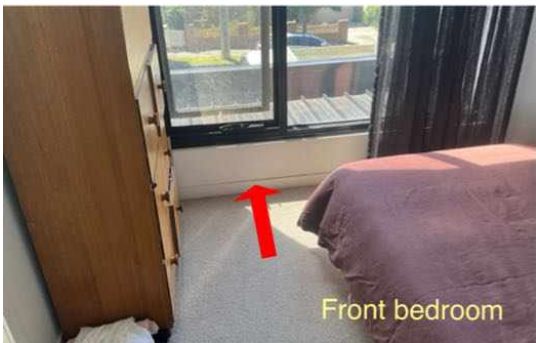
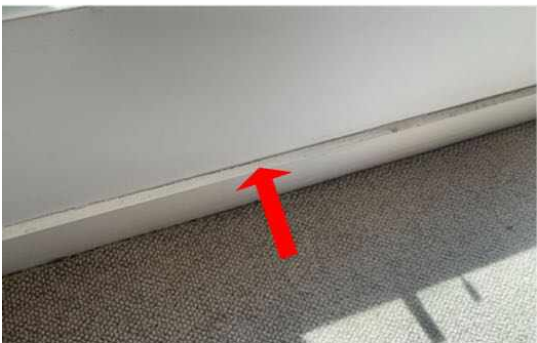
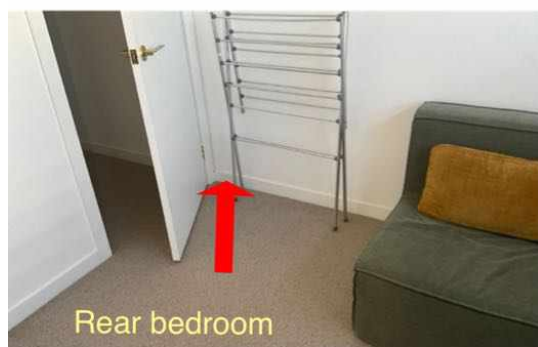
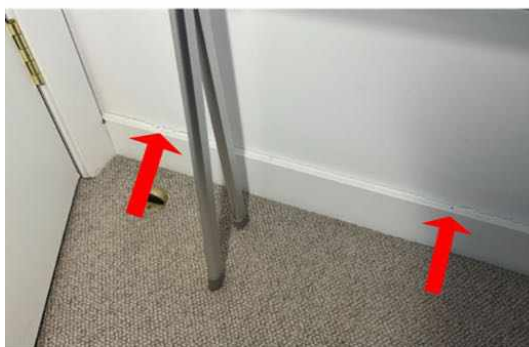
### Finding 3.02

Building:	
Location:	All Areas
Finding:	Cracking - fine
Information:	Some fine cracking was noted throughout the property.

Although fine cracks are quite noticeable, they are often only considered to be an appearance defect, and usually do not indicate any structural damage. Generally, the cause of a fine crack is indicative of a separation between building materials and finishes (e.g. paint, plaster, etc.) along joints.

Cracking of this nature can generally be repaired with minor sanding, filling and/or repainting. Such works should be performed by a qualified painter or a general handyman.

Monitoring of all cracking should be conducted frequently. Always contact a building inspector should cracks widen, lengthen, or become more numerous.

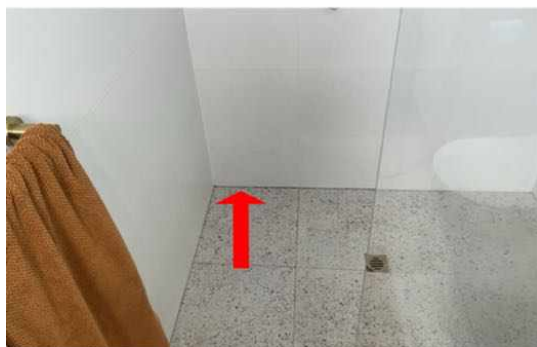
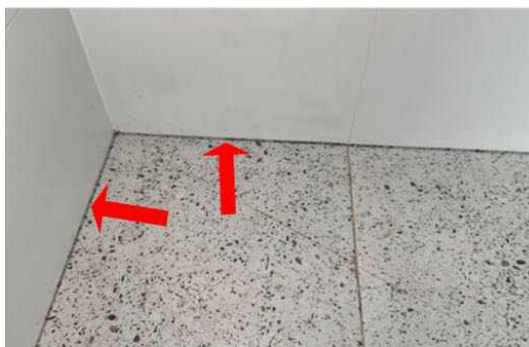
### Finding 3.03

Finding: Sealant - Degraded within the shower area

Information: It was noted on inspection that the sealant is degraded to the tiled shower alcove within the ensuite bathroom.

Build up of moisture in the shower area can cause sealants to degrade and become mouldy.

Any damaged or degraded materials should be scraped out and flexible and mould resistant materials should be applied to affected areas to prevent any subsequent water damage that may occur. Regular maintenance and replacement of damaged or missing grout/ sealant is highly recommended to the wet areas, as this is a regular wear and tear defect. Both grout and sealant in areas that come into regular contact with water should be maintained for the long term care of your property.

A bathroom specialist or tiling contractor should be appointed to complete these works as soon as possible.

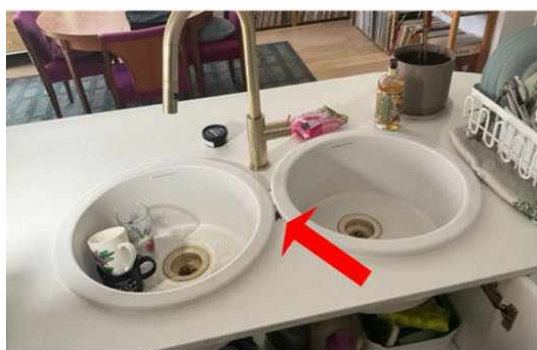
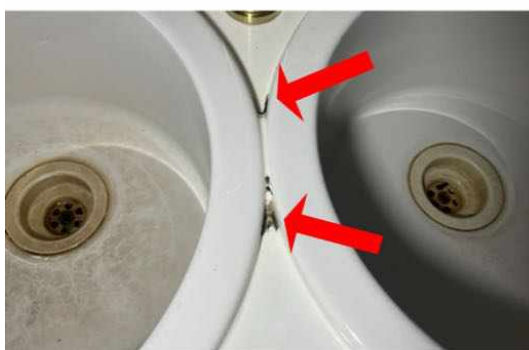
### Finding 3.04

Finding: Sealant - Degraded and mouldy in areas of kitchen

Information: Sealant is degraded and mouldy in this area.

Where sealant is damaged or mouldy , a tiling contractor should be appointed immediately to re-apply any silicone where necessary.

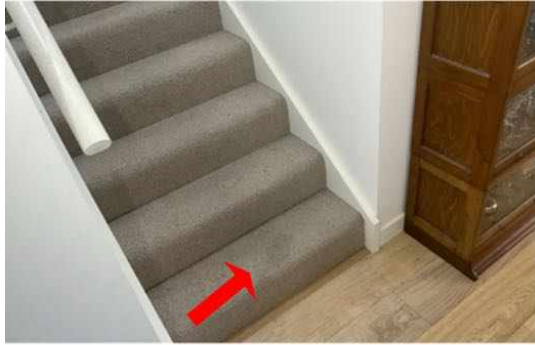
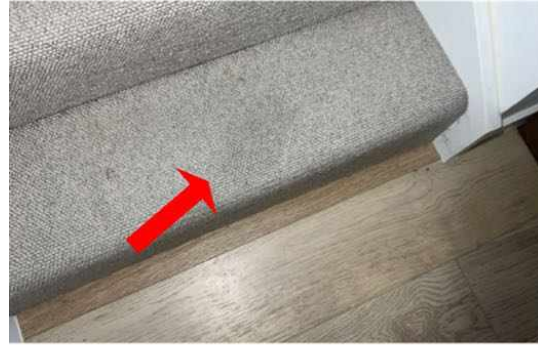
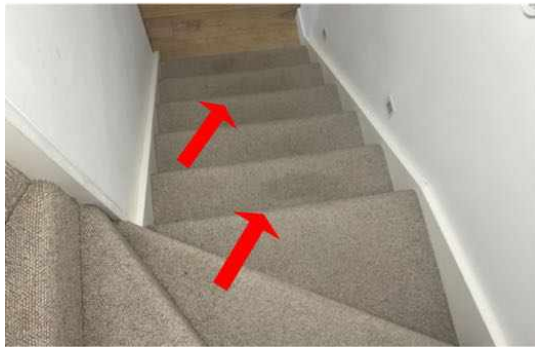
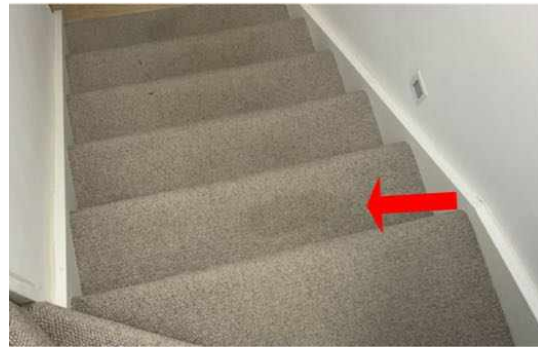
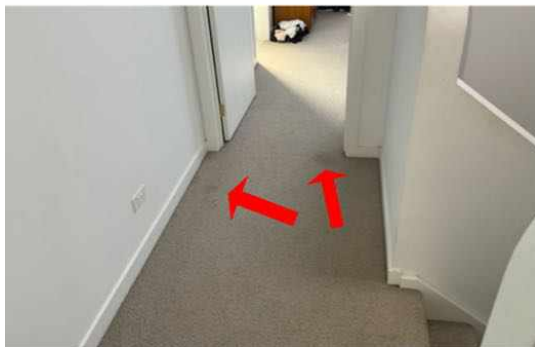
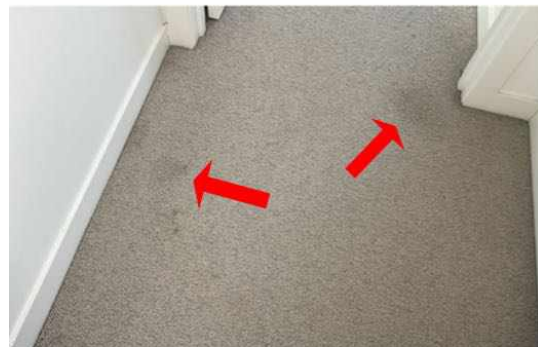
### Finding 3.05

Finding: Carpet stained in some areas

Information: At the time of inspection, some areas of the carpet throughout the property showed signs of staining .

The carpet should be cleaned to try and get rid of the staining. Should this not work, the carpet may be replaced at the discretion of the homeowner.

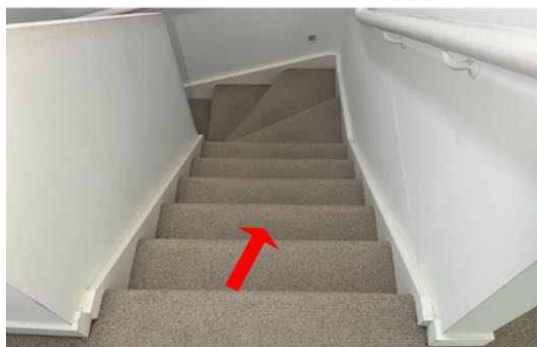
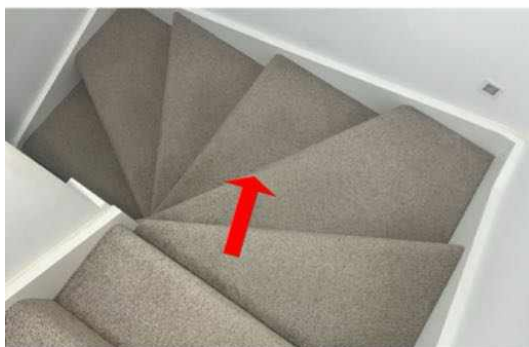
### Finding 3.06

Creaking flooring generally indicate that the treads are coming loose slightly from the supporting structures that they are installed on as opposed to any structural issues.

Should the client wish to address this, they should seek quotations for required repairs from a qualified carpenter or Registered Builder .

The potential resolution may involve regluing and screwing the floor down through to replacement of flooring.

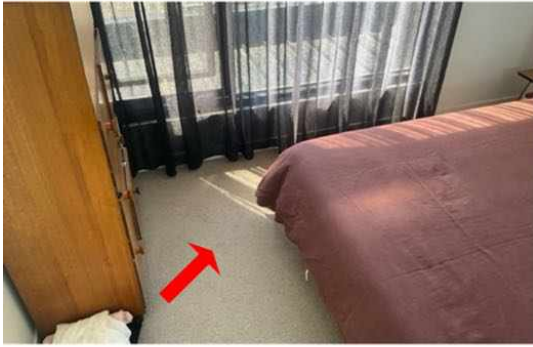
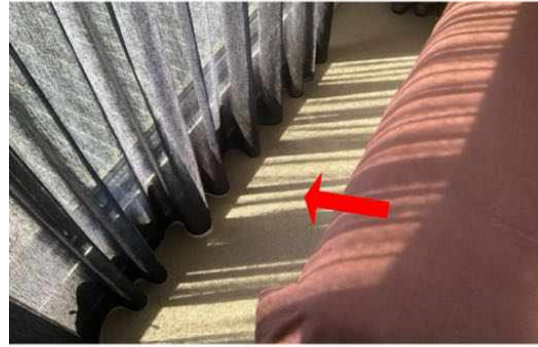
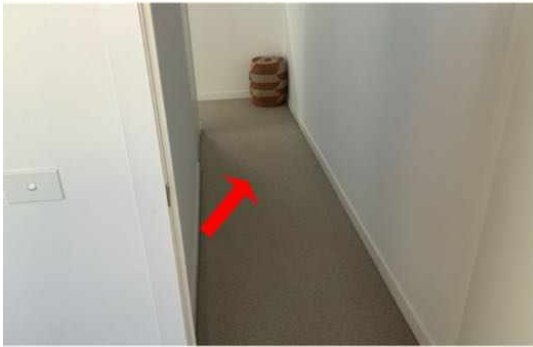
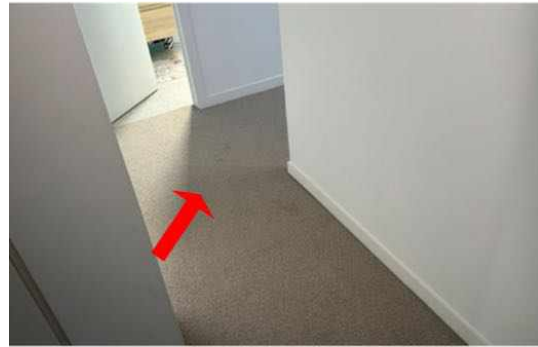
### Finding 3.07

Creaking floors generally indicate that the floorboards or the subfloor structures are coming loose from the supporting structure that they are installed on.

The area should be monitored for any changes or unevenness. Should this occur, consultation with a registered builder should be undertaken to determine the cause . The potential resolution may involve regluing and screwing the floor down through to replacement of subfloor support structures.

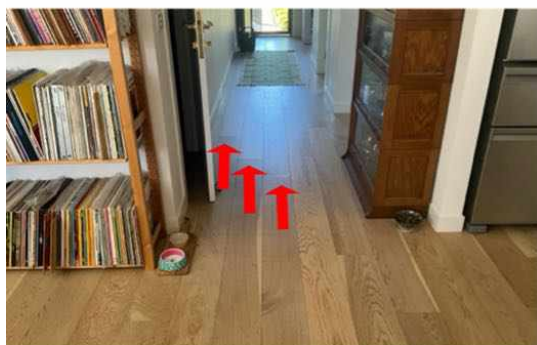
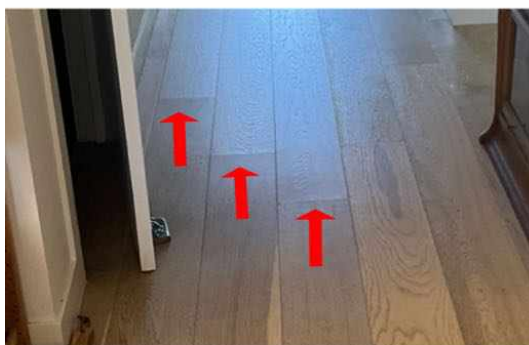
### Finding 3.08

Information: At the time of inspection, there was some evidence of suspected slight moisture damage to the floor boards, as noted where the floor boards were lifted slightly at the end joins.

It is suspected this has occurred due to moisture possibly from mopping the floor.

The flooring should be monitored for any further damage or changes and should that occur, consultation with a flooring specialist should be sought.

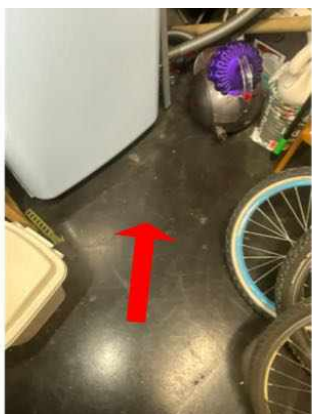
### Finding 3.09

Finding: Hairline Cracking - concrete within garage floor

Information: Hairline cracks were identified in concrete flooring of the garage . Hairline cracks are very minor in nature and generally are only ever an appearance defect. While such cracking may be noticeable in some cases, it is common and does not indicate any structural damage.

Generally the cause of a hairline crack in existing concrete such as driveways, pathways and garage floors is indicative of the expansion and contraction of the concrete. Such causes are generally due to environmental factors, such as moisture levels, weather conditions, root systems of nearby trees or the soil types on which they are laid.

Hairline cracks may also be due to poor original installation of the concrete. Factors such as poor compaction of the sub surface and/or inadequate reinforcing of the slab may create cracking and other secondary defects.

Monitoring of all cracking should be conducted frequently. Always contact a building inspector should cracks widen, lengthen, or become more numerous.

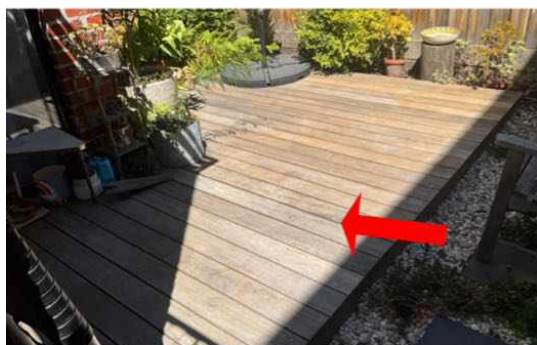
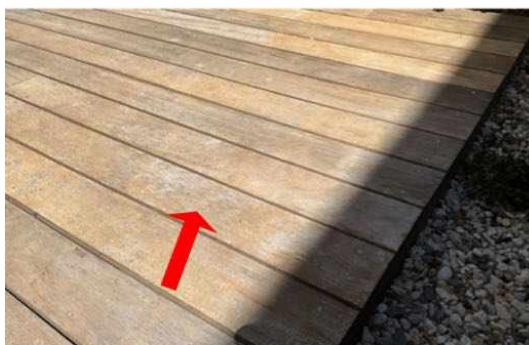
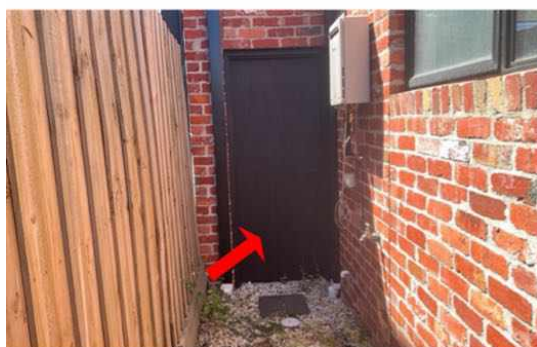
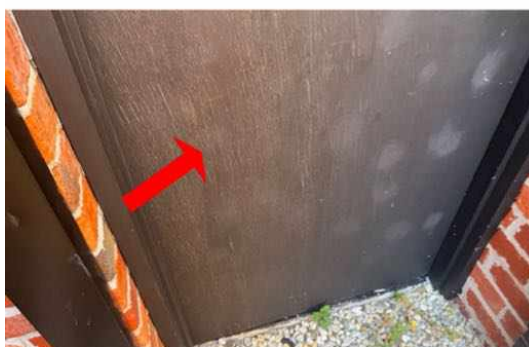
### Finding 3.10

Information: External timber areas that are frequently exposed to harsh weather conditions require adequate protection in order to maintain their condition. Where these areas have not been painted or treated adequately, general deterioration is likely to occur at an accelerated rate.

If left unattended, replacement of some items may likely to be necessary in the future.

Adequate treatment of external timbered areas is required by a painting contractor or general handyman.

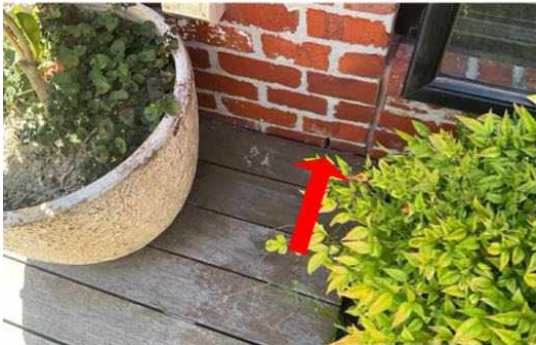
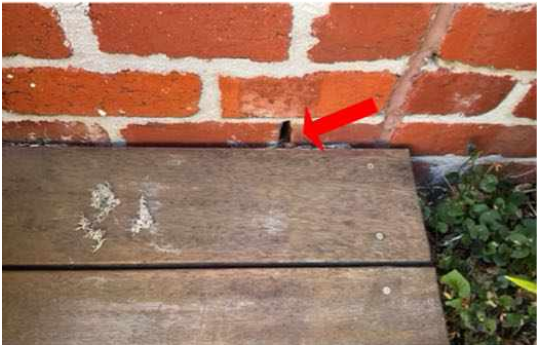
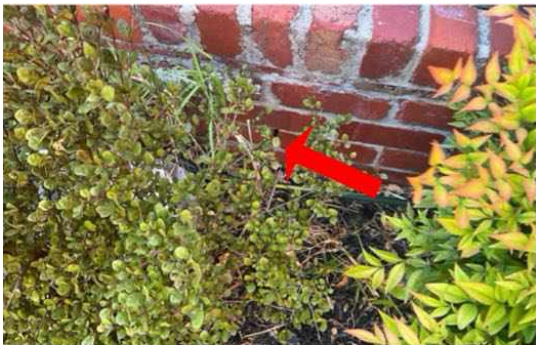
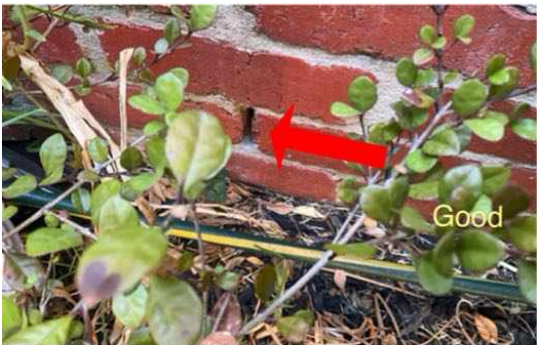
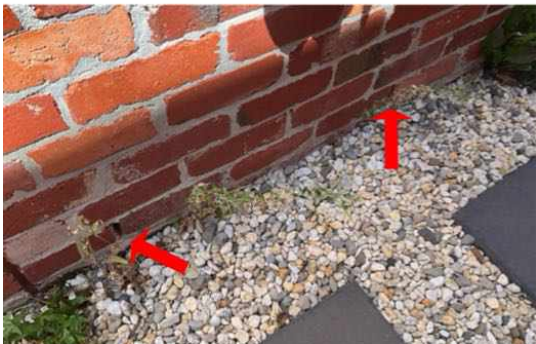
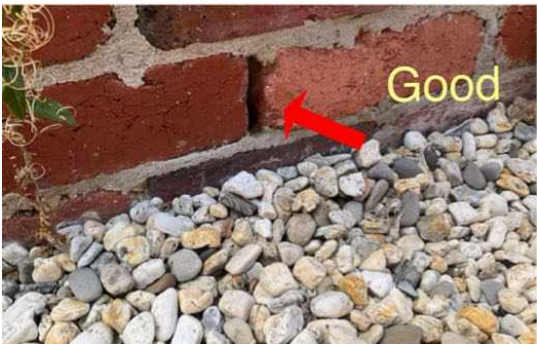
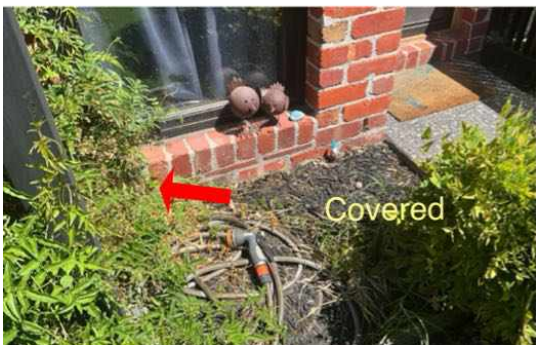
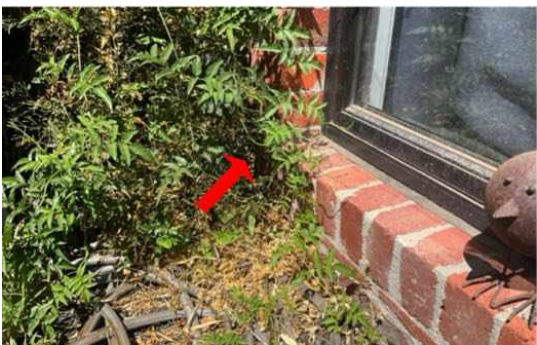
### Finding 3.11

Information: It was noted during the time of inspection that some of the weep holes to the exterior brick walls were partially blocked. Weep holes are designed to allow water from leaks or seepages in brickwork to be directed to the external environment, prior to entering the wall cavity or associated building materials. Weep holes should therefore be kept clear and free of debris or blockages.

Blocked weep holes are likely to result in the presence of excessive moisture within the brickwork and associated structures, creating potential for water damage and moisture problems.

Depending on the nature of the blockage, the homeowner may be able to undertake remedial works to remove blockages. Alternatively, appointment of a registered builder may be required to remove blockages. Preventative works are necessary in ensuring the structural integrity of the affected brickwork and should be performed as soon as possible.

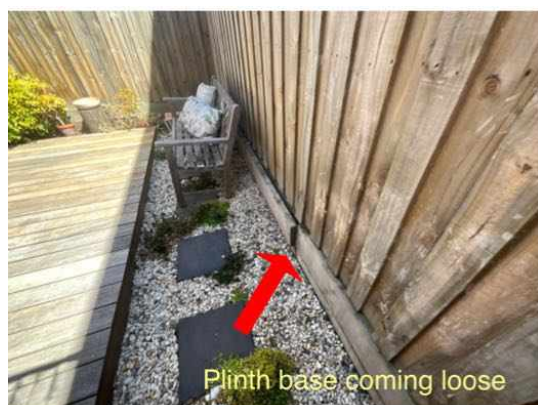
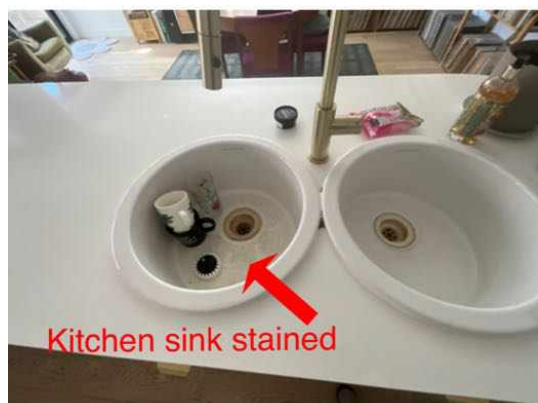
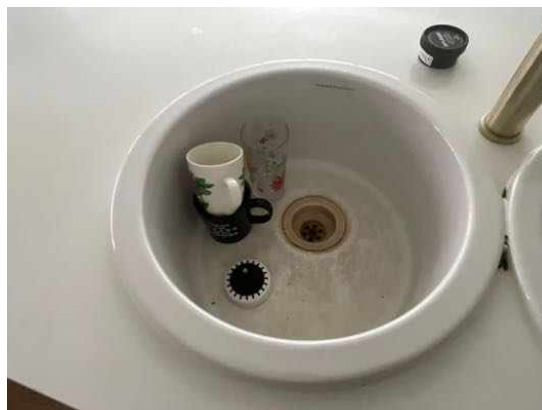
Building:  
 Location: All Areas  
 Finding: Additional Photos - minor defects  
 Information: Additional photos are provided for your general reference.

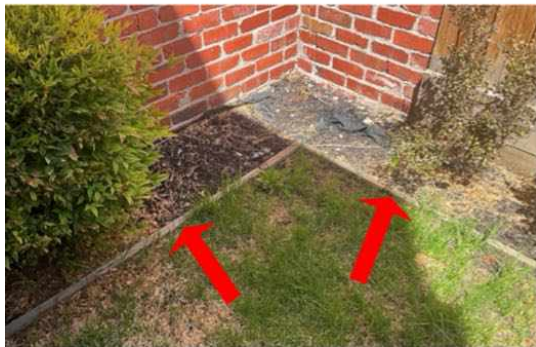
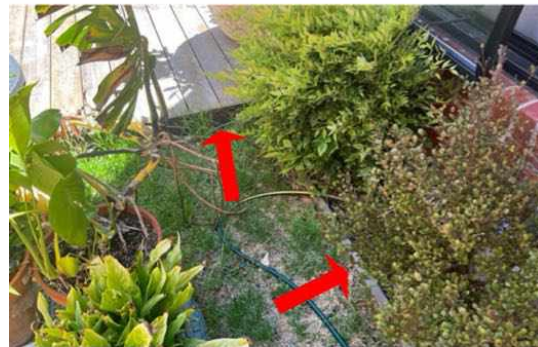
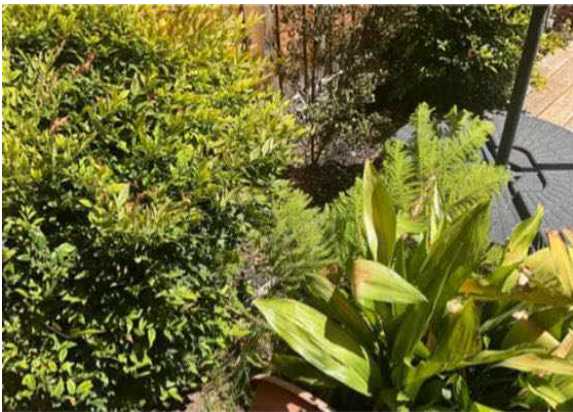
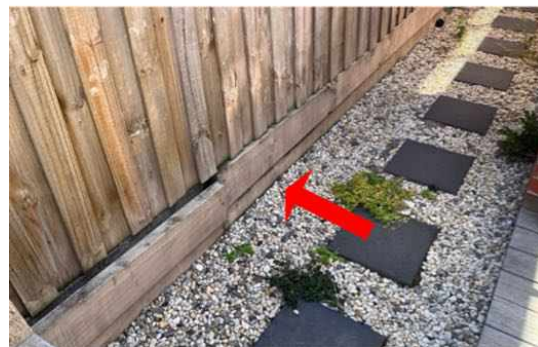
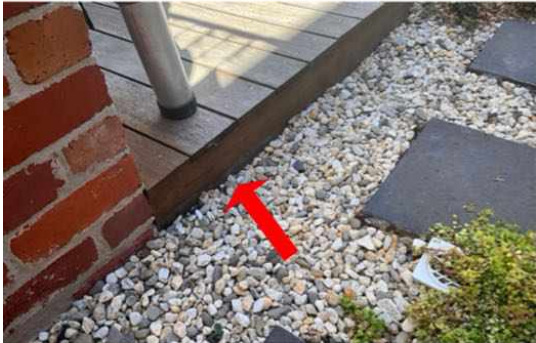
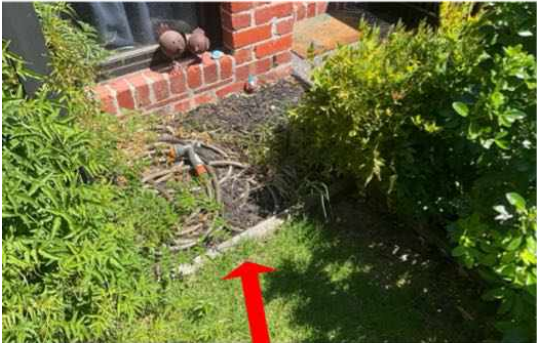
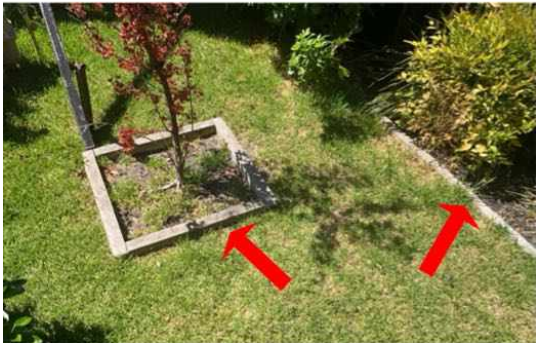
Finding: Garden Beds - Conditions Conducive to Termites

Information: Garden beds were found to be evident around and against the property. These garden beds can include untreated timber, and with a combination of moisture from rainfall and hosing, can make conditions conducive to termite activity and termite ingress.

moisture or dampness, they become conducive to termite activity. Whether timber is used as a building element, part of a fencing structure or stored as an unused item, they can provide an environment that is attractive to termite infestation.

When met with excessive moisture, timber begins to decay and develop wood rot. Any timbers that are in direct contact with external grounds especially if left untreated or non-durable also provide ingress for subterranean termites into that particular element.

Where possible, the removal of any such materials that may be conducive to termite activity should be carried out as soon as possible to minimise the risk of termite attack. Where not possible or practical, regular monitoring of timber elements is recommended. Replacement of any damaged materials should be carried out where necessary.

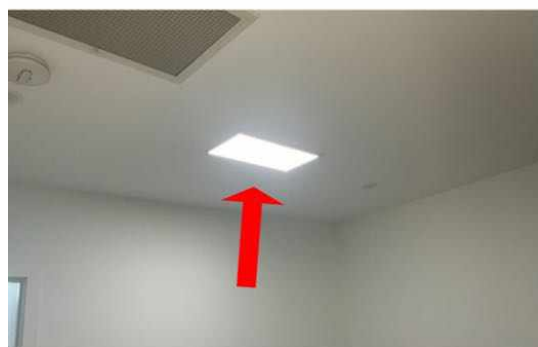
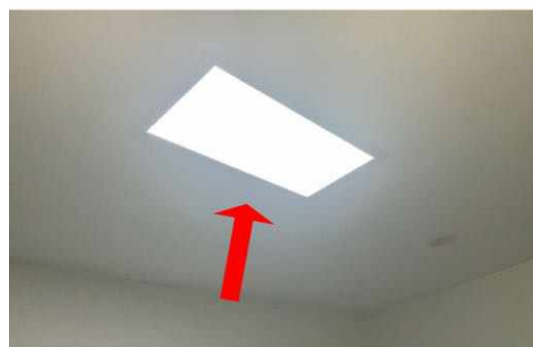
Information: It was noted the property has skylights present.

Whilst no evidence of any moisture leaking was noted during the inspection, skylights are notorious for leaking. The seals and/or flashing around the skylights can deteriorate allowing moisture to enter.

The ceilings around the skylights should be regularly monitored for any evidence of moisture leaking eg staining or bubbling of paint.

Where moisture damage is evident, a plumber should be appointed as soon as possible to identify the leak and perform rectification works as necessary, ensuring the moisture damage is restricted.

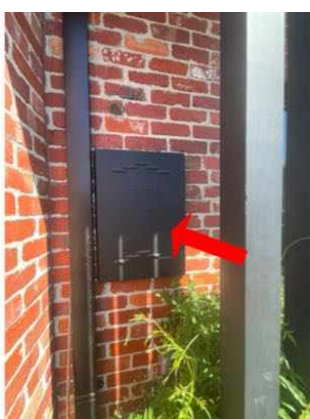
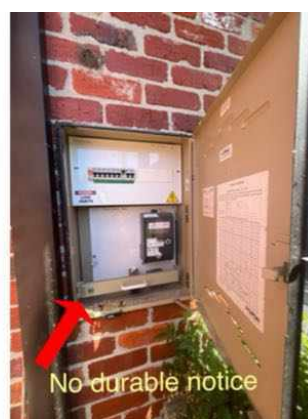
Building: All Areas  
 Location: All Areas  
 Finding: Termite Management System - no evidence of a chemical installation  
 Information: The application of a post-construction chemical termite barrier is highly recommended for all properties, particularly if live termite activity has been found on the site previously. Such barriers are highly effective in preventing termite attack on any timber building elements throughout the property.

Please note: due to the construction of the building, it would not be possible for a chemical treatment to be carried out successfully (access issues around the full property due to the adjoining property )

Regular inspections are recommended for all properties, in particular those where chemical treatments are not possible.
