Building and Timber Pest Inspection Report

Inspection Date: Tue, 24 Mar 2026

Property Address: 5A Gordon St, Burwood NSW 2134,
Australia

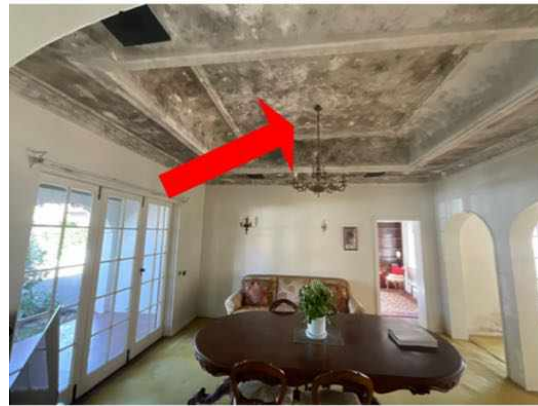
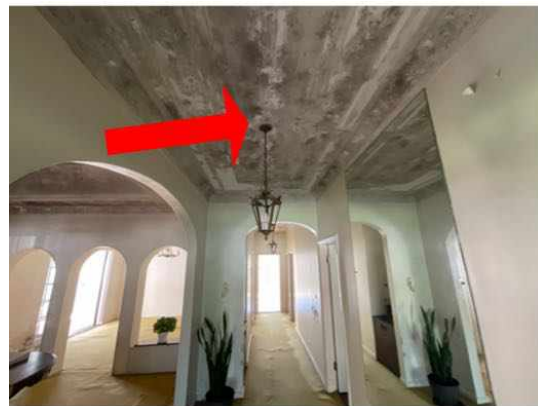
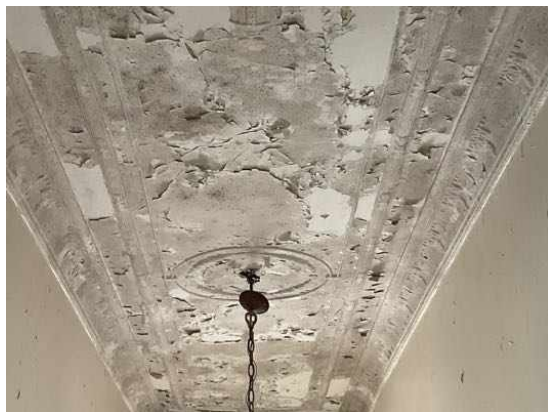
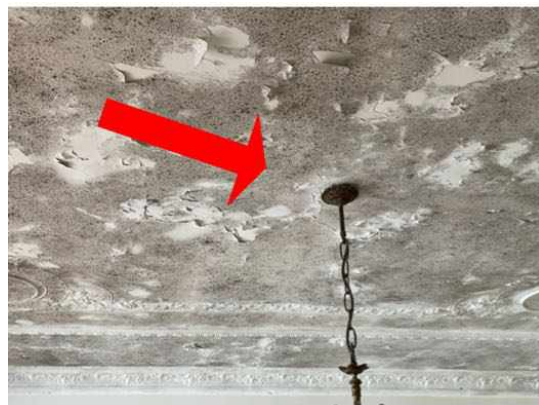
Information: Major mould growth was observed to the ceilings. This is likely due to condensation and elevated moisture levels within the subfloor environment.

While the mould appears localised and minor at the time of inspection, prolonged moisture exposure may lead to further deterioration of paint finishes and potential substrate damage.

- Clean and treat affected areas with an appropriate mould removal solution.
- Repaint with mould-resistant paint if required.
- Improve ventilation (ensure exhaust fan is operational and ducted externally).
- Monitor for recurrence.

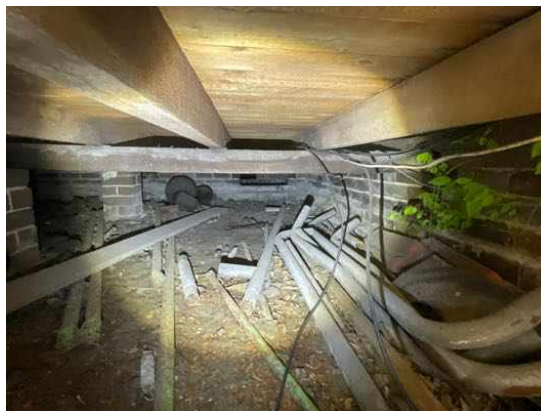
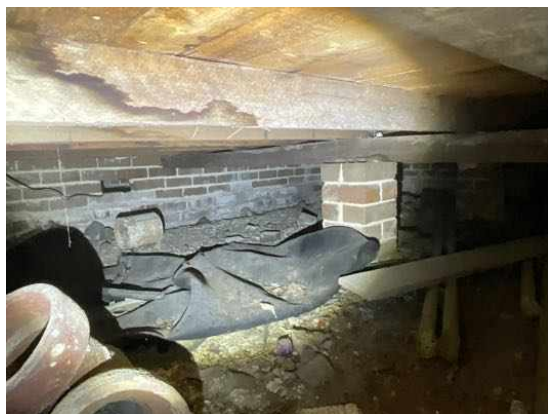
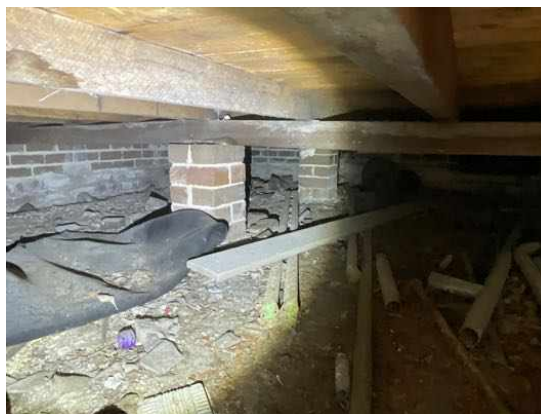
Building:	Main Building
Location:	Subfloor
Finding:	Subfloor ventilation - Inadequate
Information:	Adequate subfloor ventilation aids in preventing excessive moisture wood rot and termite activity by ensuring a dry subfloor environment.

Where ventilation is substandard it is usually caused by factors such as failure to install adequate vents during construction subsequent building works or earth and vegetation covering over vents low subfloor clearance and items or debris in the subfloor restricting airflow.

Subfloor ventilation can be improved in most cases by addressing the causes such as exposing subfloor vents installing additional new vents installing mechanical (forced airflow) ventilation and removing debris from the subfloor.

A registered builder should be appointed as soon as possible to perform these works as necessary.

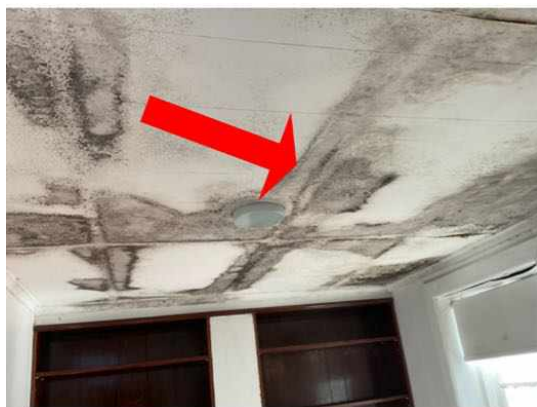
Finding 2.03

Building:	Main Building
Location:	All Internal Areas
Finding:	Ceiling - Water damaged
Information:	Water damage to the ceiling lining is generally an indication of excessive moisture being present in the roof void, usually via a leak to the roof covering.

Where water damage is evident to the ceiling, the primary requirement is to identify and rectify the source of the leak. A roofing plumber should be appointed as soon as possible to identify the leak and perform rectification works as necessary, ensuring the water damage is restricted.

Once the leak is repaired, consultation with relevant tradespeople, including plasterers and painters, is advised. Rectification works may include replacement of ceiling lining or minor repainting, depending on the extent of the damage.

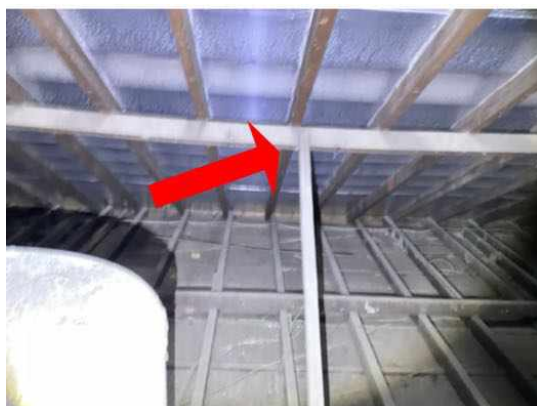
Information: The roofing structure was found to be sagging in certain sections at the time of inspection. Upon closer inspection within the ceiling void, it is suspected that the sagging is a direct result of inadequate connections, which appear to have deteriorated over a prolonged period of time.

Sagging roof structures are likely to create strain on associated building elements, creating potential for secondary damage. The roof is also unlikely to have sufficient support, which will lead to further sagging if left unmanaged.

It is critical to ensure that the fastenings holding important roof elements together remain structurally sound (i.e. not corroded) and tightly fastened. Any failure in fastenings can lead to movement of roof members, which is likely to result in an uneven or sagged appearance of the roof exterior. Improper nailing at the point where the ceiling joist connects to the bottom of the rafter may also cause sagging.

Remedial works are highly advised and should be performed by a registered builder or roofing contractor as soon as possible.

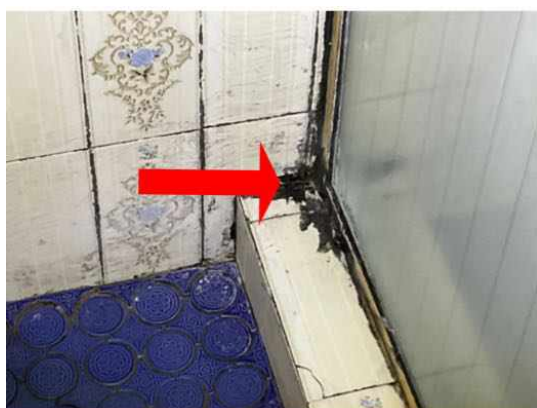
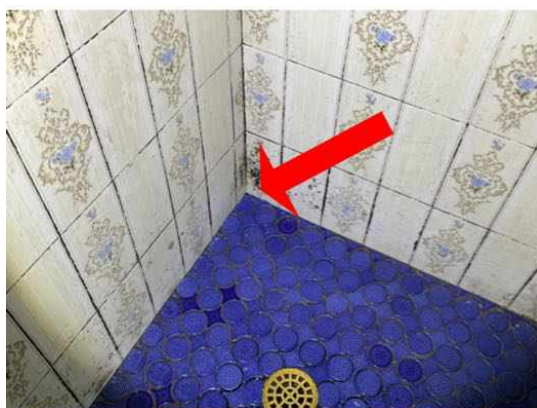
Finding 3.01

Building:	Main Building
Location:	Bathroom
Finding:	Shower damp - Sealant and grout
Information:	Damp is evident to the lower 400mm of wall to the shower alcove. This defect is quite common, and is suspected to have been caused by moisture permeating or leaching through the grouting and sealant in this area, which shows evidence of deterioration. Leaking pipes within the wall is also a possible cause however this seems unlikely in this instance as there is no moisture build up around the taps or transferring to the other side of the wall. There appears to be no sealant around the tap spindles which may be a small contributing factor.

Damp (or structural damp) refers to the presence of unwanted moisture in the structure of a building, either as the result of intrusion from outside, or condensation from within the structure. In the shower area, internal water leaks, degraded materials or other sources of excessive moisture are generally the cause of damp.

Unmanaged damp in the shower recess is likely to facilitate the formation and development of mould and fungi growth, decaying associated building materials and compromising their structural integrity of associated elements. It is important to

Consultation with a bathroom sealant specialist is advised immediately to identify the cause of damp and to perform remedial works as required.

Always ensure that sealant and grout is in good condition to prevent any moisture issues occurring in the future.

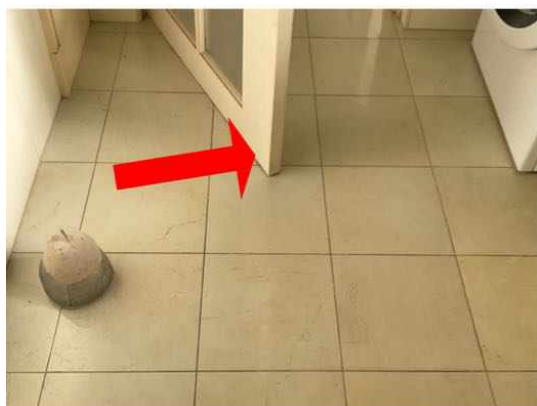
Building:	Main Building
Location:	All Internal Areas
Finding:	Door - Binding/jamming
Information:	Binding and/or jamming of this door is evident during standard operation. This defect inhibits the functionality of the affected door as well as creating potential for secondary defects to associated building elements, such as damage to the floor covering.

A door that binds to flooring or to the associated door frame may have several causes, ranging from minor defects, such as poor installation of the door or deteriorated hinges, through to major structural issues, such as damage to subfloor structures.

Where door binding/jamming appears to indicate major structural issues, a registered builder specialising in re-stumping should be appointed to provide an estimate on the cost of rectification.

For minor causes, a qualified carpenter or general handyperson should be appointed to perform minor rectification works at client discretion.

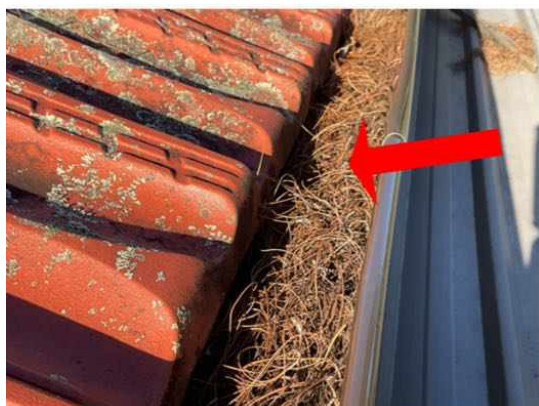
Finding 3.05

Building:	Main Building
Location:	Roof Exterior
Finding:	Gutters - Blocked
Information:	Roof plumbing structures, such as guttering and downpipes, should be free of all debris to prevent blockages. Blockages of the guttering and downpipes will lead to pooling and accumulated water overflows, which is likely to subsequently flood eaves and exterior walls.

Blocked gutters are likely to lead to high levels of moisture in the affected areas. Such moisture will not only cause rust and decay of the associated building materials, but can also provide conditions that are conducive to termite and timber pest activity. Blockages in gutters should therefore be removed immediately to ensure dry conditions are maintained.

Consult a Licensed Plumber for further specific advice on remedial works that may be required. In the interim, it is highly advised that blocked gutters be removed by the homeowner or a general handyperson as a matter of urgency.

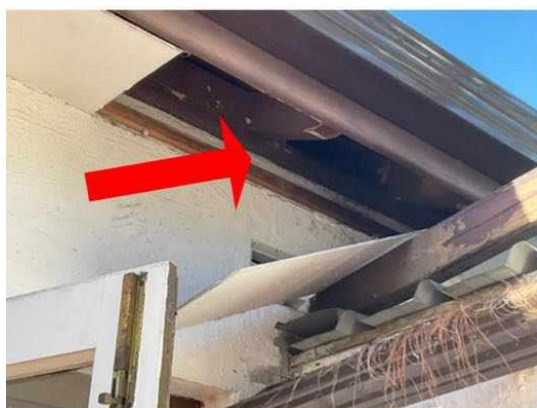
Finding: Eaves - Damaged

Information: The eaves around the external property were found to be in a visibly poor condition. The damage may have been sustained as a result of a number of possible causes, including poor roof drainage, leaking roof plumbing or minor impact damage.

The damage to the eave sheeting in this area detracts from the appearance of the structure, as well as potentially compromising the structural integrity of the roofing area.

Where eaves show moderate to severe damage, remedial works may be required. Where water damage is suspected as being the underlying cause, appointment of a licensed plumber is advised as a matter of urgency to identify the source of the water leak.

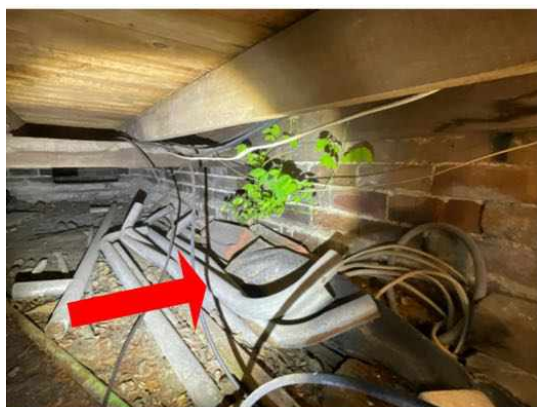
Finding 3.08

Building:	Main Building
Location:	Subfloor
Finding:	Subfloor - Debris
Information:	An array of debris was found in the subfloor area at the time of inspection. Debris in this area restricts subfloor ventilation and creates potential for concealed pest entry. Stored timbers and other materials may also make the area susceptible to termite activity and wood rot.

A clear and empty subfloor will be better ventilated and easier to maintain in a dry condition. The removal of any timber debris is vital in minimising the risk of termite or wood borer activity.

Debris in the subfloor should be removed as soon as possible. Depending on the location and amount of debris and stored items, the homeowner may elect to undertake this task. Alternatively there are a large number of rubbish removal subcontractors that could undertake these works.

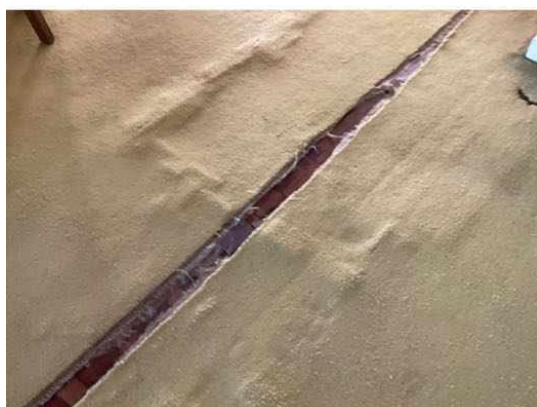
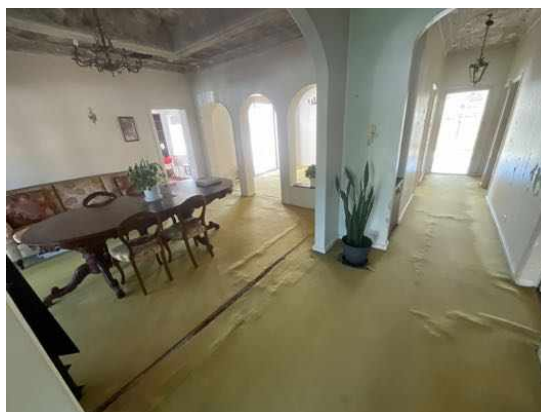
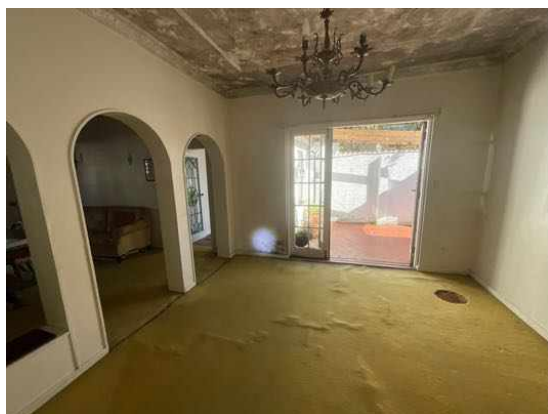
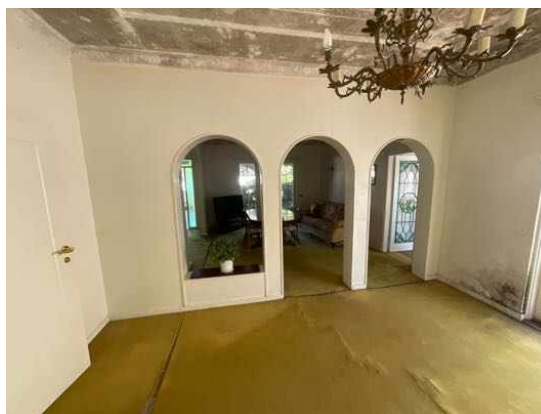
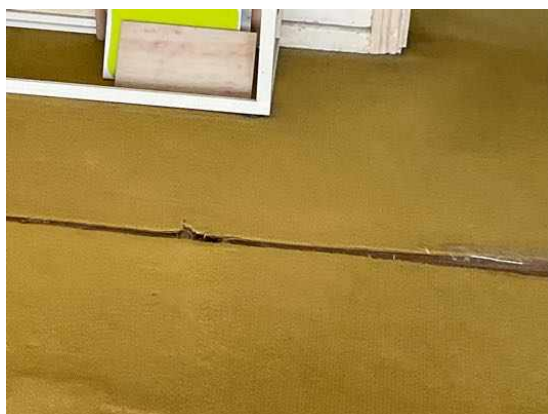
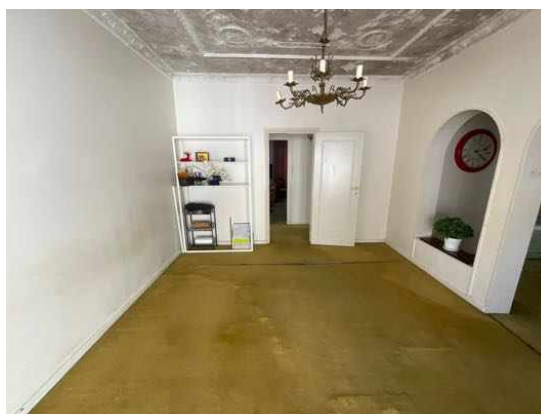
Finding 3.09

Building:	Main Building
Location:	All Internal Areas
Finding:	Carpet - damaged / deteriorated
Information:	Static Damage

Static is created through friction and as a result, the carpet snaps, crackles and pop as you walk across. Due to the dry weather and low humidity, static charges are formed within the carpet thus resulting to static damage. Although new types of carpets have anti-static agents like conductive agents and fine metal wires that protects the carpet.

Replacement of the affected carpet is required as a matter of urgency to ensure the safety of the area. Where required, remedial works should be undertaken to any associated walls and flooring showing evidence of mould.

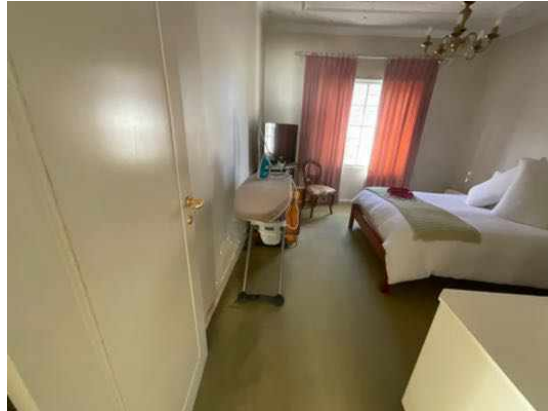
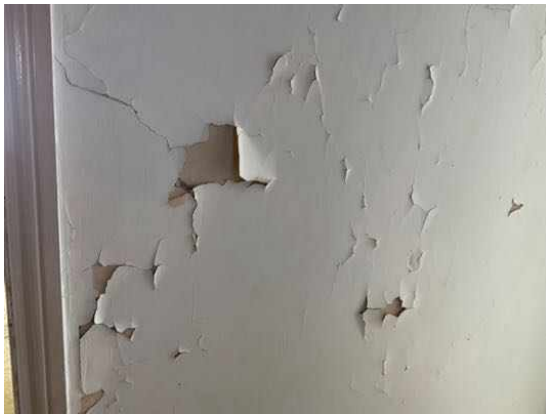
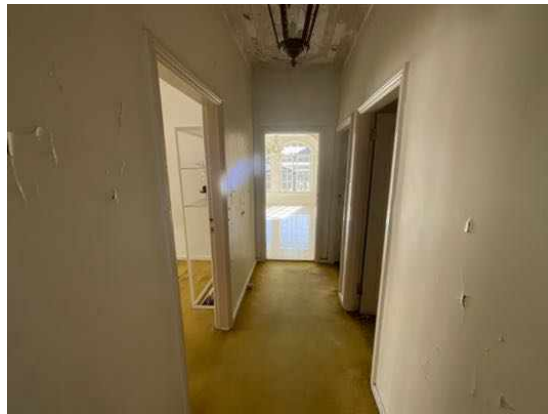
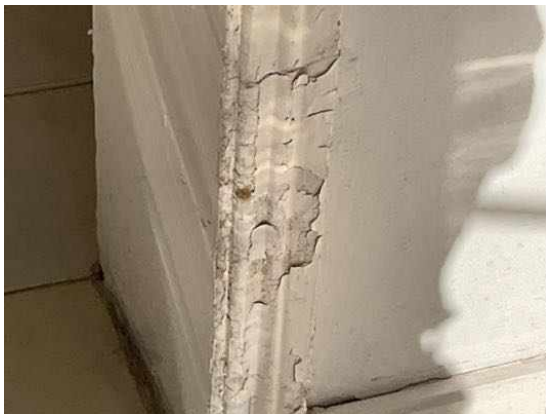
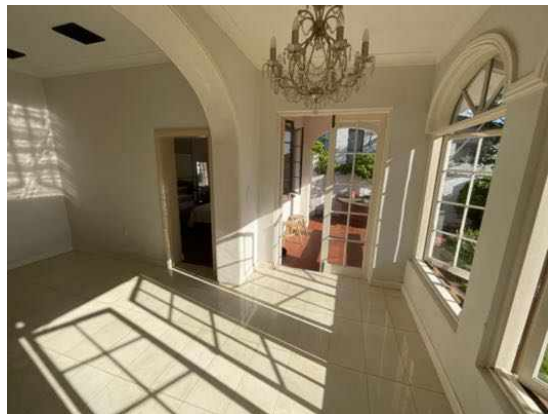
Finding 3.10

Building: Main Building
 Location: All Internal Areas
 Finding: Painted surface - Bubbling
 Information: Sections of paint in this area was found to have bubbled and deteriorated. Paint bubbling is generally an indication of excessive moisture in the area, that is currently hidden by the painted surface.

The presence of excessive moisture can have major implications on associated building elements if left unattended. While only seemingly minor at this stage, the damage cannot be determined due to the paint obstructing any further inspection of the damage.

It is highly advised that the affected paint be cleaned to allow a further, more invasive inspection by a licensed plumber. Failure to act on this defect may necessitate major works in the future.

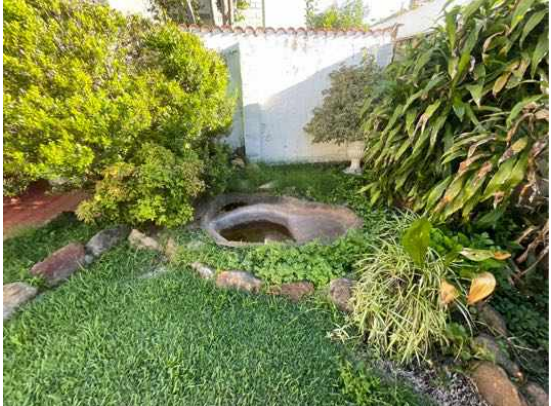
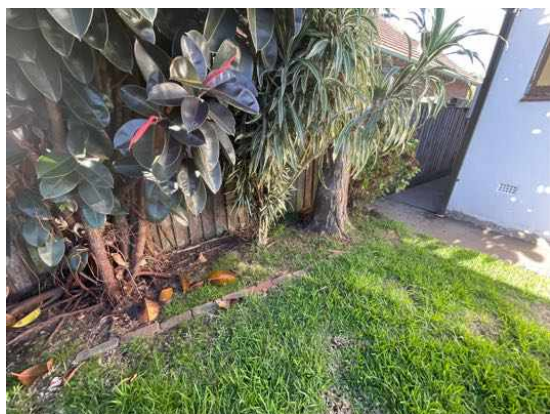
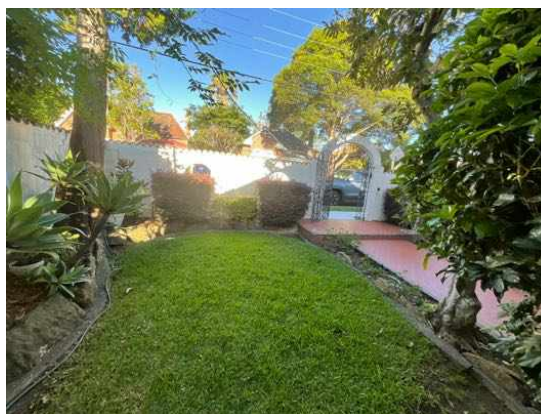
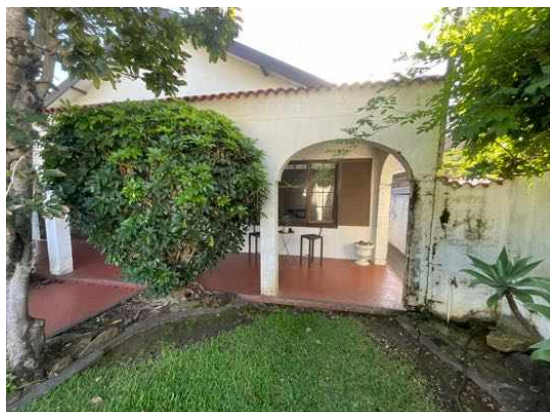
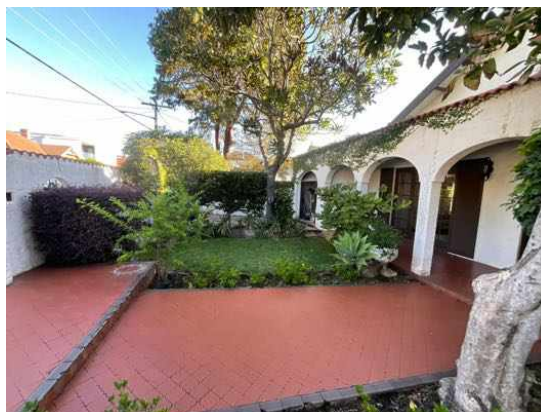
Finding 6.01

Building: Main Building
Location: All Areas
Finding: Garden Beds - Conditions Conducive to Termites
Information: Garden beds were found to be evident in the garden area. These garden beds can include untreated timber, and with a combination of moisture from watering hosing can make conditions conducive to termite activity and termite ingress.

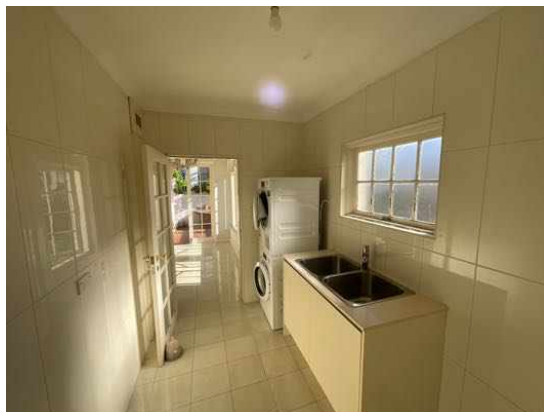
Building:	Main Building
Location:	All Areas
Finding:	Water Proofing Membranes - Information Only
Information:	Internal Water Proofing Membranes, are crucial in preventing water ingress into the property is important to know that the Membrane System used is to Australian Standards and has been installed correctly. Please refer to the original Building Documents or Maintenance Schedule for the relevant information including; - Membrane used and Manufacturers Specifications. - The Installer and Installation Certification. Especially with older property's where this information is unavailable, all wet areas should be monitored. Generally new waterproofing with a certificate may only have a guarantee of 8yrs. If any leaks, water staining, peeling or bubbling of the

paint become evident to any adjacent walls or ceilings below a licensed builder or waterproofing specialist is recommended to investigate further.

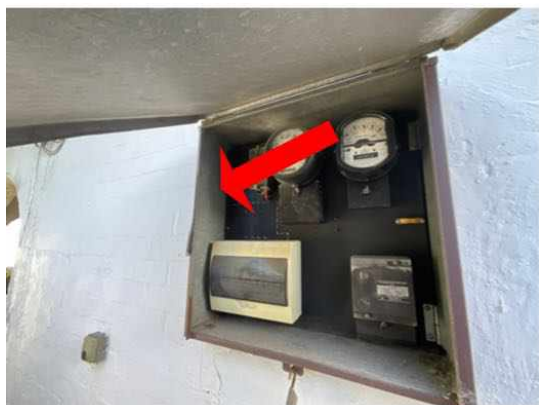
Building: Main Building
Location: All Areas
Finding: Termite Management System - no evidence of a chemical installation
Information: The application of a post-construction chemical termite barrier is highly recommended for all properties, particularly if live termite activity has been found on the site previously. Such barriers are highly effective in preventing termite attack on any timber building elements throughout the property.

A durable notice should be placed in the switchboard unit to indicate current termite barriers. At the time of inspection, it appeared as though no termite management system has been installed, with no evidence to suggest preventative works taking place.

The client may consider gaining further advice from a pest controller as to the costs and procedures involved with this application. It is recommended that obtaining such advice be a short-term priority.
