Building and Timber Pest Inspection Report

Inspection Date: Thu, 12 Feb 2026

Property Address: 5/56 Belmore St, North Parramatta NSW
2151, Australia

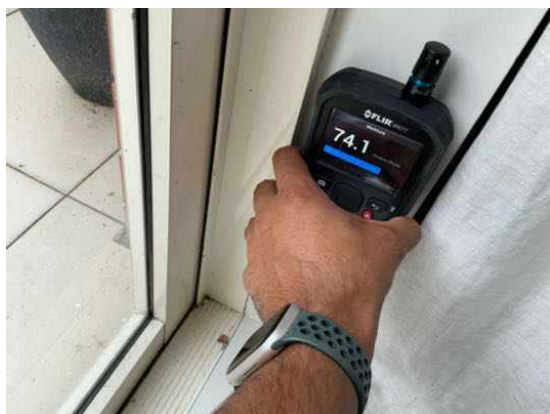
Building:	Main Building
Location:	All Areas
Finding:	External Moisture Ingress, Drainage Issues & Surface Deterioration
Information:	At the time of inspection, multiple moisture-related defects were observed to the external areas of the property. The guttering and associated downpipe sections showed signs of leakage and overflow staining to the brickwork, indicating possible blockage, joint failure, or inadequate drainage. Significant water staining and dampness were noted to the external walls below the balcony and roof drainage discharge points, consistent with prolonged moisture exposure.

The balcony floor tiles exhibited deteriorated and failing sealant to joints and perimeter junctions. Evidence of water leakage from the balcony area was visible, with staining and surface breakdown to the walls below, suggesting possible waterproofing failure and/or inadequate drainage falls. The rendered wall surfaces displayed moisture-related deterioration, including blistering, staining, cracking and previous patch repairs, likely due to ongoing water penetration from above.

Vegetation growth was observed emerging from wall junctions and cavities, indicating persistent moisture retention within the structure. Plant growth within wall systems can accelerate deterioration of mortar joints, render finishes and brickwork over time.

As a result of the above external moisture defects, elevated moisture readings were recorded to the internal wall surfaces in the front living area using a moisture meter. These high readings are consistent with water ingress from the external balcony and drainage areas and indicate that moisture is tracking internally through the wall system.

These conditions collectively present a risk of continued water ingress, concealed damage, potential mould development, and long-term structural deterioration if not rectified. As the affected elements appear to form part of the common property, the

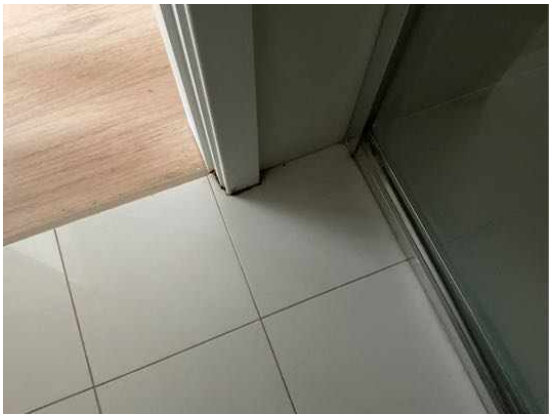
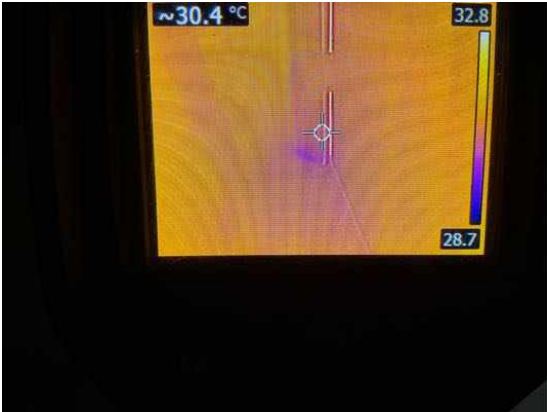
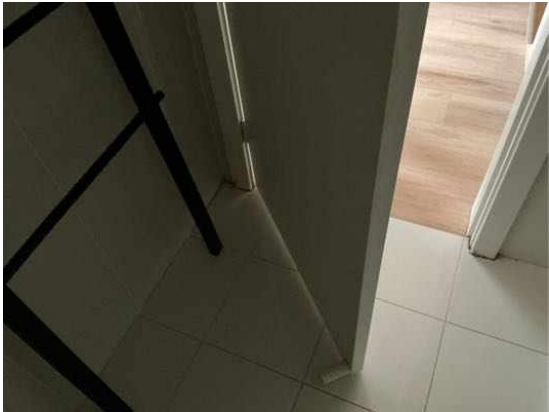
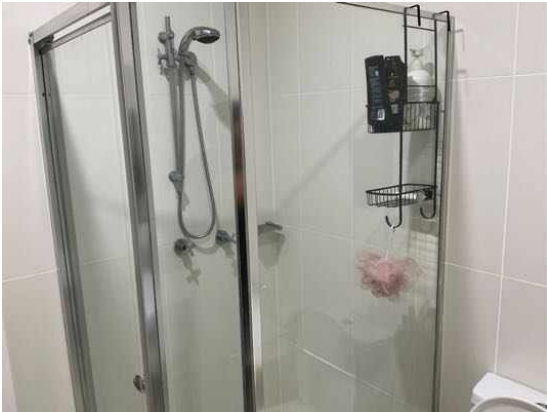
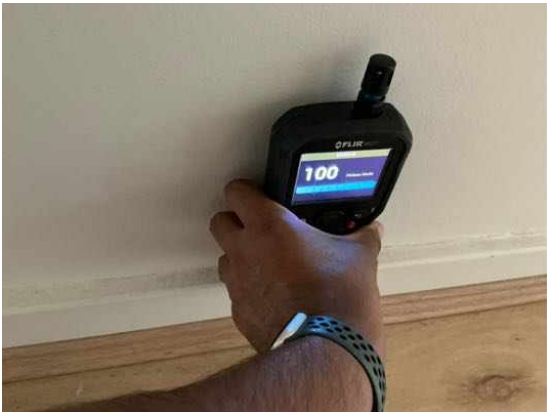
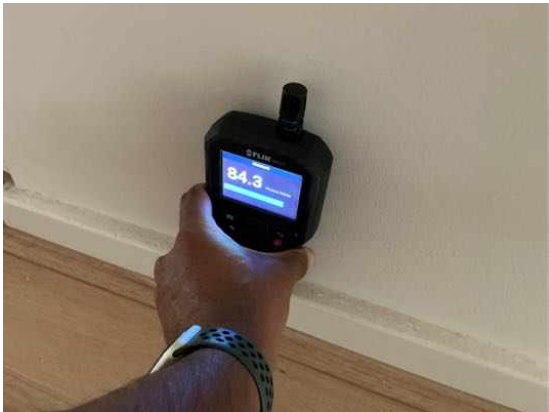
Finding 2.02

Building:	Main Building
Location:	Bathroom
Finding:	Excessive Moisture on Walls (Adjacent Bathroom) - Major Defect
Information:	A major defect was identified during the inspection, with evidence of moisture penetration noted on the walls adjoining the bathroom and shower area. The presence of moisture raises serious concerns about the integrity of the waterproofing system, which is a critical component in preventing water ingress into adjoining structures.

The moisture penetration is likely due to a failure or inadequacy in the waterproofing membrane beneath the tiled surfaces in the bathroom and shower area. Waterproofing systems are designed to act as a barrier, and any breach can result in water escaping into adjacent walls. This could also be exacerbated by inadequate sealing around fixtures, joints, or tiles, which are common entry points for water. Additionally, the defect may be attributed to substandard installation practices or the natural wear and tear of waterproofing materials over time, both of which can compromise the membrane's effectiveness.

If left unaddressed, this issue could lead to significant consequences. Persistent moisture can weaken the structural integrity of the walls, resulting in costly repairs or replacement. Damp conditions also create an ideal environment for mould growth, which poses health risks and further compromises the interior condition of the property. Moreover, unresolved waterproofing issues can adversely impact the property's value and marketability.

The client is advised to use services of a professional waterproofing specialist as soon as possible.

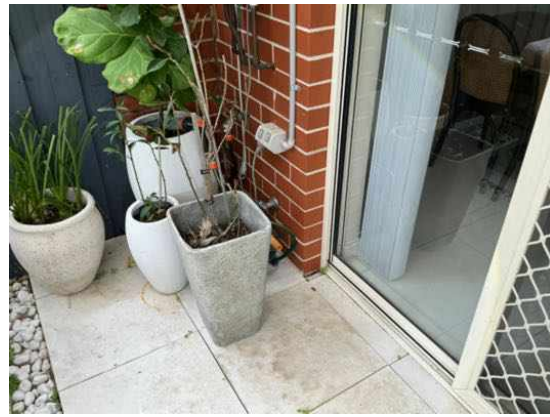
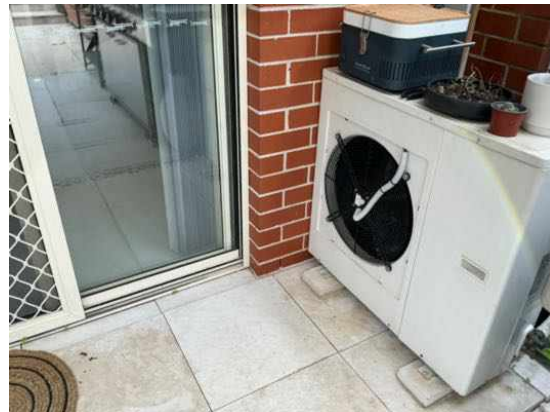
Building:	Main Building
Location:	Dining Room
Finding:	Damp - Rising (Drainage Issue)
Information:	At the time of inspection, evidence of rising damp was noted, with external ground levels observed to be at same level as the internal floor level and ground surfaces sloping towards the building. The weep holes were also noted to be on ground level. This condition allows moisture to migrate into the lower sections of the walls and flooring and can lead to dampness, deterioration of building materials, and ongoing moisture-related issues. Reducing external ground levels and improving drainage to ensure ground surfaces fall away from the building is required to minimise moisture ingress. This defect will turn into major defect soon if not rectified on time.

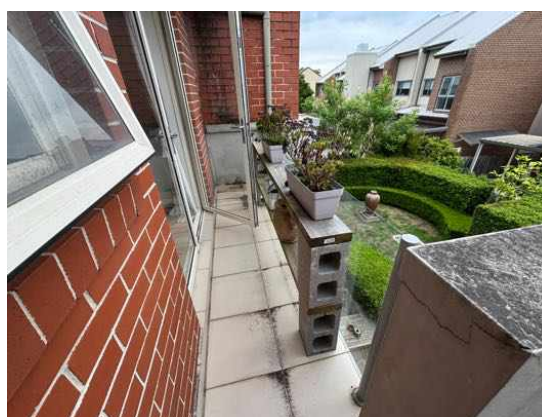
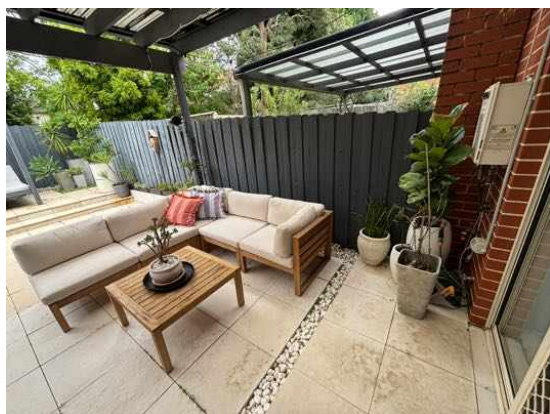
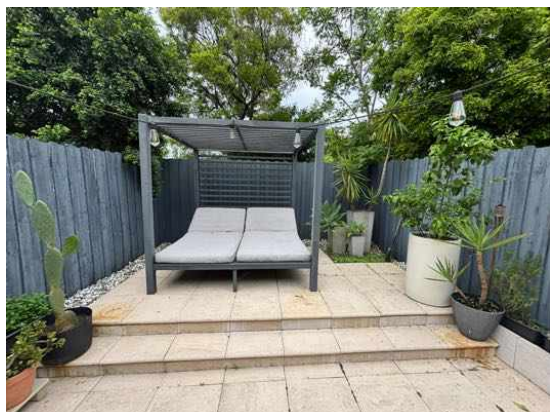
It is essential that these obstructions be cleared to allow for a comprehensive inspection of the external areas. Removing these barriers will enable a more accurate assessment of the property's condition and allow any hidden defects to be identified and addressed promptly. Failure to do so could result in undetected issues worsening over time, potentially leading to more costly repairs in the future.

Therefore, it is strongly recommended that the obstructions be removed and a re-inspection be scheduled once the affected areas are made fully accessible. This will ensure a complete evaluation of the property's exterior and provide the client with a clear understanding of any potential issues that may have been concealed during the initial inspection.

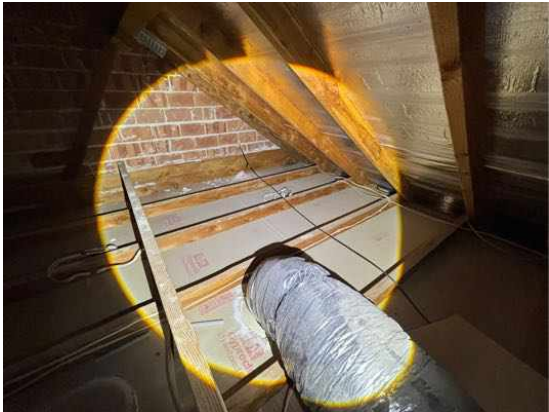
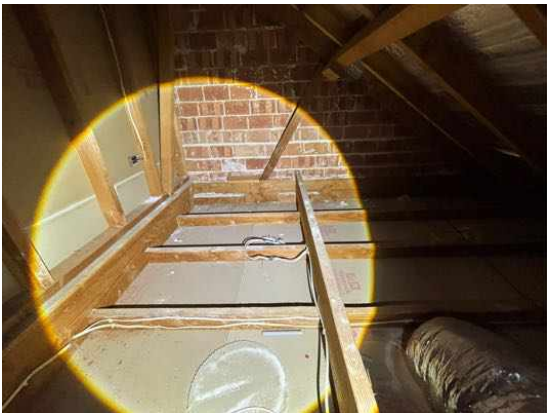
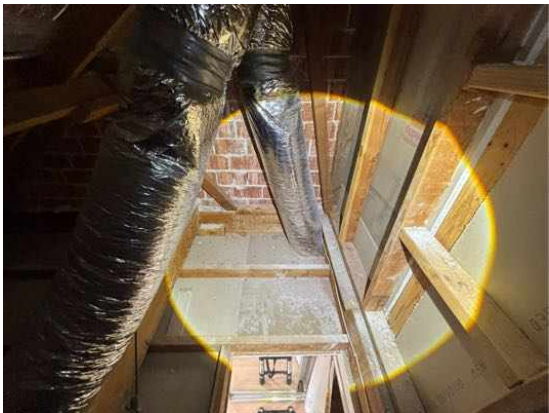
Building: Main Building
Location: Roof Void
Finding: Obstructions, Limitations, and General Roof Space Condition
Information:

Obstructions of this nature may conceal a variety of potential defects, including damaged framing, compromised insulation, evidence of moisture ingress, pest activity, or electrical hazards. While no major issues were observed in the visible areas, the presence of these limitations means that some defects may remain undetected.

It is recommended that these barriers be removed or repositioned to facilitate full and safe access to the roof space. Once clear, a follow-up inspection should be conducted to allow for a thorough assessment of all concealed areas. This will help ensure that the condition of the roof cavity is accurately evaluated and any hidden issues are appropriately identified and addressed.

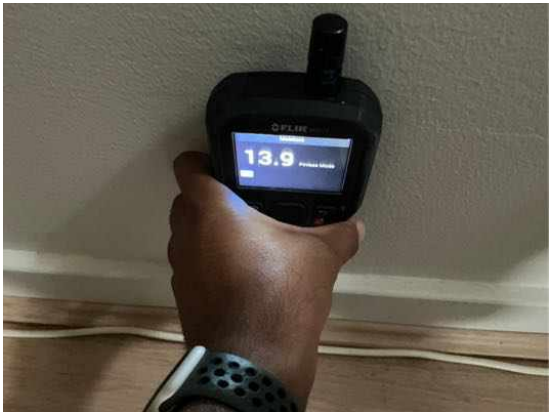
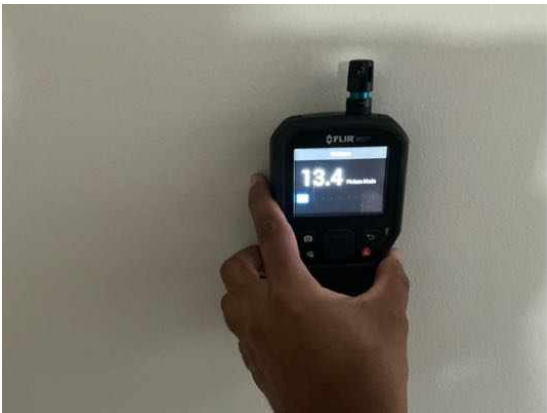
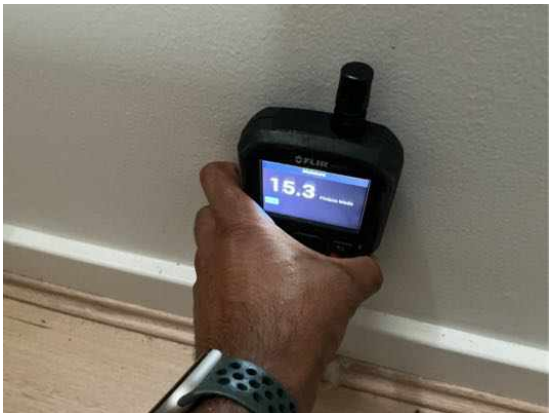
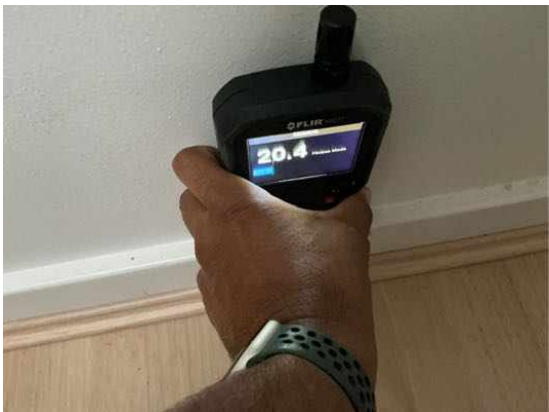
Building:	Main Building
Location:	All Areas
Finding:	Additional Photos - Moisture Meter Readings
Information:	<p>Additional moisture meter reading photos have been provided for the property to offer further clarity on areas tested during the inspection. These photos are intended to give a visual reference for the specific locations where moisture levels were measured.</p> <p>These readings were taken at the time of the inspection to assess any potential moisture-related issues within the property. Any defects related to moisture that were identified during the inspection have been separately mentioned in the defect statements within the report.</p>

It is important for the client to understand that moisture levels can fluctuate over time due to various factors, including changes in weather, humidity, and environmental conditions. While the readings reflect the property's moisture levels during the inspection, they may not represent future conditions, and increased moisture could lead to issues such as dampness, mould growth, or deterioration of building materials if left unmonitored.
