Building Inspection Report

Inspection Date: Fri, 16 Jan 2026

Property Address: 21 Yunga Ct, Broadbeach Waters QLD
4218, Australia

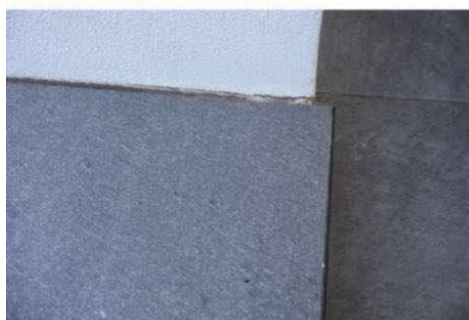
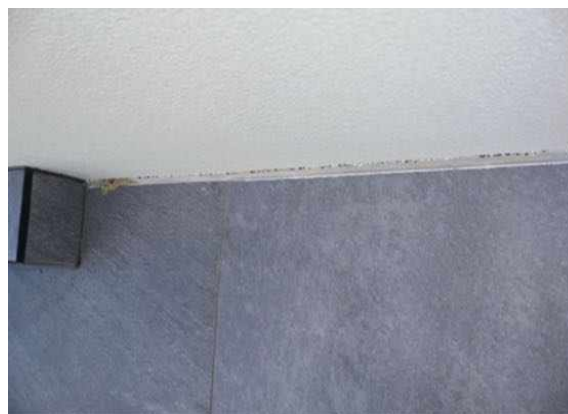
Defects 3.01

This may allow water ingress rain water can track cavities or slab edges, dampness efflorescence, render/paint failure, or internal moisture issues.

Rectification works are required.

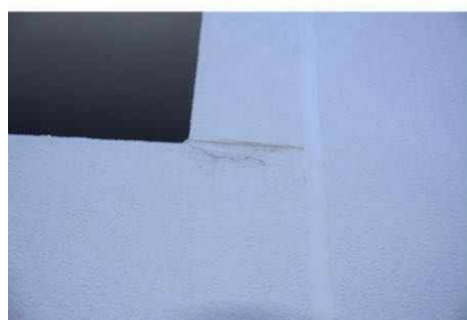
Defects 3.02

Building:	Main Building
Location:	Walls > Front
Finding:	External wall weatherboard- cracks
Information:	Cracks to the external weatherboard wall right side of building was found at the time of the inspection.

Weatherboard walls cracking can be signs of underlying defects or issues with the building due to natural expansion and contraction of timber due to moisture and temperature changes, uneven settling of foundations or soil movement, buckling splitting or separation between boards.

This may also be due to frequent exposure to weather.

It is recommended that repairs to wall be carried out to prevent moisture ingress.

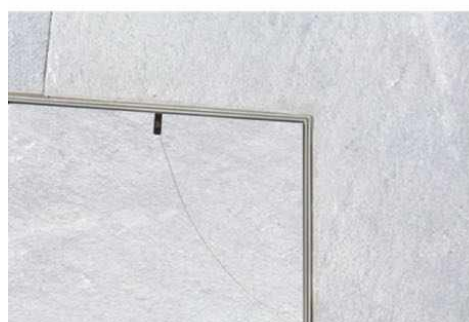
Defects 3.04

Location: Pool Area > Front
 Finding: Tiles - Cracked or damaged
 Information: Cracking was evident to the tiling in this area at the time of inspection. While the cracking appears to be minor, this area is frequently exposed to water, allowing potential for water penetration into adjoining sections of walls or flooring.

If left unmanaged, water penetration to these areas may lead to subsequent water damage, which is likely necessitate repair work to affected building elements.

A tiling contractor should be appointed to ensure that no further water damage occurs. The re-application of silicone and grouting throughout remaining tile work is also advised, to further protect the area against water penetration.

Where water penetration has led to water damage, appointment of a relevant tradesperson may be required to repair damaged building elements.

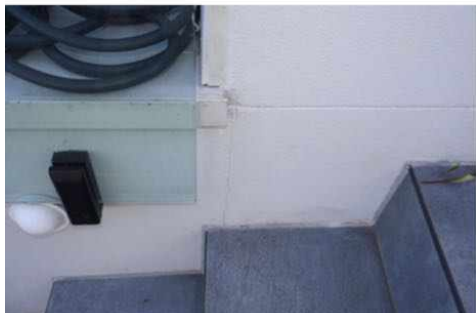
Defects 3.05

Building: Yard
 Location: Pool Area > Front
 Finding: Cracks to external render - Category 1
 Information: It has been observed that cracking to rendered surfaces has occurred. The degree of damage falls within Category 1, described as fine cracks that do not need repair and

which are less than 1.0mm in width limit.

Damage of this category is not considered a defect for rectification. Always contact your building inspector should cracks widen, lengthen, or become more numerous.

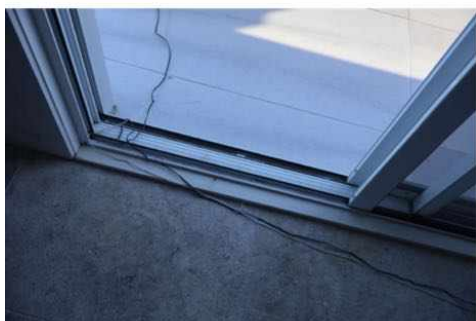
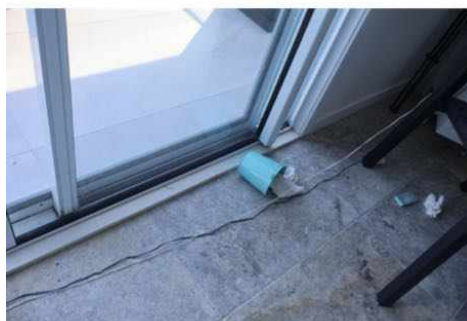
Defects 3.06

Building:	Main Building
Location:	Sunroom/entry > Front
Finding:	Unconventional handyman work
Information:	This handyman work appears to have been completed to a substandard level and does not comply with regular building practices. Where handyman work is not completed satisfactorily, accelerated deterioration of the associated building elements is likely to occur and secondary defects to surrounding structures may develop.

It is highly recommended that the substandard work be rectified by professional services. Works to improve this area are likely to increase the safety and the operation of the associated building elements.

The client should exercise care when coming into the immediate vicinity of the substandard works. Rectification works are advised as soon as possible by the appropriate trades.

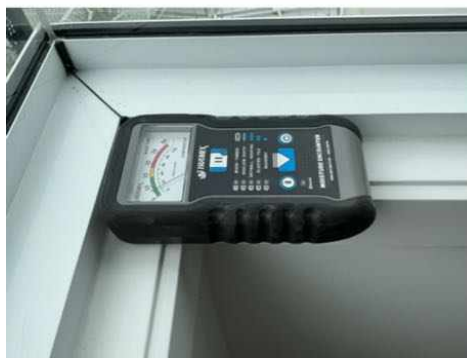
Defects 3.07

Building:	Main Building
Location:	Bedroom - Master > Rear Right
Finding:	Water staining
Information:	Water staining was evident in this area at the time of inspection. Water staining indicates that surfaces have been exposed to excessive moisture over time. The minerals and other elements in the water lead to staining, which may graduate to corrosion and deterioration if left unmanaged.

While mostly an appearance defect, water staining can be indicative of more serious defects, which may be currently concealed by other building elements.

Where water staining is active, a licensed plumber must be consulted to identify the cause of the staining and to provide advice on any reparation works that may be required. Replacement of any broken or damaged structures is advised.

Conversely, where water staining is old and inactive, affected building materials may be repaired or replaced at client discretion. A qualified carpenter or registered builder may be appointed to perform these works.

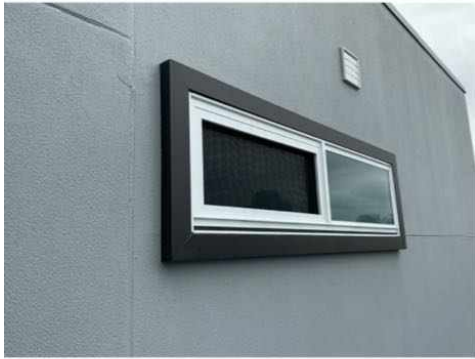
Defects 3.08

Building:	Main Building
Location:	Weather board > Front
Finding:	External weather board - cracks
Information:	Cracking was observed to sections of the external weather board cladding.

This condition may allow moisture ingress and indicates movement of the cladding material.

Repair and maintenance are recommended.

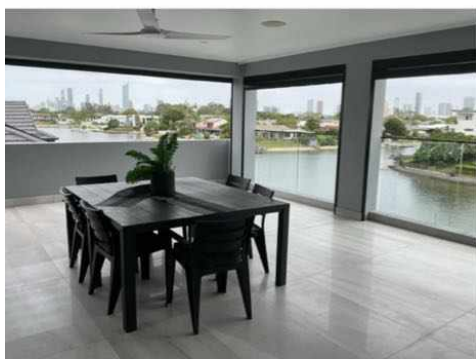
Defects 3.10

Building:	Main Building
Location:	Upper alfresco > Rear Right
Finding:	Ceiling - Water stained
Information:	Water staining to ceiling linings in this area was evident at the time of inspection. Water staining indicates that surfaces have been exposed to excessive moisture over time. The minerals and other elements in the water lead to staining, which may graduate to corrosion and deterioration if left unmanaged.

While mostly an appearance defect, water staining can be indicative of more serious defects, which may be currently concealed by interior ceilings.

Where water staining is active, a licensed plumber must be consulted to identify the cause of the staining and to provide advice on any reparation works that may be required. Replacement of any damaged structures is advised.

Conversely, where water staining is old and inactive, affected building materials may be repaired or replaced at client discretion.

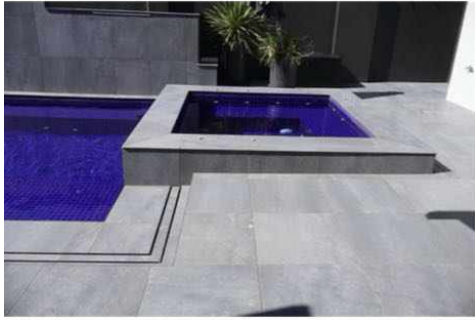
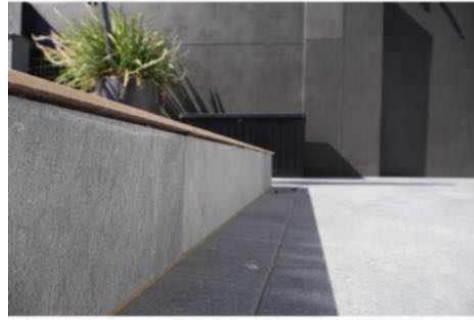
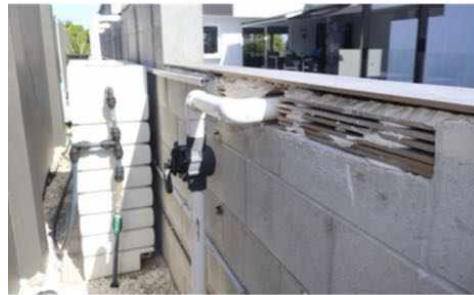
Building:	Yard
Location:	Pool Area > Front
Finding:	Pool tile - junctions sealant missing
Information:	The junctions where the pool tiles meet the coping/ pool edging has no flexible sealant.

This may also allow cracking to junctions due to thermal and structural movement.

It is recommended that sealant be carried out as soon as possible.

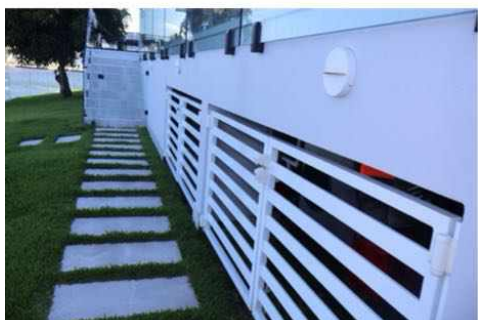
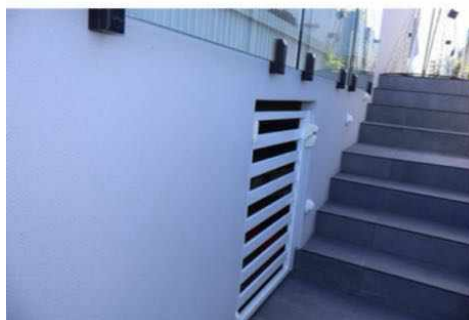
Building: Main Building
 Location: Alfresco > Rear
 Finding: External wall weatherboard- cracks
 Information: Cracks to the external weatherboard wall right side of building was found at the time of the inspection.

Weatherboard walls cracking can be signs of underlying defects or issues with the building due to natural expansion and contraction of timber due to moisture and temperature changes, uneven settling of foundations or soil movement, buckling splitting or separation between boards.

This may also be due to frequent exposure to weather.

It is recommended that repairs to wall be carried out to prevent moisture ingress.

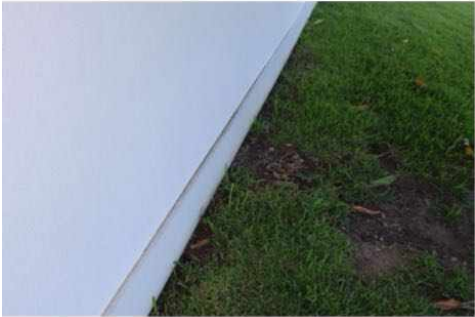
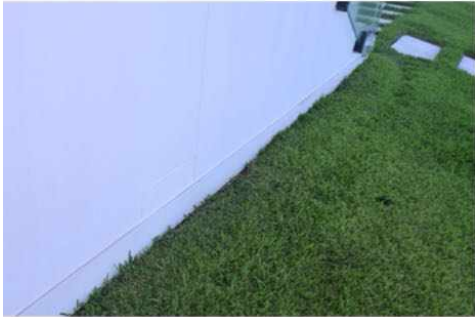
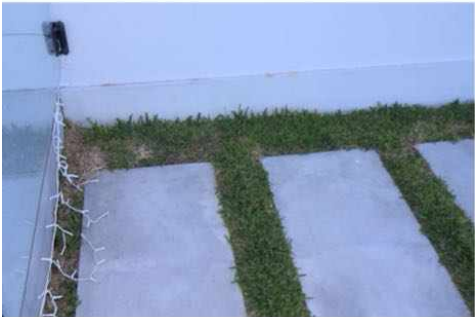
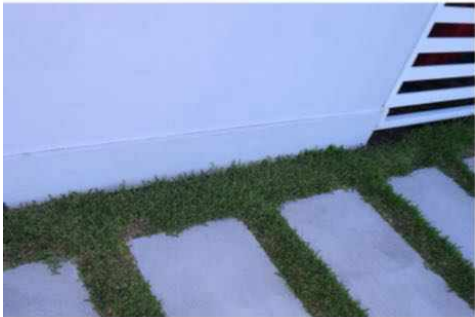
Building:	Main Building
Location:	Alfresco > Rear
Finding:	Cracks to external render - Category 2
Information:	It has been observed that cracking to external rendered surfaces has occurred. The degree of damage falls within Category 2, described as noticeable cracks which are easily filled. Cracking of this size are generally less than 5mm in width.

Category 2 damage is required to be monitored for a period of 12 months. After the monitoring period, a crack rated at Category 2 or above is considered a defect requiring rectification.

Always contact your building inspector should cracks widen, lengthen, or become more numerous.

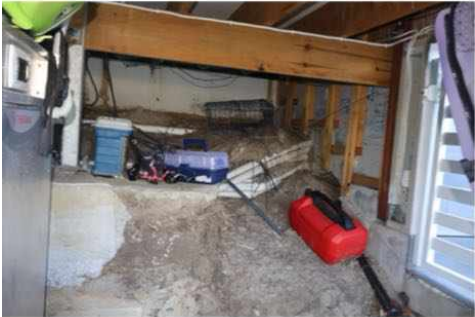
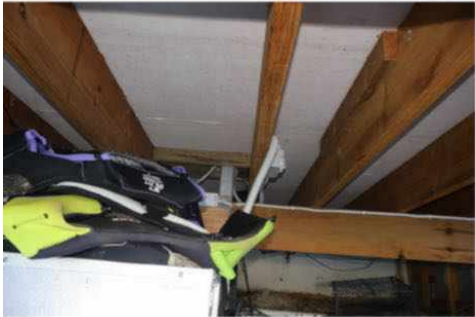
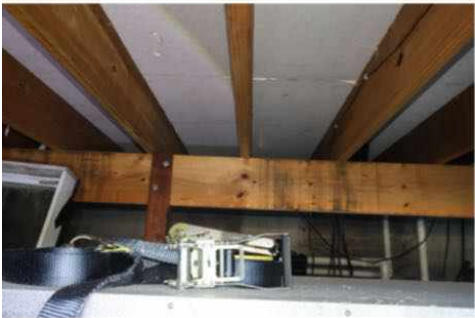
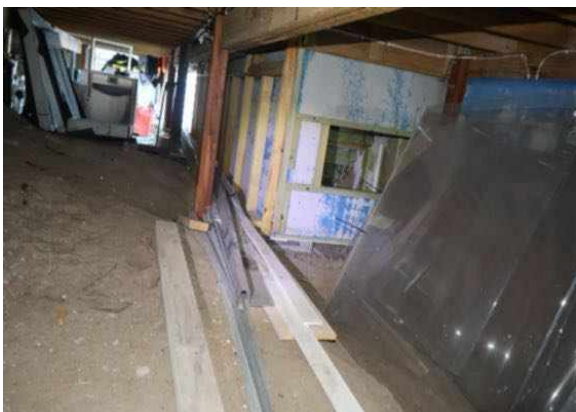
Building: Main Building
 Location: Subfloor > Rear
 Finding: Building materials in direct ground contact - conducive to termites
 Information: Where timber elements are in direct contact with the ground and consequently moisture or dampness they become conducive to termite activity. Whether timber is used as a building element part of a fencing structure they can provide an environment that is attractive to termite infestation.

When met with excessive moisture timber begins to decay and develop wood rot. Any timbers that are in direct contact with external grounds especially if left untreated or non-durable also provide ingress for subterranean termites into that particular element.

Regular inspections of materials that may be conducive to termite activity should be regularly monitored to minimise the risk of termite attack.

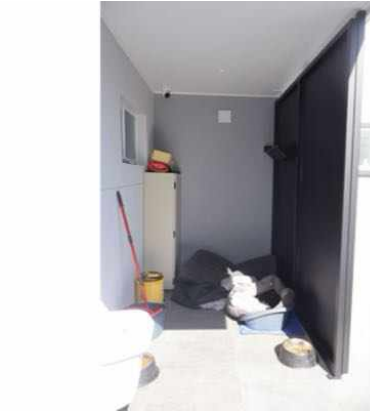
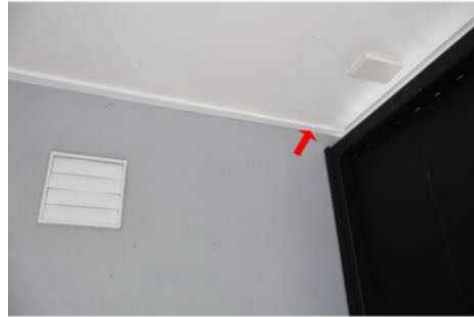
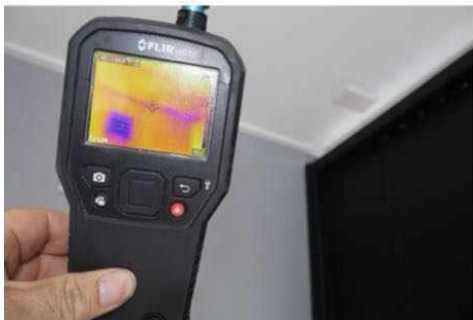
Building: Main Building
 Location:
 Finding: Ceiling - Water stained
 Information: Water staining to ceiling linings in this area was evident at the time of inspection. Water staining indicates that surfaces have been exposed to excessive moisture over time. The minerals and other elements in the water lead to staining, which may graduate to corrosion and deterioration if left unmanaged.

While mostly an appearance defect, water staining can be indicative of more serious defects, which may be currently concealed by interior ceilings.

Where water staining is active, a licensed plumber must be consulted to identify the cause of the staining and to provide advice on any reparation works that may be required. Replacement of any damaged structures is advised.

Conversely, where water staining is old and inactive, affected building materials may be repaired or replaced at client discretion.

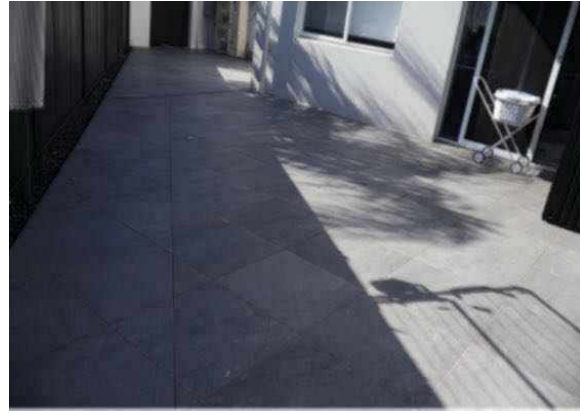
Building: Main Building
 Location: Paving > Rear Right
 Finding: Grout cracking - external tile area
 Information: Cracks are visible in the grout joints between external floor tiles.

The cracking may be isolated across a section of tiled surface.

Movement or flexing of the substrate (e.g slab or screed) due to temperature changes ground movement or inadequate control joints.

A tiler or handyman may be required to rectify this condition.

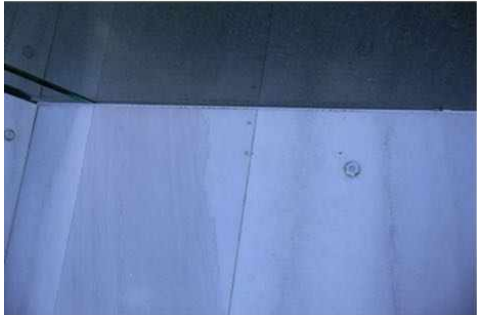
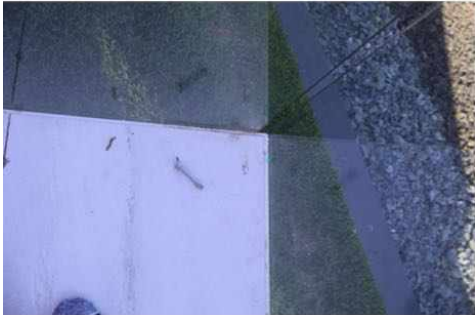
The condition indicates possible use of incorrect or low-grade sealant, inadequate surface preparation or moisture ingress.

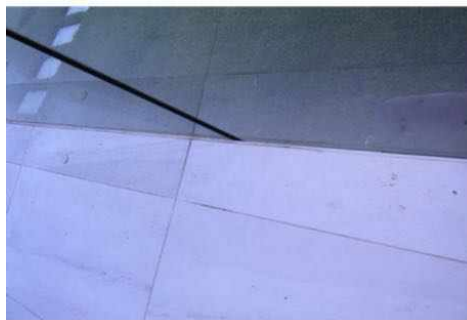
Building: Main Building
Location: Alfresco > Front
Finding: Balcony sealant discoloured - edge
Information:

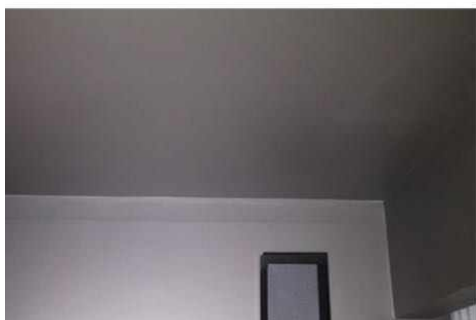
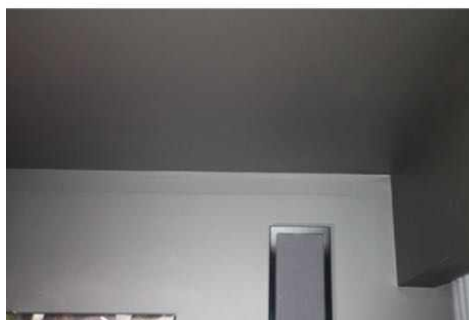
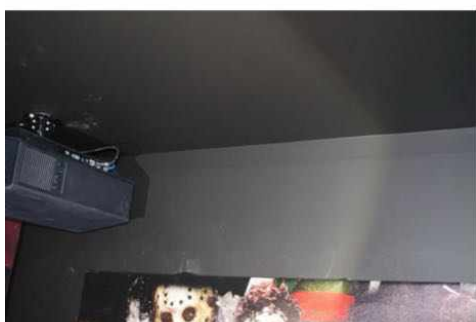
Building:	Main Building
Location:	Media > Centre
Finding:	Paint finish - Substandard
Information:	The paint finish in this area was found to have been completed to a substandard level. Substandard painting is generally classified as an appearance defect. However, the substandard appearance may also be indicative of poor surface preparation and substandard workmanship.

If this applies, further areas of poor and incomplete finishes could develop over time. Furthermore, substandard paint finishes in areas exposed to moisture, e.g. external areas or wet areas, could lead to deterioration of underlying building materials.

Substandard paint finishes should be sanded back, filled, leveled and repainted, as applicable. Where inadequate paint protection has led to the deterioration of the associated building element, repair and/or replacement of this building element may be required.

A painting contractor should be appointed as soon as possible to perform necessary works to aid the appearance of the affected area and to ensure that the area is protected against further deterioration. Alternatively, the homeowner following manufacturer instructions may be able to provide this service.

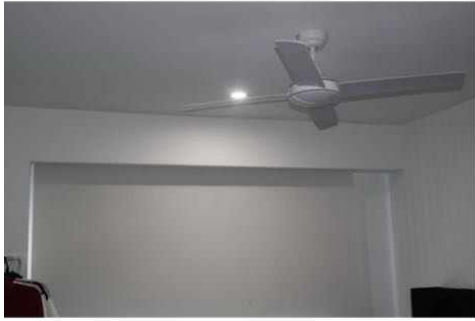
Building:	Main Building
Location:	Bedroom > Rear
Finding:	Excessive moisture - identified walls
Information:	Excessive moisture can attract termites and produce conditions that promote fungal growth and wood decay.

Excessive moisture is generally caused by inadequate external sealing to walls or poor site drainage.

Prior to any remedial works being performed, further inspection of the property drainage to identify the cause of the excessive moisture. Works to affected building

elements may then be necessary and should be performed by an appropriate tradesperson.

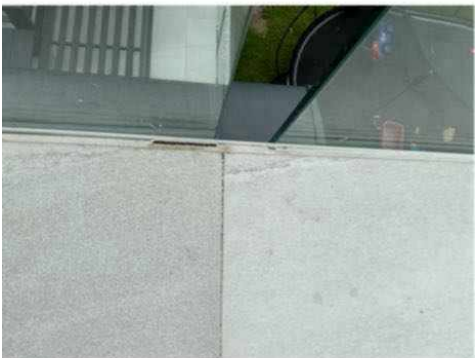
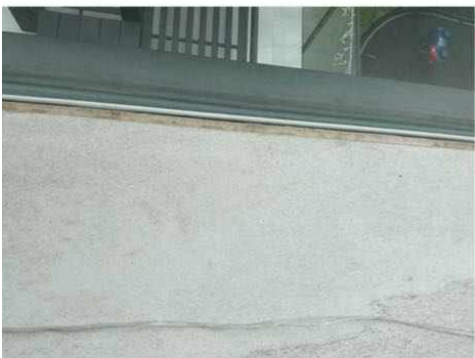
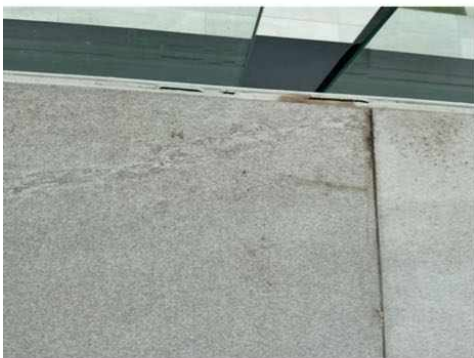
Building: Main Building
Location: Balcony > Rear
Finding: Sealant gaps - deterioration
Information: Gaps and deterioration were observed to the sealant to balcony edge junctions.

Associated moisture staining is visible to adjacent finishes below indicating water staining occurring at the balcony perimeter.

The likely causes are; Poorly applied flexible sealant, inadequate sealant to balcony edge and tile terminations.

Implications/ risks of moisture damage to substrates, soft fits and external finishes.

It is recommended a licensed water proofer or sealant technician be engaged to inspect condition and make recommendations.

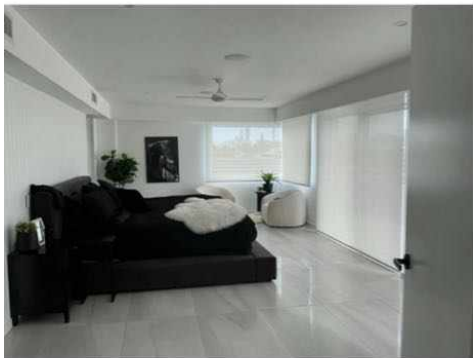
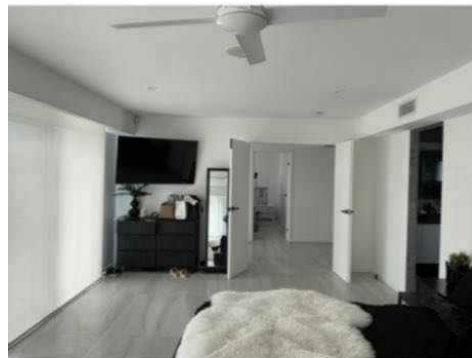
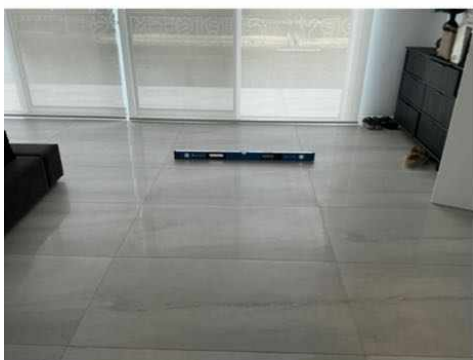
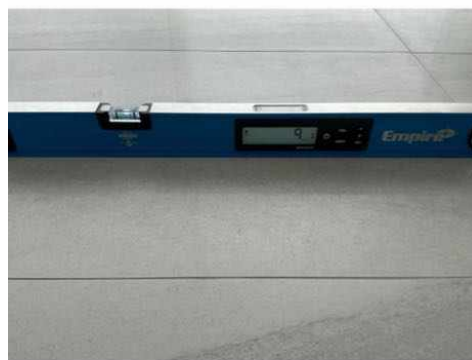
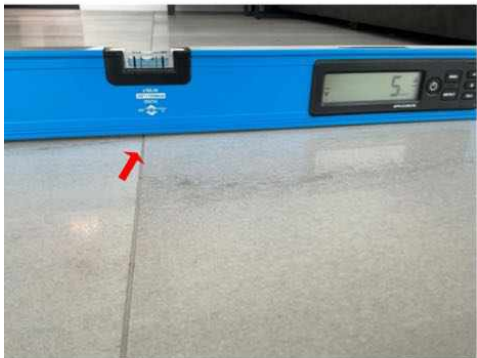
The defect is noticeable under normal lighting conditions and is evident when viewed across the floor plane.

This may indicate poor installation, affects aesthetics looks and may lead to premature cracking or debonding.

Excessive lippage visible under normal viewing conditions is not acceptable.

Rectification may be required under standards and tolerances guide.

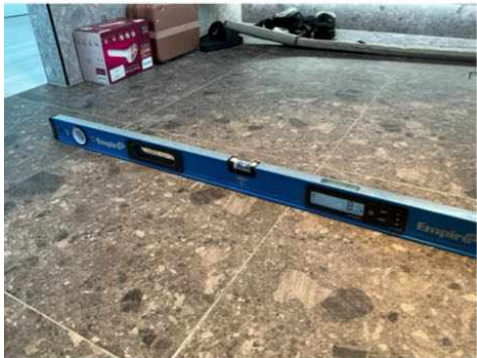
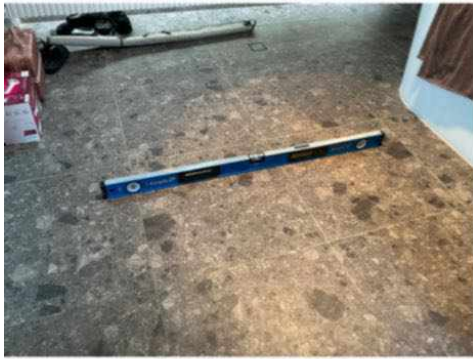
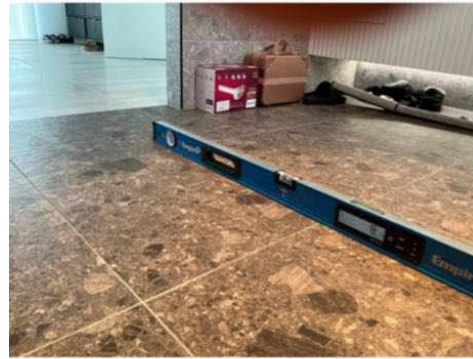
Building: Main Building
Location: Ensuite - Master > Existing
Finding: Falls in tiled floor towards - ensuite entry
Information: Under QBCC guidance, aligned with the NCC and AS 3740 (Waterproofing of domestic wet areas), ensuite floors must be constructed to direct water to the floor waste and away from doorways.

There is no tolerance for incorrect falls that compromise drainage or waterproofing performance.

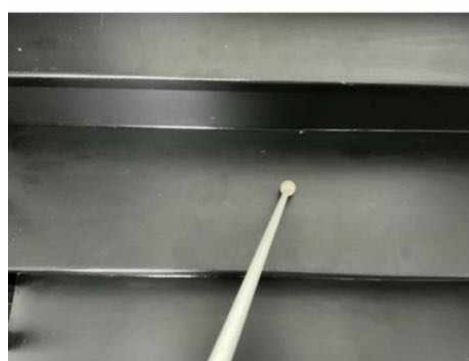
Building: Main Building
 Location: Stairs - Internal > Existing
 Finding: Stair case tread loose (going)
 Information: The internal staircase contains a loose tread (going) 3rd from top that moves under load.

Where movement is noted rectification works should be undertaken to prevent further deterioration.

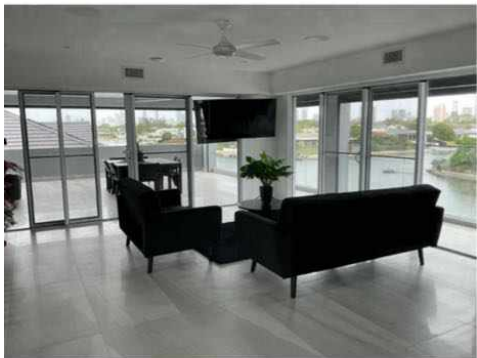
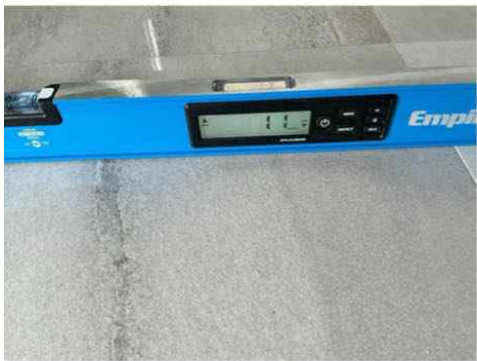
Building: Main Building
 Location: Upstairs living > Front Right
 Finding: Flooring out of level
 Information: Under the QBCC guidance which adopts the NCC and AS.3958.1 ceramic tiles, the key tolerance applied to finished tiled floor is as follows:

This is measured over finished tiled surface.

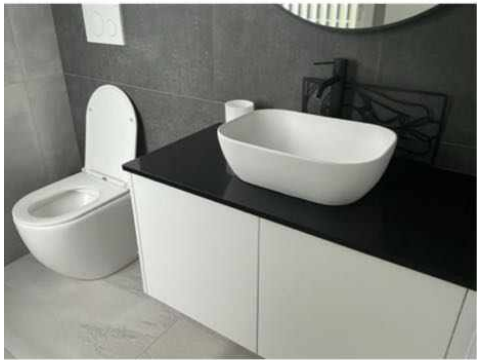
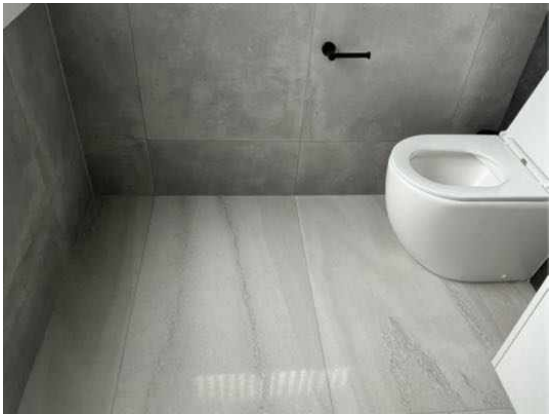
Building: Main Building
Location: Toilet (WC) > Front
Finding: Door - Binding
Information: Binding of this door is evident during standard operation. This defect inhibits the functionality of the affected door as well as creating potential for secondary defects to associated building elements, such as damage to the door jamb.

For minor causes, a qualified carpenter or general handyperson should be appointed to perform minor rectification works at client discretion.
