# Building and Timber Pest Inspection Report

Inspection Date: Fri, 6 Mar 2026

Property Address: 7 Lachlan Cres, St Georges Basin NSW  
2540, Australia

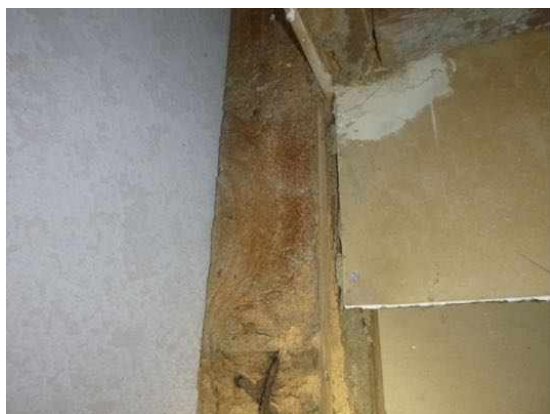
Building:	Main Building
Location:	Subfloor
Finding:	Evidence of termite workings and damage was present at the time of inspection
Information:	Despite no live termite or timber pest activity being indicated, previous termite damage was found to have affected this area.

Evidence was found at the time of inspection to suggest that termite activity has been present on the property including past workings to wall framing and panelling to the store room and subfloor below the stairs. Further damage could be evident inside the walls.

A licensed building contractor and a suitably qualified termite specialist should be appointed to provide a further invasive inspection as soon as possible.

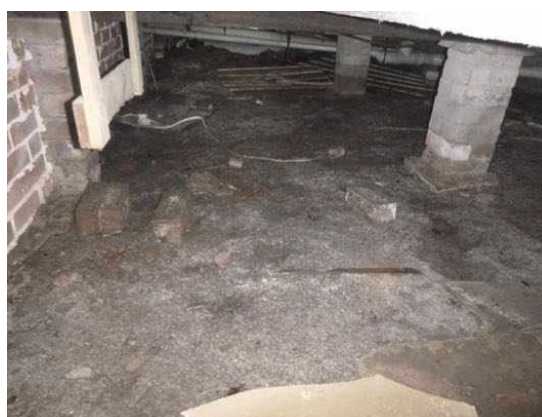
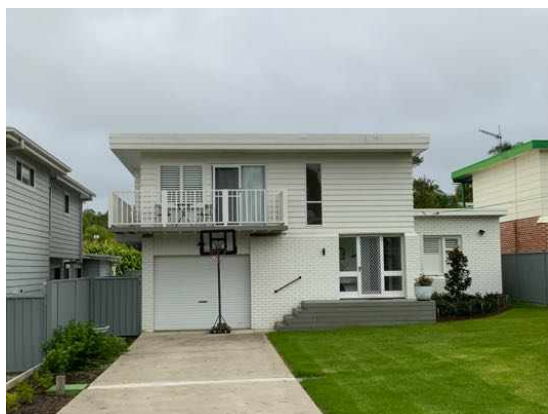
### Finding 3.01

Building: Main Building  
Location: Subfloor  
Finding: Subfloor Ventilation - Inadequate (mouldy subfloor soil to some areas)  
Information: Adequate subfloor ventilation and drainage aids in preventing excessive moisture, mouldy subsoil, wood rot and termite activity by ensuring a dry subfloor environment.

Subfloor ventilation can be improved in most cases by addressing the causes such as exposing subfloor vents, replacing access doors with a gauze or slat door, installing additional new vents (large gauze type is best- 2 bricks high x 2 bricks wide), installing mechanical (forced airflow) ventilation and removing debris & obstructions to air flow from the subfloor.

A registered builder or sub floor ventilation specialist should be appointed as soon as possible to look at improving ventilation & drainage to the perimeter of the building and to perform these works as necessary.

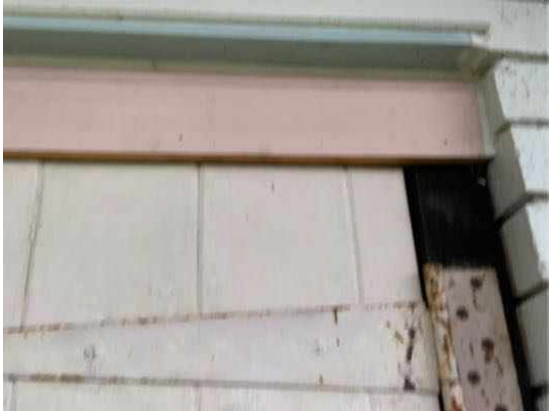
Whilst incomplete or missing paint finish is generally an appearance defect, it can also lead to the development of secondary building defects over time. Incomplete areas of

paint finish expose the area to moisture, potentially accelerating the deterioration of underlying building materials.

Incomplete paint finishes should be sanded back, filled, leveled and painted, as applicable. Where inadequate or missing paint protection has led to the deterioration of the associated building element, repair and/or replacement of this building element may be required.

A painting contractor should be appointed as soon as possible to perform necessary works to aid the appearance of the affected area and to ensure the area is protected against further deterioration. Alternatively, the homeowner following manufacturer instructions may perform these works.

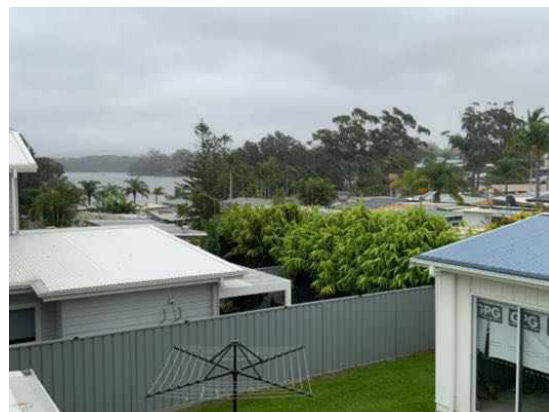
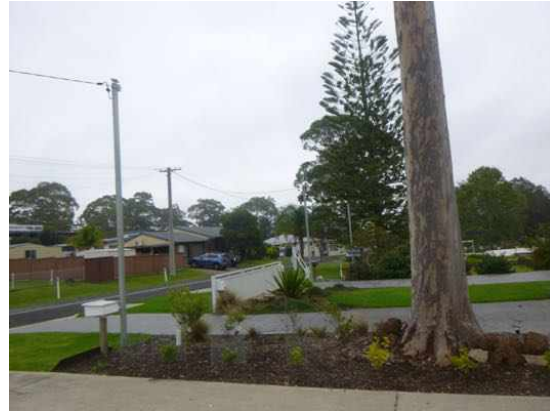
### Finding 6.06

Building:	Main Building
Location:	All Areas
Finding:	Trees within 50m of the property
Information:	Trees within 50m of the property can be conducive to termite activity. It is recommended an invasive inspection of all trees with 50m to the property be carried out by a qualified pest control expert.

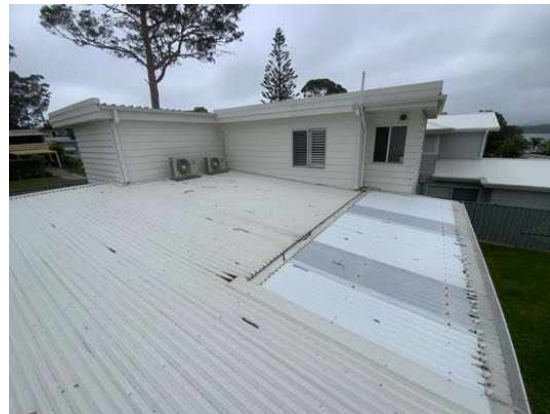
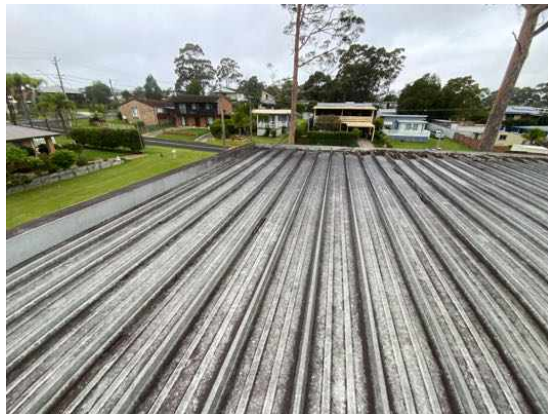
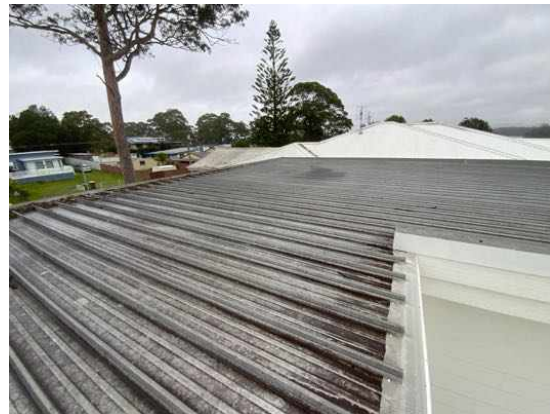
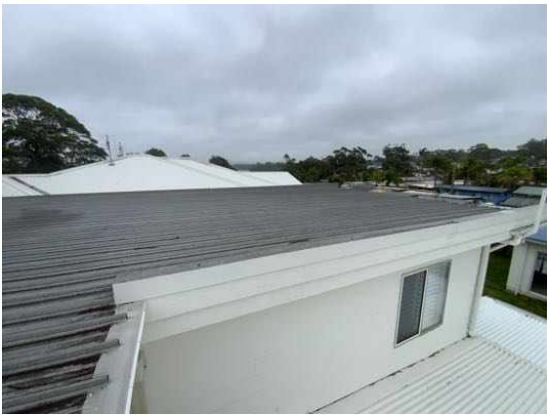
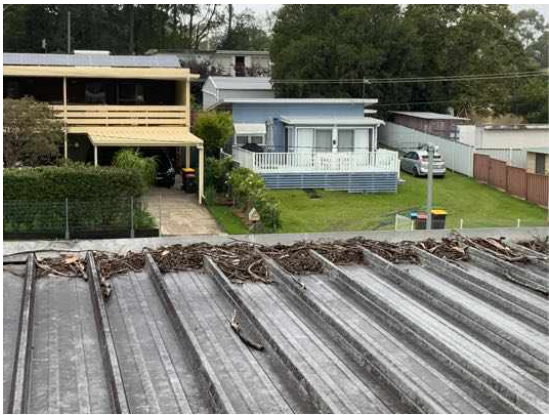
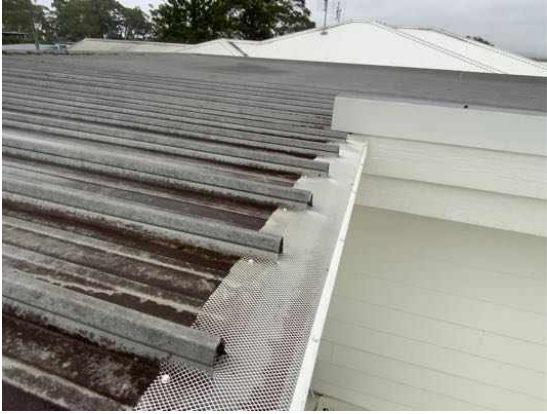
Building: Main Building  
Location: Roof Exterior  
Finding: Additional Photos - Obstructions and Limitations  
Information: These photographs are an indication of the obstructions and limitations which impeded full inspection of the property at the time of inspection. These obstructions can hide an array of defects and should be removed to allow full inspection to be carried out. A re-inspection is recommended once the areas are made accessible.

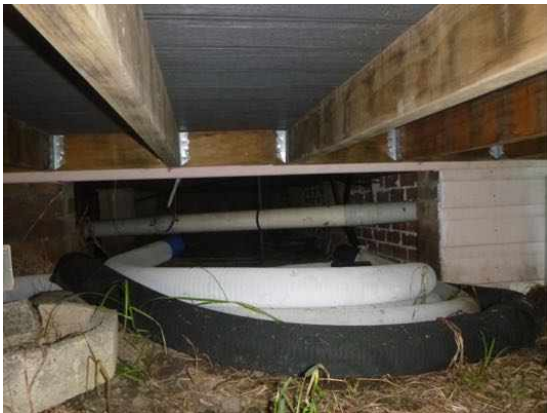
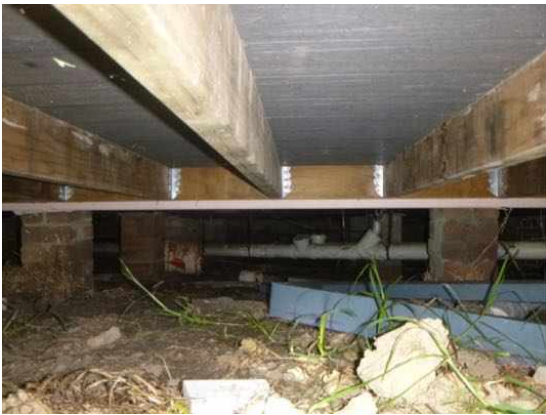
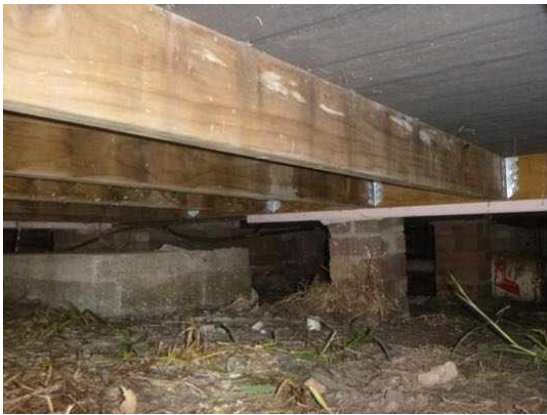
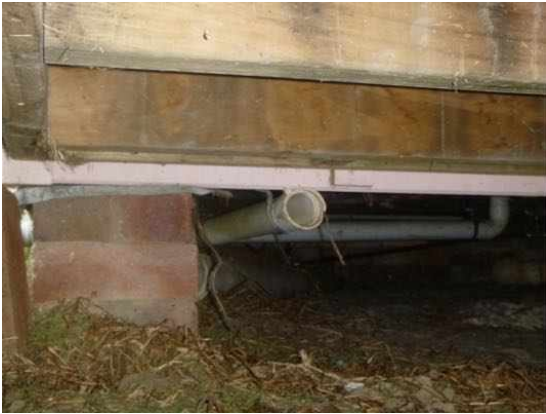
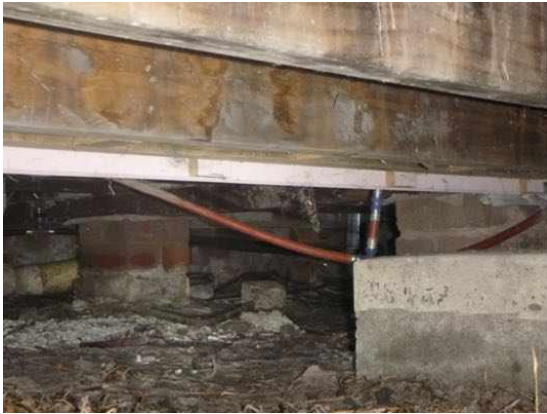
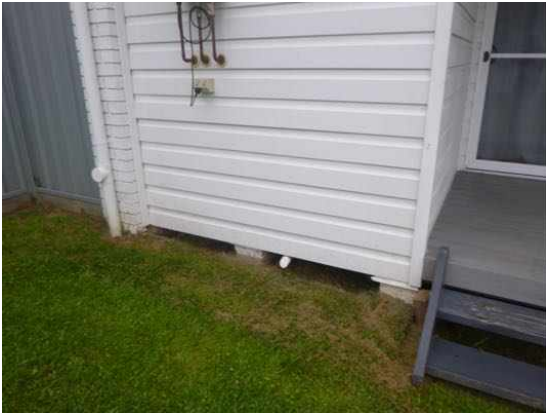
Building: Main Building  
Location: Subfloor  
Finding: Additional Photos - Obstructions and Limitations  
Information: These photographs are an indication of the obstructions and limitations which impeded full inspection of the property at the time of inspection. These obstructions can hide an array of defects and should be removed to allow full inspection to be carried out. A re-inspection is recommended once the areas are made accessible.

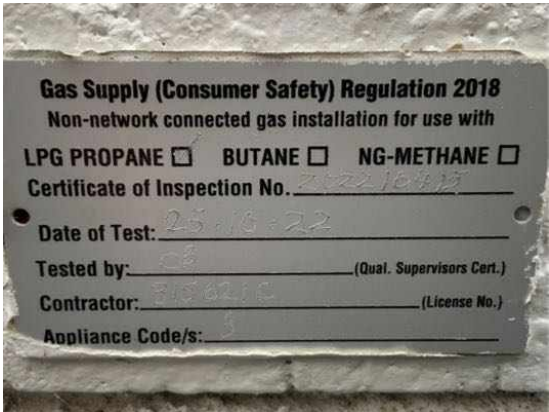
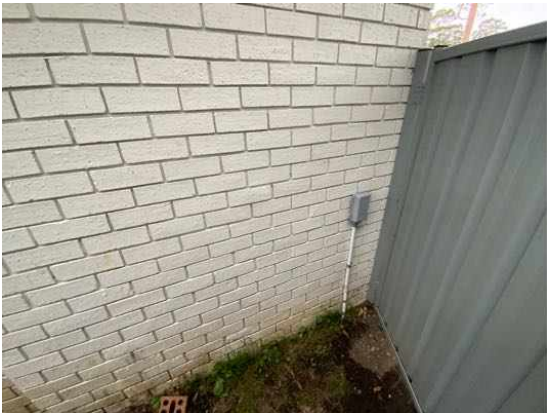
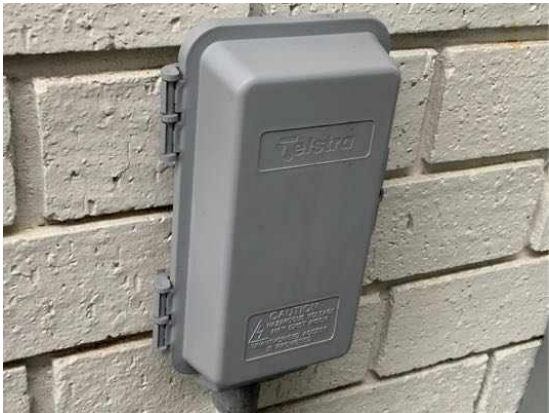
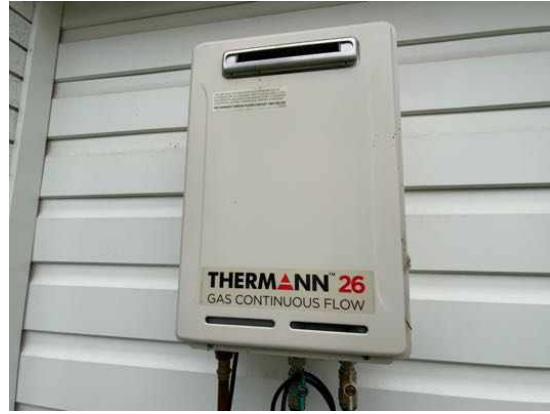
Building: Main Building  
Location: All Areas  
Finding: Additional Photos  
Information:

Additional photos are provided for your general reference. Arrows have been included to highlight areas of importance. Please discuss these photos with your building consultant for clarification.

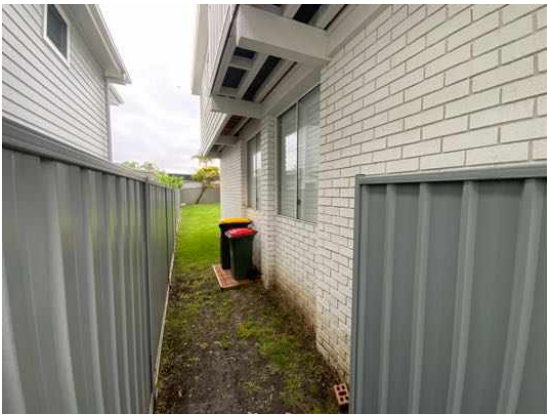
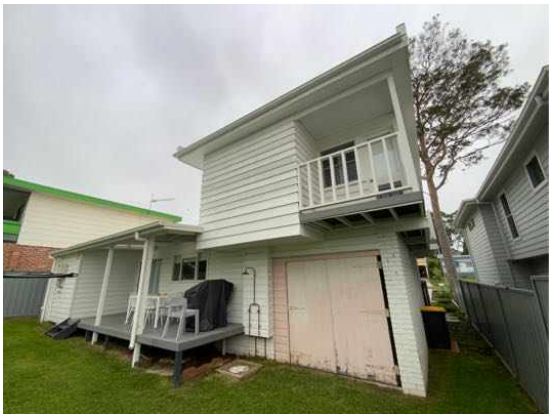
Building: Main Building  
 Location: Balcony, Deck, Verandah or Similar  
 Finding: Elevated structure inspections (Elevated Structure)  
 Information: Where any elevated Structure (deck, balcony, verandah etc) is present, and this elevated structure is designed to accommodate people, you MUST have this structure checked by an engineer or other suitably qualified person.
