Building Inspection Report

Inspection Date: Mon, 23 Feb 2026

Property Address: 1106/2 Kingfisher St, Lidcombe NSW 2141,
Australia

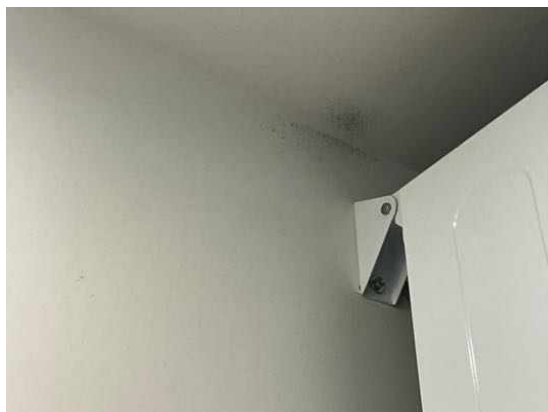
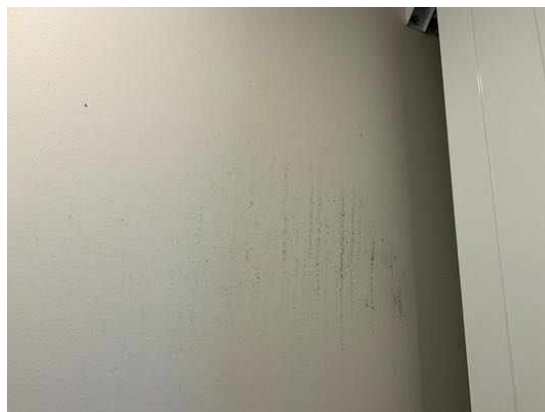
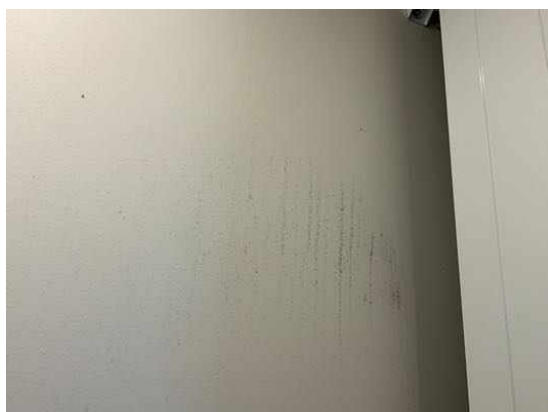
Defects 1.01

Building: Main Building
Location: Laundry
Finding: Mould - Present
Information: Mold growth is present throughout the property, primarily due to inadequate ventilation. Poor airflow and moisture accumulation within the house have created ideal conditions for mold to thrive.

- **Health Hazards**: Mold growth can pose serious health risks to occupants, particularly those with allergies, asthma, or other respiratory conditions. Prolonged exposure to mold spores can cause respiratory issues, skin irritation, and other allergic reactions.
- **Structural Damage**: Mold can degrade building materials over time, leading to rot and weakening of the structural components such as timber, drywall, and insulation, which can result in costly repairs.
- **Decreased Property Value**: The presence of mold can significantly reduce the value of the property, as it indicates underlying moisture and ventilation issues that need addressing.

A licensed mold remediation specialist should be engaged to remove the mold and treat affected areas. In addition, a ventilation expert or builder should assess and improve the house's ventilation system, possibly installing exhaust fans, vents, or mechanical ventilation systems to ensure adequate airflow and prevent future mold growth.

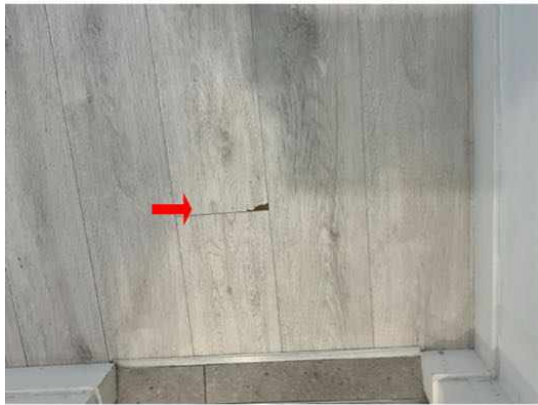
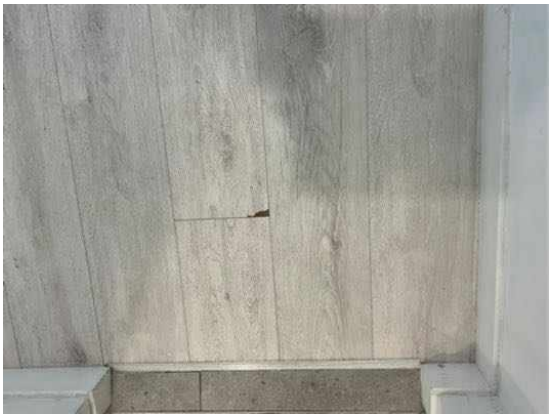
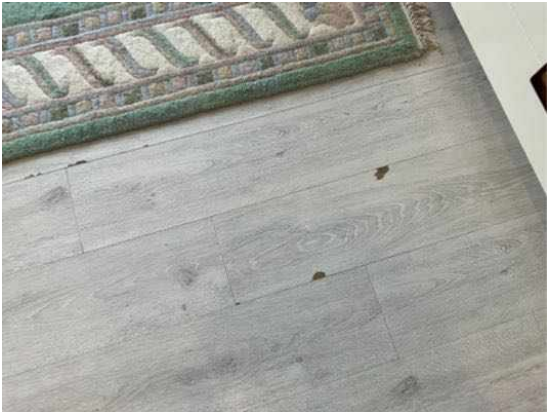
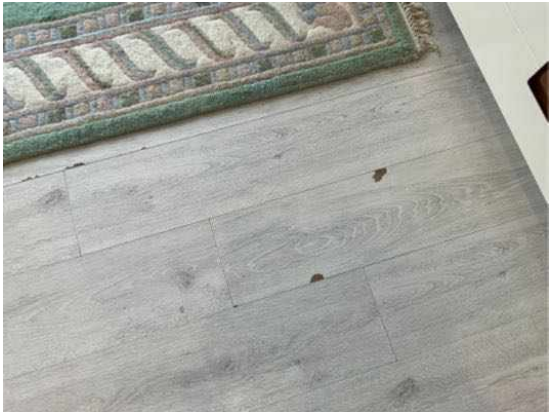
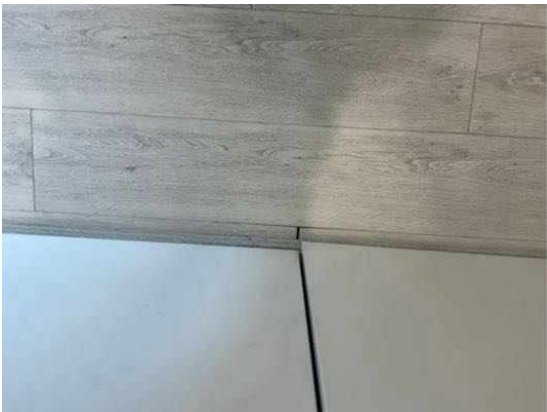
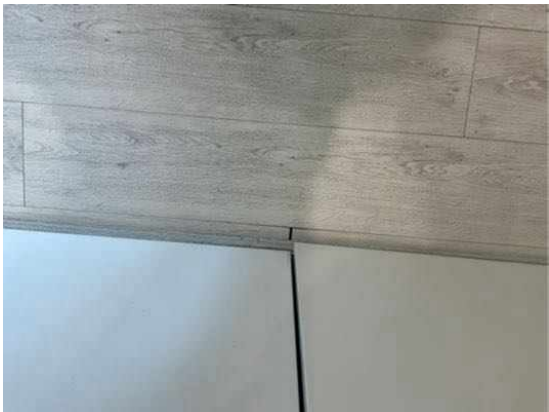
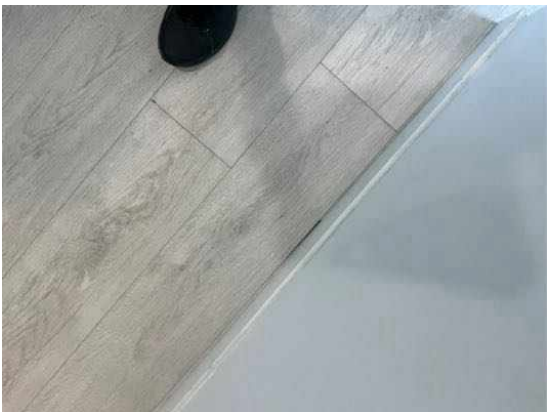
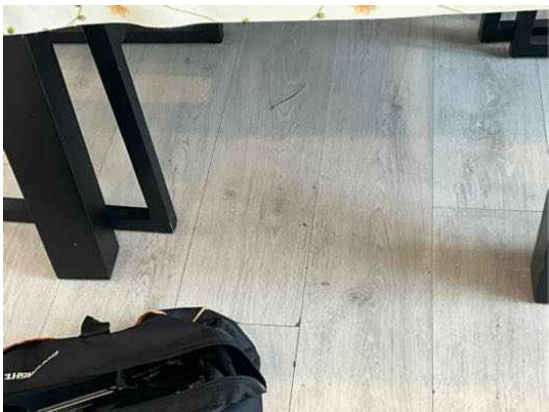
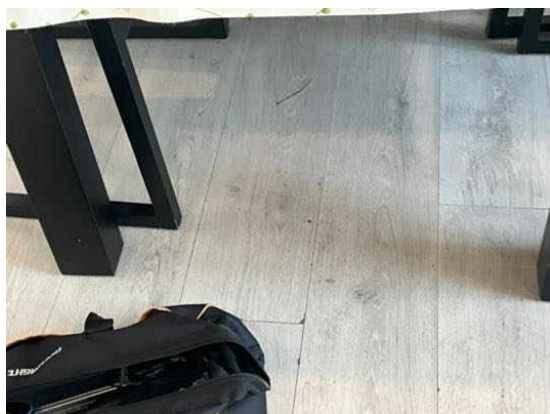
Defects 3.01

Building: Main Building
Location: All Areas
Finding: Timber Floor Damage

Information: The timber floor in the property displays visible signs of damage, including scratches, dents, or warping. This defect compromises the aesthetic appeal of the flooring and raises concerns about the long-term durability and structural integrity of the timber.

- Engage a professional flooring specialist or carpenter to assess the extent of the damage and recommend appropriate repair or restoration methods.

- Depending on the severity of the damage, options may include refinishing the surface to address minor issues or replacing damaged sections for more extensive damage.

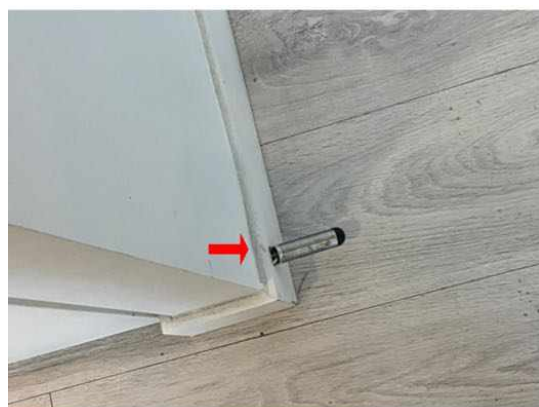
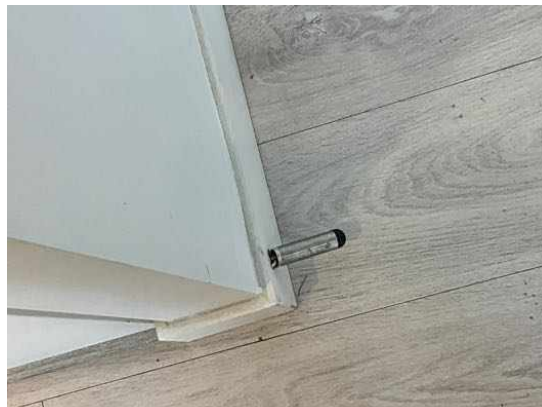
Defects 3.02

Building: Main Building
 Location: Front door
 Finding: Damaged Door Stopper
 Information: The door stopper has been damaged and detached from its original position and the stopper is no longer functioning as intended.

- Damage to Wall or Door: Without a functional door stopper, the door can swing fully open and strike the adjacent wall or skirting, potentially causing damage to the door, hinges, or wall surface.
- Trip Hazard: The loose stopper on the floor presents a minor trip hazard, especially if unnoticed.
- Safety Risk: In certain cases, the absence of a stopper may lead to finger entrapment between the door and wall.

- Handyman or Carpenter – to remove or re-secure the door stopper properly.

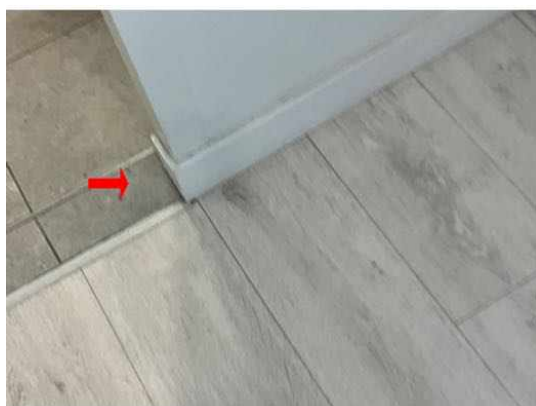
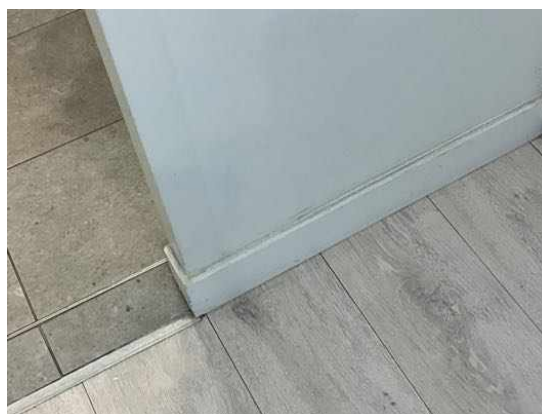
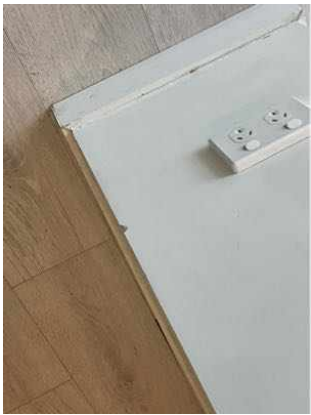
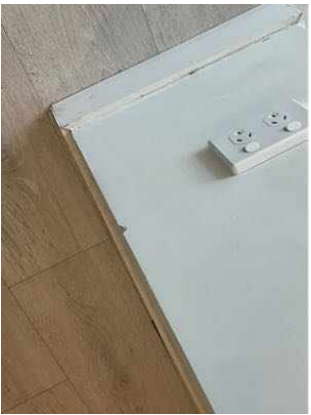
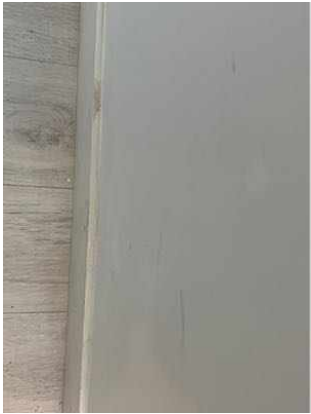
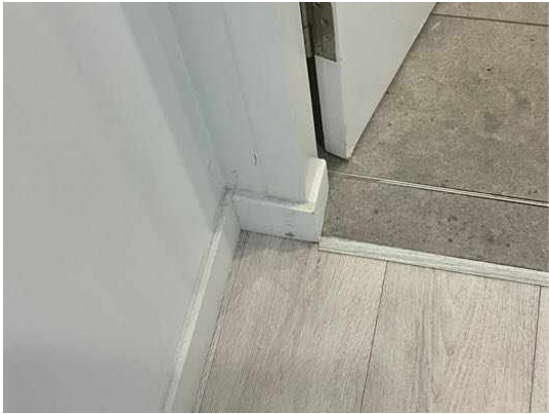
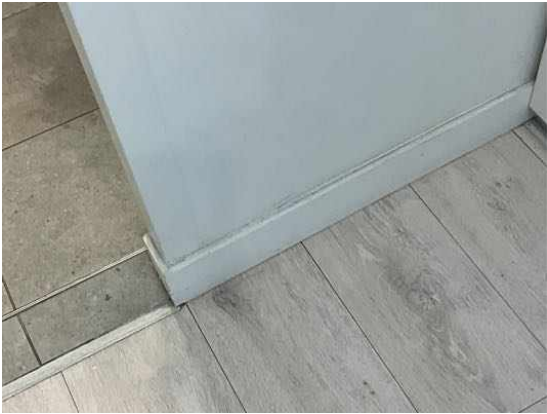
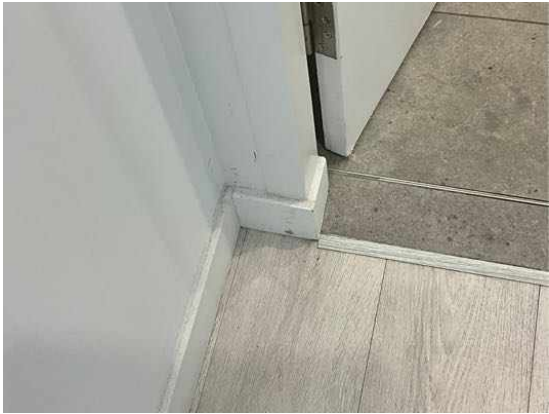
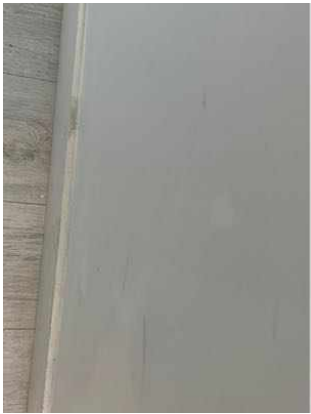
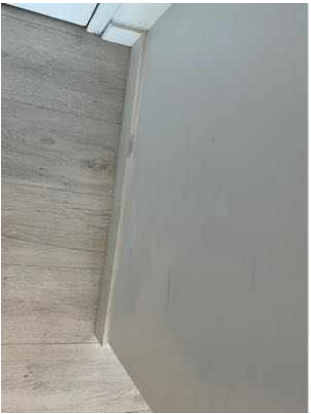
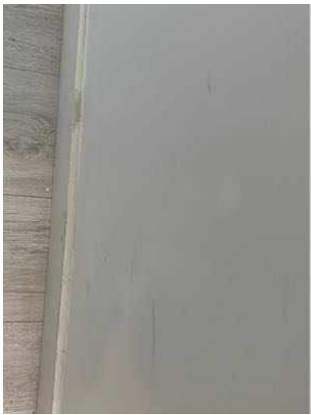
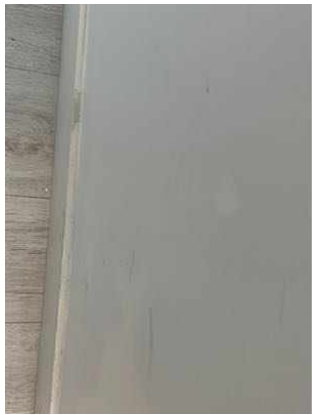
Defects 3.03

Building:	Main Building
Location:	All Areas
Finding:	Paint surface - Scratches
Information:	Scratches have been identified on the paint surface, detracting from the overall appearance and quality of the painted surface.

1. Aesthetic Degradation: Scratches mar the appearance of the painted surface, diminishing its visual appeal and potentially lowering property value.
2. Corrosion Vulnerability: Exposed areas of bare metal due to scratched paint are susceptible to corrosion, leading to structural damage and compromised durability.
3. Environmental Hazards: Scratched paint can release hazardous chemicals into the environment, posing risks to both human health and the ecosystem.

A qualified painter should address the issue promptly to repair the scratched paint. Depending on the severity of the scratches, repair options may include sanding, priming, and repainting the affected area to restore the integrity and appearance of the paint surface.

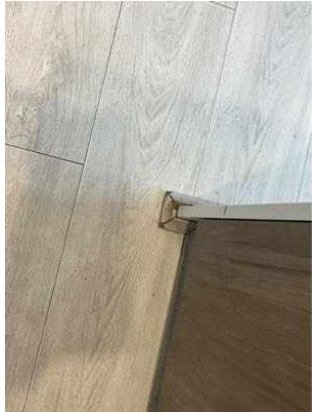
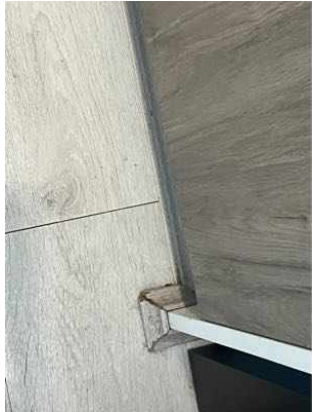
Defects 3.04

Building: Main Building
Location: Kitchen
Finding: Trim – Deteriorated
Information: Deterioration and delamination were noted to the trim, consistent with moisture exposure. Ongoing deterioration may occur if not rectified. Repair or replacement by a licensed carpenter is recommended.

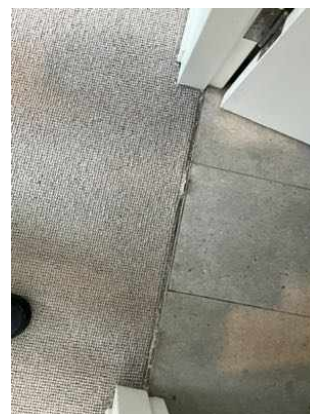
Defects 3.05

Building: Main Building
 Location: Bedroom - Master
 Finding: Carpet - Tear
 Information: Tear observed in the carpet, posing a risk of further damage and creating an unsightly appearance.”

Risk: Potential tripping hazard, accelerated wear and tear, and a negative impact on the overall aesthetics of the space.

Resolution: A carpet repair specialist or professional installer should be engaged to assess and fix the tear, ensuring a seamless and safe carpet surface.

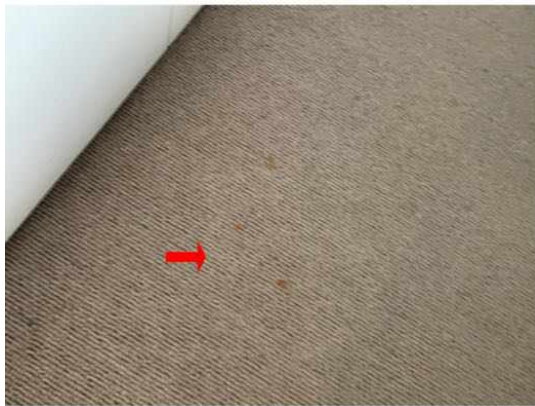
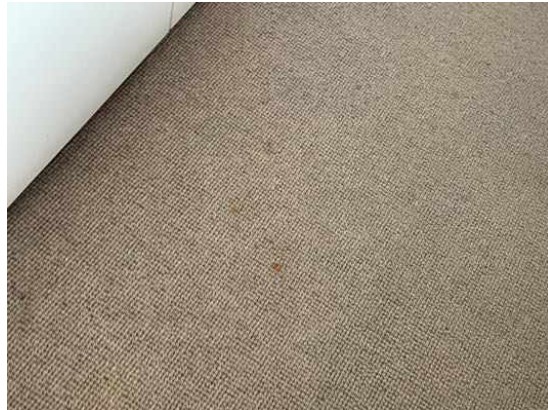
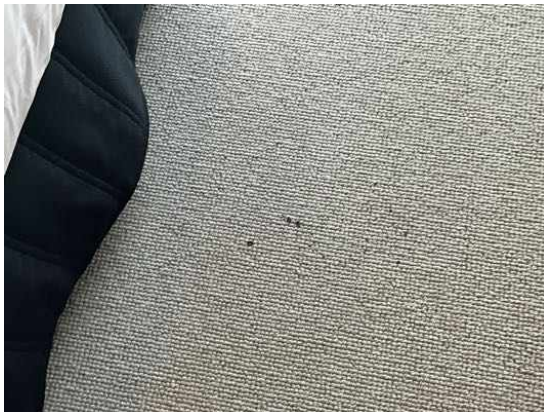
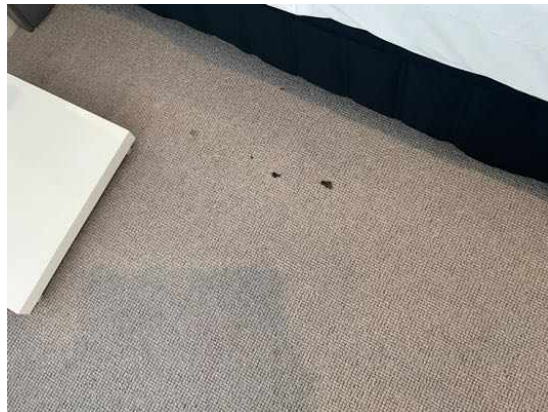
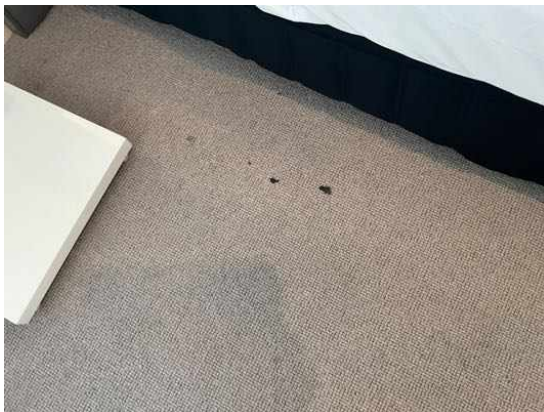
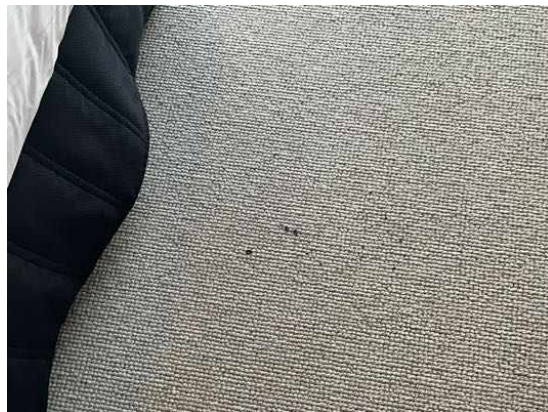
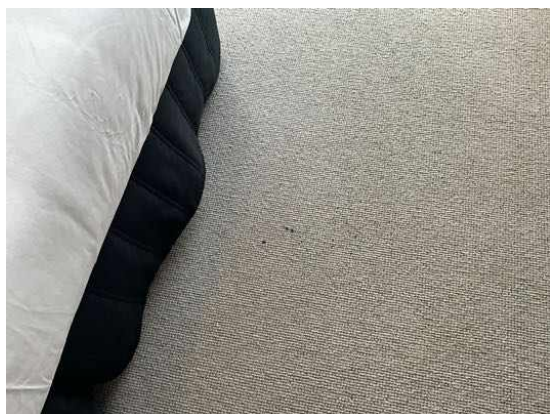
Defects 3.06

Building: Main Building
 Location: All Areas
 Finding: carpet exhibits visible signs of aging
 Information: Carpets are exhibiting visible signs of aging, including fraying edges, faded colors, and flattened fibers, diminishing their aesthetic appeal and functional quality.

The risk associated with aging carpets includes diminished appearance, decreased comfort, potential tripping hazards due to frayed edges, and a negative impact on indoor air quality if fibers begin to degrade and release particles into the air.

Professional carpet cleaning and restoration services can address issues such as deep cleaning to rejuvenate colors, repairing frayed edges, and restoring fibers. Additionally, replacing the carpets entirely may be necessary in severe cases of aging or damage beyond repair.

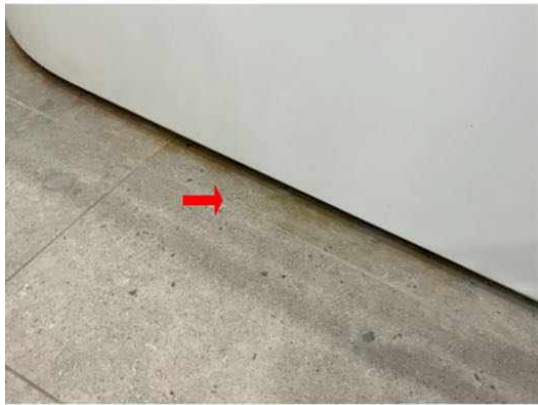
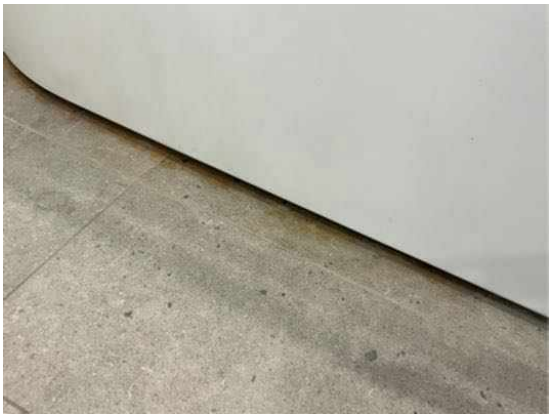
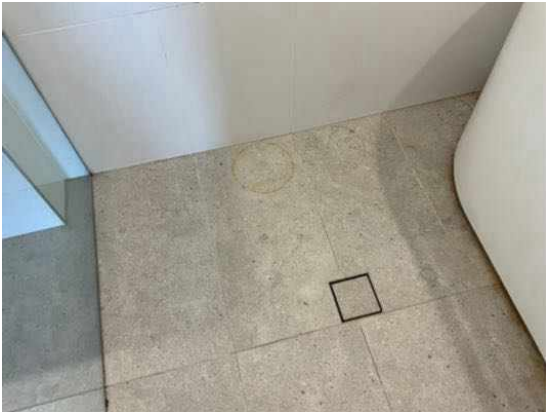
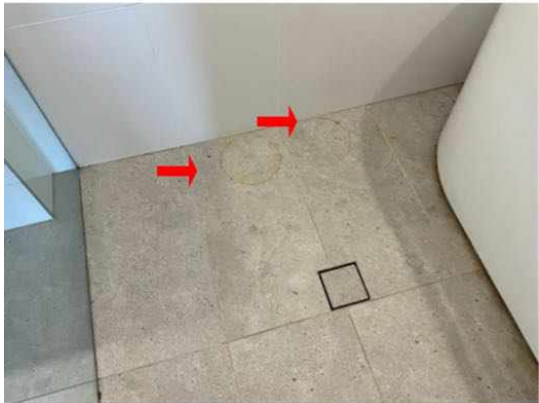
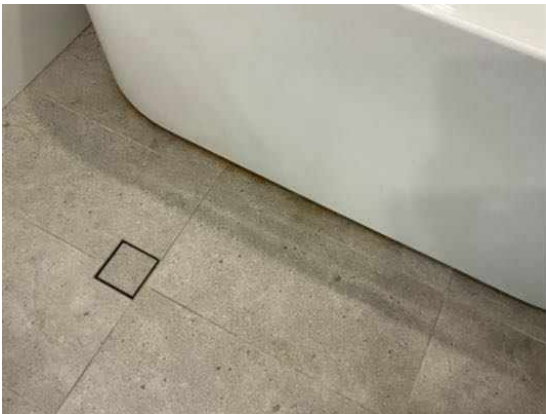
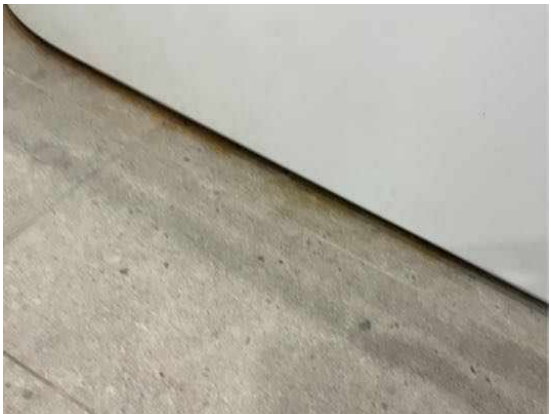
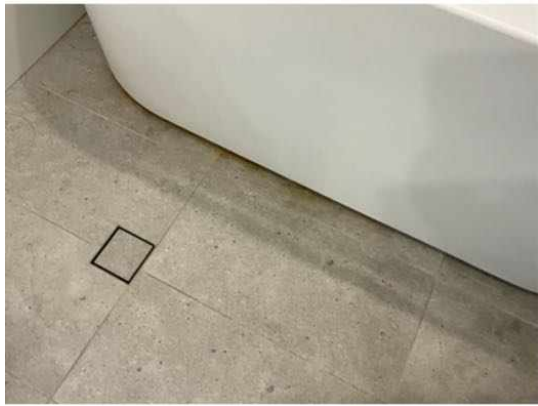
Defects 3.07

Building:	Main Building
Location:	Ensuite
Finding:	Floor tiles - stained
Information:	The floor tiles exhibits noticeable staining, which is causing aesthetic and potentially hygiene-related concerns.

1. Unsightly stains on the surface, possibly resulting from mineral deposits, rust, or other substances.
2. Stains may be difficult to remove through regular cleaning..

1. DIY Cleaning: Attempt cleaning using appropriate stain-removing products or home remedies, such as vinegar or baking soda. Follow manufacturer recommendations and exercise caution with abrasive materials to avoid damaging the basin's surface.
2. Professional Cleaning Service: Engage a professional cleaning service that specializes in surface restoration to assess and clean the stained basin thoroughly.
3. Replacement: If the stains are permanent and significantly affect the appearance, consider replacing the tiles with a new one, which may require the expertise of a tiler or a general contractor.

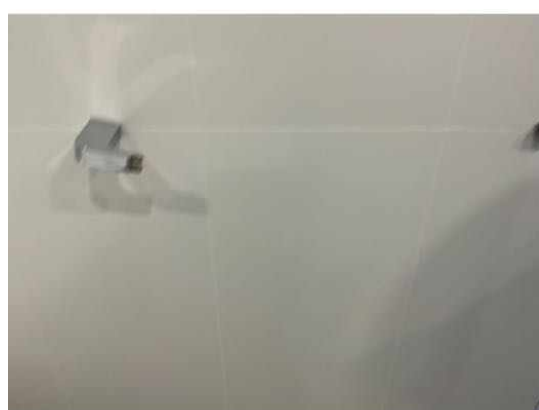
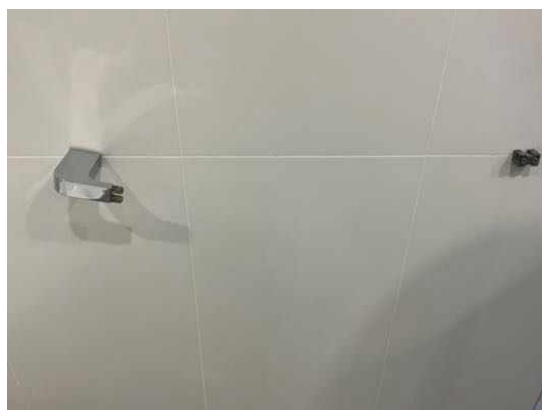
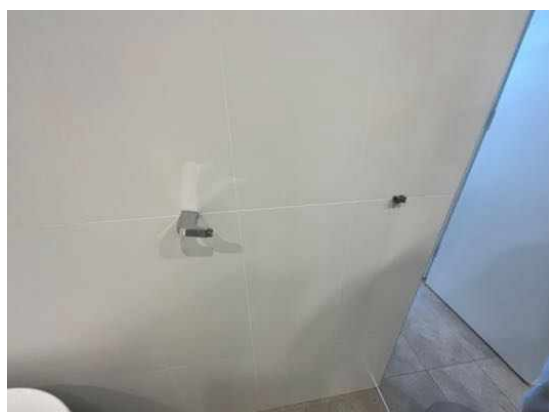
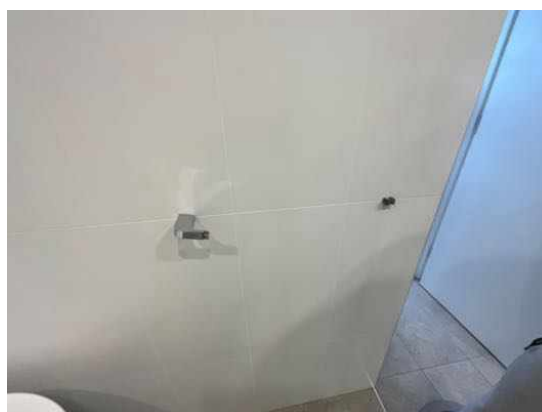
Defects 3.08

Building: Main Building
 Location: Ensuite
 Finding: Broken Towel Rail
 Information: The towel rail in the bathroom was found to be broken at the time of inspection. One mounting bracket has detached from the wall, leaving the rail unsupported and unable to function as intended. The fixing points appear to have failed, which may be due to inadequate anchoring or wear and tear over time.

The loose fitting presents a minor safety hazard, as the rail may fall or cause injury if pulled or leaned on. It is recommended that a qualified handyman re-secure or replace the towel rail and ensure appropriate wall fixings are installed to provide adequate support.

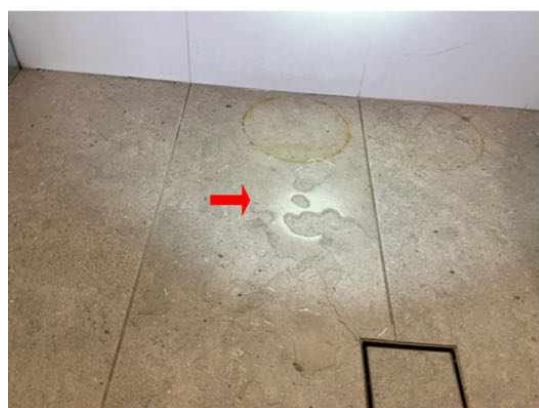
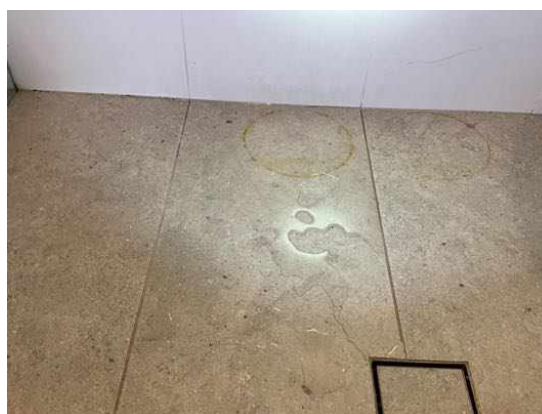
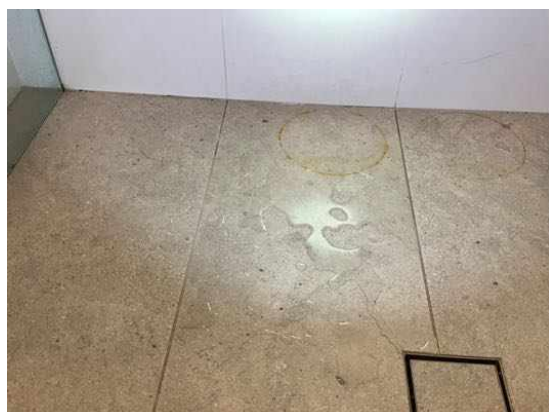
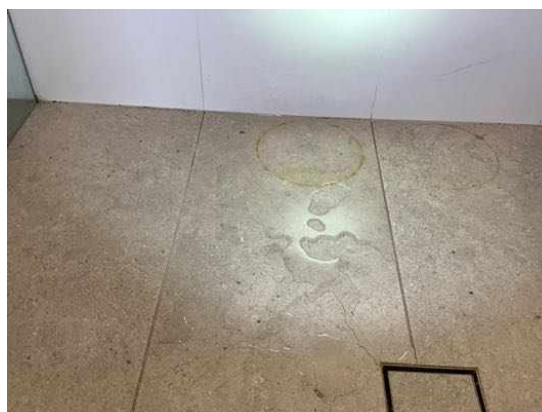
Defects 3.09

Building: Main Building
 Location: Ensuite
 Finding: Shower base - Water pooling
 Information: Evidence of water pooling around the floor waste in the shower recess was noticed at the time of inspection. It is suspected that this excessive moisture is attributed to insufficient fall in the shower floor tiles.

practices would not permit this situation to occur. Pooling water around floor wastes can create a slip hazard in extreme cases and create conditions that are conducive to mould growth over time. Where left unmanaged, the degradation of sealant and grouting is also likely to occur, possibly necessitating further repair works.

Remedial works may involve some sections of tiling and flooring repair and replacement. A tiling contractor or bathroom specialist should be appointed to provide further advice on reparation options and to perform works as necessary.

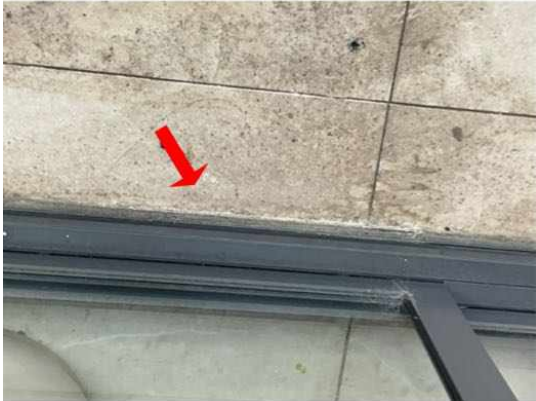
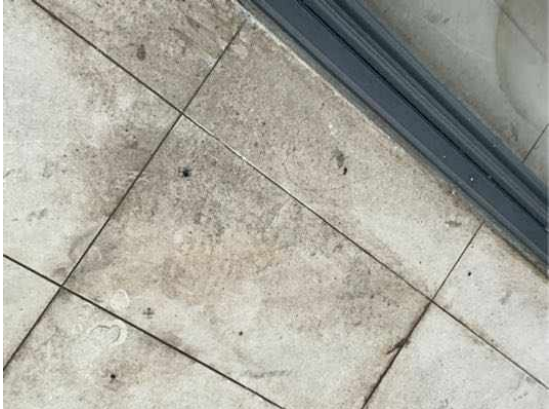
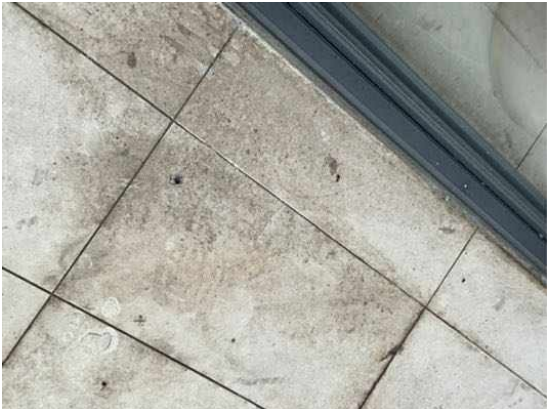
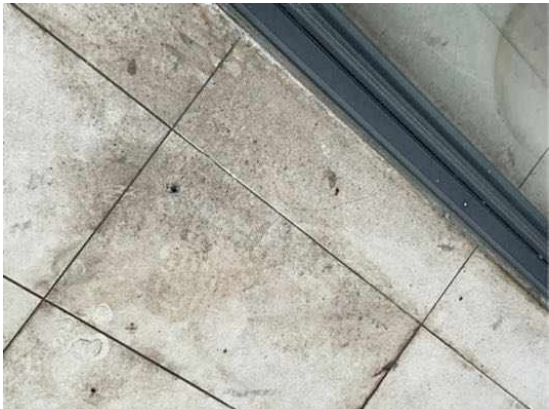
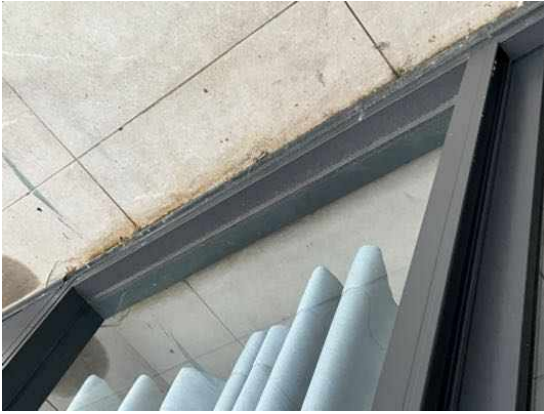
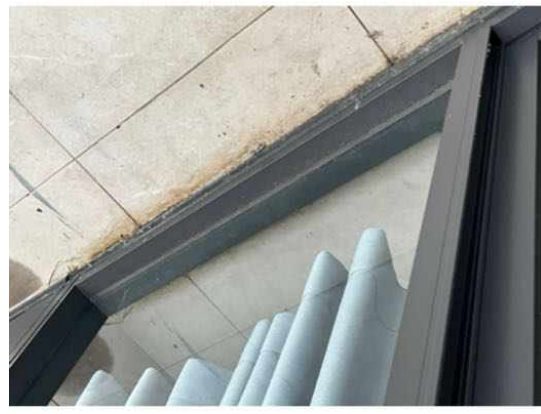
Defects 3.10

Finding: Water staining

Information: Water staining was evident in this area at the time of inspection. Water staining indicates that surfaces have been exposed to excessive moisture over time. The minerals and other elements in the water lead to staining, which may graduate to corrosion and deterioration if left unmanaged.

While mostly an appearance defect, water staining can be indicative of more serious defects, which may be currently concealed by other building elements.

Where water staining is active, a licensed plumber must be consulted to identify the cause of the staining and to provide advice on any reparation works that may be

required. Replacement of any broken or damaged structures is advised.

Conversely, where water staining is old and inactive, affected building materials may be repaired or replaced at client discretion. A qualified carpenter or registered builder may be appointed to perform these works.

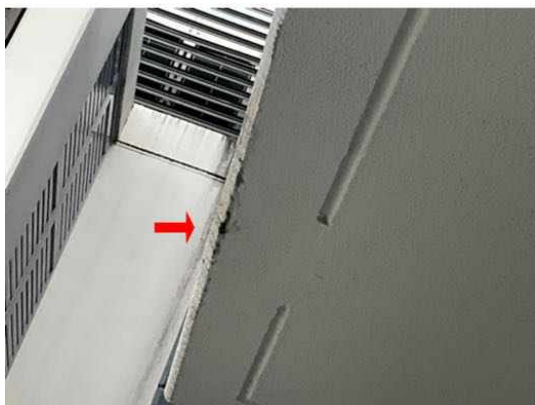
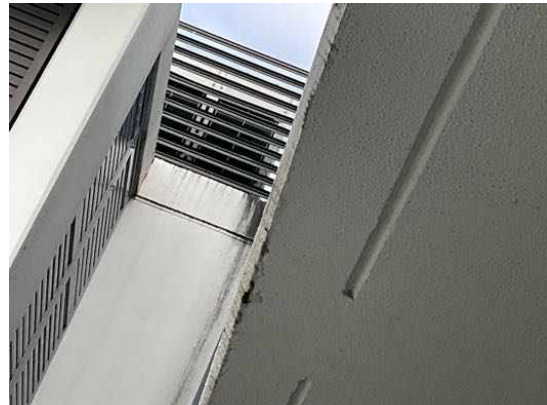
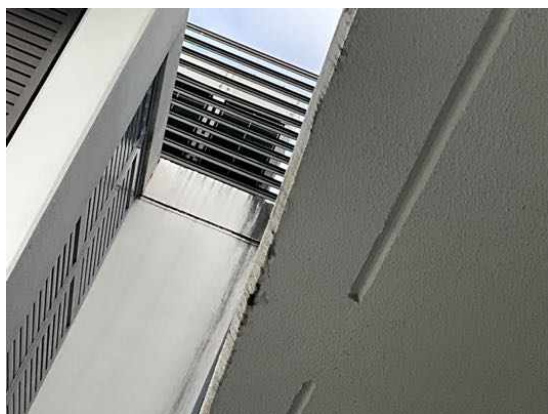
Defects 3.11

Finding: Soffit- Water stained

Information: Water staining to Soffit in this area was evident at the time of inspection. Water staining indicates that surfaces have been exposed to excessive moisture over time. The minerals and other elements in the water lead to staining, which may graduate to corrosion and deterioration if left unmanaged.

While mostly an appearance defect, water staining can be indicative of more serious defects, which may be currently concealed by interior ceilings.

Where water staining is active, a licensed plumber must be consulted to identify the cause of the staining and to provide advice on any reparation works that may be required. Replacement of any damaged structures is advised.

Conversely, where water staining is old and inactive, affected building materials may be repaired or replaced at client discretion.

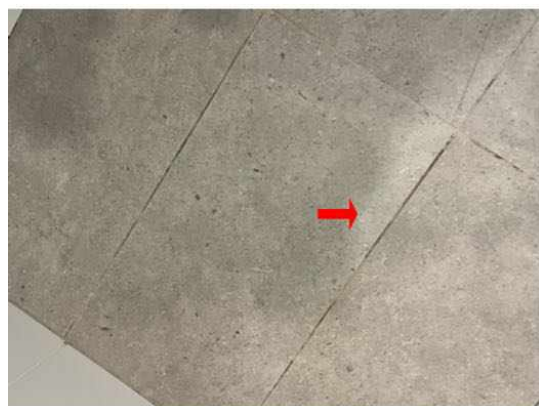
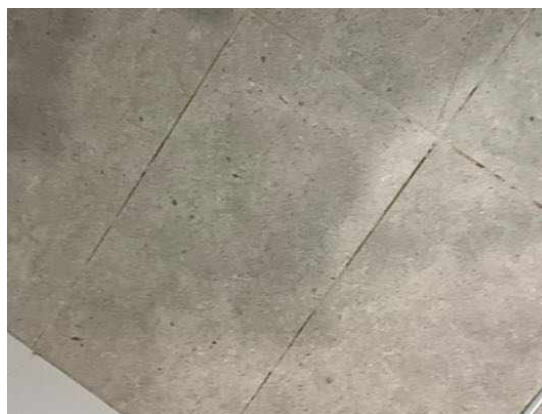
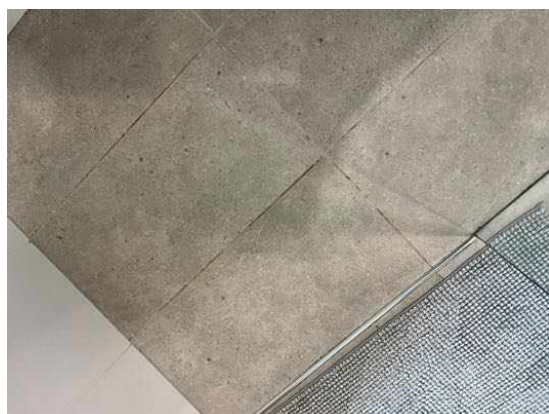
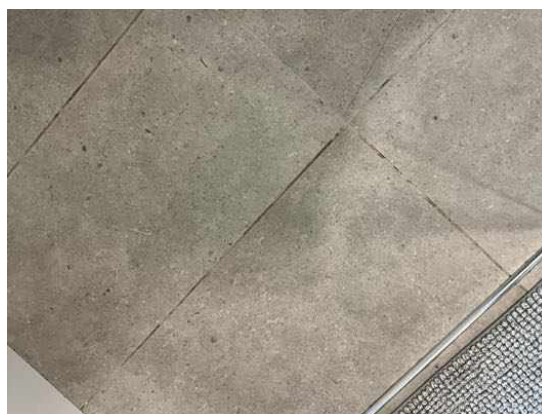
Defects 3.12

Building:	Main Building
Location:	Ensuite - Other
Finding:	Sealant and grouting - Missing or damaged
Information:	It was noted on inspection that sealant or grout is degraded to the tiled shower alcove and or other areas of the bathroom.

Different materials and floor areas move at different rates, generally causing cracking to grout or sealant at this point. A flexible sealant is required to allow for expected expansion and contraction, while keeping the joint water tight and protective of all associated building materials.

There appears to be excessive mould to the sealant and grout which will likely require scraping out and replacement.

Flexible and mould resistant materials should be applied to affected areas to prevent any subsequent water damage that is likely to occur. Regular maintenance and replacement of damage or missing or damaged sealant and grout is highly recommended to the wet areas, as this is a regular wear and tear defect. Sealant and grouting in areas that come into regular contact with water should be maintained for the long term care of your property.

A sealant specialist or tiling contractor should be appointed to complete these works as soon as possible

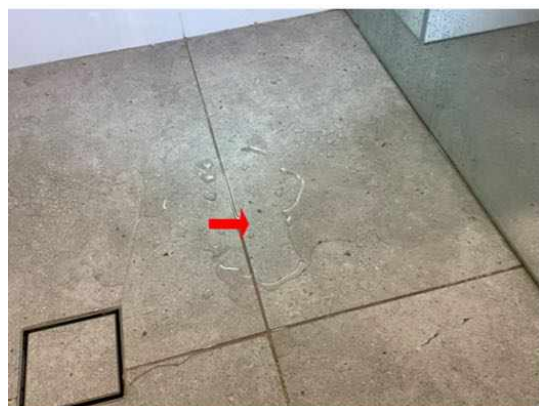
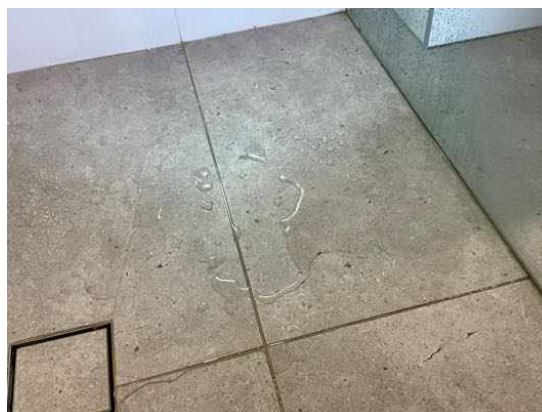
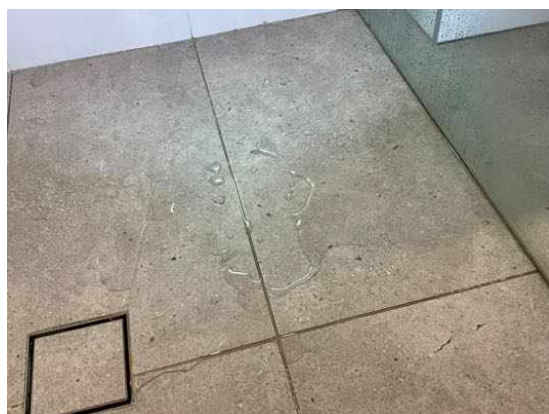
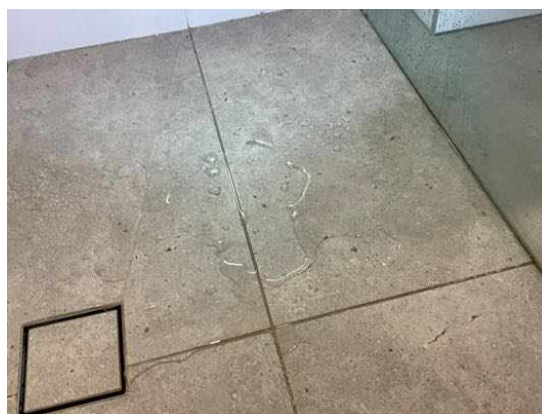
Defects 3.13

Building:	Main Building
Location:	Ensuite - Other
Finding:	Shower base - Water pooling
Information:	Evidence of water pooling around the floor waste in the shower recess was noticed at the time of inspection. It is suspected that this excessive moisture is attributed to insufficient fall in the shower floor tiles.

This pooling is minor overall but is still considered unsatisfactory, as standard tiling practices would not permit this situation to occur. Pooling water around floor wastes can create a slip hazard in extreme cases and create conditions that are conducive to mould growth over time. Where left unmanaged, the degradation of sealant and grouting is also likely to occur, possibly necessitating further repair works.

Remedial works may involve some sections of tiling and flooring repair and replacement. A tiling contractor or bathroom specialist should be appointed to provide further advice on reparation options and to perform works as necessary.

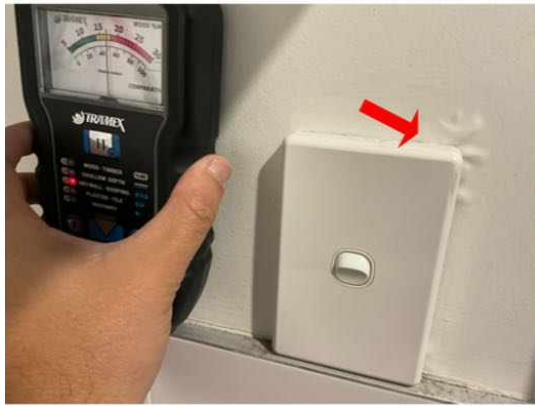
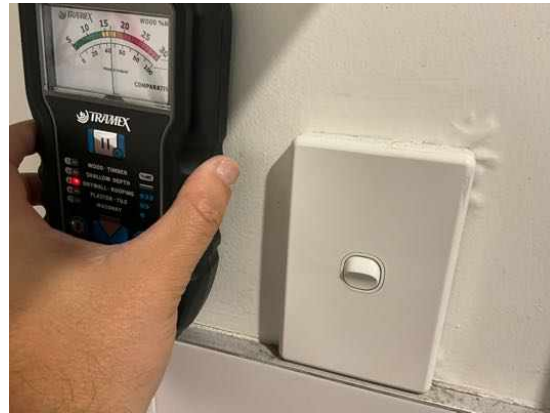
Defects 3.14

Information: A visible paint bubble (or blister) was identified on the surface. The deformation appears as a raised area in the paint film, typically resulting from adhesion failure between the paint and substrate, possibly due to moisture, poor surface preparation, or incompatible paint layers.

As per AS 4349.1-2007, this is considered a minor defect. However, if moisture is the cause, it may indicate an underlying issue such as water ingress or high humidity, which could worsen over time and lead to mould growth or plasterboard deterioration if left unattended.

Minor Defect — unless associated with active moisture ingress, in which case it may be upgraded depending on extent and cause.

A licensed painter or plasterer should assess the cause of the blister. If moisture is present, the source must be identified and rectified before repairs. Once dry, the affected area should be scraped back, sealed, patched, and repainted. Further investigation may be required if there is suspicion of plumbing or roofing leaks above the ceiling.
