Building Inspection Report

Inspection Date: Thu, 19 Feb 2026

Property Address: 41 Bonanza Rd, Beaumaris VIC 3193,
Australia

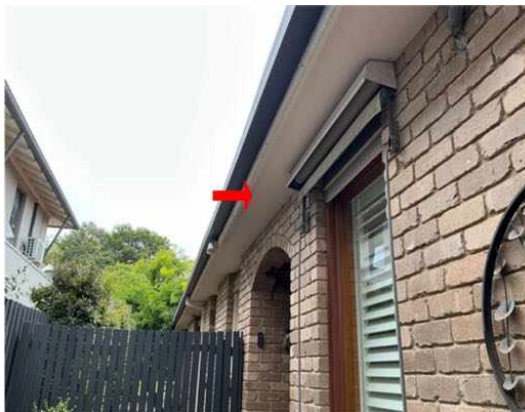
Defects 1.01

Building:	Main Building
Location:	Eaves
Finding:	Asbestos - Suspected ACM Identified on Site
Information:	Reporting on Asbestos is outside the Scope of this Report. This suspected defect is highlighted as a caution only. We suspect, based on our experience in the building industry, that there is a higher risk of the identified building element containing asbestos.

As Asbestos Reporting is outside the scope of this report, we advise that you consider a separate Asbestos Inspection and Condition Audit, which can include the taking of samples for definitive confirmation of the presence of Asbestos.

In the interim, the client is advised to act with caution, especially when considering any damage to building materials general wear and tear renovations extensions demolition and general maintenance activities due to the suspected presence of Asbestos.

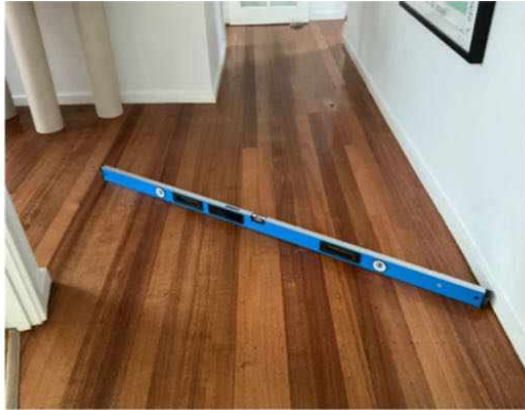
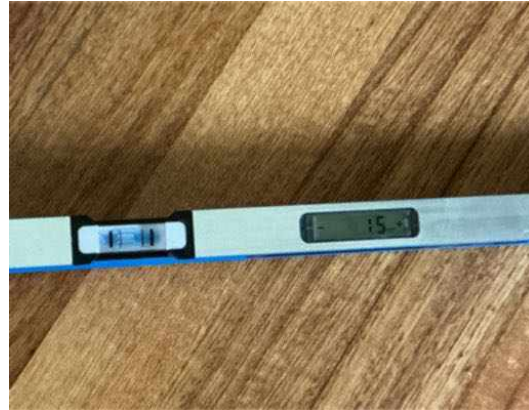
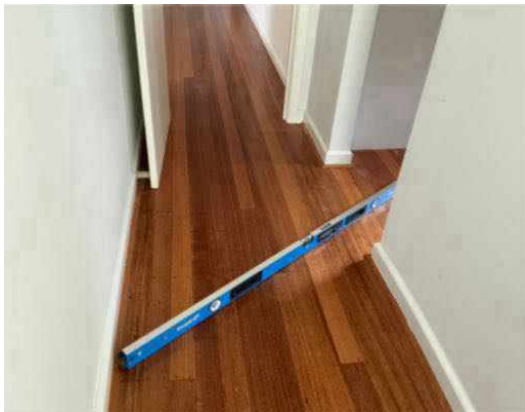
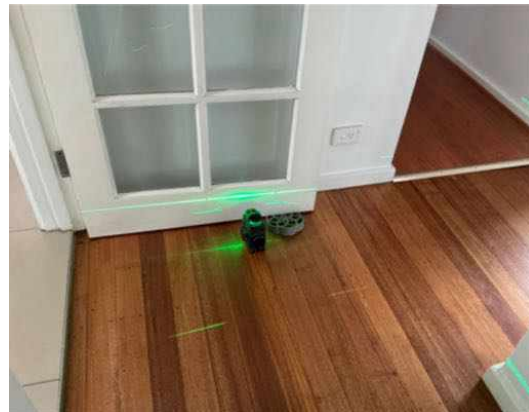
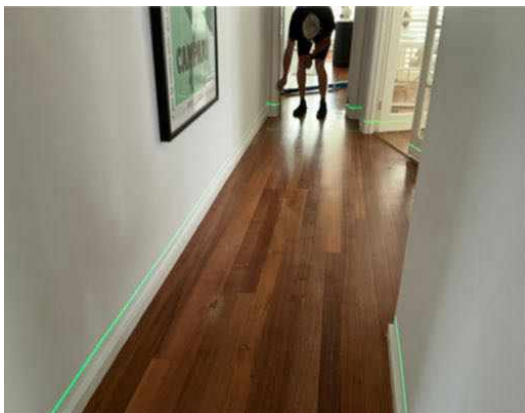
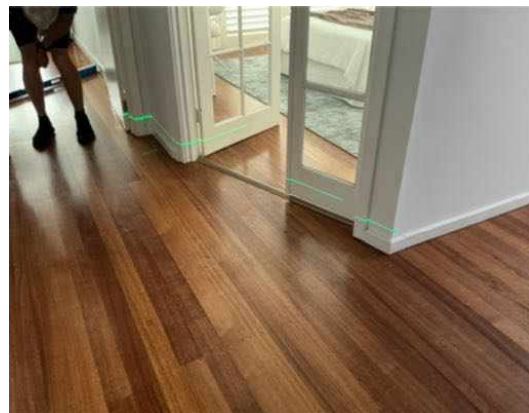
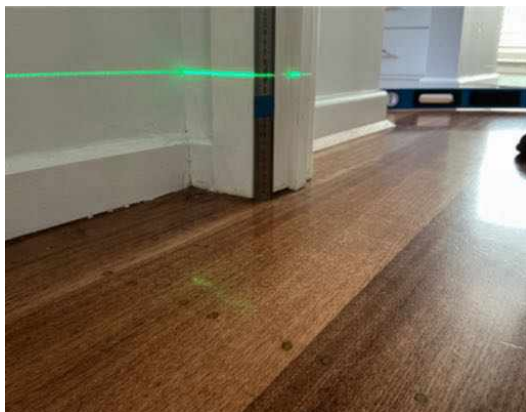
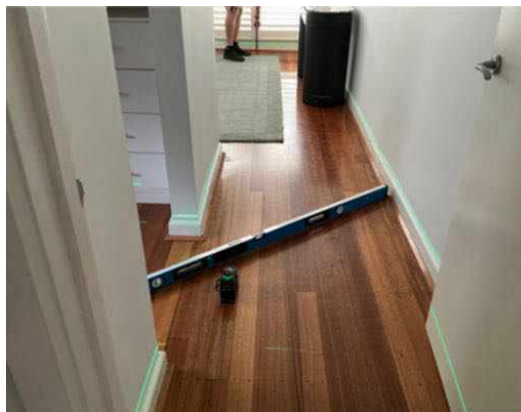
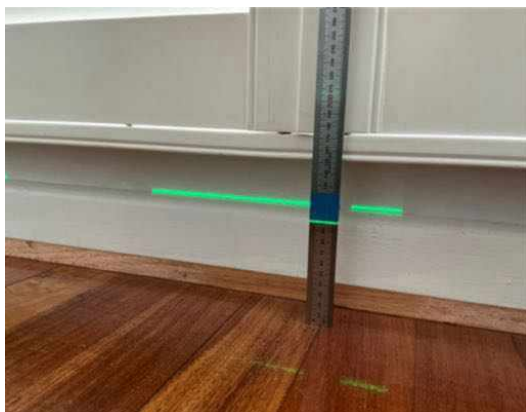
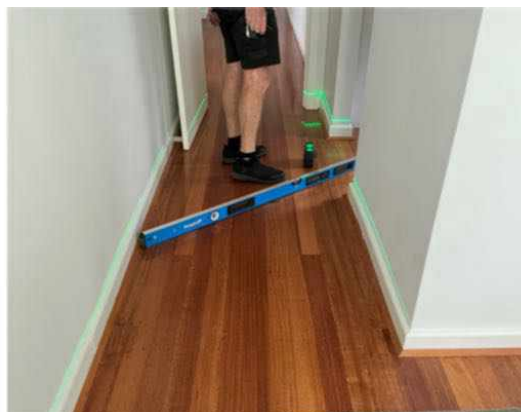
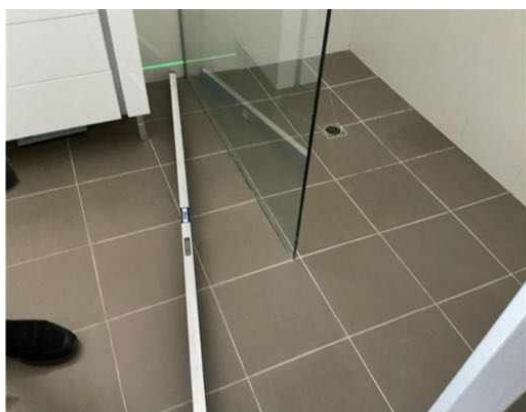
Defects 2.01

Building:	Main Building
Location:	All Areas
Finding:	Flooring - Uneven
Information:	The internal flooring in this area is out of level and uneven. Uneven flooring is likely to indicate minor defects such as expected movement of the foundations of the property, but may also indicate subsidence of the associated subfloor stumps.

It is advised that the flooring be closely monitored to identify any further movement. Where flooring remains relatively unchanged for an extended period of time (i.e. several months), it is likely that this defect has been caused by expected movement of the foundations of the property.

However, where flooring is uneven further, potentially invasive inspection of the subfloor structures and stumps in this area is required. In this case, works to repair are likely to be required, and would be carried out by a registered builder specialising in re-stumping.

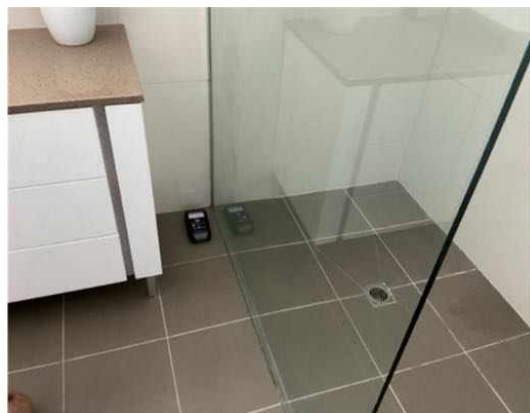
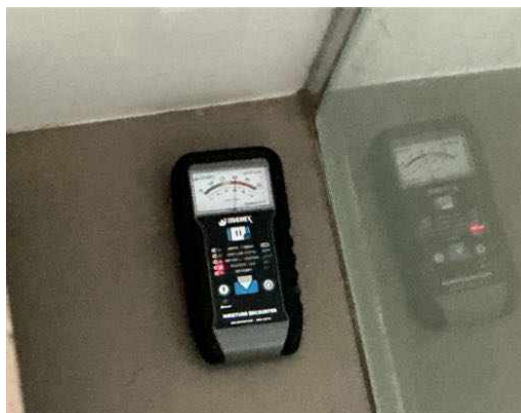
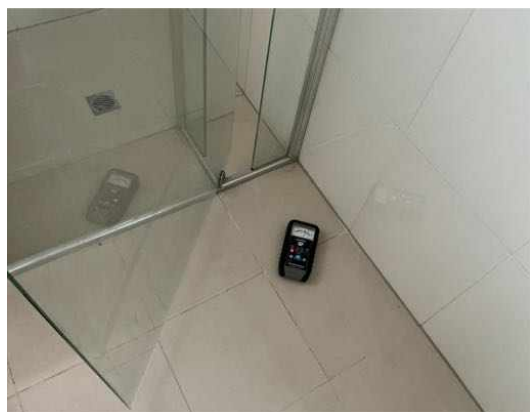
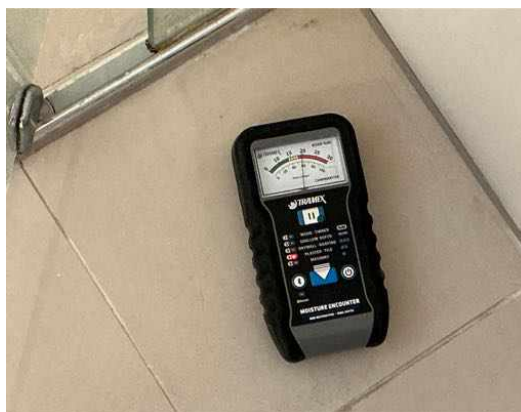
Defects 2.02

Building:	Main Building
Location:	Bathrooms
Finding:	Showers - Leaking
Information:	Leaking was evident to the shower area at the time of inspection as shown in photos with the moisture meter. It is suspected that the leaking has occurred as a result of general ageing of the building elements.

Leaking from the shower base, where left unattended, is likely to lead to water damage to adjoining flooring and walls. Leaking can lead to water damage and necessitate extensive remedial works being required. Active water leaks may also create an environment that is susceptible to the formation and development of mould.

2. Excess moisture around the showers.

Works to re waterproof and re tile the bathroom and ensuite may be required in the short term as excess moisture was found to tiling outside the shower area suggesting leaking of the shower. Further investigation of the bathroom is necessary to determine the cause and quantify the damage and rectifications.

Appointment of a tiling contractor is required to replace the shower the bathroom waterproofing and tiling. Such works should be performed as soon as possible to ensure that no further damage occurs.

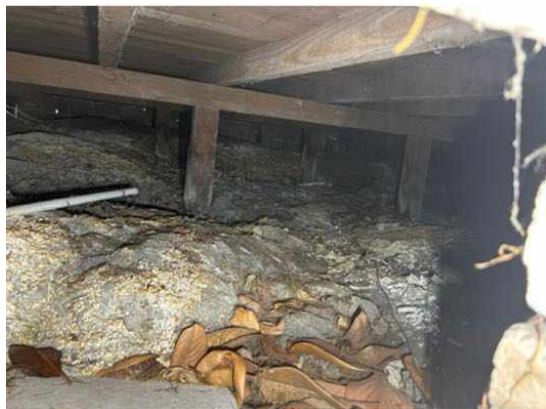
Defects 2.03

Building:	Main Building
Location:	All Areas
Finding:	Timber stumps - Suspected deterioration
Information:	It was noted that the property has timber stumps. Inspection of the condition of the timber stumps - below the surface of the ground - is excluded from the scope of this report. However, it is suspected that several timber stumps are deteriorating, evidenced by secondary defects such as uneven flooring, visually-observable subsidence or major cracking within the property. Even without these secondary defects, deteriorated stumps may still be present.

Where timber stumps are failing, a high degree of maintenance or even replacement of stumps may be required in the short- to medium-term future. It is probable that there is some degree of wood rot or deterioration beginning to occur in areas that are currently inaccessible for inspection. Timber stumps are no longer used in current building practices due to their susceptibility to wood rot and deterioration over a prolonged period of time.

The client should be prepared that in purchasing a property with timber stumps, that the need to restump the property in the short- to medium-term future is highly likely, which involves expensive works.

1. Timber stumps to the front original part of the house

Timber stumps are no longer used in current building practices due to their propensity to rot in the ground, they have a lifespan of around 50. Uneven flooring, door gaps and bouncy floors were also found suggesting structural movement which may require some re stumping works. Further inspection by a registered builder specialising in Restumping is required in order to ascertain and quote on works required in order to stabilise

A registered builder specialising in re-stumping may be appointed to provide a more invasive inspection of the timber stumps and provide estimates on any works that may be required.

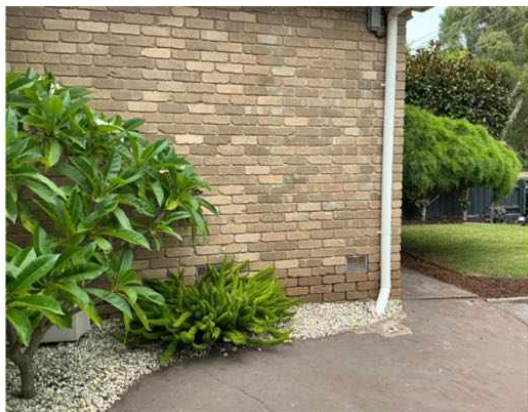
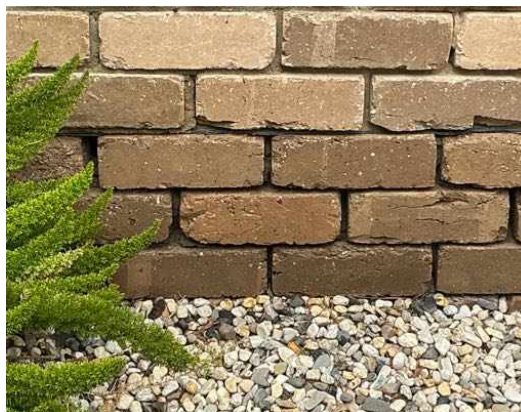
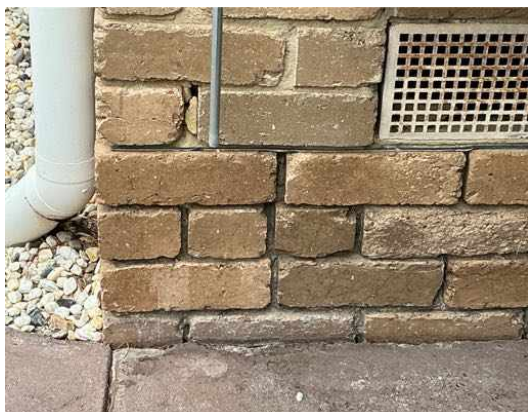
Defects 3.01

Building:	Main Building
Location:	All Areas
Finding:	Brickwork - Deteriorated mortar
Information:	Mortar, or 'bedding', is the material which fills joins and intersections between bricks in masonry walls and structures. Sections of mortar in this brickwork were identified as having deteriorated, which is generally expected for a property of this age and condition.

Mortar may deteriorate as a result of age of building materials, minor movement of bricks, or frequent exposure to weathering. Mortar should be replaced to ensure that bricks remain in their intended location and to prevent gaps, which would allow water or moisture ingress and secondary damage as a result.

Mortar deterioration can be addressed by a bricklayer where areas of deterioration are localised and easily accessible. Alternatively, appointment of a registered builder is advised, to repoint large areas of decaying mortar. Where secondary structural defects have become evident, consultation with a structural engineer may be required.

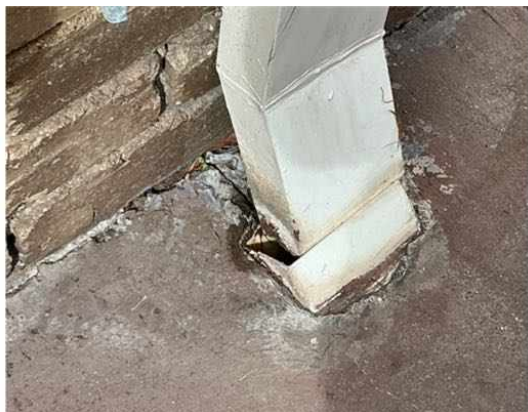
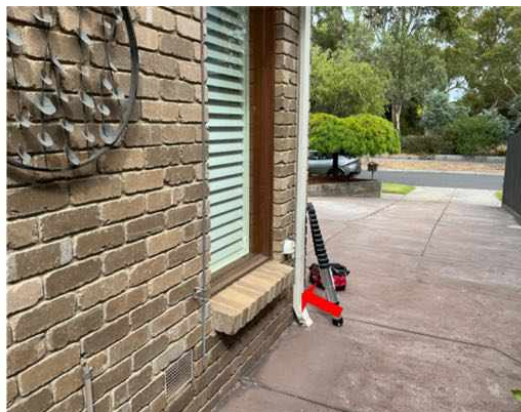
Defects 3.02

Building:	Main Building
Location:	Front Elevation
Finding:	Stormwater drain - Not connected
Information:	The roof plumbing is not adequately connected to stormwater drainage on the site. This disconnection negatively impacts the functional capacity of the roof plumbing.

Where roof plumbing doesn't drain adequately, the area at the base perimeter can become excessively damp, potentially creating an environment that is susceptible to rust and corrosion of surrounding building elements, as well as attracting termites and other pests.

It is highly recommended that a plumber be appointed to further inspect the area and to install adequate drainage equipment where necessary.

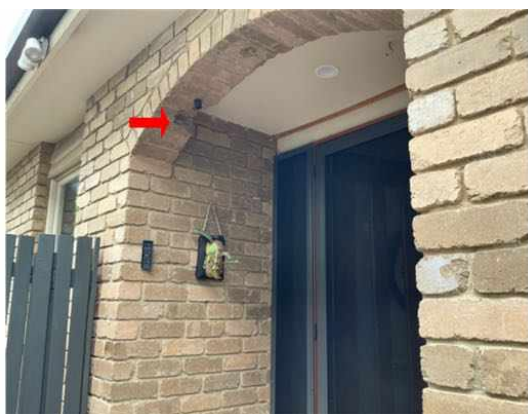
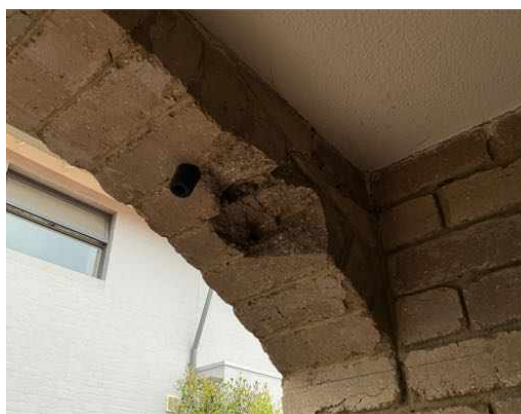
Defects 3.03

Building:	Main Building
Location:	Entry
Finding:	Brickwork - damaged
Information:	Damage was identified to the brickwork in this area at the time of inspection.

This damaged brickwork may be able to be repaired by a qualified bricklayer

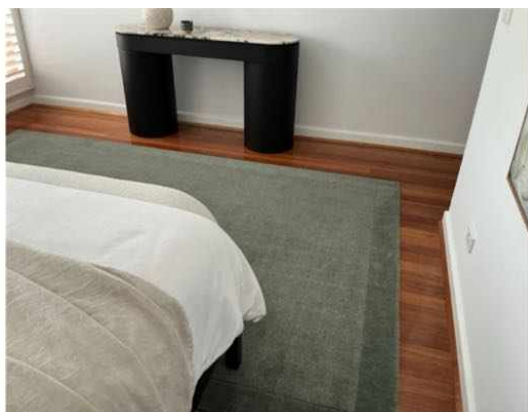
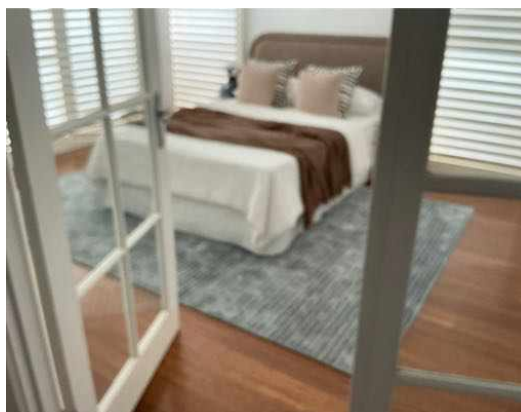
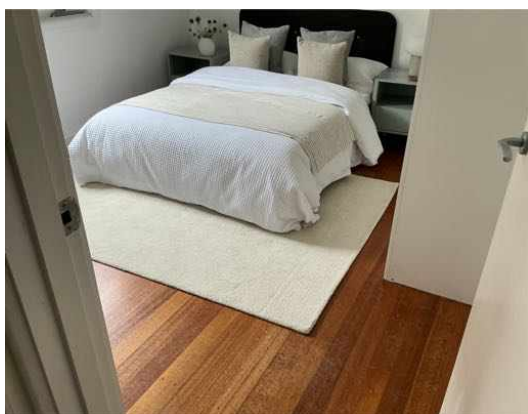
Defects 3.04

Building:	Main Building
Location:	All Areas
Finding:	Floors - bouncy
Information:	The internal flooring in this area was identified as being bouncy at the time of inspection. A bouncy floor surface generally presents as a discernible change in level as they are walked across, in noisy or creaking flooring, or in consequent movement of surrounding furniture and fixtures.

Bouncy floors generally indicate that the floorboards or the subfloor structures are coming loose from the joists that they are installed on. Bouncy flooring may also be the result of gaps between flooring and stumps or joist structures, which require packing.

The client is advised to seek quotations for required repairs from a Registered Builder

specialising in re-stumping. The potential resolution may range from packing gaps in subfloor structures through to replacement of subfloors stumps and refixing of flooring.

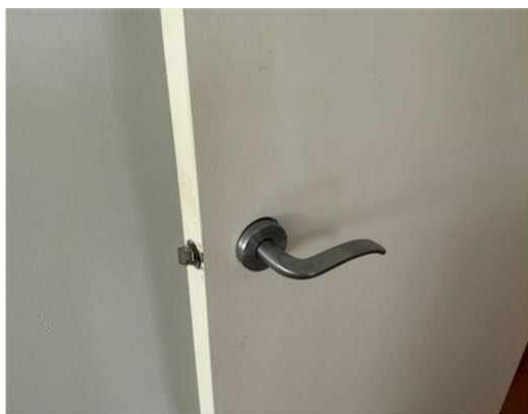
Defects 3.05

Building:	Main Building
Location:	Bedroom - Master
Finding:	Fitting or fixture - Loose door handle
Information:	The fitting in this area is loose and requires adjustment to tighten.

If left unmanaged, the fitting may further deteriorate, causing potential for the development of other minor secondary defects.

A relevant tradesperson should be appointed to perform these rectification works at discretion of the client.

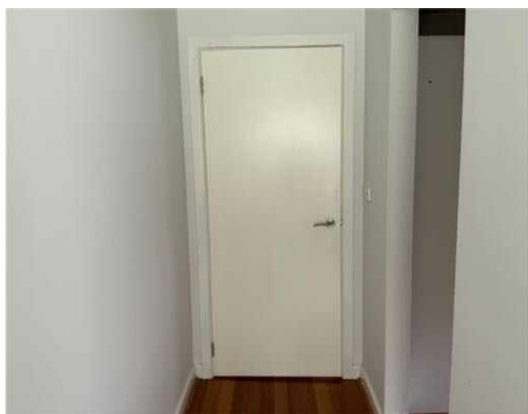
Defects 3.06

Building:	Main Building
Location:	All Areas
Finding:	Door - Binding/jamming
Information:	Binding and/or jamming of this door is evident during standard operation. This defect inhibits the functionality of the affected door as well as creating potential for secondary defects to associated building elements, such as damage to the floor covering.

A door that binds to flooring or to the associated door frame may have several causes, ranging from minor defects, such as poor installation of the door or deteriorated hinges, through to major structural issues, such as damage to subfloor structures.

Where door binding/jamming appears to indicate major structural issues, a registered builder specialising in re-stumping should be appointed to provide an estimate on the cost of rectification.

For minor causes, a qualified carpenter or general handyperson should be appointed to perform minor rectification works at client discretion.

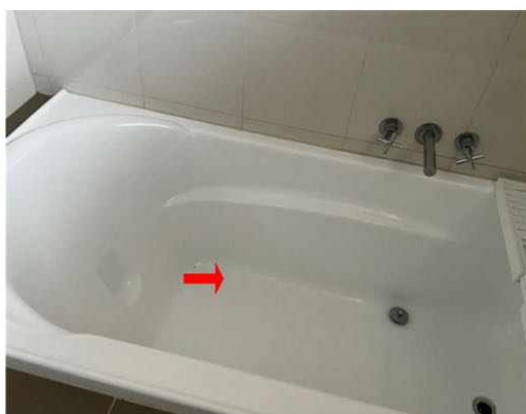
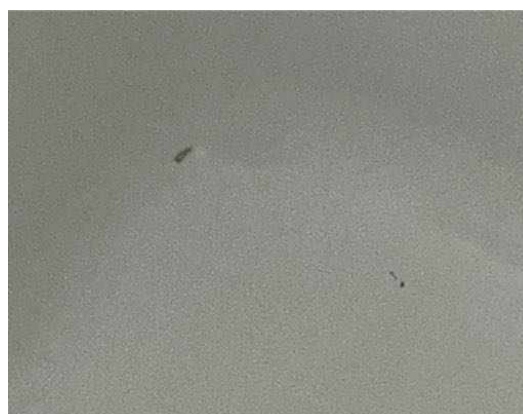
Defects 3.07

Location:	Ensuite Bathroom
Finding:	Surface - Chipped
Information:	The surface of this building element appears to have chipped as a result of general wear and tear. While being an appearance defect, such damage is expected of a property of this age and condition.

Chipped surfaces rarely impede on the structure or functionality of the affected building element and generally only create a blemish on its appearance. Chipped surfaces may be left in situ at client discretion, as no repairs or replacement are necessarily required. However, the client may wish to seek quotations for the cost of refurbishment or replacement of the identified building element.

A qualified carpenter or cabinet maker should be appointed to repair chipped surfaces and replace building elements where major damage has occurred.

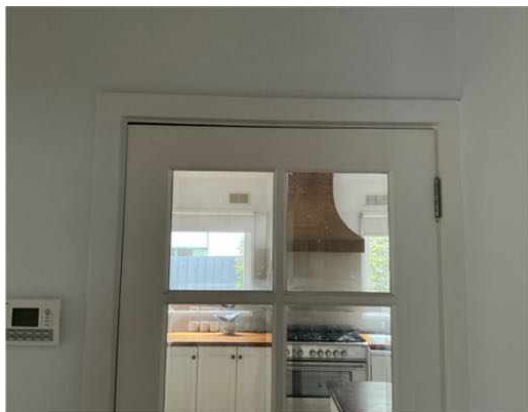
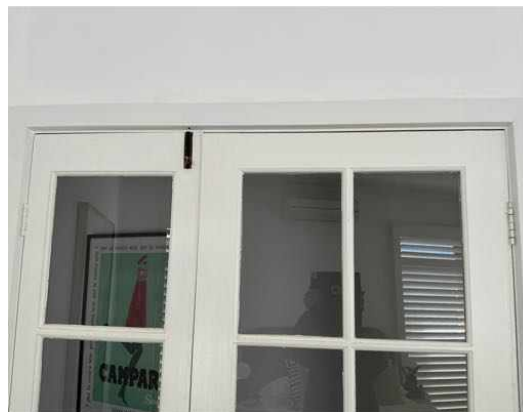
Defects 3.08

Building:	Main Building
Location:	All Areas
Finding:	Door - Gap
Information:	An inconsistent gap was identified between the door and door frame in this area. Where large gaps to the head or foot of door frames appear, it may be indicative of a variety of defects, ranging from uneven framework, sagging hinges or uneven flooring.

A gap to the head of the door may also indicate movement of the foundation of the property, which is a common occurrence and may or may not indicate structural damage.

A registered builder should be appointed to perform remedial works to restore the door to a fully operational level and ascertain the cause (whether structural in nature)

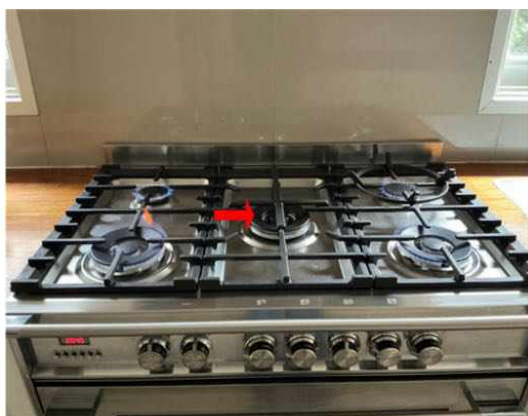
Defects 3.09

Building:	Main Building
Location:	Kitchen
Finding:	Building element - Not operating igniters to stove top
Information:	Non-operational items should be addressed to ensure that the full function of the building structure is available. Where some building elements are not operating as intended, it is possible that secondary building defects could arise due to their non-operation.

Repair and/or replacement of the faulty building element is recommended. It is highly recommended that the relevant tradesperson be engaged to perform any necessary works.

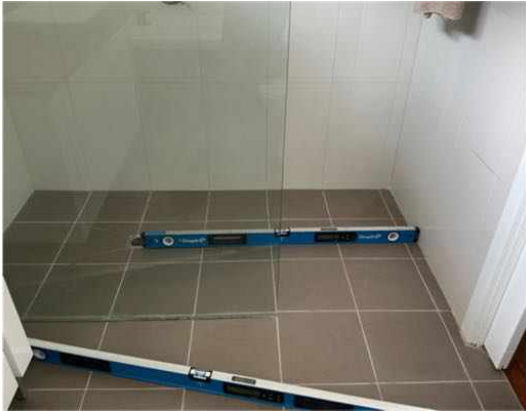
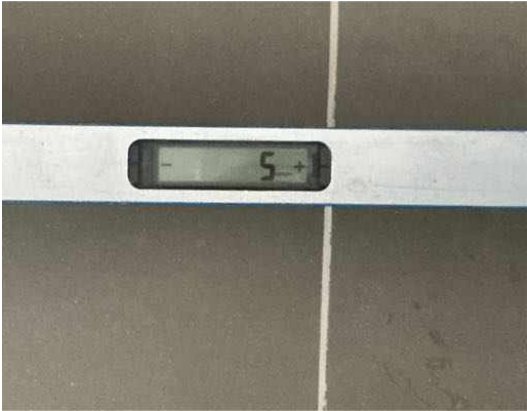
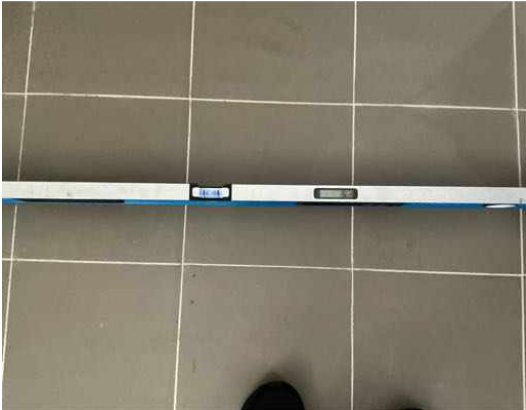
Defects 3.10

Building:	Main Building
Location:	Ensuite Bathroom
Finding:	Shower component - defective (Tiles Insufficient fall towards the floor grate)
Information:	It was identified that there is a performance issue with a shower base tiling component does not have sufficient fall towards the grate 1/100

This is a defect with reference to Standards and Tolerances.

This shower base tiling will need to be reworked in order to achieve the minimum fall towards the grate.

These works are to be completed prior to final Handover.

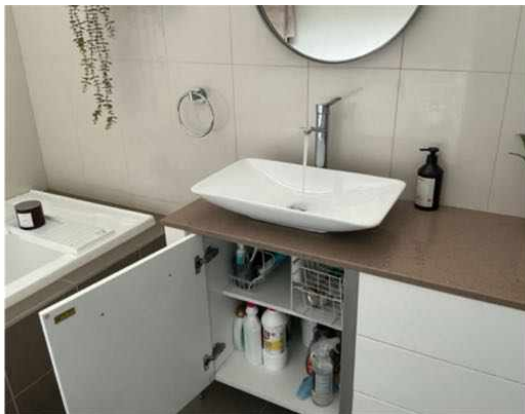
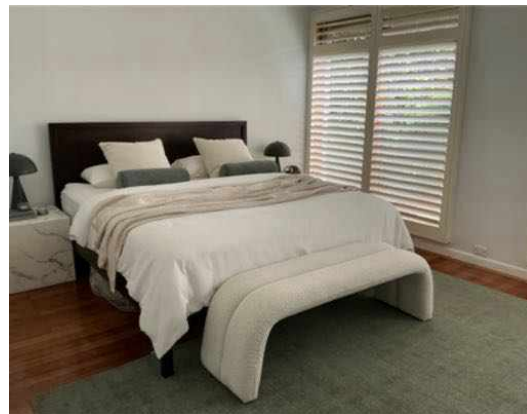
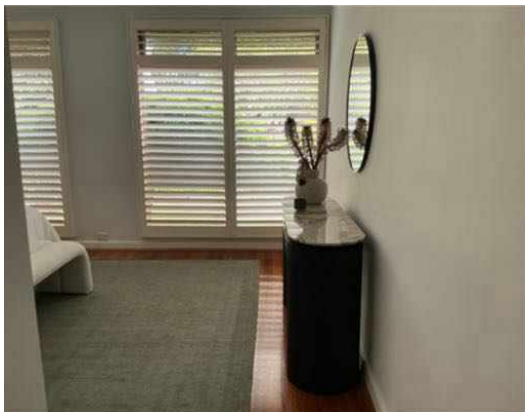
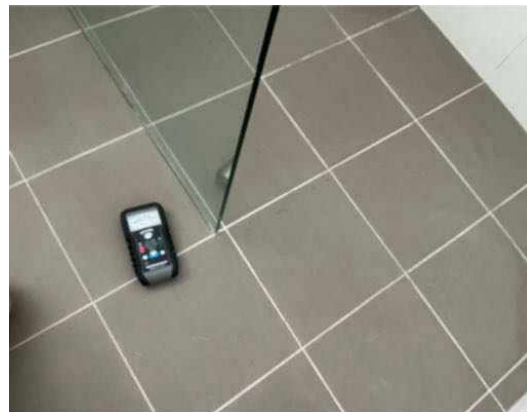
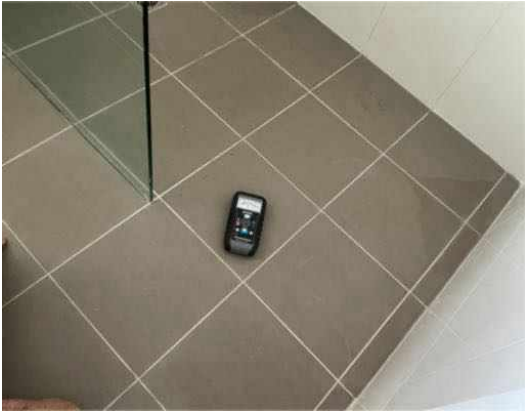
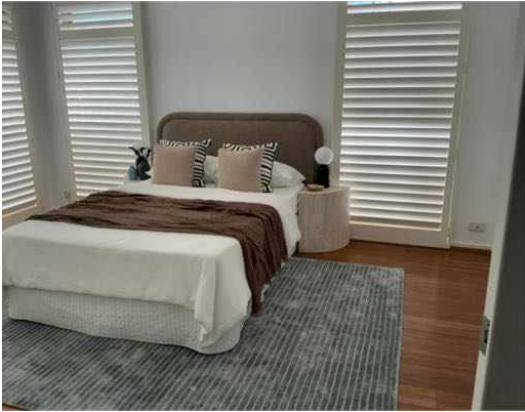
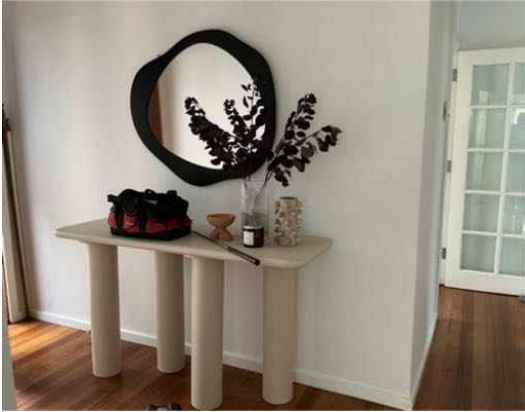
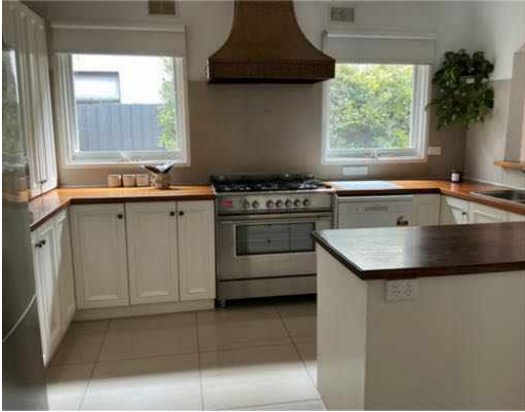
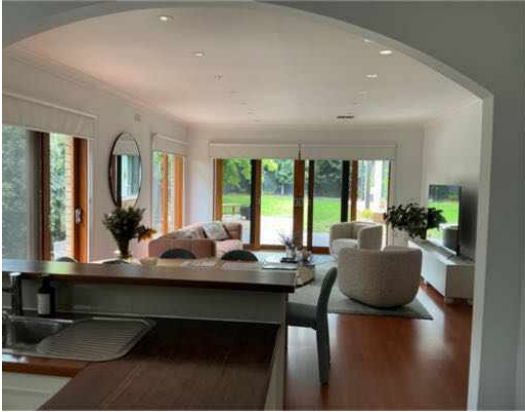
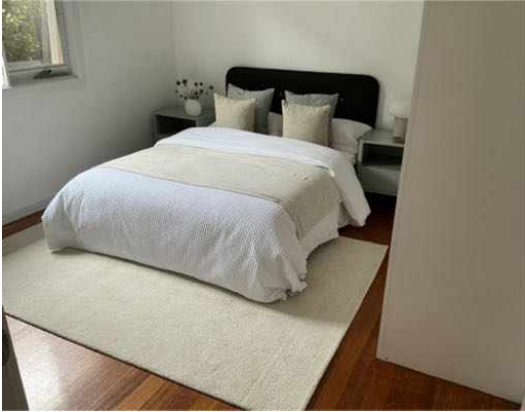
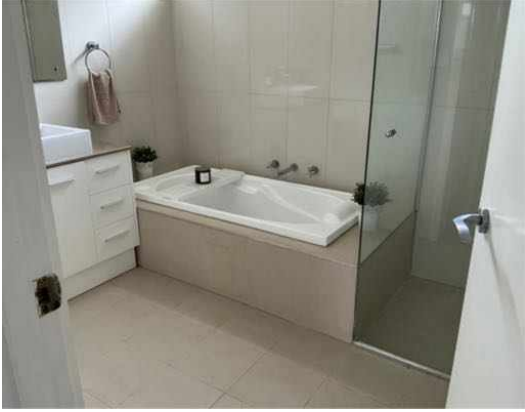
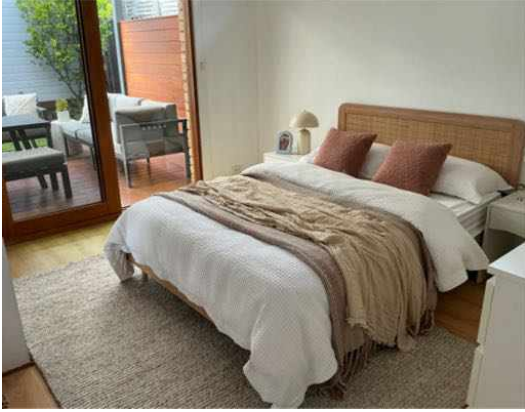
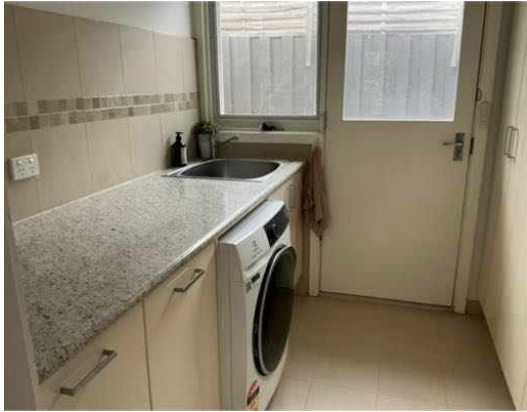
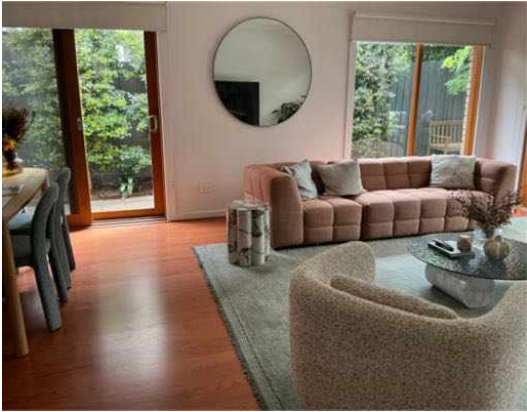
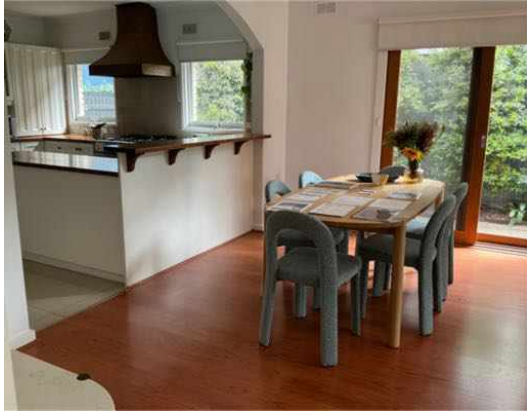
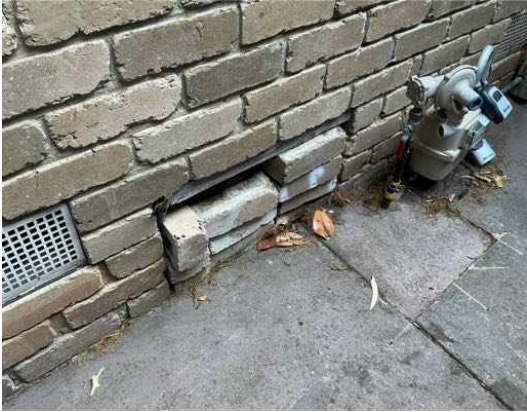
Building: Main Building
Location: All Areas
Finding: Additional Photos and Obstructions and Limitations
Information: These are additional photographs and photographs of the obstructions and limitations inside and outside (furniture, landscaping etc) which may impede full inspection of the property at the time of inspection. These obstructions can hide an array of defects and may be removed to allow full inspection to be carried out. A re-inspection may be made if clients require once the areas are made accessible.

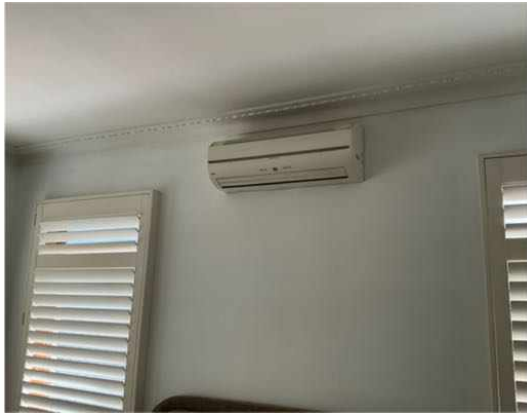
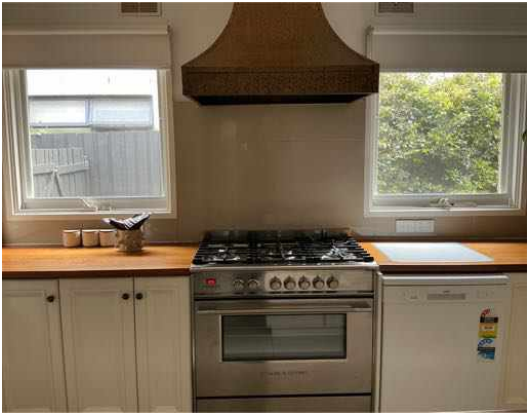
Building: Main Building
 Location: All appliances
 Finding: Warranty - Expired
 Information: Where appliances are beyond their warranty period, the owner should be prepared to meet the cost of replacement or repair of the item at any time. The operation of the appliance can not be guaranteed and further inspection by an appropriately qualified tradesperson may be required.
