Building and Timber Pest Inspection Report

Inspection Date: Fri, 13 Feb 2026

Property Address: 3 Kurrajong Rd, Gatton QLD 4343, Australia

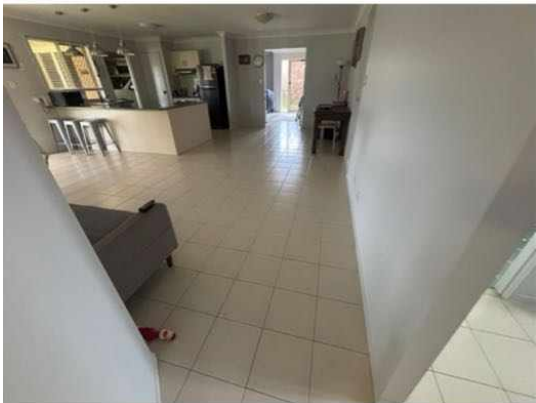
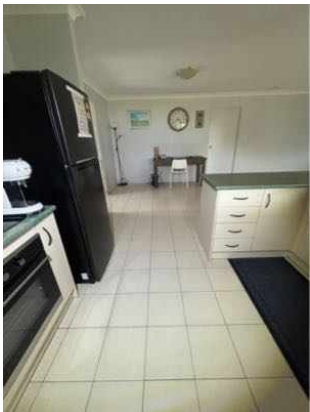
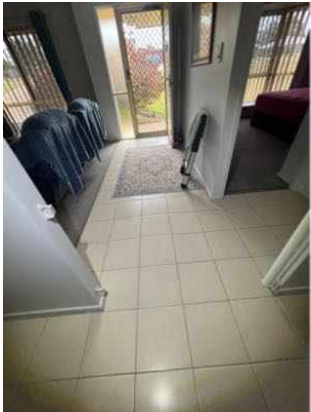
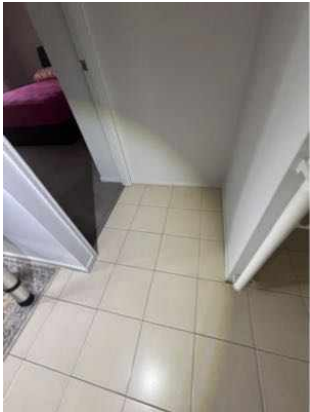
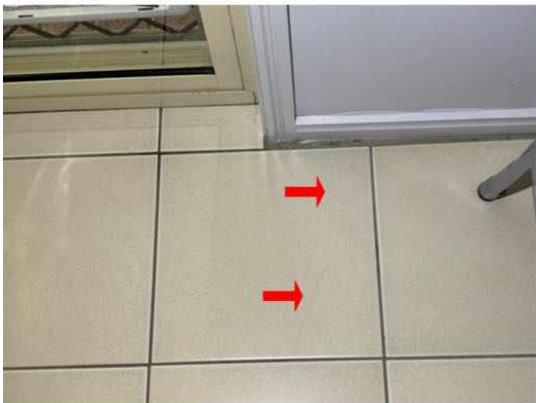
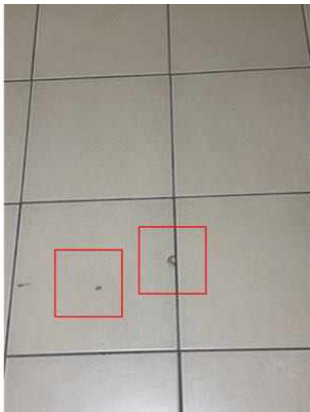
Finding 3.01

Building:	Main Building
Location:	All Internal Areas
Finding:	Tiles - Drummy
Information:	Drummy tiled areas were identified at the time of inspection. Drummy tiles are more likely to chip or cracked if items are dropped on them. A cracked tile was found near the sliding door. A chipped tile was found near the kitchen.

The term 'drummy' refers to tiles that have become detached from their fixing, despite otherwise being in relatively good condition. Such defects are generally caused by physical or moisture damage to the area. Drummy tiled areas may also be a direct result of poor workmanship during the construction process.

Tiled areas may swell and shrink with changes in air humidity if the area has sustained moisture damage. Any exposure to moisture is capable of causing tiled areas to become drummy and/or cracked over a prolonged period of time. Drummy tiled areas generally require removal and replacement of affected tiles, with adequate sealant and grouting.

Specialist trades are available for these types of services. A registered builder may be required to undertake works if damage is extensive or if secondary building defects have resulted. Otherwise, it is advised that a tiling contractor be appointed to perform works as necessary. Immediate action is recommended to ensure that no further damage is sustained in the affected area.

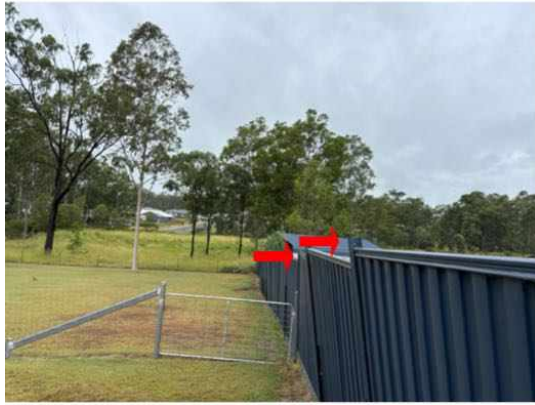
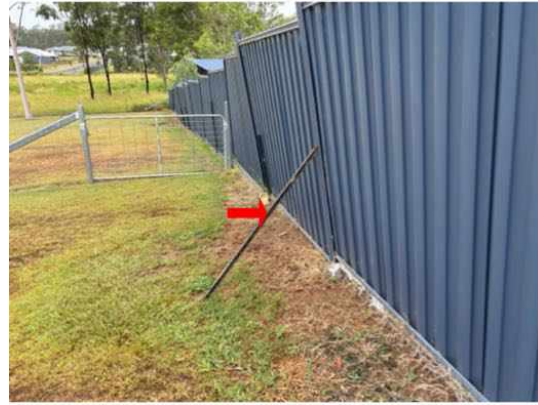
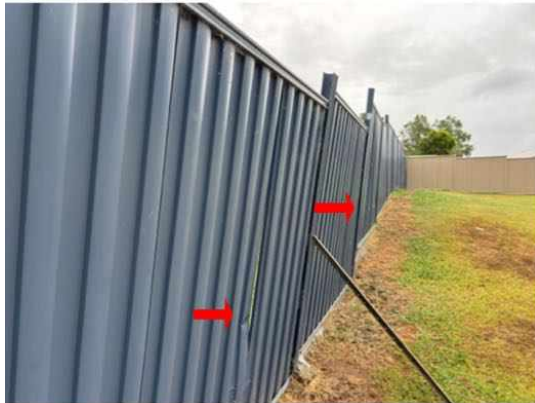
Finding 3.02

Building: Main Building
Location: Boundary fence
Finding: Boundary fence - damaged
Information: At the time of the inspection, it was noted that the right hand boundary fence has damage some of the panels. The fence is leaning and is being supported by a star picket.

A fencing contractor could be engaged to carry out the necessary repairs to the fence. This can be done at the clients discretion.

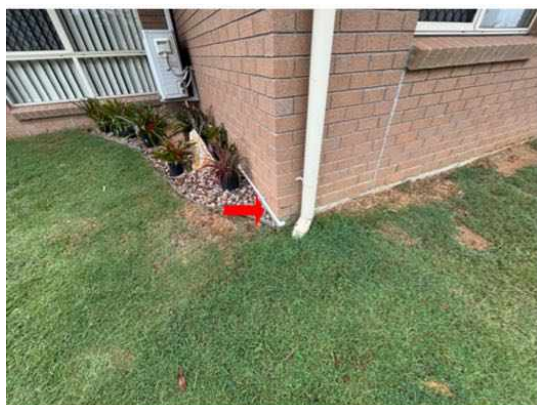
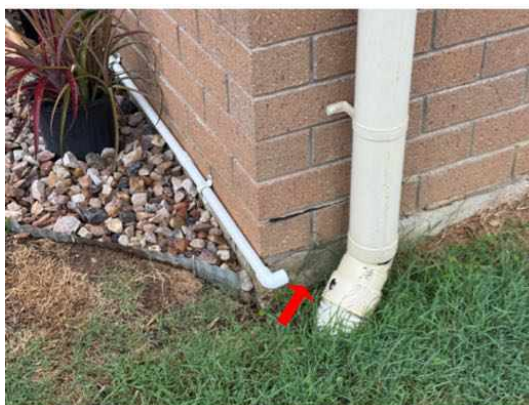
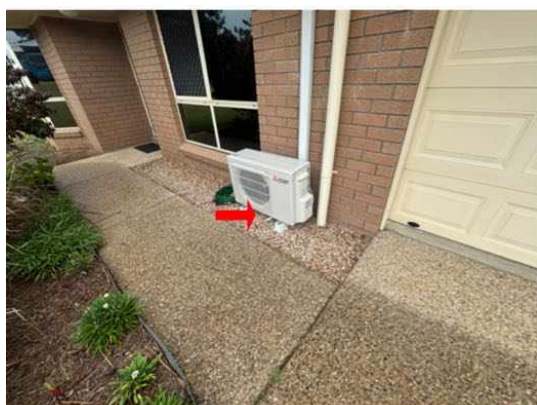
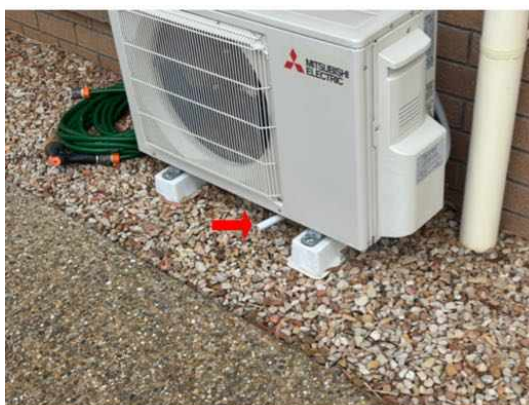
Finding 6.01

Building: Main Building
 Location: All External Areas
 Finding: Air conditioner - Disconnected overflows
 Information: At the time of the inspection, it was noted that the air conditioner drain overflows to all the units were not connected to the storm water drainage and as a result are draining next to the foundations of the dwelling.

Air conditioning overflows that are not connected to the storm water drainage and are draining near the foundation can create excessive moisture in the surrounding area.

Such leaking creates an environment which is conducive to an array of defects,

including water damage to associated building elements and the attraction of termite or timber pest infestation.

It is highly recommended that a licensed plumber be appointed to connect the A/C overflow in order to prevent such an environment from being created. These minor works should be carried out as soon as possible.

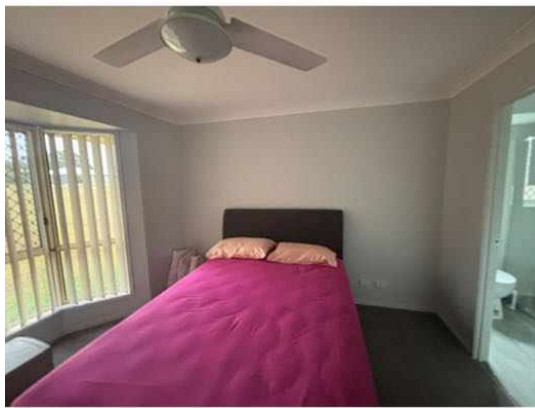
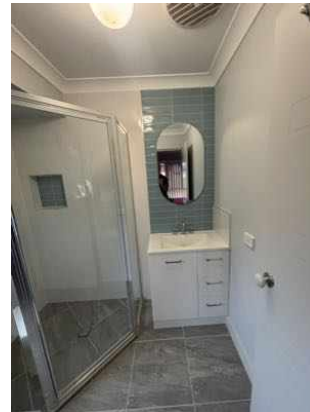
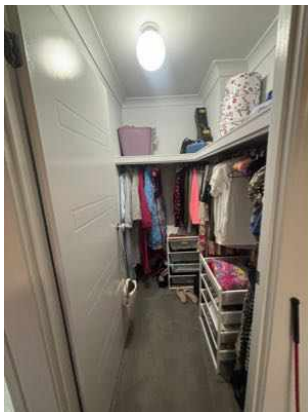
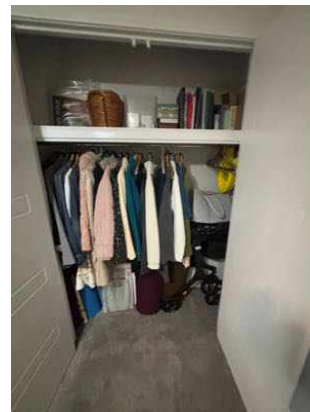
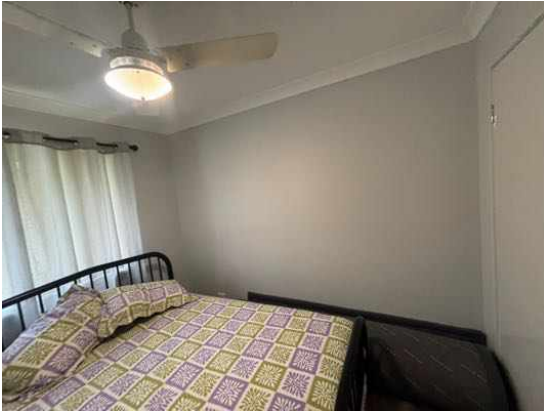
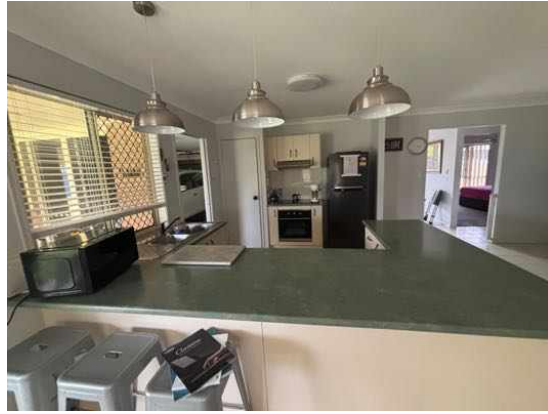
Building: Main Building
Location: All Internal Areas
Finding: Obstructions and Limitations - Internal areas
Information: These photographs are an indication of the obstructions and limitations which impeded full inspection of the property of the internal areas at the time of inspection. These obstructions can hide an array of defects and should be removed to allow full inspection to be carried out. A re-inspection is recommended once the areas are made accessible.

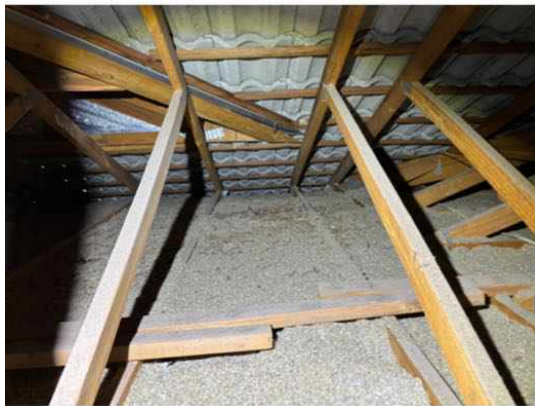
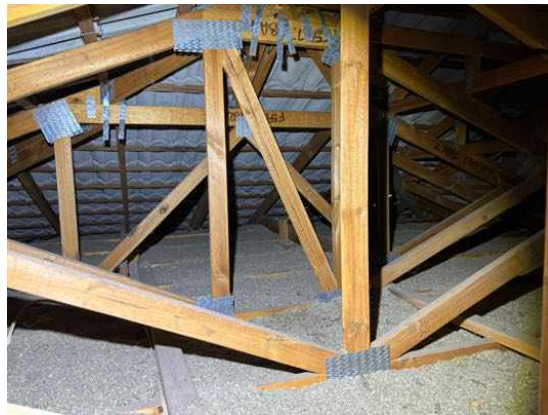
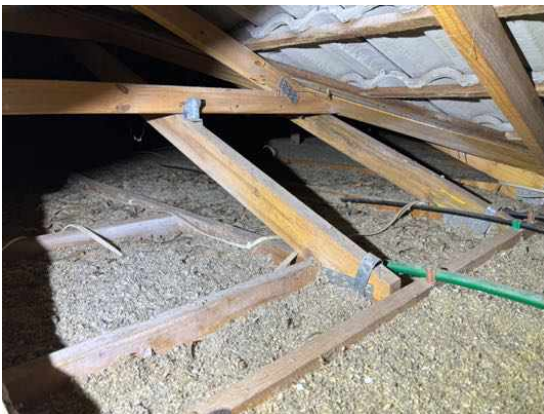
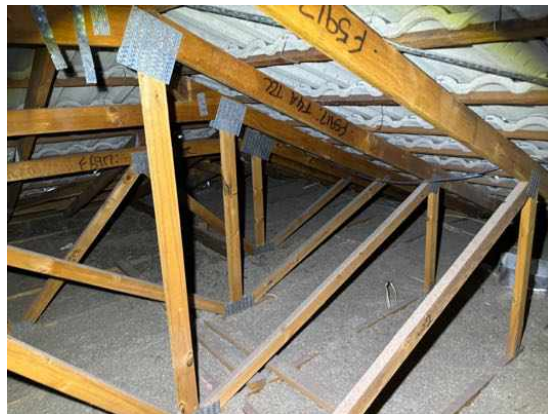
Building: Main Building
 Location: Roof Void
 Finding: Obstructions and Limitations - Roof cavity
 Information: These photographs are an indication of the obstructions and limitations which impeded full inspection of the property of the roof cavity

at the time of inspection. These obstructions can hide an array of defects and should be removed to allow full inspection to be carried out. A re-inspection is recommended once the areas are made accessible.

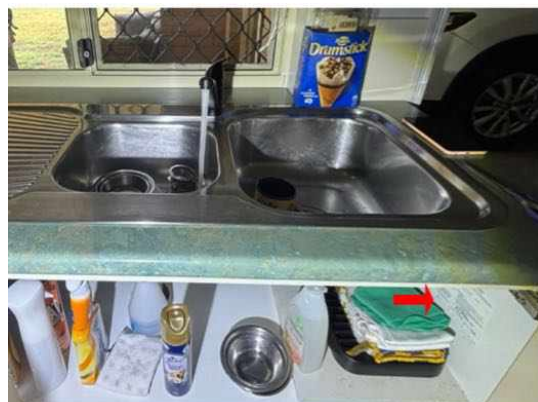
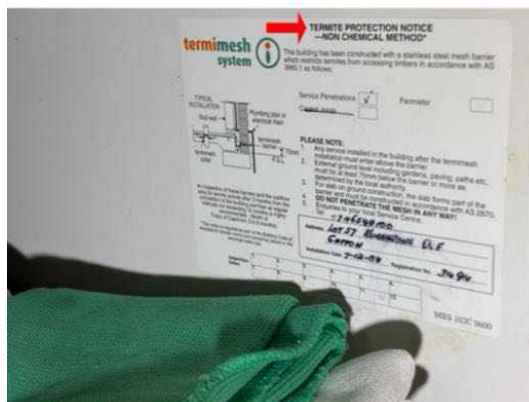
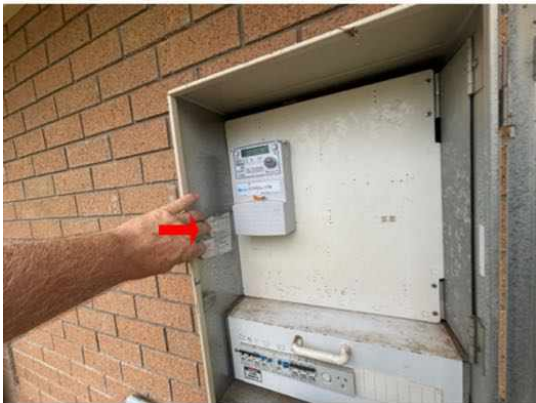
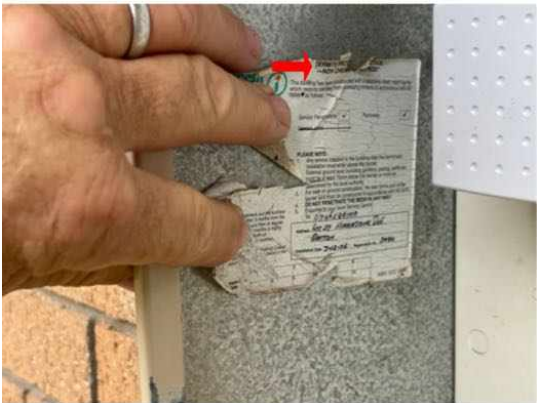
Building:	Main Building
Location:	All External Areas
Finding:	Evidence of a physical termite management system was identified.
Information:	At the time of the inspection, evidence of a physical termite management system was found by way of a durable notice in the electricity meter box and the kitchen sink cabinet.

A physical termite barrier was installed to the slab penetrations and perimeter during construction. The durable notice is dated the 07/12/2008. The product used was Termimesh. Physical termite barriers do not stop or eliminate termites. Physical termite barriers are designed to expose concealed termite activity.

A termite and timber pest technician should be engaged to carry out annual termite inspections as per AS 3660 in order to further protect the dwelling. Annual termite inspections must be carried out in partnership with any termite treatment system, physical or chemical, as no termite treatment system can be expected to be 100% effective.

A termite treatment system and annual termite inspections are important parts of an ongoing termite management plan.
