# Building and Timber Pest Inspection Report

Inspection Date: Wed, 18 Feb 2026

Property Address: 50 Undercliffe Rd, Earlwood NSW 2206,  
Australia

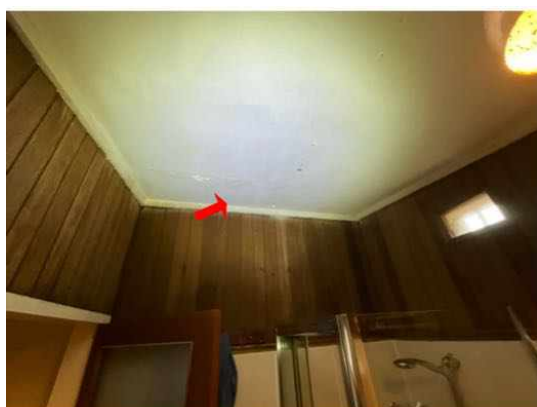
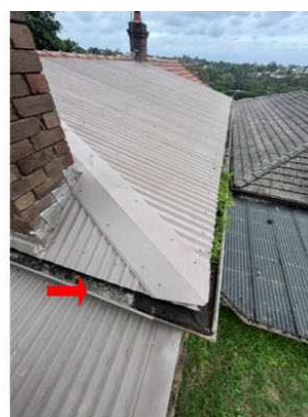
Building: Main Building  
 Location: Bathroom  
 Finding: Water leak - Active  
 Information: Generally, water leaks occur when a particular area of the property is not weather or water tight. As the surrounding area was found to be damp at the time of inspection, the leak is considered ongoing and hence requires urgent action.

Regardless of the location, even minor leaks that are left unmanaged can lead to serious damage of associated building elements and result in the need for replacement of building materials. Mould and other hazards such as electrical hazards may also arise if the leak is left to develop.

It is highly advised that the cause of the leak be identified and resolved immediately by a licensed plumber to prevent any further damage. Depending on the extent of the damage previously sustained, repair and/or replacement of any affected building materials may be required.

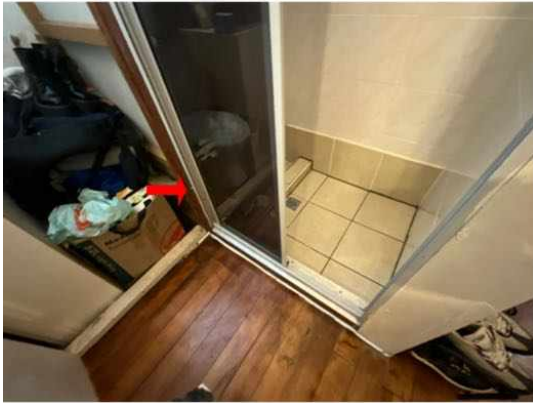
#### Finding 2.02

Building: Main Building  
 Location: Ensuite  
 Finding: Water proofing - Failed  
 Information: The waterproofing membrane in this area appears to have failed. Generally this could occur from substandard installation or through damage from physical force.

The failure of the waterproofing membrane system be it in a bathroom, balcony or basement can lead to severe consequences and costly repair. Waterproofing is an essential part of any construction in a wet environment and its installation should be truly sustainable. Unfortunately, despite the best intentions, failures tend to occur.

It is advised that a builder be appointed to see what necessary works are required.

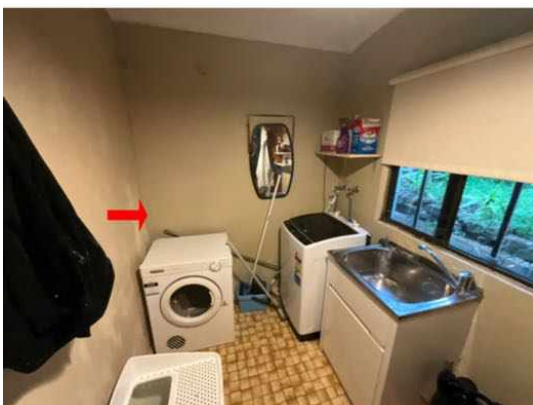
### Finding 2.03

Information: Lateral penetrating damp refers to the sideways movement of moisture. The implications of unmanaged damp range from mould fungi growth, wood rot and decaying building materials, to finishes including lifting, bubbling, peeling and staining of paint, plaster and wallpaper.

Consultation with a damp proofing contractor is advised to address the cause of the damp and to perform remedial works as necessary.

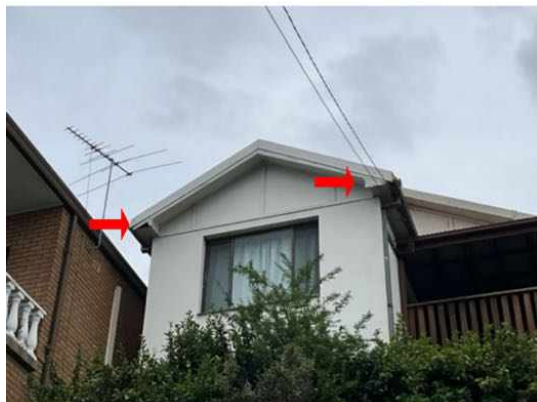
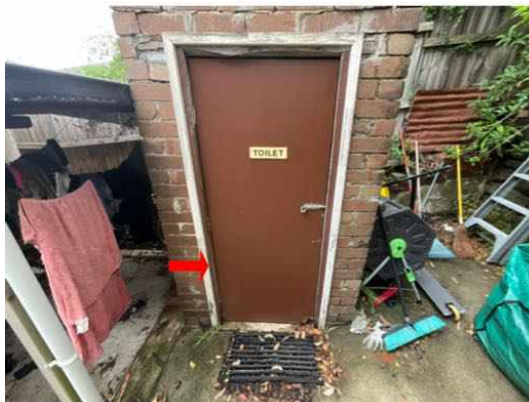
### Finding 3.01

Building:	Main Building
Location:	External Areas
Finding:	Wood rot
Information:	This building element shows evidence of wood rot. Wood rot, also known as Fungal Decay, occurs when timbers and other cellulose building materials are exposed to damp conditions on an ongoing basis. This could be the result of exposure to weathering over a prolonged period of time, or the attraction of excessive moisture from other abutting building materials.

Early intervention and regular maintenance, particularly of exterior timbers, will prolong the useful life of these building elements. Prior to any works being performed, the cause of the moisture that has created the visible wood rot should be identified and addressed in a suitable manner. Replacement of affected timbers may then be a necessary step in protecting surrounding building elements from such deterioration.

A qualified carpenter or registered builder may also be required to replace affected building materials.

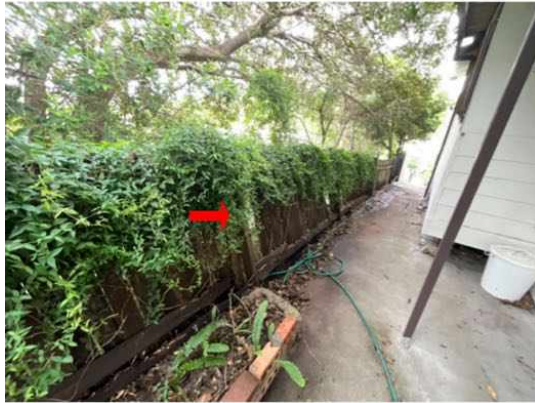
### Finding 3.02

Building:	Yard
Location:	Fencing
Finding:	Fencing - Deteriorated
Information:	It was noted at the time of inspection that sections of the fencing throughout the property have deteriorated. Typically fencing deteriorates due to age and or wear, rot and or rust which is generally expected for a structure of this age, due to prolonged exposure to weather conditions. Sometimes inadequate installation or maintenance can be to blame.

If left unattended, it is likely that further damage will occur. It is suspected that repair of several elements of the fencing may be required however replacement may be a consideration of the client also.

A licensed fencing contractor should be appointed to provide further advice and perform rectification works as necessary.

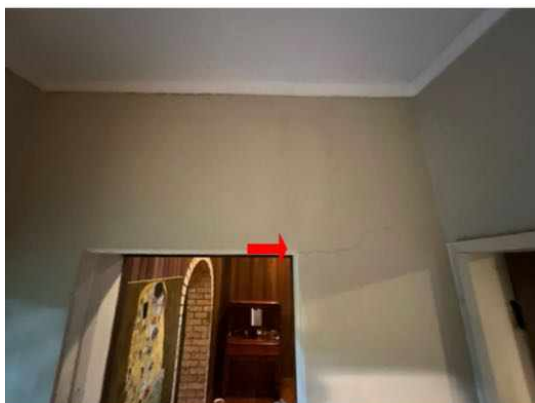
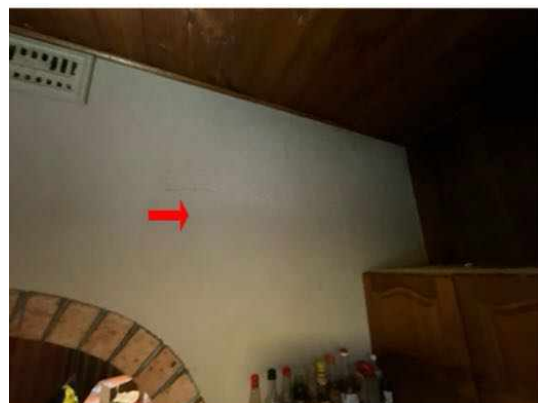
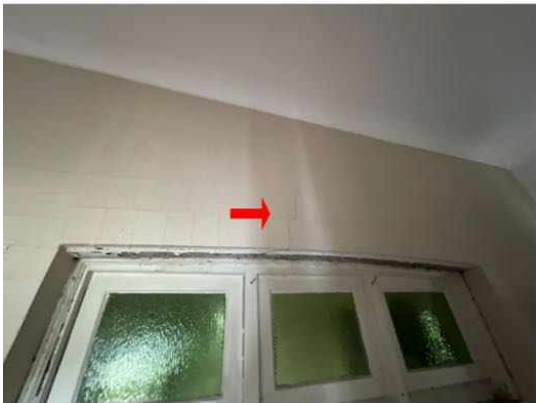
### Finding 3.03

Finding: Cracking - Damage Category 2 - Noticeable (up to 5mm)

Information: Noticeable cracks are a common occurrence as a result of many primary defects. Such causes may include age, general wear and tear, expected building movement, general expansion/contraction of building materials in different weather conditions, and/or minor failings in the installation or application of building materials.

I recommend monitoring and if further cracking is evident appoint a bricklayer to see what works are required.

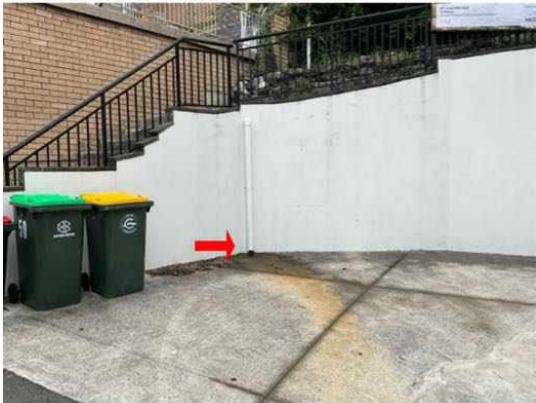
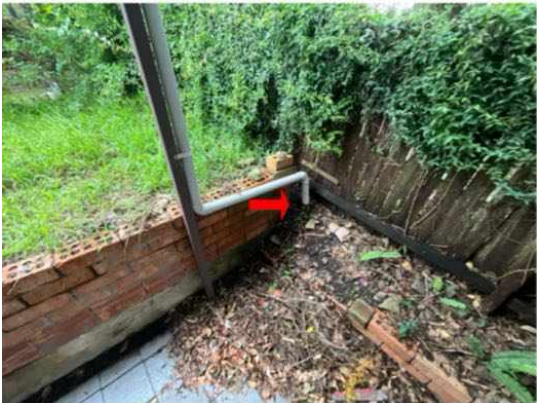
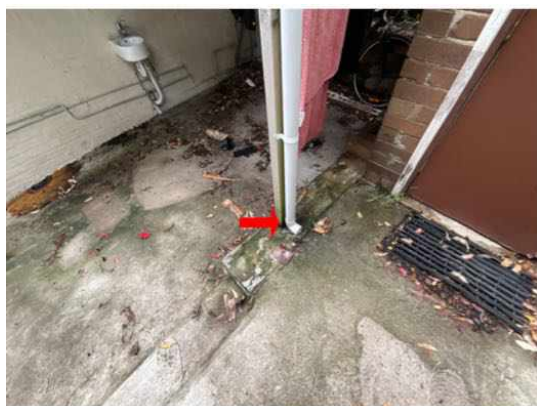
**Finding 3.04**

Building: Main Building  
Location: Exterior walls  
Finding: Stormwater drain - Not connected  
Information: The roof plumbing is not adequately connected to stormwater drainage on the site. This disconnection negatively impacts the functional capacity of the roof plumbing.

Where roof plumbing doesn't drain adequately, the area at the base perimeter can become excessively damp, potentially creating an environment that is susceptible to rust and corrosion of surrounding building elements, as well as attracting termites and other pests.

It is highly recommended that a plumber be appointed to further inspect the area and to install adequate drainage equipment where necessary.

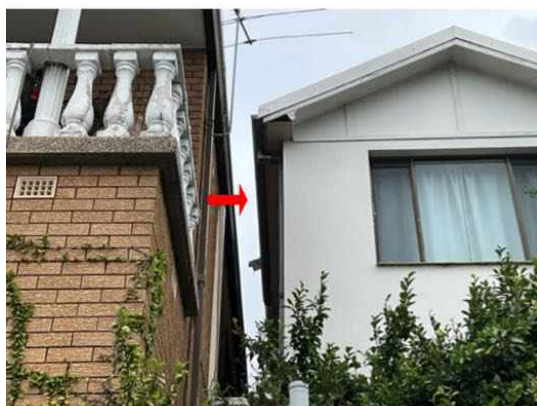
### Finding 3.05

Building:	Main Building
Location:	Roof Exterior
Finding:	Roof plumbing - Rusted or corroded
Information:	The roof plumbing has areas of rust and corrosion. It is suspected that this has been caused by blockages, resulting in pooling or standing water, that have prematurely rusted elements of the roof plumbing.

Rusted roof plumbing will generally develop holes and leaks that can affect other building elements with poor drainage of storm water. Poorly drained roof areas will also lead to damp conditions surrounding the base perimeter of the building which, if left unmanaged, can lead to a range of secondary building defects.

Repair and/or replacement of rusted roof plumbing is highly required in order to reinstate the roof drainage system to a fully operational level. To further maintain these areas, gutters should be cleaned frequently, allowing the avoidance of any partial blockages.

A licensed plumber or specialist roof restoration company should be appointed to undertake these works.

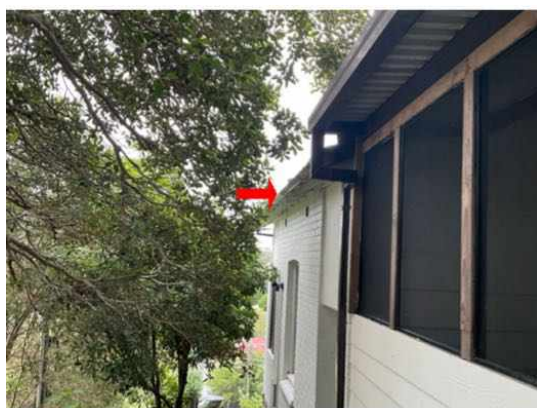
### Finding 3.06

Building: Main Building  
 Location: Roof Exterior  
 Finding: Roof plumbing - Insufficient fall  
 Information: There is an insufficient fall in the roof drainage, which means that the angle is inadequate to facilitate movement of rainwater. This is resulting in pooling of water in the area, creating the potential for water damage to associated building elements.

Without adequate roof drainage, premature rust and decay of the roof plumbing structures is imminent. The development of such deterioration is likely to lead to the formation of secondary defects to adjoining wall sections and roofing elements.

Adjustment by a roofing plumber is required to prevent any further damage to the area.

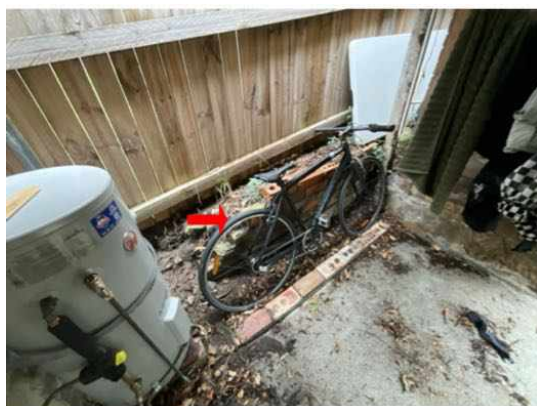
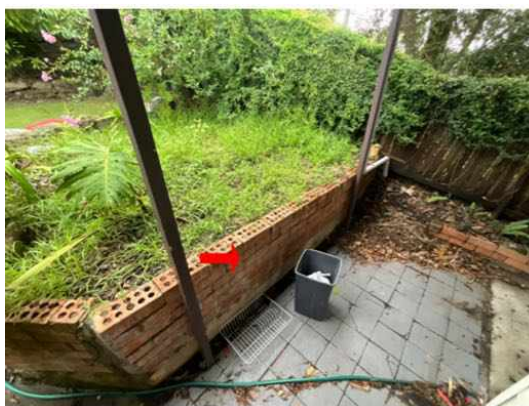
### Finding 3.07

Building: Yard  
 Location: Yard - Back  
 Finding: Brickwork - leaning  
 Information: The exterior brick work in this area was leaning.

Although the wall does appear to be stable, works will need to be done to the brickwork in the area.

I recommend appointing a bricklayer to see what necessary works are required.

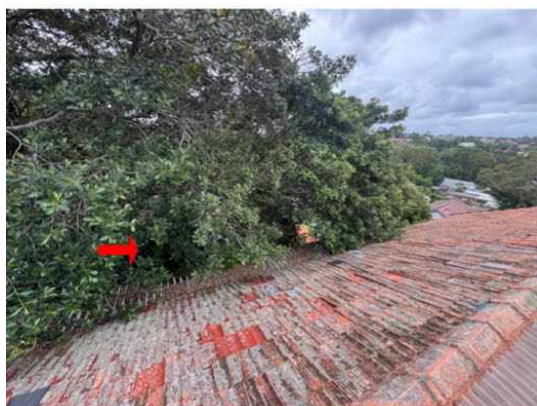
### Finding 3.08

Building:	Main Building
Location:	Roof Exterior
Finding:	Trees - Overhanging and filling gutters
Information:	Overhanging trees often result in excessive amounts of leaf debris accumulating in gutters.

Gutters are a critical part of the building's management of storm water and rain. It is therefore important that they be kept clear to prevent secondary damage to associated building elements, including exterior and interior walls, ceiling linings and any adjoining building elements. Where gutters are blocked, pooling of rainwater is likely to occur, fast-tracking rust and corrosion of the roof plumbing elements.

It is highly advised that all overhanging tree branches be removed as soon as possible to prevent any further damage. Repair and/or replacement of sections of damaged guttering may also be required where the extent of the damage necessitates.

Such works should be performed by the homeowner; however, appointment of a landscape contractor or an arborist may be required. Consultation with a licensed roof plumber is required where guttering has been damaged.

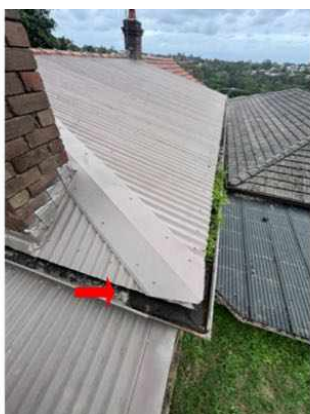
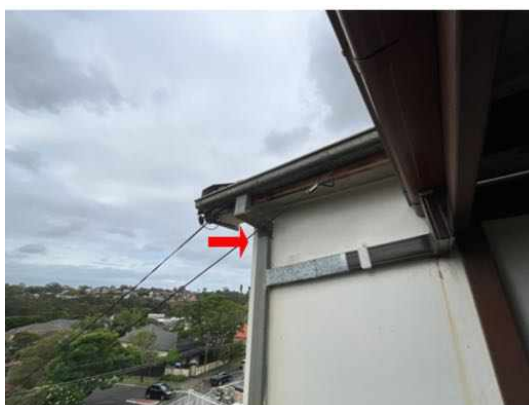
### Finding 3.09

Building:	Main Building
Location:	Roof Exterior
Finding:	Roof plumbing - Rusted or corroded
Information:	The roof plumbing has areas of rust and corrosion. It is suspected that this has been caused by blockages, resulting in pooling or standing water, that have prematurely rusted elements of the roof plumbing.

Rusted roof plumbing will generally develop holes and leaks that can affect other building elements with poor drainage of storm water. Poorly drained roof areas will also lead to damp conditions surrounding the base perimeter of the building which, if left unmanaged, can lead to a range of secondary building defects.

Repair and/or replacement of rusted roof plumbing is highly required in order to reinstate the roof drainage system to a fully operational level. To further maintain these areas, gutters should be cleaned frequently, allowing the avoidance of any partial blockages.

A licensed plumber or specialist roof restoration company should be appointed to undertake these works.

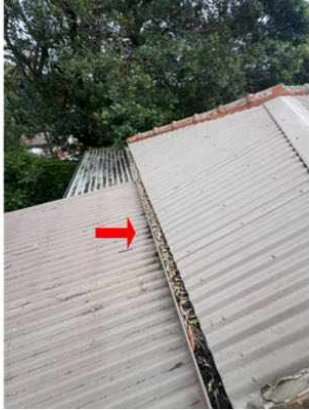
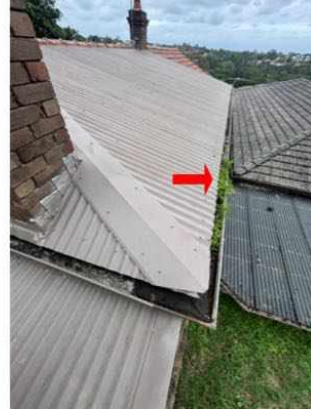
### Finding 3.10

Building:	Main Building
Location:	Roof Exterior
Finding:	Gutters - Blocked
Information:	Roof plumbing structures, such as guttering and downpipes, should be free of all debris to prevent blockages. Blockages of the guttering and downpipes will lead to pooling and accumulated water overflows, which is likely to subsequently flood eaves and exterior walls.

Blocked gutters are likely to lead to high levels of moisture in the affected areas. Such moisture will not only cause rust and decay of the associated building materials, but can also provide conditions that are conducive to termite and timber pest activity. Blockages in gutters should therefore be removed to ensure dry conditions are

maintained.

Consult a Licensed Plumber for further specific advice on remedial works that may be required. In the interim, it is highly advised that blocked gutters be removed by the homeowner or a general handyperson as a matter of urgency.

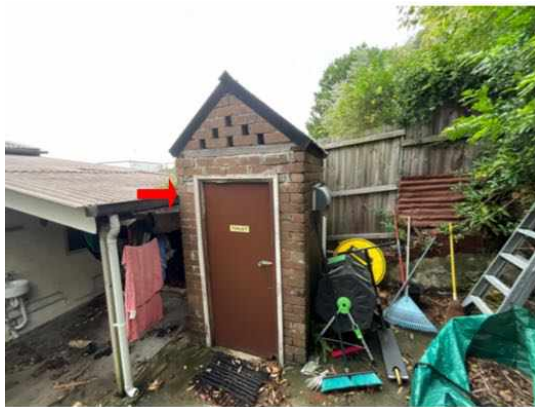
### Finding 3.11

Building: Yard  
 Location: Shed  
 Finding: Deteriorated Structure  
 Information: It was identified that some elements have suffered from environmental effects with replacement required.

I would highly recommend appointing a builder to see what necessary works are required.

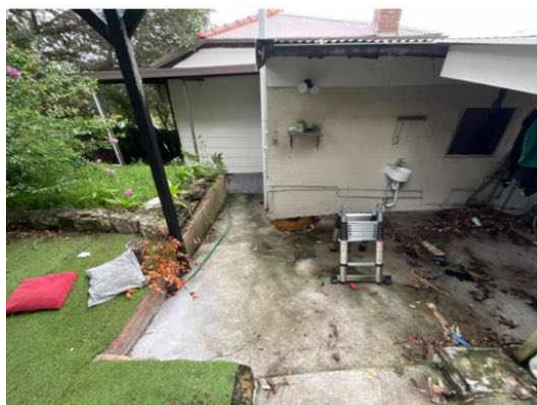
### Finding 3.12

Building: Yard  
 Location: The Site  
 Finding: Site drainage - Inadequate  
 Information: The site drainage in this area was found to be inadequate at the time of inspection,

creating potential for subsequent water damage to associated building elements.

It is important that water does not lie against the base of walls; surrounding paths and ground levels should be sloped to drain water away from walls.

Where site drainage is inadequate, installation of drains may be required. A qualified plumber should be appointed to further inspect the property and perform any remedial works as necessary. Water damage and secondary defects are likely to occur if left unmanaged.

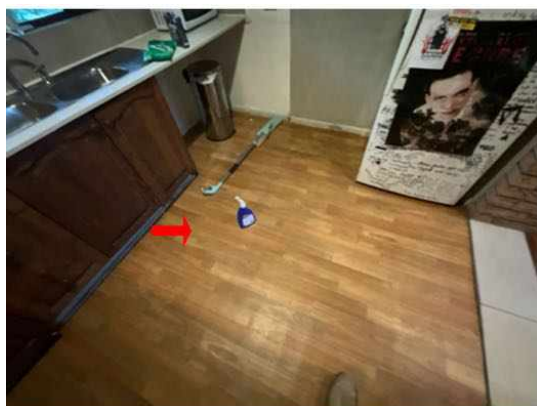
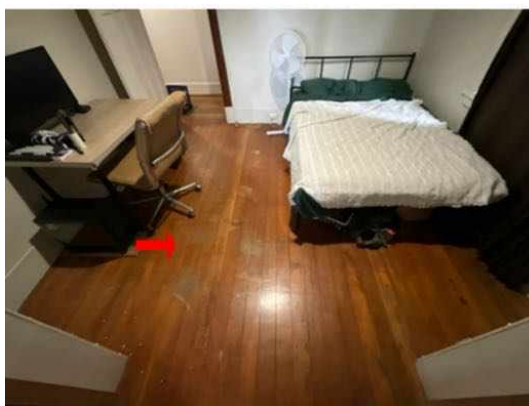
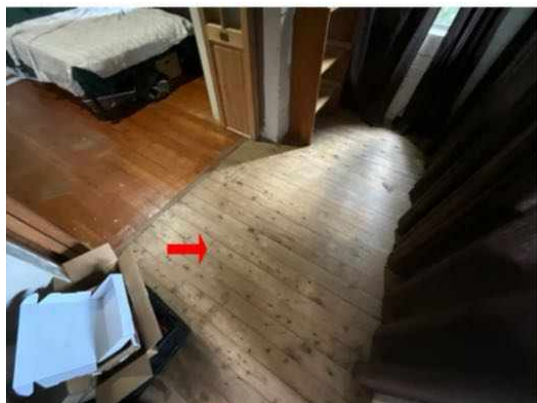
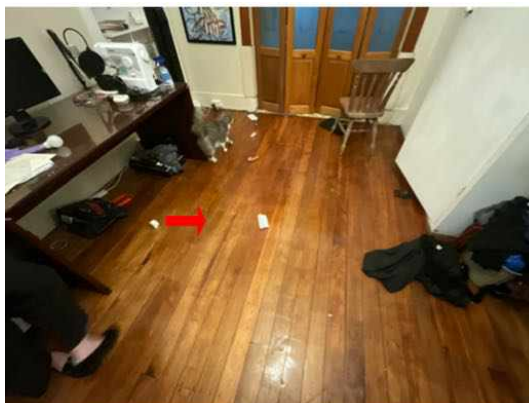
### Finding 3.13

Building:	Main Building
Location:	Kitchen, Bedroom
Finding:	Floors - bouncy
Information:	The internal flooring in this area was identified as being bouncy at the time of inspection. A bouncy floor surface generally presents as a discernible change in level as they are walked across, in noisy or creaking flooring, or in consequent movement of surrounding furniture and fixtures.

Bouncy floors generally indicate that the floorboards or the subfloor structures are coming loose from the joists that they are installed on. Bouncy flooring may also be the result of gaps between flooring and joist structures, which require packing.

The client is advised to seek quotations for required repairs from a Registered Builder.

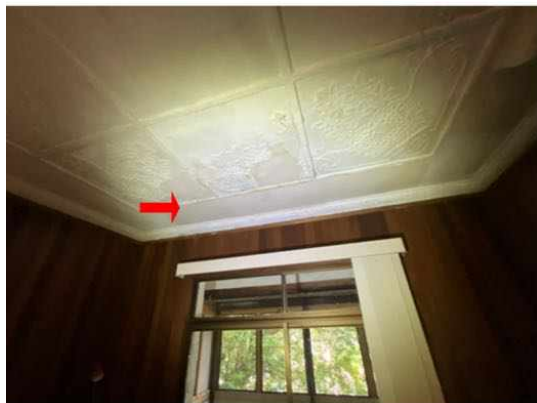
### Finding 3.14

Building:	Main Building
Location:	Lounge Room
Finding:	Ceiling - Water stained
Information:	Water staining to ceiling linings in this area was evident at the time of inspection. Water staining indicates that surfaces have been exposed to excessive moisture over time. The minerals and other elements in the water lead to staining, which may graduate to corrosion and deterioration if left unmanaged.

Although there was no moisture detected in the ceiling I would recommend monitoring and acting on one of the following.

Where water staining is active, a licensed plumber must be consulted to identify the cause of the staining and to provide advice on any reparation works that may be required. Replacement of any damaged structures is advised.

Conversely, where water staining is old and inactive, affected building materials may be repaired or replaced at client discretion.

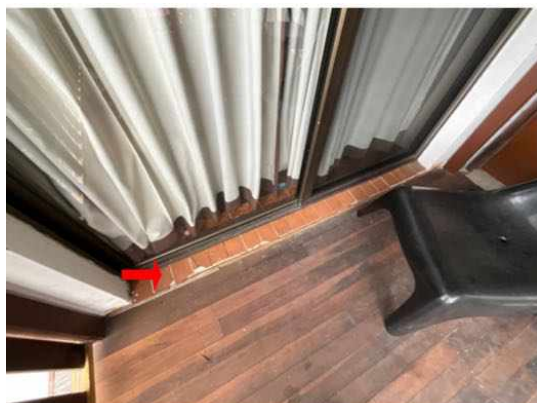
### Finding 3.15

Building:	Main Building
Location:	Balcony
Finding:	Tile - Cracked or damaged
Information:	Cracking was evident to the tiling in this area at the time of inspection.

I recommend appointing a tiling contractor to see what necessary works are required to replace any damaged tiles.

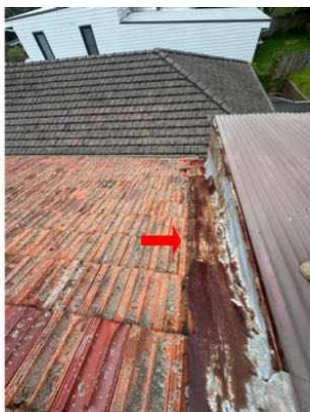
### Finding 3.16

Building:	Main Building
Location:	Roof Exterior
Finding:	Building element - Rusted or corroded
Information:	This building element shows evidence of rusting and corrosion, which is likely to have developed as a result of excessive exposure to moisture and or inadequate coatings.

As surface rust provides no protection to the underlying iron, the deteriorating condition is likely to worsen if not addressed in the short-term future.

Where possible, the use of galvanized (treated) metals or aluminium coated metals aid in rust prevention, as does regular general maintenance. Rust formation can be controlled with coatings, such as paint, that isolate the iron from the environment.

Rusting and corrosion should be managed by ideally removing or limiting the affected surface from exposure to moisture.

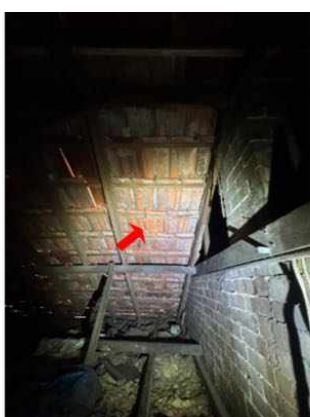
### Finding 3.17

Building:	Main Building
Location:	Roof Void
Finding:	Roof Battens Appearing to Overspan in Sections
Information:	Sections of the roof battens appear to be overspanning between supports. The condition was not noted throughout the entire roof structure but is present in isolated areas.

A builder or roofing contractor should assess the affected areas and install additional support or rectification works as required to ensure adequate structural support.

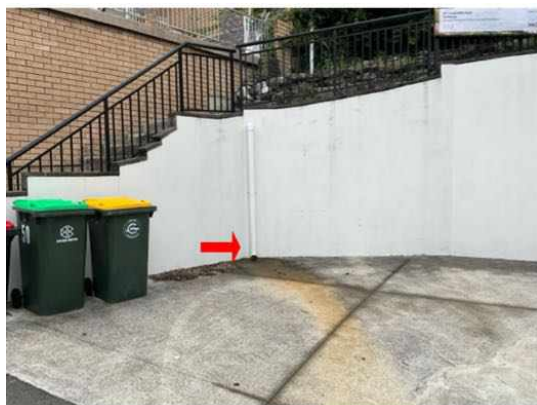
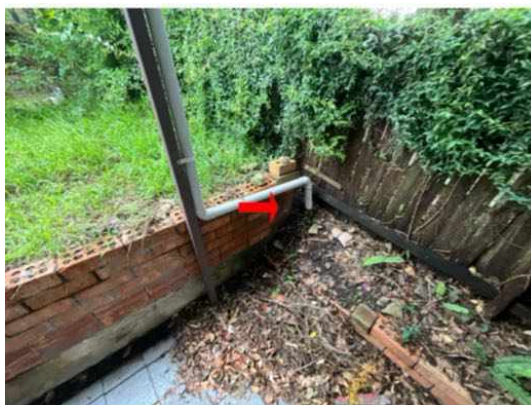
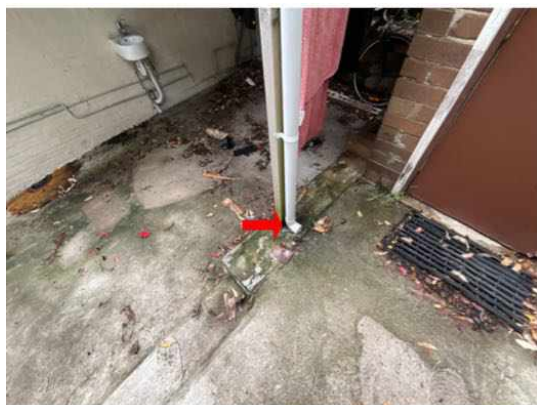
#### Finding 6.02

Building:	Main Building
Location:	Exterior walls
Finding:	Excessive moisture - identified
Information:	Excessive moisture can attract termites and produce conditions that promote fungal growth and wood decay.

to further inspect the property and to identify the cause of the excessive moisture.

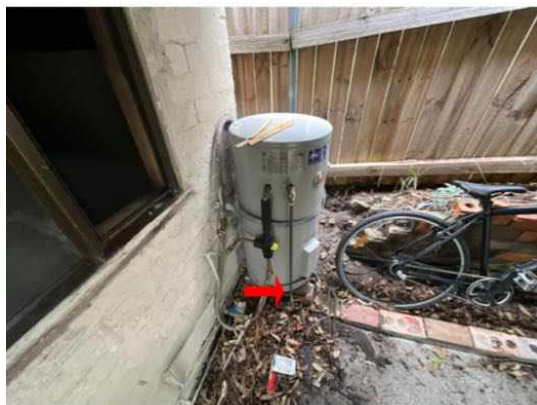
### Finding 6.03

Building: Yard  
Location: Yard - Back  
Finding: HWS Overflow - Not Connected  
Information: The Hot Water System (HWS) overflow was found to be disconnected from storm water drainage and is creating excessive moisture in the surrounding area.

It is highly recommended that a licensed plumber be appointed to connect the HWS overflow in order to prevent such an environment from being created.

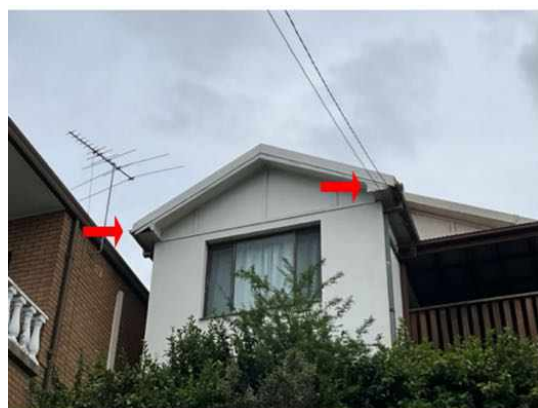
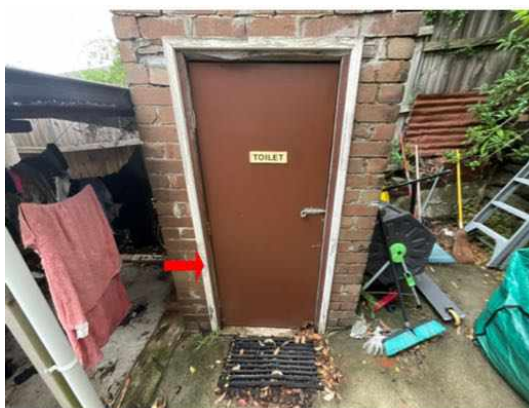
### Finding 7.01

Building:	Main Building
Location:	External Areas
Finding:	Fungal decay - present (localised)
Information:	Fungal decay also known as wood decay or wood rot generally refers to the deterioration of timber elements when in contact with excessive levels of moisture for a prolonged period of time.

In this case although the affected timber element is in a decaying state the extent of any visible damage appears to be localised to a specific area and is yet to spread to other parts of the building element or affect adjoining structures. The fungal decay is therefore likely to be of a relatively superficial nature with minimal impact on the structural integrity or tensile strength of the timber element.

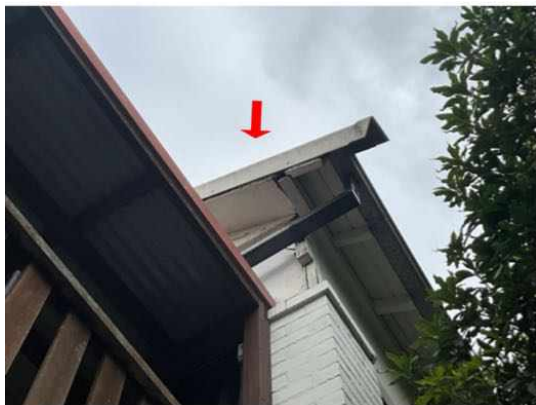
**Noted Item**

Building: Main Building  
 Location: Roof Exterior  
 Finding: Asbestos - Suspected ACM Identified on Site

Information: Reporting on Asbestos is outside the Scope of this Report. This suspected defect is highlighted as a caution only. We suspect, based on our experience in the building industry, that there is a higher risk of the identified building element containing asbestos.

As Asbestos Reporting is outside the scope of this report, we advise that you consider a separate Asbestos Inspection and Condition Audit, which can include the taking of samples for definitive confirmation of the presence of Asbestos.

In the interim, the client is advised to act with caution, especially when considering any damage to building materials general wear and tear renovations extensions demolition and general maintenance activities due to the suspected presence of Asbestos.
