Building and Timber Pest Inspection Report VR

Inspection Date: Fri, 23 Jan 2026

Property Address: 29 Kiora St, Panania NSW 2213, Australia

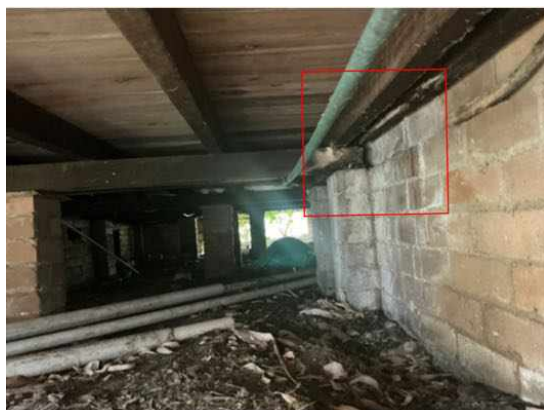
Finding: Subfloor structure - Wood rot

Information: The subfloor structures underneath the bathroom area are showing signs of deterioration. It is suspected that this defect has developed as a result of damp conditions in the subfloor or the possibility of previous excessive moisture from the bathroom above.

Damp conditions cause the timbers to fail, resulting in the subfloor structures failing to bear the load (or weight) of the building as originally intended. Without repairs and maintenance, including potential replacement of affected elements, it is likely that serious structural faults will result, as well as an array of minor defects.

A licensed builder or carpenter is highly advised to attend to the issue and undertake further investigation for rectification works as soon as possible.

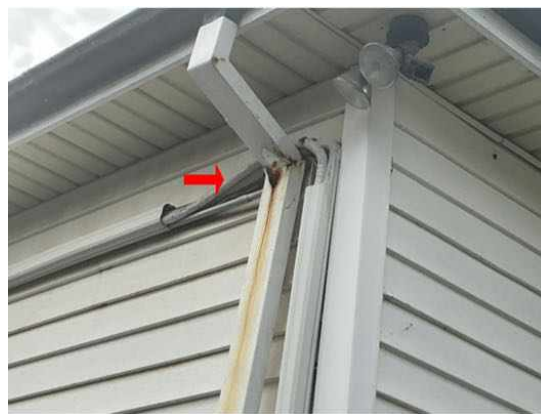
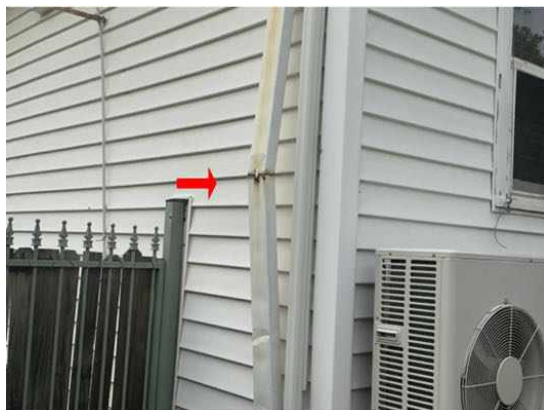
Building:	Main Building
Location:	Exterior walls - left side
Finding:	Down Pipe - Deteriorated
Information:	The damage of the down pipe has occurred as shown in the photos.

Breakage and deterioration occurs generally when either the metal/timber has aged and decayed with excessive moisture, or as a result of damage (accidental or deliberate).

Repair and/or replacement of the down pipe is advised to ensure that additional secondary defects do not arise as a consequence. Such works are necessary, as all building elements play a key role in the operation and function of the overall structure and its performance.

A licensed roof plumber should be appointed immediately to repair or replace the damaged gutter prior to any subsequent damage being caused.

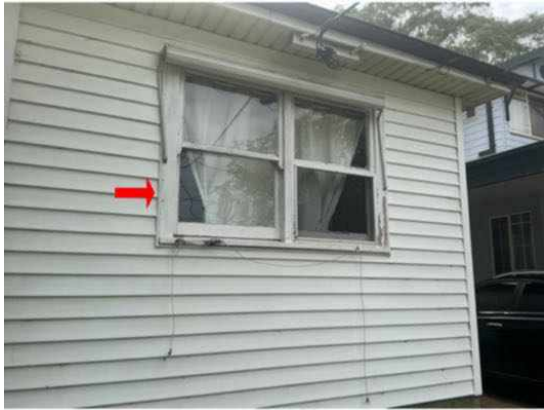
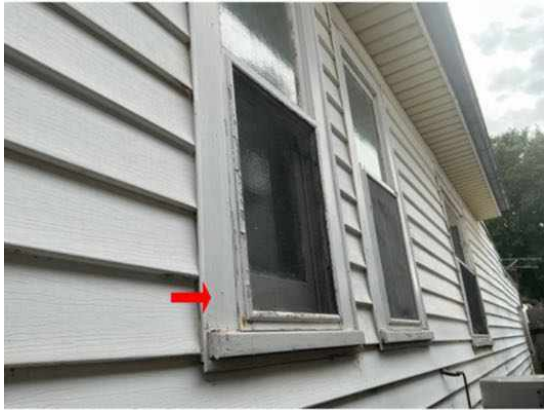
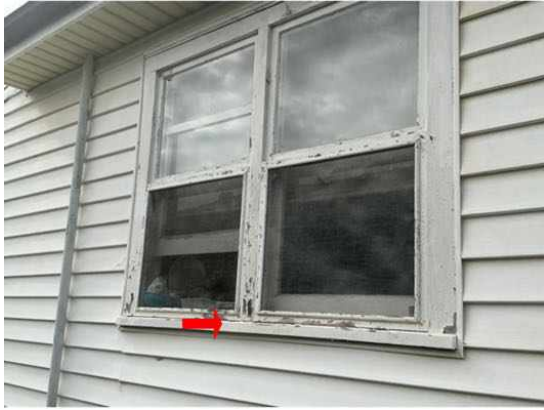
Finding 3.02

Building:	Main Building
Location:	All External Areas
Finding:	Timber Windows - Weathered
Information:	The timber-framed windows throughout the property are showing signs of weathering and deterioration, including peeling paint, surface cracking, and general wear, likely resulting from prolonged exposure to the elements and a lack of routine maintenance.

Timber windows require regular sealing, painting, and inspection to prevent moisture ingress, timber decay, and eventual structural compromise. If left unaddressed, ongoing deterioration may lead to rot, air and water leaks, and costly repair or replacement.

It is recommended that a qualified tradesperson assess the extent of the damage and undertake repairs or restoration, followed by an appropriate maintenance schedule to preserve the condition of the timber.

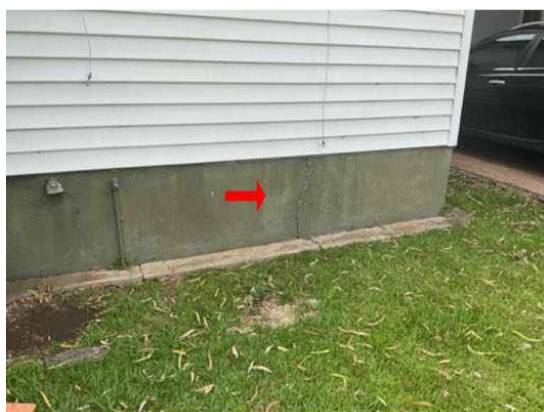
Finding 3.03

Building:	Main Building
Location:	Exterior walls - front
Finding:	Brickwork - Cracking Foundations General
Information:	Cracking was identified to the brickwork in various areas at the time of inspection. Cracking, has a variety of possible causes. However, the most common is the subsidence of adjacent footings.

Cracking is a relatively common defect, and is most likely to occur adjacent to windows, doors and other openings. Mortar failure in the gaps between affected bricks indicates the stresses and tensions affecting the wall.

Where cracking is extensive or severe, the client is advised to consult a structural engineer. Minor step cracking can be used as a warning sign to address factors causing stress to the wall, which can include the effect of surrounding trees, water leaks, soil erosion, or even the presence of reactive soils in the surrounding area.

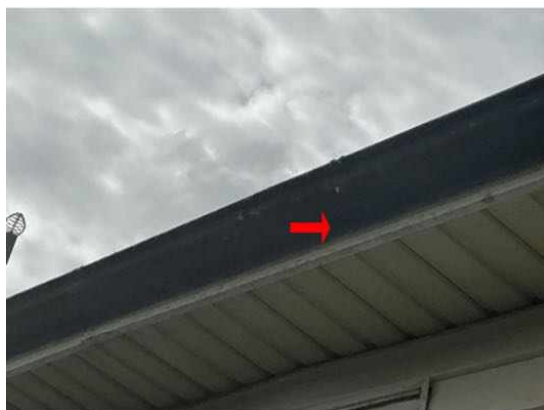
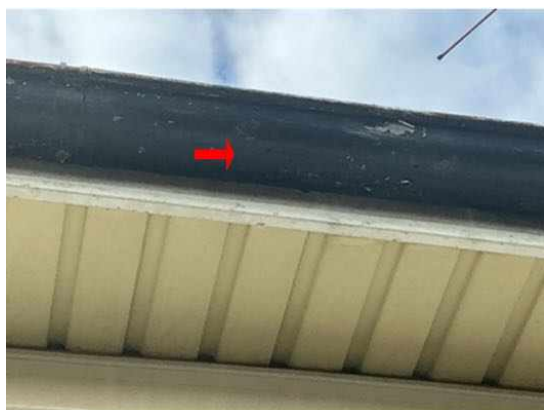
Finding 3.04

Building:	Main Building
Location:	All External Areas
Finding:	Gutters Damaged/Deteriorated
Information:	Breakage and deterioration occurs generally when the building materials have either aged and decayed with excessive moisture, or as a result of damage (accidental or deliberate).

Repair and/or replacement of these materials is advised to ensure that additional secondary defects do not arise as a consequence. Such works are necessary, as all building elements play a key role in the operation and function of the overall structure and its performance.

A licensed roof plumber should be appointed to repair or replace the affected building element prior to any subsequent damage being caused.

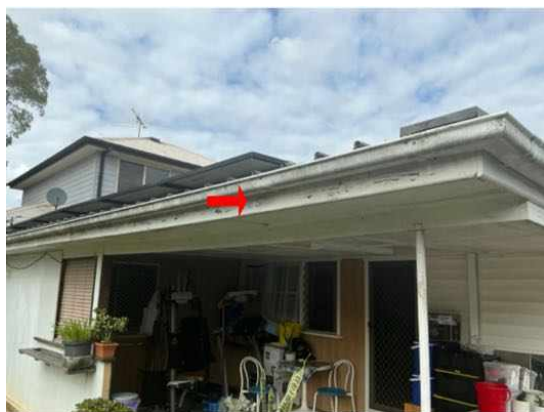
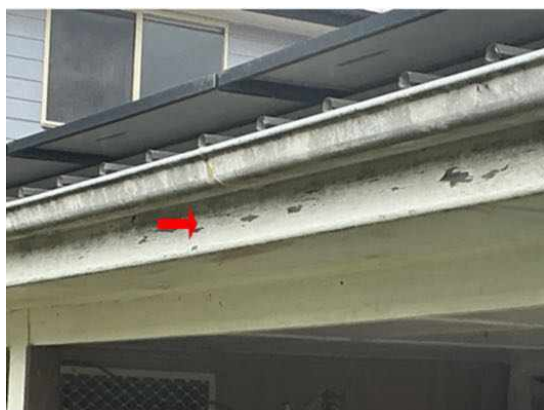
Finding 3.05

Information: External timber elements around the property were observed to be showing signs of general wear and tear, including surface deterioration, fading, and early signs of weather exposure. These conditions are commonly caused by prolonged exposure to sunlight, moisture, and temperature fluctuations, which can lead to cracking, splitting, or degradation over time if not properly maintained.

It is recommended that all external timber be inspected and maintained to ensure ongoing protection. This may include sanding, sealing, or repainting affected sections. Regular maintenance will help preserve the timber's integrity, extend its lifespan, and prevent more extensive damage in the future.

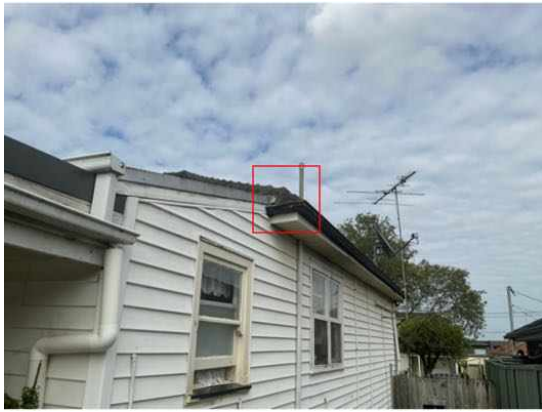
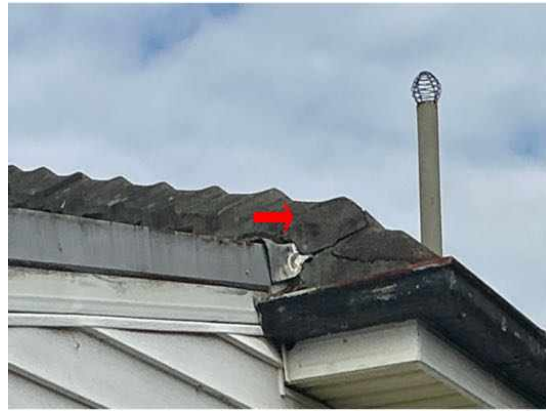
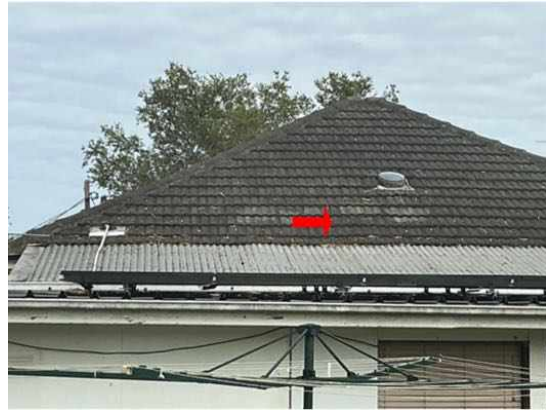
Finding 3.06

Building:	Main Building
Location:	Roof Exterior
Finding:	Roof tiles - Weathered
Information:	Upon inspection of the exterior roofing, the majority of roof tiles were considered to be in a fair condition. While weathering of the tiles is consistent with the age of the property, maintenance works are required.

Isolated areas of mortar have come loose on the ridges and minor cracking is also present. Re-pointing and re-sealing the may be considered as an interim solution by the client to help preserve and extend the life span of the tiles.

Where left unmanaged, deteriorating roof tiles are likely to lead to a number of secondary defects, including minor water leaks and weather exposure to internal roofing structures.

Consultation with a roofing contractor is highly advised to gain advice on cost of remedial works that may be required in the short to medium term. Remedial works are likely to increase the longevity of the exterior roofing structure.

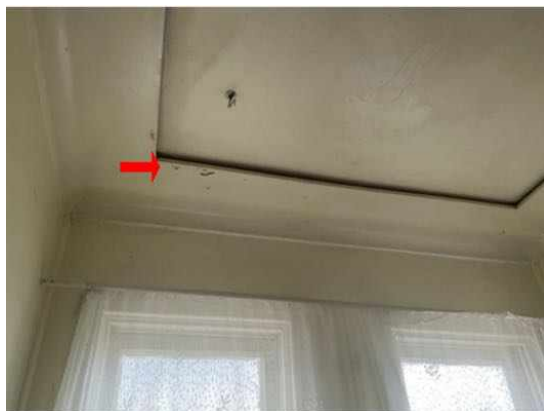
Finding 3.07

Information: Sections of paint in this area was found to have peeled and deteriorated. Paint peeling and or bubbling is generally an indication of excessive moisture in the area, that is currently hidden by the painted surface.

The presence of excessive moisture can have major implications on associated building elements if left unattended. While only seemingly minor at this stage, the damage cannot be determined due to the paint obstructing any further inspection of the damage.

It is highly advised that the affected paint be cleaned to allow a further, more invasive inspection by a licensed plumber. Failure to act on this defect may necessitate major works in the future.

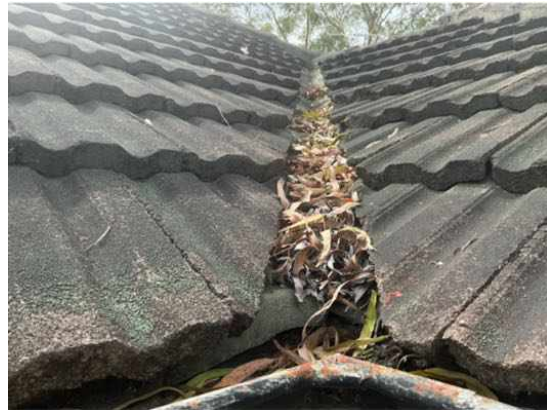
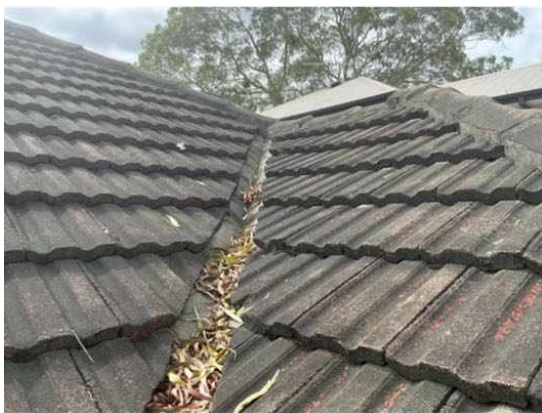
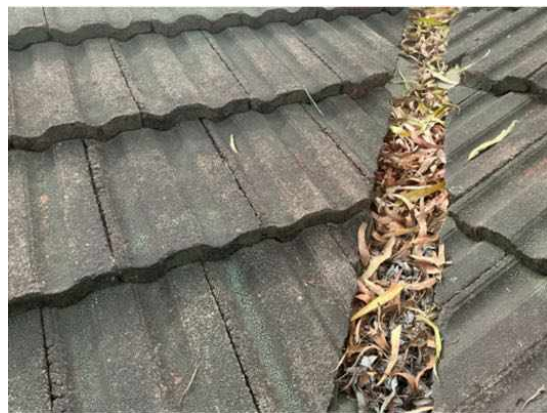
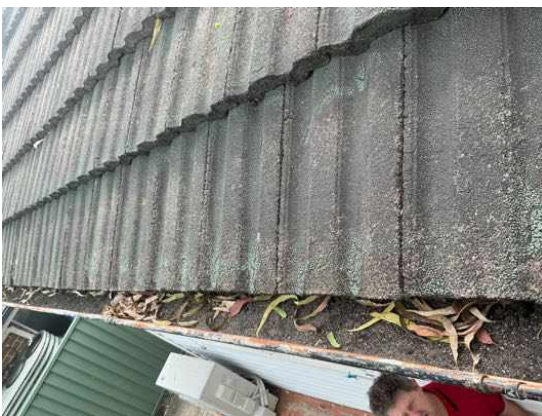
Finding 3.08

Building:	Main Building
Location:	Roof Exterior
Finding:	Gutters - Debris
Information:	Roof plumbing structures, such as guttering and downpipes, should be free of all debris to prevent blockages. Blockages in the guttering and downpipes will lead to pooling and accumulated water overflow, which is likely to flood the eaves and exterior walls.

In addition to blockages, leftover materials in the gutters could also cause damage. These materials, if not cleared, may contribute to rust, decay, and further deterioration of the building materials. Over time, moisture buildup caused by blockages and debris can also create conditions which could lead to additional structural issues.

Blockages and debris should be removed immediately to ensure dry conditions are maintained.

It is recommended to consult a licensed plumber for specific advice on any necessary

remedial works. In the interim, it is strongly advised that a general handyperson clear the building material as a matter of urgency to prevent further damage.

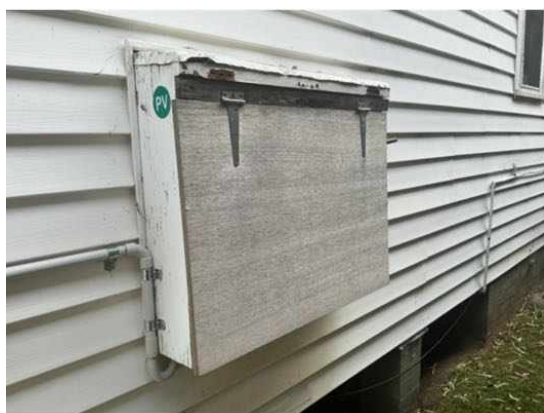
Evidence of this sticker has NOT been located in the meter box. Please see photos attached

Where a Termite Management System has not been identified you should consult a licensed pest inspector immediately to undergo further investigation in what measures would be necessary to maintain a functional pest management system. It is also recommended that a Licensed Pest Controller attend to determine the viability of the current or past treatments

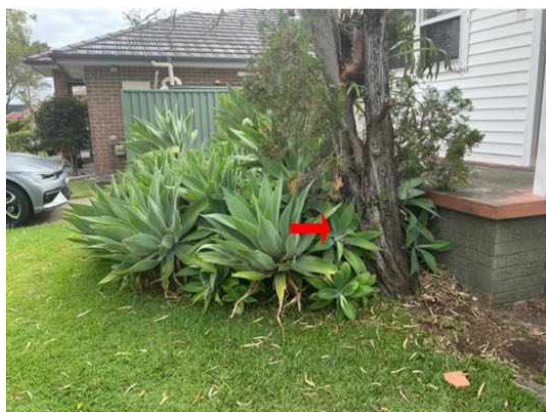
Finding 6.02

Building:	Main Building
Location:	All External Areas
Finding:	Garden Beds - Conditions Conducive to Termites
Information:	Garden beds were observed in direct contact with the building's perimeter across various areas of the property. In some areas, untreated timber and mulch were used. This configuration, combined with regular watering or hosing, creates conditions conducive to termite activity and increases the risk of termite ingress into the structure.

Garden beds placed against external walls, particularly those incorporating untreated timber or excessive mulch, can retain moisture and create hidden entry points for termites. This undermines the effectiveness of termite barriers, compromises weep hole visibility, and elevates the risk of concealed termite activity that may lead to structural damage.

The current placement and construction of garden beds present a termite risk and deviate from best practice recommendations for termite management. Rectification and professional input from both a landscaper and pest management specialist are advised to ensure the building remains protected while achieving the desired landscape design.

Implement regular pest inspections and engage a licensed pest control specialist to assess and manage termite protection systems.

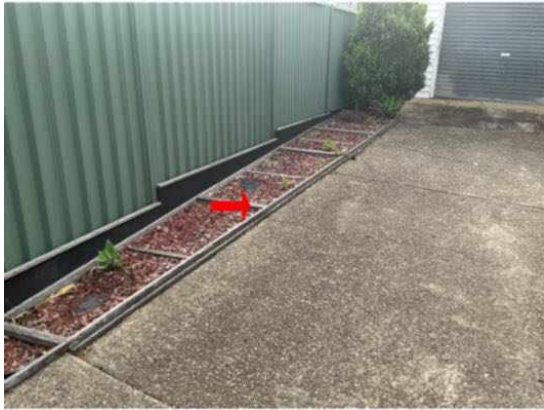
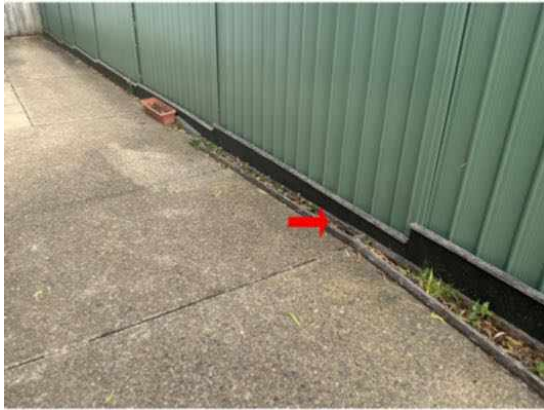
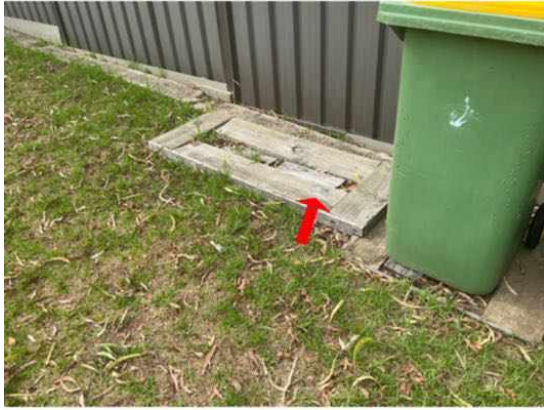
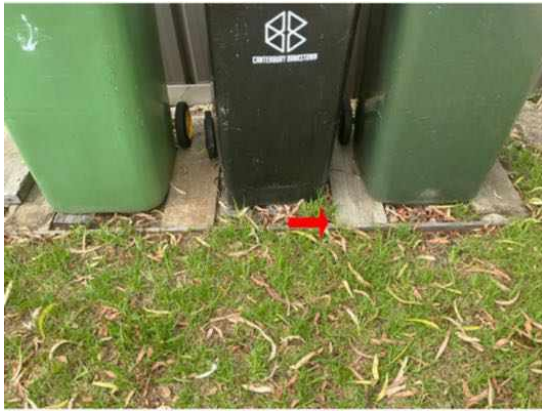
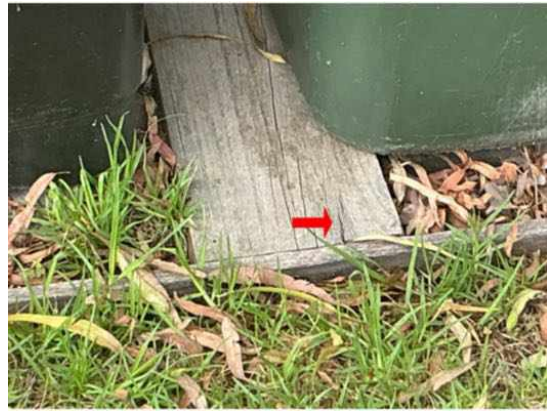
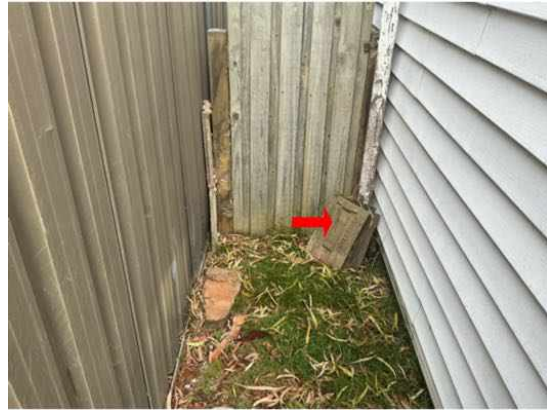
Finding 6.03

Building:	Main Building
Location:	All External Areas
Finding:	Timber Materials In Direct Ground Contact- Conducive to Termites
Information:	Timber elements that are in direct contact with the ground and exposed to moisture or damp conditions are highly conducive to termite activity. This susceptible arises because of timber, when in contact with soil and dampness, create an environment that is particularly attractive to termites, encouraging infestation and potential structural compromise. Whether the timber is used as part of the building construction or incorporated into fencing, the presence near or on the ground can become a pathway for termites to access And damage the property.

When exposed to excessive moisture, timber begins to deteriorate developing condition such as wood decay or rot. These compromised areas of timber are even more appealing to termites as they are easier to infest and consume. This is especially true for untreated or non-durable timber, which lacks the protective treatments that can deter or withstand termite attacks. Termites can use these weakened moisture laden elements as a bridge into other parts of the structure, creating an entry point for potential infestations that can spread and cause extensive damage if left unchecked.

For any timber in direct contact with the external ground special attention is required the combination of moisture untreated wood and direct ground contact not only accelerate the decay process but also provide subterranean termites with a straightforward means of ingress into the structure this can lead to termites moving undetected into other vulnerable areas resulting in potentially significant structural issues and costly repairs.

To mitigate the risk of termite activity it is imperative that any such materials or timber elements be appropriately treated or removed as soon as possible. Timbers that are necessary for use should be made durable through appropriate treatments and maintained to ensure they do not create conditions conducive to termites. Additionally the client is advised to schedule regular termite treatments to maintain an effective barrier against infestations and ensure ongoing protection.

Regular inspections, proactive maintenance and consistent termite treatment are essential steps in minimising the risk of termite attack and protecting the structural integrity of the property. Taking these preventative measures is crucial for maintaining a termite free environment and avoiding potentially costly damage and future repairs.

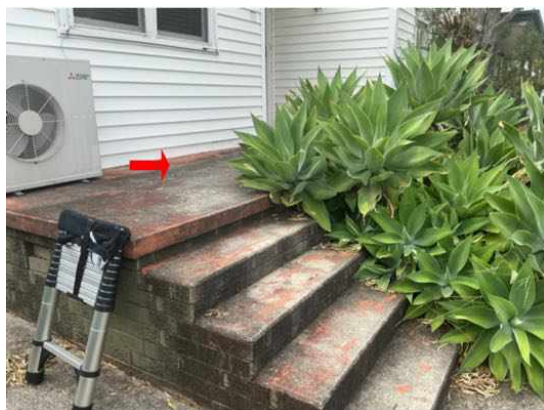
Finding 6.04

Building:	Main Building
Location:	All External Areas >
Finding:	Bridging Of Physical Barriers - Patios/Porches
Information:	Breaching is the spanning of a physical termite barrier or inspection zone so that subterranean termites are provided with an entry point over or around that barrier.

The concrete porch/patios are providing a concealed entry point at the time of the inspection. Where the location of the porch is retrospectively installed against an external wall this will provide a concealed entry point for termites.

The client should consider gaining further advice from a timber pest technician as to treatments required in this area. It is recommended that obtaining such advice be a short-term priority.

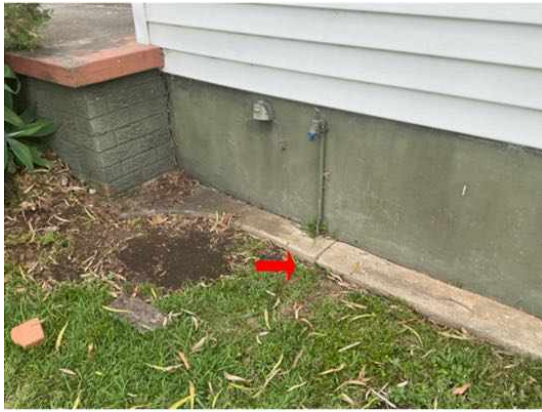
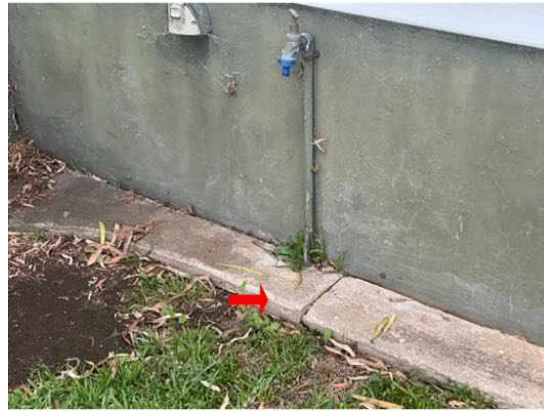
Finding 6.05

Information: The external garden taps were found to have inadequate drainage at the time of inspection, creating potential for subsequent water damage to associated building elements. In this case the waste is not directly beneath the water tap which poses a significant risk of water pooling around the base of the tap which can result in a series of moisture related problems that could compromise the structural integrity of the property and create an unsafe environment.

Excessive moisture encourages the growth of mould and mildew, which can spread to other areas of the property. This not only affects the aesthetics but can also have serious health implications for occupants particularly those with respiratory conditions or allergies.

Stagnant water around an exterior tap can attract pests such as termites which thrive in moist environments. This creates a pathway for these pest to enter the property and cause extensive damage to wooden structures. The presence of termites can compromise the property structural integrity and lead to costly and invasive repairs if not promptly address.

It is highly recommended that a licensed plumber be engaged to inspect the exterior tap area comprehensively and determine the best course of action. This may involve the installation of a stormwater drain or other drainage solution designed to redirect water away effectively by taking these measures the property owner or client can significantly reduce the risk of structural damage mould growth and termite attack insuring the property remains safe and well maintained

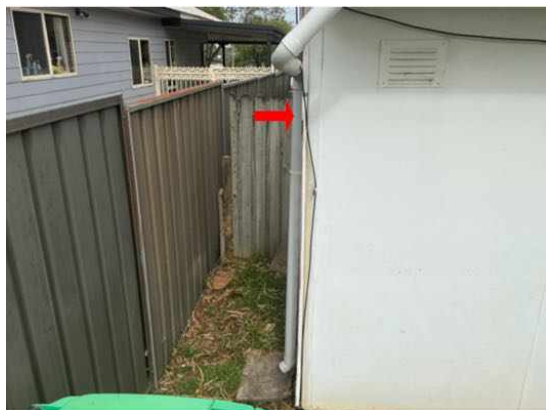
Finding 6.06

Building:	Main Building
Location:	Exterior walls - right side
Finding:	HWS - Disconnected overflow
Information:	The Hot Water System overflow was found NOT to be connected to the storm water drainage and is creating excessive moisture in the surrounding area.

Poorly aligned materials can and will lead to further damage to nearby areas.

rust and corrosion of surrounding building elements, as well as attracting termites and other pests.

It is highly recommended that a licensed plumber be appointed to connect the A/C overflow in order to prevent such an environment from being created. These minor works should be carried out as soon as possible.

It is highly recommended that a plumber be appointed to further inspect the area and to install adequate drainage equipment where necessary.

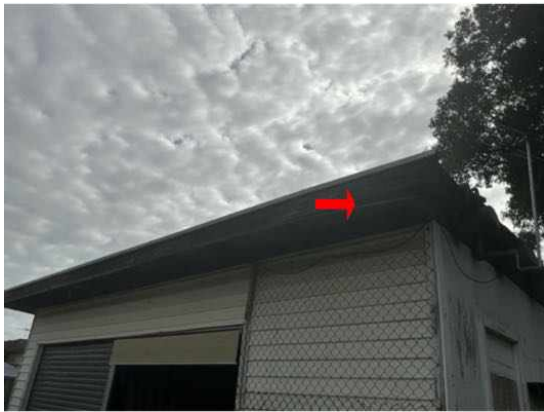
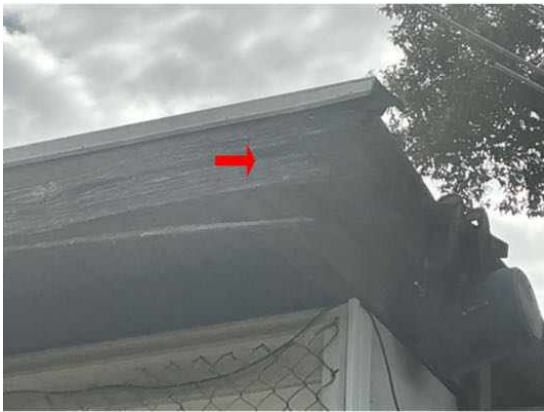
Finding 7.01

Building:	Main Building
Location:	Garage
Finding:	Fascias - Wood rot
Information:	Wood rot was found to be affecting fascias and barges in this area. Wood rot, also known as Fungal Decay, occurs when timbers and other cellulose building materials are exposed to damp conditions on an ongoing basis.

It is likely that this wood rot has developed as a result of faults in the roof plumbing, creating excessive moisture in this areas. Frequent exposure to rain and other weather conditions also make fascias and barges susceptible to accelerated deterioration.

Early intervention and regular maintenance will prolong the useful life of these building elements. Prior to any works being performed, the cause of the moisture that has created the visible wood rot should be identified and addressed in a suitable manner.

It is advised that a roof plumber be appointed to inspect all roof plumbing and subsequently identify the cause of the wood rot. Replacement of affected fascias and barges may then be a necessary step in protecting surrounding building elements from such deterioration.

A qualified plumber may be appointed to assess the cause of excessive moisture and to provide advice on any remedial works as required. A qualified carpenter or registered builder may also be required to replace affected building materials.

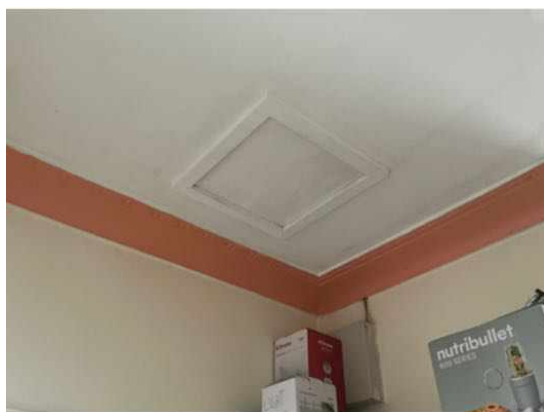
Building: Main Building
Location: Roof Void

It is recommended that the access opening be reviewed and enlarged to meet the minimum standard for inspection and maintenance purposes.

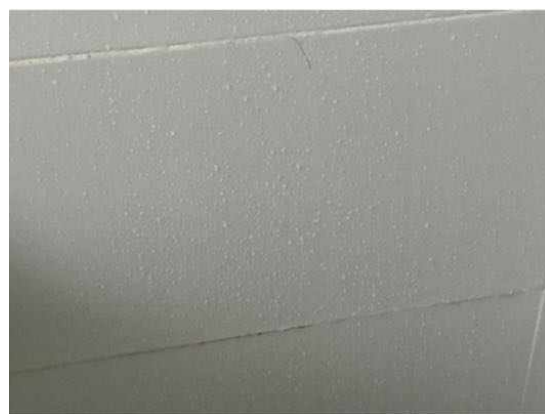
Building: Main Building
Location: Bedroom
Finding: Locked Or Inaccessible
Information: At the time of the inspection the associated room was locked or inaccessible.

Accordingly, the moisture condition of the underlying wall and floor areas could not be determined at the time of inspection.
