# Building and Timber Pest Inspection Report

Inspection Date: Wed, 8 Apr 2026

Property Address: 48 Combermere St, Goulburn NSW 2580,  
Australia

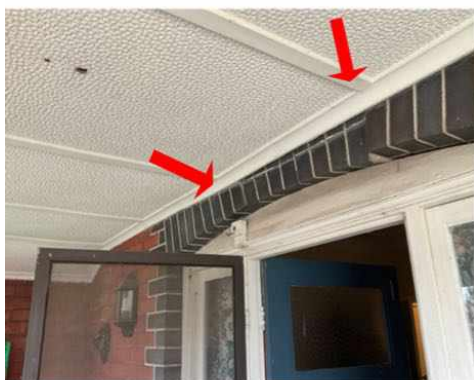
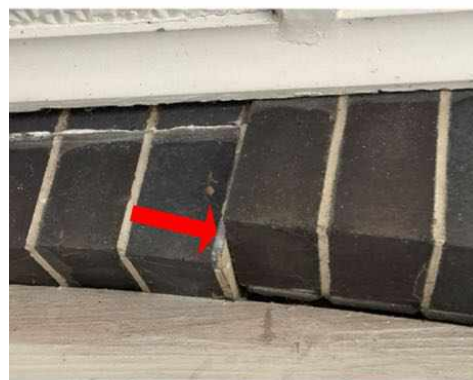
Building:	Building 1
Location:	Yard - front
Finding:	Step cracking to brickwork - major
Information:	Step cracking was identified to the brickwork in the front verandah arch external wall area at the time of inspection. Eight bricks are now loose and may fall causing injury.

The NSW Standards and Tolerances 2017 states cracks over 5mm in width are a major defect requiring rectification work.

Step cracking, which is similar to other forms of cracking, has a variety of possible causes. However, the most common is the subsidence of adjacent footings.

Where step cracking is extensive or severe, the client is advised to consult a structural engineer. Minor step cracking can be used as a warning sign to address factors causing stress to the wall, which can include the effect of surrounding trees, water leaks, soil erosion, or even the presence of reactive soils in the surrounding area.

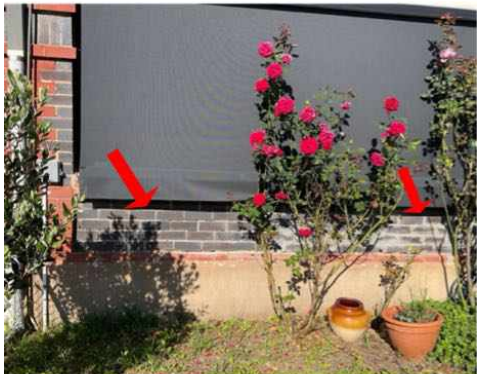
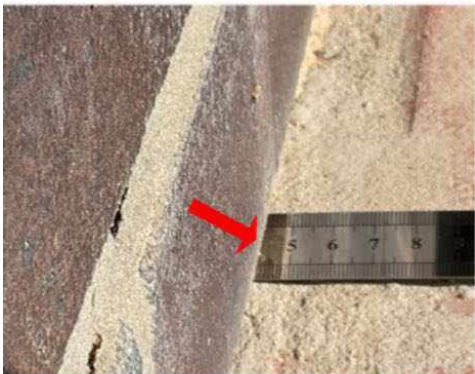
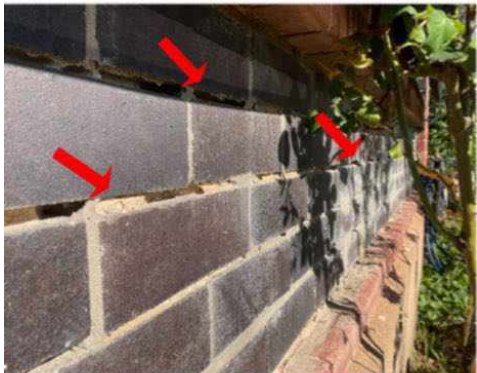
#### Finding 2.01

Finding: Brickwork mortar missing (major on front wall, minor on chimneys)  
Information: Many areas of mortar was found to be missing at the time of the inspection. Some areas have been repaired, more repairs are now required (next few months).

Mortar that is missing may allow water ingress into these areas, putting associated building elements at risk of water damage.

Missing mortar should be attended to by bricklayer as soon as possible.

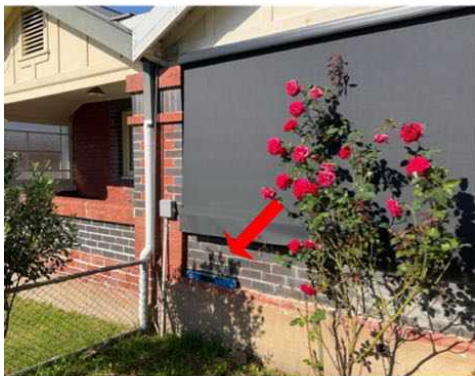
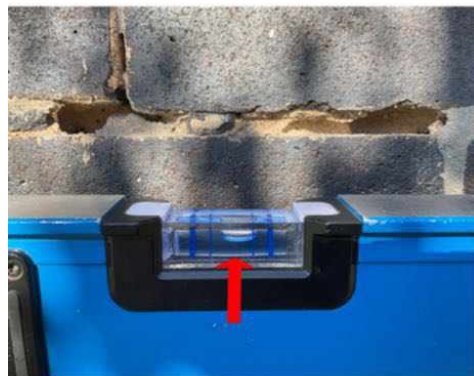
Building:	Building 1
Location:	Front wall and right path areas
Finding:	Subsidence - monitor annually
Information:	It appears that this some paved areas has been affected by movement, often referred to as sinking or subsidence. General subsidence is usually initiated by changes in soil moisture content. The most critical factor is identifying the specific causes, and identifying if this is a recurring or ongoing problem, or one that has been resolved by previous works in the past.

At this point it is recommended to contain storm water flows, ensure pavements flow away from buildings to lessen any excessive wetting and drying effects.

A landscaping contractor can repair these path areas when convenient. Levelling the front walls would not be economically viable.

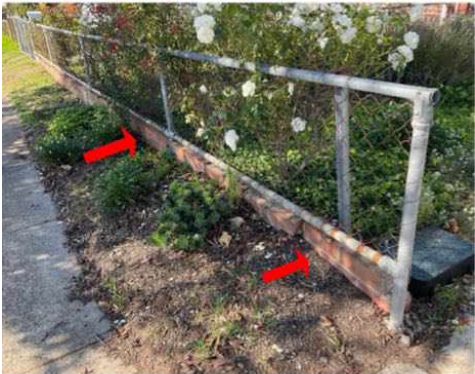
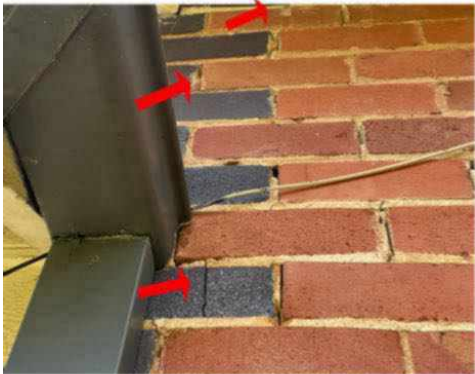
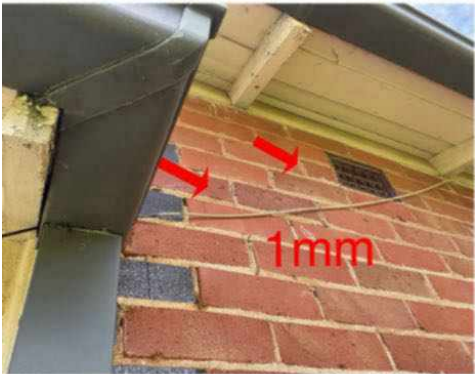
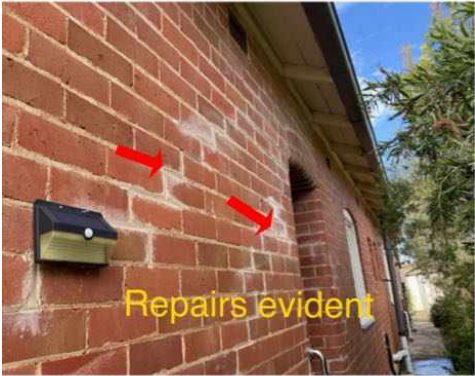
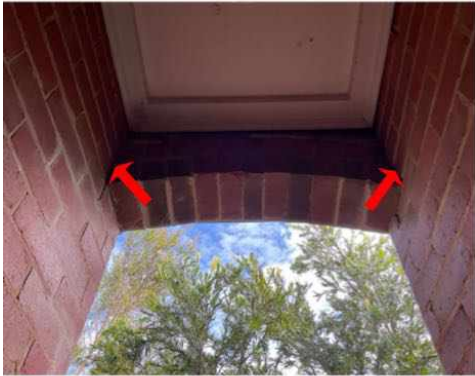
**Finding 3.02**

Building: Building 1  
Location: Exterior walls  
Finding: Step cracking to brickwork (minor)  
Information: Step cracking was identified to the brickwork in these areas at the time of inspection. This minor step cracking can be used as a warning sign to address factors causing stress to the wall, which can include the effect of surrounding trees, water leaks, soil erosion, or even the presence of reactive soils in the surrounding area.

As the front fence is only 3 bricks high, this is described as a minor defect in this report.

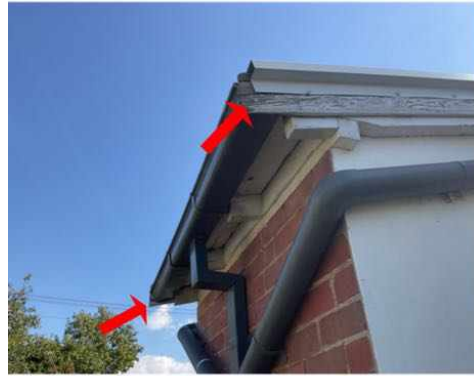
Building: Building 1  
Location: Some perimeter roof areas  
Finding: Roofing areas - Weathered  
Information: Upon inspection of the exterior roofing, the majority of the roof areas were considered to be in a good condition. While weathering of these pictured areas is consistent with the age of the property, maintenance works are required.

Re-sealing and replacing small areas of gaps, damage or rust the may be considered as an interim solution by the client to help preserve and extend the life span of these roofing areas. Where left unmanaged, deteriorating roofing materials are likely to lead to a number of secondary defects, including minor water leaks and weather exposure to internal roofing structures.

Remedial works are likely to increase the longevity of the exterior roofing structure.

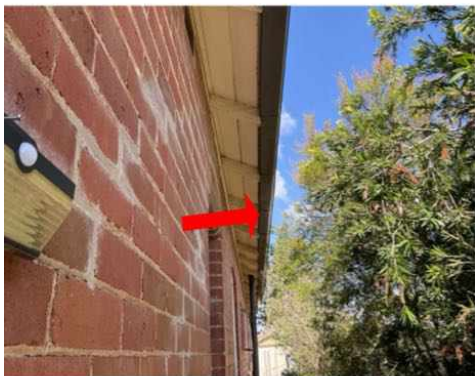
### Finding 3.05

Building:	Building 1
Location:	Laundry toilet and right middle gutter
Finding:	Gutters - Water pooling
Information:	Water was found to be pooling in sections of the roof guttering. This is generally a secondary defect caused by blocked or partially blocked gutters. Such blockages and subsequent water pooling are likely to lead to rust and water damage to associated structures if left unattended.

Any areas of guttering that shows evidence of water pooling should be checked for partial or full blockages and any secondary damage that may have occurred as a result. Depending on the extent of the damage, building elements may require repair and/or replacement to ensure adequate roof drainage and function of exterior plumbing system.

A roofing plumber should be appointed as soon as possible to rectify this issue. It is highly advised that all gutters be maintained on a frequent basis to ensure the condition of roof plumbing.

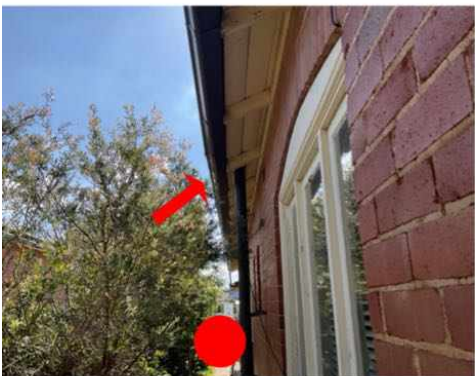
**Building:** Building 1  
**Location:** Laundry toilet and right middle gutter  
**Finding:** Toilet and gutter sagging and leaking  
**Information:** The laundry toilet rear seals from the tank need replacement by a plumber due to leaks. The left gutter is also leaking onto the path.

Non-operational building elements such as this are vital to the function of the household and must be fixed.

A qualified plumber should be appointed immediately to repair the toilet and gutter and return these areas to an operational state.

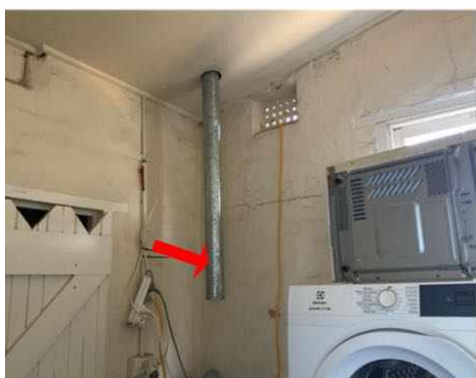
Building:	Building 1
Location:	Pictured external areas
Finding:	Building elements - Loose
Information:	This laundry vent pipe is hanging loose and requires removal and the roof sealing to stop rainwater ingress.

A carpenter would be the trade responsible for rectification of these areas when convenient.

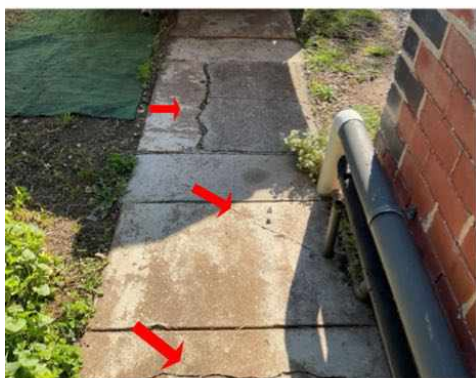
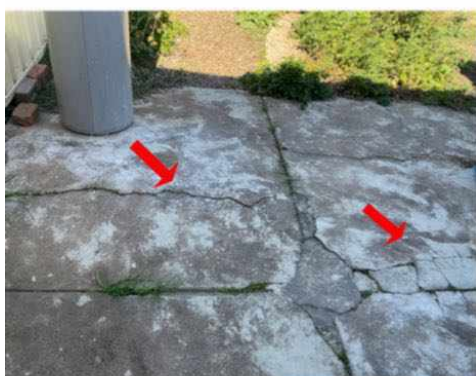
Building:	Building 1
Location:	Yard - front and rear
Finding:	Crack in concrete slab - Category 3
Information:	Cracks coded up to Category 3 was identified in these slabs. A Category 3 crack is described as a wide crack with obvious curvature or change in level, affecting the slab.

The approximate width of the crack to be considered Category 3 is greater than 2.0mm, or a change in offset of 15-25mm when a 3m straight edge is placed over the defect.

Category 3 cracks to slabs exceed allowable Standards and Tolerances, and are considered defects requiring rectification.

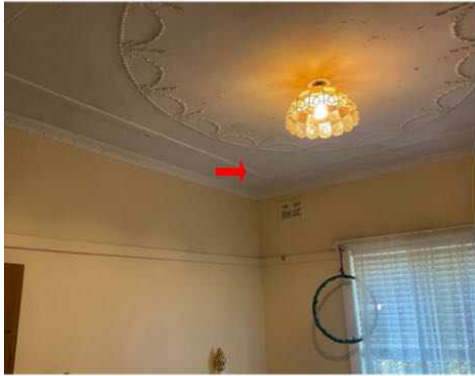
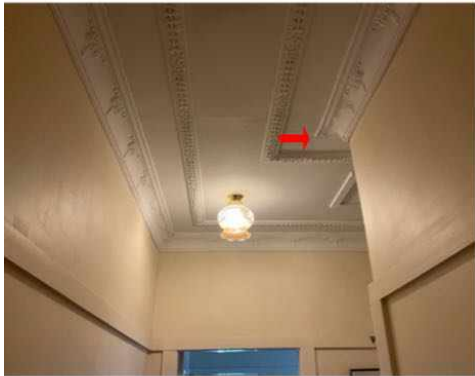
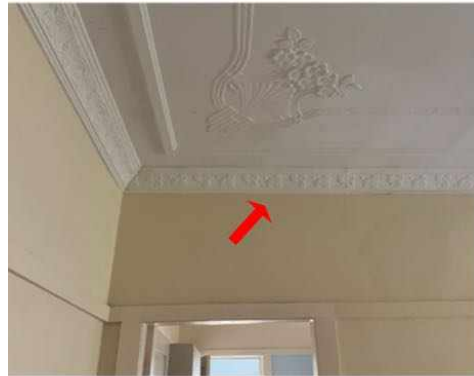
### Finding 3.12

Building:	Building 1
Location:	Small areas of each room
Finding:	Cracking - Damage Category 1 - Fine (up to 1mm)
Information:	Although fine cracks are quite noticeable, they are often only considered to be an appearance defect, and usually do not indicate any structural damage. Generally, the cause of a fine crack is indicative of a separation between building materials and finishes (e.g. paint, plaster, etc.) along joints.

Cracking of this nature can generally be repaired with minor sanding, filling and/or repainting. Such works should be performed by a qualified painter or a general handyman.

Monitoring of all cracking should be conducted frequently. Always contact a building inspector should cracks widen, lengthen, or become more numerous.

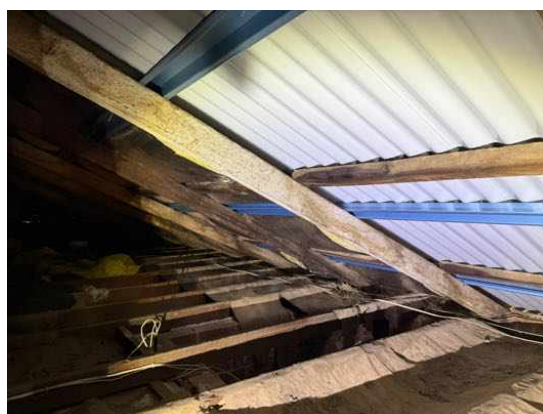
Building: Building 1  
Location: Roof cavity areas  
Finding: Insulation - Partly Missing  
Information: Upon inspection of the roof void it was noted that some insulation is missing.

Insufficient insulation will result in a comparatively higher cost to heat and cool a property as there is a lack of Insulation (or uneven coverage of insulation) which works as a barrier to heat transfer. This helps to keep out unwanted heat in summer and preserves warmth inside your home in winter. It can also help soundproof your home from unwanted airborne noise transfer.

Where insulation is absent, the area does not meet current Australian Standards. Installation of adequate insulation is required and should be conducted as soon as possible.

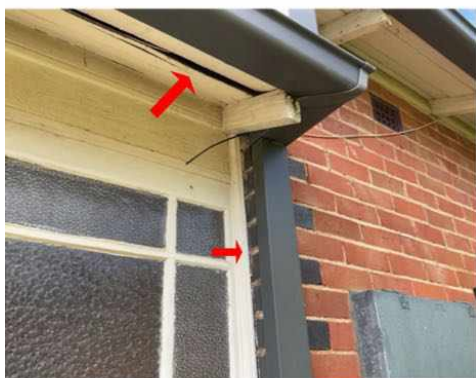
### Finding 3.17

Building: Building 1  
Location: Some window and eave areas  
Finding: Sealant (external) - Missing.  
Information: It was noted on inspection that areas of external sealant was missing to small areas of

Flexible sealants should be applied to these affected areas to prevent any subsequent water damage that is likely to occur.

A sealant specialist or skilled handy person should be appointed to complete these works as soon as possible

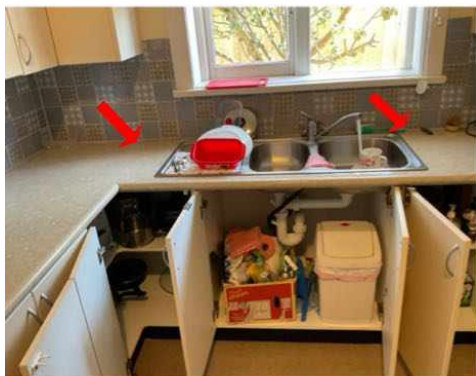
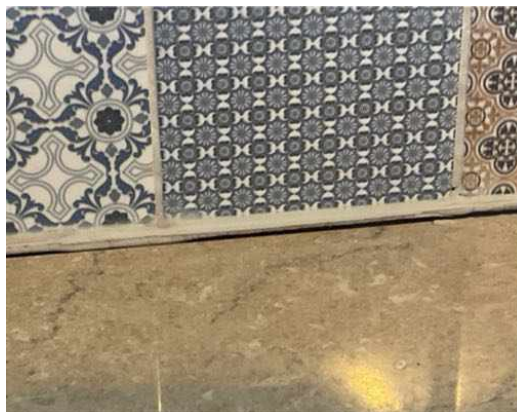
Building:	Building 1
Location:	Kitchen & bathroom shower screen
Finding:	Sealant and grouting - Missing or damaged
Information:	It was noted on inspection that sealant or grout is degraded to these pictured wet areas.

Different materials and floor areas move at different rates, generally causing cracking to grout or sealant at this point. A flexible sealant is required to allow for expected expansion and contraction, while keeping the joint water tight and protective of all associated building materials.

Flexible and mould resistant materials should be applied to affected areas to prevent any subsequent water damage that is likely to occur. Regular maintenance and replacement of damage or missing or damaged sealant and grout is highly recommended to the wet areas, as this is a regular wear and tear defect. Sealant and grouting in areas that come into regular contact with water should be maintained for the long term care of your property.

A sealant specialist or tiling contractor should be appointed to complete these works as soon as possible

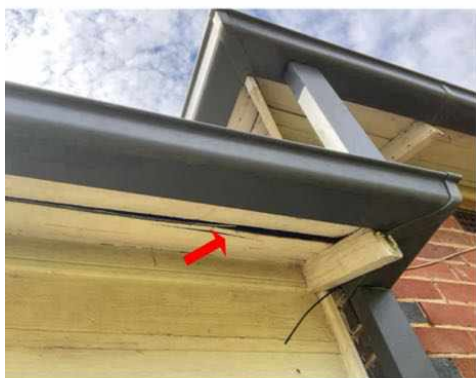
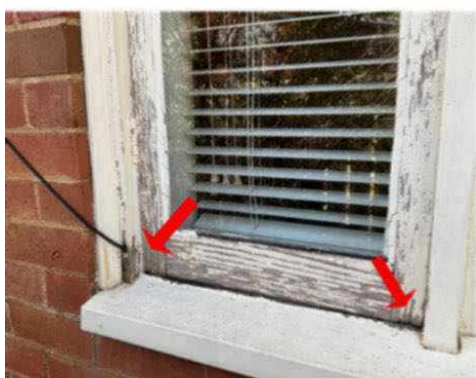
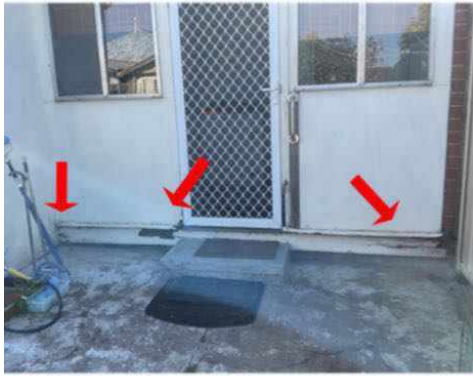
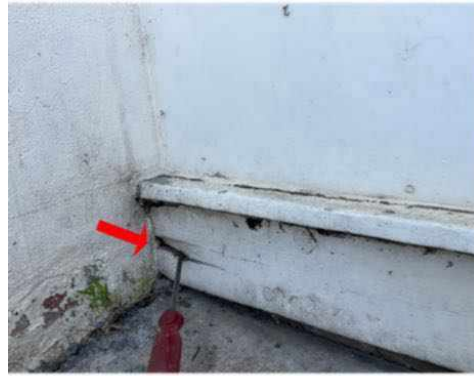
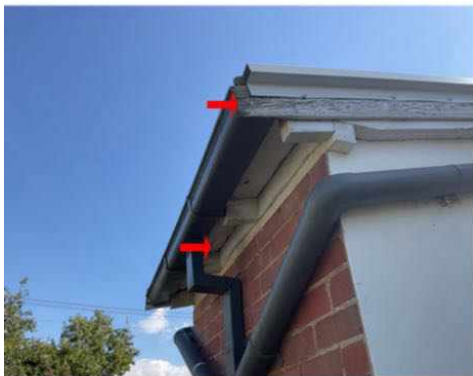
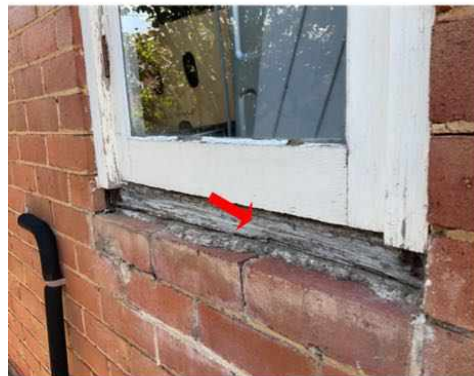
### Finding 3.20

Building: Building 1  
Location: Pictured areas  
Finding: Wood rot  
Information: The building shows evidence of wood rot in many areas. The rear verandah lower timber shows severe rot and wood bora damage required replacement. The flashing above this timber slopes toward the house allowing all rain to rot away this timber over time. There still appears to be supportive timber under the floorboards.

A qualified carpenter or registered builder may also be required to replace affected building materials.

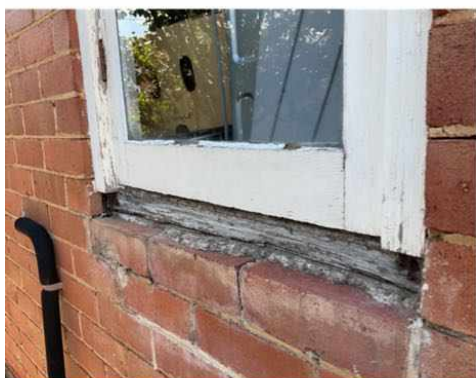
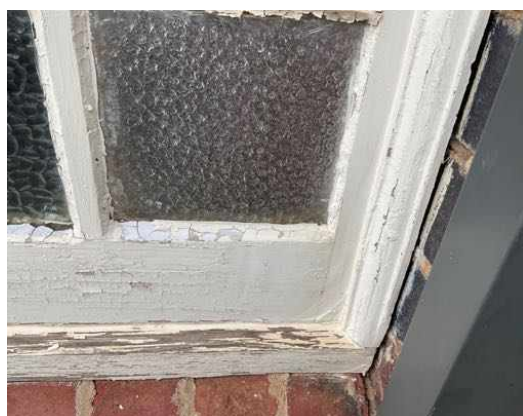
### Finding 3.23

Building:	Building 1
Location:	All windows, facias and garage
Finding:	Painting deteriorated
Information:	Much of the external paintwork has been neglected and require attention to prepare and re-paint.

A painting contractor should be appointed as soon as possible to perform necessary works to aid the appearance of the affected area and to ensure the area is protected against further deterioration. Alternatively, the homeowner following manufacturer instructions may perform these works.

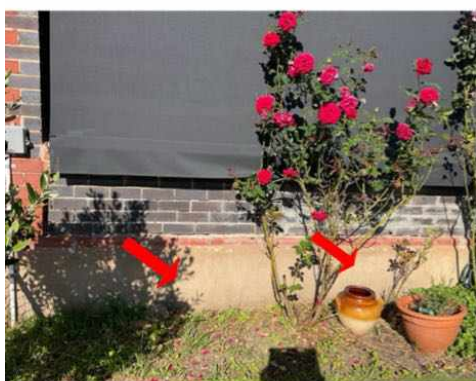
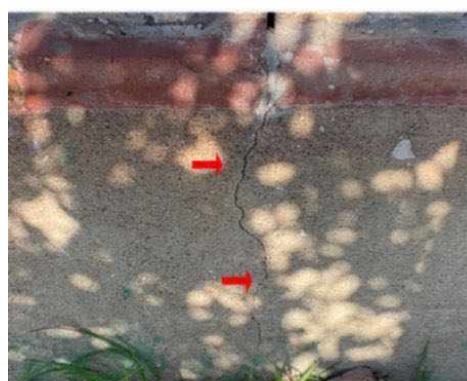
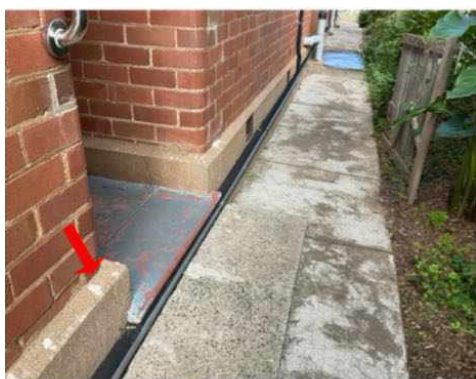
### Finding 3.24

Building:	Building 1
Location:	Some External Wall Areas
Finding:	Render (external) cracking and repairs
Information:	It has been observed that cracking to some external rendered surfaces. The degree of damage is described as “slight” noticeable cracks which are easily filled. Cracking of this size are generally less than 5mm in width. Numerous repairs were evident.

Always contact your building inspector should cracks widen, lengthen, or become more numerous.

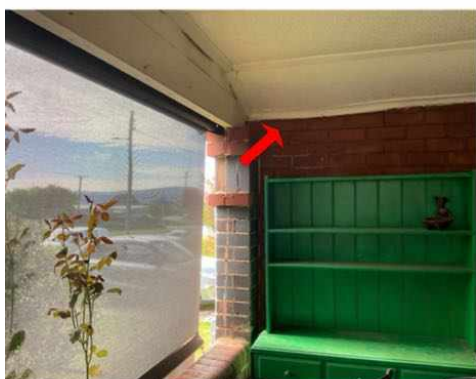
In some cases, sagging ceiling linings may also indicate that there are structural issues, causing surfaces to warp, twist or sag, or that structural timber elements have been weakened from termite activity. An invasive inspection is required to check this area for the cause of this minor deflection.

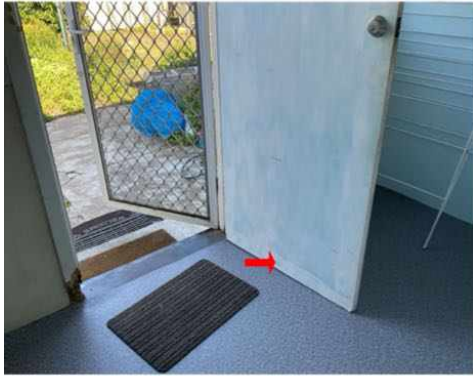
### Finding 3.27

Building:	Building 1
Location:	Rear door
Finding:	Door - Binding/jamming
Information:	Binding and/or jamming of this door is evident during standard operation. This defect inhibits the functionality of the affected door as well as creating potential for secondary defects to associated building elements, such as damage to the floor covering.

For minor causes, a qualified carpenter or general handyman should be appointed to perform minor rectification works at client discretion.

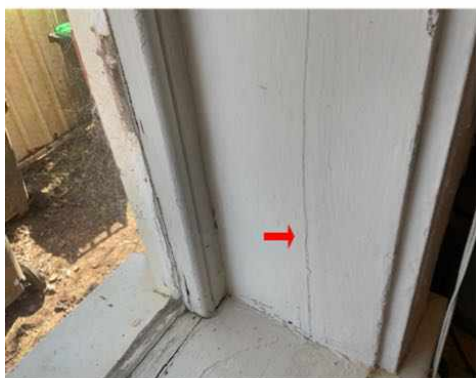
### Finding 3.28

Building:	Building 1
Location:	Pictured areas
Finding:	Windows - jamming and damaged
Information:	Binding and/or jamming and damage to these windows was evident during standard operation. This defect inhibits the functionality of the windows.

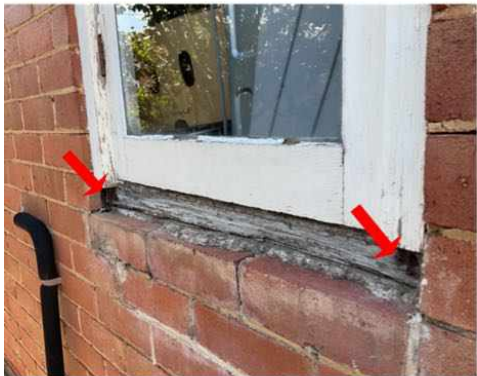
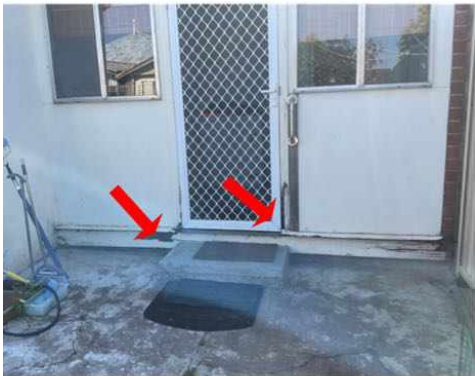
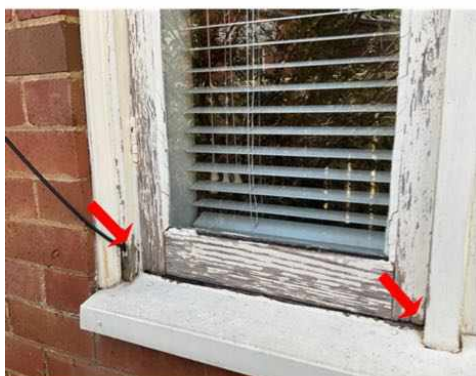
**Finding 6.02**

Building: Building 1  
Location: Exterior walls  
Finding: Sealant (external) - missing and attractive to termites  
Information: It was noted on inspection that areas of external sealant was missing to small areas of the external walls. A flexible sealant or flashing is required to protect the associated building materials from rainwater ingress. Any moisture ingress into the property is very attractive to termites. Flexible sealants or flashing should be applied to these affected areas to prevent termite activity.

A sealant specialist or skilled handy person should be appointed to complete these works as soon as possible.

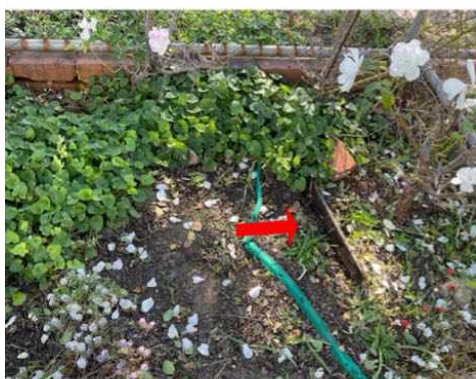
### Finding 6.03

Building:	Building 1
Location:	Yard - Front & Back
Finding:	Timber in contact with the ground
Information:	Any timbers in direct ground contact provide opportunity for concealed termite entry and are likely to be subject to premature rot and decay as the soil retains moisture or damp conditions against the timbers.

Frequent pest inspections are advised to readily identify any termite activity in these areas. No subfloor access was found to check these areas.

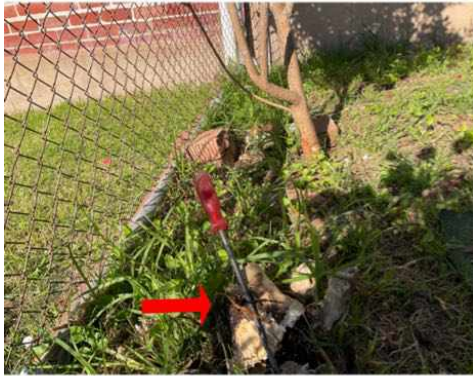
### Finding 6.04

Building:	Building 1
Location:	Pictured yard area
Finding:	Tree stumps - left in ground
Information:	Tree stumps left in ground provide opportunity for termite attack as they are likely to be subject to rot and decay providing an attractive food source. Treatment and/or Removal of the stump is highly recommended. A pest controller and tree removalist

should be engaged to perform such works.

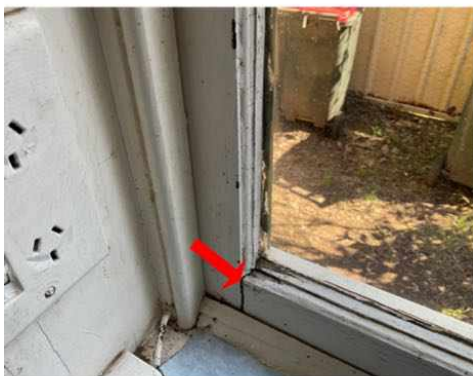
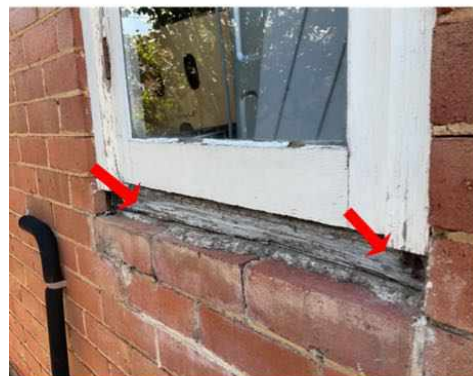
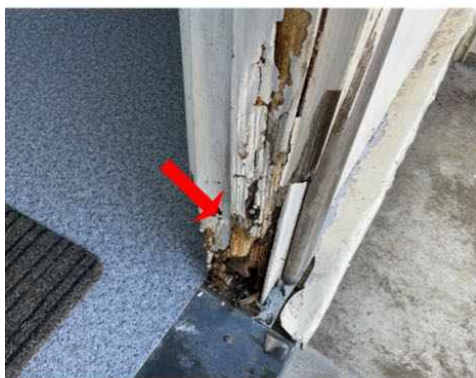
### Finding 7.01

Note - See ALL wood rot photos, all these show fungal decay.
