Building and Timber Pest Inspection Report

Inspection Date: Wed, 28 Jan 2026

Property Address: 5 Karoon Ave, Canley Heights 2166

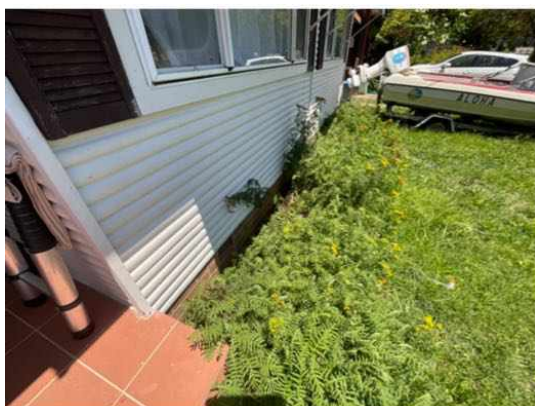
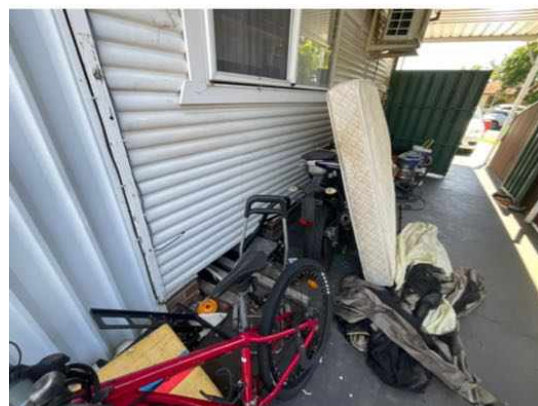
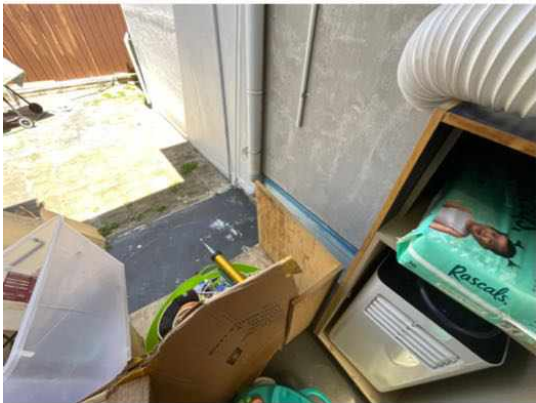
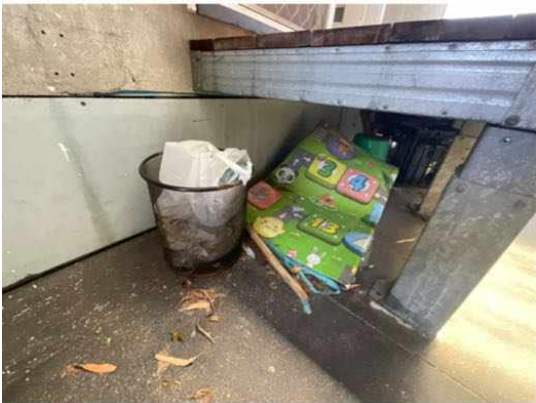
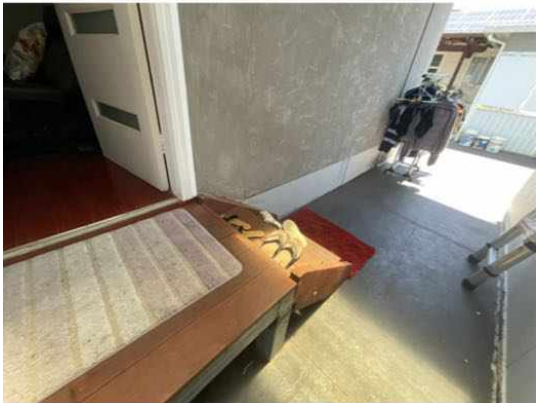
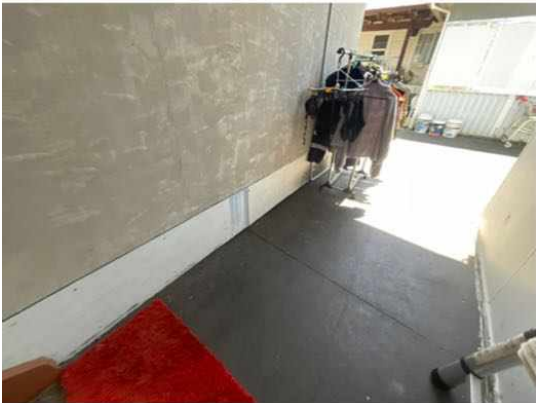
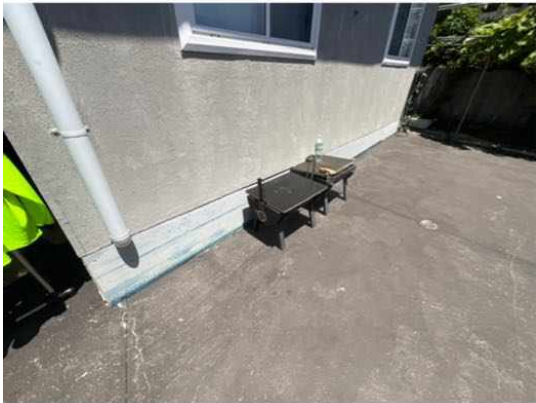
At the time of inspection, the subfloor areas to both the main dwelling and the granny flat were inaccessible. As a result, a full internal assessment of subfloor conditions, including moisture levels, ventilation effectiveness, and evidence of timber pest activity, could not be undertaken. Observations were therefore limited to the external perimeter of the buildings and any visible ventilation provisions.

External inspection identified perimeter subfloor ventilation openings forming part of a passive ventilation system. To the main dwelling, several vents were observed to be partially covered or obstructed, which may restrict airflow into the subfloor space. To the granny flat, no subfloor vents were observed; fibre cement sheeting has been installed around the perimeter, effectively preventing natural airflow to the subfloor area.

While no obvious external signs of moisture distress or timber pest activity were noted at the time of inspection, the actual condition and performance of the subfloor ventilation system could not be confirmed due to access restrictions. Blocked vents, inadequate airflow, elevated moisture levels, or concealed defects may be present but remain undetected.

Restricted or absent subfloor ventilation may lead to ongoing moisture accumulation beneath the building. If left unmanaged, this can result in progressive deterioration of timber elements, increased risk of termite activity, and potential long-term structural issues. The inability to access the subfloor represents a limitation to the inspection and increases uncertainty regarding the overall condition of these areas.

It is recommended that the subfloor areas to both the main dwelling and the granny flat be reinspected once safe and practical access is made available, to allow for a comprehensive assessment of internal conditions, including moisture levels, ventilation effectiveness, and signs of timber pest activity.

- Assess the adequacy and performance of the existing subfloor ventilation system
- Remove obstructions to existing vents where applicable
- Install additional passive vents or mechanical ventilation, where required
- Confirm that the subfloor environment is suitably managed to minimise moisture build-up and reduce termite-conducive conditions
- Identify and rectify any defects or deterioration identified within the subfloor space

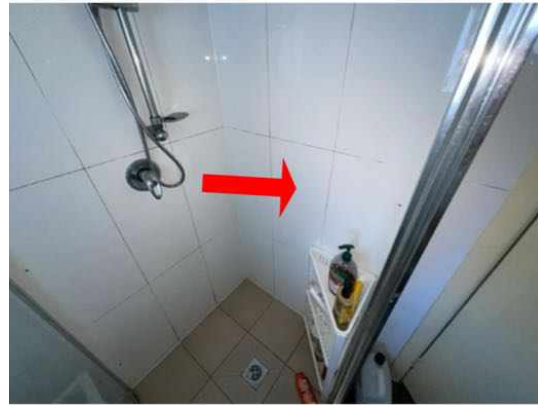
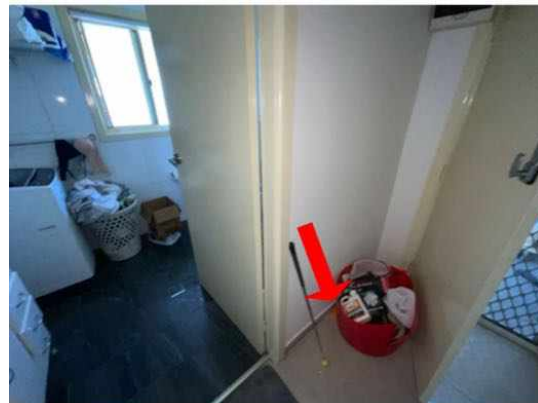
Finding 2.02

Building:	Main Building
Location:	Bathroom - Retreat/Sleepout
Finding:	Major Defect – Dampness to Shower Alcove
Information:	Observation

Evidence of dampness was identified within the shower alcove at the time of inspection. Elevated moisture meter readings were recorded to the wall on the right-hand side of the shower, with additional elevated moisture readings detected behind the shower area. No visible water staining, surface deterioration, or obvious signs of active water damage were observed at the time of inspection; however, moisture levels were above what would be expected for dry internal wall linings.

The presence of elevated moisture readings in this location is indicative of moisture ingress or retention within the wall structure. Likely contributing factors may include leaking plumbing pipes or fittings, failed or inadequate waterproofing to the shower recess, deteriorated sealants, or water penetration through wall linings and junctions.

If left unmanaged, ongoing dampness within the shower alcove is likely to result in the development of mould and fungal growth and may lead to the progressive deterioration of wall linings, framing timbers, fixings, and adjacent building materials. Prolonged moisture exposure can compromise the structural integrity of concealed elements and may result in costly repairs, including partial or full bathroom strip-out, to rectify underlying waterproofing failures.

It is recommended that this matter be treated as a major defect and further investigated as a priority. A suitably qualified and licensed plumber and/or bathroom or waterproofing specialist should be engaged to:

- Identify the source and extent of moisture ingress
- Assess the condition and compliance of the existing waterproofing system

- Check plumbing pipes, fittings, and fixtures for leaks
- Undertake necessary remedial works, which may include repair or replacement of waterproofing membranes, plumbing components, or affected building materials

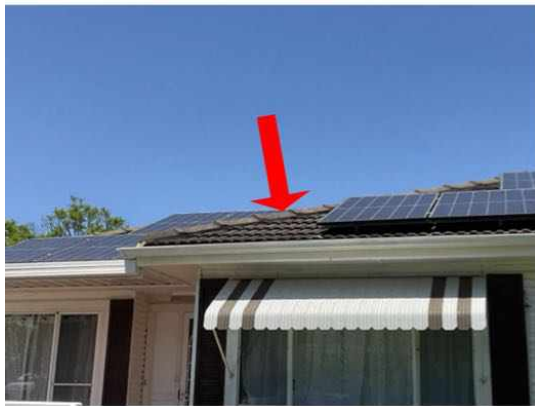
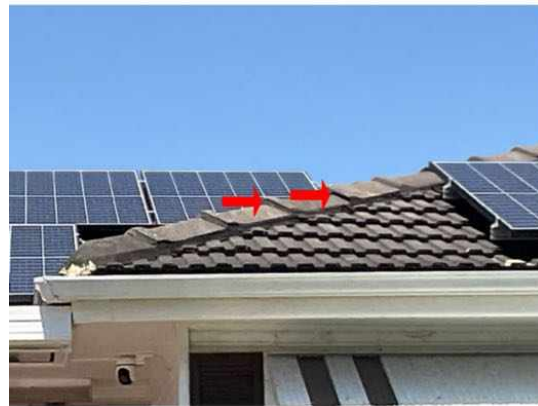
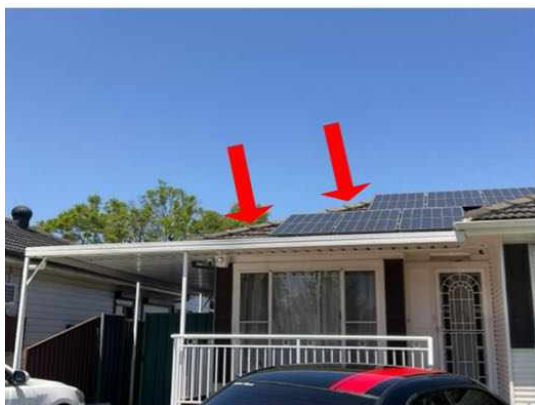
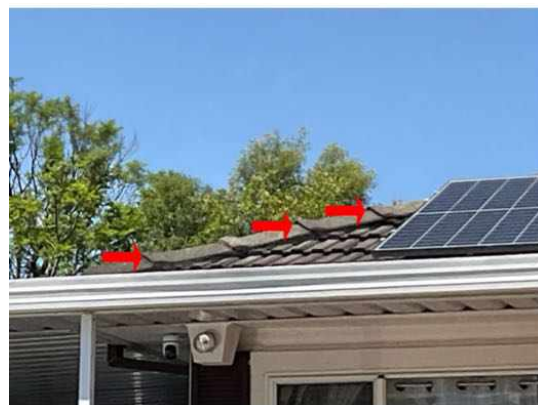
Finding 3.01

Based on the areas observed, the roof tiles were found to be in generally sound condition. Tiles appeared well seated, with no widespread cracking, displacement, or missing tiles noted at the time of inspection. Some isolated areas may exhibit minor wear and surface weathering consistent with the age of the roof and normal environmental exposure.

Tile alignment appeared generally uniform across the visible roof planes. Minor deterioration to bedding or pointing was observed at ridge and/or hip cappings in some locations. While not considered urgent at this stage, such deterioration can reduce the overall weatherproofing performance of the roof over time if left unmanaged.

Ridge and hip cappings were observed to be generally intact. Minor cracking and

weathering to bedding and pointing were noted in places. Routine maintenance, including re-pointing where required, is recommended to maintain long-term weather resistance and reduce the risk of water penetration.

The tiled roof covering was observed to be in generally sound condition at the time of inspection, with no evidence of active leaks noted. Minor maintenance, particularly to ridge and hip cappings, is recommended to maintain effective weatherproofing. Due to access limitations related to roof height and pitch, the inspection was restricted to safely accessible areas only. Regular maintenance, including cleaning of valleys and gutters and periodic re-pointing of ridge tiles, is advised to help extend the overall service life of the roof covering.

Photographs were taken at the time of inspection for reference purposes. Roof condition may vary depending on weather conditions, seasonal exposure, and areas not readily visible at the time of inspection. Further assessment by a roofing contractor is recommended, maintenance may be required in the future.

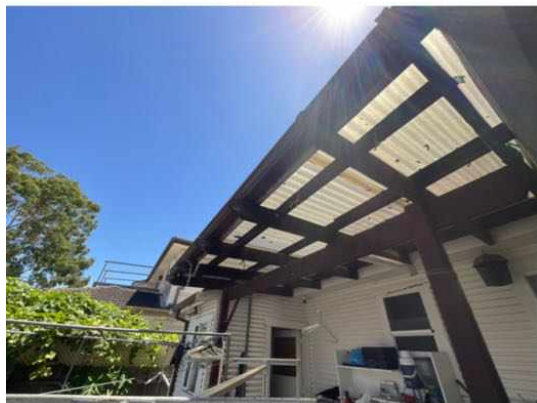
Finding 3.02

Building:	Main Building
Location:	Pergola
Finding:	External Timber Elements – Weather Exposure and Maintenance.
Information:	Findings:

- External timber components of the building, which are frequently exposed to harsh weather conditions, show signs of wear and lack adequate protective treatment.
- In areas where timbers have not been properly painted or sealed, deterioration is likely to progress at an accelerated rate due to constant exposure to moisture, UV radiation, and temperature changes.
- Without timely intervention, the condition of these timbers may continue to degrade, potentially requiring replacement in the short-term future.

- Where timber elements have already deteriorated beyond restoration, repairs or replacement will be necessary.
- A qualified carpenter should be appointed to assess and carry out any required structural or cosmetic timber repairs.

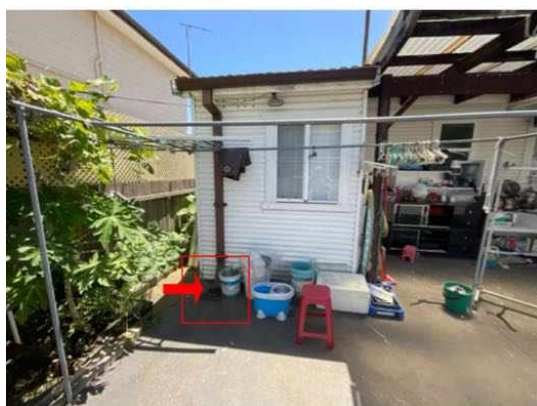
Building:	Main Building
Location:	Rear Elevation
Finding:	Downpipe – Unsealed Connections to Stormwater.
Information:	During the inspection, it was noted that the roof plumbing (downpipes) are not sealed at the connection points to the stormwater drainage system on-site. Evidence of water staining to nearby paving suggests ongoing leakage, indicating this may be a persistent issue.

- Unsealed or poorly connected downpipes commonly result in water leakage or pooling during periods of heavy rainfall or when surface drains are blocked or unmaintained.
- Leaking or overflowing roof plumbing can lead to stagnant water accumulating around the base of the building, potentially allowing water ingress beneath the structure.

- This may create damp conditions, increasing the risk of:
- Subfloor moisture issues
- Pest activity
- Timber decay
- Brick and mortar damage

- Further inspection by a licensed plumber is advised to assess the adequacy of the current roof drainage setup.
- Where necessary, repairs or replacements should be undertaken, and proper stormwater drainage connections installed.
- Ongoing monitoring and regular cleaning of surface drains is recommended to prevent blockages and reduce the risk of pooling or overflow.
- Remedial works should be carried out to ensure stormwater is being efficiently diverted away from the building perimeter to avoid long-term structural or moisture-related defects.

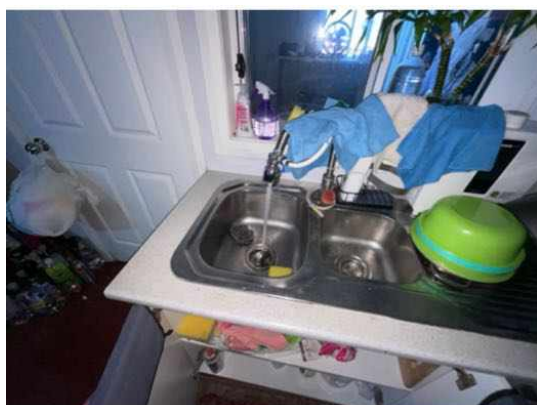
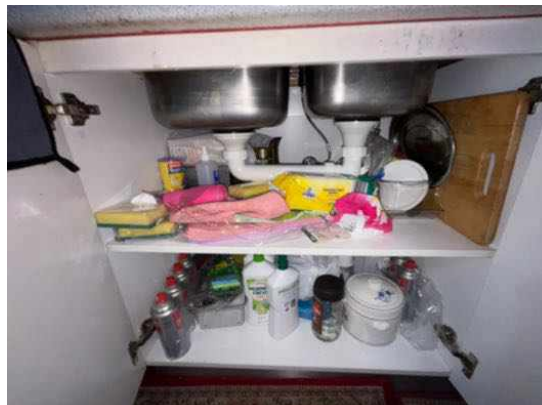
Building: Main Building
Location: Kitchens
Finding: Kitchen Sink – Overall Condition & Recommendations.
Information: Observations:

- Further monitoring and testing are recommended once the tap(s) are in constant use, to identify any drainage issues or signs of slow leaks not evident during the limited inspection.
- Flexible, mould-resistant sealant should be applied at wall junctions and other wet-area interfaces to prevent water ingress and potential damage. This is considered routine maintenance, and damaged or missing sealant should be replaced as needed.
- For long-term property care, it is advised that sealant and grouting in water-exposed areas be regularly inspected and maintained. A sealant specialist or tiling contractor may be engaged to carry out these works where necessary.
- It is recommended that the stored items beneath the sink be removed to allow for a full re-inspection of the plumbing and cabinetry, ensuring no concealed defects are present.

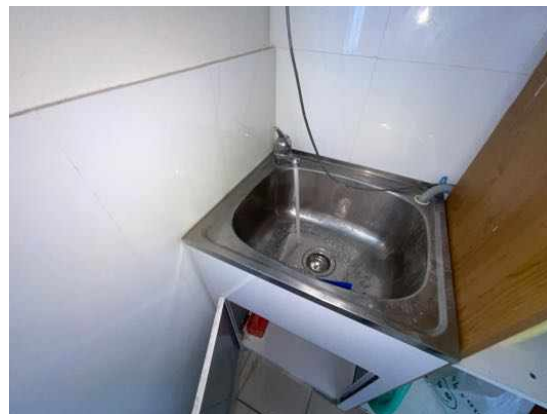
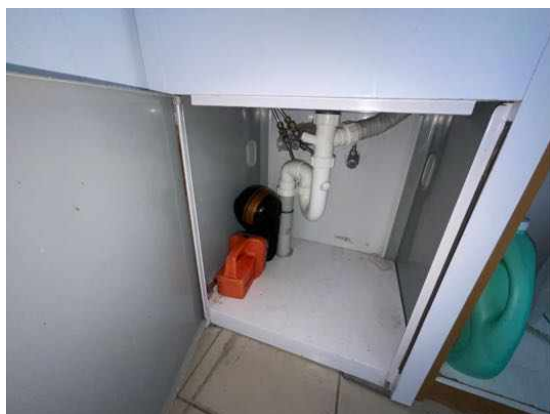
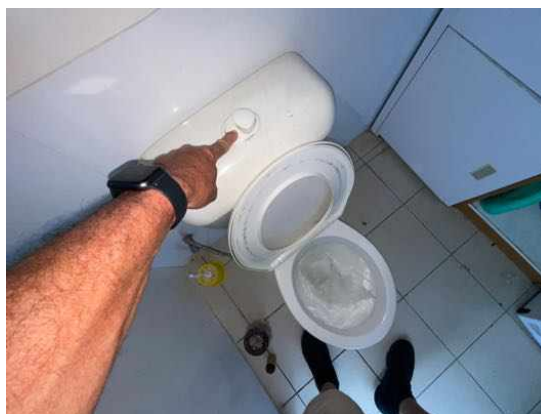
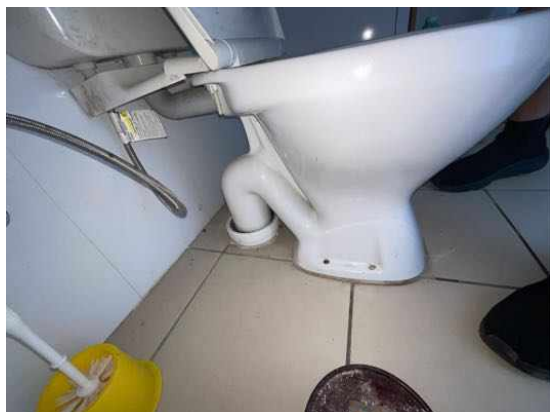
Building: Main Building
 Location: Laundry
 Finding: Laundry - Taps/Plumbing/Drainage.
 Information: Observation: Laundry Tub – Taps, Plumbing, and Cabinetry

- Further monitoring or testing is recommended once the taps are placed into regular use, to ensure no leaks develop over time and that the drainage system continues to perform adequately.
- Flexible and mould-resistant sealant should be applied to junctions between the basin and the wall to prevent water ingress that may lead to damage.
- Regular maintenance and prompt replacement of missing or deteriorated sealant is highly recommended, as this is a common wear-and-tear issue.
- Sealant and grouting in wet areas should be maintained as part of the long-term care and upkeep of the property.
- Where required, a sealant specialist or qualified tiling contractor should be appointed to carry out remedial sealing works.
