# Building and Timber Pest Inspection Report

Inspection Date: Wed, 25 Mar 2026

Property Address: 5/9 Mason St, North Parramatta NSW 2151, Australia

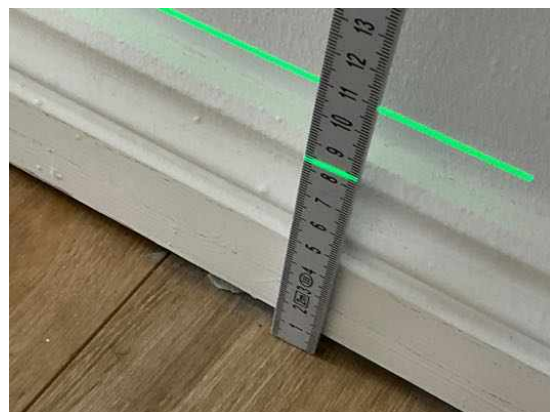
Building:	Main Building
Location:	Hallway Upstairs
Finding:	Flooring - Uneven
Information:	It was noted during inspection, the flooring exhibits noticeable unevenness, which may be due to floor cavity irregularities, structural movement, or improper installation.

This can result in gaps, creaking, or an unstable walking surface. While the issue may not pose an immediate structural risk, it can affect the overall durability and appearance of the flooring. Further actions are recommended such as leveling the subfloor, adjusting the flooring material, or reinforcing the underlying structure.

The client is advised to engage services of a flooring specialist at their own discretion.

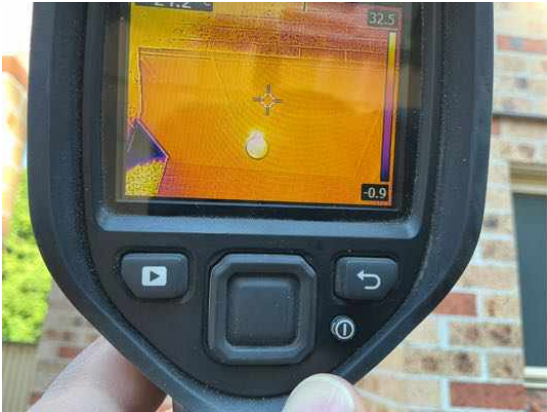
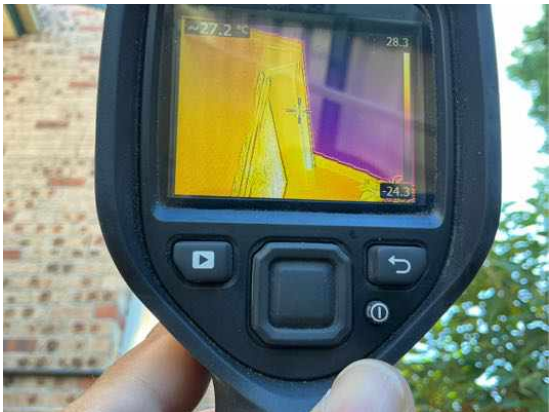
Building: Main Building  
Location: Eaves  
Finding: Eaves - Water stained  
Information:

Water staining to eaves linings in this area was evident at the time of inspection. Water staining indicates that surfaces have been exposed to excessive moisture over time. The minerals and other elements in the water lead to staining, which may graduate to corrosion and deterioration if left unmanaged.

While mostly an appearance defect, water staining can be indicative of more serious defects, which may be currently concealed by interior ceilings, even though they were

noted dry at the time of inspection.

Where water staining is active, a licensed plumber must be consulted to provide advice on any repairation works that may be required. Replacement of any damaged structures is advised.

Conversely, where water staining is old and inactive, affected building materials may be repaired or replaced at client discretion.

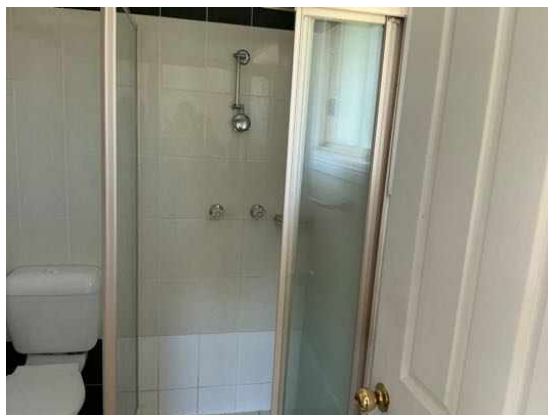
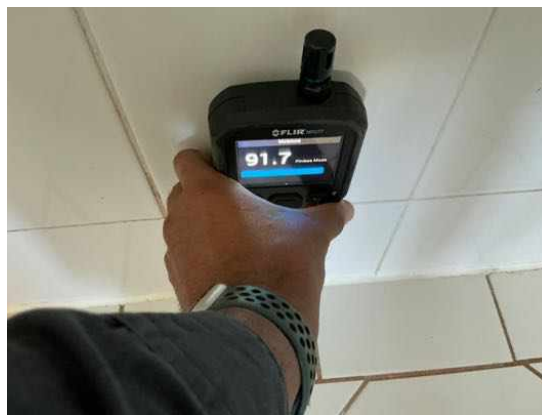
However, persistently damp conditions may act as conducive conditions for termite activity, as termites are strongly attracted to moisture-rich environments. It is recommended that the client ensures regular use of the exhaust fan and maintains adequate ventilation after shower use to promote drying and reduce long-term moisture build-up, thereby also reducing the risk of attracting termites.

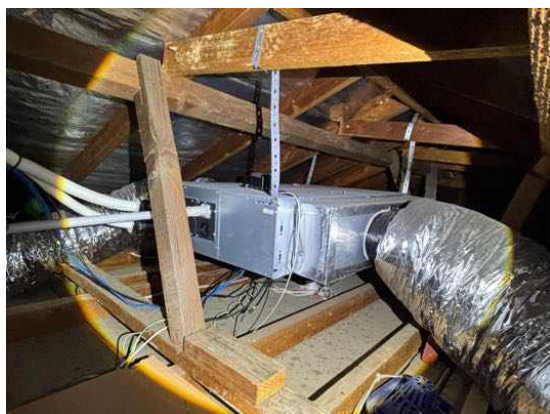
### Finding 3.22

Building:	Main Building
Location:	Ensuite - Master
Finding:	Potential Moisture Risk – Air Conditioning Ducting
Information:	At the time of inspection, no visible staining or damage was noted to the ceiling surface. However, thermal imaging indicated temperature variation consistent with possible condensation. Upon inspection of the roof space, it was noted that the air conditioning ducting was installed in direct contact with the plasterboard ceiling, with no visible insulation separating the ducting from the ceiling lining.

It is recommended that an air conditioning specialist be engaged to assess the duct installation to confirm there's no condensation.

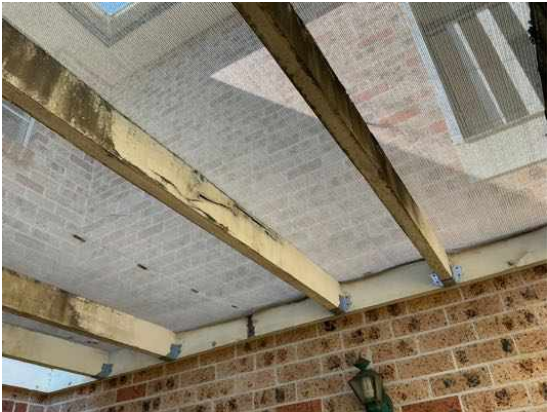
Building:	Yard
Location:	Yard - Front
Finding:	Fungal Decay - Present (Localised)
Information:	Fungal decay, also referred to as wood decay or wood rot, typically occurs when timber elements are exposed to excessive moisture for extended periods. This deterioration process is accelerated by temperatures ranging between 5°C and 40°C, as well as the presence of oxygen. Fungal decay is commonly found in timber components used in external environments, particularly when they are exposed to rain or moisture penetration.

In this instance, although the timber element shows signs of decay, the visible damage appears to be localized to a specific area and has not yet spread to adjoining structures or other parts of the building element. As a result, the fungal decay is likely to be relatively superficial, with minimal impact on the structural integrity or tensile strength of the timber. However, it is advisable to monitor the affected area to prevent further deterioration and address the underlying moisture issue to mitigate future risk.

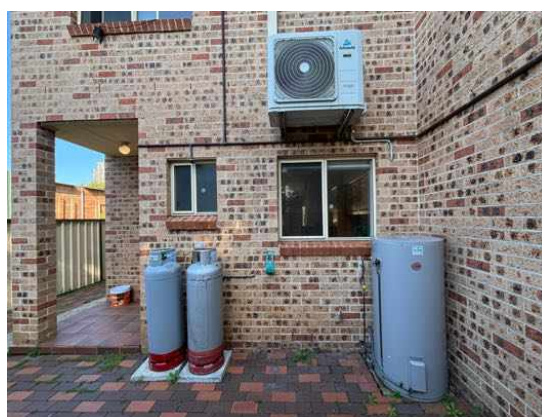
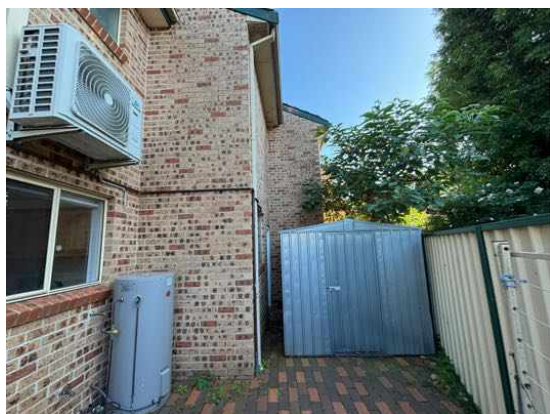
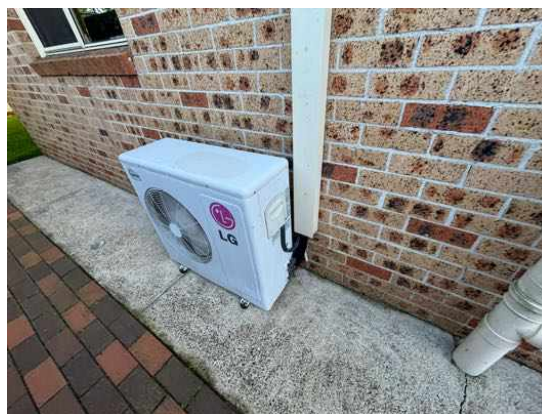
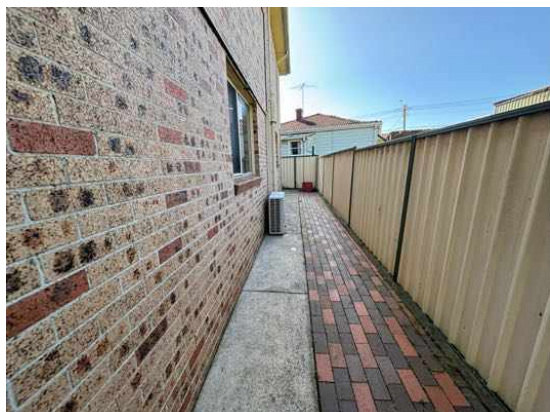
It is essential that these obstructions be cleared to allow for a comprehensive inspection of the external areas. Removing these barriers will enable a more accurate assessment of the property's condition and allow any hidden defects to be identified and addressed promptly. Failure to do so could result in undetected issues worsening over time, potentially leading to more costly repairs in the future.

Therefore, it is strongly recommended that the obstructions be removed and a re-inspection be scheduled once the affected areas are made fully accessible. This will ensure a complete evaluation of the property's exterior and provide the client with a clear understanding of any potential issues that may have been concealed during the initial inspection.

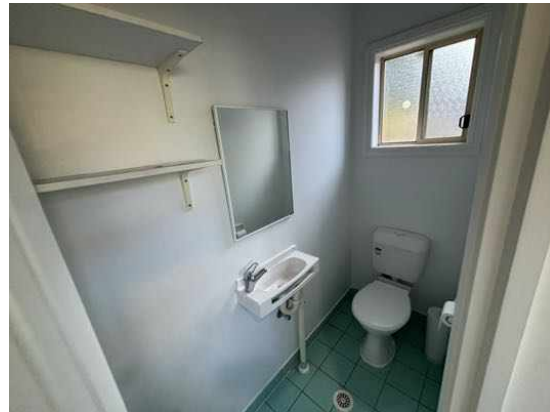
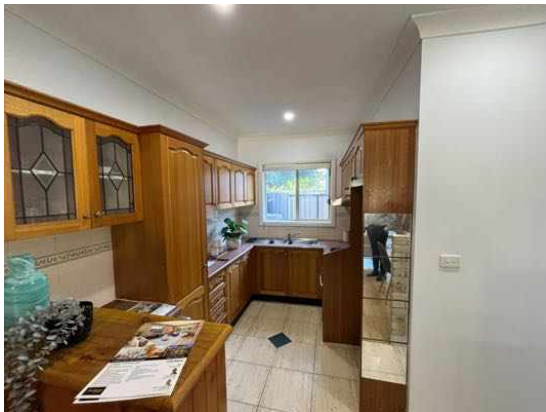
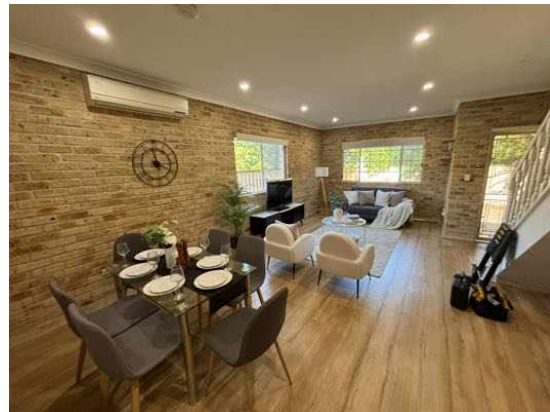
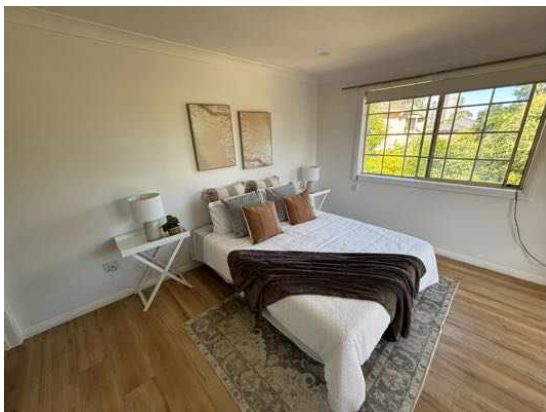
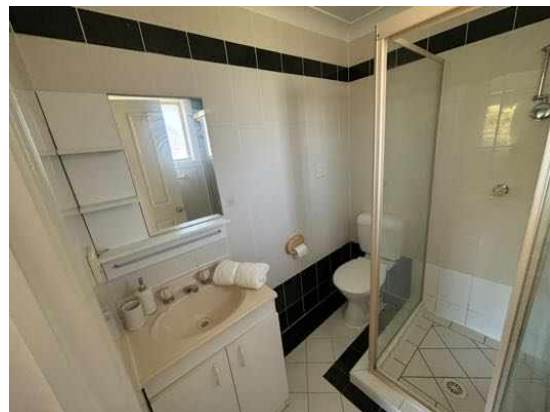
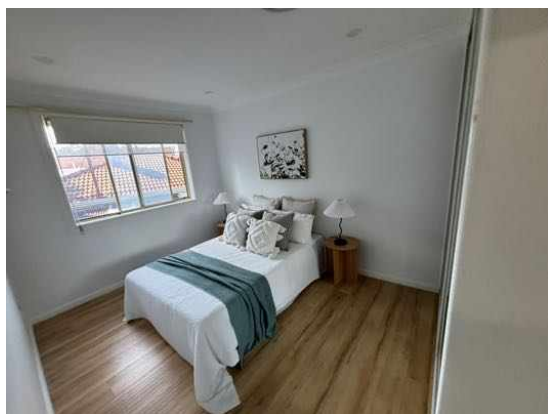
Building:	Main Building
Location:	All Internal Areas
Finding:	Obstructions and Limitations - Internal Areas
Information:	The accompanying photographs provide clear evidence of the obstructions and limitations that restricted a comprehensive inspection of the internal areas of the property at the time of assessment. These obstructions, which may include furniture, personal belongings, stored items, or structural elements such as wall coverings and built-ins, significantly hindered the ability to thoroughly evaluate these areas. It is important to note that such obstructions can potentially conceal a wide array of defects, ranging from hidden structural damage, water leaks, pest infestations, or electrical issues, to deteriorating materials that may not be visible during the initial inspection.

previously concealed issues can be properly identified and rectified. This follow-up inspection will provide a more accurate assessment of the property's internal condition and help the client make informed decisions about any necessary repairs or maintenance.

In summary, the limitations encountered during the inspection highlight the importance of ensuring full access to all areas of the property to accurately assess its overall condition. A re-inspection is strongly advised once these areas are made accessible.

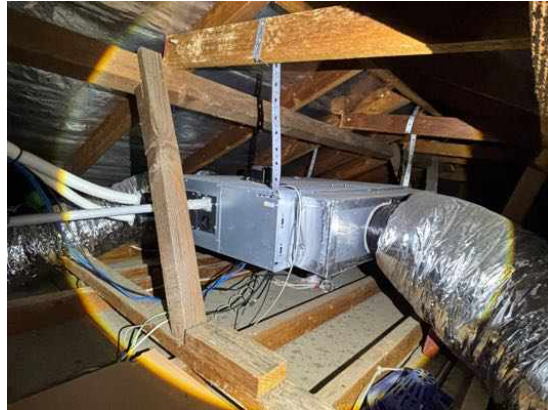
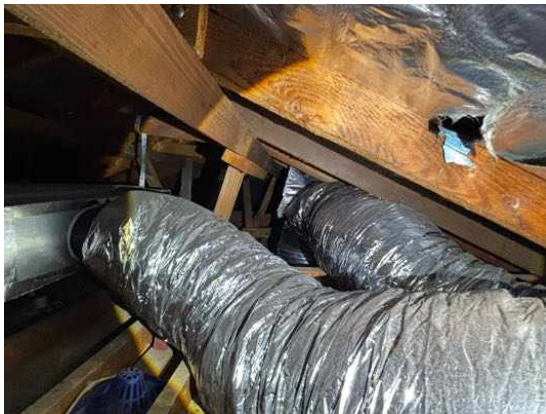
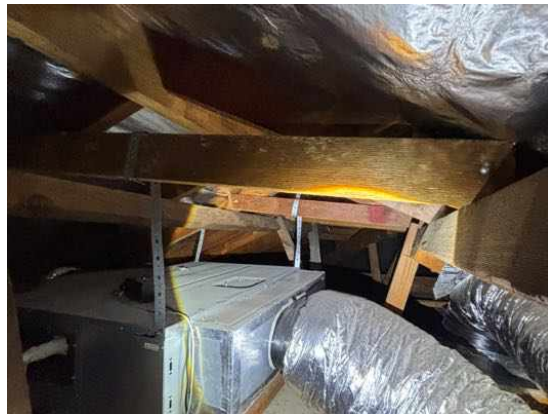
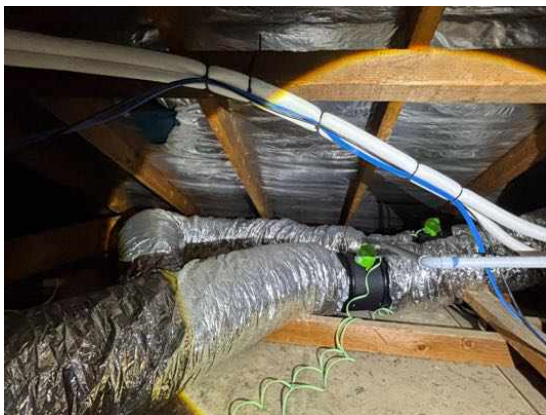
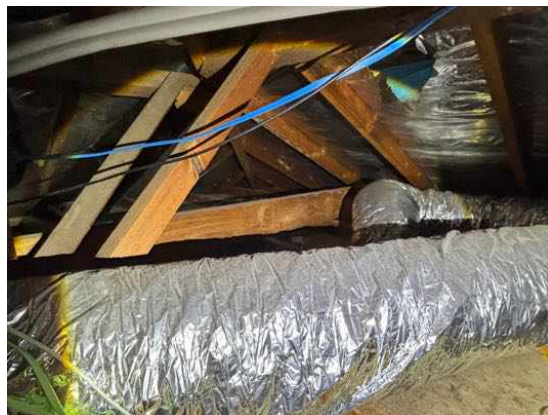
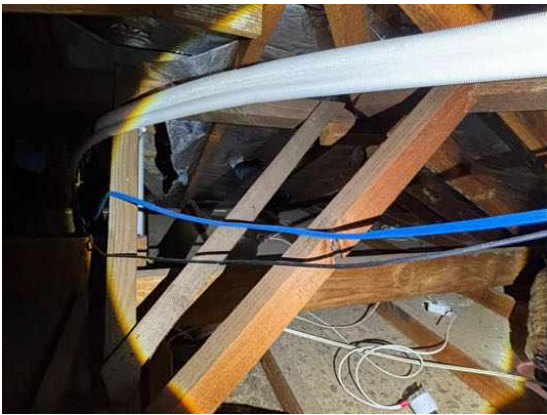
Building: Main Building  
 Location: Roof Void  
 Finding: Obstructions, Limitations, and General Roof Space Condition  
 Information: The photographs provided document both the general condition and the obstructions and limitations that were present in the roof cavity of the main building at the time of inspection. These obstructions—such as insulation materials, stored items, structural elements, or electrical wiring—restricted safe and adequate access to key areas within the roof space. As a result, a comprehensive inspection of all components could not be completed.

damaged framing, compromised insulation, evidence of moisture ingress, pest activity, or electrical hazards. While no major issues were observed in the visible areas, the presence of these limitations means that some defects may remain undetected.

It is recommended that these barriers be removed or repositioned to facilitate full and safe access to the roof space. Once clear, a follow-up inspection should be conducted to allow for a thorough assessment of all concealed areas. This will help ensure that the condition of the roof cavity is accurately evaluated and any hidden issues are appropriately identified and addressed.

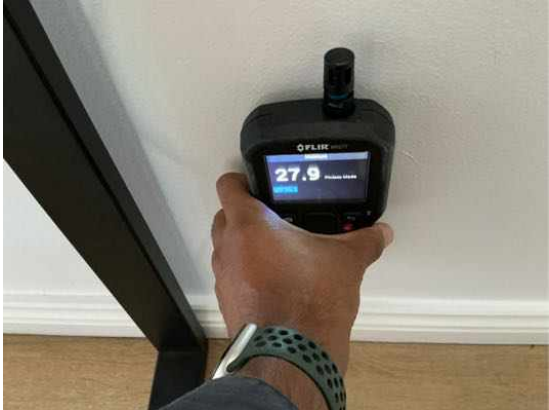
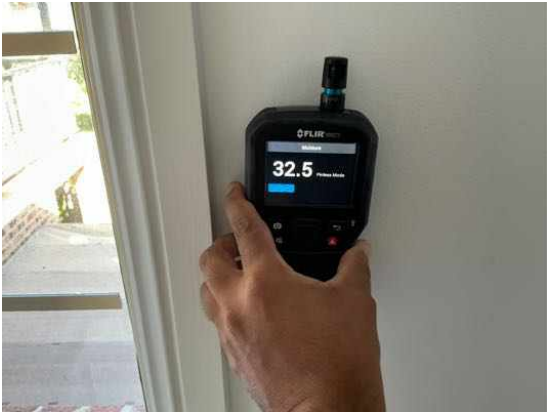
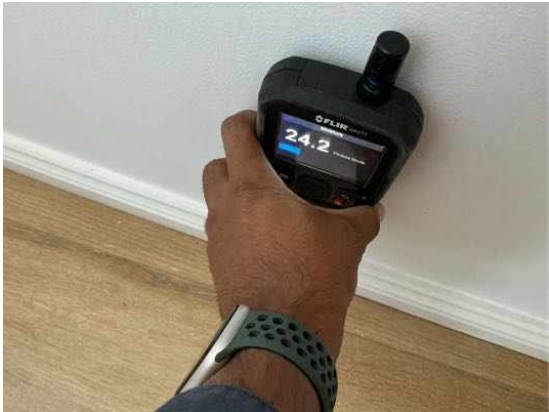
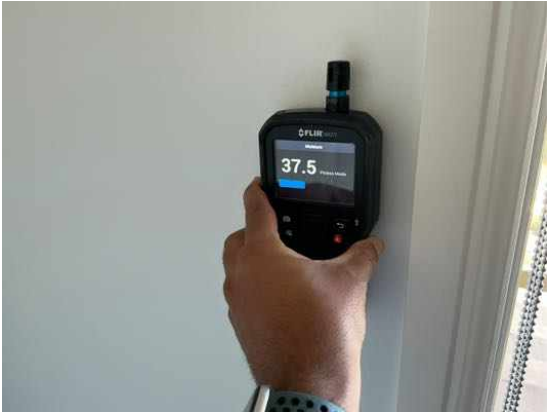
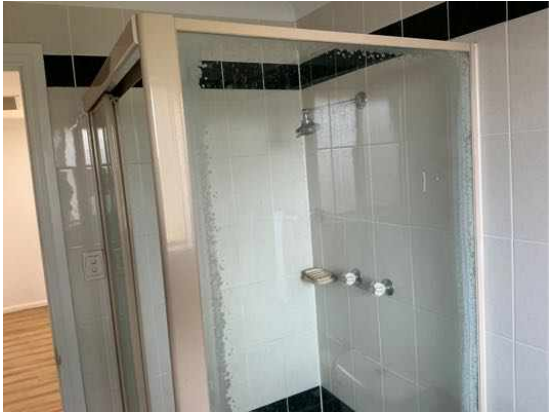
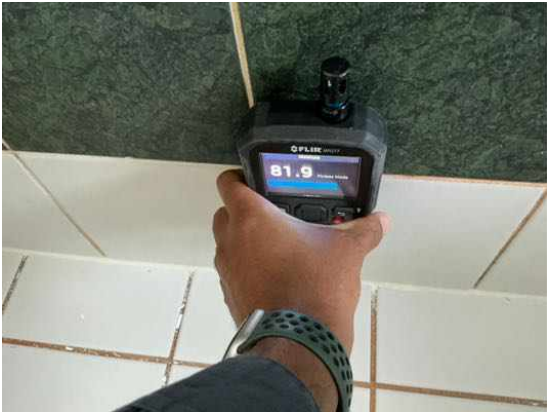
Building:	Main Building
Location:	All Areas
Finding:	Additional Photos - Moisture Meter Readings
Information:	Additional moisture meter reading photos have been provided for the property to offer further clarity on areas tested during the inspection. These photos are intended to give a visual reference for the specific locations where moisture levels were measured. These readings were taken at the time of the inspection to assess any potential moisture-related issues within the property. Any defects related to moisture that were identified during the inspection have been separately mentioned in the defect statements within the report.

It is important for the client to understand that moisture levels can fluctuate over time due to various factors, including changes in weather, humidity, and environmental conditions. While the readings reflect the property's moisture levels during the inspection, they may not represent future conditions, and increased moisture could lead to issues such as dampness, mould growth, or deterioration of building materials if left unmonitored.

For further clarification or additional information regarding the moisture readings, the client is encouraged to contact the building inspector directly. Regular monitoring of moisture-prone areas is recommended to ensure any emerging concerns are addressed promptly, particularly during wetter seasons or in high-humidity conditions.
