Building and Timber Pest Inspection Report

Inspection Date: Thu, 19 Feb 2026

Property Address: 10 Stephen St, Urbenville NSW 2475,
Australia

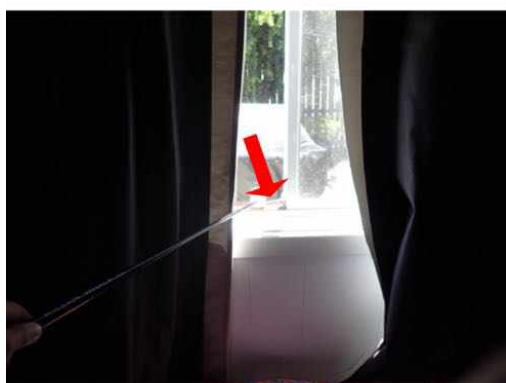
Finding 1.01

Building:	Main Building
Location:	Bedroom
Finding:	Small Crack To Bedroom Glass Window Pane
Information:	A small crack was identified to the glass pane of the bedroom window. This type of defect is commonly caused by minor impact, thermal stress or age-related movement. In plain terms, the bedroom window glass is cracked. Even small cracks can expand over time and may compromise the integrity and safety of the glazing. Preventative measures include timely replacement to avoid further cracking or potential breakage. A qualified glazier should assess and replace the affected pane as deemed necessary. Repair is recommended at the owner's discretion to maintain safety, weatherproofing and security.

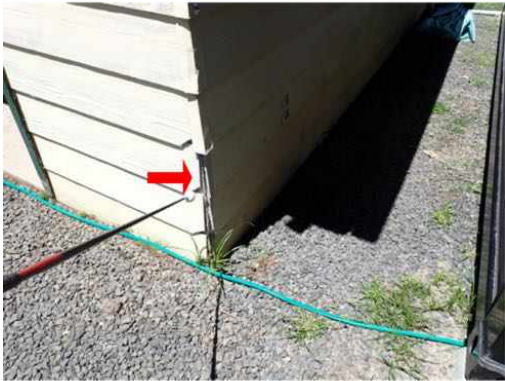
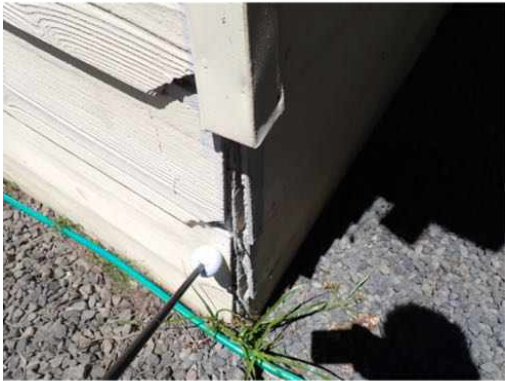
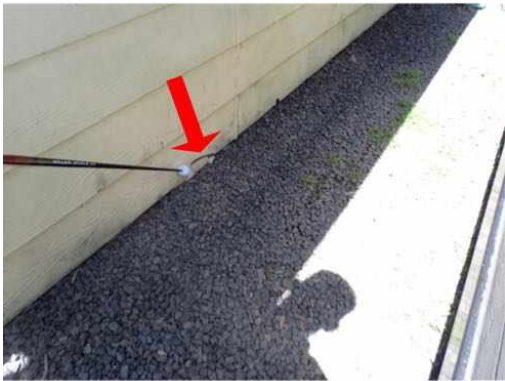
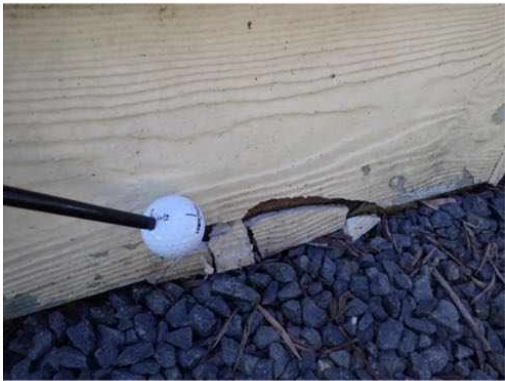
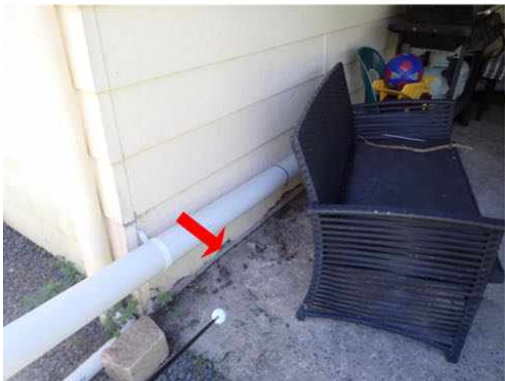
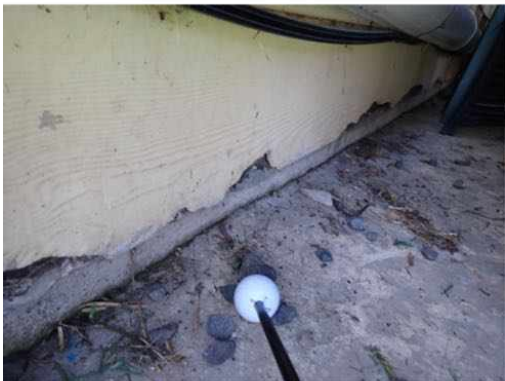
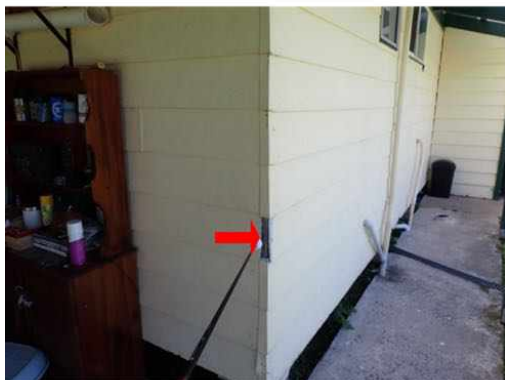
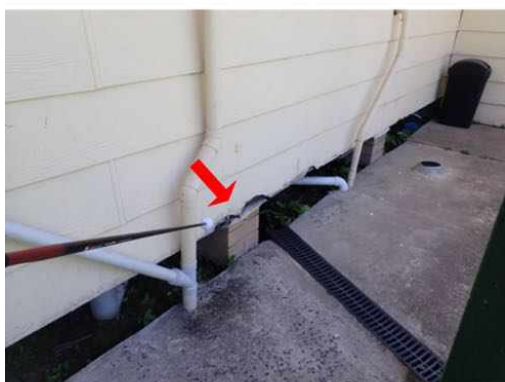
Finding 1.02

Building:	Main Building
Location:	External walls
Finding:	Damaged External Wall Cladding To Several Areas – Possible Asbestos Containing Material
Information:	Damage was identified to the external wall cladding at several locations. Based on the age and appearance of the material, the cladding may contain asbestos; however, confirmation is outside the scope of this visual inspection and laboratory testing would be required to verify. In plain terms, parts of the external wall sheeting are damaged and could be made from older asbestos-type material. Damaged cladding may allow moisture ingress and, if asbestos-containing, may pose a health risk if disturbed and fibres become airborne. Preventative measures include avoiding disturbance of the material and maintaining it in good condition. A licensed asbestos assessor and/or appropriately licensed removal contractor should be engaged to test and repair or

replace the affected cladding as deemed necessary. Rectification is recommended at the owner's discretion with appropriate safety controls in place.

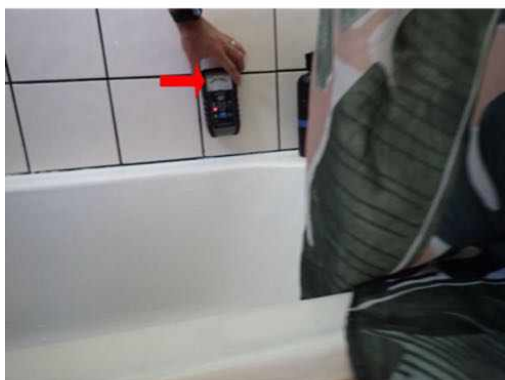
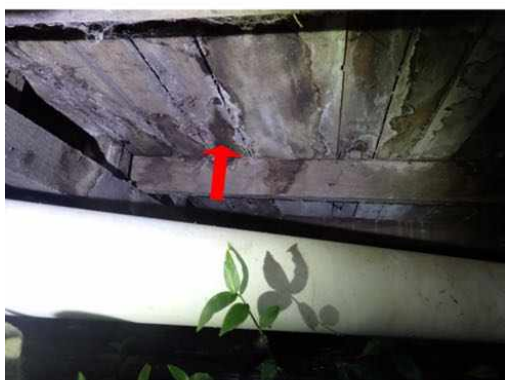
Finding 2.01

Building:	Main Building
Location:	Bathroom
Finding:	Elevated Moisture Readings And Water Staining To Subfloor With In The Bathroom Vicinity.
Information:	Higher than normal moisture meter readings were obtained around the top edge of the bath tub, with water staining observed to subfloor timber in the bathroom vicinity. This condition may be associated with failed or deteriorated silicone seals, plumbing leaks, splash-back from showering or bath use, or compromised waterproofing. In plain terms, elevated moisture levels were detected near the bath and there are signs that some water has reached the timber underneath. Ongoing moisture exposure can contribute to timber deterioration, mould growth and potential structural damage if left unaddressed. Preventative measures include maintaining effective sealing to bath edges and ensuring plumbing connections are watertight. A licensed plumber should investigate for leaks and a qualified bathroom or waterproofing contractor should assess and rectify as deemed necessary. Prompt investigation and repair is recommended at the owner's discretion to prevent further moisture-related damage.

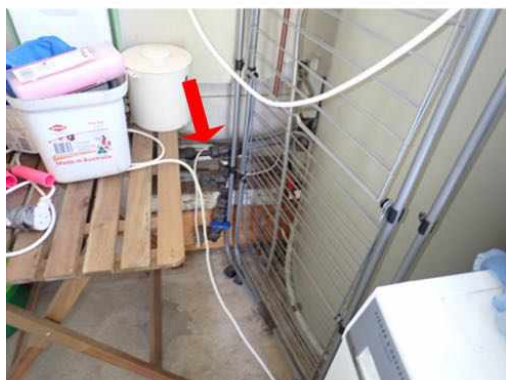
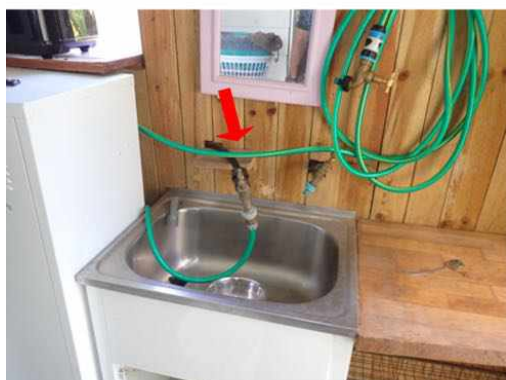
Finding 2.02

Building:	Main Building
Location:	Laundry
Finding:	Laundry Plumbing Appears Unprofessionally Installed
Information:	<p>The laundry plumbing installation appeared to be of a substandard and unprofessional standard, with poor alignment, inadequate support and/or untidy workmanship noted. This condition may be associated with non-licensed installation or previous DIY modifications. In plain terms, the plumbing under or around the laundry area looks poorly done. Poor workmanship can increase the risk of leaks, blockages or premature failure of fittings over time. Preventative measures include ensuring all plumbing work is carried out by a licensed plumber in accordance with relevant standards. A licensed plumber should assess the installation and rectify any non-compliant or defective work as deemed necessary through out the property. Rectification is recommended at the owner's discretion to ensure reliability, compliance and long-term serviceability.</p>

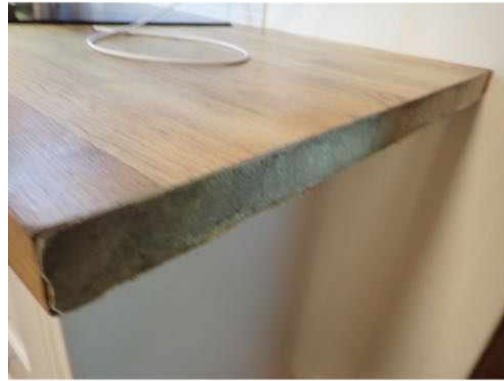
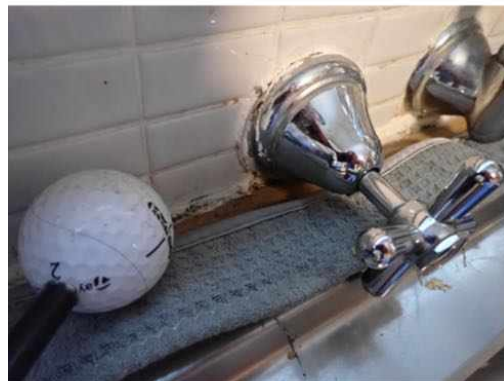
Finding 3.01

Building:	Main Building
Location:	Kitchen
Finding:	Kitchen In Fair Condition However Poor Installation Workmanship Noted
Information:	The kitchen was observed to be in generally fair condition; however, defects including the unsealed cut end of the timber benchtop and poor silicone application to tap penetrations and benchtop junctions indicate substandard installation workmanship. Exposed timber ends are susceptible to moisture ingress which may result in swelling, delamination or premature deterioration. In plain terms, parts of the benchtop have not been properly sealed and the silicone work is messy and inadequate, suggesting the kitchen was not finished to a high standard. Poor sealing around taps and junctions can allow water to enter cabinetry and surrounding materials over time. Preventative measures include properly sealing all exposed timber surfaces and ensuring neat, continuous silicone to wet area junctions. A qualified cabinet maker, carpenter or kitchen installer should assess and rectify the defective workmanship as deemed necessary. Repairs are recommended at the owner's discretion to prevent moisture damage and improve overall finish and durability.

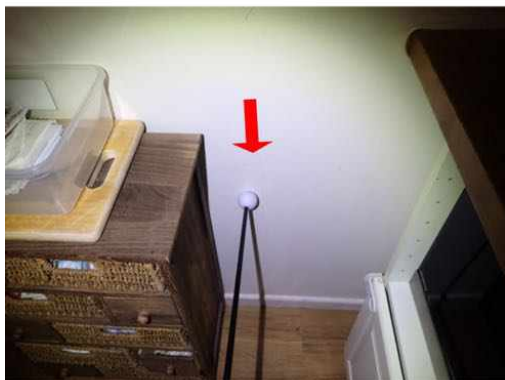
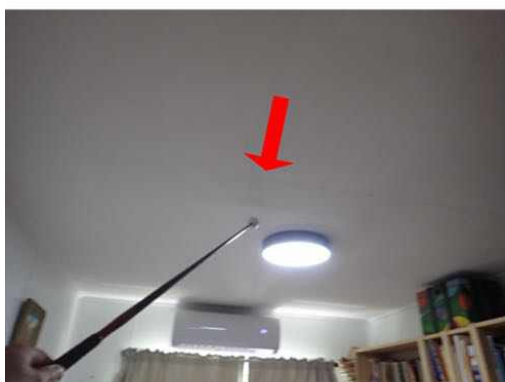
Finding 3.02

Building:	Main Building
Location:	All Areas
Finding:	Several Cracks Identified To Internal Wall And/Or Ceiling Cladding
Information:	Several cracks were identified to the internal wall and/or ceiling cladding surfaces. This is commonly associated with normal building movement, material shrinkage and age-related settlement and is considered a common defect for a property of this age. In plain terms, there are visible cracks in the internal lining boards or plaster surfaces. While often cosmetic, cracking can worsen if movement continues and may indicate minor substrate movement. Preventative measures include monitoring for further movement and maintaining stable internal conditions. A qualified plasterer or painter should assess and carry out patch repairs and repainting as deemed necessary. Repairs are recommended at the owner's discretion to maintain appearance and prevent further deterioration.

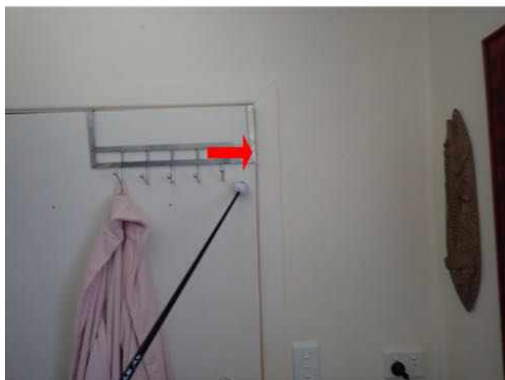
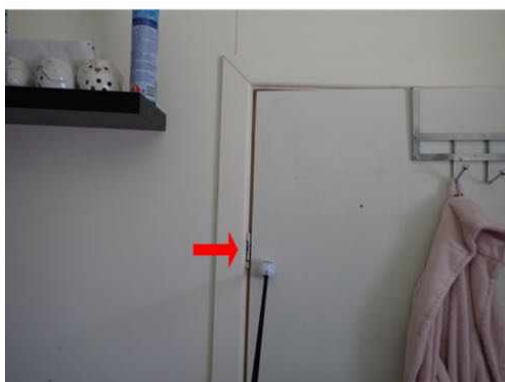
Finding 3.03

Building:	Main Building
Location:	Bathroom
Finding:	Bathroom Door Catching On Frame Due To Damaged Hinge
Information:	The bathroom door was observed to be catching on the door frame during normal operation, likely due to a damaged or worn hinge. This condition may be caused by hinge wear, loose fixings, minor door/frame movement or age-related deterioration. In plain terms, the door does not open and close properly because the hinge is damaged. Continued use in this condition may result in further damage to the door, frame or hardware. Preventative measures include ensuring hinges are properly secured and replaced when worn. A qualified carpenter or handyman should assess and repair or replace the damaged hinge and adjust the door as deemed necessary. Repairs are recommended at the owner's discretion to restore proper function and prevent further damage.

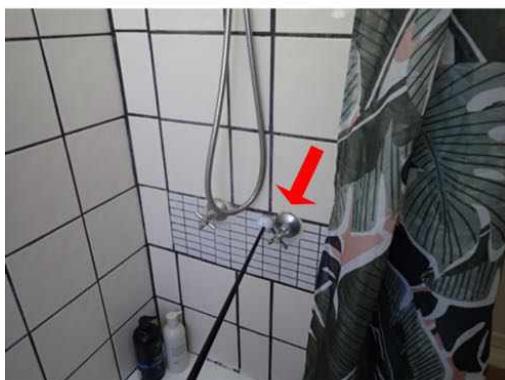
Finding 3.04

Building:	Main Building
Location:	Bathroom
Finding:	Poor Silicone Work Around Shower Plumbing Fittings
Information:	<p>Poor and inadequately applied silicone sealant was identified around the shower plumbing fittings. This is commonly caused by substandard workmanship or previous patch repairs and is considered a maintenance-related defect. In plain terms, the sealing around the shower fittings is messy and not properly finished. Inadequate sealing in wet areas can allow water to penetrate behind wall linings, potentially affecting waterproofing and causing concealed moisture damage over time. Preventative measures include ensuring neat, continuous and properly bonded silicone to all wet area penetrations. A qualified plumber, tiler or handyman should remove and reapply the silicone sealant as deemed necessary. Rectification is recommended at the owner's discretion to prevent moisture ingress and maintain waterproof integrity.</p>

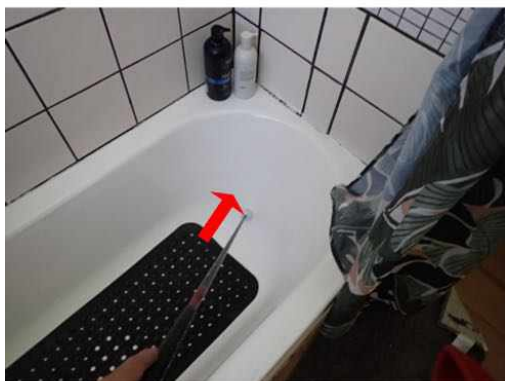
Finding 3.05

Finding: Poorly Applied Paint Finish To Bath Tub – Cosmetic Defect

Information: The bath tub was observed to have a poorly applied paint finish, with visible inconsistencies and cosmetic imperfections noted. This is typically associated with substandard preparation or application during resurfacing works. In plain terms, the bath has been painted but the finish is rough and does not look professionally done. While primarily cosmetic, poorly applied coatings may wear prematurely or peel over time. Preventative measures include proper surface preparation and application by a suitably qualified contractor. A bath resurfacing specialist or licensed painter should assess and refinish the bath as deemed necessary. Rectification is recommended at the owner's discretion to improve appearance and durability.

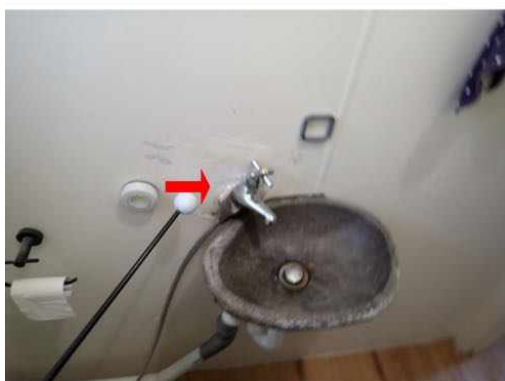
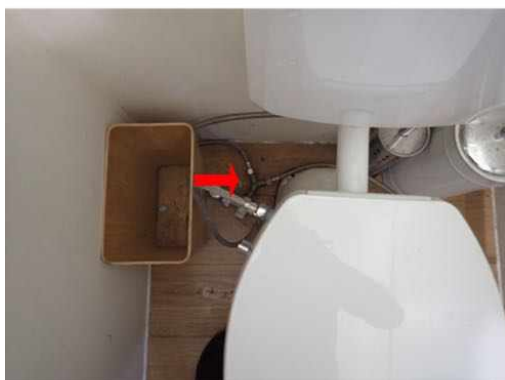
Finding 3.07

Building: Main Building
 Location: Toilet (WC)
 Finding: Toilet Vanity Tap Poorly Fitted
 Information: The vanity tap to the toilet WC was observed to be poorly fitted, with movement and/or inadequate securing noted at the base. This is commonly due to substandard installation or loose fixings over time. In plain terms, the tap is not properly secured and may wobble during normal use. A loose tap can allow water to penetrate around the base and potentially cause damage to cabinetry or surrounding materials. Preventative measures include ensuring taps are firmly secured and properly sealed at installation. A licensed plumber should assess and refit or secure the tap as deemed necessary. Rectification is recommended at the owner’s discretion to prevent moisture damage and ensure proper operation.

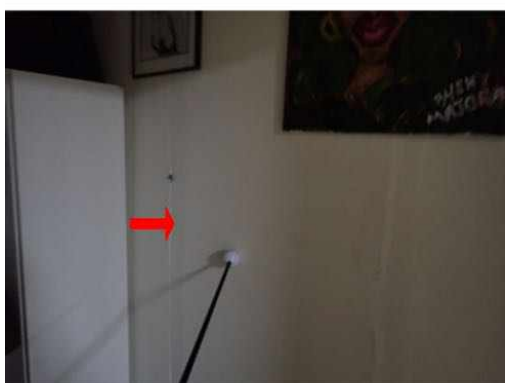
Finding 3.08

Building:	Main Building
Location:	Store room
Finding:	Store Room Cladding Poorly Fitted
Information:	The cladding within the store room was observed to be poorly fitted, with misalignment and/or inadequate fixing noted. This condition is typically associated with substandard installation or lack of proper securing to the framing. In plain terms, the wall lining in the store room has not been installed properly and does not sit or fix correctly. Poorly fitted cladding may loosen over time and affect the overall finish and durability of the wall surface. Preventative measures include ensuring cladding is properly aligned and securely fixed in accordance with manufacturer guidelines. A qualified carpenter or handyman should assess and refit or secure the cladding as deemed necessary. Rectification is recommended at the owner's discretion to improve finish and long-term performance.

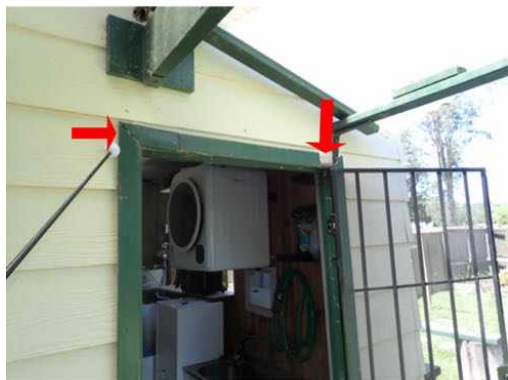
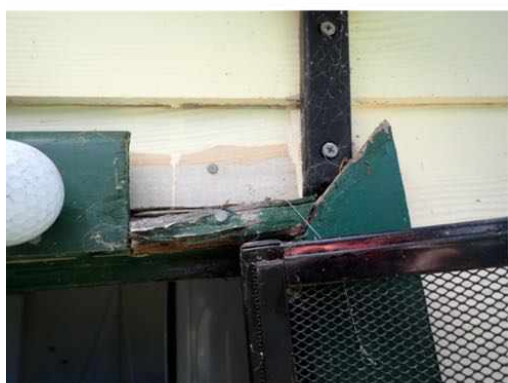
Finding 3.09

Building:	Main Building
Location:	Laundry
Finding:	Damaged External Door Architrave To Laundry
Information:	Damage was identified to the external door architrave at the laundry. This condition is commonly caused by moisture exposure, impact damage or age-related deterioration.

In plain terms, the timber trim around the laundry door is damaged. If left unrepaired, exposed timber can absorb moisture and lead to swelling or wood rot over time. Preventative measures include maintaining protective paint coatings and ensuring effective sealing around door frames. A qualified carpenter or handyman should assess and repair or replace the damaged architrave as deemed necessary. Repairs are recommended at the owner's discretion to prevent further deterioration and maintain weather resistance.

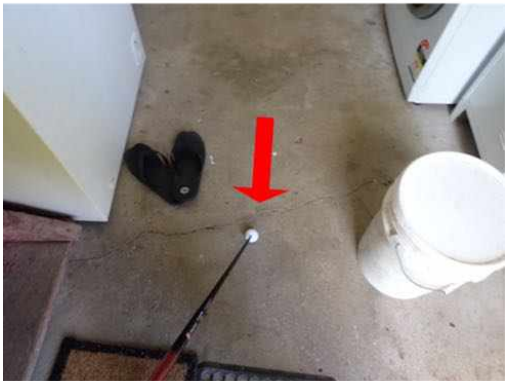
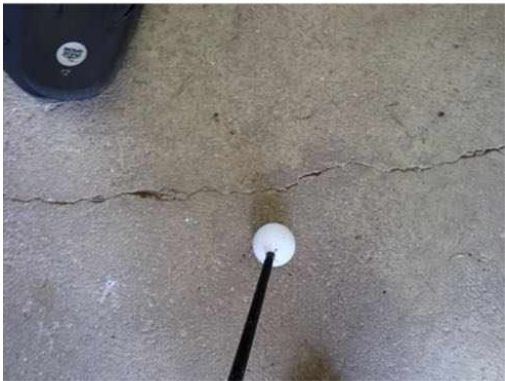
Finding 3.10

Building:	Main Building
Location:	Laundry
Finding:	Crack Identified To Laundry Concrete Floor
Information:	A crack was identified to the concrete floor within the laundry area. This is commonly associated with shrinkage during curing, minor ground movement or age-related settlement and is considered a common defect in concrete slabs of this age. In plain terms, there is a visible crack in the laundry floor. While minor cracking can be typical, cracks may allow moisture ingress and gradual deterioration over time if left unsealed. Preventative measures include sealing cracks and maintaining adequate drainage to the area. A qualified concreter or builder should assess and seal or repair the crack as deemed necessary. Repairs are recommended at the owner's discretion to prevent further deterioration.

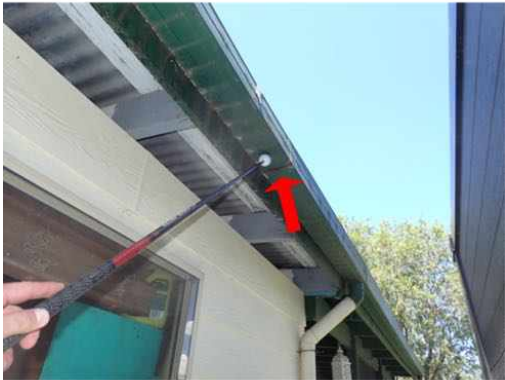
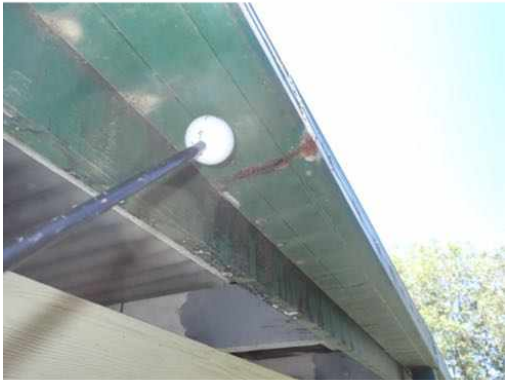
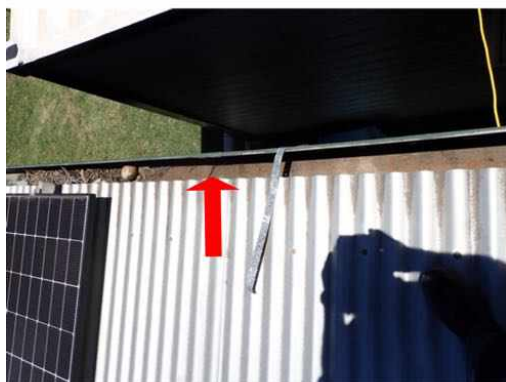
Finding 3.11

Building: Main Building
Location: Roof
Finding: Surface Rust Identified To Gutters
Information: Surface rust was identified to sections of the roof gutters. This condition is typically caused by prolonged moisture exposure, debris build-up and age-related deterioration of protective coatings and is considered a common defect for gutters of this age. In plain terms, the gutters are starting to rust on the surface. While currently superficial, untreated rust can progress and lead to perforation and water leakage over time. Preventative measures include regular cleaning of gutters and application of rust treatment and protective coatings. A qualified roofer, gutter contractor or handyman should assess and treat the affected areas or replace sections as deemed necessary. Repairs are recommended at the owner’s discretion to prevent further corrosion and maintain effective stormwater drainage.

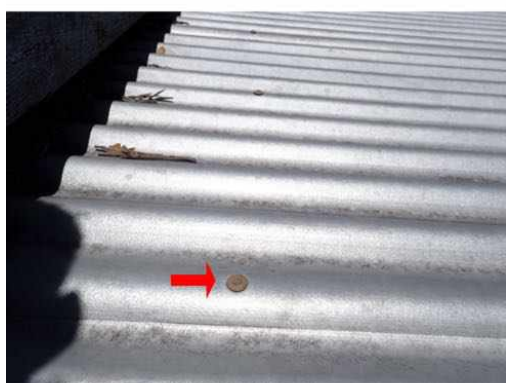
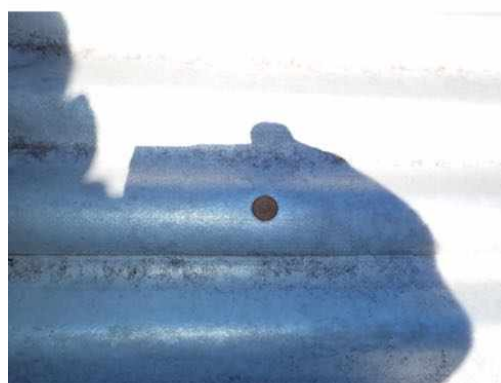
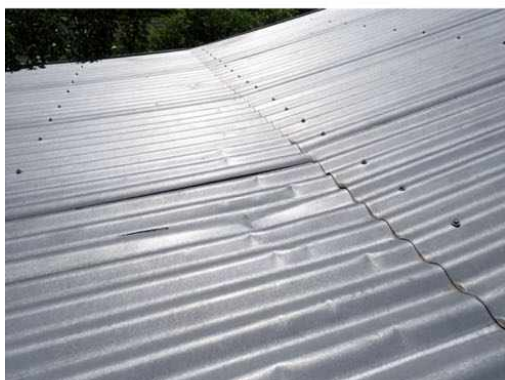
Finding 3.12

Building:	Main Building
Location:	Roof
Finding:	Surface Rust To Roof Fixings And Minor Isolated Rust To Roof Cladding
Information:	<p>Surface rust was identified to some roof fixings, along with minor isolated areas of surface rust and localised impact related damage to sections of the roof cladding. This condition is typically associated with age-related deterioration, long-term weather exposure and breakdown of protective coatings and is considered common for roofing materials of this age. In plain terms, some of the screws and small areas of the roof sheeting are starting to rust. While currently minor, ongoing corrosion can lead to loosening of fixings, water ingress and further deterioration of the roof covering. Preventative measures include treating rusted areas, replacing corroded fixings and maintaining protective coatings. A qualified roofer should assess and replace affected fixings and repair or treat rusted cladding as deemed necessary. Rectification is recommended at the owner's discretion to prevent further corrosion and potential leaks.</p>

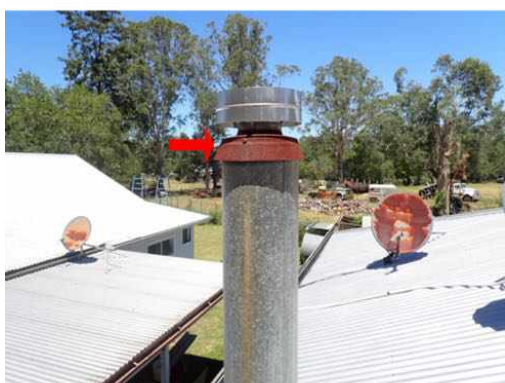
Finding 3.13

Building:	Main Building
Location:	Roof
Finding:	Rust Identified To Fireplace Flue
Information:	Rust was identified to the metal fireplace flue. This condition is typically caused by prolonged exposure to heat, condensation and external weathering and is common in flue components of this age. In plain terms, the metal chimney pipe is rusting. While surface rust may initially be cosmetic, progressive corrosion can lead to metal thinning, perforation and reduced performance or safety over time. Preventative measures include regular inspection and maintenance, including protective coatings where applicable. A qualified plumber, roofer or fireplace specialist should assess and repair or replace the affected flue sections as deemed necessary. Rectification is recommended at the owner's discretion to prevent further deterioration and ensure continued safe operation.

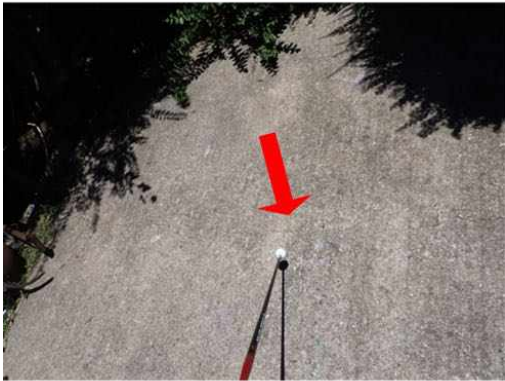
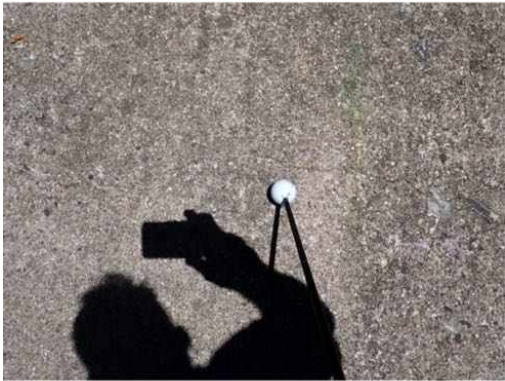
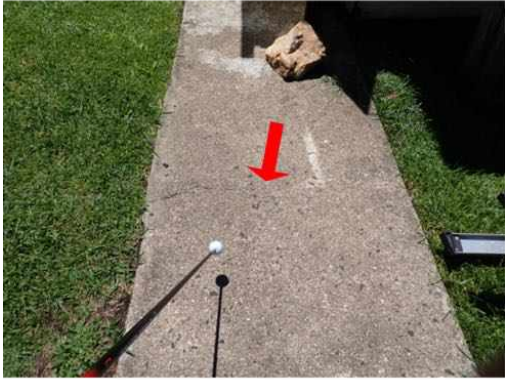
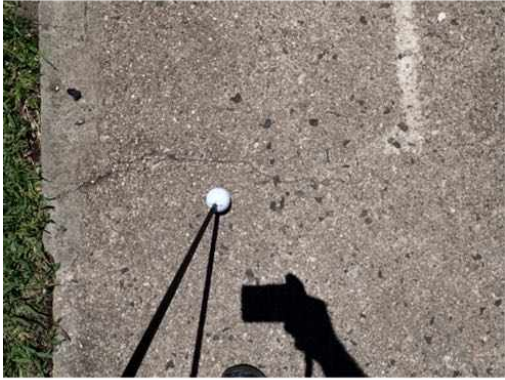
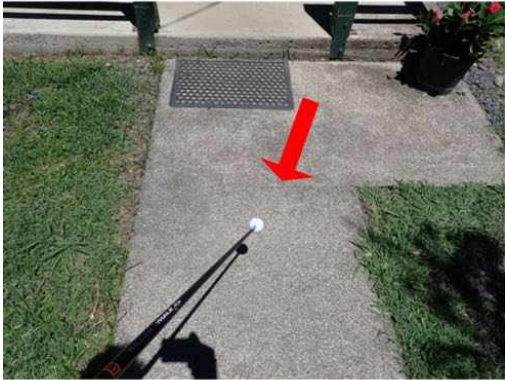
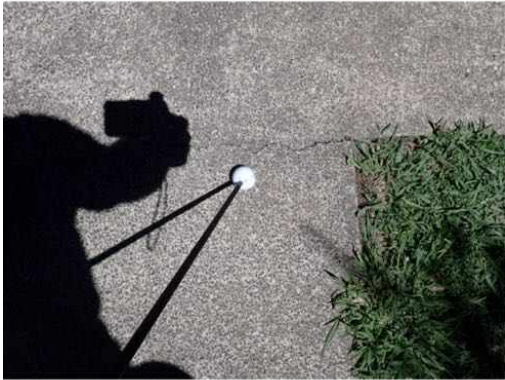
Finding 3.15

Location: Concrete paths
Finding: Minor Cracks To Concreted Paths
Information: Minor cracks were identified to the concreted paths around the property. This is commonly associated with normal shrinkage during curing, minor ground movement and age-related wear and is considered a common defect for concrete of this age. In plain terms, there are small cracks in the concrete walkways. While generally minor, cracks can allow water ingress which may contribute to gradual deterioration over time. Preventative measures include sealing cracks and maintaining adequate drainage away from the paths. A qualified concreter should assess and seal or repair the cracks as deemed necessary. Repairs are recommended at the owner's discretion to maintain durability and prevent further deterioration.

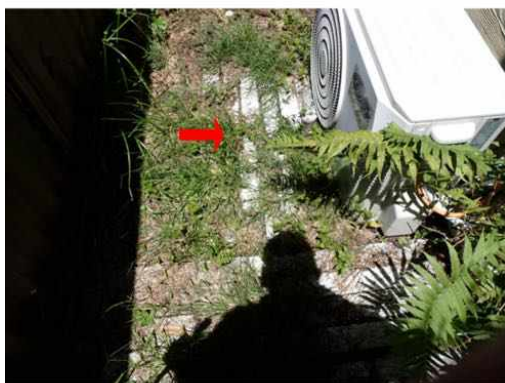
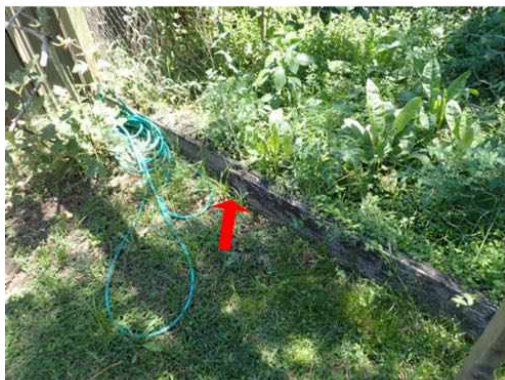
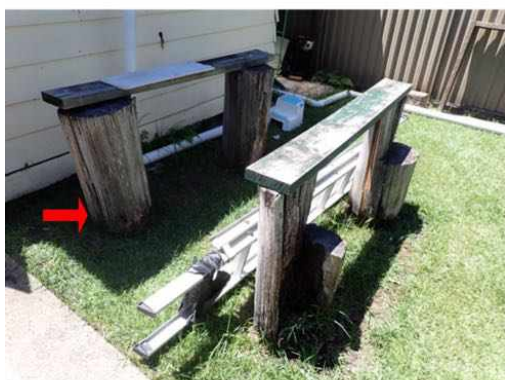
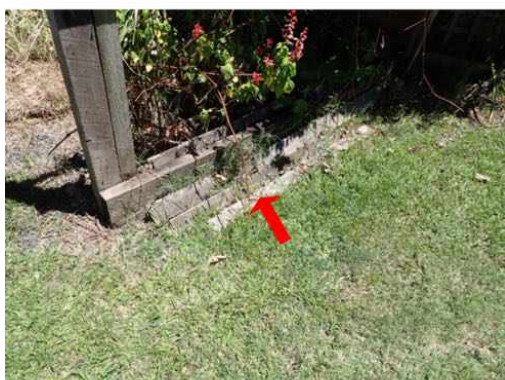
Finding 6.01

Building:	Yard
Location:	All areas
Finding:	Timber In Contact With Ground Around Yard Area – Conducive To Termite Attack
Information:	Timber elements were identified in contact with the ground around the yard area. This condition is conducive to termite activity as it provides concealed access and a moisture source, increasing the risk of infestation. In plain terms, some timber in the yard is touching the soil which makes it easier for termites to attack. Timber-to-ground contact is a common risk factor in properties of this type and age. Ongoing contact may also contribute to timber decay. Preventative measures include removing soil build-up, maintaining adequate clearances and ensuring a visible inspection zone is present where applicable. A licensed pest control contractor and/or qualified carpenter should assess and separate timber from soil, replace affected sections or remove as deemed necessary. Rectification is recommended at the owner's discretion to reduce the risk of termite attack and further deterioration.

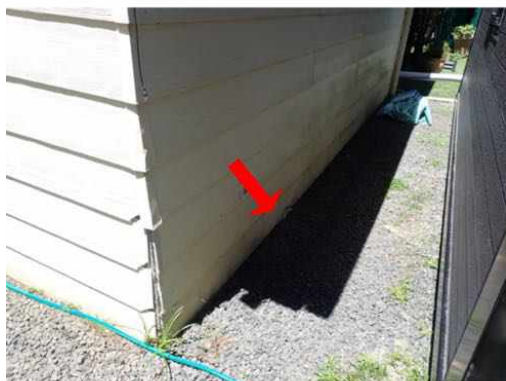
Finding 6.02

Building:	Main Building
Location:	Garage
Finding:	No Slab Edge Exposure – Conducive To Termite Attack
Information:	No visible slab edge exposure was identified around sections of the perimeter, with soil, paving and/or landscaping built up above the slab level. This condition is conducive to termite activity as it can conceal termite entry points and reduce the effectiveness of visual inspections. In plain terms, the edge of the concrete slab cannot be seen in some areas because it is covered, making it easier for termites to enter unnoticed. This is a common risk factor in properties of this type and age. Preventative measures include maintaining a clear and visible slab inspection zone in accordance

with current guidelines. A licensed pest control contractor and/or qualified landscaper or builder should be engaged to lower soil levels and expose the slab edge as deemed necessary. Rectification is recommended at the owner's discretion to reduce the risk of concealed termite entry.

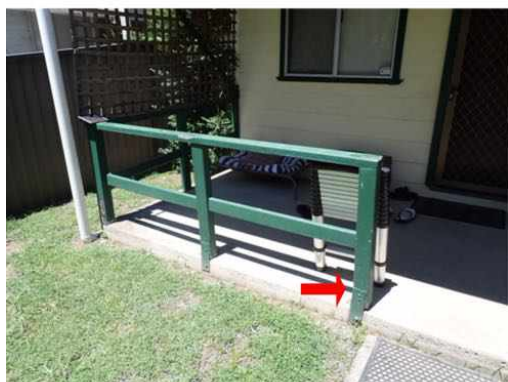
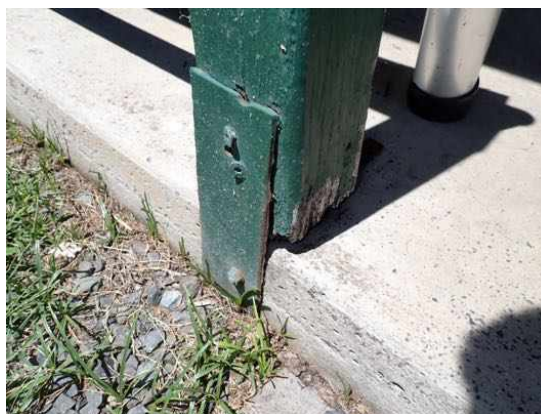
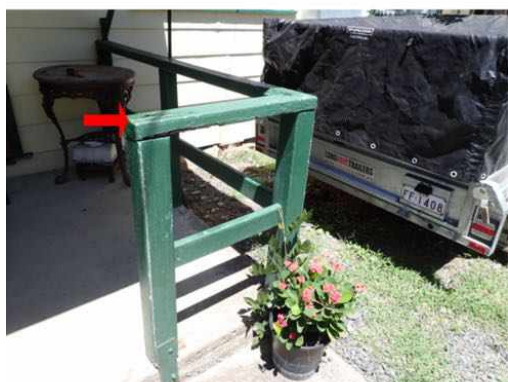
Finding 7.01

Building:	Main Building
Location:	Front porch
Finding:	Entry Porch Handrail In Poor Condition With Wood Rot And Poor Installation
Information:	The entry porch handrail was observed to be in poor condition, with areas of wood rot and evidence of substandard installation noted. Timber deterioration is typically caused by prolonged moisture exposure, inadequate sealing and age-related wear. In plain terms, the handrail is rotting and does not appear to have been installed properly. Wood rot can compromise the structural integrity of the handrail. Preventative measures include ensuring timber elements are properly treated, sealed and installed with adequate protection from moisture. A qualified carpenter or licensed builder should assess and repair or replace the affected sections and rectify installation defects as deemed necessary. Prompt rectification is recommended at the owner's discretion due to potential safety implications and ongoing deterioration.

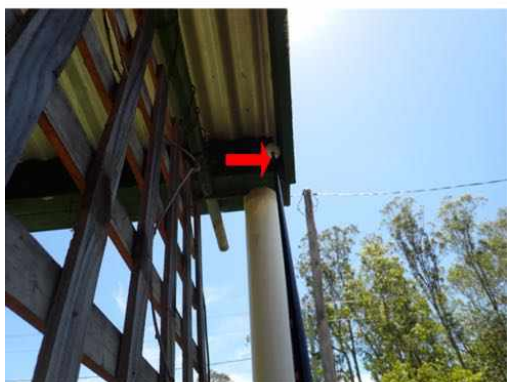
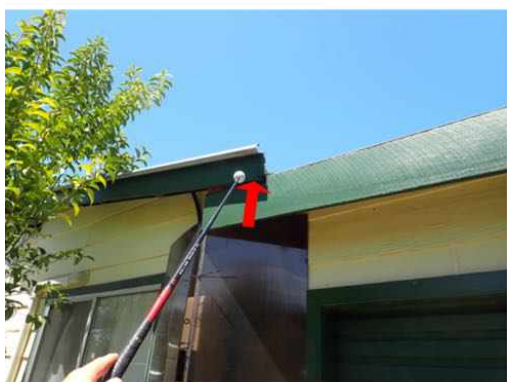
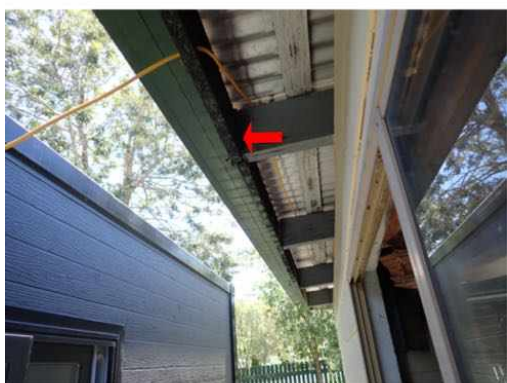
Finding 7.02

Building:	Main Building
Location:	Fascia boards
Finding:	Wood Rot Identified To Timber Fascia Boards At Several Locations.
Information:	Wood rot was identified to sections of the timber fascia boards at several locations, with some areas requiring re-fixing. Deterioration is typically caused by prolonged moisture exposure, failed paint coatings and age-related wear and is considered a common defect with a property of this age. In plain terms, parts of the fascia boards are rotting and some sections are loose. Timber decay can worsen over time and may affect the stability of attached gutters. Preventative measures include maintaining protective paint coatings and ensuring effective roof drainage. A qualified carpenter or licensed builder should assess, replace or repair the affected timber and securely re-fix loose sections as deemed necessary. Repairs are recommended at the owner's discretion to prevent further deterioration and maintain structural integrity.

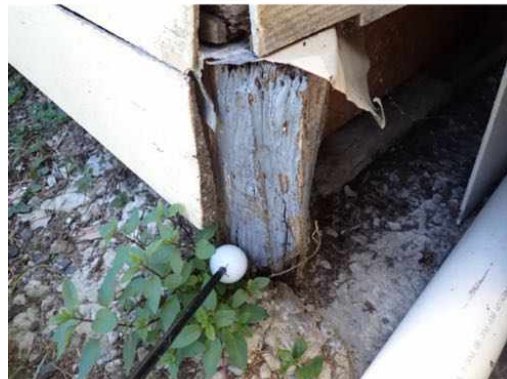
Finding 7.03

Building:	Main Building
Location:	Laundry
Finding:	Wood Rot Identified To Laundry Timber Stumps And Weatherboards
Information:	Wood rot was identified to the timber stumps and sections of weatherboards in the laundry area. Deterioration is typically caused by prolonged moisture exposure, inadequate ventilation and age-related wear, and is considered a common defect in timber elements of this age. In plain terms, some of the timber supports and wall boards in the laundry are rotting. Timber decay can reduce structural capacity and, if left unaddressed, may worsen over time. Preventative measures include addressing moisture sources, improving ventilation and maintaining protective coatings. A

qualified carpenter or licensed builder should assess and repair or replace the affected timber components as deemed necessary. Rectification is recommended at the owner's discretion to prevent further deterioration and maintain structural integrity.
