# Building and Timber Pest Inspection Report

Inspection Date: Mon, 16 Feb 2026

Property Address: 890 Punchbowl Rd, Punchbowl NSW 2196,  
Australia

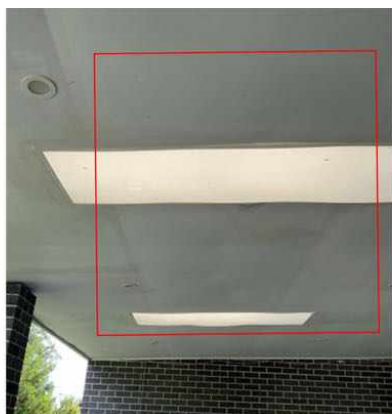
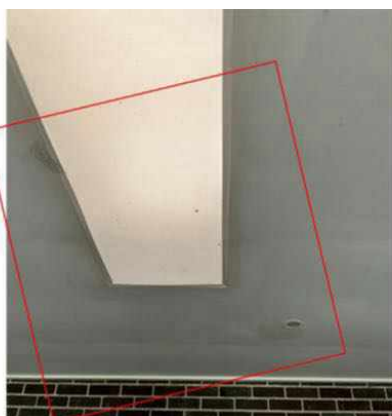
Building: Main Building  
 Location: All External Areas - Rear  
 Finding: Ceiling - Water damaged and evidence of past repairs  
 Information: Water damage to the ceiling lining is generally an indication of excessive moisture being present in the roof void, usually via a leak to the roof covering.

Where water damage is evident to the ceiling, the primary requirement is to identify and rectify the source of the leak. A roofing plumber should be appointed as soon as possible to identify the leak and perform rectification works as necessary, ensuring the water damage is restricted.

Once the leak is repaired, consultation with relevant tradespeople, including plasterers and painters, is advised. Rectification works may include replacement of ceiling lining or minor repainting, depending on the extent of the damage.

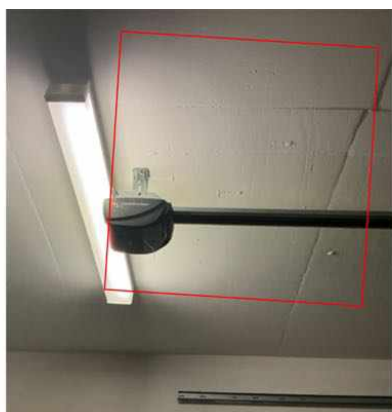
### Finding 3.02

Building: Main Building  
 Location: Garage  
 Finding: Elevated Moisture – Further Investigation Recommended  
 Information: Elevated moisture readings were detected with some areas also showing signs of localised bubbling/swelling to paint finish. While others did not present visible surface issues, although no significant structural damage was evident at the time of inspection,

dampness can contribute to deterioration if left unaddressed. A further investigation by a licensed plumber or waterproofing specialist is recommended to confirm the source and ensure no concealed issues are developing.

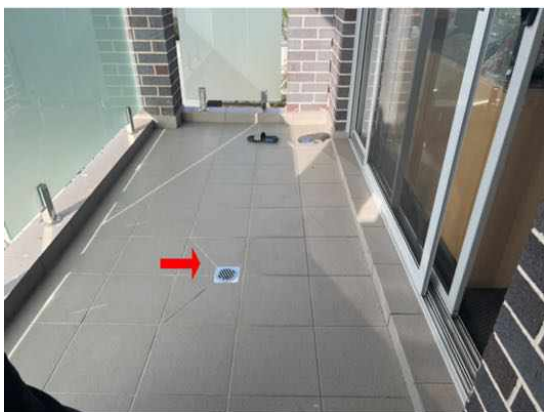
### Finding 3.03

Building:	Main Building
Location:	Balcony
Finding:	Balcony – Elevated Moisture to Tiled Floor Area
Information:	Elevated moisture readings were detected to the tiled balcony floor with visible minor efflorescence and discolouration to grout lines indicating prolonged or recurring moisture presence beneath the tile finish. This condition is commonly associated with failed grout or sealant joints, insufficient surface drainage and/or inadequate waterproofing allowing moisture to become trapped within the balcony substrate. While no internal water ingress was evident at the time of inspection, the readings exceed what would be expected under normal dry conditions and warrant further investigation. This issue is considered a minor defect at present, with the potential to escalate if moisture migration continues, and assessment by a suitably qualified waterproofing specialist is recommended.

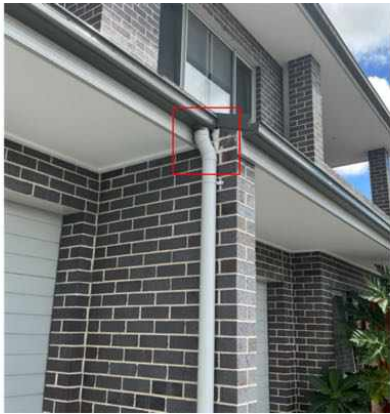
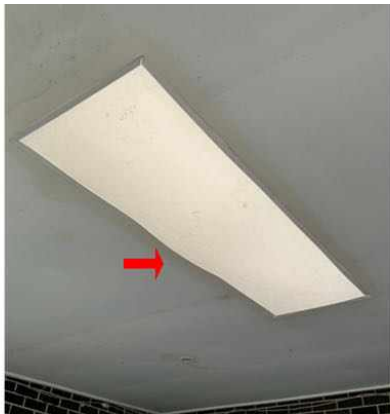
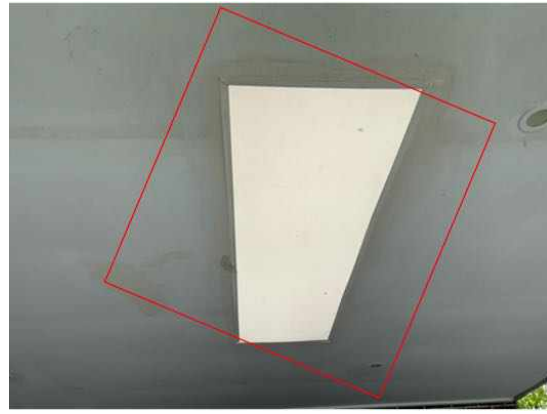
Building: Main Building  
Location: All External Areas  
Finding: Incomplete or substandard works - Unsealed gap (Possible Moisture ingress) , Ceiling lights incomplete repairs  
Information: The works to this area appear to be incomplete or have been completed to a substandard level.

Works that have not been completed to a satisfactory level create potential for the development of building defects and may impede on the safety and integrity of the overall structure.

It is highly recommended that the relevant trades be appointed to complete these works and ensure the safety of the area and the longevity of all associated building elements.

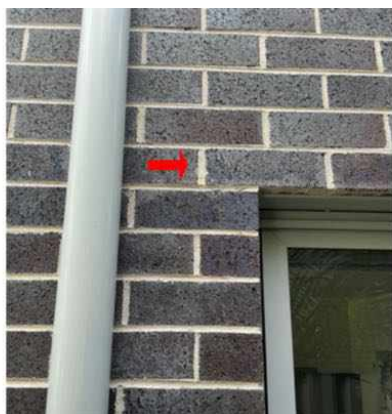
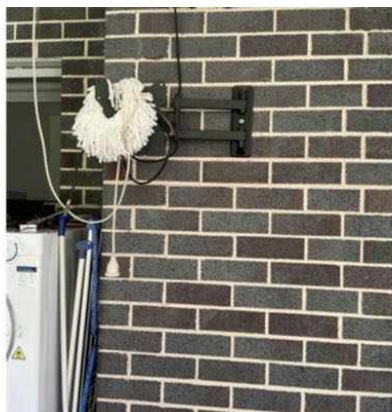
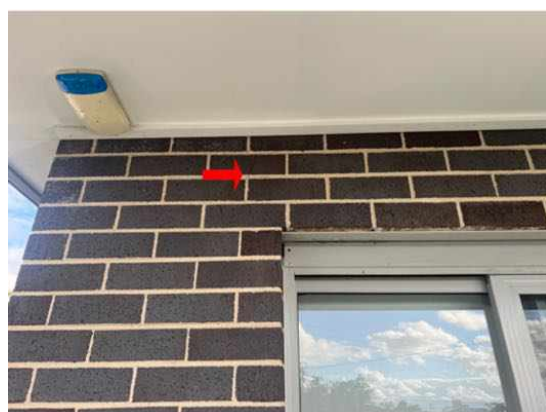
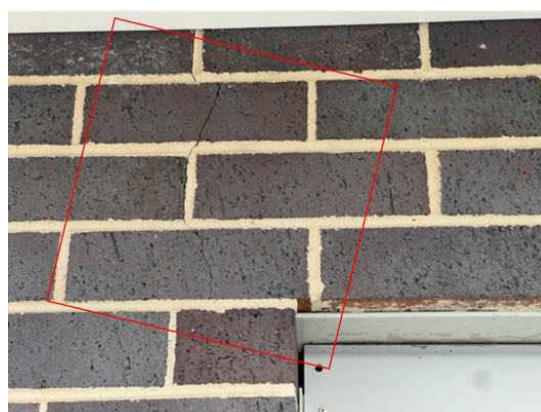
### Finding 3.06

Finding: Brickwork - Cracking [Fine] to some areas

Information: Although fine cracks are quite noticeable, they are often only considered to be an appearance defect and usually do not indicate any structural damage. Generally, the cause of a fine crack is indicative of a separation between brickwork and mortar throughout the structure, but single bricks may also show cracks of this nature.

Cracking of this nature can generally be repaired with minor filling and should be conducted by a qualified bricklayer.

Always contact a building inspector should cracks widen lengthen or become more numerous.

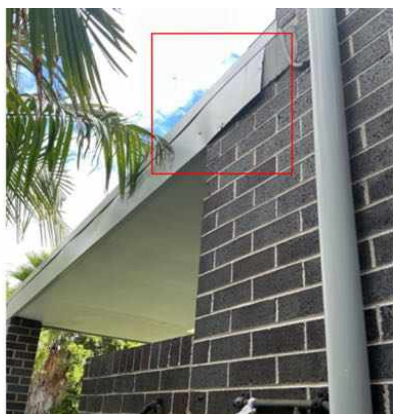
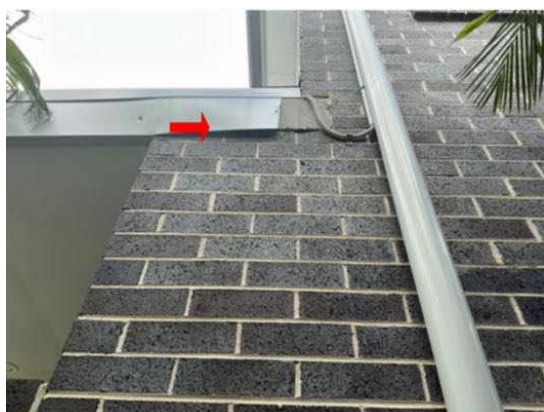
Building: Main Building  
Location: Roof Exterior  
Finding: Building element - Dam(Loose flashing possible moisture ingress)  
Information: Breakage occurs generally when the building materials have either aged and decayed,

or as a result of damage (accidental or deliberate).

Repair and/or replacement of broken elements is advised to ensure that additional secondary defects do not arise as a consequence. Such works are necessary, as all building elements play a key role in the operation and function of the overall structure and its performance.

A relevant tradesperson should be appointed to repair or replace the affected building element prior to any subsequent damage being caused.

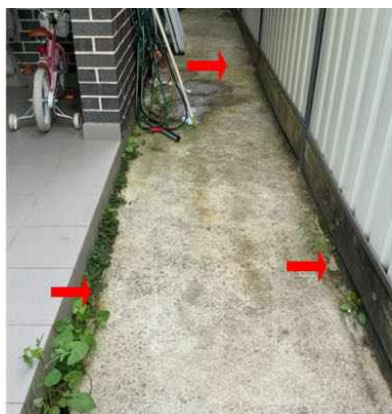
### Finding 3.09

Building:	Main Building
Location:	All External Areas
Finding:	Poor Surface Drainage & Vegetation Growth – Side Passage
Information:	The concrete pathway along the side of the dwelling appears to have visible organic staining, algae growth and vegetation along the slab edges, indicating prolonged moisture retention and inadequate surface drainage. No clear drainage outlet was observed within the inspected section. Poor drainage in this location may allow water to track toward the external wall, increasing the risk of rising damp, mortar deterioration, damp-proof course bridging and termite conducive conditions over time. While no immediate structural failure was evident, A further inspection by a licensed plumber is recommended along with removal of vegetation build-up and ensure

adequate exposure of the damp-proof course in accordance with good building practice.

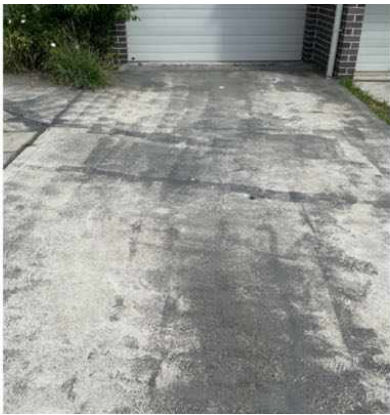
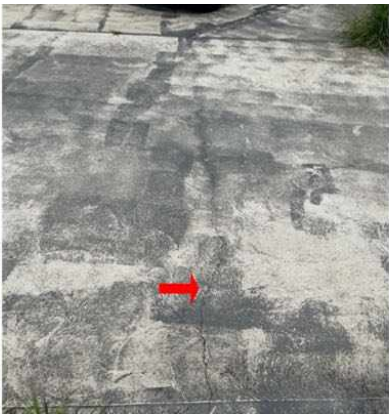
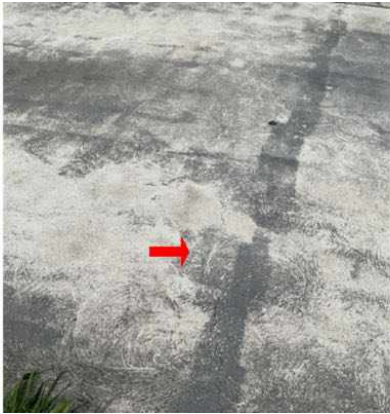
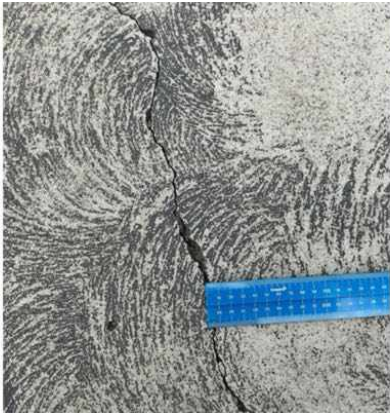
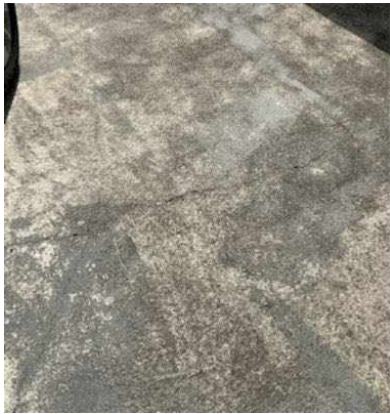
### Finding 3.10

Building:	Main Building
Location:	All External Areas
Finding:	Cracking - External Concrete Paving Damage Category 3 - Wide Cracks (2mm - 4mm)
Information:	Wide cracks were identified in external concrete paving Wide cracks are significant and are likely to lead to the development of safety hazards and secondary defects if left unmanaged.

General age and expected deterioration of the paved areas is a common cause of this type of cracking. However, expansion and contraction of the slab may also have occurred due to environmental factors. Such factors include variable moisture and weather conditions, the presence of trees and their roots having a settling or lifting affect on the soil, or the effect of load bearing, e.g. heavy vehicles over a sustained period of time.

Cracking to this degree may also be due to poor original installation of the concrete. Factors such as poor compaction of the sub surface and/or inadequate reinforcing of the slab may create cracking and other secondary defects. Wide cracks may also have a more significant structural cause, such as subsidence of soils.

Where the crack is located adjacent to structural elements of the building, the advice of a Structural Engineer is advisable before undertaking repairs. Significant repair and likely replacement of the concrete paving is probable.

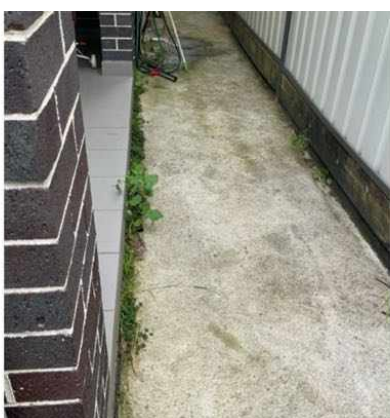
This separation may permit water ingress and contribute to concealed moisture-related damage, pest ingress, or slab movement if left unsealed.

The defect appears consistent with common differential settlement or poor sealant detailing at the slab-to-wall junction. Recommend a licensed contractor seal the gap with an appropriate flexible, UV-stable exterior-grade sealant to prevent moisture entry and pest intrusion.

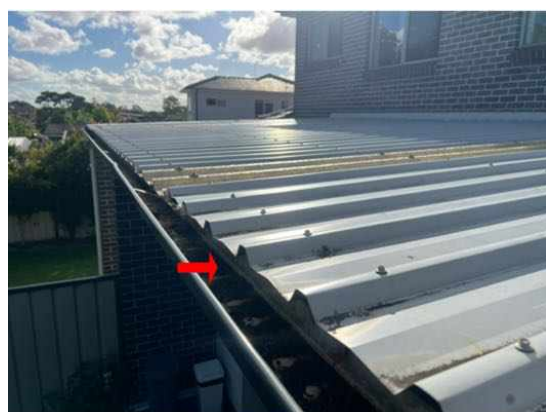
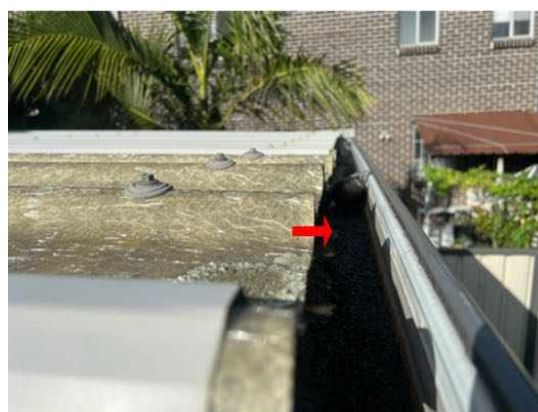
Blocked gutters are likely to lead to high levels of moisture in the affected areas. Such moisture will not only cause rust and decay of the associated building materials, but can also provide conditions that are conducive to termite and timber pest activity. Blockages in gutters should therefore be removed immediately to ensure dry conditions are maintained.

Consult a Licensed Plumber for further specific advice on remedial works that may be required. In the interim, it is highly advised that blocked gutters be removed by the homeowner or a general handyperson as a matter of urgency.

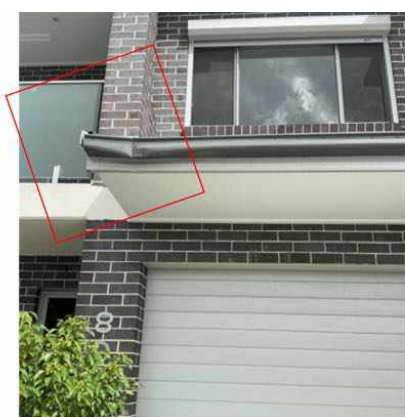
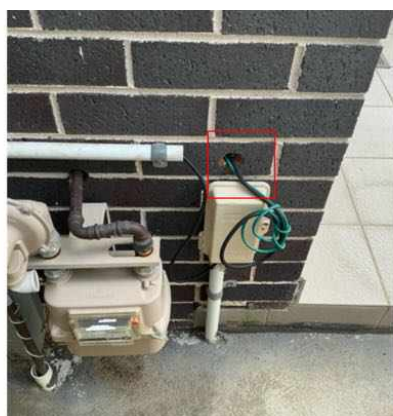
### Finding 3.16

Building:	Main Building
Location:	All External Areas - Front
Finding:	Building element - Damaged - Gutter damaged , hole not sealed side
Information:	Breakage occurs generally when the building materials have either aged and decayed, or as a result of damage (accidental or deliberate).

Repair and/or replacement of broken elements is advised to ensure that additional secondary defects do not arise as a consequence. Such works are necessary, as all building elements play a key role in the operation and function of the overall structure and its performance.

A relevant tradesperson should be appointed to repair or replace the affected building element prior to any subsequent damage being caused.

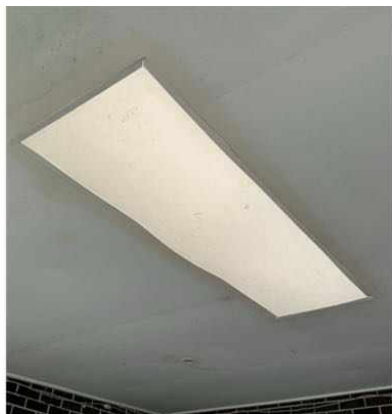
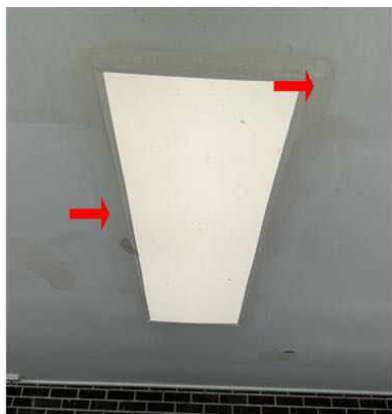
### Finding 3.17

Building:	Main Building
Location:	All External Areas - Rear
Finding:	Incomplete or substandard works - Poor workmanship and incomplete repair work
Information:	The works to this area appear to be incomplete or have been completed to a substandard level.

development of building defects and may impede on the safety and integrity of the overall structure.

It is highly recommended that the relevant trades be appointed to complete these works and ensure the safety of the area and the longevity of all associated building elements.

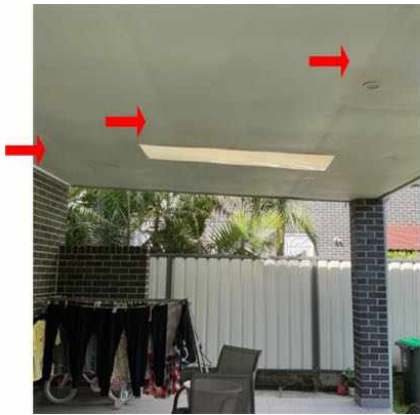
### Finding 3.18

Building:	Main Building
Location:	All External Areas - Rear
Finding:	Paint Defect - Shadowing
Information:	Minor cosmetic shadowing is visible on the alfresco ceiling, presenting as faint straight lines along the plasterboard joints, this is a common effect caused by raking light, normal thermal movement, and variations in paint or compound finish, with no signs of moisture ingress this is considered a minor defect under AS 4349.1, with improvement achievable through skim-coating and repainting if desired.

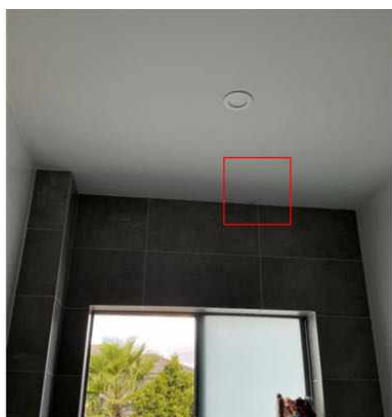
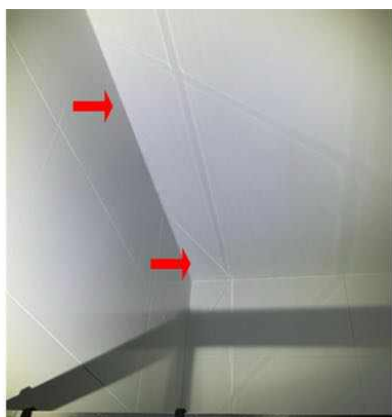
### Finding 3.20

Building:	Main Building
Location:	Bathroom
Finding:	Water Staining - Humidity or Ventilation
Information:	The ceiling surface shows faint darkened spotting or shadowing, commonly consistent with surface mould or humidity-related staining, often found in bathroom or wet area ceilings with insufficient ventilation. While there is no visible sagging or major water damage, the pattern suggests prolonged moisture exposure, possibly due to steam accumulation or minor condensation issues. According to AS 4349.1–2007 (Appendix C), this would be classified as a minor defect unless further deterioration or active leaks are found. Recommend improving mechanical or natural ventilation, cleaning the surface with mould treatment, and monitoring for recurrence.

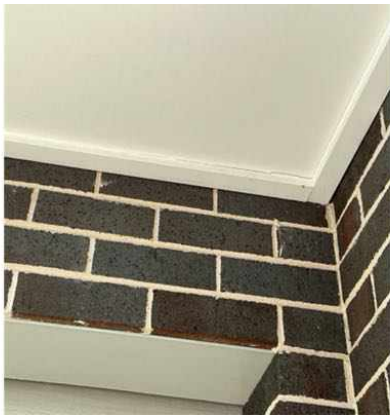
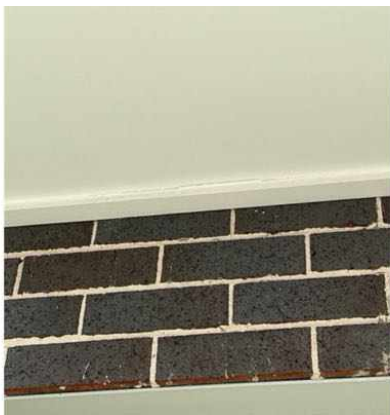
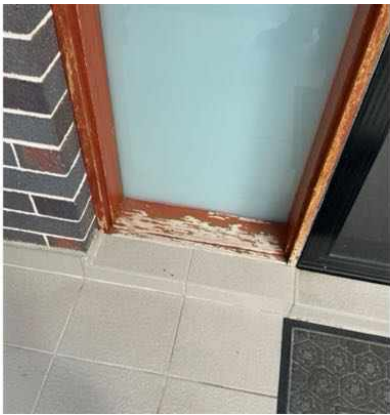
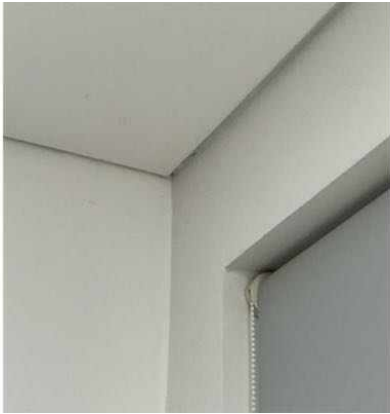
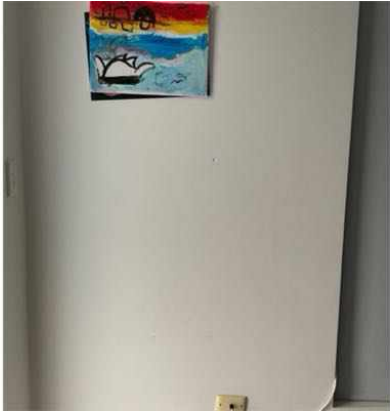
### Finding 3.21

Building:	Main Building
Location:	All Internal Areas
Finding:	Paint Finish & Hairline Cracking - To some areas
Information:	The paint finish in this area was identified as being incomplete or substandard at the time of inspection including some hairline minor cracking/separation. Monitoring is recommended where cracking and separation is evident.

Incomplete paint finishes should be sanded back, filled, leveled and painted, as applicable. Where inadequate or missing paint protection has led to the deterioration of the associated building element, repair and/or replacement of this building element may be required.

A painting contractor should be appointed as soon as possible to perform necessary works to aid the appearance of the affected area and to ensure the area is protected against further deterioration. Alternatively, the homeowner following manufacturer instructions may perform these works.

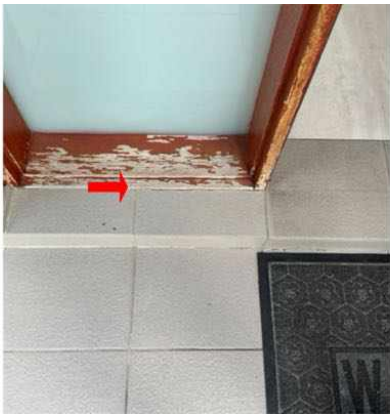
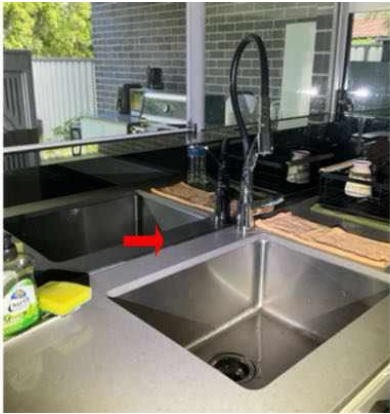
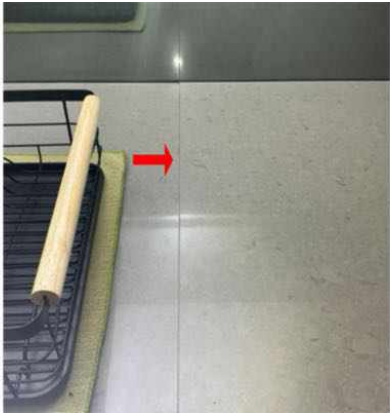
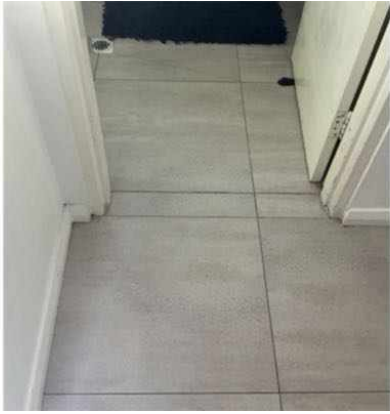
### Finding 3.22

Building:	Main Building
Location:	All Internal Areas and balcony
Finding:	Sealant and grouting - Missing or degraded to some areas
Information:	It was noted on inspection that sealant or grout is degraded.

Flexible and mould resistant materials should be applied to affected areas to prevent any subsequent water damage that is likely to occur. Regular maintenance and replacement of damage or missing or damaged sealant and grout is highly recommended to the wet areas, as this is a regular wear and tear defect. Sealant and grouting in areas that come into regular contact with water should be maintained for the long term care of your property.

A sealant specialist or tiling contractor should be appointed to complete these works as soon as possible

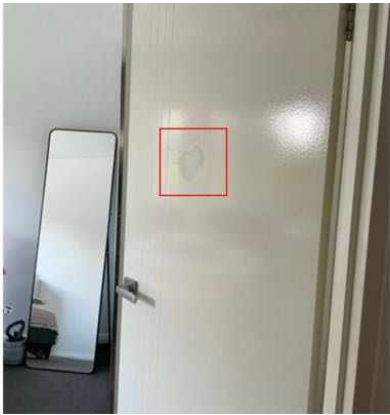
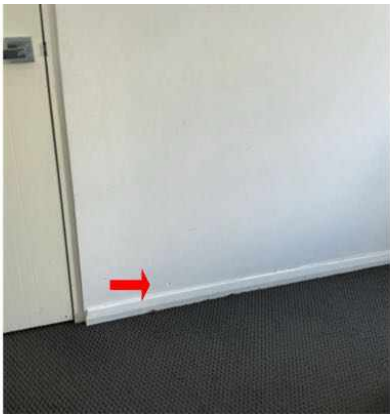
**Finding 3.24**

Building: Main Building  
Location: All Internal Areas - Bedroom Rear  
Finding: Building element - Damaged- (Door damaged bedroom, skirting loose upstairs rear )  
Information: Breakage occurs generally when the building materials have either aged and decayed, or as a result of damage (accidental or deliberate).

Repair and/or replacement of broken elements is advised to ensure that additional secondary defects do not arise as a consequence. Such works are necessary, as all building elements play a key role in the operation and function of the overall structure and its performance.

A relevant tradesperson should be appointed to repair or replace the affected building element prior to any subsequent damage being caused.

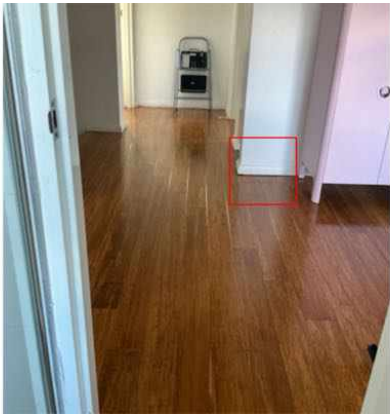
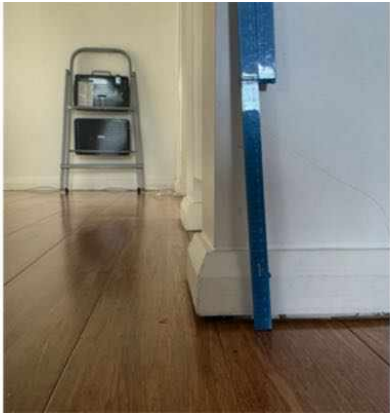
**Finding 3.25**

Building: Main Building  
Location: Lounge Room 2  
Finding: Gap between skirting and Floor  
Information: A localised gap is visible between the skirting board and the laminate/timber floor finish, indicating minor floor level variation or movement of the floating floor system. This condition is most consistent with minor slab/floor unevenness, floor finish movement or shrinkage. While primarily cosmetic/serviceability in nature, monitoring is recommended and further assessment may be warranted by a licensed builder if additional signs of structural movement become apparent.

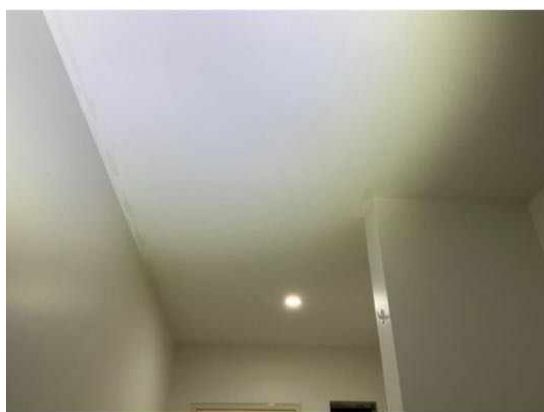
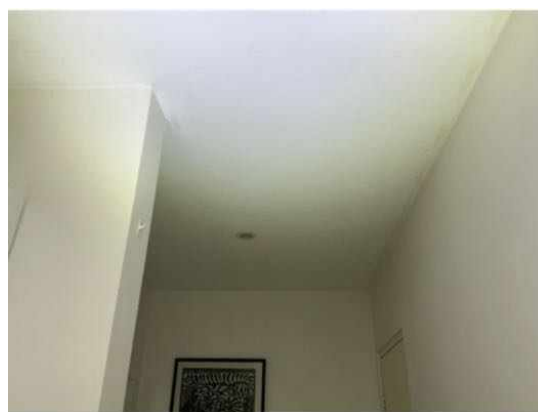
### Finding 3.26

Building:	Main Building
Location:	Laundry, ensuite, bathroom
Finding:	Building element - Missing - No ventilation
Information:	Although some building elements may seem irrelevant or unnecessary, all building elements play a key role in the operation and function of the overall structure and its performance.

Replacement of any missing building element should be conducted as soon as possible to ensure that no damage or functional issues occur to associated building materials.

The appropriate tradesperson should be appointed as soon as possible to replace the missing building element.

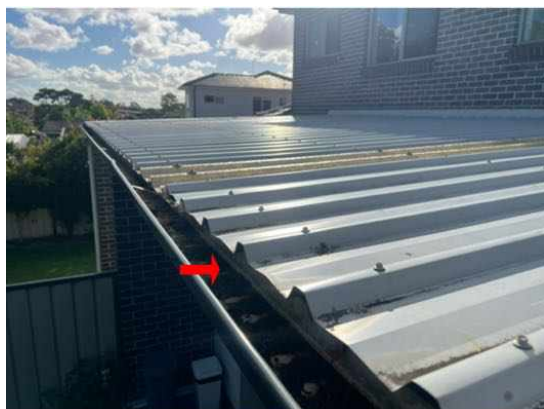
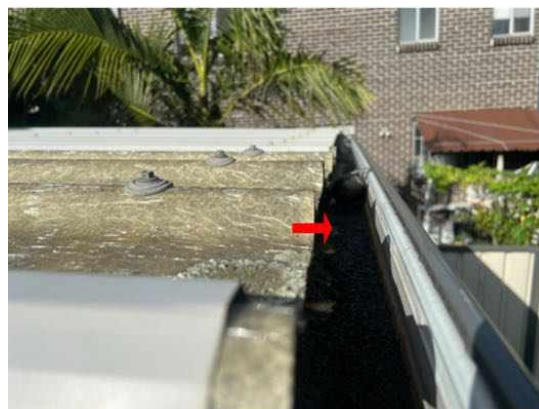
### Finding 6.05

Building:	Main Building
Location:	All External Areas
Finding:	Gutters - Blocked
Information:	Roof plumbing structures, such as guttering and downpipes, should be free of all debris to prevent blockages. Blockages of the guttering and downpipes will lead to pooling and accumulated water overflows, which is likely to subsequently flood eaves and exterior walls.

Consult a Licensed Plumber for further specific advice on remedial works that may be required. In the interim, it is highly advised that blocked gutters be removed by the homeowner or a general handyperson as a matter of urgency.

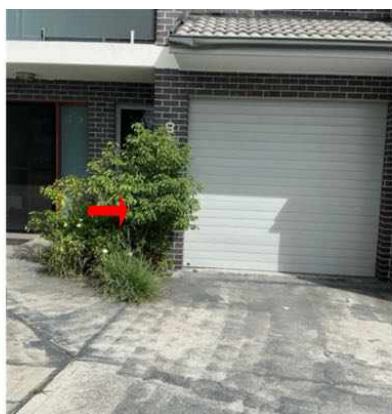
### Finding 6.06

Building: Main Building  
 Location: All External Areas  
 Finding: Bridging - Vegetation  
 Information: Where vegetation obstructs inspection of building elements, also known as bridging as it provides a bridging point for the access of termites, full inspection can not be achieved. Consequently moisture or dampness may be present and the areas becomes conducive to termite activity. Plants against or very close to buildings provide cover, shade and can provide an environment that is attractive to termite infestation.

The removal and replanting of species that do not provide "cover" or cutting back of existing vegetation will assist greatly in preventing Bridging from occurring.

The removal of any such materials that may be conducive to termite activity should be carried out as soon as possible and arrange re inspection to minimize the risk of termite attack.
