Building and Timber Pest Inspection Report

Inspection Date: Thu, 2 Apr 2026

Property Address: 13A Havelock Pl, Kiama Downs NSW 2533,
Australia

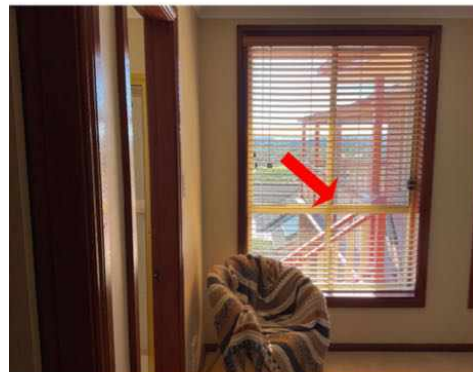
Building:	Building 1
Location:	Pictured upstairs windows
Finding:	Window opening restrictors missing.
Information:	Many upstairs windows are missing window restrictors. The Building Code of Australia rules require all openable windows (where the internal floor is more than 2m above the ground outside) in residential rooms to be fitted with a suitable screen or restrictor. Windows located 1.7m above the floor level do not require protection.

Window restrictors are required where people who are vulnerable to the risk of falling have access to windows. This means all windows above ground level which do not have another fall prevention safety measure in place, such as a balcony or balustrade should have a restrictor.

These need to be added urgently for the safety of all persons.

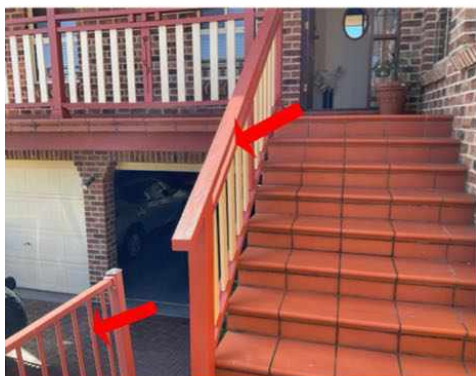
Finding 1.02

Building:	Building 1
Location:	Front Stairs Areas
Finding:	Balcony railing loose and metal railing leaning
Information:	The timber balcony railing in the front stairs area is loose, wobbling and requires additional support. The metal railing is leaning due to the retaining wall underneath also leaning. If left unmanaged, these railings will further deteriorate, causing potential for falls.

A carpenter should be appointed to perform these rectification works immediately.

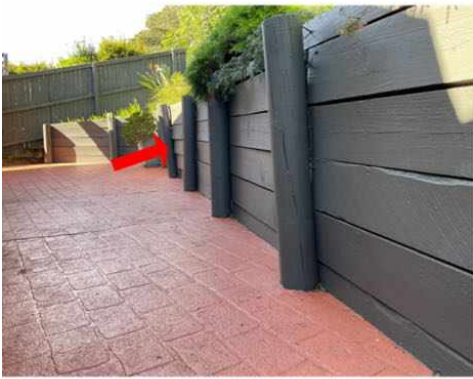
Building: Building 1
Location: Pictured front driveway and rear areas
Finding: Retaining walls - Defective
Information:

Most retaining walls were found to be defective at the time of inspection. Generally, defective retaining walls are caused by poor original design or material use. However, deteriorated retaining walls may also be a result of substandard construction, poor site drainage or unmanaged stormwater flows.

If left unmanaged, these retaining walls may become a safety hazard if it continues to destabilise. Where retaining walls further rot and decay, an environment is created that is conducive to termite and pest infestation.

Significant repair and replacement should be expected. Where retaining walls are considered structural walls, a structural engineer / surveyor should be consulted regarding required remedial works. Otherwise, a landscaper or retaining wall installer may be appointed to repair or replace the wall, at the discretion of the client.

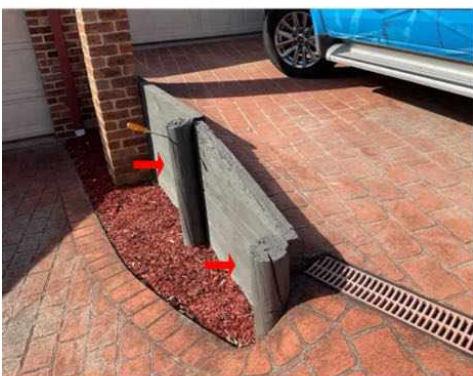
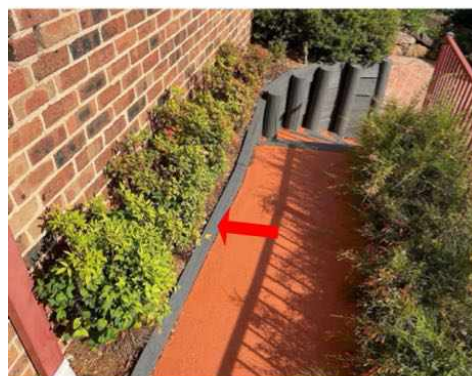
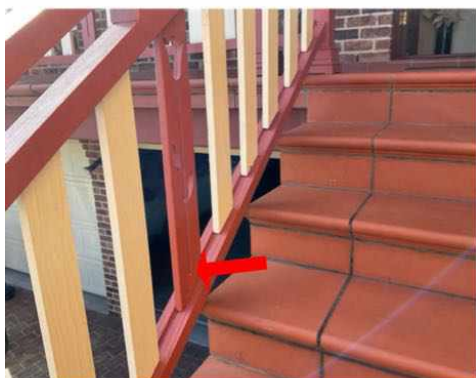
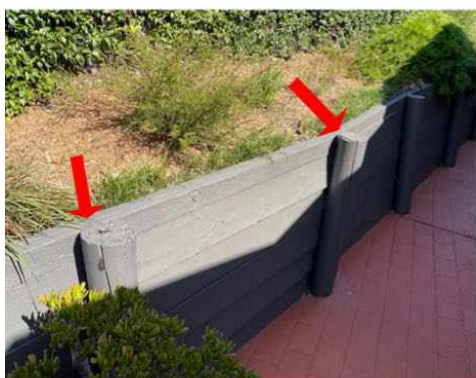
Finding 3.01

Building:	Building 1
Location:	Pictured retaining walls and railing
Finding:	Wood rot to external areas
Information:	These pictured areas show evidence of wood rot. Wood rot, also known as Fungal Decay, occurs when timbers and other cellulose building materials are exposed to damp conditions on an ongoing basis. This could be the result of exposure to weathering over a prolonged period of time, or the attraction of excessive moisture from other abutting building materials.

Early intervention and regular maintenance, particularly of exterior timbers, will prolong the useful life of these building elements. Prior to any works being performed, the cause of the moisture that has created the visible wood rot should be identified and addressed in a suitable manner. Replacement of affected timbers may then be a necessary step in protecting surrounding building elements from such deterioration.

A retaining wall installer may also be required to replace affected building materials in the near future.

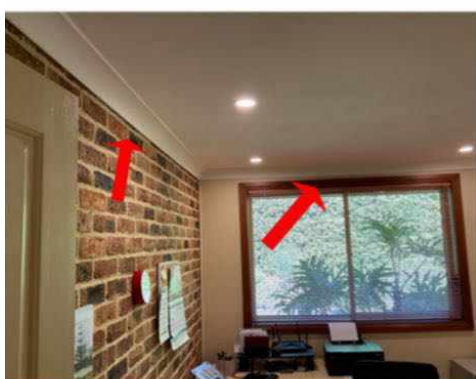
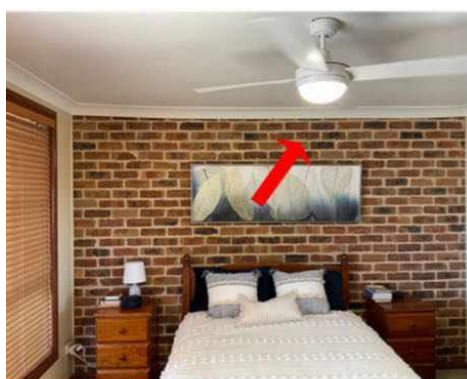
Finding 3.02

Building:	Building 1
Location:	Some upper and one lower room
Finding:	Ceiling - Sagging
Information:	Sections of four ceilings were found to be sagging at the time of inspection. Sagging to these fixed ceiling structures indicates that fixings (e.g. nails or glue) have become loose and require reattachment. This is the case in the middle of house areas and most likely in other areas. Some of these ceilings appear to have very little plaster glue applied.

Where minor sagging is evident, comparatively minor works, such as re-gluing of ceiling sheets, may be required. Such works may be performed by relevant tradespeople, such as plasterers and painters. If excessive moisture has caused the roofing structure to swell and sag in areas not accessible from the roof void, the source of any water leak should primarily be identified prior to any remedial works being performed.

The appropriate action should be taken by the client as soon as possible to ensure

that any potential further damage is limited.

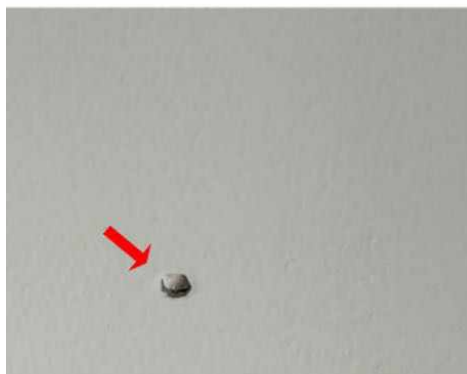
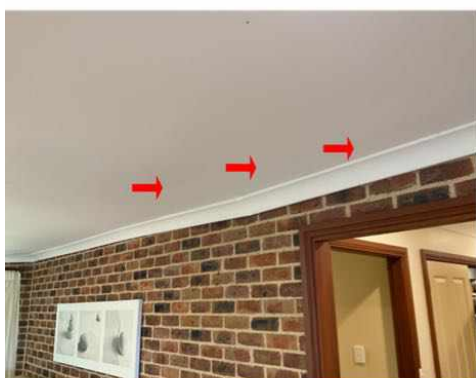
Finding 3.03

Building:	Building 1
Location:	Some upper and one lower room
Finding:	Ceiling nails - Popping
Information:	Random popped nails were identified in some internal ceilings at the time of inspection. Nails and screws hold simply by the friction between them and the surface they are applied to. Over time, the nails and screws can back out, which is often a result of general ageing and deterioration of the building structure.

If left unmanaged, the ceiling sheets may become loose and unstable, increasing the rate of deterioration of the internal ceiling and creating potential for the development of secondary defects.

Re-fastening of popped nails will help to maintain the stability of the internal ceiling and associated building elements. Such minor works will also help to improve the appearance of the affected area and secure the ceiling sheets, so as to prevent the onset of ceiling sagging. These works should be performed by a qualified carpenter or plasterer at client discretion.

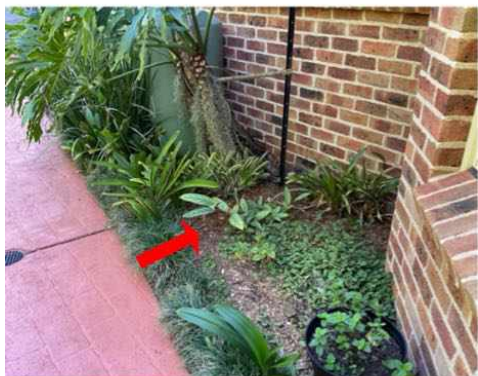
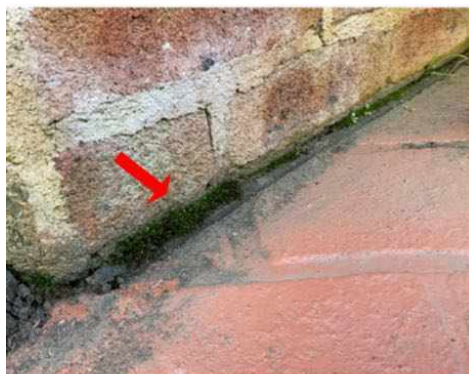
Finding: Site drainage - Inadequate

Information: The site drainage in the rear wall area was found to be inadequate at the time of inspection, creating potential for subsequent water damage to associated building elements.

No rear wall garden bed drainage was evident. The air conditioner, laundry floor waste and hot water system overflows run against the house walls. These defects are causing rising damp in the subfloor.

It is important that water does not lie against the base of walls; surrounding paths and ground levels should be sloped to drain water away from walls. Downpipes should not discharge stormwater onto lower walls or plinths. Stormwater should be carried away by large, regularly cleaned drains. Ground levels may need to be lowered to expose a buried DPC.

Where site drainage is inadequate, installation of an Agricultural (Aggie) Drain may be required. A qualified plumber should be appointed to further inspect the property and perform any remedial works as necessary. Secondary defects are likely to occur if left unmanaged.

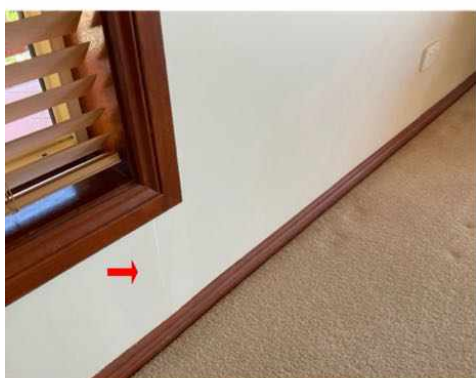
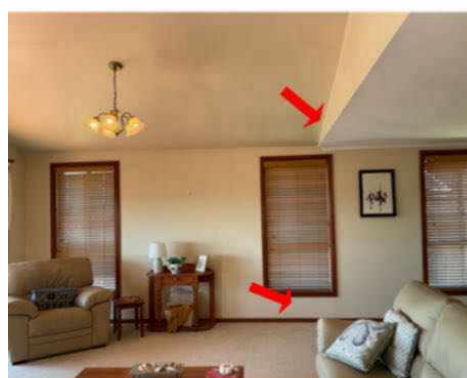
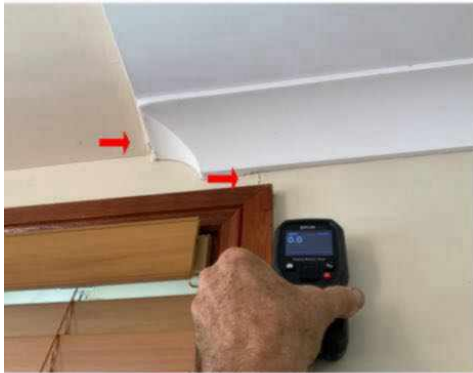
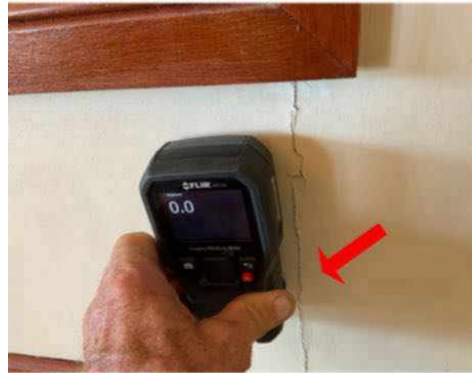
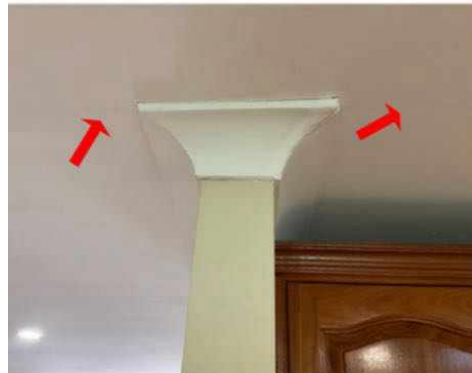
Finding 3.06

Building:	Building 1
Location:	Small areas
Finding:	Cracking - Damage Category 1 - Fine (up to 1mm)
Information:	Although fine cracks are quite noticeable, they are often only considered to be an appearance defect, and usually do not indicate any structural damage. Generally, the cause of a fine crack is indicative of a separation between building materials and finishes (e.g. paint, plaster, etc.) along joins.

Cracking of this nature can generally be repaired with minor sanding, filling and/or repainting. Such works should be performed by a qualified painter or a general handyman.

Monitoring of all cracking should be conducted frequently. Always contact a building inspector should cracks widen, lengthen, or become more numerous.

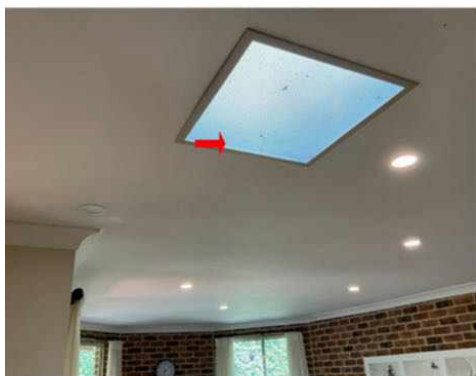
Finding 3.07

Building: Building 1
 Location: Pictured external areas
 Finding: Building elements - Damaged
 Information: Evidence of minor missing or damaged areas was identified at the time of the inspection. These include -

1. The skylight cover has cracked.
2. The water filter is not operating.
3. The fan light and lower room lights were not working (possibly bulbs).

Various trades would be responsible for rectification of these areas when convenient.

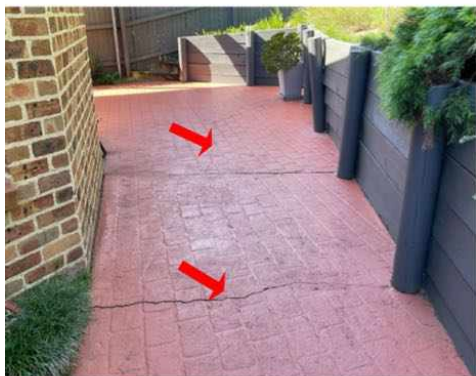
Finding 3.08

Building:	Building 1
Location:	Path areas
Finding:	Crack in concrete slabs - Category 1
Information:	Cracks coded as Category 1 was identified in these pictured slabs. A Category 1 crack is described as a fine but noticeable crack, with the slab at an otherwise reasonable level. To be considered Category 1, the approximate width of the crack is less than 1.0mm, or a less than 10mm change in offset when a 3m straight edge is placed over the defect.

Category 1 cracks should be monitored for a period of 12 months. At the end of the monitoring period, identified cracks that are rated greater than Category 2 are considered defects, and require rectification.

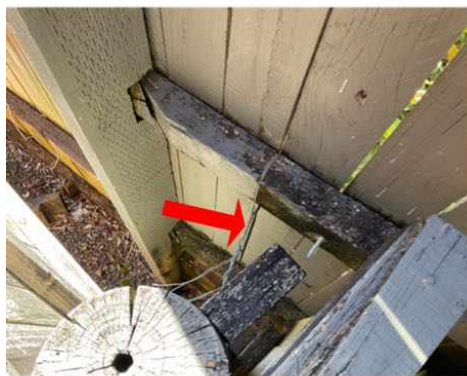
Finding: Fences damaged - leaning
 Information: Evidence of damage to the pictured left rear fences and gate was identified at the time of the inspection. The likely cause of this fence leaning is not enough concrete used in the post footings. The gate is held by wire. If left unmanaged these areas will deteriorate further.

It is suggest a fencing contractor be engaged for rectification when convenient.

The cost of repairing some fences is often shared between neighbours.

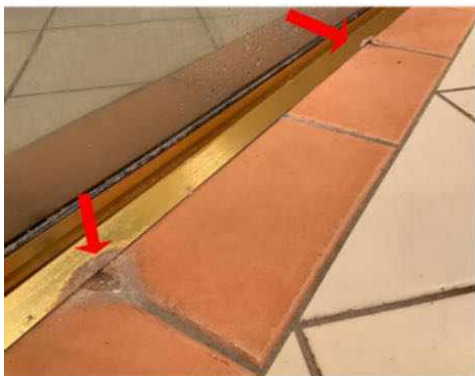
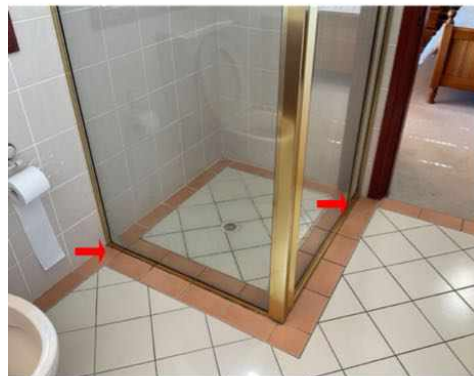
Building:	Building 1
Location:	Bathroom
Finding:	Shower screens - Leaking
Information:	Leaks were evident to two shower screens at the time of inspection. It is suspected that the leaking has occurred as a result missing sealant. Leaking from the shower , where left unattended, is likely to lead to water damage to adjoining flooring and walls. Such damage can lead to water damage and necessitate extensive remedial works being required. Active water leaks may also create an environment that is susceptible to the formation and development of mould.

Appointment of a sealant expert is required to repair or replace this missing sealant. Such works should be performed as soon as possible to ensure that no further

damage occurs.

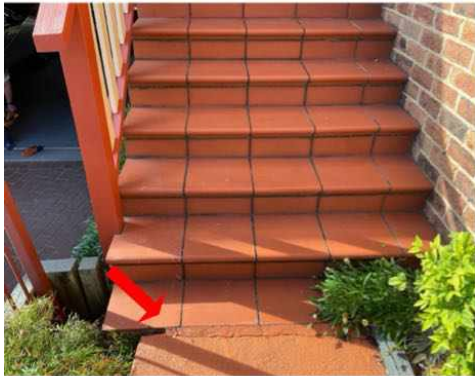
Finding 3.14

Building: Building 1
 Location: Verandah
 Finding: Tiles cracked

Information: A few cracked tiles were evident in these pictured areas at the time of inspection. It is suspected that this cracking has occurred as a result of minor settlement or impact damage. MCracked tiles throughout the household detract from the overall appearance of the affected areas. In wet areas of kitchens and bathrooms, it can lead to water damage of adjoining walls and floors.

Replacement of cracked tiles is recommended as soon as possible. A tiling contractor may be appointed to perform these works. Where cracks become more numerous, contact a licensed building inspector for further investigation.

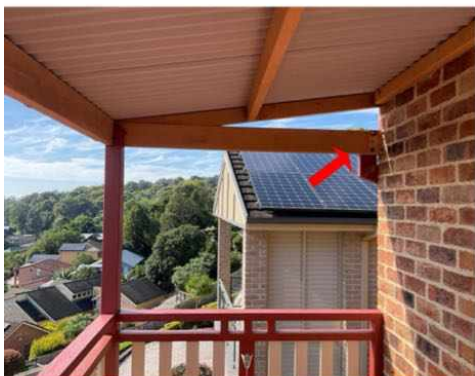
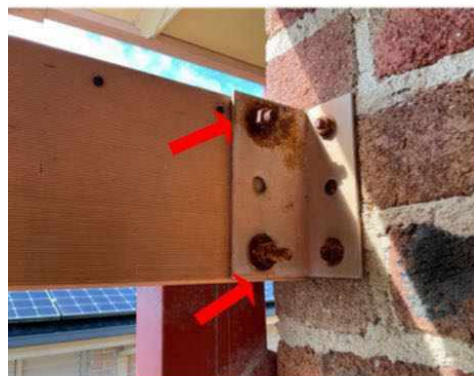
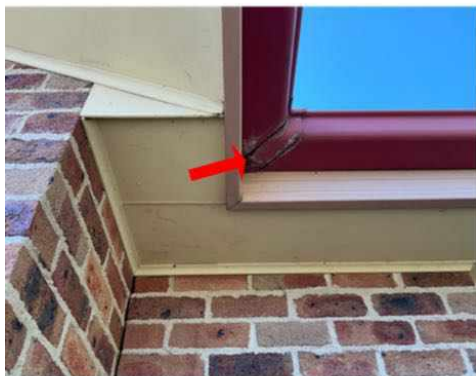
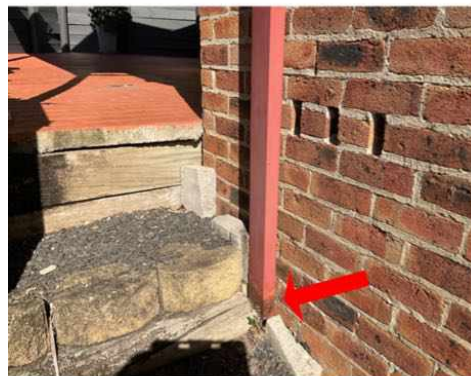
Finding 3.15

Building:	Building 1
Location:	Verandah, Bathroom
Finding:	Areas rusted or corroded
Information:	These areas shows evidence of minor rusting and corrosion, which is likely to have developed as a result of excessive exposure to moisture and or inadequate coatings.

As surface rust provides no protection to the underlying iron, the deteriorating condition is likely to worsen if not addressed in the short-term future.

Where possible, the use of galvanized (treated) metals or aluminium coated metals aid in rust prevention, as does regular general maintenance. Rust formation can be controlled with coatings, such as paint, that isolate the iron from the environment.

Rusting and corrosion should be managed by ideally removing or limiting the affected surface from exposure to moisture. A registered plumber or skilled handy person should be appointed immediately to replace these plumbing lines that have been severely affected by rust or water damage.

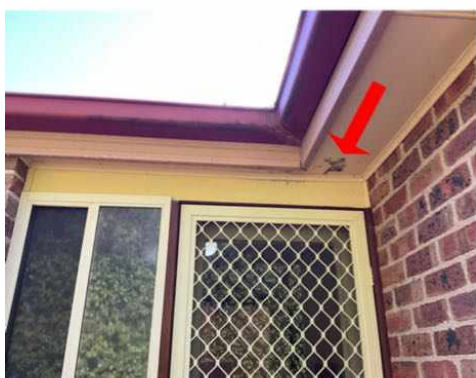
Finding 3.16

Building:	Building 1
Location:	Laundry eaves
Finding:	Mould - Present
Information:	Where evidence of mould growth was noted, there may be environmental, biological or health issues associated with the report. A specialist inspection by a suitably qualified environmental health inspector is warranted, where mould is extensive or where any queries regarding air quality spores or other related issues apply.

This eave mould is thought to be caused by the above roof valley blocked by leaf debris.

Generally, the client is advised to ensure that the general environment is free of moisture and humidity to aid in the prevention of mould formation and development. Any mould found during the inspection should be cleaned immediately by a cleaning contractor or the homeowner as applicable.

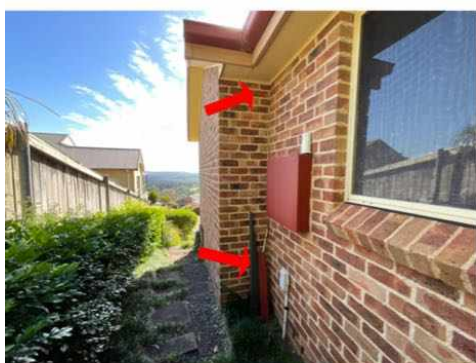
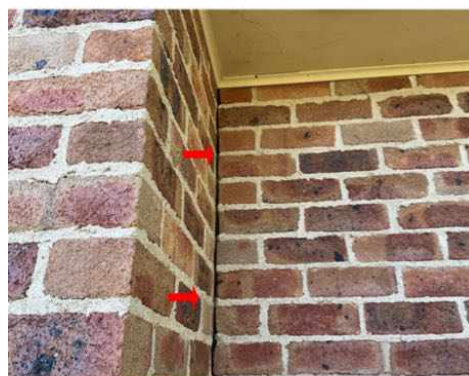
Finding 3.17

Building:	Building 1
Location:	Wall - right

Where expansion strips are missing, an entry point for vermin, termites and other pests is created. Excessive moisture is also likely to accumulate in this area, making the control joint susceptible to water damage.

Expansion strips should be installed prior to final handover to meet requirements. Failure to install these building elements is non-compliant with AS1720 Timber Structures.

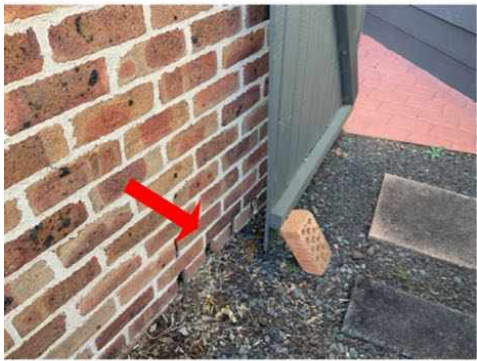
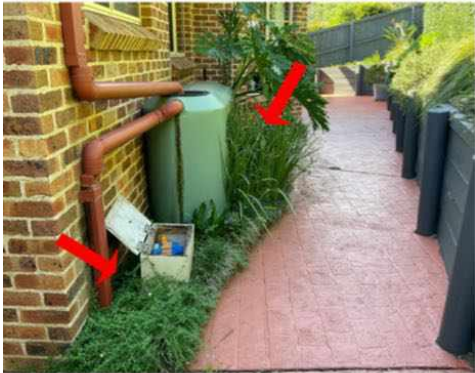
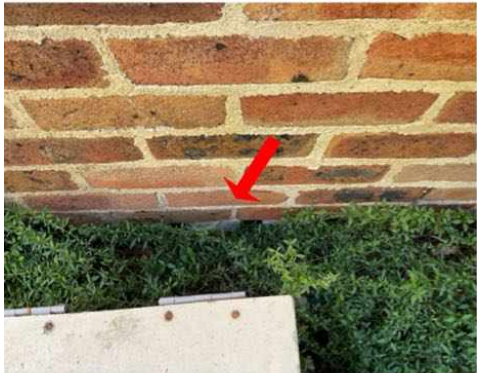
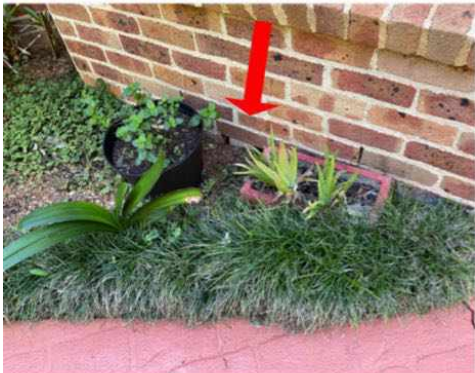
Finding 3.18

Building: Building 1
 Location: All Subfloor Areas
 Finding: Subfloor - Lack of ventilation
 Information: It was noted at the time of inspection that the subfloor area lacks adequate ventilation. Ventilation can be restricted by a variety of minor defects, including obstructions in the subfloor space, a lack of vents or a low clearance.

The client may also consider mechanical ventilation (powered fans) to improve subfloor airflow. Remedial works should be conducted as a matter of urgency to protect against the development of potentially harmful subfloor conditions.

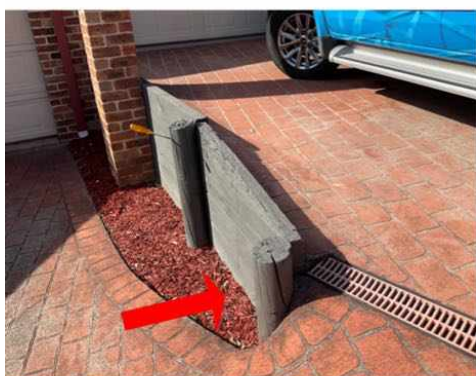
Finding 6.03

Building: Building 1
 Location: Subfloor & driveway
 Finding: Timber in contact with the ground
 Information: Any timbers in direct ground contact provide opportunity for concealed termite entry and are likely to be subject to premature rot and decay as the soil retains moisture or damp conditions against the timbers.

Frequent pest inspections are advised to readily identify any termite activity in these areas.

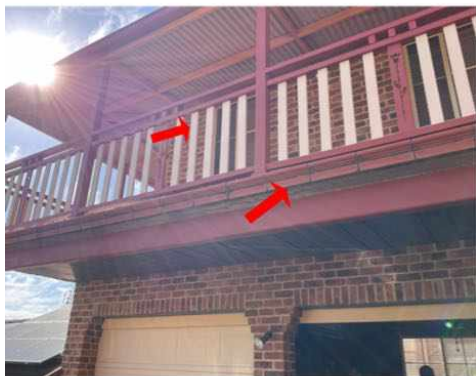
Building: Building 1
 Location: Rear deck
 Finding: Elevated structure inspections
 Information: Where any elevated Structure (deck, balcony, verandah etc) is present, and this elevated structure is designed to accommodate people, you MUST have this structure checked by an engineer or other suitably qualified person.

For the purpose of this report, the Structure includes the elevated front balconies, handrails and stairs that appear to be in good condition except the loose and leaning front stairs railings.
