# Building and Timber Pest Inspection Report

Inspection Date: Thu, 19 Mar 2026

Property Address: 5/253 Chalmers St, Redfern NSW 2016,  
Australia

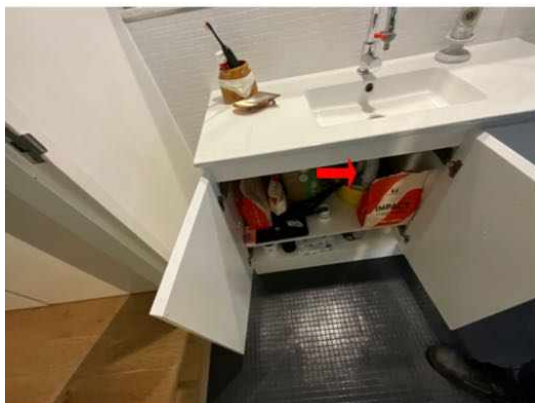
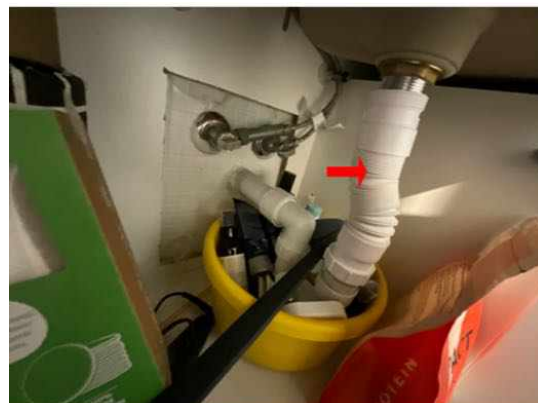
#### Finding 3.01

Building: Main Building  
 Location: Bathroom  
 Finding: Plumbing - Non-Compliant  
 Information: The plumbing work in this area does not appear to be compliant to the current Australian standard practices. Plumbing and electrical inspections are outside the scope of the building inspection and must be conducted by a Licensed and registered Trades person.

Whilst we note and comment of visually apparent defects that present during the building inspection, legislation requires the checking and documenting of compliance for plumbing and electrical requirements be done by licensed electrician and plumbers respectively to ensure they are functioning correctly.

It is highly recommended that the client makes immediate arrangements to have the plumbing work inspected to ensure compliance.

- Repair noncompliant plumbing work under the wash basin

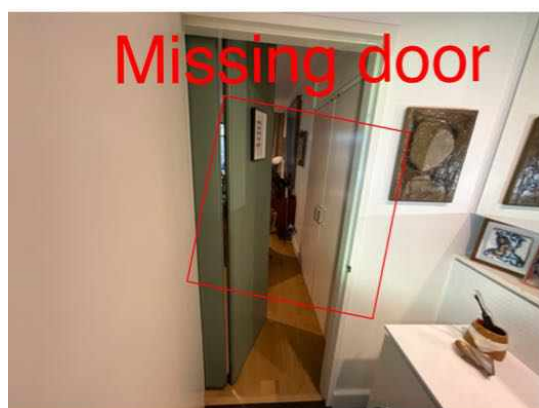
#### Finding 3.02

Building: Main Building  
 Location: Bathroom

Finding: Building element - Missing

Information: Although some building elements may seem irrelevant or unnecessary, all building elements play a key role in the operation and function of the overall structure and its performance.

Replacement of any missing building element should be conducted as soon as possible to ensure that no damage or functional issues occur to associated building materials.

The appropriate tradesperson should be appointed as soon as possible to replace the missing building element.

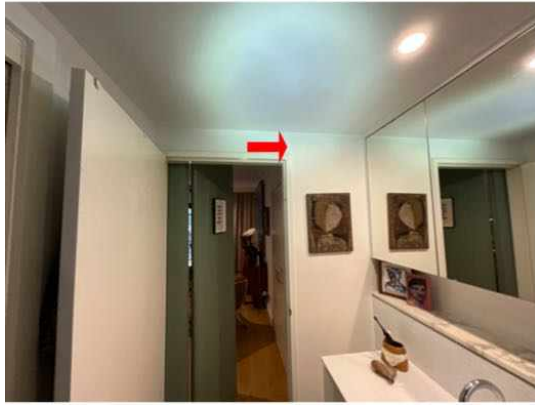
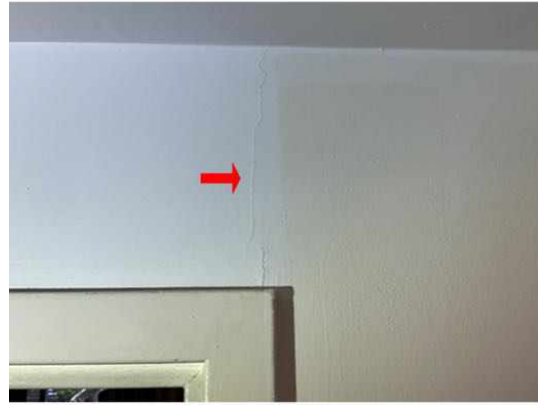
### Finding 3.03

Building: Main Building

Location: Bathroom

Finding: Cracking - Damage Category 1 - Fine (up to 1mm)

Information: Although fine cracks are quite noticeable, they are often only considered to be an appearance defect, and usually do not indicate any structural damage. Generally, the cause of a fine crack is indicative of a separation between building materials and finishes (e.g. paint, plaster, etc.) along joins.

Cracking of this nature can generally be repaired with minor sanding, filling and/or repainting. Such works should be performed by a qualified painter or a general handyman.

Monitoring of all cracking should be conducted frequently. Always contact a building inspector should cracks widen, lengthen, or become more numerous.

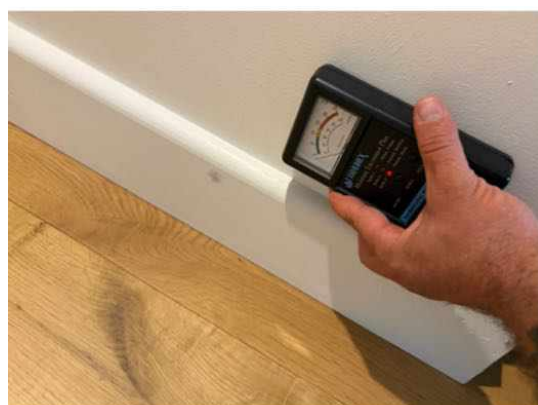
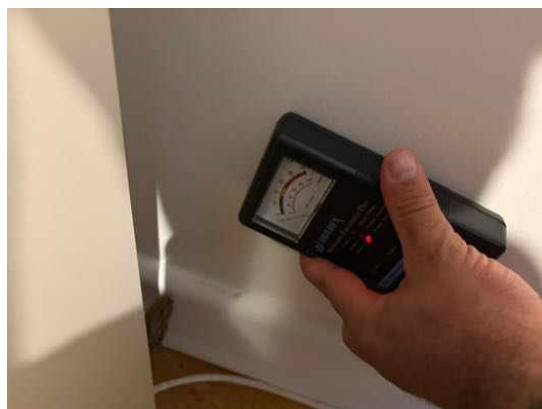
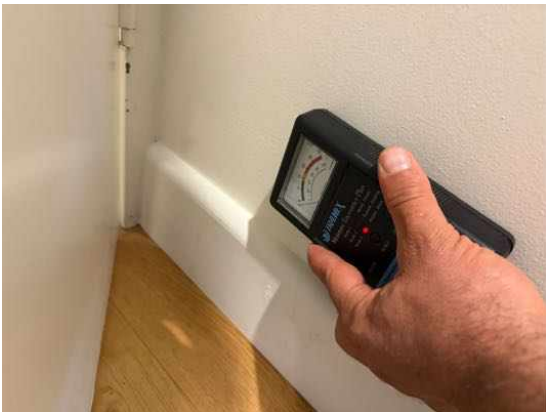
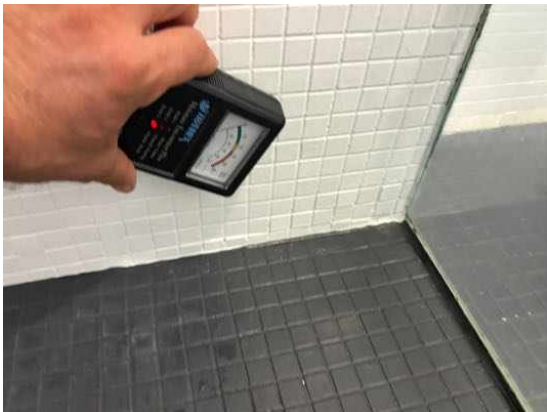
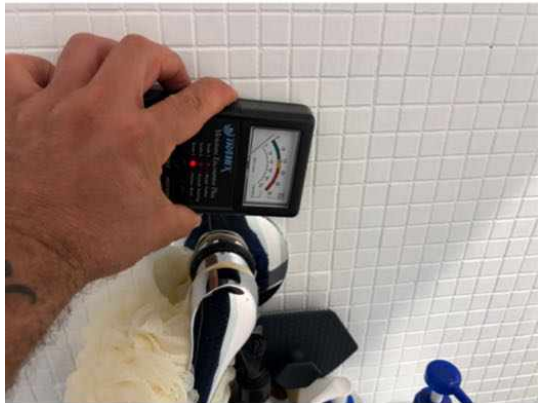
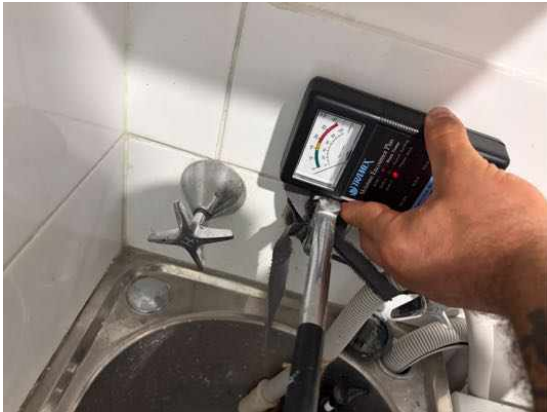
Building: Main Building  
 Location: All Areas  
 Finding: Moisture metre  
 Information: During the inspection the property was checked for moisture using a moisture metre.

This is for information only.

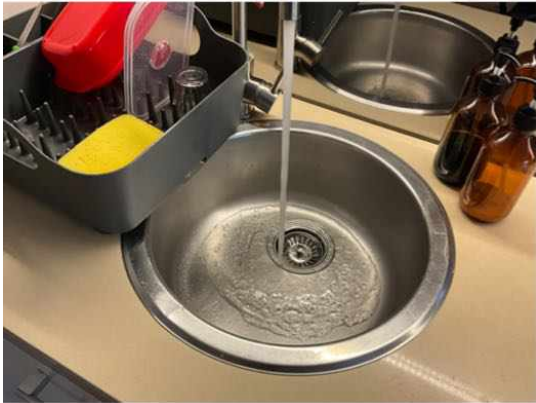
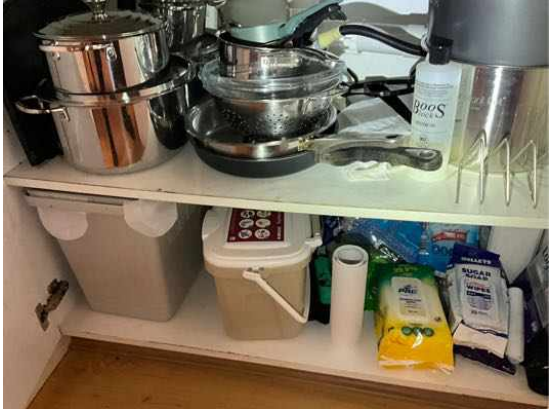
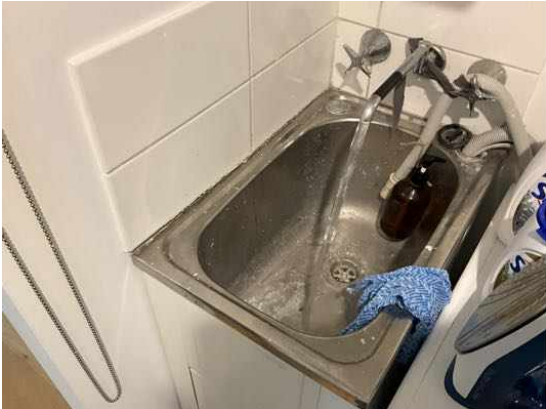
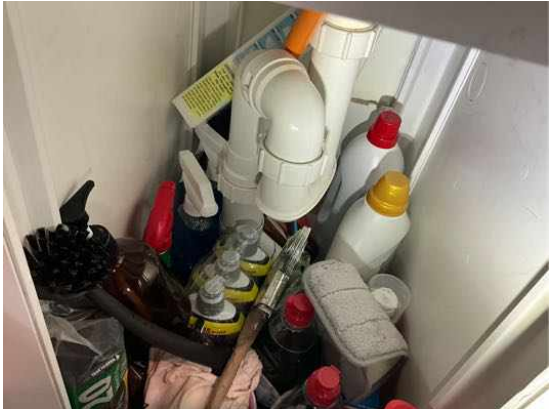
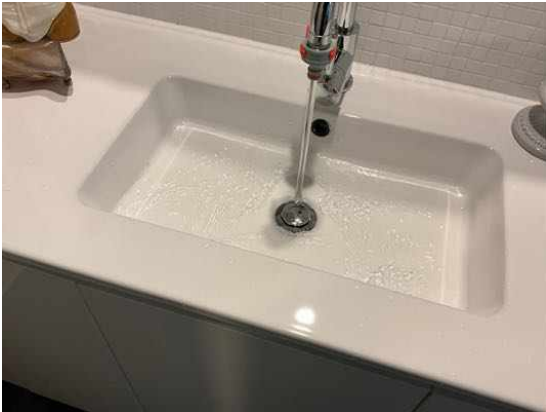
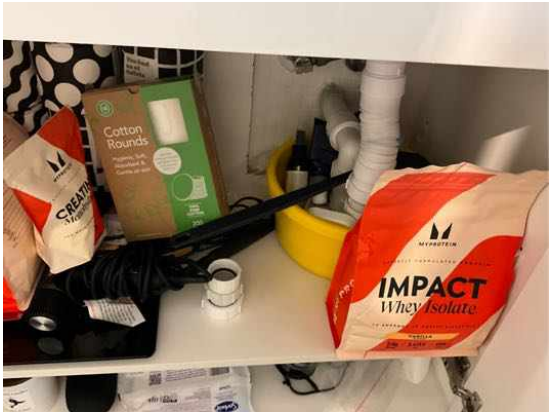
Building: Main Building  
Location: All Wet Areas  
Finding: Additional Photos  
Information:

Additional photos are provided for your general reference.

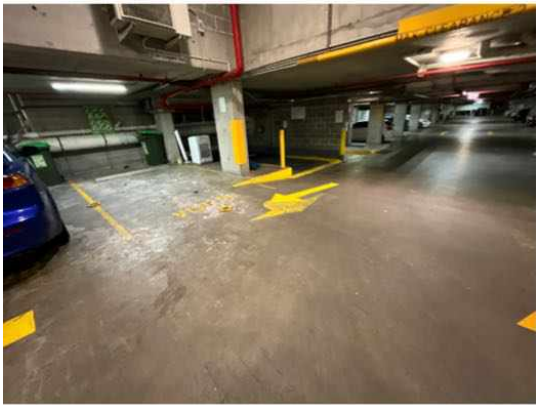
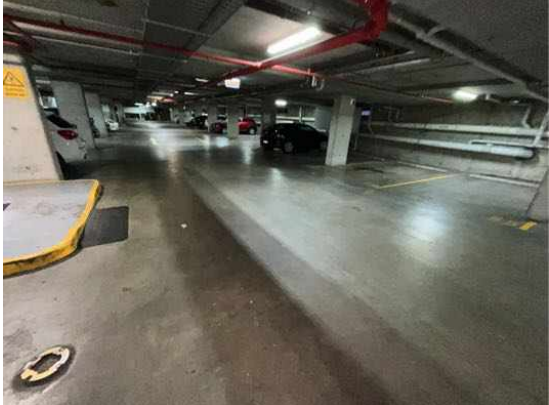
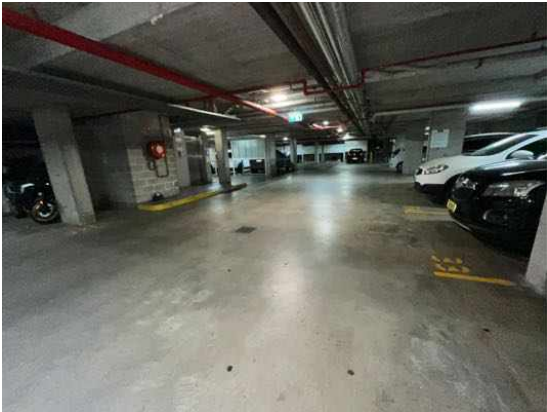
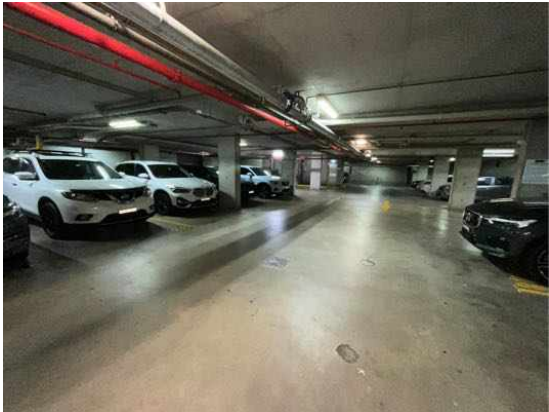
Building: Main Building  
 Location: Garage  
 Finding: Additional Photos- Garage  
 Information: Additional photos are provided for your general reference. Arrows may have been included to highlight areas of importance. Please discuss these photos with your building consultant for clarification.

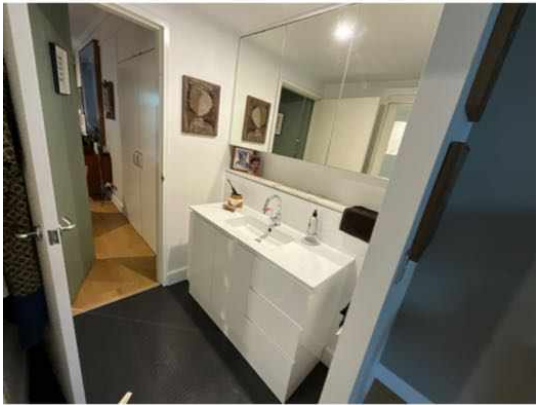
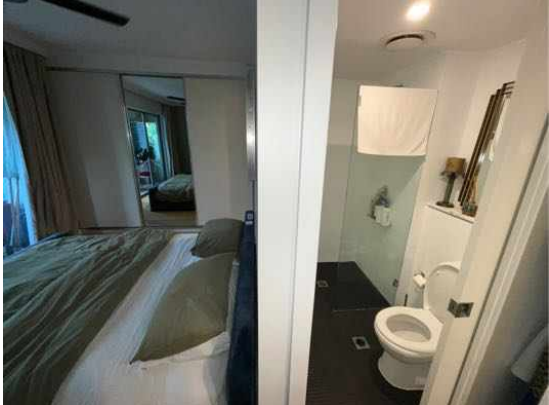
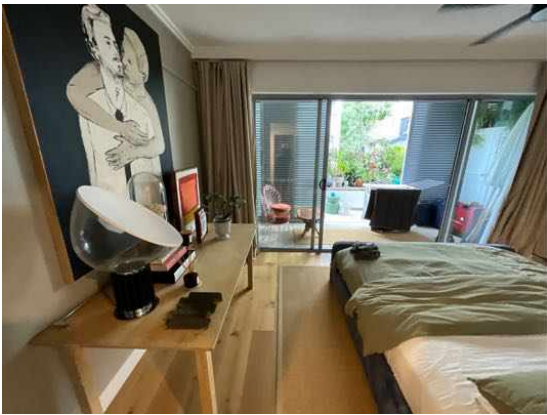
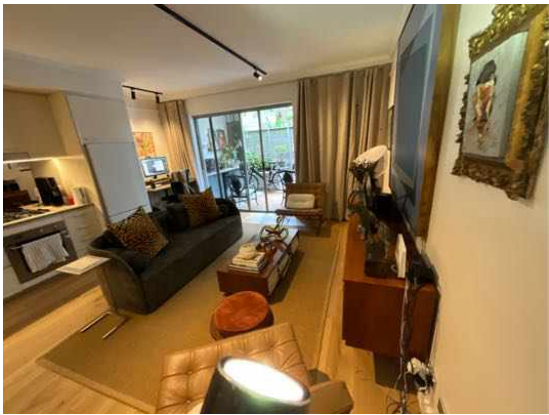
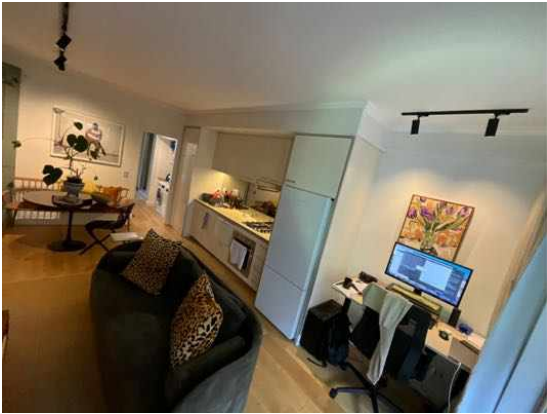
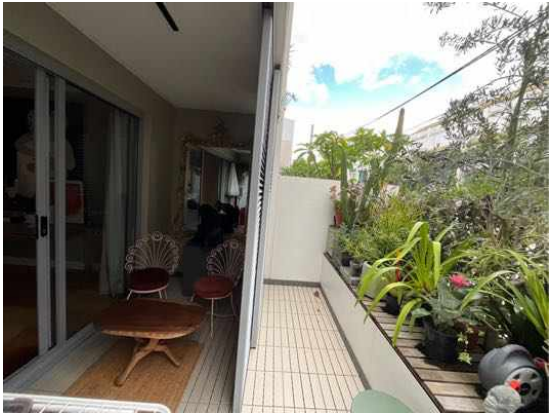
Building: Main Building  
Location: All Areas  
Finding: Additional Photos - Obstructions and Limitations  
Information:

These photographs are an indication of the obstructions and limitations which impeded full inspection of the property at the time of inspection. These obstructions can hide an array of defects and should be removed to allow full inspection to be carried out. A re-inspection is recommended once the areas are made accessible.
