Building and Timber Pest Inspection Report

Inspection Date: Thu, 15 Jan 2026

Property Address: 93B Neville St, Carnegie VIC 3163, Australia

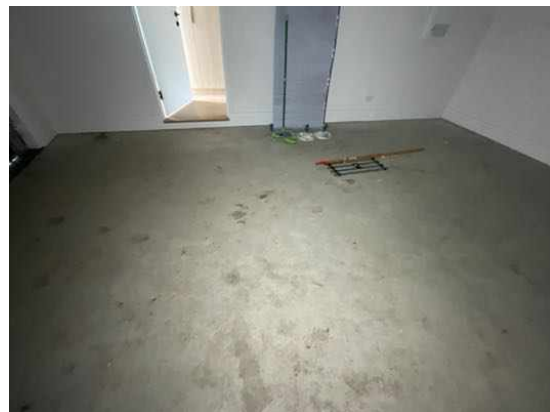
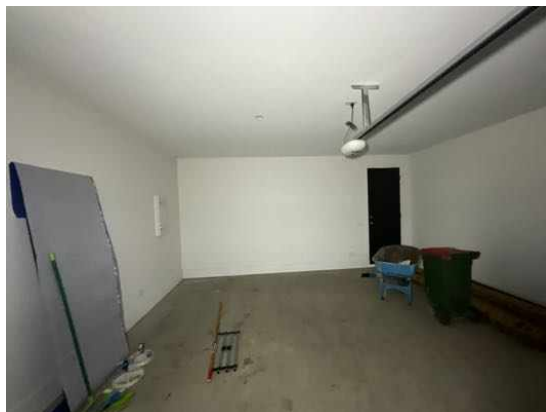
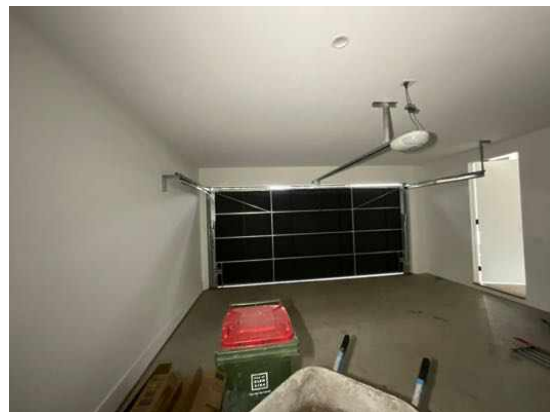
Finding 3.01

Location: All Areas

Finding: Cleaning - all surfaces (new build)

Information: It was observed that building elements throughout the property still require their final clean.

The property should be professionally cleaned prior to final handover.

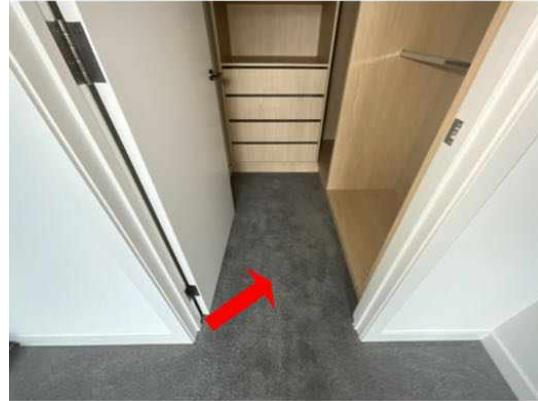
Creaking floors generally indicate that the fixings for the flooring may be coming loose slightly.

Minor noises soon after installation can be expected as the material acclimatises. Persistent or widespread creaking is not normal in a compliant new build however.

The area should be monitored for any changes or unevenness. Should this occur, consultation with the builder should be undertaken to determine the cause. The potential resolution may involve regluing and screwing the floor down through to replacement of subfloor support structures.

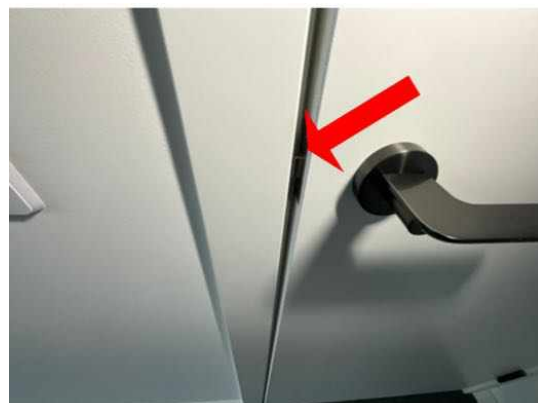
Finding 3.07

This is a common defect and is generally due to substandard installation of the door hardware.

Readjustment of the striker plate is recommended.

Works should be completed by qualified carpenter or builder prior to handover.

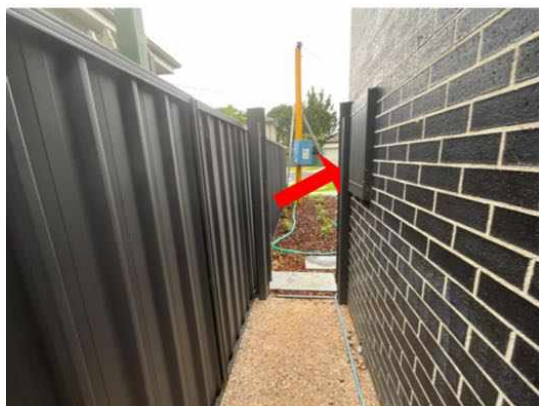
Finding 3.08

Location: Meter Box
 Finding: Electrical Switchboard - incomplete works
 Information: At the time of inspection, there was no power within the property. Upon inspection of the meter box, it was noted that the electrical works were incomplete.

The purchaser should ensure that the switchboard is fully installed and all lights and Power points operate as intended.

A licensed electrician should be engaged to check this prior to handover.

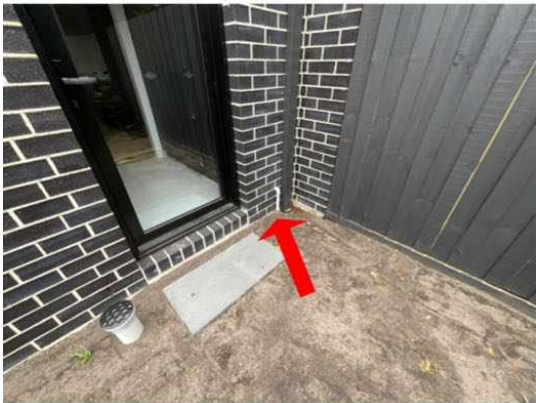
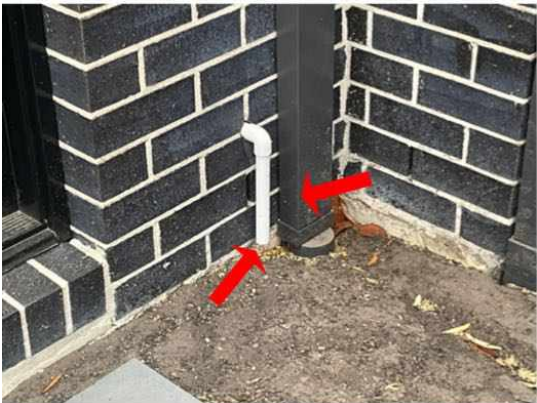
Finding 3.09

Building: Exterior walls - rear
 Location: Exterior walls - rear
 Finding: Overflow - Not plumbed for drainage (new build)
 Information: The overflow in this area is not plumbed or connected to suitable drainage, which may result in moisture being deposited at the base of the exterior wall. This can over time create conditions which may undermine the foundations of the wall, as well as allowing the formation of fungal decay. When coupled with poor site drainage, pooling of water can also attract termite activity to this area.

It is highly recommended that the overflow be directed into the downpipe immediately next to the overflow. These works will ensure that the area remains dry and free of any secondary defects.

A licensed plumber should be engaged to perform this task prior to handover.

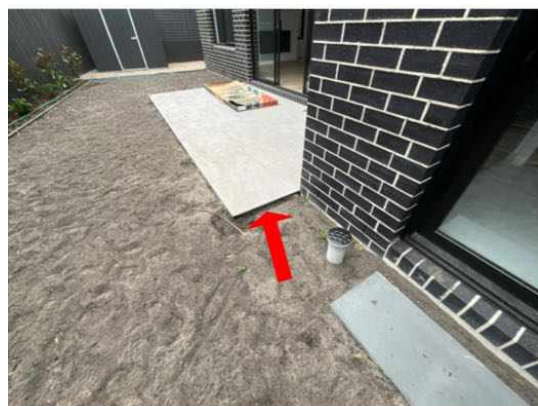
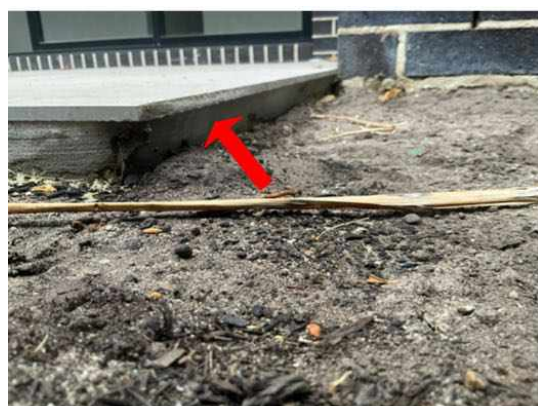
Building:
Location: Yard - Back
Finding: Additional Photos for your information - paving tiles overhang (new build)
Information: It was noted at the time of inspection, the paving tiles at the rear of the property had a slight overhang past the concrete slab they are laid on.

This has the potential to cause the tiles to chip or crack if stepped on at this edge as there may be insufficient support in the area.

It is recommended that additional amount of concrete be added to the edge of the slab in this area to provide the necessary support and prevent any possible cracking .

Consultation with the builder would be recommended prior to handover.

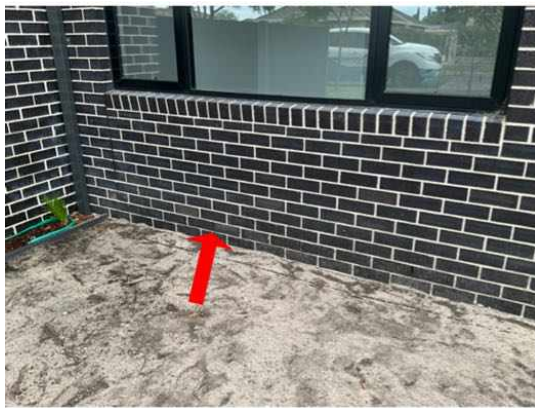
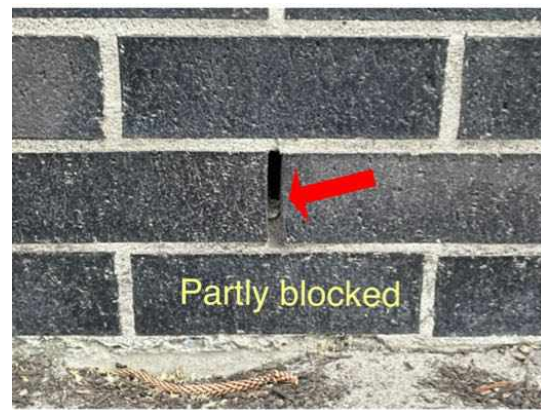
Finding 3.12

Building:
Location: All External Areas
Finding: Weep holes - blocked (new build)
Information: It was noted during the time of inspection that some of the weep holes to the brickwork were blocked. Weep holes are designed to allow water from leaks or

Blocked weep holes are likely to result in the presence of excessive moisture within the brickwork and associated structures, creating potential for water damage and moisture problems.

Weep holes should also be a minimum of 150 mm above soil or a minimum of 75 mm above paved surfaces to allow them to function correctly and prevent them becoming blocked.

Any blocked weep holes should be cleared prior to handover.

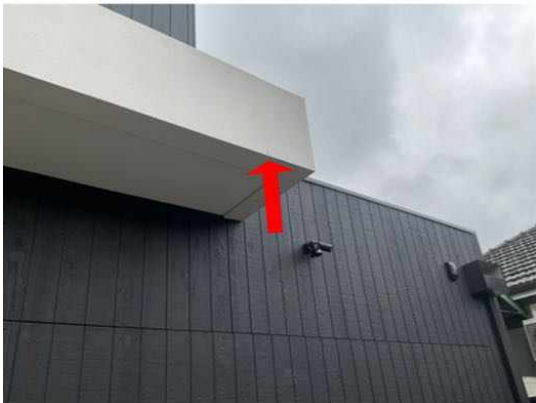
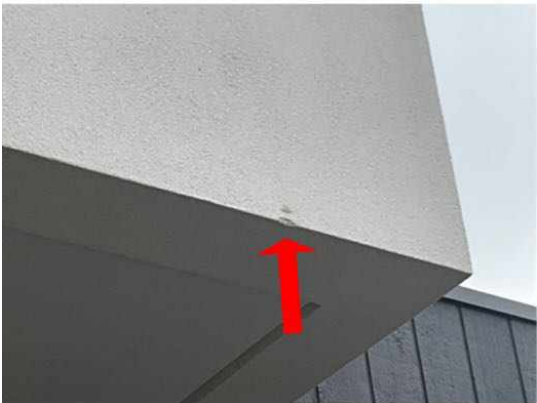
Finding 3.13

Building:	
Location:	Exterior walls - front
Finding:	Rendered exterior wall - minor chipping of wall (new build)
Information:	Minor chipping was noted to the rendered wall above the garage at the time of inspection.

This type of defect is consistent with impact damage and is not considered a major structural defect.

Consultation with the builder may be sought to have this chip repaired prior to handover.

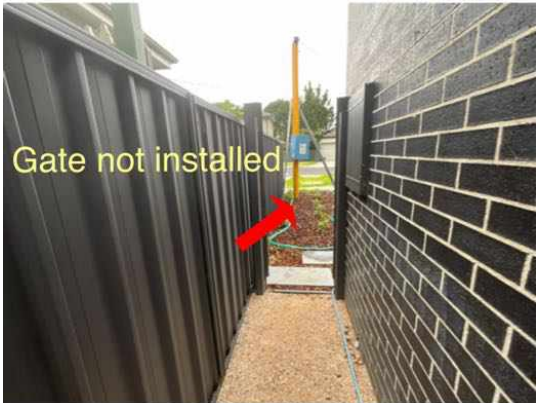
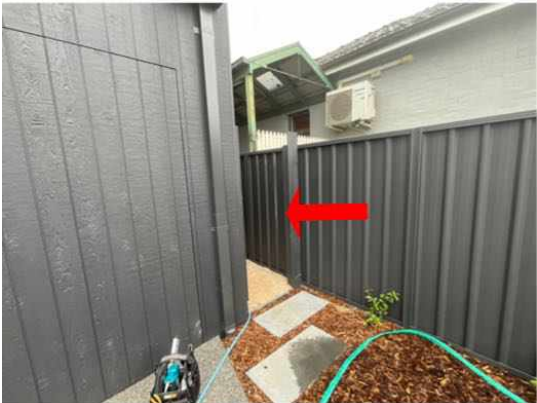
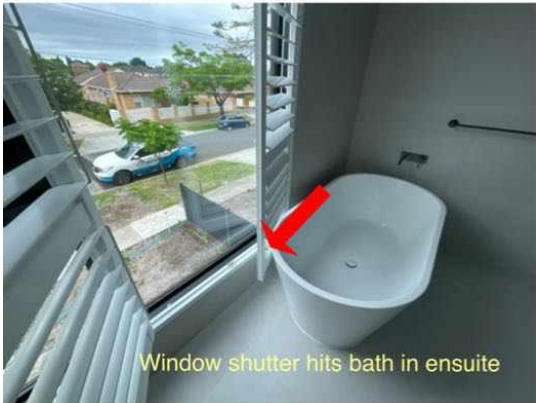
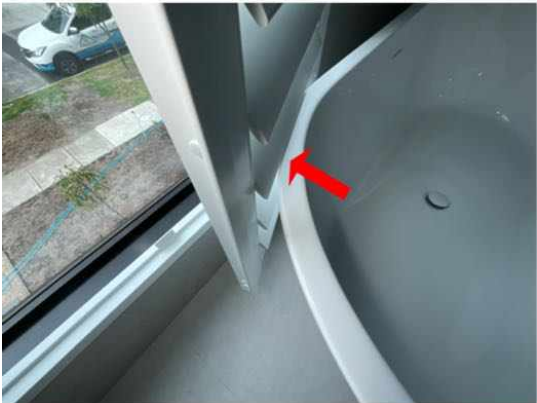
Finding 3.14

Building:
 Location: All Areas
 Finding: Additional Photos - minor defects
 Information: Additional photos are provided for your general reference. Arrows have been included where necessary to highlight areas of importance.

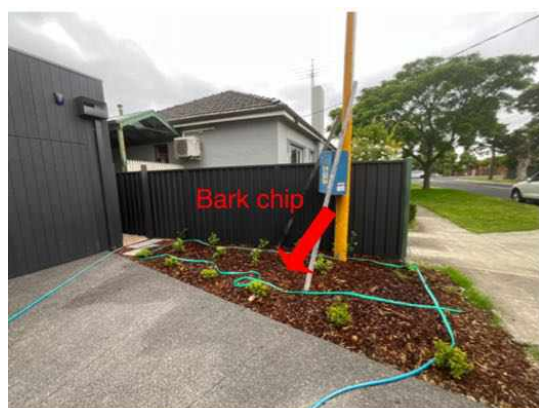
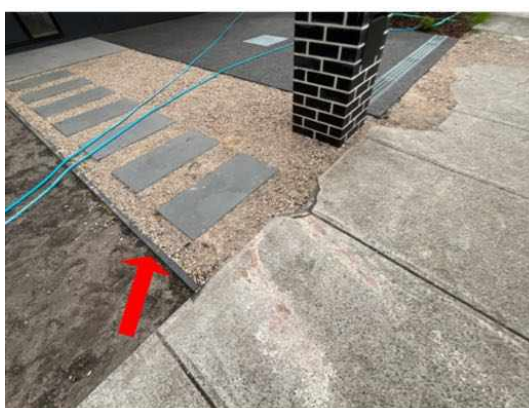
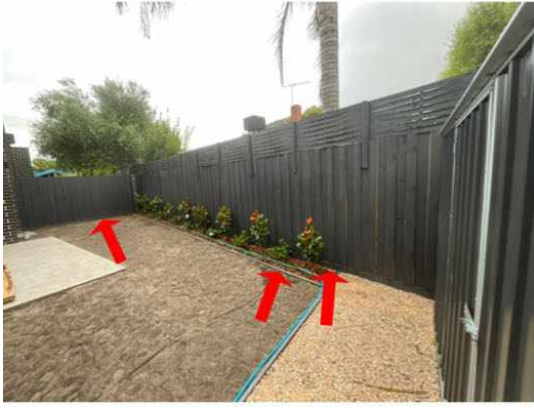
Information: Where timber elements are in direct contact with the ground and consequently moisture or dampness, they become conducive to termite activity. Whether timber is used as a building element, part of a fencing structure or stored as an unused item, they can provide an environment that is attractive to termite infestation.

When met with excessive moisture, timber begins to decay and develop wood rot. Any timbers that are in direct contact with external grounds especially if left untreated or non-durable also provide ingress for subterranean termites into that particular element.

Where possible, the removal of any such materials that may be conducive to termite activity should be carried out as soon as possible to minimise the risk of termite attack. Where not possible or practical, regular monitoring of timber elements is recommended. Replacement of any damaged materials should be carried out where necessary.

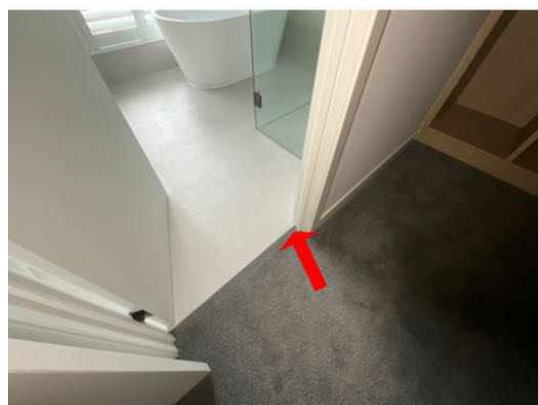
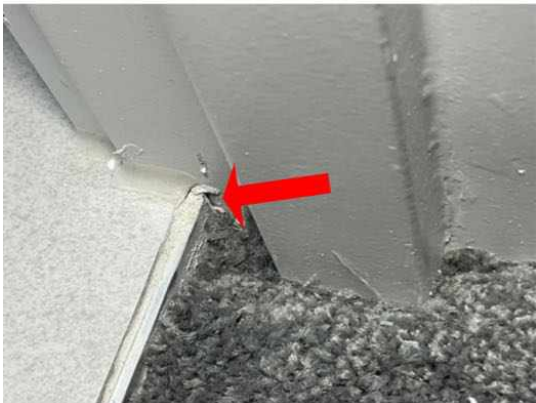
Information: It was noted at the time of inspection that there was a small gap at the end of the water stop at the doorway entrance to the ensuite bathroom.

A water stop is a barrier that is installed at the entrance to the bathroom to help prevent moisture which has got under the tiles escaping the wet area and getting out into the hallway outside the bathroom.

It is recommended the area be monitored on a regular basis for any signs of moisture to the frame and/or carpet area outside the bathroom. Should any signs of moisture occur in these areas, the builder should be contacted to inspect the area .

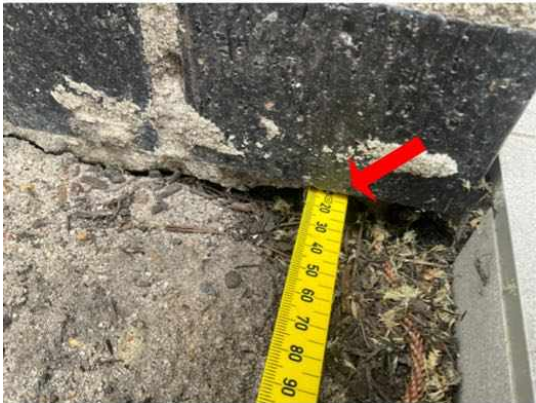
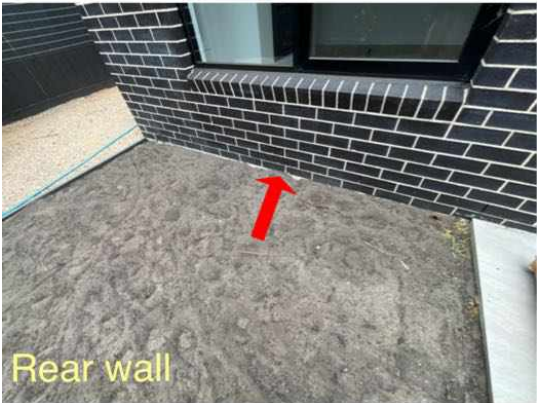
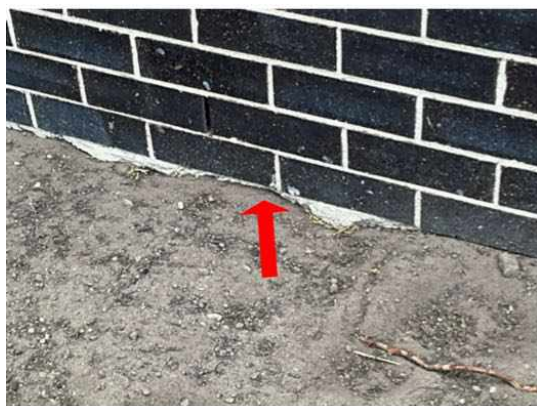
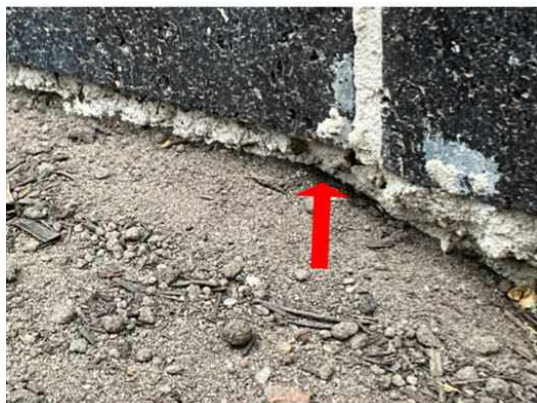
Building:
 Location: All External Areas
 Finding: Additional Photos for your information - brick overhang (new build)
 Information: There appeared to be a slight overhang of the brickwork in the exterior wall in this area . Upon inspection it was noted that it is within intolerance and is suspected to not be causing any structural issues.
