Building and Timber Pest Inspection Report

Inspection Date: Mon, 9 Feb 2026

Property Address: 5/72 Campbellfield Ave, Bradbury NSW
2560, Australia

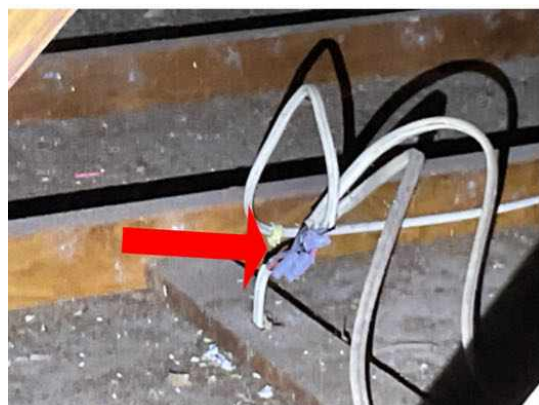
Building:	Main Building
Location:	Roof Void
Finding:	Electrical junction box - Missing
Information:	Several wiring joins in the roof space are not adequately protected by a junction box. Junction boxes provide a second insulation barrier to adequately seal off and protect the wires, increasing the safety of the immediate environment and ensuring that the wiring is not damaged.

The absence of junction boxes in the roof space poses as an electrical safety hazard, providing risk of electrocution. It appears as though wiring in this area has been completed to a substandard level of workmanship, evidenced by the lack of adequate wiring protection.

Appointment of a licensed electrician is highly advised to provide additional information on the risks of unprotected wiring and to install junction boxes and any other elements as required. Such works should be carried out as a matter of urgency; until this time, any persons within the roof space should exercise a high level of caution.

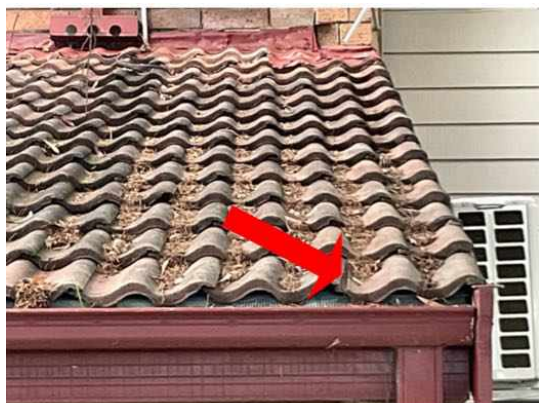
Blocked gutters are likely to lead to high levels of moisture in the affected areas. Such moisture will not only cause rust and decay of the associated building materials, but can also provide conditions that are conducive to termite and timber pest activity. Blockages in gutters should therefore be removed immediately to ensure dry conditions are maintained.

Consult a Licensed Plumber for further specific advice on remedial works that may be required. In the interim, it is highly advised that blocked gutters be removed by the homeowner or a general handyperson as a matter of urgency.

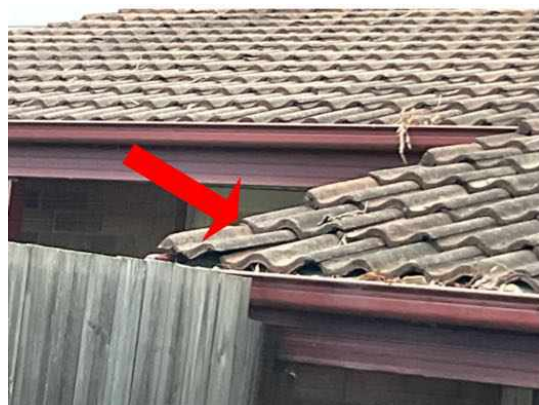
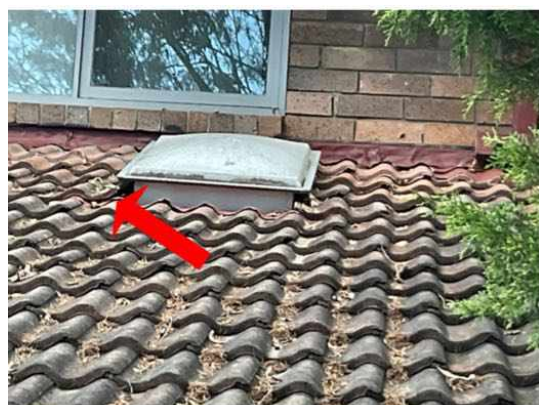
Finding 3.02

Building: Main Building
 Location: Roof Exterior
 Finding: Roof tiles - Slippage
 Information: Upon inspection of the exterior roof covering, it was noted that numerous tiles have slipped from their original fixing. Tiles may slip over time due to a number of minor causes, including breakage of tiles, failings in the adjoining battens, or fixings that may have failed.

Roof tiles that have moved from their original position are very likely to allow water penetration into the roof void, exposing roofing structures to excessive moisture. This creates an environment that is conducive to water damage and accelerated deterioration of all associated building elements.

Replacement of loose or missing roofing tiles is recommended immediately to prevent the development of any secondary defects. A roofing restoration specialist should be appointed to complete such works as necessary.

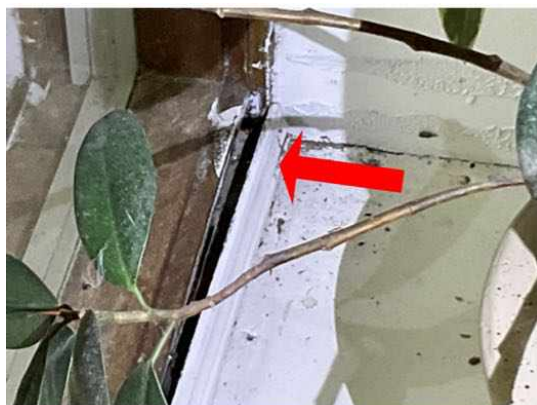
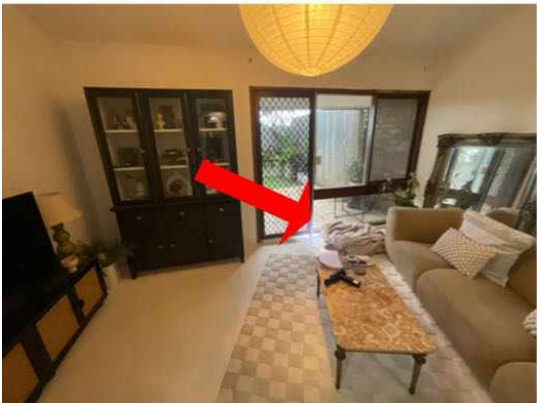
Building: Main Building
Location: All Internal Areas
Finding: Skirting board / Architraves - Loose or missing or damaged
Information: The skirting board / architraves in this area is loose / missing / damaged and requires adjustment to tighten.

If left unmanaged, the timber skirting / architraves may further deteriorate, causing potential for the development of other minor secondary defects.

A relevant tradesperson should be appointed to perform these rectification works at discretion of the client.

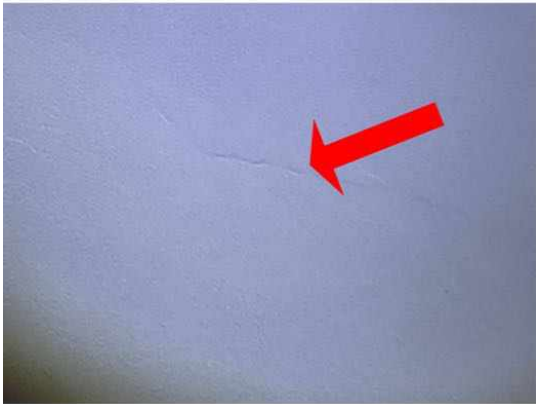
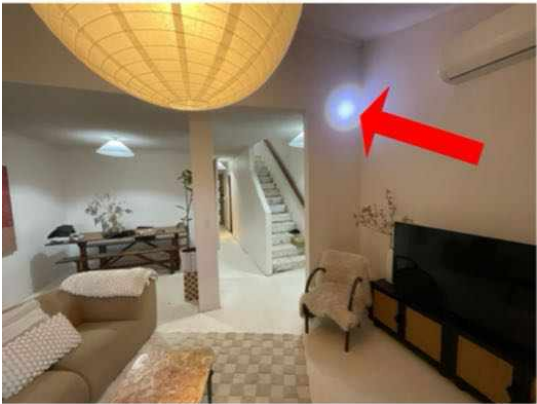
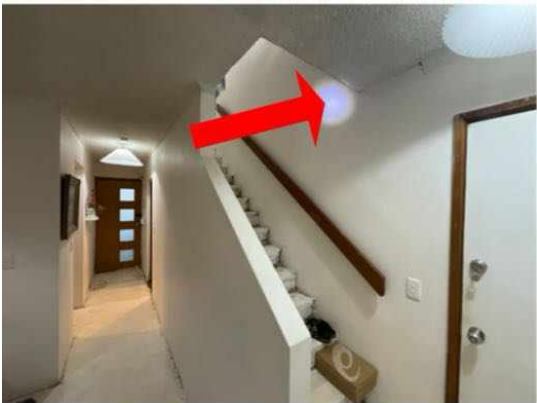
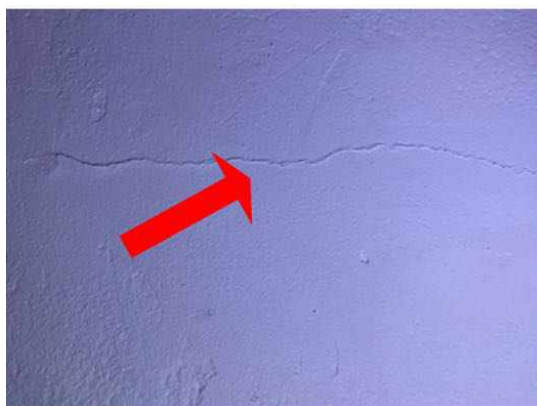
Finding 3.05

Building: Main Building
Location: All External Areas
Finding: Cracks to internal rendered surfaces - Category 1
Information: It has been observed that cracking to internal rendered surfaces has occurred in this area. The degree of damage falls within Category 1, described as fine cracks that do not need repair and which are less than 1.0mm in width limit.

Damage of this category is not considered a defect for rectification. Always contact your building inspector should cracks widen, lengthen, or become more numerous.

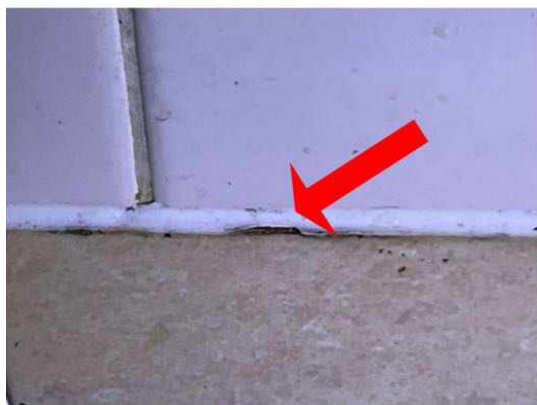
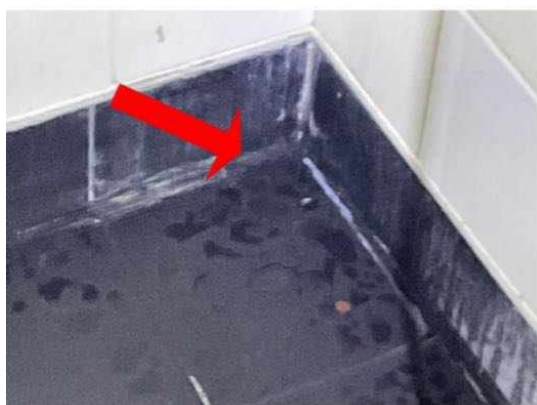
Finding 3.06

Building:	Main Building
Location:	Kitchen/ Bathroom
Finding:	Sealant and grouting - Missing or damaged
Information:	It was noted on inspection that sealant or grout is degraded to the tiled shower alcove and or other areas of the bathroom.

Different materials and floor areas move at different rates, generally causing cracking to grout or sealant at this point. A flexible sealant is required to allow for expected expansion and contraction, while keeping the joint water tight and protective of all associated building materials.

There appears to be excessive mould to the sealant and grout which will likely require scraping out and replacement.

Flexible and mould resistant materials should be applied to affected areas to prevent any subsequent water damage that is likely to occur. Regular maintenance and replacement of damage or missing or damaged sealant and grout is highly recommended to the wet areas, as this is a regular wear and tear defect. Sealant and grouting in areas that come into regular contact with water should be maintained for the long term care of your property.

A sealant specialist or tiling contractor should be appointed to complete these works

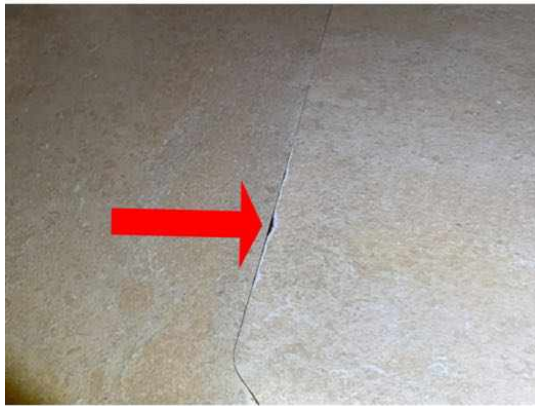
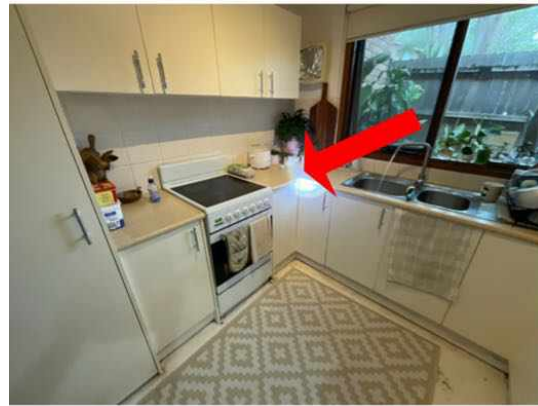
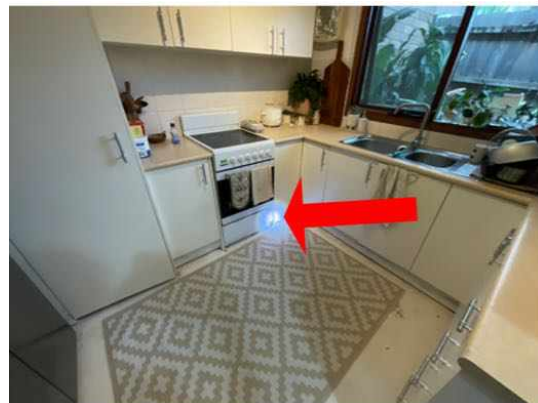
Finding 3.07

Building: Main Building
 Location: Kitchen
 Finding: Multiple Kitchen Cabinet and Benchtop Deficiencies
 Information: The kitchen exhibits several issues affecting both functionality and aesthetic consistency:

Lower cabinet doors display clear signs of moisture damage, including swelling, bubbling, and delamination of the surface finish. This is particularly evident near the kickboard where water exposure is likely more frequent.

One overhead cabinet door has been replaced with a mismatched flat white panel, differing noticeably in profile and colour from the original cream-toned routed doors. This impacts the uniformity of the kitchen's design and may indicate previous repair attempts.

Prolonged water exposure and inadequate sealing can compromise the structural integrity of cabinetry and benchtops. Unsealed joints and delaminated doors can harbour moisture and bacteria, and mismatched replacements may affect property presentation or resale value.

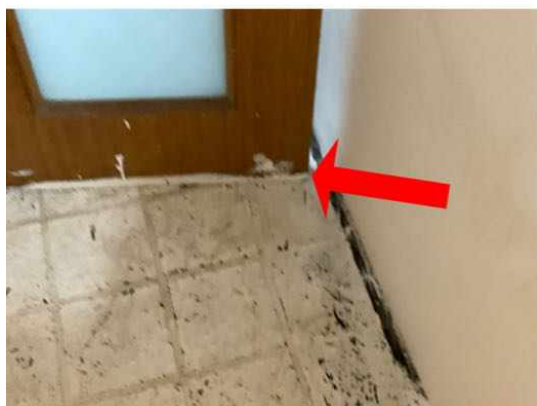
Finding 3.08

Building:	Main Building
Location:	All Internal Areas
Finding:	Door - Binding/jamming
Information:	Binding and/or jamming of this door is evident during standard operation. This defect inhibits the functionality of the affected door as well as creating potential for secondary defects to associated building elements, such as damage to the floor covering.

A door that binds to flooring or to the associated door frame may have several causes, ranging from minor defects, such as poor installation of the door or deteriorated hinges, through to major structural issues, such as damage to subfloor structures.

Where door binding/jamming appears to indicate major structural issues, a registered builder specialising in re-stumping should be appointed to provide an estimate on the cost of rectification.

For minor causes, a qualified carpenter or general handyman should be appointed to perform minor rectification works at client discretion.

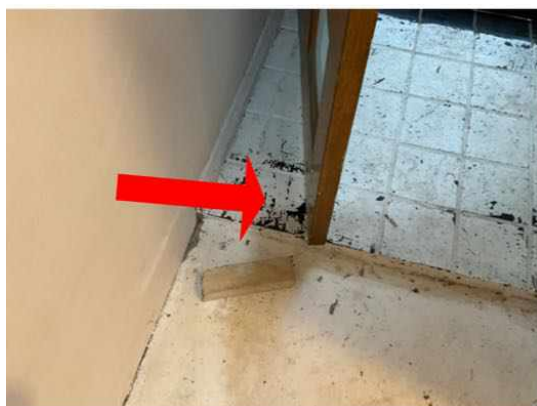
Finding 3.09

Building:	Main Building
Location:	All Internal Areas
Finding:	Door stop - Missing
Information:	The door stop is missing or is inadequate to stop the door handle from damaging the wall. Although some building elements may seem irrelevant or unnecessary, all building elements play a key role in the operation and function of the overall structure and its performance.

Re-installation or replacement of the door stop is advised as soon as possible to prevent any subsequent damage to the door or associated structures. A general handyman may be appointed to perform these works at client discretion.

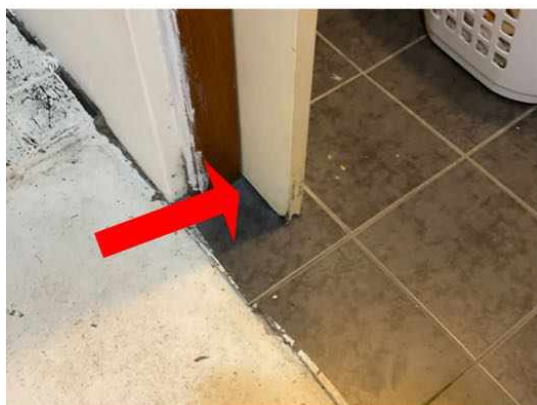
Finding 3.10

Building:	Main Building
Location:	All Internal Areas
Finding:	Door's Floor Guide - Missing
Information:	The door 's floor guide at kitchen area was missing at the time of inspection and not functional the door using as its performance.

Replacement of any missing door' s floor guide should be conducted as soon as possible to ensure that no damage or functional issues occur to associated building materials.

The appropriate tradesperson should be appointed as soon as possible to replace the missing building element.

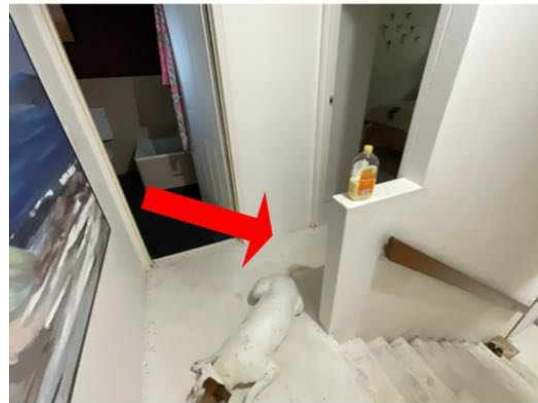
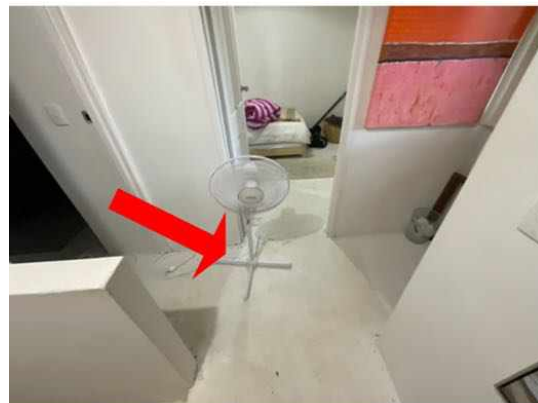
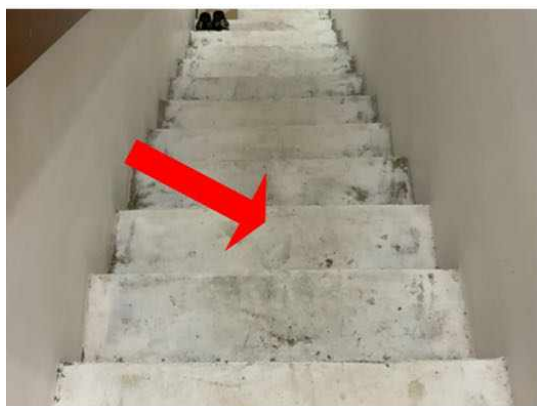
Location: All Internal Areas
Finding: Unfinished Floor Surfaces (Post Carpet Removal)
Information: Following the removal of the carpet, the underlying floor surfaces were observed to be unfinished and in poor condition in the inspected areas, including the stairwell. The exposed substrate is rough and patchy, with visible residue and inconsistent surface finish, indicating it was not intended to be a final floor surface.

In its current state, the flooring is not suitable for normal residential use and may impact presentation, ease of cleaning, and safe use, particularly to the stairs where a finished surface is typically required.

It is recommended that a suitably qualified flooring contractor be engaged to assess the condition of the substrate and carry out appropriate rectification works, including surface preparation and installation of a suitable finished floor covering.

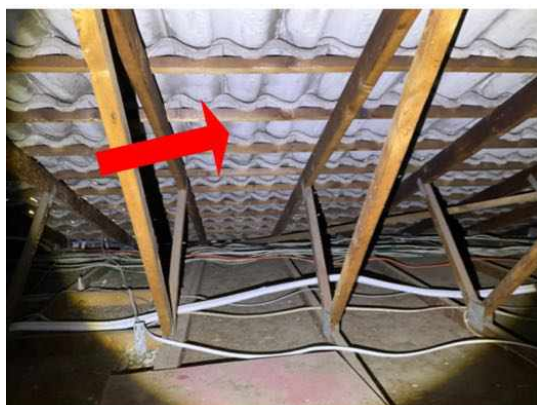
Finding 3.14

Finding: Insulation and Sarking - inadequate

Information: Upon inspection of the roof void it was noted that insulation is not present. Insufficient insulation will result in a comparatively higher cost to heat and cool a property as there is a lack of Insulation (or uneven coverage of insulation) which works as a barrier to heat transfer. This helps to keep out unwanted heat in summer and preserves warmth inside your home in winter. It can also help soundproof your home from unwanted airborne noise transfer. Where insulation is absent, the area does not meet current Australian Standards. Installation of adequate insulation is required and should be conducted as soon as possible. Sarking is missing under the roof sheeting. Sarking acts as an insulator that helps with noise reduction and protects against water penetration. Sarking plays a key role in the operation and function of the overall roofing structure and its performance. Although not a requirement at the time of construction, replacement of any missing building element is advisable (although this can be quite expensive to do after the time of construction). Where sarking is missing, regular inspections of the roof tiles for cracking and potential moisture penetration is required. Sarking may be retrospectively fitted by a registered builder at the discretion of the client.

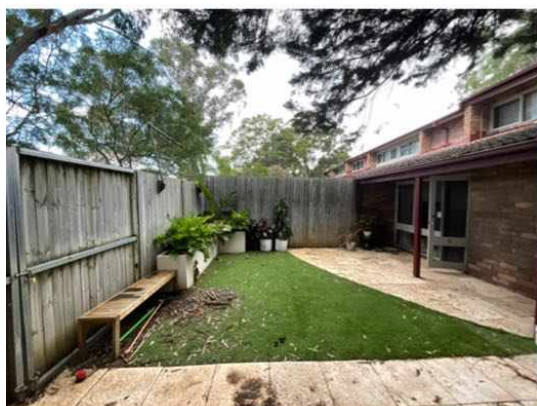
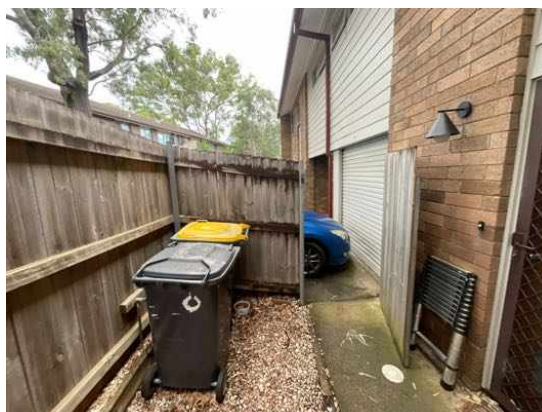
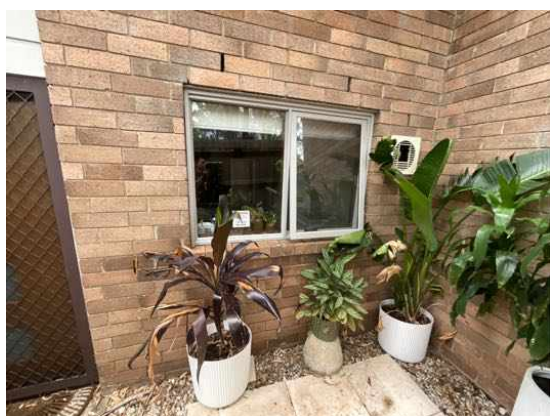
Finding 6.01

Building: Main Building
Location: All Areas
Finding: Garden Beds - Conditions Conducive to Termites
Information: Garden beds were found to be evident in the garden area. These garden beds can include untreated timber, and with a combination of moisture from watering hosing can make conditions conducive to termite activity and termite ingress.

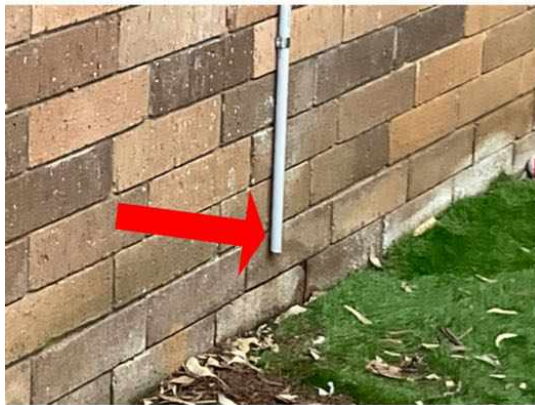
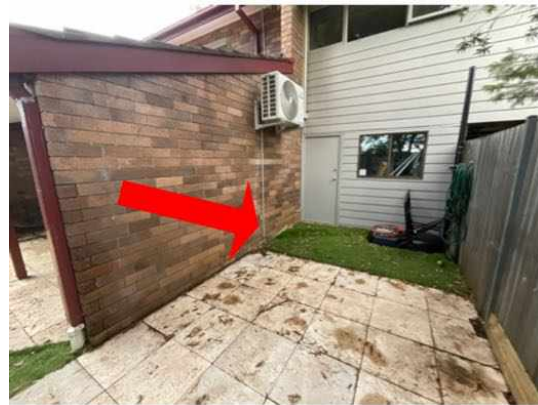
Finding 6.02

Finding: Air conditioner - Disconnected overflow
 Information: The Air Conditioner (A/C) overflow was found to be disconnected from storm water drainage and is creating excessive moisture in the surrounding area.

Such leaking creates an environment which is conducive to an array of defects, including water damage to associated building elements and the attraction of termite or timber pest infestation.

It is highly recommended that a licensed plumber be appointed to connect the A/C overflow in order to prevent such an environment from being created. These minor works should be carried out as soon as possible.

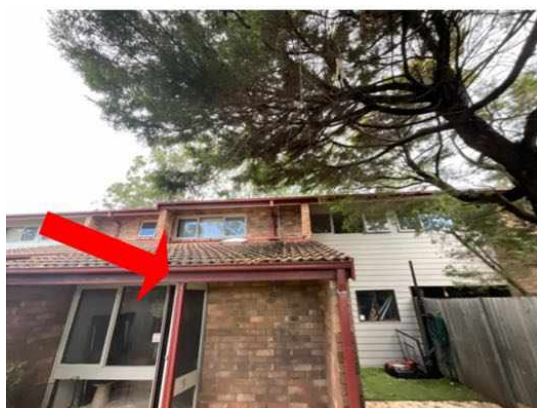
Building:	Main Building
Location:	All Areas
Finding:	Timber - exposed to weather
Information:	External timbers that are frequently exposed to harsh weather conditions require adequate protection in order to maintain their condition. Where timbers have not been painted or treated adequately, general deterioration is likely to occur at an accelerated rate.

If left unattended, replacement of these timbers is likely to be necessary in the short-term future. Adequate treatment of these timbers is required as soon as possible by a painting contractor or general handyman.
