Building and Timber Pest Inspection Report

Inspection Date: Tue, 31 Mar 2026

Property Address: 1810/30 Shepherd Street, Liverpool NSW
2170

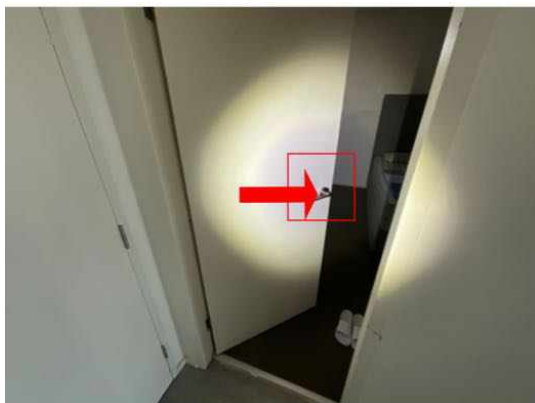
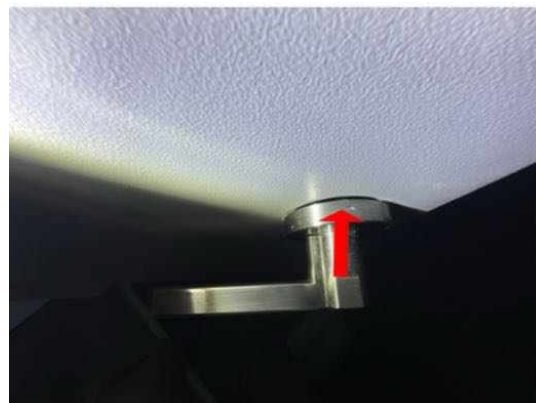
1. Loose Door Handle

Building:	Main Building
Location:	Bedroom
Finding:	Door(s) - Loose handle.
Information:	During the inspection, minor maintenance-related defects were identified. These issues are generally the result of normal wear and tear associated with the age and usage of the property. While they are not considered to pose an immediate risk to the structure or occupants, routine repairs and maintenance are recommended to ensure continued functionality and to prevent further deterioration.

A door handle was observed to be loose at the time of inspection. This commonly occurs due to aged or worn internal fixings or repeated usage over time. While not currently impacting security or usability in a major way, it may worsen if left unrepaired.

Tighten the handle fixings where possible. If components are stripped or damaged, repair or replacement of the hardware may be necessary. A qualified carpenter or general handyman can carry out this work at the client's discretion.

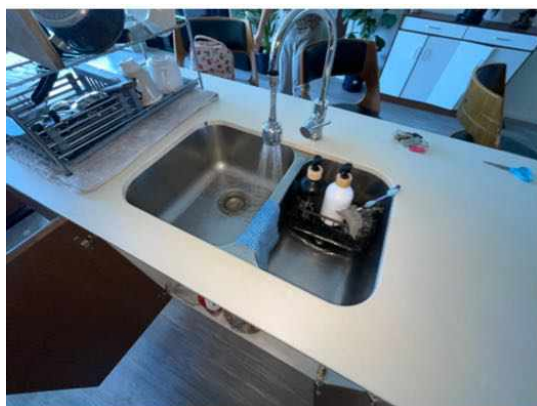
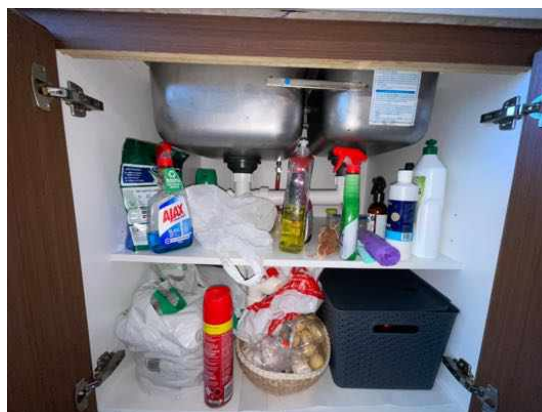
Building:	Main Building
Location:	Kitchen
Finding:	Kitchen Sink – Overall Condition & Recommendations.
Information:	Observations:

- The kitchen sink tap(s) were water tested at the time of inspection, with no evidence of leaks or blockages observed in the visible plumbing or drainage.
- No significant water damage was observed to the cabinetry/unit.
- Stored items under the sink obstructed access, limiting a full inspection of the plumbing and internal cabinetry.

- Further monitoring and testing are recommended once the tap(s) are in constant use, to identify any drainage issues or signs of slow leaks not evident during the limited inspection.
- It is recommended that the stored items beneath the sink be removed to allow for a full re-inspection of the plumbing and cabinetry, ensuring no concealed defects are present.

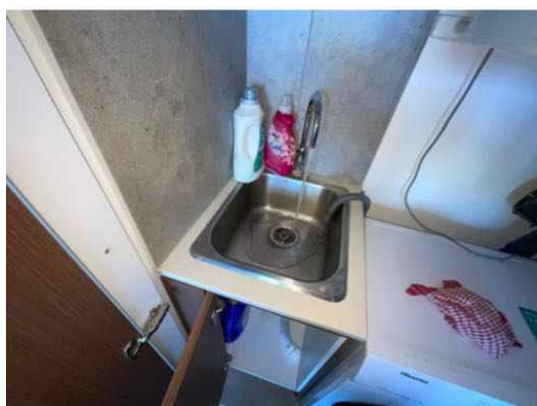
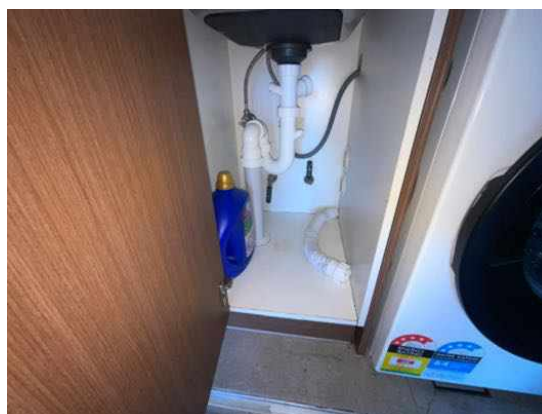
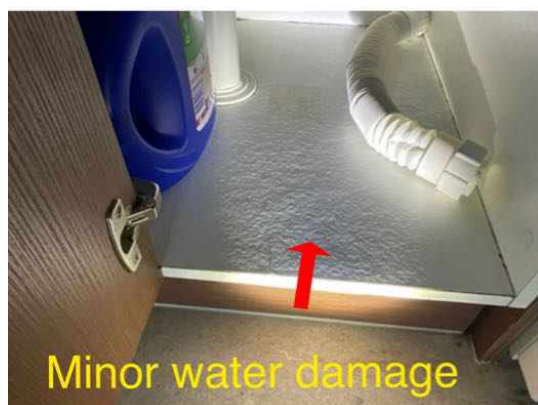
Building: Main Building
 Location: Laundry
 Finding: Laundry - Taps/Plumbing/Drainage.
 Information: Observation: Laundry Tub – Taps, Plumbing, and Cabinetry

- The taps to the laundry tub were water tested and inspected, with no evidence of plumbing or drainage leaks observed at the time of inspection.
- Signs of minor water damage was noted to the cabinetry unit during the inspection.

- Further monitoring or testing is recommended once the taps are placed into regular use, to ensure no leaks develop over time and that the drainage system continues to perform adequately.
- Regular maintenance and prompt replacement of missing or deteriorated sealant is highly recommended, as this is a common wear-and-tear issue.

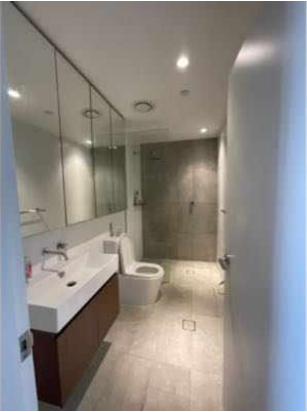
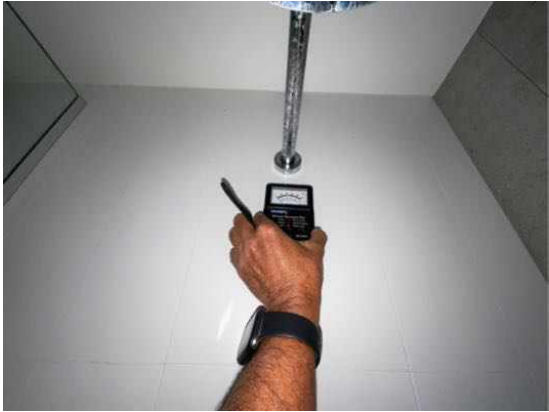
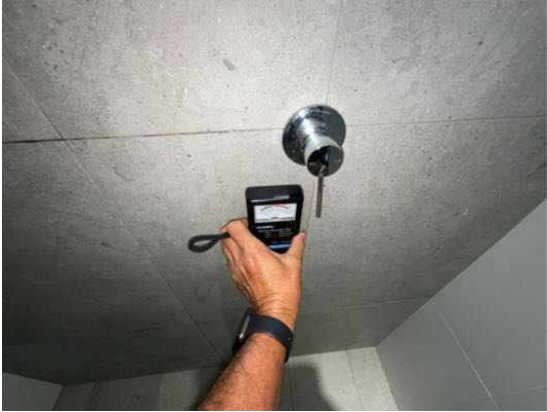
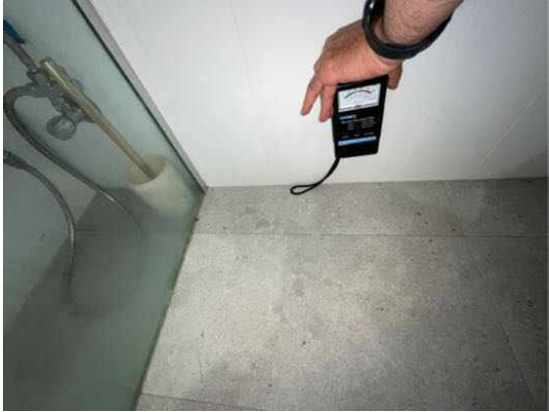
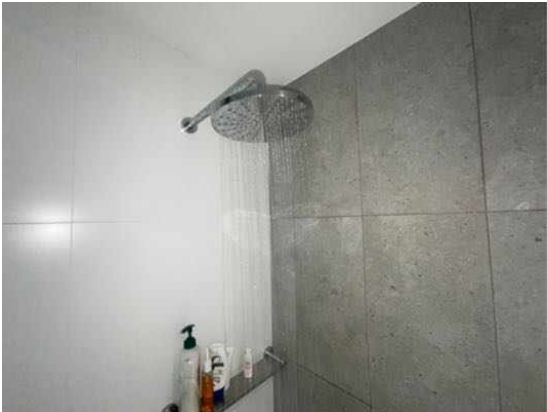
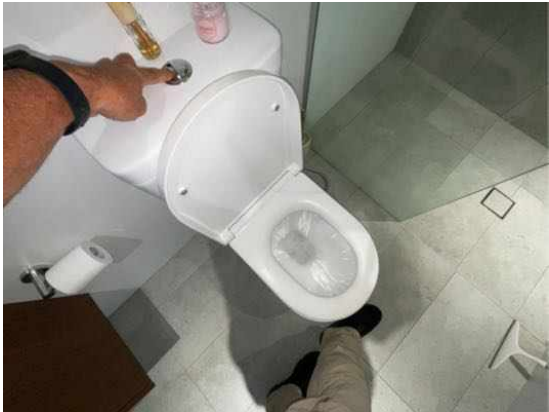
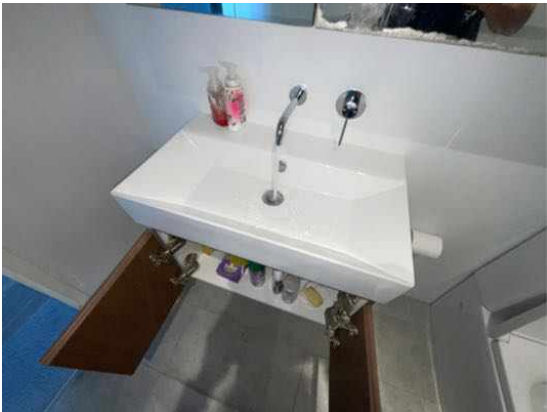
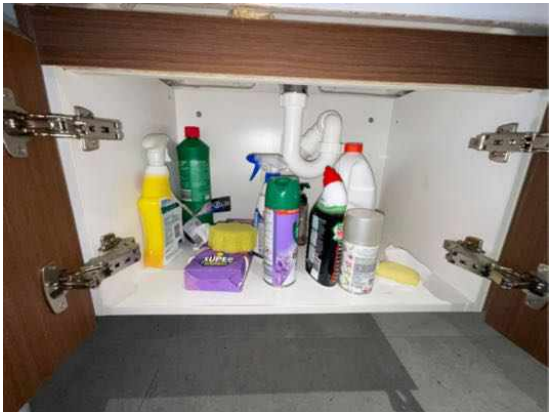
Building: Main Building
 Location: Bathroom
 Finding: Wet Areas - Bathroom(s) - Overall Condition & Recommendations.
 Information: Overall Condition & Recommendations

- Floor waste was found to be clear and free of blockages at the time of inspection. Further monitoring is advised after consistent use to identify any drainage issues or buildup requiring cleaning.

- No elevated moisture readings were detected around the tap fittings or behind the shower walls (as viewed from adjacent rooms), suggesting no active plumbing leaks at the time of inspection.

- Elevated moisture readings were found in the lower shower walls, which is a common occurrence with certain tile types that naturally absorb more moisture. This should be monitored over time.

- Sealing of grout and tiles is recommended to prevent moisture buildup and mould growth in damp areas such as showers.
- The condition of grout and sealant appeared to be good.

- The exhaust fan appeared to be operational, which supports moisture control in the bathroom.

- No leaks were observed during flushing. The toilet operated normally, and the toilet pan appeared to be securely fixed to the floor.

- Basin(s) were water tested and inspected, with no leaks or blockages identified in the plumbing or drainage system at the time of inspection.

- No visible water damage was observed to the vanity cabinetry at the time of inspection.

- Flood testing of the shower recess is recommended. This may reveal inadequacies in the waterproofing or shower screens, which could lead to water damage in surrounding areas.

- Further monitoring is recommended after the basin(s) are placed under regular use to confirm ongoing performance and cleanliness.

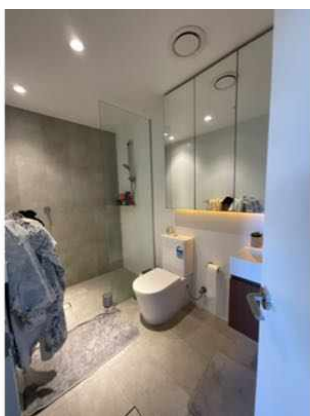
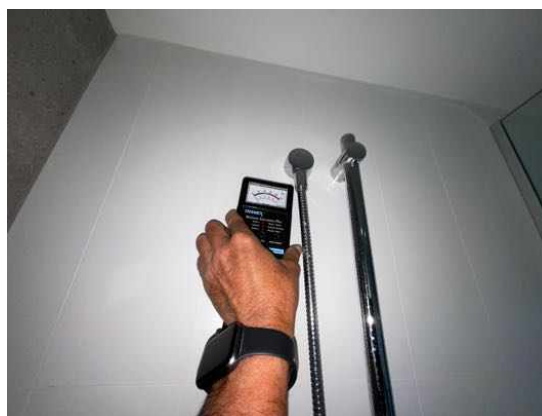
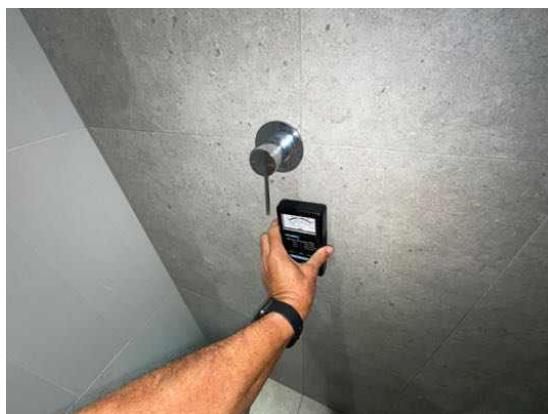
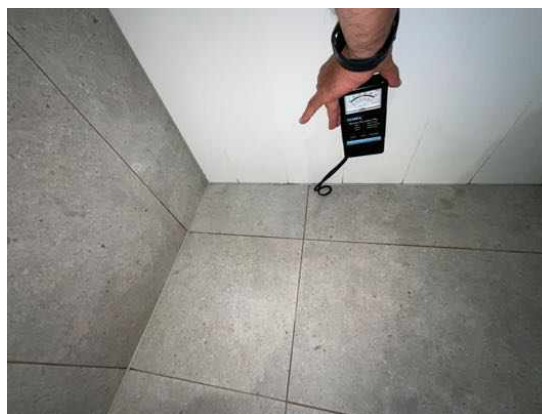
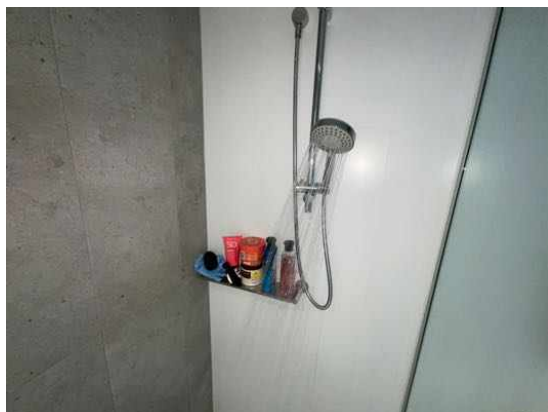
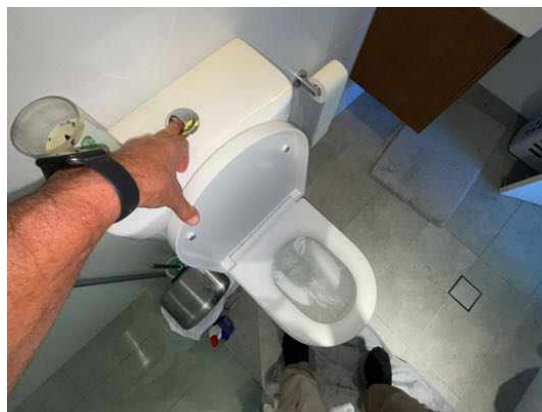
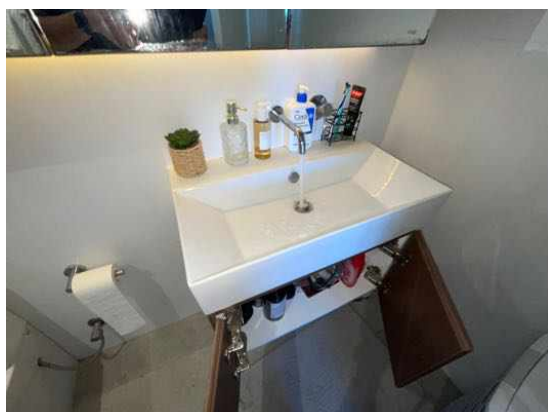
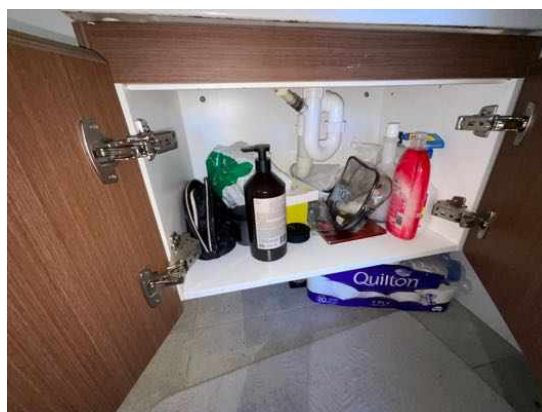
Building: Main Building
Location: Ensuite
Finding: Wet Areas - Bathroom(s) - Overall Condition & Recommendations.
Information: Overall Condition & Recommendations

- Floor waste was found to be clear and free of blockages at the time of inspection. Further monitoring is advised after consistent use to identify any drainage issues or buildup requiring cleaning.

- No elevated moisture readings were detected around the tap fittings or behind the shower walls (as viewed from adjacent rooms), suggesting no active plumbing leaks at the time of inspection.

- Elevated moisture readings were found in the lower shower walls, which is a common occurrence with certain tile types that naturally absorb more moisture. This should be monitored over time.

- Sealing of grout and tiles is recommended to prevent moisture buildup and mould growth in damp areas such as showers.
- The condition of grout and sealant appeared to be good.

- The exhaust fan appeared to be operational, which supports moisture control in the bathroom.

- No leaks were observed during flushing. The toilet operated normally, and the toilet pan appeared to be securely fixed to the floor.

- Basin(s) were water tested and inspected, with no leaks or blockages identified in the plumbing or drainage system at the time of inspection.
- Further monitoring is recommended after the basin(s) are placed under regular use to confirm ongoing performance and cleanliness.
- No visible water damage was observed to the vanity cabinetry at the time of inspection.
- Stored items inside the vanity obstructed full visibility during the inspection. It is advised that the area be re-inspected once all obstructions are removed.

- Flood testing of the shower recess is recommended. This may reveal inadequacies in the waterproofing or shower screens, which could lead to water damage in surrounding areas.

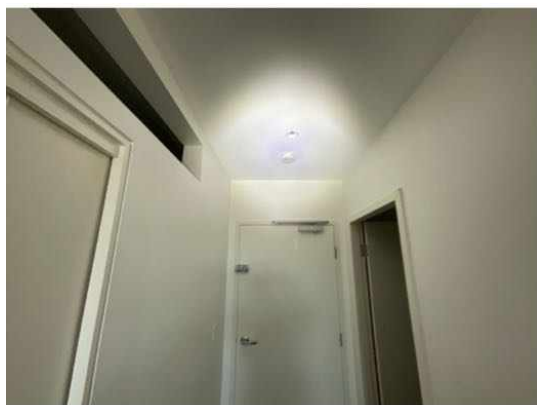
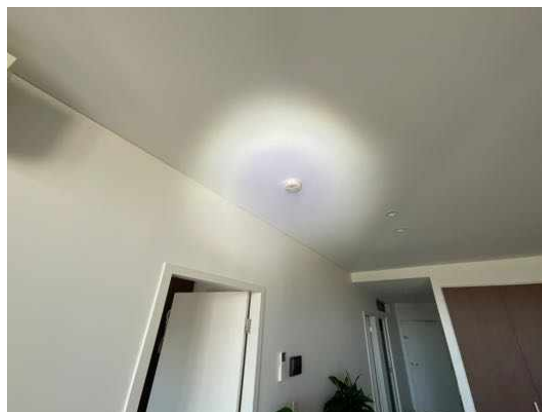
Building: Main Building
 Location: All Areas
 Finding: Smoke Detectors / Alarms.
 Information: Reporting on the presence, type, location, or compliance of smoke detectors or alarms, including hard-wired smoke detection systems and their legislative requirements, is outside the scope of this inspection report.

To ensure compliance and safety, further inspection and/or advisory services from a qualified specialist are recommended. These services can confirm the sufficiency, type, location, and functionality of all smoke detection devices within the property.

- All smoke detectors be tested monthly by the homeowner.
- All systems comply with the requirements of AS 3786 and any applicable state-based legislation.
