# Building and Timber Pest Inspection Report

Inspection Date: Thu, 19 Feb 2026

Property Address: 20 Tandarra Cres, Lalor VIC 3075, Australia

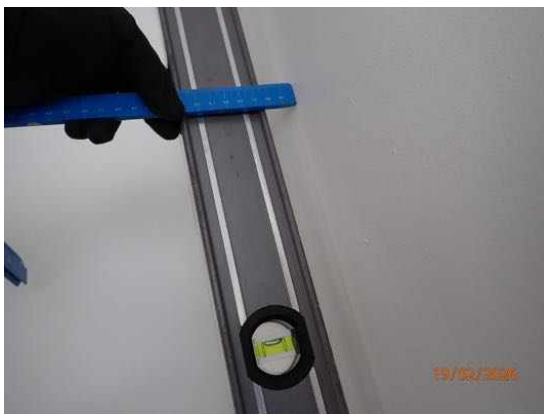
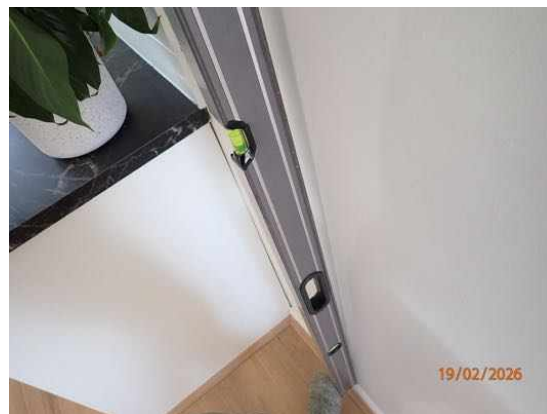
Building:	Main Building
Location:	Entry
Finding:	Wall Leaning and Associated Brickwork Cracking
Information:	The internal wall in the entry area was noted leaning by approximately 10mm during inspection. The adjoining external wall near the kitchen was observed leaning by approximately 20mm, with a crack noted in the corresponding external brickwork. The deviation appears localised to this section only.

This condition may be the result of substandard construction practices at the time of original construction or minor settlement over time, rather than widespread structural movement. No significant associated distortion was observed in surrounding areas at the time of inspection.

It is recommended to monitor this section of the wall for any changes, including widening cracks, increased leaning, or difficulty in operation of nearby doors or windows. Should further movement be observed, a structural engineer should be engaged to assess the area and provide appropriate advice.

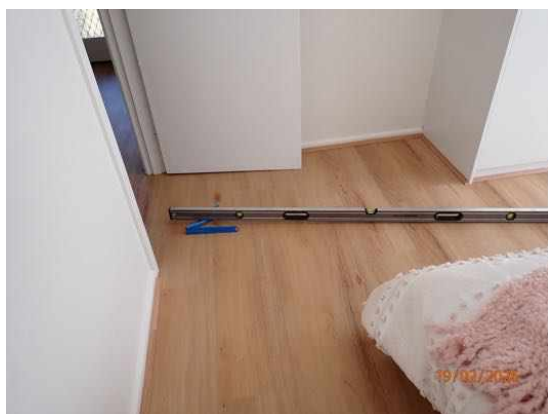
Building: Main Building  
Location: Bedroom 2 and 3  
Finding: Flooring - Uneven  
Information: The internal flooring in this area is out of level and uneven, more than what is typically expected. Uneven flooring can indicate minor defects such as movement of the foundations, but in this case, the extent of unevenness suggests potential subsidence of the associated subfloor stumps.

It is advised that further inspection of the subfloor structures and stumps be conducted to determine the cause of the excessive unevenness. This may involve a potentially invasive inspection to accurately assess the condition and stability of the subfloor components. This is noted as a minor defect with major implications.

Based on the findings, works to repair the flooring may be required. It is recommended that a registered builder specializing in re-stumping be engaged to carry out these necessary repairs to ensure the structural integrity and levelness of the flooring.

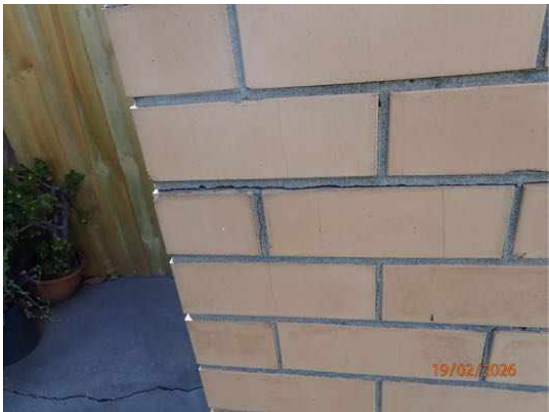
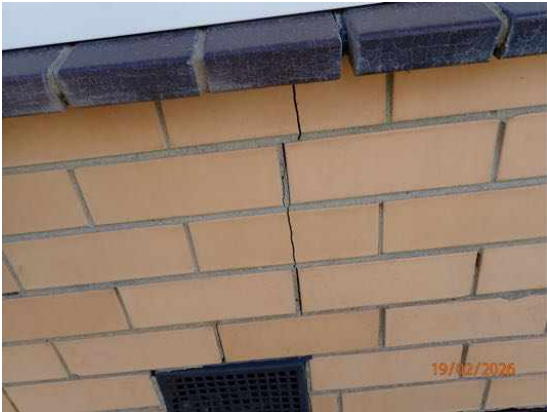
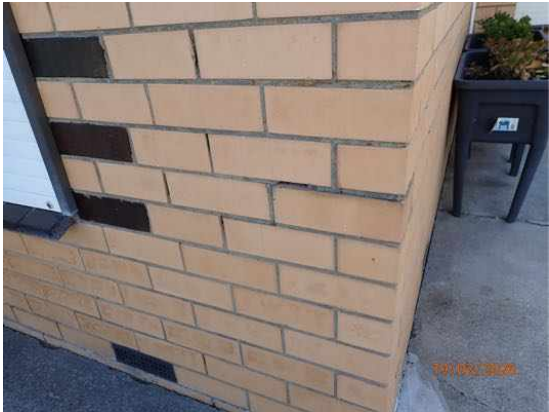
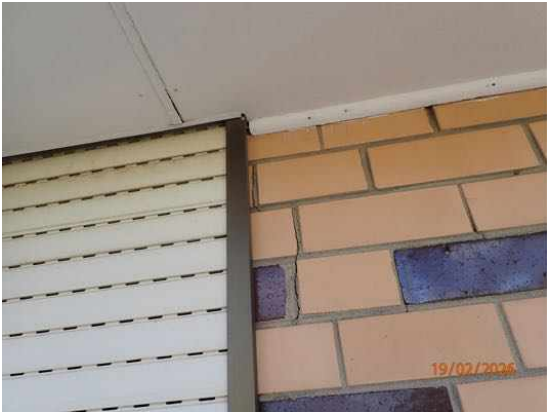
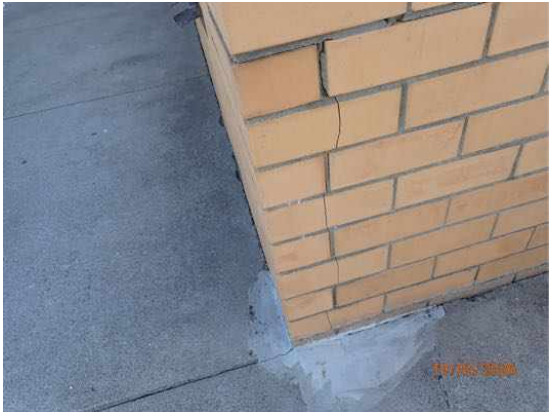
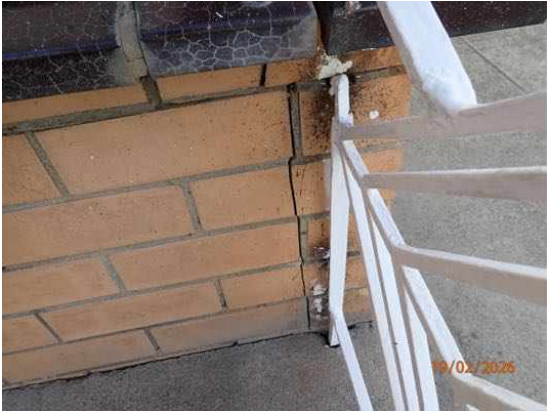
### Finding 3.04

Building:	Main Building
Location:	All External Areas
Finding:	Brickwork - Cracking Noticeable
Information:	Minor to moderate cracking was observed on the external brickwork during the inspection. The cracks were more than hairline and are suspected to be the result of structural movement or gradual settlement of the foundation over time, which is not uncommon in older homes.

While no immediate structural issues were evident at the time of inspection, it is important to closely monitor these cracks for any signs of progression, such as widening or lengthening. If any changes are observed, or if further concerns arise, it is recommended to engage a structural engineer to carry out a detailed assessment and provide guidance on any necessary remedial measures to ensure the ongoing stability of the structure.

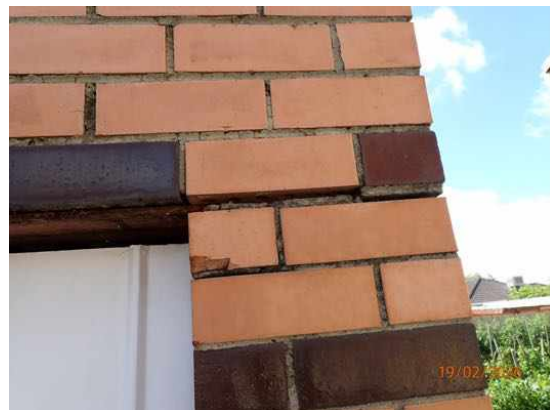
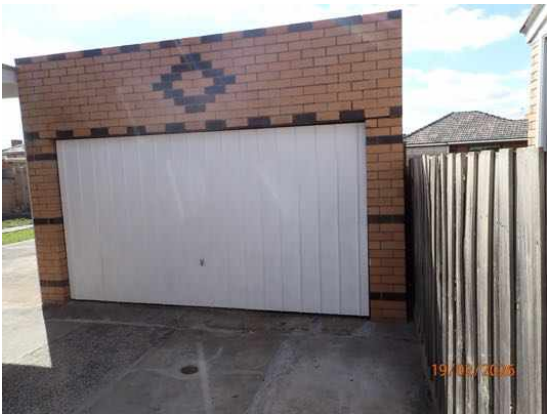
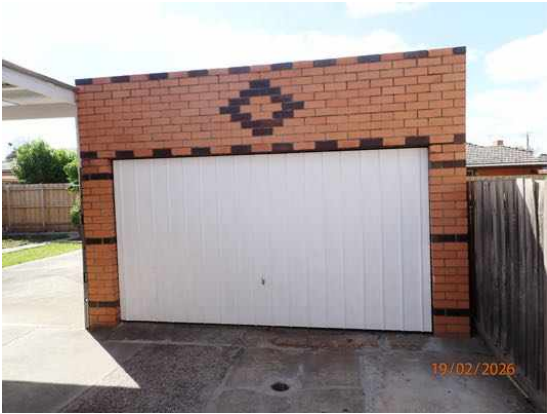
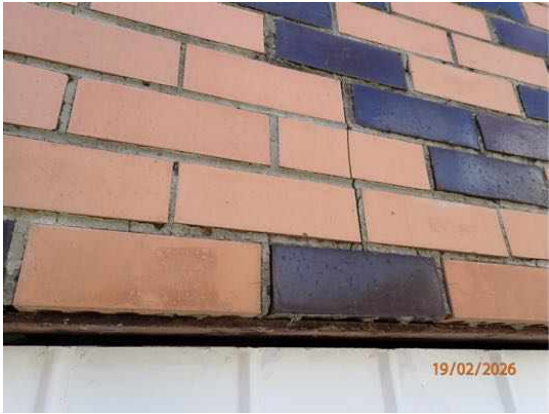
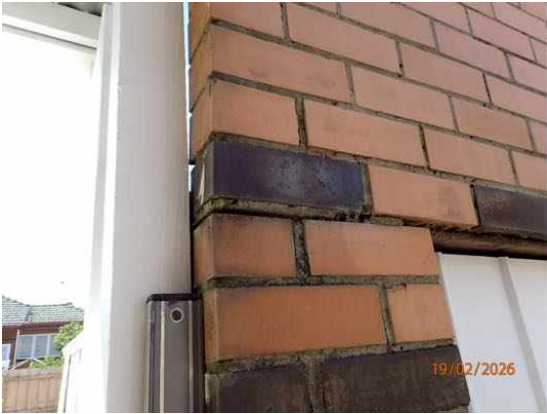
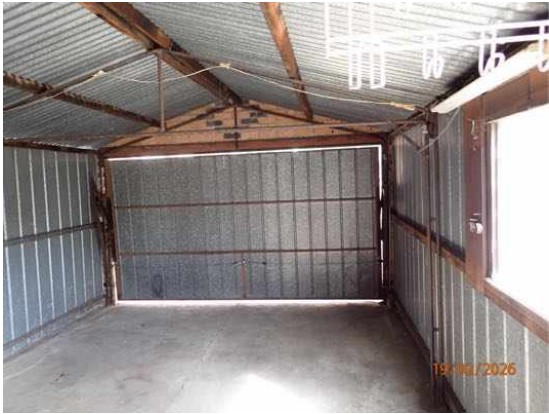
### Finding 3.05

Building: Main Building  
 Location: Exterior walls - rear  
 Finding: Garage Brickwork Movement & Leaning Piers  
 Information:

Cracking to the brickwork at the front of the garage was noted during inspection. Both supporting brick piers were observed to be out of plumb, leaning approximately 20mm. Separation cracking was also noted between the brickwork and the lintel, with visible movement and signs of rusting to the lintel, contributing to separation of the upper brick panel from the supporting pier.

This condition is indicative of structural movement and possible lintel deterioration, which may compromise the stability of the garage opening if left unmanaged. It is strongly recommended to engage a structural engineer to assess the extent of movement and lintel condition, with a qualified bricklayer or registered builder to carry out rectification works as directed. Prompt attention is advised.

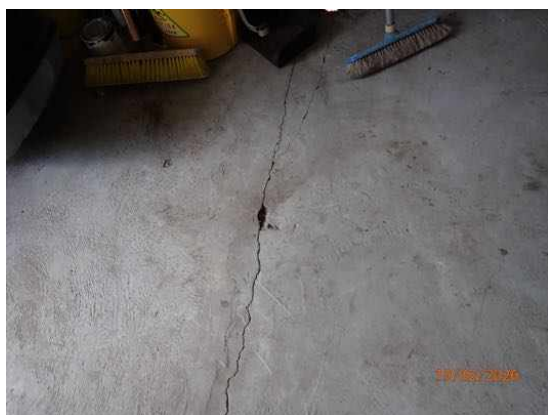
**Finding 3.06**

Building: Main Building  
 Location: Garage  
 Finding: Cracking to Garage Slab and Disconnected Downpipe  
 Information: Cracking to the garage concrete slab was noted during the inspection. The garage downpipe was also found disconnected, allowing roof water to discharge adjacent to the slab. Continued discharge of stormwater in this manner may contribute to moisture build-up and further movement or deterioration of the concrete over time. It is recommended to engage a licensed plumber to reconnect the downpipe to an appropriate stormwater discharge point and monitor the slab cracking for any signs of progression.

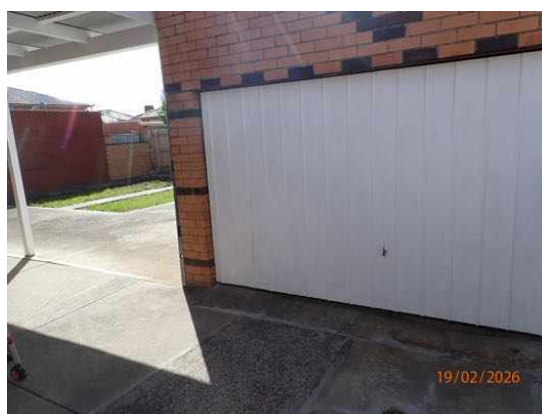
Building: Main Building  
 Location: Garage  
 Finding: Garage Door Binding  
 Information: The metal garage door was noted binding against the adjacent brickwork during inspection and was difficult to open and close. Damage to the brickwork caused by ongoing rubbing of the door was also observed in this section.

This condition may be due to minor movement, misalignment of the door tracks, or deformation of the opening over time. Continued operation in this condition may result in further damage to both the door and surrounding brickwork. It is recommended to engage a garage door technician or registered builder to assess alignment and carry out necessary adjustments or repairs in the short term.

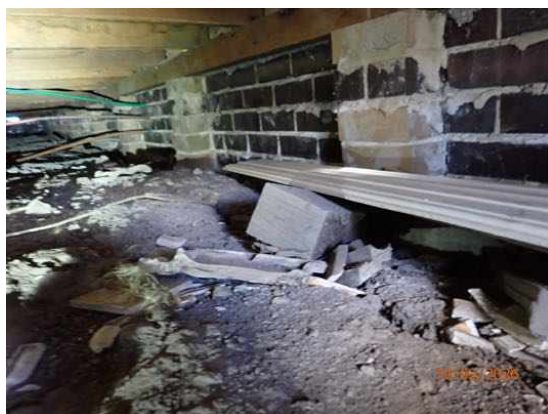
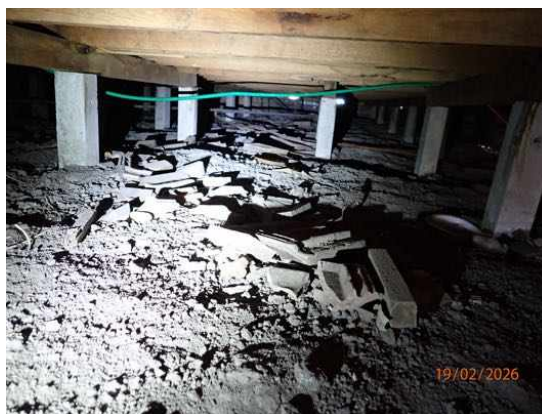
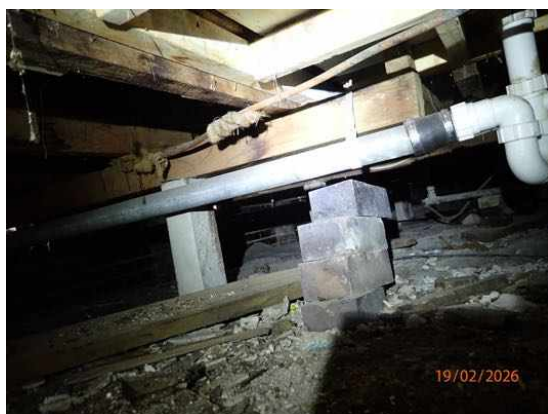
Building:	Main Building
Location:	Subfloor
Finding:	Stored timbers - subfloor space or external area
Information:	The storing of timbers in the subfloor space increases the risk of termite activity being present. As they are likely to come into contact with weather conditions or excessive moisture wood rot is likely to develop on timbers that are not treated.

It is highly recommended that any stored timbers be immediately removed from areas in which they may attract any termite / timber pest attack. Minimisation of risk / prevention of termite attack is far more adequate than dealing with the presence of termite activity.

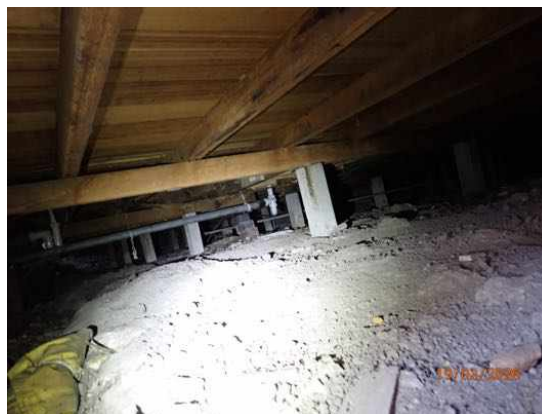
### Finding 6.05

Building:	Main Building
Location:	Subfloor
Finding:	Ant caps - Not installed
Information:	Ant caps have not been installed to the subfloor structure at the time of inspection. Generally, ant caps are installed to the intersection between the top of the stumps (or

Installed during the construction process, ant caps are designed to easily identify termite or pest ingress from stumps to the adjoining bearers.

Where ant caps have not been installed, frequent monitoring of these areas should be carried out in order to identify any signs of termite or timber pest workings.

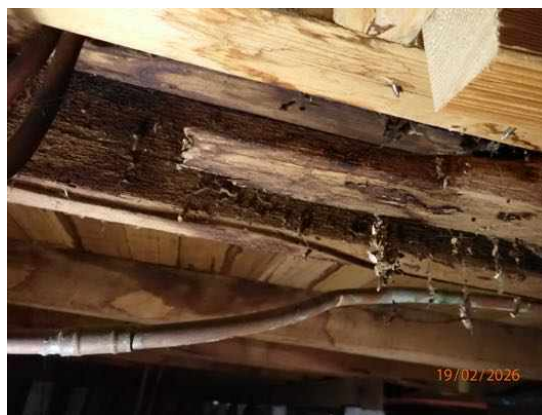
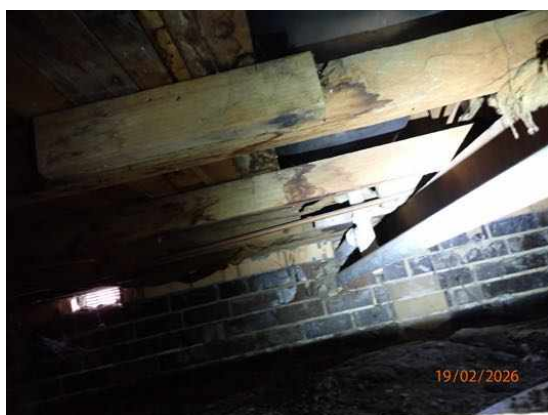
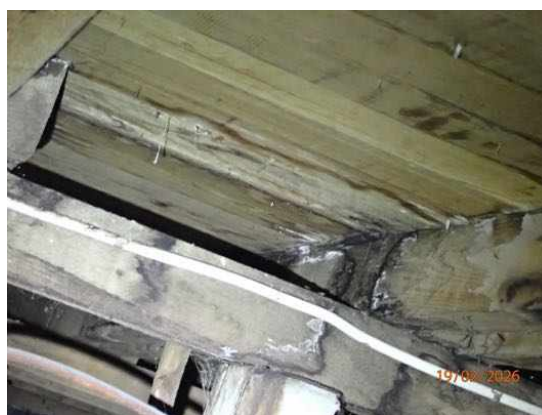
### Finding 7.01

Building:	Main Building
Location:	Subfloor
Finding:	Subfloor structure - Wood rot
Information:	The subfloor structures are showing signs of deterioration and wood rot (fungal decay) of the timbers. It is suspected that this defect has developed as a result of damp conditions in the subfloor.

Damp conditions cause the timbers to fail, resulting in the subfloor structures failing to bear the load (or weight) of the building as originally intended. Without repairs and maintenance, including potential replacement of affected elements, it is likely that serious structural faults will result, as well as an array of minor defects.

The presence of wood rot to the subfloor structure is also conducive to termite infestation. As timber stumps are in direct contact with the ground, concealed termite is made possible. Such entry is made easier if the timbers become non-durable due to even slight wood rot.

Where wood rot is present to any structural timber, rectification or replacement of the affected timber building element is required. The adequate timeframe for such works are dependent on the severity of the rot. Where rot has developed to become widespread, replacement of sections of the subfloor structure may be required. Consultation with a structural engineer or registered builder specialising in re-stumping

is highly advised as soon as possible.

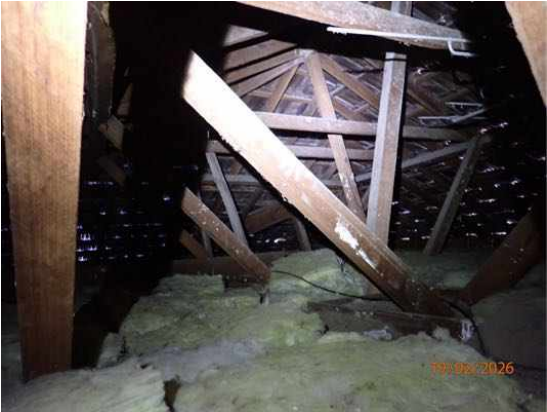
### Finding 8.01

Building:	Main Building
Location:	Subfloor and roof void
Finding:	Evidence of wood borer activity identified
Information:	Wood borers small beetles that colonise in exposed timber elements are a common timber pest that are regularly mistaken for termites. Although wood borer activity is generally not detrimental to the affected timber they may lead to serious damage and necessitate replacement of certain building elements if left unattended.

The other commonly known borer the Anobium borer is more likely to attack floorboards and may cause severe structural damage to flooring areas.

As no live wood borer activity was identified treatment is not required at this time. Replacement of affected timbers may be considered by the client for superficial

reasons.

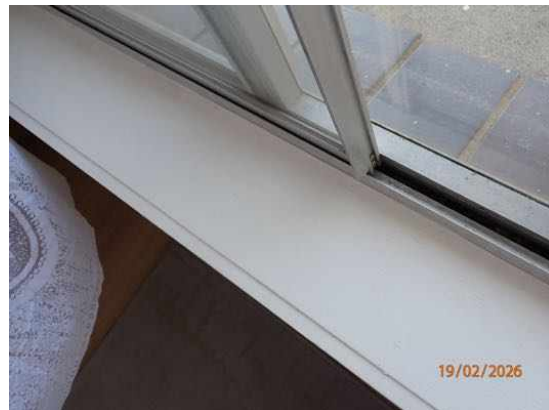
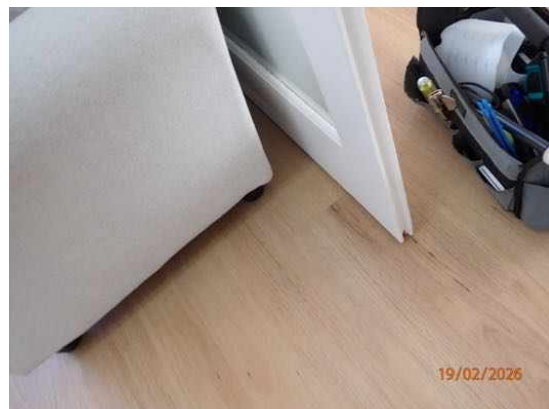
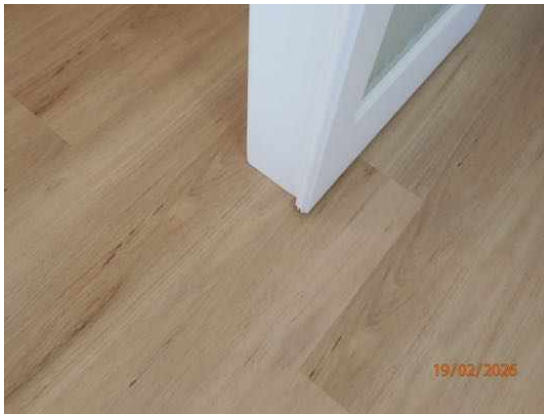
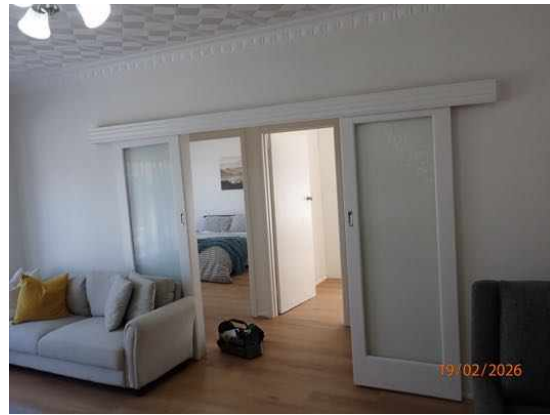
Binding of sliding components is commonly caused by minor movement, track misalignment, wear to rollers, or buildup of debris within the track. If left unaddressed, this may result in further wear to hardware and difficulty in securing the openings properly.

It is recommended to engage a qualified carpenter or door/window specialist to inspect, service, and realign the affected window and sliding door as required to ensure smooth operation and proper latching.

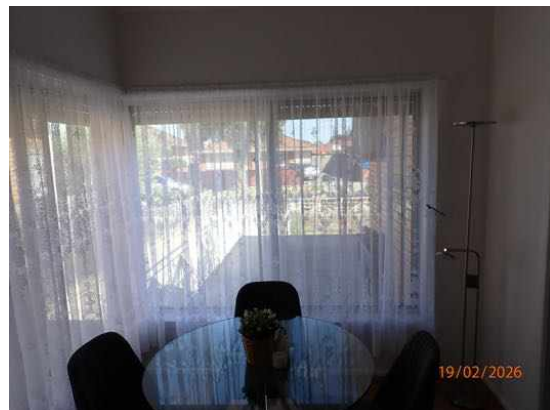
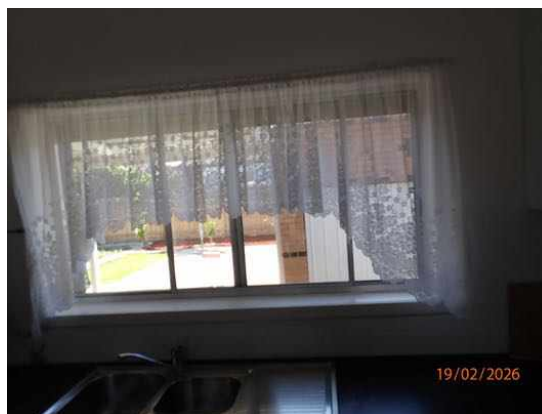
Deteriorated window seals can allow moisture ingress and air leakage over time, while a non-functioning latch may affect security and weather tightness. Missing shelf supports may lead to sagging or failure of the cabinet shelf under load.

It is recommended to engage a qualified carpenter or handyman to replace the window seal, repair or adjust the window latch, and install the missing shelf support to restore proper function and prevent further deterioration.

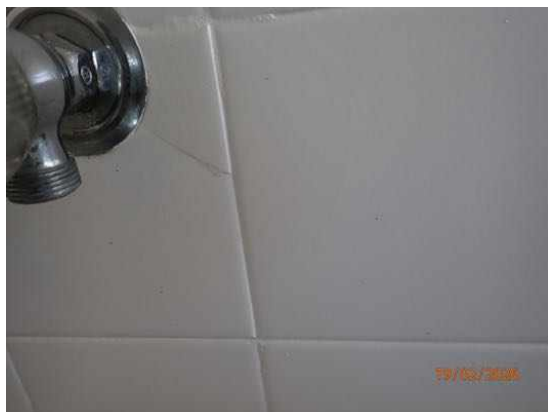
Building: Main Building  
 Location: Laundry  
 Finding: Laundry Sink Ponding & Wall Tile Condition  
 Information: Water ponding was noted at the base of one of the laundry sinks during inspection. The wall tiles above the sink were noted cracked and previously sealed and painted over, suggesting past moisture-related deterioration.

The ponding is suspected to be due to inadequate fall to the waste or improper installation. Ongoing ponding may contribute to moisture damage to surrounding building elements if not rectified.

It is recommended to engage a licensed plumber to assess and rectify the drainage issue. A tiling contractor or qualified tradesperson should also assess and repair the cracked tiles to prevent further deterioration.

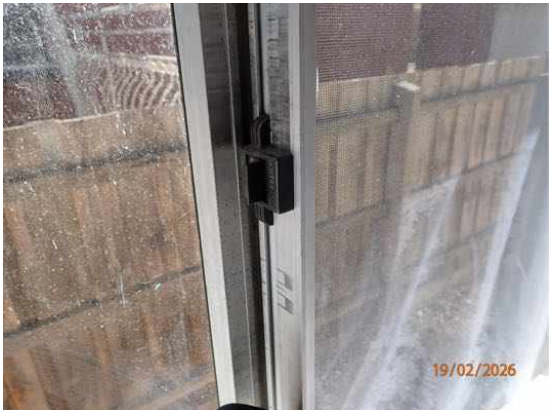
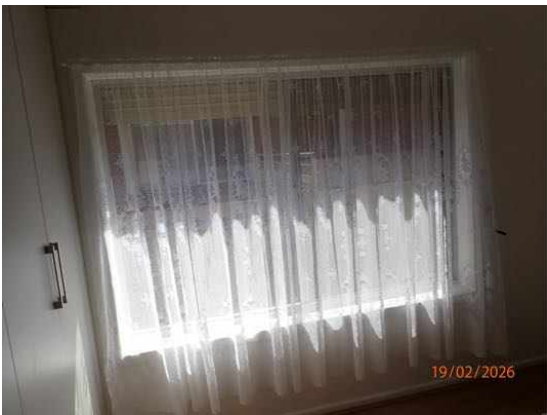
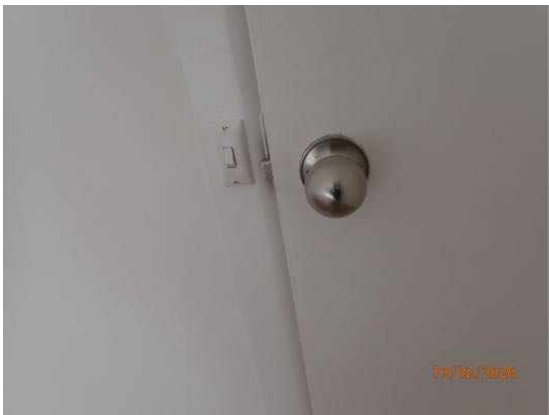
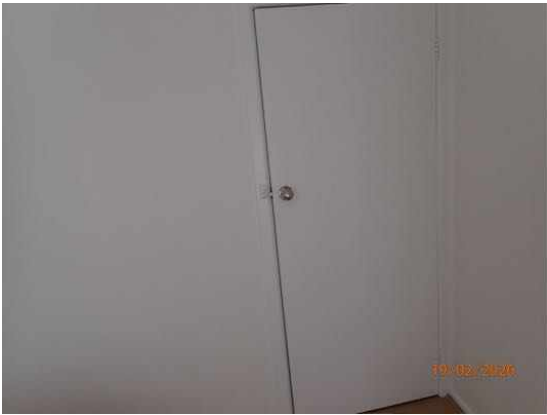
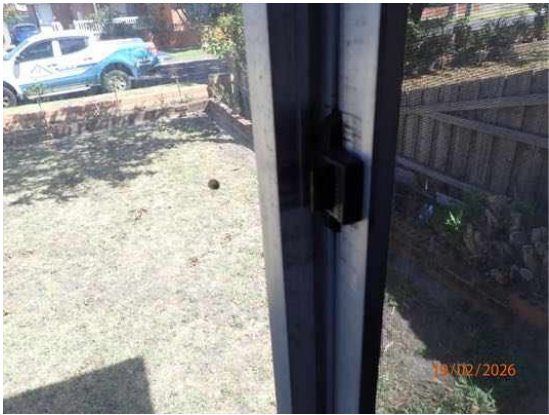
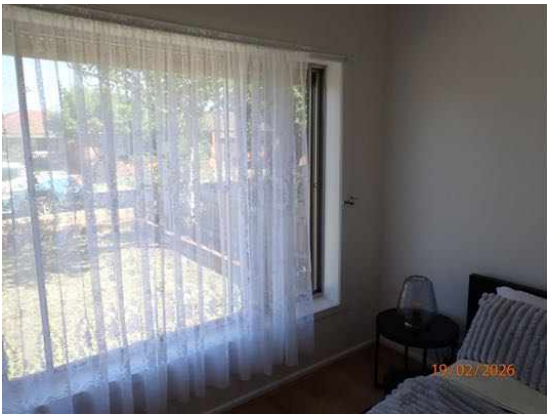
Building: Main Building  
 Location: Bathroom  
 Finding: Bathroom Window & Door Issues  
 Information: The sliding bathroom window latch was noted missing, preventing the window from being securely latched or locked during inspection. The sealant around the tap penetration above the bath was also noted missing, which may allow moisture ingress into surrounding building elements. In addition, the bathroom door was noted binding during operation.

These defects affect normal operation and security of the doors and windows. It is recommended to engage a qualified carpenter or handy person to adjust, repair, or

replace the affected hardware to ensure proper function. Rectification is advised in the short term.

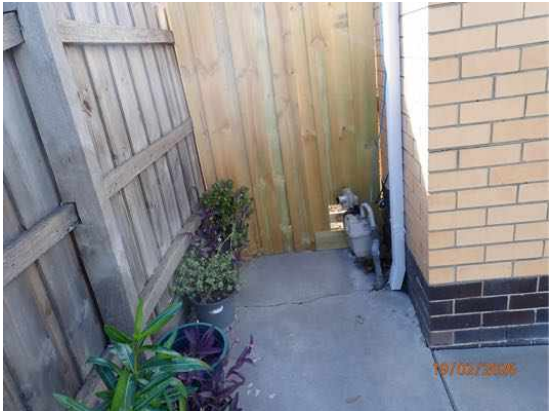
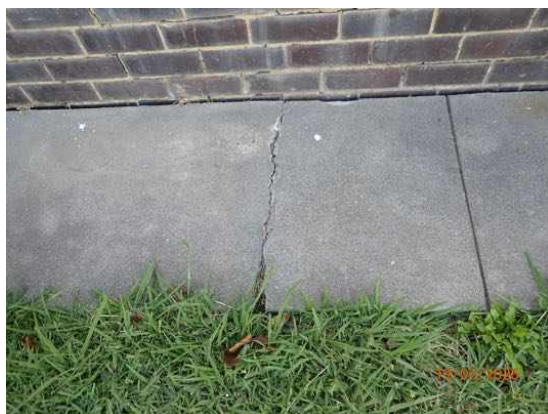
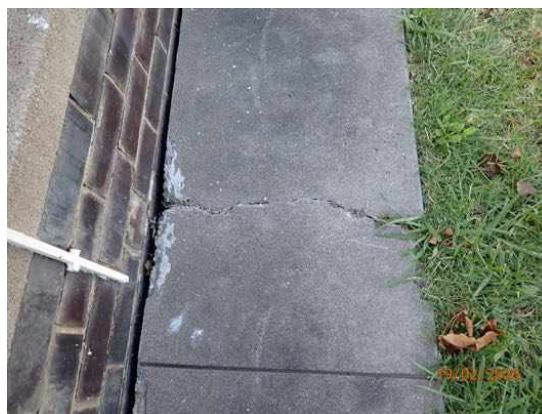
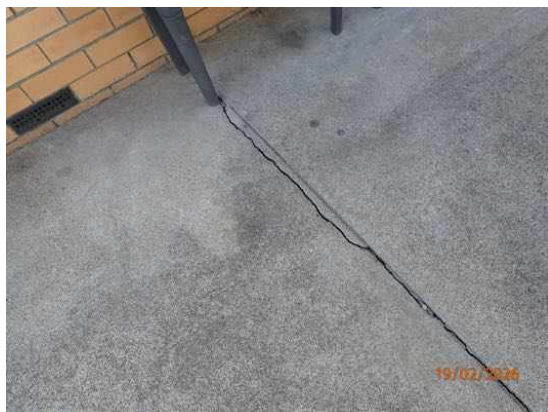
Building: Main Building  
Location: All External Areas  
Finding: Cracking Concrete- Noticeable  
Information: Noticeable cracks in the concrete were observed, likely caused by factors such as age, weather-related expansion and contraction, or minor installation issues. These cracks are typically straightforward to fill and repair.

It is recommended to consult a concreter or handyman for necessary remedial work and consider installing an expansion joint to accommodate future movement. Regular monitoring is advised, and if the cracks worsen, a building inspector should be consulted for further evaluation.

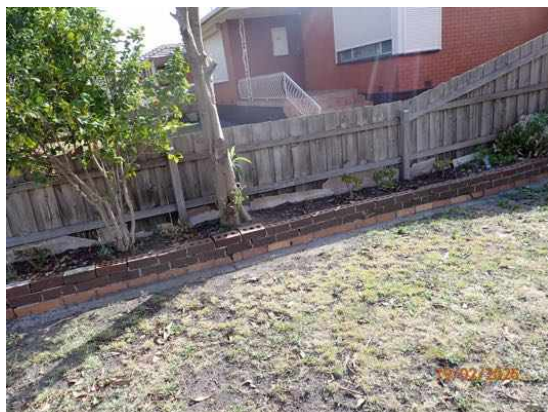
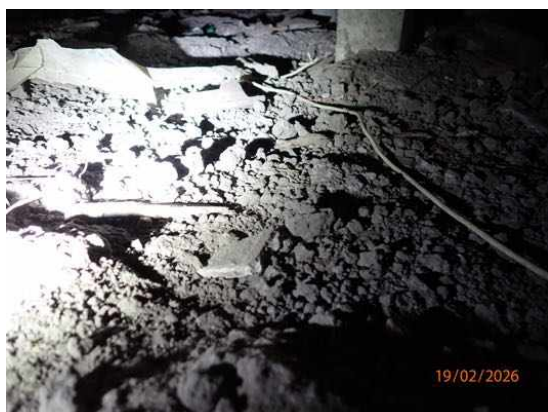
Building:	Main Building
Location:	All External Areas
Finding:	Asbestos - Suspected ACM Identified on Site
Information:	Reporting on Asbestos is outside the Scope of this Report. This suspected defect is highlighted as a caution only. We suspect, based on our experience in the building industry, that there is a higher risk of the identified building element containing asbestos.

As Asbestos Reporting is outside the scope of this report, we advise that you consider a separate Asbestos Inspection and Condition Audit, which can include the taking of samples for definitive confirmation of the presence of Asbestos.

In the interim, the client is advised to act with caution, especially when considering any damage to building materials general wear and tear renovations extensions demolition and general maintenance activities due to the suspected presence of Asbestos.

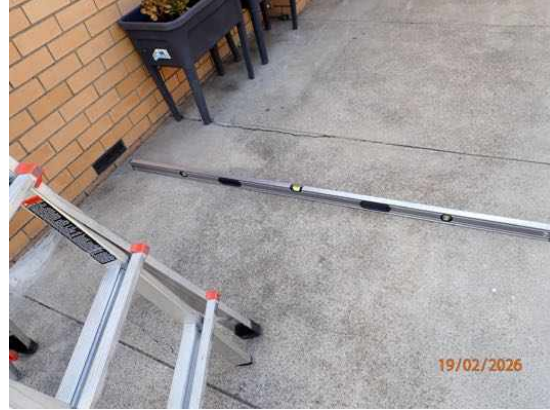
Building: Main Building  
 Location: Exterior walls - front  
 Finding: Site drainage - Inadequate  
 Information: The site drainage in this area was found to be inadequate at the time of inspection, creating potential for subsequent water damage to associated building elements.

It is important that water does not lie against the base of walls; surrounding paths and ground levels should be sloped to drain water away from walls. Downpipes should not discharge stormwater onto lower walls or plinths. Stormwater should be carried away by large, regularly cleaned drains. Ground levels may need to be lowered to expose a buried DPC.

Where site drainage is inadequate, installation of an Agricultural (Aggie) Drain may be required. A qualified plumber should be appointed to further inspect the property and perform any remedial works as necessary. Water damage and secondary defects are likely to occur if left unmanaged.

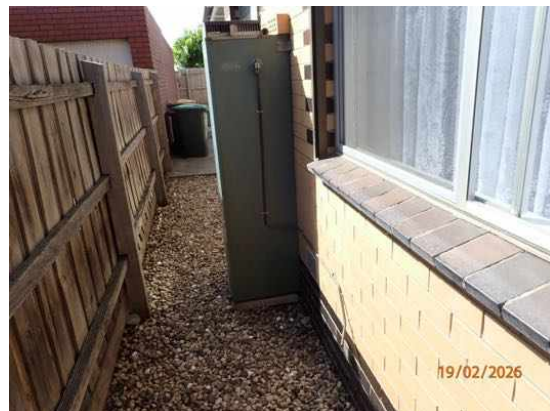
Building: Main Building  
 Location: Exterior walls - left side  
 Finding: Hot Water System Rusting  
 Information: The hot water system was noted rusted during inspection. Corrosion to the unit indicates age-related deterioration and may lead to leakage or failure if not addressed over time. It is recommended to engage a licensed plumber to assess the condition of the unit and advise on maintenance, repair, or replacement as required.
