Building and Timber Pest Inspection Report

Inspection Date: Tue, 17 Mar 2026

Property Address: 17 Poinciana Street Kingston

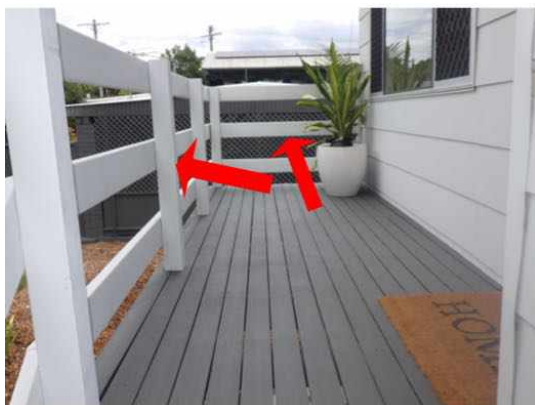
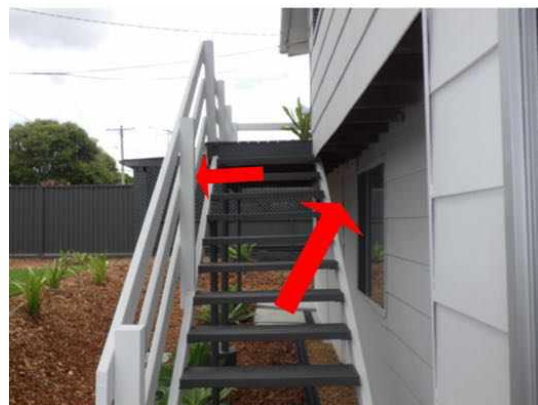
Building: Main Building
 Location: Stairs - External > Existing
 Finding: Balustrade - Suspected Non-Compliance
 Information: The spacing between the timber rails to the front external stair and timber deck area balustrade were measured and found to be (.225mm wide) greater than the present building regulation requirement of 125mm.

This defect creates a potential safety hazard and should be rectified as soon as possible to ensure the safety of the area and to meet present building standards and regulations.

A registered builder should be contacted to discuss possible rectification solutions.

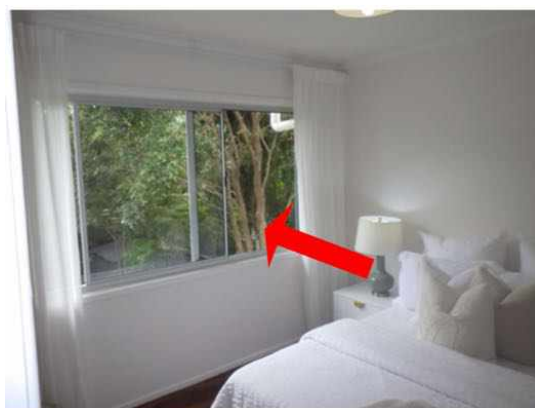
Finding 1.02

Building: Main Building
 Location: Bedroom 2 > Centre,Rear
 Finding: Window safety
 Information: It was noted that the window of the upper level bedroom 2 is less than 1.7m from the

This is noted as a safety concern and this regulation may not have been in place at the time of construction.

See NCC Vol2 Part 3.9.2.6 for further detail on this matter.

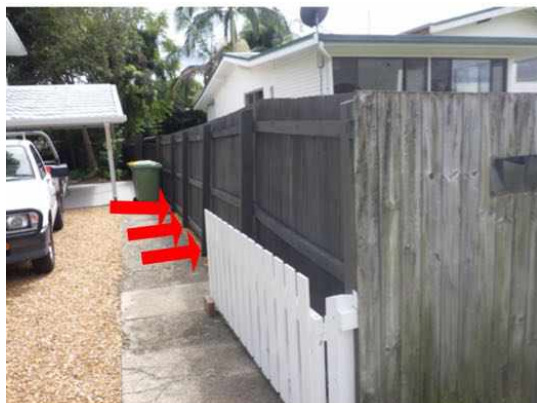
- Building: Main Building
- Location: Yard - Side > Centre Right
- Finding: Fencing - Deteriorated
- Information: It was noted at the time of inspection that the timber fence posts to the right side of the property appear to have deteriorated at ground level, resulting in significant fence movement when pushed on. Typically fencing deteriorates due to age and or wear, rot

and or rust which is generally expected for a structure of this age, due to prolonged exposure to weather conditions. Sometimes inadequate installation or maintenance can be to blame.

If left unattended, it is likely that further damage will occur. It is suspected that repair of several of the fence posts may be required however replacement may be a consideration of the client also.

A licensed fencing contractor should be appointed to provide further advice and perform rectification works as necessary.

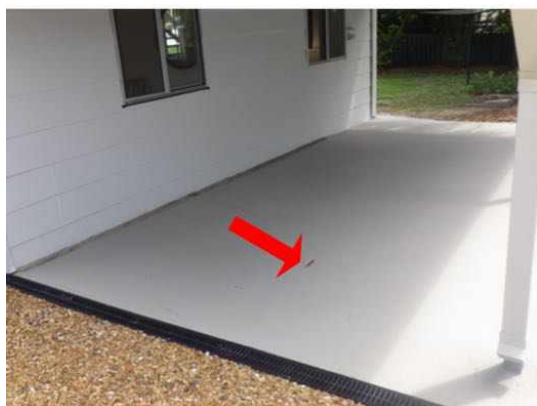
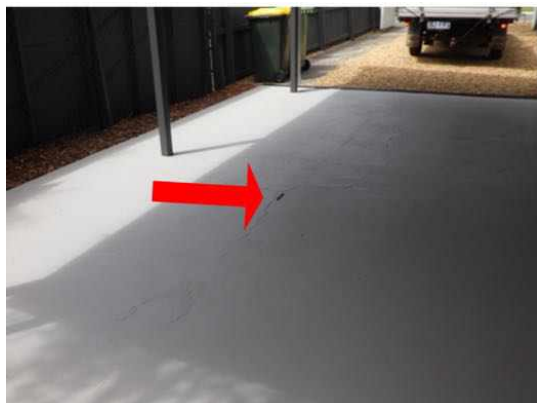
Finding 3.02

Building:	Main Building
Location:	Carport > Ground Level
Finding:	Cracking in concrete slab - Category 1 - 2
Information:	Cracking coded as Category 1 was identified in the carport concrete slab (as per example photos). A Category 1 crack is described as a fine but noticeable crack, with the slab at an otherwise reasonable level.

To be considered Category 1, the approximate width of the crack is less than 1.0mm, or a less than 10mm change in offset when a 3m straight edge is placed over the defect.

Category 1 cracks should be monitored for a period of 12 months. At the end of the monitoring period, identified cracks that are rated greater than Category 2 are considered defects, and require rectification.

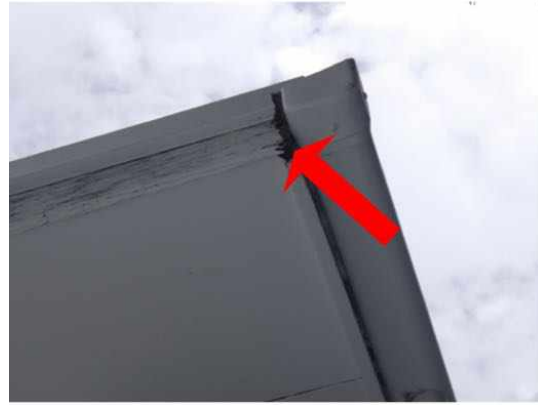
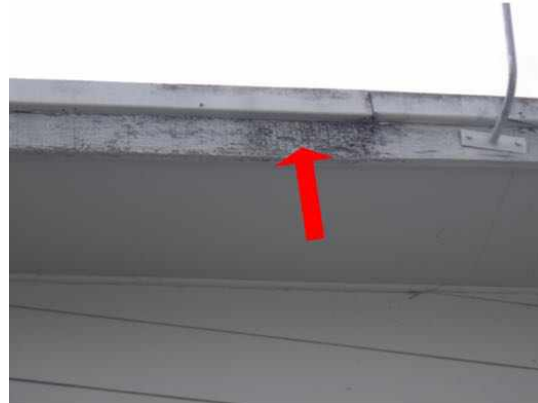
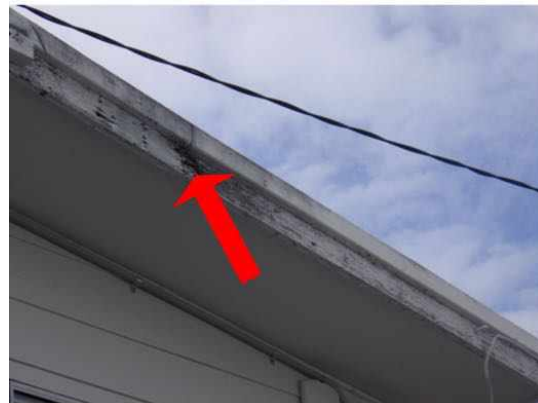
Finding 3.03

Building:	Main Building
Location:	Roof Exterior > Existing
Finding:	Fascias - Wood rot
Information:	Wood rot was found to be affecting fascias and barges, evidenced by the presence of mould on the surface in some areas (as per example photos). Wood rot, also known as Fungal Decay, occurs when timbers and other cellulose building materials are exposed to damp conditions on an ongoing basis.

Frequent exposure to rain and other weather conditions make fascias and barges susceptible to accelerated deterioration.

Early intervention and regular maintenance will prolong the useful life of these building elements. Prior to any works being performed, the cause of the moisture that has created the visible wood rot should be identified and addressed in a suitable manner.

A qualified carpenter or registered builder may be required to replace affected fascia's.

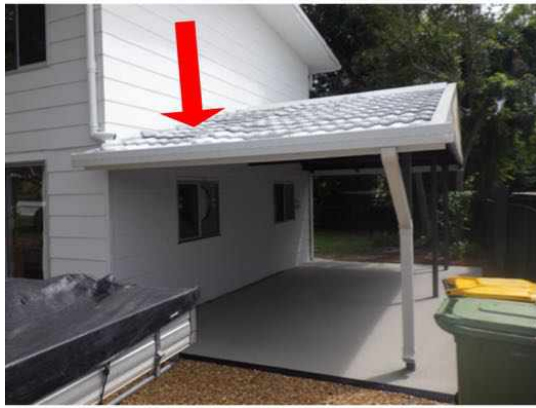
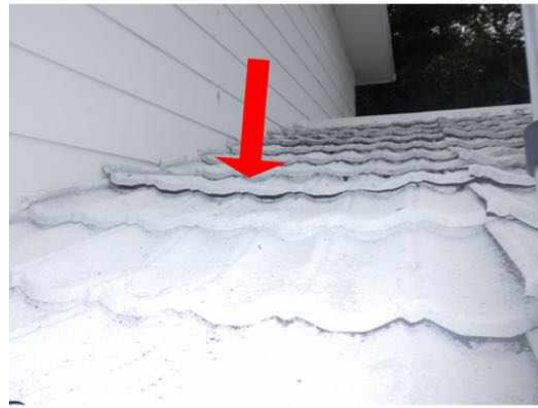
Finding 3.04

Building: Main Building
 Location: Carport > Existing
 Finding: Roof tiles - Weathered
 Information: Upon inspection of the carport area exterior roofing, the majority of metal roof tiles were considered to be in a fair condition. While weathering or deterioration of the tiles is consistent with the age of the property, maintenance works will be required.

The client should consult a roofing contractor to gain advice on costs of any remedial works that may be required in the short to medium term. Remedial works are likely to increase the longevity of the exterior roofing structure.

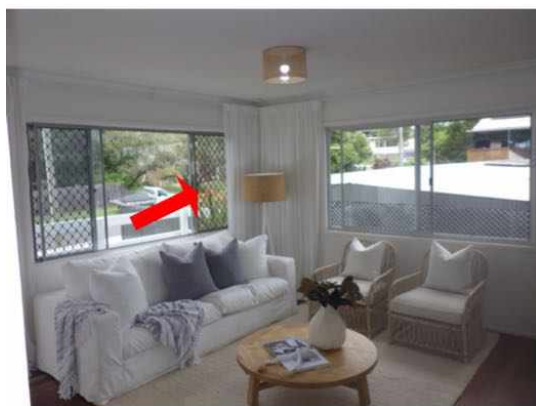
Building:	Main Building
Location:	Lounge Room > Front Left
Finding:	Window - Stiff to Slide
Information:	The left side aluminium sliding window in the lounge room area was stiff to operate at the time of the inspection. Additionally the right side sliding window sash was missing the handle.

Windows provide ventilation to the adjoining area and should be at a fully operational level to ensure user comfort. Restricted function of the window may also pose as a potential safety hazard if required for emergency egress from the building.

Generally, factors such as general age of the building element and a lack of maintenance are the usual causes for this type of defect.

An aluminium window service agent will be required to repair the affected windows.

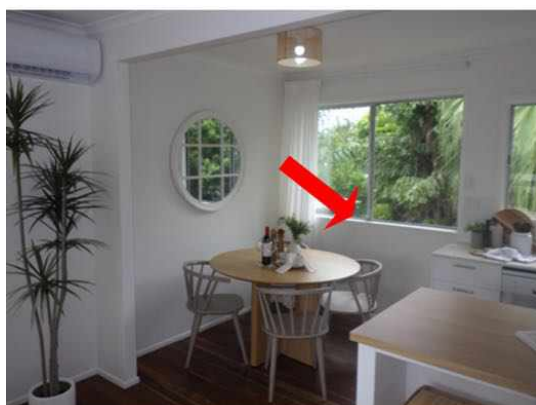
Finding 3.08

Building:	Main Building
Location:	Dining Room > Centre,Rear
Finding:	Window - Stiff to Slide
Information:	The aluminium sliding window in the dining room area was stiff to operate at the time of the inspection. Windows provide ventilation to the adjoining area and should be at a fully operational level to ensure user comfort. Restricted function of the window may also pose as a potential safety hazard if required for emergency egress from the building.

Generally, factors such as general age of the building element and a lack of maintenance are the usual causes for this type of defect.

An aluminium window service agent will be required to repair the affected windows.

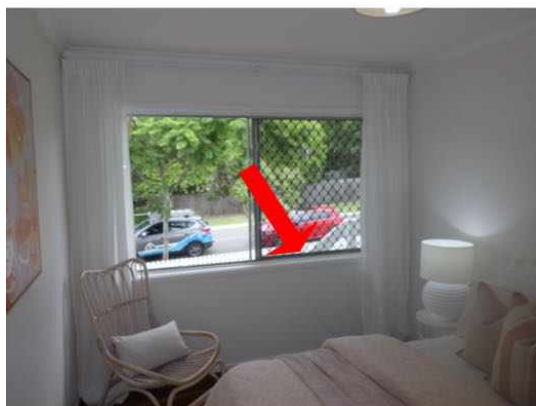
Finding 3.09

Building:	Main Building
Location:	Bedroom 3 > Centre,Rear
Finding:	Window - Stiff to Slide
Information:	The aluminium sliding window in bedroom 3 was stiff to operate at the time of the inspection. Windows provide ventilation to the adjoining area and should be at a fully

operational level to ensure user comfort. Restricted function of the window may also pose as a potential safety hazard if required for emergency egress from the building.

Generally, factors such as general age of the building element and a lack of maintenance are the usual causes for this type of defect.

An aluminium window service agent will be required to repair the affected windows.

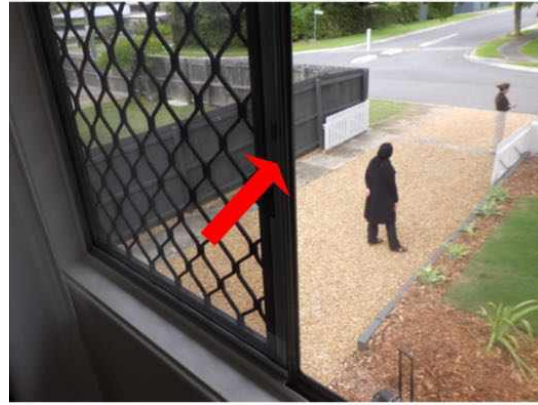
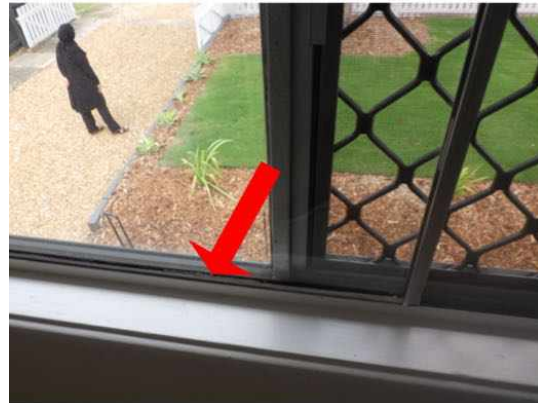
Finding 3.10

Building:	Main Building
Location:	Bedroom 1 > Centre,Rear
Finding:	Window - Stiff to Slide
Information:	The right side aluminium sliding window in the main bedroom area was stiff to operate at the time of the inspection. Additionally it was noted the left side sash was fixed in a closed position. Windows provide ventilation to the adjoining area and should be at a fully operational level to ensure user comfort. Restricted function of the window may also pose as a potential safety hazard if required for emergency egress from the building.

Generally, factors such as general age of the building element and a lack of maintenance or alterations are the usual causes for this type of defect.

An aluminium window service agent will be required to repair the affected windows.

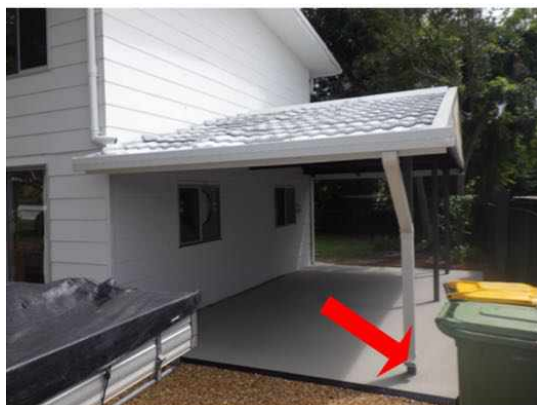
Finding 6.02

Building:	Main Building
Location:	Carport > Front Right
Finding:	Stormwater downpipes
Information:	The down pipe to the carport roof area at the front of the property is not connected to the stormwater drainage on the site. This disconnection negatively impacts the functional capacity of the downpipes and the surrounding ground area.

Where roof plumbing doesn't drain as required, the area at the base perimeter can become excessively damp, potentially creating an environment that is susceptible to flooding and rust or corrosion of surrounding building elements, as well as attracting termites and other pests.

It is recommended that a licensed plumber be appointed to further inspect and to

extend the down pipes to the properties stormwater line as necessary.

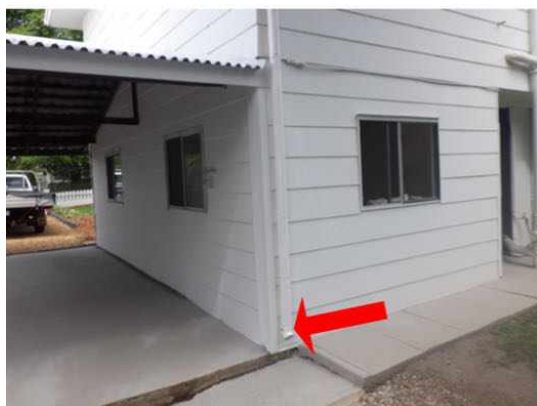
Where roof plumbing doesn't drain as required, the area at the base perimeter can become excessively damp, potentially creating an environment that is susceptible to flooding and rust or corrosion of surrounding building elements, as well as attracting termites and other pests.

It is recommended that a licensed plumber be appointed to further inspect and to extend the down pipes to the properties stormwater line as necessary.

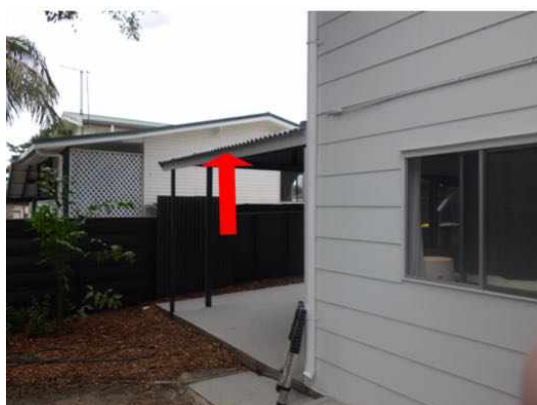
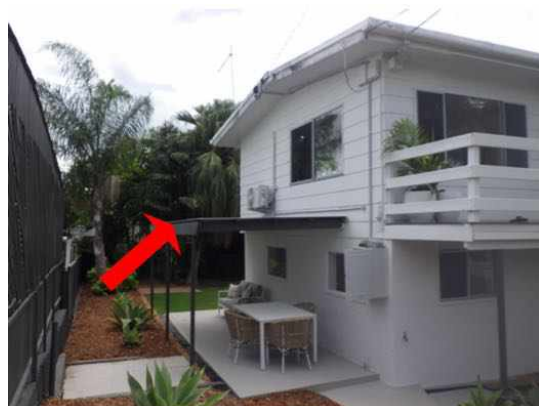
Finding 6.05

Building:	Main Building
Location:	Roof Exterior > Existing
Finding:	Roof Guttering Missing
Information:	At the time of inspection there was no roof guttering installed to Carport and patio area roofs.

Although some building elements may seem irrelevant or unnecessary, all building elements play a key role in the operation and function of the overall structure and its performance. Roof areas missing gutters are likely to lead to high levels of moisture in the ground areas directly below. Such moisture will not only cause rust and decay of the associated building materials, but can also provide conditions that are conducive to termite and timber pest activity.

Installation of roof guttering and stormwater downpipes should be conducted as soon as possible to ensure that no damage or functional issues occur to associated building materials.

A qualified roof plumber should be appointed to replace the missing guttering.

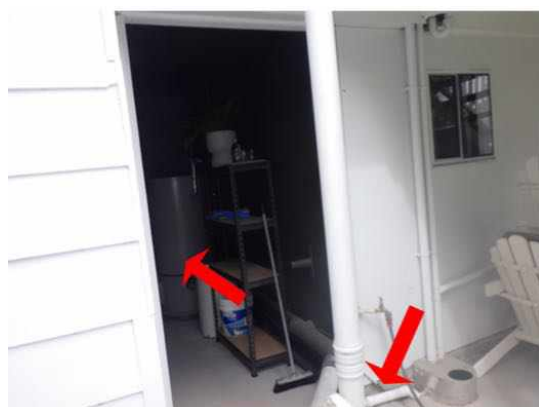
Finding 6.06

Building: Main Building
 Location: Exterior walls - rear > Ground Level
 Finding: Overflow - Not plumbed for drainage
 Information: The hot water system overflow is not plumbed or connected to suitable drainage, which can result in the surrounding area becoming excessively damp. These damp conditions can lead to secondary defects such as rot, rust or corrosion of associated building elements, the formation of fungal decay, or even the creation of potential slip hazards. When coupled with poor site drainage, pooling of water may also attract termite activity to this area. It is highly recommended that a qualified plumber be appointed to install adequate drainage to the overflow. These works will ensure that the area remains dry and free of any secondary defects.

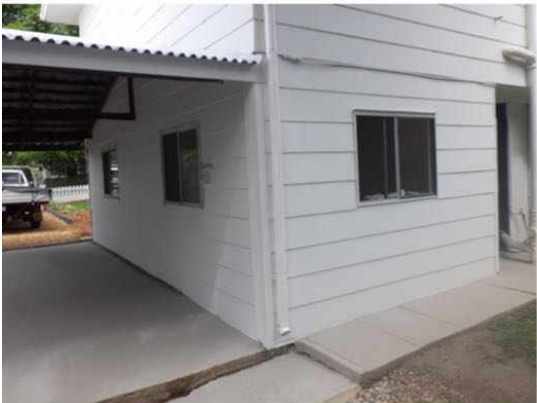
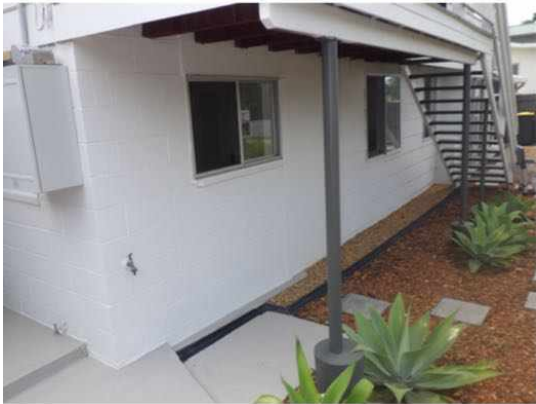
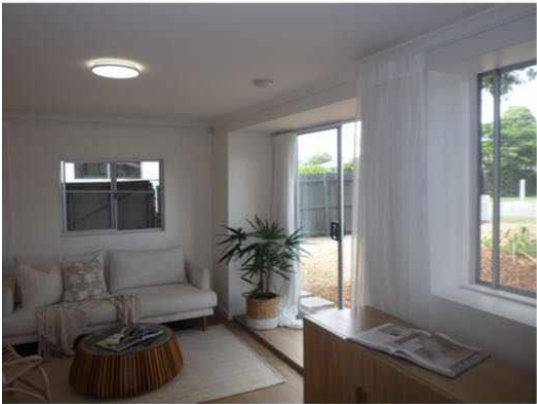
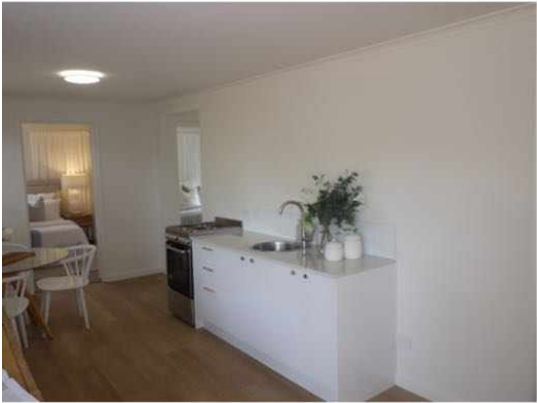
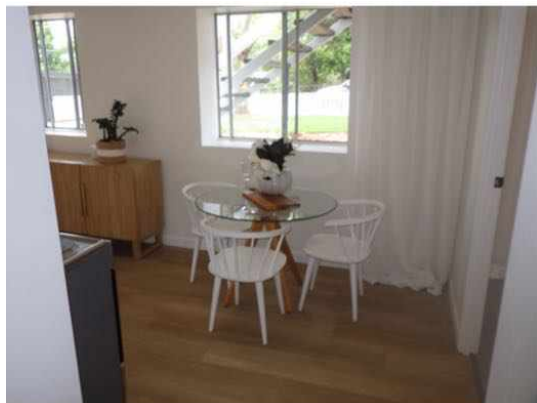
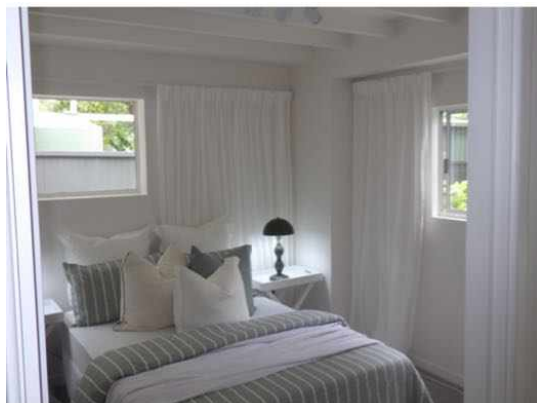
Building: Main Building
Location: Internal Areas > Ground Level
Finding: Suspected Non Compliance
Information: Renovation or alteration works to the dwelling may not comply with contemporary building practices and current Australian Standards. While the structure does not currently appear to be unsafe, compliance with such standards ensures the structural integrity of the dwelling.

If building standards have not been followed, these areas provide a heightened risk of the development of building defects. The structural integrity of the area may be compromised, which creates potential for the development or presence of major safety issues.

It is highly recommended that a search of the Local Council and QBCC records be made to determine what approvals have been granted for any renovation/alteration works to the property.

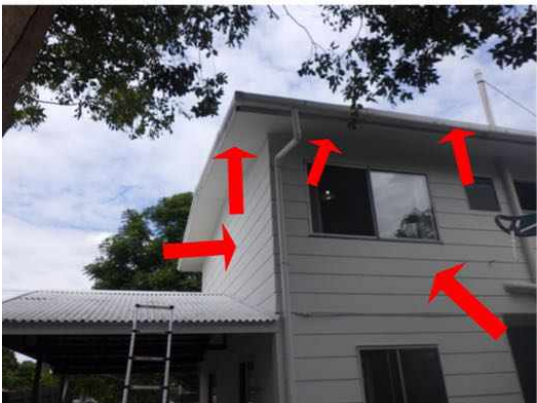
Building:	Main Building
Location:	External Areas > Existing
Finding:	Asbestos - Suspected ACM Identified on Site
Information:	At the time of inspection it was suspected the upper level exterior wall cladding, roof coverings, gutters and eaves linings may be of asbestos containing materials (ACM).

Reporting on Asbestos is outside the Scope of this Report. This suspected defect is highlighted as a caution only. We suspect, based on our experience in the building industry, that there is a higher risk of the identified building elements containing asbestos.

As Asbestos Reporting is outside the scope of this report, we advise that you consider a separate Asbestos Inspection and Condition Audit, which can include the taking of samples for definitive confirmation of the presence of Asbestos.

In the interim, the client is advised to act with caution, especially when considering any damage to building materials general wear and tear renovations extensions demolition and general maintenance activities due to the suspected presence of Asbestos.
