# Building and Timber Pest Inspection Report

Inspection Date: Wed, 25 Feb 2026

Property Address: 5 Cusack Pl, Blackett NSW 2770, Australia

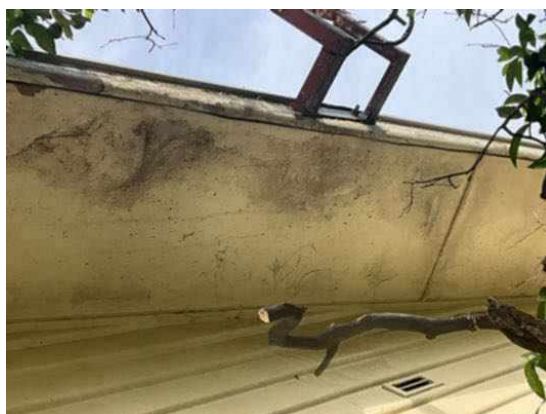
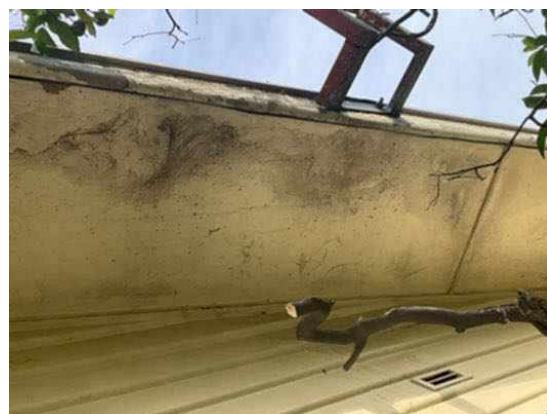
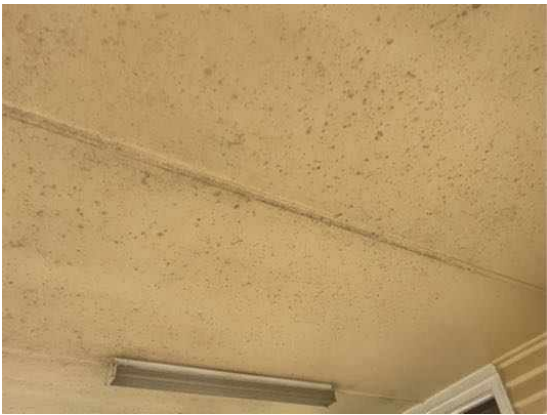
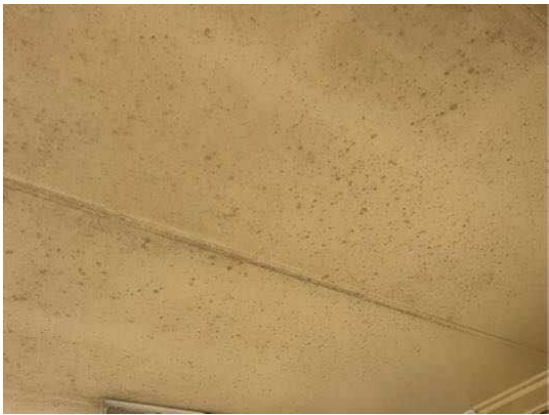
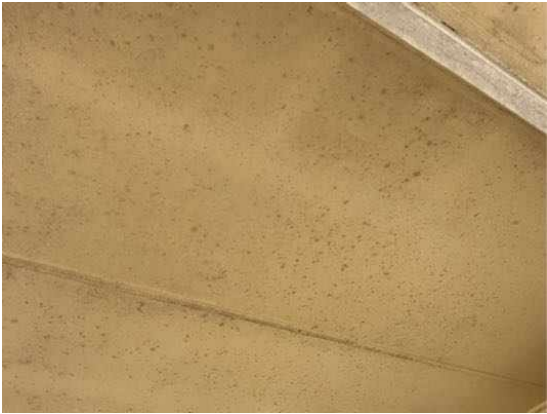
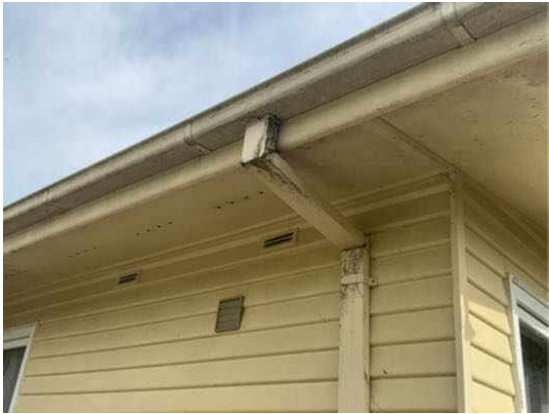
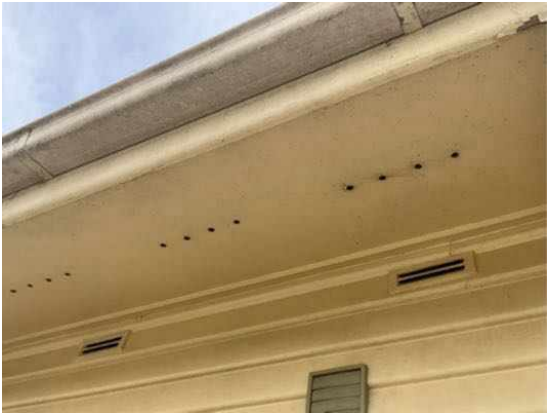
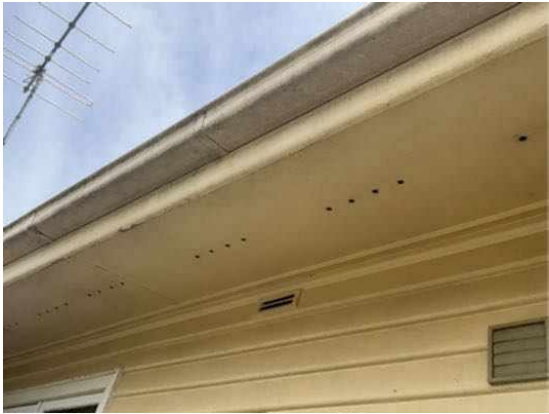
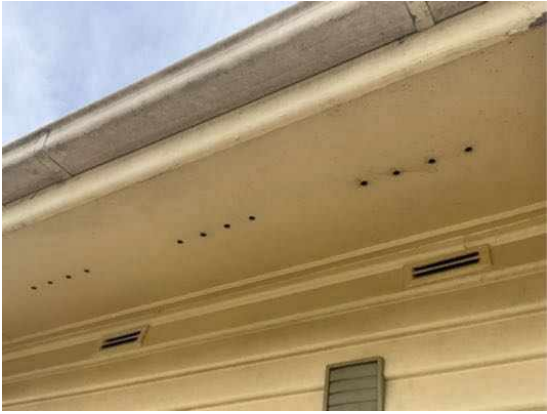
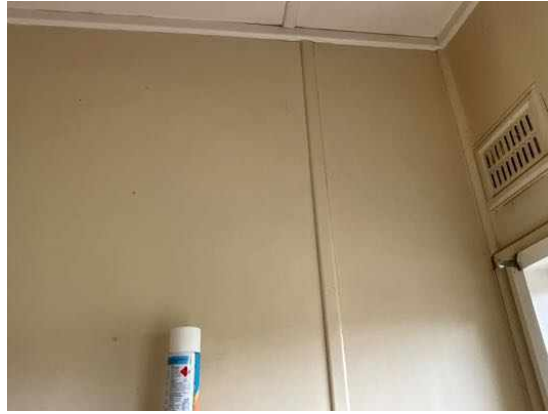
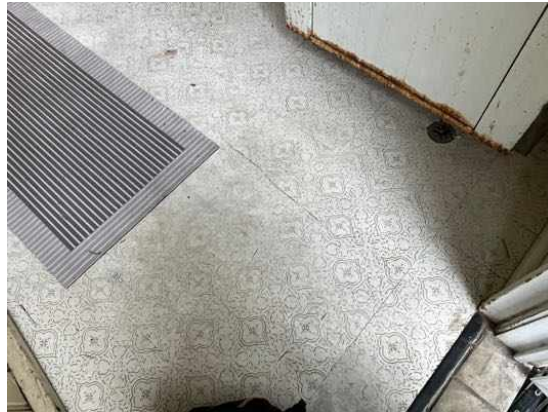
Building:	Main Building
Location:	All Areas
Finding:	Asbestos - Suspected ACM Identified on Site
Information:	Reporting on Asbestos is outside the Scope of this Report. This suspected defect is highlighted as a caution only. We suspect, based on our experience in the building industry, that there is a higher risk of the identified building element containing asbestos.

As Asbestos Reporting is outside the scope of this report, we advise that you consider a separate Asbestos Inspection and Condition Audit, which can include the taking of samples for definitive confirmation of the presence of Asbestos.

In the interim, the client is advised to act with caution, especially when considering any damage to building materials general wear and tear renovations extensions demolition and general maintenance activities due to the suspected presence of Asbestos.

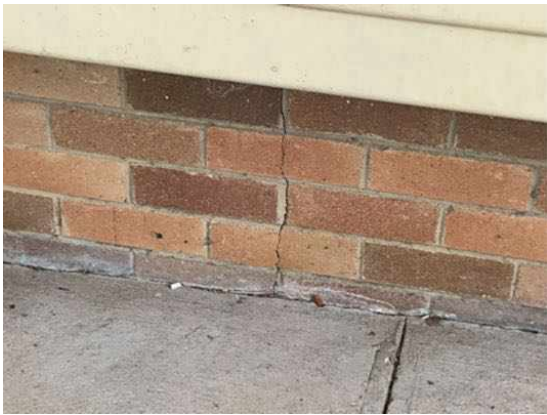
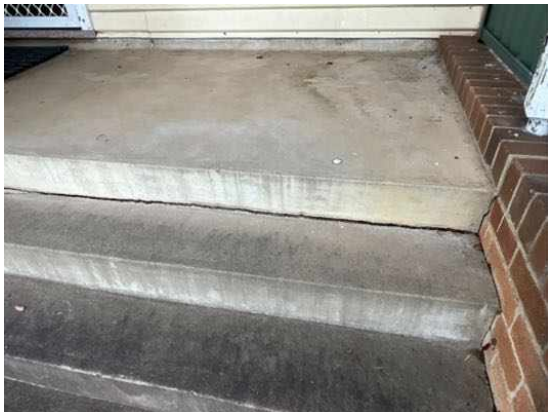
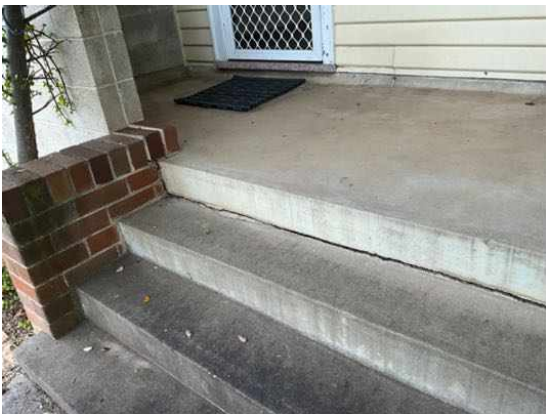
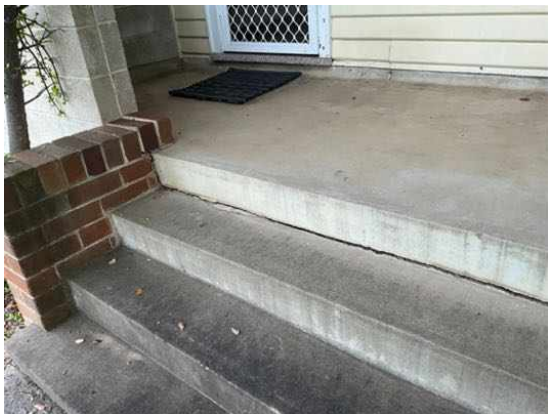
### Finding 2.01

Building:	Main Building
Location:	All Areas
Finding:	Brickwork - Cracking [Repair required]
Information:	Major cracking was identified to the brickwork in this area. Cracks of this type are likely to have been caused by minor expected movement of building elements, but may also have a structural cause that is more significant.

A crack of this size may be repaired by extensive filling. Additionally, further remedial works to associated building elements, such as eave sheeting or external door frames, is likely to be required.

A qualified bricklayer should be contacted immediately to estimate and perform repair and restoration works. Consultation with a structural engineer may be required where structural instability is found to be the underlying cause of the cracking.

Always contact a building inspector should cracks widen, lengthen, or become more numerous.

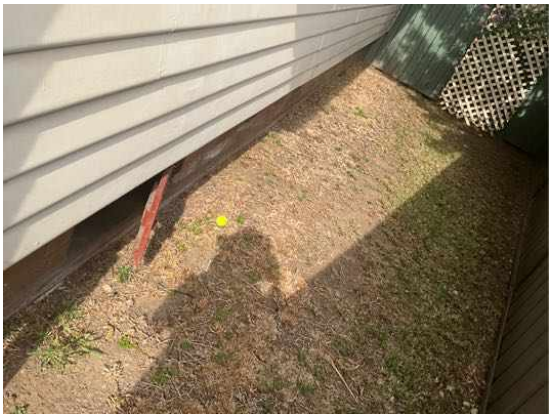
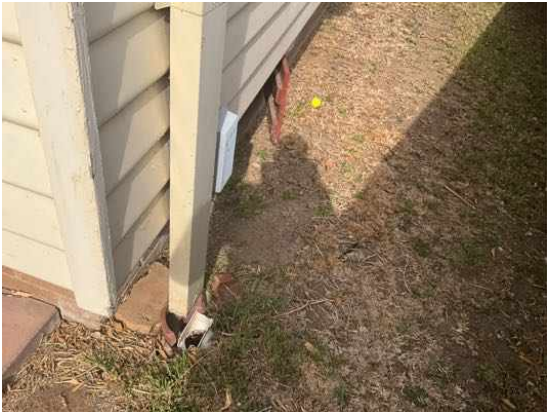
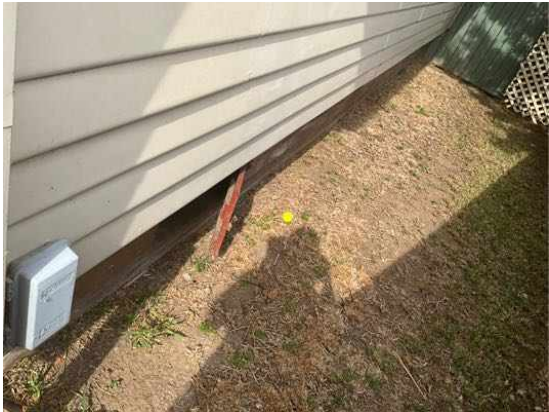
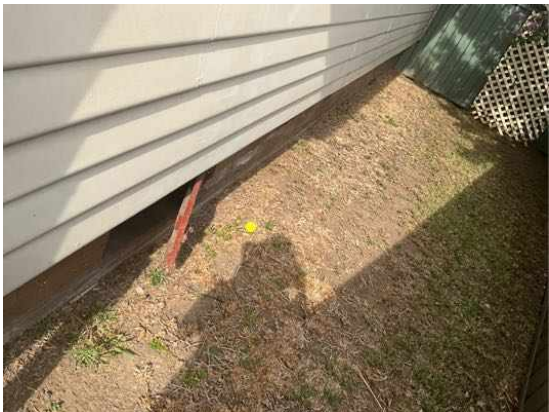
Building:	Main Building
Location:	All Areas
Finding:	Perimeter - Insufficient Fall
Information:	The perimeter ground levels were found to have an inadequate slope away from the adjoining building structure, creating potential for water pooling in this area.

Perimeter is required to fall from the building by a minimum of 25mm in the first metre and bare ground should fall away from the house by 50mm in the first meter. This standard ensures that excessive moisture does not pool around the base of building structures, which creates potential for water and structural damage, as well as making the area susceptible to termite and timber pest activity.

Where ground levels do not have adequate fall, a licensed paving contractor should be appointed to install or remove and re-level pavement.

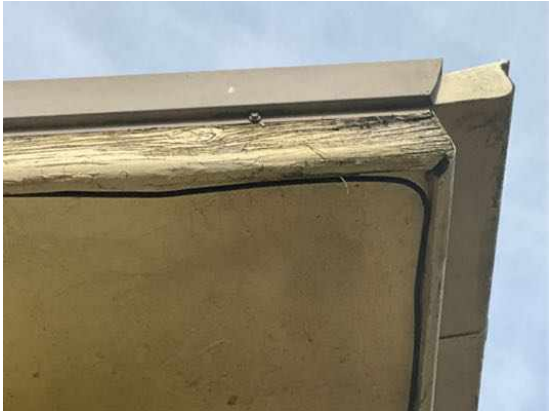
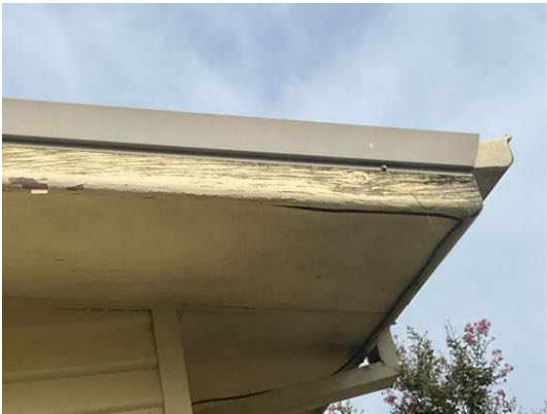
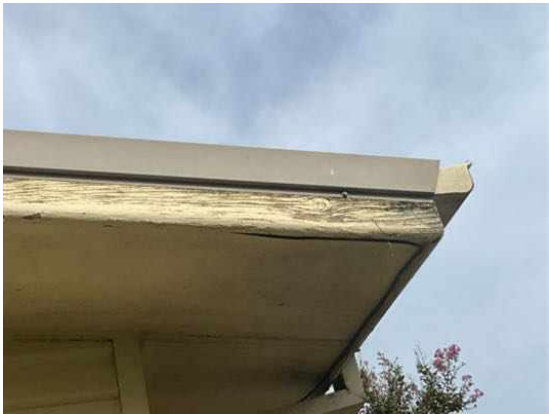
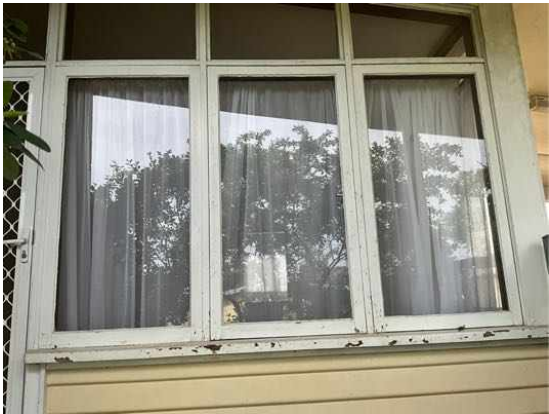
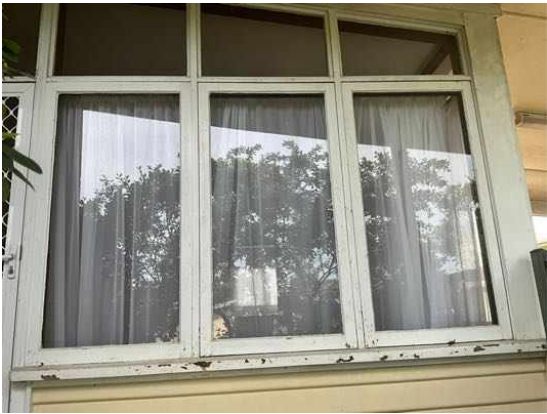
**Finding 3.02**

Building: Main Building  
Location: All Areas  
Finding: Timber - exposed to weather  
Information: External timbers that are frequently exposed to harsh weather conditions require adequate protection in order to maintain their condition. Where timbers have not been painted or treated adequately, general deterioration is likely to occur at an accelerated rate.

If left unattended, replacement of these timbers is likely to be necessary in the short-term future. Adequate treatment of these timbers is required as soon as possible by a painting contractor or general handyman.

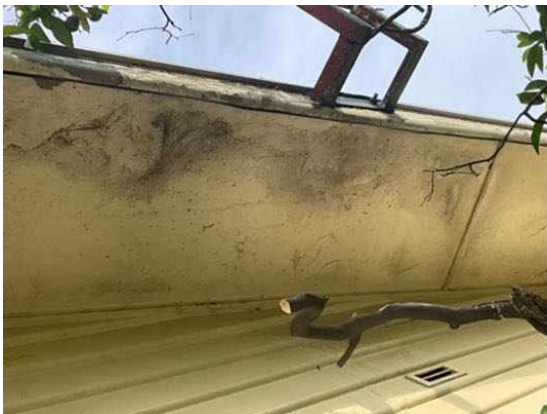
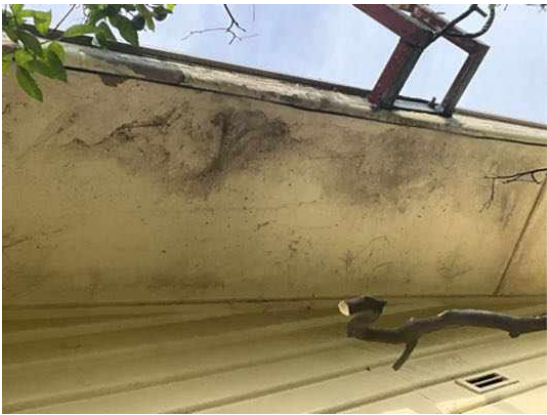
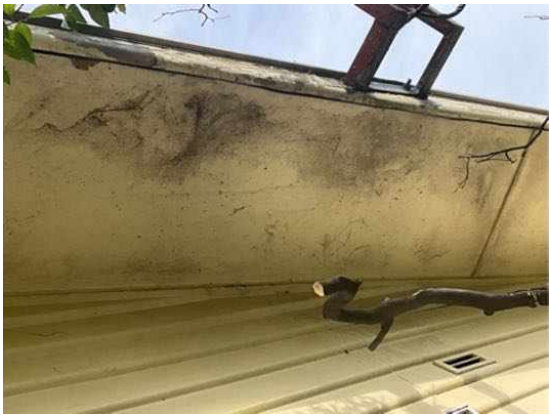
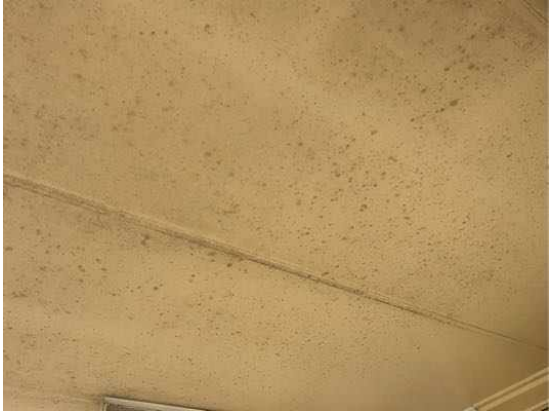
**Finding 3.03**

Building: Main Building  
Location: All Areas  
Finding: Eaves - water Stained  
Information: Water stains are present on eaves, indicating a potential water leak or seepage issue.

Prolonged water exposure can lead to structural damage, mold growth, and compromise the aesthetic appeal of the affected area. Additionally, it may indicate underlying issues that, if unaddressed, can escalate and result in more extensive damage.

A qualified plumber or water damage restoration specialist should investigate and address the source of the water stains. Repairing leaks, improving waterproofing, and, if necessary, restoring the affected surfaces are crucial to preventing further damage and maintaining the integrity of the space.

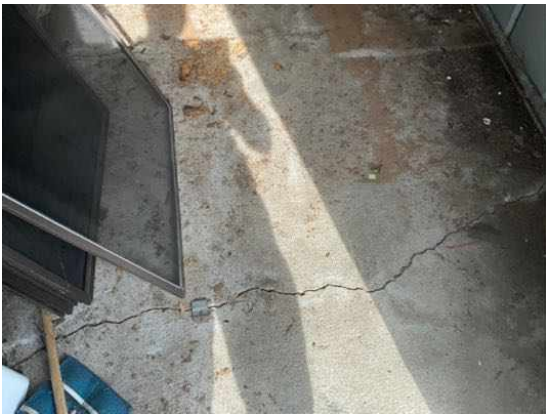
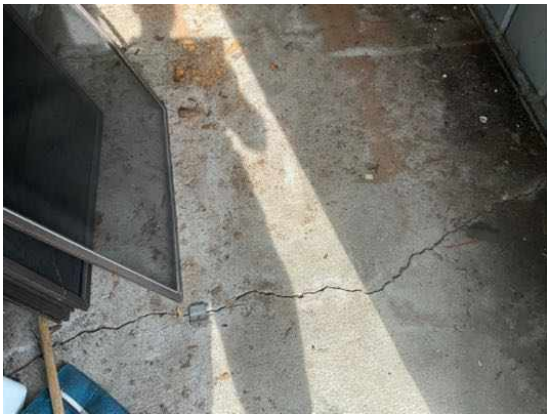
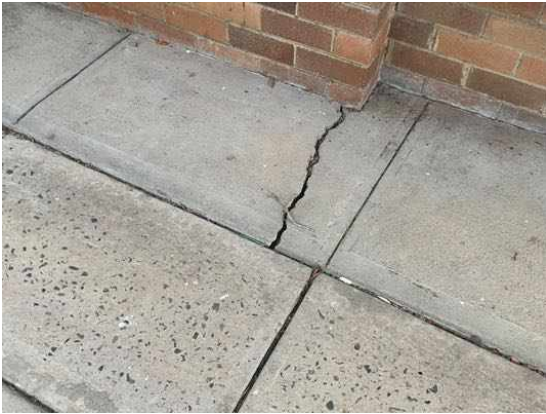
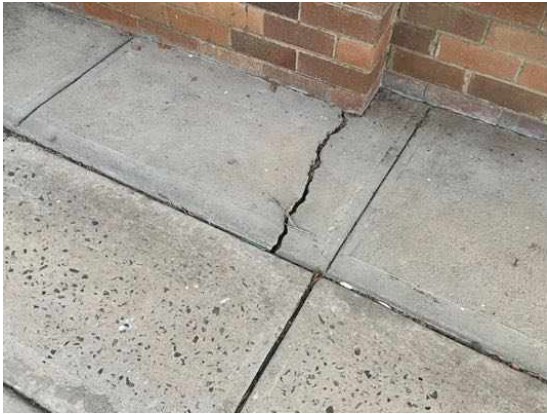
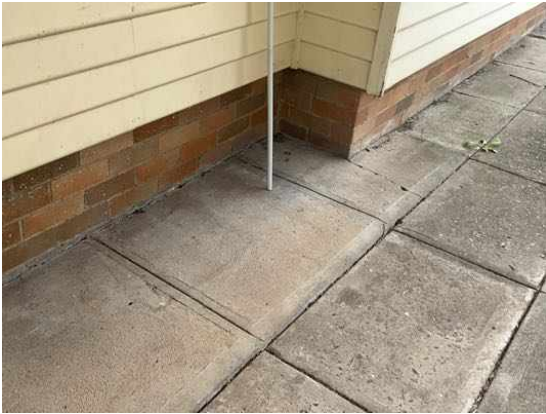
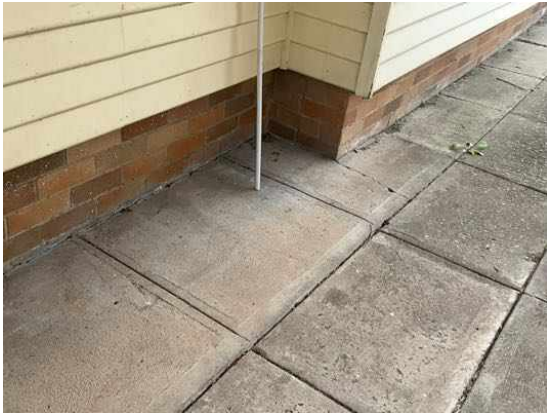
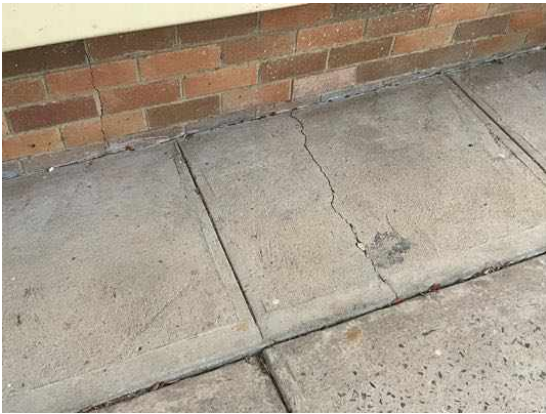
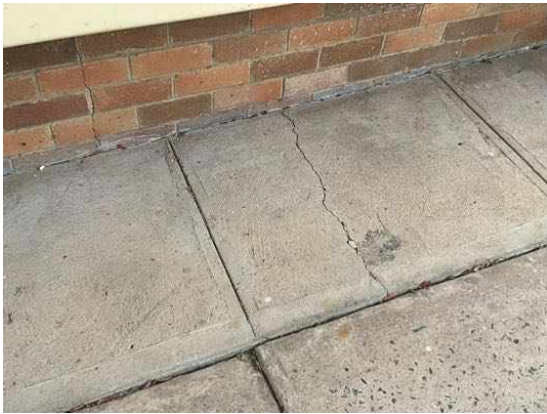
Building:	Main Building
Location:	All Areas
Finding:	Noticeable Cracking in Concrete Slab
Information:	Noticeable cracking has been observed in the concrete slab, failing to meet the required construction and quality standards.

- Cracks are visible on the surface and may extend through the depth of the slab.
- Evidence of improper curing or inadequate reinforcement leading to cracking.

- Compromised structural integrity of the slab, potentially leading to failure under load.
- Water ingress through cracks, causing corrosion of reinforcement and further weakening the structure.
- Potential trip hazards and aesthetic issues, reducing the overall value and safety of the property.
- Increased maintenance and repair costs due to ongoing deterioration.

- A structural engineer should be engaged to assess the extent of the cracking and recommend appropriate repair methods.
- A licensed contractor or concrete repair specialist should carry out the recommended repairs under the guidance of the structural engineer.

A detailed inspection should be conducted post-repair to confirm compliance with the required standards and to ensure that the structural integrity of the concrete slab has been restored.

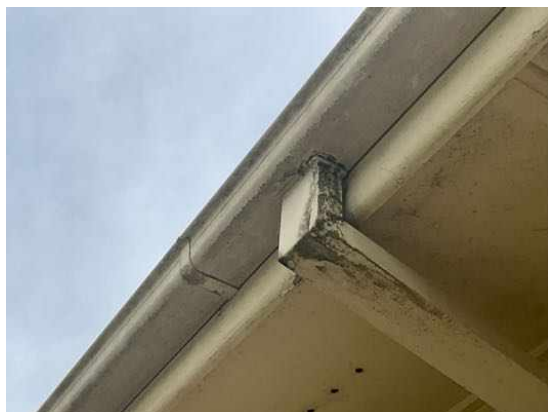
Building:	Main Building
Location:	All Areas
Finding:	Downpipe leakage
Information:	The downpipes in the drainage system exhibit leaking water.

The leaking downpipes pose a risk of water damage to the building's foundation, exterior walls, and surrounding landscape. Prolonged exposure to moisture can lead to structural deterioration, mold growth, and compromised drainage.

A qualified plumber or roofing specialist should inspect and replace the leaking downpipes. Repair or replacement may involve fixing the areas, applying protective coatings, or installing new downpipes to ensure proper drainage and prevent further water damage. Early intervention is crucial to avoid escalating issues.

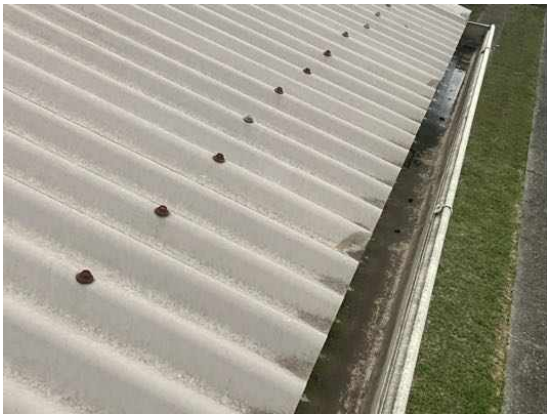
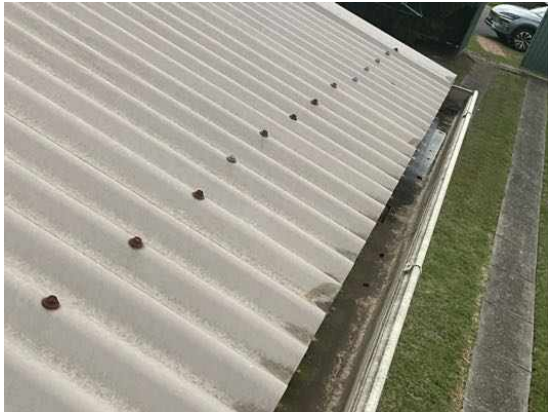
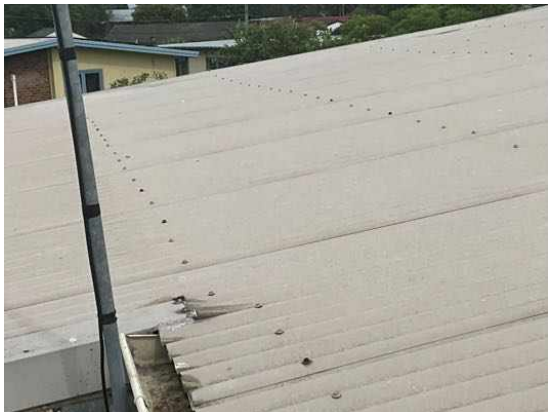
### Finding 3.08

Building:	Main Building
Location:	All Areas
Finding:	Roof Weathered - metal roof sheeting
Information:	The roof sheeting shows visible weathering, surface oxidation, and deterioration of fastener washers. Some sheet overlaps appear uneven and may not provide adequate weatherproofing at joints near the dormer. The sealant and flashing junctions also show signs of age and deterioration.

Prolonged weather exposure and rusting can lead to corrosion, potential roof leaks, and reduced lifespan of the sheeting. Deteriorated fasteners may allow water ingress, particularly around joints and penetrations.

Engage a licensed roofing contractor to inspect and maintain the affected areas. Replace rusted screws and washers, resecure loose or uneven sheets, and apply protective roof coating or repainting as required. Check flashings and sealants to ensure watertightness.

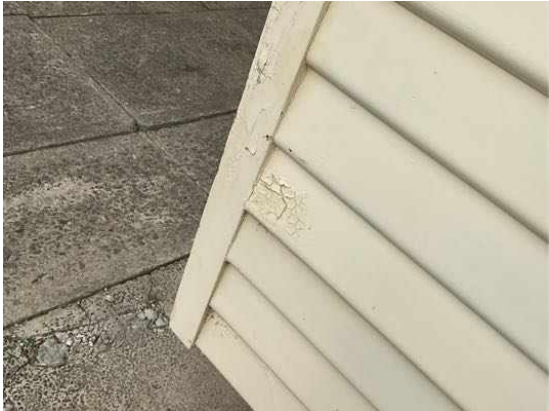
**Finding 3.09**

Building: Main Building  
Location: All Areas  
Finding: Flaky Paint  
Information: Sections of the paint in this area was found to have deteriorated. Paint deteriorating is generally an indication of excessive moisture in the area that is currently hidden by the painted surface.

The presence of excessive moisture can have major implications on associated building elements if left unattended. While only seemingly minor at this stage, the damage cannot be determined due to the paint, obstructing any further inspection of the damage.

It is highly advised that the affected paint to be cleaned to allow a further, more invasive inspection by a licensed builder/painter. Failure to act on this defect may necessitate major works in the future.

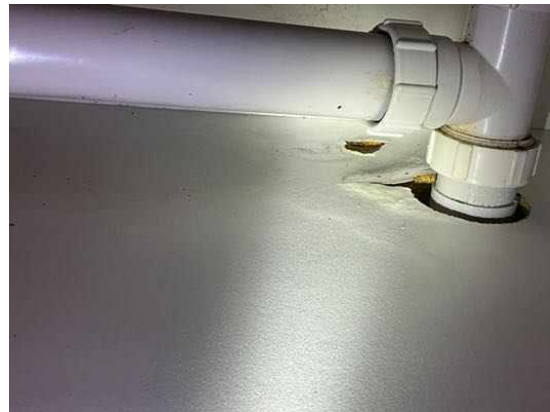
Building:	Main Building
Location:	Kitchen
Finding:	Water damage / Vanity
Information:	"The vanity in the shower area has sustained water damage, resulting in swelling and discoloration of the wood, as well as potential structural issues. This damage compromises both the aesthetic and functional aspects of the vanity."

1. **\*\*Carpenter or Woodworker:\*\*** They can assess and repair the damage to the

2. **Plumber:** If the water damage is due to plumbing issues, a plumber can fix leaks and ensure there are no further water-related problems.

3. **General Contractor:** If the damage is extensive and affects the surrounding area, a general contractor can coordinate the repair work, including both the vanity and any related structural or cosmetic repairs.

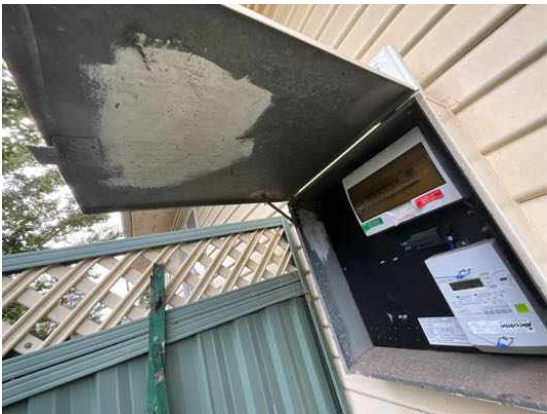
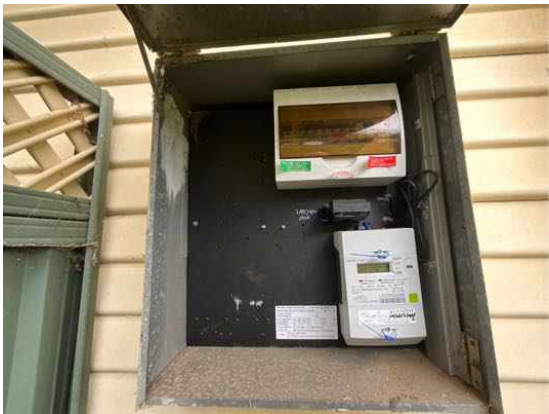
Building: Main Building  
 Location: Exterior walls - right side  
 Finding: No Evidence of Termite Management System - Durable notice / Legible Sticker  
 Information: The application of a pre & post-construction chemical termite barrier is highly recommended for all properties. Such barriers are highly effective in preventing termite attack on any timber building elements throughout the property.

A durable notice was not placed in the switchboard unit to indicate current termite barriers is legible at the time of inspection.

Client must seek further information from the vendor or real estate agent if the conditions of termite management systems were maintained.

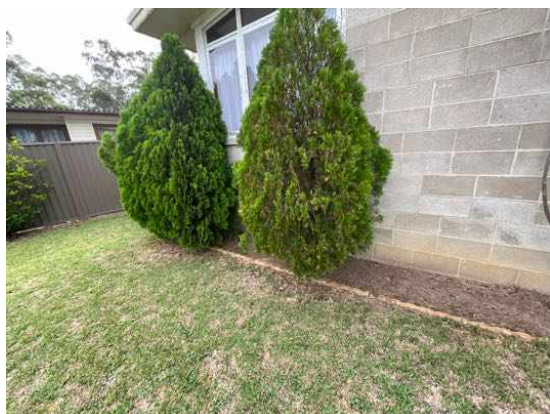
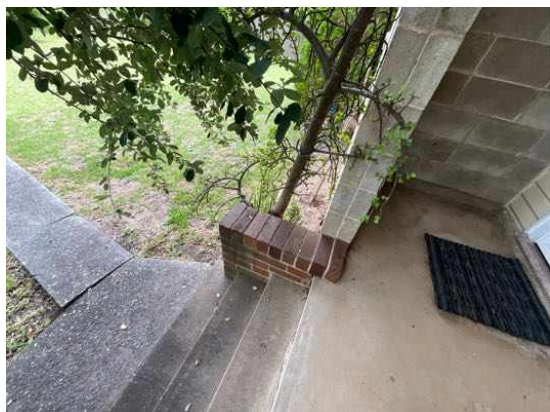
Building:	Main Building
Location:	All Areas
Finding:	Dense vegetation around a property can increase the risk of termite infestation
Information:	The presence of dense vegetation around a property can increase the risk of termite infestation, as it provides a conducive environment for them. To address this, consider maintaining a clear space between the vegetation and your home. If you suspect a termite issue, it's advisable to consult with a licensed pest control professional for inspection and treatment.

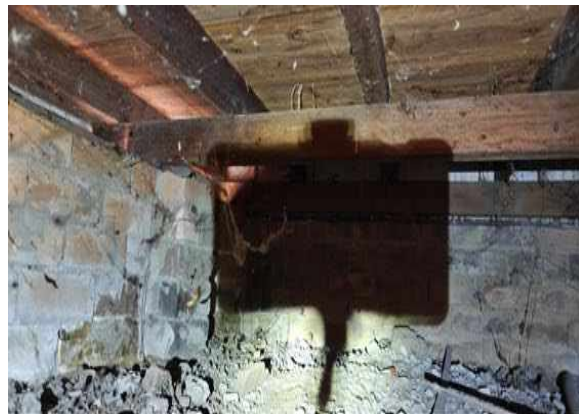
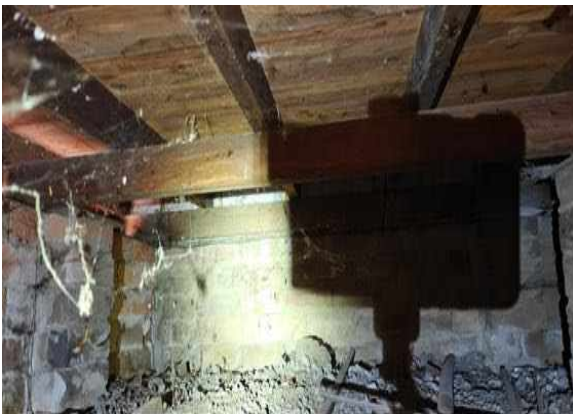
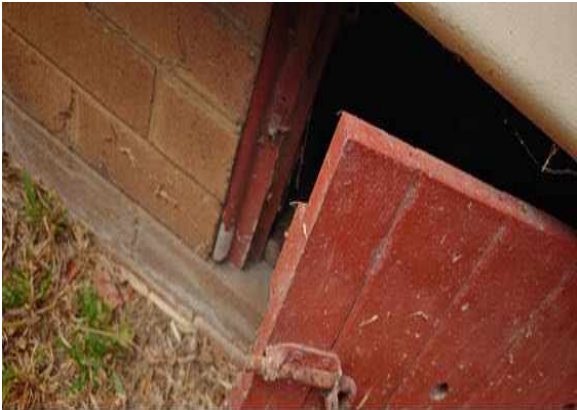
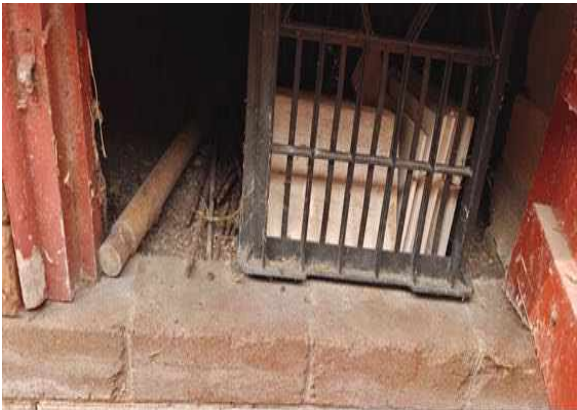
Building: Main Building  
 Location: Bathroom  
 Finding: Subfloor - poor ventilation, inadequate site drainage, water stains  
 Information: The subfloor lacks adequate ventilation, suffers from inadequate site drainage, exhibits water stains, creating conducive conditions for timber pests such as termites.

Risk: The combination of poor ventilation, inadequate drainage, water stains significantly increases the risk of timber pest infestations. Termites are attracted to moist environments and can thrive in subfloors with high humidity levels and water

damage. The lack of proper ventilation and drainage exacerbates moisture retention, providing an ideal habitat for timber pests to establish colonies and cause extensive damage to the subfloor structure. Additionally, water stains indicate previous or ongoing moisture issues, which further attract timber pests and contribute to the deterioration of timber materials.

A licensed pest control professional specializing in timber pest management should be consulted to assess the extent of the infestation and develop a comprehensive treatment plan. They can implement strategies to eliminate existing timber pests, such as termites and prevent future infestations by addressing underlying moisture issues. Additionally, a qualified plumber or builder may be needed to improve subfloor ventilation, enhance site drainage, repair water-damaged areas. Regular inspections and maintenance are essential to ensure ongoing protection against timber pests and maintain the structural integrity of the subfloor.

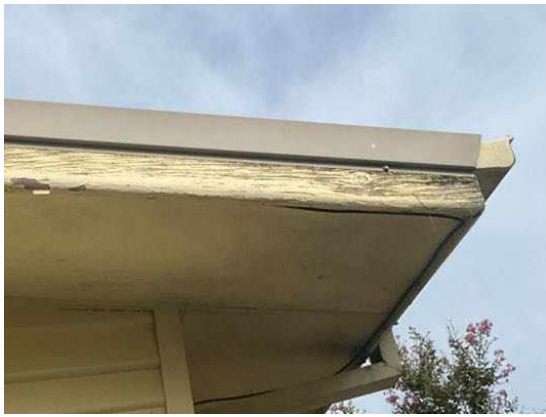
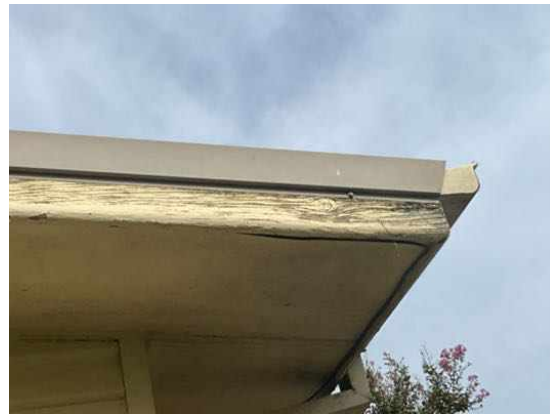
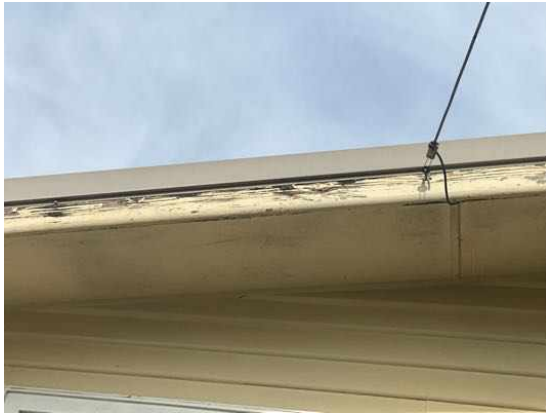
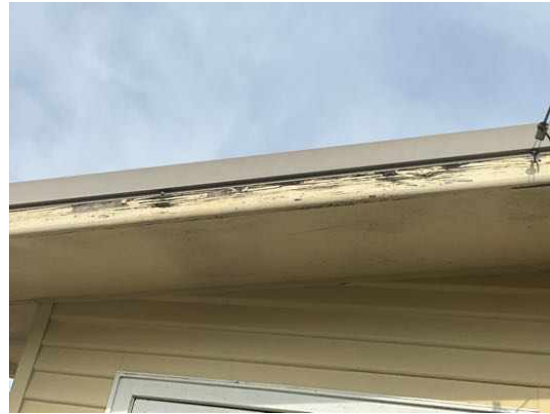
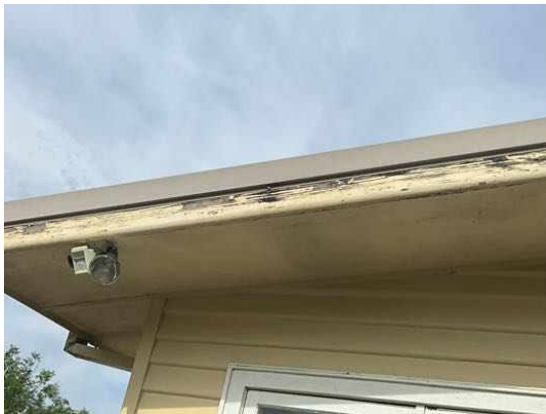
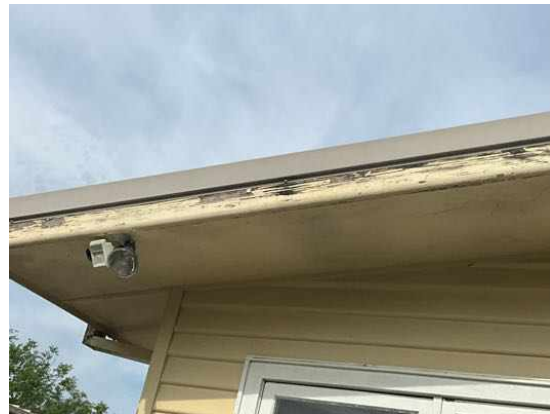
### Finding 7.01

Building:	Main Building
Location:	All Areas
Finding:	Wood rot
Information:	This building element shows evidence of wood rot. Wood rot, also known as Fungal Decay, occurs when timbers and other cellulose building materials are exposed to damp conditions on an ongoing basis. This could be the result of exposure to weathering over a prolonged period of time, or the attraction of excessive moisture from other abutting building materials. Contributing factors also include poor air ventilation in the area.

Wood rot is often associated with general damp problems and is evidenced by a 'musty' smell or mould and mildew occurring on surfaces. If left unmanaged, damp conditions can lead to further health problems and the decay of timbers will continue.

A qualified plumber may be appointed to assess the cause of excessive moisture and to provide advice on any remedial works as required. A qualified carpenter or registered builder may also be required to replace affected building materials.

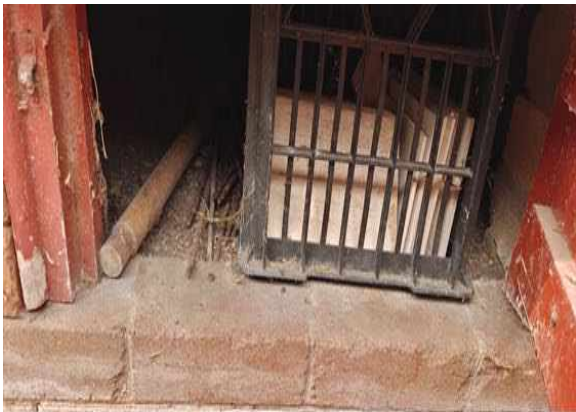
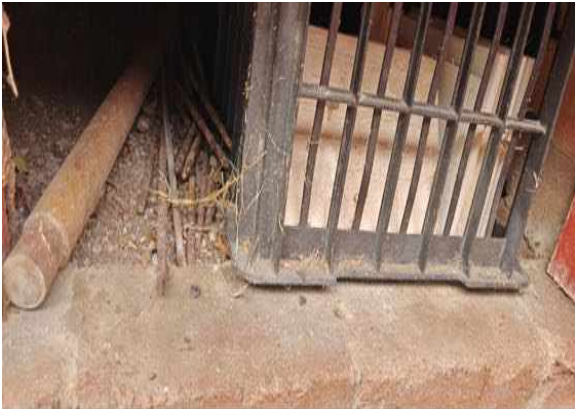
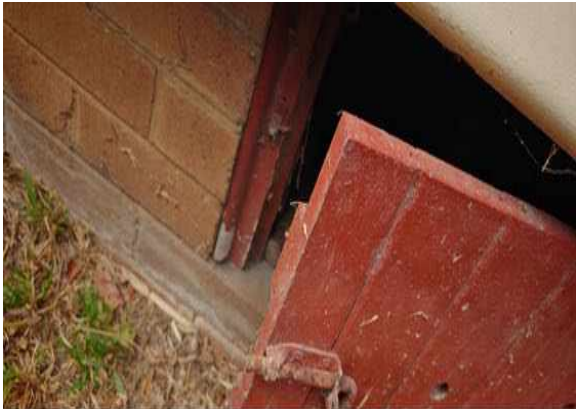
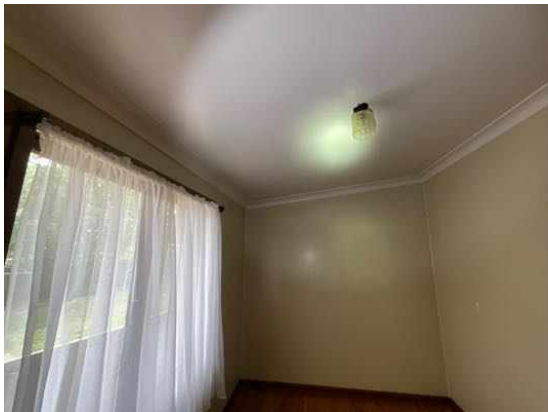
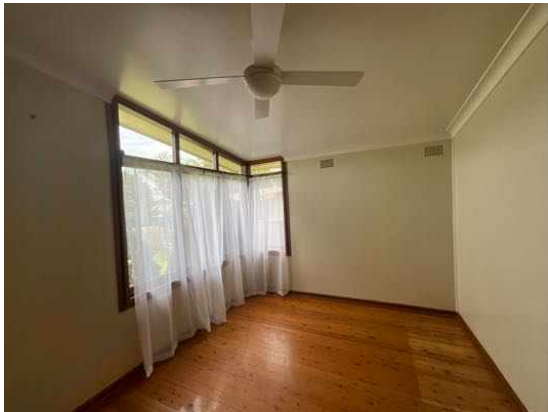
Building: Main Building  
 Location: All Areas  
 Finding: Additional Photos - Obstructions and Limitations  
 Information: These photographs are an indication of the obstructions and limitations which impeded full inspection of the property at the time of inspection. These obstructions can hide an array of defects and should be removed to allow full inspection to be carried out. A re-inspection is recommended once the areas are made accessible.
