Building and Timber Pest Inspection Report

Inspection Date: Tue, 20 Jan 2026

Property Address: 2/74 Lower King St, Caboolture QLD 4510, Australia

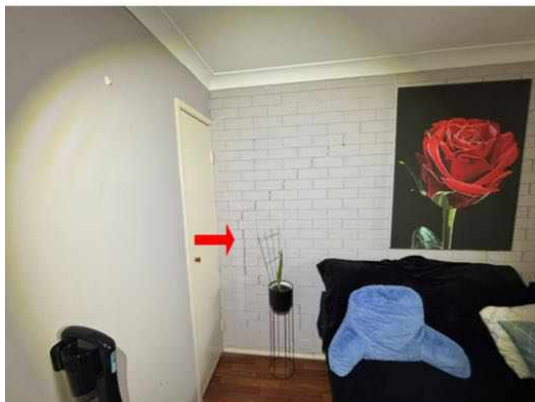
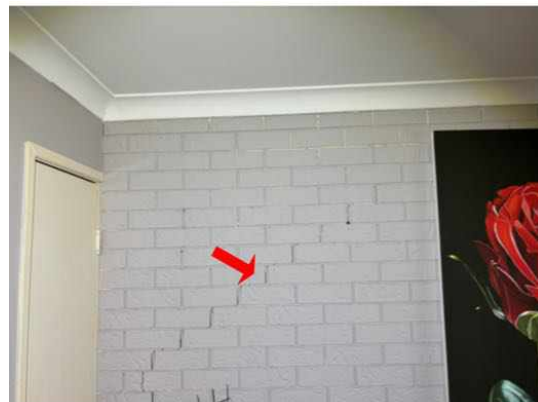
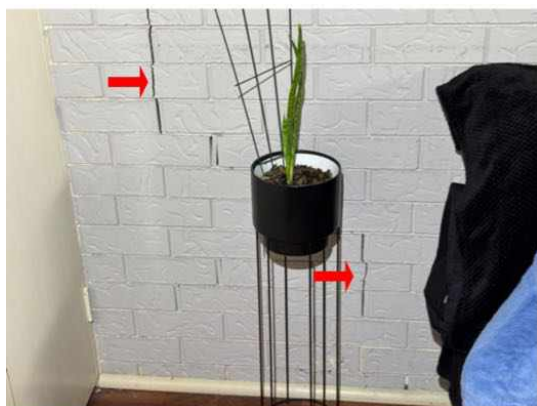
Finding 3.01

Building: Main Building
 Location: Lounge
 Finding: Brickwork - Step cracking - internal
 Information: At the time of the inspection, it was noted that there was minor step cracking to the brickwork in the lounge. This step cracking appears to be historic. The client should monitor this area for any change to the step cracking.

Step cracking, which is similar to other forms of cracking, has a variety of possible causes. However, the most common is the subsidence of adjacent footings.

Step cracking is a relatively common defect, and is most likely to occur adjacent to windows, doors and other openings. Mortar failure in the gaps between affected bricks indicates the stresses and tensions affecting the wall.

The step cracking to the brickwork in the lounge appears to be historic. The client should inform the body corporate of the step cracking to the exterior of the dwelling, and that there are rusted fasteners on the metal roof.

Where step cracking is extensive or severe, the client is advised to consult a structural engineer. Minor step cracking can be used as a warning sign to address factors causing stress to the wall, which can include the effect of surrounding trees, water leaks, soil erosion, or even the presence of reactive soils in the surrounding area.

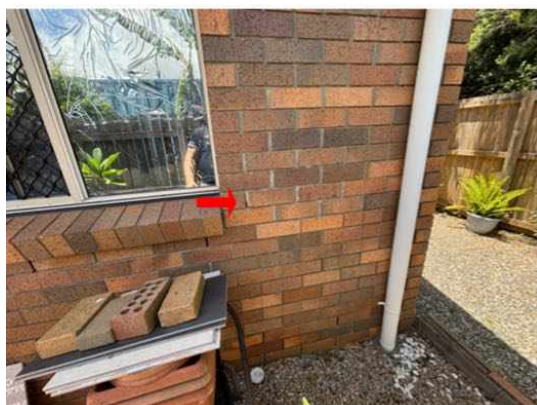
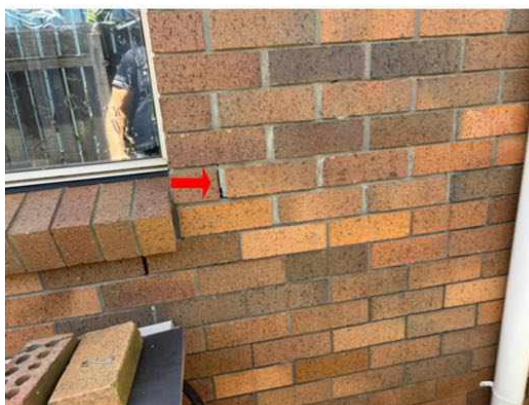
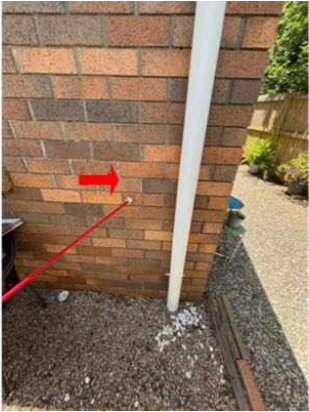
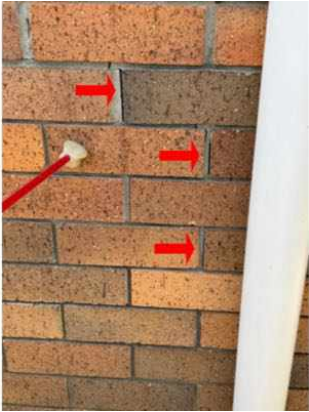
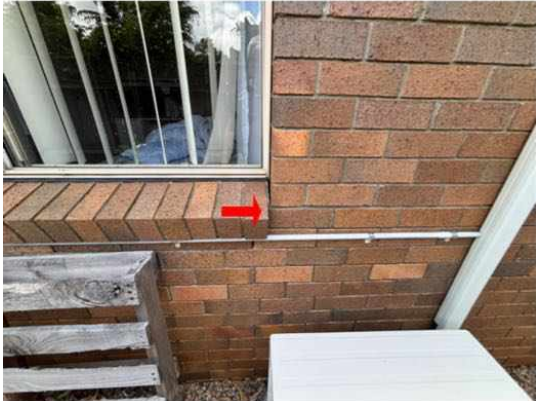
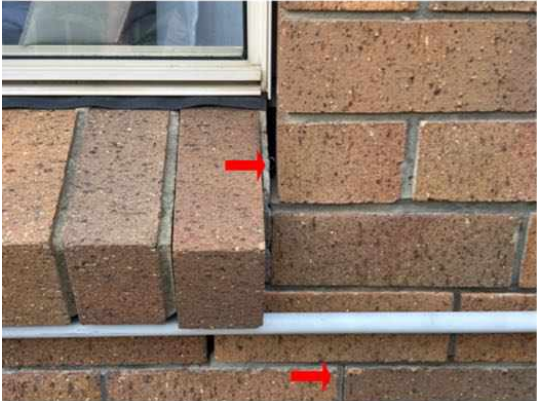
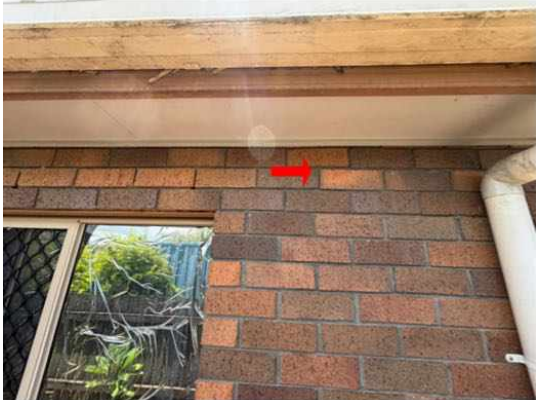
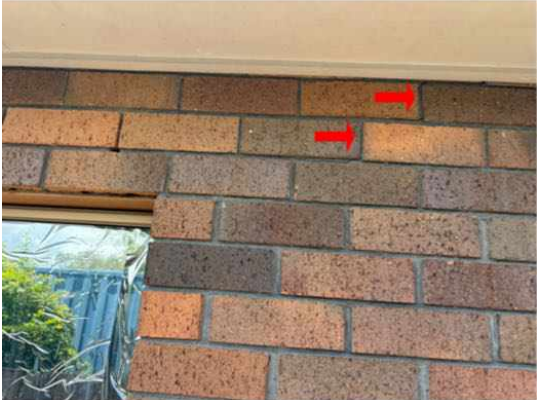
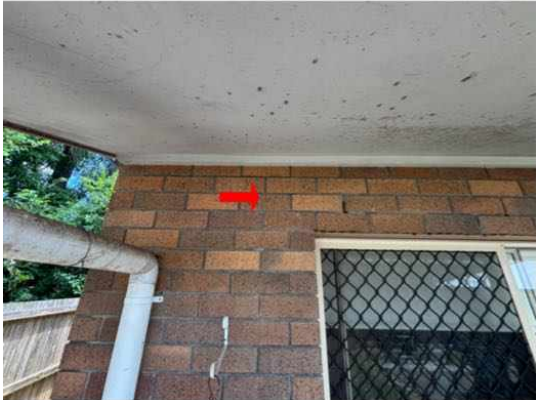
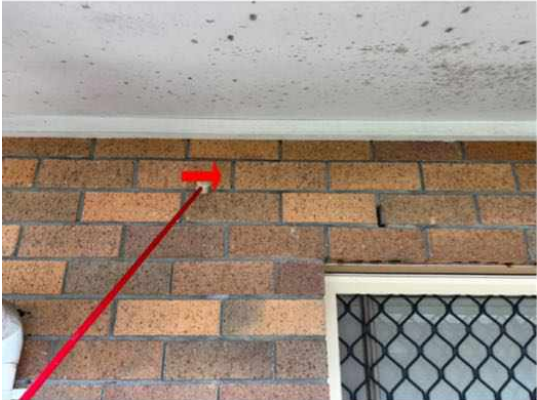
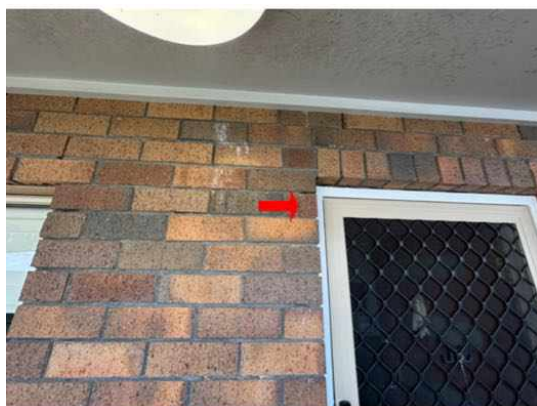
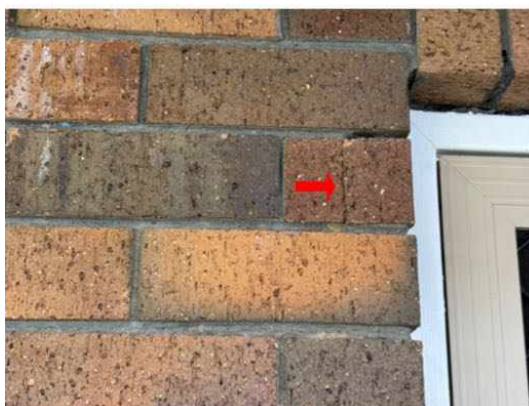
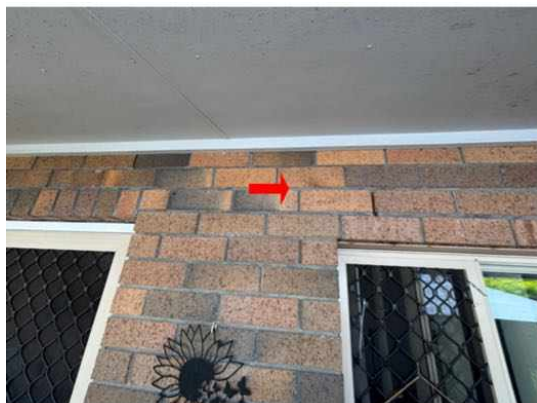
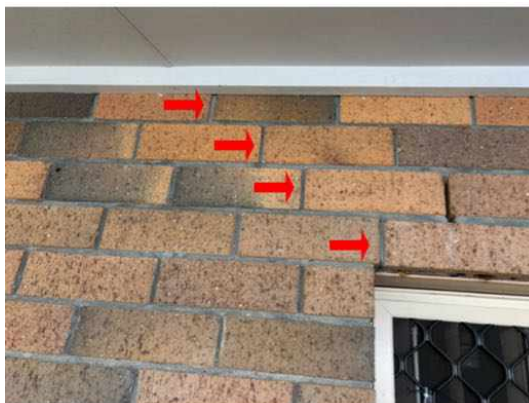
Finding 3.02

Building:	Main Building
Location:	All External Areas
Finding:	Brickwork - Step cracking - external
Information:	At the time of the inspection, it was noted that there was minor step cracking to the brickwork on the exterior of the dwelling. The client should monitor this area for any change to the step cracking. The client may wish to inform the body corporate of the evidence of step cracking so that this is on record in the event of any change in appearance of the step cracking.

Step cracking, which is similar to other forms of cracking, has a variety of possible causes. However, the most common is the subsidence of adjacent footings.

Step cracking is a relatively common defect, and is most likely to occur adjacent to windows, doors and other openings. Mortar failure in the gaps between affected bricks indicates the stresses and tensions affecting the wall.

Where step cracking is extensive or severe, the client is advised to consult a structural engineer. Minor step cracking can be used as a warning sign to address factors causing stress to the wall, which can include the effect of surrounding trees, water leaks, soil erosion, or even the presence of reactive soils in the surrounding area.

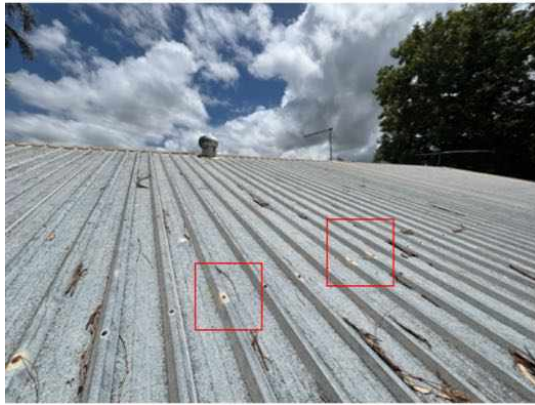
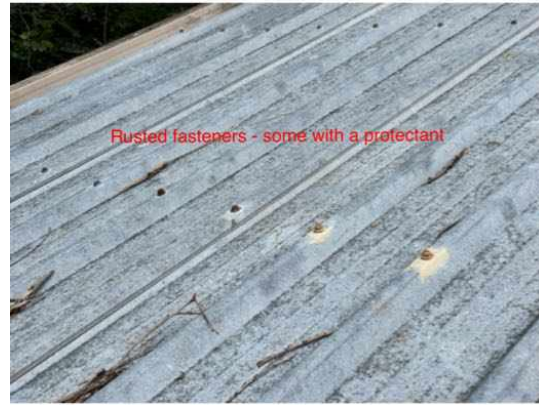
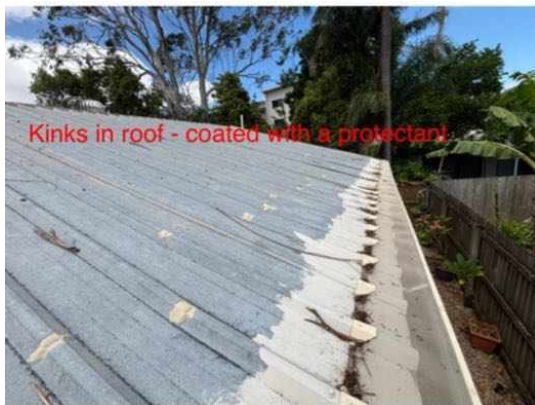
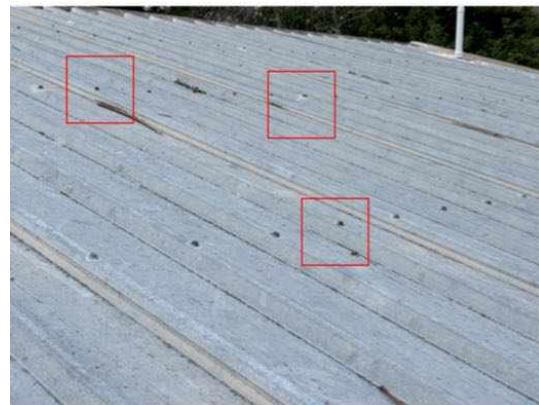
Finding 3.03

Building:	Main Building
Location:	Roof Exterior
Finding:	Metal roof covering - Weathered
Information:	Upon inspection of the exterior roofing, the majority of the metal roof sheets were considered to be in a fair condition. While weathering of the metal roof sheets is consistent with the age of the property, maintenance works are required.

Several of the roof fasteners have evidence of rust to them, some have been coated with a protectant which needs to be re-applied. On the back section of the roof, kinks have occurred to several ridges, consistent with someone walking on the roof. These have been coated with a protectant. The client may wish to notify the body corporate that some preventative maintenance should be carried out to the metal roof covering.

Where left unmanaged, the rust on the roof fasteners can transfer to the metal roof sheets causing deterioration of the metal roof sheets. This is likely to lead to a number of secondary defects, including minor water leaks and weather exposure to internal roofing structures.

Consultation with a roofing contractor is highly advised to gain advice on cost of remedial works that may be required in the short to medium term. Remedial works are likely to increase the longevity of the exterior roofing structure.

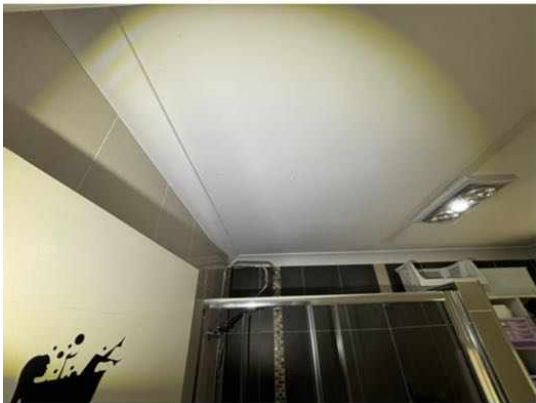
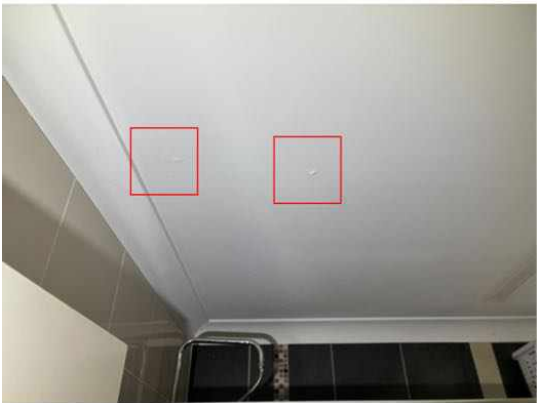
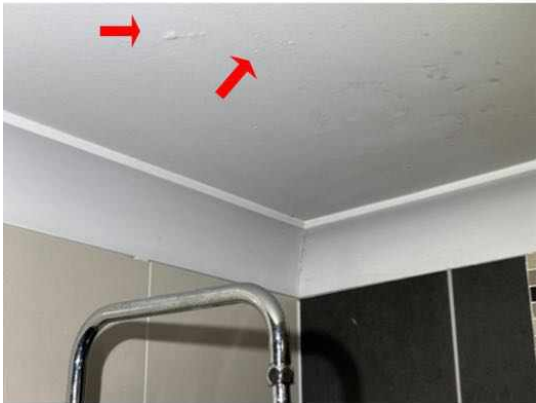
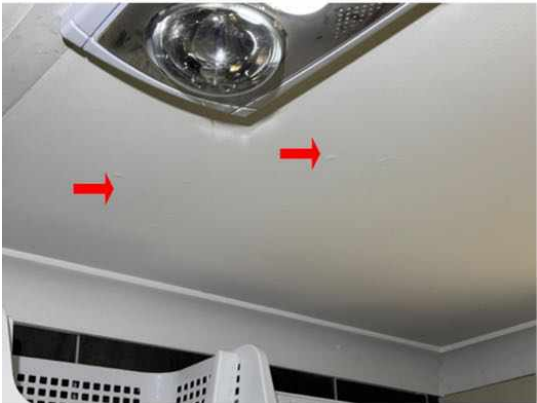
Finding 3.04

Building:	Main Building
Location:	Bathroom
Finding:	Bathroom - paint peeling
Information:	At the time of the inspection, it was noted that the paint to the ceiling in the bathroom was peeling. This is consistent with the location.

Peeling paint can be caused by moisture, poor preparation or age. There was no evidence of moisture found.

A painter or building maintenance professional could be engaged to rectify this issue. This can be done at the clients discretion.

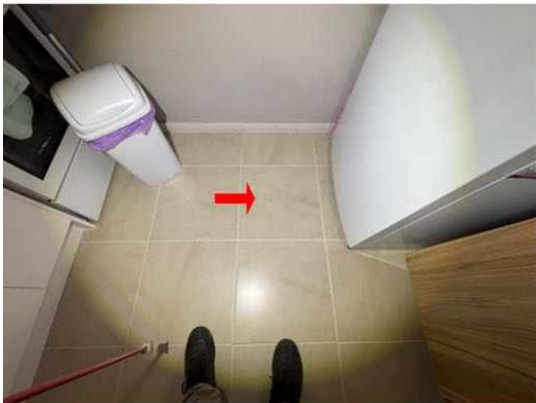
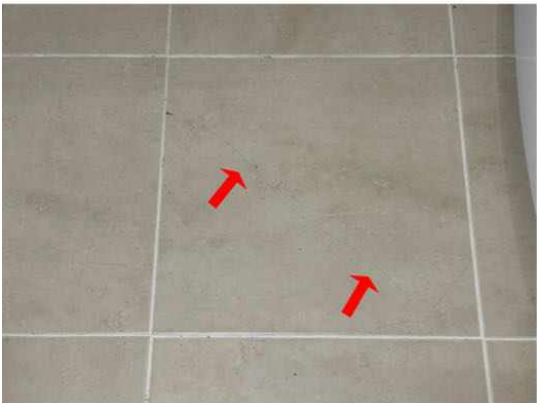
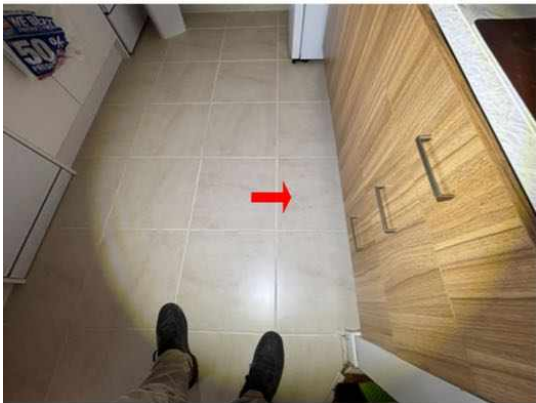
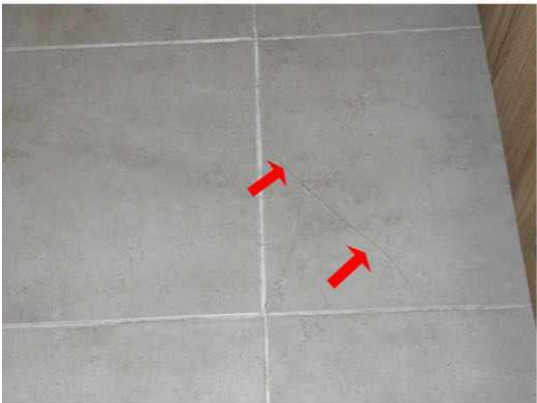
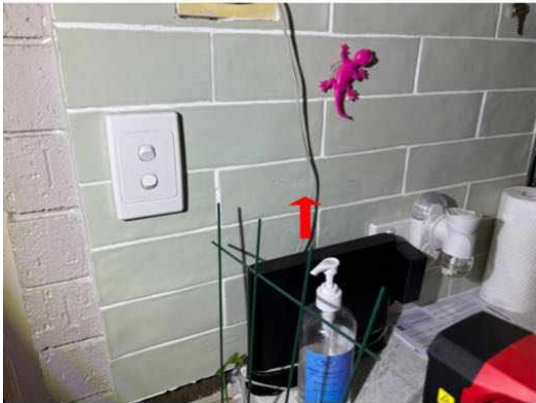
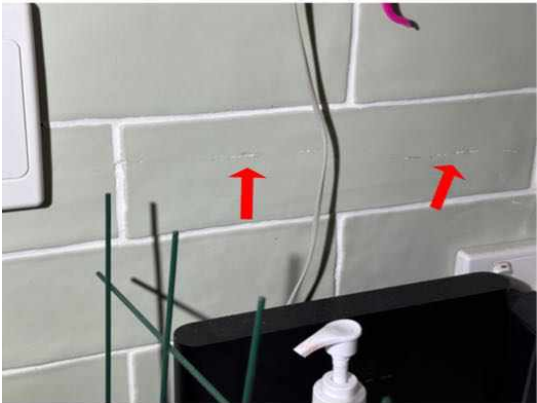
Finding 3.05

Building: Main Building
Location: Kitchen
Finding: Kitchen - cracked tiles
Information: At the time of the inspection it was noted that two tiles were cracked on the kitchen floor and on the kitchen splash back. This appears to be purely an aesthetic issues and could be attended to at the clients discretion.

A tiler or building maintenance professional would be able to carry out the necessary works.

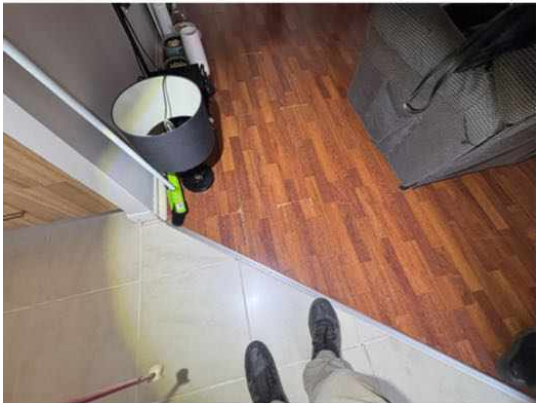
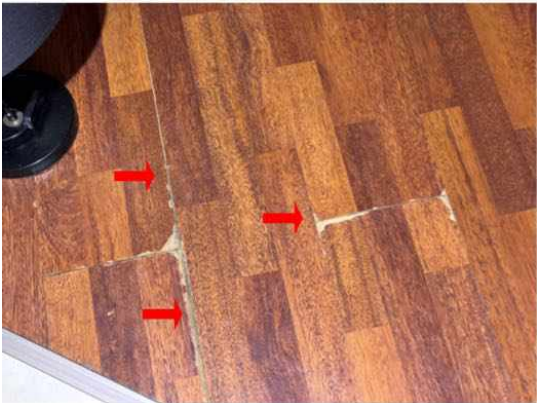
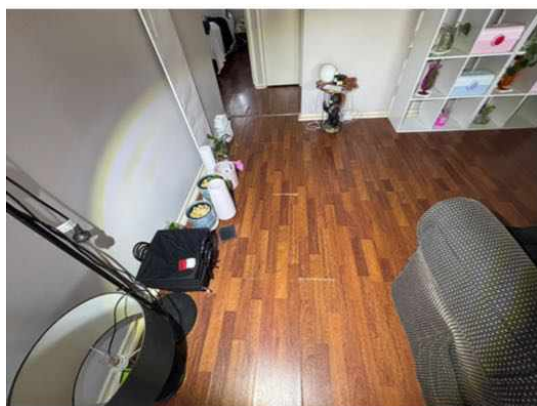
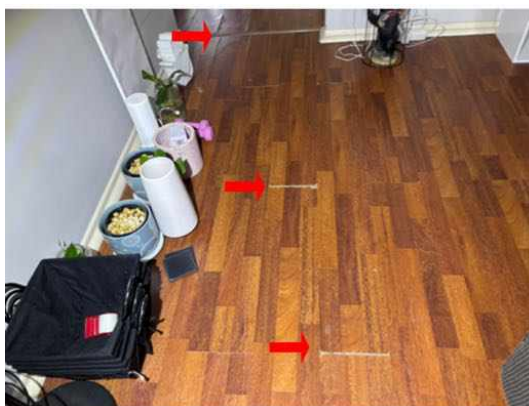
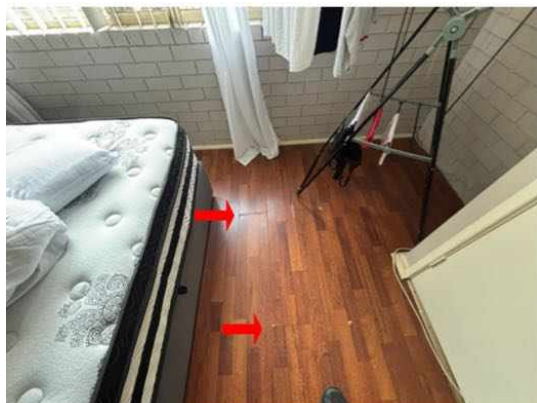
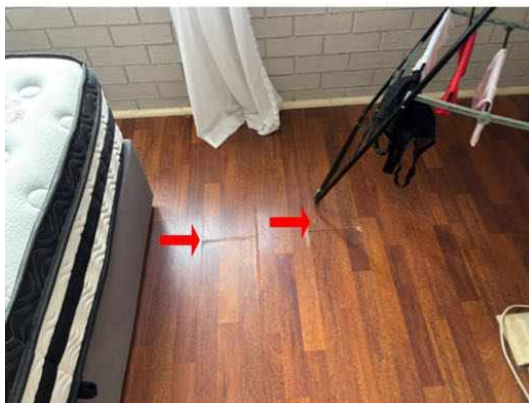
Finding 3.06

Building: Main Building
Location: All Internal Areas
Finding: Internal areas - damage to floating flooring
Information: At the time of the inspection, it was noted that there was damage to the timber floating flooring in the dwelling. This may be due to general wear and tear.

A flooring specialist could be engaged to replace to floating flooring. This can be done at the clients discretion.

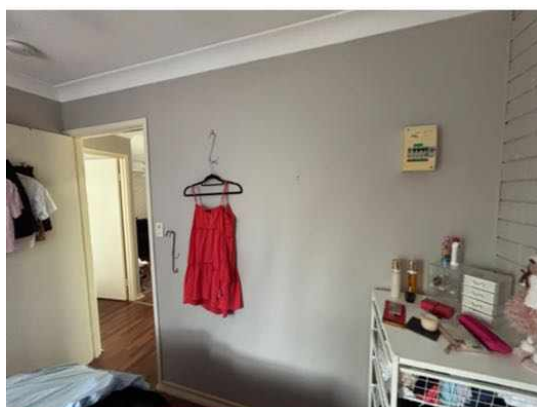
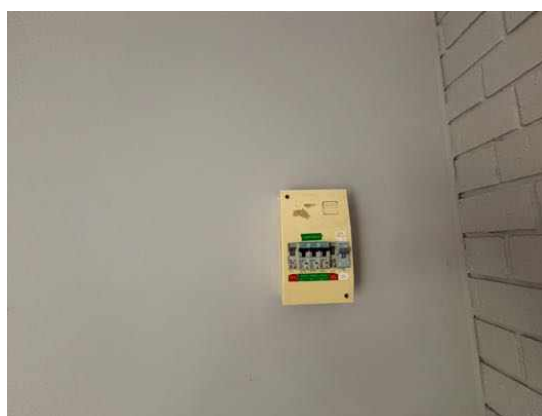
Finding 6.01

Building: Main Building
 Location: All External Areas
 Finding: Termite Management System - no evidence of a chemical installation
 Information: At the time of the inspection, no evidence of a chemical termite management system was found. There is no durable notice in the meter box. The client may wish to enquire of the body corporate as to the nature of the termite management plan and to confirm that annual termite inspections are being carried out and are up to date.

A durable notice should be placed in the switchboard unit to indicate current termite barriers. At the time of inspection, it appeared as though no termite management system has been installed, with no evidence to suggest preventative works taking place.

The application of a post-construction chemical termite barrier is highly recommended for all properties, particularly if live termite activity has been found on the site

The client may consider gaining further advice from a pest controller as to the costs and procedures involved with this application. It is recommended that obtaining such advice be a short-term priority.

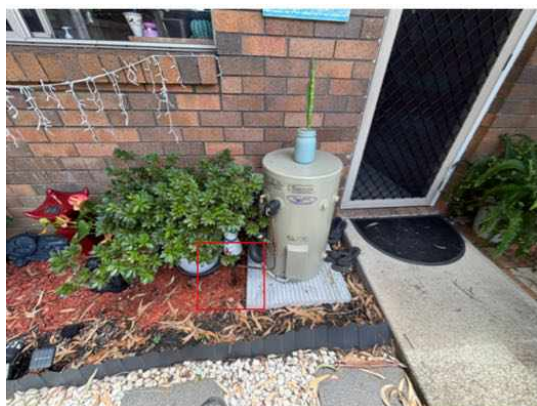
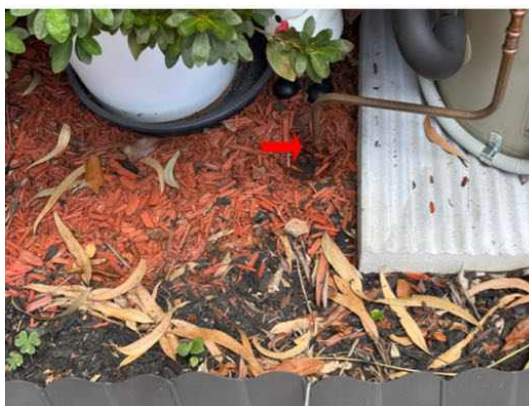
Finding 6.02

Building:	Main Building
Location:	Front elevation
Finding:	Hot water tank - not plumbed to stormwater
Information:	At the time of the inspection, it was noted that the overflow for the hot water tank was not plumbed to the storm water system.

Excessive moisture next to the foundations of the dwelling creates a conducive environment for termite activity. Moisture may also damage the associated building materials.

A licensed plumber should be engaged to plumbing the overflow into the storm water system. This should be done as a matter of urgency.

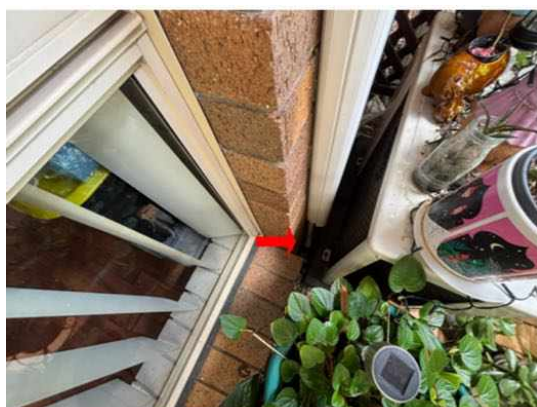
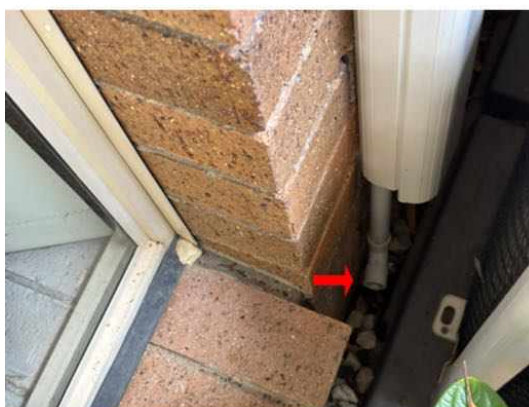
Finding 6.03

Building:	Main Building
Location:	Front elevation
Finding:	Air conditioner - Disconnected overflows
Information:	At the time of the inspection, it was noted that the air conditioner drain overflow to the unit at the front of the dwelling was not connected to the storm water drainage and as a result are draining next to the foundations of the dwelling.

Air conditioning overflows that are not connected to the storm water drainage and are draining near the foundation can create excessive moisture in the surrounding area.

Such leaking creates an environment which is conducive to an array of defects, including water damage to associated building elements and the attraction of termite or timber pest infestation.

It is highly recommended that a licensed plumber be appointed to connect the A/C overflow in order to prevent such an environment from being created. These minor works should be carried out as soon as possible.

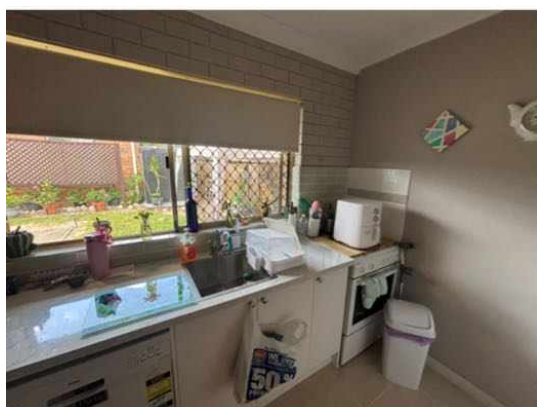
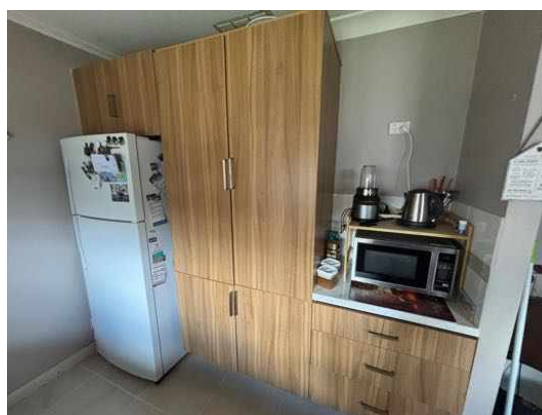
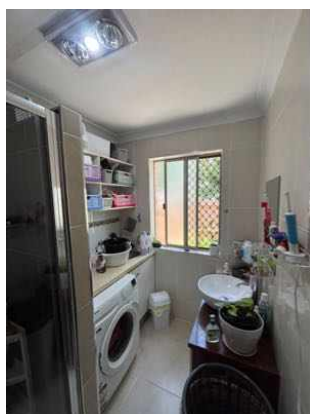
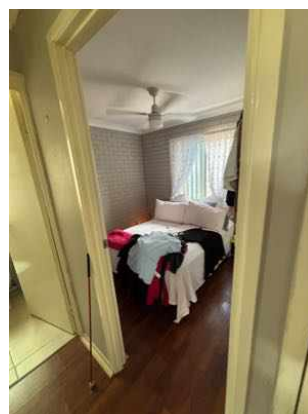
Building: Main Building
 Location: All Internal Areas
 Finding: Obstructions and Limitations - Internal areas
 Information: These photographs are an indication of the obstructions and limitations which impeded full inspection of the property of the internal areas at the time of inspection. These obstructions can hide an array of defects and should be removed to allow full inspection to be carried out. A re-inspection is recommended once the areas are made accessible.

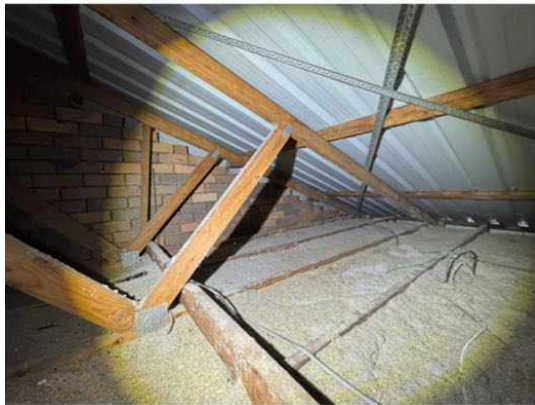
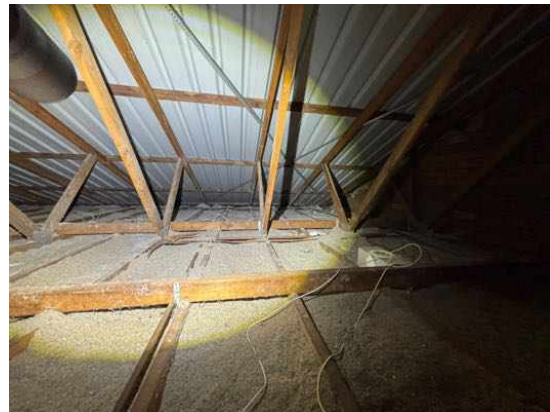
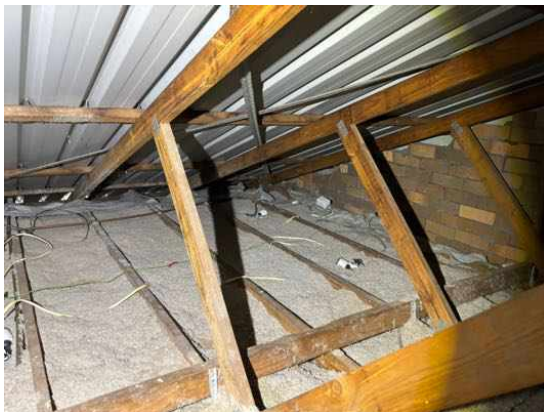
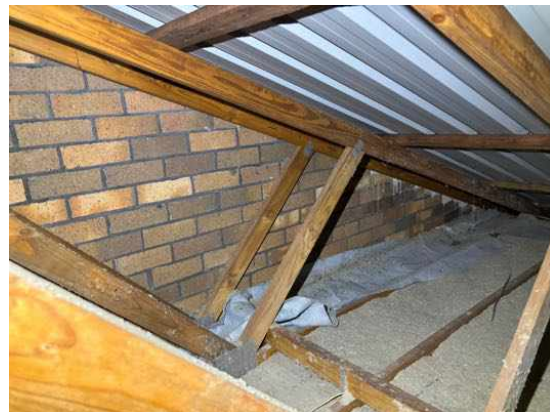
Building: Main Building
 Location: Roof Void
 Finding: Obstructions and Limitations - Roof cavity
 Information: These photographs are an indication of the obstructions and limitations which impeded full inspection of the property of the roof cavity

at the time of inspection. These obstructions can hide an array of defects and should be removed to allow full inspection to be carried out. A re-inspection is recommended once the areas are made accessible.

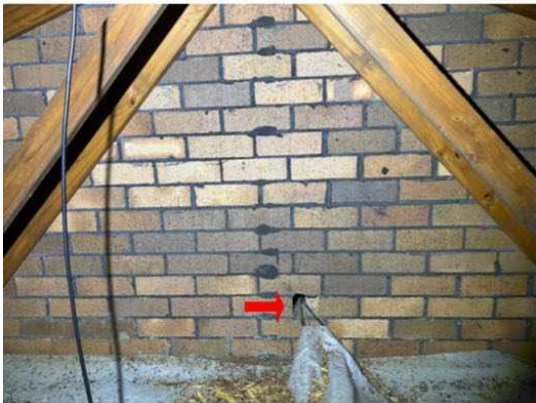
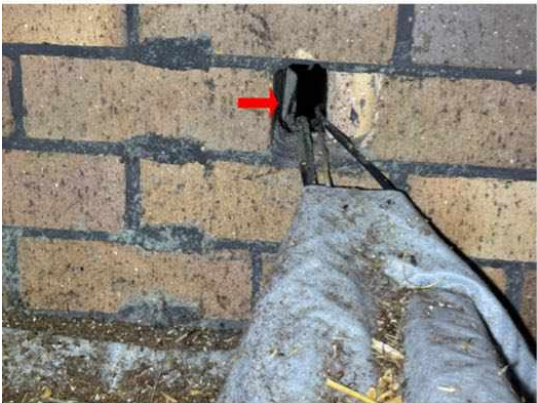
Building: Main Building
Location: Roof Void
Finding: Roof void - party wall hole
Information: At the time of the inspection, it was noted that there was a hole in the party wall between unit 1 and unit 2. It may not have been a requirement for the party wall to act as a fire stop at the time of construction. It is advisable to have the hole filled.

A building maintenance professional should be engaged to fill this hole. This should be done as a short term priority.
