# Building and Timber Pest Inspection Report

Inspection Date: Thu, 12 Feb 2026

Property Address: 17 Jindabyne Ave, Baulkham Hills NSW  
2153, Australia

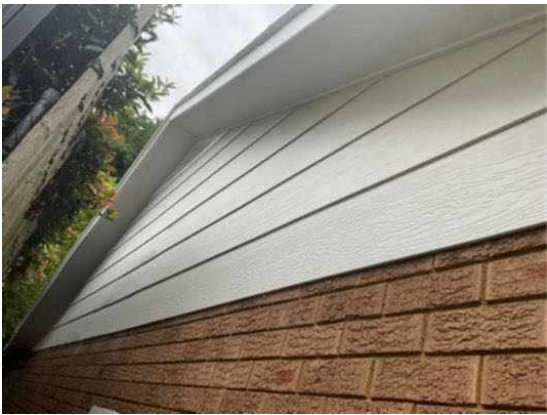
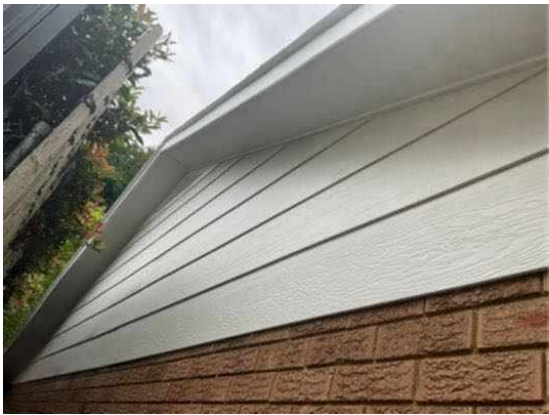
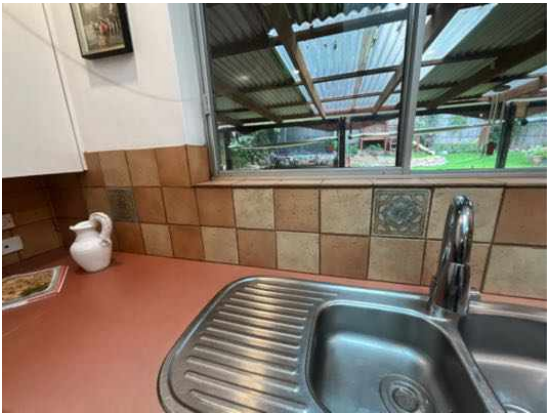
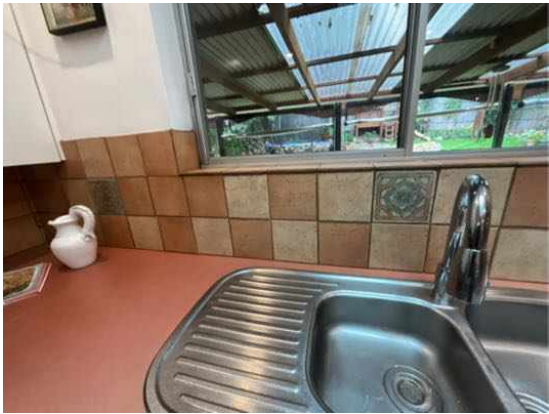
Building:	Main Building
Location:	All Areas
Finding:	Asbestos - Suspected ACM Identified on Site
Information:	Reporting on Asbestos is outside the Scope of this Report. This suspected defect is highlighted as a caution only. We suspect, based on our experience in the building industry, that there is a higher risk of the identified building element containing asbestos.

As Asbestos Reporting is outside the scope of this report, we advise that you consider a separate Asbestos Inspection and Condition Audit, which can include the taking of samples for definitive confirmation of the presence of Asbestos.

In the interim, the client is advised to act with caution, especially when considering any damage to building materials general wear and tear renovations extensions demolition and general maintenance activities due to the suspected presence of Asbestos.

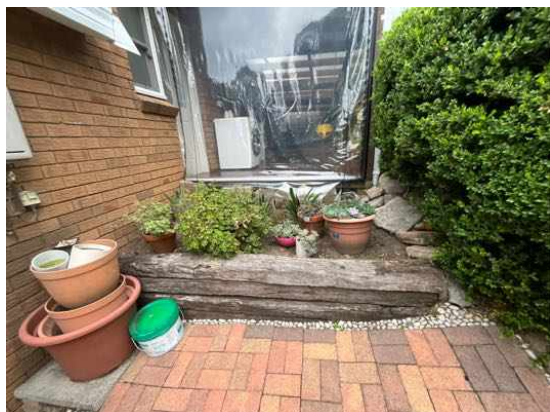
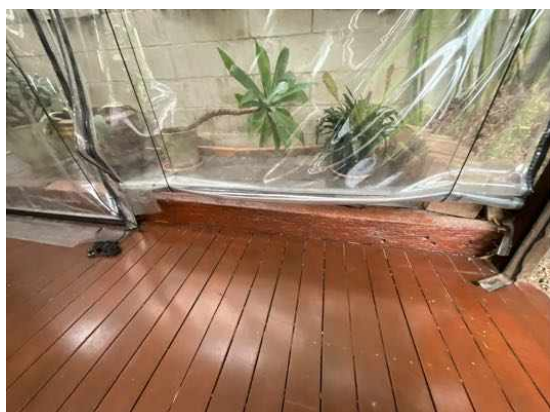
### Finding 1.02

External timber structures are also constantly exposed to weather deteriorates in an exhilarate manner, ongoing assessments are required.

It is highly recommended that a structural engineer further, assess the external timber balcony or a deck to inform the client of its load capacity.

Regular maintenance inspections by competent practitioners is needed.

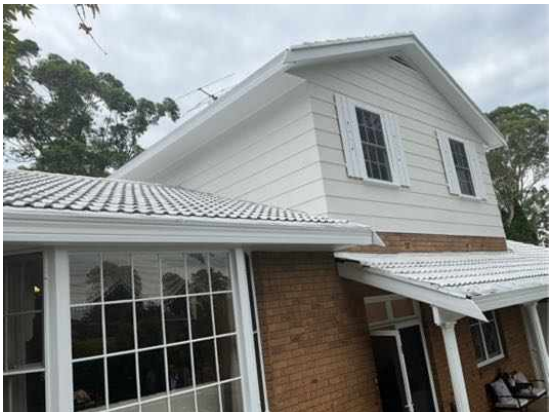
Information: Upon inspection of the exterior roofing, the majority of roof was not in a fair condition. While weathering of the roof is consistent with the age of the property, maintenance works are required.

Isolated areas of mortar have come loose in the valleys and minor cracking is also present. Re-pointing and re-sealing the may be considered as an interim solution by the client to help preserve and extend the life span of the tiles.

Where left unmanaged, deteriorating roof are likely to lead to a number of secondary defects, including minor water leaks and weather exposure to internal roofing structures.

Consultation with a roofing contractor is highly advised to gain advice on cost of remedial works that may be required in the short to medium term. Remedial works are likely to increase the longevity of the exterior roofing structure.

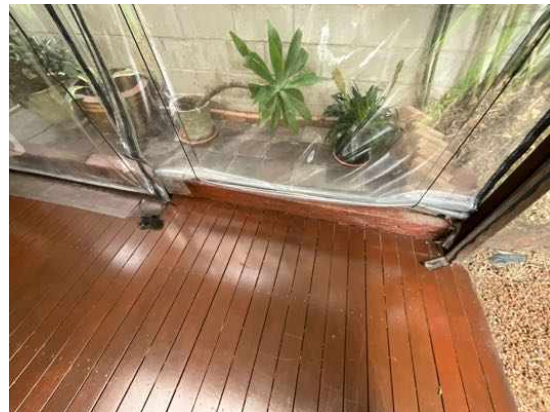
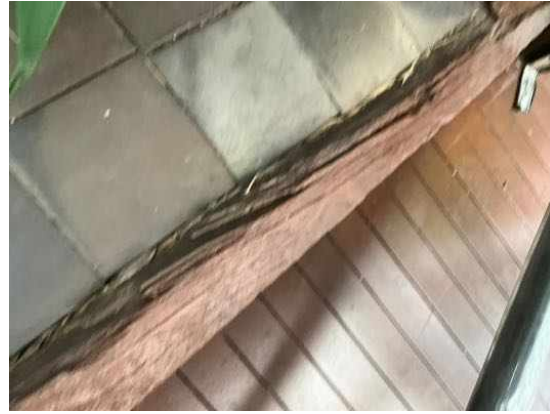
**Finding 3.03**

Building: Main Building  
Location: Pergola

Finding: Retaining wall - Defective

Information: The retaining wall in this area was found to be defective at the time of inspection. Generally, defective retaining walls are caused by poor original design or material use. However, deteriorated retaining walls may also be a result of substandard construction, poor site drainage or unmanaged stormwater flows.

If left unmanaged, the retaining wall may become a safety hazard if it continues to destabilise. Where retaining walls further rot and decay, an environment is created that is conducive to termite and pest infestation.

Significant repair and replacement should be expected. Where retaining walls are considered structural walls, a structural engineer / surveyor should be consulted regarding required remedial works. Otherwise, a landscaper or retaining wall installer may be appointed to repair or replace the wall, at the discretion of the client.

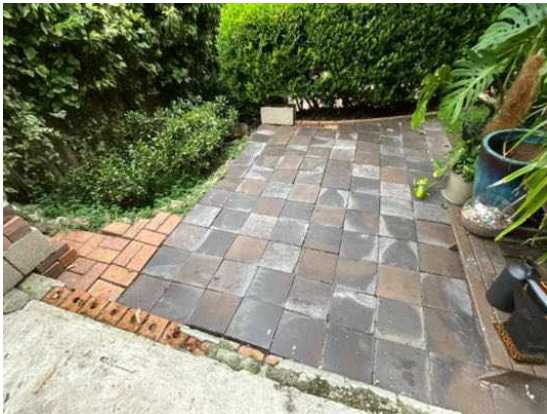
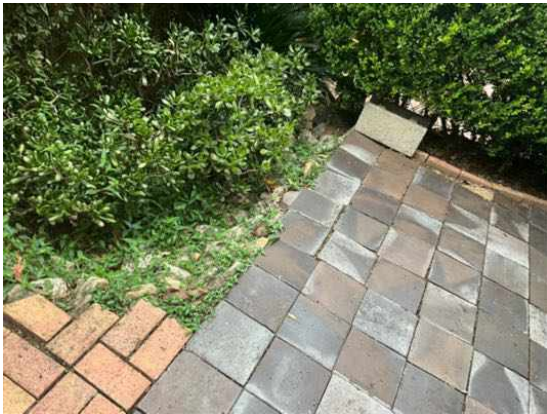
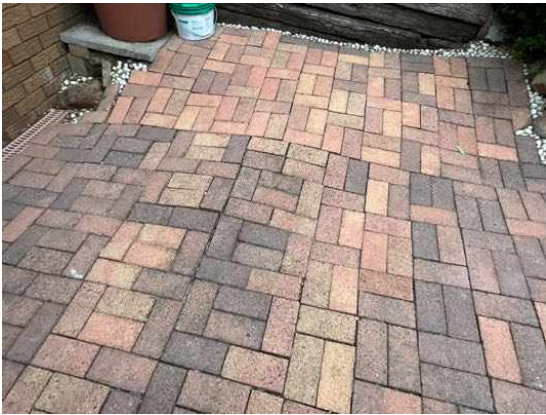
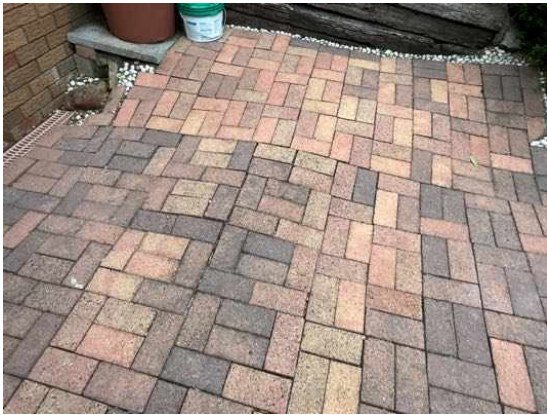
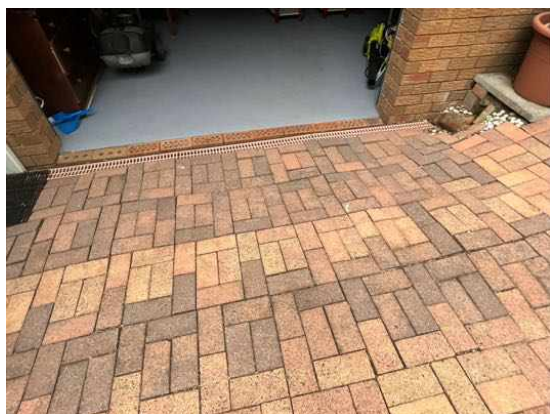
### Finding 3.04

Building: Main Building  
 Location: Pergola  
 Finding: Bricks / Pavers uneven and displaced....  
 Information: Cracked, uneven, and displaced pavers were observed. Several pavers appear loose, misaligned, or deteriorated.

The uneven surface poses a significant trip hazard for pedestrians and may impact the usability of the driveway. Displacement and cracking can worsen over time due to vehicle traffic, poor subbase compaction, or water ingress. Wall cracking may lead to moisture entry or structural wear if left untreated.

- A qualified paving contractor should be engaged to lift, relevel, and relay the affected pavers with proper bedding and compaction.
- A licensed builder or bricklayer should repair and seal the masonry wall crack around the pipe to prevent further water ingress and deterioration.
- Drainage should also be checked to ensure water is not contributing to the issue.

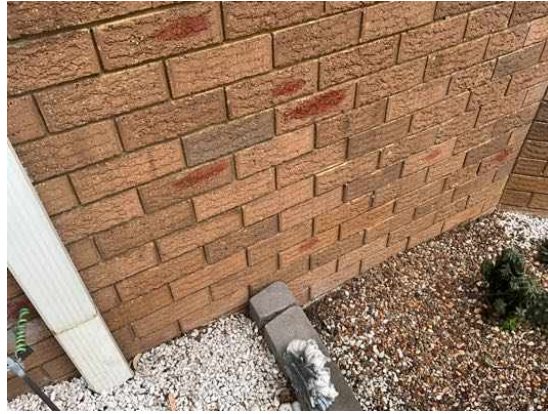
### Finding 3.05

Building:	Main Building
Location:	All Areas
Finding:	Weep holes - Missing
Information:	The external masonry wall of the building lacks the necessary weepholes, which are crucial for the drainage and ventilation of the wall cavity.

1. **Moisture Accumulation:** Without weepholes, moisture can accumulate within the wall cavity, leading to dampness and potential water damage to the building structure.
2. **Mold and Mildew Growth:** The trapped moisture creates an ideal environment for mold and mildew, which can cause health issues for occupants and degrade building materials.
3. **Structural Damage:** Prolonged exposure to moisture can weaken the structural integrity of the wall, causing deterioration of bricks, mortar, and internal framing.
4. **Efflorescence:** The absence of proper drainage can lead to the formation of efflorescence (white salt deposits) on the surface of the masonry, which can be unsightly and indicative of moisture problems.
5. **Pest Infestation:** Inadequate ventilation and moisture control can attract pests such as termites, leading to further damage and potential infestation.

A qualified bricklayer or masonry contractor should be contacted to assess and install the missing weepholes. They will:

- Inspect the wall cavity for any existing moisture damage and recommend additional repairs if necessary.

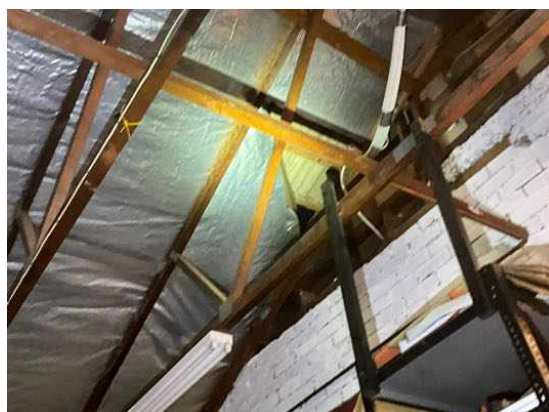
### Finding 3.06

Building: Main Building  
 Location: Garage  
 Finding: Sarking - Damaged  
 Information: Sarking, a laminated aluminium foil applied to the interior of the roof covering, assists in insulating the property and acting as a vapour-barrier to the roof void and, subsequently, to the household.

Where sarking is damaged, both insulation and moisture protection of the property are inhibited. This creates a loss of energy and thus negatively impacts the energy efficiency of the property, allowing potential for moisture ingress from condensation or leaking roof tiles.

It is important to repair any holes or damaged sections of sarking to ensure that the building material is fully functional. A registered builder or qualified carpenter should be consulted to provide further advice on this defect and to perform rectification works at client discretion.

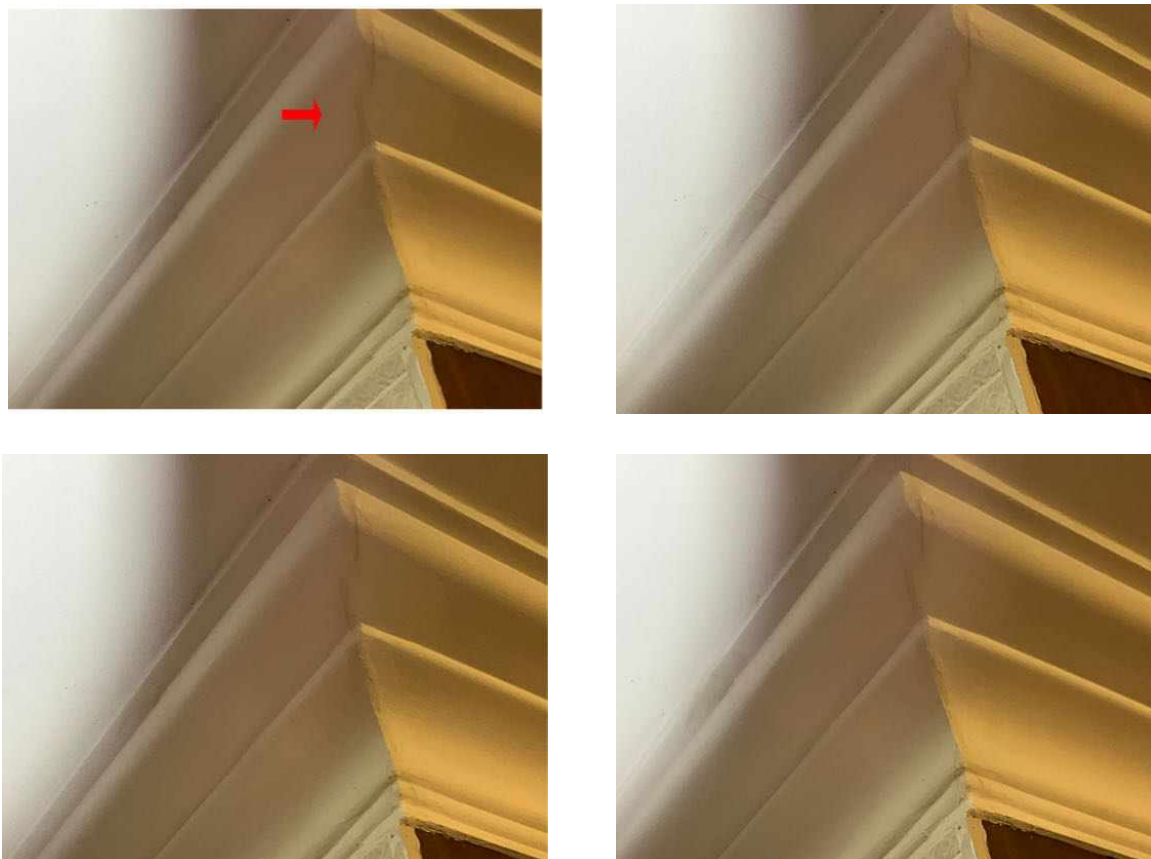
Building:	Main Building
Location:	Living Room
Finding:	Cornice - Cracking [Fine]
Information:	Fine cracking observed in the cornice, indicating potential structural issues or settling concerns.

Fine cracks in the cornice may lead to aesthetic deterioration and, if left unaddressed, could contribute to more significant structural problems over time.

Engaging the services of a skilled plasterer or home renovation specialist is recommended to assess and repair the fine cracking in the cornice, ensuring proper restoration and preventing further issues.

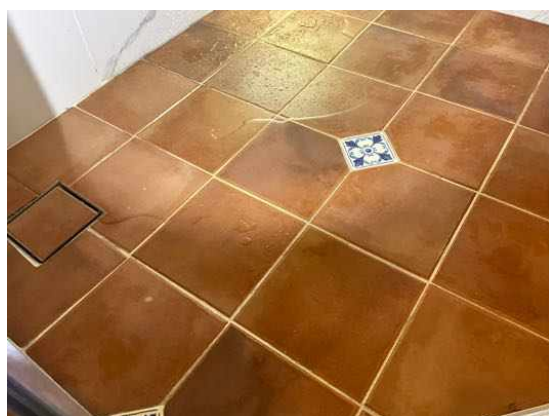
Finding: Shower base - Water pooling  
 Information: Evidence of water pooling around the floor waste in the shower recess was noticed at the time of inspection. It is suspected that this excessive moisture is attributed to insufficient fall in the shower floor tiles.

This pooling is minor overall but is still considered unsatisfactory, as standard tiling practices would not permit this situation to occur. Pooling water around floor wastes can create a slip hazard in extreme cases and create conditions that are conducive to mould growth over time. Where left unmanaged, the degradation of sealant and grouting is also likely to occur, possibly necessitating further repair works.

Remedial works may involve some sections of tiling and flooring repair and replacement. A tiling contractor or bathroom specialist should be appointed to provide further advice on reparation options and to perform works as necessary.

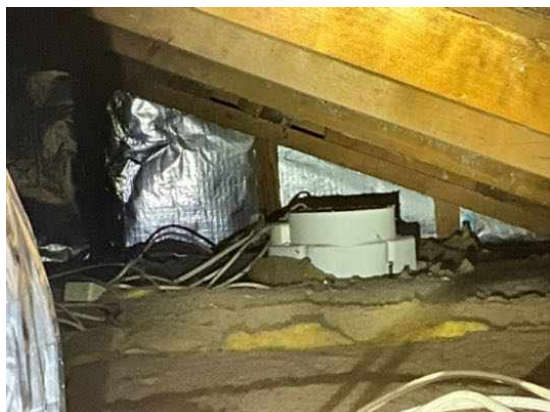
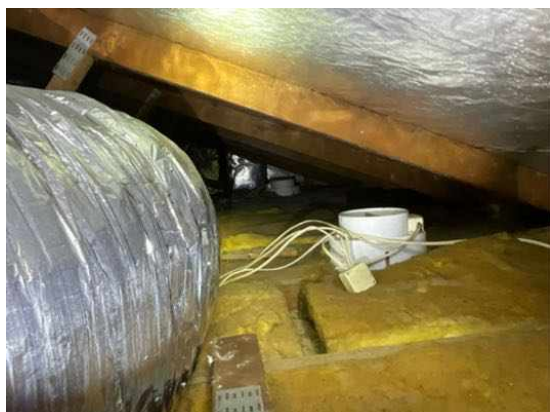
Building:	Main Building
Location:	Roof Void
Finding:	Exhaust fan not vented out
Information:	The exhaust fan located within the roof void is not appropriately ducted to the external atmosphere and is currently discharging moist air directly into the roof space. This is considered a defect under AS 4349.1, as it does not meet the minimum standard of residential building performance expected under normal residential building practices.

This condition may lead to excessive condensation within the roof void, increasing the risk of mould growth, deterioration of insulation, timber decay, and overall reduced durability of building elements. It may also result in poor indoor air quality, potentially affecting occupant health.

It is recommended that the exhaust fan be modified by a licensed HVAC contractor or

qualified builder, ensuring it is properly ducted to discharge externally in accordance with manufacturer specifications, the National Construction Code (NCC), and applicable Australian Standards.

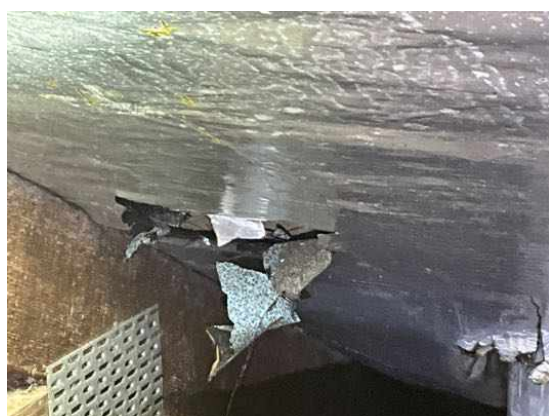
### Finding 3.14

Building:	Main Building
Location:	Roof Void
Finding:	Sarking - Damaged
Information:	Sarking, a laminated aluminium foil applied to the interior of the roof covering, assists in insulating the property and acting as a vapour-barrier to the roof void and, subsequently, to the household.

Where sarking is damaged, both insulation and moisture protection of the property are inhibited. This creates a loss of energy and thus negatively impacts the energy efficiency of the property, allowing potential for moisture ingress from condensation or leaking roof tiles.

It is important to repair any holes or damaged sections of sarking to ensure that the building material is fully functional. A registered builder or qualified carpenter should be consulted to provide further advice on this defect and to perform rectification works at client discretion.

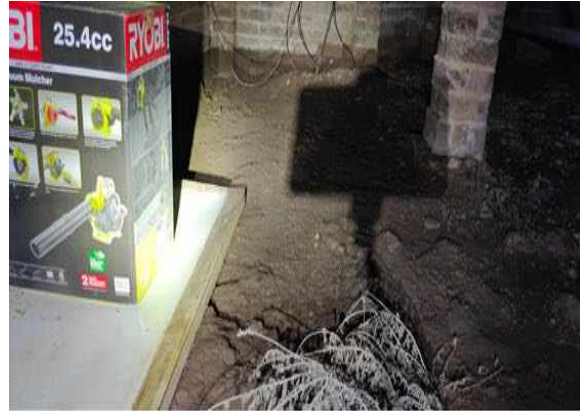
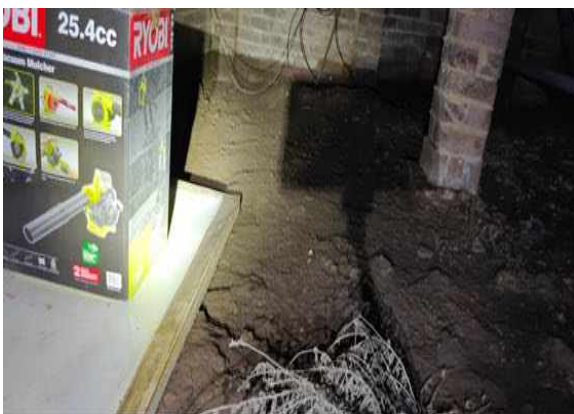
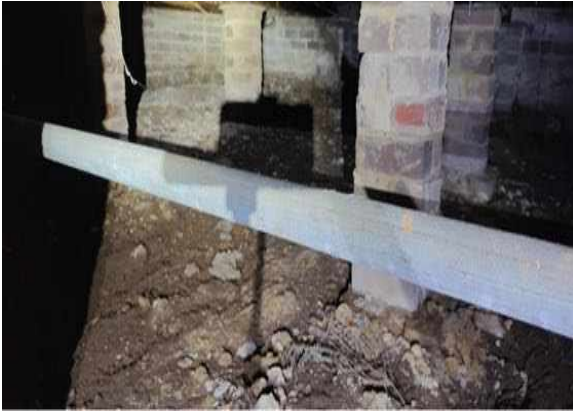
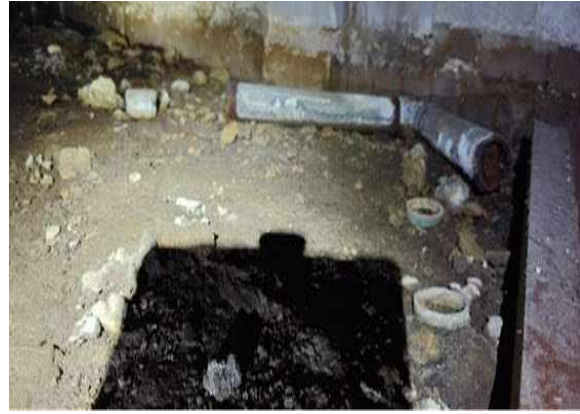
### Finding 3.15

Building: Main Building  
 Location: Subfloor  
 Finding: Subfloor - Site drainage - Inadequate  
 Information: The site exhibits poor drainage under the subfloor, leading to several critical issues. Water accumulates and does not properly drain away from the subfloor area, creating a hazardous condition.

1. Frequent water pooling and stagnation under the subfloor.
2. Risk of subfloor structural damage due to prolonged moisture exposure.

4. Safety hazard for occupants due to slippery surfaces and potential electrical hazards.

The poor site drainage under the subfloor poses a significant safety risk to the occupants, as it can lead to structural damage and health hazards.

This issue requires immediate attention and rectification. A licensed and experienced plumber or licensed builder specialising in drainage and foundation work should be engaged to assess the problem and implement necessary drainage solutions, such as improved grading, installation of drainage systems, and moisture barrier enhancements. Regular maintenance and inspections should also be scheduled to prevent future occurrences. Water damage and secondary defects are likely to occur if left unmanaged.

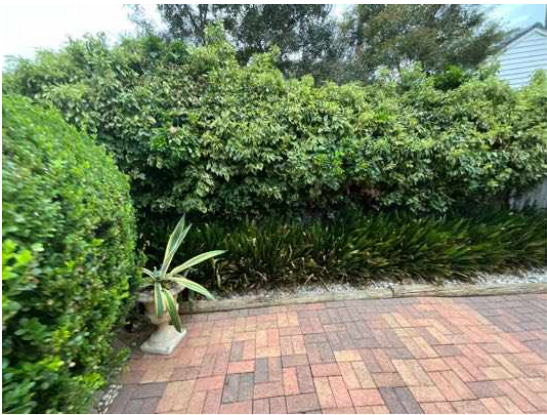
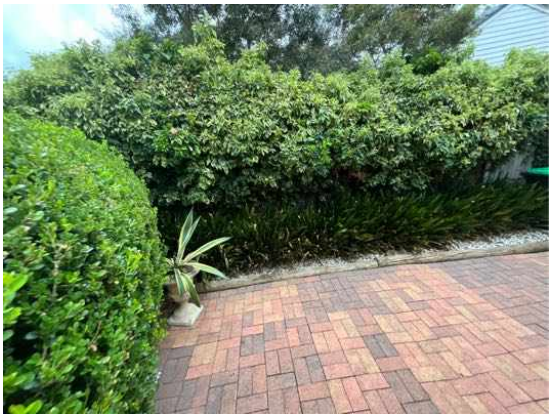
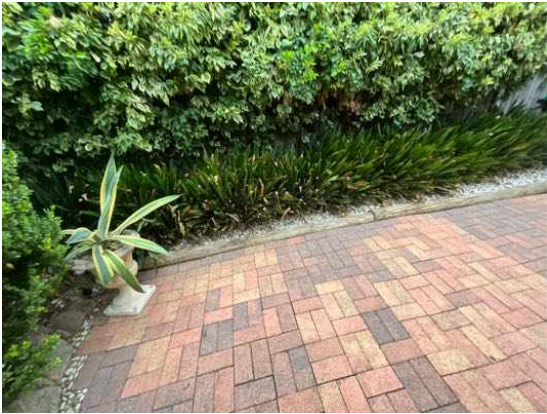
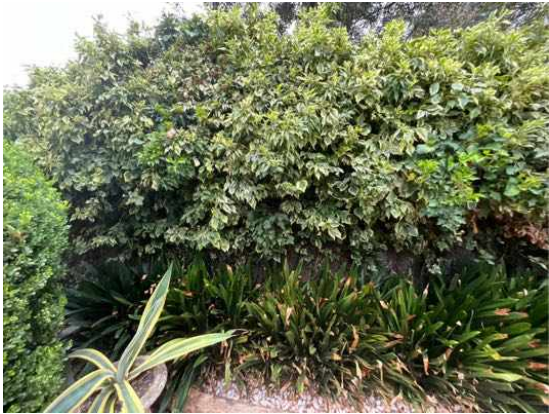
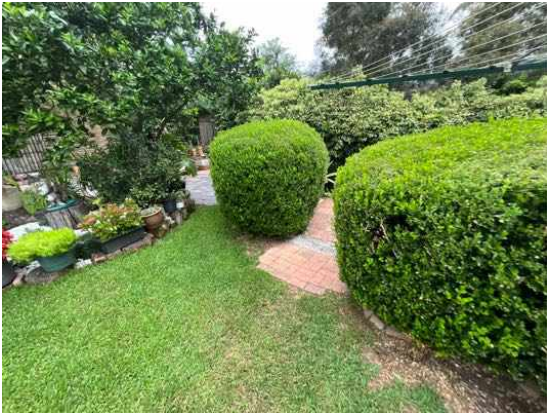
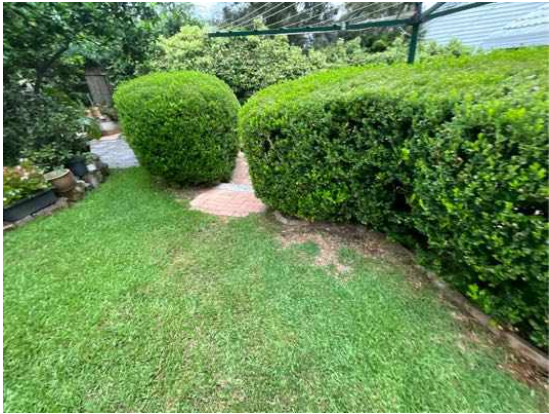
**Finding 6.02**

Building: Main Building  
Location: All Areas  
Finding: Dense vegetation around a property can increase the risk of termite infestation  
Information: The presence of dense vegetation around a property can increase the risk of termite infestation, as it provides a conducive environment for them. To address this, consider maintaining a clear space between the vegetation and your home. If you suspect a termite issue, it's advisable to consult with a licensed pest control professional for inspection and treatment.

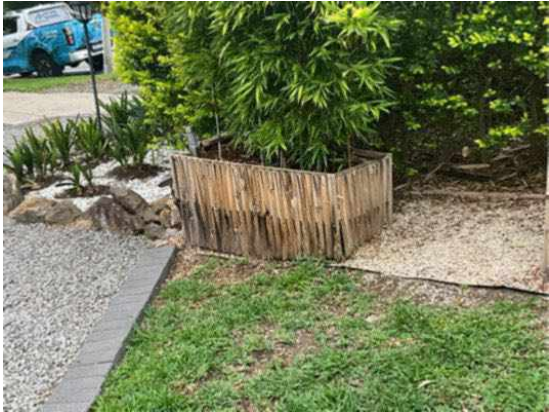
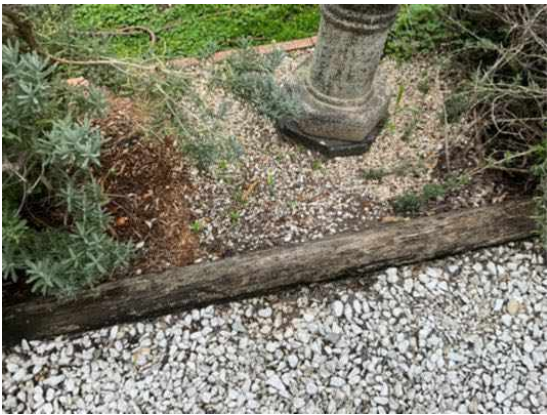
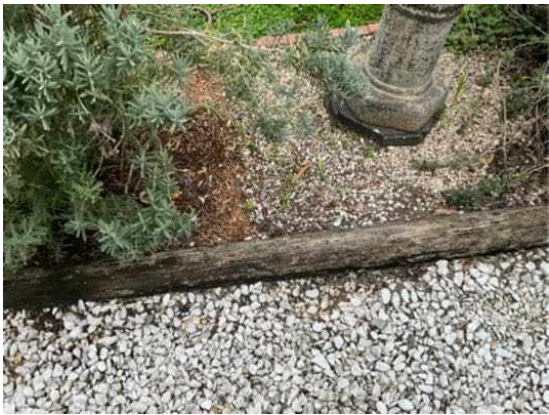
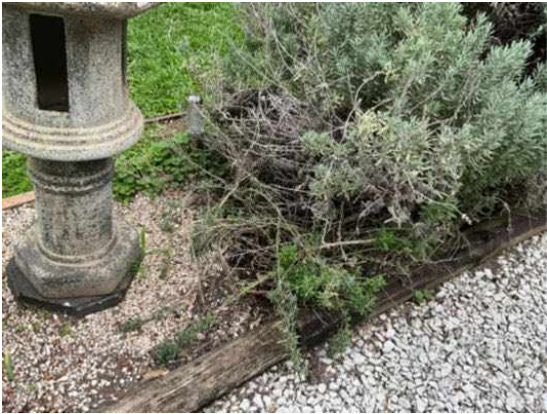
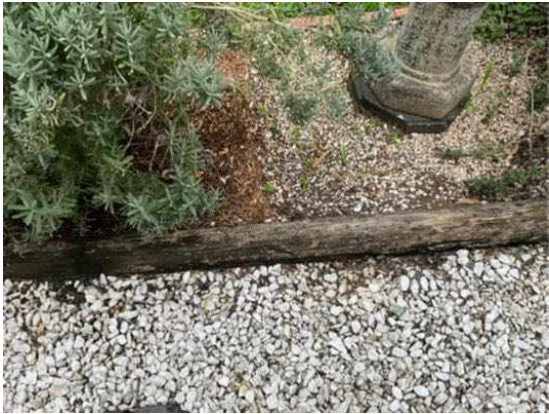
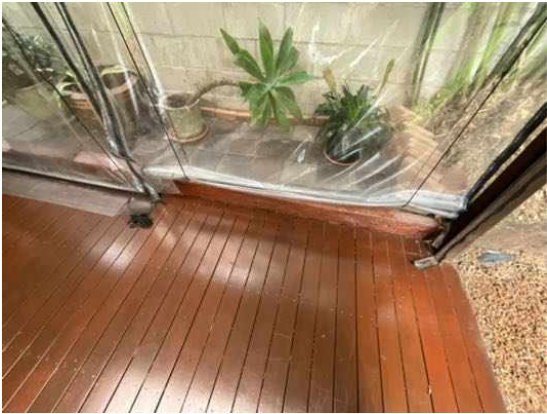
Finding 6.03

Building: Main Building  
Location: All Areas  
Finding: Timber on ground / conducive conditions to termite damage  
Information: Timber on the ground is indeed conducive to termite damage. Termites are known to thrive in moist environments, and wood in contact with soil or moisture is more susceptible to infestation.

To prevent this, it's important to keep timber elevated and away from direct ground contact. Regular inspections and proper termite control measures are also essential to protect your wooden structures from termite damage.

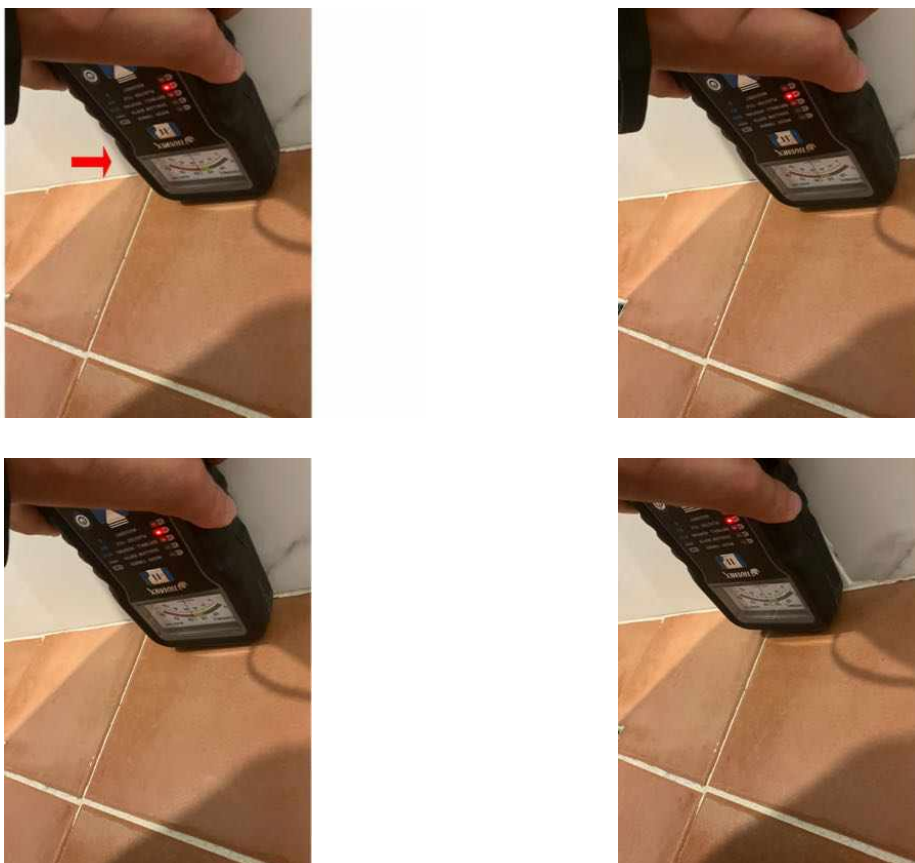
### Finding 6.04

Building:	Main Building
Location:	Bathroom downstairs
Finding:	Excessive moisture - Conducive to Timber pest
Information:	Excessive moisture can attract termites and produce conditions that promote fungal growth and wood decay.

Excessive moisture is generally caused by deteriorated inadequate or missing roof drainage leaking plumbing pipes or fixtures poorly plumbed HWS overflows or condenser units and poor site drainage.

If mould growth has been found there may be environmental biological or health issues involved. In these cases an appropriately qualified inspector should also be contacted.

Prior to any remedial works being performed a qualified plumber should be appointed to further inspect the property and to identify the cause of the excessive moisture. Works to remove affected building elements may then be necessary and should be performed by an appropriate tradesperson.
