# Building and Timber Pest Inspection Report

Inspection Date: Fri, 20 Mar 2026

Property Address: 96 Bradley St, Glenmore Park NSW 2745,  
Australia

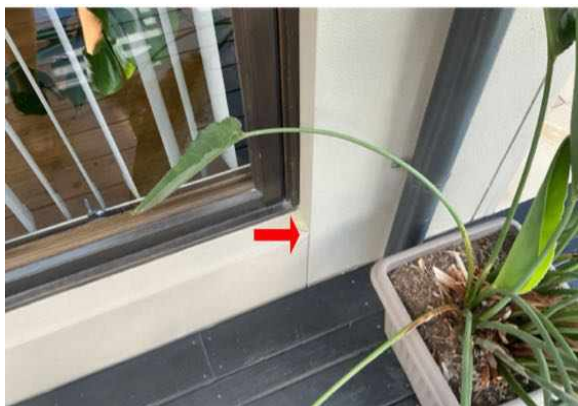
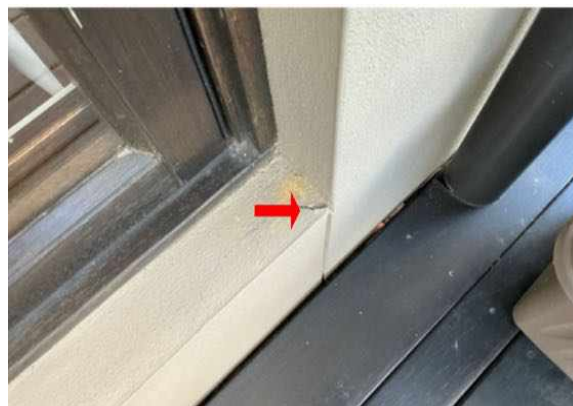
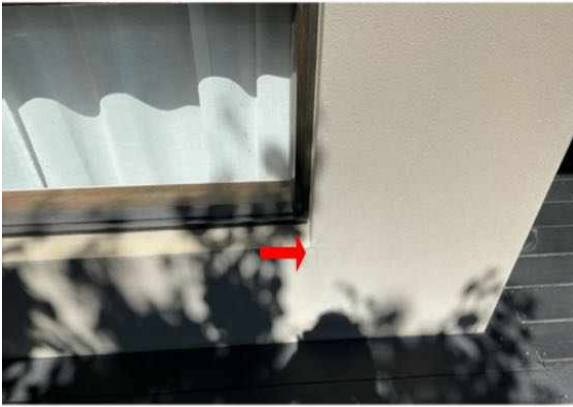
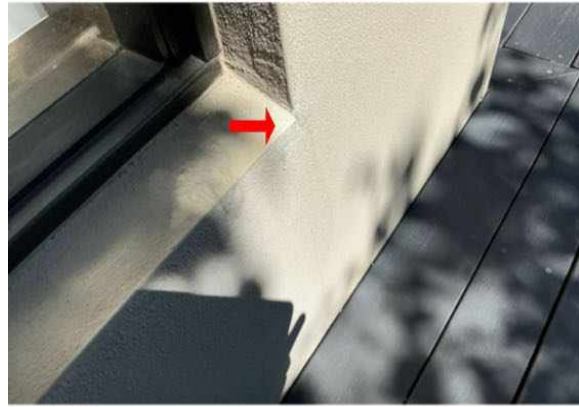
Building: Main Building  
Location: Exterior walls  
Finding: Exterior Hebel Walls Hairline Cracks  
Information: During the inspection, hairline cracks were observed in sections of the exterior Hebel wall panels. Minor cracking can occur due to normal building movement, material shrinkage, or environmental exposure over time.

At the time of inspection, the cracks appear minor in nature, monitoring is recommended to ensure the cracks do not widen or develop further. If movement progresses, assessment and repair by a qualified tradesperson may be required to seal the cracks and maintain the integrity of the wall.

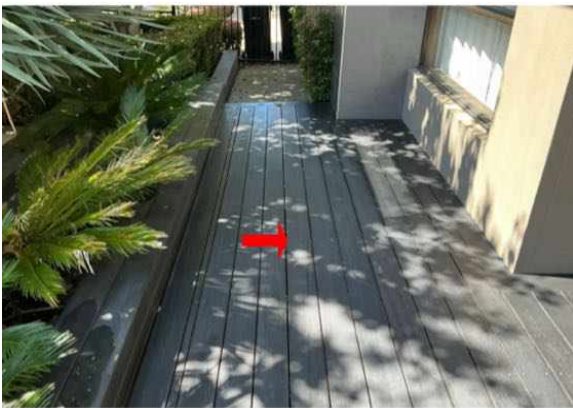
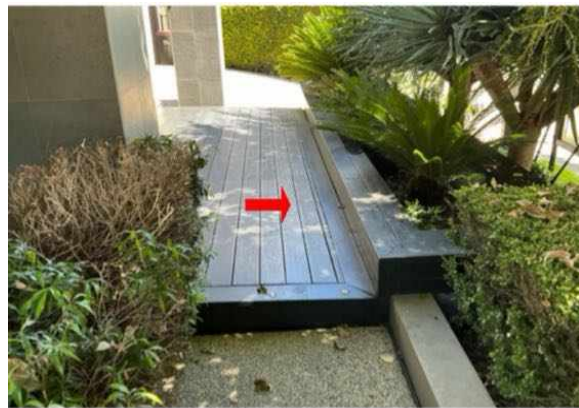
### Finding 3.02

Building: Main Building  
 Location: Front Porch  
 Finding: Front Porch Deck Minor Settlement / Sinking  
 Information:

During the inspection, the front porch deck was observed to have slightly dropped or sunk in sections. This condition may be associated with minor settlement, ground movement, or movement of supporting elements over time.

While slight settlement can occur in external structures, monitoring of the affected area is recommended to ensure no further movement develops. If the condition worsens or concerns arise, a qualified builder should be engaged to assess the structure and carry out any necessary remedial works to restore stability and level.

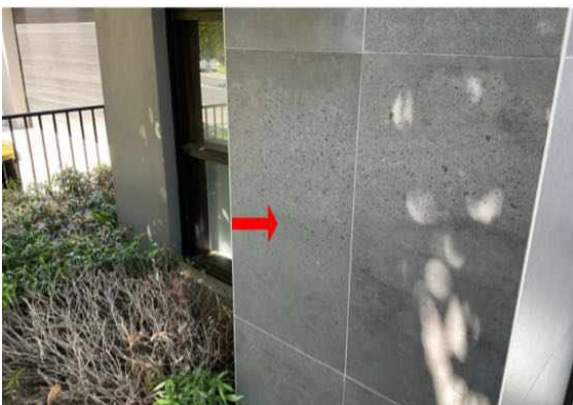
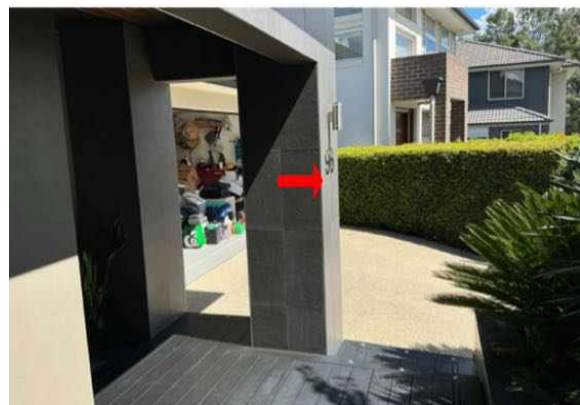
During the inspection, sections of the wall tiles at the front porch were found to be drummy (hollow sounding), indicating a loss of adhesion to the underlying surface.

This condition may be associated with moisture exposure, minor movement, or installation-related factors. It is recommended that the affected tiles be monitored and, if deterioration progresses or tiles become loose, a qualified tiling contractor be engaged to assess and carry out appropriate repairs.

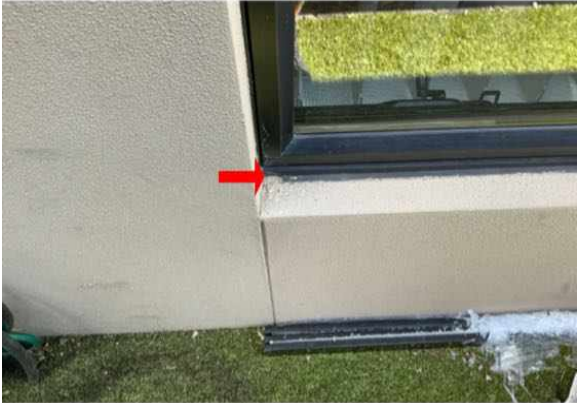
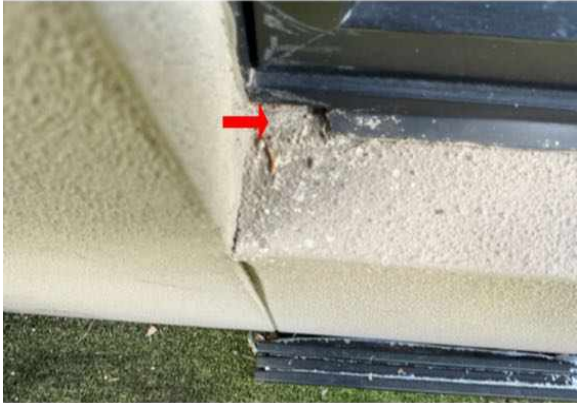
### Finding 3.05

Location: Exterior walls  
Finding: Windows Rubber Seals Inadequate  
Information: Some window rubber seals were found to be installed short, resulting in gaps that may affect weatherproofing. Repair or replacement of the seals is recommended to prevent potential water ingress.

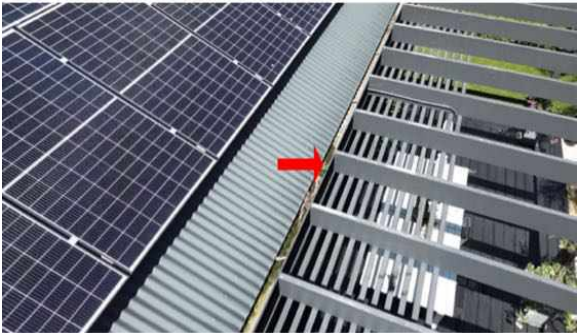
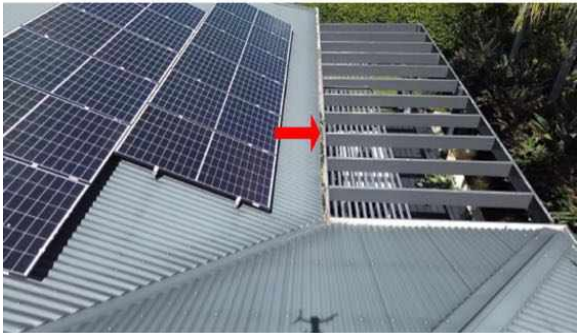
**Finding 3.06**

Building: Main Building  
Location:  
Finding: Gutters Blocked by Debris  
Information: During the inspection, sections of the gutters were found to be blocked by debris. Blocked gutters can restrict the flow of rainwater, potentially leading to overflow during rainfall.

Overflowing gutters may result in moisture accumulation around the building and contribute to deterioration of building elements over time. It is recommended that the gutters be cleaned and maintained regularly to ensure effective stormwater drainage and reduce the risk of moisture-related issues.

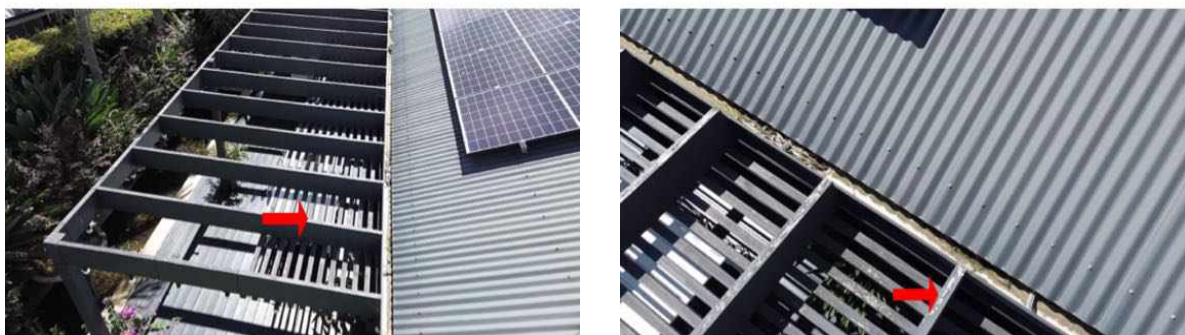
**Finding 3.07**

Finding: External Painting Deteriorated

Information: Due to frequent exposure to weather conditions, deterioration of the exterior painted surfaces is expected in a property of this age and condition. Where paint deterioration has occurred, the protective layer is compromised, which can lead to moisture ingress, surface degradation, and the eventual need for repair or replacement of the affected building elements.

It is recommended to engage a qualified painting contractor to carry out the necessary preparation and repainting works. This will improve the appearance of the affected areas and help protect the underlying materials from further weather-related deterioration. Regular maintenance of external finishes is essential to prolong the life of building elements and maintain overall property condition.

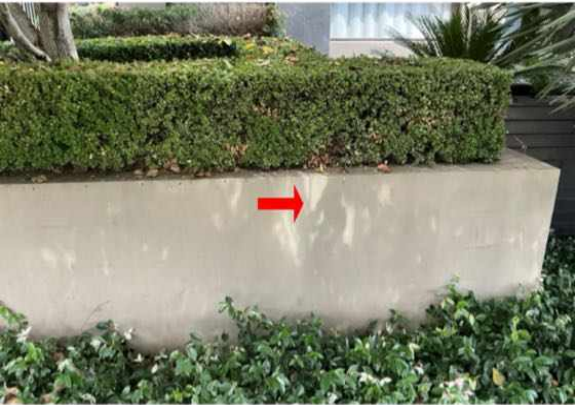
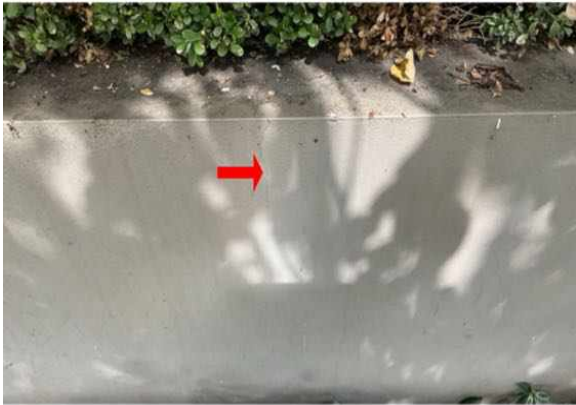
### Finding 3.08

Finding: Retaining Wall Hairline Cracks in Render

During the inspection, hairline cracks were observed in the rendered surface of the retaining wall. Such cracking is commonly associated with minor movement, shrinkage of the render, or general ageing.

While hairline cracks are typically cosmetic in nature, they may allow moisture penetration over time if left unsealed. Monitoring of the affected areas is recommended, and sealing or repainting may be carried out as part of routine maintenance. If cracking worsens or movement becomes evident, a qualified builder should be engaged to assess the retaining wall and advise on any necessary remedial works.

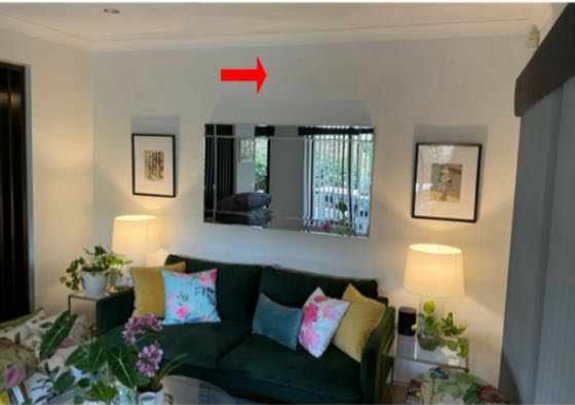
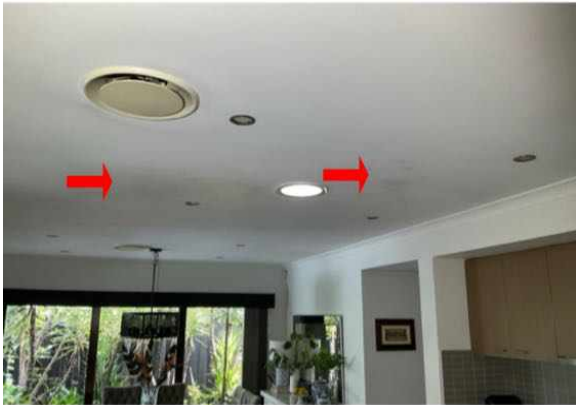
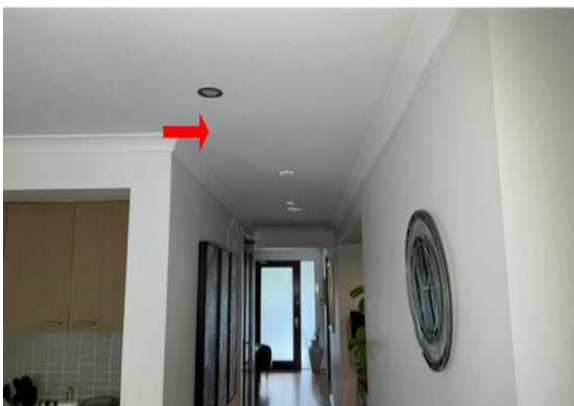
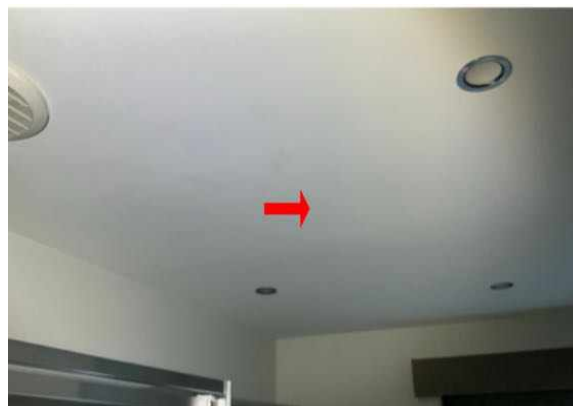
**Finding 3.09**

Building: Main Building  
Location: All Areas  
Finding: Cosmetic Paint Defects  
Information: Incomplete paint coverage, minor surface blemishes, over-painting, inconsistent finishes, and colour variations were observed during the inspection. These conditions are generally considered cosmetic in nature and are commonly found in residential properties. Such irregularities may become more noticeable under certain lighting conditions while appearing less evident in lower light environments.

Rectification of these items is considered routine maintenance. To achieve a consistent appearance and improved finish, it is recommended that a qualified painter be engaged to prepare and repaint the affected areas, thereby enhancing both the visual presentation and long-term durability of the painted surfaces.

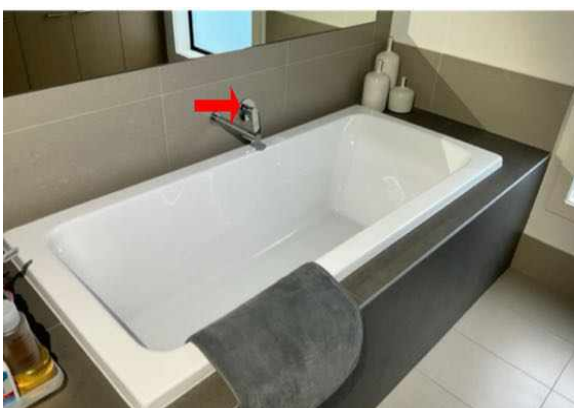
### Finding 3.10

Building:	Main Building
Location:	Main Bathroom
Finding:	Bathtub Tap Water Hammer
Information:	During the inspection, water hammer was observed when operating the bathtub tap. Water hammer is typically caused by sudden changes in water flow or pressure within the plumbing system and may occur due to unsecured pipework or the absence of water hammer arrestors.

While this condition is often considered a minor plumbing issue, if left unaddressed it may contribute to wear or damage within the plumbing system over time.

It is recommended that a qualified plumber assess the condition and determine the most appropriate remedial action. Possible solutions may include adjusting water pressure, securing pipework, installing water hammer arrestors, or servicing the affected plumbing fixtures to reduce the impact and improve the overall performance of the system.

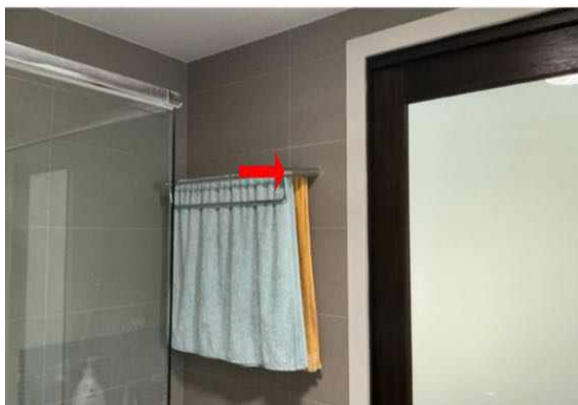
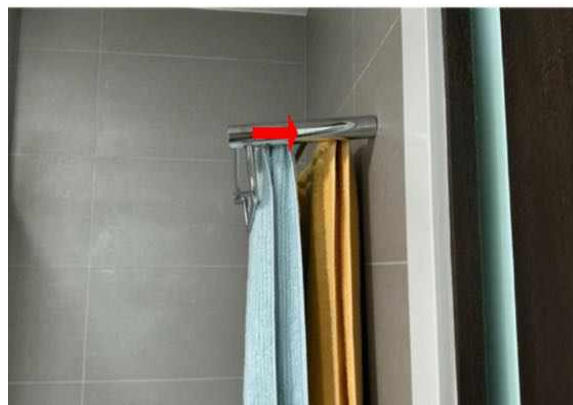
### Finding 3.11

Finding: Towel Holder Loose  
 Information: During the inspection, the towel holder was found to be loose. Loose fittings may worsen over time with regular use and can detach from the wall if not secured.

It is recommended that the towel holder be re-secured or repaired as required to restore proper function. This is considered a minor maintenance item and can be addressed by a qualified tradesperson or handyman.

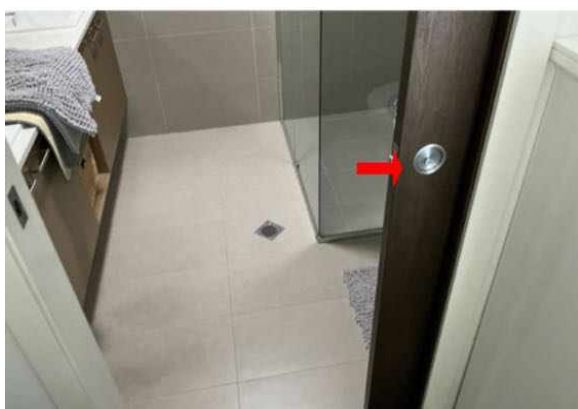
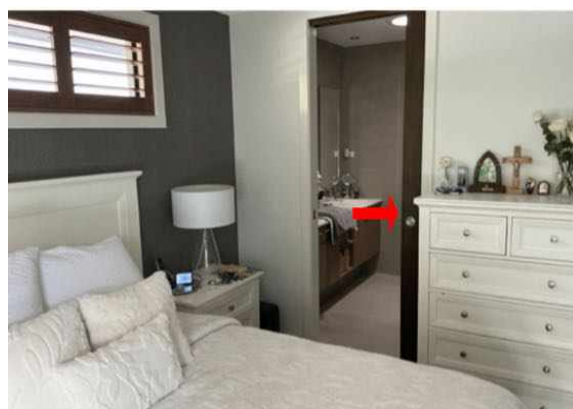
### Finding 3.12

Building: Main Building  
 Location: Ensuite - Master  
 Finding: Ensuite Bathroom Door Lock Not Operating  
 Information:

During the inspection, the lock to the ensuite bathroom door was found to be not functioning correctly and requires adjustment.

It is recommended that the door hardware be adjusted, repaired, or replaced as necessary to restore proper operation. This is considered a minor maintenance item and can be addressed by a qualified tradesperson or handyman.

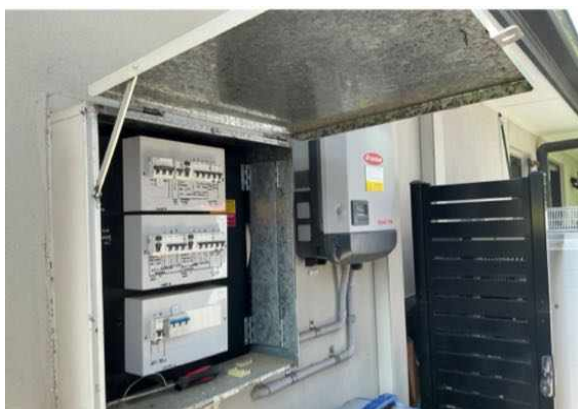
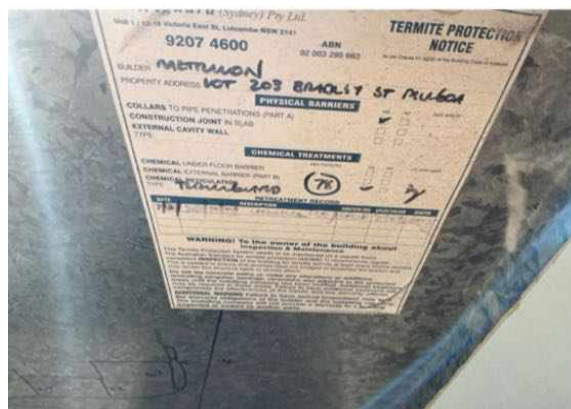
However, while a physical barrier provides one level of protection, it is crucial to apply a post-construction chemical termite management system as an additional layer of defense. Chemical termite management systems, unlike physical barriers, have a limited lifespan and require periodic replenishment to remain effective. Without a chemical treatment in place, given the significant risk posed by termites, it is essential to conduct timber pest inspections every 90 days to ensure early detection and prevention of infestations.

It is advised to consult with a licensed pest controller to discuss the installation of a termite management system. Implementing these measures will help protect the property from termite-related damage and ensure peace of mind.

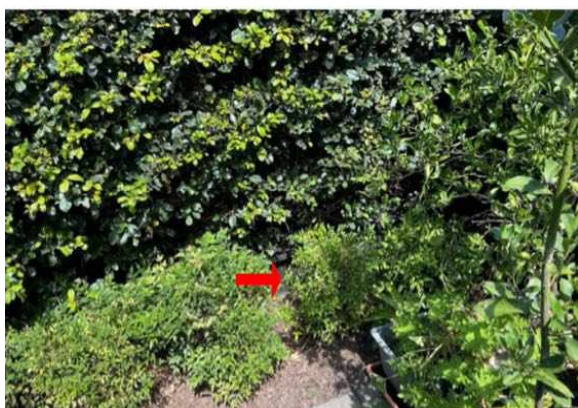
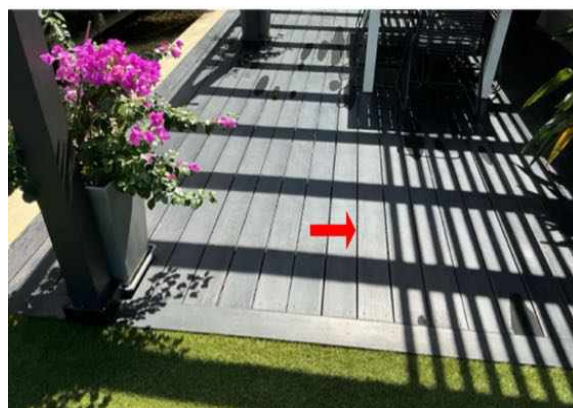
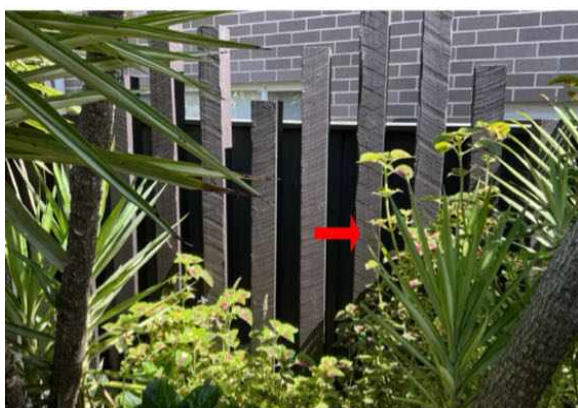
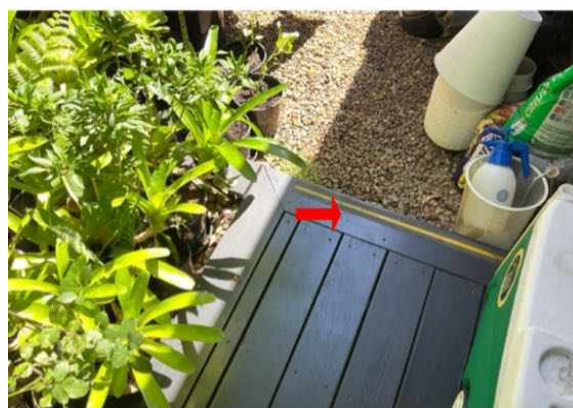
### Finding 6.02

Building: Main Building  
 Location: All Areas  
 Finding: In Contact With The Ground  
 Information: During the inspection, wood and timber materials were observed in direct contact with the ground. This condition is highly conducive to timber pest activity, particularly termites, as it provides an ideal environment for infestation and timber decay due to elevated moisture levels, concealment, and direct access to cellulose material. Untreated or inadequately protected timber in ground contact significantly increases the risk of concealed termite entry and potential structural damage.

To reduce the risk of infestation, all ground-contacting timber should be promptly removed. It is recommended to engage a qualified pest control to assess the subfloor and implement appropriate termite management system, in accordance with AS 3660.2. Regular timber pest inspections, ideally every 90 days, are advised until all conducive conditions have been fully addressed.

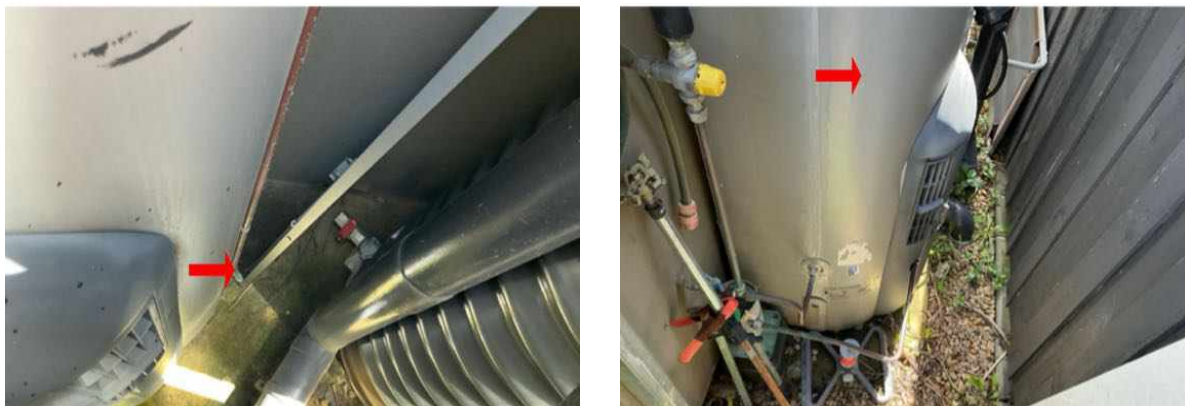
### Finding 6.03

Building: Main Building  
 Location: Exterior walls  
 Finding: Overflows Not Connected  
 Information: During the inspection, it was observed that the overflows are not connected to the stormwater drainage system. This condition may result in moisture accumulation

around the property and creating conditions conducive to termite activity. To mitigate these risks, it is recommended to engage a qualified plumber to connect the overflows to the stormwater drainage system. This will prevent excessive moisture accumulation, reduce the risk of termite infestations, and protect the surrounding structures from potential water-related deterioration.

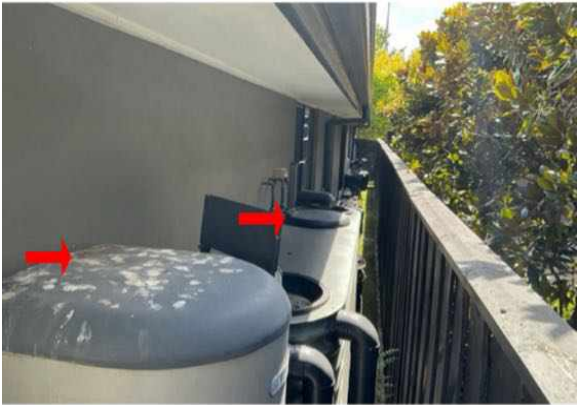
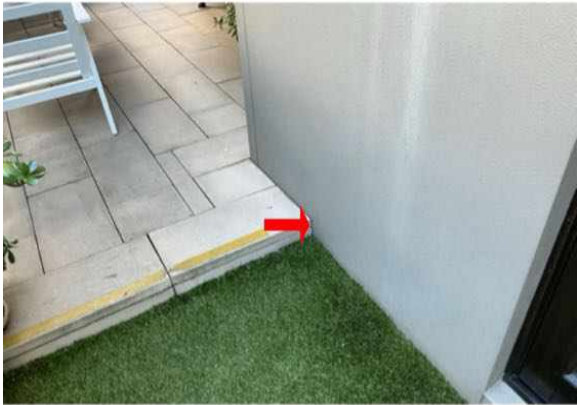
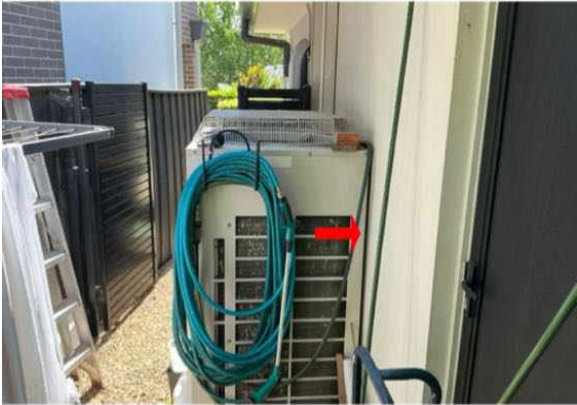
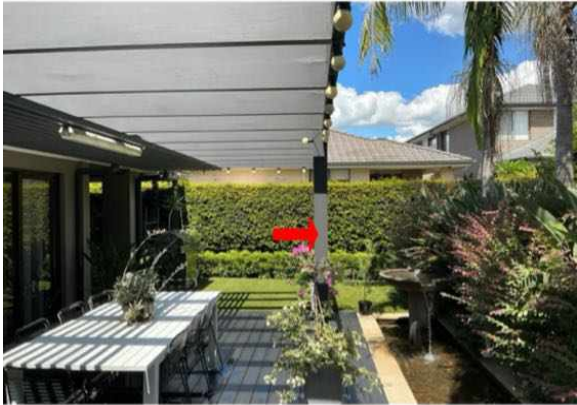
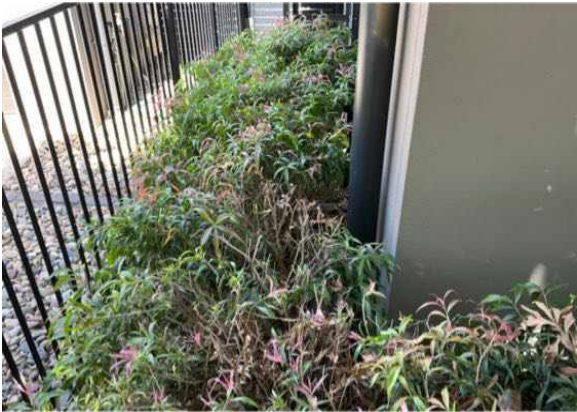
### Finding 6.04

Information: Bridging of a termite physical barrier occurs when termites bypass a preventative measure designed to block or expose their access to a structure. This can happen when soil, vegetation, or debris accumulates against exterior walls above the barrier level. Appliances such as hot water units and air conditioning systems, or wooden structures like decks and porches that touch the ground and connect to the main building, can also contribute to bridging. Even structural modifications may unintentionally create pathways that allow termites to bypass barriers or inspection zones. These breaches provide termites with a direct and often undetectable route into the property, increasing the risk of substantial and unnoticed infestations that can cause extensive structural damage.

To safeguard your property from termite infestations, it is essential to maintain a minimum clearance of 75mm from the exposed slab edge. This clearance forces termites into the open, where they can be more easily detected during regular inspections. If this clearance is not achievable, it is crucial to conduct consistent timber pest inspections every 30 days or implement a post-construction termite management system compliant with Australian Standard AS 3660. Taking these precautionary measures helps ensure the property remains protected from termite threats and allows for early detection and intervention.

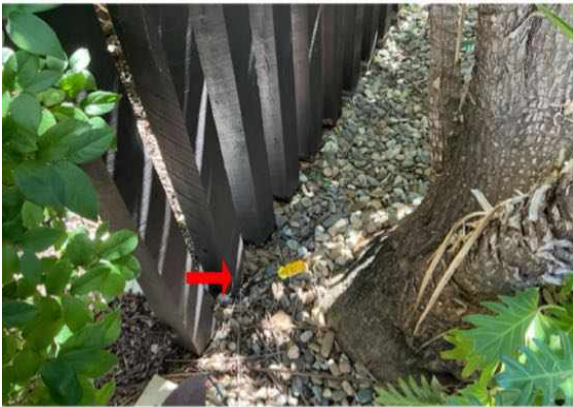
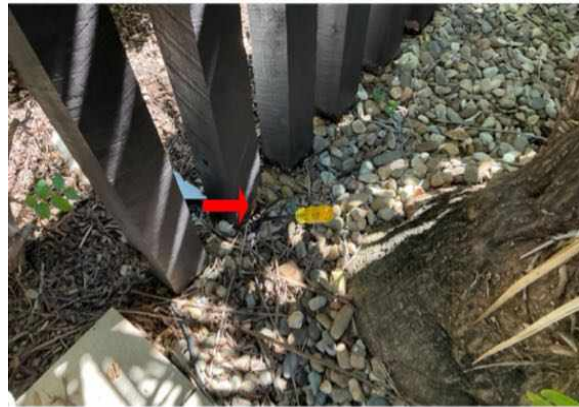
**Finding 7.01**

Building: Main Building  
Location: All Areas  
Finding: Wood Rot / Fungal Decay  
Information: Wood rot was found in the exterior timbers, a condition commonly caused by prolonged moisture exposure. This accelerates the decay process and creates an environment conducive to termite activity and fungal growth. To prevent further deterioration and reduce the risk of termite infestations, it is essential to replace the

affected timber with treated or moisture-resistant alternatives. It is recommended to engage a qualified carpenter or landscaper to undertake the necessary replacements and ensure the long-term durability of the building materials.

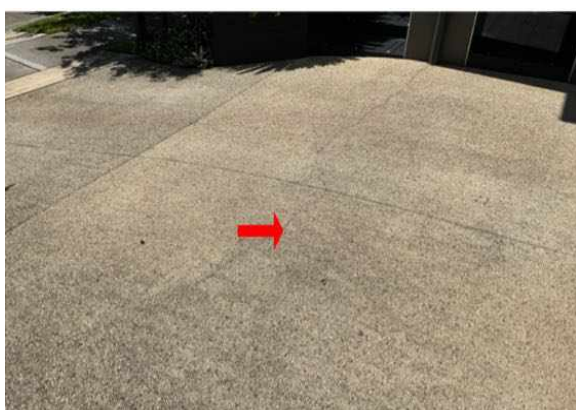
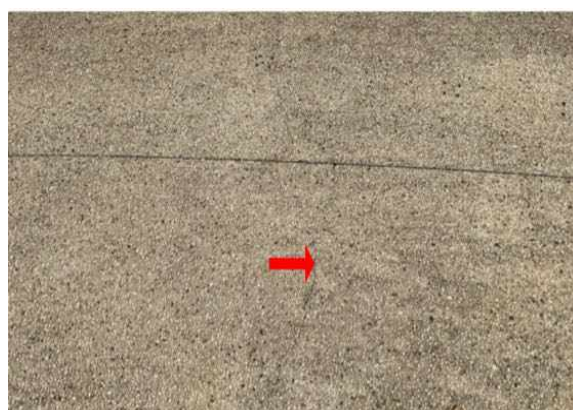
Building:	Main Building
Location:	Driveway
Finding:	Concrete (Pavement) Cracking Category 1 - Fine
Information:	Fine cracks were observed in the external concrete paving. These cracks, typically are less than 2mm in width, and often considered to be an aesthetic defect rather than indicative of structural damage. They are commonly attributed to the natural expansion and contraction of the concrete, influenced by environmental factors such as moisture levels, weather conditions, roots of nearby trees, or soil erosion and settlement. While these fine cracks may also result from poor original installation practices such as inadequate sub-surface compaction or insufficient reinforcement, they generally do not pose significant structural concerns. However, it is recommended to monitor the cracks regularly for any changes. If the cracks widen, lengthen, or increase in number, it is advisable to seek the expertise of a building inspector or builder for further inspection and to determine the appropriate course of action.

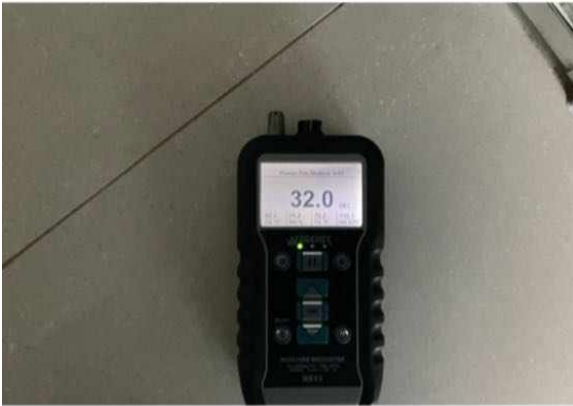
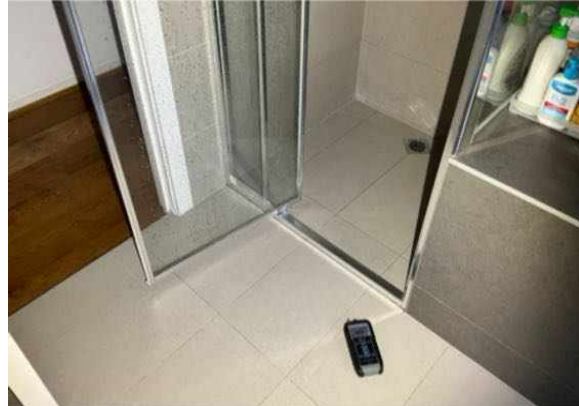
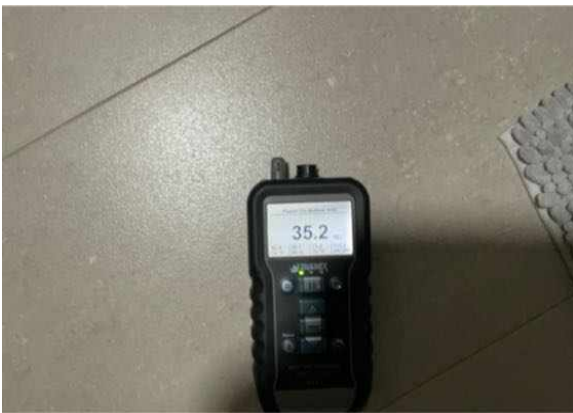
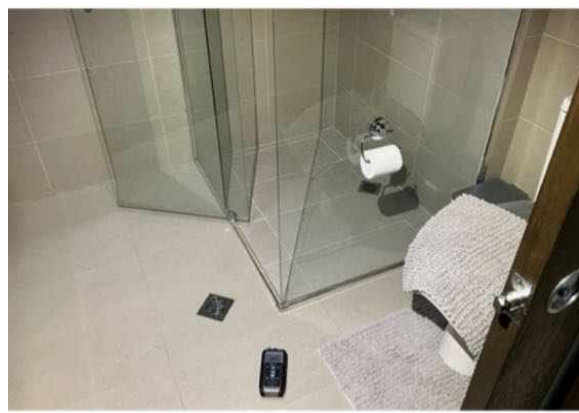
Building:	Main Building
Location:	Bathrooms
Finding:	Showers (For Your Information)
Information:	The showers were inspected by assessing the moisture content of the surrounding floor and walls, no signs of moisture or damage were detected at the time of the assessment in the accessible and visible areas.

Regular maintenance of wet areas is crucial for the long-term protection of your property. To ensure the ongoing integrity of these areas, consulting with a qualified bathroom specialist if any remedial work becomes necessary. This proactive approach

will help to address potential issues before they develop into more significant problems.
