# Building and Timber Pest Inspection Report

Inspection Date: Thu, 2 Apr 2026

Property Address: 28 Churchill Ave, Flora Hill VIC 3550,  
Australia

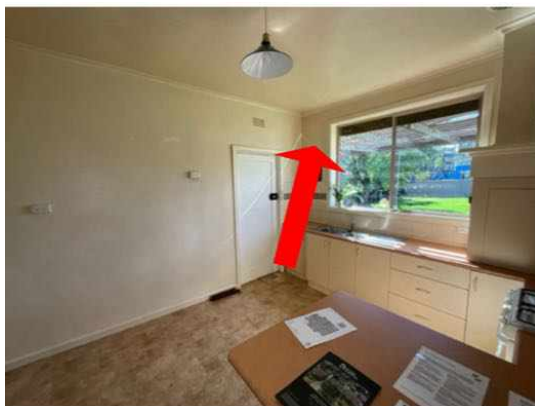
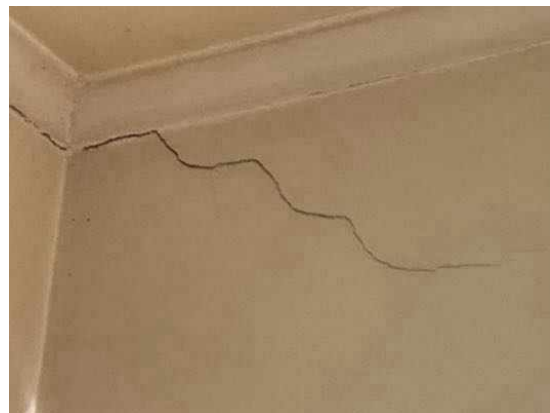
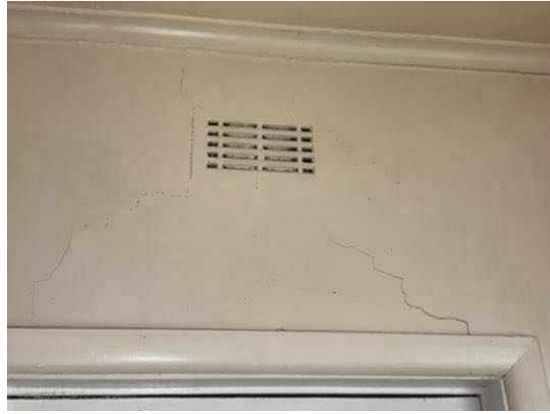
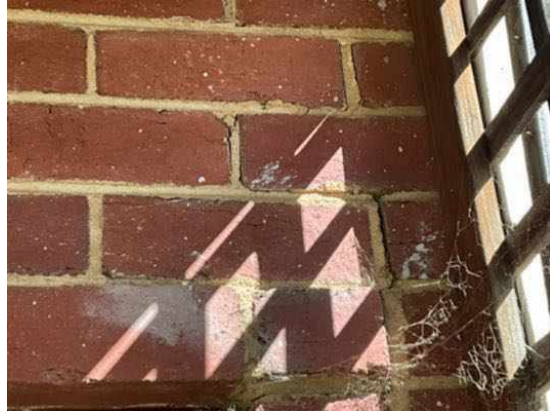
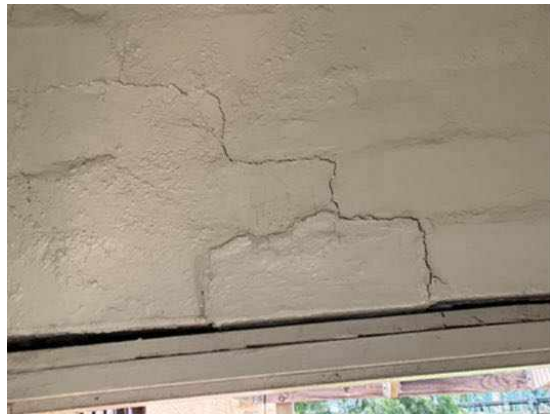
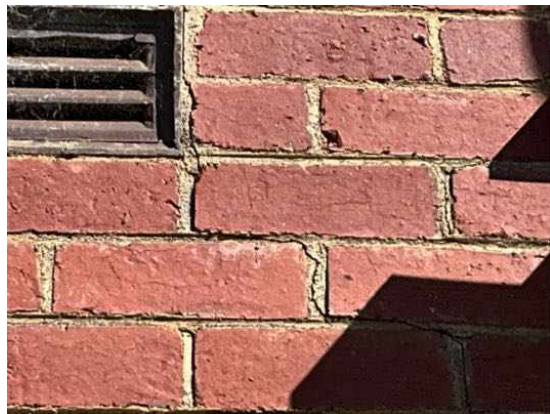
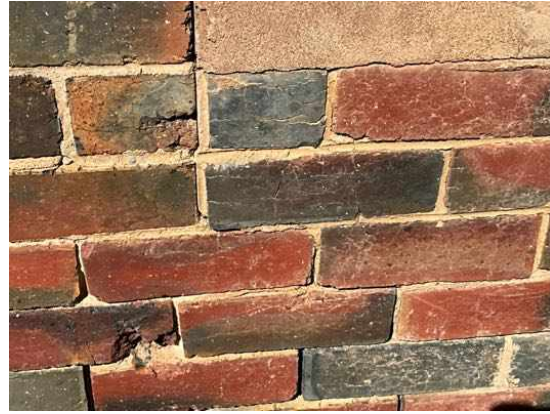
Building: Building 1  
Location: Kitchen, Wc, back wall, driveway side  
Finding: Brickwork- Step cracking  
Information: Step cracking was identified to the brickwork in this area at the time of inspection. Step cracking, which is similar to other forms of cracking, has a variety of possible causes. However, the most common is the subsidence of adjacent footings.

Step cracking is a relatively common defect, and is most likely to occur adjacent to windows, doors and other openings. Mortar failure in the gaps between affected bricks indicates the stresses and tensions affecting the wall.

Minor step cracking can be used as a warning sign to address factors causing stress to the wall, which can include the effect of surrounding trees, water leaks, soil erosion, or even the presence of reactive soils in the surrounding area.

If cracks increase in size or number contact a Licensed builder immediately to make all needed repairs.

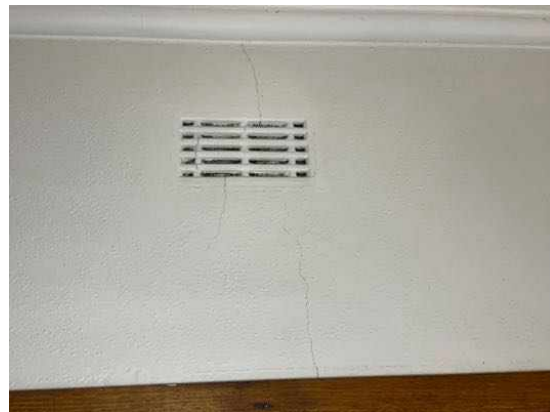
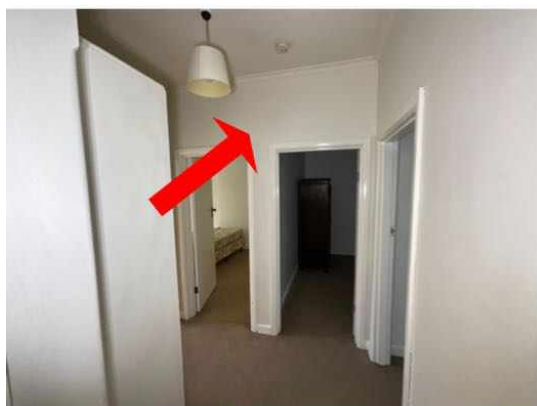
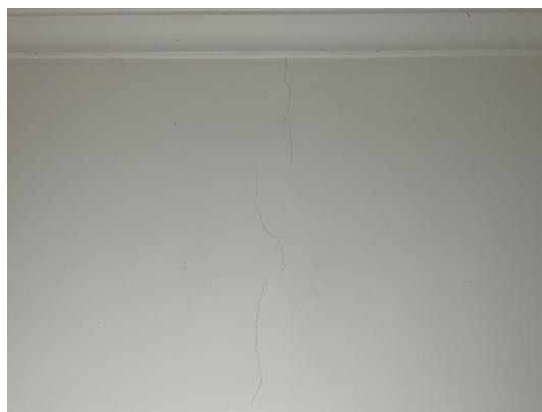
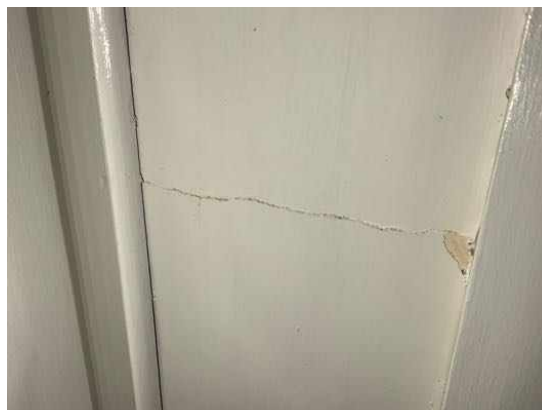
### Finding 3.02

Building: Building 1  
 Location: Living Room, hall  
 Finding: Cracks to internal render - Category 2  
 Information: It has been observed that cracking to internal rendered surfaces has occurred. The degree of damage falls within Category 2, described as noticeable cracks which are easily filled. Cracking of this size are generally less than 5mm in width.

Category 2 damage is required to be monitored for a period of 12 months. After the monitoring period, a crack rated at Category 2 or above is considered a defect requiring rectification.

The extent of cracking would suggest that this is a Major defect.

Always contact your building inspector should cracks widen, lengthen, or become more numerous.

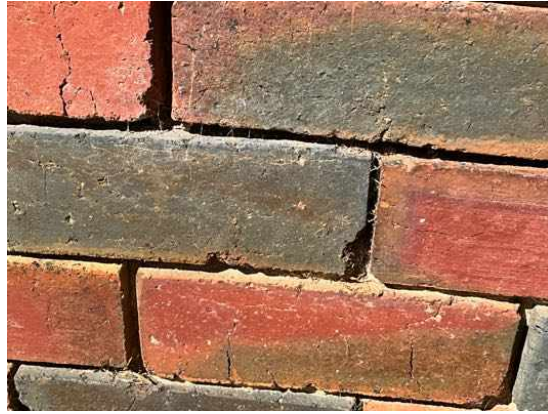
### Finding 3.03

Building:	Building 1
Location:	Driveway
Finding:	Brickwork - Deteriorated mortar
Information:	Mortar, or 'bedding', is the material which fills joints and intersections between bricks in masonry walls and structures. Sections of mortar in this brickwork were identified as having deteriorated, which is generally expected for a property of this age and condition.

Mortar may deteriorate as a result of age of building materials, minor movement of bricks, or frequent exposure to weathering. Mortar should be replaced to ensure that bricks remain in their intended location and to prevent gaps, which would allow water or moisture ingress and secondary damage as a result.

Mortar deterioration can be addressed by a bricklayer where areas of deterioration are localised and easily accessible. Alternatively, appointment of a registered builder is advised, to repoint large areas of decaying mortar. Where secondary structural defects have become evident, consultation with a structural engineer may be required.

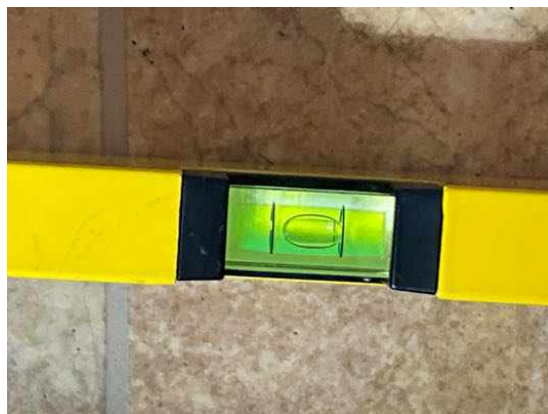
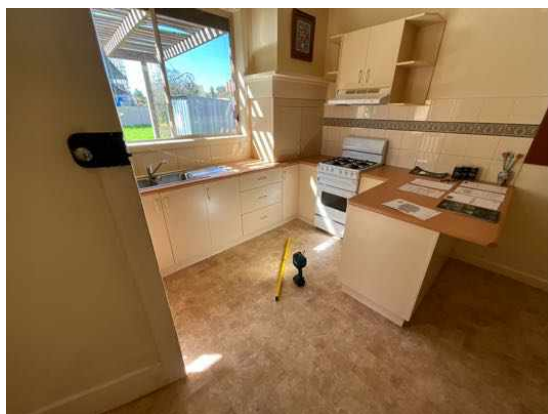
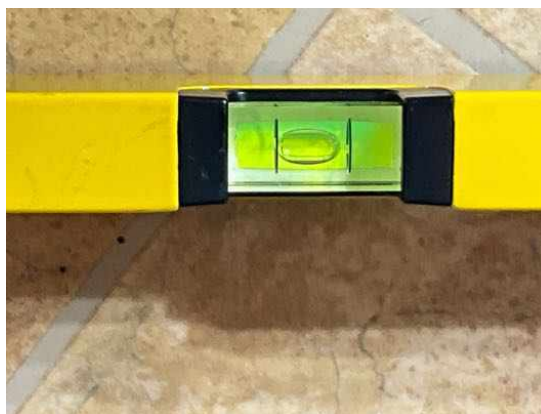
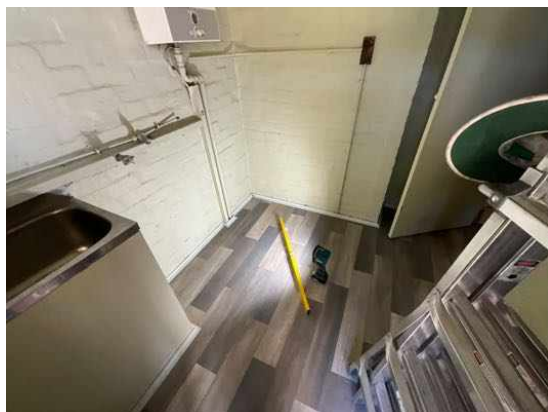
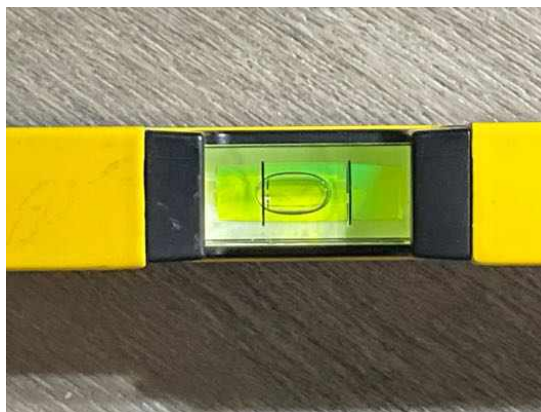
### Finding 3.04

Building: Building 1  
 Location: All Internal Areas  
 Finding: Flooring - Uneven  
 Information: The internal flooring in this area is out of level and uneven. Uneven flooring is likely to indicate minor defects such as expected movement of the foundations of the property, but may also indicate subsidence of the associated subfloor stumps.

It is advised that the flooring be closely monitored to identify any further movement. Where flooring remains relatively unchanged for an extended period of time (i.e. several months), it is likely that this defect has been caused by expected movement of the foundations of the property.

However, where flooring is uneven further, potentially invasive inspection of the subfloor structures and stumps in this area is required. In this case, works to repair are likely to be required, and would be carried out by a registered builder specialising in re-stumping.

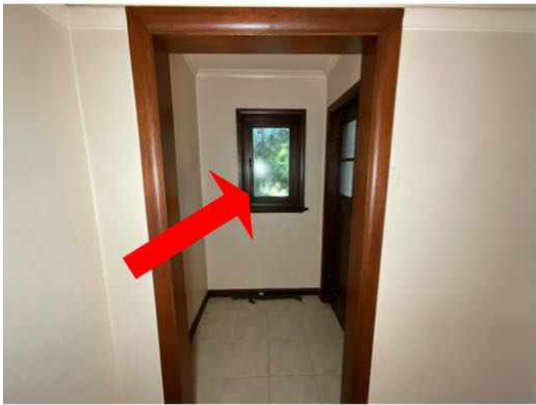
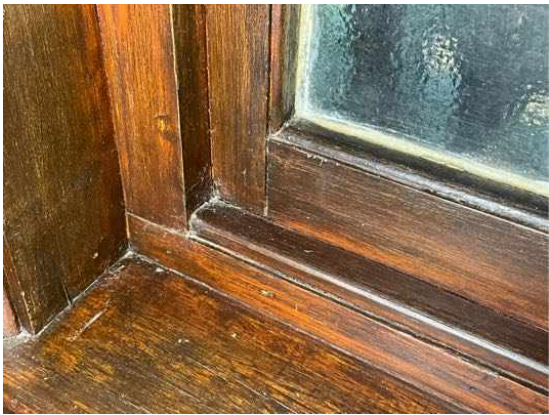
### Finding 3.05

Building:	Building 1
Location:	Entry
Finding:	Window - Binding/jamming
Information:	Binding and/or jamming of this window is evident during standard operation. This defect inhibits the functionality of the affected window as well as creating potential for secondary defects to associated building elements, such as damage to the frame.

A window that binds to the associated frame may have several causes, ranging from minor defects, such as poor installation or deteriorated hinges, through to major structural issues, such as damage to framing structures.

Where binding/jamming appears to indicate major structural issues, a registered builder specialising in re-stumping should be appointed to provide an estimate on the cost of rectification.

For minor causes, a qualified carpenter, general handy person or window specialist should be appointed to perform minor rectification works at client discretion.

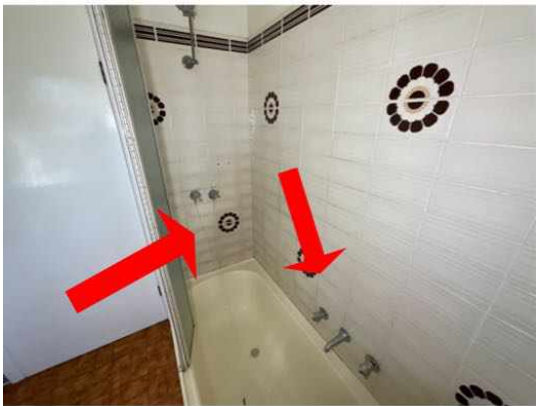
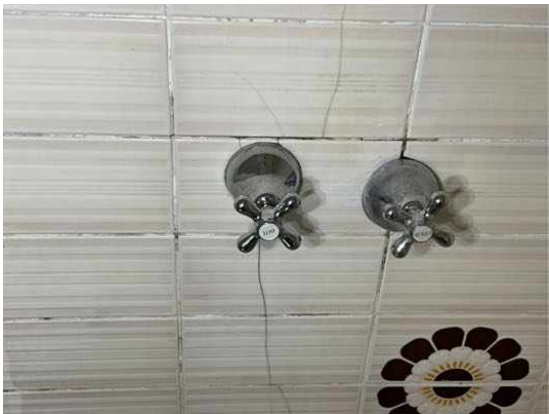
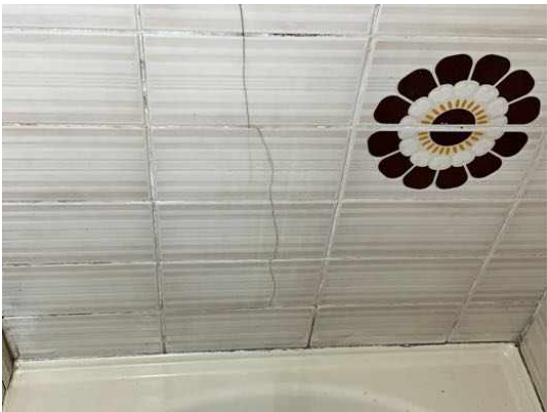
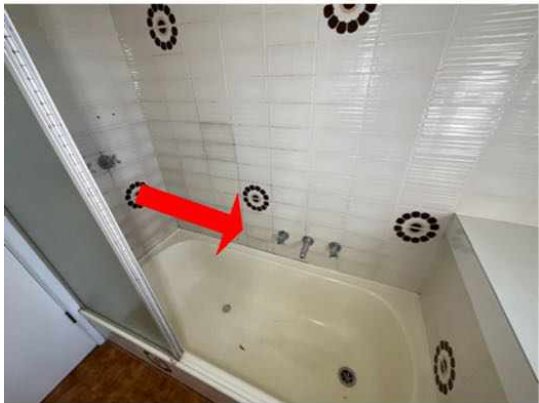
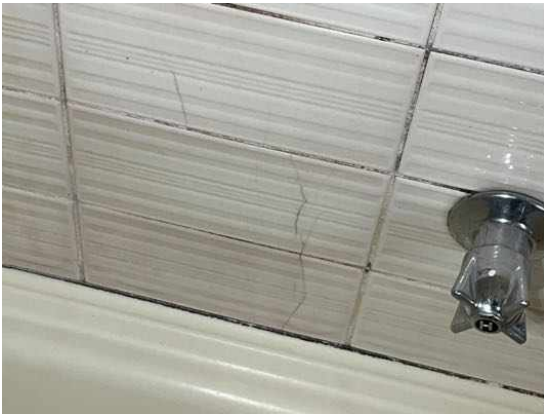
**Finding 3.06**

Building: Building 1  
Location: Bathroom  
Finding: Wall Tiles- Cracked  
Information: Cracked tiles within the household detract from the overall appearance of the affected areas, as well as creating potential for water penetration to adjoining building elements. If left unmanaged, water damage may occur as a result of constant water penetration over a prolonged period of time.

While not considered a matter of urgency, replacement of tiles is advised as a solution. A Tiling Contractor may be appointed to perform these works at client discretion.

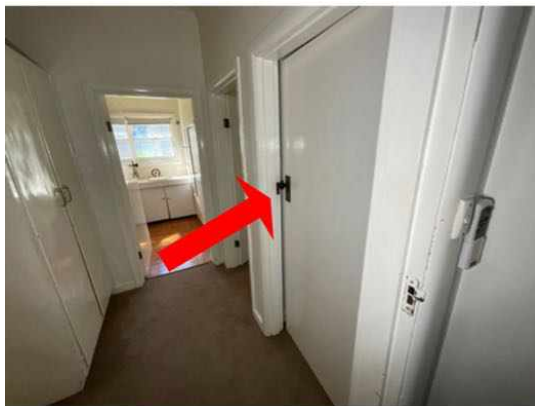
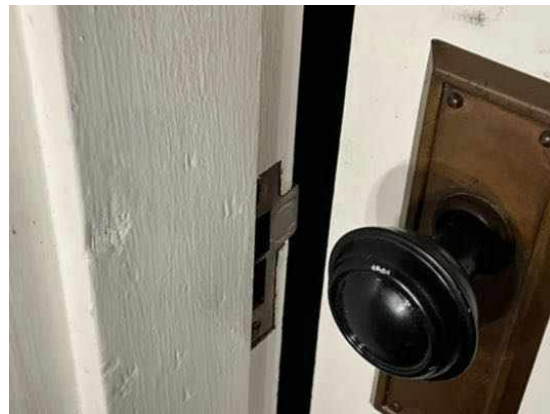
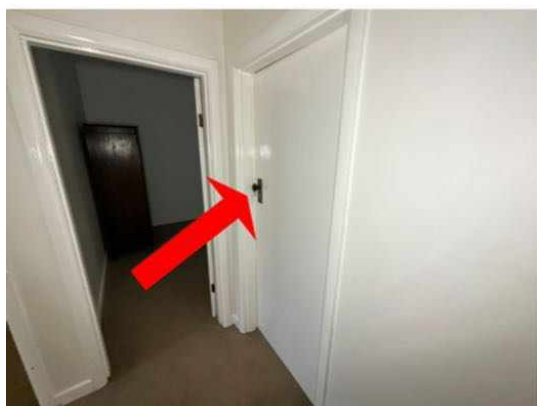
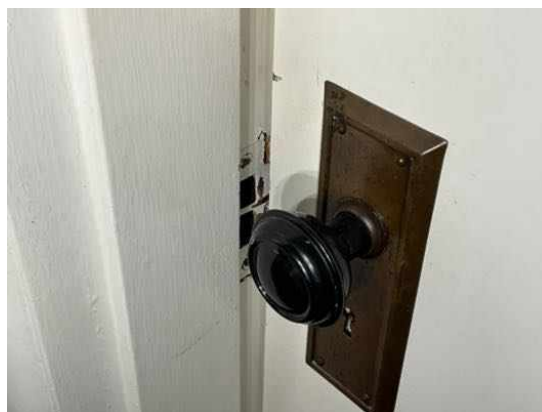
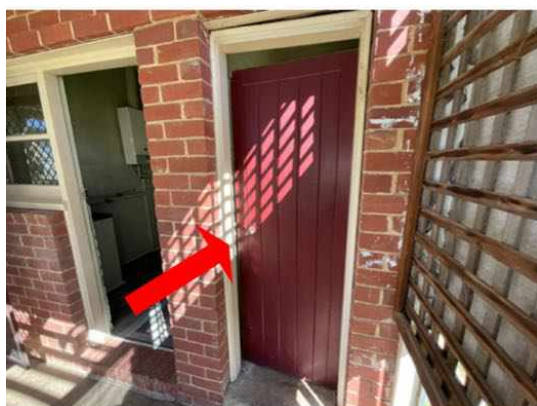
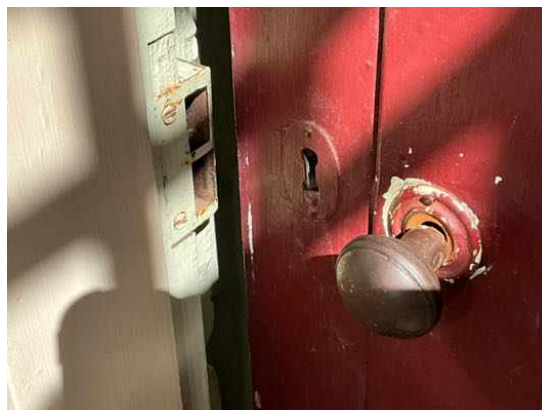
### Finding 3.07

Building: Building 1  
Location: Bedroom 2, 3, Wc  
Finding: Door - Striker plate misaligned  
Information: The striker plate to this door appears to have become misaligned and has consequently resulted in the door's operation being compromised.

This is a common defect and is expected in a property of this age, whether being due to substandard installation or general deterioration of the door hardware.

Readjustment of the striker plate is recommended at client discretion. Works such as these can be completed by a general handyman or qualified carpenter.

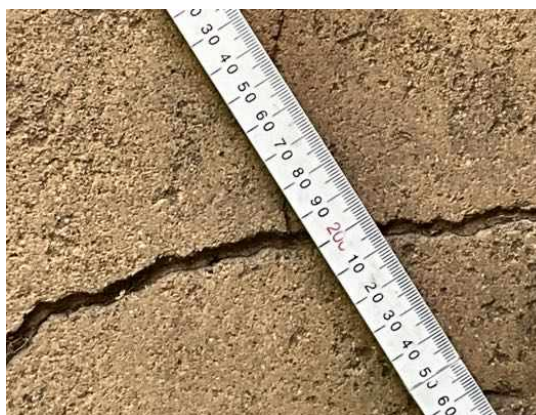
### Finding 3.08

Building:	Building 1
Location:	Verandah front and back
Finding:	Cracking - External Concrete Paving Damage Category 3 - Wide Cracks (2mm - 4mm)
Information:	Wide cracks were identified in external concrete paving Wide cracks are significant and are likely to lead to the development of safety hazards and secondary defects if left unmanaged.

General age and expected deterioration of the paved areas is a common cause of this type of cracking. However, expansion and contraction of the slab may also have occurred due to environmental factors. Such factors include variable moisture and weather conditions, the presence of trees and their roots having a settling or lifting affect on the soil, or the effect of load bearing, e.g. heavy vehicles over a sustained period of time.

Cracking to this degree may also be due to poor original installation of the concrete. Factors such as poor compaction of the sub surface and/or inadequate reinforcing of the slab may create cracking and other secondary defects. Wide cracks may also have a more significant structural cause, such as subsidence of soils.

Where the crack is located adjacent to structural elements of the building, the advice of a Structural Engineer is advisable before undertaking repairs. Significant repair and likely replacement of the concrete paving is probable.

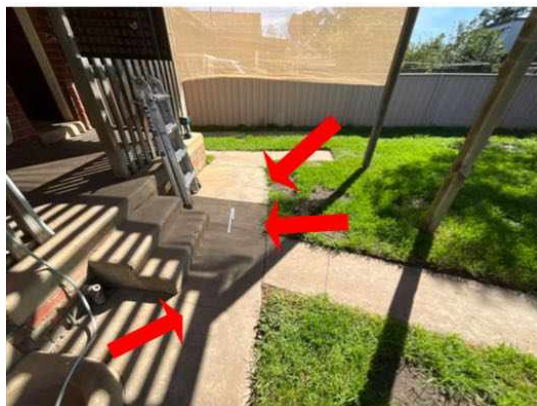
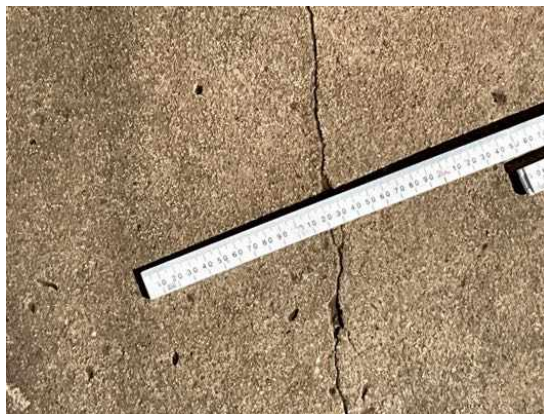
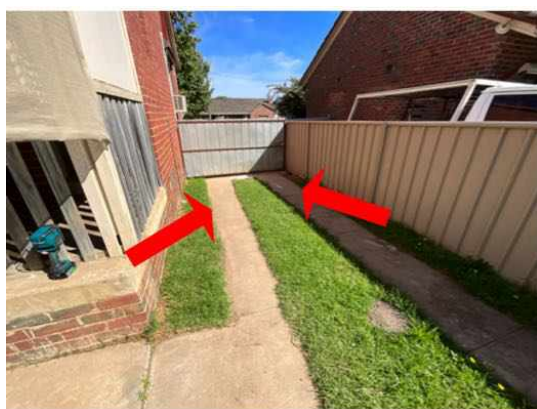
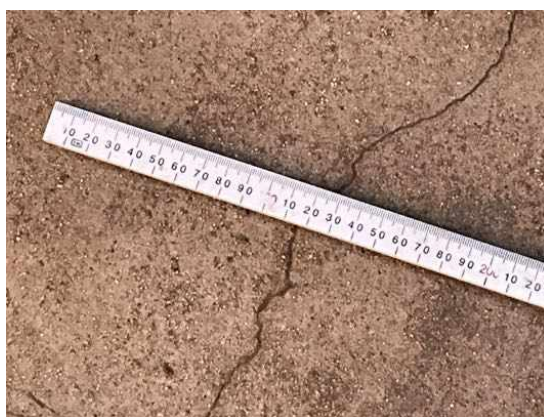
### Finding 3.09

Building:	Building 1
Location:	Yard - Back
Finding:	Cracking - External Concrete Paving Damage Category 2 - Distinct (less than 3mm)
Information:	Distinct cracks were identified in external concrete paving. Distinct cracks are generally found in older concrete paving, and may also present as a trip hazard as consequence of an uneven or curved surface.

General age and expected deterioration of the paved areas is a common cause of this type of cracking. However, expansion and contraction of the slab may also have occurred due to environmental factors. Such factors include variable moisture and weather conditions, the presence of trees and their roots having a settling or lifting affect on the soil, or the effect of load bearing, e.g. heavy vehicles over a sustained period of time.

Cracking to this degree may also be due to poor original installation of the concrete. Factors such as poor compaction of the sub surface and/or inadequate reinforcing of the slab may create cracking and other secondary defects.

Repairs are likely to be required to prevent further cracking and to reduce hazards associated with cracking, such as tripping. Monitoring of all cracking should be

conducted frequently. Always contact a building inspector should cracks widen, lengthen, or become more numerous.

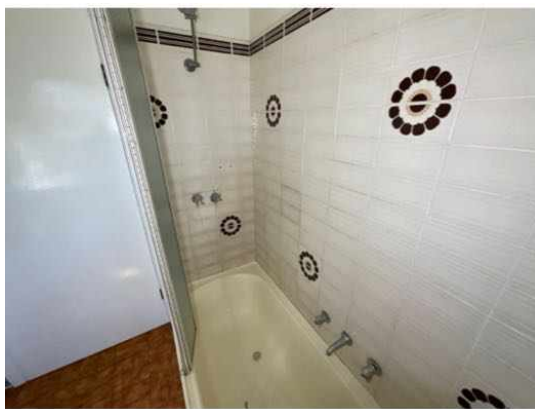
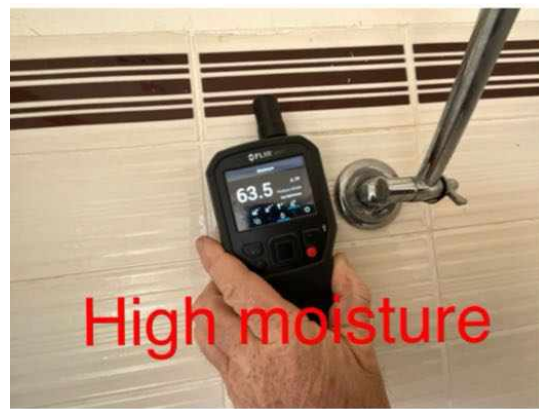
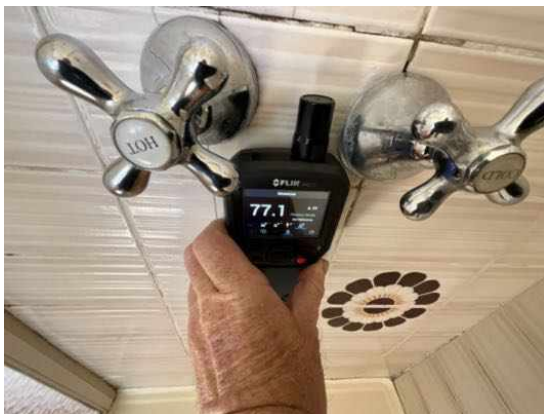
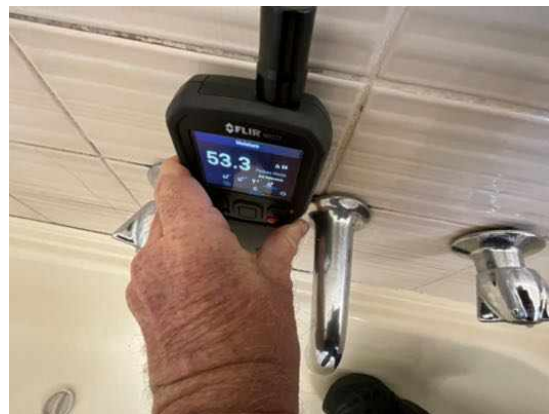
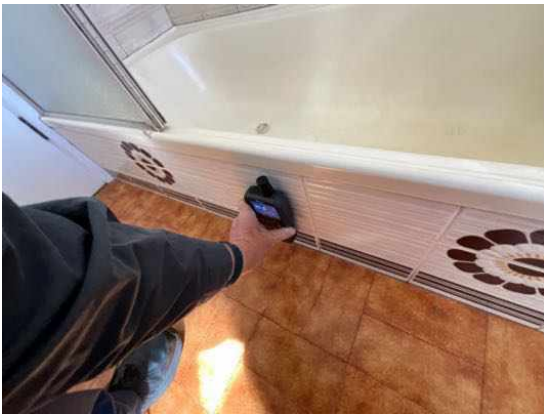
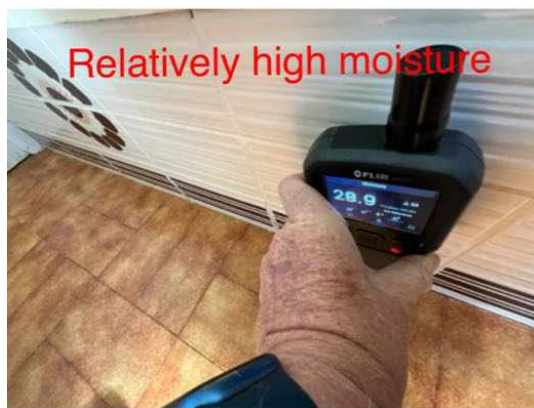
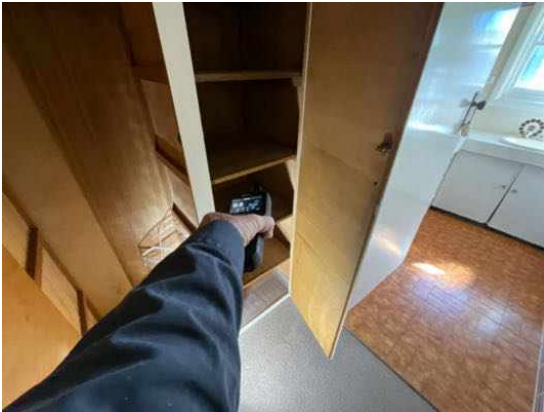
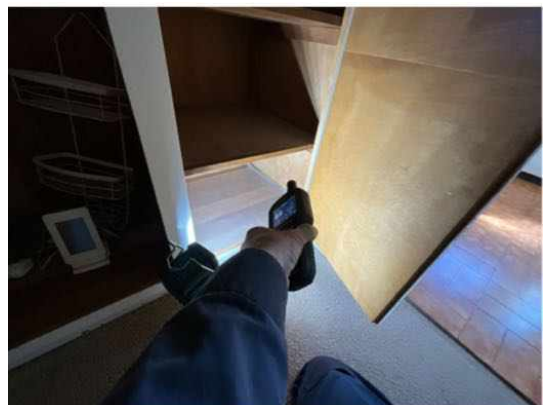
Building:	Building 1
Location:	Bathroom
Finding:	Showers Damp- Major
Information:	Damp is evident to the lower 300mm of wall to the Shower Alcove. This is suspected to have been caused by moisture permeating through the grouting in this area, which shows evidence of deterioration.

High levels of moisture were observed on the outside of the shower walls in the opposite wall.

Damp (or structural damp) refers to the presence of unwanted moisture in the structure of the building, either as a result of intrusion from outside, or condensation from within the structure. In the Shower area, internal water leaks or other sources of excessive moisture are generally the cause of damp.

Consultation with a qualified Plumber or Bathroom Specialist is advised immediately to identify the cause of damp and to perform remedial works as required.

Always ensure that sealant and grout is in good condition to prevent any moisture issues occurring in the future.

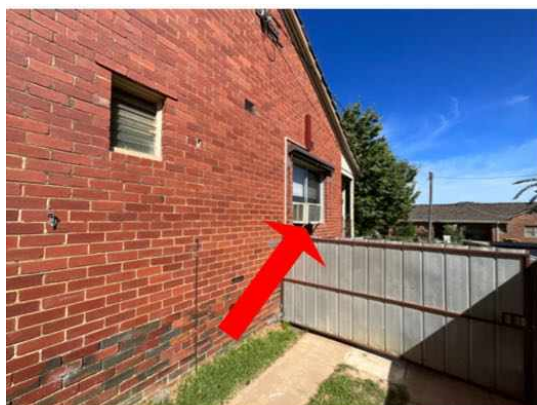
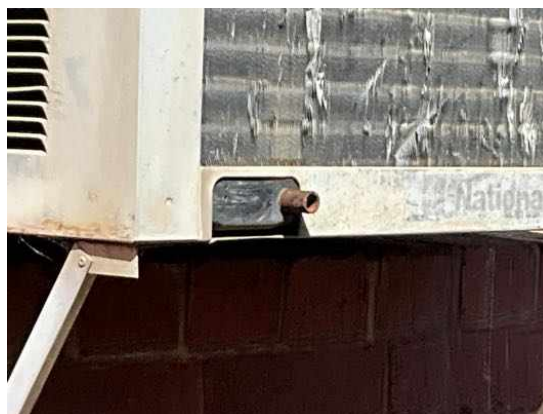
## Finding 6.02

Building:	Building 1
Location:	Driveway
Finding:	Air conditioner - Disconnected overflow
Information:	The Air Conditioner (A/C) overflow was found to be disconnected from storm water drainage and is creating excessive moisture in the surrounding area.

Such leaking creates an environment which is conducive to an array of defects, including water damage to associated building elements and the attraction of termite or timber pest infestation.

It is highly recommended that a licensed plumber be appointed to connect the A/C

overflow in order to prevent such an environment from being created. These minor works should be carried out as soon as possible.

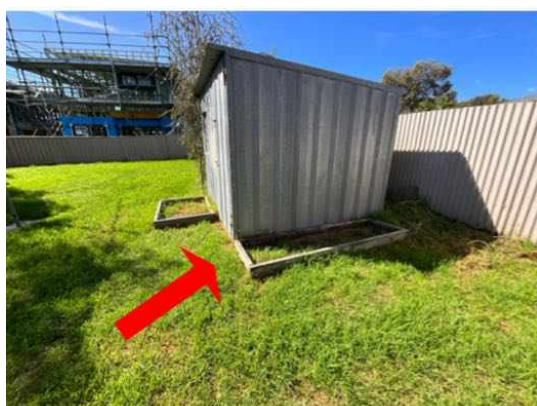
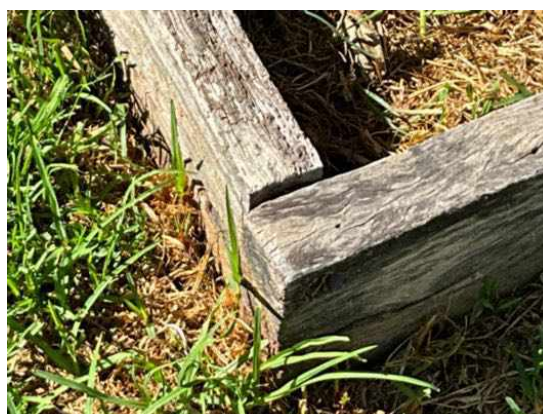
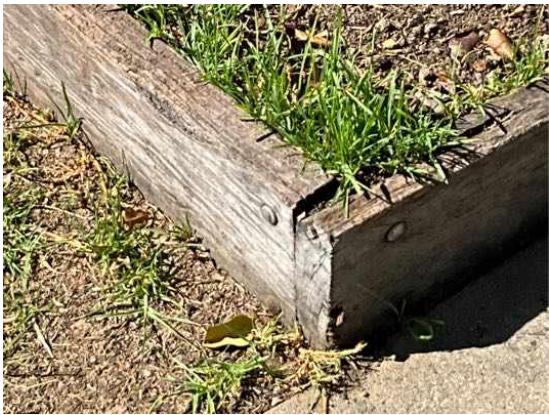
### Finding 6.03

Building: Building 1  
Location: Yard - Back, front  
Finding: Untreated or non-durable timbers in a hazardous environment  
Information: To reduce the risk of timber pest attack it is essential that timber used in a hazardous environment (e.g. in direct contact with the ground or frequently exposed to damp conditions) is of sufficient durability and/or is adequately preservative treated.

Untreated timbers in direct contact with the ground are likely to develop severe wood rot and/or fungal decay if left unattended creating attraction for subterranean termites to infest the timbers from surrounding areas.

If untreated or non-durable timbers are found to be in a hazardous environment it is highly advised that replacement of these building elements be performed as soon as possible to aid the protection of the property against termite / timber pest attack.

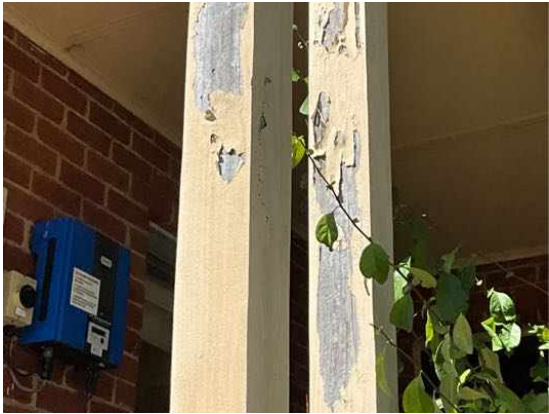
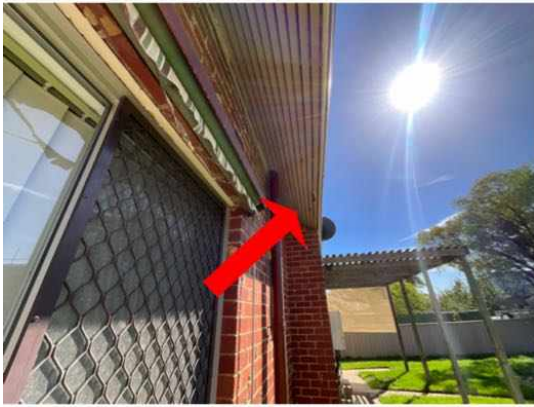
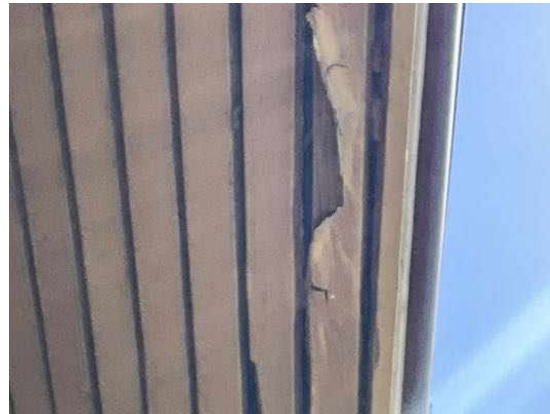
**Finding 6.04**

Building: Building 1  
 Location: All External Areas  
 Finding: External painting deteriorated  
 Information: Much of the external paintwork including but not limited to windows, fascias, guttering, veranda and other external fitments have been neglected and require attention to prepare and re-paint.

Whilst incomplete or missing paint finish is generally an appearance defect, it can also lead to the development of secondary building defects over time. Incomplete areas of paint finish expose the area to moisture, potentially accelerating the deterioration of underlying building materials.

Degraded paint finishes should be sanded back, filled, leveled and painted, as applicable. Where inadequate or missing paint protection has led to the deterioration of the associated building element, repair and/or replacement of this building element may be required.

A painting contractor should be appointed as soon as possible to perform necessary works to aid the appearance of the affected area and to ensure the area is protected against further deterioration. Alternatively, the homeowner following manufacturer instructions may perform these works.

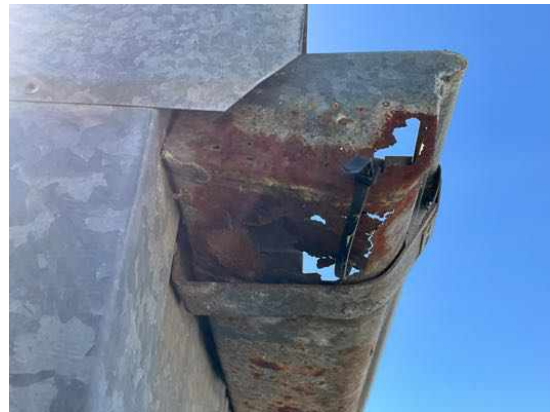
### Finding 6.05

Building:	Building 1
Location:	Shed
Finding:	Gutters- Deteriorated
Information:	The guttering and some downpipes have deteriorated.

Although not a major problem now, they will deteriorate further if left for an extended period.

Sagging can be seen in the gutter.

A Licensed Plumber should be engaged as soon as possible to advise on any repairs or maintenance that may be required.

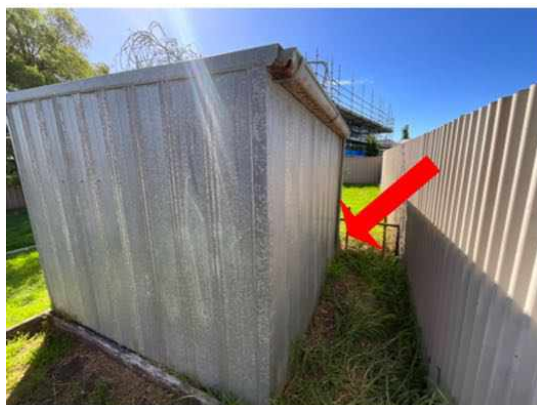
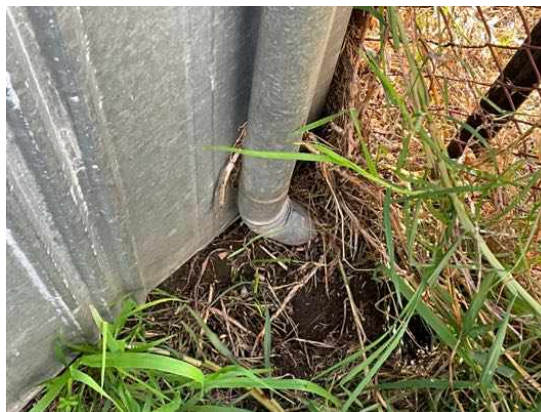
### Finding 6.06

Building:	Building 1
Location:	Shed
Finding:	Stormwater drain - Not connected
Information:	The roof plumbing is not adequately connected to stormwater drainage on the site. This disconnection negatively impacts the functional capacity of the roof plumbing.

become excessively damp, potentially creating an environment that is susceptible to rust and corrosion of surrounding building elements, as well as attracting termites and other pests.

It is highly recommended that a plumber be appointed to further inspect the area and to install adequate drainage equipment where necessary.

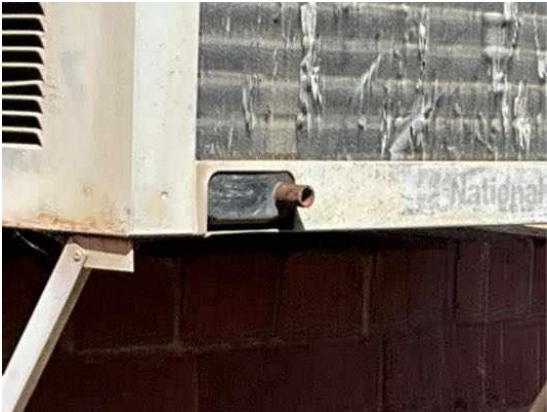
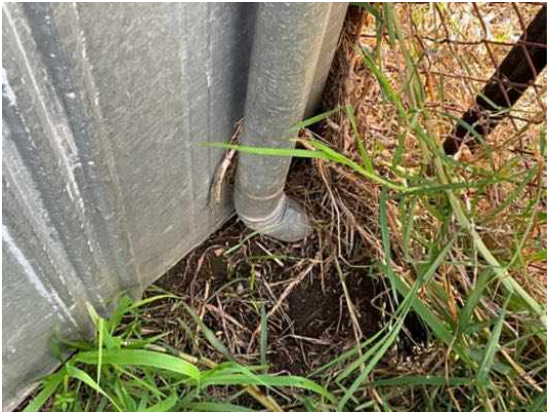
### Finding 6.07

Building:	Building 1
Location:	All External Areas
Finding:	Termite Management System - no evidence of a chemical installation
Information:	The application of a post-construction chemical termite barrier is highly recommended for all properties, particularly if live termite activity has been found on the site previously. Such barriers are highly effective in preventing termite attack on any timber building elements throughout the property.

A durable notice should be placed in the switchboard unit to indicate current termite barriers. At the time of inspection, it appeared as though no termite management system has been installed, with no evidence to suggest preventative works taking place.

The client may consider gaining further advice from a pest controller as to the costs and procedures involved with this application. It is recommended that obtaining such advice be a short-term priority.

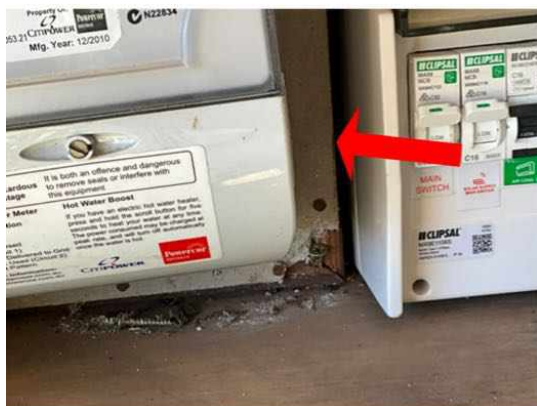
Building:	Building 1
Location:	Laundry, Wc, verandah, meters
Finding:	Asbestos - Suspected ACM Identified on Site
Information:	Reporting on Asbestos is outside the Scope of this Report. This suspected defect is highlighted as a caution only. We suspect, based on our experience in the building industry, that there is a higher risk of the identified building element containing asbestos.

As Asbestos Reporting is outside the scope of this report, we advise that you consider a separate Asbestos Inspection and Condition Audit, which can include the taking of samples for definitive confirmation of the presence of Asbestos.

In the interim, the client is advised to act with caution, especially when considering any damage to building materials general wear and tear renovations extensions demolition and general maintenance activities due to the suspected presence of Asbestos.

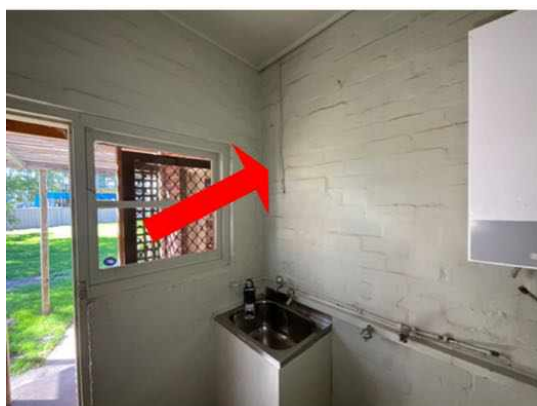
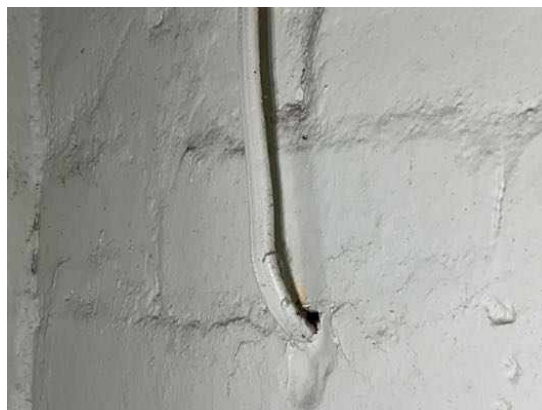
Building: Building 1  
 Location: All Areas  
 Finding: Plumbing and Electrical  
 Information: All gas appliances need to be serviced and maintained in good order.

It is highly recommended that the client makes immediate arrangements to have the gas appliances checked by a licensed gas plumber to ensure that the appliances are working safely and efficiently.

We recommend all other installations be checked also.

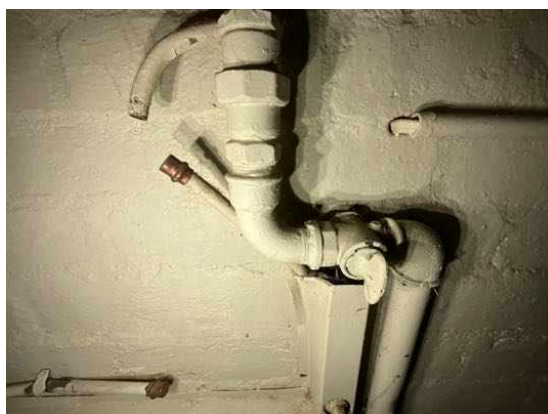
Location: Laundry  
Finding: Gas water heater  
Information: This unit has been permanently disabled.

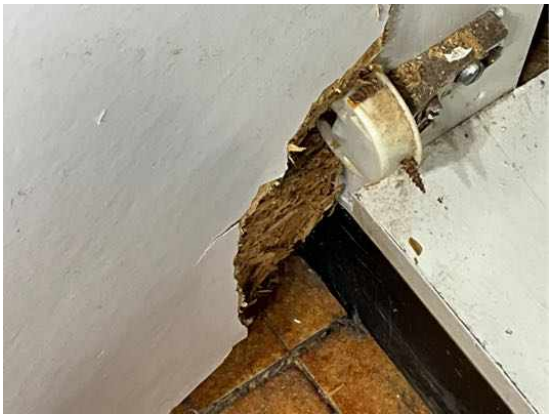
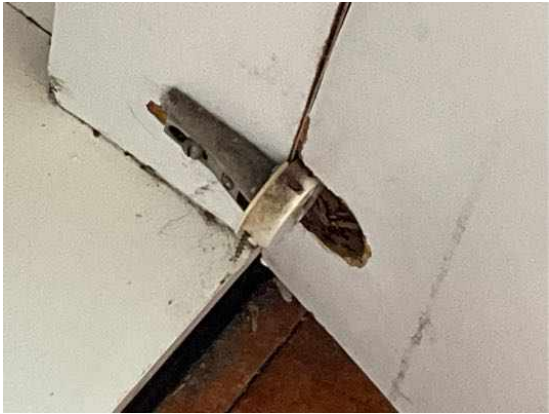
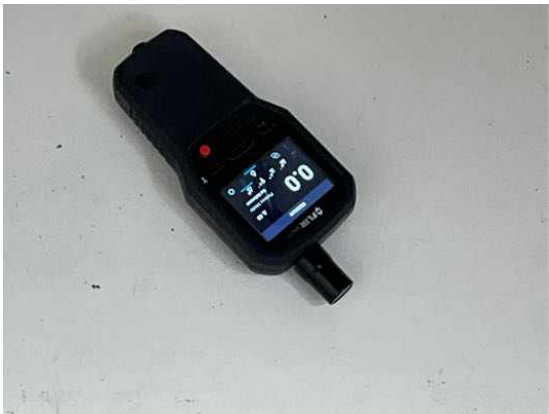
Building: Building 1  
Location: Bathroom  
Finding: Cabinets- moisture affected.  
Information: The structure of the Cabinets in this area was found to be deteriorating due to the effects of excessive moisture. Replacement of any damaged board materials is recommended. Parts of the Cabinetry not badly damaged or swollen may be re-sealed or painted.

The source of the moisture must be identified and rectified before repairs and replacement is carried out. The services of a Cabinet maker or General Handy Person should be sought at the discretion of the owner.

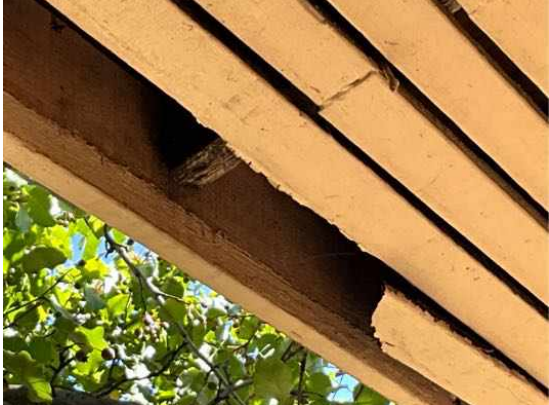
Building: Building 1  
Location: Eaves  
Finding: Incomplete or substandard works  
Information: The works to this area appear to be incomplete or have been completed to a substandard level.

Works that have not been completed to a satisfactory level create potential for the development of building defects and may impede on the safety and integrity of the overall structure.

It is highly recommended that the relevant trades be appointed to complete these

works and ensure the safety of the area and the longevity of all associated building elements.

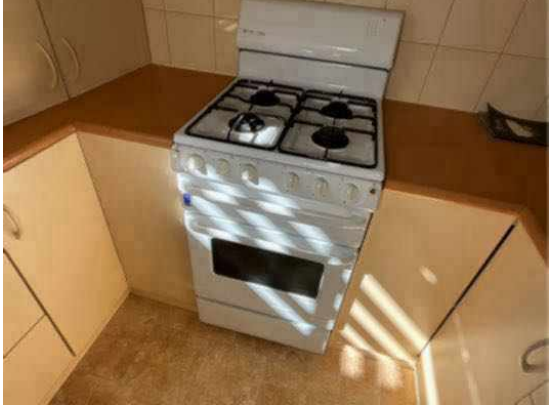
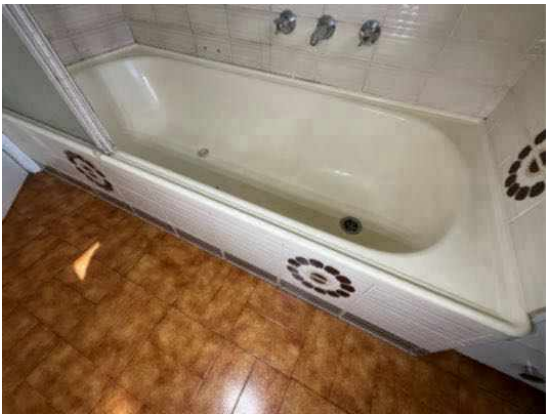
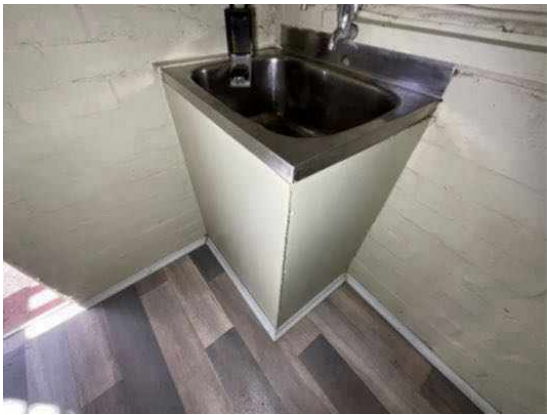
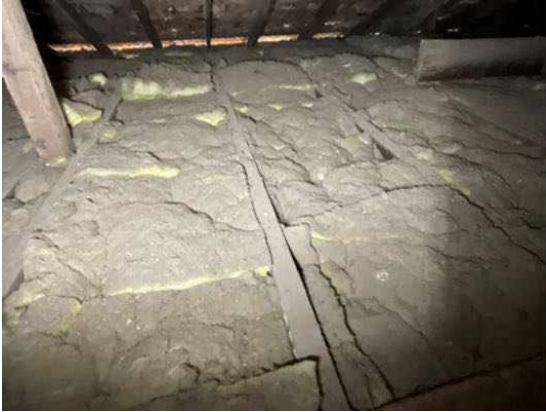
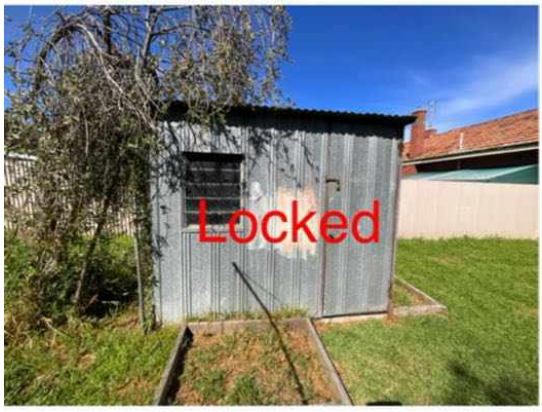
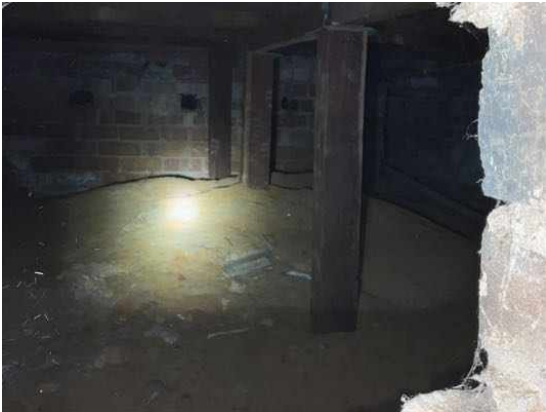
Building: Building 1  
Location: All Areas  
Finding: Additional Photos - Obstructions and Limitations  
Information: These photographs are an indication of the obstructions and limitations which impeded full inspection of the property at the time of inspection. These obstructions can hide an array of defects and should be removed to allow full inspection to be carried out. A re-inspection is recommended once the areas are made accessible.
