## Building Inspection Report

Inspection Date: Tue, 7 Apr 2026

Property Address: 2/3 Dagola Ave, Nunawading VIC 3131,  
Australia

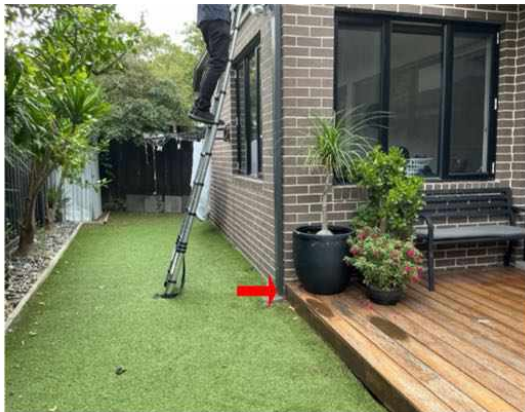
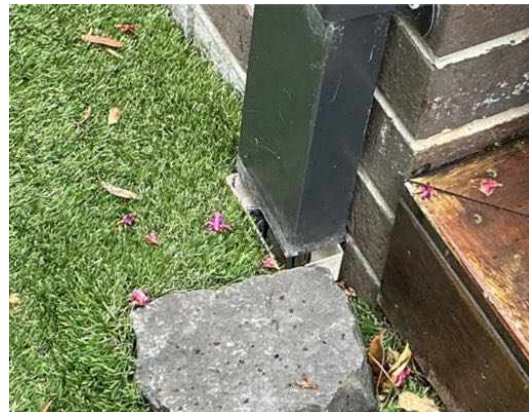
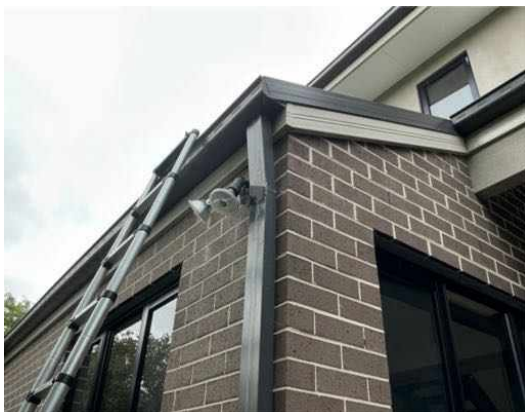
#### Defects 2.01

Where roof plumbing doesn't drain adequately, the area at the base perimeter can become excessively damp, potentially creating an environment that is susceptible to rust and corrosion of surrounding building elements, as well as attracting termites and other pests.

It is highly recommended that a plumber be appointed to further inspect the area and to install adequate drainage equipment where necessary.

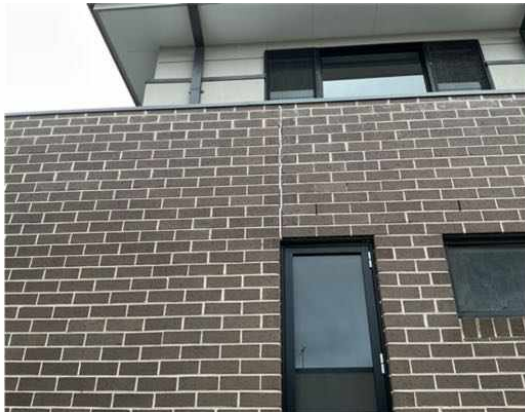
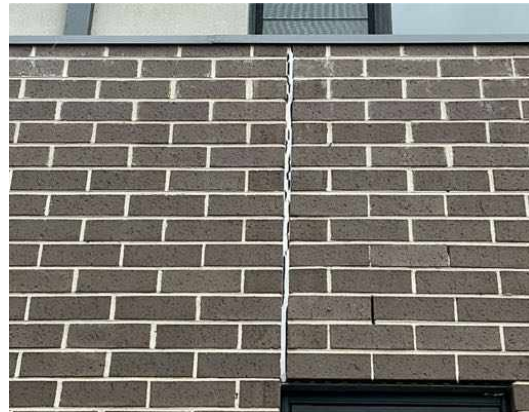
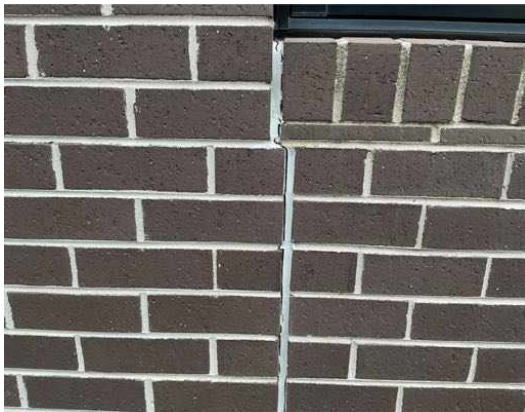
### Defects 3.01

Building:	Main Building
Location:	Control joins
Finding:	Caulking/sealant to junctions - Missing
Information:	Areas where waterproof sealant to is missing to junctions were identified.

All Sealant/ Caulking works should be completed by the builder prior to final handover.

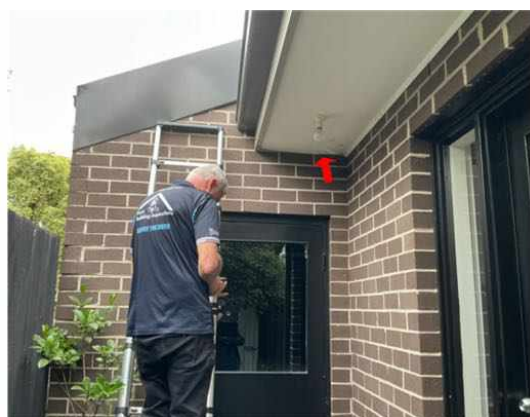
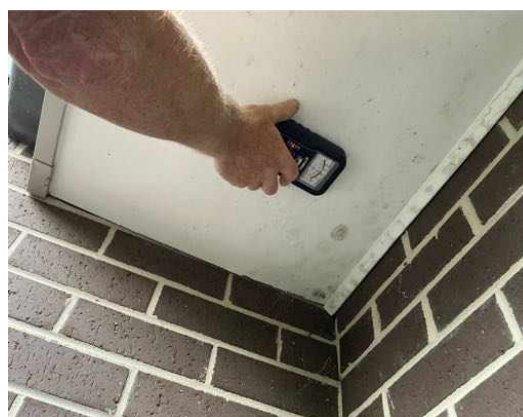
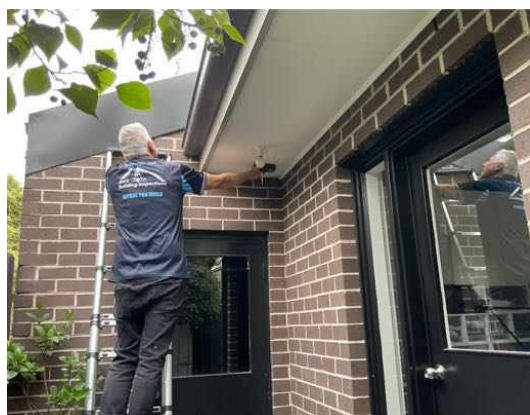
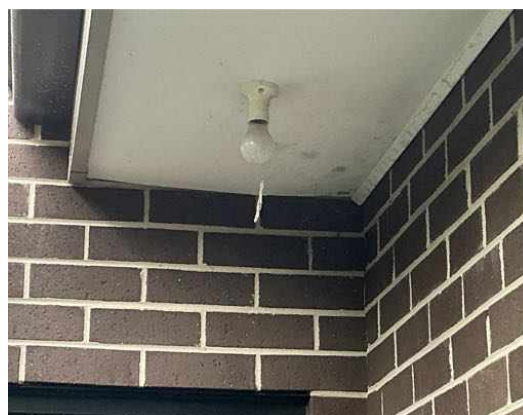
### Defects 3.02

Building:	Main Building
Location:	Rear Elevation
Finding:	Eaves - Sagging
Information:	Sagging to the eaves was evident in this area at the time of inspection. This type of defect is generally consistent with older properties, where the eave sheeting has worn over time.

Sagging eaves are susceptible to the attraction of excessive moisture, and are therefore considered non-functional. This defect also detracts from the overall appearance and condition of the roofing structure and any associated structures.

A roofing plumbing or general handyman is recommended to perform rectification works as soon as possible. Subsequent water damage is likely to result over time if left unattended.

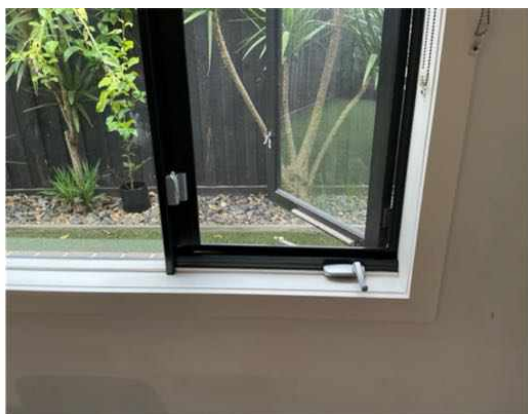
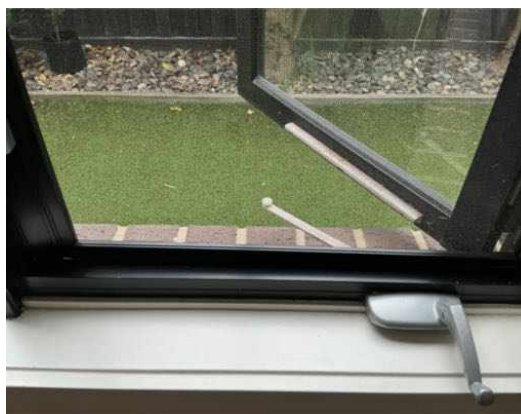
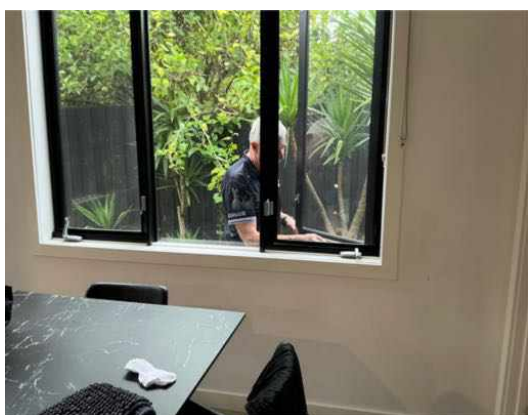
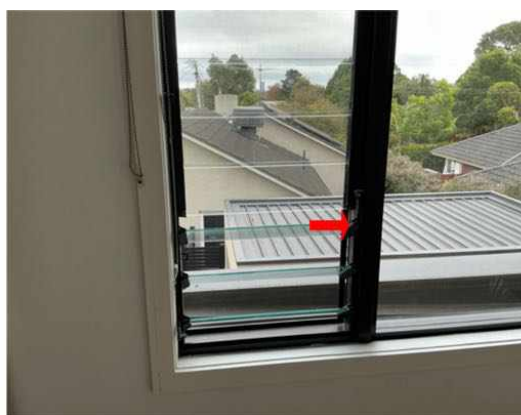
### Defects 3.03

Building:	Main Building
Location:	Dining Room
Finding:	Window- Broken handle
Information:	The window handle in this area was found to be broken at the time of inspection. Breakage occurs generally when the building materials have aged and decayed, but may be indicative of impact damage (accidental or deliberate).

Repair and/or replacement of the broken handle is advised to improve the operational state of the associated window

A qualified carpenter or general handyman should be appointed to repair/replace the handle at the client's discretion.

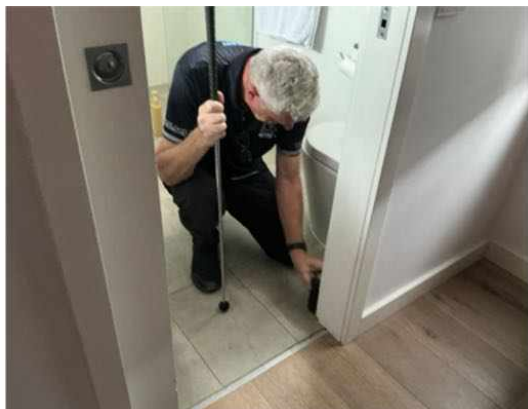
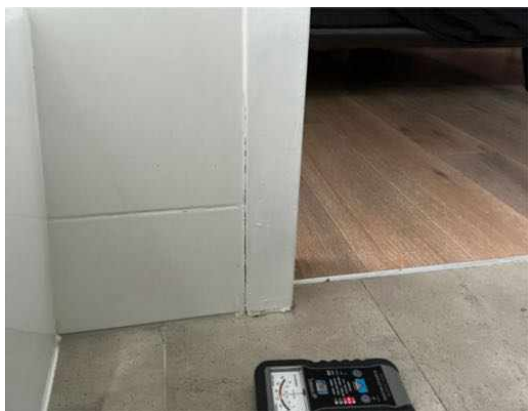
### Defects 3.04

Building:	Main Building
Location:	Ensuite - Master
Finding:	Building element - Swollen
Information:	Swollen building elements generally indicate that the building materials have been affected by excessive moisture over a prolonged period of time, and have swollen as a result. The formation and development of mould/fungi or mildew is also a likely consequence of excessive moisture, which may pose major respiratory issues for occupants, particularly the elderly, the very young and those with existing illnesses and could be potential health safety hazards. In these cases an appropriately qualified inspector/tester should also be contacted for advice and/or technical assistance.

The structural integrity of swollen building elements can not be guaranteed, and further damage is likely to develop if left unmanaged. Excessive moisture is likely to lead to the development of secondary damage to any associated building elements, which may necessitate major reparation works if prolonged.

Rectification of the cause of the water leak should be addressed prior to any remedial works to the swollen building elements. A licensed plumber should be appointed

immediately to identify the cause of the leak and provide advice on remedial works as necessary, Repair and/or replacement of swollen building elements should be conducted as a matter of urgency by a registered builder or qualified carpenter.

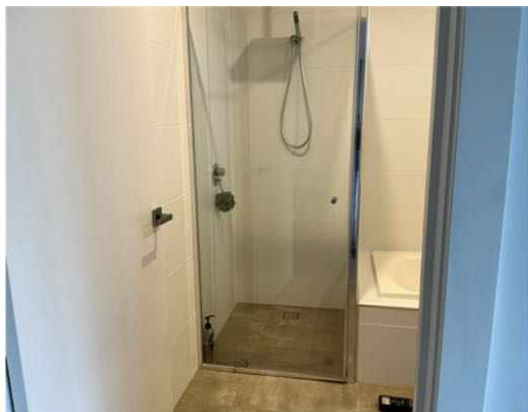
### Defects 3.05

Building:	Main Building
Location:	Bathroom
Finding:	Sticking or jamming
Information:	Building elements which are sticking or jamming are difficult to operate and don't function as intended. There are a variety of causes for sticking and jamming.

The most usual causes are swelling of timbers due to moisture, bulging or bowing of metal frames, or general material deterioration. Generally, sticking and jamming building elements indicate that their frames are uneven or out of level, generally as result of movement to surrounding walls and floors.

Appointment of a carpenter or general handyman is recommended to rectify any

sticking/jamming building elements.

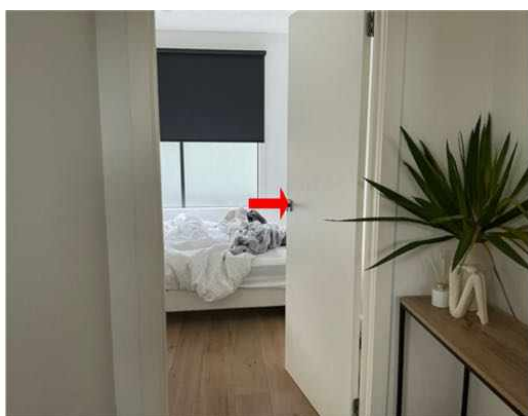
### Defects 3.06

Building:	Main Building
Location:	Bedroom
Finding:	Door handle - Not latching
Information:	It was noted that the door in this area was not latching during operation at the time of inspection. Whilst detracting from the functionality of this building element, this minor defect may also be a security risk, and may therefore have serious implications if left unattended.

It is suspected that this defect has occurred due to minor issues with the associated hinges. Such damage is identified as general wear and tear, which is expected for building elements of this age.

A qualified carpenter or general handyperson may be appointed to perform rectification works as necessary, at client discretion. If left unattended, further functional impairment is likely to occur.

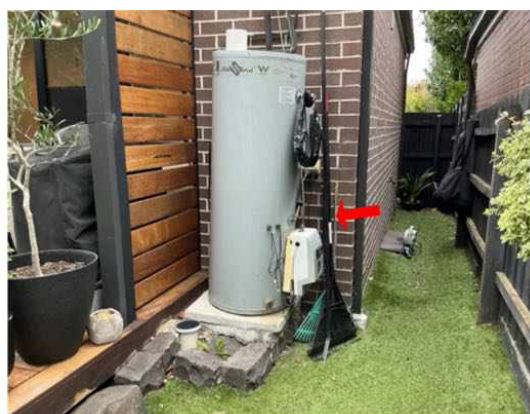
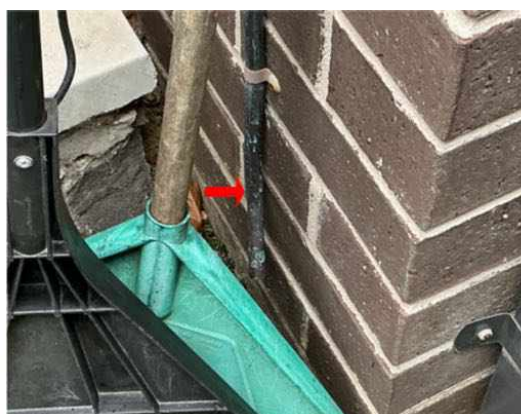
### Defects 3.07

Building:	Main Building
Location:	Rear Elevation

Finding: HWS Overflow - Not Connected  
 Information: The Hot Water System (HWS) overflow was found to be disconnected from storm water drainage and is creating excessive moisture in the surrounding area.

These damp conditions can lead to secondary defects such as rot, rust or corrosion of associated building elements, the formation of fungal decay, or even the creation of potential slip hazards. When coupled with poor site drainage, pooling of water may also attract termite activity to this area.

It is highly recommended that a licensed plumber be appointed to connect the HWS overflow in order to prevent such an environment from being created. These minor works should be carried out as soon as possible.

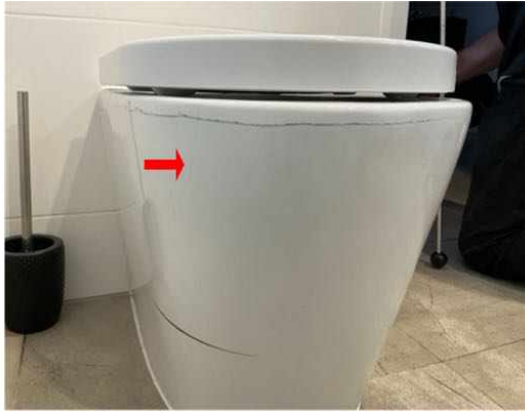
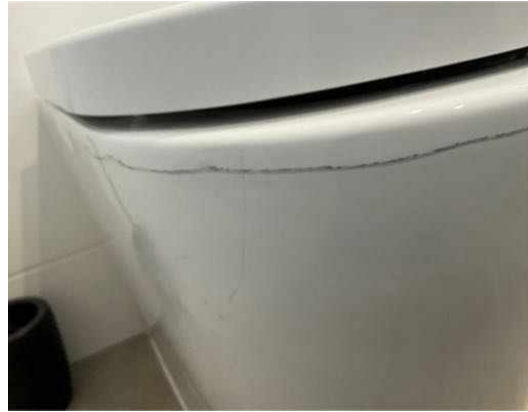
### Defects 3.08

Building: Main Building  
 Location: Ensuite - Master  
 Finding: Toilet- Cracked  
 Information: Cracking was evident to the toilet base at the time of inspection, which is suspected to have been by minor impact damage and age. While the cracking appears to be minor, this will continue to deteriorate and may leak if not replaced.

As the cracking provides potential for water leaks, secondary water damage may occur to associated cabinetry, walls or flooring, if the cracking is left unmanaged.

Consultation with a plumber regarding replacement is required. Remedial works may be required to protect against any further damage.

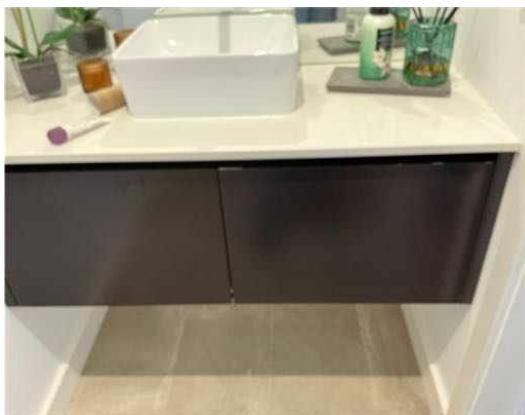
### Defects 3.09

Building:	Main Building
Location:	Powder Room
Finding:	Cabinetry - Loose hinges
Information:	Several cupboard doors are not level and detract from the operational state of the cabinetry. Upon further inspection, it was noted that the hinges to the cupboard doors have deteriorated over time and, as a result, have come loose from their original fixing. To improve operation of the affected cupboard doors, a general handyman may be appointed to replace the faulty hinges. Such works should be completed at discretion of the client.

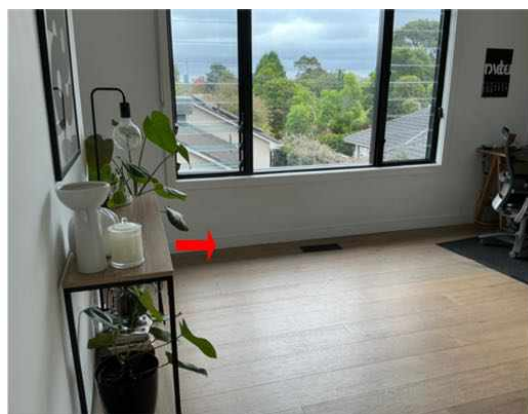
## Defects 3.10

Building:	Main Building
Location:	Rumpus Room
Finding:	Building element - Swollen
Information:	Swollen building elements generally indicate that the building materials have been affected by excessive moisture over a prolonged period of time, and have swollen as a result. The formation and development of mould/fungi or mildew is also a likely consequence of excessive moisture, which may pose major respiratory issues for occupants, particularly the elderly, the very young and those with existing illnesses and could be potential health safety hazards. In these cases an appropriately qualified inspector/tester should also be contacted for advice and/or technical assistance.

The structural integrity of swollen building elements can not be guaranteed, and further damage is likely to develop if left unmanaged. Excessive moisture is likely to lead to the development of secondary damage to any associated building elements, which may necessitate major repair works if prolonged.

Rectification of the cause of the water leak should be addressed prior to any remedial works to the swollen building elements. A licensed plumber should be appointed immediately to identify the cause of the leak and provide advice on remedial works as necessary. Repair and/or replacement of swollen building elements should be conducted as a matter of urgency by a registered builder or qualified carpenter.

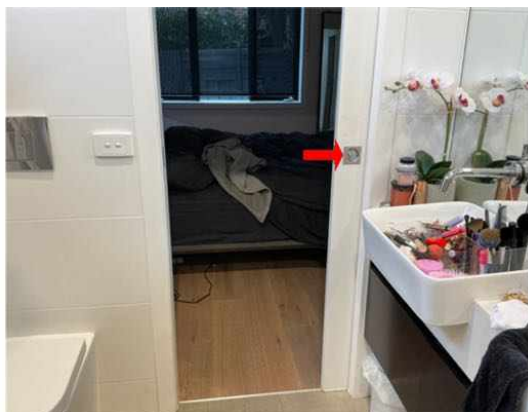
## Defects 3.11

Building:	Main Building
Location:	Ensuite - Master
Finding:	Sticking or jamming
Information:	Building elements which are sticking or jamming are difficult to operate and don't function as intended. There are a variety of causes for sticking and jamming.

The most usual causes are swelling of timbers due to moisture, bulging or bowing of metal frames, or general material deterioration. Generally, sticking and jamming

Easement will be required, which usually depends on the building materials used. This may involve some sanding and/or application of a lubricant. It will almost always include ensuring the areas are cleaned and free of any debris that may be detrimental to their operational state.

Appointment of a carpenter or general handyman is recommended to rectify any sticking/jamming building elements.

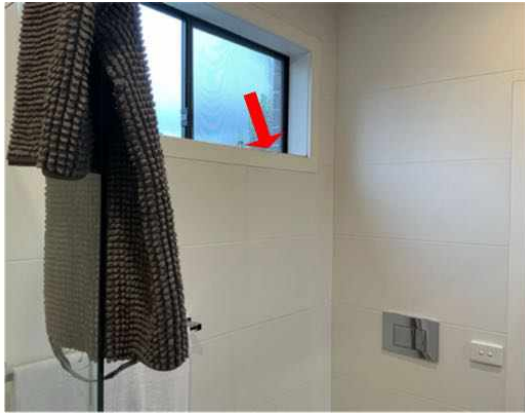
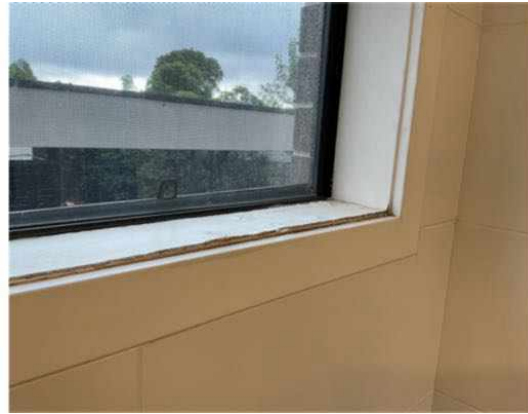
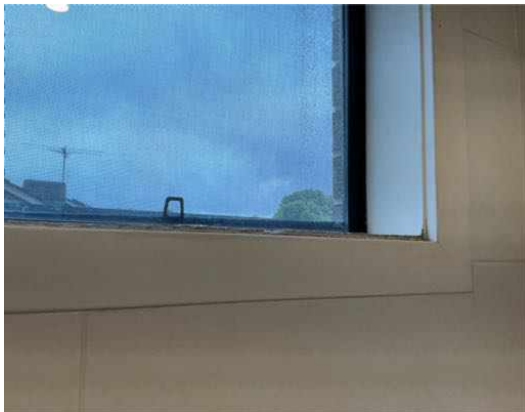
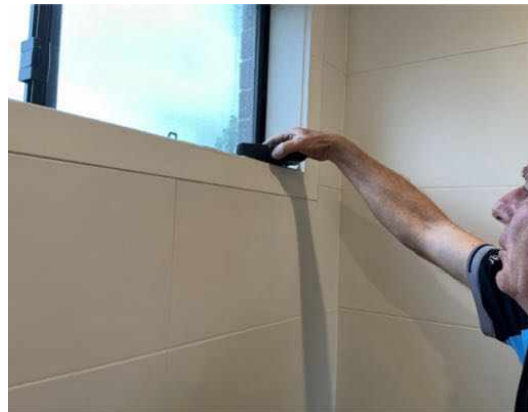
### Defects 3.12

Building:	Main Building
Location:	Ensuite - Master
Finding:	Building element - Swollen
Information:	Swollen building elements generally indicate that the building materials have been affected by excessive moisture over a prolonged period of time, and have swollen as a result. The formation and development of mould/fungi or mildew is also a likely consequence of excessive moisture, which may pose major respiratory issues for occupants, particularly the elderly, the very young and those with existing illnesses and could be potential health safety hazards. In these cases an appropriately qualified inspector/tester should also be contacted for advice and/or technical assistance.

The structural integrity of swollen building elements can not be guaranteed, and further damage is likely to develop if left unmanaged. Excessive moisture is likely to lead to the development of secondary damage to any associated building elements, which may necessitate major reparation works if prolonged.

Rectification of the cause of the water leak should be addressed prior to any remedial works to the swollen building elements. A licensed plumber should be appointed immediately to identify the cause of the leak and provide advice on remedial works as necessary. Repair and/or replacement of swollen building elements should be conducted as a matter of urgency by a registered builder or qualified carpenter.

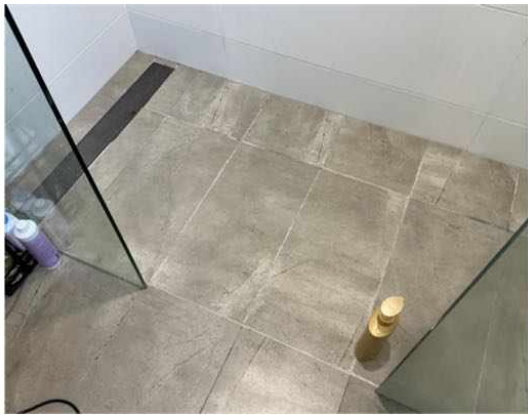
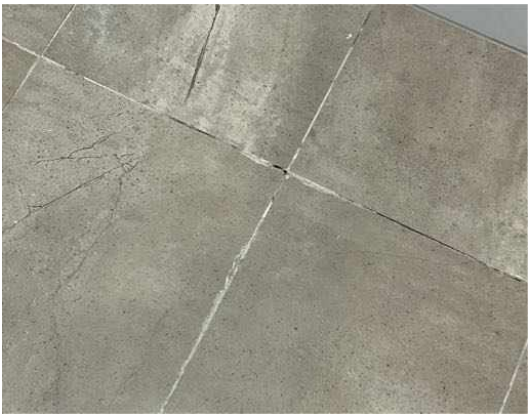
### Defects 3.13

Building:	Main Building
Location:	Ensuite - Master
Finding:	Tiling - Efflorescence
Information:	Efflorescence appears to be affecting the tiles in this area. Efflorescence typically occurs when excess salts within the concrete or cement mortar is leached to the surface due to water transfer.

It is typically seen as white salt deposits on the surfaces of concrete pavement or mortar between bricks or tiles. While detracting from the overall appearance of the affected area, efflorescence is not likely to develop into secondary damage if left unmanaged.

Generally, soluble salt deposits can be removed by dry brushing with a stiff-bristled brush. Repeated dry brushing is an ideal treatment for eliminating this forming of efflorescence. A cleaning contractor or general handyman may be appointed to perform these works at the discretion of the client.

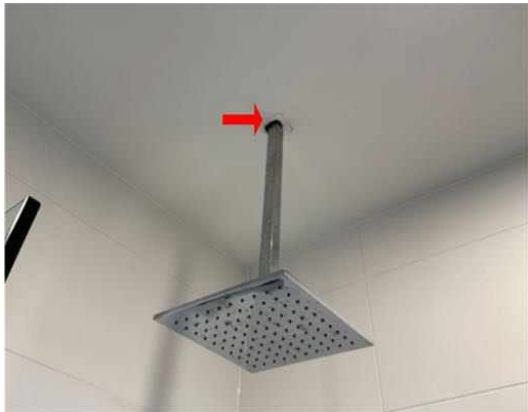
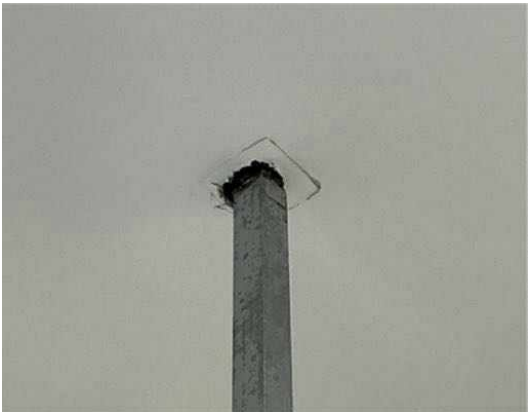
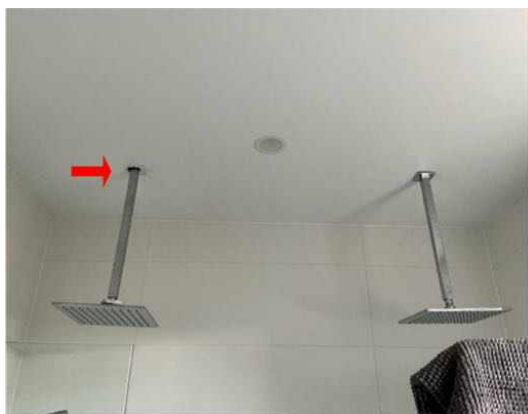
**Defects 3.14**

Building: Main Building  
Location: Ensuite - Master  
Finding: Building element - Missing trim  
Information:

Replacement of any missing building element should be conducted as soon as possible to ensure that no damage or functional issues occur to associated building materials.

The appropriate tradesperson should be appointed as soon as possible to replace the missing building element.

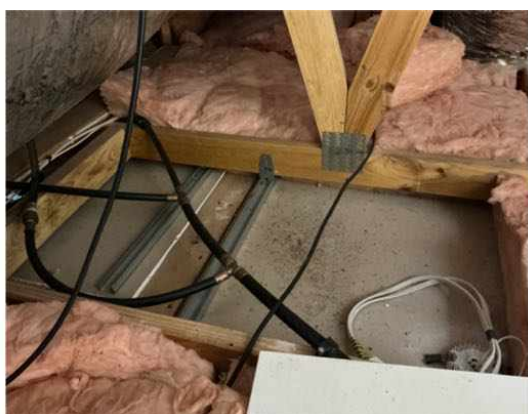
### Defects 3.15

Building:	Main Building
Location:	Roof Void
Finding:	Insulation - Moved (AS4859)
Information:	Although the insulation batts appear to have been installed correctly, it appears as though several of the batts have been moved by other tradespeople and replaced incorrectly post-works.

As a general rule, a 5% gap in the insulation creates potential for a 50% decrease in the energy efficiency of the property.

All insulation batts should be reinstated prior to final handover to comply with standards and to ensure maximal energy efficiency within the property. Failure to do so results in non-compliance with AS4859.1 Materials for Thermal Insulation of Buildings.

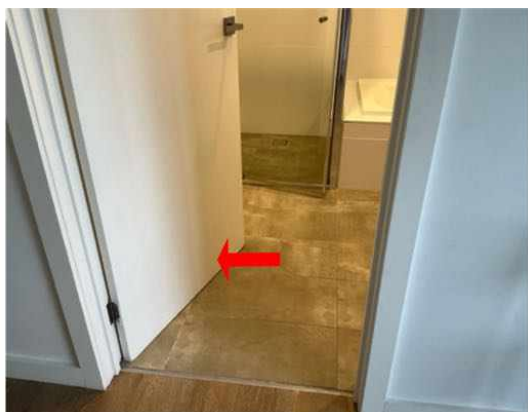
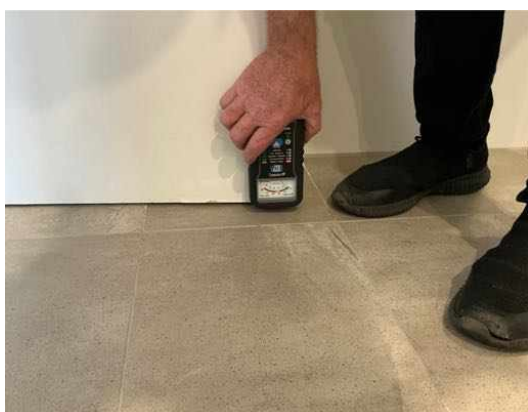
### Defects 3.16

Building:	Main Building
Location:	Bathroom
Finding:	Building element - Swollen
Information:	Swollen building elements generally indicate that the building materials have been

affected by excessive moisture over a prolonged period of time, and have swollen as a result. The formation and development of mould/fungi or mildew is also a likely consequence of excessive moisture, which may pose major respiratory issues for occupants, particularly the elderly, the very young and those with existing illnesses and could be potential health safety hazards. In these cases an appropriately qualified inspector/tester should also be contacted for advice and/or technical assistance.

The structural integrity of swollen building elements can not be guaranteed, and further damage is likely to develop if left unmanaged. Excessive moisture is likely to lead to the development of secondary damage to any associated building elements, which may necessitate major reparation works if prolonged.

Rectification of the cause of the water leak should be addressed prior to any remedial works to the swollen building elements. A licensed plumber should be appointed immediately to identify the cause of the leak and provide advice on remedial works as necessary. Repair and/or replacement of swollen building elements should be conducted as a matter of urgency by a registered builder or qualified carpenter.

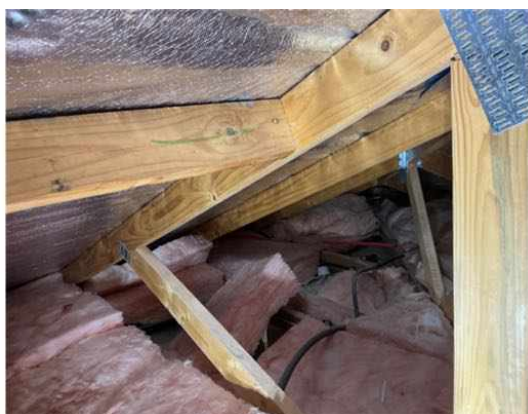
### Defects 3.17

Building:	Main Building
Location:	Roof Void
Finding:	Exhaust fan - sarking on roof

Information: On inspection of the roof void, it was observed that the exhaust fans to the bathroom and ensuite do not exhaust directly to the outside of the building, which is required by the NCC if sarking has been fitted, as it has in this home.

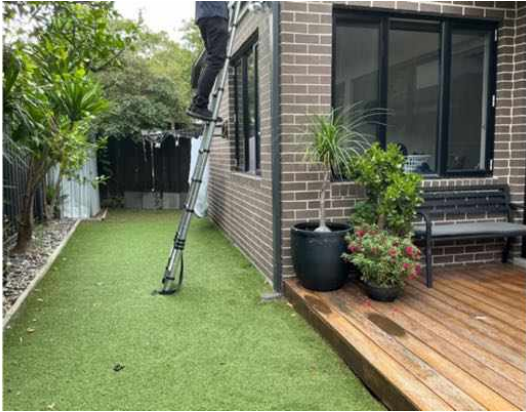
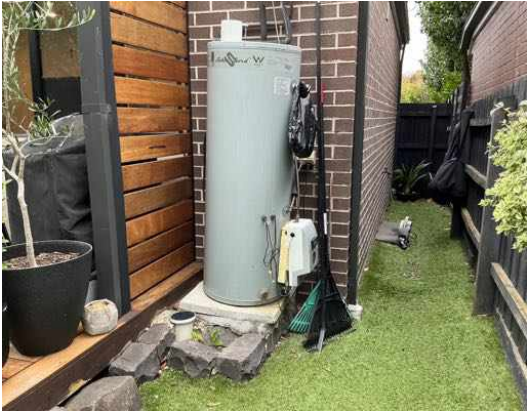
### Defects 3.21

Building:	Main Building
Location:	Rear Elevation
Finding:	Perimeter Paving - Insufficient Fall
Information:	The perimeter paving or ground levels were found to have an inadequate slope away from the adjoining building structure, creating potential for water pooling in this area.

Perimeter paving is required to fall from the building by a minimum of 25mm in the first metre and bare ground should fall away from the house by 50mm in the first meter. This standard ensures that excessive moisture does not pool around the base of building structures, which creates potential for water and structural damage, as well as making the area susceptible to termite and timber pest activity.

Where paving or ground levels do not have adequate fall, a licensed paving contractor should be appointed to install or remove and re-level pavement.

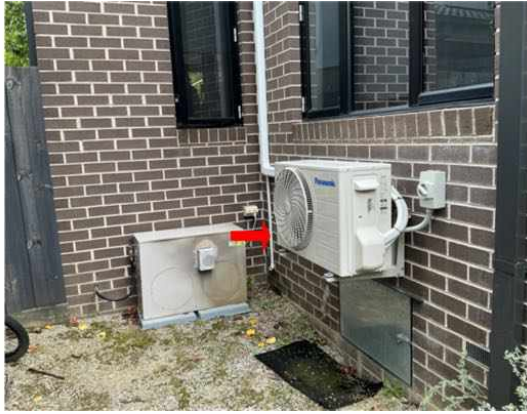
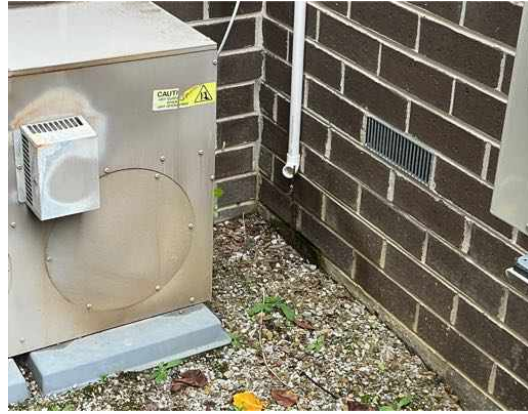
### Noted Item

Building: Main Building  
 Location: Exterior walls - left side  
 Finding: Air conditioner - Disconnected overflow  
 Information: The Air Conditioner (A/C) overflow was found to be disconnected from storm water drainage and is creating excessive moisture in the surrounding area.

Such leaking creates an environment which is conducive to an array of defects, including water damage to associated building elements and the attraction of termite or timber pest infestation.

It is highly recommended that a licensed plumber be appointed to connect the A/C overflow in order to prevent such an environment from being created. These minor works should be carried out as soon as possible.

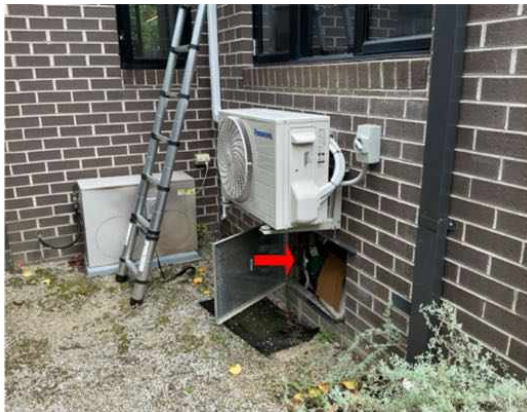
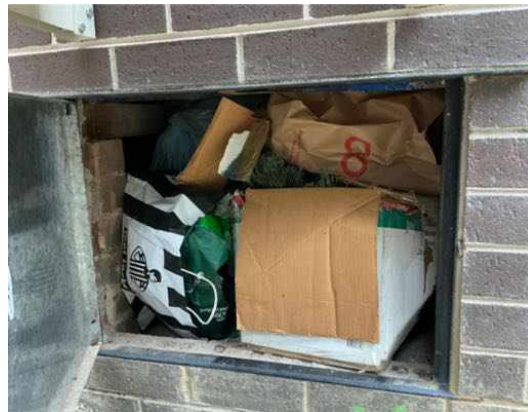
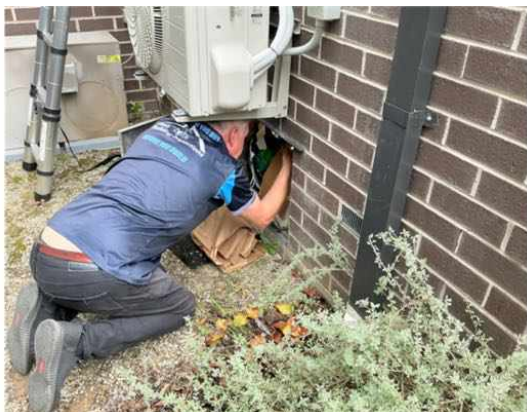
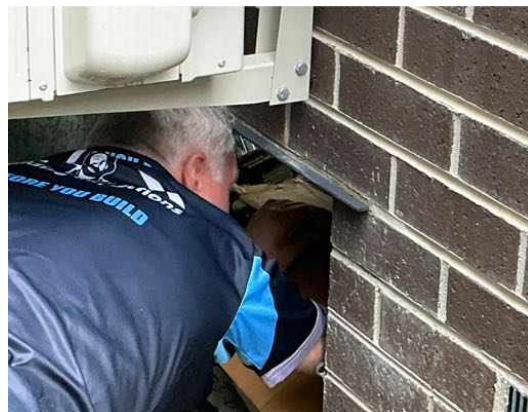
**Noted Item**

Building: Main Building  
Location: Subfloor  
Finding: Subfloor access limitations  
Information: Limited access to the subfloor was present due to facts including but not limited to access hatch size or placement and stored items, for this reason access to the subfloor was minimal.

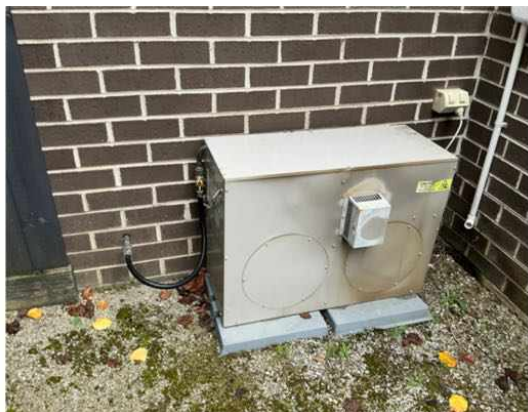
**Noted Item**

Building: Main Building  
Location: Exterior walls - left side  
Finding: Pipework incorrect  
Information:

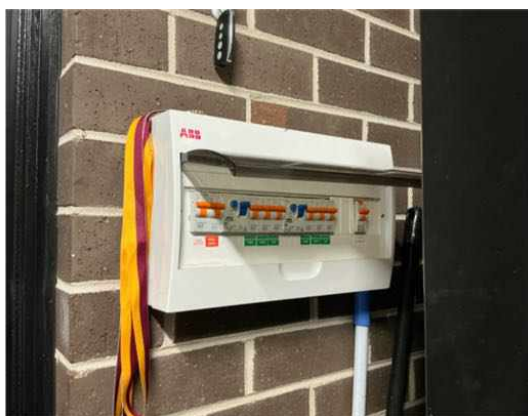
### Noted Item

Building:	Main Building
Location:	Electrical Switchboard
Finding:	Termite Management System - no evidence of a chemical installation
Information:	The application of a post-construction chemical termite barrier is highly recommended for all properties, particularly if live termite activity has been found on the site previously. Such barriers are highly effective in preventing termite attack on any timber building elements throughout the property.

The client may consider gaining further advice from a pest controller as to the costs and procedures involved with this application. It is recommended that obtaining such advice be a short-term priority.
