# Building and Timber Pest Inspection Report

Inspection Date: Wed, 18 Mar 2026

Property Address: 2/35 Surrey Rd, Mount Waverley VIC 3149,  
Australia

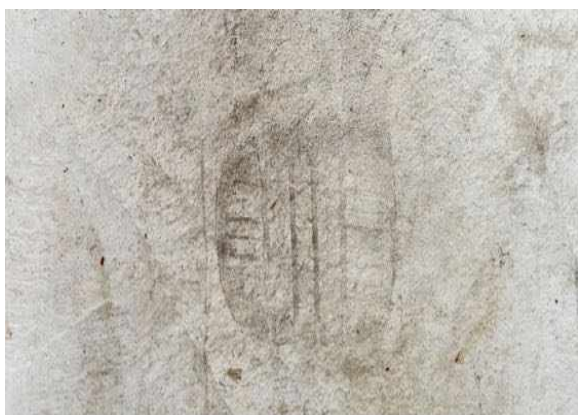
Building: Main Building  
 Location: Garage >  
 Finding: Garage - Stains To Concrete Slab

Information: The garage floor was observed to have stains in this area. While primarily a cosmetic issue, these stains can reduce slip resistance and may indicate leaks from vehicles or stored equipment.

The staining appears to be caused by spillage or leakage from vehicles, machinery, or general maintenance activities.

When practical, a qualified cleaning or maintenance professional should be engaged to remove the oil stains using appropriate methods. Regular cleaning and monitoring will help maintain the appearance of the floor, reduce slip hazards, and minimise potential long-term damage to the concrete surface.

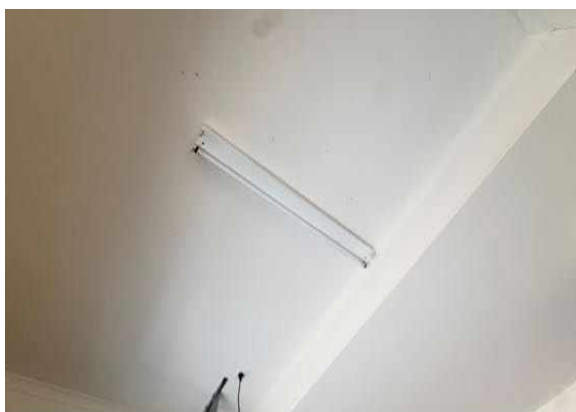
### Finding 3.03

Building: Main Building  
 Location: Garage >  
 Finding: Ceilings - Light Fittings Not Operational  
 Information: The ceilings were inspected and non-operational light fittings were observed in this area. Defective light fittings can pose electrical hazards, increase the risk of fire, and create potential injury risks if fixtures detach.

This may be due to age-related deterioration of fixings, poor installation, mechanical impact or vibration, or lack of regular inspection and maintenance.

A licensed electrician should be engaged immediately to inspect, repair, or replace the affected light fittings. Prompt action will prevent electrical hazards and ensure safe operation of ceiling-mounted fixtures.

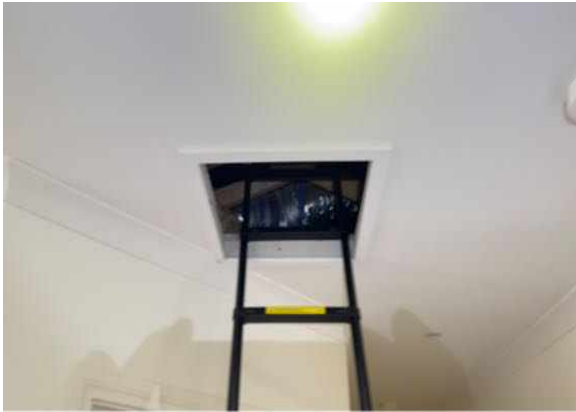
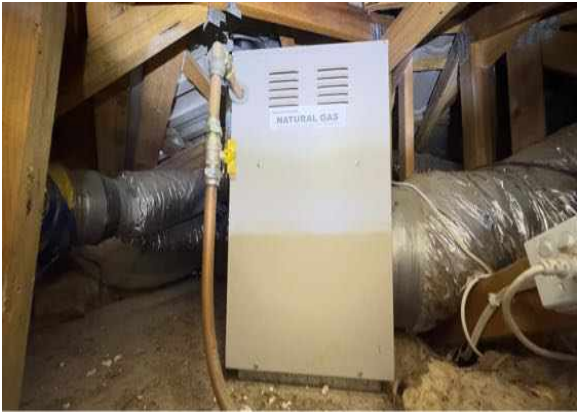
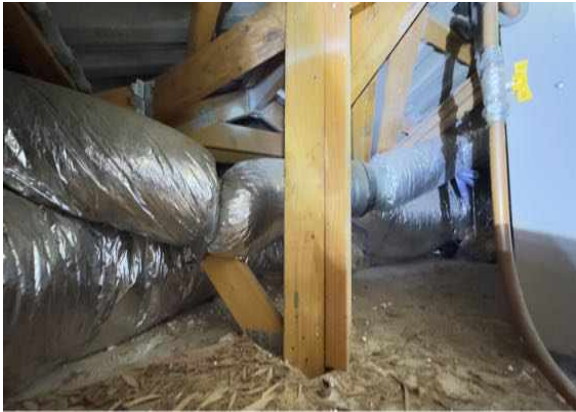
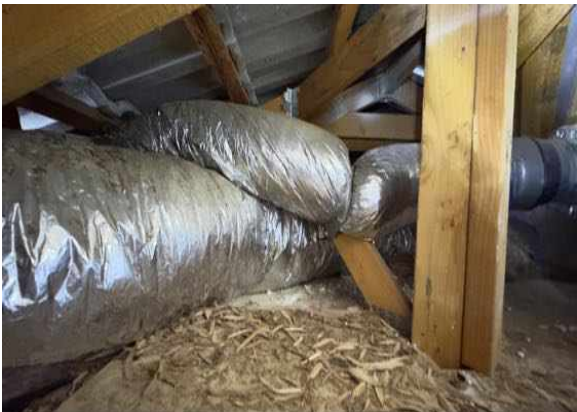
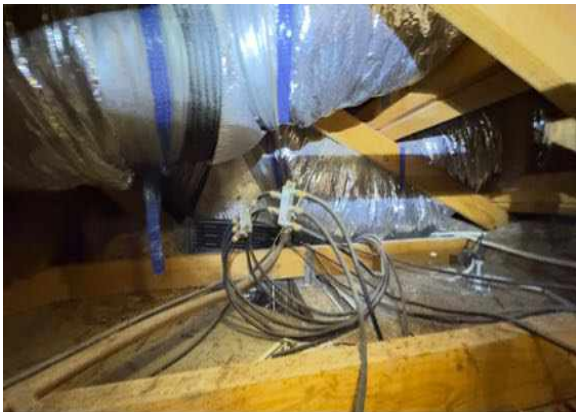
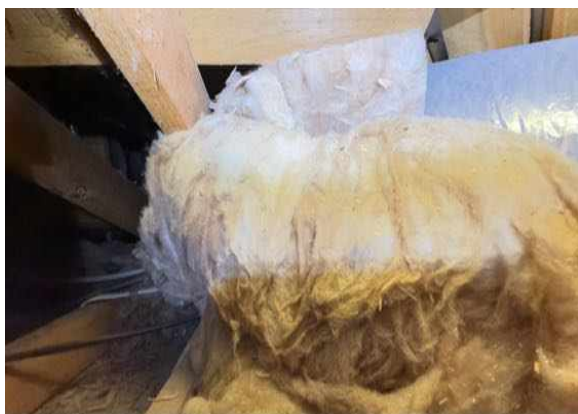
| Information: | Limited access to the roof void was present due to facts including but not limited to, limited access, insulation, Air condition Unit & ducting, obstructions or placement of insulation and or sarking, for this reason complete access to the roof void was not possible. |

A visual inspection was carried out from accessible areas only, recommend installing another access hatch in a more accessible area for a re-inspection.

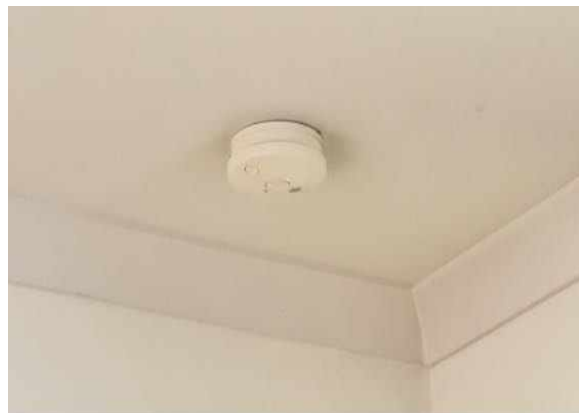
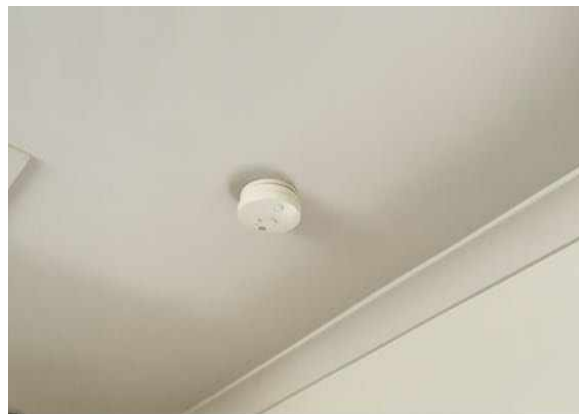
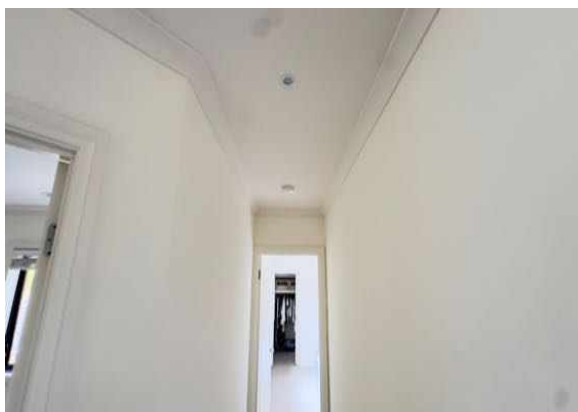
Building: Main Building  
Location: All Internal Areas  
Finding: Smoke Detectors - Advisory  
Information: During the inspection, smoke detectors were noted for advisory purposes only. The operation, age, type, and compliance of smoke detectors could not be fully verified as part of this inspection.

Smoke detectors are critical life-safety devices, and non-compliant, outdated, or non-operational units may not provide adequate warning in the event of a fire.

It is recommended that a licensed electrician be engaged immediately to test, service, and upgrade smoke detectors as required to ensure correct operation and compliance with current safety requirements.

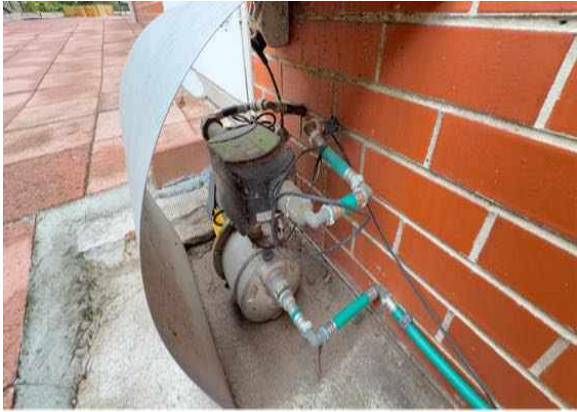
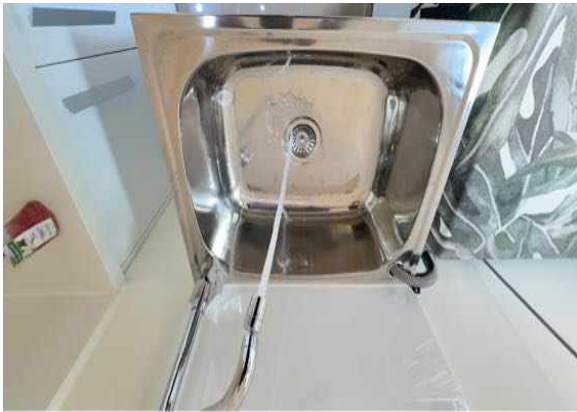
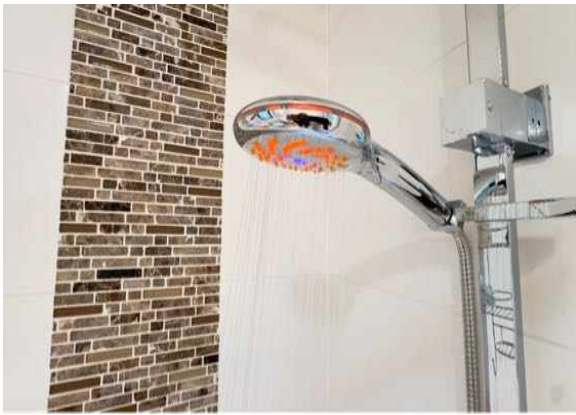
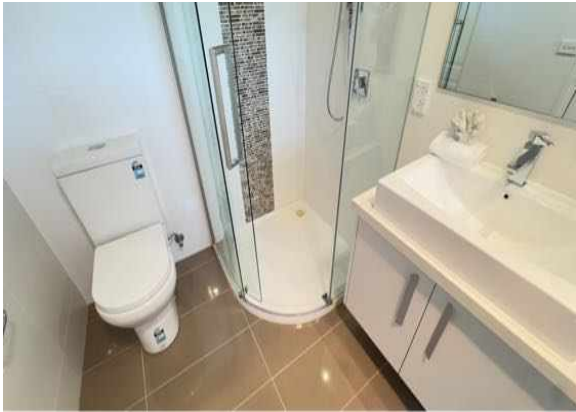
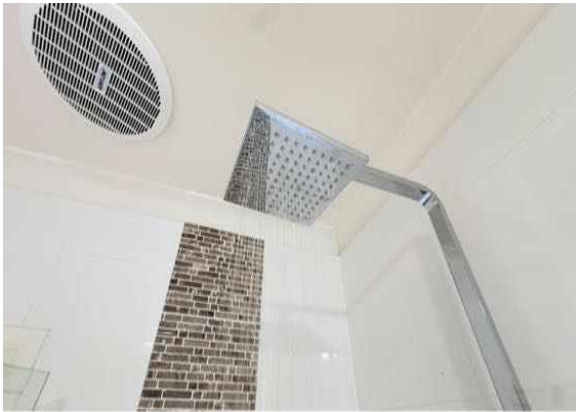
Building: Main Building  
 Location: All Internal Areas  
 Finding: Water Supply & Drainage - Shower, Basins, Toilets, & Plumbing Fixtures  
 Information: The shower recess was tested, and no visible water penetration to surrounding areas was observed at the time of inspection, except where noted as a separate defect elsewhere in this report. Water appeared to flow freely toward the floor waste. Moisture detected to the shower walls is documented separately in the report. The shower floor waste appeared clear during inspection.

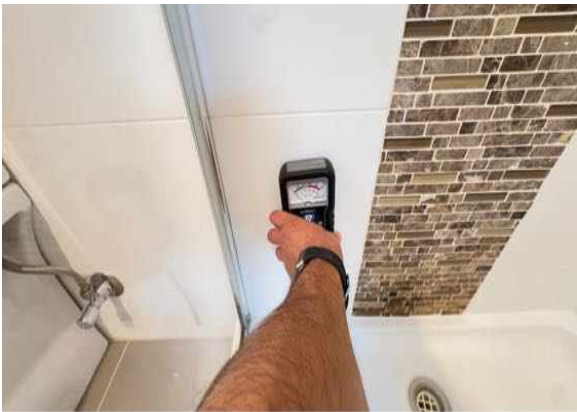
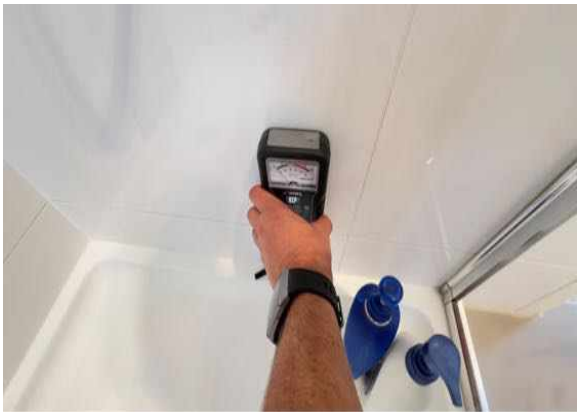
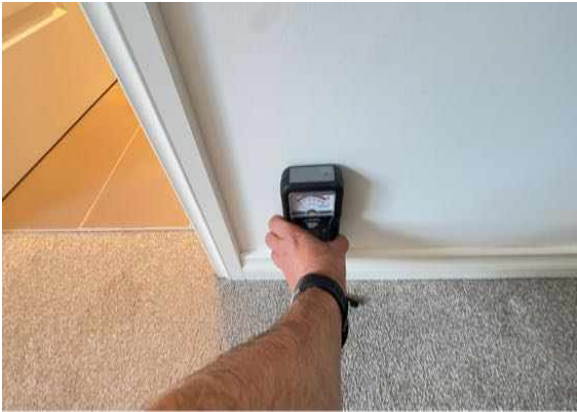
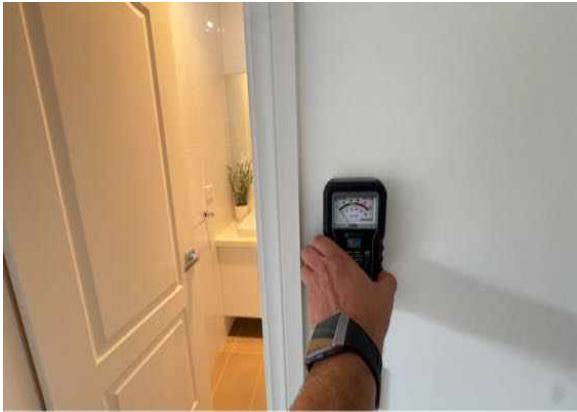
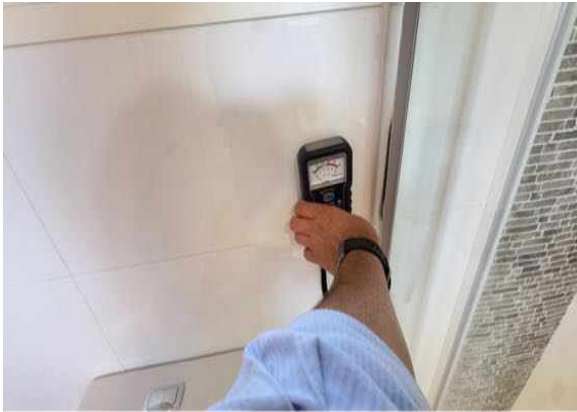
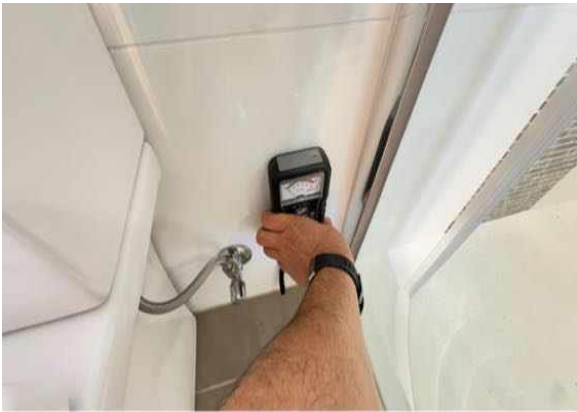
Building: Main Building  
Location: All Areas Interior & Exterior  
Finding: Moisture Levels - Advisory - No Elevated Moisture Levels Present  
Information: At the time of inspection, no elevated moisture levels were detected in these areas. Moisture readings were taken (using a Tramex Moisture Meter) and non-invasive testing methods and reflect conditions present at the time of inspection only. This item is noted for advisory purposes and should not be relied upon as a guarantee that moisture issues are not present elsewhere or may not occur in the future.

Ongoing monitoring of the property is recommended, and further investigation by a qualified tradesperson should be considered if signs of water ingress, dampness, staining, mould growth, or material deterioration become apparent.
