# Building and Timber Pest Inspection Report

Inspection Date: Thu, 22 Jan 2026

Property Address: 60 Wolseley St, Fairfield NSW 2165,  
Australia

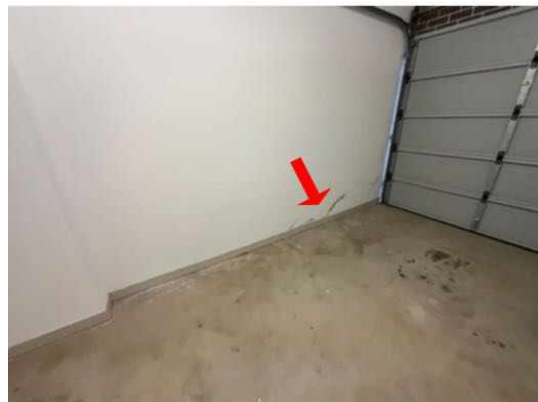
Building:	Main Building
Location:	Garage
Finding:	Evidence of excessive moisture was present at the time of inspection
Information:	Excessive moisture can attract termites and produce conditions that promote termite attack, fungal growth and wood decay. Excessive moisture is generally caused by deteriorated, inadequate or missing roof drainage, leaking plumbing pipes or fixtures, poorly plumbed HWS overflows or condenser units and poor site drainage. It is highly recommended that all plumbing and drainage fixtures and fittings be maintained regularly in order to prevent excessive moisture being present in the external / internal property.

A licensed plumber must be appointed urgently for assessment and rectifications.

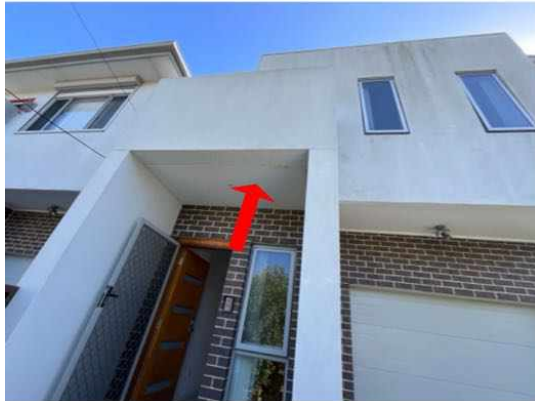
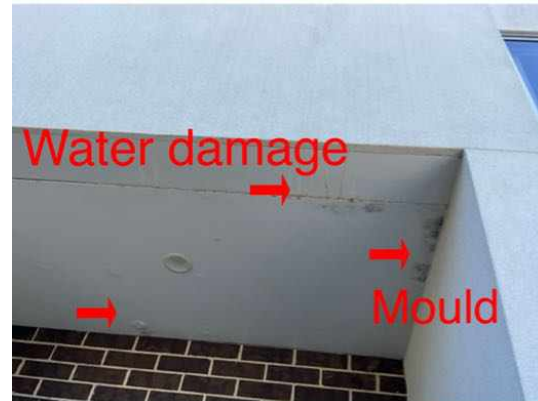
#### Finding 2.02

Building:	Main Building
Location:	Balcony
Finding:	Water leak - Internal
Information:	A water leak was found in this area at the time of inspection. Internal water leaks can be detrimental to surrounding building elements. It is suspected that the balcony waterproofing has failed, causing the internal leak.

Rust, corrosion, decay and water damage are potential outcomes where a minor water leak is left unattended. More serious defects may also result, such as electrical

hazards, or water damage to structural building elements.

In extreme cases, structural damage may develop due to a prolonged water leak. It is highly advised that a licensed plumber be engaged to confirm the leak. Major works should be expected to re-waterproof the balcony and re-tile to suite.

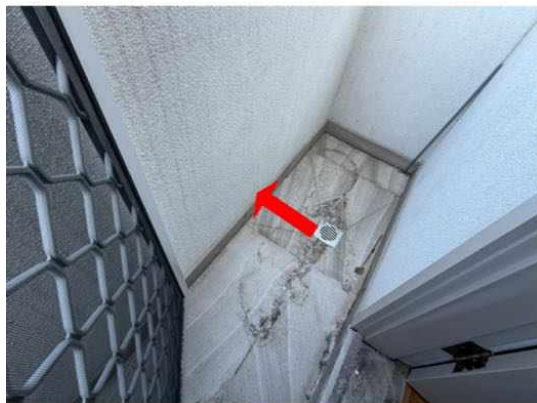
### Finding 3.01

Building: Main Building  
 Location: Balcony  
 Finding: Balcony — Missing overflow  
 Information: NCC Volume Two (Housing Provisions), Part 10.6 and Part 10.7, and

Any area exposed to rainfall (including balconies, roofs, and podiums) with a drainage outlet must have an overflow provision to prevent water ingress during blockages. This must be designed for both 20 year ARI and a 100 year ARI.

The client is highly advised to seek further advice from a licensed plumber.

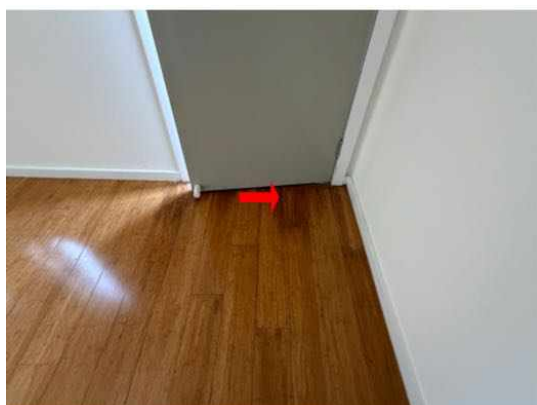
### Finding 3.02

Building:	Main Building
Location:	Balcony
Finding:	Building element - Swollen
Information:	Swollen building elements generally indicate that the building materials have been affected by excessive moisture over a prolonged period of time, and have swollen as a result. It is suspected that rain penetration occurs from the bottom of the door.

The swollen flooring does not appear to have lost its integrity, hence replacement is not a requirement. However the client is recommended to engage a general handyman to install a weather seal at the bottom of the door to ensure any further damage is restricted.

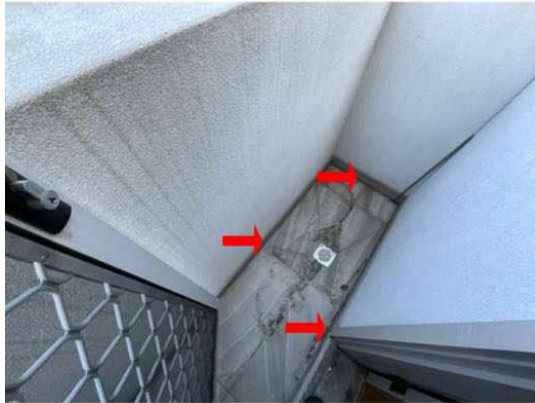
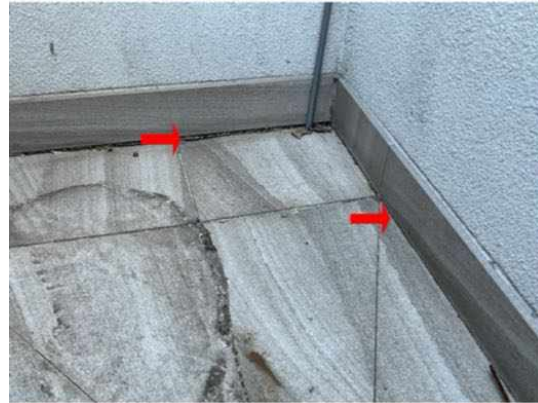
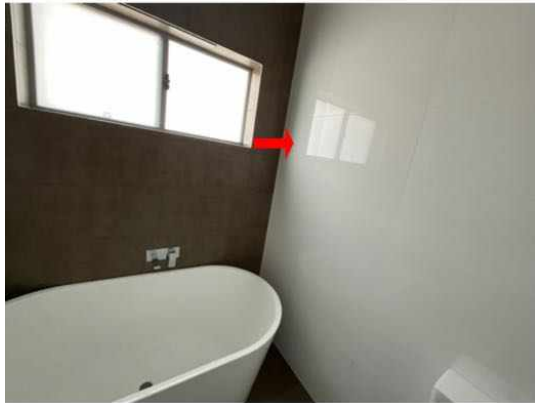
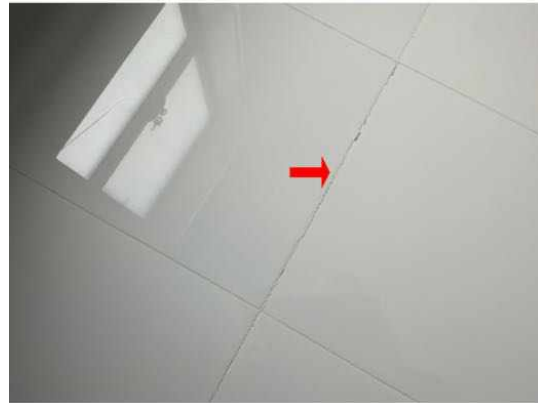
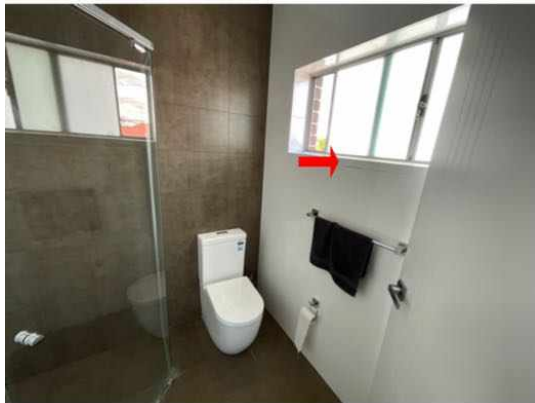
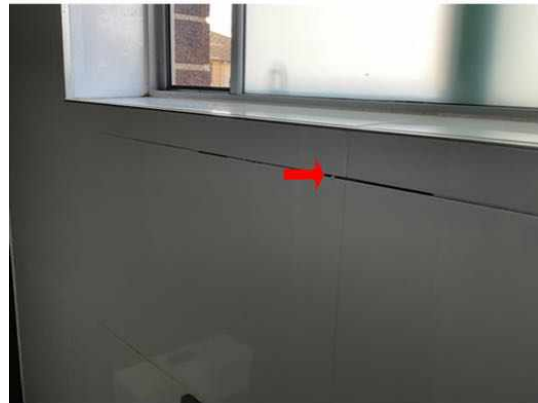
### Finding 3.03

Building:	Main Building
Location:	Balcony, bathroom, ensuite
Finding:	Sealant — Missing/deteriorated
Information:	Silicone or grout is missing or deteriorated in this area, which is used to protect gaps and crevices in building materials to ensure that they are water-tight and prevent water penetration to the associated structures.

Where silicone or grout is missing, a sealant specialist should be appointed immediately to apply grout and re-apply any silicone where necessary. Failure to do so is likely to lead to water damage to the surrounding area.

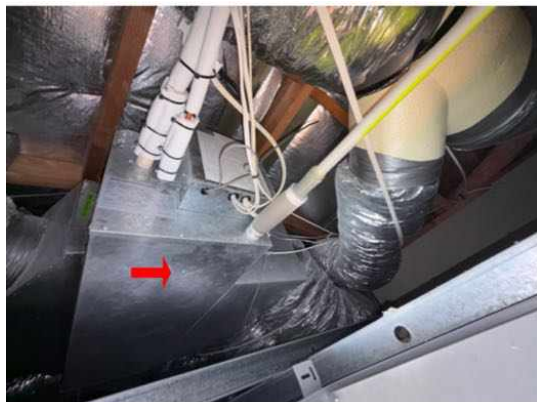
### Finding 3.04

Building:	Main Building
Location:	Roof Void
Finding:	Internal air conditioning unit - Missing condensation tray
Information:	The internal air conditioning unit in the roof was found to be missing the condensation tray at the time of inspection.

An internal air conditioning unit inside the roof must have a secondary drip tray with a separate drain line to ensure any condensation is dealt with accordingly to avoid water leaks.

A HVAC specialist must be appointed urgently for consultation and rectification, ensuring the manufacturer guidelines are closely followed.

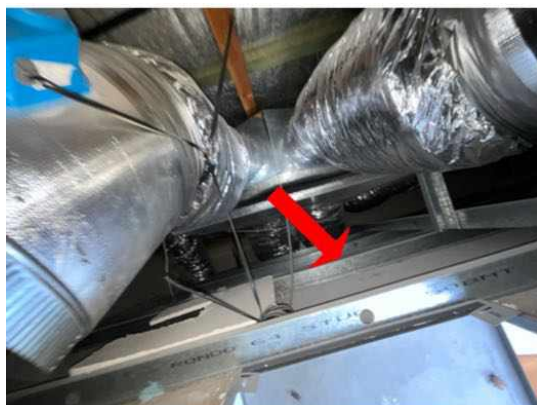
### Finding 3.05

Building:	Main Building
Location:	Roof Void
Finding:	Insulation - Missing
Information:	Upon inspection of the roof void it was noted that insulation is not present.

Insufficient insulation will result in a comparatively higher cost to heat and cool a property as there is a lack of Insulation (or uneven coverage of insulation) which works as a barrier to heat transfer. This helps to keep out unwanted heat in summer and preserves warmth inside your home in winter. It can also help soundproof your home from unwanted airborne noise transfer.

Where insulation is absent, the area does not meet current Australian Standards. Installation of adequate insulation is required and should be conducted as soon as possible.

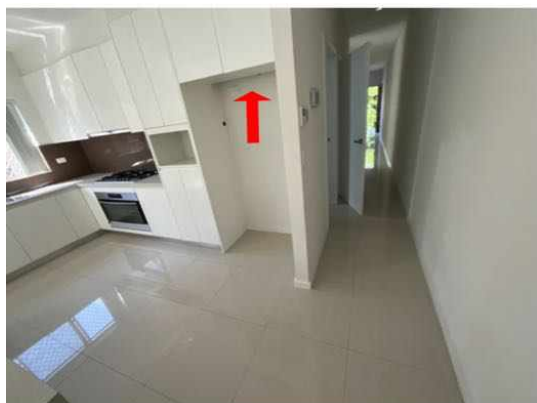
### Finding 3.06

Building:	Main Building
Location:	Kitchen
Finding:	Building element - Missing
Information:	A cornice or a plasterboard was noted to be missing in this area, allowing pest ingress. Furthermore the conditioned kitchen air may escape into the cavity. Although some building elements may seem irrelevant or unnecessary, all building elements play a key role in the operation and function of the overall structure and its performance.

Replacement of any missing building element should be conducted as soon as possible to ensure that no damage or functional issues occur to associated building materials.

The appropriate tradesperson should be appointed as soon as possible to replace the missing building element.

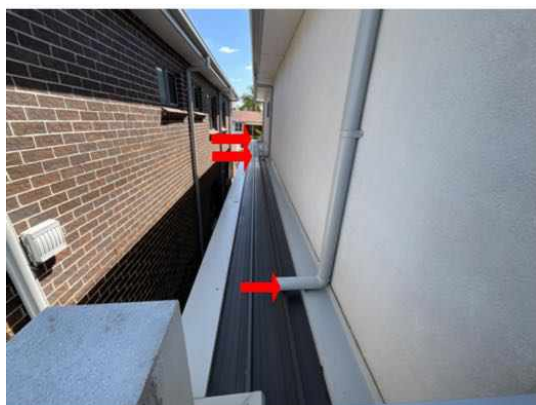
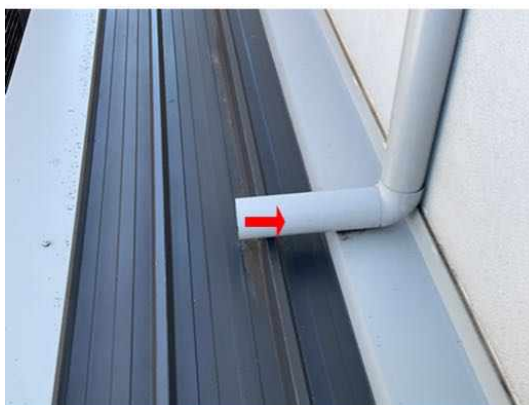
**Finding 3.08**

Building: Main Building  
 Location: Roof Exterior  
 Finding: Downpipe Spreader — Missing  
 Information: The downpipe spreader to the lower roof is missing. A spreader has a series of holes and is designed to spread the water so it is distributed evenly. This is considered to be incomplete works and should be completed.

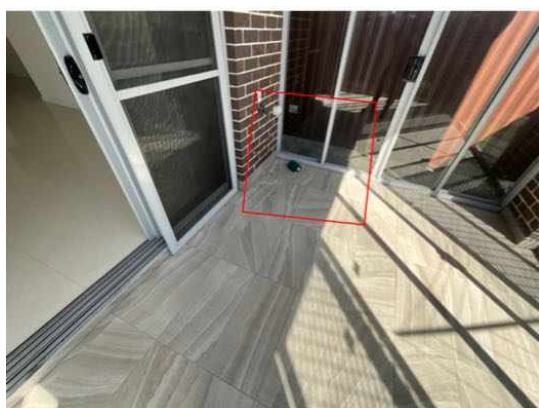
**Finding 3.09**

Building: Main Building  
 Location: Alfresco

Finding: Incomplete or substandard works  
 Information: The works to this area appear to be incomplete or have been completed to a substandard level. The alfresco was found to have been closed up and there no drain point for the external tap. Usage of water tap in this area will cause water pooling in the alfresco, hence the rise of associated damages as a result.

Works that have not been completed to a satisfactory level create potential for the development of building defects and may impede on the safety and integrity of the overall structure.

It is highly recommended that the relevant trades be appointed to complete these works and ensure the safety of the area and the longevity of all associated building elements.

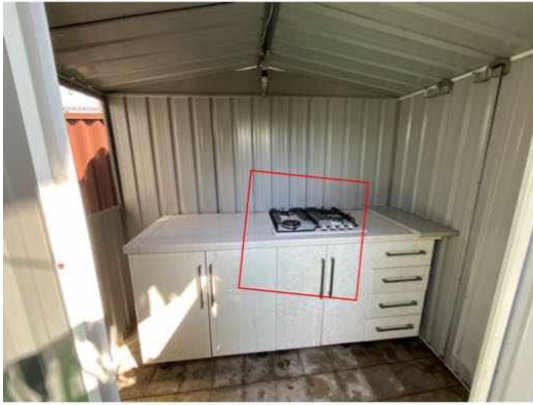
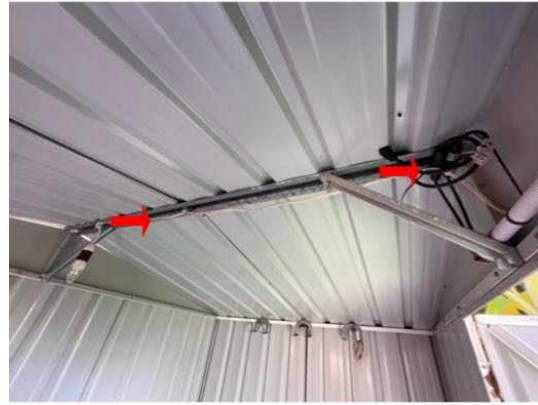
### Finding 3.10

Building: Main Building  
 Location: Shed  
 Finding: Plumbing & Electrical - Non-Compliant  
 Information: The plumbing and electrical works in this area do not appear to be compliant to the current Australian standard practices. Plumbing and electrical inspections are outside the scope of the building inspection and must be conducted by a Licensed and registered Trades person.

It is highly recommended that the client makes immediate arranges to have the plumbing and electrical works in this area inspected to ensure compliance.

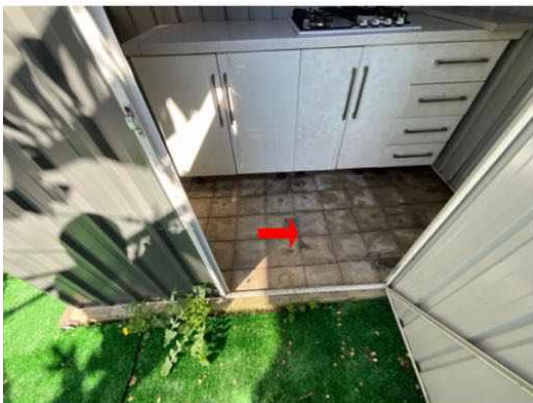
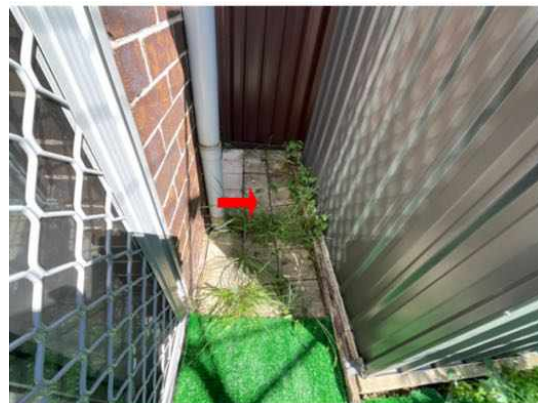
### Finding 3.11

Building: Main Building  
 Location: Shed  
 Finding: Paving — Uneven  
 Information:

Sections of the external paved area are uneven, which may develop into a trip hazard. It appears as though the area has been subject to rough installation, or that paving sections have lifted due to movements in the foundation.

Left unmanaged, the May develop into a safety hazard due to trip and fall.

Re-paving of the area is required to remedy this situation. Further consultation with a specialist concreter is advised.

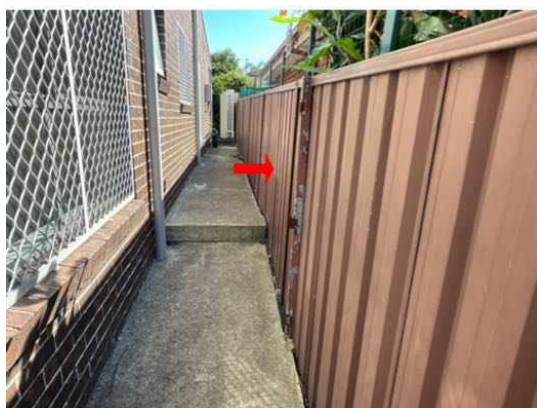
### Finding 3.12

Building: Main Building  
 Location: Fencing  
 Finding: Fencing - Deteriorated  
 Information:

It was noted at the time of inspection that sections of the fencing in this area has deteriorated. Typically fencing deteriorates due to age and or wear, rot and or rust which is generally expected for a structure of this age, due to prolonged exposure to weather conditions. Sometimes inadequate installation or maintenance can be to

If left unattended, it is likely that further damage will occur. It is suspected that repair of several elements of the fencing may be required however replacement may be a consideration of the client also.

A licensed fencing contractor should be appointed to provide further advice and perform rectification works as necessary.

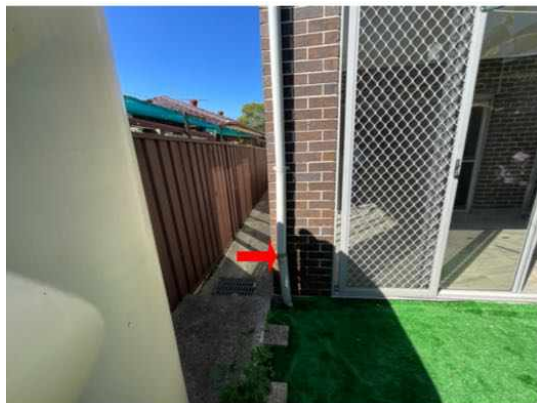
### Finding 3.13

Building:	Main Building
Location:	Rear left corner
Finding:	Water leak - External
Information:	Water leaks were found to be present to exterior plumbing work. Leaks are generally caused by deterioration of the plumbing elements over time, due to exposure to weather conditions, but may have also been caused by minor impact damage.

Such leaking creates damp conditions in the affected area, causing potential for water pooling and subsequent water damage if left unattended. These conditions may also attract termite attack, particularly if the area is subject to minimal levels of sun throughout daylight hours.

It is highly advised that a licensed plumber be appointed to rectify any water leaks that may be present. Areas of repair and replacement of plumbing fittings and fixtures may be required and, as such, a quotation should be sought.

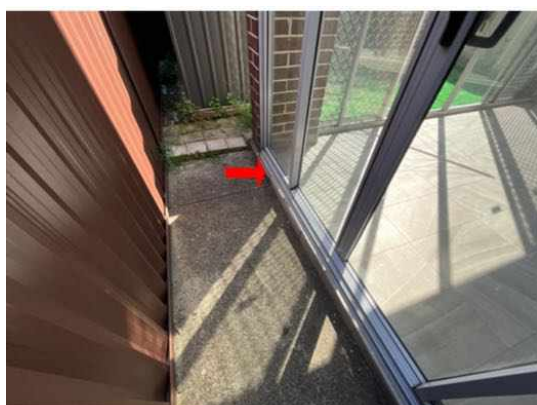
### Finding 3.14

Building:	Main Building
Location:	Alfresco
Finding:	Tiles - Drummy
Information:	Drummy tiled areas were identified at the time of inspection. The term 'drummy' refers to tiles that have become detached from their fixing, despite otherwise being in relatively good condition. Such defects are generally caused by physical or moisture damage to the area. Drummy tiled areas may also be a direct result of poor workmanship during the construction process.

Tiled areas may swell and shrink with changes in air humidity if the area has sustained moisture damage. Any exposure to moisture is capable of causing tiled areas to become drummy and/or cracked over a prolonged period of time. Drummy tiled areas generally require removal and replacement of affected tiles, with adequate sealant and grouting.

Specialist trades are available for these types of services. A licensed tiling contractor may be appointed to perform works as necessary.

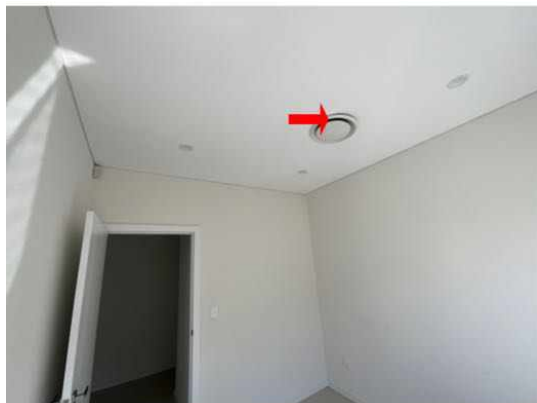
### Finding 3.15

Location: Guest  
 Finding: Fitting or fixture - Loose  
 Information: The fitting in this area is loose and requires adjustment to tighten.

If left unmanaged, the fitting may further deteriorate, causing potential for the development of other minor secondary defects.

A relevant tradesperson should be appointed to perform these rectification works at discretion of the client.

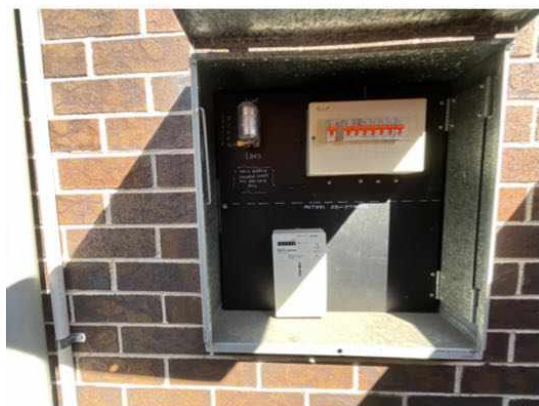
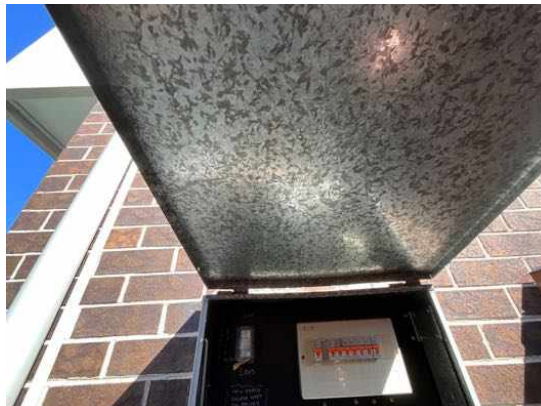
Building: Main Building  
 Location: Meterbox  
 Finding: Termite Management System - no evidence of installation  
 Information: The application of a post-construction chemical termite barrier is highly recommended for all properties, particularly if live termite activity has been found on the site previously. Such barriers are highly effective in preventing termite attack on any timber building elements throughout the property.

The client may consider gaining further advice from a pest controller as to the costs and procedures involved with this application. It is recommended that obtaining such advice be a short-term priority.

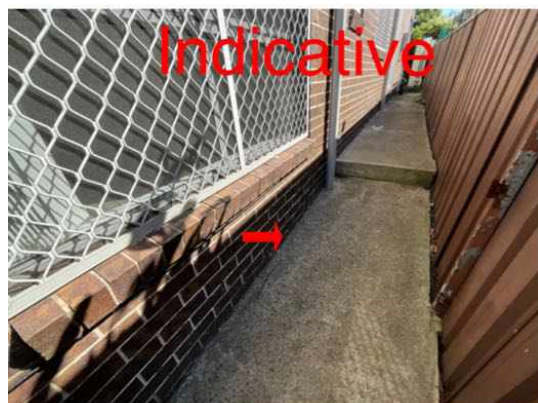
### Finding 6.02

Building:	Main Building
Location:	Perimeter
Finding:	Slab Edge - Exposure
Information:	Slab Edge Exposure: Where external concrete slab edges are not exposed there is a high risk of concealed termite entry. In some buildings built since July 1995 the edge of the slab forms part of the termite shield system. In these buildings an inspection zone of at least 75mm should be maintained to permit detection of termite entry. The concrete edge should not be concealed by render, tiles, cladding, flashings, adjoining structures, paving, soil, turf or landscaping etc. Where this is the case you should arrange to have the slab edge exposed for inspection. Concealed termite entry may already be taking place but could not be detected at the time of the inspection. This may have resulted in concealed timber damage. Does the slab edge inspection zone fully comply?

Not able to comment. A very high proportion of termite attacks are over the edge of both Infill and other concrete slabs types. Covering the edge of a concrete slab makes concealed termite entry easy. Infill slab type construction has an even higher risk of concealed termite ingress as the slab edge is concealed due to the construction design and cannot be exposed. The type of slab may only be determined by assessment of the construction plans by a qualified person e.g. Builder, Architect. Construction Plans may be obtainable by your local Council or Builder. Termite activity and or damage may be present in concealed timbers of the building. We strongly recommend frequent regular inspections in accordance with AS 3660.2. Where the slab edge is not fully exposed or the slab is an infill slab or the slab type cannot be determined then we strongly recommend inspections every 3 to 6 months in accordance with AS 3660.2 or AS 4349.3.

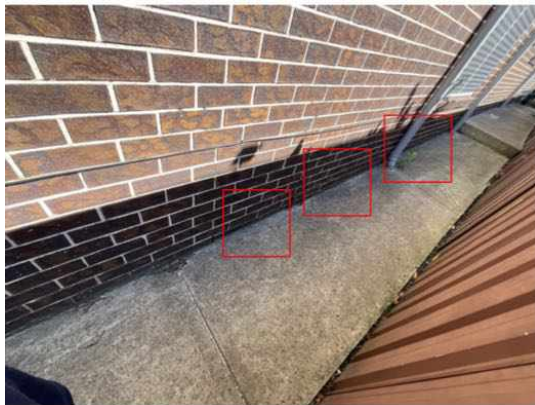
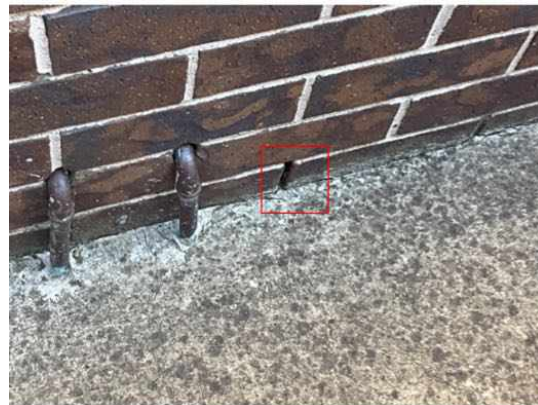
Weep holes in the exterior brickwork of the property are designed to allow condensation that may build up between the brickwork and subsequent timber framework to drain from within the wall hence preventing any deterioration of the timber building elements.

Additionally build-up of moisture is likely to occur if weep holes are covered further attracting termite activity to these areas.

It is highly recommended that weep holes are left exposed in all areas throughout the external property. Therefore if any termite activity leading into weep holes becomes easily detectable during frequent pest inspections.

The client is recommended to contact a concrete specialist to lower the ground level, ensuring all weepholes are fully exposed.

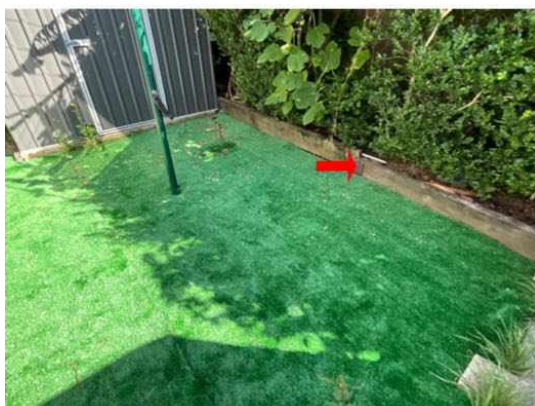
### Finding 6.05

Building:	Main Building
Location:	Fencing & Landscaping
Finding:	Building materials in direct ground contact - conducive to termites
Information:	Where timber elements are in direct contact with the ground and consequently moisture or dampness they become conducive to termite activity. Whether timber is used as a building element part of a fencing structure or stored as an unused item they can provide an environment that is attractive to termite infestation.

When met with excessive moisture timber begins to decay and develop wood rot. Any timbers that are in direct contact with external grounds especially if left untreated or non-durable also provide ingress for subterranean termites into that particular element.

The removal of any such materials that may be conducive to termite activity should be removed as soon as possible to minimise the risk of termite attack.

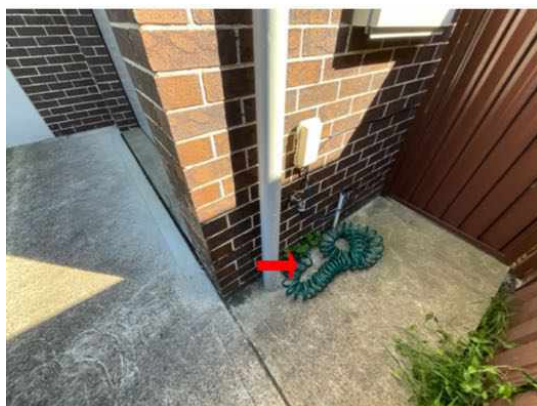
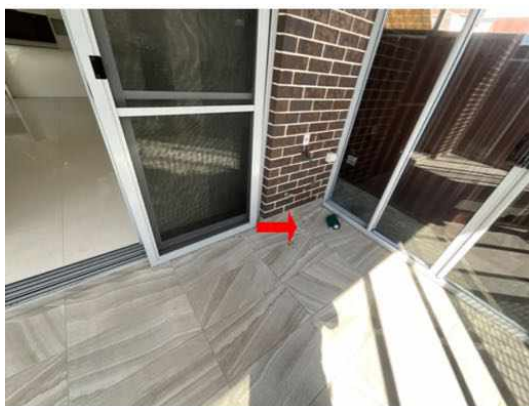
### Finding 6.06

Building: Main Building  
 Location: External tap  
 Finding: Tap - No drain  
 Information: The external tap in this area was noted to have no drain at the time of inspection.

This keeps the surrounding surfaces damp while using the tap, which becomes conducive to termite activity.

A licensed plumber must be appointed to ensure an appropriate drain is installed.

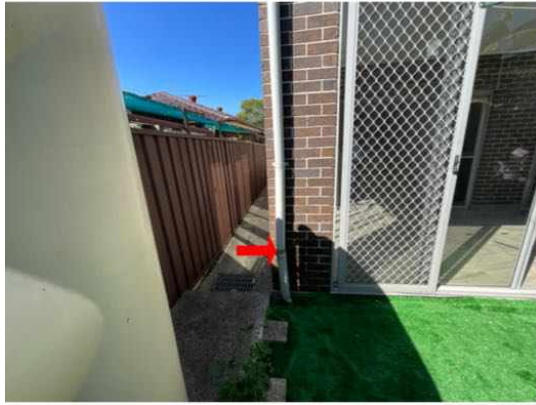
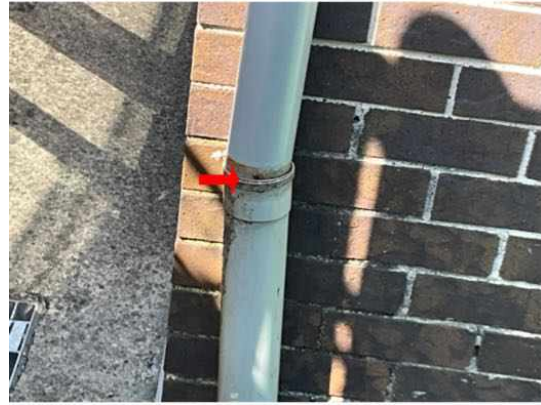
### Finding 6.07

Building: Main Building  
 Location: Rear left corner  
 Finding: Water leak - External  
 Information: Water leaks were found to be present to exterior plumbing work. Leaks are generally caused by deterioration of the plumbing elements over time, due to exposure to weather conditions, but may have also been caused by minor impact damage.

Such leaking creates damp conditions in the affected area, causing potential for water pooling and subsequent water damage if left unattended. These conditions may also attract termite attack, particularly if the area is subject to minimal levels of sun throughout daylight hours.

It is highly advised that a licensed plumber be appointed to rectify any water leaks that may be present. Areas of repair and replacement of plumbing fittings and fixtures may be required and, as such, a quotation should be sought.
