Building Inspection Report

Inspection Date: Thu, 9 Apr 2026

Property Address: 12/46 Military Rd, West Beach SA 5024,
Australia

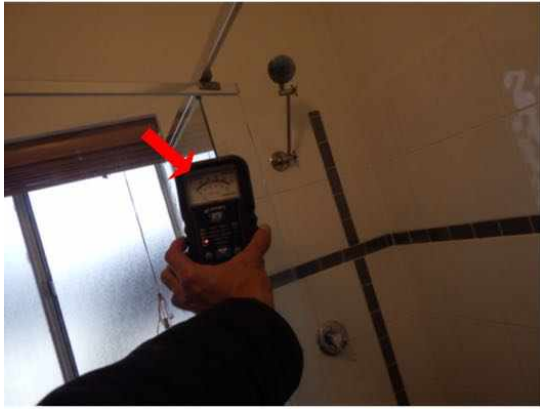
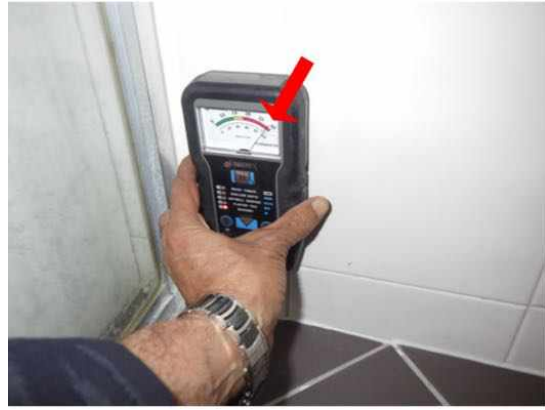
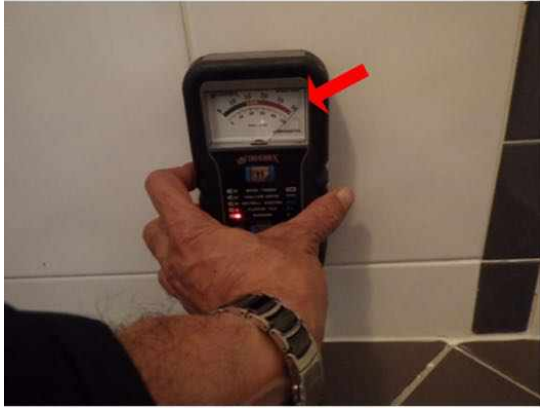
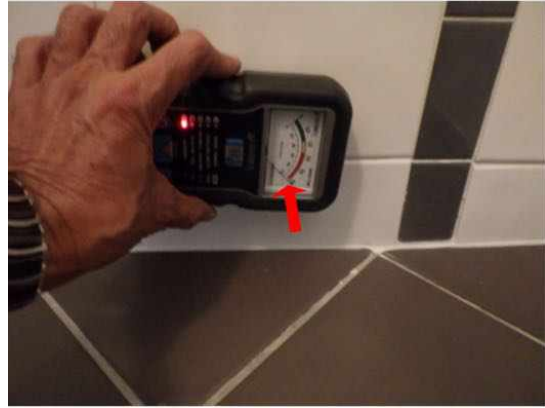
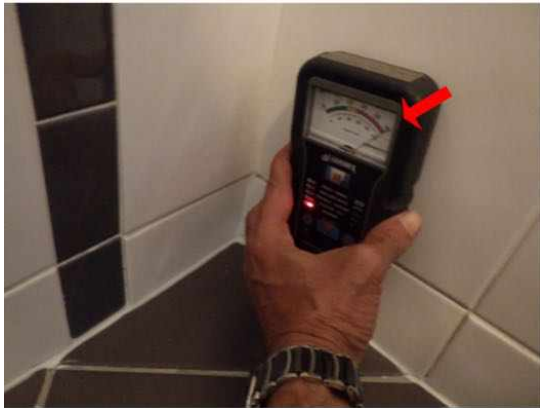
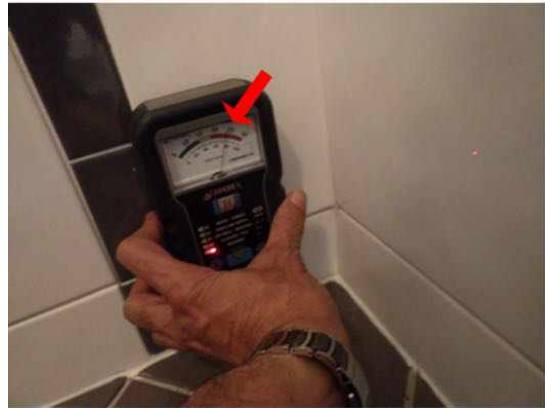
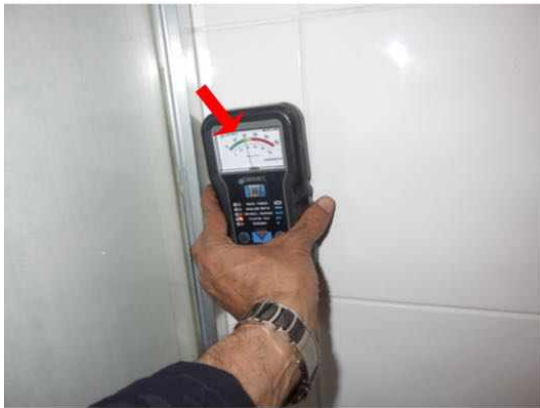
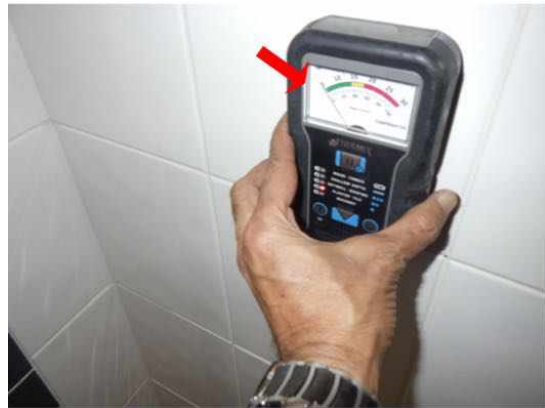
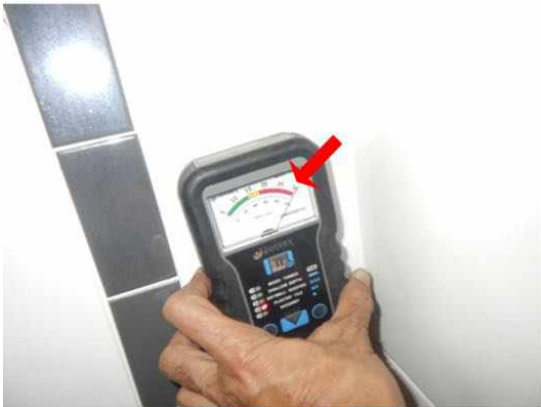
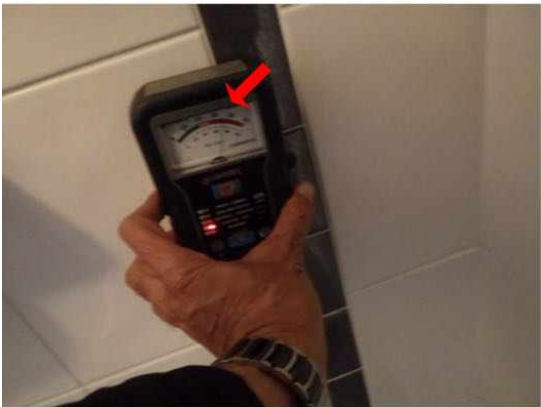
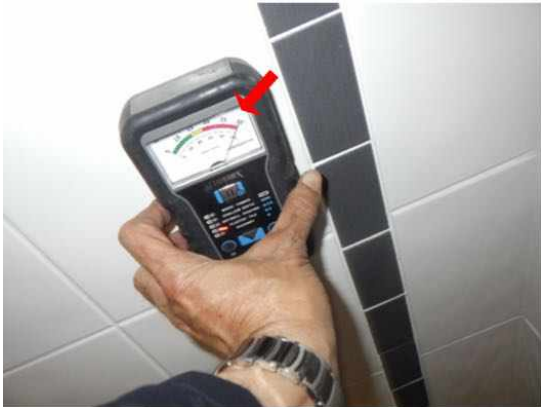
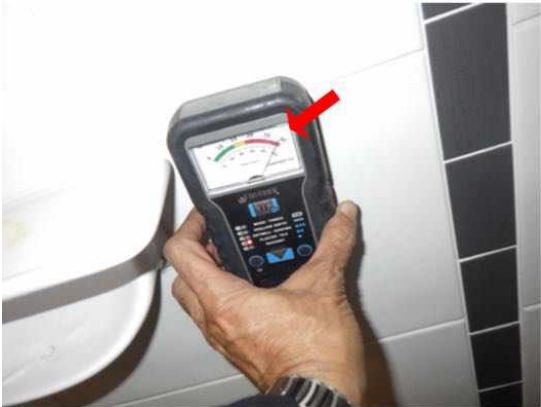
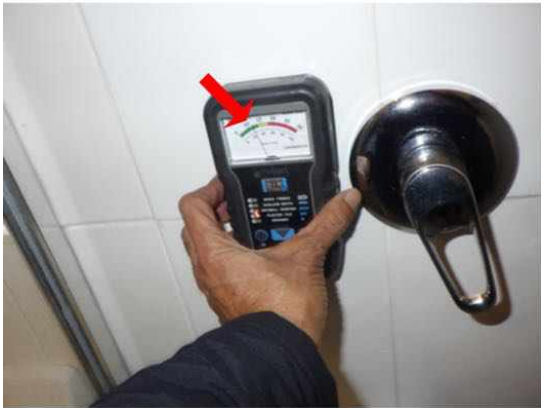
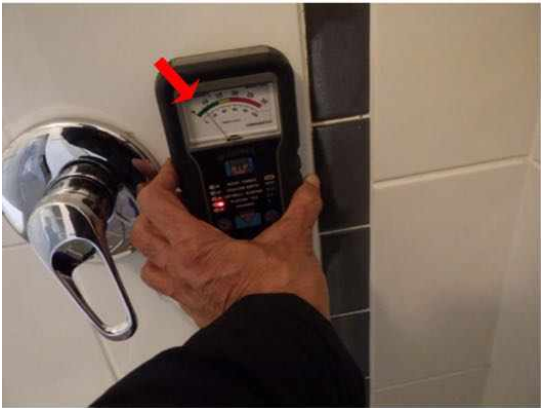
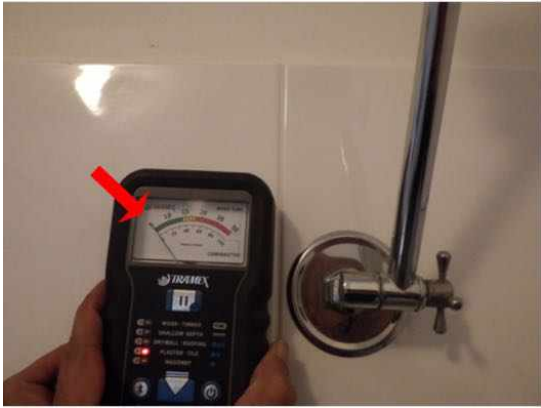
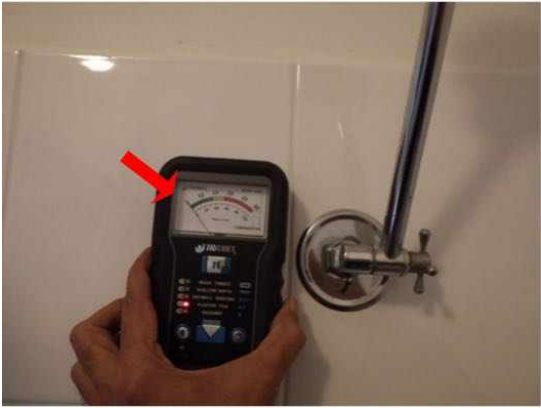
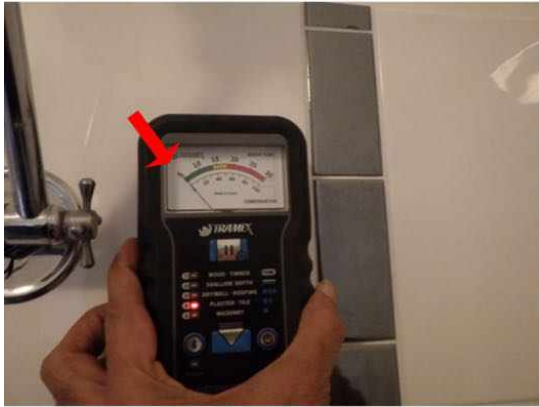
Defects 2.01

Building:	Building 1
Location:	Bathroom
Finding:	Shower Alcove - Damp
Information:	Damp is evident to the lower 400mm approximately of wall to the shower alcove. This defect is quite common, and is suspected to have been caused by moisture permeating through the grouting in this area, which shows evidence of deterioration. Leaking pipes within the adjoining wall is also a possible cause.

Damp (or structural damp) refers to the presence of unwanted moisture in the structure of a building, either as the result of intrusion from outside, or condensation from within the structure. In the shower area, internal water leaks or other sources of excessive moisture are generally the cause of damp.

Unmanaged damp in the shower recess is likely to facilitate the formation and development of mould and fungi growth, decaying associated building materials and compromising their structural integrity. Exposure to these contaminants is associated with a wide range of respiratory and other health-related problems.

Consultation with a qualified plumber or bathroom specialist is advised immediately to identify the cause of damp and to perform remedial works as required. Where excessive mould growth is present, further inspection by a specialist environmental health inspector should also be considered.

Always ensure that sealant and grout is in good condition to prevent any moisture issues occurring in the future.

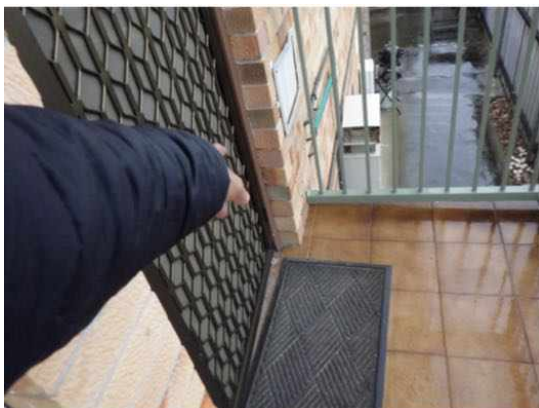
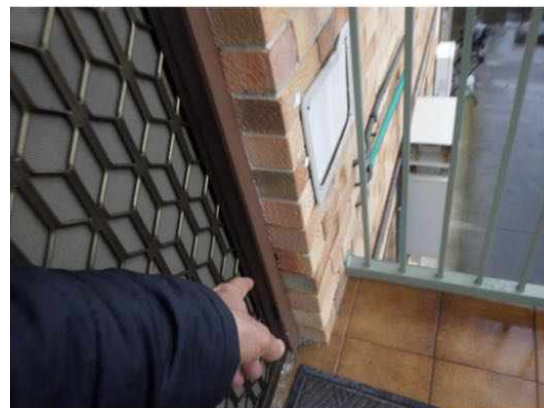
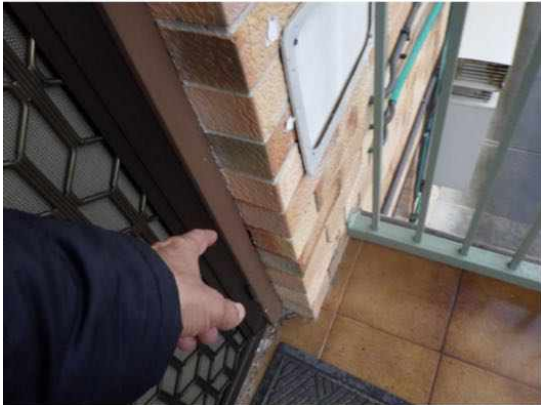
Defects 3.01

Building:	Building 1
Location:	All External Areas
Finding:	Entry Area- External walls & Door frame assembly - Significant Gaps
Information:	At the time of inspection it was noticed that significant gaps between external walls and door frame assembly in this entry area.

Breakage occurs generally when the building materials have either aged and decayed, or as a result of damage (accidental or deliberate).

Repair and/or replacement of broken elements is advised to ensure that additional secondary defects do not arise as a consequence. Such works are necessary, as all building elements play a key role in the operation and function of the overall structure and its performance.

A relevant tradesperson should be appointed to repair or replace the affected building element prior to any subsequent damage being caused.

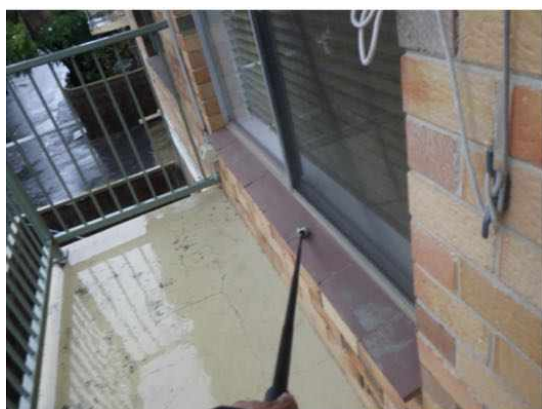
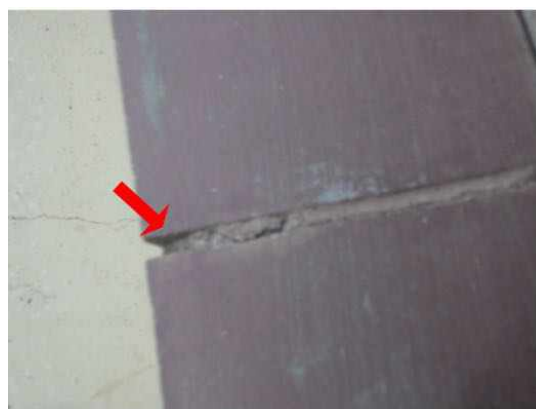
Defects 3.02

Building:	Building 1
Location:	All External Areas
Finding:	Grout - Missing/ Deteriorated
Information:	Grout is missing/ deteriorated in this rear window area. Grout is used to protect gaps and crevices in building materials to ensure that they are water-tight and prevent water penetration to the associated structures.

Where grout is missing, a tiling contractor should be appointed immediately to apply grout and re-apply any silicone where necessary. Failure to do so is likely to lead to water damage to the surrounding area.

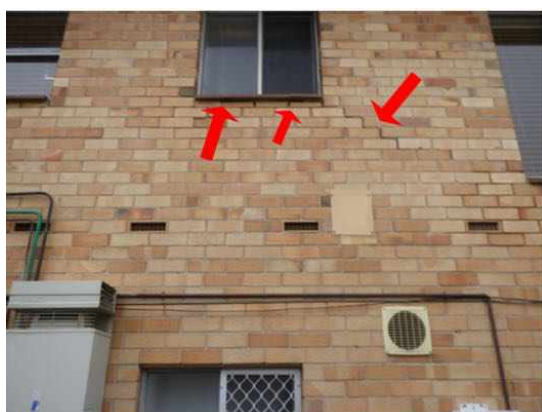
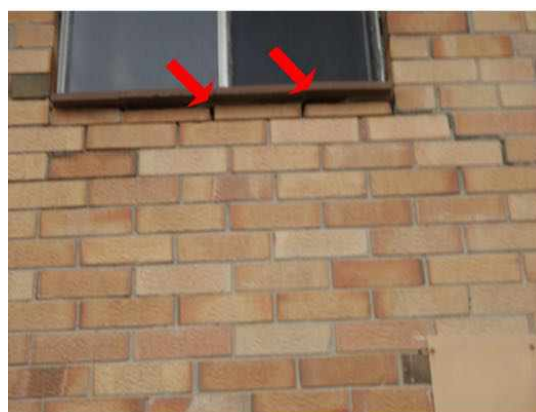
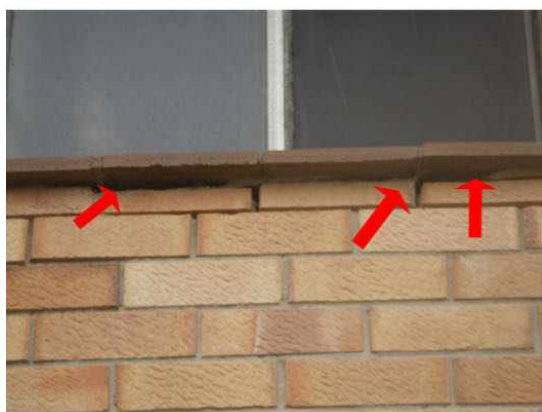
Defects 3.03

Building:	Building 1
Location:	All External Areas
Finding:	Brickwork - Deteriorated mortar & Evidence of repairs
Information:	At the time of inspection it was noticed that evidences of mortar deterioration to few brick works around the property.

Mortar, or 'bedding', is the material which fills joins and intersections between bricks in masonry walls and structures. Sections of mortar in this brickwork were identified as having deteriorated, which is generally expected for a property of this age and condition.

Mortar may deteriorate as a result of age of building materials, minor movement of bricks, or frequent exposure to weathering. Mortar should be replaced to ensure that bricks remain in their intended location and to prevent gaps, which would allow water or moisture ingress and secondary damage as a result.

Apart from that at the time of inspection it was also noticed that evidence of repairs to the brick works around the property. For further details please discuss with your realestate agent.

Mortar deterioration can be addressed by a bricklayer where areas of deterioration are localised and easily accessible. Alternatively, appointment of a registered builder is advised, to repoint large areas of decaying mortar. Where secondary structural defects have become evident, consultation with a structural engineer may be required.

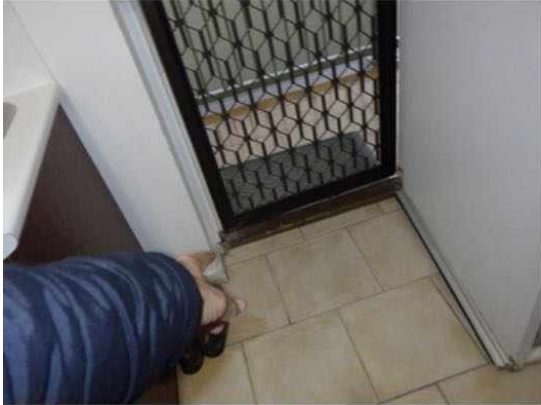
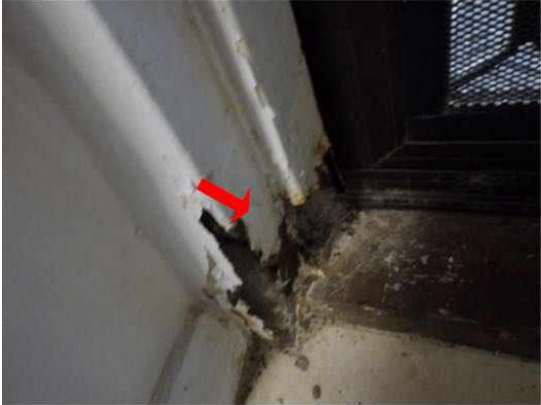
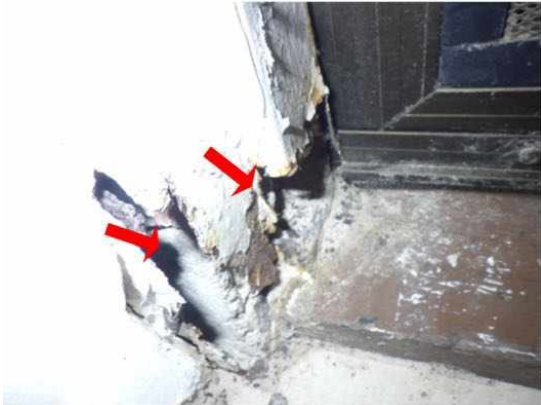
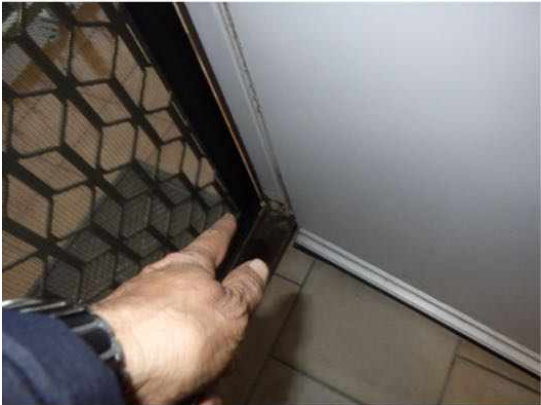
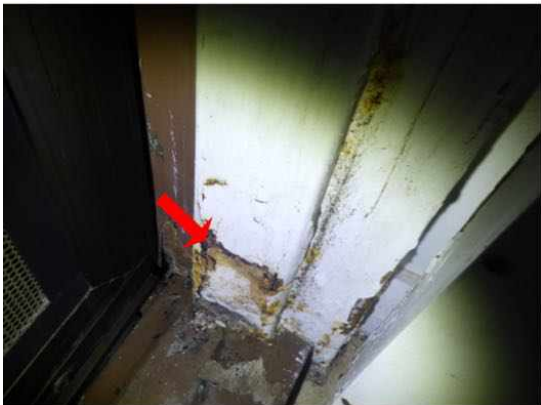
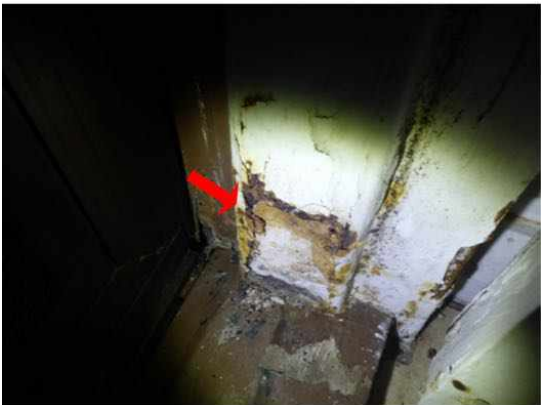
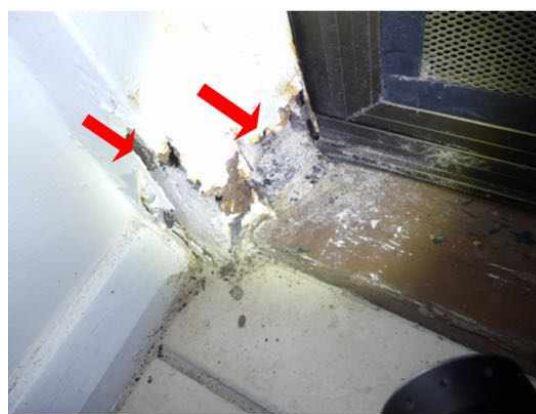
Defects 3.04

Building:	Building 1
Location:	All Internal Areas
Finding:	Entry area- Door jamb - Damaged at lower base
Information:	At the time of inspection it was noticed that entry door jamb is damaged in this lower base.

Breakage occurs generally when the building materials have either aged and decayed,

or as a result of damage (accidental or deliberate).

Repair and/or replacement of broken elements is advised to ensure that additional secondary defects do not arise as a consequence. Such works are necessary, as all building elements play a key role in the operation and function of the overall structure and its performance.

A relevant tradesperson should be appointed to repair or replace the affected building element prior to any subsequent damage being caused.

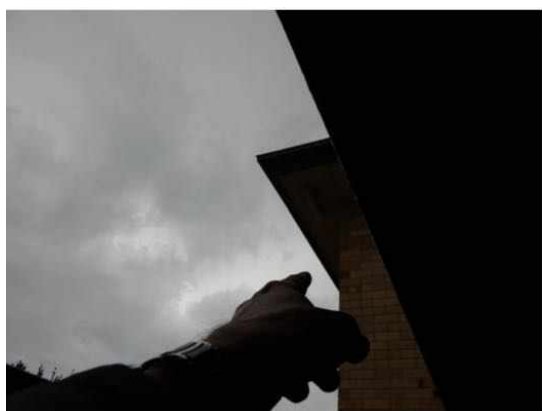
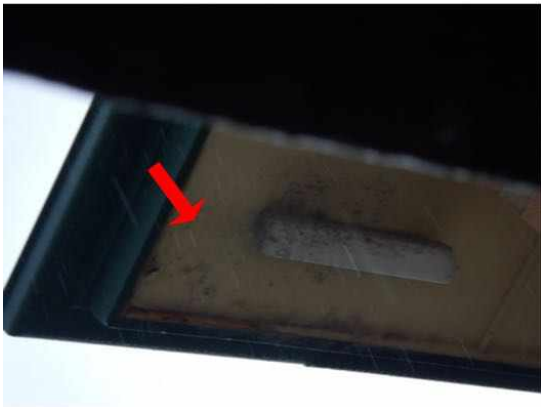
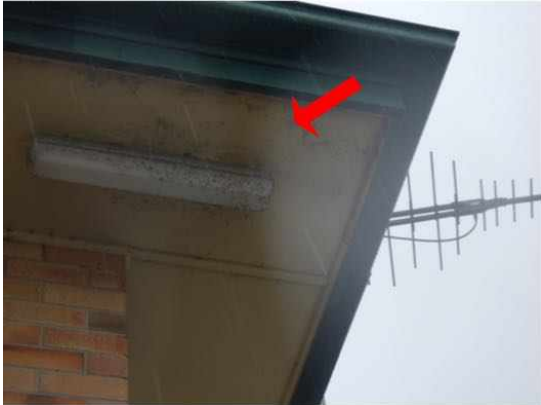
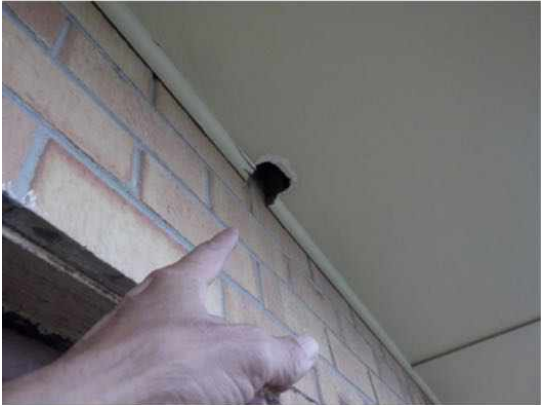
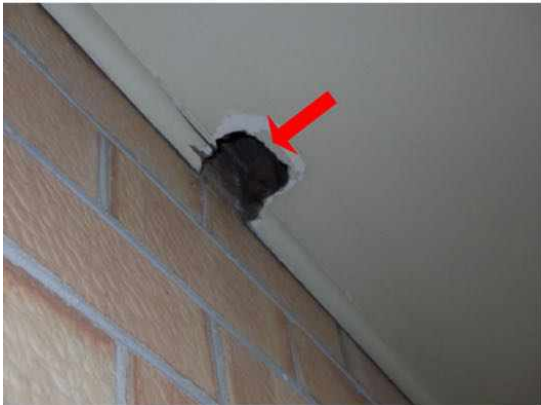
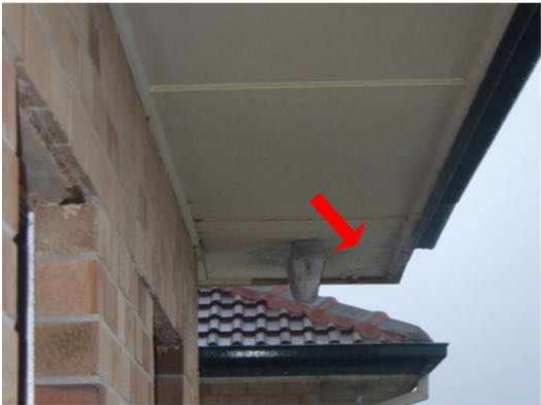
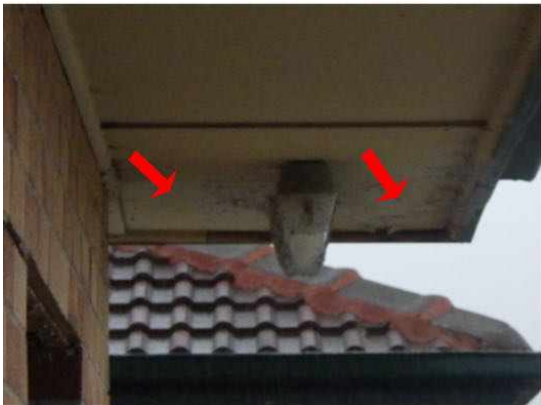
Defects 3.05

Building:	Building 1
Location:	All External Areas
Finding:	Eaves - Damaged
Information:	The few sections of eaves around the external property were found to be in a visibly poor condition. The damage may have been sustained as a result of a number of possible causes, including poor roof drainage, leaking roof plumbing or minor impact damage.

Apart from that at the time of inspection it was also noticed that section of eaves were damaged in this entry area.

The damage to the eave sheeting in this area detracts from the appearance of the structure, as well as potentially compromising the structural integrity of the roofing area.

Where eaves show moderate to severe damage, remedial works may be required. Where water damage is suspected as being the underlying cause, appointment of a licensed plumber is advised as a matter of urgency to identify the source of the water leak.

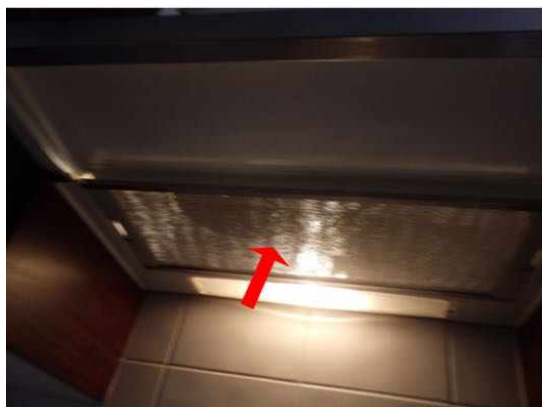
Defects 3.06

Building:	Building 1
Location:	Kitchen
Finding:	Rangehood - Fan not working
Information:	While the range hood appears to be working at a satisfactory level, the fan to the structure was not working at the time of inspection.

Without a functional fan, a build-up of grease and evaporative moisture is likely to accelerate deterioration of the range hood and associated flue. This potential build up may also create a minor fire hazard, particularly if left uncleaned.

A licensed electrician should be appointed to replace the fan on the range hood to restore it to a fully operational state.

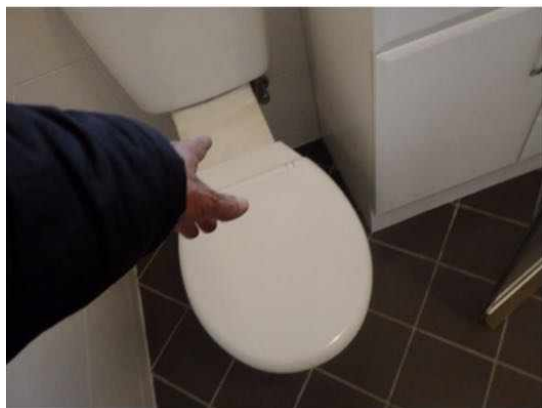
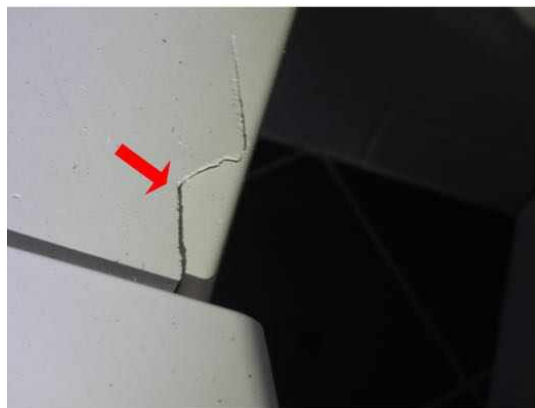
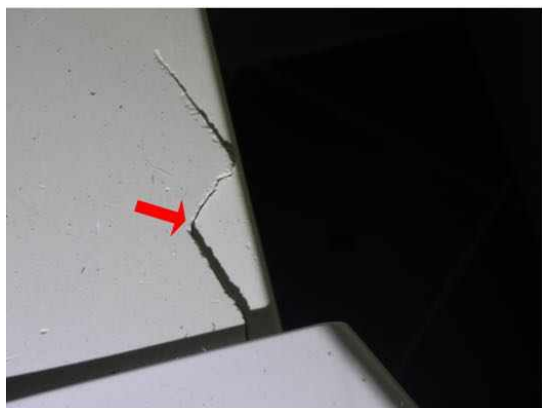
Defects 3.07

Building:	Building 1
Location:	Toilet (WC)
Finding:	Building element - Damaged
Information:	At the time of inspection it was noticed that toilet assembly cover is damaged / cracked.

Breakage occurs generally when the building materials have either aged and decayed, or as a result of damage (accidental or deliberate).

Repair and/or replacement of broken elements is advised to ensure that additional secondary defects do not arise as a consequence. Such works are necessary, as all building elements play a key role in the operation and function of the overall structure and its performance.

A relevant tradesperson should be appointed to repair or replace the affected building element prior to any subsequent damage being caused.

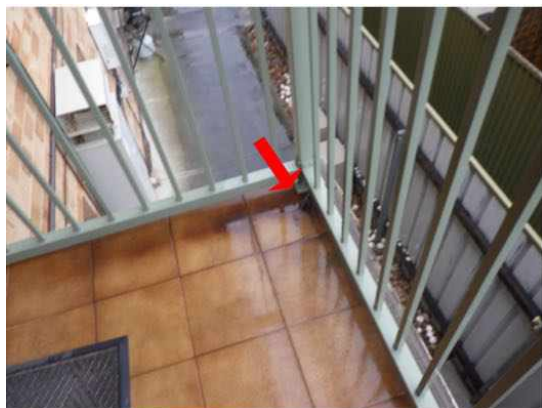
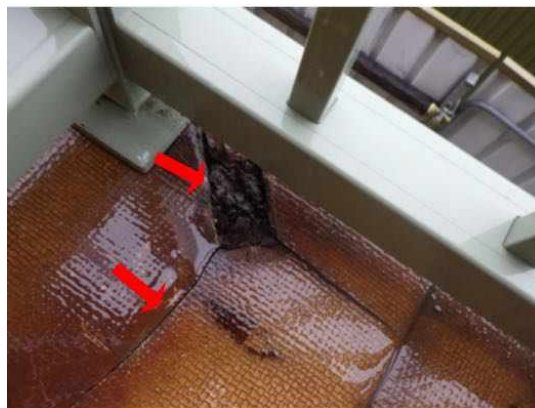
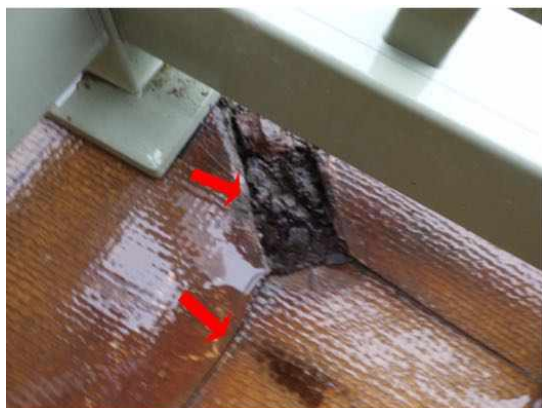
Defects 3.08

Building:	Building 1
Location:	All External Areas
Finding:	Tiles - Cracked or damaged
Information:	Cracking was evident to the tiling in this entry area at the time of inspection. While the cracking appears to be minor, this area is frequently exposed to water, allowing potential for water penetration into adjoining sections of walls or flooring.

If left unmanaged, water penetration to these areas may lead to subsequent water damage, which is likely necessitate repair work to affected building elements.

A tiling contractor should be appointed to ensure that no further water damage occurs. The re-application of silicone and grouting throughout remaining tile work is also advised, to further protect the area against water penetration.

Where water penetration has led to water damage, appointment of a relevant tradesperson may be required to repair damaged building elements.

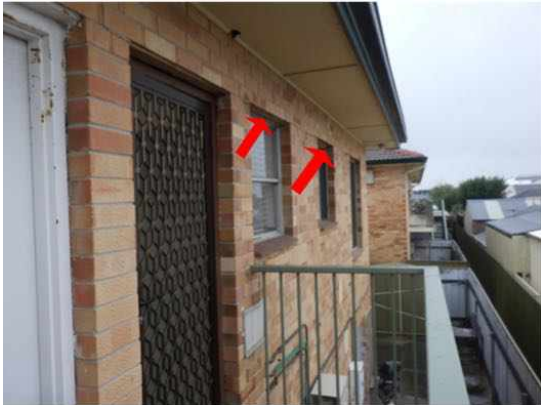
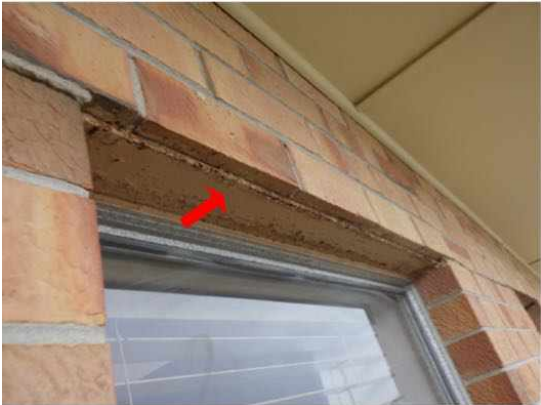
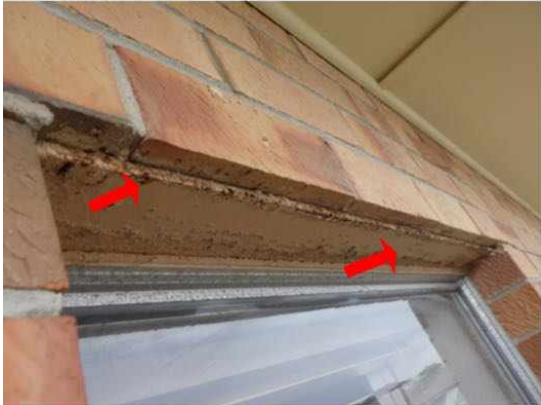
Defects 3.09

Building:	Building 1
Location:	All External Areas
Finding:	Building element - Rusted or corroded
Information:	This building element shows evidence of rusting and corrosion, which is likely to have developed as a result of excessive exposure to moisture and or inadequate coatings.

As surface rust provides no protection to the underlying iron, the deteriorating condition is likely to worsen if not addressed in the short-term future.

Where possible, the use of galvanized (treated) metals or aluminium coated metals aid in rust prevention, as does regular general maintenance. Rust formation can be controlled with coatings, such as paint, that isolate the iron from the environment.

Rusting and corrosion should be managed by ideally removing or limiting the affected surface from exposure to moisture. A registered builder may be appointed to replace any building elements that have been severely affected by rust or water damage.

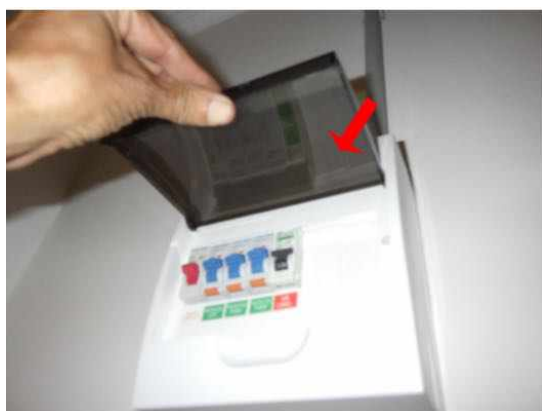
Building: Building 1
 Location: All External Areas >
 Finding: Termite Management System - No evidence of a chemical installation
 Information: The application of a post-construction chemical termite barrier is highly recommended for all properties, particularly if live termite activity has been found on the site previously. Such barriers are highly effective in preventing termite attack on any timber building elements throughout the property.

A durable notice should be placed in the switchboard unit to indicate current termite barriers. At the time of inspection, it appeared as though no termite management system has been installed, with no evidence to suggest preventative works taking place.

The client may consider gaining further advice from a pest controller as to the costs and procedures involved with this application. It is recommended that obtaining such advice be a short-term priority.

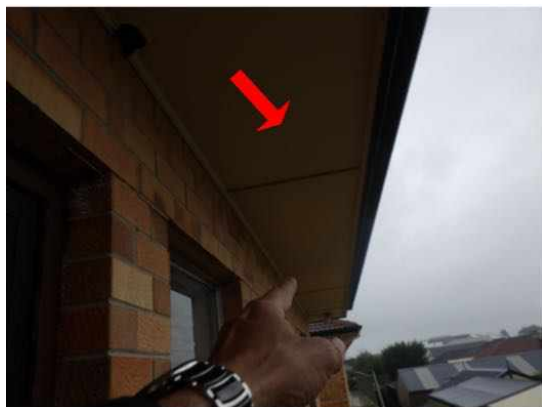
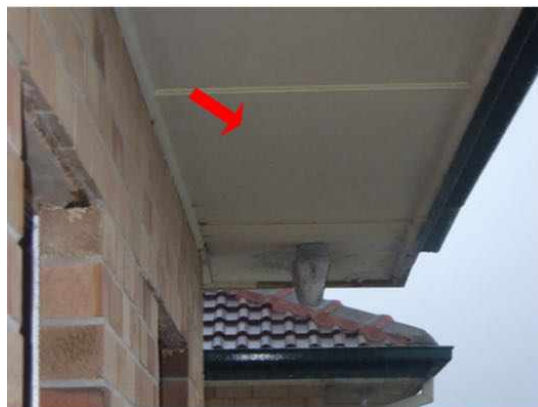
Building: Building 1
 Location: All External Areas
 Finding: Asbestos - Suspected ACM Identified on Site
 Information: Reporting on Asbestos is outside the Scope of this Report. This suspected defect is highlighted as a caution only. We suspect, based on our experience in the building industry, that there is a higher risk of the identified building element containing asbestos.

As Asbestos Reporting is outside the scope of this report, we advise that you consider

a separate Asbestos Inspection and Condition Audit, which can include the taking of samples for definitive confirmation of the presence of Asbestos.

In the interim, the client is advised to act with caution, especially when considering any damage to building materials general wear and tear renovations extensions demolition and general maintenance activities due to the suspected presence of Asbestos.

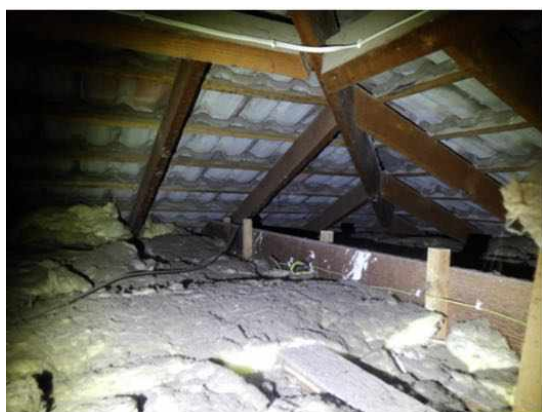
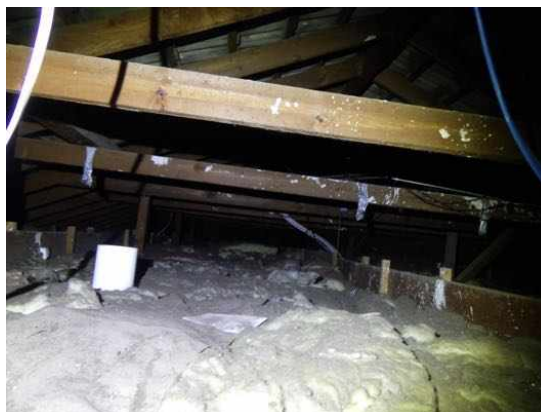
Building: Building 1
Location: All Areas
Finding: Additional Photos - Obstructions and Limitations
Information: These photographs are an indication of the obstructions and limitations which impeded full inspection of the property at the time of inspection. These obstructions can hide an array of defects and should be removed to allow full inspection to be carried out. A re-inspection is recommended once the areas are made accessible.
