Building and Timber Pest Inspection Report

Inspection Date: Wed, 11 Feb 2026

Property Address: 30 Shirley Cres, Matraville NSW 2036,
Australia

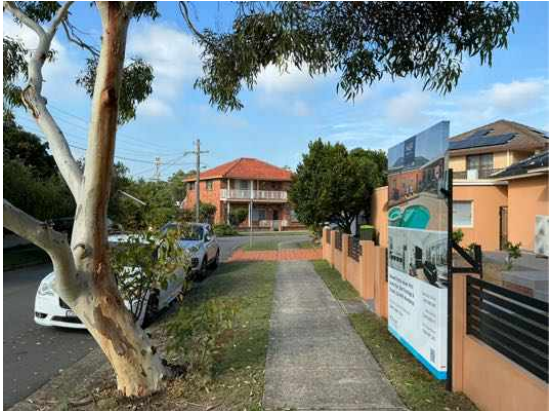
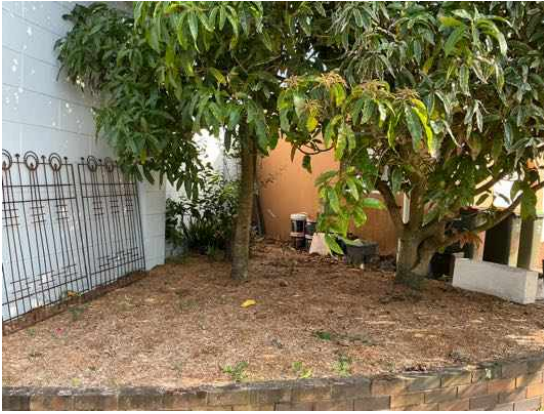
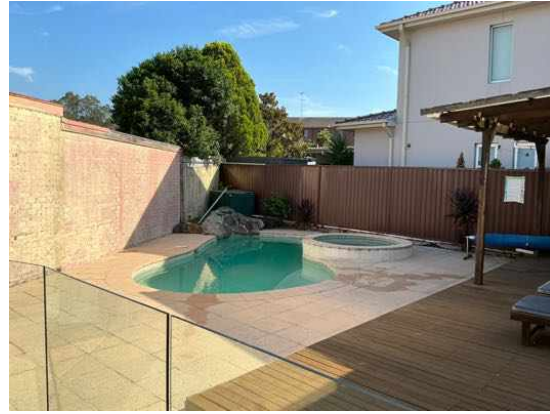
Building: Main Building
Location: All Areas
Finding: Trees to be inspected within the property.
Information: Trees can be conducive to termite activity and nesting. Trees over 100mm on the property, should be drilled and tested for termite activity.

Regular inspections every 6-12 months- or advised by the termite management system installer.

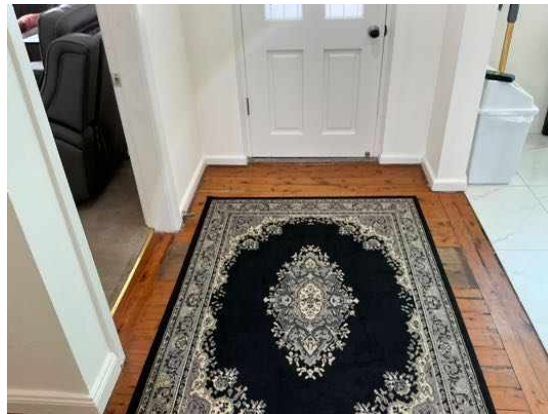
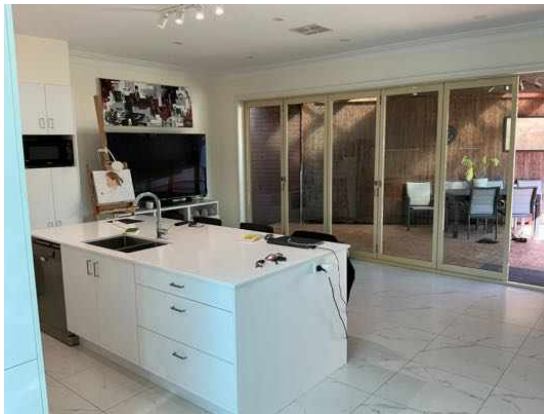
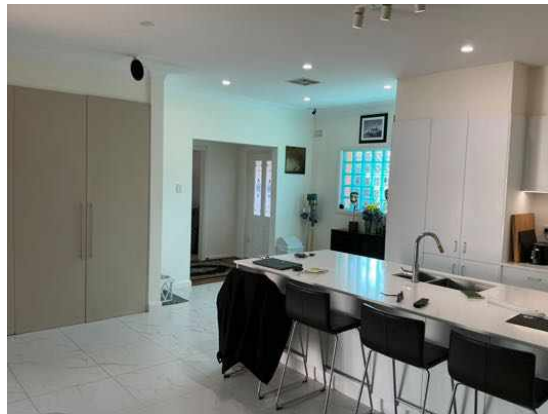
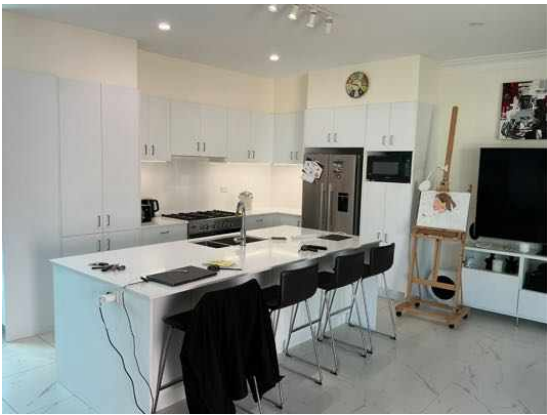
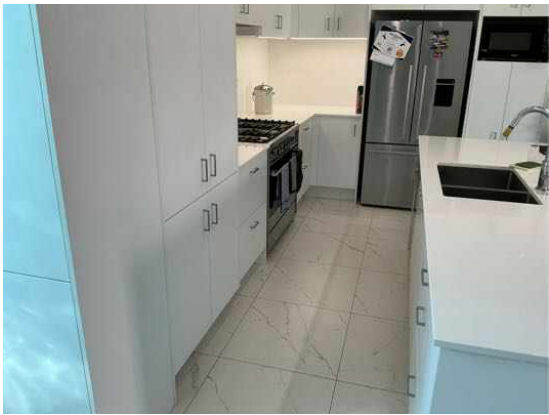
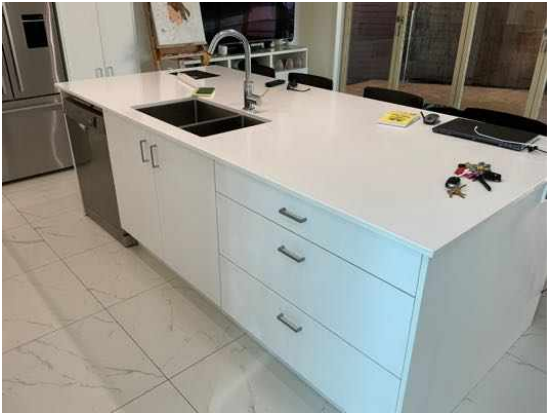
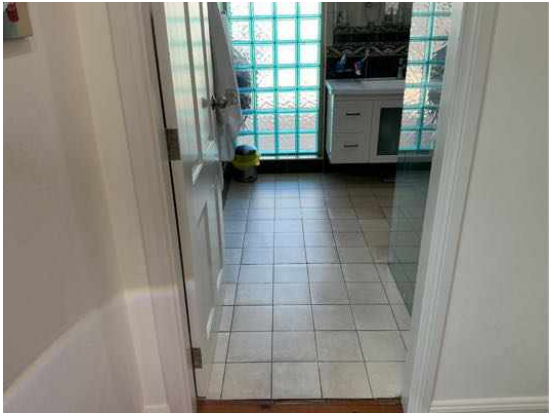
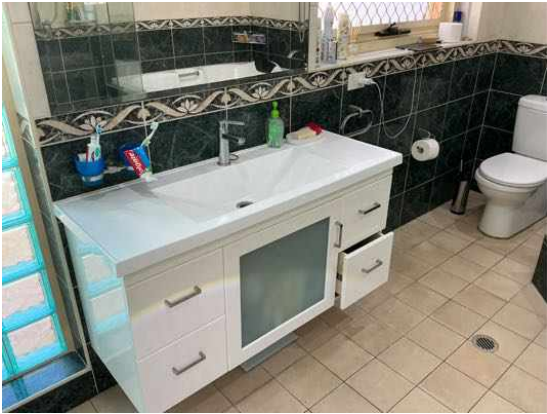
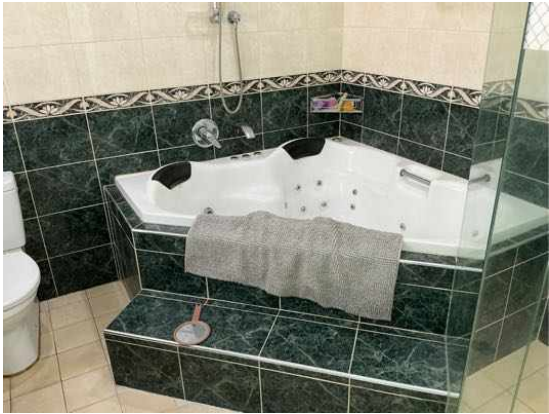
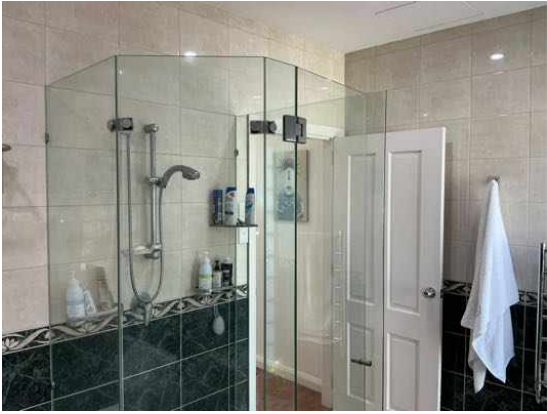
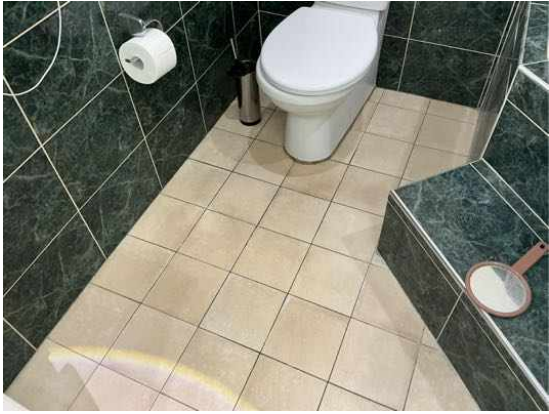
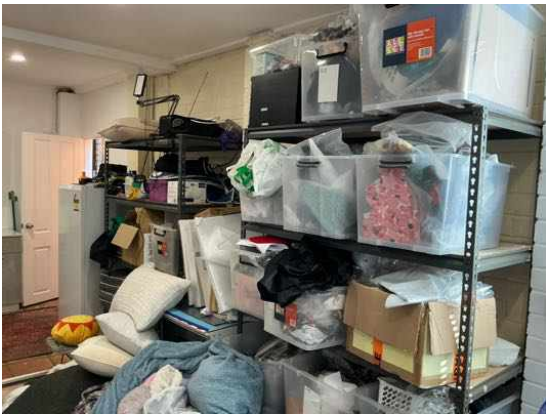
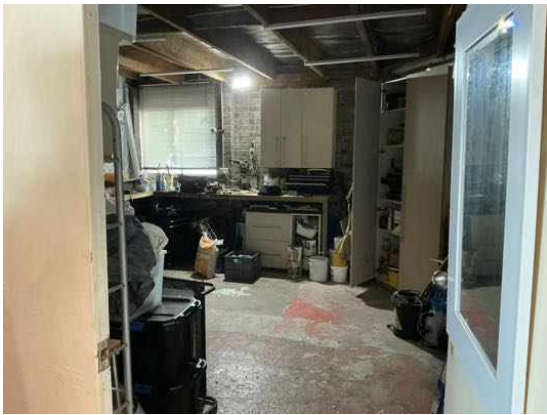
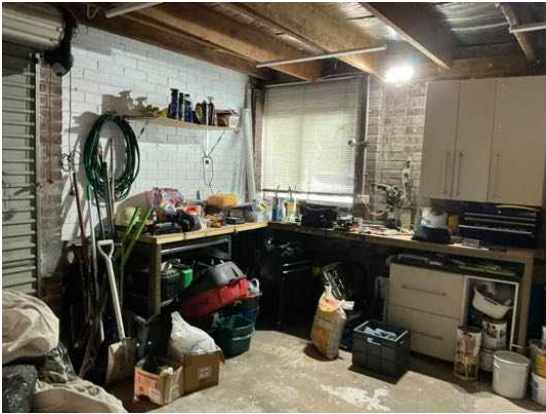
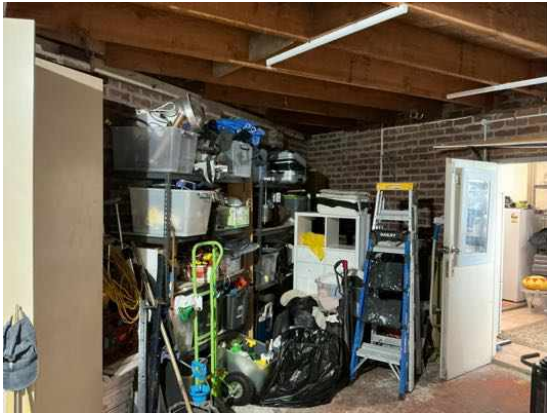
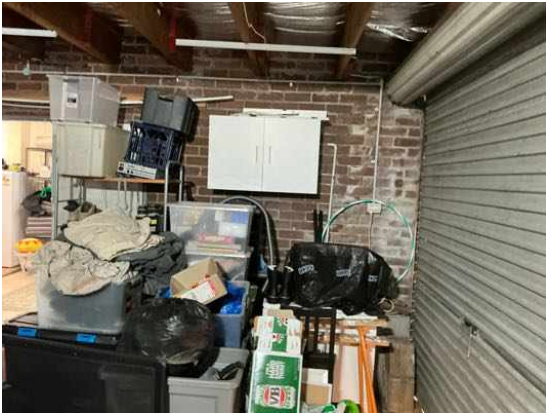
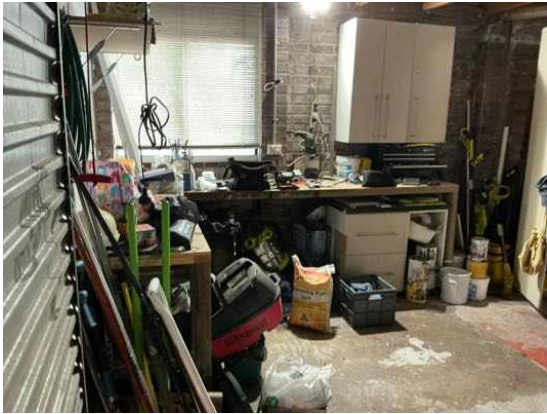
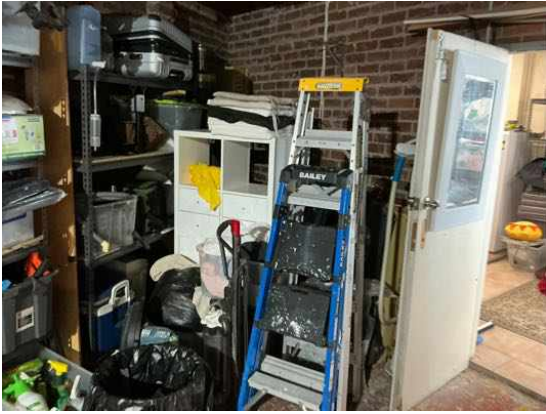
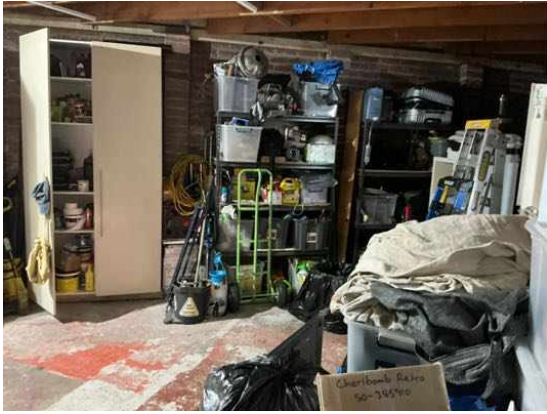
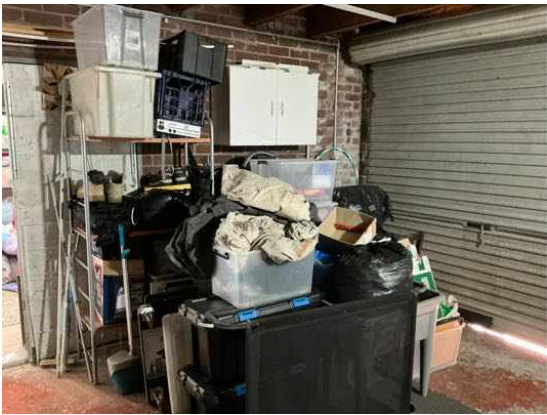
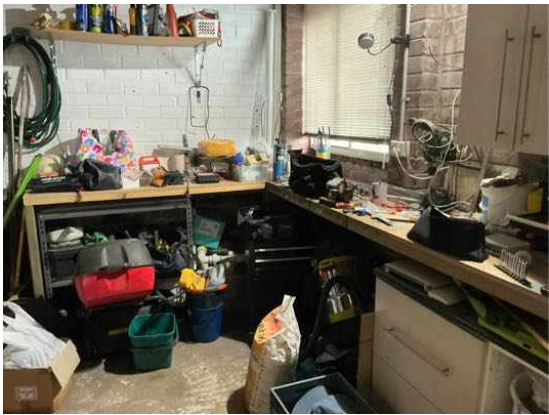
Building: Main Building
Location: All Areas- internal
Finding: Additional Photos - Obstructions and Limitations
Information: These photographs are an indication of the obstructions and limitations which impeded full inspection of the property at the time of inspection. These obstructions can hide an array of defects and should be removed to allow full inspection to be carried out. A re-inspection is recommended once the areas are made accessible.

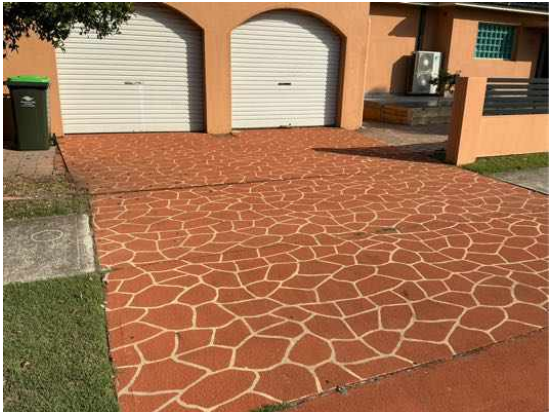
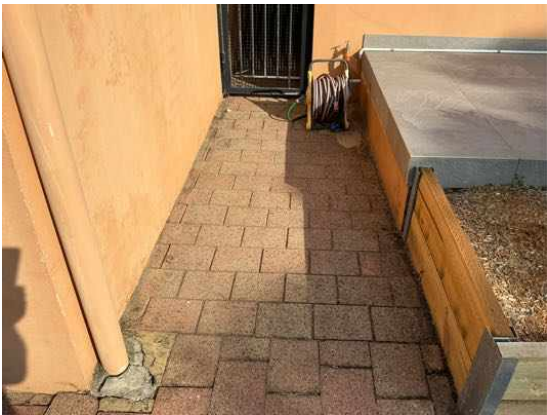
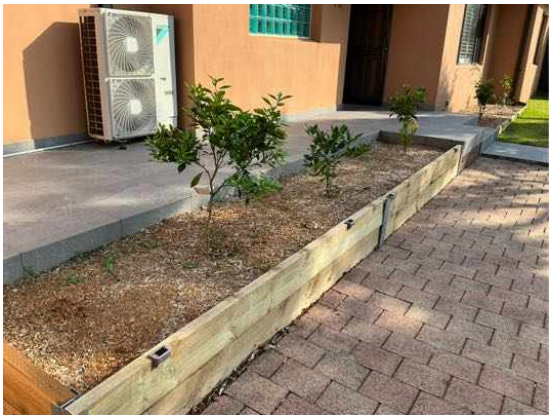
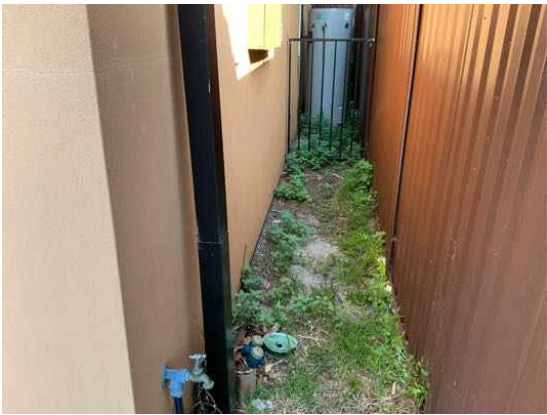
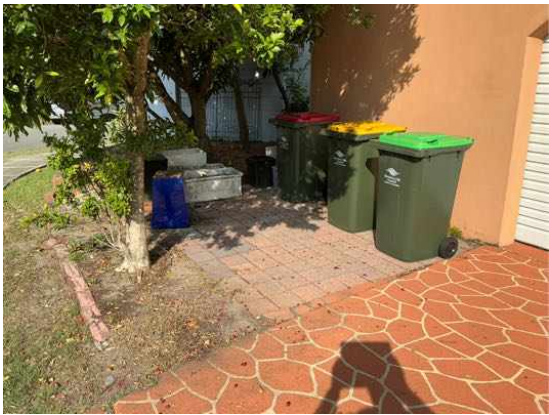
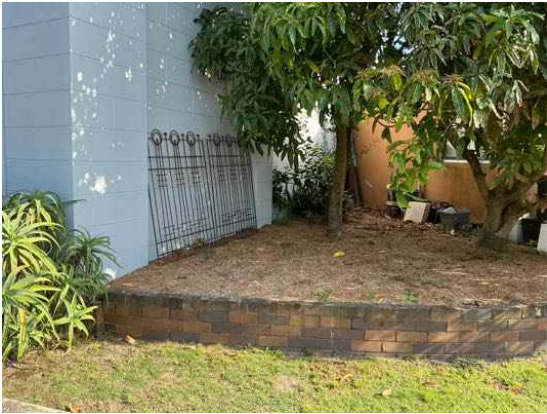
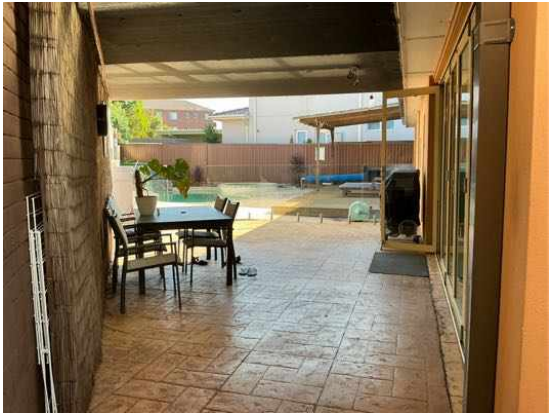
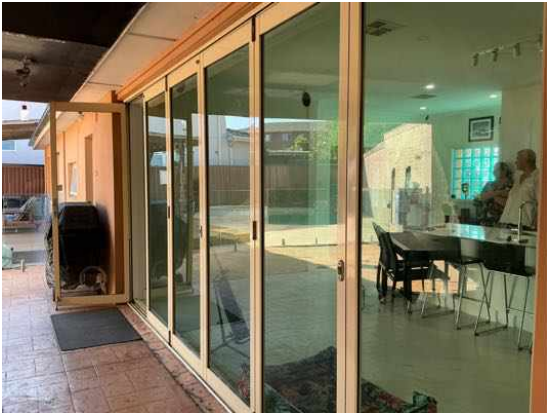
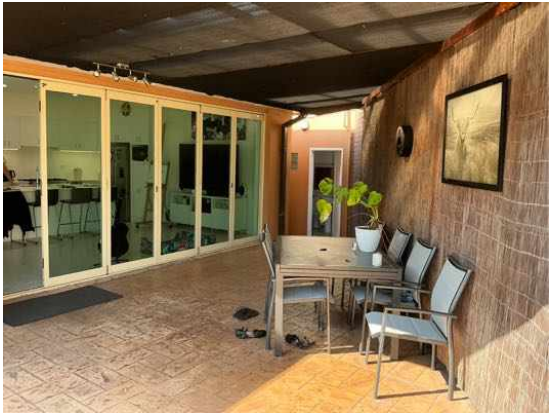
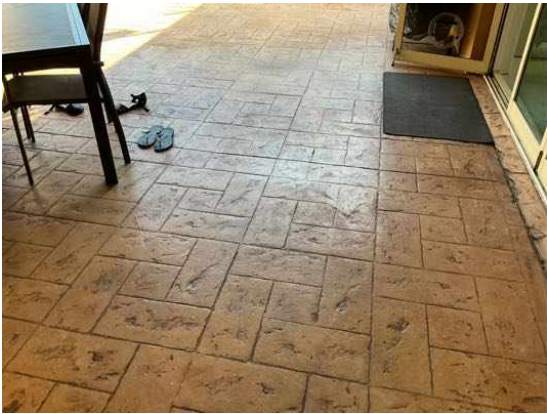
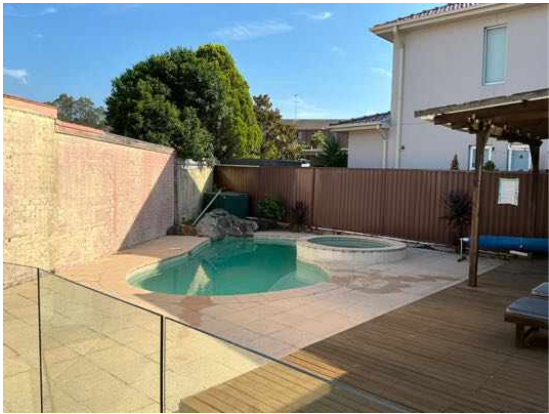
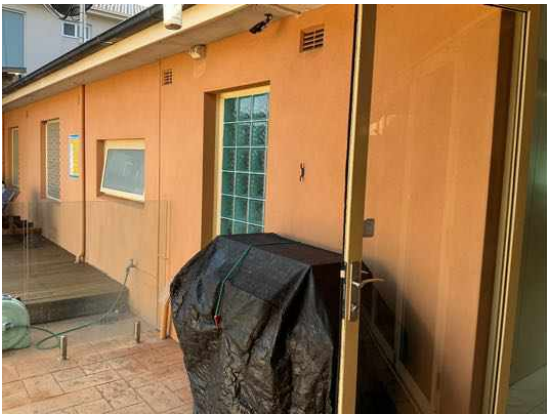
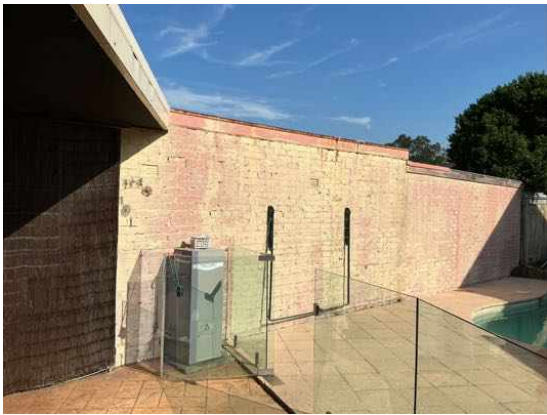
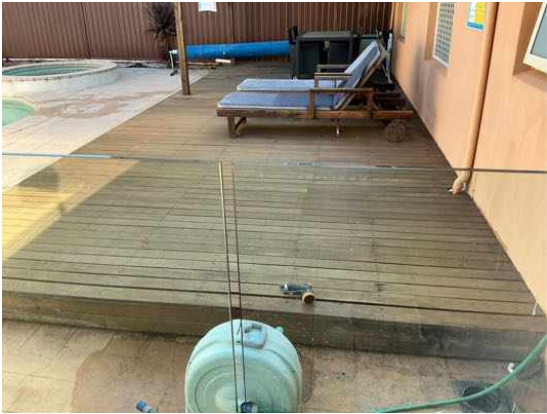
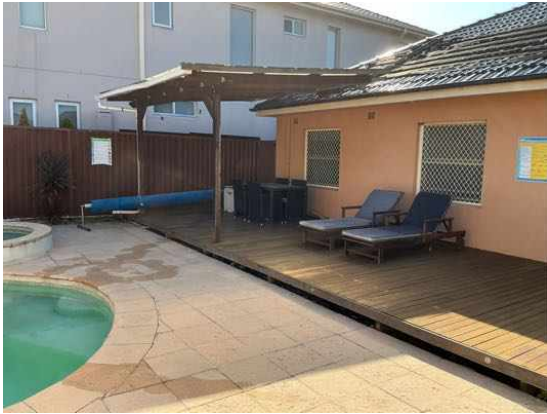
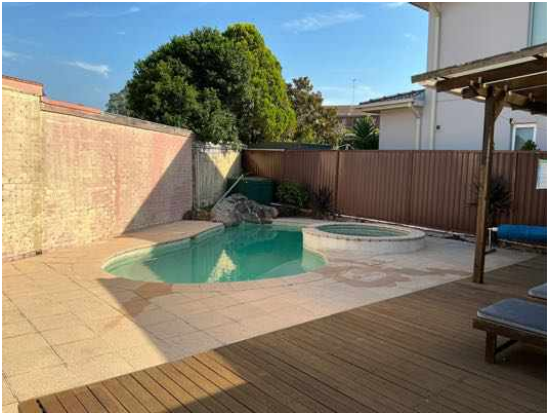
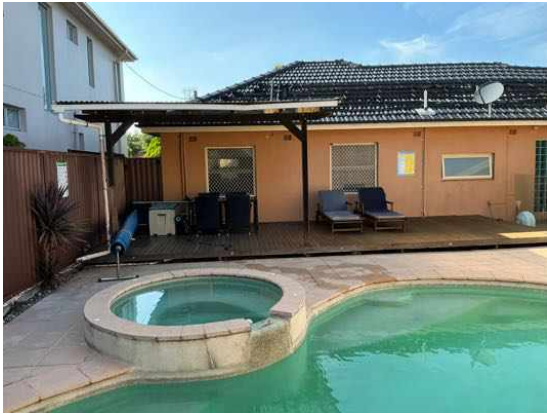
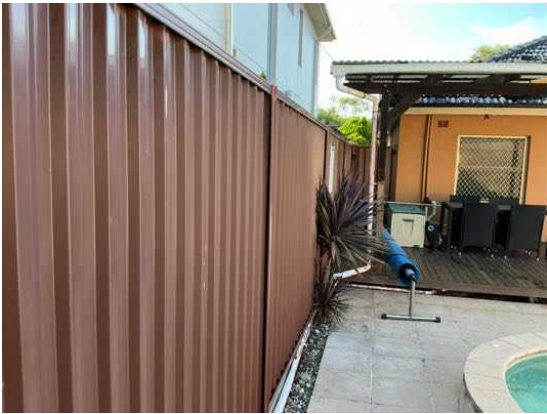
Building: Main Building
Location: All Areas- external
Finding: Additional Photos - Obstructions and Limitations
Information: These photographs are an indication of the obstructions and limitations which impeded full inspection of the property at the time of inspection. These obstructions can hide an array of defects and should be removed to allow full inspection to be carried out. A re-inspection is recommended once the areas are made accessible.

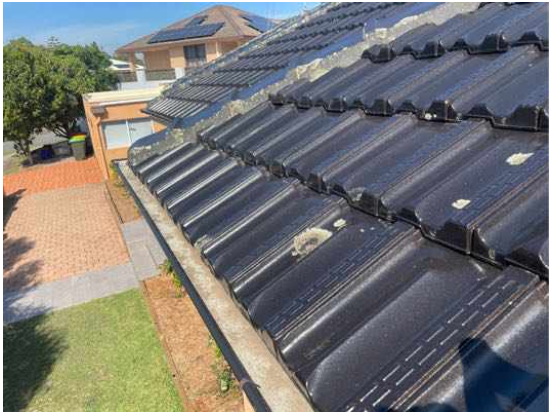
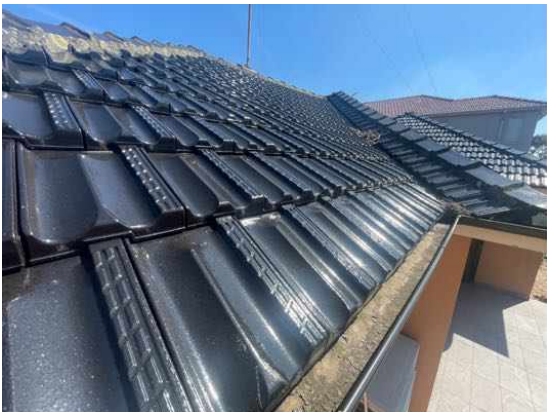
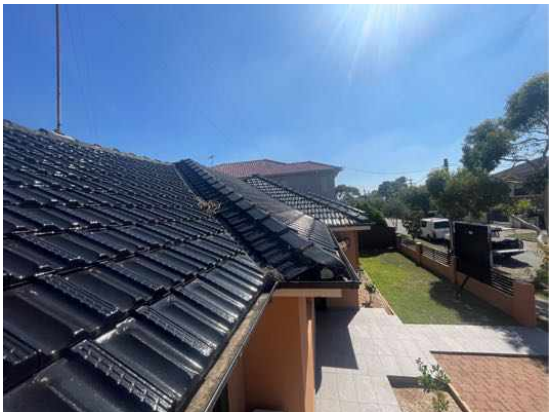
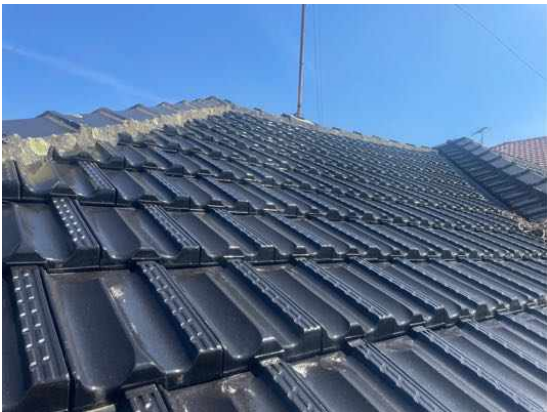
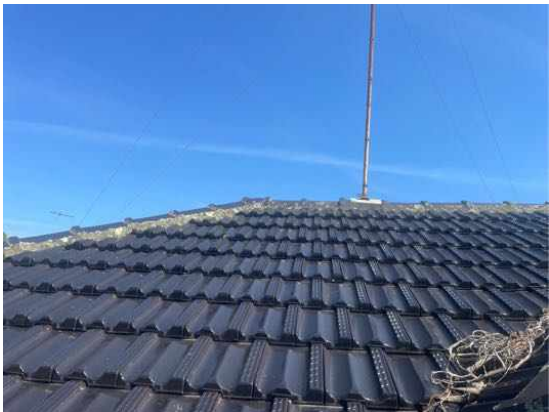
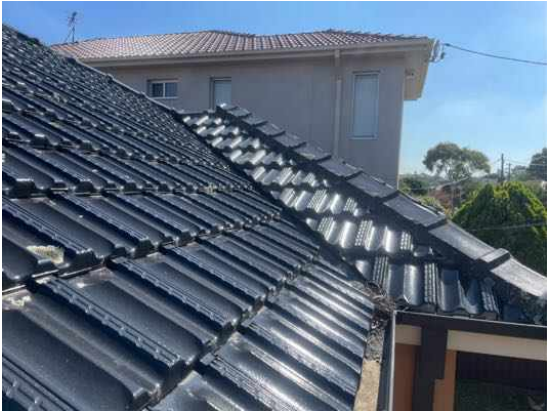
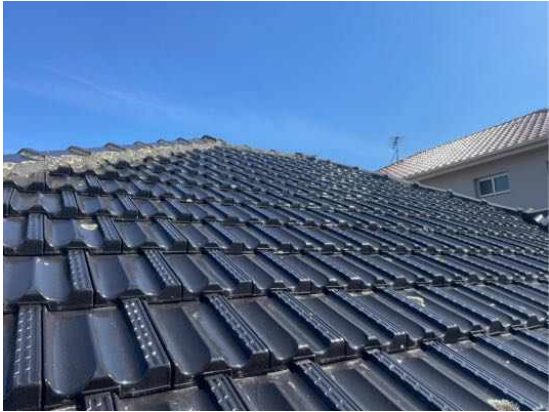
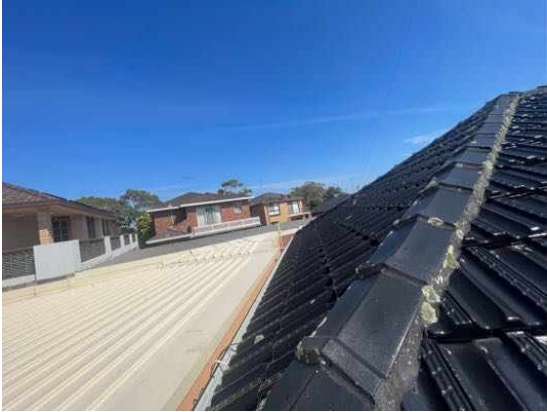
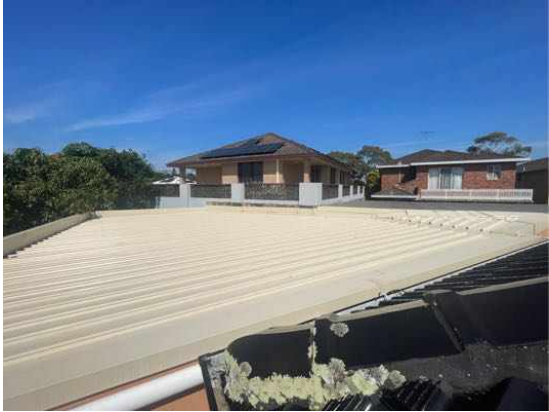
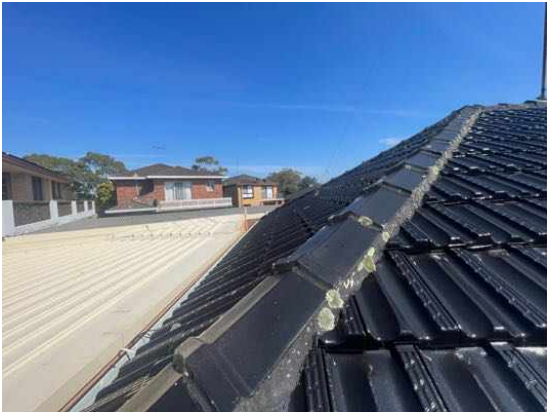
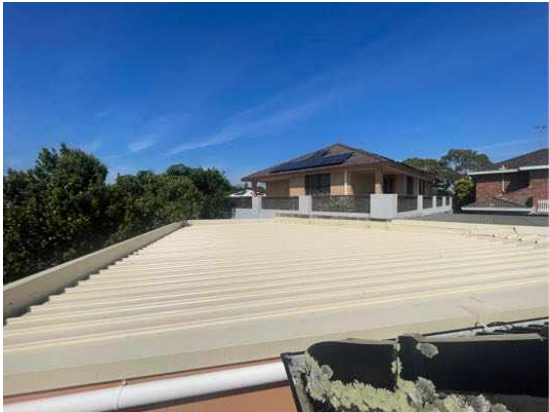
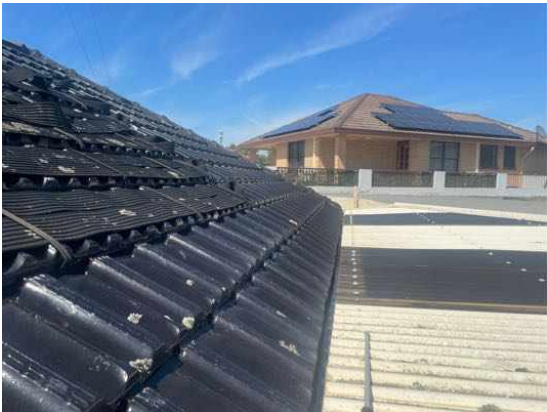
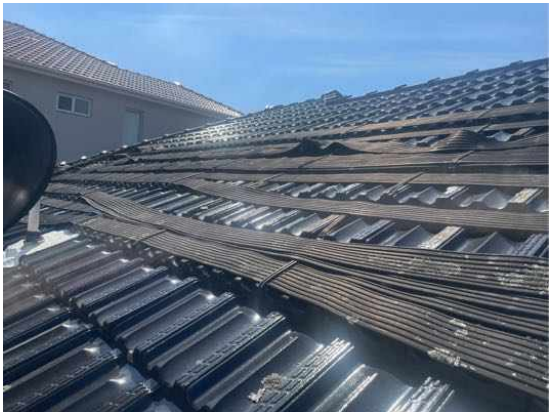
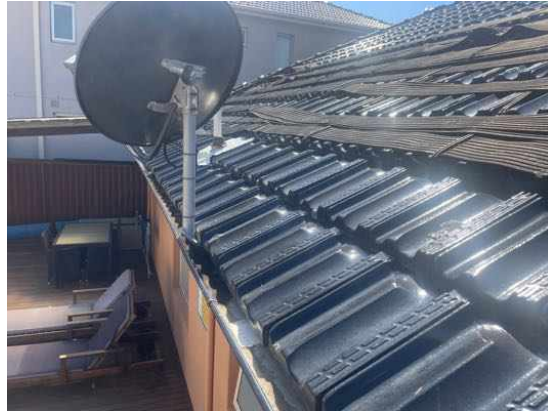
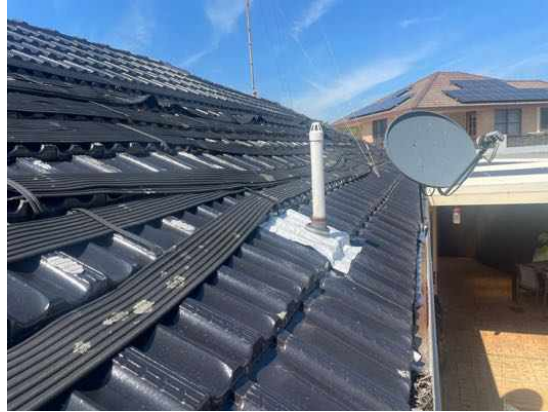
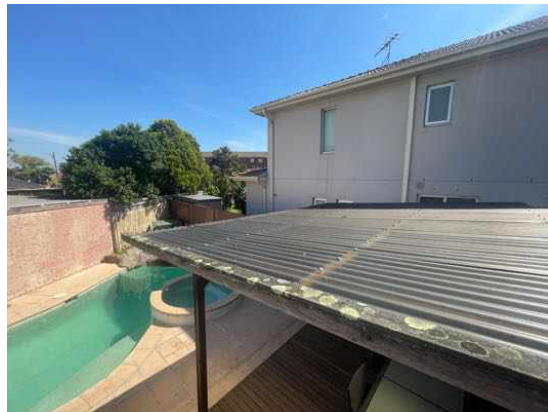
Building: Main Building
Location: Roof Exterior
Finding: Additional Photos - Obstructions and Limitations
Information: These photographs are an indication of the obstructions and limitations which impeded full inspection of the property at the time of inspection. These obstructions can hide an array of defects and should be removed to allow full inspection to be carried out. A re-inspection is recommended once the areas are made accessible.

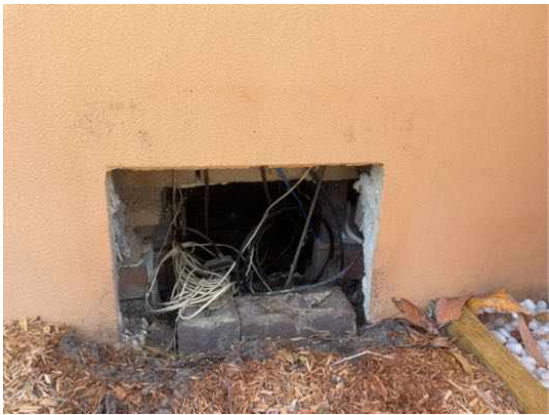
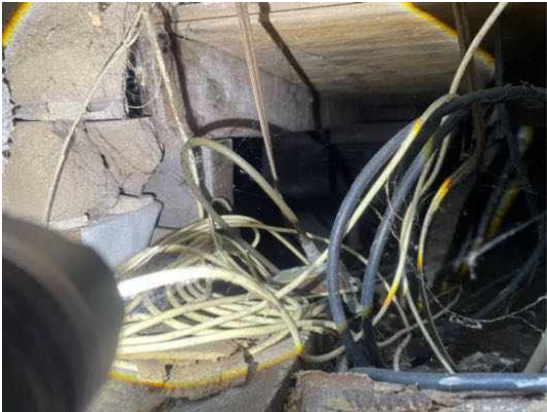
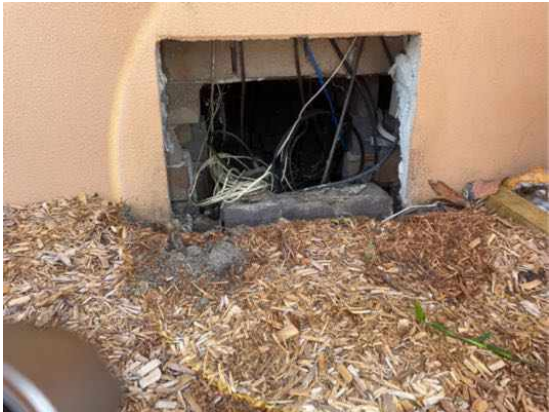
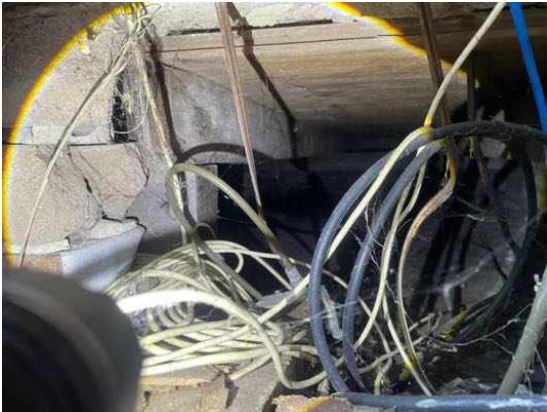
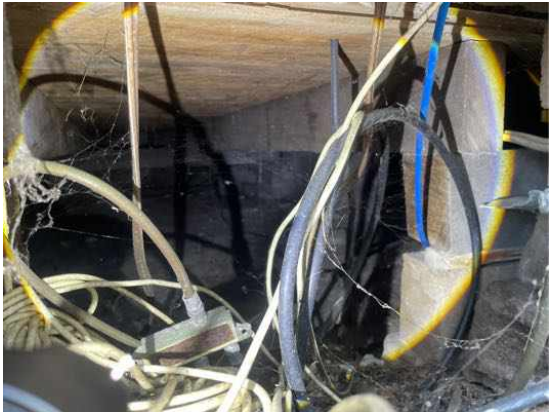
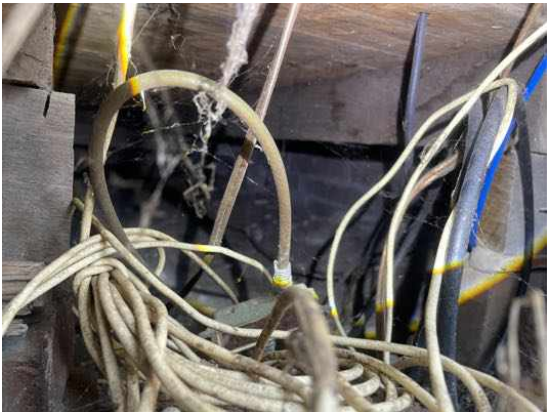
Building:	Main Building
Location:	Subfloor
Finding:	Additional Photos - Obstructions and Limitations
Information:	These photographs are an indication of the obstructions and limitations which impeded full inspection of the property at the time of inspection. These obstructions can hide an array of defects and should be removed to allow full inspection to be carried out. A re-inspection is recommended once the areas are made accessible.

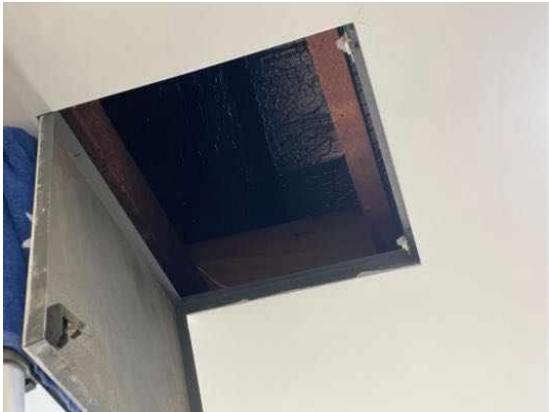
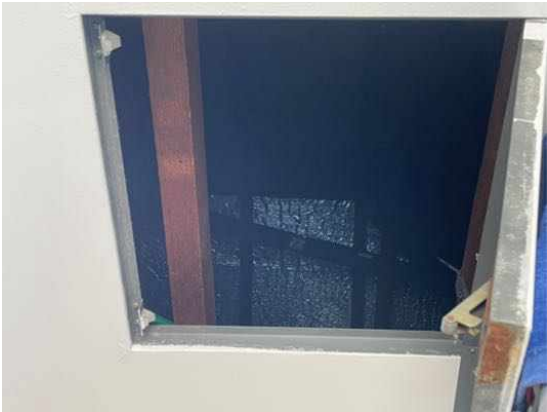
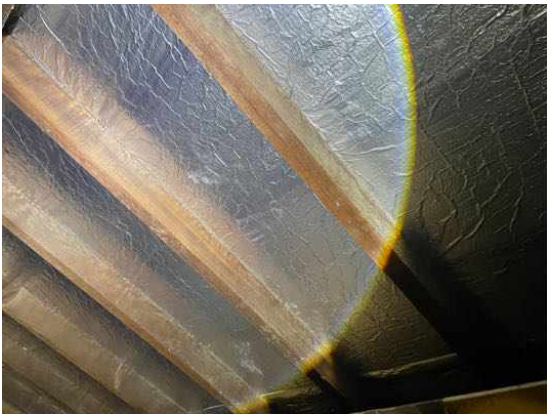
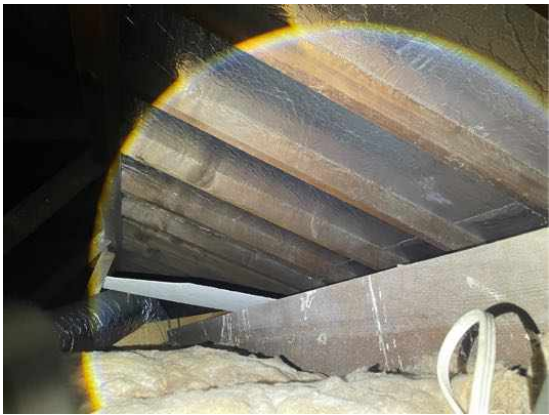
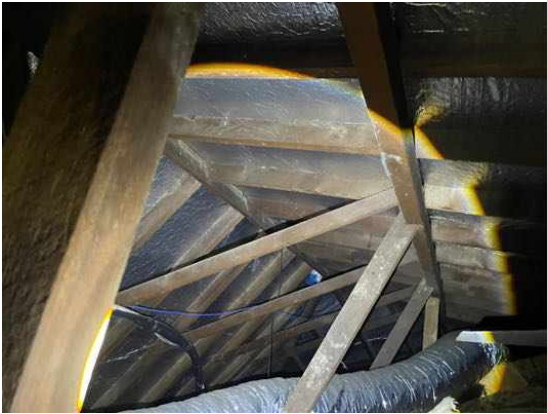
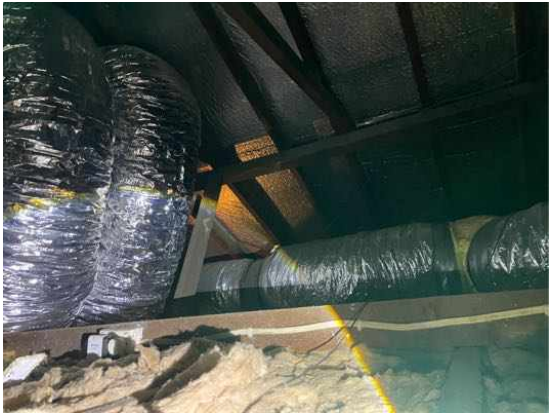
Building: Main Building
Location: Roof Void
Finding: Additional Photos - Obstructions and Limitations
Information: These photographs are an indication of the obstructions and limitations which impeded full inspection of the property at the time of inspection. These obstructions can hide an array of defects and should be removed to allow full inspection to be carried out. A re-inspection is recommended once the areas are made accessible.
