Building Inspection Report

Inspection Date: Mon, 23 Mar 2026

Property Address: 1/16 First St, Black Rock VIC 3193, Australia

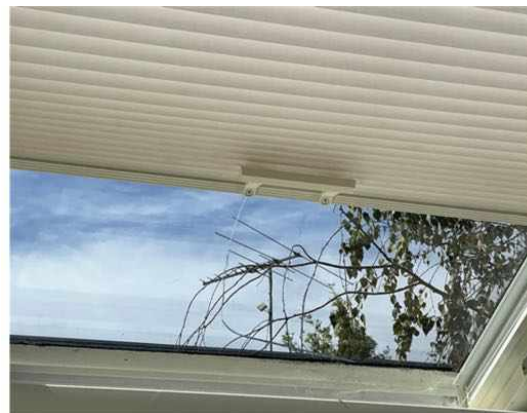
Defects 3.01

Building: Main Building
 Location: Family Room
 Finding: Window - Cracked
 Information: Cracks were identified in the window in this area. Cracking in windows is generally the result of impact damage, and is likely to develop further when left unmanaged.

The likelihood of this windowpane further cracking and shattering is increased exponentially, providing a safety hazard in the area. The cracked window also impairs the weather tightness of the building, creating potential for minor water leaks.

The vendor has a obtained a quote to replace this window and assured us that these works will be completed prior to settlement

A qualified glazier is required to repair the window as soon as possible. Depending on the extent of the cracking, replacement of the window may be required. Please be advised that any persons coming into contact with the cracked window should do so with due caution to avoid any personal injury that may ensue.

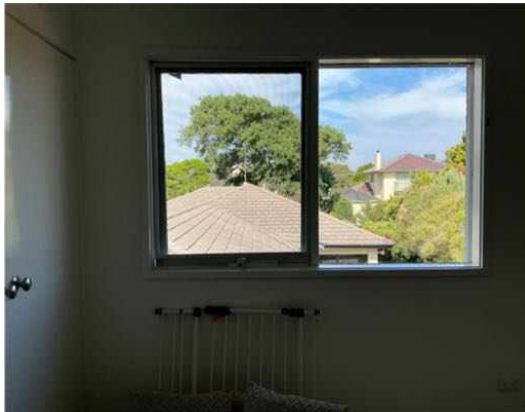
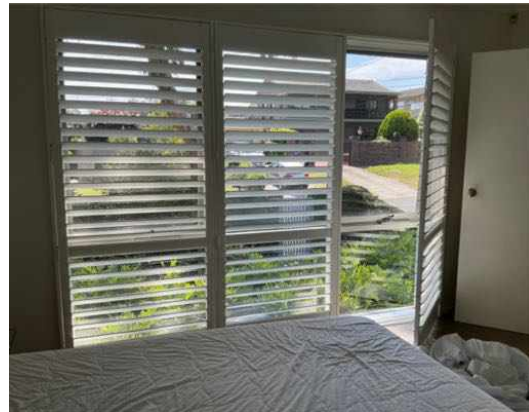
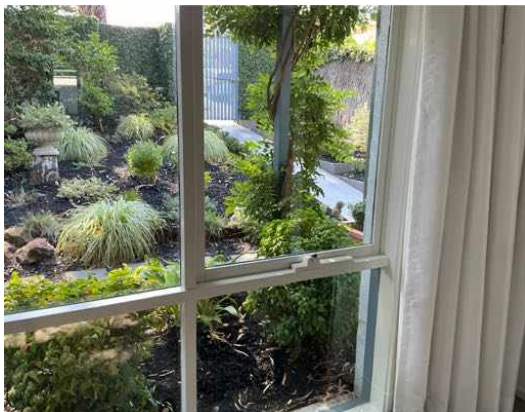
Defects 3.02

Building: Main Building
 Location: Windows
 Finding: Windows- stiff to open
 Information: Several windows throughout with found to be sticking and jamming and difficult to operate at the time of inspection.

Windows provide ventilation and exits to the adjoining area and should be at a fully operational level to ensure user comfort and safety. Restricted function may also pose as a potential safety hazard if required for emergency egress from the building.

Generally, factors such as general age of the building element and a lack of maintenance are the usual causes for this type of defect.

Replacement of windows running hardware may be required, as well as minor repairs and cleaning. A registered builder or general handy person will be required to repair the windows

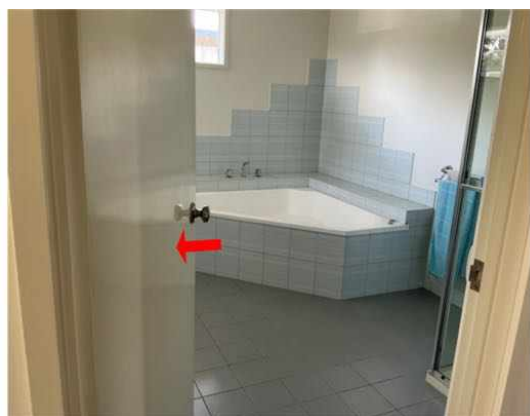
Defects 3.03

Building: Main Building
 Location: Bathroom
 Finding: Sticking or jamming
 Information: Building elements which are sticking or jamming are difficult to operate and don't

function as intended. There are a variety of causes for sticking and jamming.

The most usual causes are swelling of timbers due to moisture, bulging or bowing of metal frames, or general material deterioration. Generally, sticking and jamming building elements indicate that their frames are uneven or out of level, generally as result of movement to surrounding walls and floors.

Easement will be required, which usually depends on the building materials used. This may involve some sanding and/or application of a lubricant. It will almost always include ensuring the areas are cleaned and free of any debris that may be detrimental to their operational state.

Appointment of a carpenter or general handyman is recommended to rectify any sticking/jamming building elements.

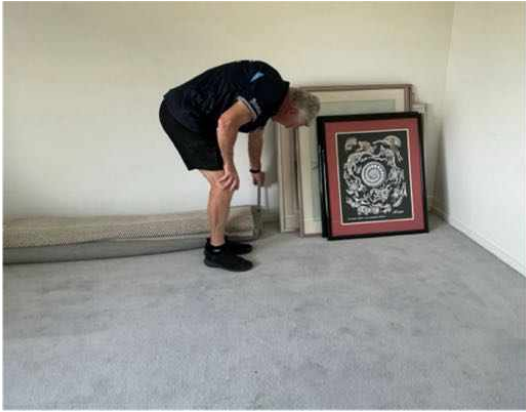
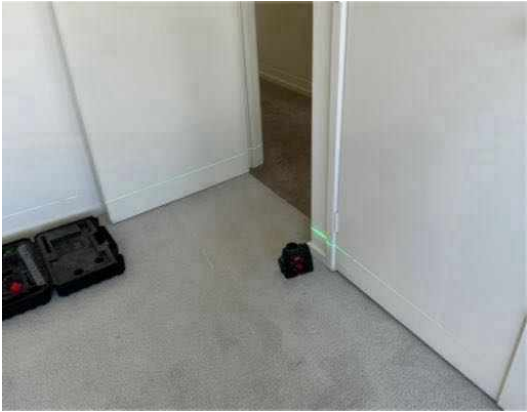
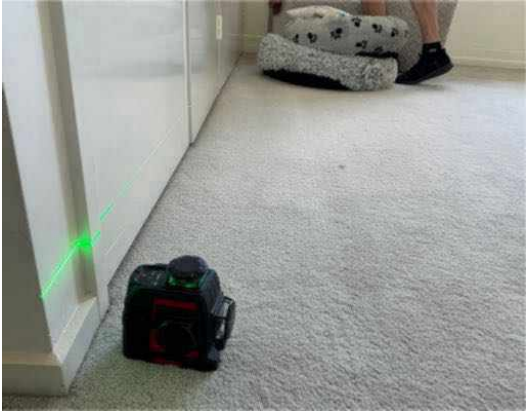
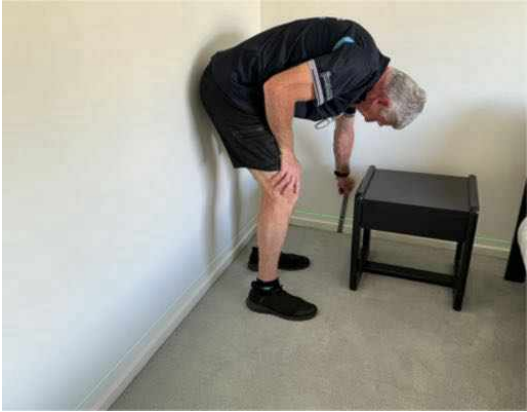
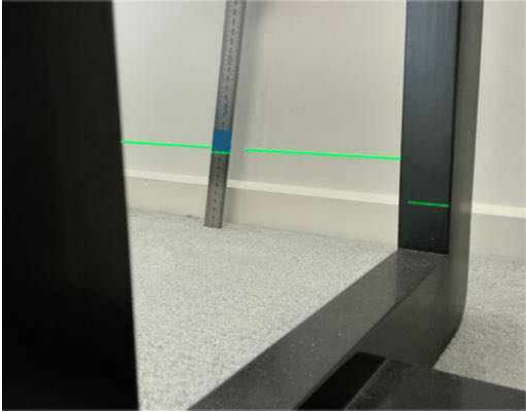
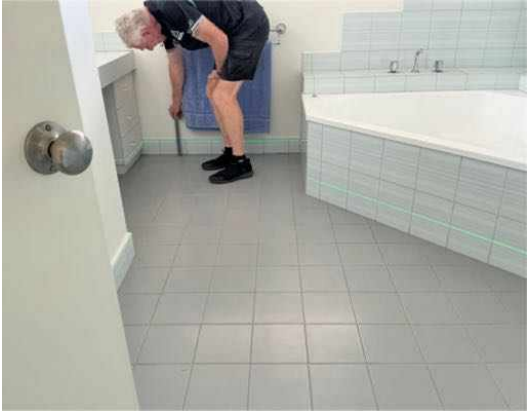
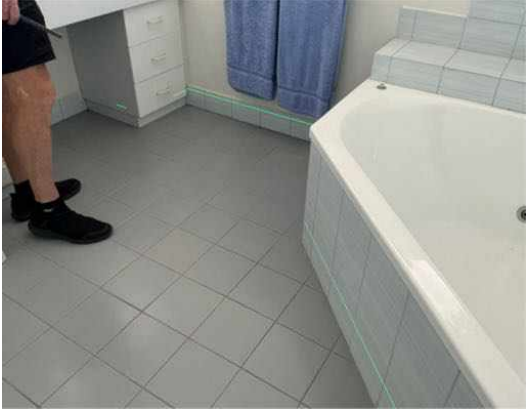
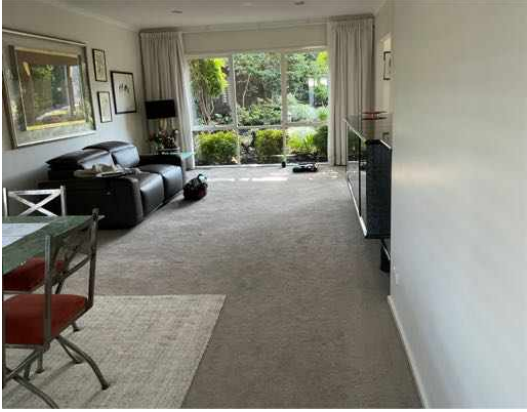
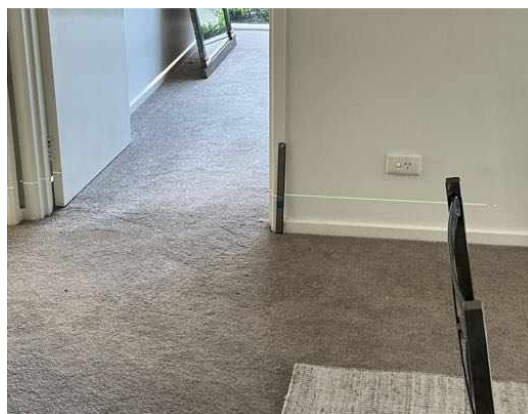
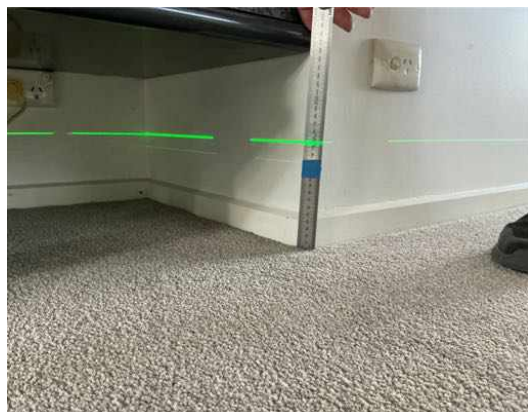
Defects 3.04

Building:	Main Building
Location:	All Areas
Finding:	Flooring - Uneven
Information:	The internal flooring in this area is out of level and uneven. Uneven flooring is likely to indicate minor defects such as expected movement of the foundations of the property, but may also indicate subsidence of the associated subfloor stumps.

Flooring throughout was found to be uneven, we recommend inspection and instructions from a registered builder specializing in Restumping in order to ascertain if any stabilization works are required.

It is advised that the flooring be closely monitored to identify any further movement. Where flooring remains relatively unchanged for an extended period of time (i.e. several months), it is likely that this defect has been caused by expected movement of the foundations of the property.

However, where flooring is uneven further, potentially invasive inspection of the subfloor structures and stumps in this area is required. In this case, works to repair are likely to be required, and would be carried out by a registered builder specialising in re-stumping.

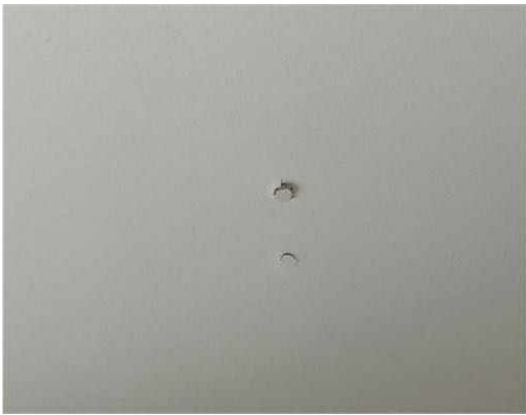
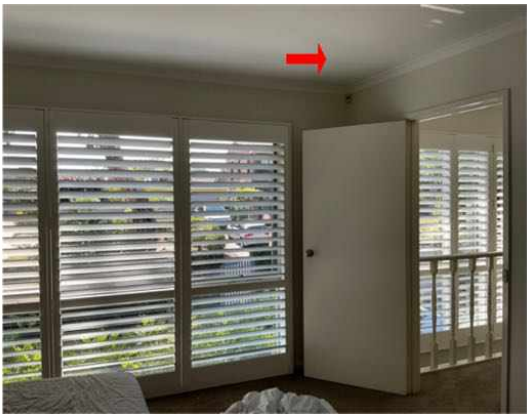
Defects 3.05

Building:	Main Building
Location:	Bedroom - Master
Finding:	Ceiling nails - Popping
Information:	Numerous popped nails were identified in the internal ceiling at the time of inspection. Nails and screws hold simply by the friction between them and the surface they are applied to. Over time, the nails and screws can back out, which is often a result of general ageing and deterioration of the building structure.

If left unmanaged, the ceiling sheets may become loose and unstable, increasing the rate of deterioration of the internal ceiling and creating potential for the development of secondary defects.

Re-fastening of popped nails will help to maintain the stability of the internal ceiling and associated building elements. Such minor works will also help to improve the appearance of the affected area and secure the ceiling sheets, so as to prevent the onset of ceiling sagging. These works should be performed by a qualified carpenter or plasterer at client discretion.

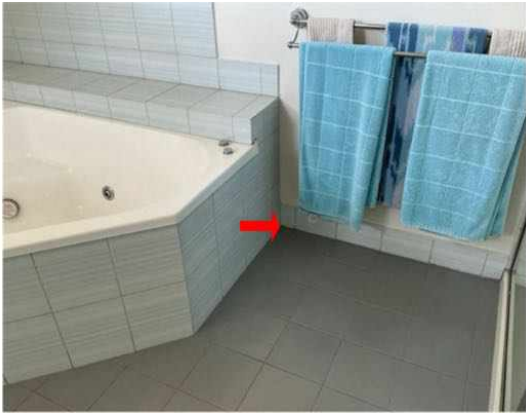
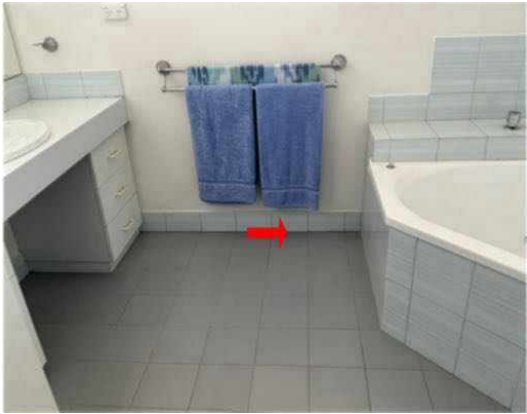
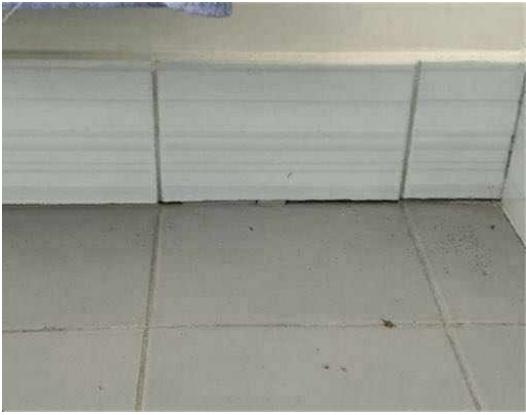
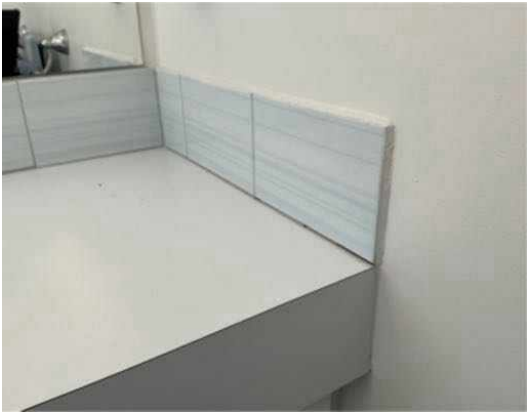
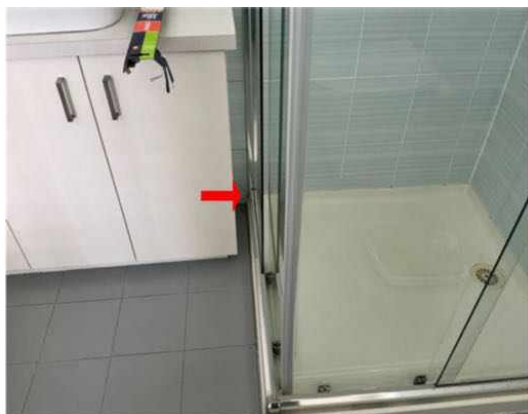
Defects 3.06

Building: Main Building
Location: Bathrooms
Finding: Grout - Missing
Information: Grout is missing in this area. Grout is used to protect gaps and crevices in building materials to ensure that they are water-tight and prevent water penetration to the associated structures.

Where grout is missing, a tiling contractor should be appointed immediately to apply grout and re-apply any silicone where necessary. Failure to do so is likely to lead to water damage to the surrounding area.

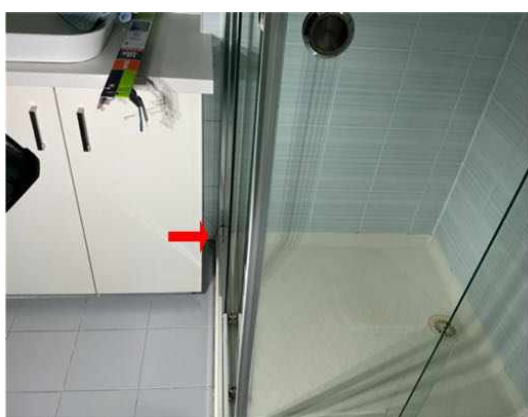
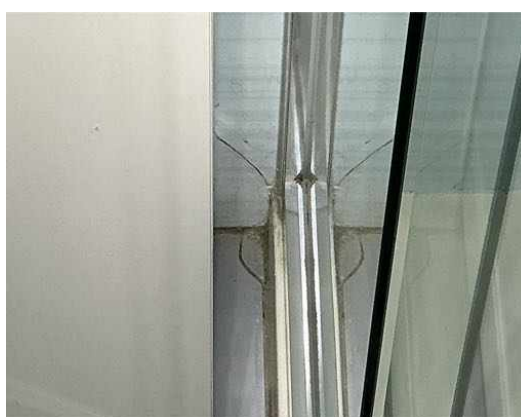
Defects 3.07

Building:	Main Building
Location:	Ensuite - Master
Finding:	Tiles - Cracked or damaged
Information:	Cracking was evident to the tiling in this area at the time of inspection. While the cracking appears to be minor, this area is frequently exposed to water, allowing potential for water penetration into adjoining sections of walls or flooring.

If left unmanaged, water penetration to these areas may lead to subsequent water damage, which is likely necessitate repair work to affected building elements.

A tiling contractor should be appointed to ensure that no further water damage occurs. The re-application of silicone and grouting throughout remaining tile work is also advised, to further protect the area against water penetration.

Where water penetration has led to water damage, appointment of a relevant tradesperson may be required to repair damaged building elements.

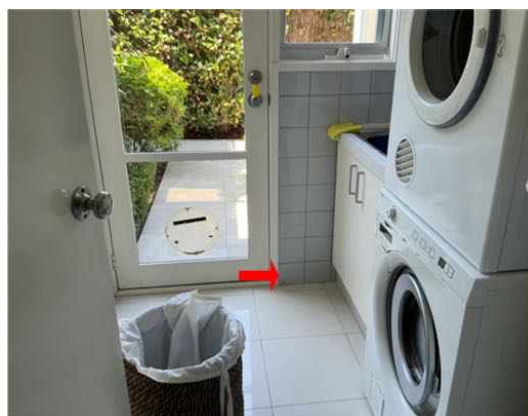
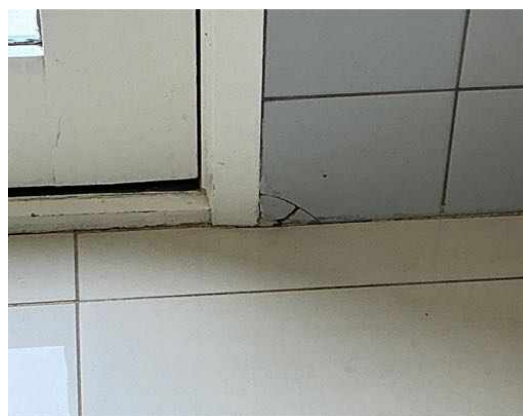
Defects 3.08

Building:	Main Building
Location:	Laundry

Finding:	Tiles - Cracked or damaged
Information:	Cracking was evident to the tiling in this area at the time of inspection. While the cracking appears to be minor, this area is frequently exposed to water, allowing potential for water penetration into adjoining sections of walls or flooring. If left unmanaged, water penetration to these areas may lead to subsequent water damage, which is likely necessitate repair work to affected building elements. A tiling contractor should be appointed to ensure that no further water damage occurs. The re-application of silicone and grouting throughout remaining tile work is also advised, to further protect the area against water penetration. Where water penetration has led to water damage, appointment of a relevant tradesperson may be required to repair damaged building elements.

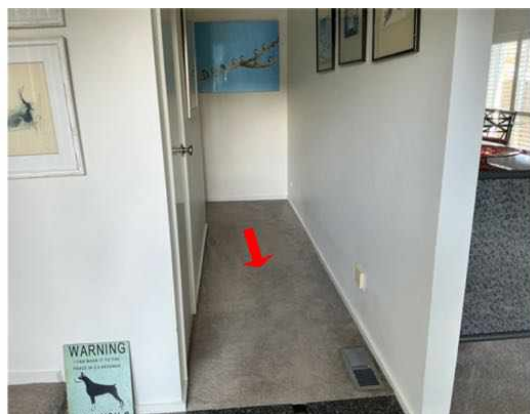
Defects 3.09

Building:	Main Building
Location:	Hallway
Finding:	Flooring - creaking
Information:	Flooring in this area was identified as being Creaking at the time of inspection. A bouncy floor surface generally presents as a slight change in level as they are walked across, in noisy or creaking flooring, or in consequent movement of surrounding furniture and fixtures. Creaking floors generally indicate that the floorboards or the subfloor structures are coming loose from the joists that they are installed on. Bouncy flooring may also be the result of gaps between flooring and stairs structures, which require packing. The client is advised to seek quotations for required repairs from a Registered Builder specialising in Restumping. The potential resolution may range from packing gaps to more serious works.

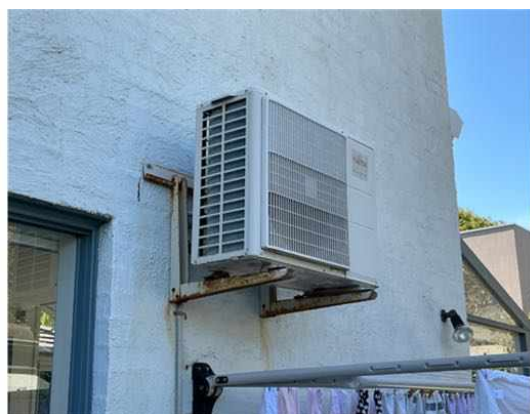
Defects 3.10

Building:	Main Building
Location:	Airconditioning bracket
Finding:	Building element - Rusted
Information:	This building element shows evidence of rusting and corrosion, which is likely to have developed as a result of excessive exposure to moisture and or leaking pipes.

Where possible, the use of galvanized (treated) metals or aluminium coated metals aid in rust prevention, as does regular general maintenance. Rust formation can be controlled with coatings, such as paint, that isolate the iron from the environment.

Rusting and corrosion should be managed by ideally removing or limiting the affected surface from exposure to moisture.

A registered plumber may be appointed to replace any plumbing pipes that may be leaking and causing this issue as soon as possible.

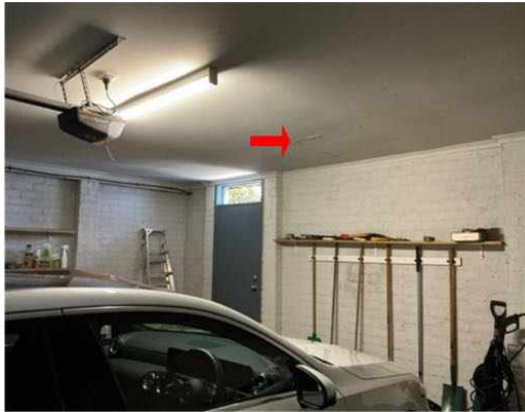
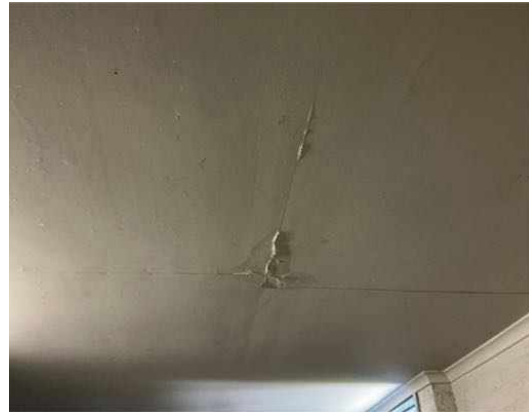
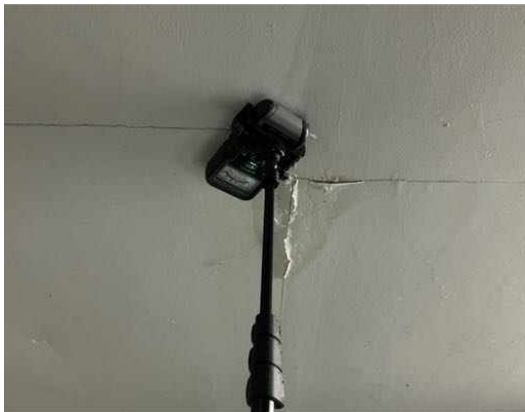
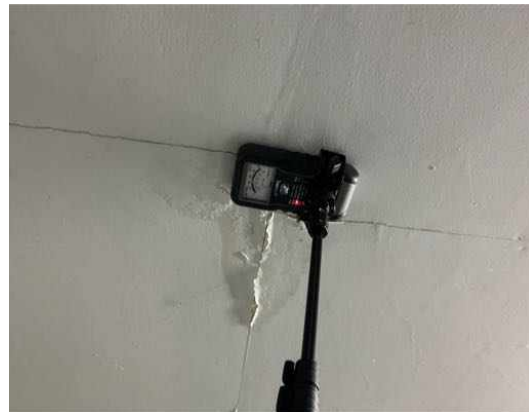
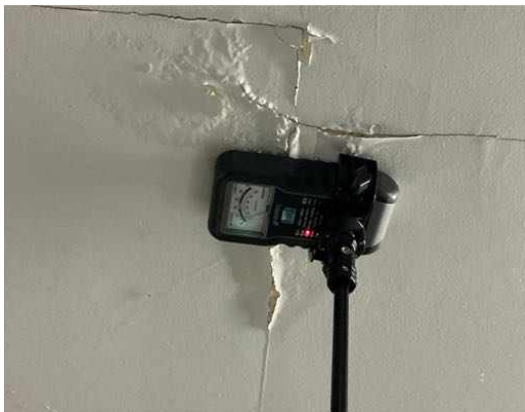
Defects 3.11

Building:	Main Building
Location:	Garage
Finding:	Ceiling - Water damaged (no excess moisture at the time of inspection)
Information:	Water damage to the ceiling lining is generally an indication of excessive moisture

being present in the roof void, usually via a leak to the roof covering.

Where water damage is evident to the ceiling, the primary requirement is to identify and rectify the source of the leak. A roofing plumber should be appointed as soon as possible to identify the leak and perform rectification works as necessary, ensuring the water damage is restricted.

Once the leak is repaired, consultation with relevant tradespeople, including plasterers and painters, is advised. Rectification works may include replacement of ceiling lining or minor repainting, depending on the extent of the damage.

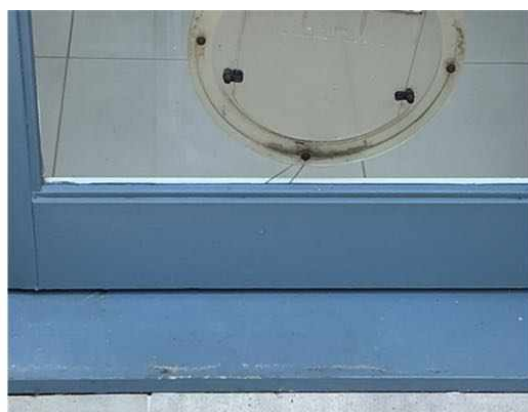
Defects 3.12

Building:	Main Building
Location:	Laundry
Finding:	Window - Cracked
Information:	Cracks were identified in the window in this area. Cracking in windows is generally the result of impact damage, and is likely to develop further when left unmanaged.

The likelihood of this windowpane further cracking and shattering is increased exponentially, providing a safety hazard in the area. The cracked window also impairs the weather tightness of the building, creating potential for minor water leaks.

A qualified glazier is required to repair the window as soon as possible. Depending on the extent of the cracking, replacement of the window may be required. Please be advised that any persons coming into contact with the cracked window should do so with due caution to avoid any personal injury that may ensue.

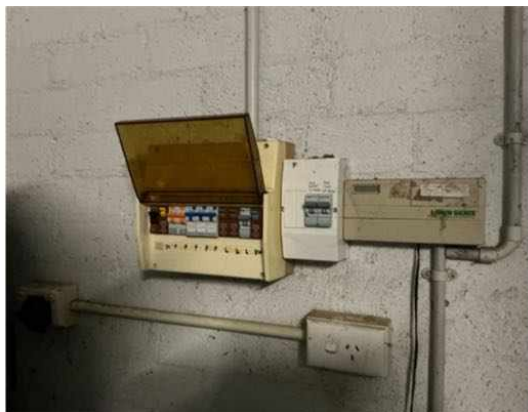
Defects 3.13

Building:	Main Building
Location:	Electrical Switchboard
Finding:	Termite Management System - no evidence of a chemical installation
Information:	The application of a post-construction chemical termite barrier is highly recommended for all properties, particularly if live termite activity has been found on the site previously. Such barriers are highly effective in preventing termite attack on any timber building elements throughout the property.

A durable notice should be placed in the switchboard unit to indicate current termite barriers. At the time of inspection, it appeared as though no termite management system has been installed, with no evidence to suggest preventative works taking place.

There was no evidence of a previous termite treatment, we recommend installation of a preventative treatment to all properties.

The client may consider gaining further advice from a pest controller as to the costs and procedures involved with this application. It is recommended that obtaining such advice be a short-term priority.

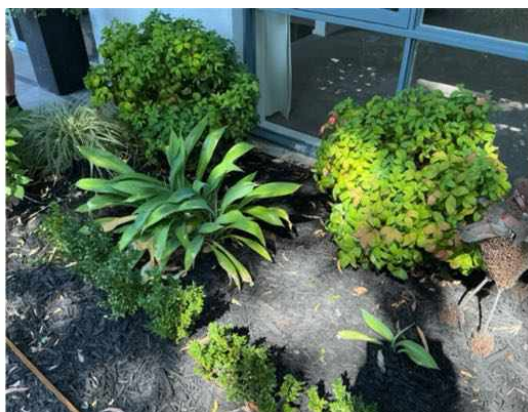
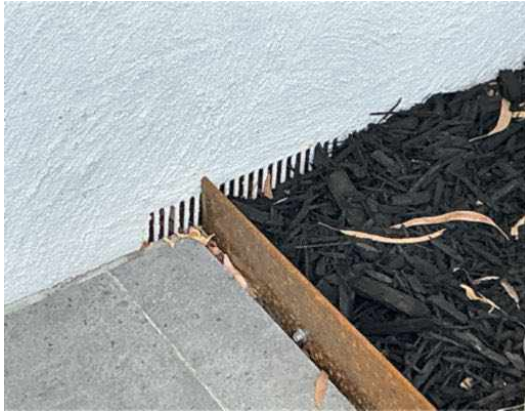
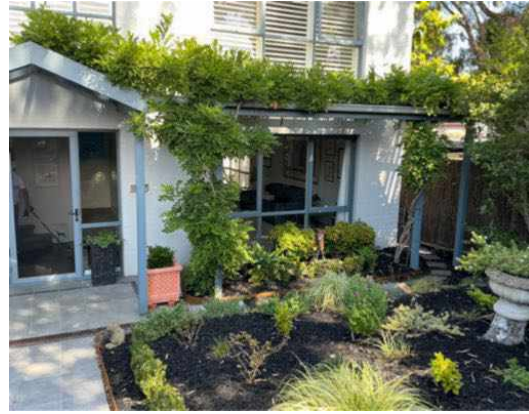
Defects 3.14

Building:	Main Building
Location:	Exterior walls - front
Finding:	Air vents - Blocked or inadequate
Information:	It was noted at the time of inspection that the subfloor area lacks adequate ventilation. The cause of this inadequate ventilation is the state of the air vents to the subfloor area. Where air vents are insufficient in number or are blocked, either fully or partially, subfloor ventilation is decreased.

A well ventilated subfloor aids in maintaining dry conditions, preventing secondary damage such as wood rot and pest activity, as well as preventing the development of mould/fungi and mildew (which can lead to major respiratory issues or safety hazards for occupants, particularly the elderly, the very young and those with existing illnesses).

All air vents should be cleared of blockages to promote adequate air flow to the area. Where ventilation is still insufficient, retrospective installation of air vents may be required. Appointment of a registered builder may be required to perform these works as necessary.

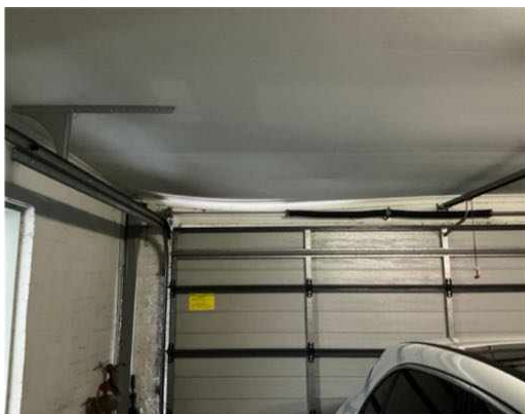
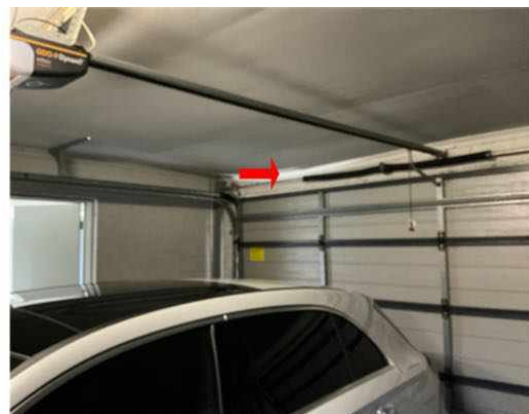
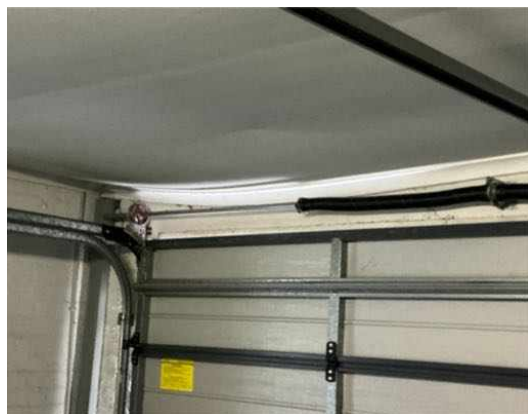
Defects 3.15

Information: Sections of the ceiling were found to be sagging at the time of inspection. Sagging to the fixed ceiling structure generally indicates that the building materials have swollen, due to contact with water, or that fixings (e.g. nails or glue) have become loose and require reattachment.

In some cases, sagging ceiling linings may also indicate that there are structural issues, causing surfaces to warp, twist or sag. Where sagging appears to be major, appointment of a structural engineer is advised to further inspect the property and identify the source and rectification works required.

Where minor sagging is evident, comparatively minor works, such as re-gluing of ceiling sheets, may be required. Such works may be performed by relevant tradespeople, such as plasterers and painters. Where excessive moisture has caused the roofing structure to swell and sag, the source of the water leak should primarily be identified prior to any remedial works being performed.

The appropriate action should be taken by the client as soon as possible to ensure that any potential further damage is limited.

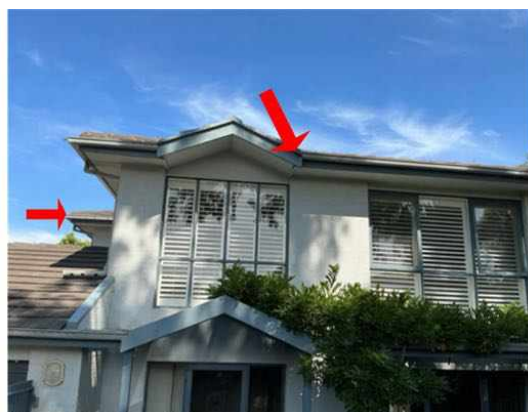
Defects 3.16

Building:	Main Building
Location:	Roof Exterior
Finding:	Gutters - Blocked
Information:	Roof plumbing structures, such as guttering and downpipes, should be free of all debris to prevent blockages. Blockages of the guttering and downpipes will lead to pooling and accumulated water overflows, which is likely to subsequently flood eaves and exterior walls.

Blocked gutters are likely to lead to high levels of moisture in the affected areas. Such moisture will not only cause rust and decay of the associated building materials, but can also provide conditions that are conducive to termite and timber pest activity. Blockages in gutters should therefore be removed immediately to ensure dry conditions are maintained.

Consult a Licensed Plumber for further specific advice on remedial works that may be required. In the interim, it is highly advised that blocked gutters be removed by the homeowner or a general handyperson as a matter of urgency.

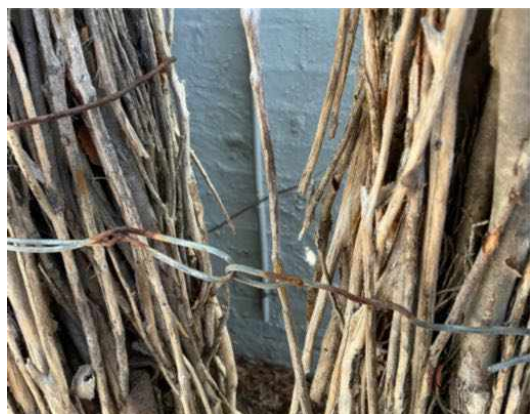
Defects 3.17

Building: Main Building
Location: Air conditioning units all
Finding: Air conditioner - Disconnected overflow
Information: The Air Conditioner (A/C) overflow was found to be disconnected from storm water drainage and is creating excessive moisture in the surrounding area.

Such leaking creates an environment which is conducive to an array of defects, including water damage to associated building elements and the attraction of termite or timber pest infestation.

It is highly recommended that a licensed plumber be appointed to connect the A/C overflow in order to prevent such an environment from being created. These minor works should be carried out as soon as possible.

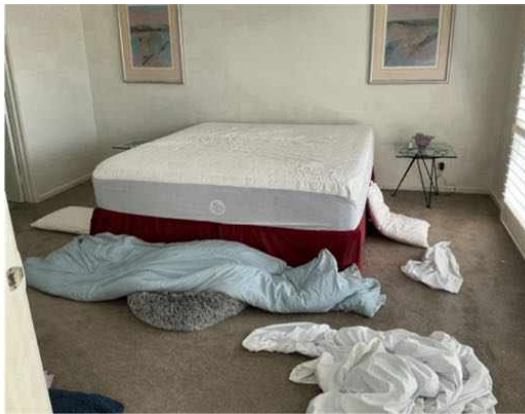
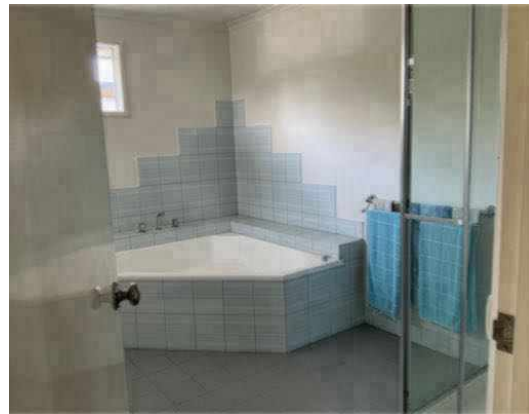
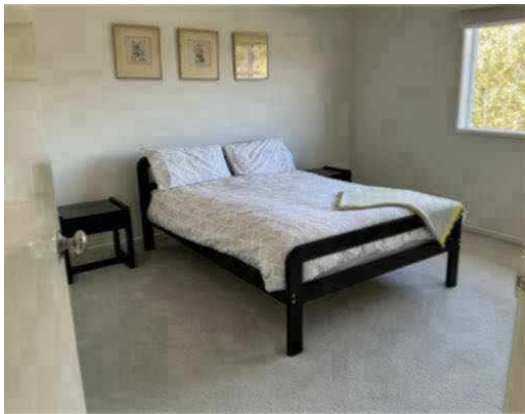
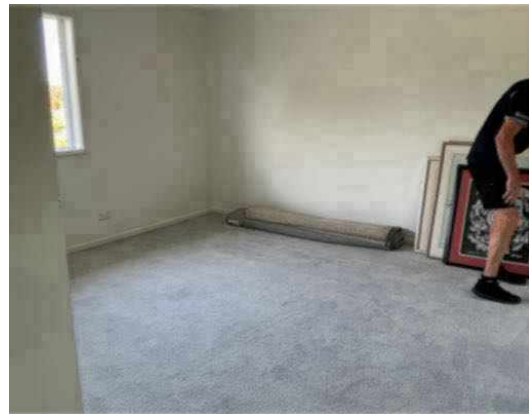
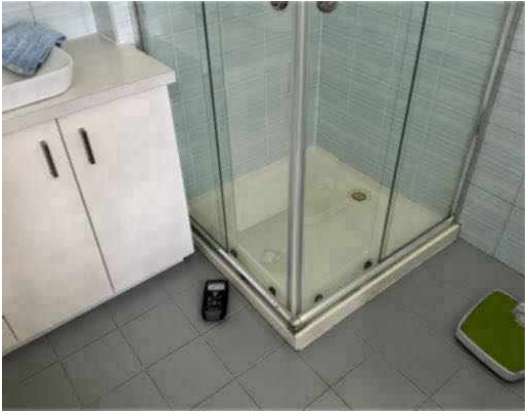
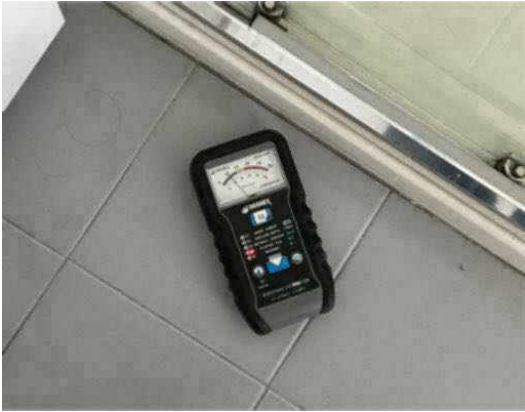
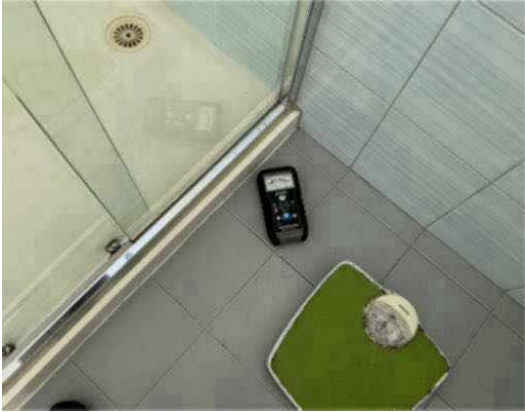
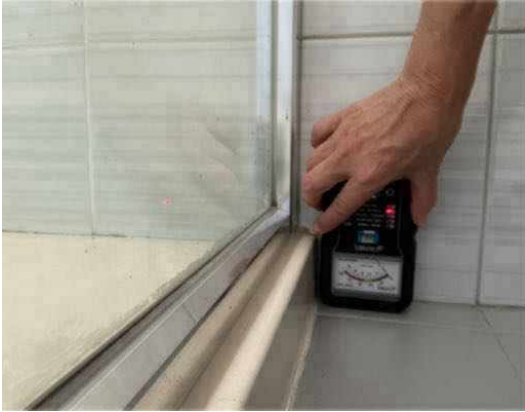
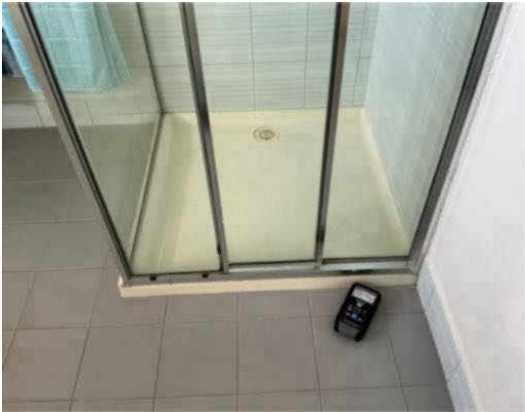
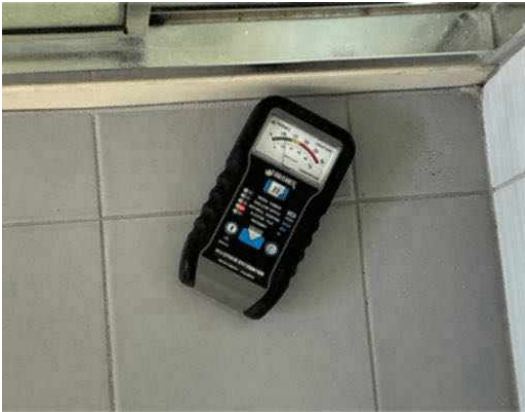
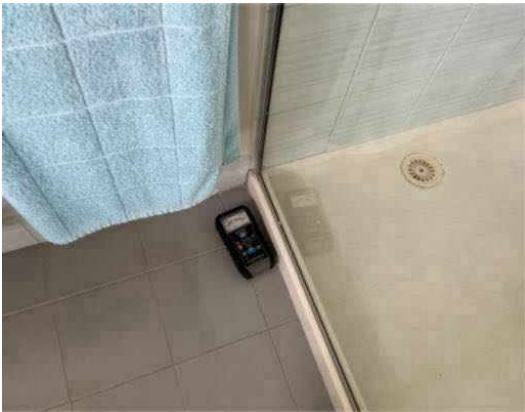
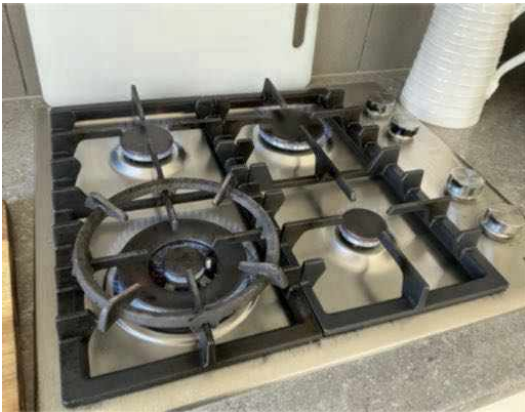
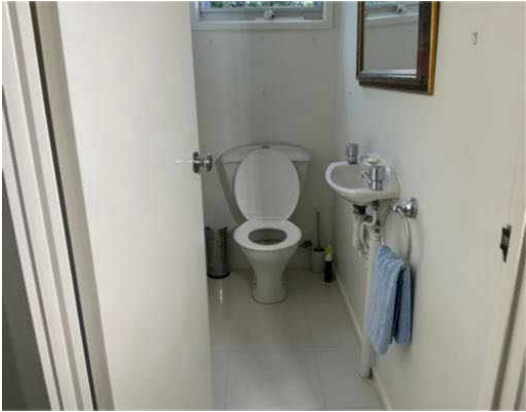
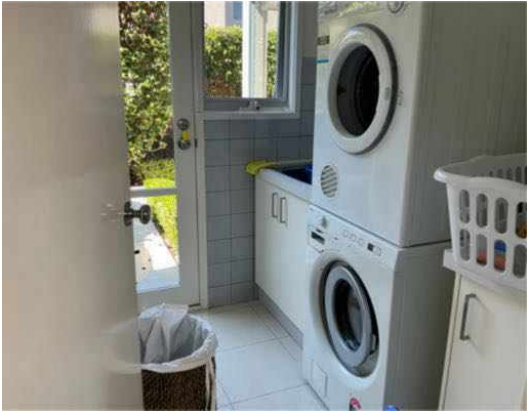
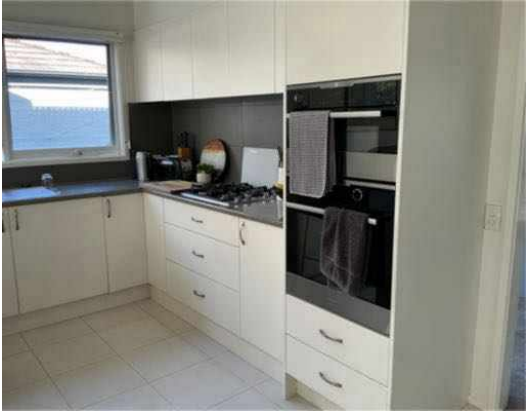
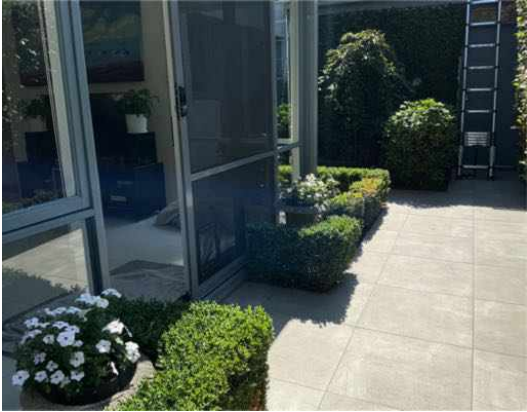
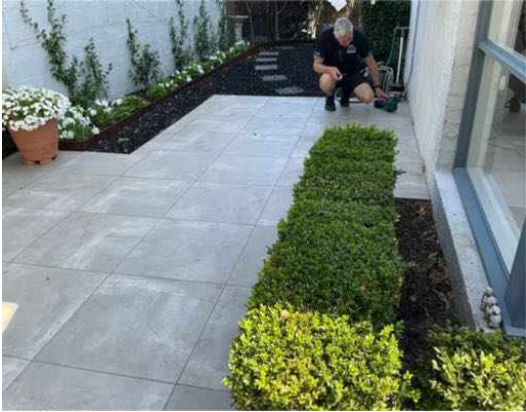
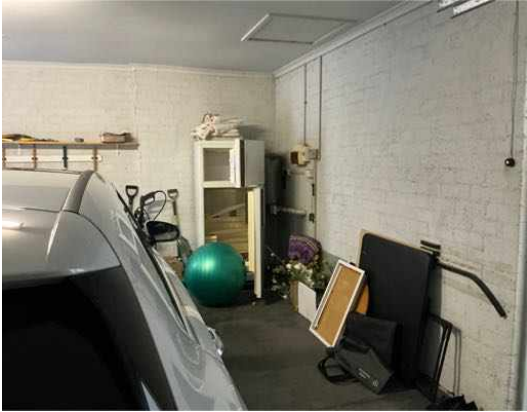
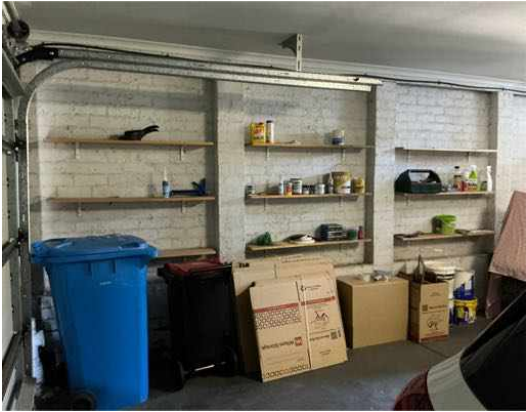
Noted Item

Building: Main Building
Location: All Areas
Finding: Additional Photos - Obstructions and Limitations
Information: These photographs are an indication of the obstructions and limitations which impeded full inspection of the property at the time of inspection. These obstructions can hide an array of defects and should be removed to allow full inspection to be carried out. A re-inspection is recommended once the areas are made accessible.

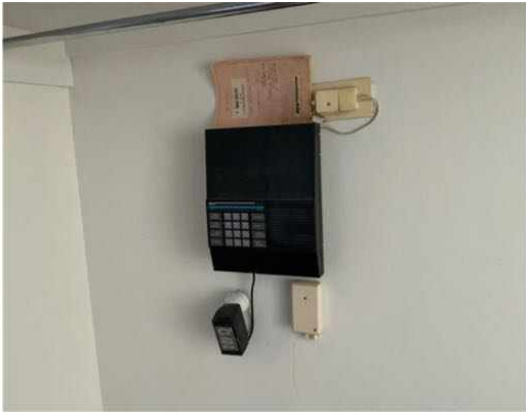
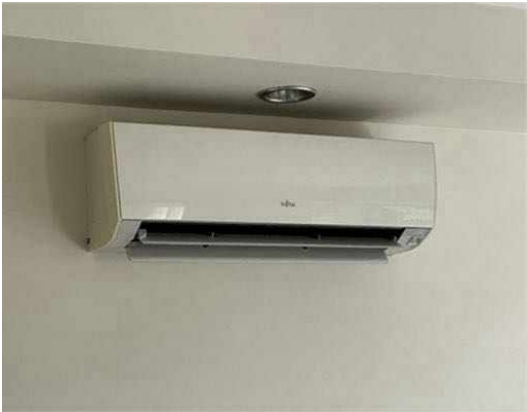
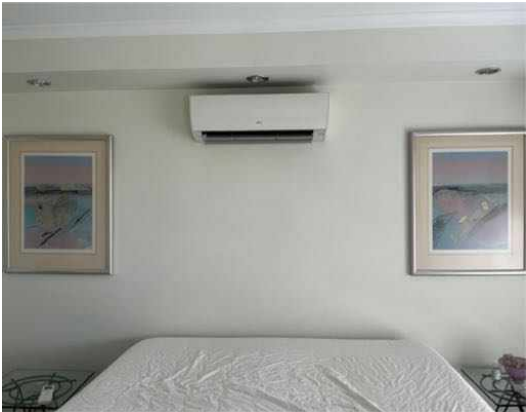
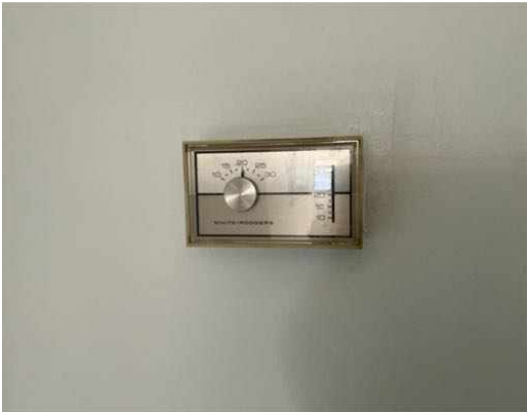
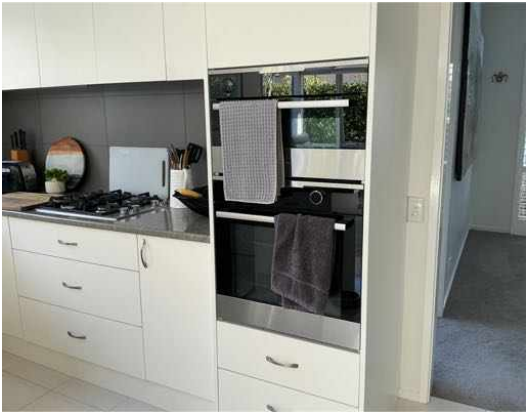
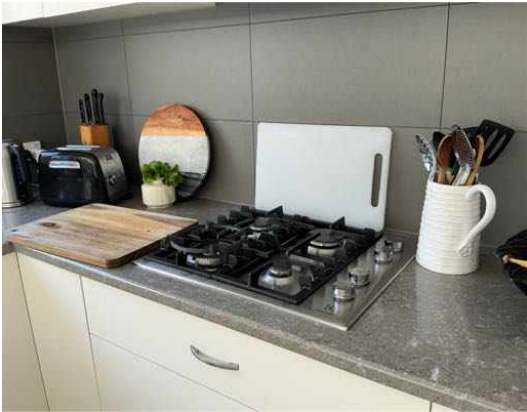
Noted Item

Building: Main Building
Location: Appliances
Finding: Warranty - Expired
Information: Where appliances are beyond their warranty period, the owner should be prepared to meet the cost of replacement or repair of the item at any time. The operation of the appliance can not be guaranteed and further inspection by an appropriately qualified tradesperson may be required.

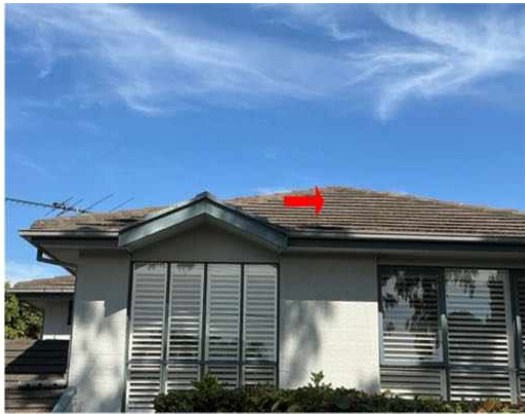
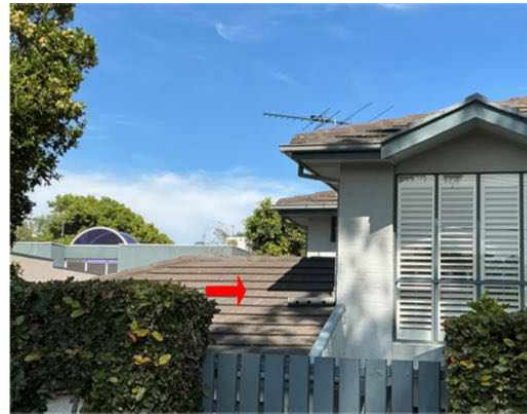
Noted Item

Building: Main Building
Location: Roof Exterior

Information: Upon inspection of the exterior roofing, the majority of roof tiles were considered to be in a fair condition. While weathering of the tiles is consistent with the age of the property, maintenance works are required.

Isolated areas of mortar have come loose in the valleys and minor cracking is also present. Re-pointing and re-sealing the may be considered as an interim solution by the client to help preserve and extend the life span of the tiles.

Where left unmanaged, deteriorating roof tiles are likely to lead to a number of secondary defects, including minor water leaks and weather exposure to internal roofing structures.

Consultation with a roofing contractor is highly advised to gain advice on cost of remedial works that may be required in the short to medium term. Remedial works are likely to increase the longevity of the exterior roofing structure.
