Building and Timber Pest Inspection Report

Inspection Date: Wed, 04 Mar 2026

Property Address: 10 Cadogan Cres, Woongarra NSW 2259,
Australia

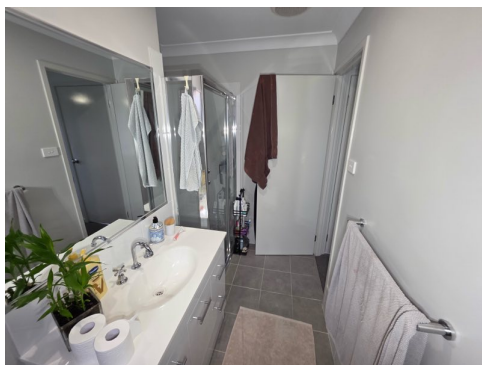
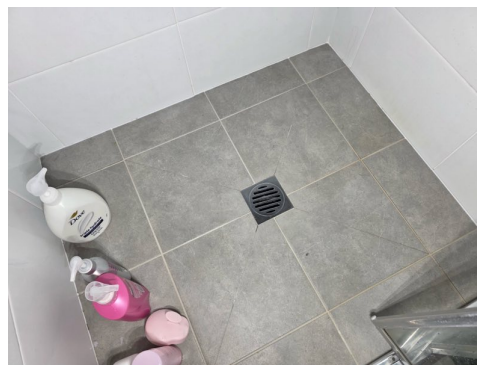
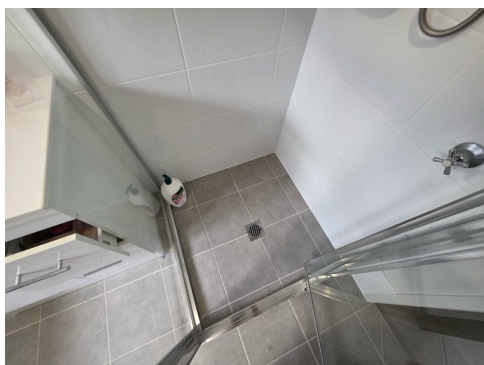
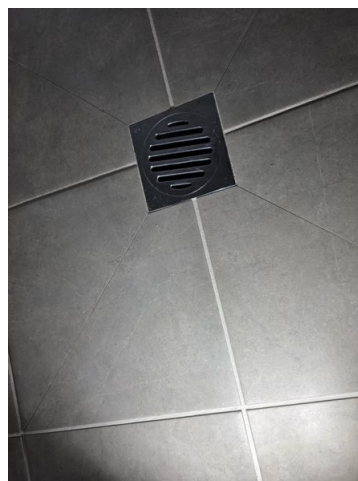
Finding 3.01

Finding: Deteriorated Shower Grout – Both Bathrooms

Information: Deterioration of the grout joints was observed within both shower enclosures. Sections of grout between floor tiles appear worn and are beginning to disintegrate in localized areas. Loss of grout reduces the integrity of the tiled surface as a moisture-resistant lining.

A tiler should be engaged to assess and rectify as required. This should be done as soon as practicable.

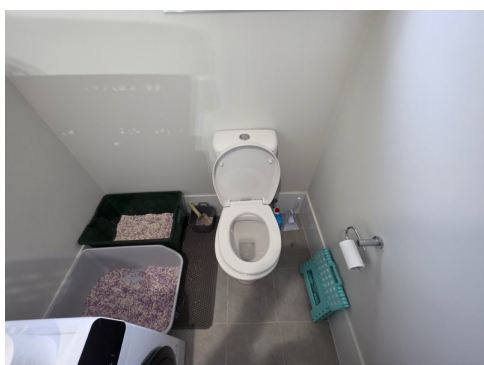
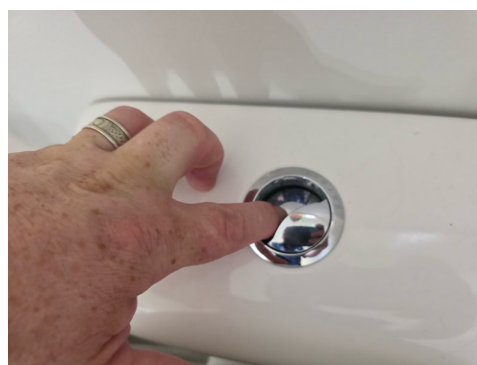
Finding 3.02

Finding: Toilet Flush Mechanism Malfunction – Laundry

Information: The dual-flush function to the toilet located in the laundry was observed not to be operating correctly at the time of inspection. Activation of the flush controls did not consistently engage the intended flush function. Faults within the flushing mechanism can affect the ability of the fixture to operate reliably and may lead to inefficient flushing performance or unnecessary water loss if the condition worsens.

A plumber should be engaged to assess and rectify as required. This should be done as soon as practicable.

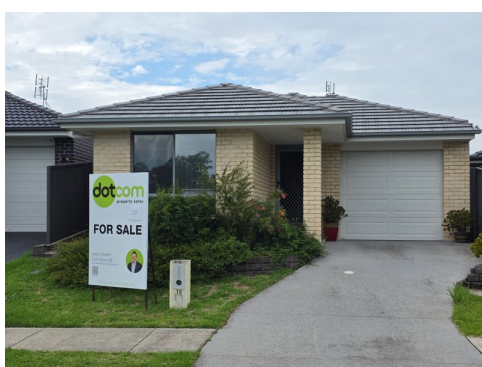
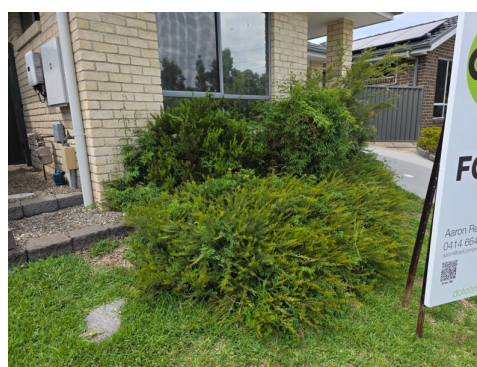
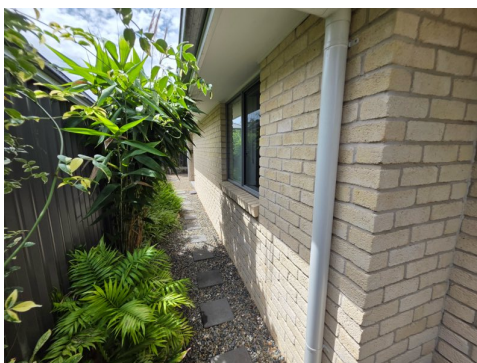
Finding 6.01

Finding: Garden Beds - Conditions Conducive to Termites

Information: Garden beds, particularly those constructed from untreated timber, were noted adjacent to the dwelling. These create a highly conducive environment for termite activity due to the combination of retained soil moisture from watering, direct soil contact, and the organic material in the soil and timber edging. Such conditions increase the risk of concealed termite ingress into the property, as termites can travel through the garden beds and enter the structure undetected.

Where practical, garden beds should be removed, relocated, or modified so that they do not abut the dwelling. Where this is impractical or undesirable, the risk of concealed termite activity remains. In these cases, a licensed pest controller should establish an ongoing termite management plan, and regular timber pest inspections should be carried out every 6–12 months to assist in protecting the property against infestation.

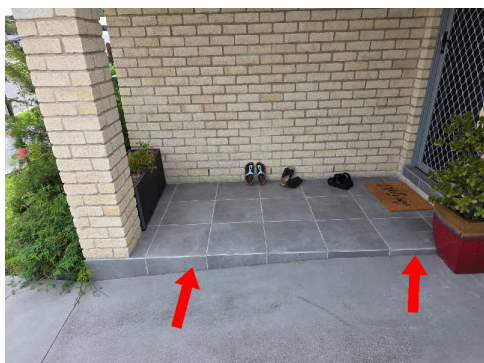
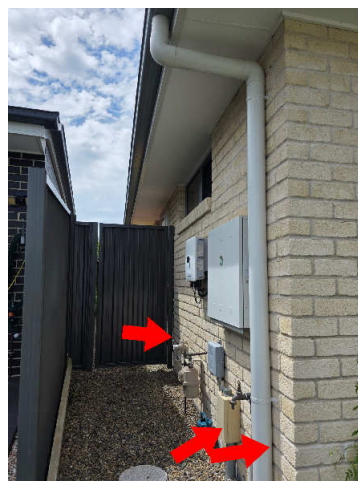
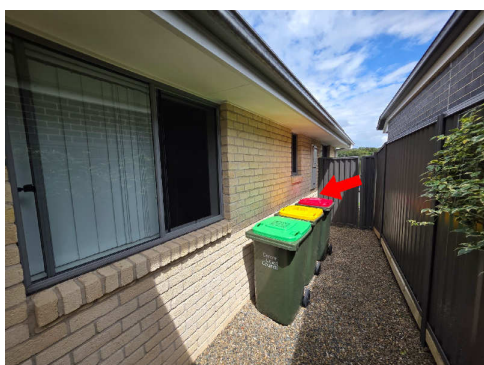
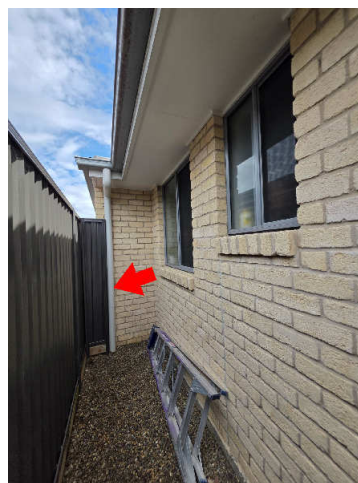
Finding 6.02

Finding: Bridging - Bridging of termite management system

Information: Bridging was observed at various locations around the external perimeter of the dwelling. Bridging occurs where materials or structures create a continuous path over or around the termite management system, allowing termites to bypass barriers and enter the dwelling undetected. Common examples include downpipes, fixed gates, hot water service units, air-conditioning units, garden beds, soil build-up, and paved surfaces installed hard against the slab or footing.

Bridging is a significant risk because it defeats the purpose of a physical or chemical termite barrier. Where practical, bridging elements should be modified or removed so that a clear and uninterrupted inspection zone remains around the entire perimeter.

Where it is not practical to remove or alter the bridging element, the risk of concealed termite entry remains. In these cases, a licensed pest controller should establish an ongoing termite management plan and carry out regular timber pest inspections every 6–12 months. This should be addressed without delay.

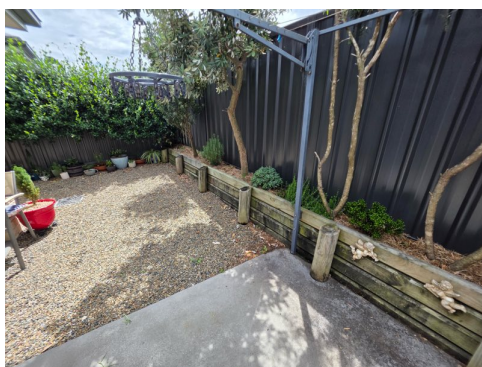
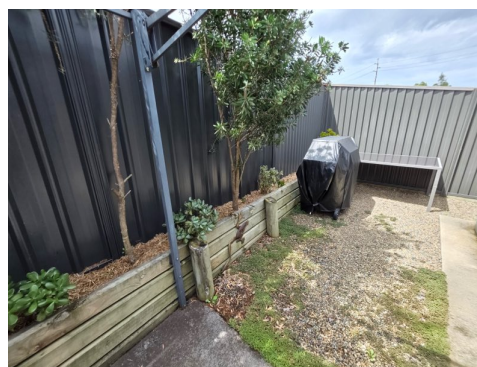
Finding 6.03

Building: Main Building
Location: Yard
Finding: Ground - Timber materials in direct ground contact

Information: Timber elements in direct contact with the ground, and consequently exposed to moisture or dampness, create conditions conducive to termite activity. Whether timber is used as part of a building structure, such as a fence or retaining wall, or stored as unused material, it can attract termite infestations.

When exposed to excessive moisture, timber begins to decay and develop wood rot. Any timber in direct contact with the ground - especially untreated or non-durable timber - provides an easy entry point for subterranean termites into the material.

To minimize the risk of termite attack, it is recommended to remove any materials that could foster termite activity. If removal is impractical or undesirable, it is strongly advised that termite or timber pest inspections be conducted every 6 to 12 months to protect the property from potential infestation.

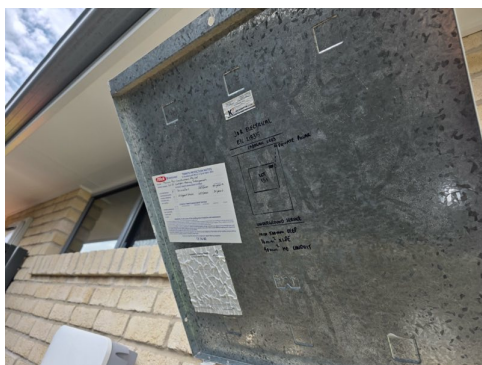
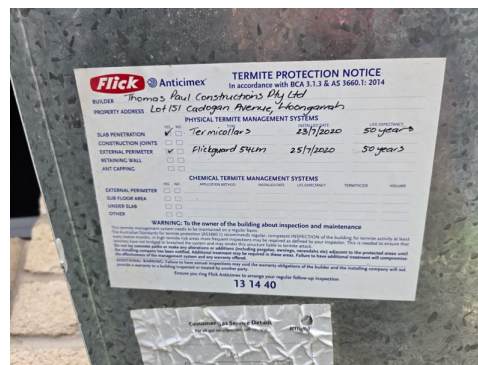
Finding 6.04

Finding: Durable Present - Durable notice observed in meter box

Information: A durable notice was observed in the meter box at the time of inspection, indicating that a termite management system has been installed at the property. The notice provides information on the type of system and treatment date, as required under AS 3660.1 and AS 3660.2.

While this confirms the presence of a past treatment, it does not verify the current effectiveness of the system. It is strongly advised that an ongoing termite management plan be established by a licensed pest controller. This should be addressed without delay.

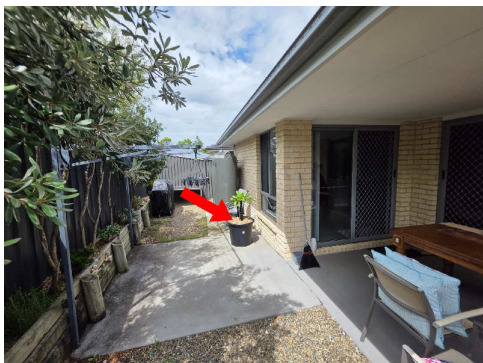
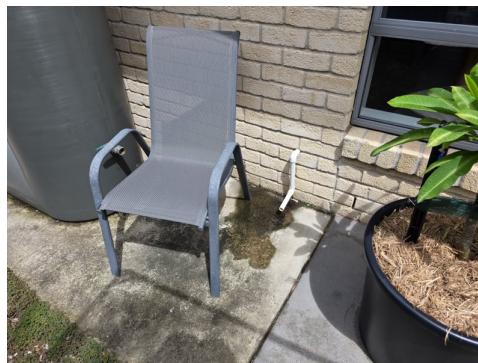
Finding 6.05

Finding: Overflow - Appliance overflow discharging to ground

Information: At the time of inspection, the overflow from the A/C unit was observed to be discharging directly onto the ground rather than into a connected stormwater system. This could potentially result in damp conditions around the perimeter of the dwelling.

Sustained dampness in these areas is considered conducive to concealed termite activity and may also contribute to timber decay or pest infestation. A licensed plumber should be engaged to redirect the discharge into an appropriate drainage system. Rectification should be undertaken without delay.

Regular timber pest inspections should also be carried out every 6–12 months.

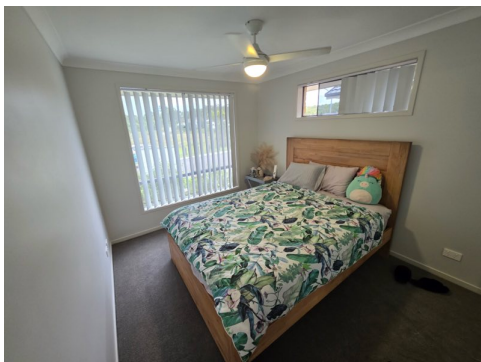
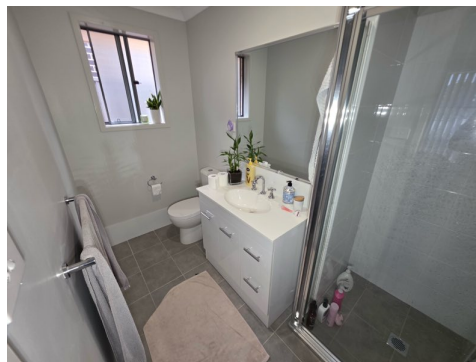
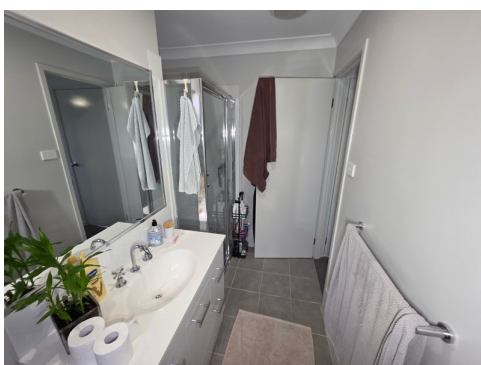
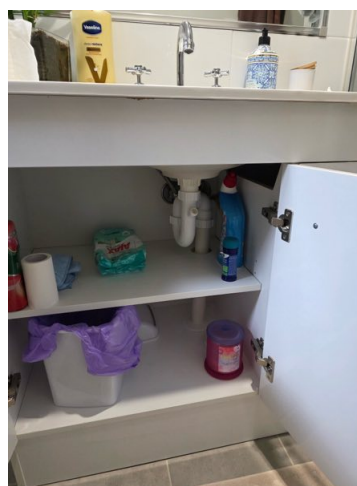
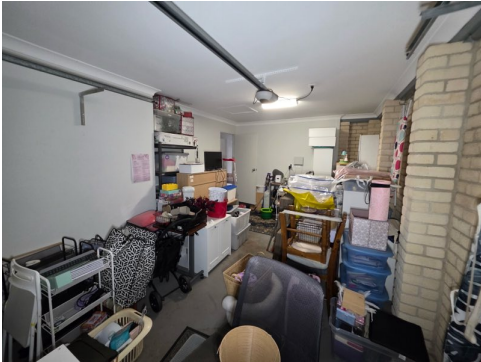
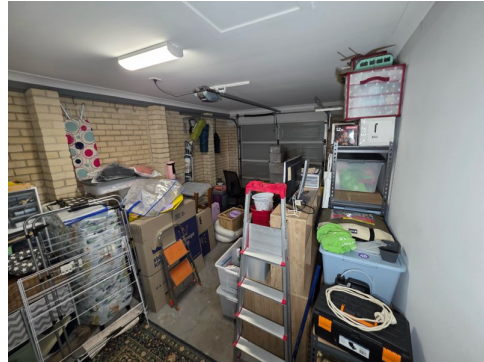
Finding: Additional Photos - Obstructions and Limitations

Information: These photographs are an indication of the obstructions and limitations which impeded full inspection of the property at the time of inspection. These obstructions can hide an array of defects and should be removed to allow full inspection to be carried out. A re-inspection is recommended once the areas are made accessible.

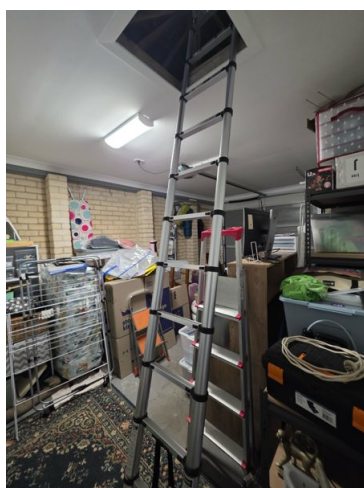
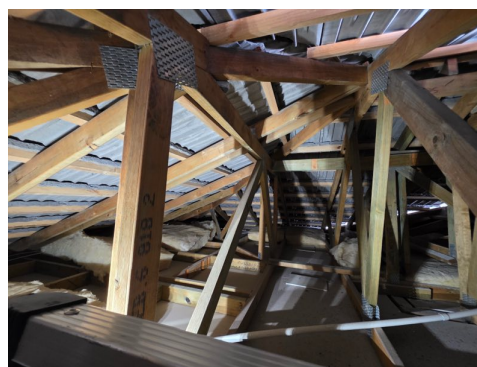
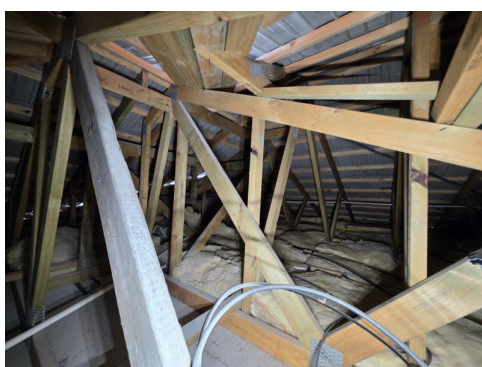
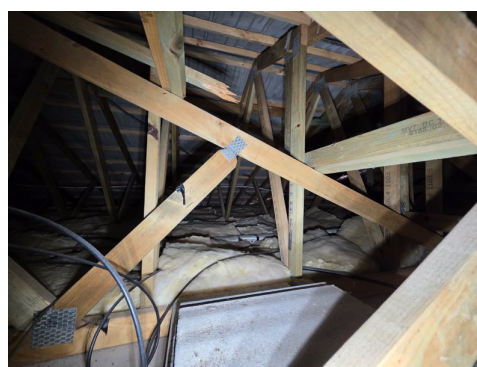
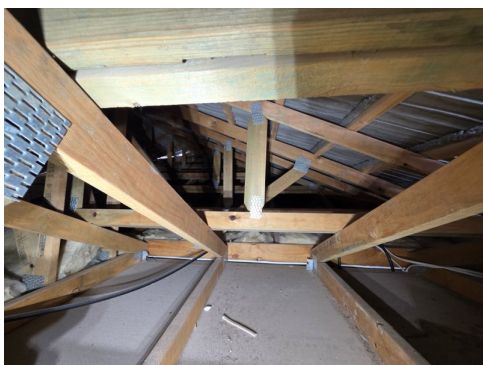
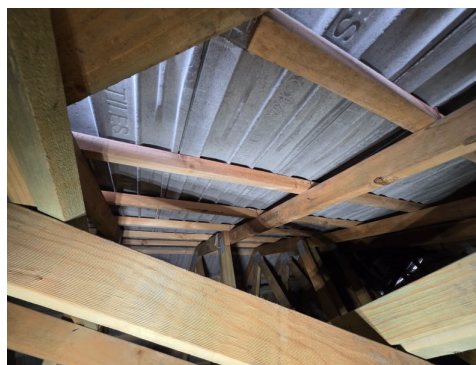
Finding: Restricted Roof Void Access – Garage Roof Space

Information: The roof void is accessed via a personal access hatch located within the garage. Due to the configuration of roof framing members and trusses within the space, physical movement within the roof void was significantly restricted and inspection was limited to visual observation from the hatch opening only. As a result, portions of the roof void could not be directly accessed or inspected, and conditions within those concealed areas could not be determined during this inspection.

No immediate action is required; however, purchasers should be aware that areas of the roof space were not accessible for inspection due to framing configuration and access limitations.

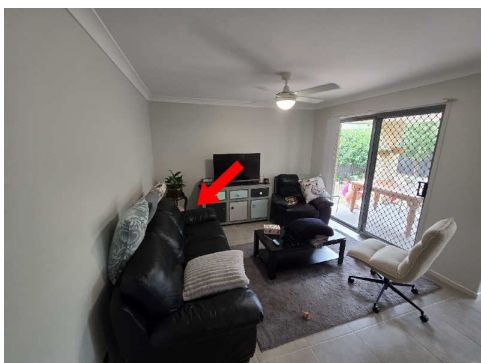
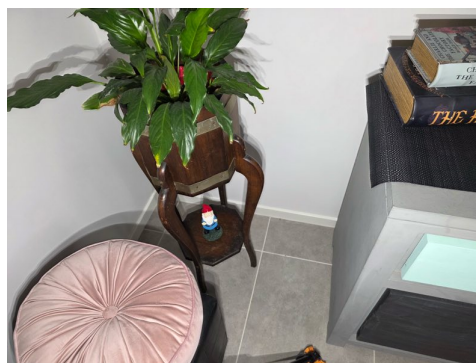
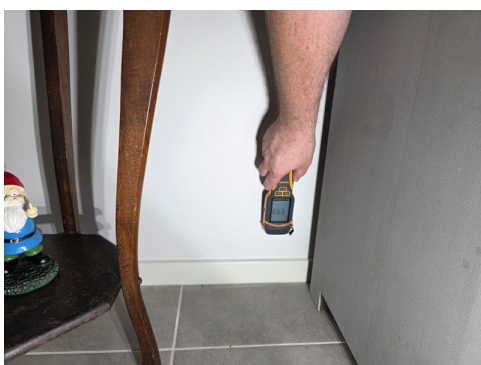
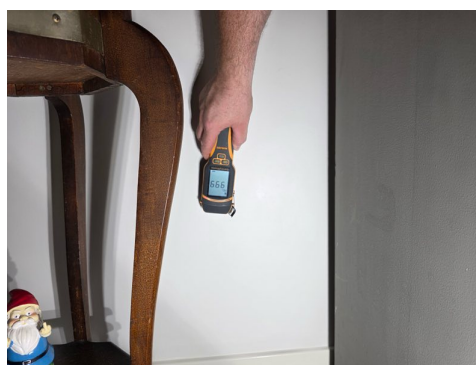
Finding: Localised Elevated Moisture Reading – Living Room Wall

Information: A very high localised moisture meter reading was recorded to the wall surface within the living room, toward the left-hand side of the area inspected. The wall lining and surface finishes appeared visually sound at the time of inspection, with no staining, discoloration, distortion, or other visible material change observed. The source of the elevated reading could not be confirmed during this visual, non-invasive inspection.

This area should be monitored for any changes in the wall surface, particularly the development of discoloration or mould. If such changes occur, a licensed builder should be engaged to carry out further investigation as required.

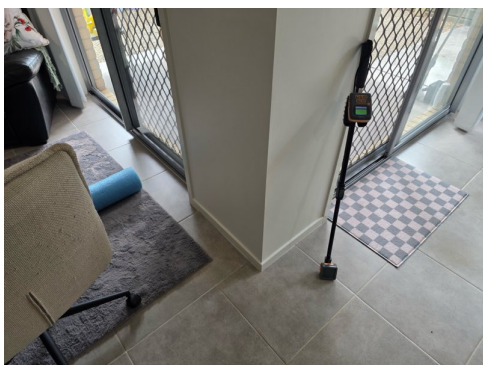
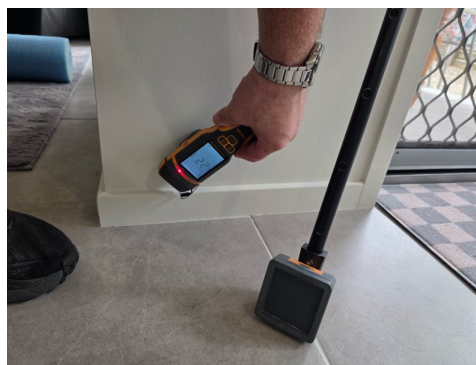
Finding: Localised Low-Level Elevated Moisture Reading – Dining Room Wall

Information: A slightly elevated moisture meter reading was recorded to a wall surface within the dining room. The wall lining and finishes appeared visually sound at the time of inspection, with no staining, discoloration, swelling, or other visible indication of moisture impact. The source of the elevated reading could not be confirmed during this visual, non-invasive inspection.

This area should be monitored for any changes in the wall surface, particularly the development of discoloration or mould. If such changes occur, a licensed builder should be engaged to carry out further investigation as required.

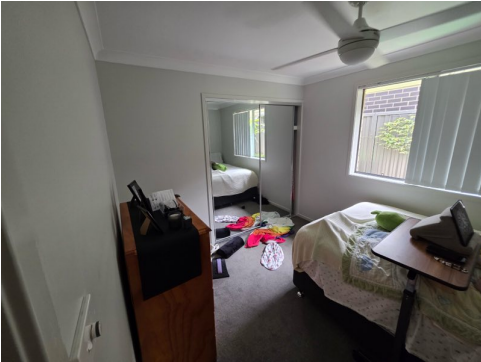
Finding: Bedroom Not Fully Inspected – Occupied Room

Information: Access to one bedroom within the dwelling was available at the time of inspection; however, the room was occupied by a person sleeping in the bed. In order to avoid disturbing the occupant, the room was not entered and a full internal inspection of the space was not undertaken. From the doorway, a limited visual observation of the room was carried out, during which the visible wall surfaces, floor coverings, wardrobe, and window areas appeared generally consistent in condition with the remainder of the dwelling.

Due to the room not being fully accessed, the internal condition of all areas within this room could not be completely confirmed during this inspection. If confirmation of the condition of this room is required, the area should be made vacant and accessible for inspection. This should be done at the owner's discretion.
