# Building and Timber Pest Inspection Report

Inspection Date: Thu, 12 Feb 2026

Property Address: 165 Beauchamp Rd, Matraville NSW 2036,  
Australia

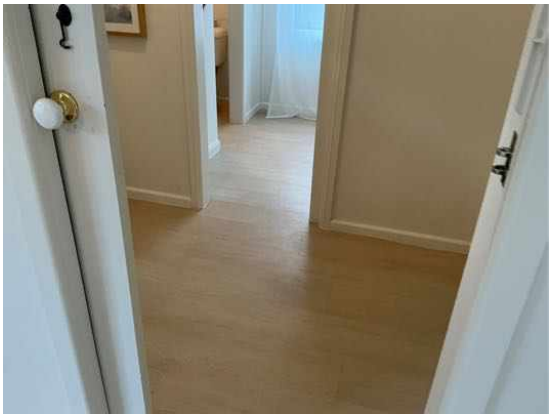
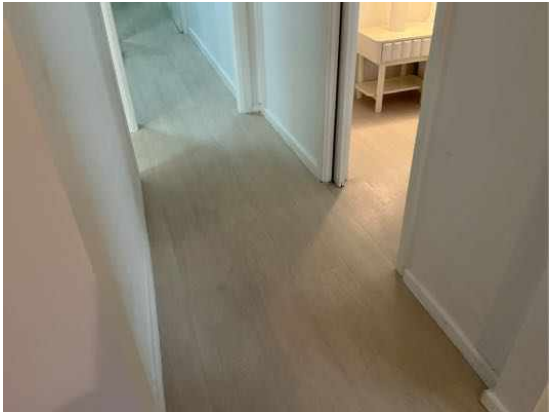
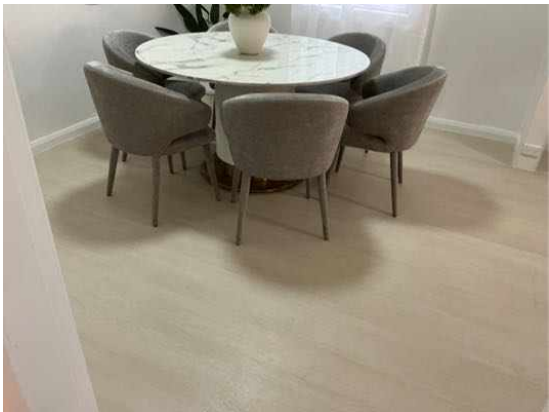
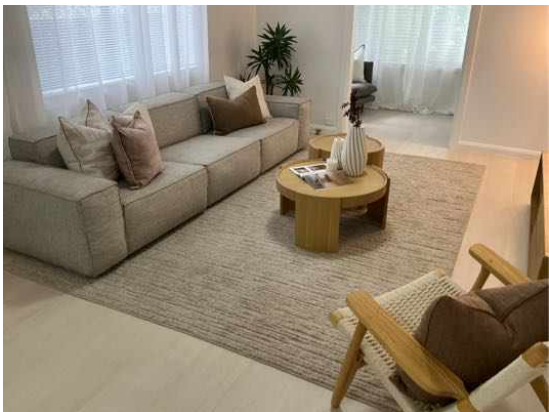
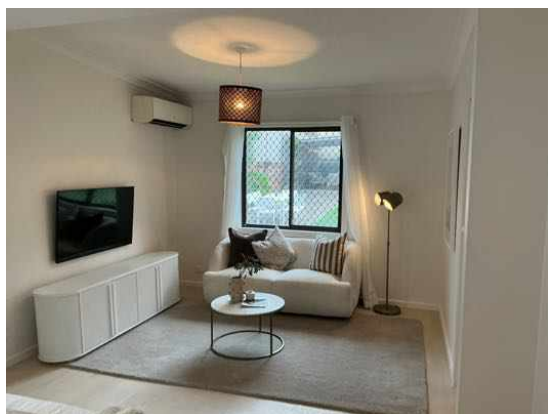
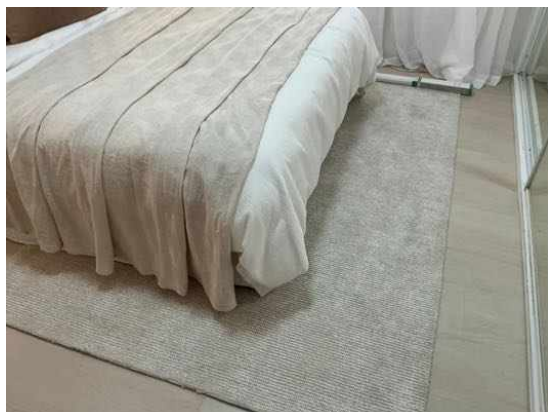
Building:	Main Building
Location:	All internal flooring throughout house
Finding:	Flooring - Uneven
Information:	The internal flooring in this area is out of level and uneven. Uneven flooring is likely to indicate minor defects such as expected movement of the foundations of the property, but may also indicate subsidence of the associated subfloor stumps.

It is advised that the flooring be closely monitored to identify any further movement. Where flooring remains relatively unchanged for an extended period of time (i.e. several months), it is likely that this defect has been caused by expected movement of the foundations of the property.

However, where flooring is uneven further, potentially invasive inspection of the subfloor structures and stumps in this area is required. In this case, works to repair are likely to be required, and would be carried out by a registered builder specialising in re-stumping.

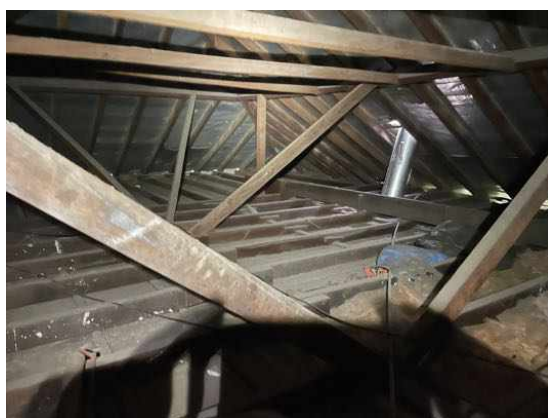
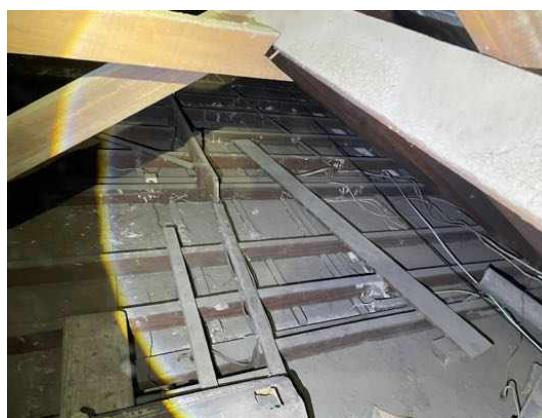
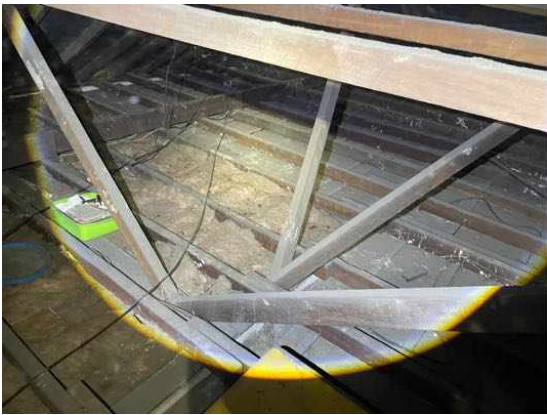
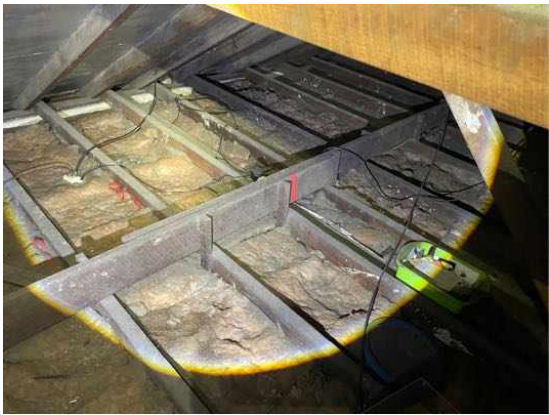
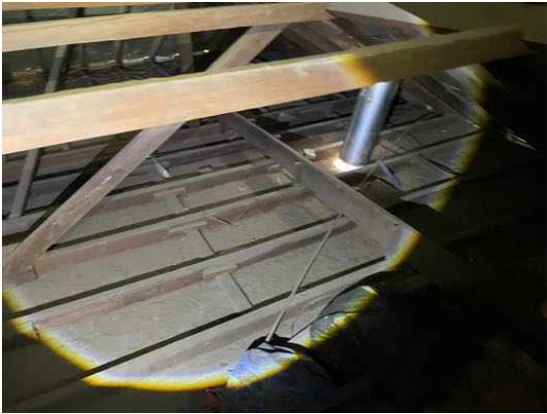
Insufficient insulation will result in a comparatively higher cost to heat and cool a property as there is a lack of Insulation (or uneven coverage of insulation) which works as a barrier to heat transfer. This helps to keep out unwanted heat in summer and preserves warmth inside your home in winter. It can also help soundproof your home from unwanted airborne noise transfer.

Where insulation is absent, the area does not meet current Australian Standards. Installation of adequate insulation is required and should be conducted as soon as possible.
