## Building Inspection Report

Inspection Date: Mon, 16 Feb 2026

Property Address: 24 Fourth Avenue, Willoughby East NSW,  
Australia

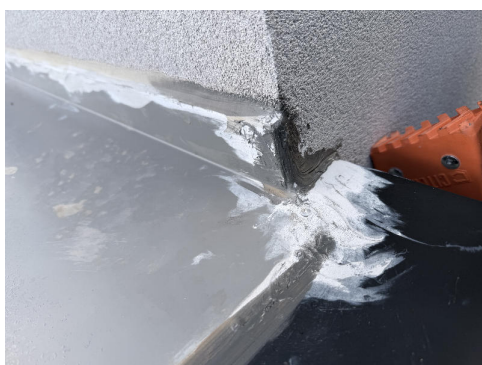
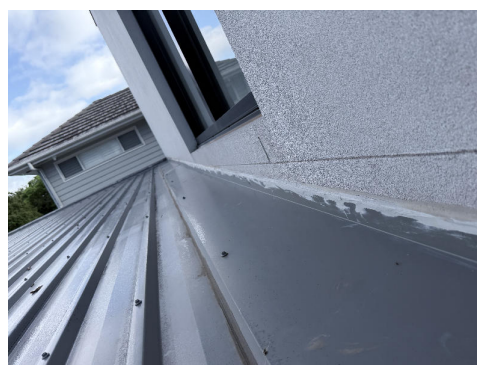
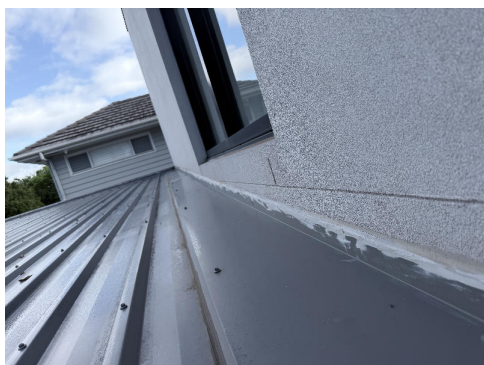
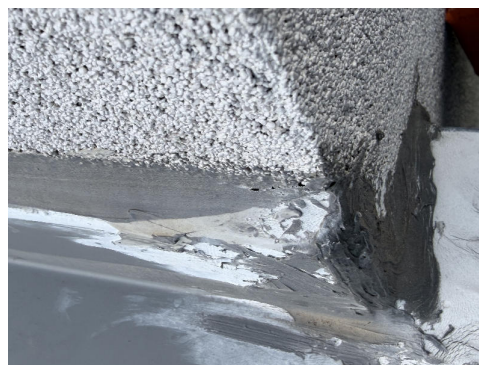
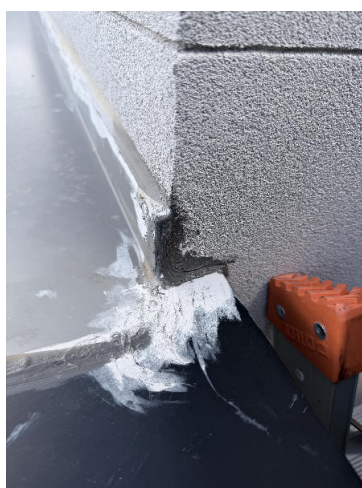
#### Defects 2.01

Building: Main Building

Location: Roof

Finding: Roof flashing - non-standard

Information: The roof flashing that has been installed does not appear to comply with current building practice. However the flashing appears to be in an acceptable condition and is fulfilling its purpose in ensuring the roof covering is weather-tight.

Whilst retrospective fixing is not required if flashing begins to come loose from its fixing or deteriorates as evidenced by roof leaks a roofing plumber should be appointed immediately to replace the building element.

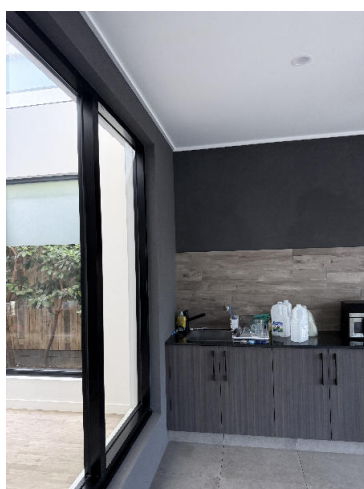
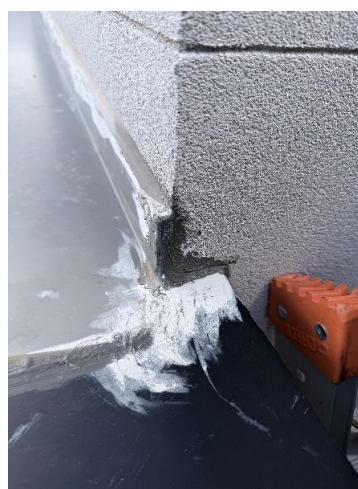
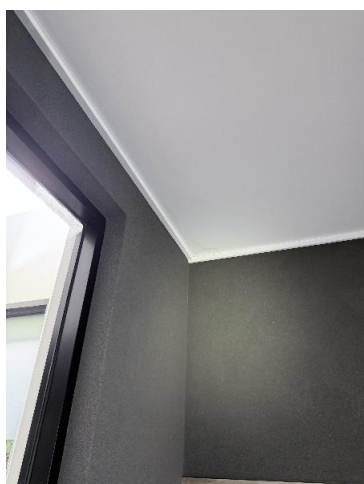
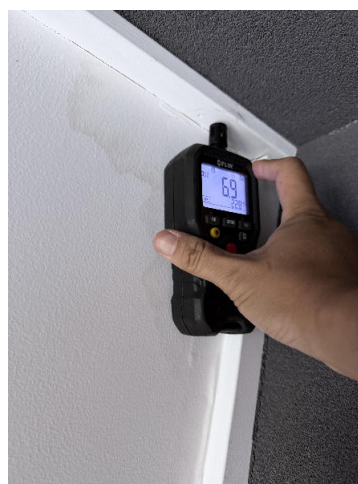
## Defects 2.02

Building: Main Building  
Location: Roof  
Finding: Roof covering - Leaking

Information: An active leak was identified to the roof covering, indicated by water ingress. It is suspected that cracked or missing roof tiles are responsible for this leak, which is evident in the ceiling void.

Where water leaks are active, rain penetration is likely to cause water damage to associated structures and building elements in this area, which can have a range of implications. If left unmanaged, the development of major structural damage to the roofing and associated structures may occur.

A roofing contractor should be appointed as soon as possible to primarily identify the cause of the leak, and to provide subsequent repair works as necessary. Depending on the extent of the damage, replacement of sections of the roof covering and/or roofing structures may be required.

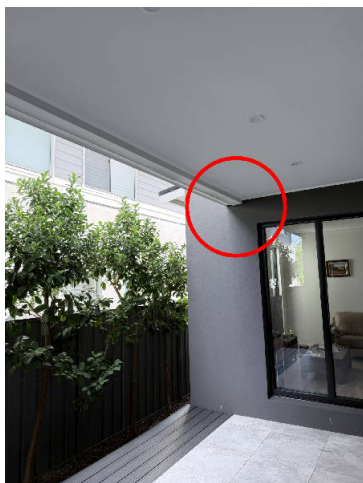
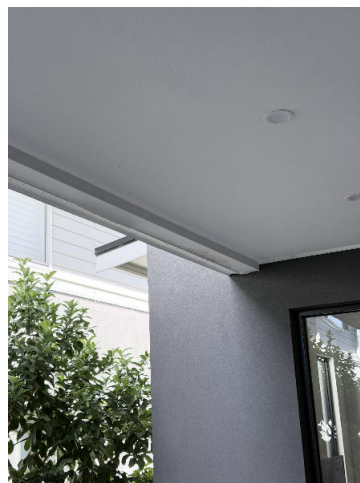
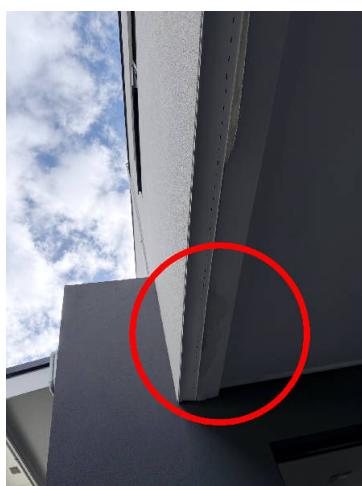
### Defects 2.03

Building: Main Building

Location: Exterior walls - right side

Finding: Water leak - Active

Information: Generally, water leaks occur when a particular area of the property is not weather or water tight. As the surrounding area was found to be damp at the time of inspection, the leak is considered ongoing and hence requires urgent action.

Regardless of the location, even minor leaks that are left unmanaged can lead to serious damage of associated building elements and result in the need for replacement of building materials. Mould and other hazards such as electrical hazards may also arise if the leak is left to develop.

It is highly advised that the cause of the leak be identified and resolved immediately by a licensed plumber to prevent any further damage. Depending on the extent of the damage previously sustained, repair and/or replacement of any affected building materials may be required.

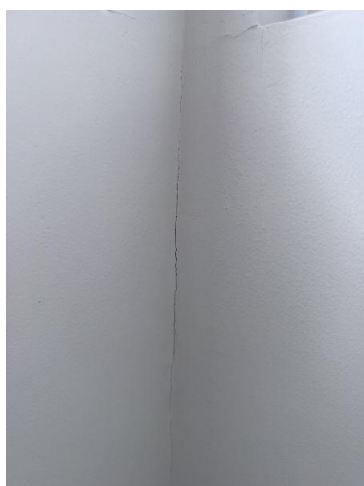
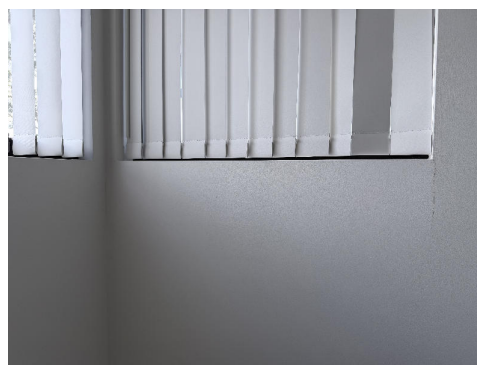
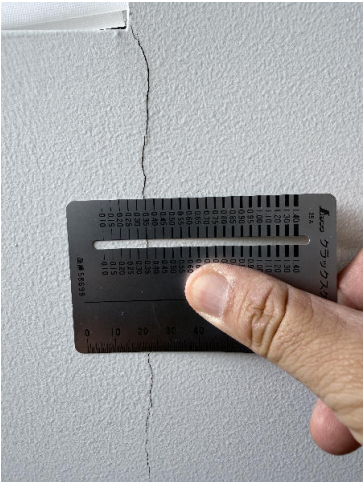
### Defects 3.01

Building:	Main Building
Location:	Bedroom 3
Finding:	Cracking - External Concrete Paving Damage Category 0 - Hairline (less than 1mm)
Information:	<p>Hairline cracks were identified in external concrete paving. Hairline cracks are very minor in nature and generally are only ever an appearance defect. To be classified as a Category 0 or hairline crack, the crack width would be less than 0.3mm. While such cracking may be noticeable in some cases, it is common and does not indicate any structural damage.</p>

Generally the cause of a hairline crack in existing concrete paving such as driveways and pathways is indicative of the expansion and contraction of the concrete. Such causes are generally due to environmental factors, such as moisture levels, weather conditions, root systems of nearby trees or the soil types on which they are laid.

Hairline cracks may also be due to poor original installation of the concrete. Factors such as poor compaction of the sub surface and/or inadequate reinforcing of the slab may create cracking and other secondary defects.

Monitoring of all cracking should be conducted frequently. Always contact a building inspector should cracks widen, lengthen, or become more numerous.
