# Building and Timber Pest Inspection Report

Inspection Date: Mon, 9 Mar 2026

Property Address: 21 Falcon Cct, West Wodonga VIC 3690,  
Australia

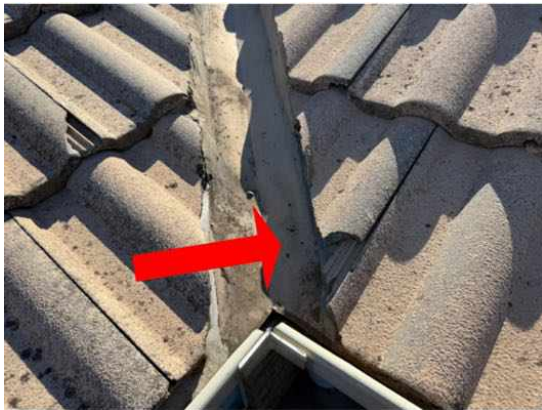
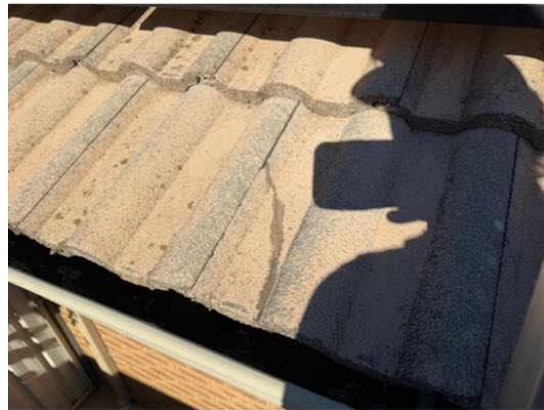
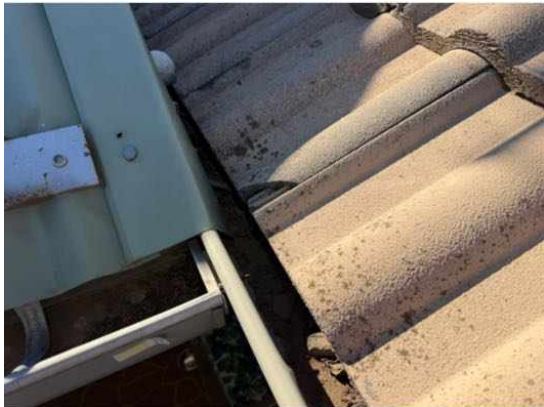
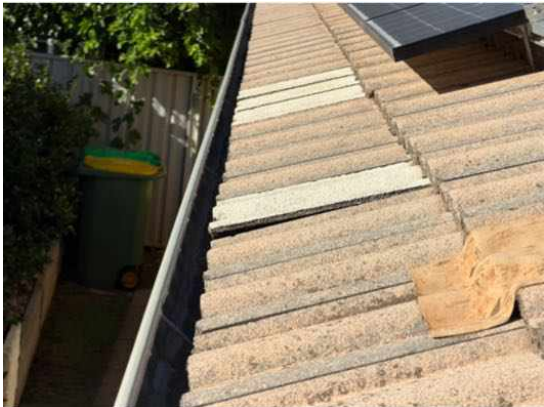
#### Finding 3.01

Building: Main Building  
Location: Roof Exterior  
Finding: Roof Exterior - General Weathering & Cracks  
Information: Areas of general weathering & cracking/chipping of the roof exterior were noted. While weathering of the roof tiles is consistent with the age of the property, maintenance works are advised, to ensure the longevity of the roof exterior.

Recommend consulting with a licensed roofing contractor in the short term, to provide further advice on maintenance works required.

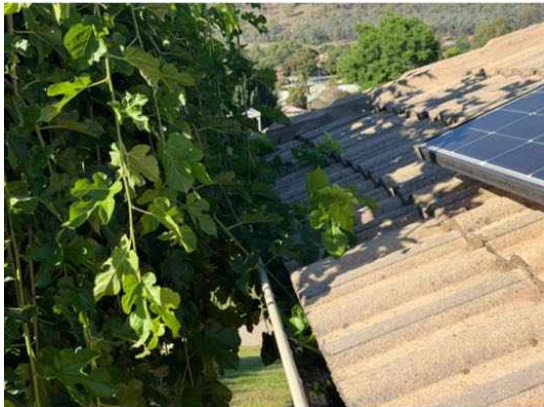
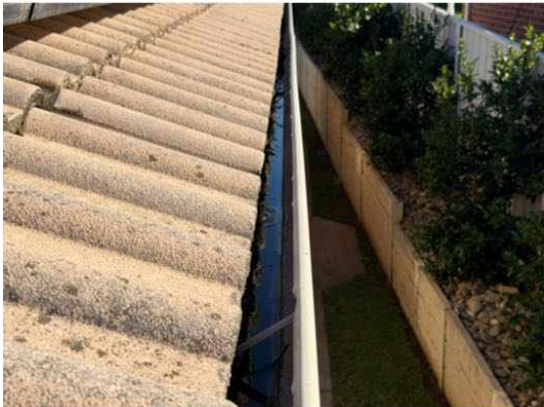
**Finding 3.02**

Building: Main Building  
Location: Guttering  
Finding: Gutters - Debris & Water pooling  
Information: Areas of water pooling and debris were noted in sections of the gutters at the time of inspection. Recommend engaging a general handyman to remove all debris, to ensure sufficient roof drainage is achieved.

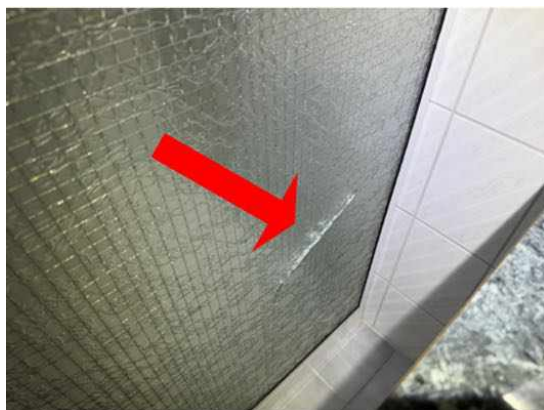
**Finding 3.03**

Building: Main Building  
Location: Main Shower  
Finding: Shower screen - Cracked  
Information: Cracking was evident to the main shower screen. While the cracking appears to be minor, further impact may lead to further cracking. Recommend client to monitor the shower screen. Should further cracking occur, a licensed glazier should be engaged to replace the shower screen.

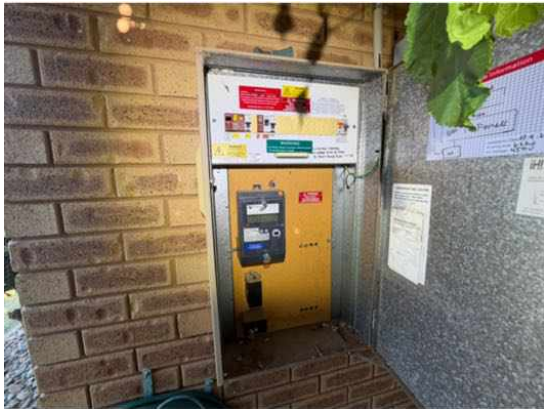
### Finding 6.01

Building: Main Building  
Location: Switchboard  
Finding: Termite Management System - no evidence of a chemical installation  
Information: The application of a termite barrier is recommended, as it appears no termite management system has been installed, with no evidence or durable notice to suggest works taking place. Generally, a durable notice is placed in the meter box to indicate current termite barriers.

Such barriers are highly effective in preventing termite attack on the building and therefore should be installed.

Recommend seeking further advice from a licensed pest controller.

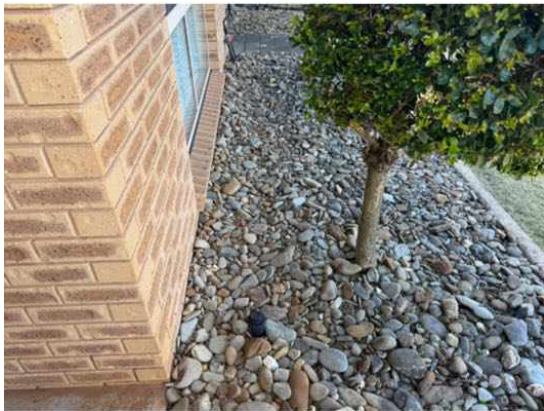
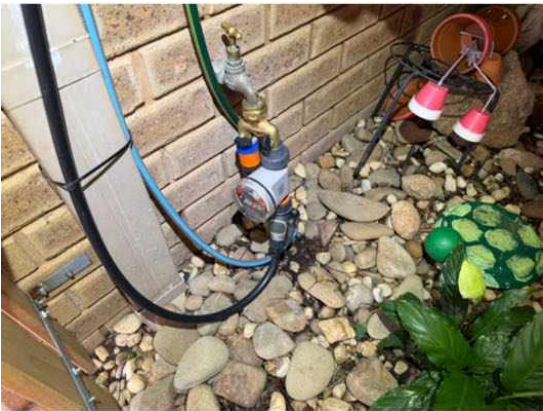
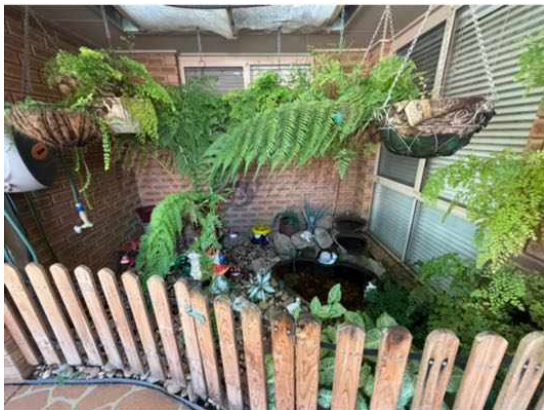
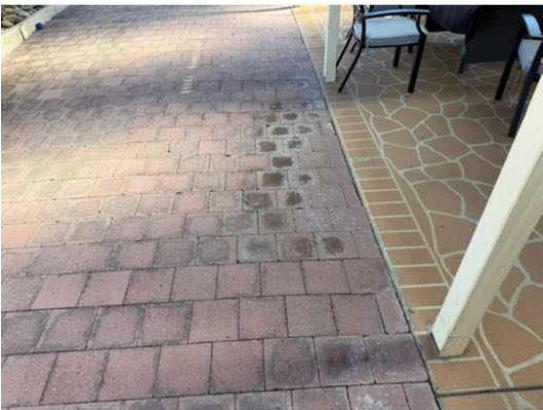
**Finding 6.02**

Building: Main Building  
 Location: All external areas  
 Finding: Potential Water pooling - against property  
 Information: Potential areas of water pooling around the perimeter of the property were identified. Where insufficient site drainage and drainage of taps are present, water pooling is likely to occur, and can create areas conducive to timber pests.

Recommend consulting with a licensed plumber and/or landscaping contractor to provide further advice.

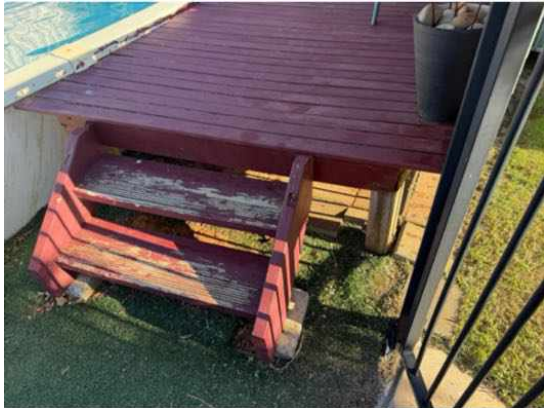
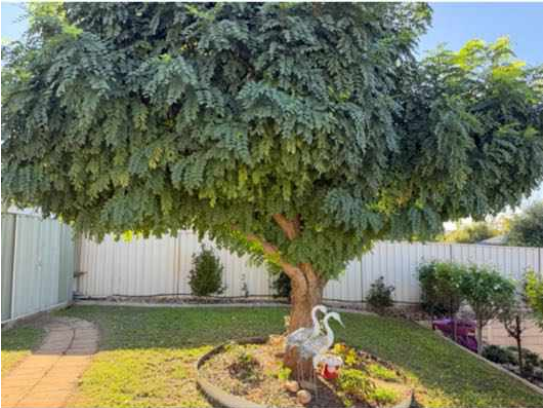
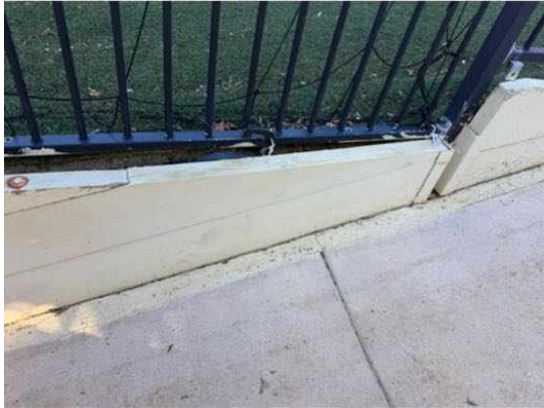
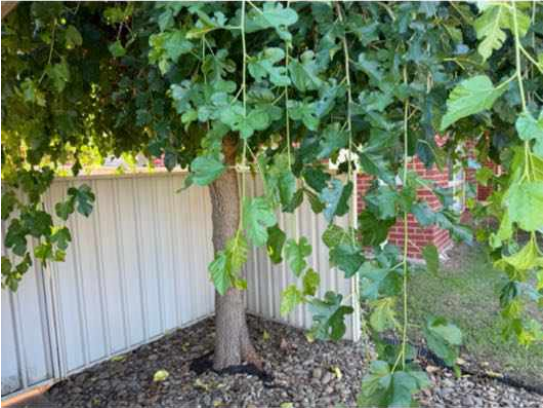
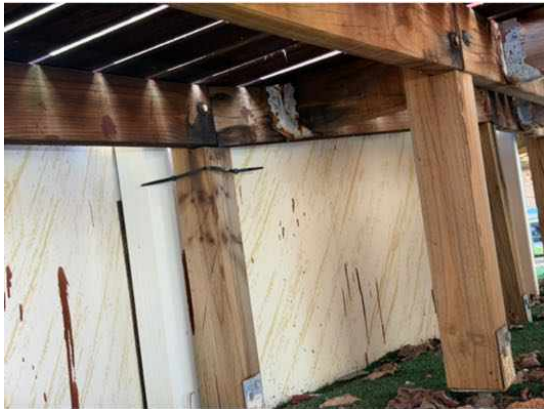
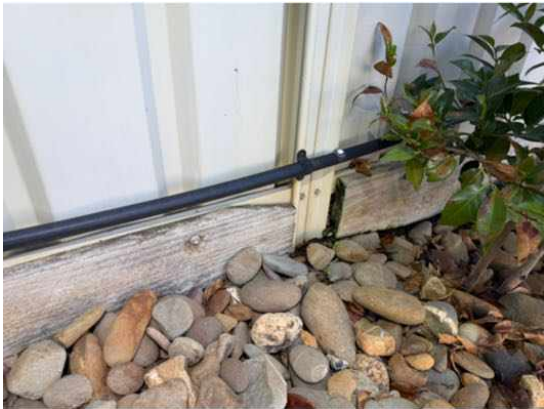
**Finding 6.03**

Building: Main Building  
Location: All External Areas  
Finding: Timber in direct ground contact & trees - conducive to termites  
Information: Where timber materials are in direct contact with the ground and consequently moisture, they become conducive to termite activity. The landscaping timbers, pool decking, and trees surrounding the building create an environment conducive to termite activity.

Where feasible, any timbers in direct contact with the ground should be removed and any trees in close proximity to the building should be removed or test drilled (inspected) at least annually to reduce the risk of termite infestation & detect any early signs of termite activity.

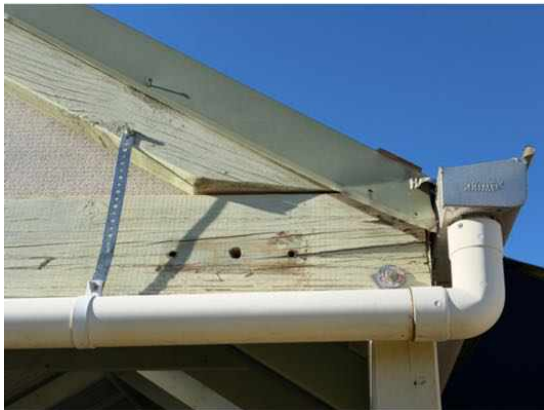
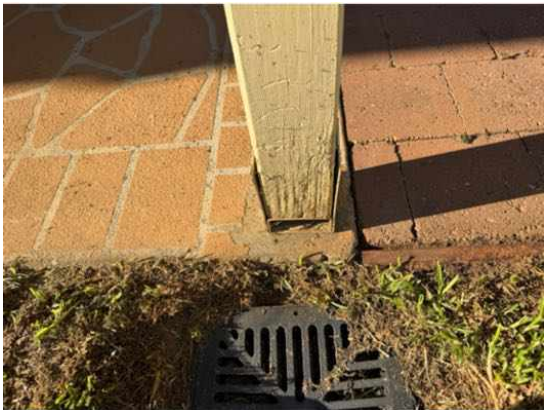
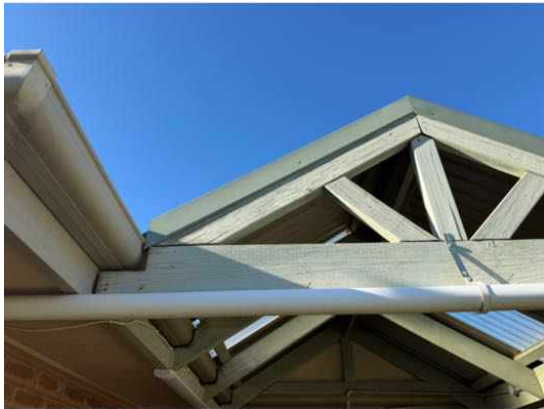
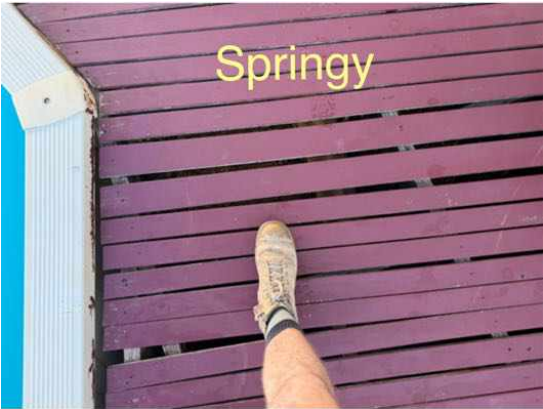
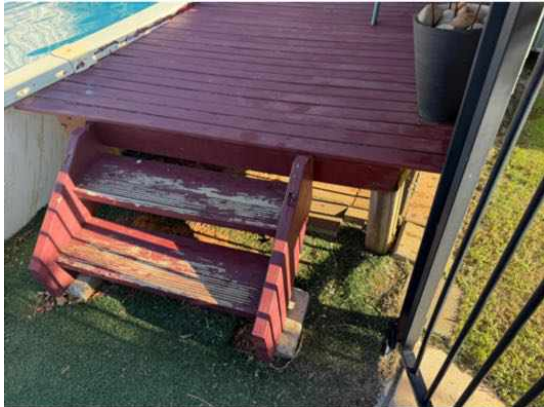
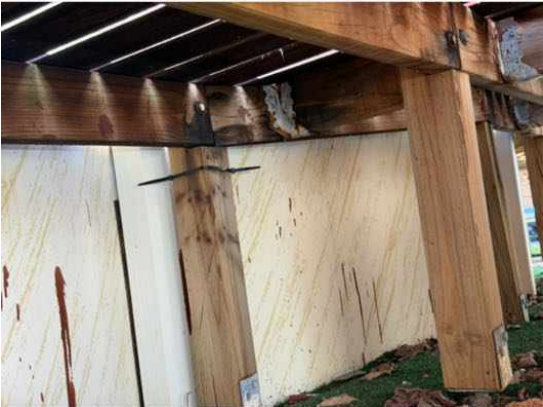
**Finding 7.01**

Building: Main Building  
Location: Patio Framing, pool decking  
Finding: Fungal decay & weathering, Pool Deck Springy  
Information: Areas of fungal decay (wood rot) & weathering were identified at but not limited to the patio framing and posts, and the deck framing. Areas of the pool decking also appeared to be springy and insufficiently supported.

For areas of fungal decay and springy decking, a licensed carpenter can be engaged at clients discretion to provide remedial works. For areas of general weathering, a licensed painter can be engaged, to apply protective sealant or coating to areas of weathered external timbers.

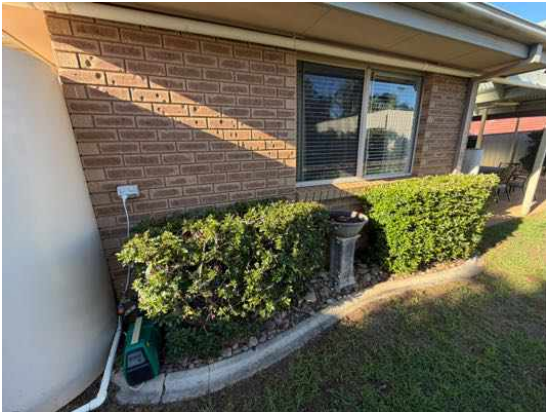
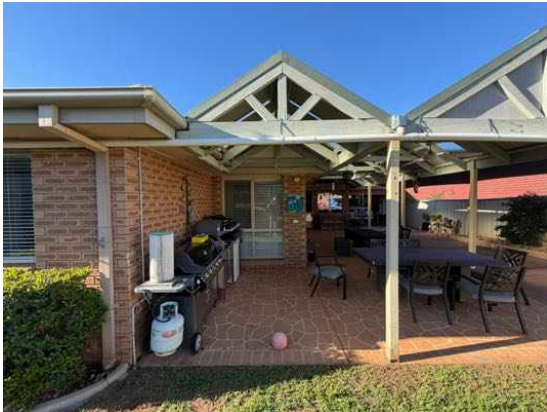
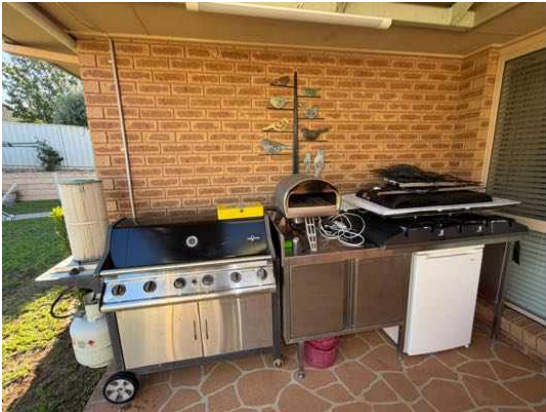
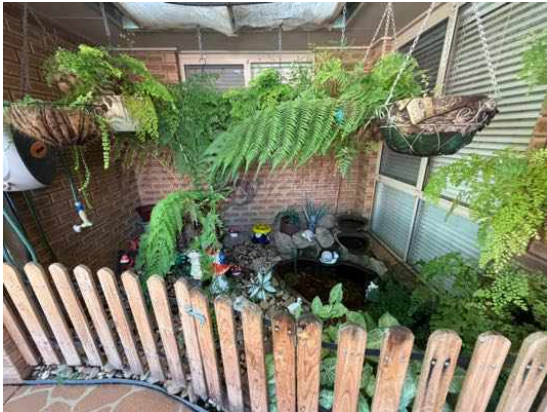
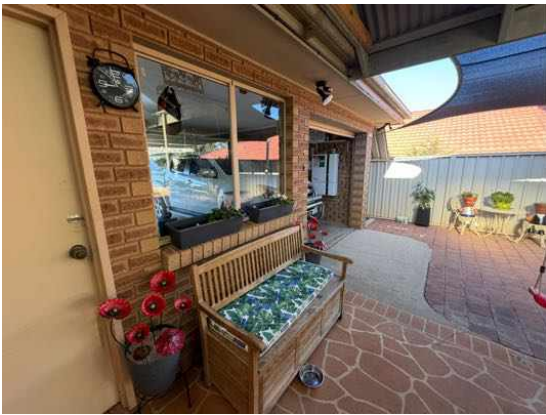
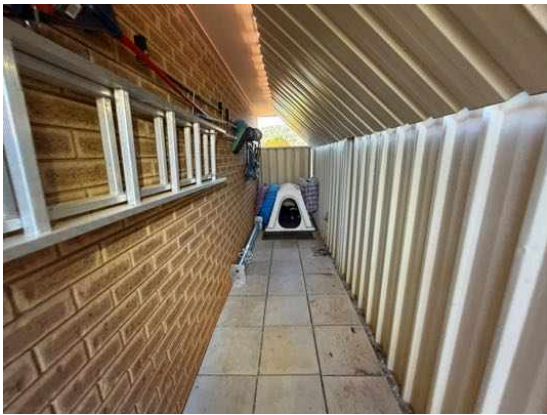
Building: Main Building  
Location: All Areas  
Finding: Additional Photos - Obstructions and Limitations  
Information: These photographs are an indication of the obstructions and limitations which impeded full inspection of the property at the time of inspection. These obstructions can hide an array of defects and should be removed to allow full inspection to be carried out. A re-inspection is recommended once the areas are made accessible.

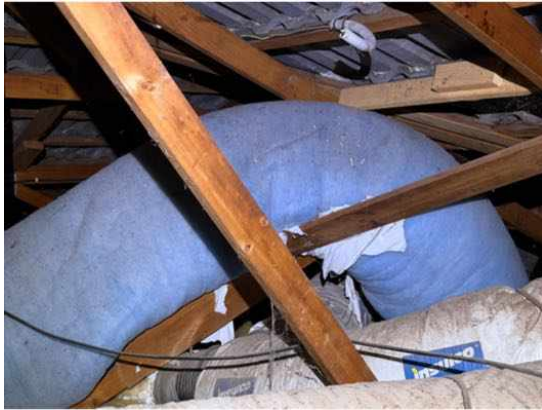
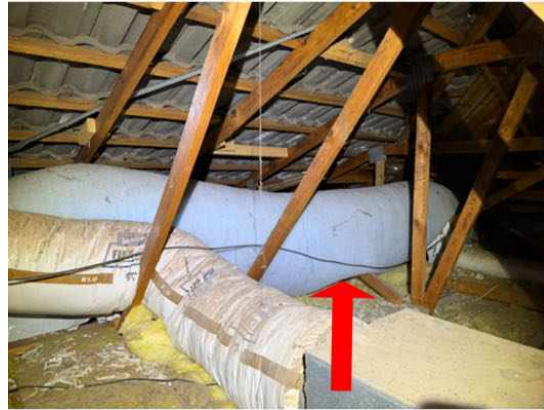
Building:	Main Building
Location:	Roof Void
Finding:	Heating / Cooling Ducts - deteriorated
Information:	It appears that areas of the heating/cooling ducts were found to be deteriorated at the time of inspection. The deterioration may detract from the functionality of the ductwork. Recommend engaging a heating/cooling specialist to provide further advice, at clients discretion.

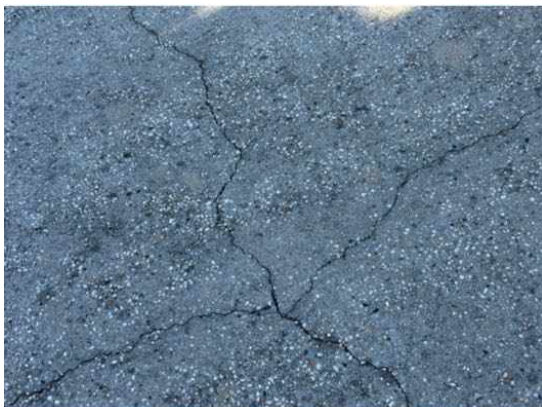
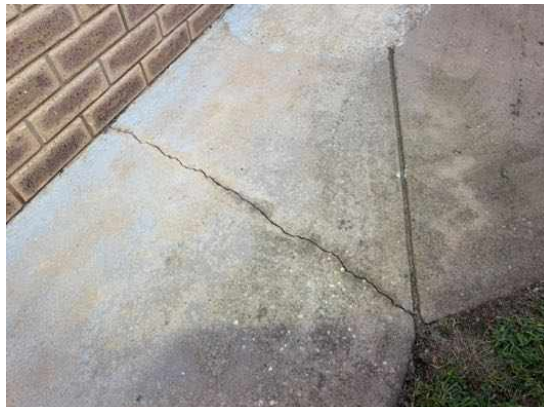
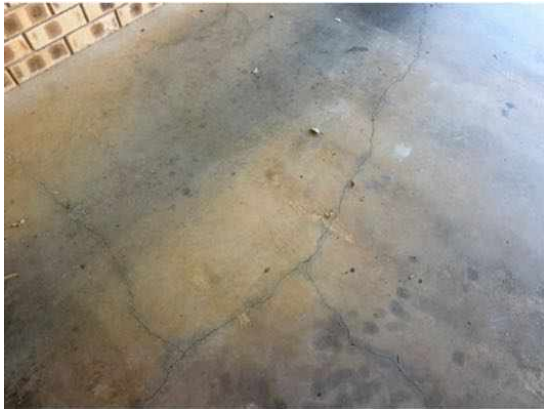
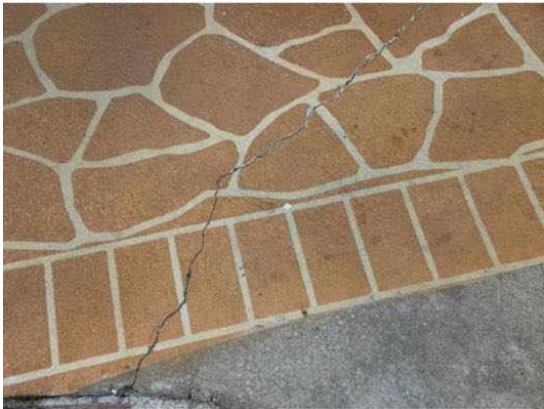
Building:	Main Building
Location:	Pavement, Garage Slab, Driveway
Finding:	Cracking - Pavement, Garage & Driveway
Information:	It was noted there is cracking in areas of the pavement, garage slab and driveway. Cracks in pavement and slabs are a common occurrence in houses of a similar age. Recommend that the client monitor the cracking. A licensed concrete specialist can be engaged at clients discretion, should cracks widen, lengthen, or become more numerous.
